NC DEPARTMENT OF TRANSPORTATION  
 DIVISION OF HIGHWAYS  
 STRUCTURE MANAGEMENT UNIT

ATTENTION: PAR SUBMITTED, NEWLY INSTALLED WEIGHT LIMITS, LOW UNDERCLEARANCE SIGNS, STRUCTURAL DATA MODIFIED, BEAMS SHAPES ADDED

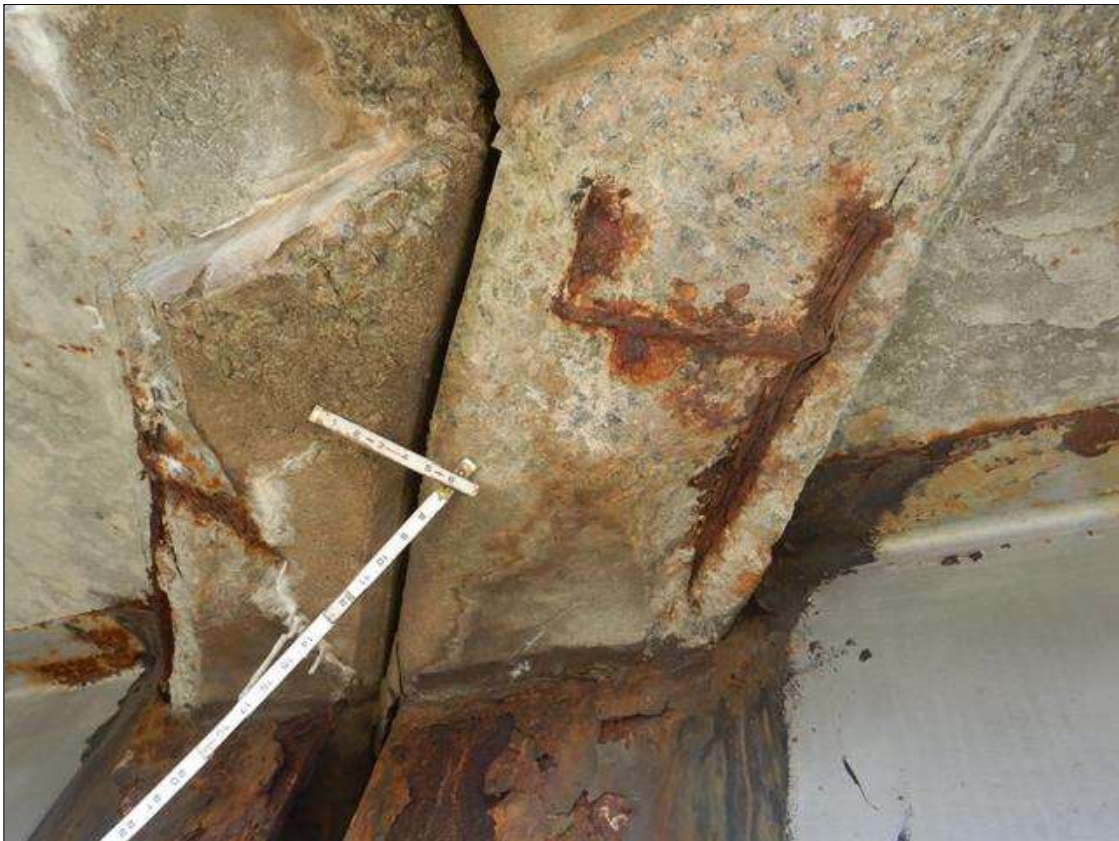
Span 2 Beam 4: RC end diaphragm at Bent 1, right overhang, Cracks (1/8" wide) and Delamination/ Spall with Exposed Steel (24" x 1 FT x 4" deep.) 80% SECTION REMAINING ON EXPOSED REBAR

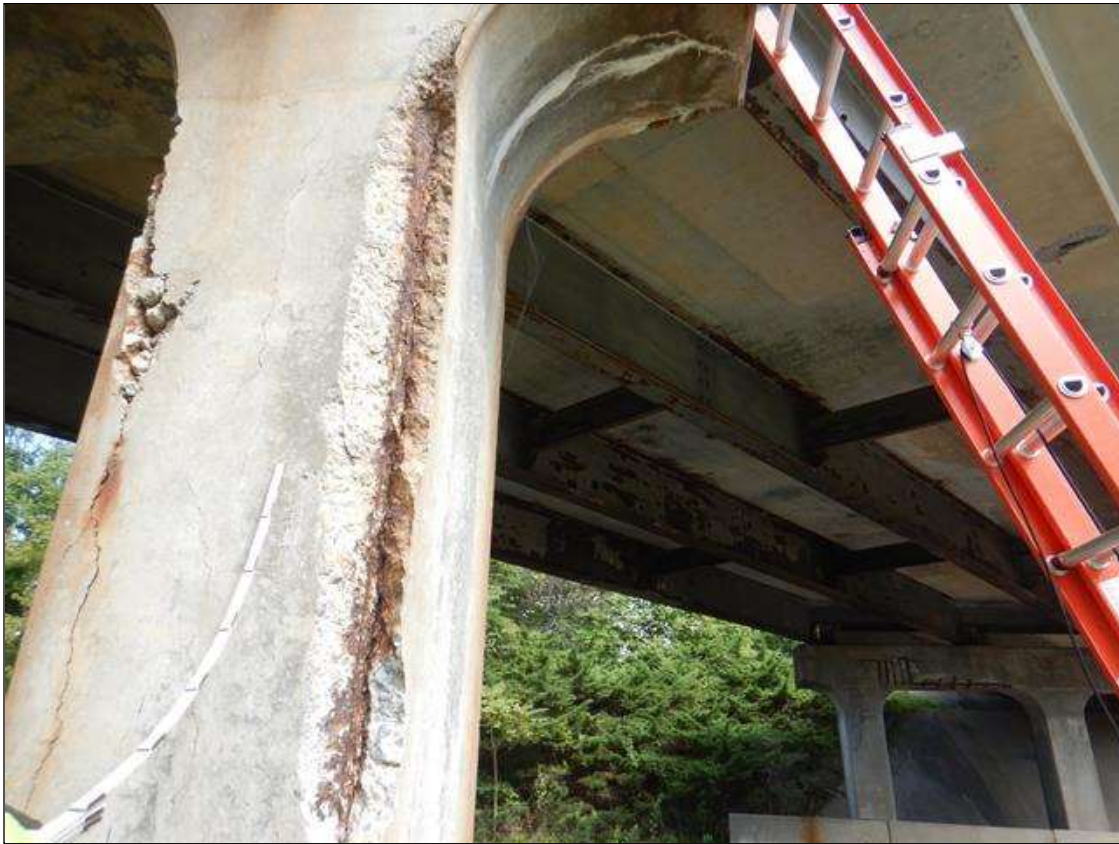
Bent 2 Pile 3: Corner Spalls with Exposed Steel SOUTHWEST FACE (Active Corrosion no measurable Section Loss,) (up to 10' high x 6" x 5",) vertical cracks (1/4" wide x full height) and Delamination in all faces. (PAR)

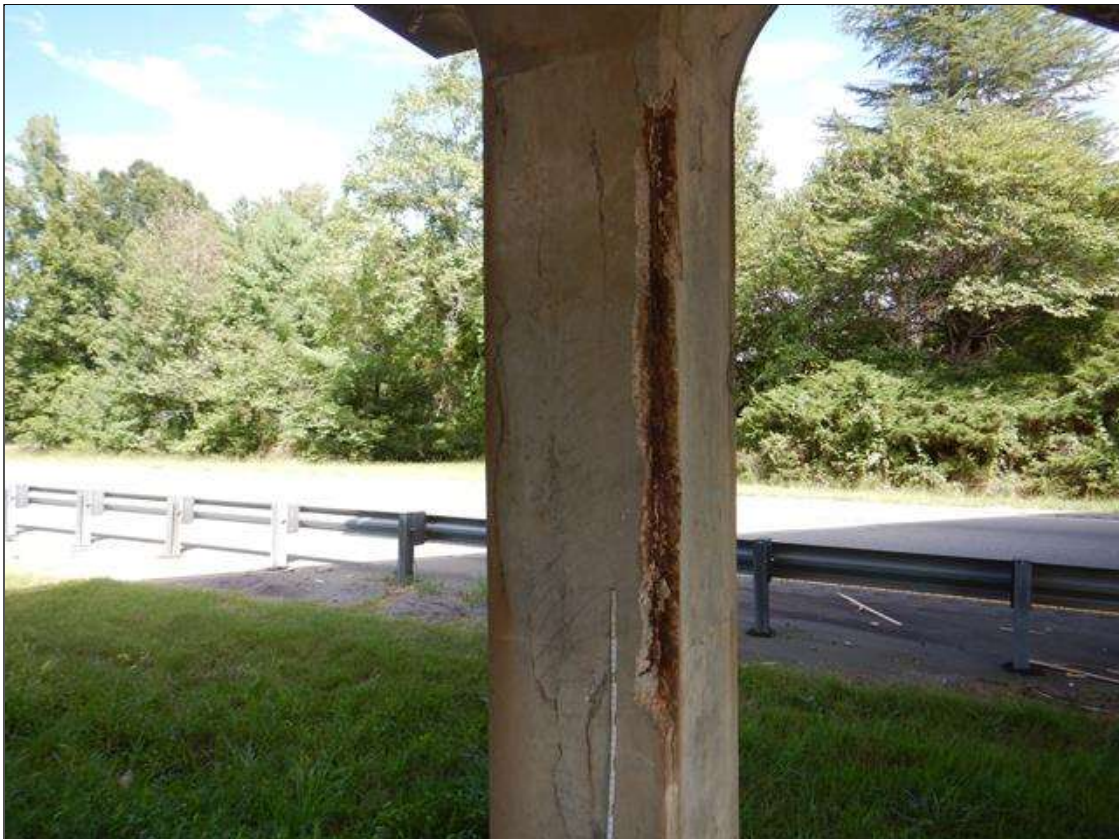
Bent 2 Pile 1: Corner Spall with Exposed Steel Active Corrosion (10' high x 6" x 5",) vertical cracks (1/4" wide x full height) and Delamination in all faces. (PAR)

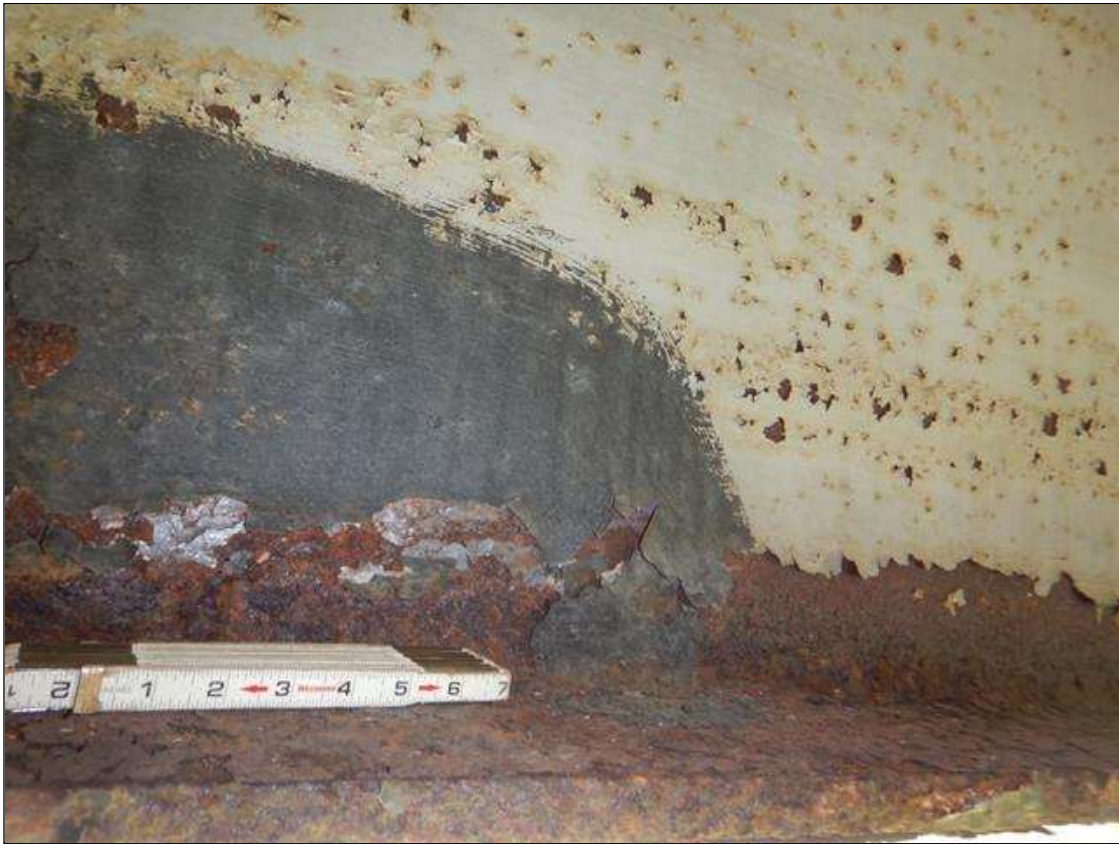
Span 2 Beam 4: at Bent 2, beginning 12" from beam end, Active Corrosion & Section Loss in lower web, (1/2" Remaining 3" high x 4' long,) Bottom Flange (3/4" Remaining 5" wide x 4' long.) (PAR)

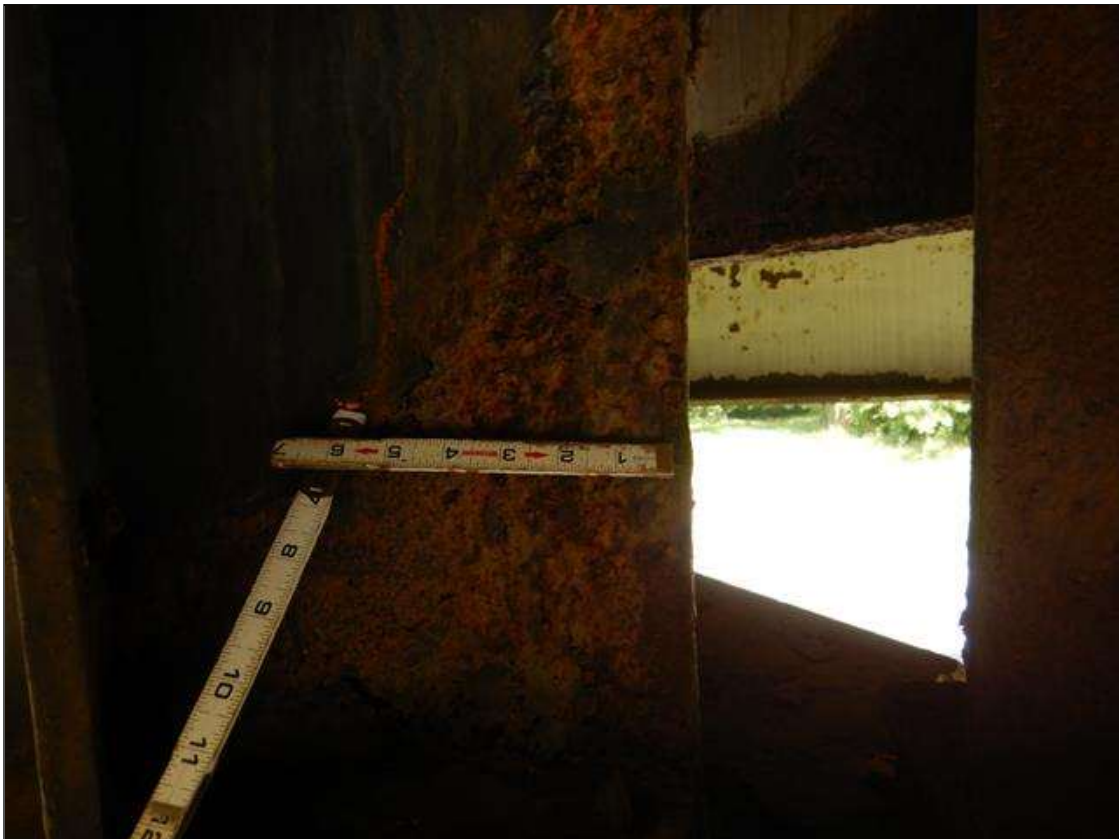
Span 2 Beam 3: at Bent 2, Active Corrosion & Section Loss in Bottom flange (7/16" Remaining full width to 5" wide x 2' long,) lower web, (5/16" Remaining full height x 10" long then 3" high x 6" long.) (PAR)

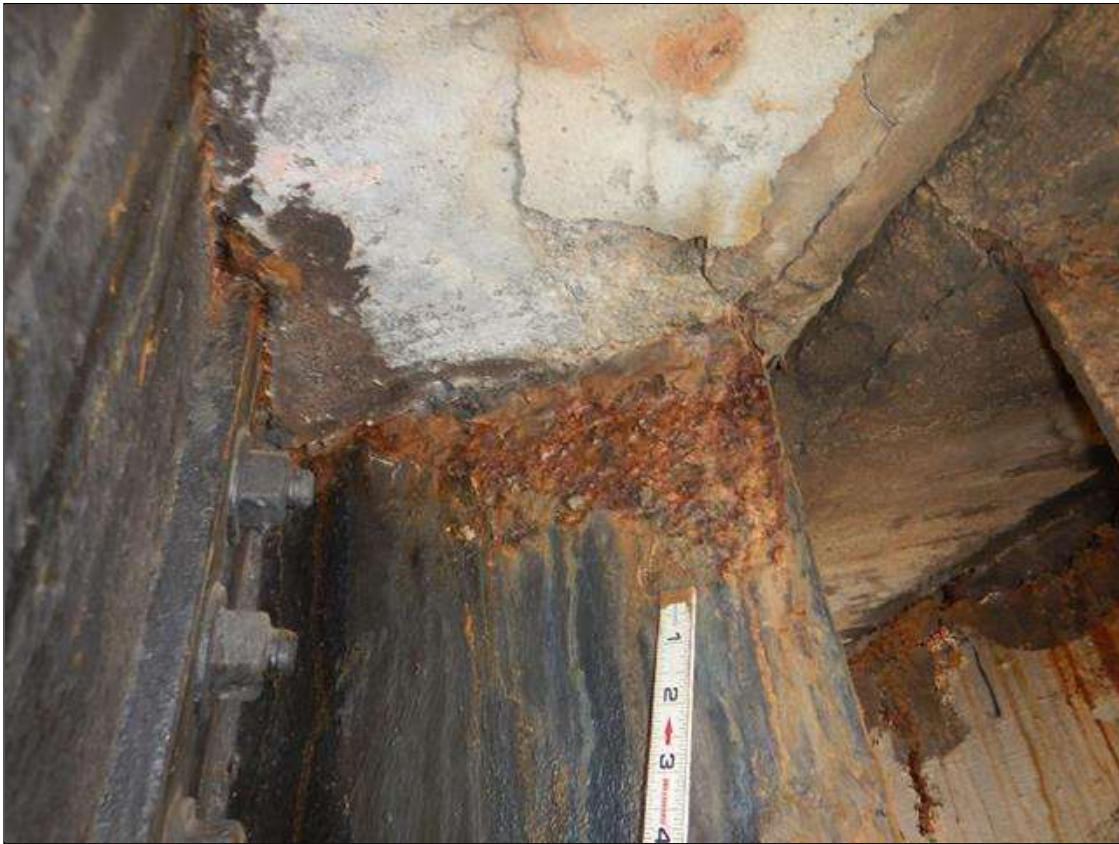
Bent 2 Cap 1: Top corners of cap, east and west faces, in bay 3 to south end, Spall with Exposed Steel (Active Corrosion no measurable Section Loss) and Delamination 6' long x up to 12" high x up to 10" wide.). (PAR)

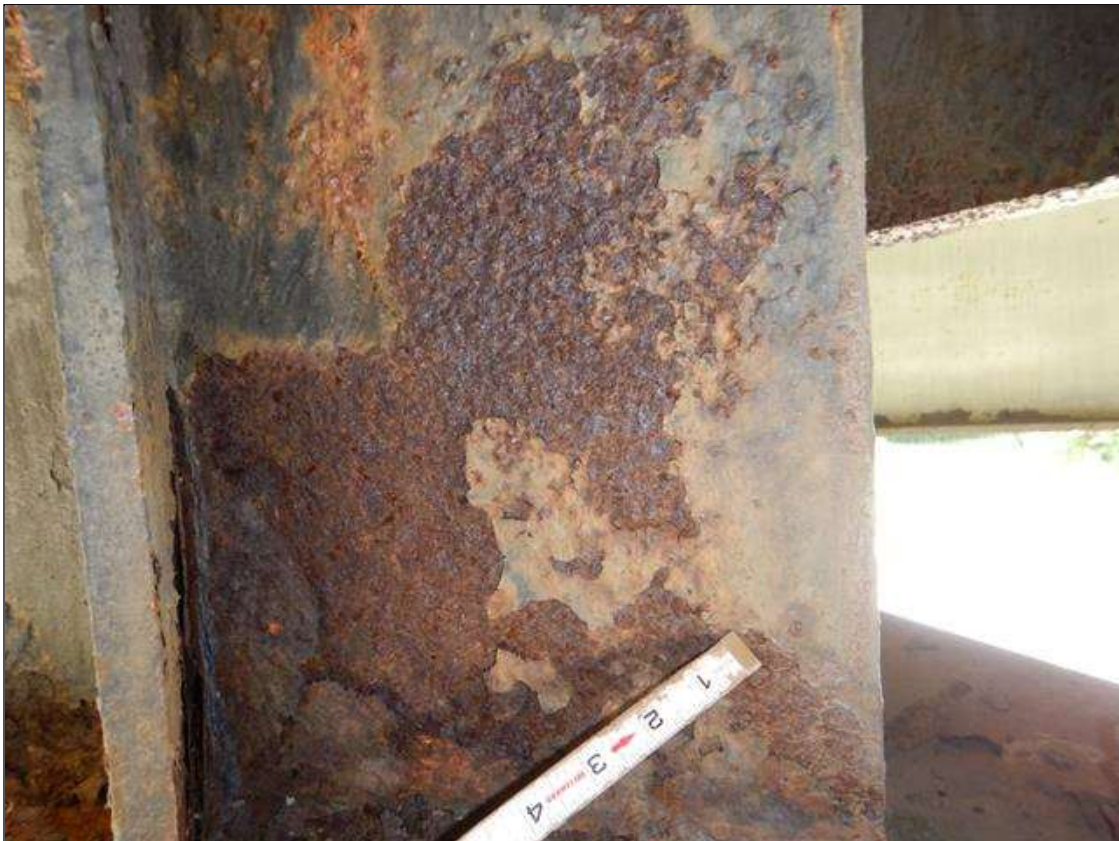
Span 2 Beam 2: At Bent 2, Active Corrosion & Section Loss in lower web, (5/16" Remaining 12" high x 10" long, then 3/8" Remaining 3" high x 12" long,) Bottom Flange (9/16" Remaining full width x 12" long.) (PAR)

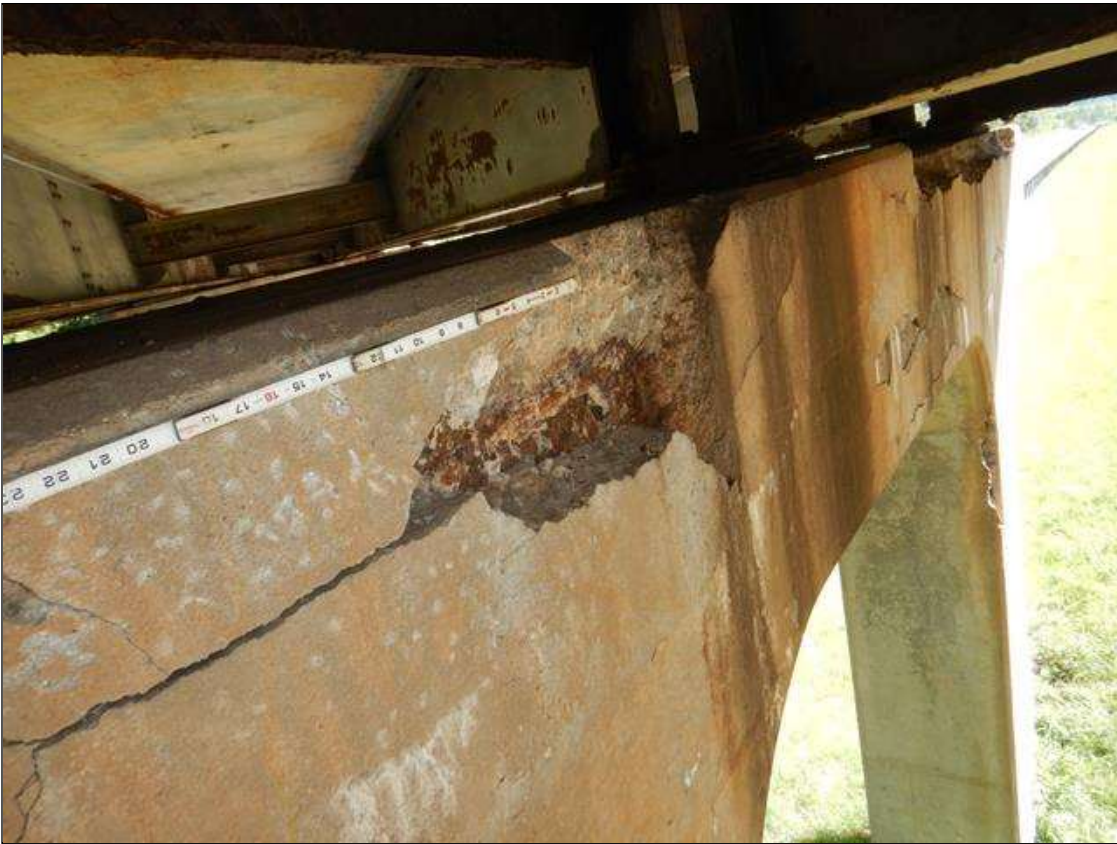
Bent 2 Cap 1: CORNER SPALL IN WEST FACE OF BAY 2 FOR 5 FT WIDE X 1.5 FT HIGH X 4 IN DEEP WITH EXPOSED REBAR. 90% SECTION REMAINING.

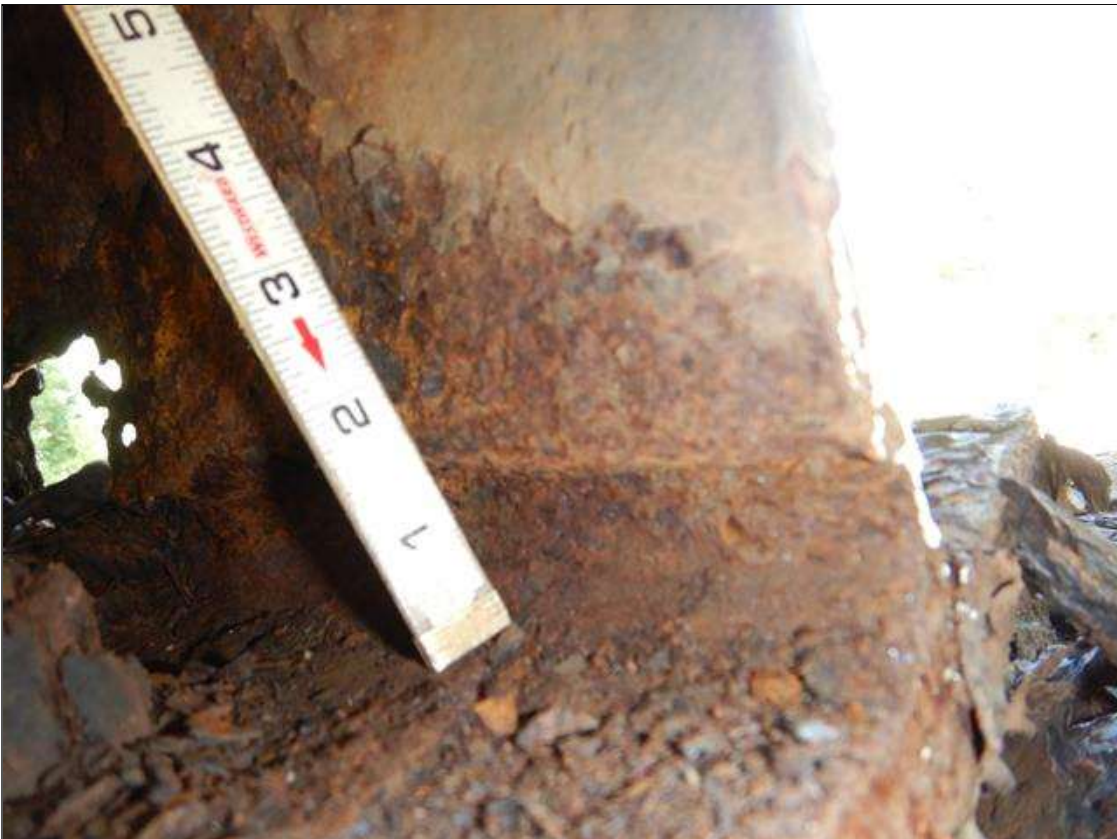
Span 3 Beam 1: 6" LONG X 1/4" WIDE CRACK IN BOTTOM FLANGE EXTENDS INTO WEB VERTICALLY IN BEAM 1 SPAN 3 LOCATED ON SOUTH SIDE OF BEAM. (PAR)

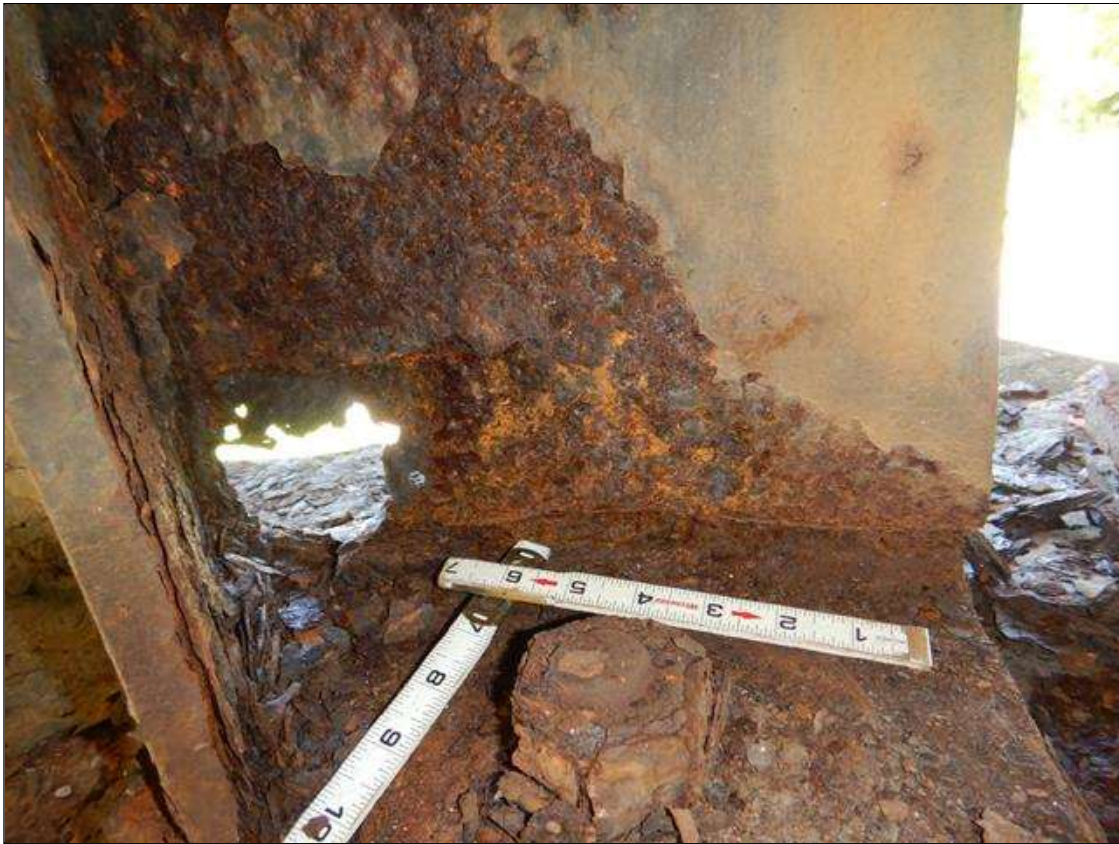
Span 3 Beam 1: 6" LONG X 1/4" WIDE CRACK IN BOTTOM FLANGE EXTENDS INTO WEB VERTICALLY IN BEAM 1 SPAN 3 LOCATED ON SOUTH SIDE OF BEAM. (PAR)

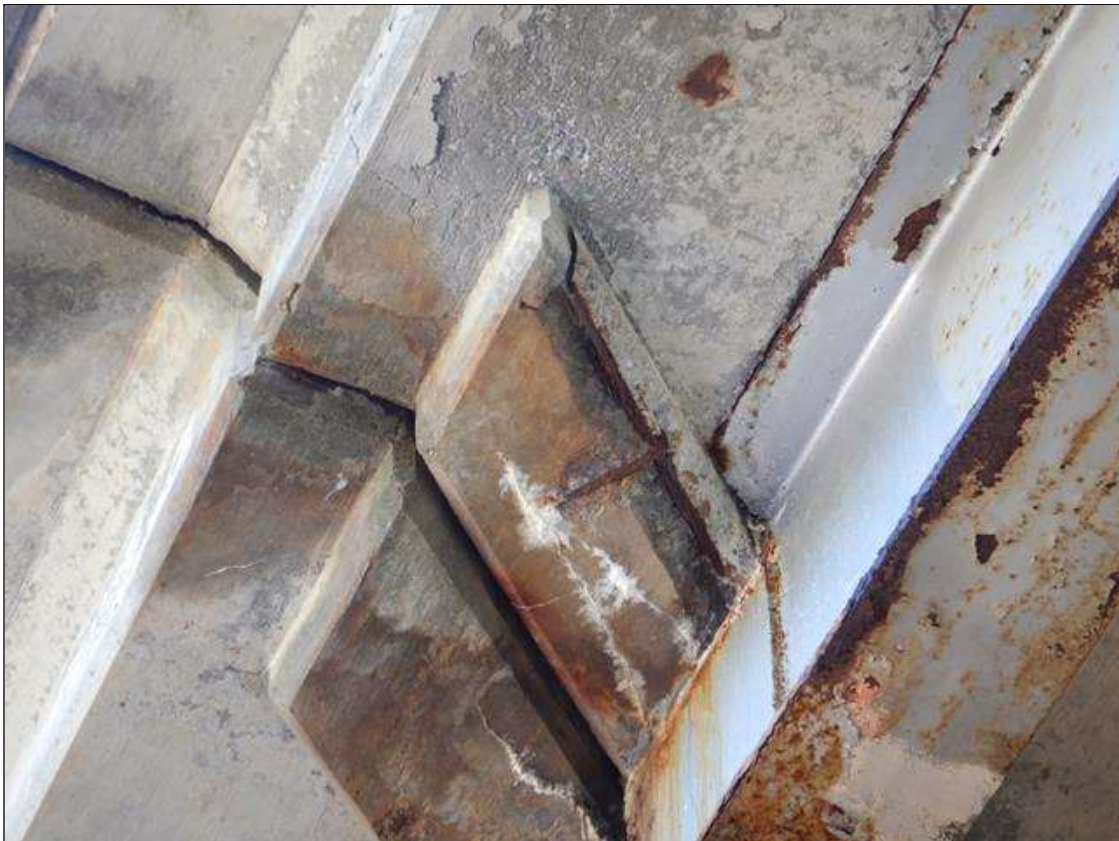
Span 1 Beam 1: RC end diaphragm at Bent 1, left overhang, Spall with Exposed Steel (28" x 6" x 3" deep.)

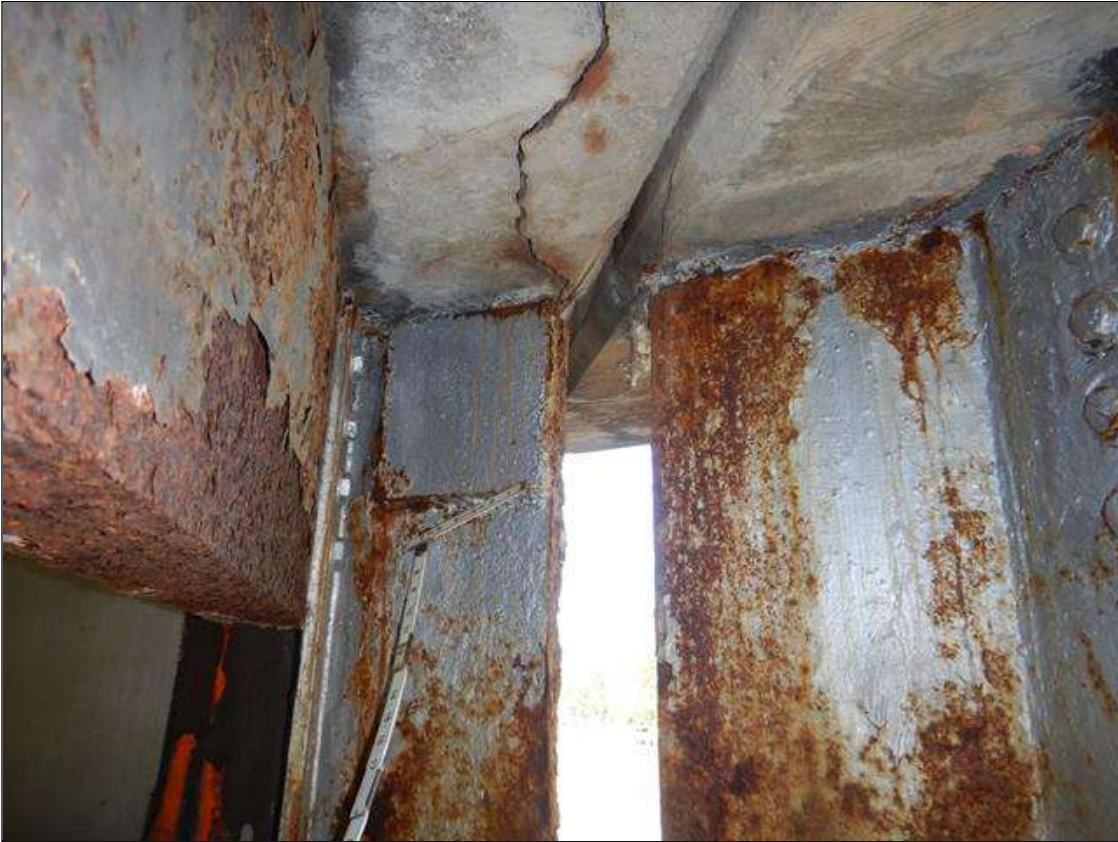
Span 1 Beam 1: (Previous repair:) at Bent 1, right side of Web, Steel plate (1/2" t. x 9" x 9") welded at top on end of beam. Left side, steel plate welded (1/2" x full height x 2' long). Surface Corrosion/Freckled Rust in web below.

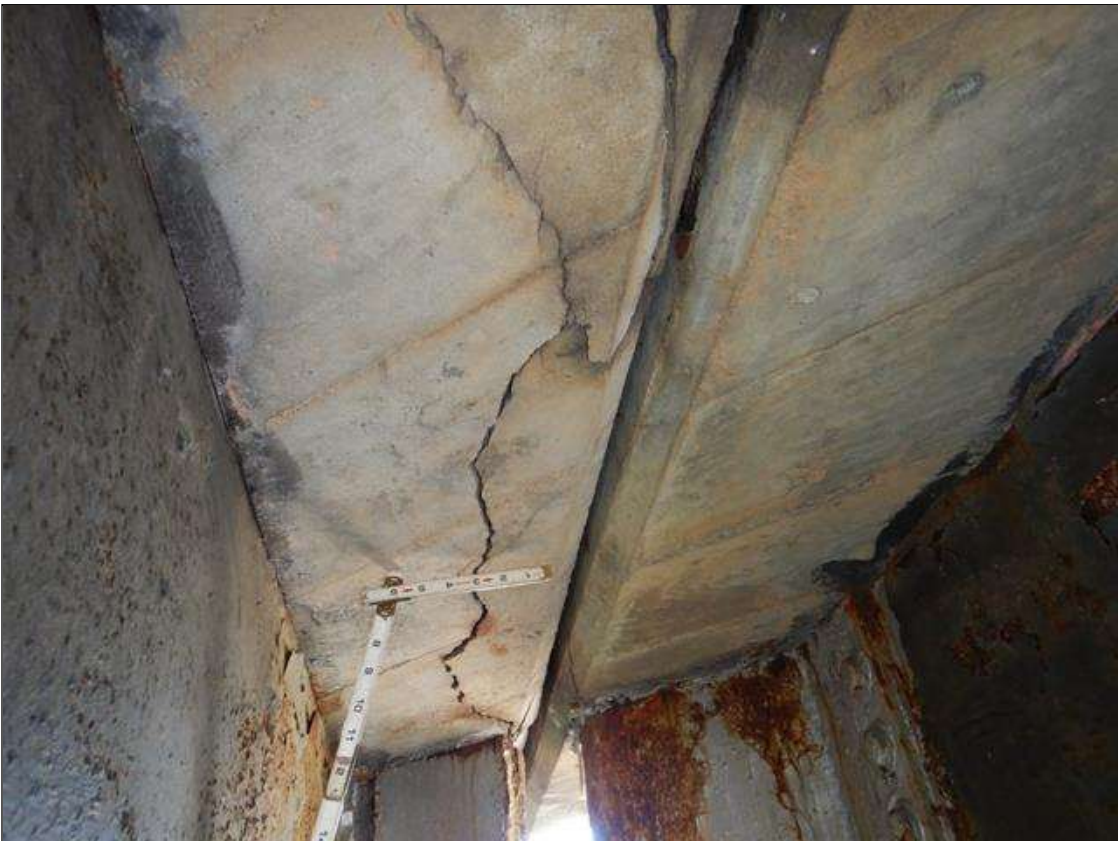
Span 1 Deck: UNDERSIDE DECK HAS CRACKING UP 1/4 IN WIDE X FULL WIDTH IN BAYS 1-3. BAY 1 PICTURED

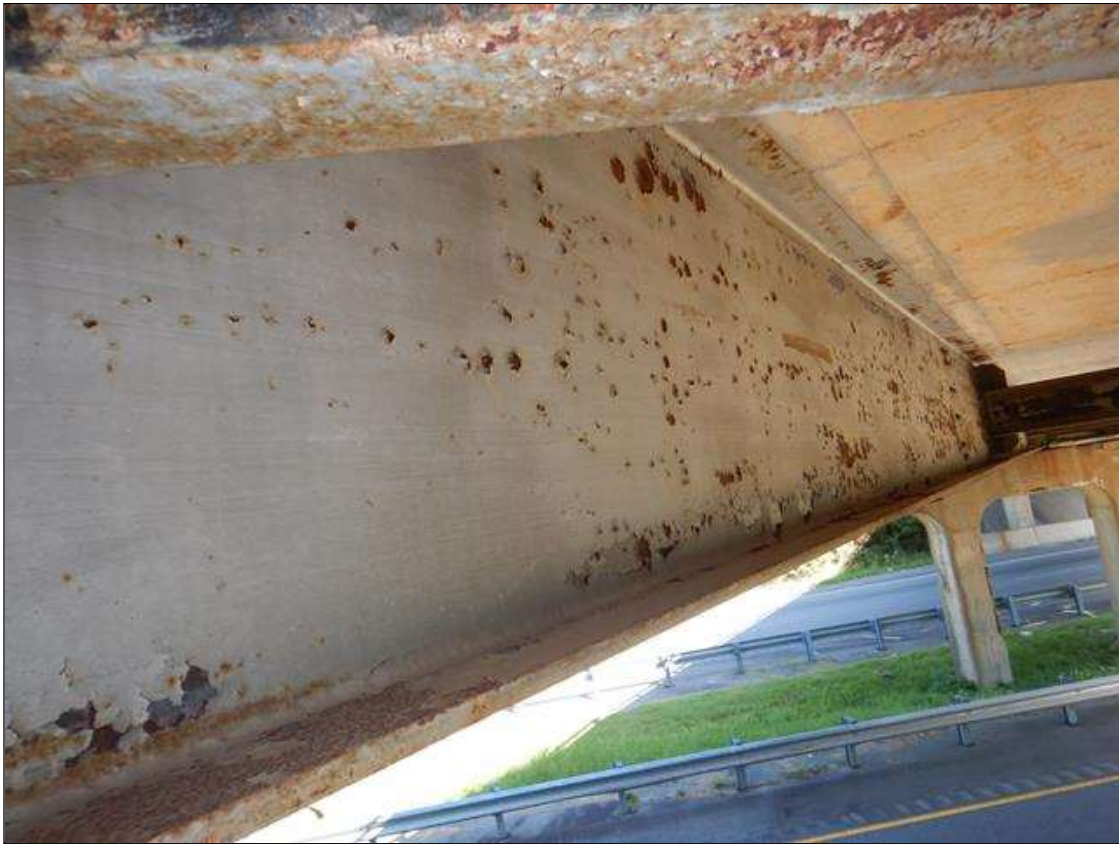
Span 1 Beam 2: 53 Feet of Corrosion: Section loss is evident or pack rust is present but does not warrant structural review. RIGHT SIDE SHOWN

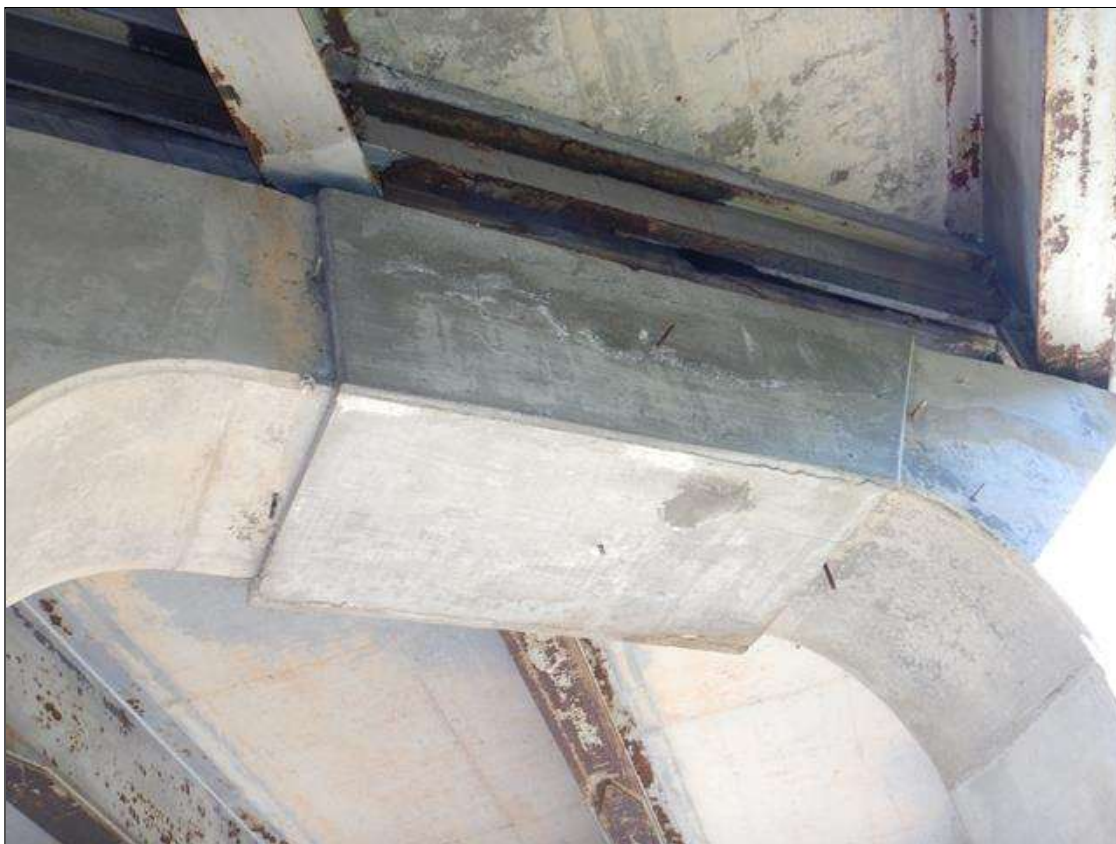
Bent 1 Cap 1: (Previous Repair:) Top of Cap, From South end to bay 3, beneath Bearings for Beam 4, Spans 1 & 2, Sound concrete repair with vertical shrinkage crack (1/64" wide) on west face. Bay 3, Sound concrete repair to full circumference, west face near top has horizontal shrinkage crack (1/64" wide x 5' long.)

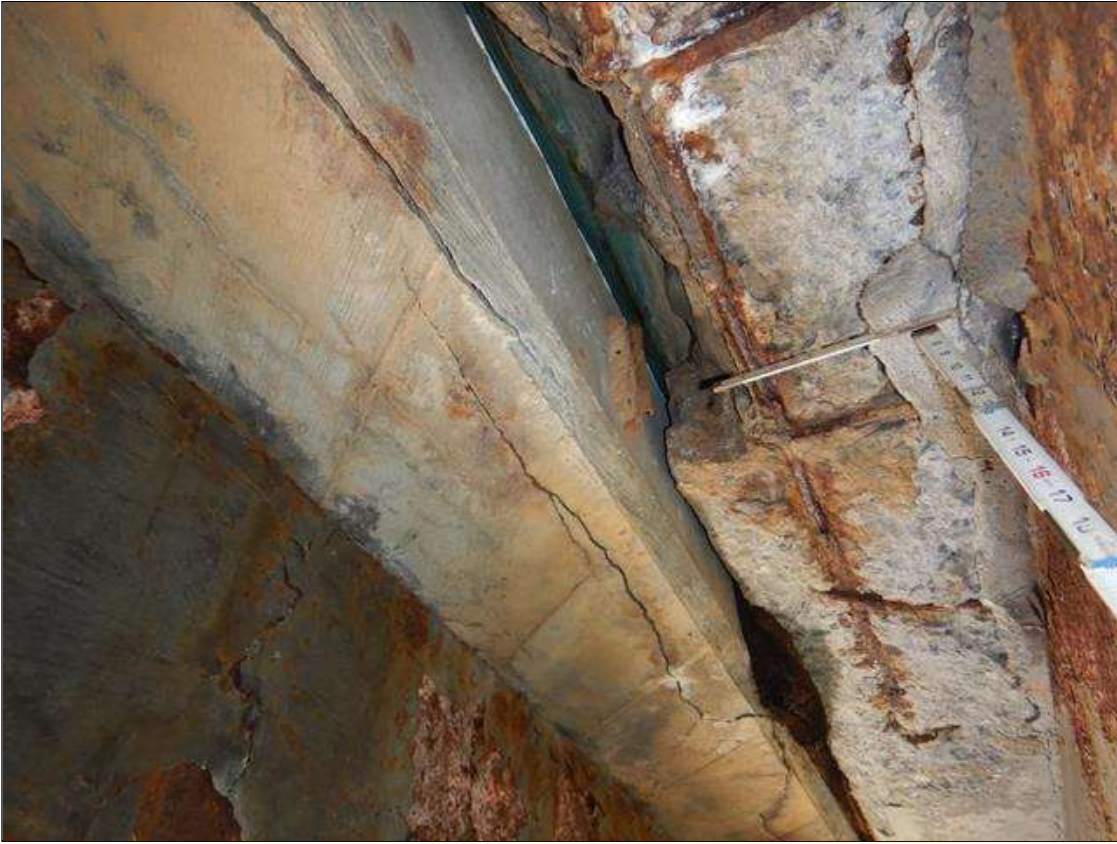
Span 1 Deck: SPALL IN DECK UNDERSIDE IN BAY 3 FOR 6 FT LONG X 1 FT WIDE X UP TO 6 IN HIGH. 80% SECTION REMAINING IN EXPOSED REBAR

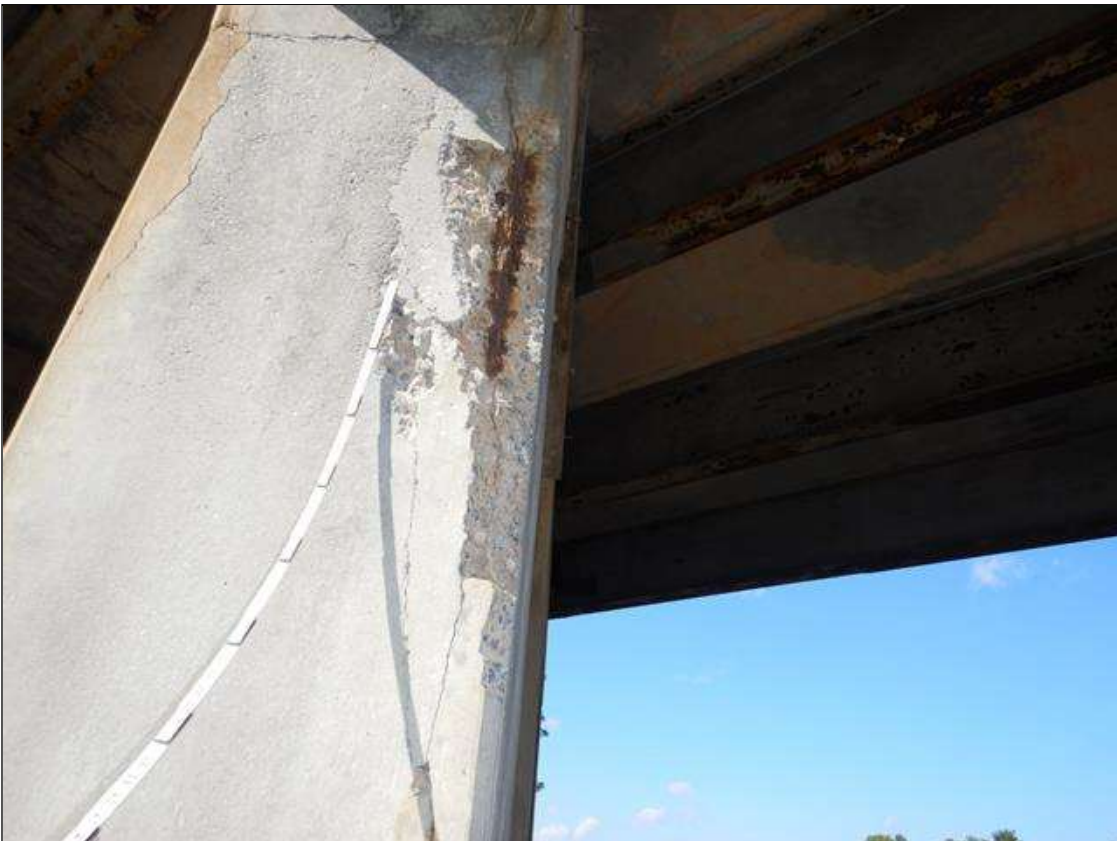
Bent 1 Pile 3: Southeast Corner, near cap, Spall with Exposed Steel (Active Corrosion no measurable Section Loss), vertical cracking 1/8" wide and Delamination (5' high x 1' x 1'.) (PAR)

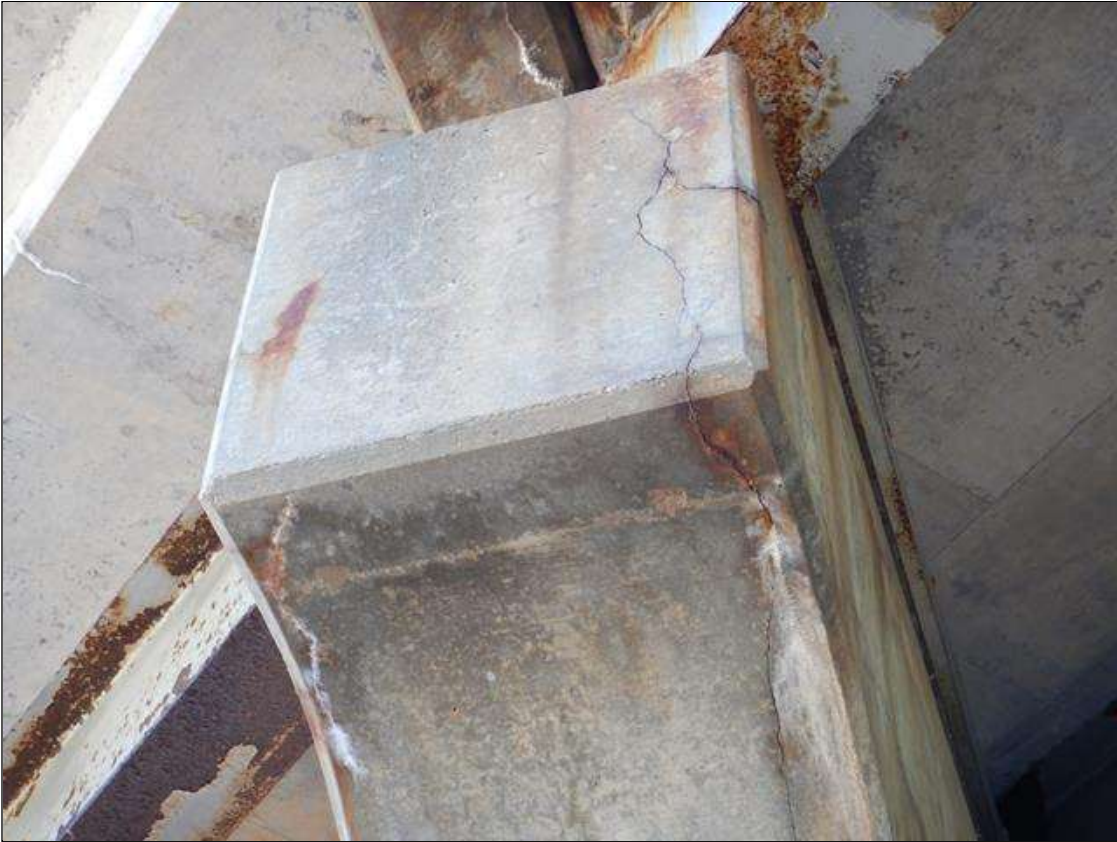
Bent 1 Cap 1: North end of cap, West and East faces, Map cracks (1/16" wide) with rust stains and efflorescence, Delamination 7' long x up to 32" high x 3" wide at top.)

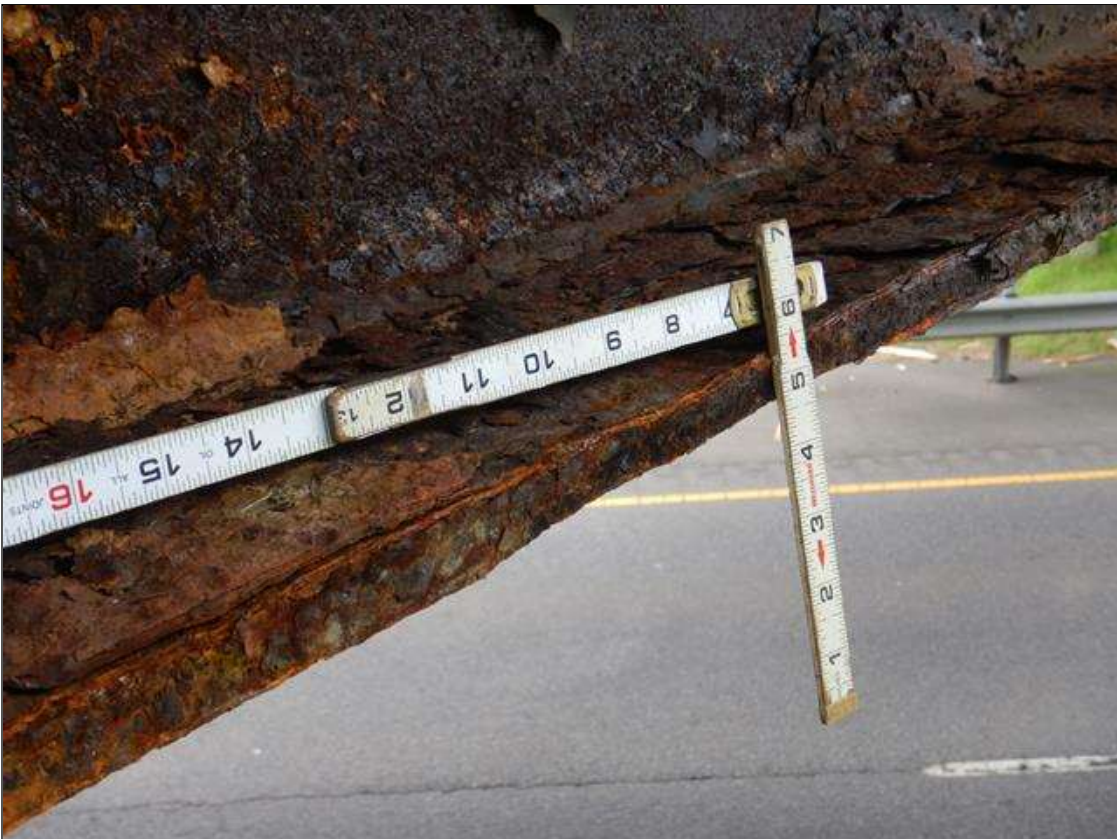
Span 3 Beam 1: BEAM 1, SPAN 3 HAS UP TO 1/8" LOSS ALONG WEB AT PIER 3, 1' HIGH X 1' LONG. ALSO HAS UP TO 1/8" LOSS ALONG BOTTOM FLANGE AT PIER 3, 1' LONG X WIDTH. (PAR)

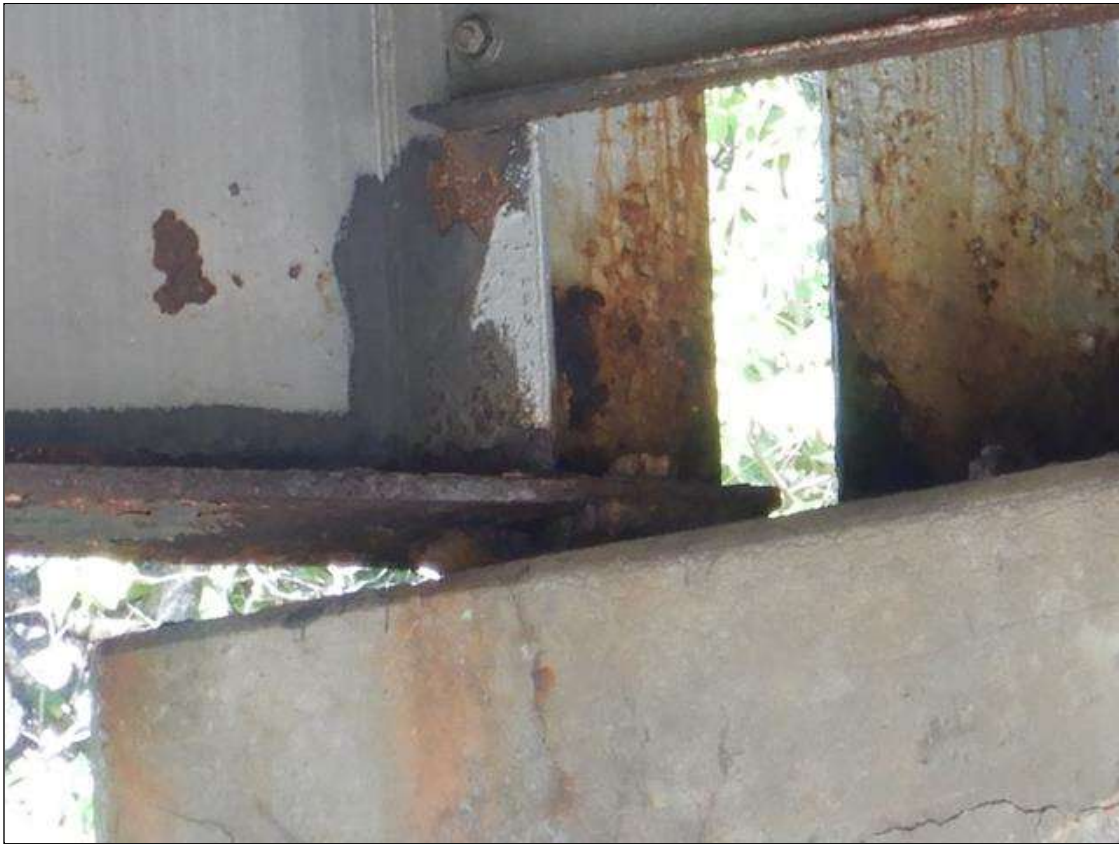
Span 2 Beam 4: at Bent 1 LEFT FACE, beginning 1' from beam end, Active Corrosion & Section Loss in lower web (1/4" Remaining 3" high x 22' long,) right bottom flange (13/16" Remaining 5" wide x 22' long.) (PAR VISUALLY INSPECTED)

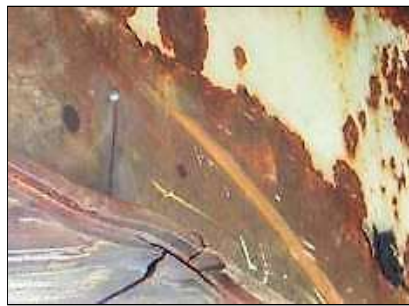
Span 3 Beam 1: NORTH SIDE OF BEAM 1 IN SPAN 3 HAS A 6" LONG X 1/8" WIDE CRACK IN TOP OF BOTTOM FLANGE & EXTENDS INTO WEB ADJACENT TO 10" LONG VERTICAL CRACK IN WEB. (PAR)

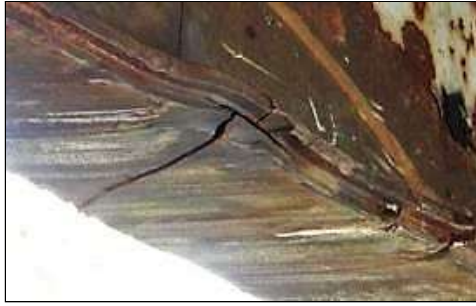
Span 3 Beam 1: 10 1/2" LONG X 3/16" WIDE CRACK IN BOTTOM FLANGE COVER PLATE TO BEAM 1 IN SPAN 3 ,  
LOCATED 23 FT FROM BENT 3 BEARING. (PAR)

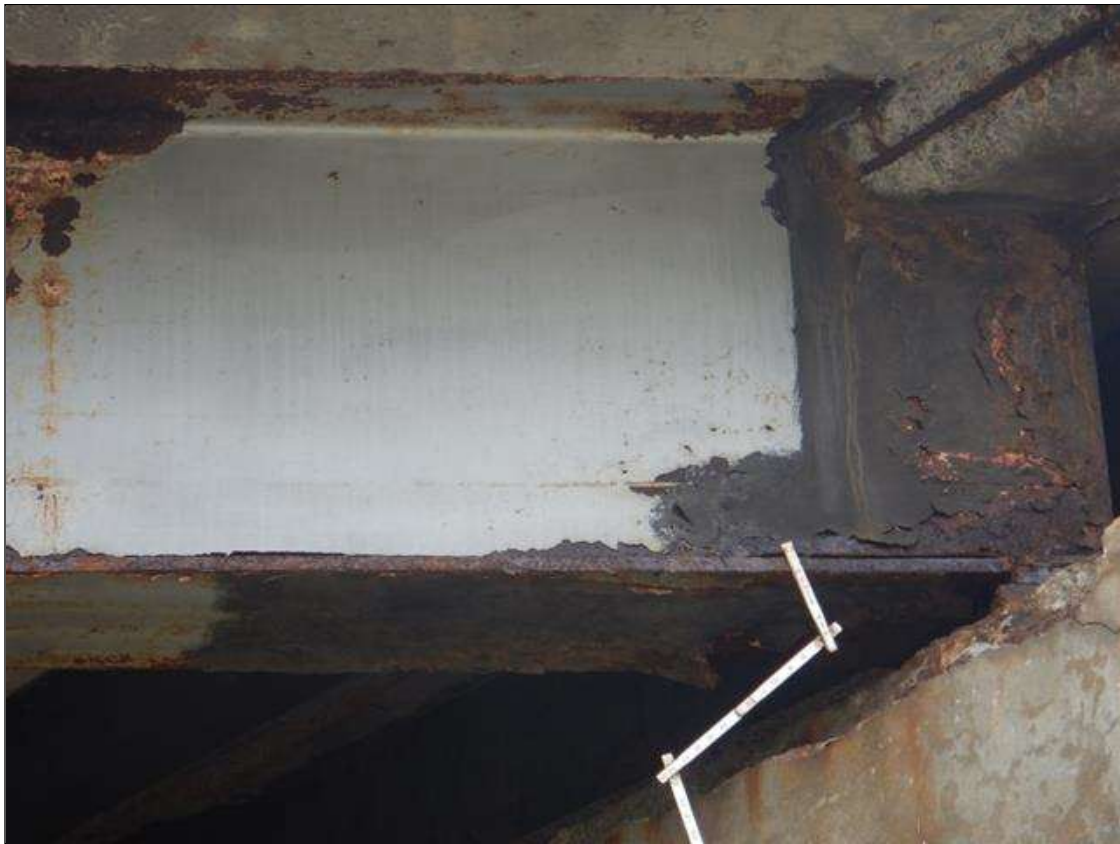
Span 2 Beam 4: at Bent 2, beginning 12" from beam end, Active Corrosion & Section Loss in lower web, (1/2" Remaining 3" high x 4' long,) Bottom Flange (3/4" Remaining 5" wide x 4' long.) (PAR)

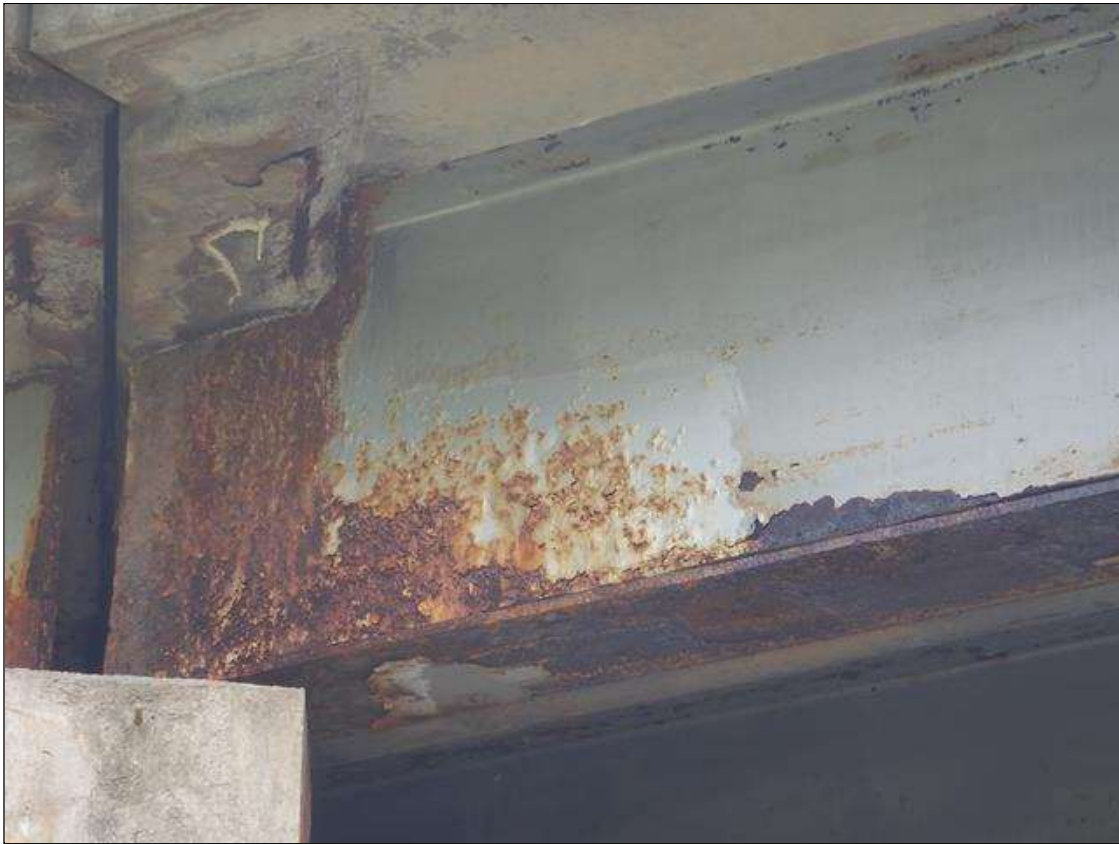
Span 2 Beam 4: at Bent 1, Active Corrosion & Section Loss in Web (down to 3/8" Remaining full height x 12"), Bottom Flange (9/16" to 3/4" Remaining full width x 12" long.) (PREVIOUS PAR VISUALLY INSPECTED DUE TO UNSAFE ROAD CONDITIONS FOR LADDER SETUP)

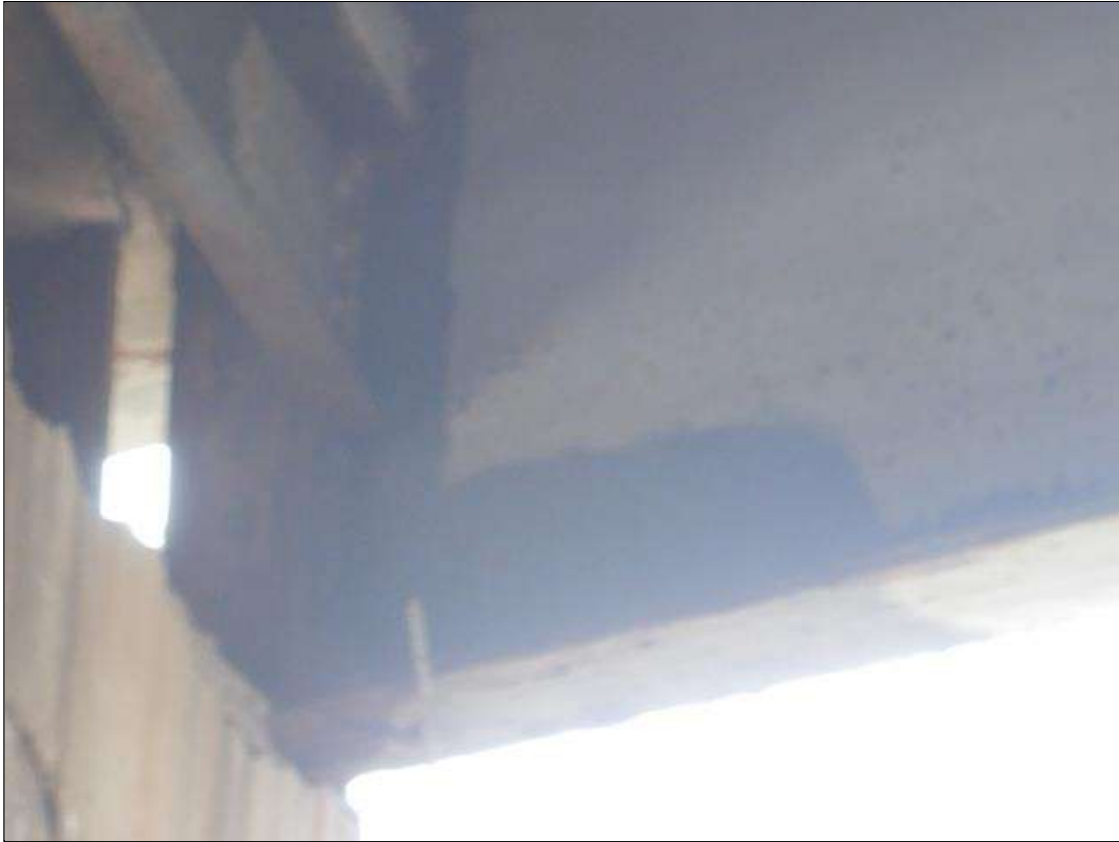
Span 2 Beam 4: at Bent 2, Active Corrosion & Section Loss in Bottom flange in front of bearing (5/8" Remaining full width x 12" long,) lower web, (5/16" Remaining 12" high x 10" long,) Upper Web (5/16" Remaining 12" high x 10" long,) Web stiffener / diaph connection plate (5/8" Remaining 5" x 4".) (PREVIOUS PAR VISUALLY INSPECTED DUE TO UNSAFE ROAD CONDITIONS FOR LADDER SETUP)
