NC DEPARTMENT OF TRANSPORTATION  
 DIVISION OF HIGHWAYS  
 STRUCTURE MANAGEMENT UNIT

ATTENTION: PAR SUBMITTED, NEWLY INSTALLED WEIGHT LIMITS, LOW UNDERCLEARANCE SIGNS, STRUCTURAL DATA MODIFIED, BEAMS SHAPES ADDED

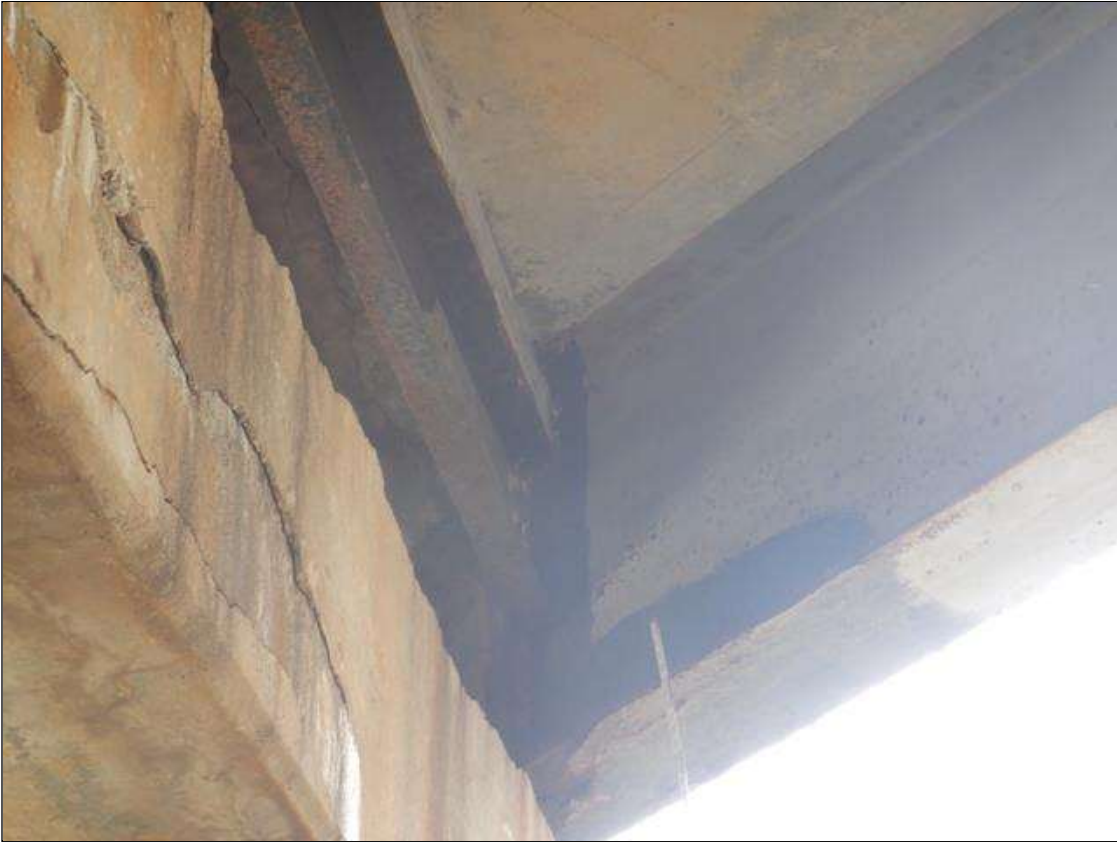
Span 2 Beam 4: at Bent 2, Active Corrosion & Section Loss in Bottom flange in front of bearing (5/8" Remaining full width x 12" long,) lower web, (5/16" Remaining 12" high x 10" long,) Upper Web (5/16" Remaining 12" high x 10" long,) Web stiffener / diaph connection plate (5/8" Remaining 5" x 4".) (PREVIOUS PAR VISUALLY INSPECTED DUE TO UNSAFE ROAD CONDITIONS FOR LADDER SETUP)

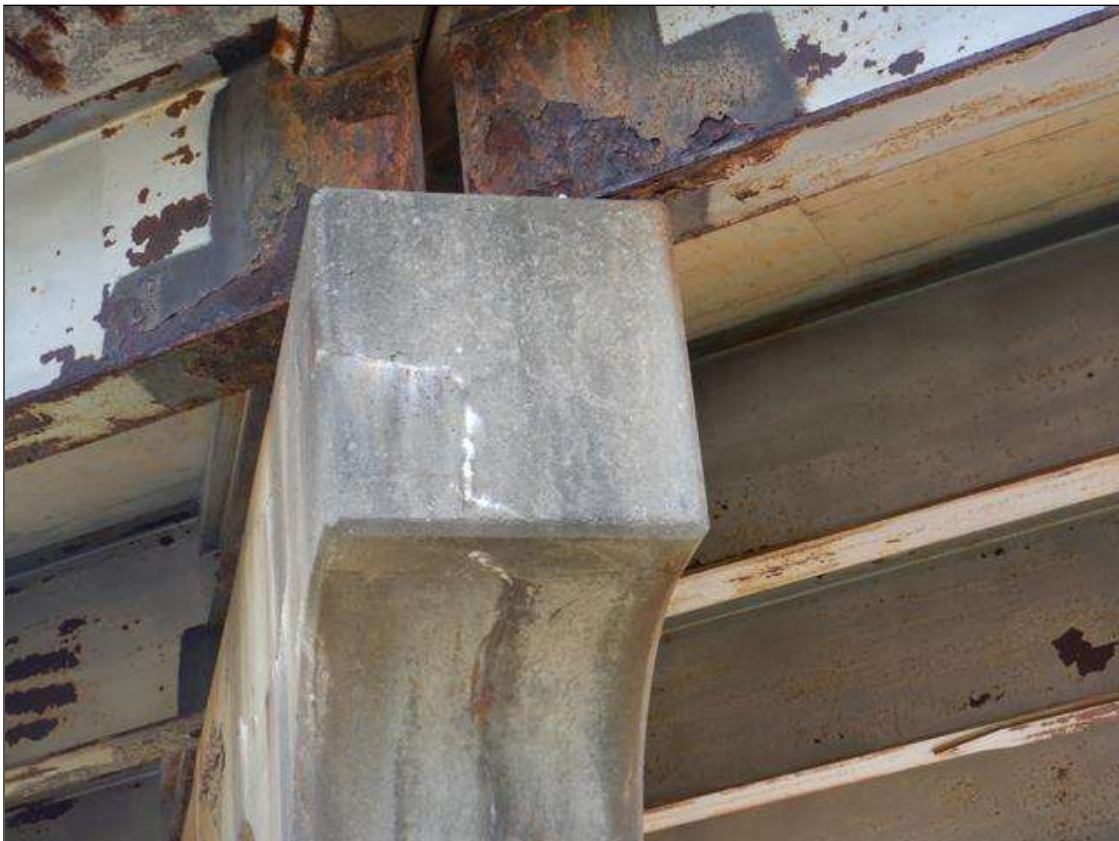
BEAM AND CAP ENDS, LEFT END CAP BENT 2

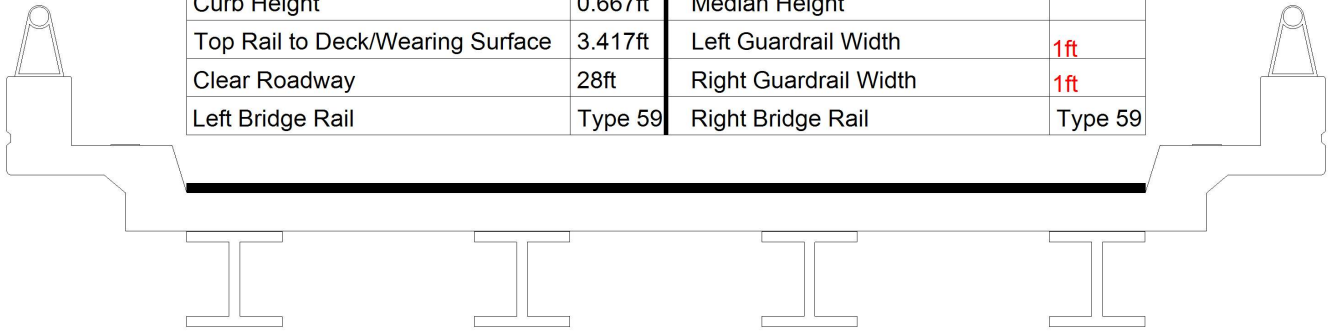
Measurements for Span #	1	spans 2,3 & 4 similar	
Deck Thickness	0.604	Left Overhang	4.667
Top of Rail to Bottom of Beam	7.042	Right Overhang	4.667

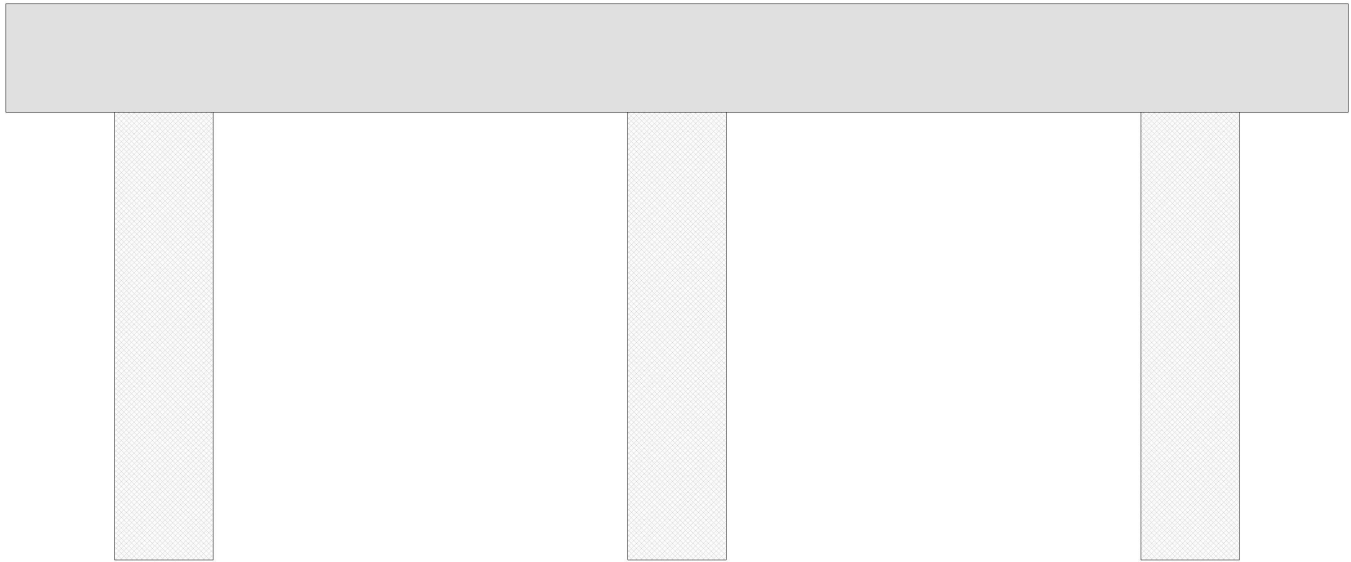
<b>Cap Information</b>			Material Cast-in-Place Concrete							
Length	Width	Height	Left Overhang	Right Overhang	Left Beam to End of Cap.	Right Beam to End of Cap.				
34.000 ft.	2.750 ft.	2.750 ft.	4.000 ft.	4.000 ft.	1.000 ft.	2.000 ft.				
<b>Subcap Information</b>			Material							
Length	Width	Height	Left Overhang	Right Overhang	Left Pile to Splice.					
<b>Sill Information</b>			Material							
Length	Width	Height								
Pile #	Material	Spacing	Width/Dia.	Height	Length	Orientation	Driven?	Replacement?	Removed?	Collar?
1	Concrete		2.500 ft.	2.750 ft.		Vertical	No	No	No	No
2	Concrete	13.000 ft.	2.500 ft.	2.750 ft.		Vertical	No	No	No	No
3	Concrete	13.000 ft.	2.500 ft.	2.750 ft.		Vertical	No	No	No	No
VERIFIED BY VDK ON 9/9/2021										
Bent/Abutment #: 1			Similar Bents: 2,3
