> I-5915B PROJECT NO. IREDELL COUNTY 480072 BRIDGE NO. _

> SUBSTRUCTURE REPAIRS

> > BENT 1

S11-9

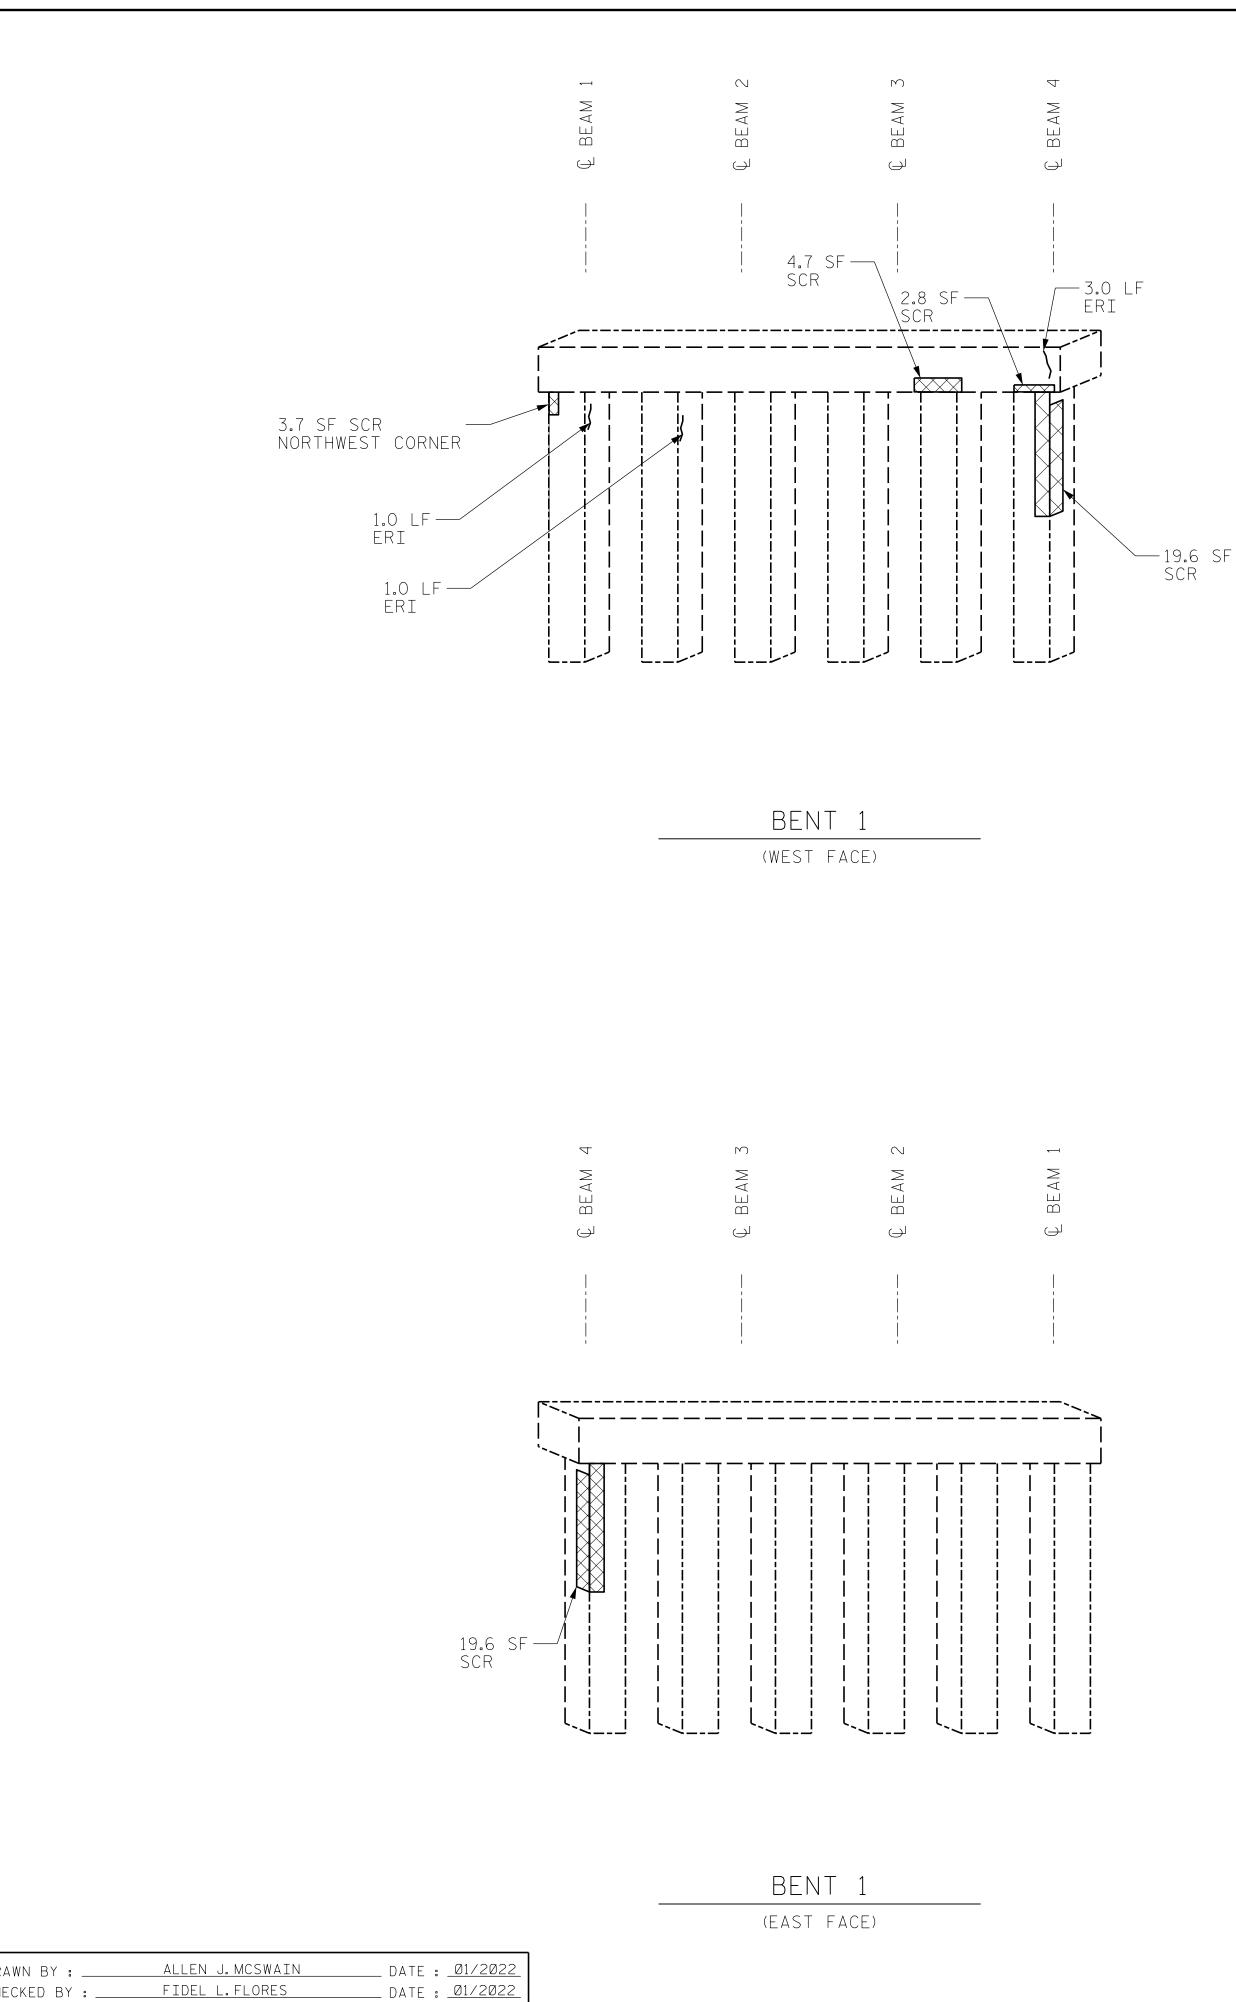
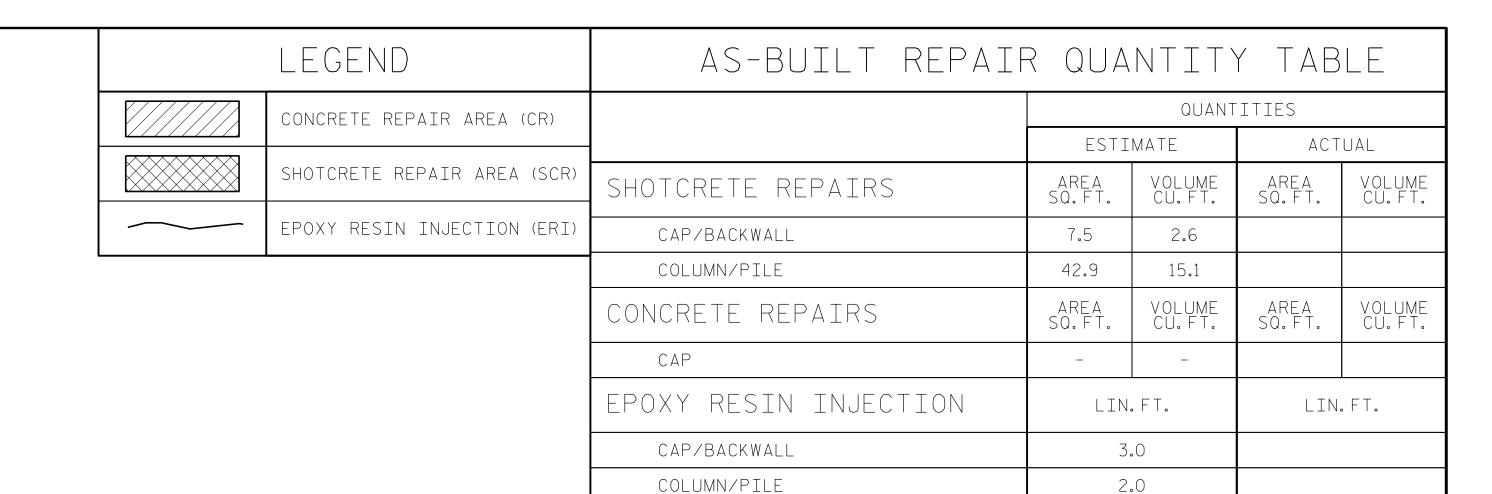
VALUES IN CHART REPRESENT ESTIMATED REPAIR TOTALS AFTER REMOVAL OF UNSOUND CONCRETE. MINIMUM OF 1"BEHIND REBAR AND MINIMUM 2"CLEARANCE TO SAWCUT. FOR REPAIR DETAILS, SEE "CONCRETE RESTORATION DETAILS" SHEETS.

CRACKING LOCATIONS AND QUANTITIES FOR LOCATIONS DESCRIBED AS "SCATTERED THROUGHOUT" IN THE INSPECTION REPORT ARE BASED ON THE BEST INFORMATION AVAILABLE. THE ENGINEER AND CONTRACTOR SHALL IDENTIFY AND REPAIR ALL CRACKS >= $\frac{1}{16}$ AS DESCRIBED IN THE SPECIAL PROVISIONS AT EACH BENT.

AVERAGE CONCRETE COVER IS EXPECTED TO BE FROM 2"TO 3"ON THE CAP AND FROM $1\frac{1}{2}$ " TO 2" ON THE PILES. ACTUAL CONCRETE COVER SHALL BE DETERMINED BY THE CONTRACTOR AND PRESENTED TO THE ENGINEER PRIOR TO BEGINNING EXCAVATION/ DEMOLITION.

FOR CONCRETE AND SHOTCRETE REPAIRS, SEE "CONCRETE RESTORATION DETAILS" SHEETS.

SHOTCRETE REPAIRS MAY BE REPLACED WITH CONCRETE REPAIRS WITH THE APPROVAL OF THE ENGINEER.

REPAIRS TO THE BENT CAP MAY REQUIRE BRIDGE JACKING. FOR BRIDGE JACKING, SEE SPECIAL PROVISIONS.
