BENT 1 (West face)

PROJECT NO. <u>I-5915B</u> <u>IREDELL</u> COUNTY BRIDGE NO. <u>480096</u>			
A111111111	SHEET 2 OF 3			
DocuSigned by: Dicas & Agurn Otherson Officer 47269F43B320323D4FB Dicas & Agurn Otherson Officer Dicas & Agurn Officer Dicas	STATE OF NORTH CAROLINA DEPARTMENT OF TRANSPORTATION RALEIGH SUBSTRUCTURE REPAIRS			
KCA	BENT 1			
KISINGER CAMPO	REVISIONS SHEET NO.			
& ASSOCIATESCONSIDERED301 FAYETTEVILLE ST., SUITE 1500	NO. BY: DATE: NO. BY: DATE: S13-8			
SSALLRALEIGH, NC 27601 (919) 882-7839OMPLETEDNC FIRM LICENSE: C-1506	1 3 TOTAL SHEETS 2 4 9

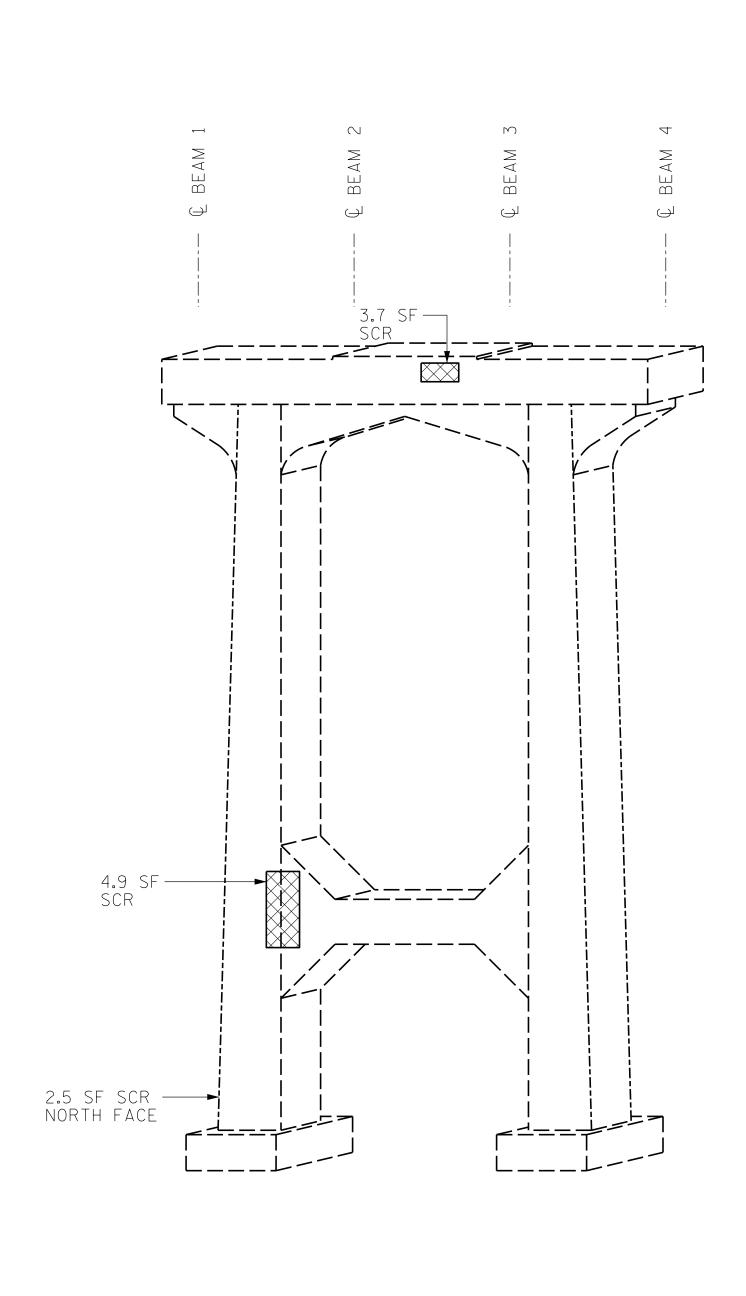
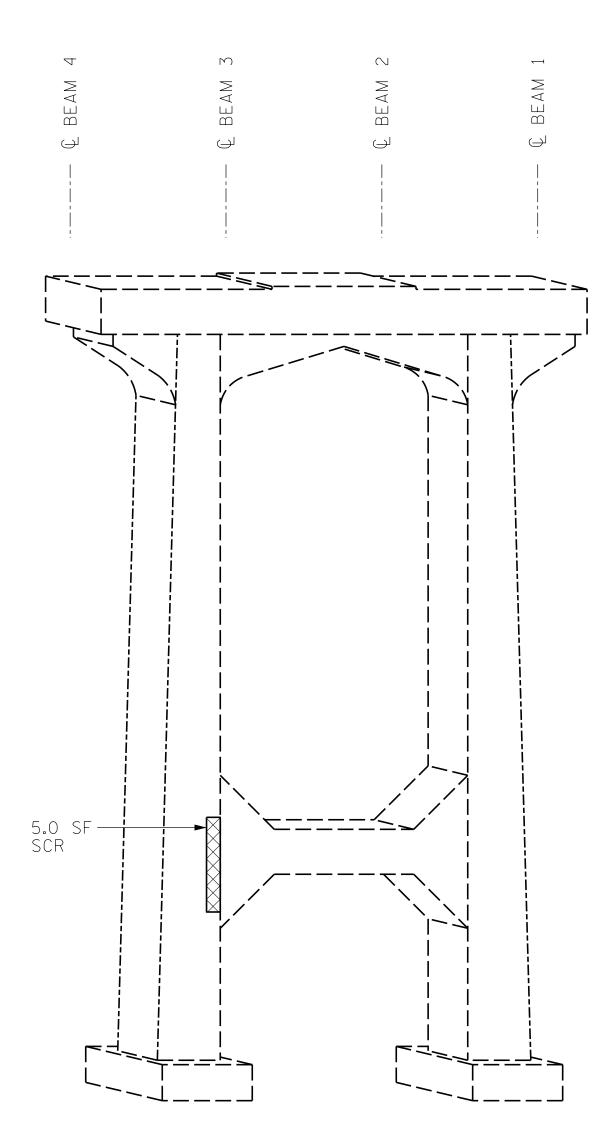
AS-BUILT REPAIR QUANTITY TABLE QUANTITIES ESTIMATE ACTUAL AREA SQ.FT. VOLUME CU.FT. SHOTCRETE REPAIRS AREA SQ.FT VOLUME CU.FT. 3.7 CAP/BACKWALL 1.3 12.4 4.3 COLUMN/PILE VOLUME CU.FT. AREA SQ.FT VOLUME CU.FT. AREA SQ.FT. CONCRETE REPAIRS CAP _ _ EPOXY RESIN INJECTION LIN.FT. LIN.FT. CAP/BACKWALL — COLUMN/PILE -

VALUES IN CHART REPRESENT ESTIMATED REPAIR TOTALS AFTER REMOVAL OF UNSOUND CONCRETE.MINIMUM OF 1"BEHIND REBAR AND MINIMUM 2"CLEARANCE TO SAWCUT.FOR REPAIR DETAILS, SEE "CONCRETE RESTORATION DETAILS" SHEETS.

FOR CONCRETE AND SHOTCRETE REPAIRS, SEE "CONCRETE RESTORATION DETAILS" SHEETS.
