> PROJECT NO._ IREDELL COUNTY 48Ø123 BRIDGE NO. _

STATE OF NORTH CAROLINA DEPARTMENT OF TRANSPORTATION

> SUBSTRUCTURE REPAIRS

> > BENT 1

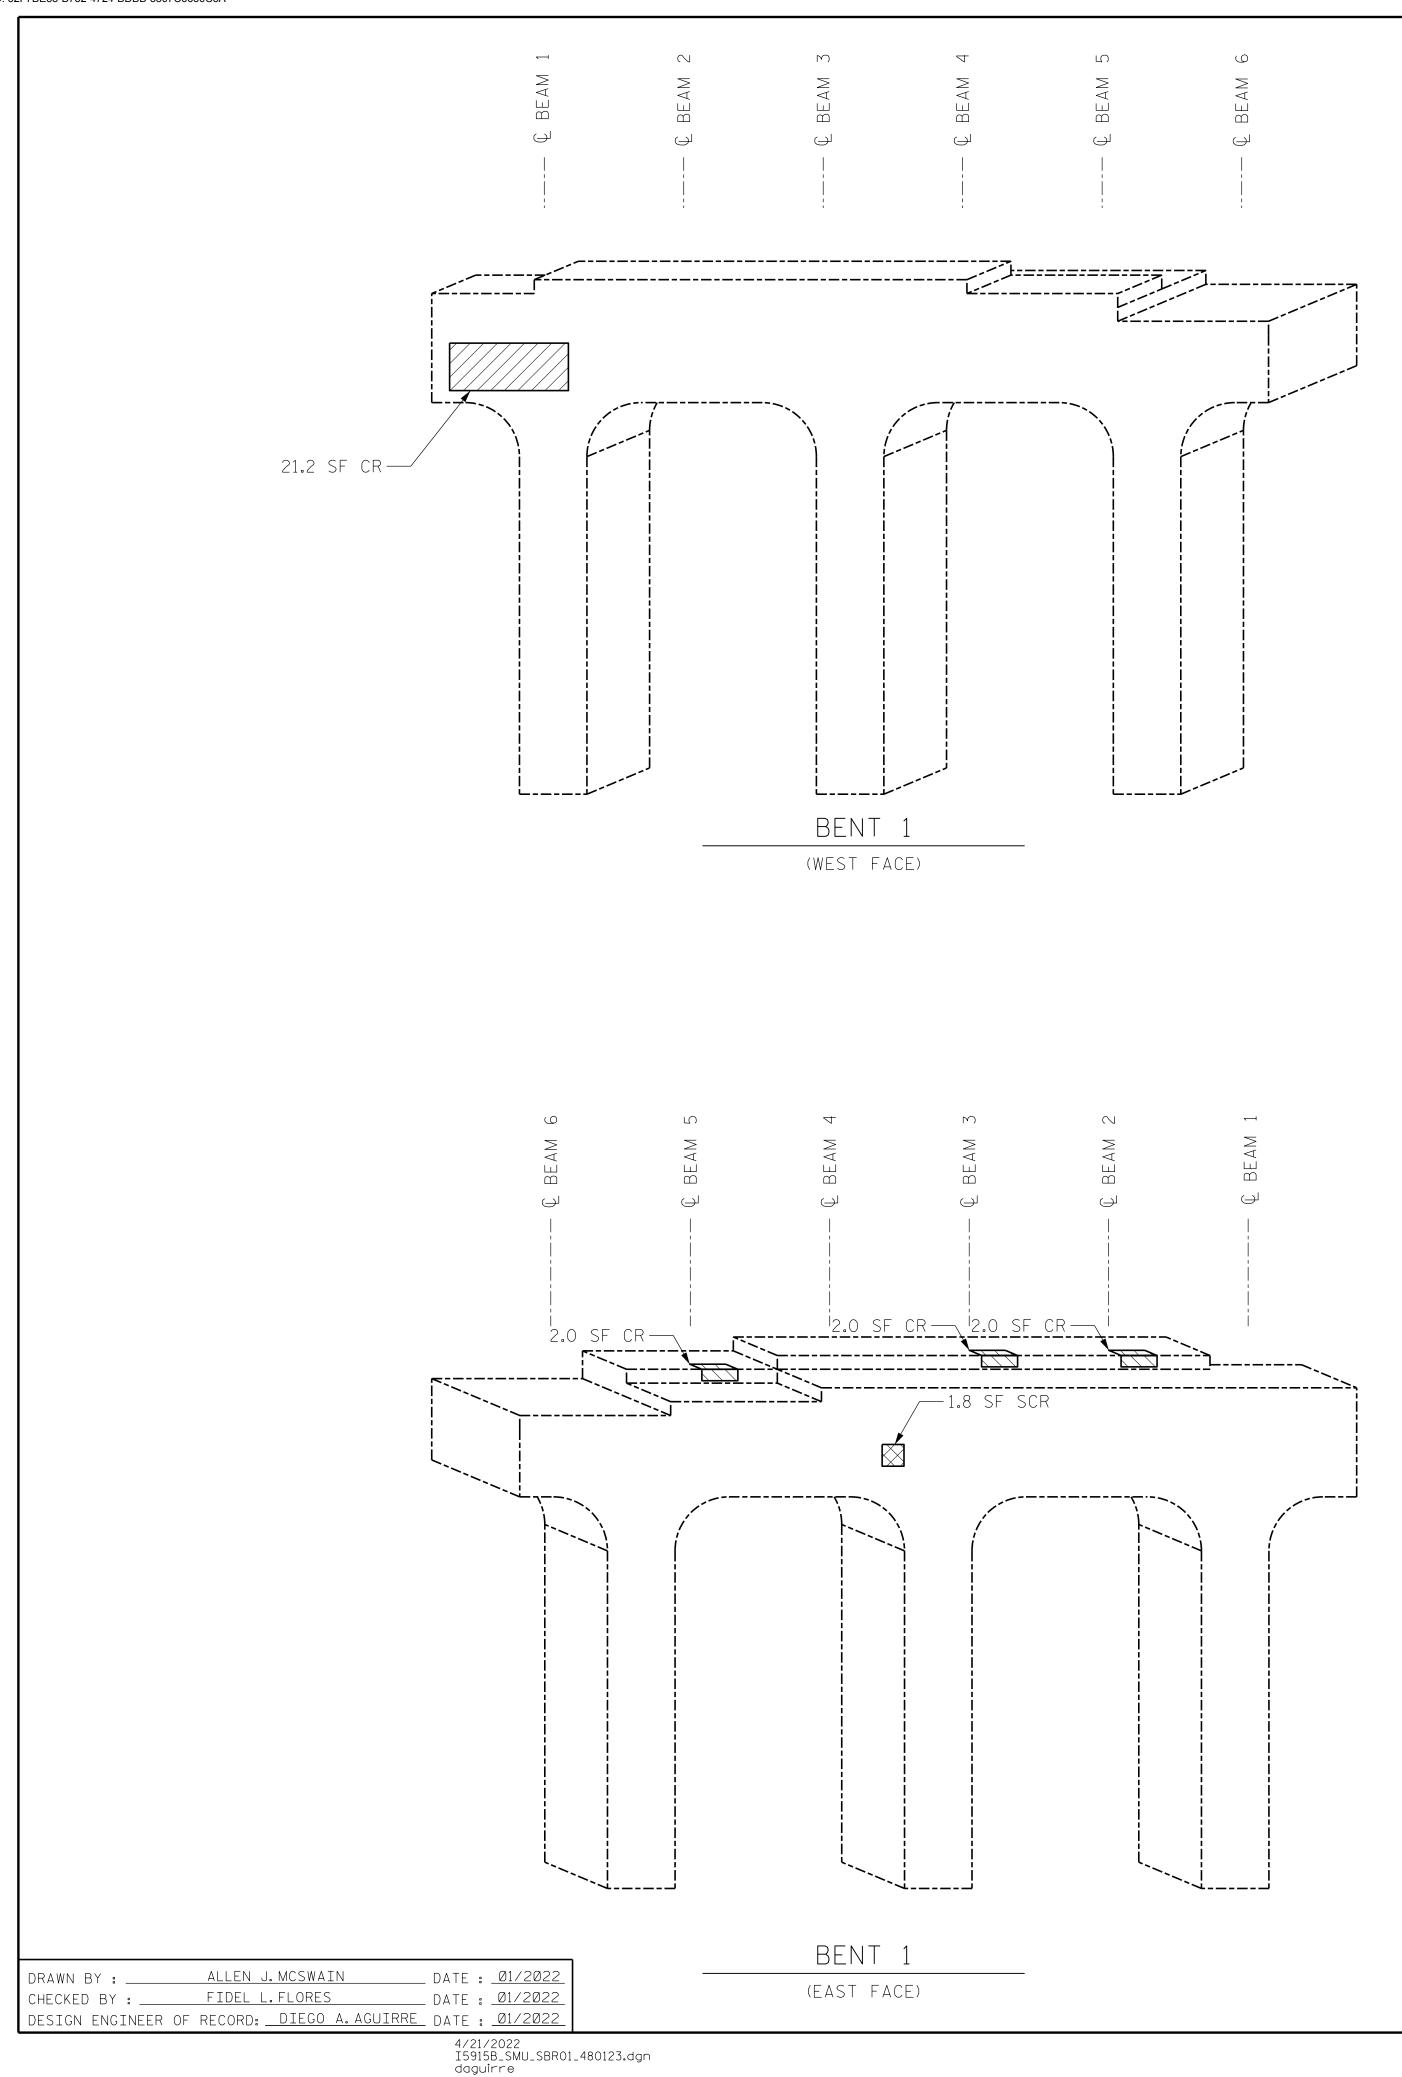
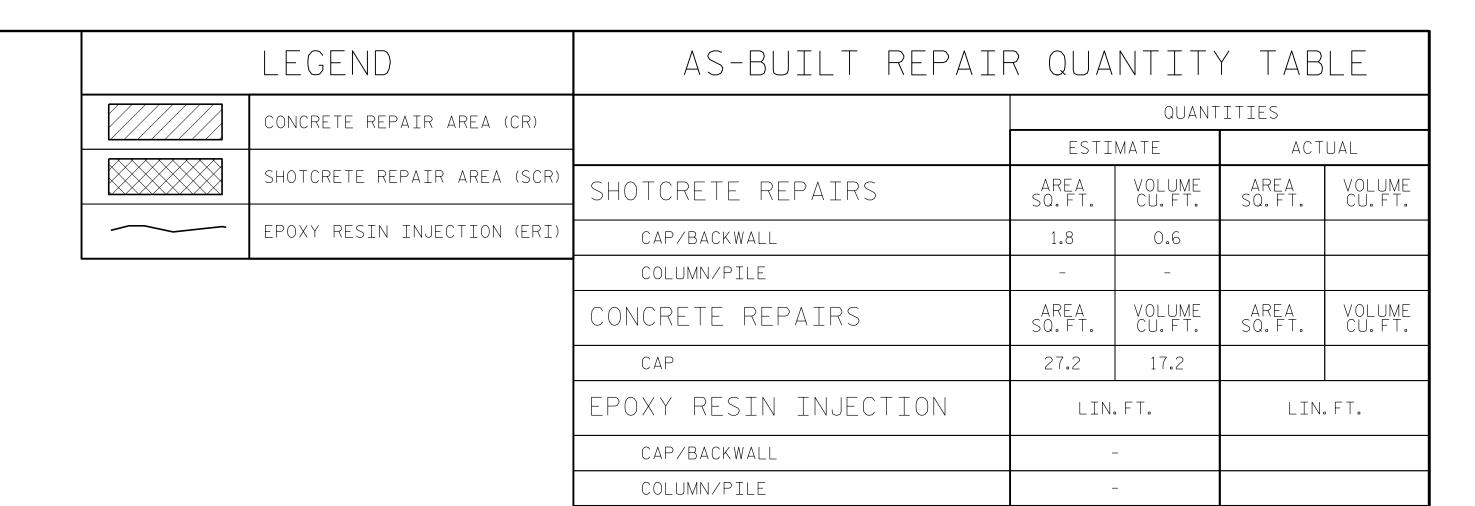
S17-7

CRACKING LOCATIONS AND QUANTITIES FOR LOCATIONS DESCRIBED AS "SCATTERED THROUGHOUT" IN THE INSPECTION REPORT ARE BASED ON THE BEST INFORMATION AVAILABLE. THE ENGINEER AND CONTRACTOR SHALL IDENTIFY AND REPAIR ALL CRACKS >= $\frac{1}{16}$ " AS DESCRIBED IN THE SPECIAL PROVISIONS AT EACH BENT.

AVERAGE CONCRETE COVER IS EXPECTED TO BE FROM 2"TO 3"ON THE CAP AND FROM $1\frac{1}{2}$ " TO 2" ON THE PILES. ACTUAL CONCRETE COVER SHALL BE DETERMINED BY THE CONTRACTOR AND PRESENTED TO THE ENGINEER PRIOR TO BEGINNING EXCAVATION/ DEMOLITION.

VALUES IN CHART REPRESENT ESTIMATED REPAIR TOTALS AFTER REMOVAL OF UNSOUND CONCRETE. MINIMUM OF 1"BEHIND REBAR AND MINIMUM 2"CLEARANCE TO SAWCUT. FOR REPAIR DETAILS, SEE "CONCRETE RESTORATION DETAILS" SHEETS.

FOR CONCRETE AND SHOTCRETE REPAIRS, SEE "CONCRETE RESTORATION DETAILS" SHEETS.

SHOTCRETE REPAIRS MAY BE REPLACED WITH CONCRETE REPAIRS WITH THE APPROVAL OF THE ENGINEER.

REPAIRS TO THE BENT CAP MAY REQUIRE BRIDGE JACKING. FOR BRIDGE JACKING, SEE SPECIAL PROVISIONS.
