PROJECT NO. I-5955
GUILFORD COUNTY
 BRIDGE NO. 400367

STATE OF NORTH CAROLINA
 DEPARTMENT OF TRANSPORTATION
 RALEIGH

**BEARING
 REPOSITIONING
 DETAILS**

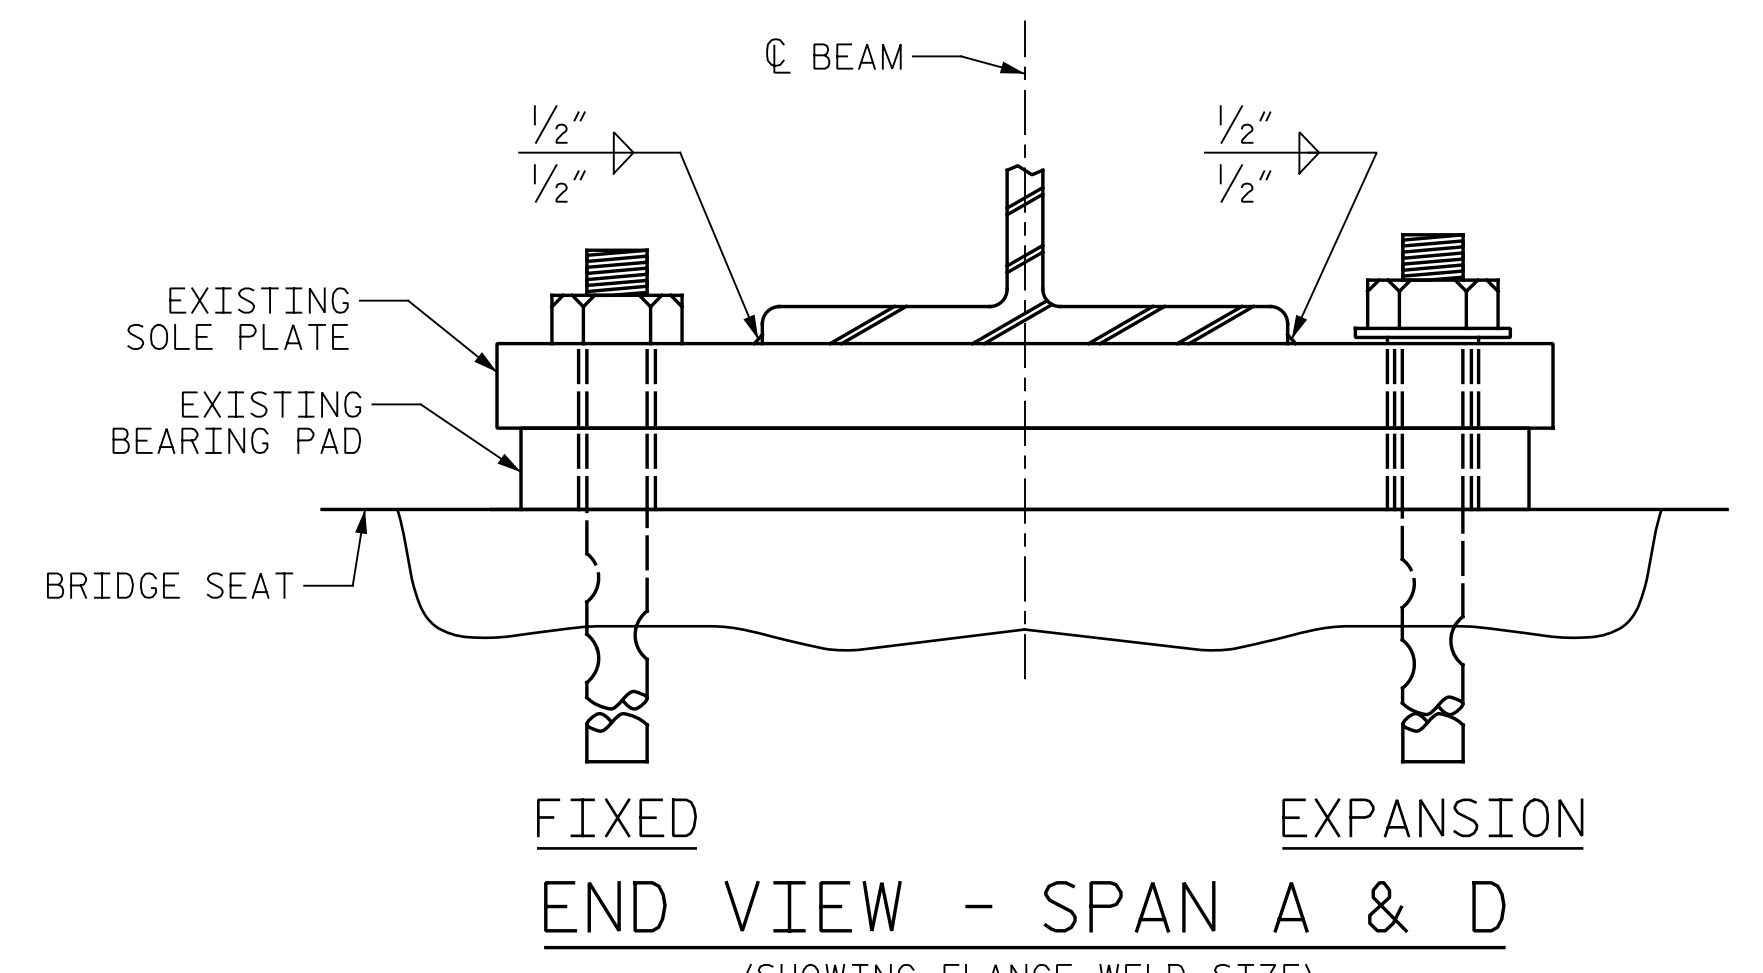
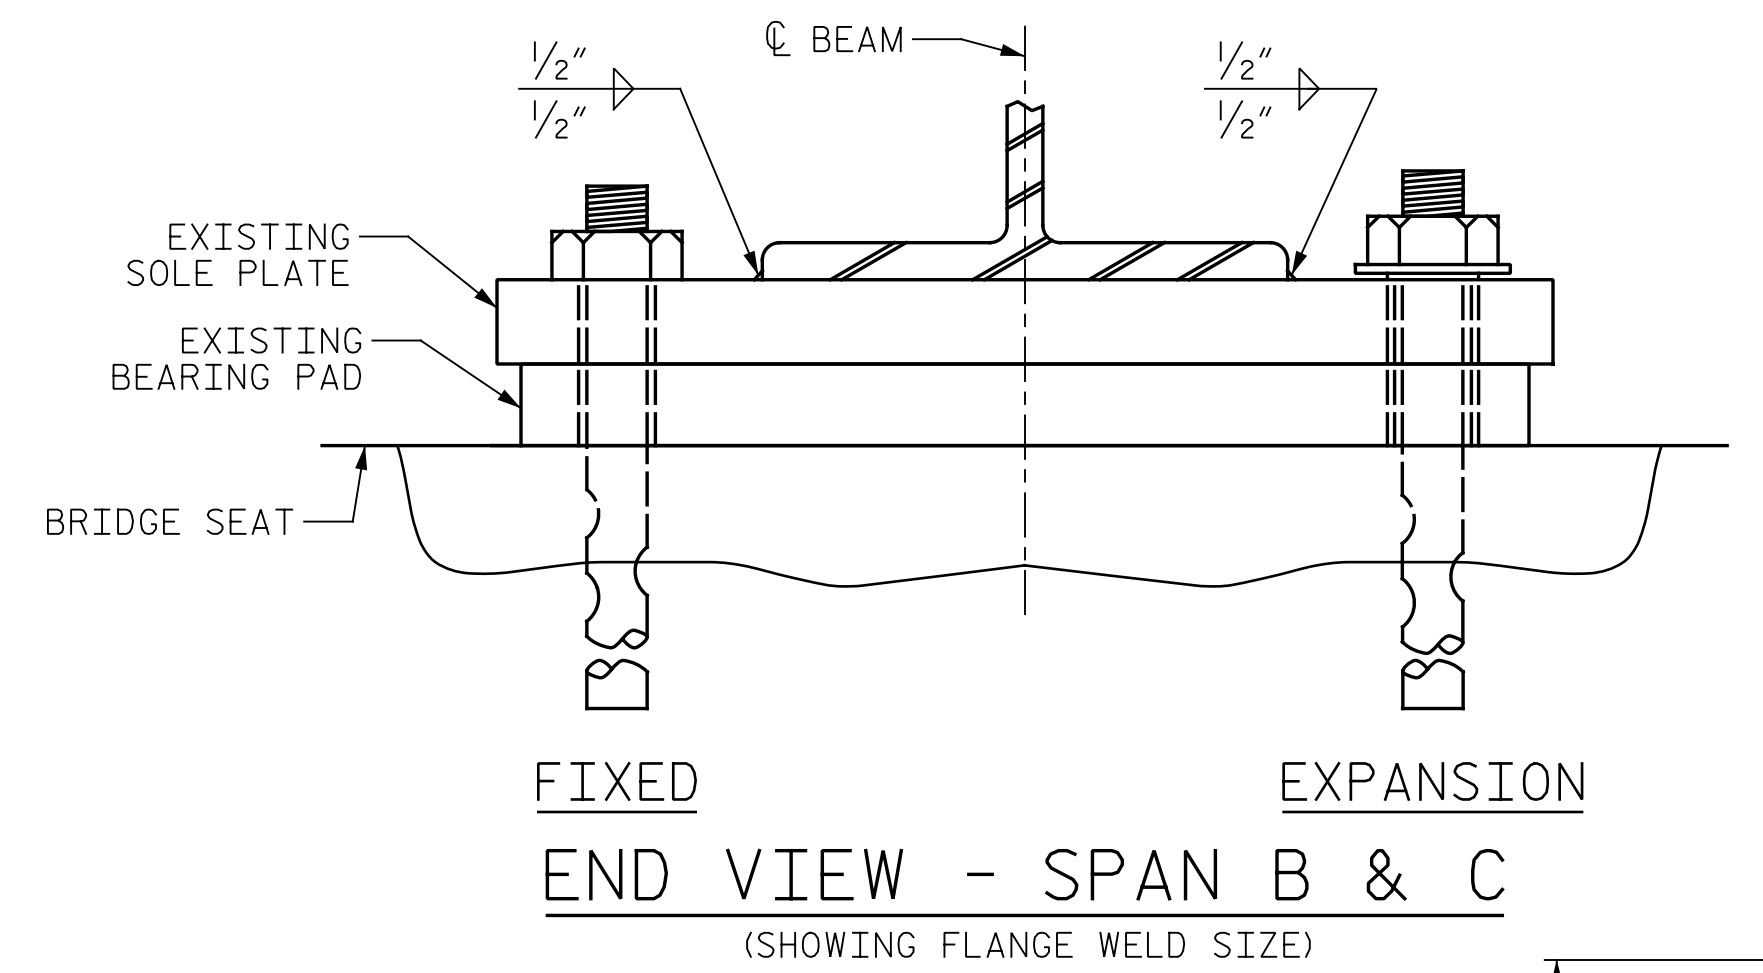
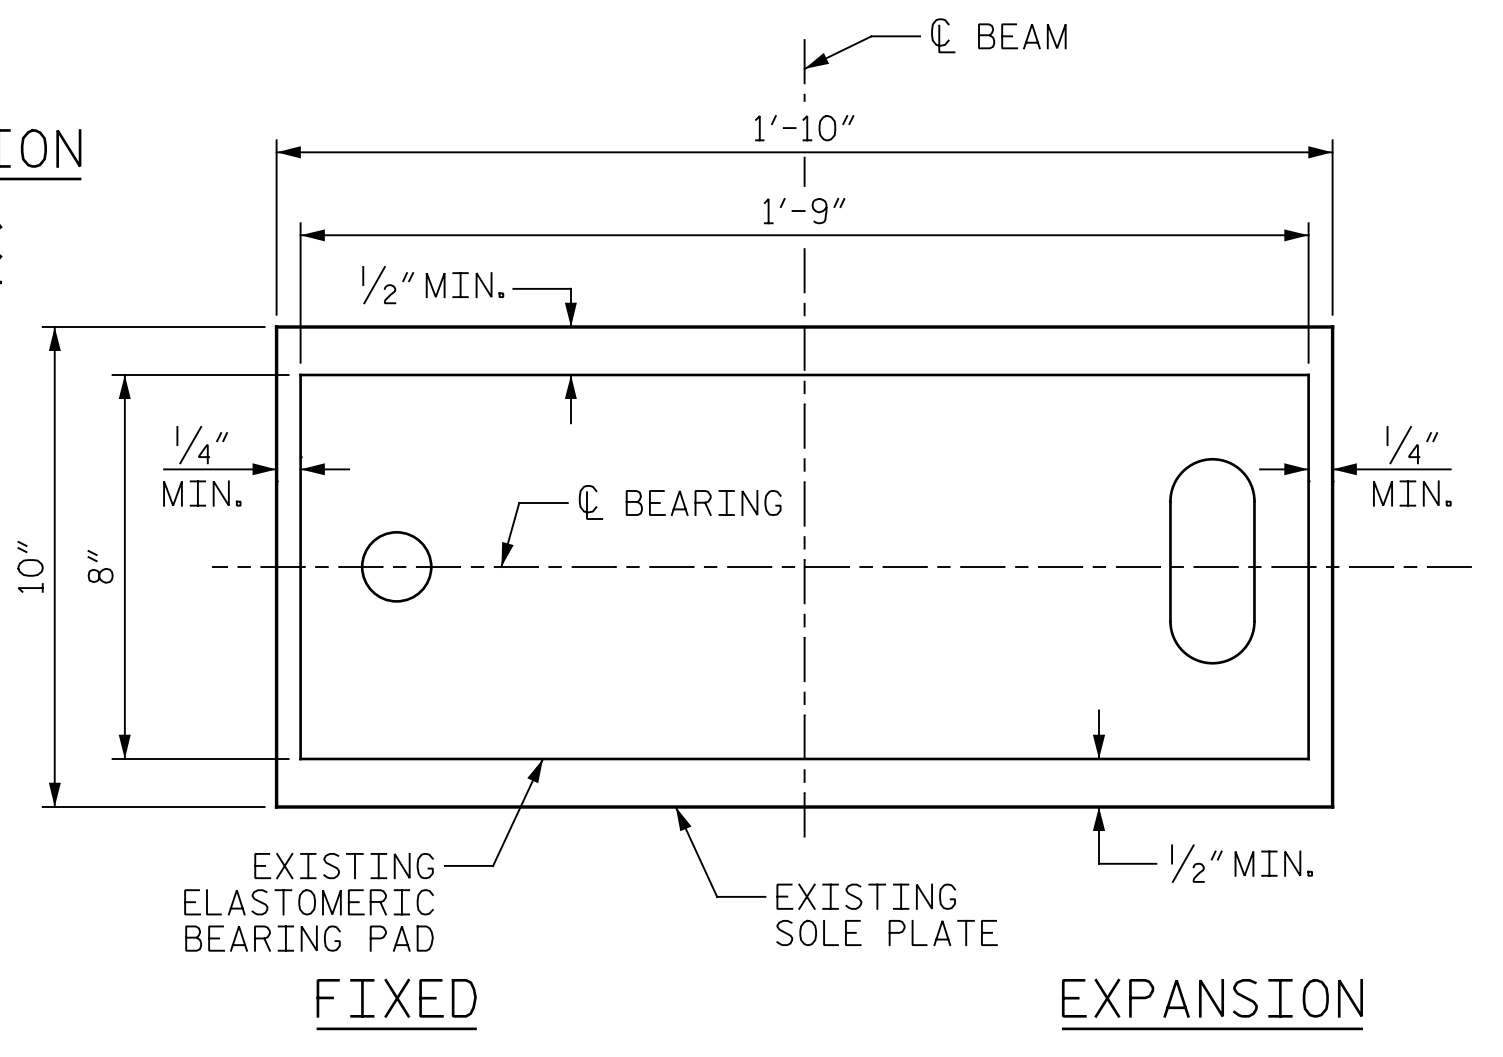
BEARING PHOTOGRAPHS

NOTES:
 THE GIRDERS SHALL BE JACKED AND THE BEARING PAD SHALL BE REPOSITIONED IN ORDER TO MEET THE MINIMUM CLEARANCES SHOWN IN THE BEARING ORIENTATION DETAIL. DUE TO THE DEFORMED ANCHOR BOLTS, ONE THE FOLLOWING MEANS MAY BE REQUIRED TO ACCOMPLISH THIS TASK:

1. DETACH THE EXISTING SOLE PLATE FROM THE GIRDER AND REPOSITION THE SOLE PLATE.
 2. REPOSITIONING THE BEARING PAD.
- THE CONTRACTOR MAY PROPOSE ALTERNATE METHODS, PROVIDED DETAILS ARE SUBMITTED TO THE ENGINEER FOR REVIEW AND APPROVAL.

WHEN FIELD WELDING THE SOLE PLATE TO THE GIRDER FLANGE, USE TEMPERATURE INDICATING WAX PENS, OR OTHER SUITABLE MEANS, TO ENSURE THAT THE TEMPERATURE OF THE SOLE PLATE DOES NOT EXCEED 300oF. TEMPERATURES ABOVE THIS MAY DAMAGE THE ELASTOMER.

FOR REPOSITIONING BEARINGS, SEE SPECIAL PROVISIONS.
