L'/4" MIN. C BEARING EXISTING	
MIN.	PROJECT NO. <u>I-5955</u> <u>GUILFORD</u> county BRIDGE NO. <u>400364</u>
Docusigned by: John Yannaccone 032492 781361754678456. 11/17/2022	DEPARTMENT OF TRANSPORTATION RALEIGH BEARING REPOSITIONING DETAILS
DOCUMENT NOT CONSIDERED FINAL UNLESS ALL SIGNATURES COMPLETED	REVISIONS SHEET NO. NO. BY: DATE: NO. BY: DATE: S12-9 1 3 Colspan="3">TOTAL SHEETS 2 4 127

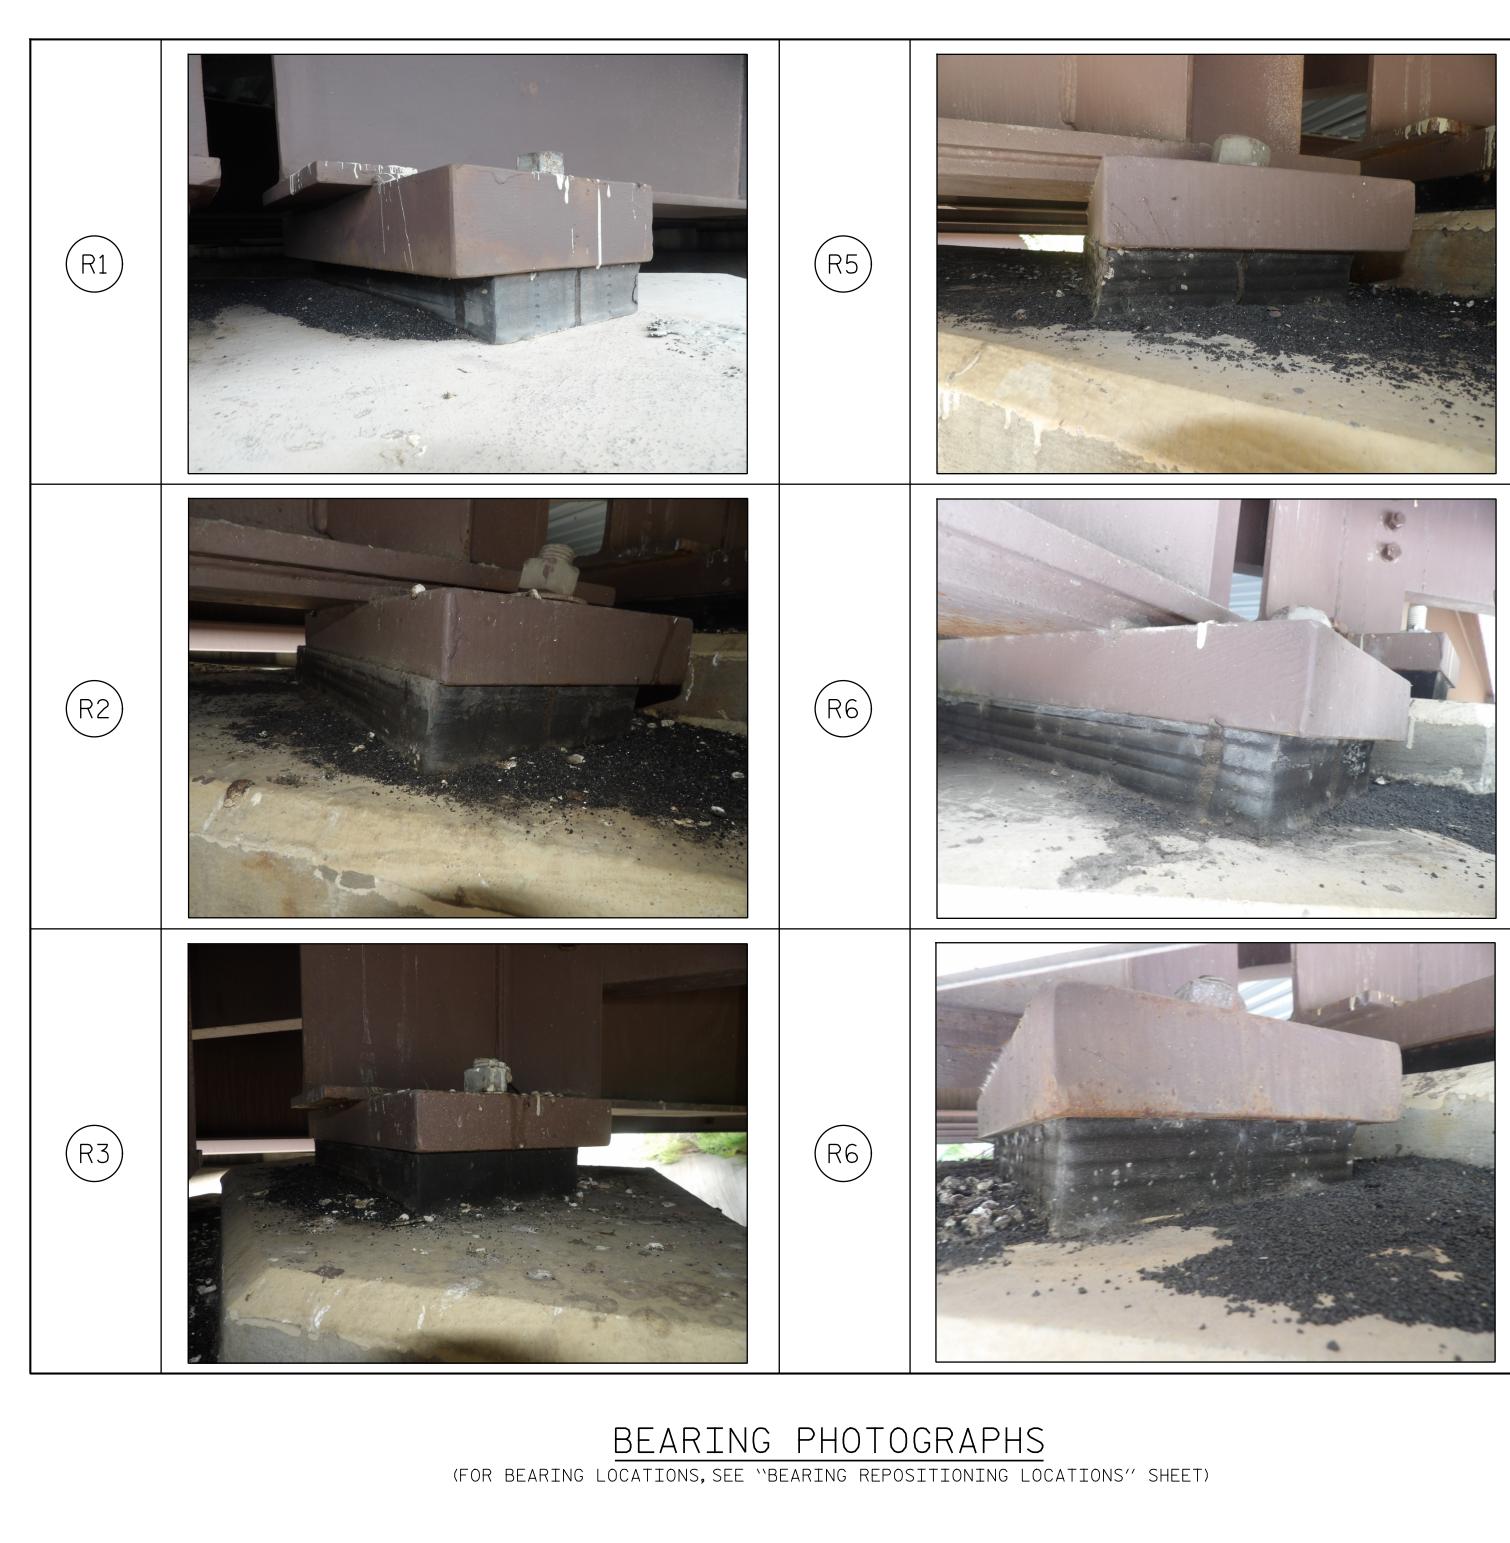
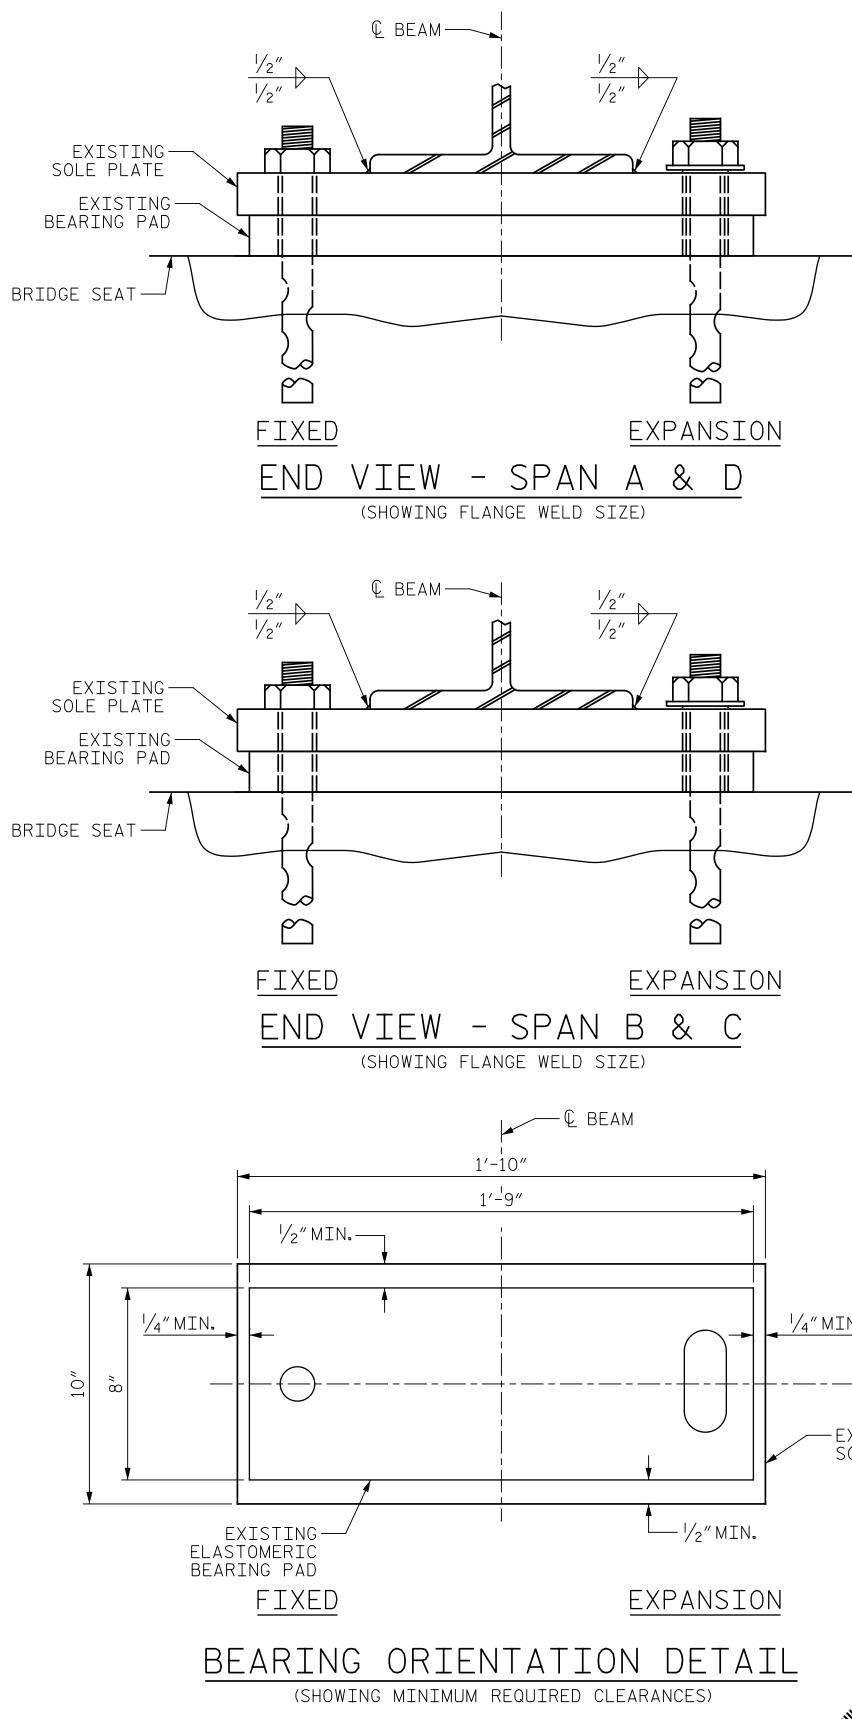
NOTES: THE GIRDERS SHALL BE JACKED AND THE BEARING PAD SHALL BE REPOSITIONED IN ORDER TO MEET THE MINIMUM CLEARANCES SHOWN IN THE BEARING ORIENTATION DETAIL.DUE TO THE DEFORMED ANCHOR BOLTS,ONE THE FOLLOWING MEANS MAY BE REQUIRED TO ACCOMPLISH THIS TASK:

1. DETACH THE EXISTING SOLE PLATE FROM THE GIRDER AND REPOSITION THE SOLE PLATE.

2. REPOSITIONING THE BEARING PAD.

THE CONTRACTOR MAY PROPOSE ALTERNATE METHODS, PROVIDED DETAILS ARE SUBMITTED TO THE ENGINEER FOR REVIEW AND APPROVAL.

WHEN FIELD WELDING THE SOLE PLATE TO THE GIRDER FLANGE, USE TEMPERATURE INDICATING WAX PENS, OR OTHER SUITABLE MEANS, TO ENSURE THAT THE TEMPERATURE OF THE SOLE PLATE DOES NOT EXCEED 3000F. TEMPERATURES ABOVE THIS MAY DAMAGE THE ELASTOMER.

SOLE PLATES AND BEARING PADS SHALL BE REPOSITIONED BEFORE ANY JOINT REPAIRS OR GIRDER END PAINTING BEGINS.
