NC DEPARTMENT OF TRANSPORTATION
 DIVISION OF HIGHWAYS
 STRUCTURE MANAGEMENT UNIT

ATTENTION: **PAR SUBMITTED. NEW REPAIRS. CHANGE IN STRUCTURE DATA.**

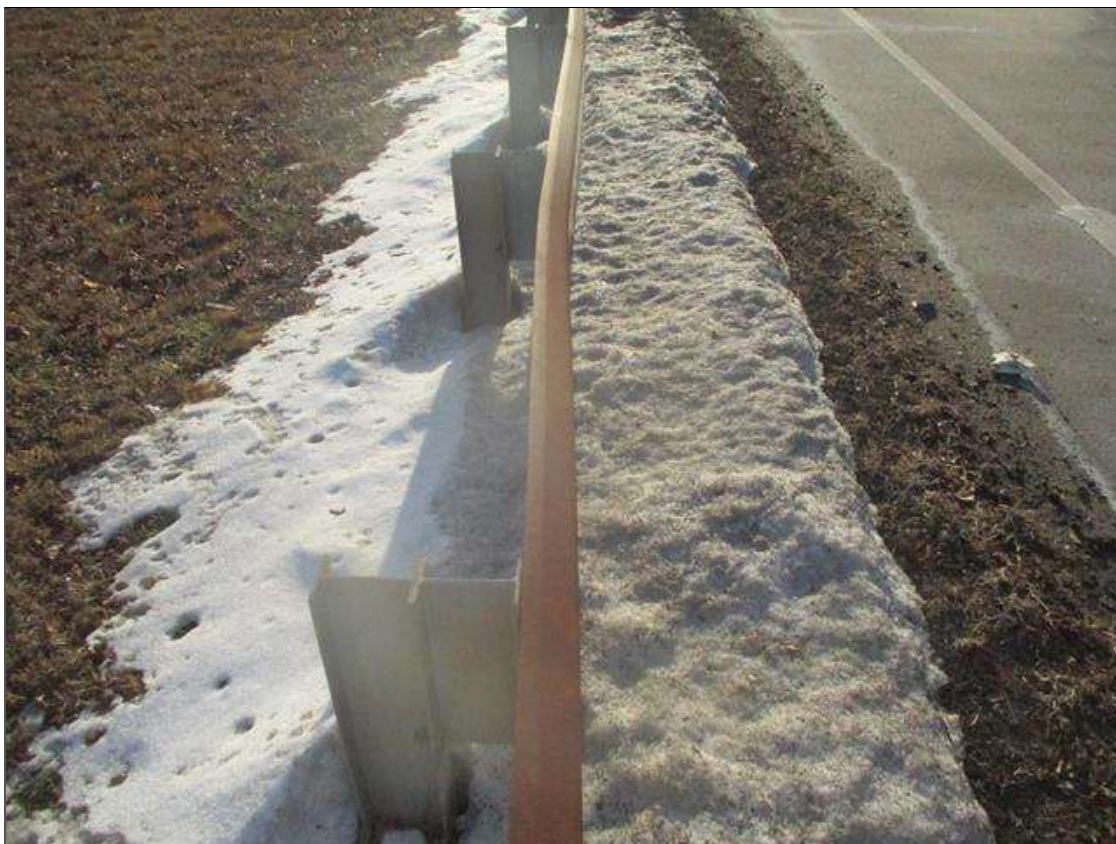
UP TO 6 FT OF IMPACT DAMAGE AT SOUTHEAST GUARDRAIL APPROX. 10 FT FROM BRIDGE

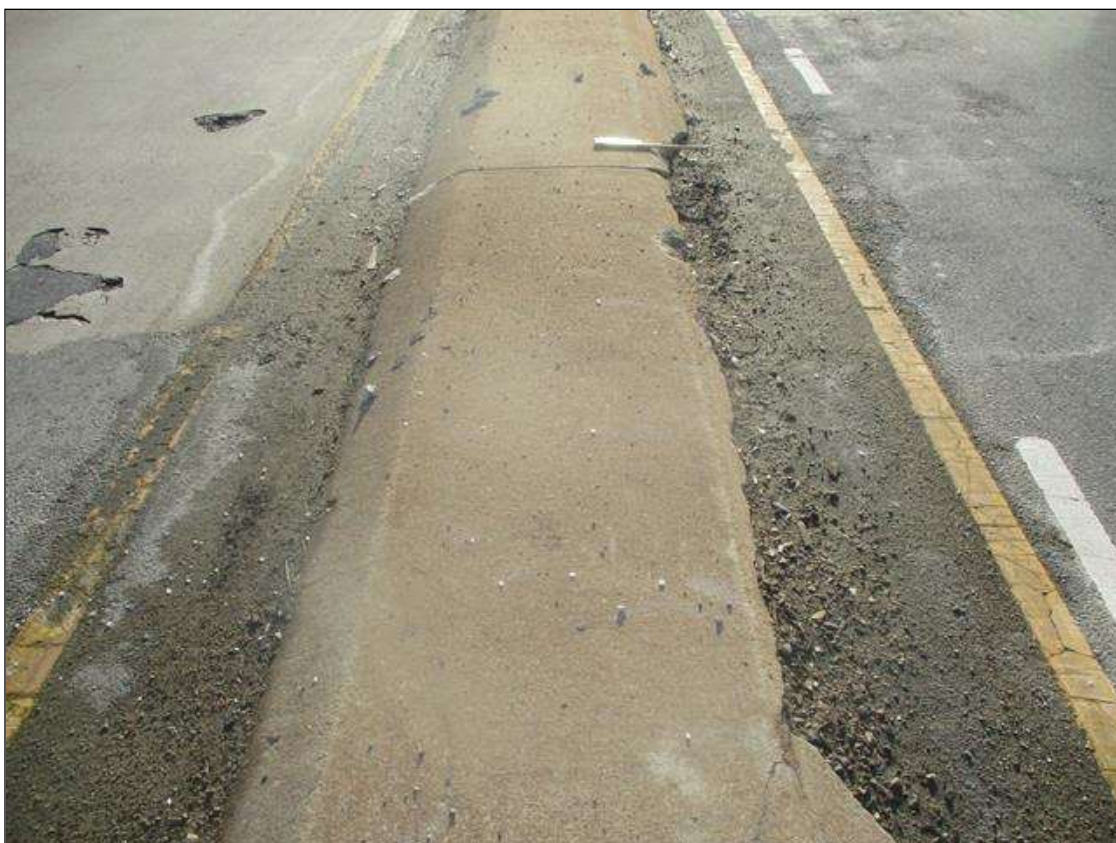
Span 1 Deck: MEDIAN - SPALL (11FT L. X 8 IN WID X FULL HEIGHT) STARTING 2FT FROM NEAR END, RIGHT SIDE

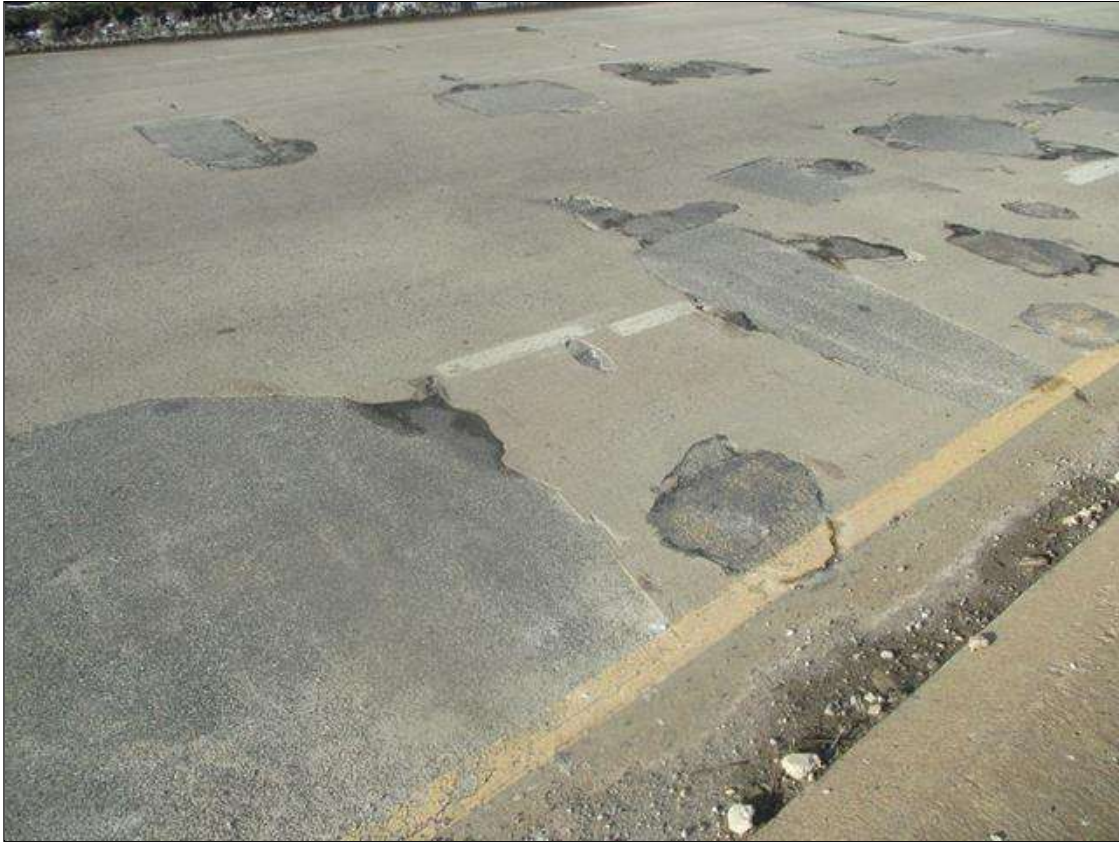
Span 2 Deck: INTERMITTENT PATCHING (UP TO 50SF) WITH SPALLING (UP TO 12IN X 12IN X 1IN) AT PERIMETER OF PATCHING

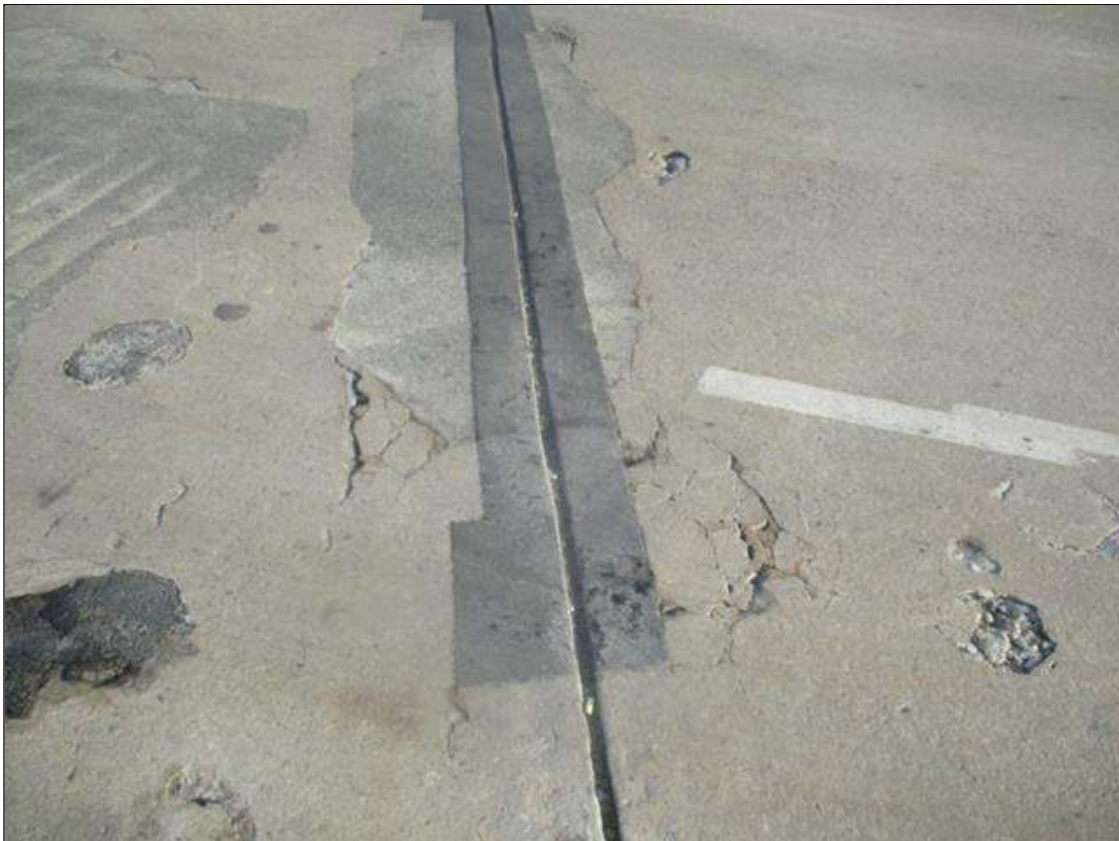
Span 2 Expansion Joint 2: PATCHING, (UP TO 2FT L. X FULL WIDTH) THROUGHOUT HEADERS

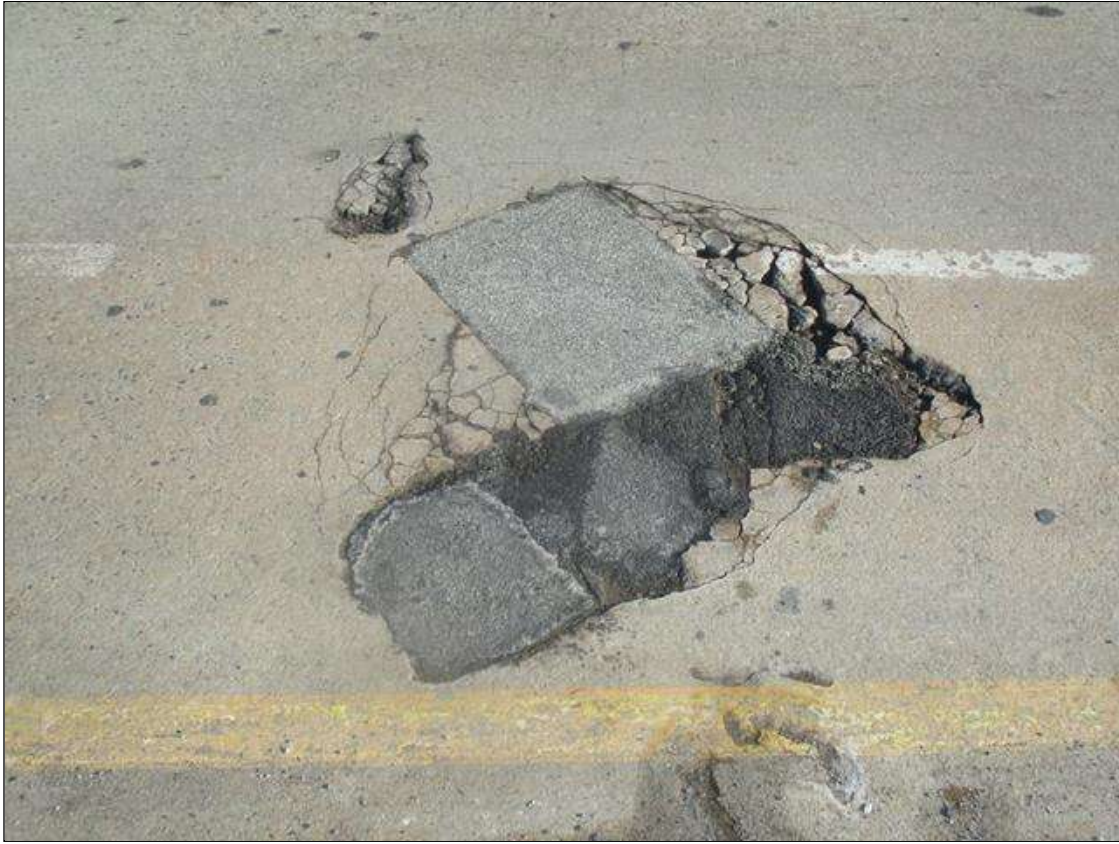
Span 3 Deck: SPALL WITH EXPOSED REBAR UP TO 12 SQ FT IN NORTHBOUND LAND RIGHT SIDE NEAR YELLOW LINE 20 FT FROM BENT 3. UP TO 90% SECTION REMAINING IN THE EXPOSED REBAR. (PAR)

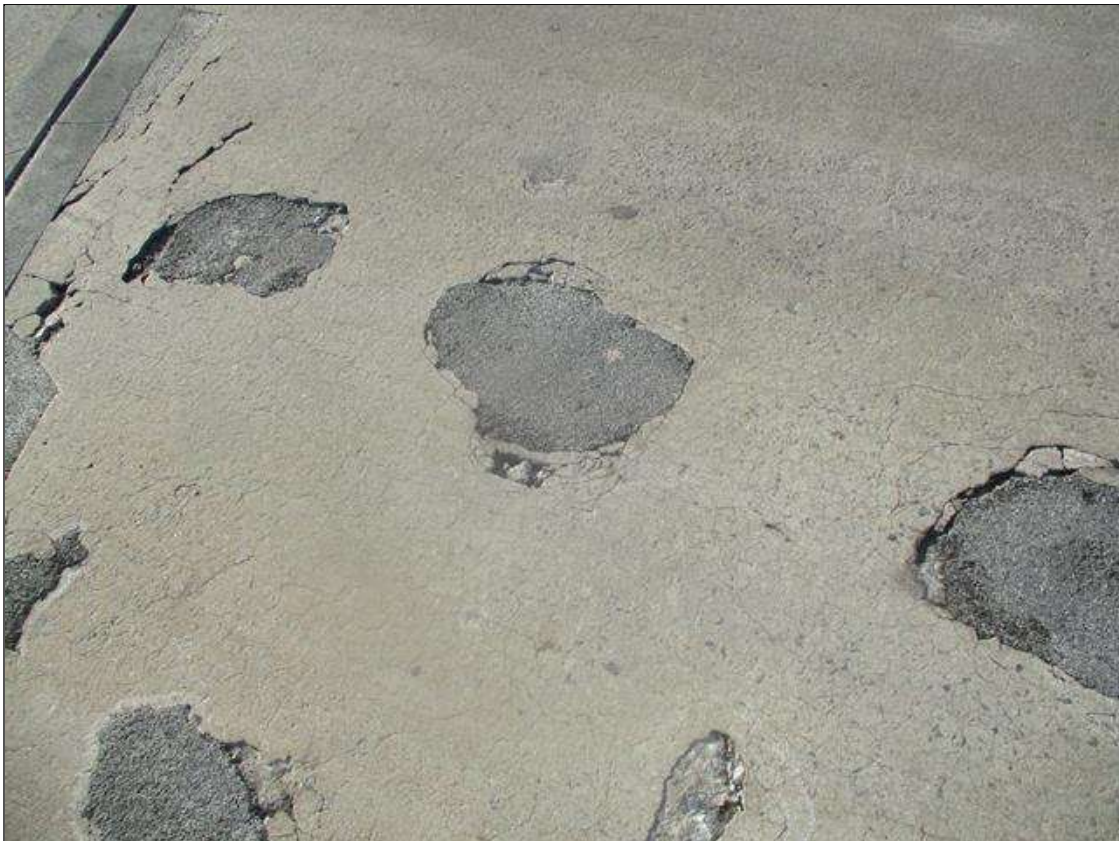
Span 3 Deck: SPALL (16IN X 12IN X 2IN) WITH EXPOSED REINFORCING, RIGHT LANE 3FT FROM FAR END. PATCHED SINCE PREVIOUS INSPECTION - NEW REPAIR

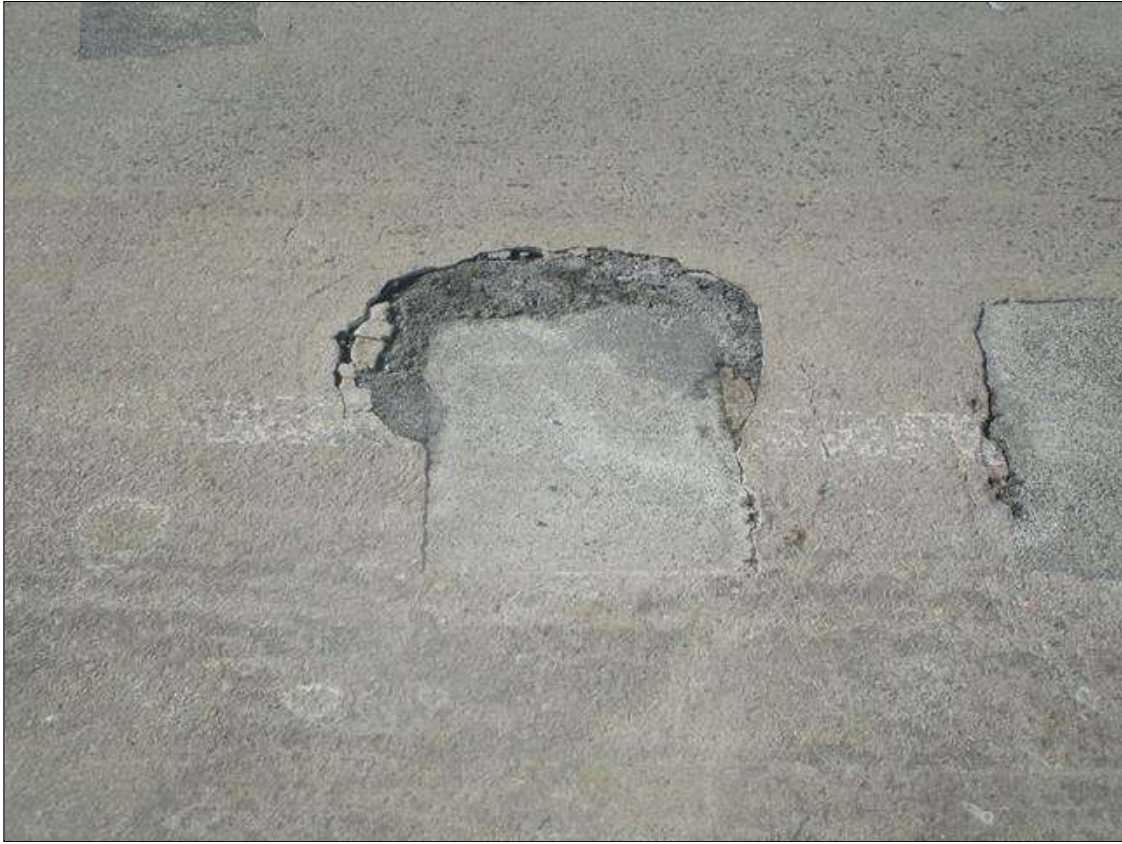
Span 2 Deck: SPALL (14IN X 12IN X 2IN) WITH EXPOSED REINFORCING, RIGHT LANE 16FT FROM FAR END. - PATCHED SINCE PREVIOUS INSPECTION, NEW REPAIR

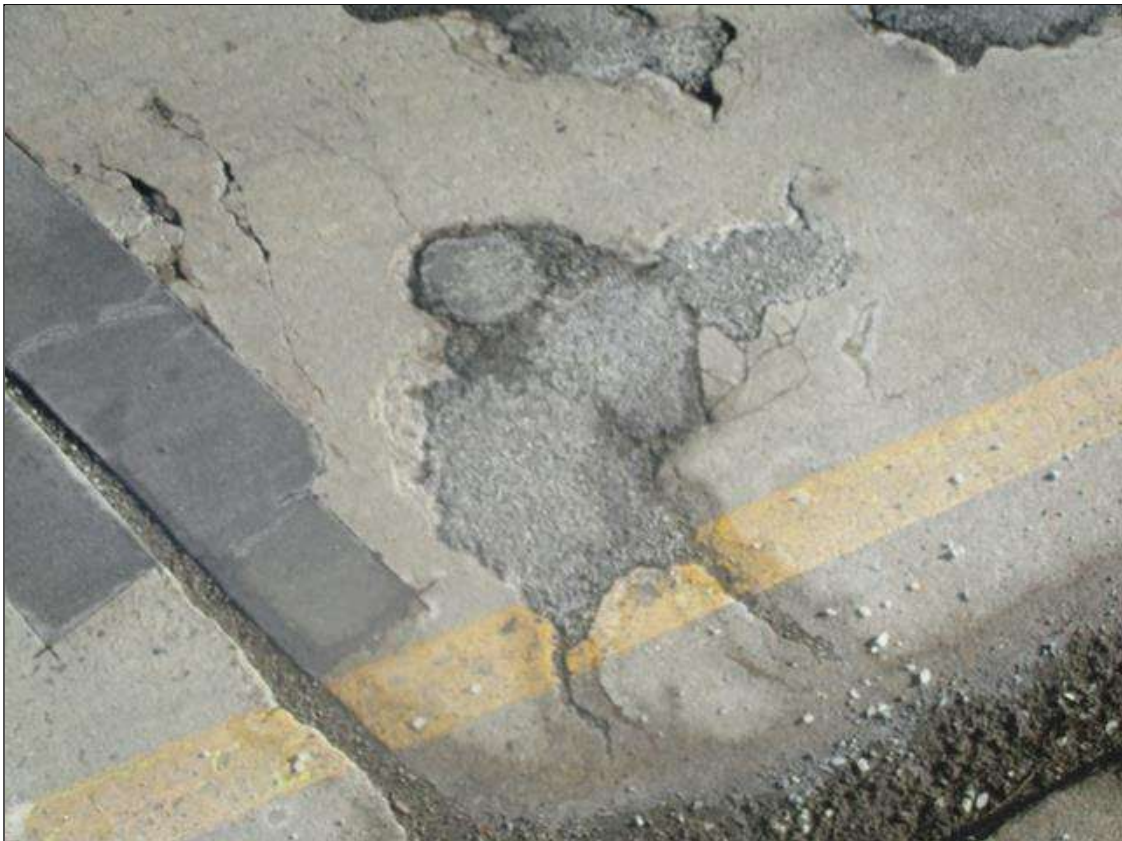
Span 2 Deck: SPALL (12IN X 10IN X 2IN) WITH EXPOSED REINFORCING, NEAR END RIGHT SIDE OF LEFT LANES. - REPAIRED SINCE PREVIOUS INSPECTION. NEW REPAIR

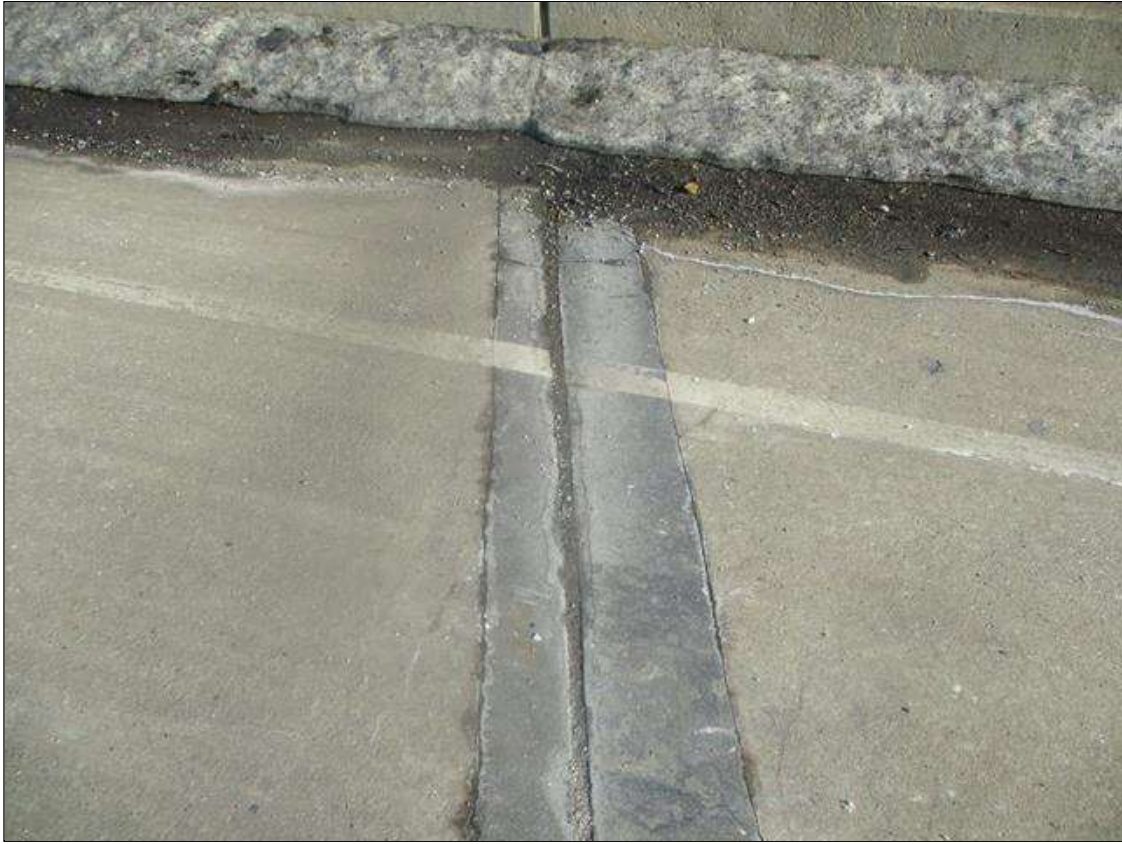
Span 2 Expansion Joint 2: DEBRIS IMPACTION FULL L.

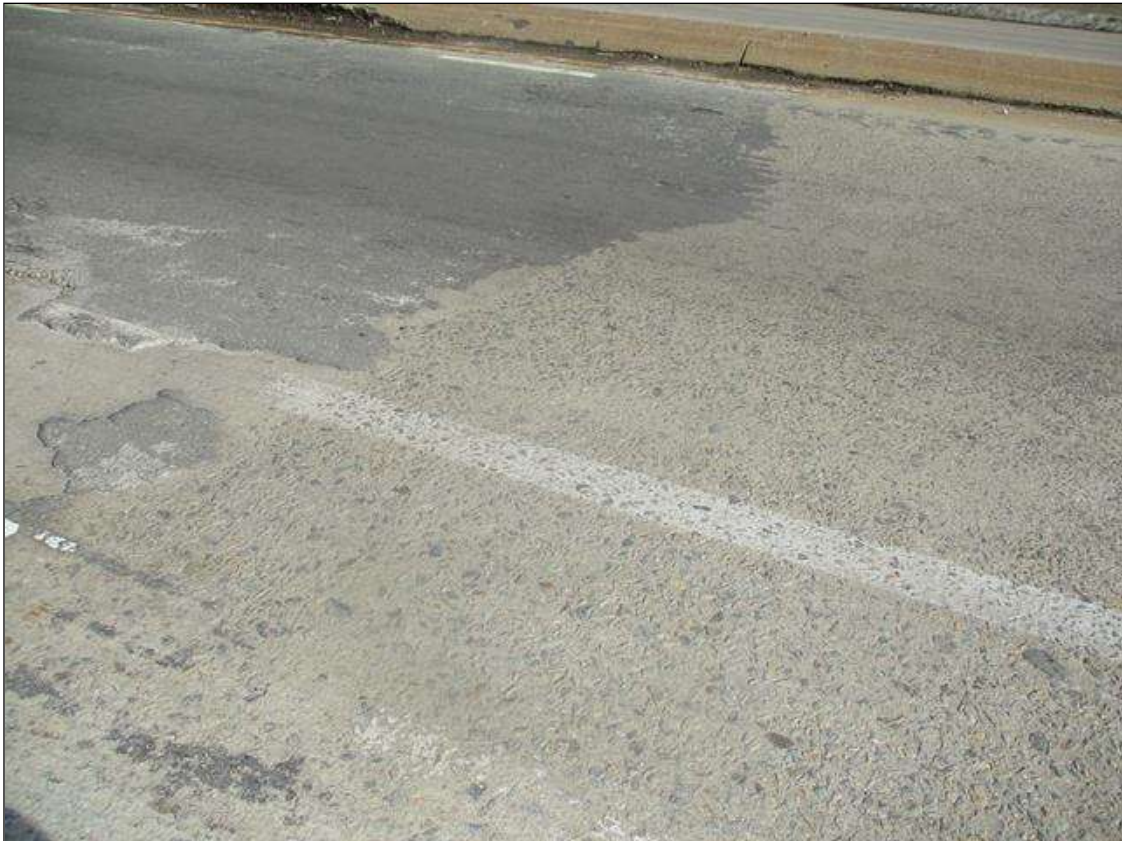
Span 1 Deck: HAIRLINE TO 1/16IN OPEN MAP CRACKING (UP TO FULL WIDTH) THROUGHOUT & WEAR WITH EXPOSED AGGREGATE THROUGHOUT RIGHT LANES

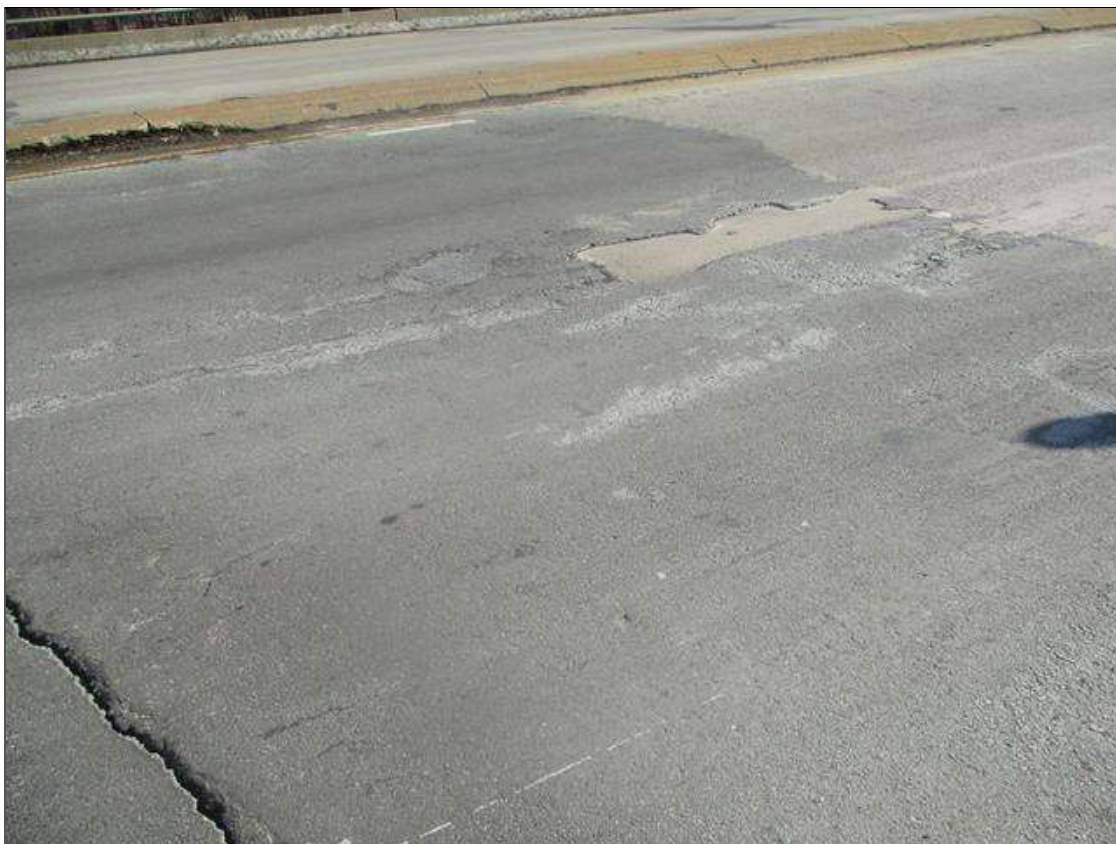
NEW OVERLAY HAS BEEN POURED FOR UP TO 15 FT LONG IN SPAN 1 STARTING AT END BENT 1. HAS MAP CRACKING UP TO 1/16 IN WIDE SCATTERED THOUGHOUT

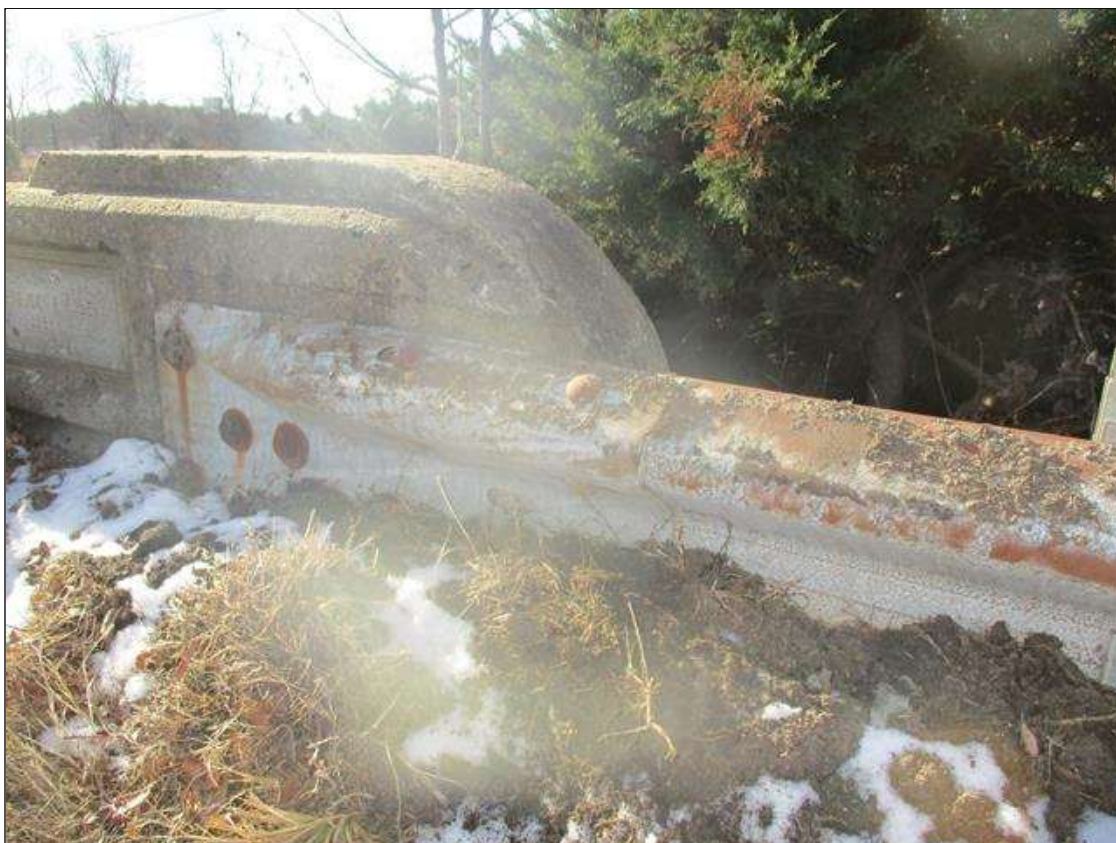
APPROACH GUARDRAIL AT NORTHWEST CORNER IS LAPPED INCORRECTLY (PAR)

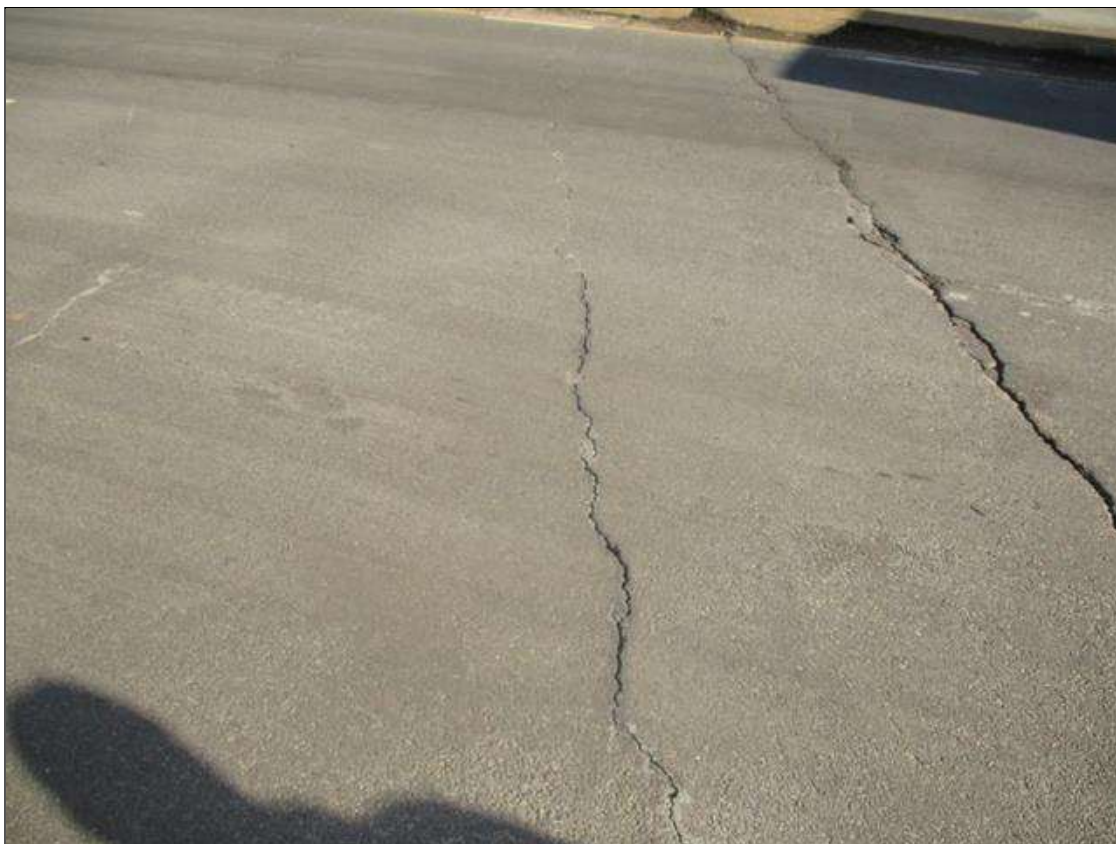
CRACKING UP TO 1/2 IN WIDE IN APPROACH PAVEMENT NEAR END BENT 1 FOR FULL WIDTH

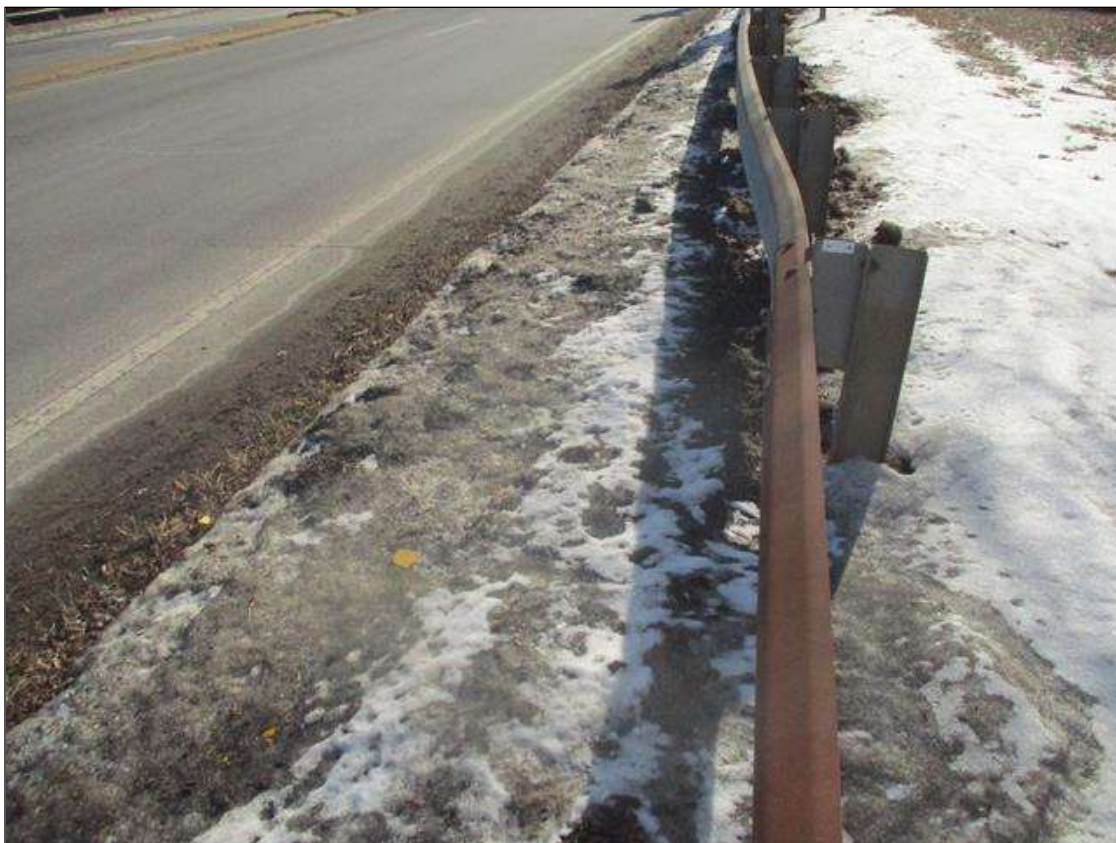
MODERATE IMPACT DAMAGE TO NORTHWEST GUARDRAIL APPROX. 50 FT FROM BRIDGE FOR 20 FT LONG.

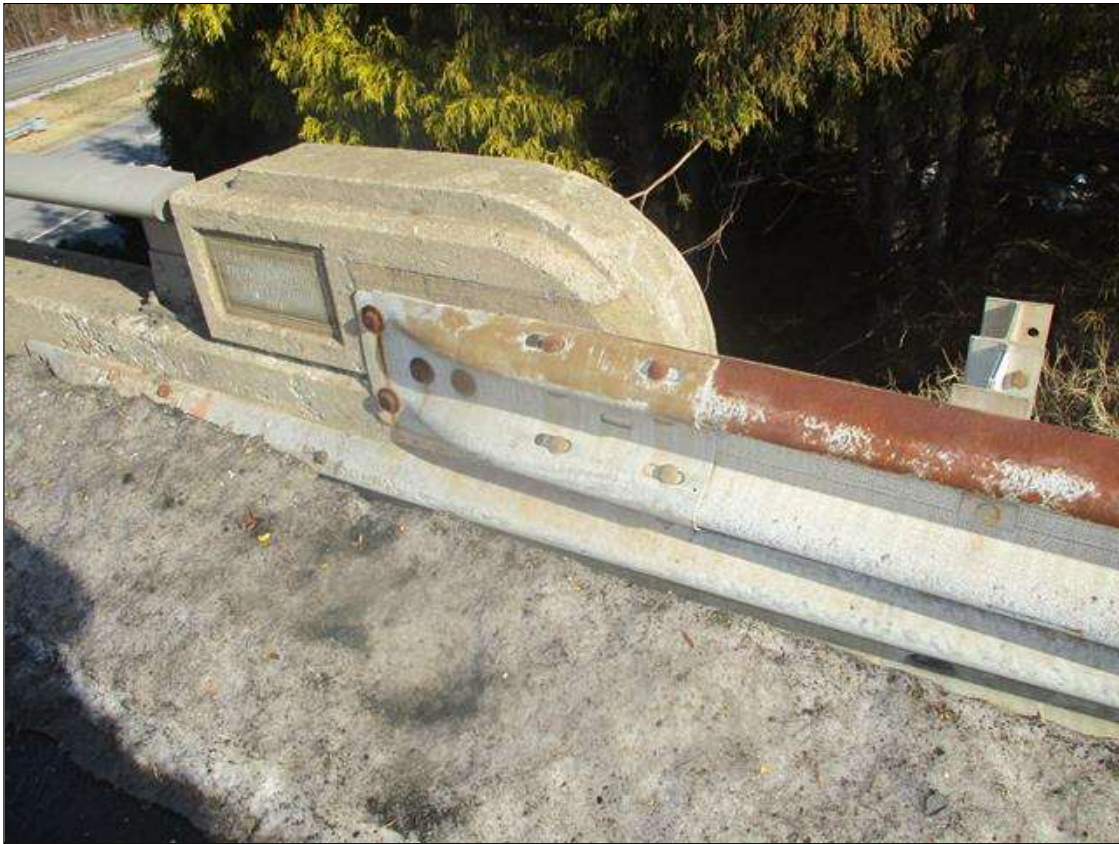
INCORRECT LAPPING AT SOUTHEAST GUARDRAIL TRANSITION (PAR)

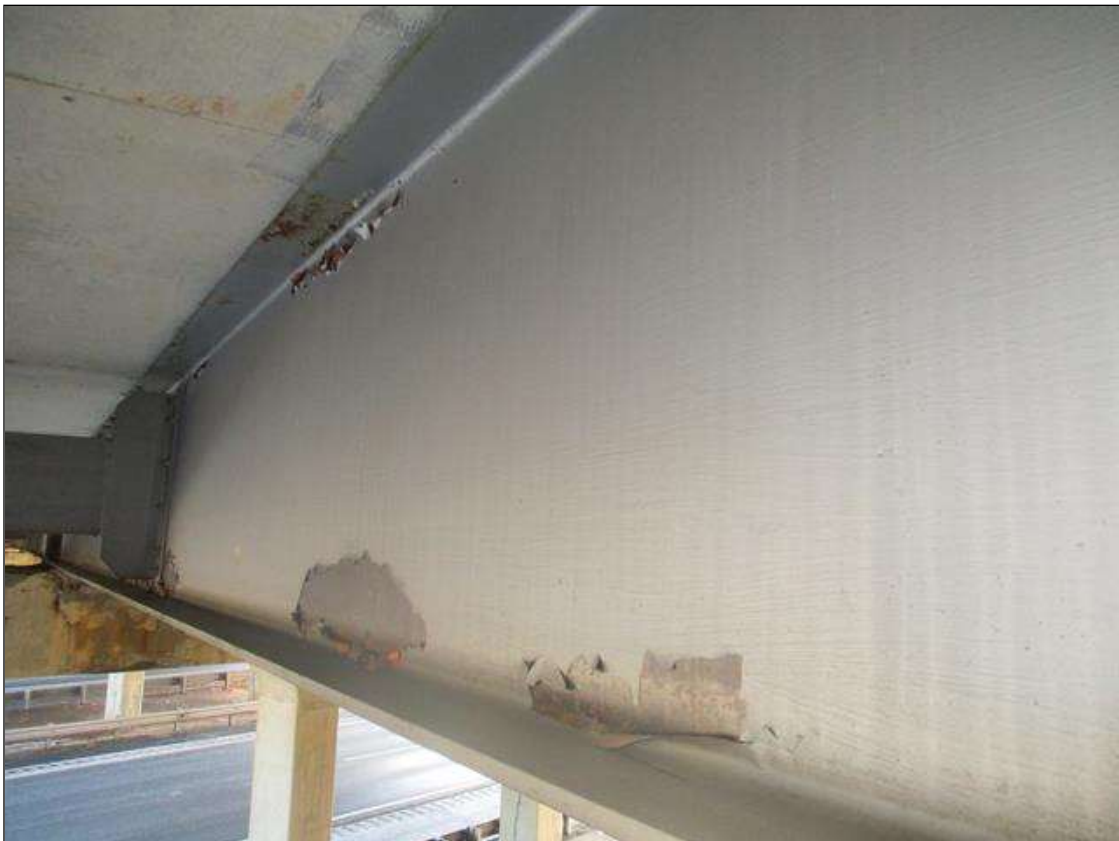
Span 1 Beam 4: MINOR SURFACE CORROSION THROUGHOUT FLANGES & BOTTOM 1/3 OF WEB

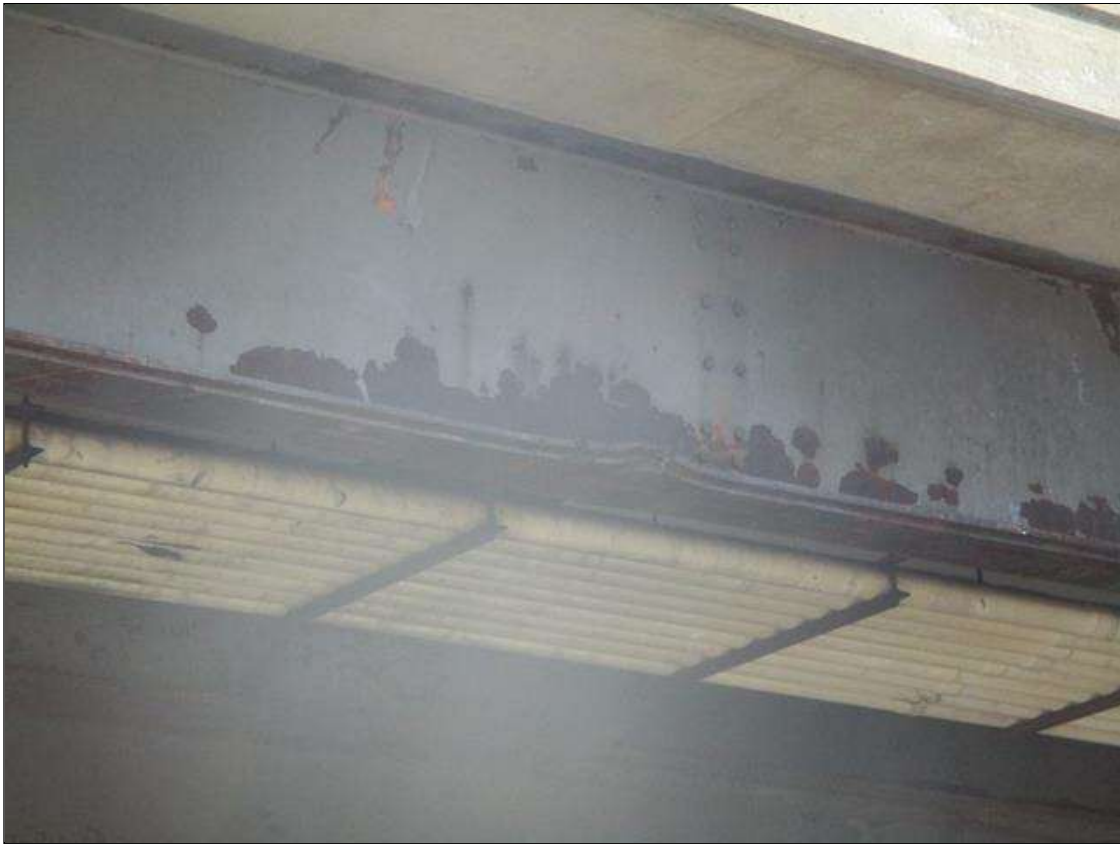
Span 3 Beam 10: IMPACT DAMAGE: 18"L SECTION OF BOTTOM FLANGE AND COVER PLATE BENT UPWARD UP TO 2-1/4" AT 24' FROM BENT 3 BEARING. (PAR)

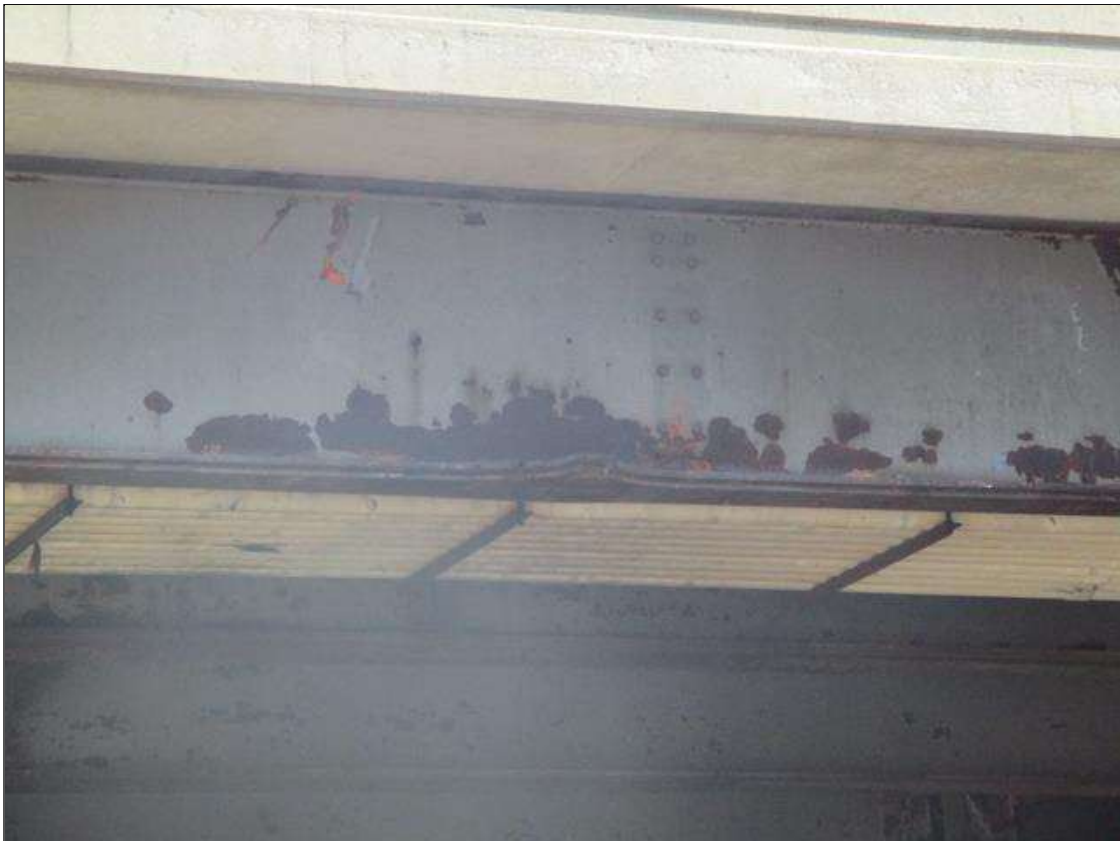
Span 3 Beam 10: IMPACT DAMAGE: 18"L SECTION OF BOTTOM FLANGE AND COVER PLATE BENT UPWARD UP TO 2-1/4" AT 24' FROM BENT 3 BEARING. (PAR)

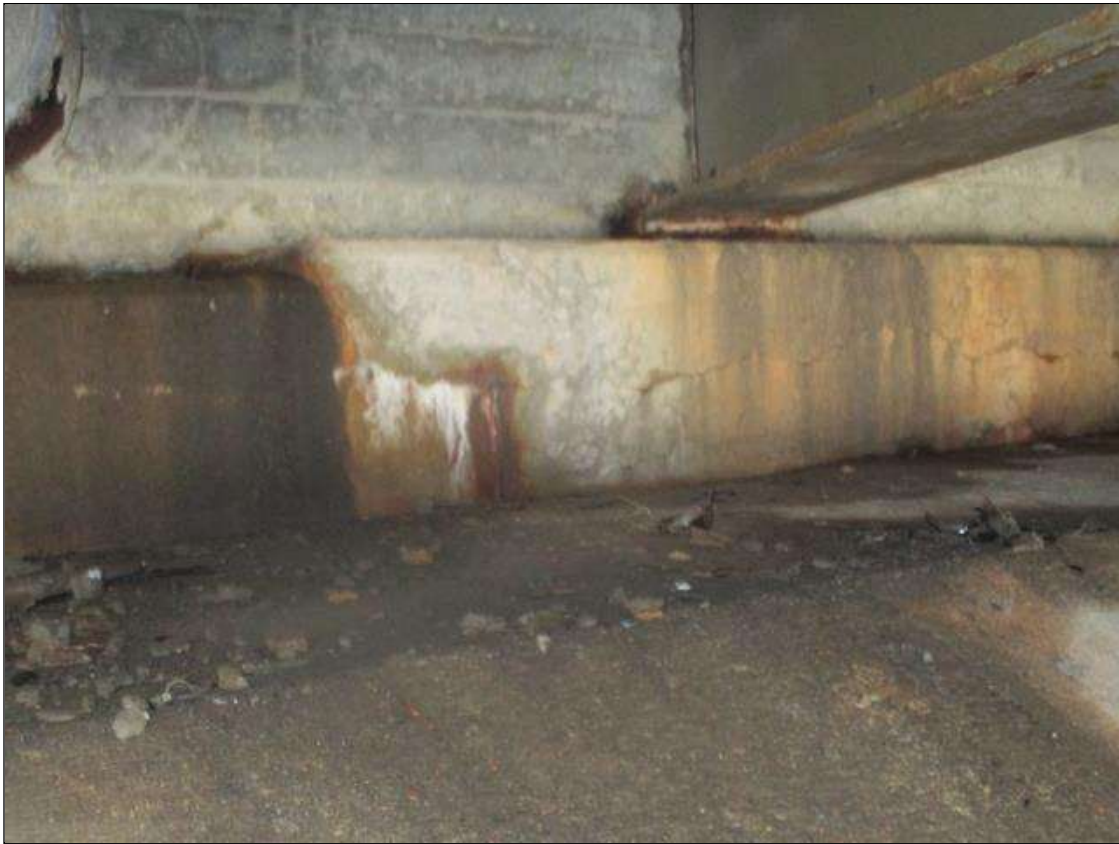
End Bent 2 Cap 1: HORIZONTAL 1/16IN CRACKING (UP TO FULL L.) WITH EFFLO. & RUST STAINING THROUGHOUT

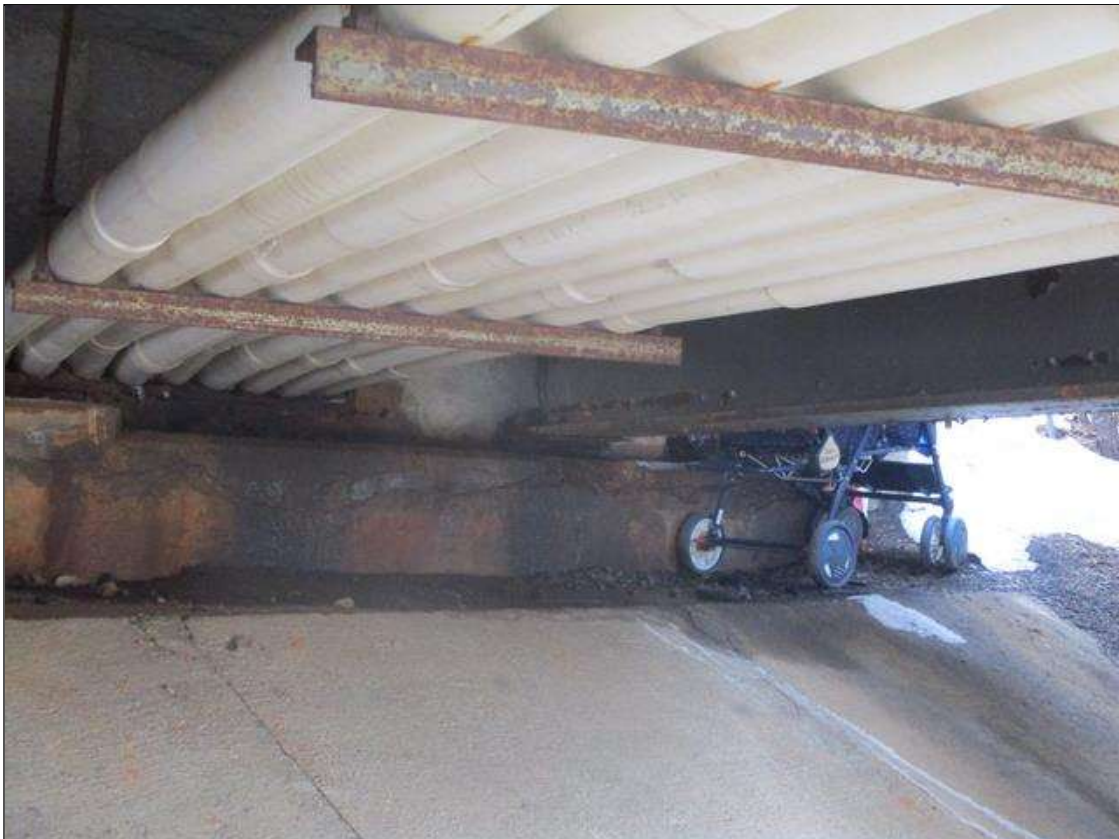
HOMELESS CAMP UNDER SPAN 4

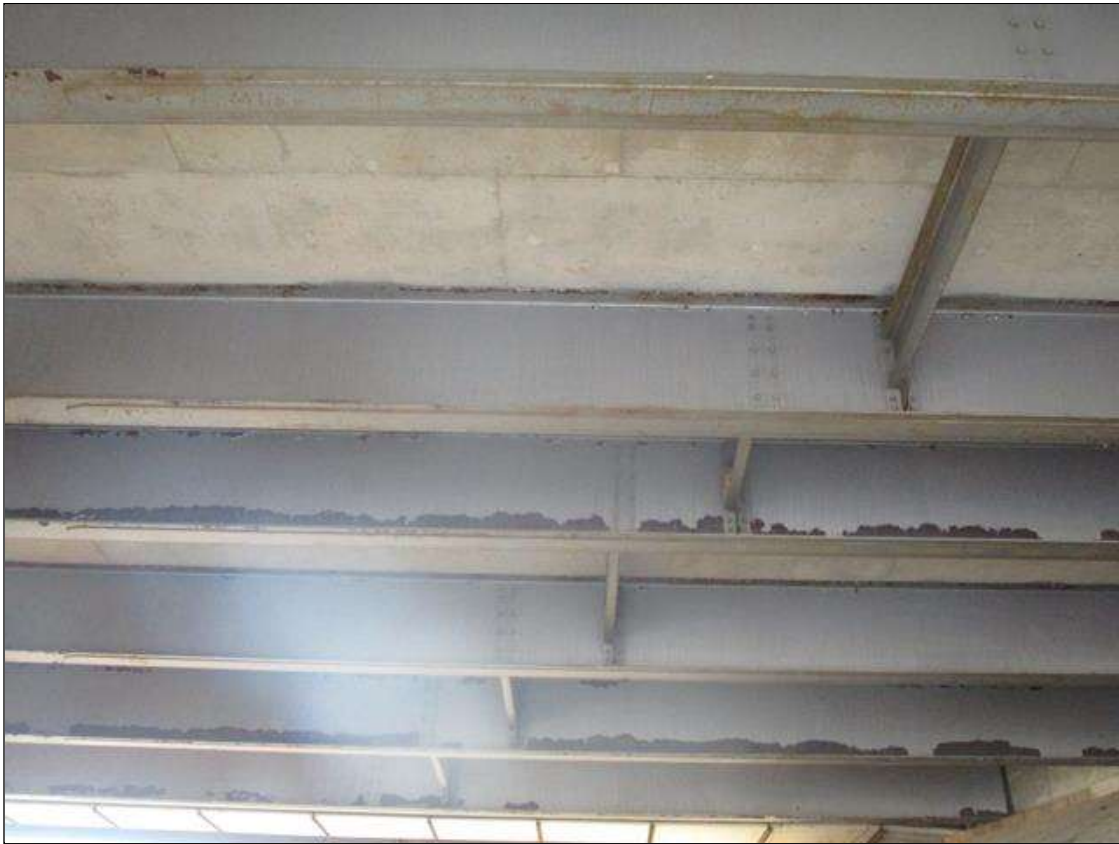
Span 1 Beam 6 - Protective System: PC LOSS AT CORRODED AREAS & PEELING THROUGHOUT FLANGES & BOTTOM 1/3 OF WEB

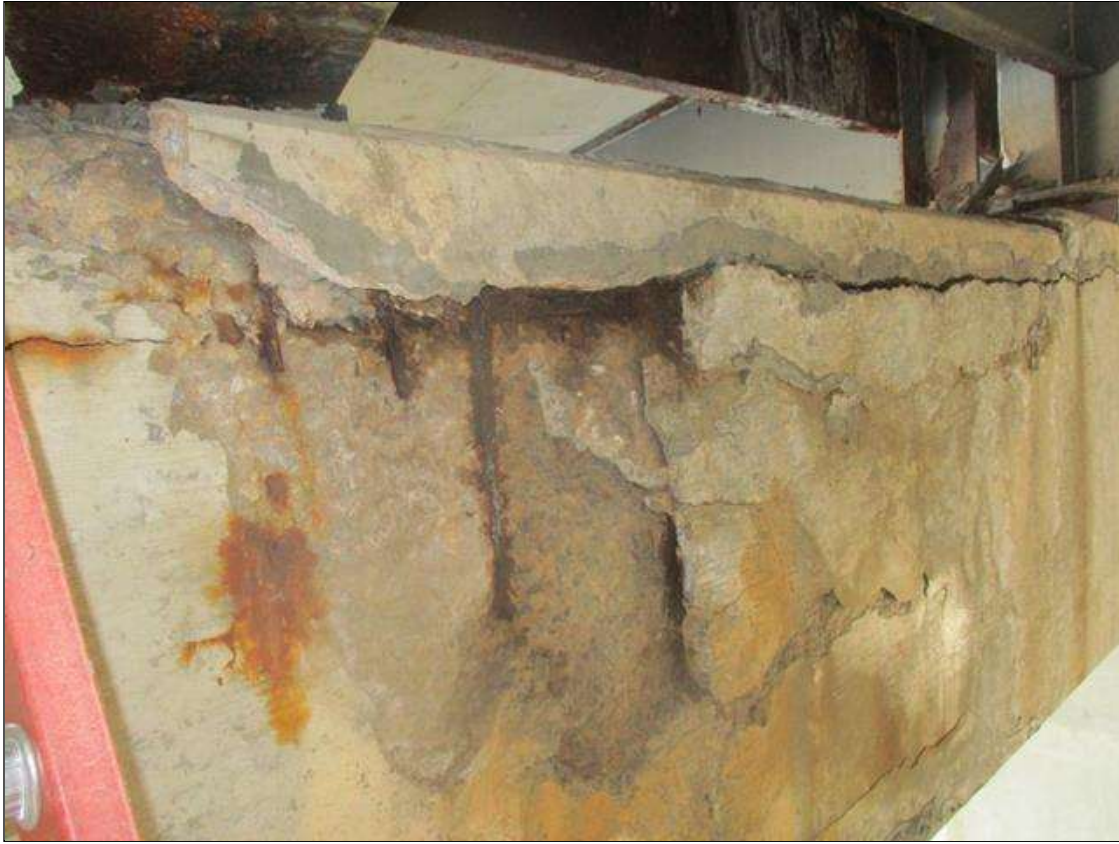
Bent 1 Cap 1: DELAM (16SF) TO TOP & BOTTOM EDGE (DELAM NOT UNDER BEARING), NEAR FACE AT BAY 4, FAR FACE SIMILAR & DELAM (5SF) NEAR FACE ABOVE COLUMN 3 & DELAM (16SF) TO TOP & BOTTOM EDGE (DELAM NOT UNDER BEARING). UP TO 80% SECTION REMAINING ON THE EXPOSED REBAR. SPALL UNDER BAY 4 IS UP TO 4 SQ FT. (PAR)

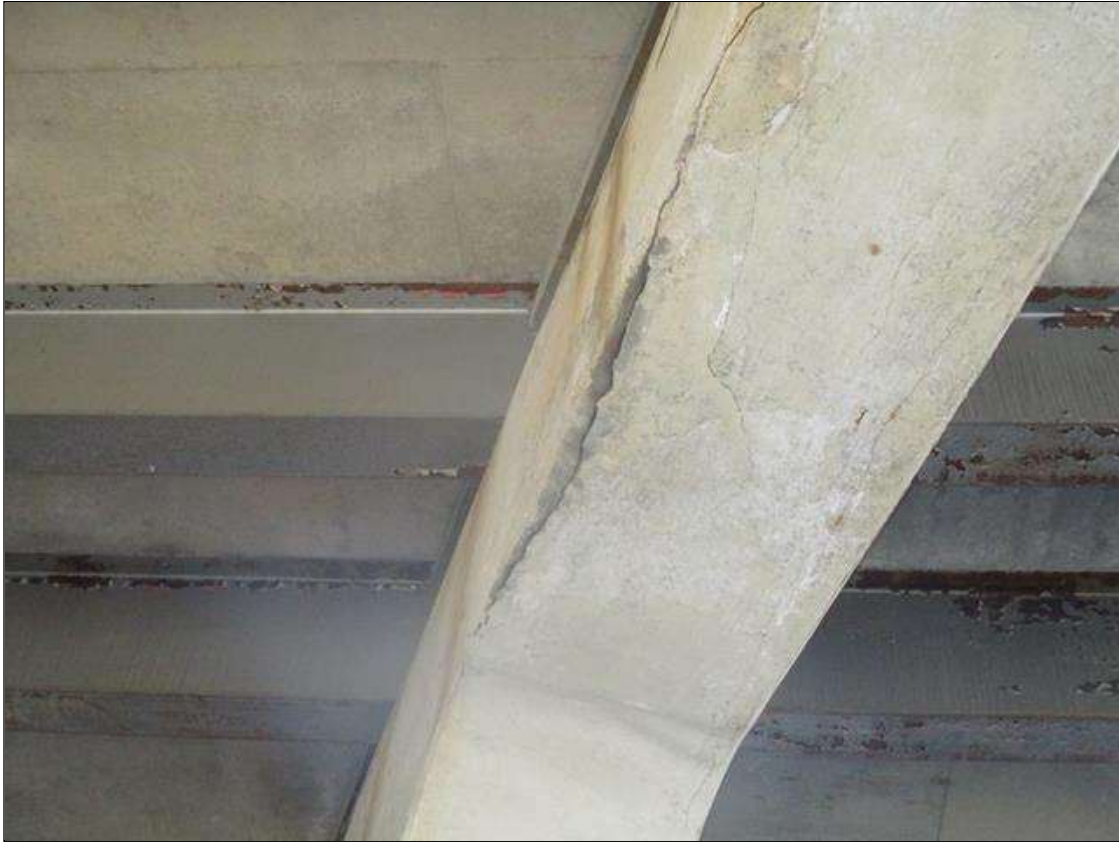
Bent 1 Cap 1: SPALL (2FT L. X 1FT H. X 8IN D.) WITH EXPOSED REINFORCING WITH UP TO 80% SECTION REMAINING IN THE EXPOSED REBAR AT THE BOTTOM EDGE TO THE LEFT OF COLUMN 4, NEAR FACE UNDER BEAM 7 & DELAM (16SF) WITH CRACK UP TO ONE IN WIDE TO TOP & BOTTOM EDGE (DELAM NOT UNDER BEARING) WITH RUST STAINING, NEAR FACE AT BAY 8, FAR FACE SIMILAR & DELAM (16SF) TO TOP & BOTTOM EDGE (DELAM NOT UNDER BEARING) WITH RUST STAINING, FAR FACE AT BAY 6 & DELAM (12SF) TO TOP EDGE (DELAM NOT UNDER BEARING), FAR FACE OVER COLUMN 1
