NC DEPARTMENT OF TRANSPORTATION
 DIVISION OF HIGHWAYS
 STRUCTURE MANAGEMENT UNIT

ATTENTION: **PAR SUBMITTED. NEW REPAIRS. CHANGE IN STRUCTURE DATA.**

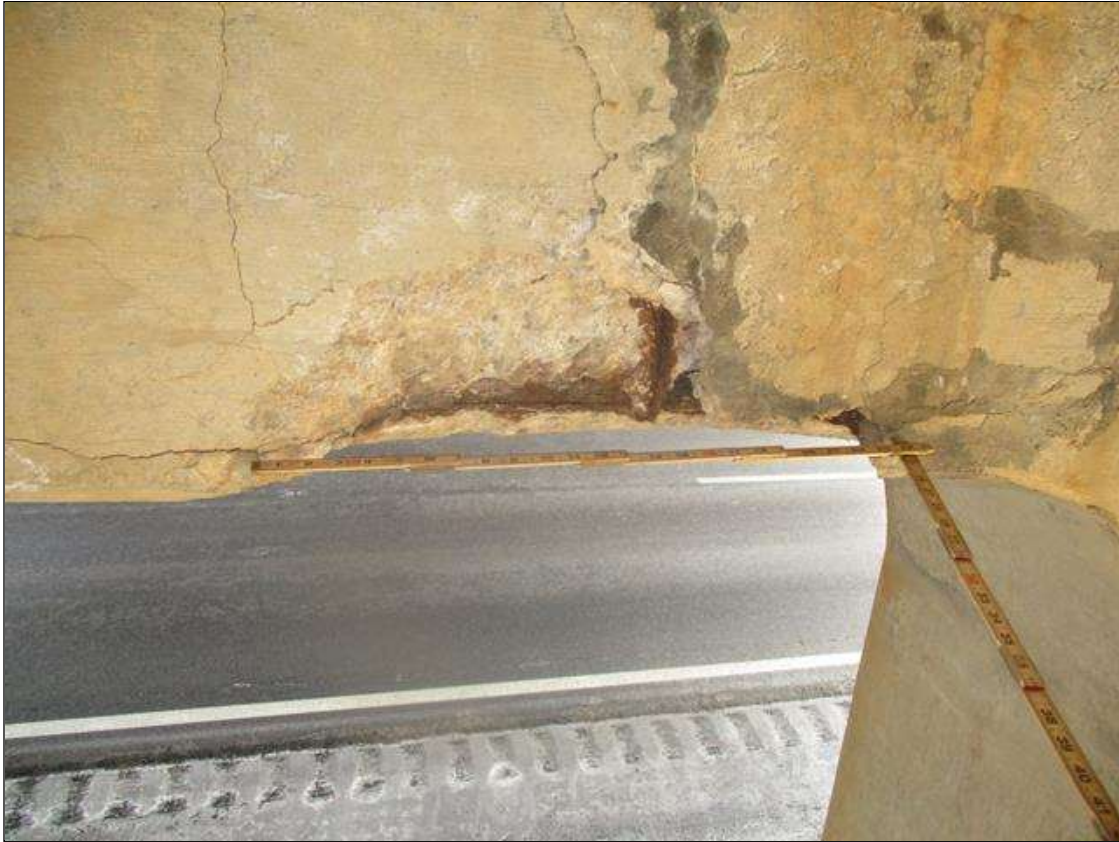
Bent 1 Cap 1: SPALL (2FT L. X 1FT H. X 8IN D.) WITH EXPOSED REINFORCING WITH UP TO 80% SECTION REMAINING IN THE EXPOSED REBAR AT THE BOTTOM EDGE TO THE LEFT OF COLUMN 4, NEAR FACE UNDER BEAM 7 & DELAM (16SF) WITH CRACK UP TO ONE IN WIDE TO TOP & BOTTOM EDGE (DELAM NOT UNDER BEARING) WITH RUST STAINING, NEAR FACE AT BAY 8, FAR FACE SIMILAR & DELAM (16SF) TO TOP & BOTTOM EDGE (DELAM NOT UNDER BEARING) WITH RUST STAINING, FAR FACE AT BAY 6 & DELAM (12SF) TO TOP EDGE (DELAM NOT UNDER BEARING), FAR FACE OVER COLUMN 1

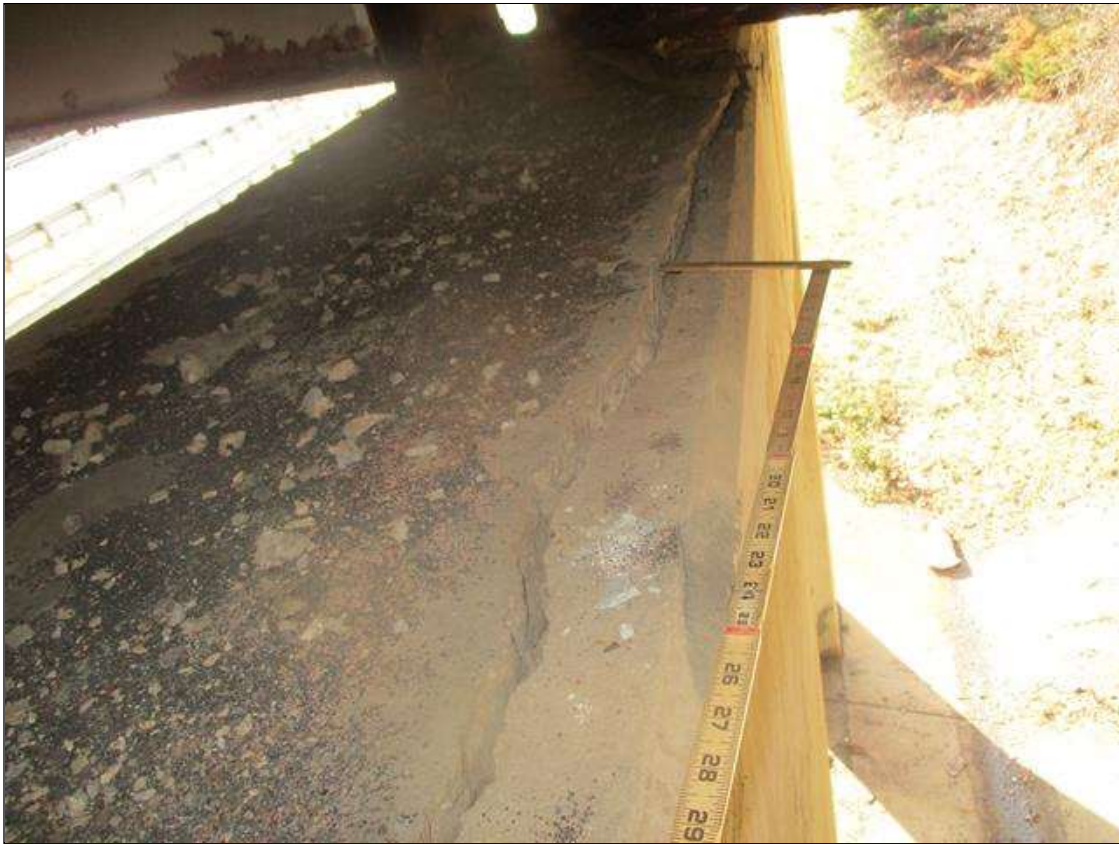
Bent 1 Cap 1: SPALL (2FT L. X 1FT H. X 8IN D.) WITH EXPOSED REINFORCING WITH UP TO 80% SECTION REMAINING IN THE EXPOSED REBAR AT THE BOTTOM EDGE TO THE LEFT OF COLUMN 4, NEAR FACE UNDER BEAM 7 & DELAM (16SF) WITH CRACK UP TO ONE IN WIDE TO TOP & BOTTOM EDGE (DELAM NOT UNDER BEARING) WITH RUST STAINING, NEAR FACE AT BAY 8, FAR FACE SIMILAR & DELAM (16SF) TO TOP & BOTTOM EDGE (DELAM NOT UNDER BEARING) WITH RUST STAINING, FAR FACE AT BAY 6 & DELAM (12SF) TO TOP EDGE (DELAM NOT UNDER BEARING), FAR FACE OVER COLUMN 1

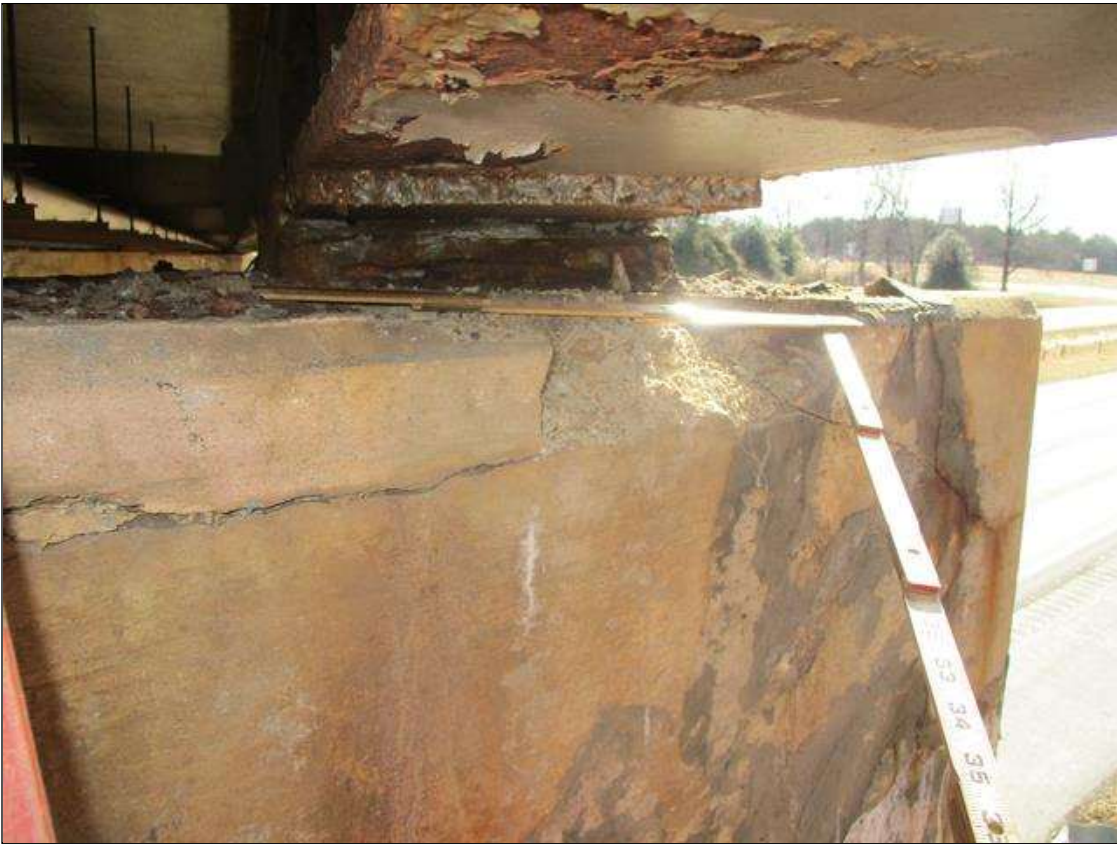
Bent 1 Cap 1: SPALL UP TO 18 IN LONG X 3 IN HIGH X 4 IN DEEP IN NEAR FACE BELOW BEAM 10. NO EXPOSED REBAR AND NOT UNDERMINING THE MASONRY PLATE

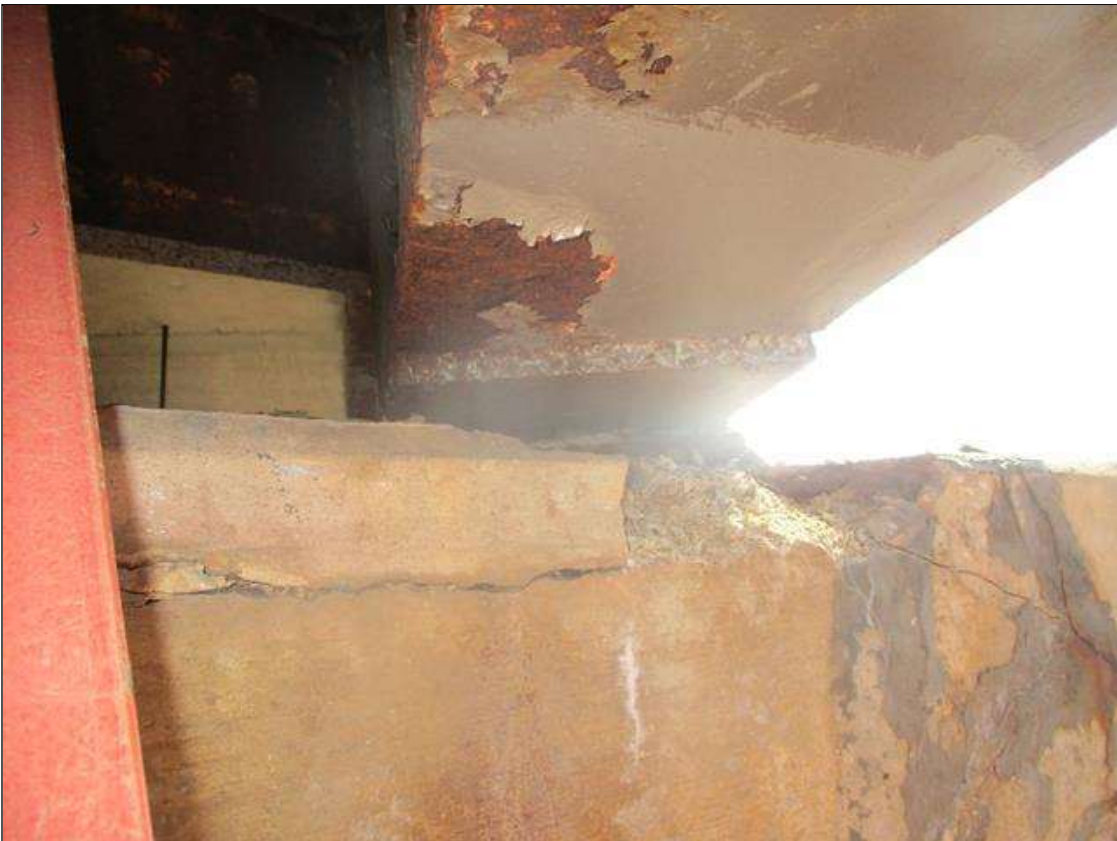
Span 1 Beam 10: REPAIR PLATE (3/4IN) TO BOTTOM FLANGE (8IN L. X FULL WIDTH) AT FAR END

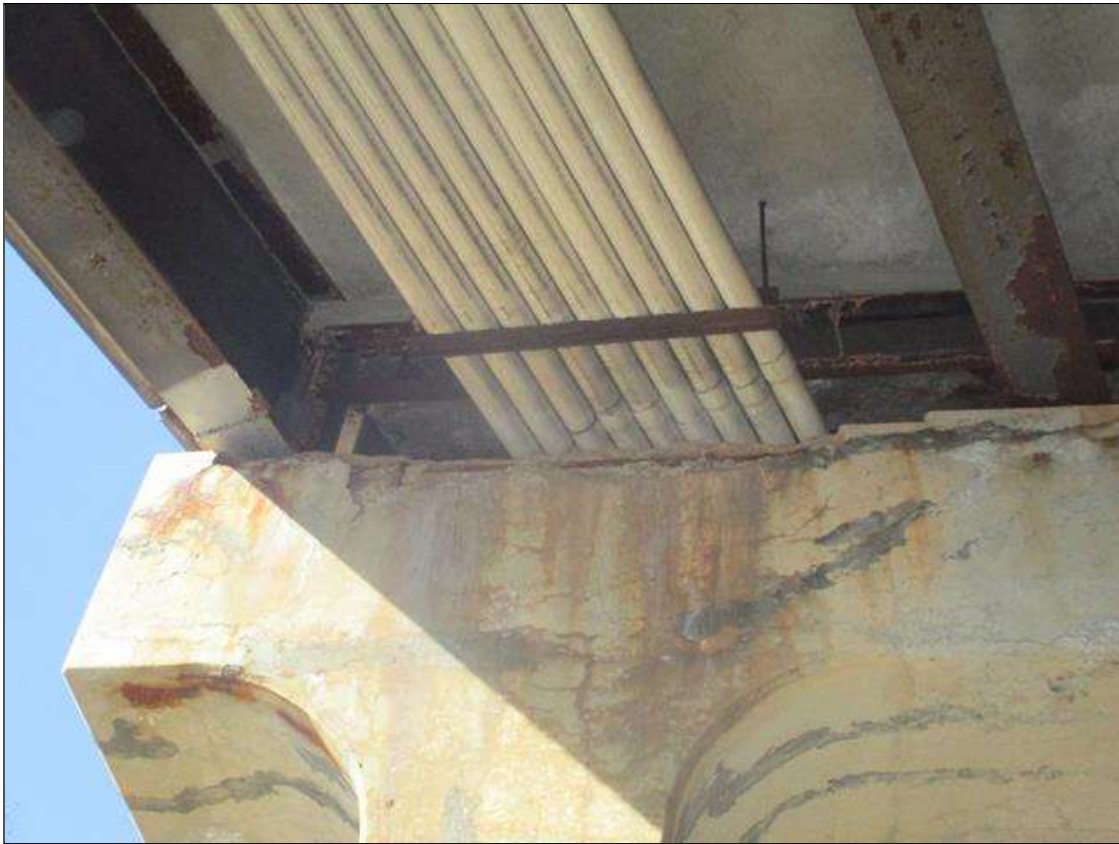
Bent 1 Cap 1: SPALL (7FT L. X 1FT WEST. X 4IN D.) WITH EXPOSED REINFORCING TO TOP EDGE, FAR FACE AT BAY 9. UP TO 90% SECTION REMAINING IN THE EXPOSED REBAR. (PAR) - COULD NOT ACCESS WITH LADDER DUE TO PROXIMITY OF LIVE TRAFFIC AT FAR FACE OF BENT.

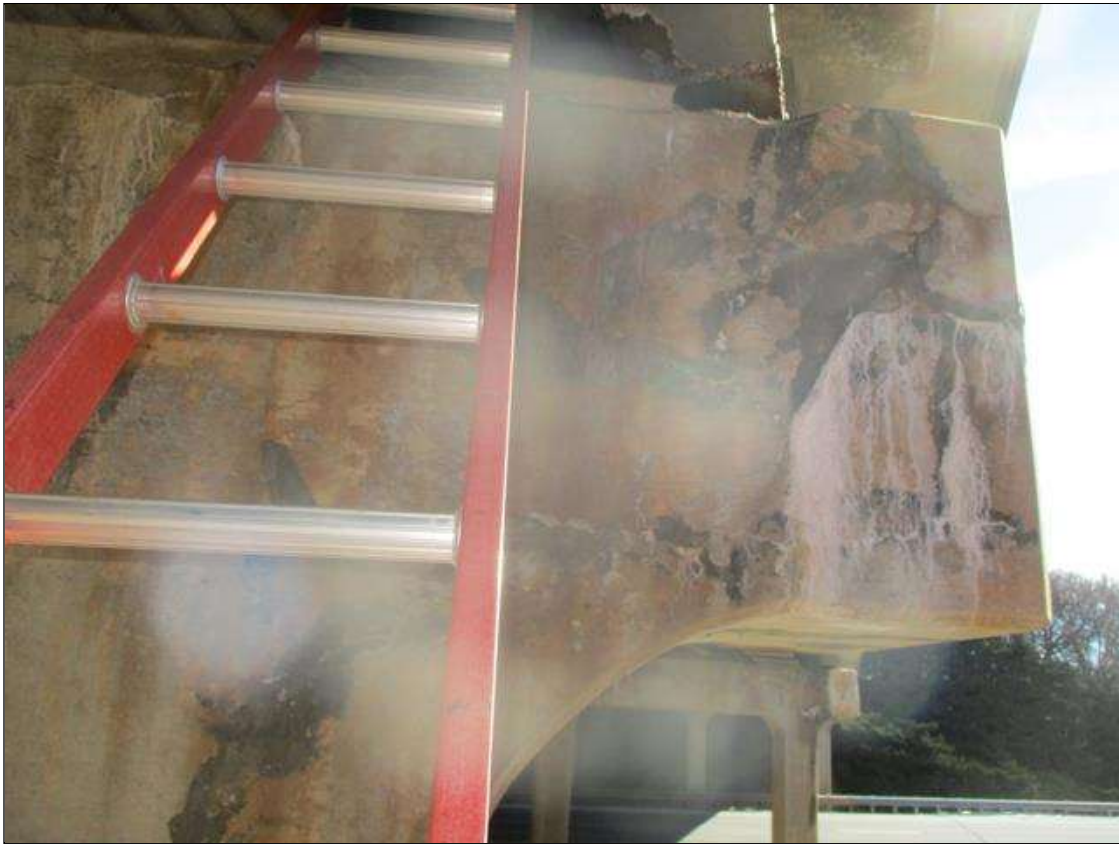
Bent 1 Cap 1: VERTICAL & HORIZONTAL OPEN CRACKING (UP TO 1/16IN X FULL HT.) WITH EFFLO. & RUST STAINING & VERTICAL & HORIZONTAL OPEN CRACKING (UP TO 1/16IN X FULL HT.) WITH EFFLO. & RUST STAINING, NEAR FACE AT RIGHT END

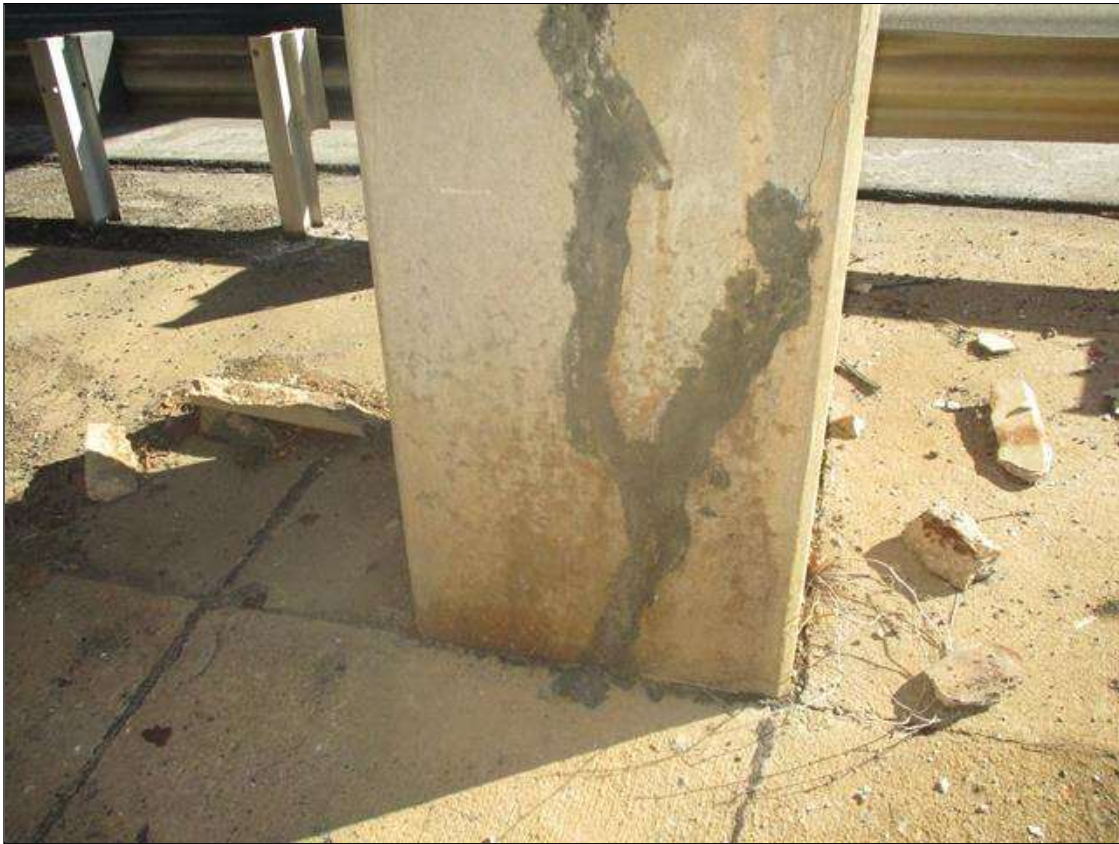
Bent 1 Pile 5: PARTIALLY SEALED CRACKS, (UP TO 1/32IN X FULL HT.) THROUGHOUT

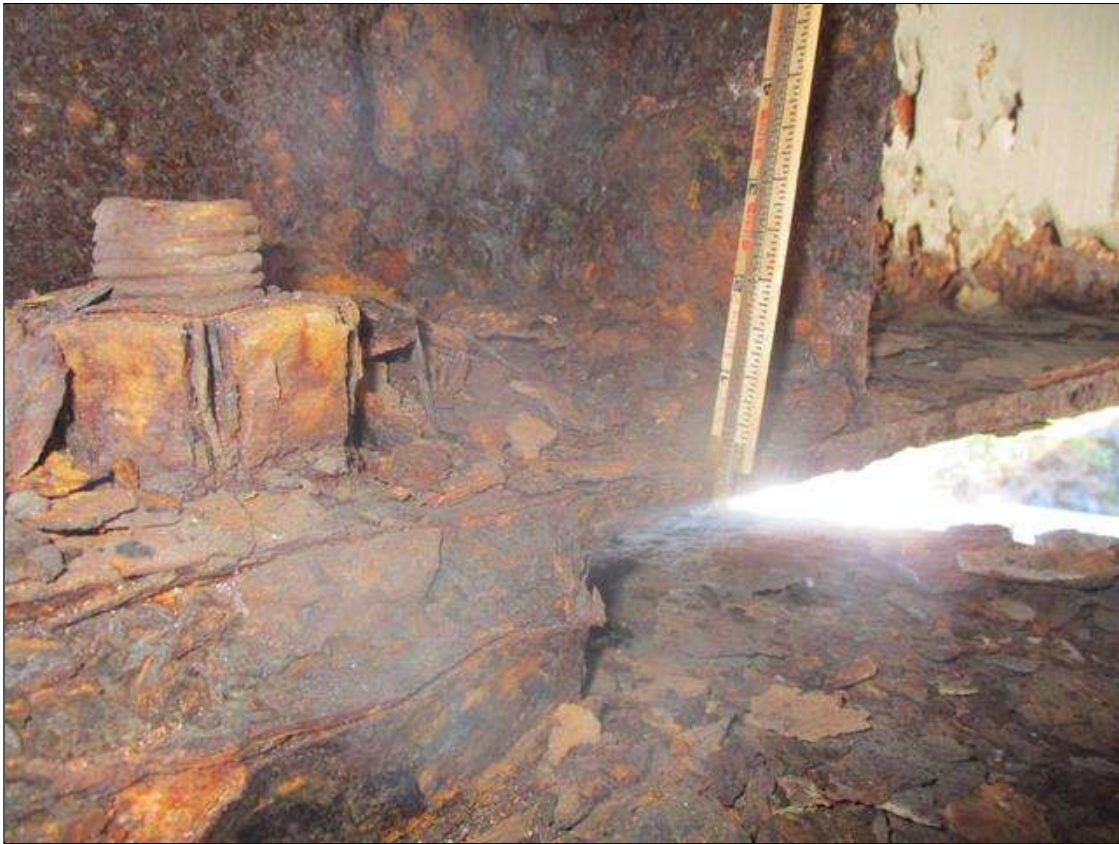
Span 3 Beam 1: BOTTOM FLANGE SECTION LOSS (UP TO 47%, 7/16IN SL, 1/2IN REMAIN) FULL WIDTH FOR 1FT L. AT NEAR END WITH REPAIR PLATES (3/4IN) TO WEB (FULL HT X 2FT L.) & STIFFENER (FULL HT. X FULL WIDTH). (PAR)

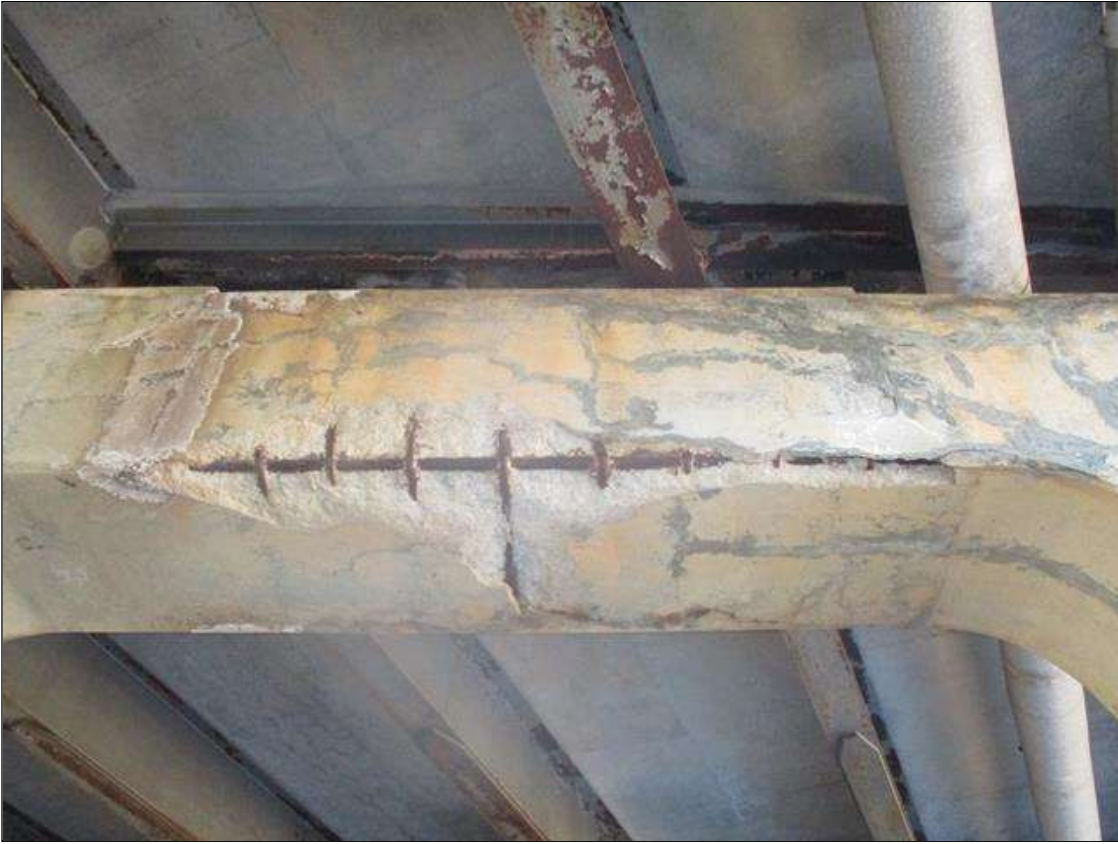
Bent 2 Cap 1: SPALLING (14FT L. X 3FT WIDE X 6IN D.) WITH EXPOSED REINFORCING, TO BOTTOM EDGE & UNDERSIDE AT BEAM 2, FAR FACE. UP TO 90% SECTION REMAINING IN THE EXPOSED REBAR (PAR)

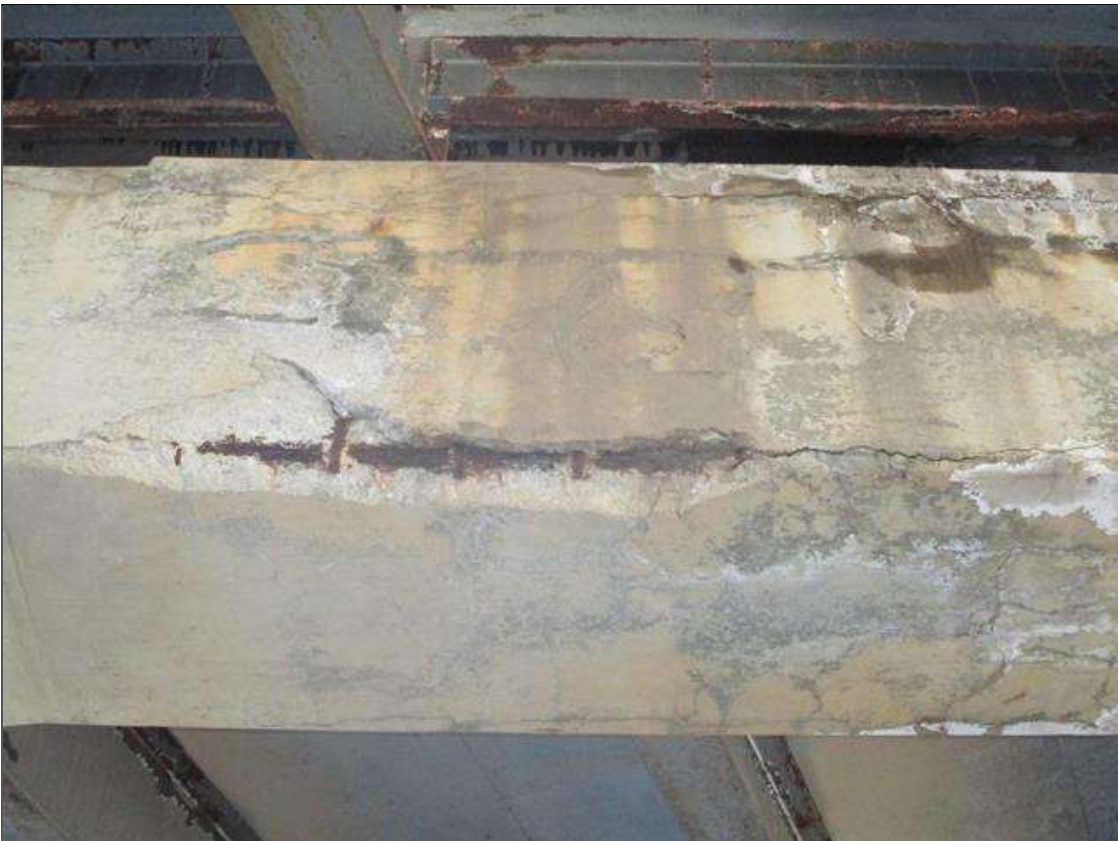
Bent 2 Cap 1: SPALLING/DELAM (10SF X 4IN D.) WITH EXPOSED REINFORCING TO BOTTOM EDGE, NEAR FACE AT BAY 4. UP TO 70% SECTION REMAINING IN THE EXPOSED REBAR. (PAR)

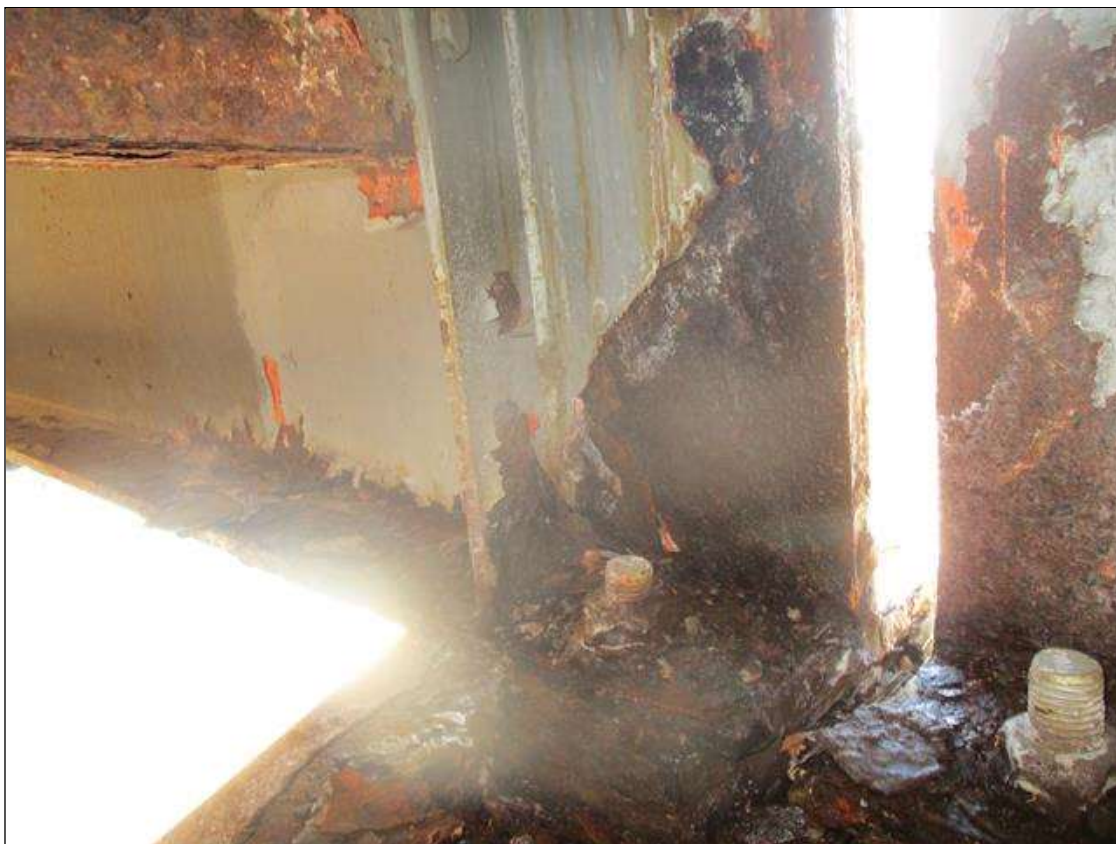
Span 3 Beam 10: REPAIR PLATES (3/4IN) TO WEB (3FT L. X 15IN H.) AT NEAR END

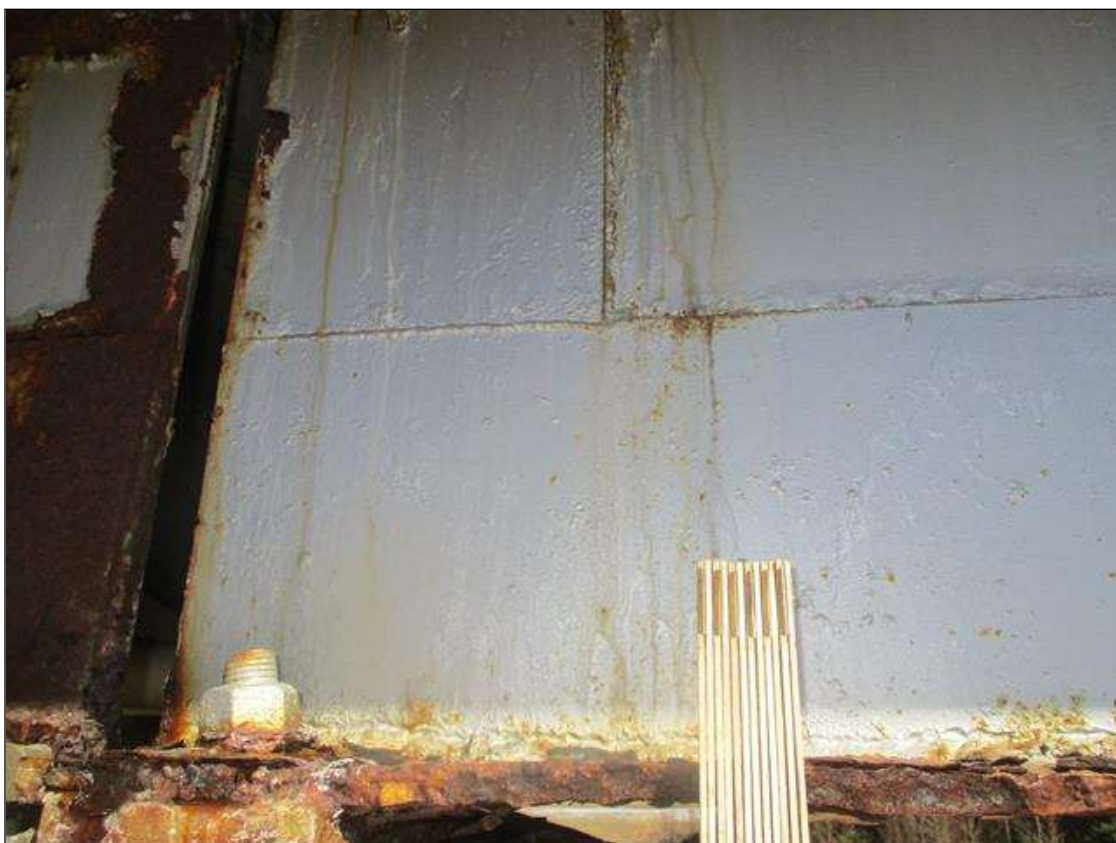
Span 3 Beam 10: BOTTOM FLANGE SECTION LOSS (UP TO 27%, 1/4IN SL, 11/16IN REMAIN) FULL WIDTH FOR 12IN L. AT NEAR END RIGHT SIDE (PAR).

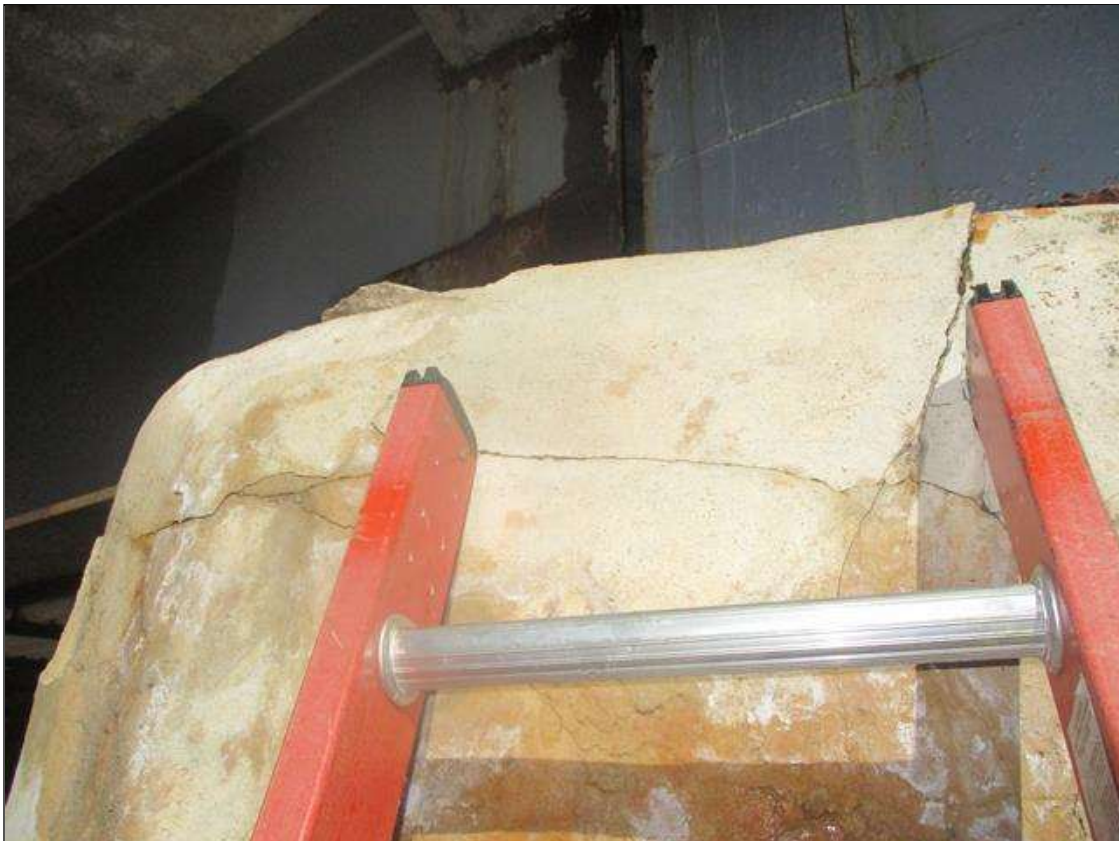
Bent 2 Cap 1: POOR PATCH (3SF) WITH OPEN 1/32IN MAP CRACKING WITH RUST STAINING & EFFLO. THROUGHOUT, RIGHT END

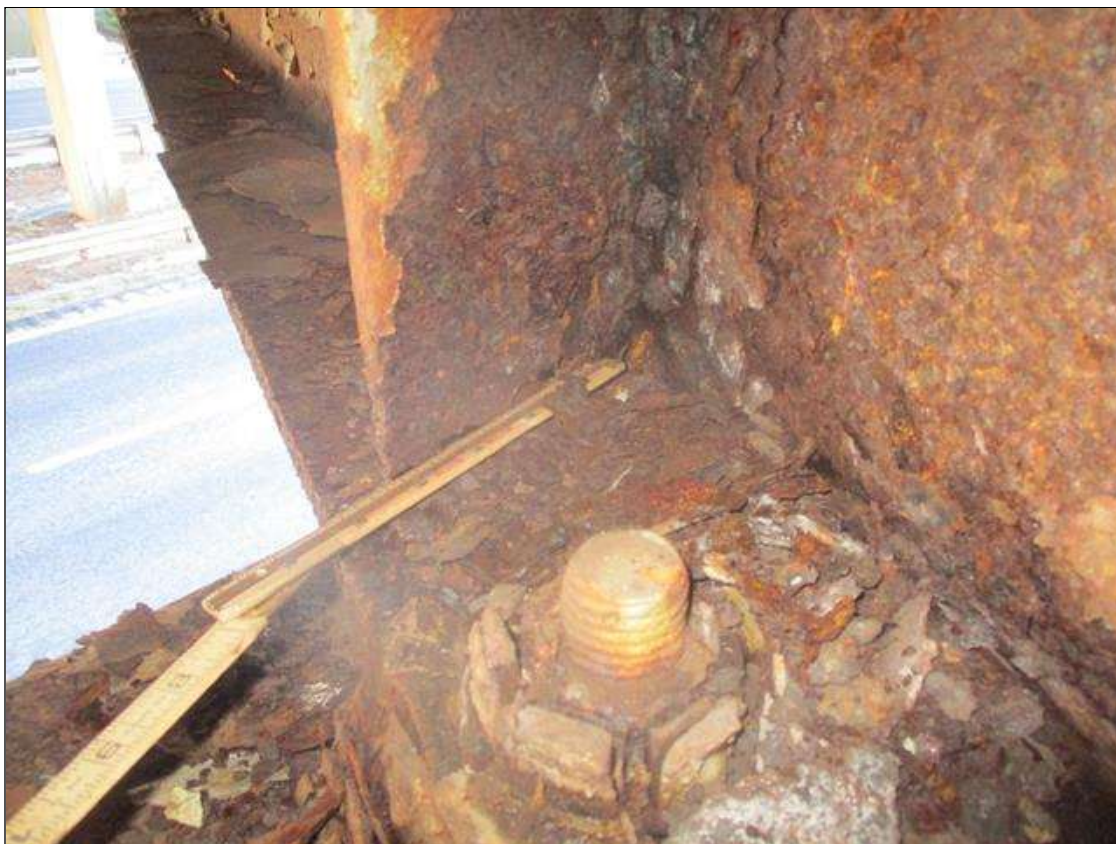
Span 3 Beam 1: FAR END, RIGHT STIFFENER SECTION LOSS (UP TO 100%) FOR 4 IN WIDE AT BOTTOM. (PAR)

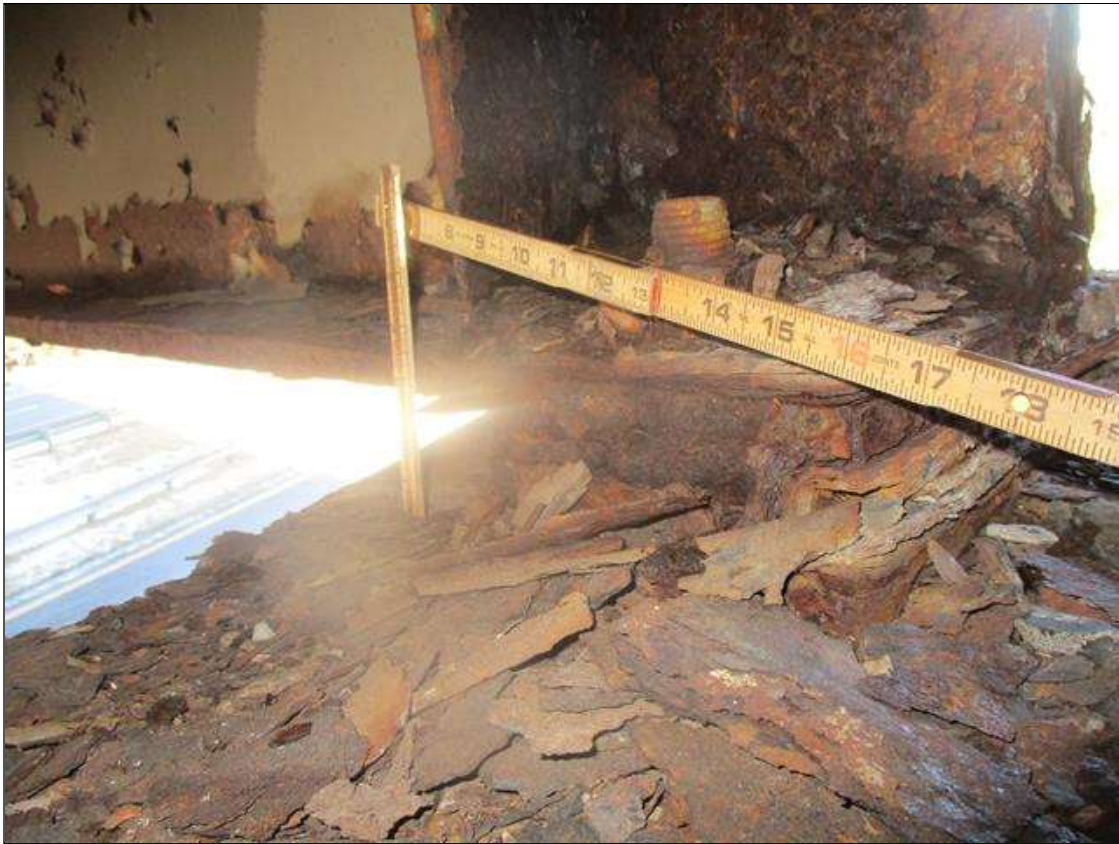
Span 3 Beam 1: BOTTOM FLANGE SECTION LOSS (UP TO 47%, 7/16IN SL, 1/2IN REMAIN) FULL WIDTH FOR 1FT L. AT NEAR END WITH REPAIR PLATES (3/4IN) TO WEB (FULL HT X 2FT L.) & STIFFENER (FULL HT. X FULL WIDTH). (PAR)

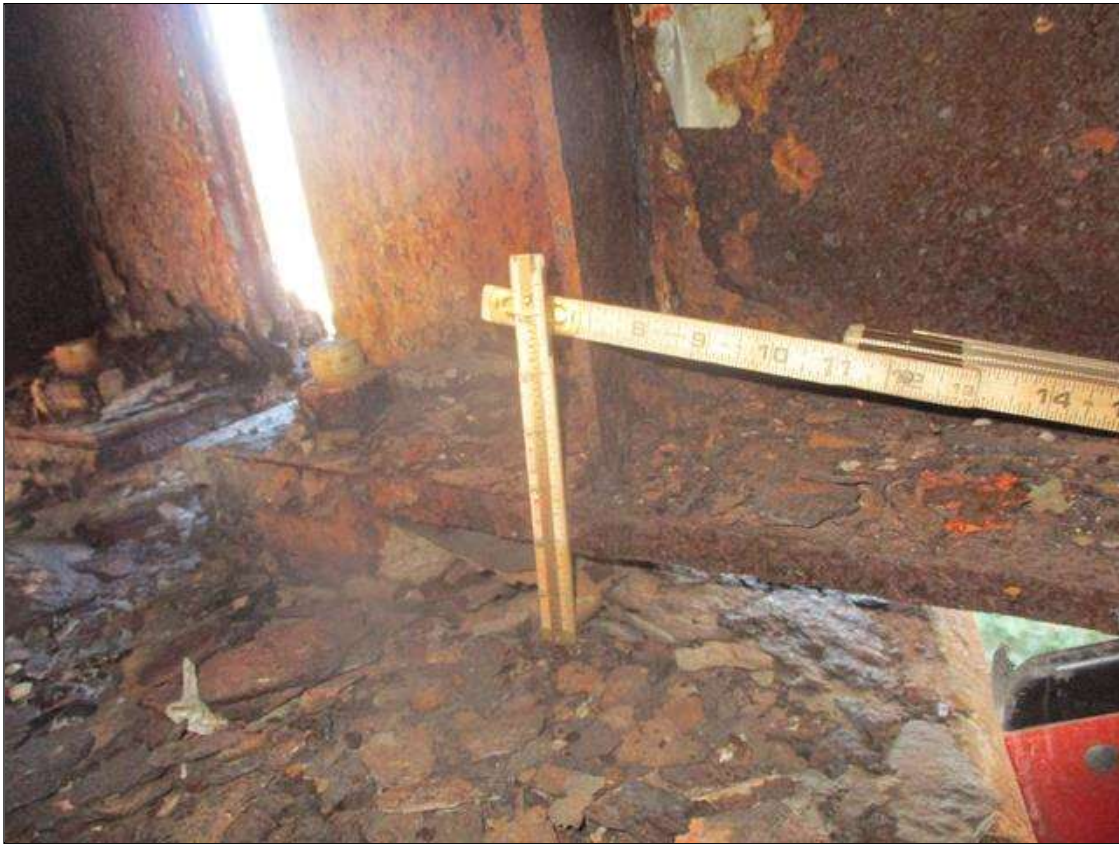
Span 4 Beam 1: BOTTOM FLANGE SECTION LOSS (UP TO 27%, 1/4IN SL, 11/16IN REMAIN) FULL WIDTH FOR 2FT L. AT NEAR END & RIGHT STIFFENER SECTION LOSS (AVG. 1/4IN REMAIN) TO BOTTOM 3IN. (PAR)

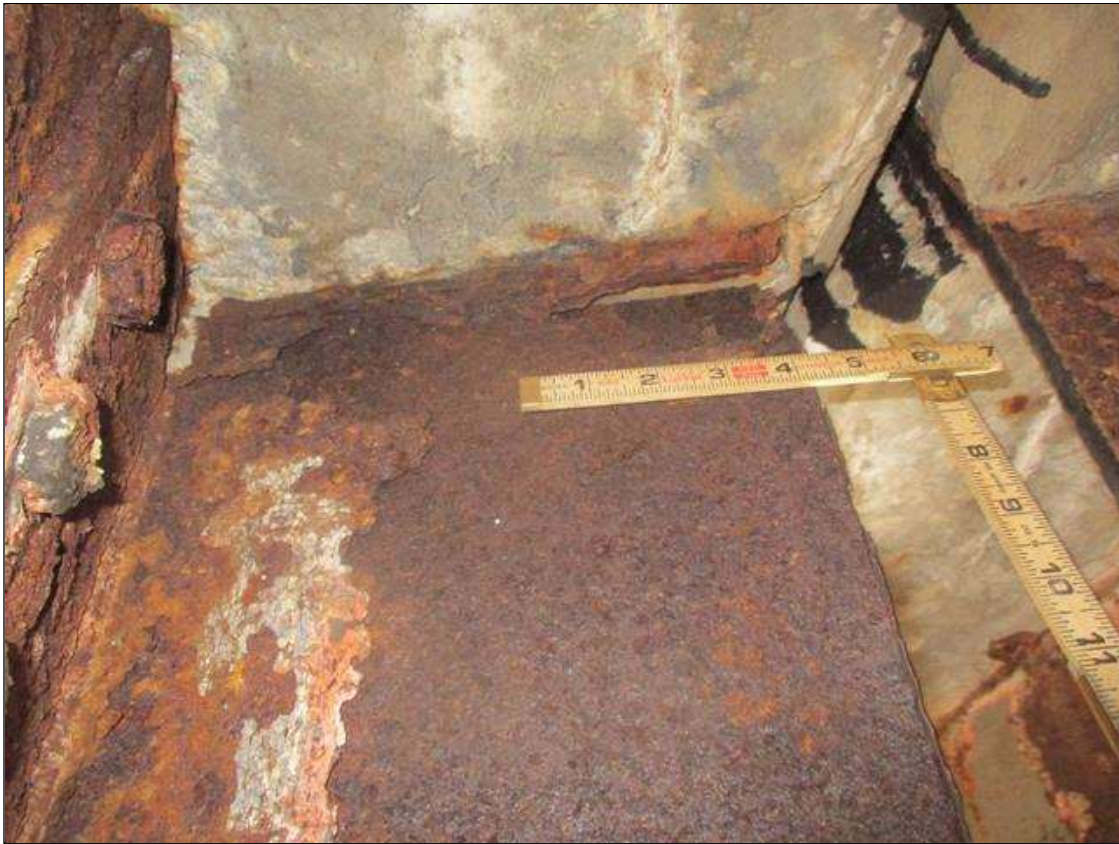
Span 4 Beam 8: WEB SECTION LOSS (UP TO 100%, AVG. 1/8IN REMAIN) TO TOP, 4IN L. X 1IN H.) AT NEAR END WITH REPAIR PLATE (3/4IN) AT RIGHT SIDE, PLATE DOES NOT COVER FULL HT. OF WEB (PAR)

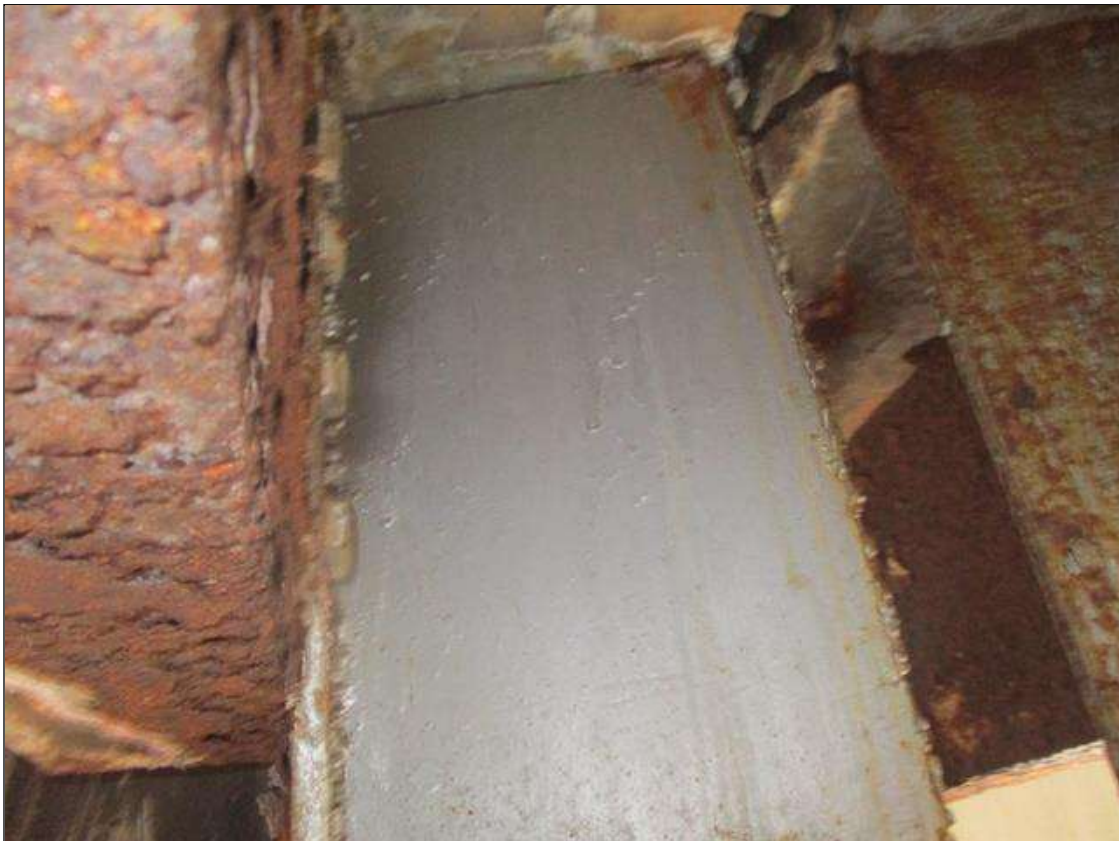
Span 4 Beam 9: WEB SECTION LOSS (UP TO 100%, AVG. 1/8IN REMAIN) TO TOP, 4IN L. FOR 2IN H. AT NEAR END WITH REPAIR PLATE (3/4IN X FULL HT.) AT LEFT SIDE. A REPAIR PLATE HAS BEEN INSTALLED.

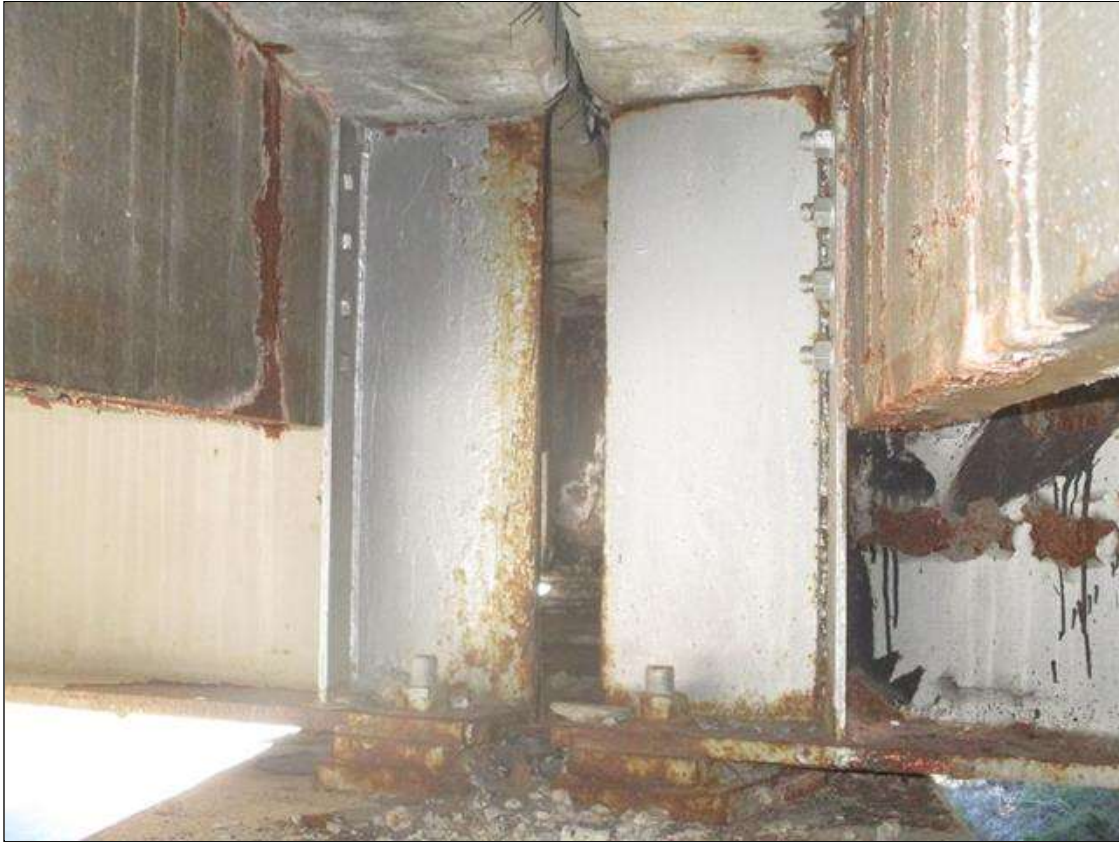
Span 4 Beam 8: WEB SECTION LOSS (UP TO 100%, AVG. 1/8IN REMAIN) TO TOP, 4IN L. X 1IN H.) AT NEAR END WITH REPAIR PLATE (3/4IN) AT RIGHT SIDE, PLATE DOES NOT COVER FULL HT. OF WEB (PAR)

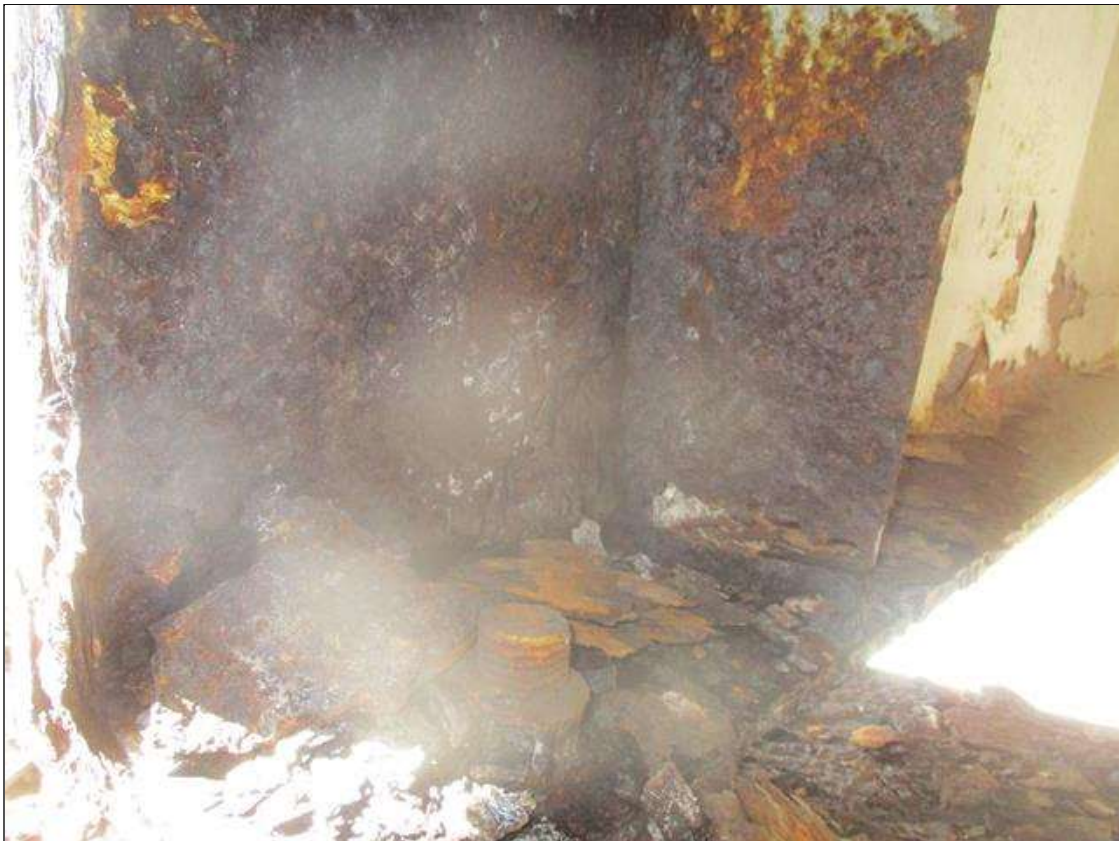
Span 3 Beam 10: LEFT STIFFENER SECTION LOSS (UP TO 100%) TO BOTTOM FOR FULL WIDTH X 1 IN HIGH. (PAR)

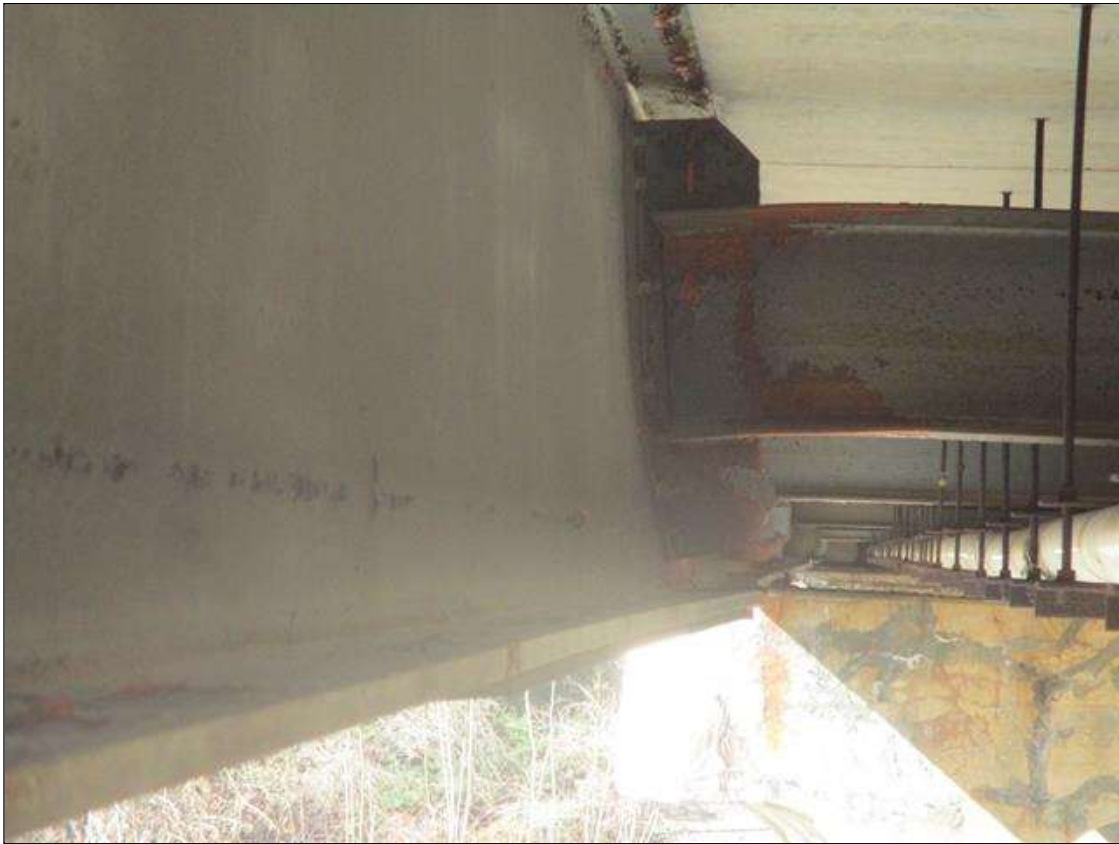
Span 3 Beam 10: IMPACT DAMAGE: 18" L SECTION OF BOTTOM FLANGE AND COVER PLATE BENT UPWARD UP TO 2-1/4" AT 24' FROM BENT 3 BEARING. (PAR)

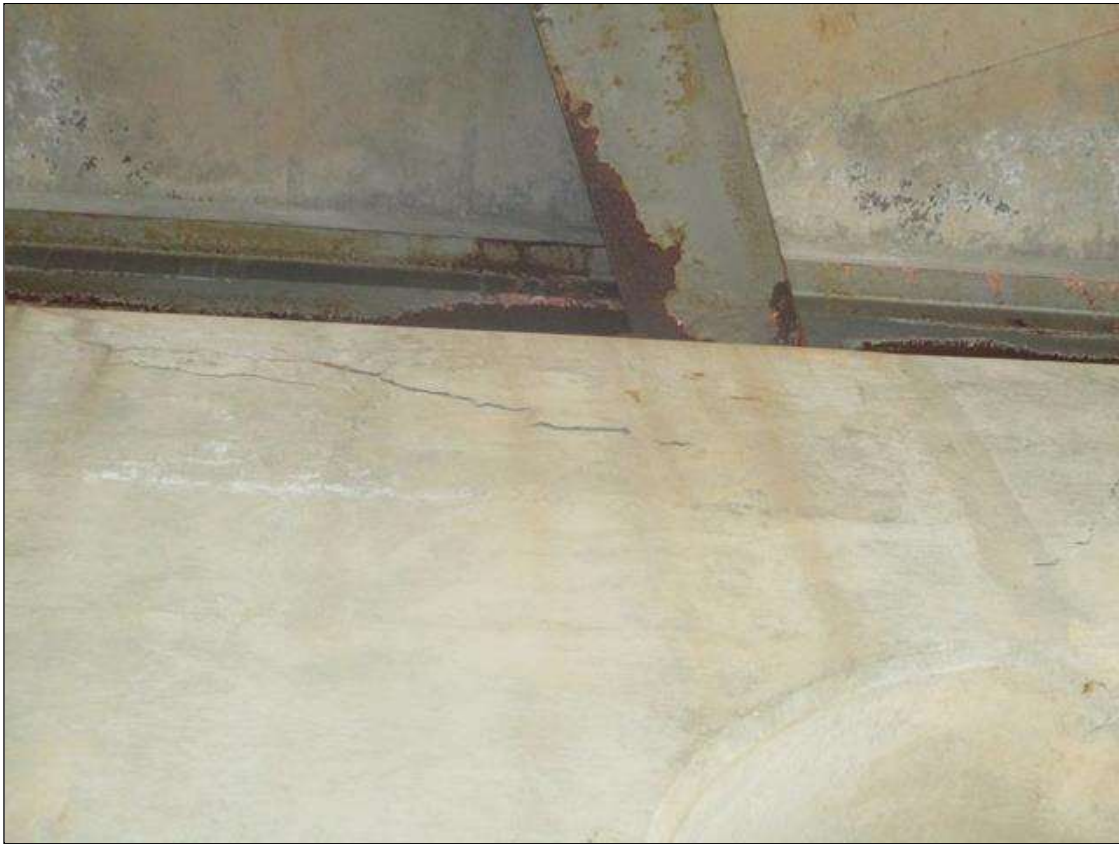
Bent 3 Cap 1: DELAM (14SF) TO BOTTOM EDGE, NEAR FACE AT BAY 2, SIMILAR AT FAR FACE & DELAM (8SF) TO NEAR FACE BELOW BEAM 6 (DEALM NOT UNDER BEARING) & DELAM (8SF) TO NEAR FACE BELOW BEAM 8 (DEALM NOT UNDER BEARING) & DELAM (8SF) TO BOTTOM EDGE, NEAR FACE UNDER BEAM 9. & DELAM (8SF) TO BOTTOM EDGE, FAR FACE BELOW BEAM 3

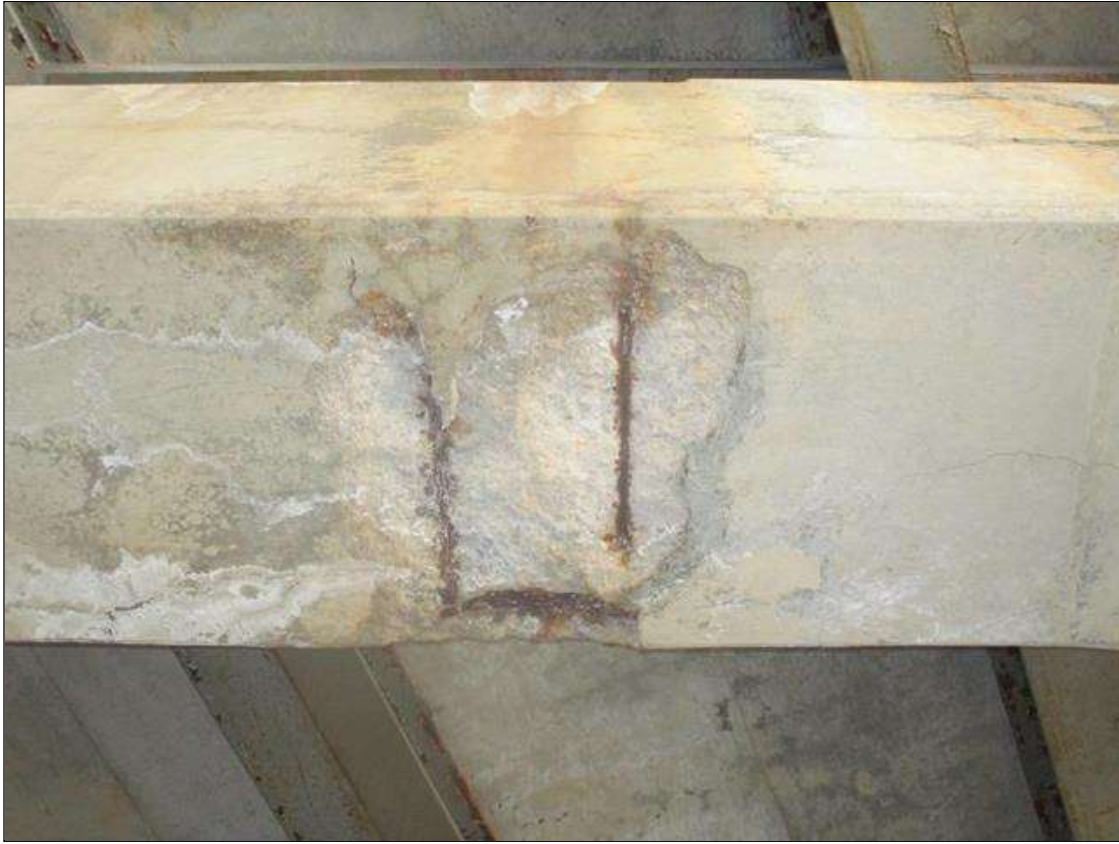
Bent 3 Cap 1: SPALL (10SF X 4IN D.) WITH EXPOSED REINFORCING, UNDERSIDE AT BAY 4. UP TO 80% SECTION REMAINING IN THE EXPOSED BAR. (PAR)
