NC DEPARTMENT OF TRANSPORTATION
 DIVISION OF HIGHWAYS
 STRUCTURE MANAGEMENT UNIT

ATTENTION: **PAR SUBMITTED. NEW REPAIRS. CHANGE IN STRUCTURE DATA.**

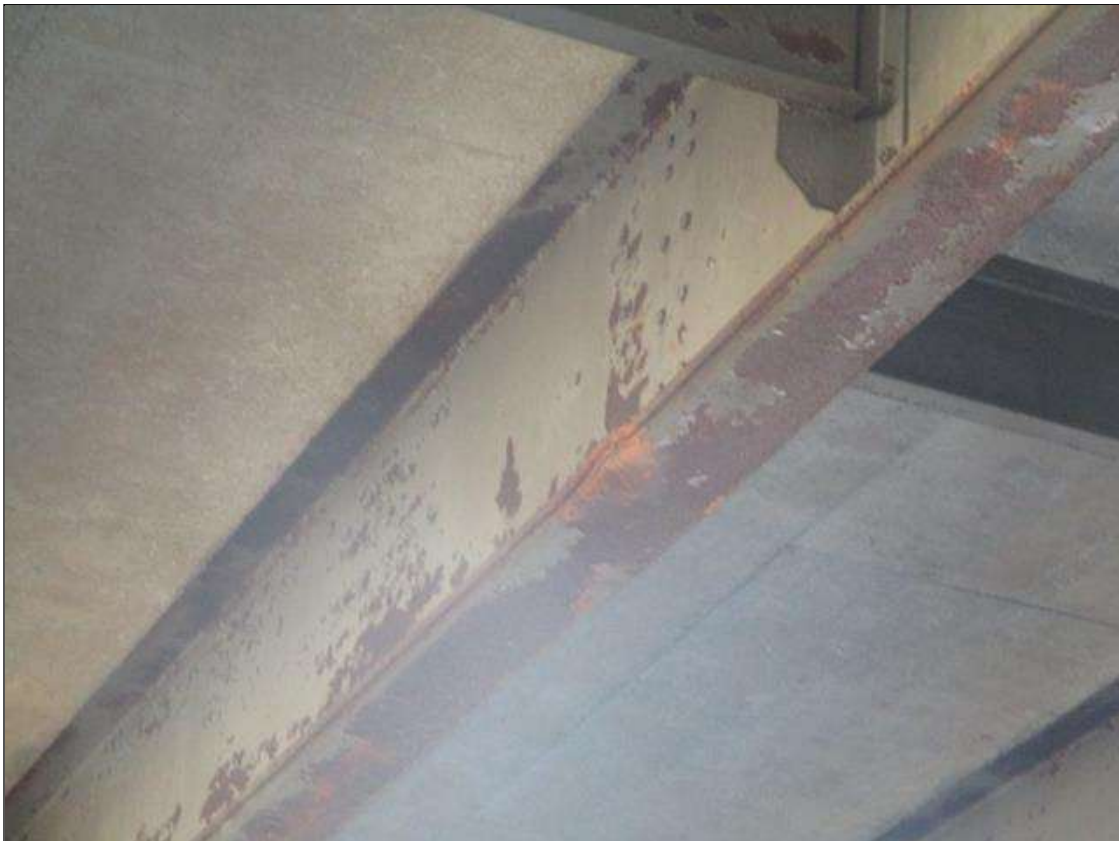
Span 3 Beam 3: IMPACT DAMAGE: 18"L SECTION OF BOTTOM FLANGE AND COVER PLATE BENT UPWARD 1-1/2" AT 24' FROM BENT 3 BEARING. (PAR)

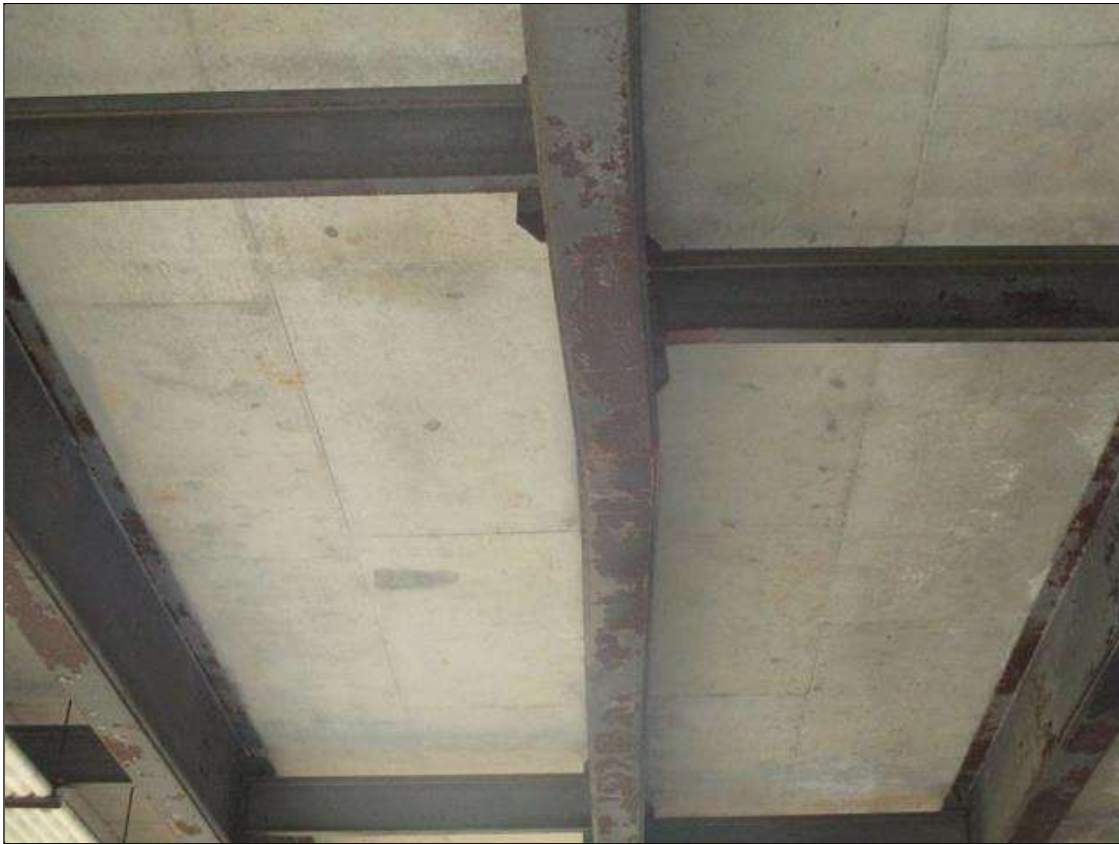
Span 3 Beam 8: IMPACT DAMAGE: 18"L SECTION OF BOTTOM FLANGE BENT UPWARD UP TO 2-1/2" AT 25' FROM BENT 3 BEARING. (PAR)

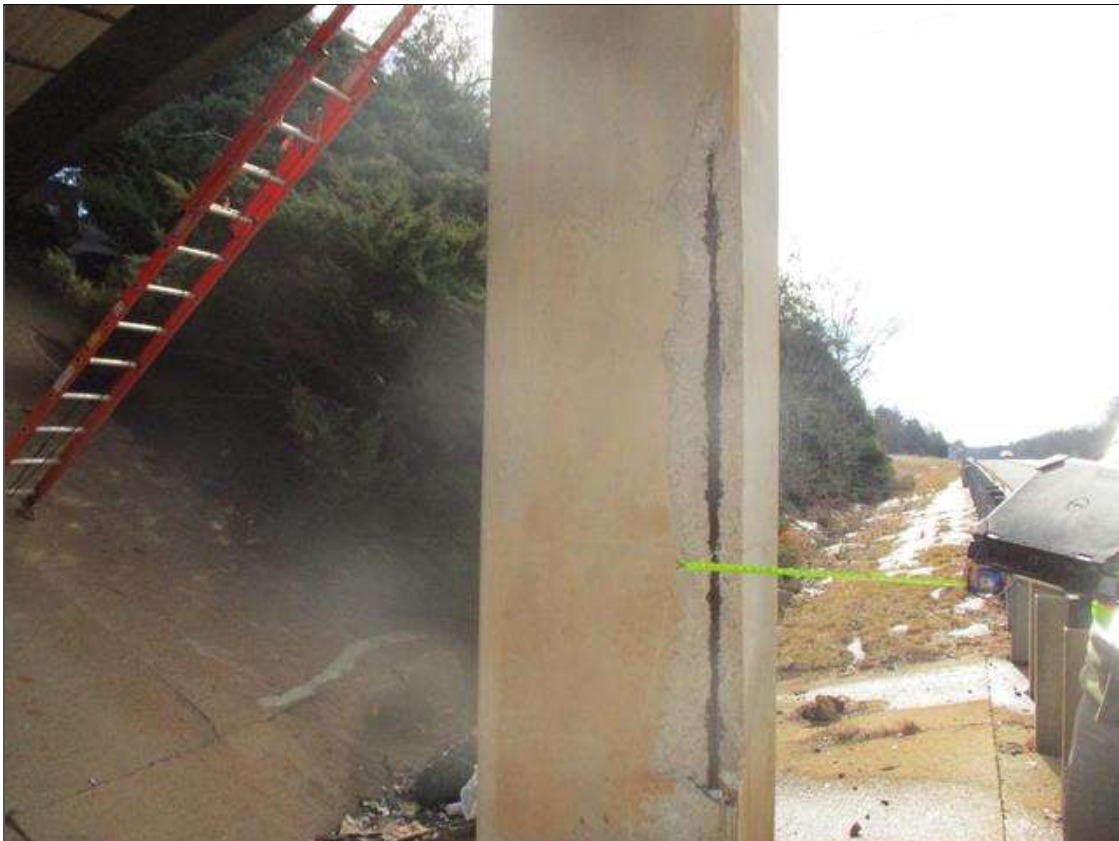
Bent 3 Pile 5: SPALL (7.5FT H. X 12N WIDE X 3IN D.) WITH EXPOSED REINFORCING, TO NEAR LEFT CORNER AT BOTTOM. UP TO 90% SECTION REMAINING IN THE EXPOSED REBAR. (PAR)

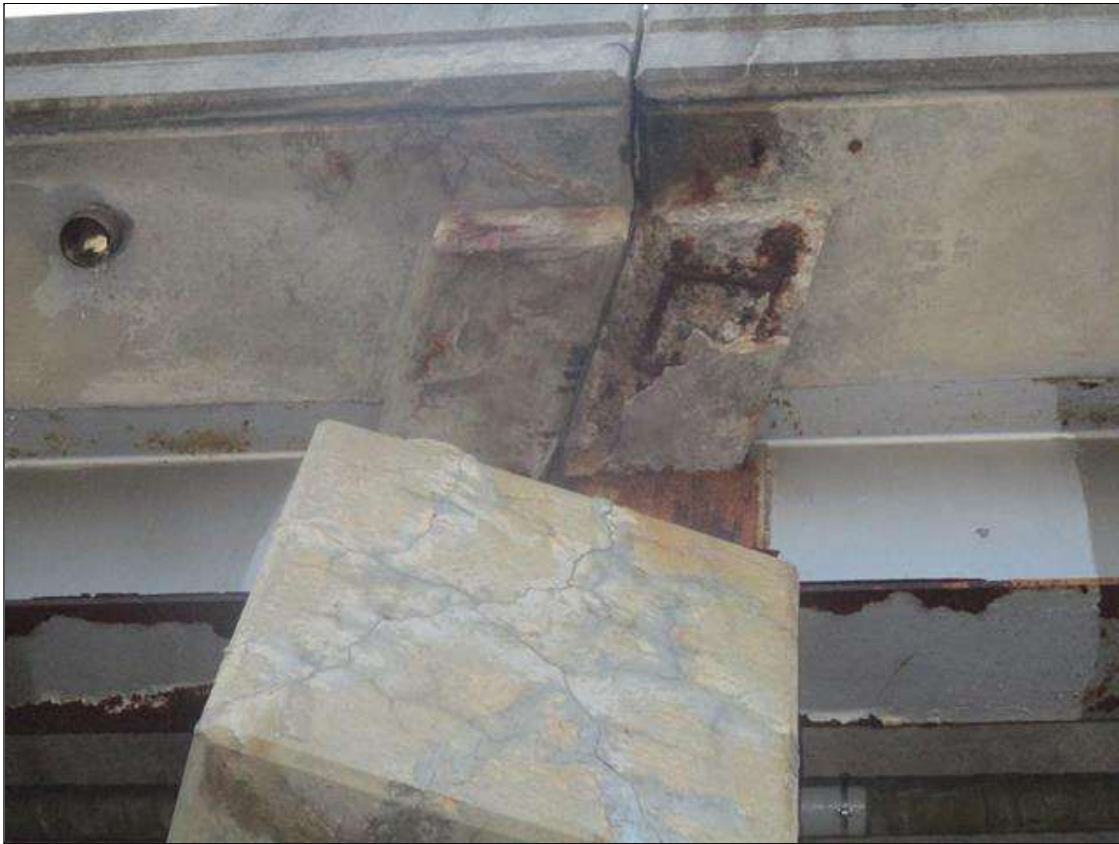
Span 2 Deck: UNDERSIDE OF DECK, LEFT OVERHANG - SPALL (18IN X 12IN X 3IN) WITH EXPOSED REINFORCING, FAR END. UP TO 80% SECTION REMAINING IN THE EXPOSED REBAR (PAR)

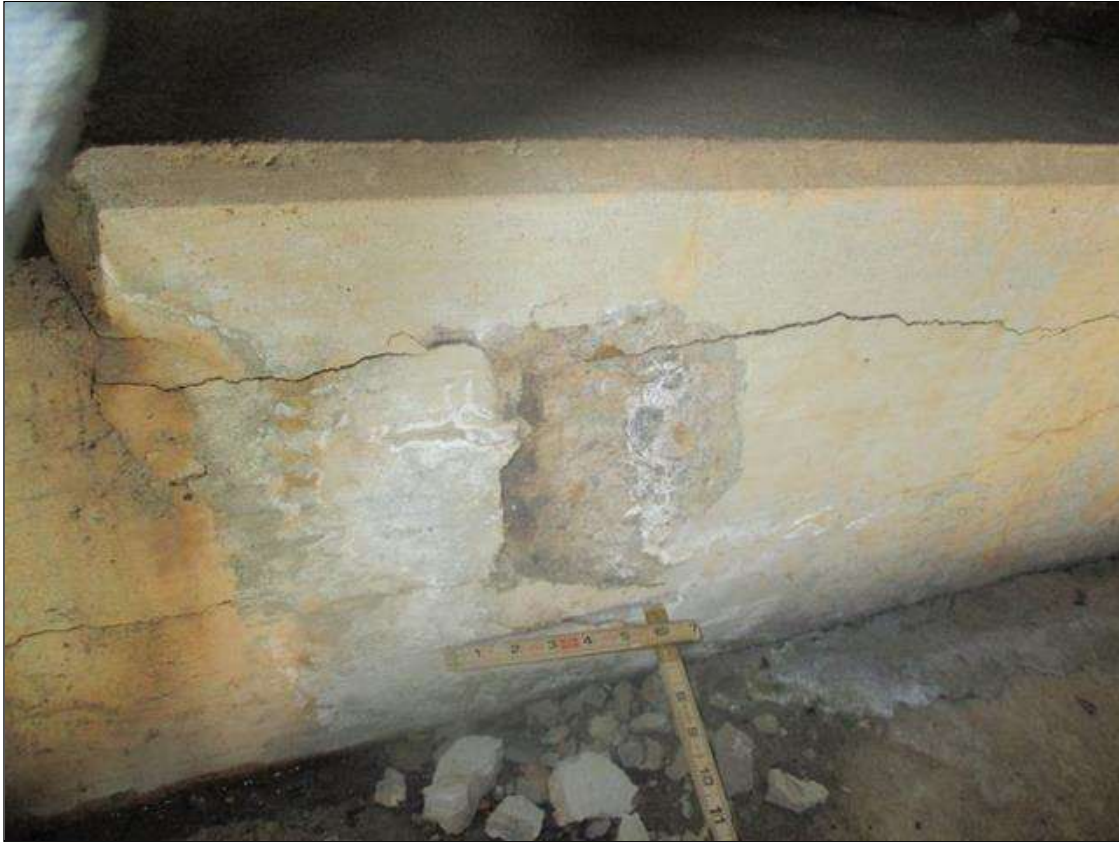
End Bent 2 Cap 1: SPALL (8IN X 8IN X 1.5IN) WITH EXPOSED REINFORCING (UP TO 90% SECTION REMAINING IN THE EXPOSED REBAR), FAR FACE AT BEAM 3 & SPALLING/DELAM (5FT L. X 6IN WIDE X 2IN D.) NO EXPOSED REINFORCING, FAR FACE TOP EDGE AT RIGHT END

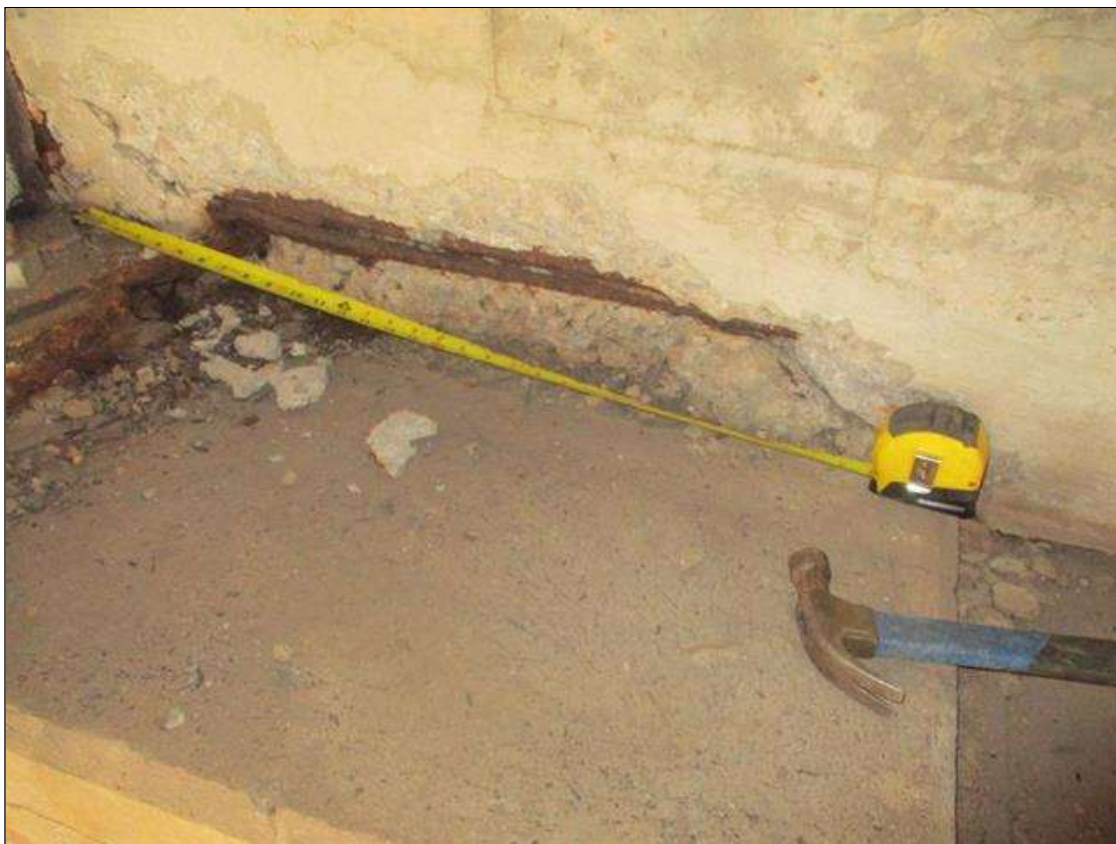
End Bent 2 Abutment: SPALL (30IN L. X 9IN H. X 3IN D.) WITH EXPOSED REINFORCING TO BOTTOM OF BACKWALL RIGHT OF BEAM 7. REBAR IS DEBONDED FOR FULL LENGTH OF SPALL AND HAS UP TO 90% SECTION REMAINING IN THE EXPOSED REBAR. (PAR)

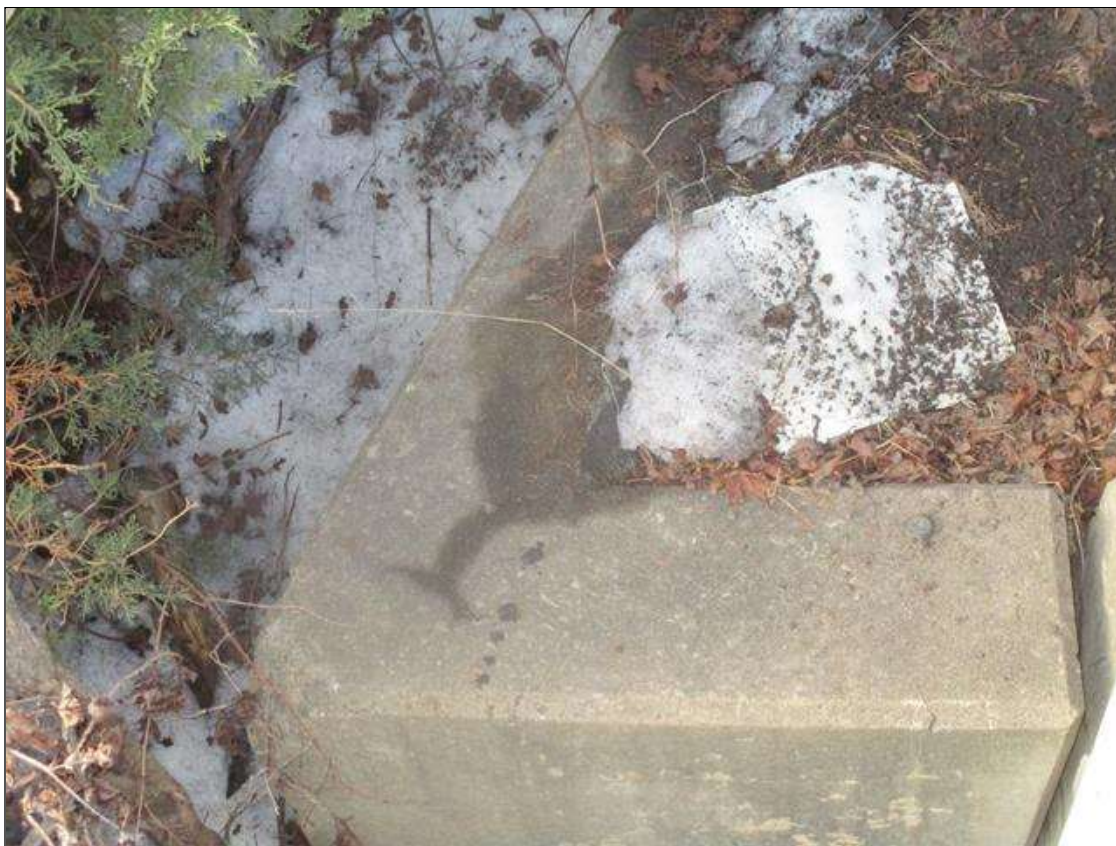
MINOR HAIRLINE MAP CRACKING AT SOUTHEAST WINGWALL.

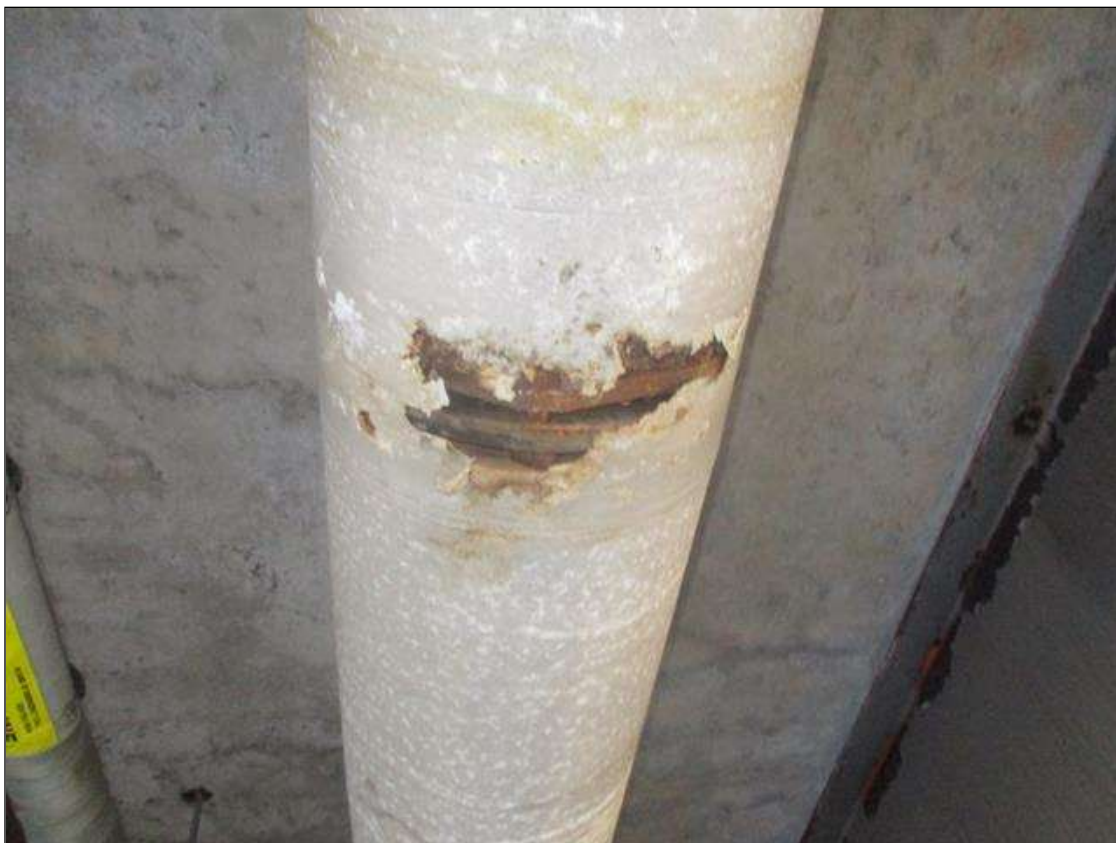
15 IN DIAMETER ULITLITY I BAY 1 HAS UP TO 100% CROSION APPROX. 15 FT FROM END BENT 2. SIMILAR AT END BENT 2.

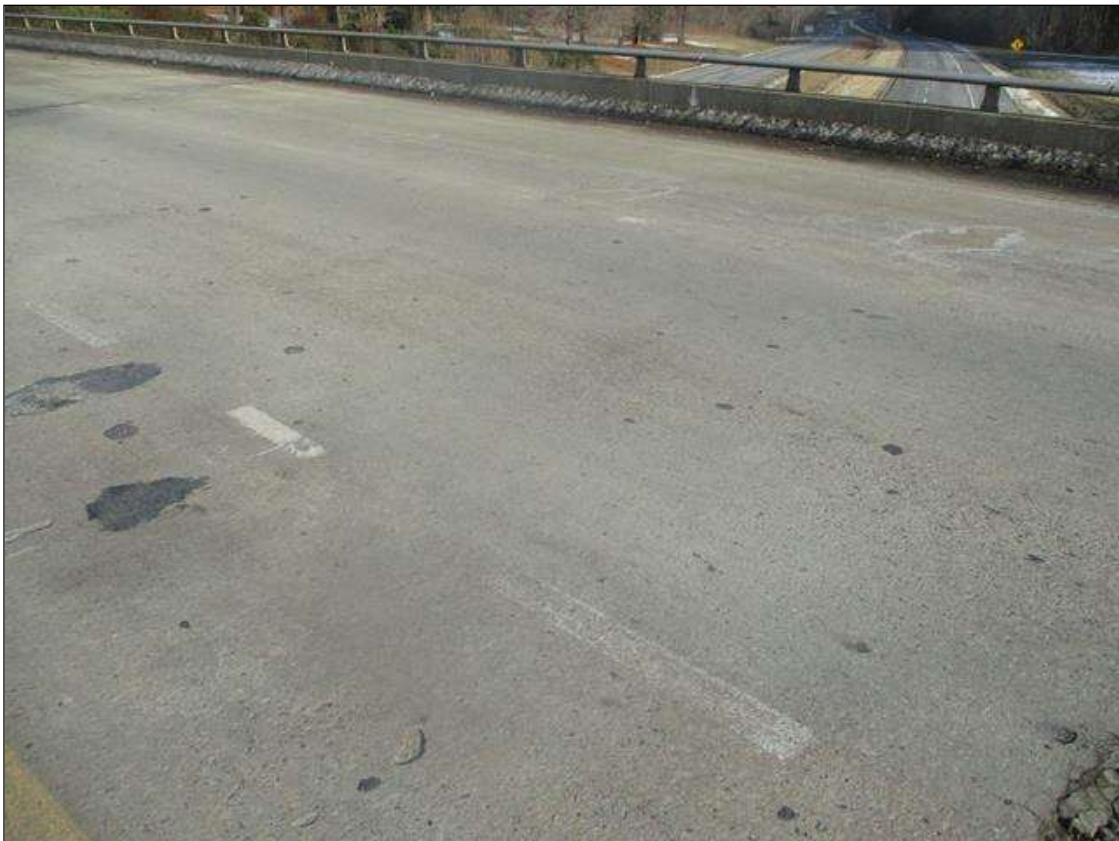
TOP OF DECK, FAIR CONDITION

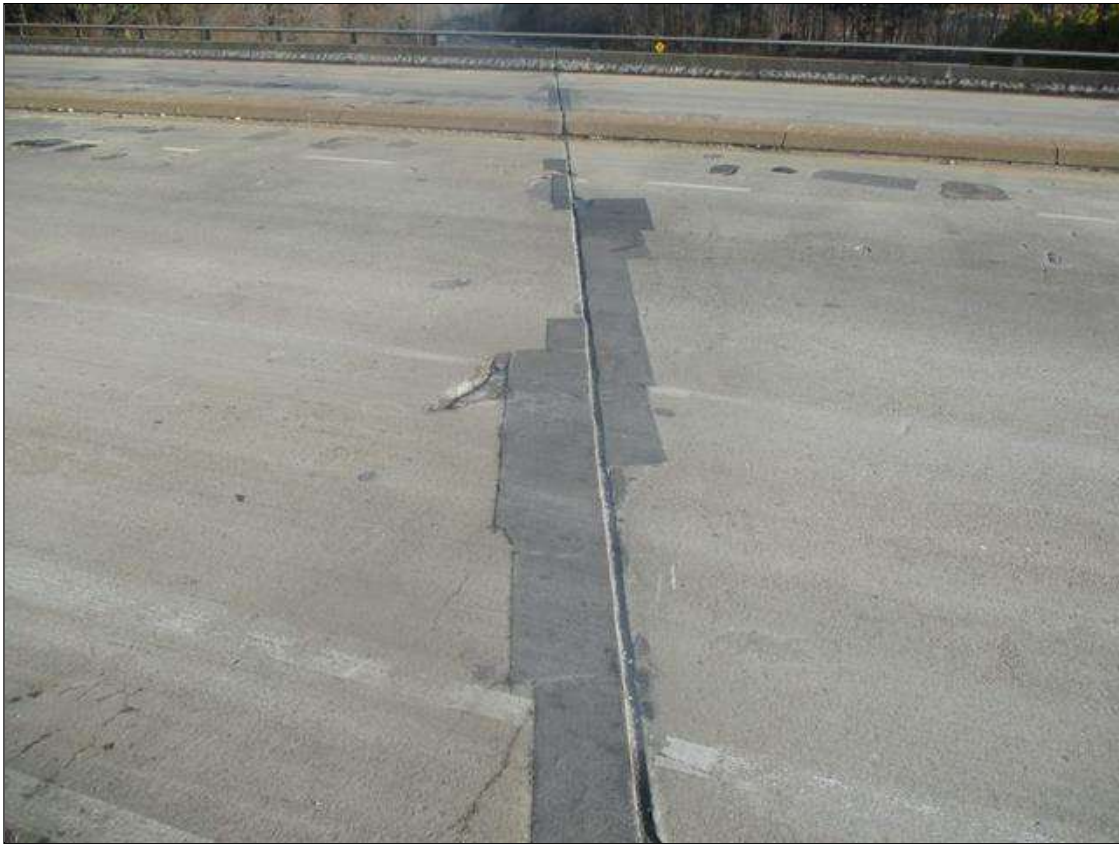
JOINT OVER BENT 2. TYPICAL AT BENTS 1 AND 3

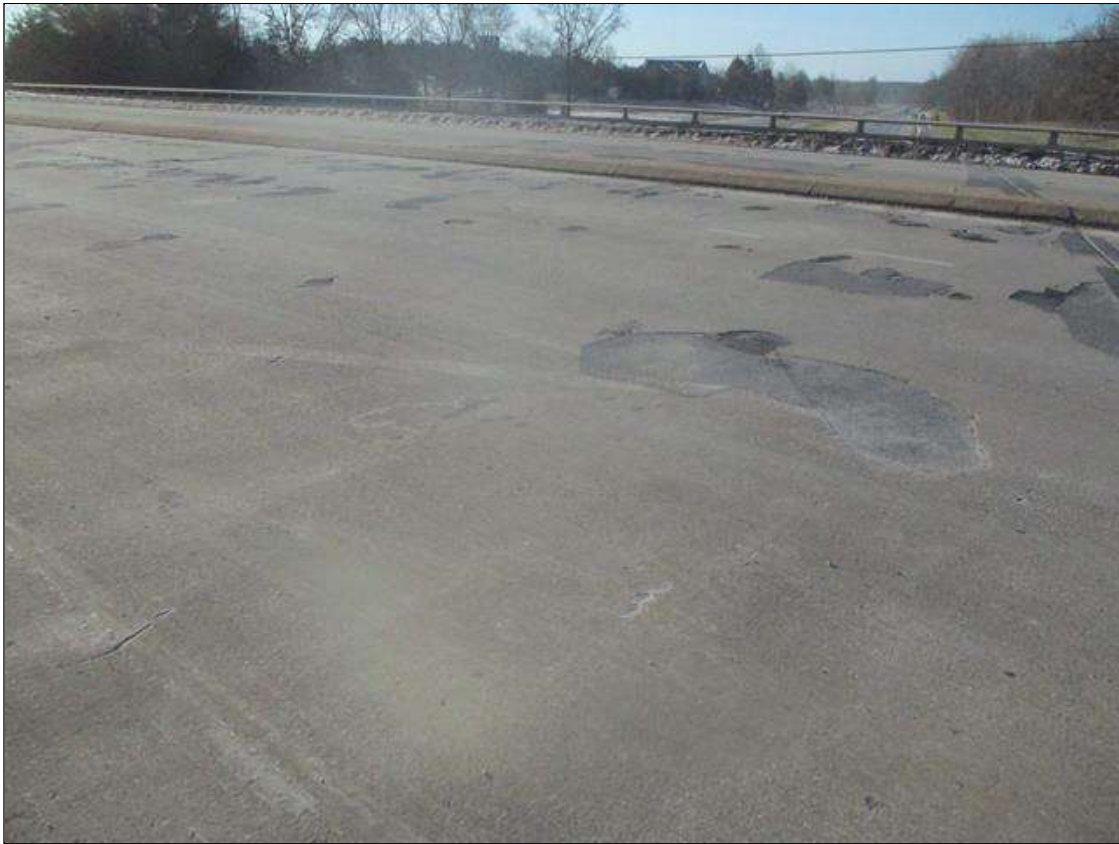
TOP OF DECK - WITH PATCHED SPALLS SCATTERED THROUGHOUT

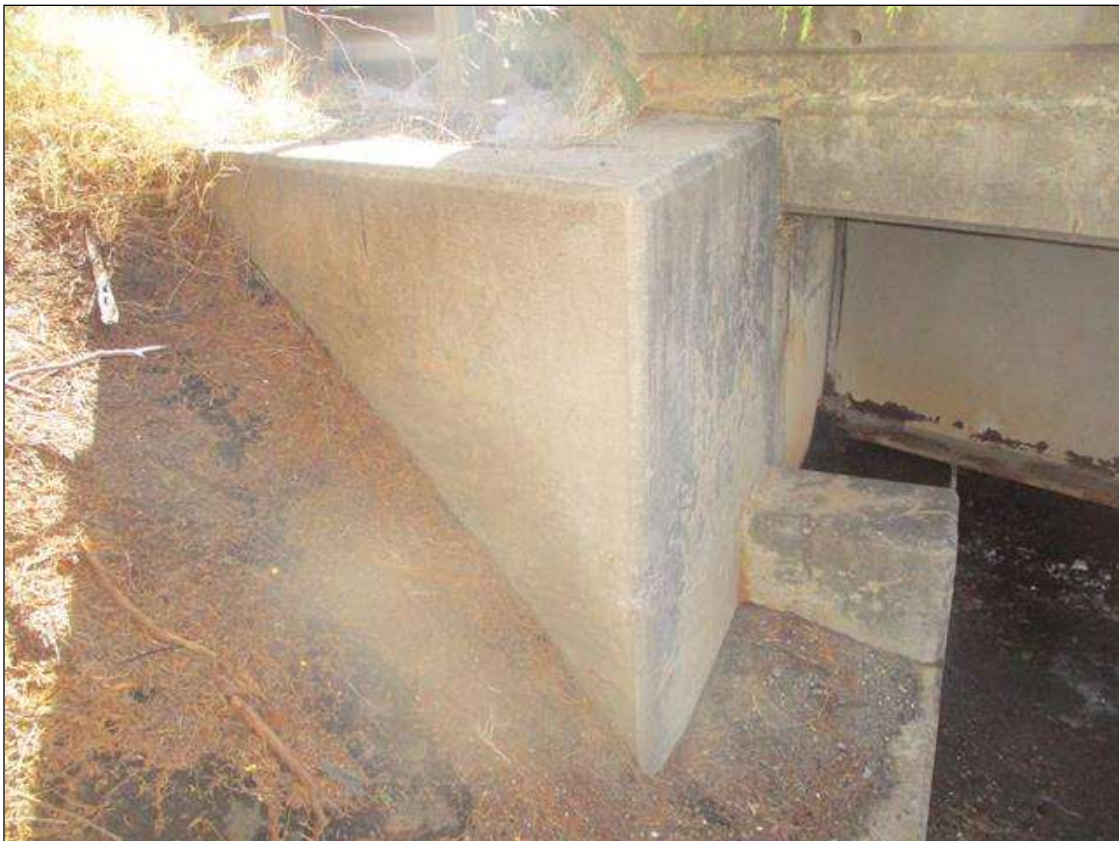
TYPICAL WINGWALL AT SOUTHEAST CORNER

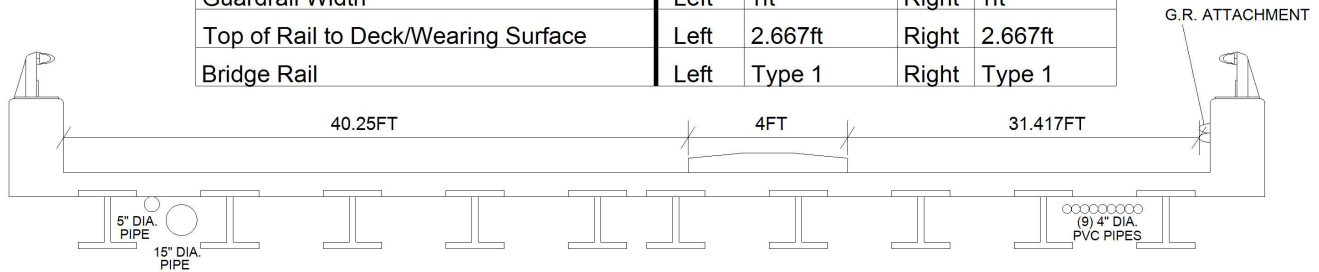
Measurements for Span #	1		
Deck Thickness	0.656	Left Overhang	3
Top of Rail to Bottom of Beam	6.323 ^[1]	Right Overhang	3

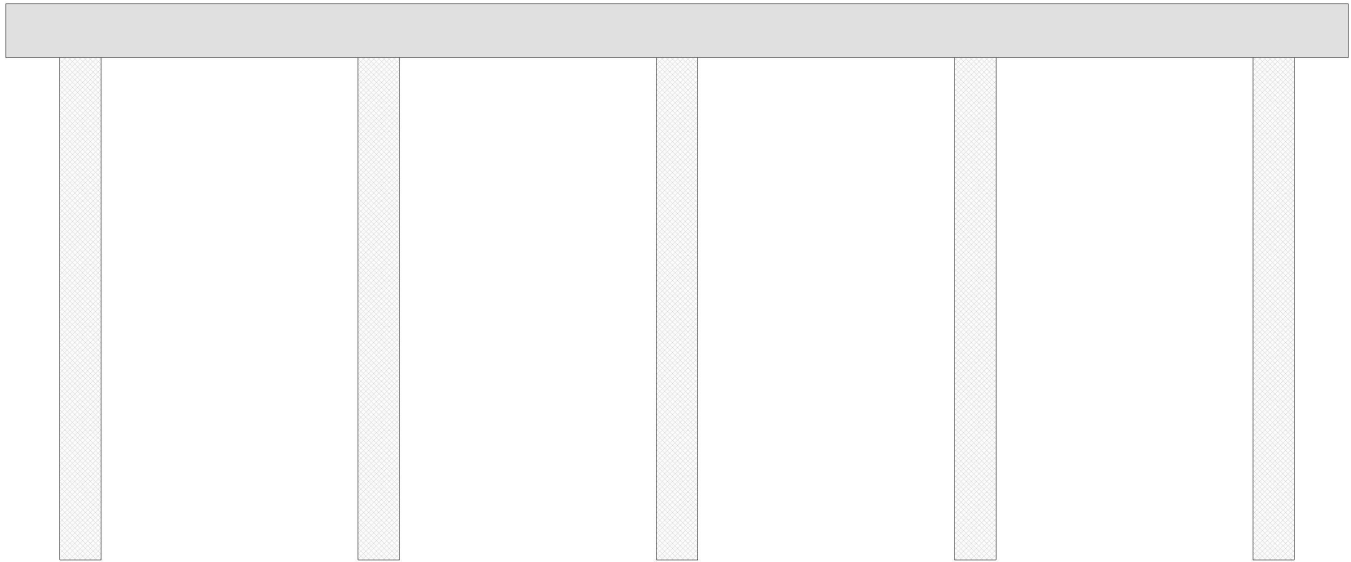
Cap Information			Material Cast-in-Place Concrete							
Length	Width	Height	Left Overhang	Right Overhang	Left Beam to End of Cap.	Right Beam to End of Cap.				
81.000 ft.	3.000 ft.	4.000 ft.	4.500 ft.	4.500 ft.	1.500 ft.	1.500 ft.				
Subcap Information			Material							
Length	Width	Height	Left Overhang	Right Overhang	Left Pile to Splice.					
Sill Information			Material							
Length	Width	Height								
Pile #	Material	Spacing	Width/Dia.	Height	Length	Orientation	Driven?	Replacement?	Removed?	Collar?
1	Concrete	18 ft.	2.5 ft.	3 ft.		Vertical	No	No	No	No
2	Concrete	18 ft.	2.5 ft.	3 ft.		Vertical	No	No	No	No
3	Concrete	18 ft.	2.5 ft.	3 ft.		Vertical	No	No	No	No
4	Concrete	18 ft.	2.5 ft.	3 ft.		Vertical	No	No	No	No
5	Concrete		2.5 ft.	3 ft.		Vertical	No	No	No	No
<p style="color: red; margin: 0;">MODIFEID BY ED ON 1/24/2022</p>										
Bent/Abutment #: 1			Similar Bents: 2, 3
