NC DEPARTMENT OF TRANSPORTATION
 DIVISION OF HIGHWAYS
 STRUCTURE MANAGEMENT UNIT

ATTENTION: **PAR SUBMITTED**

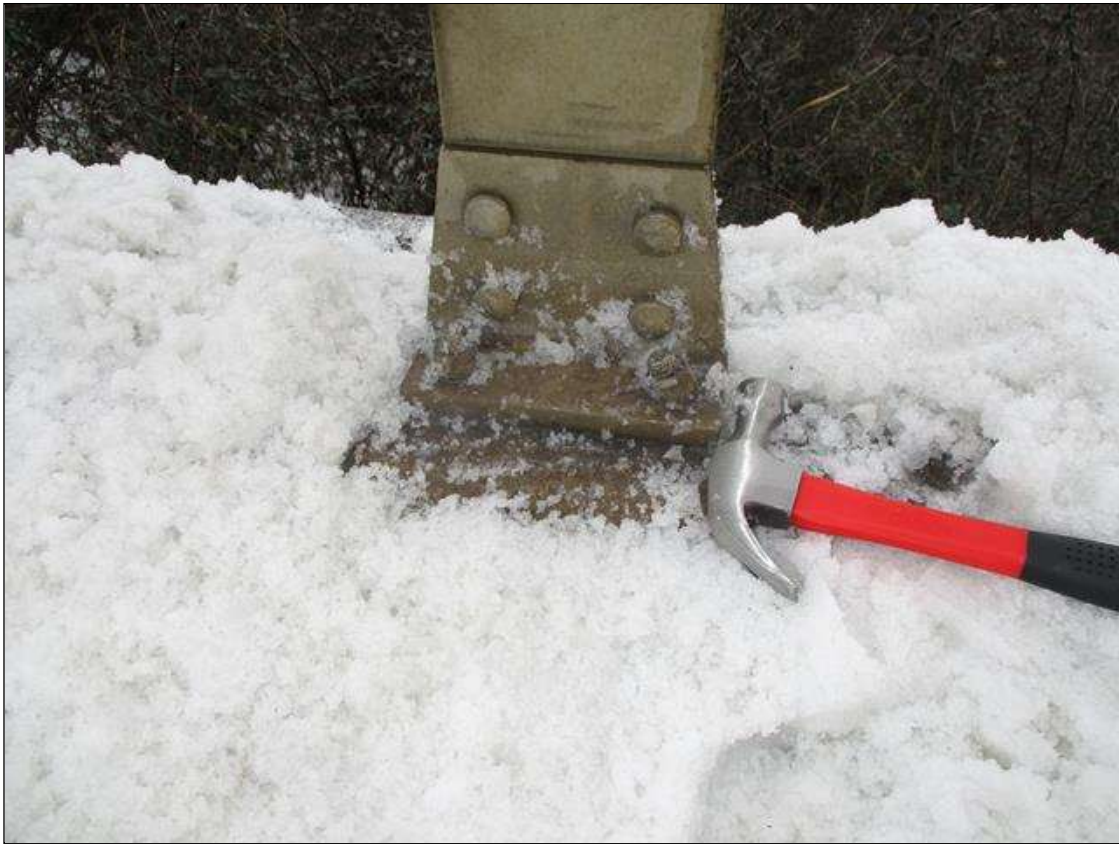
Span 1 Left Bridge Rail: MINOR DAMAGE & BENT ANCHOR AT 3RD POST (POST REMAINS SECURE)

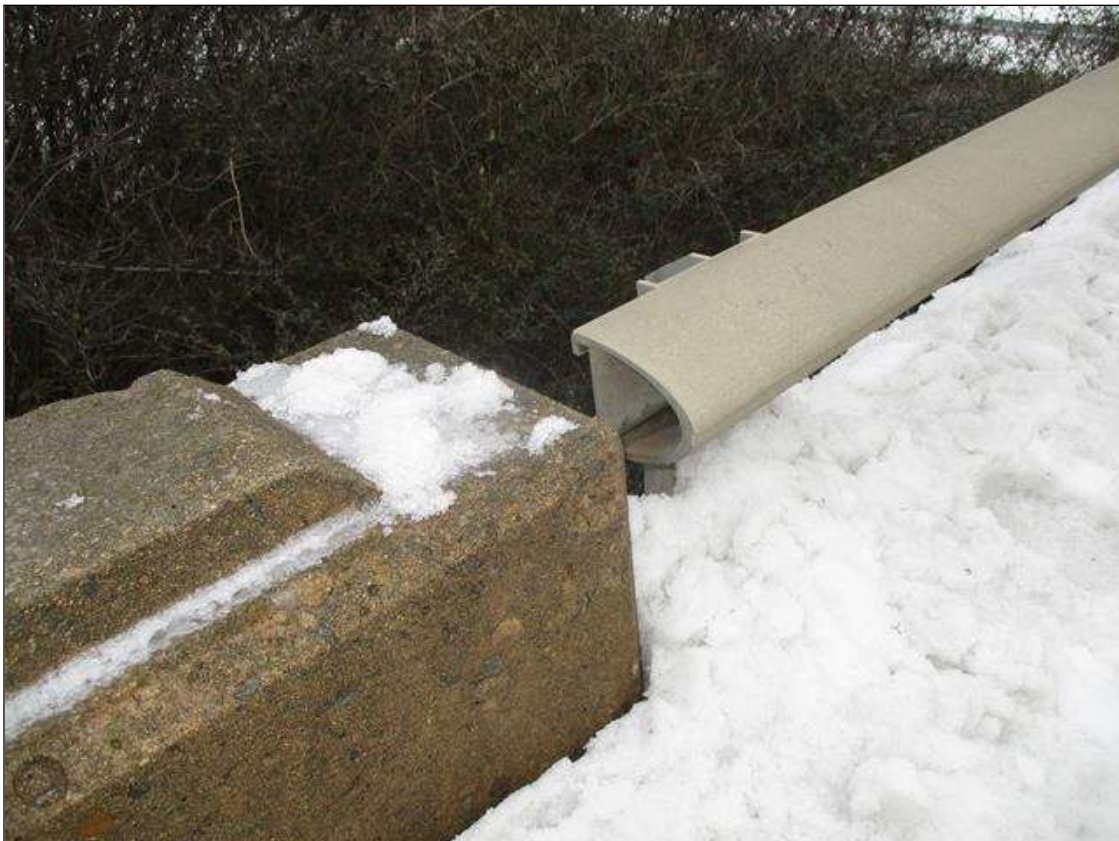
Span 1 Left Bridge Rail: MISSING ALUMINUM END CAP AT NEAR END OF RAIL

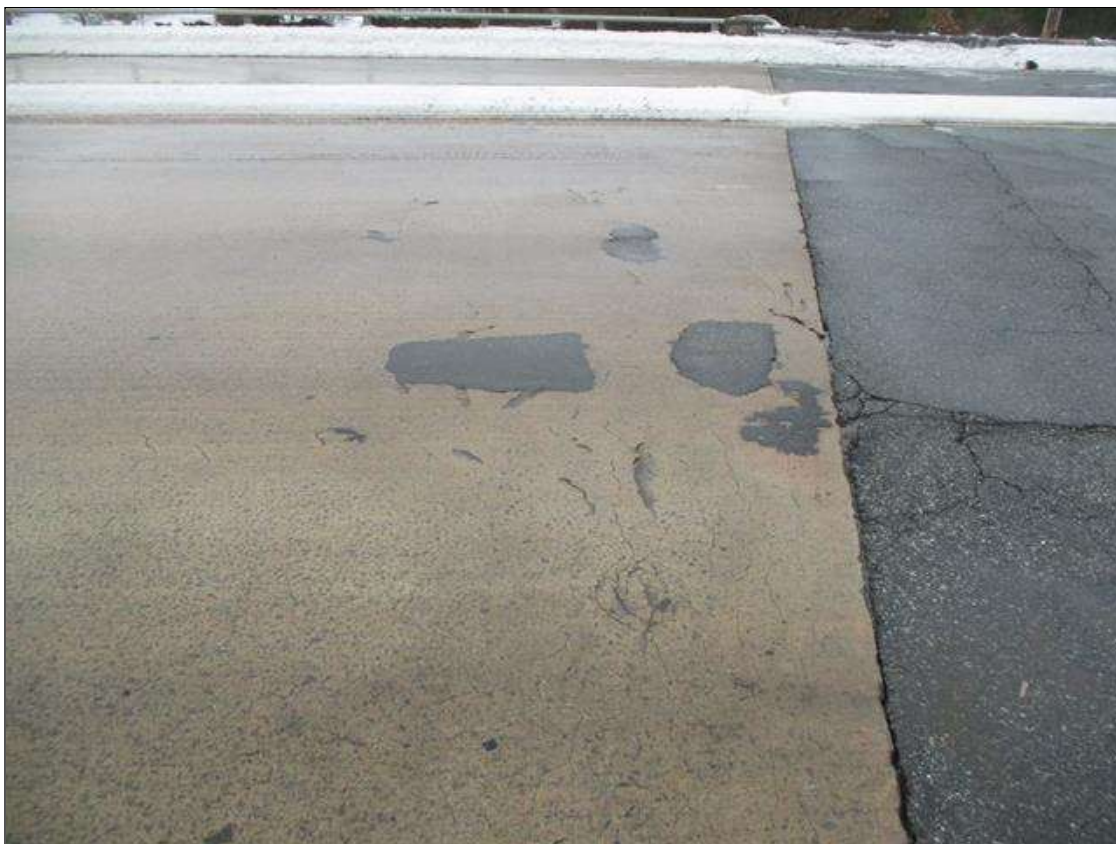
Span 1 Deck: SOUND PATCHES (UP TO 9SQFT) THRU OUT DECK IN BOTH LANES, MOSLTY AT NEAR & FAR ENDS.

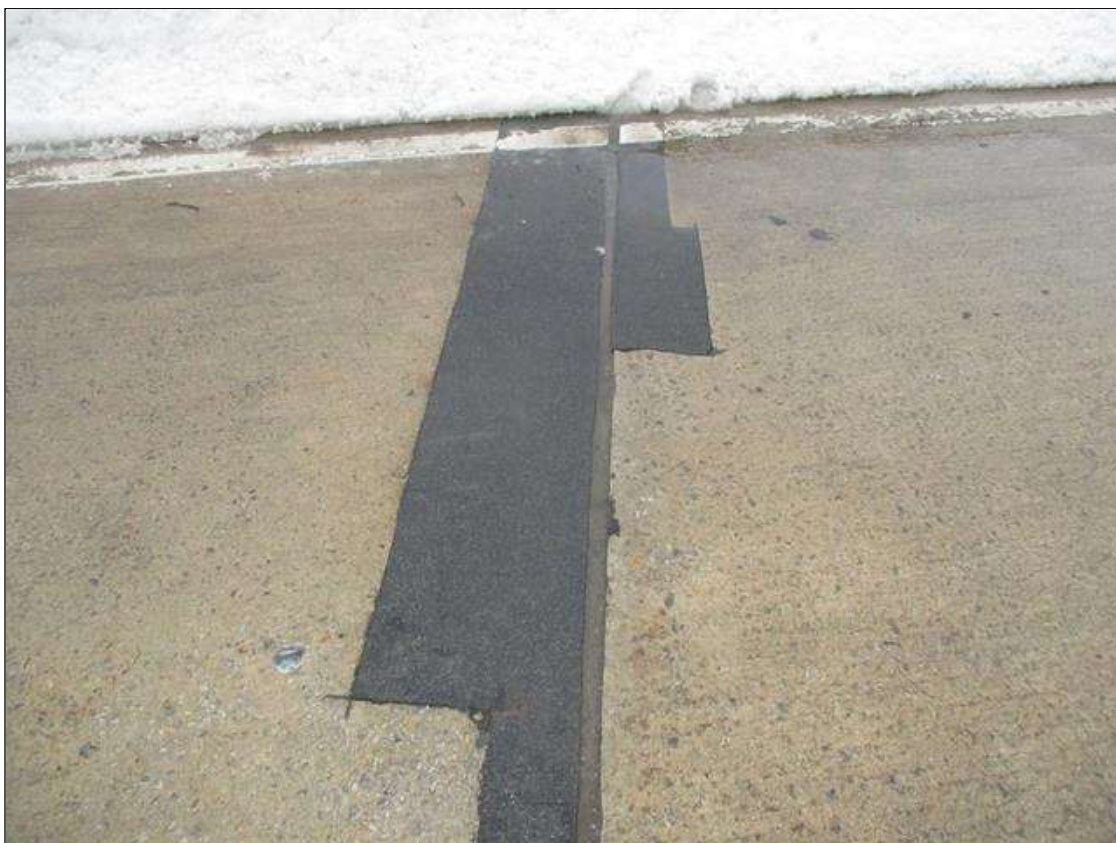
Span 1 Deck: SOUND PATCH (8FT X 2FT) IN LEFT EASTBOUND LANE AT NEAR END AT PREVIOUS: eastbound left lane next to median at end bent 1, broken concrete (8ft x 18in x up to 1/8in) and depressed (1/4in)

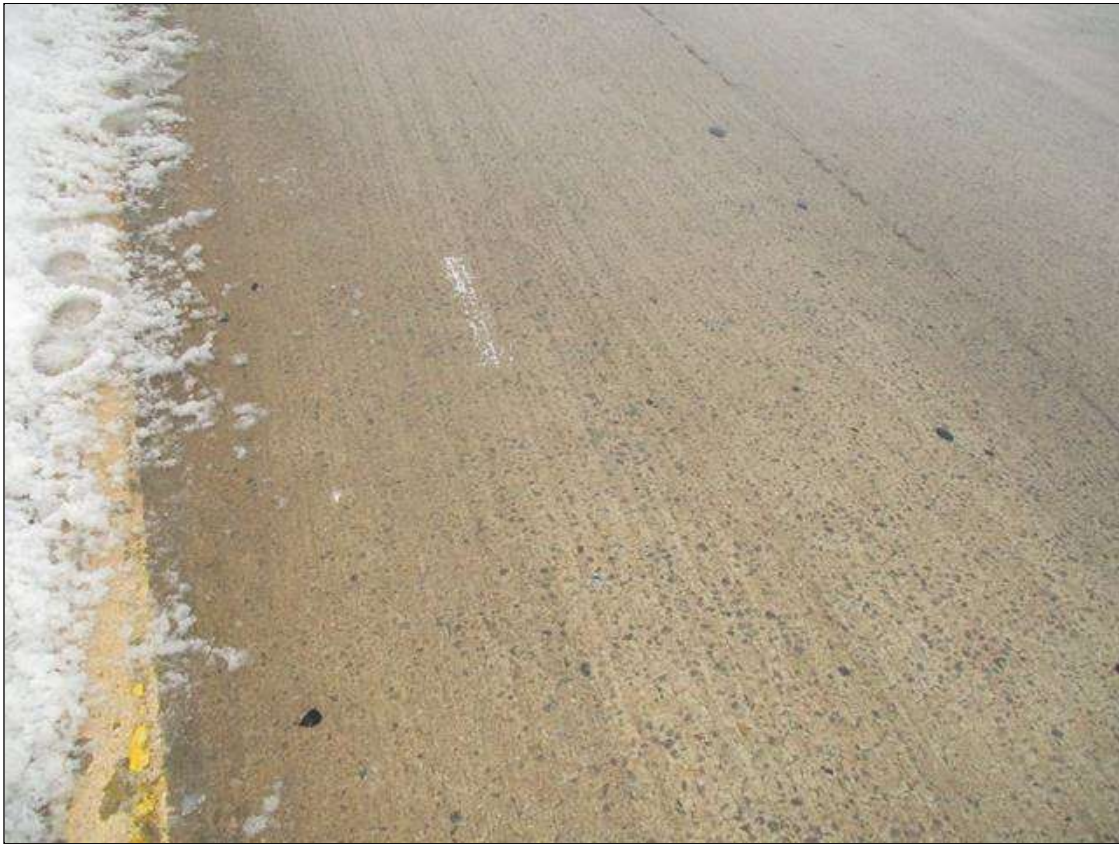
Span 1 Deck: MAP CRACKING (HAIRLINE TO 1/16IN) & WEAR WEST/ EXPOSED AGGREGATE THRU OUT CONCRETE DECK IN TRAVEL LANES.

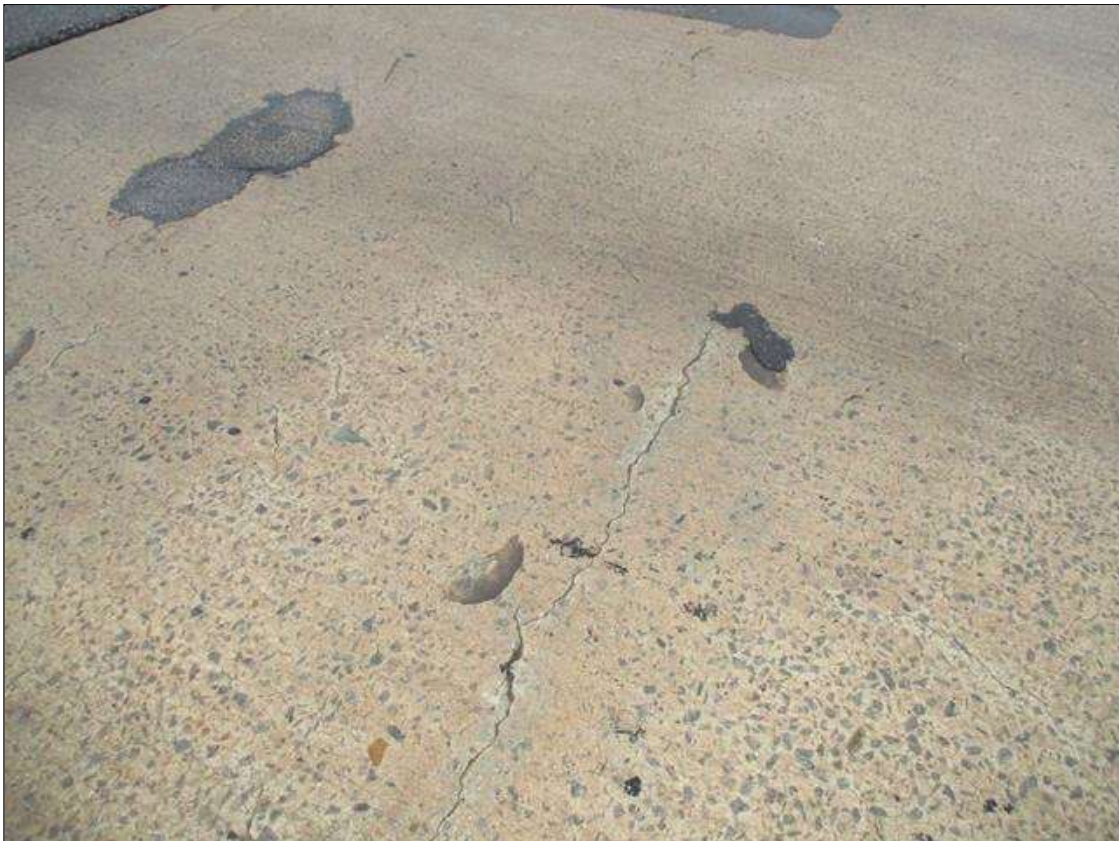
Span 1 Deck: INTERMITTENT SHALLOW SPALLS (UP TO 1.5SQFT X 1/2IN TO 3/4IN DEEP) THRU OUT TOP OF DECK AND AT PERIMETER OF PATCHED AREAS.

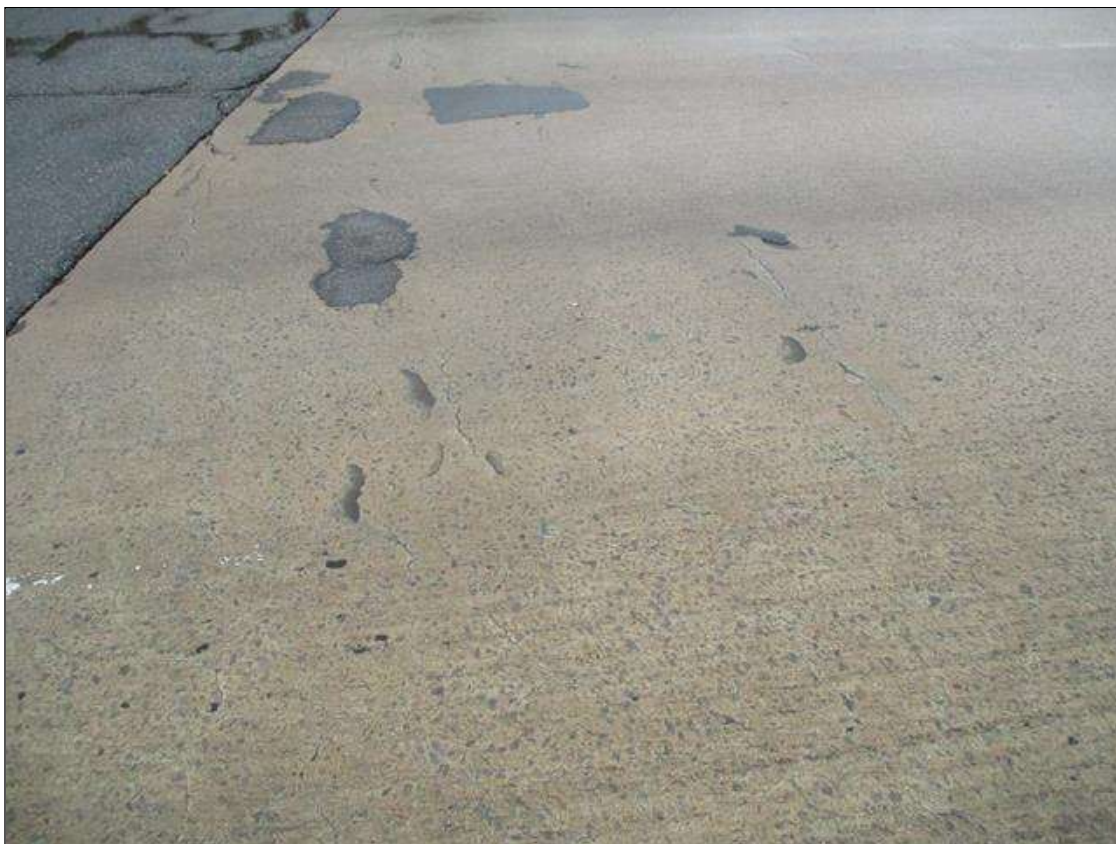
Span 1 Deck: TRANSVERSE OPEN CRACKING (UP TO 1/8IN) THRU OUT CONCRETE DECK IN ALL LANES.
DIAGONAL OPEN CRACKING IN LEFT LANES.

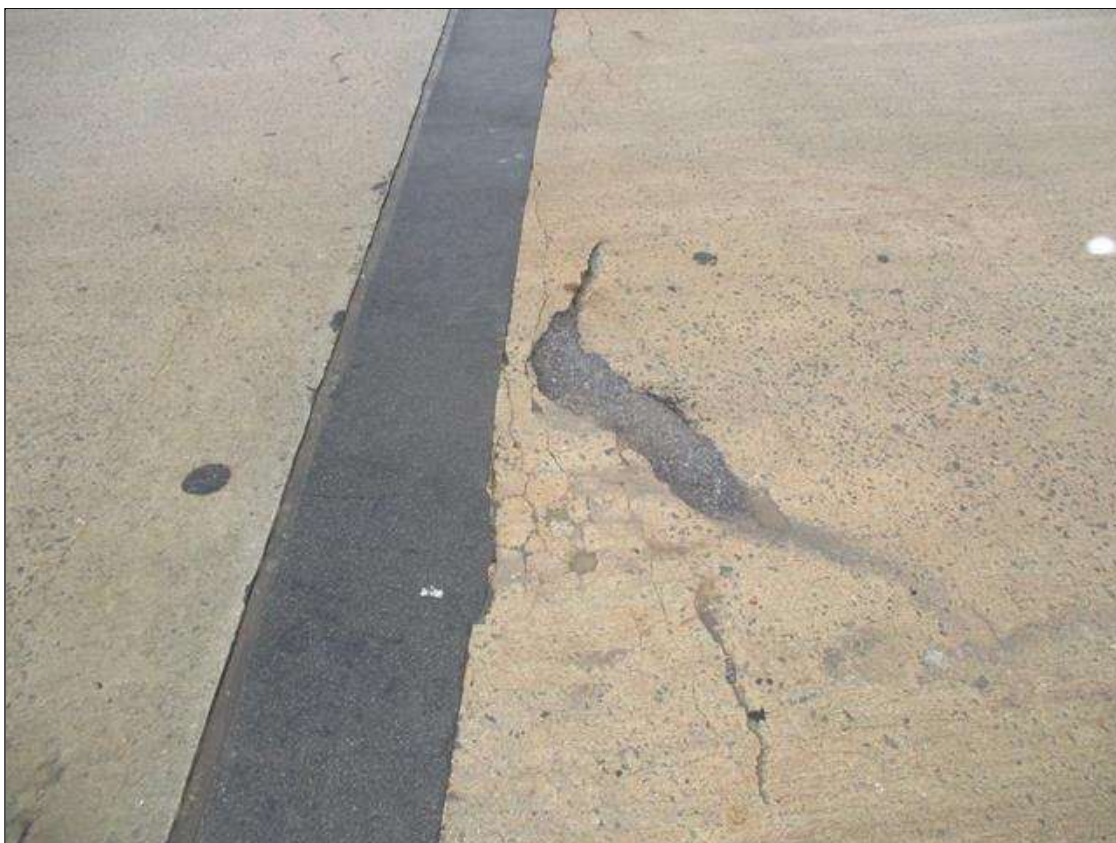
Span 3 Deck: DELAMINATED CONCRETE UP TO 3 FT DIAMETER IN EAST BOUND RIGHT LANE

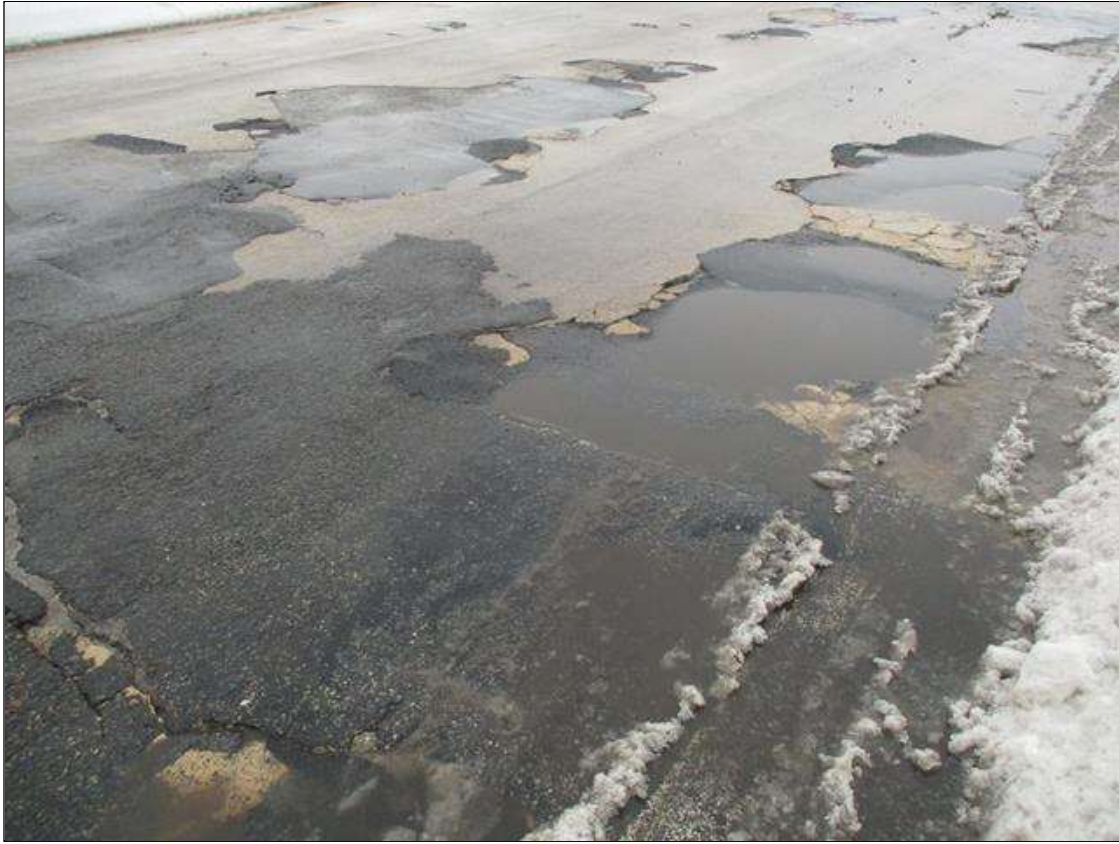
Span 4 Deck: SPALLS UP TO 6 SQ FT WITH PONDING WATER 1 IN DEEP IN RIGHT TRAVEL LANE OF WEST BOUND SIDE FOR FULL LENGTH

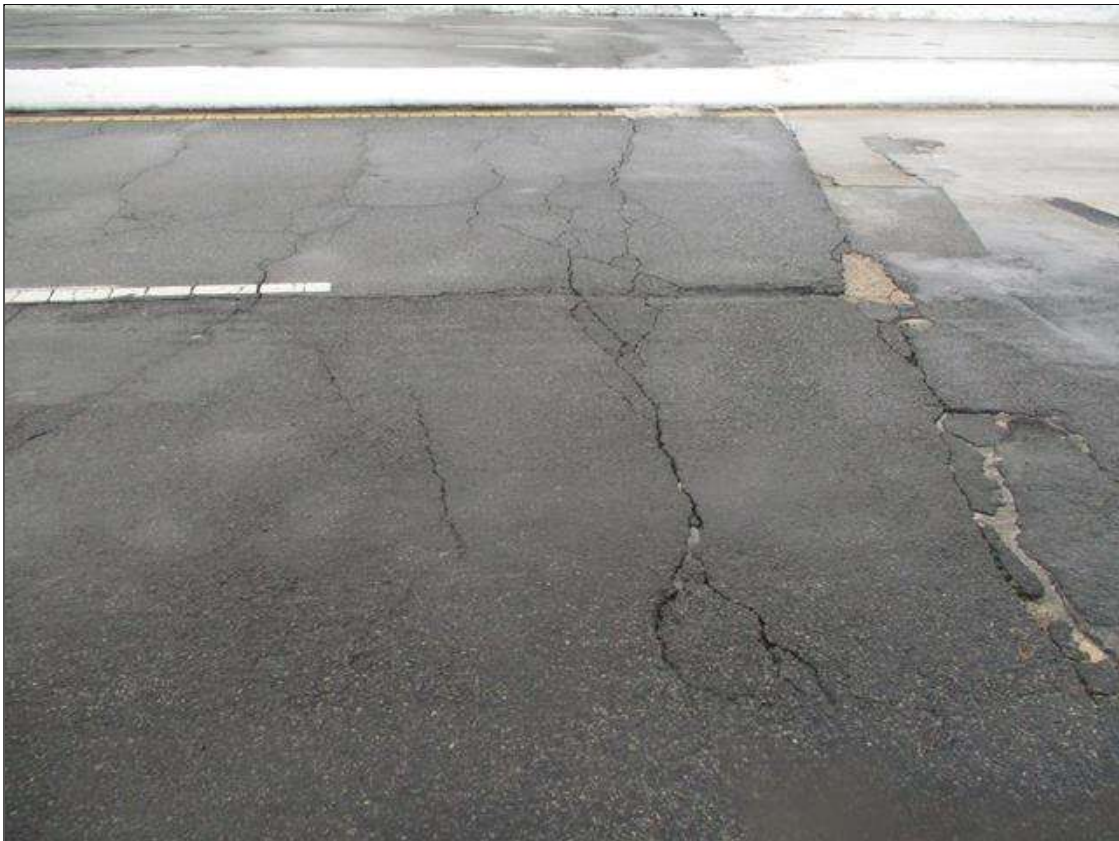
MODERATE SCATTERED CRACKING UP TO 1/2 IN WIDE IN THE APPROACH PAVEMENT NEAR END BENT 2.
TYPICAL AT APPROACH PAVEMENT NEAR END BENT 1

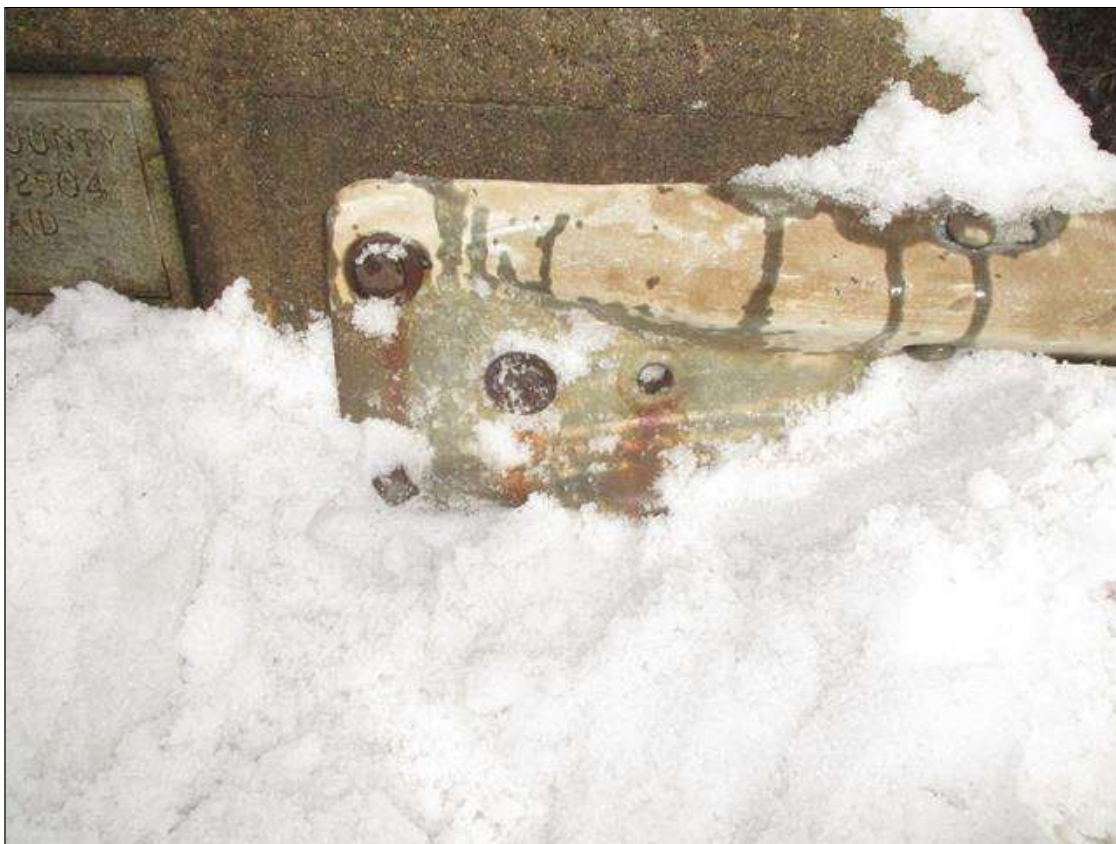
Span 4 Left Bridge Rail: 1X MISSING BOLT & 1IN SEPERATION OF GUARDRAIL ATTACHMENT AT FAR END (ATTACHMENT REMAINS SECURE)

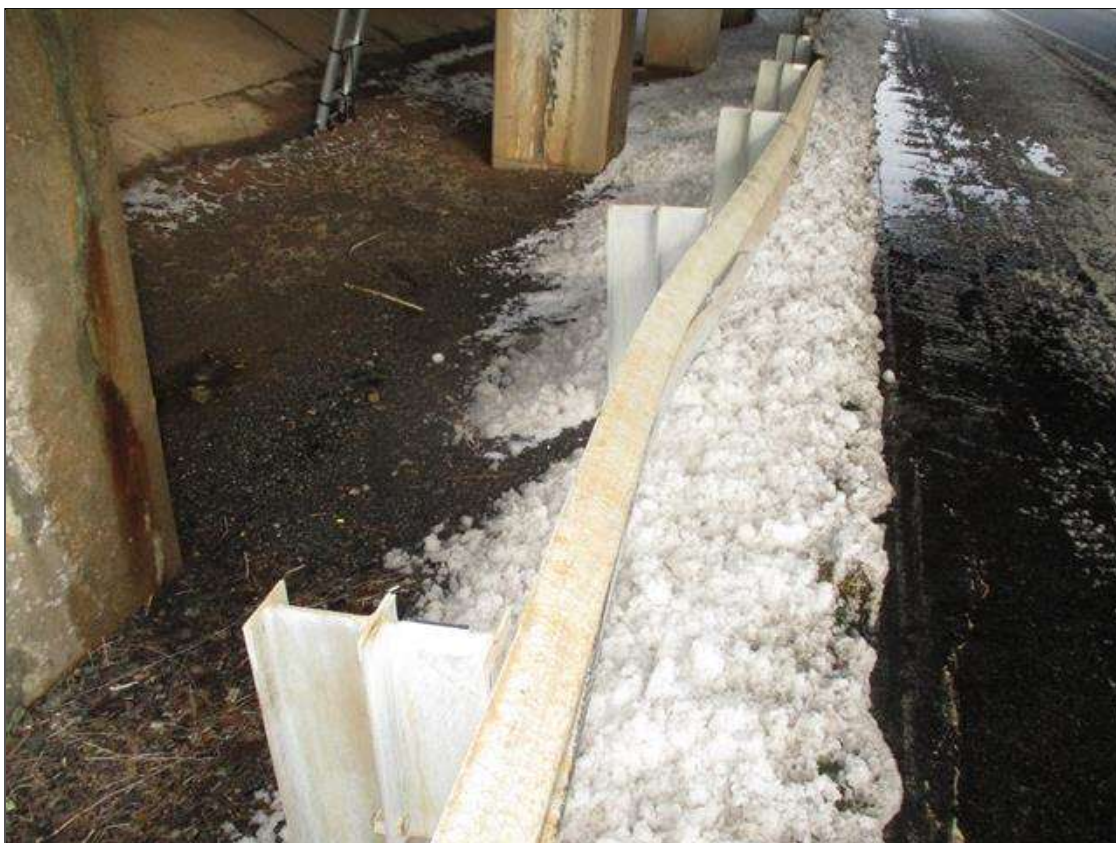
TWO AREAS OF MINOR GUARDRAIL DAMAGE UP TO 10 FT LONG ALONG HIGHWAY 29 SOUTHBOUND LANES RIGHT RAIL.

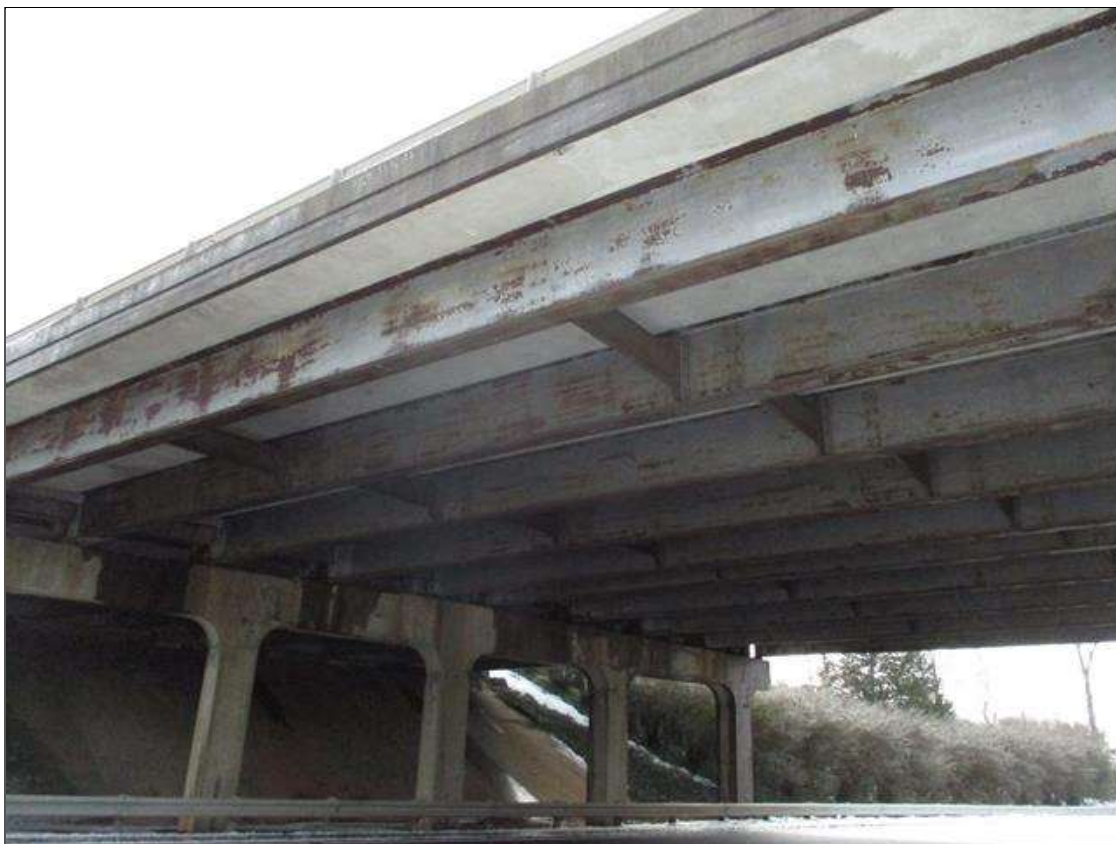
Span 3 Beam 1 - Protective System: AREAS OF PC LOSS THRU OUT LENGTH OF BEAM, MOSLTY AT FLANGES & BEAM ENDS

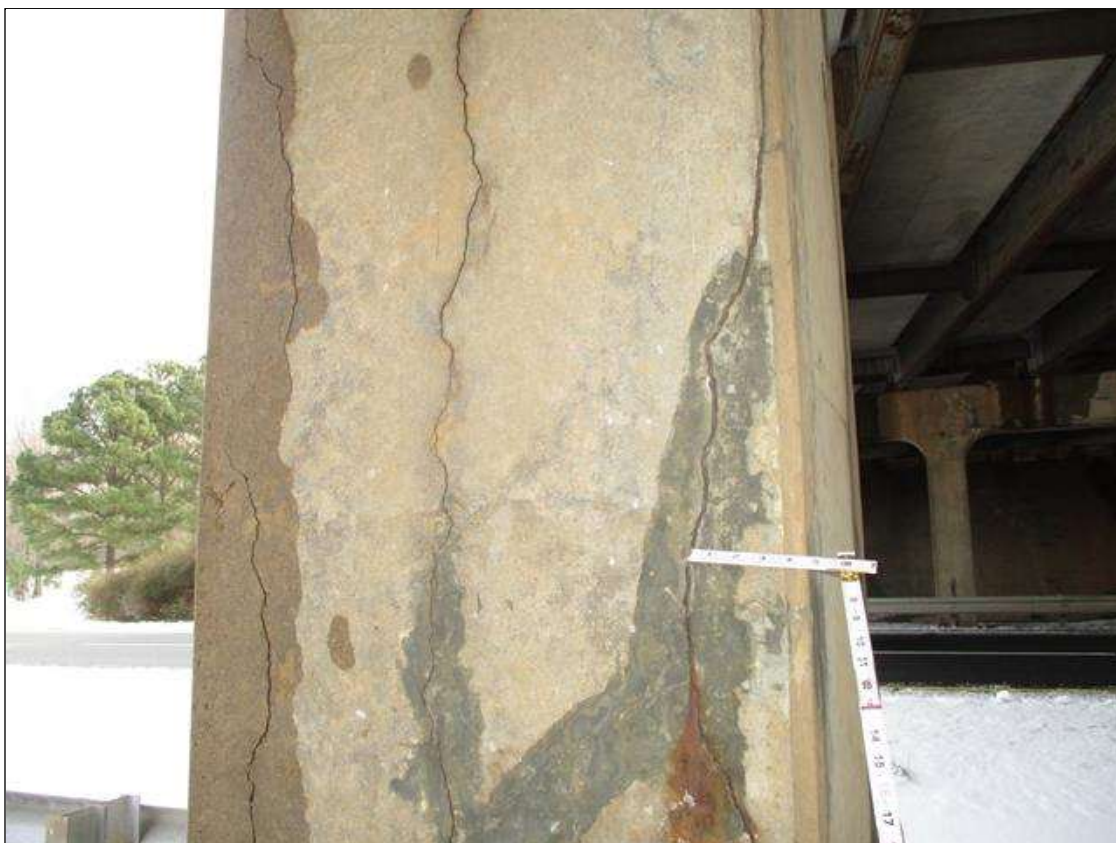
Bent 2 Pile 1: FULL HEIGHT VERTICAL OPEN CRACKING (UP TO 3/16IN) TO ALL FACES OF COLUMN. (PAR)

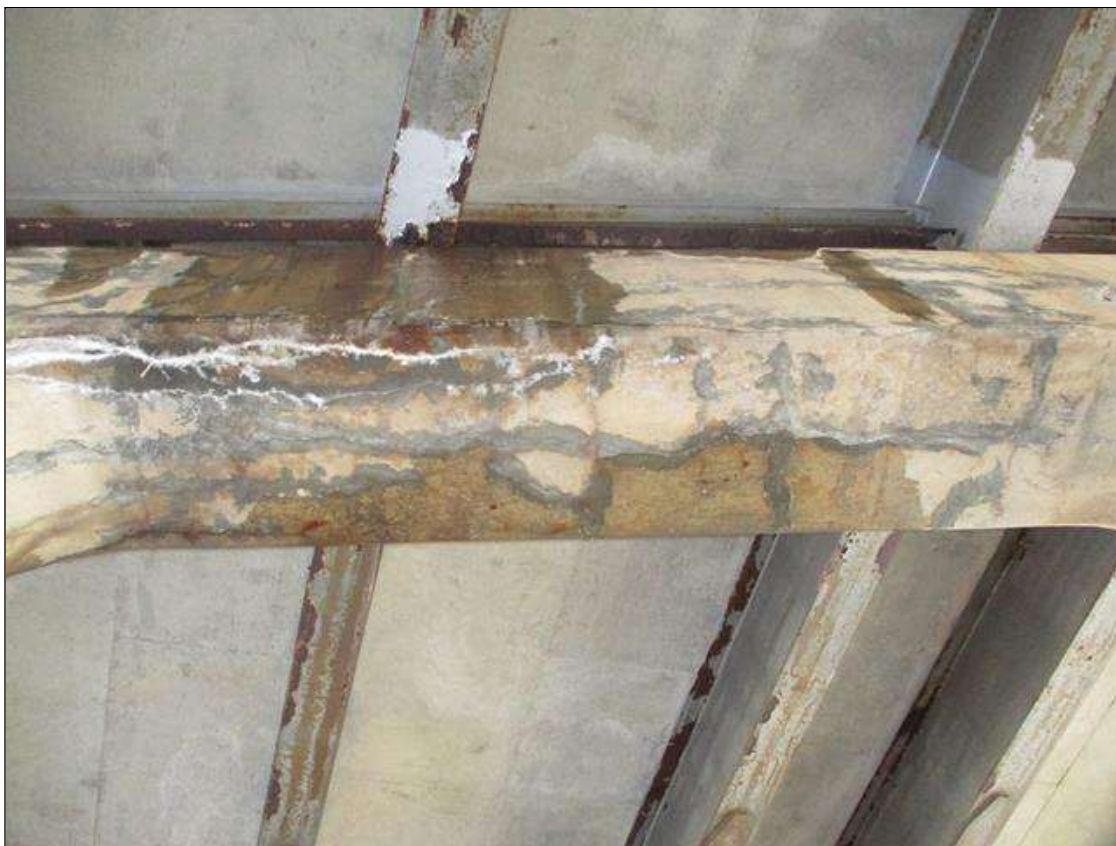
Bent 2 Cap 1: ACTIVE LEAKAGE AT BENT 2 THROUGHOUT LENGTH. TYPICAL AT ALL BENTS

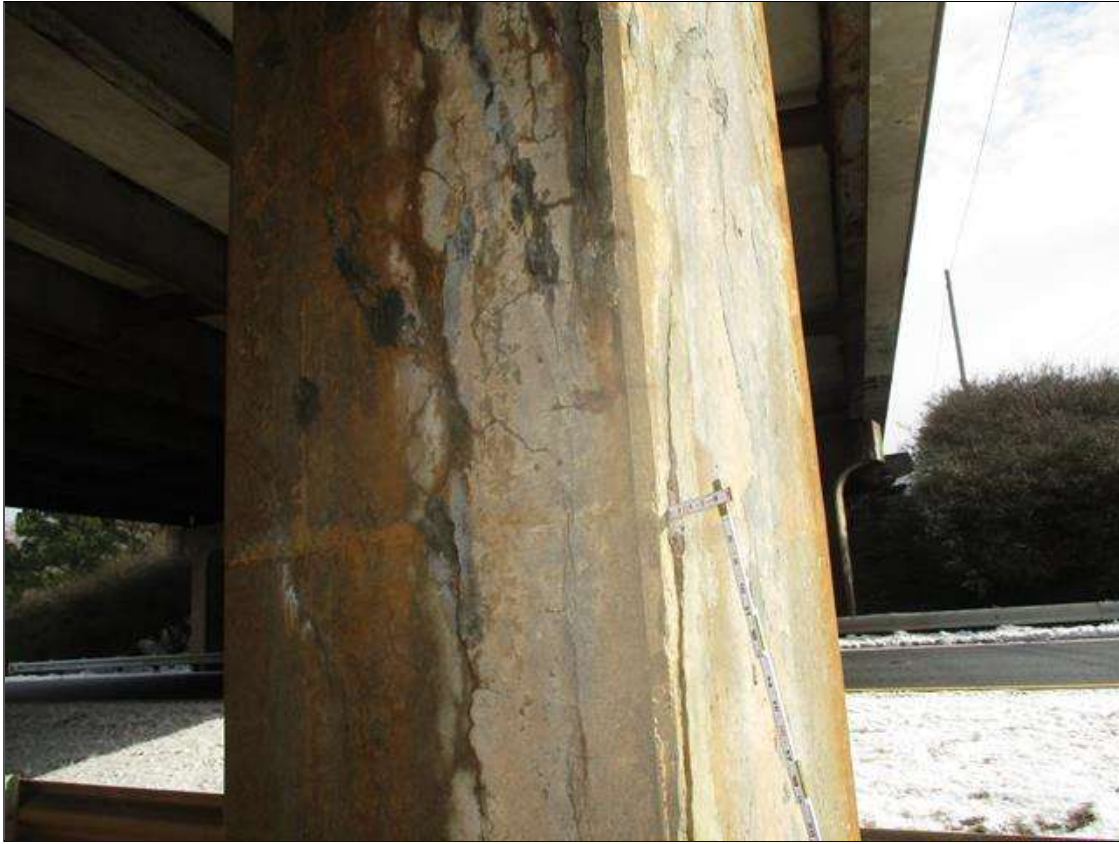
Bent 2 Pile 5: FULL HEIGHT VERTICAL OPEN CRACKING (UP TO 1/2N) TO ALL FACES OF COLUMN & FULL HEIGHT DELAM (12IN WIDE) AT NEAR FACE. ADDITIONAL SPALL IN SOUTH FACE OF PILE UP TO 5 IN LONG X 1 IN DEEP X 1 IN WIDE. (PAR)

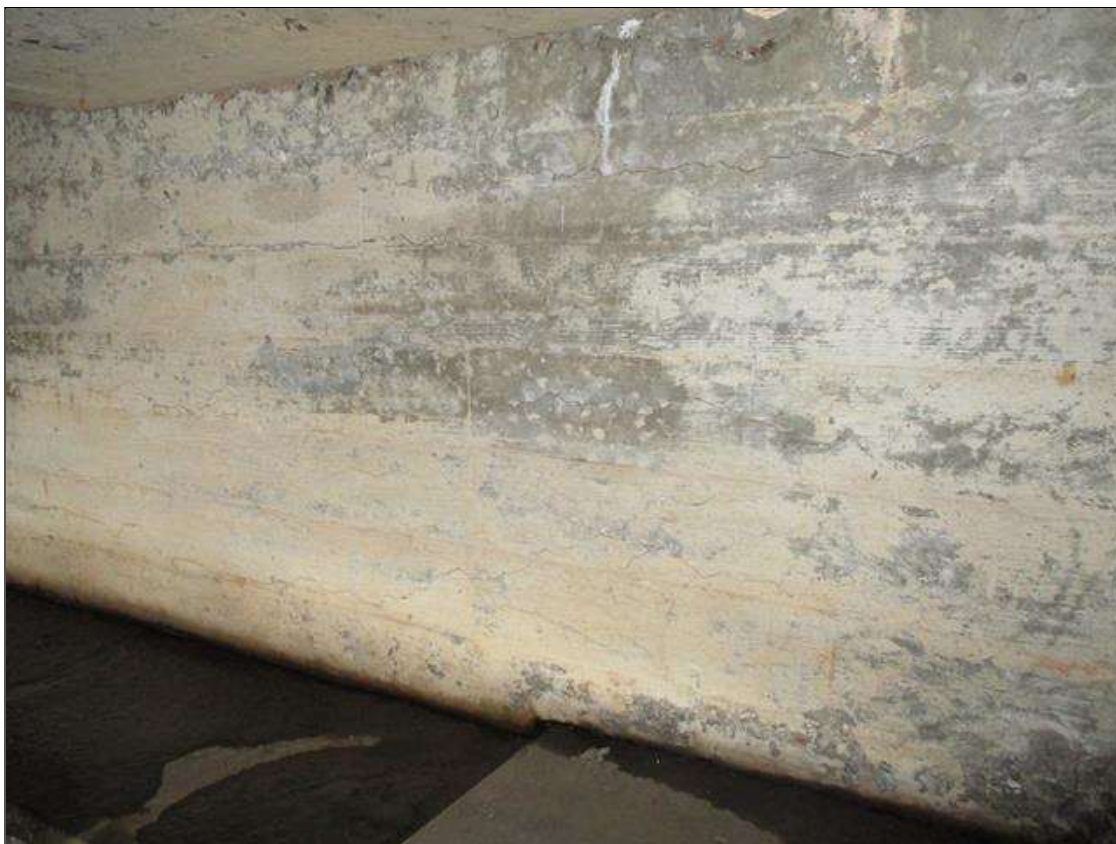
End Bent 2 Abutment: MULTIPLE HORZ. CRACKS UP TO 1/16TH IN WIDE THRU OUT END BENT BACKWALL AT OUTSIDE FACES.

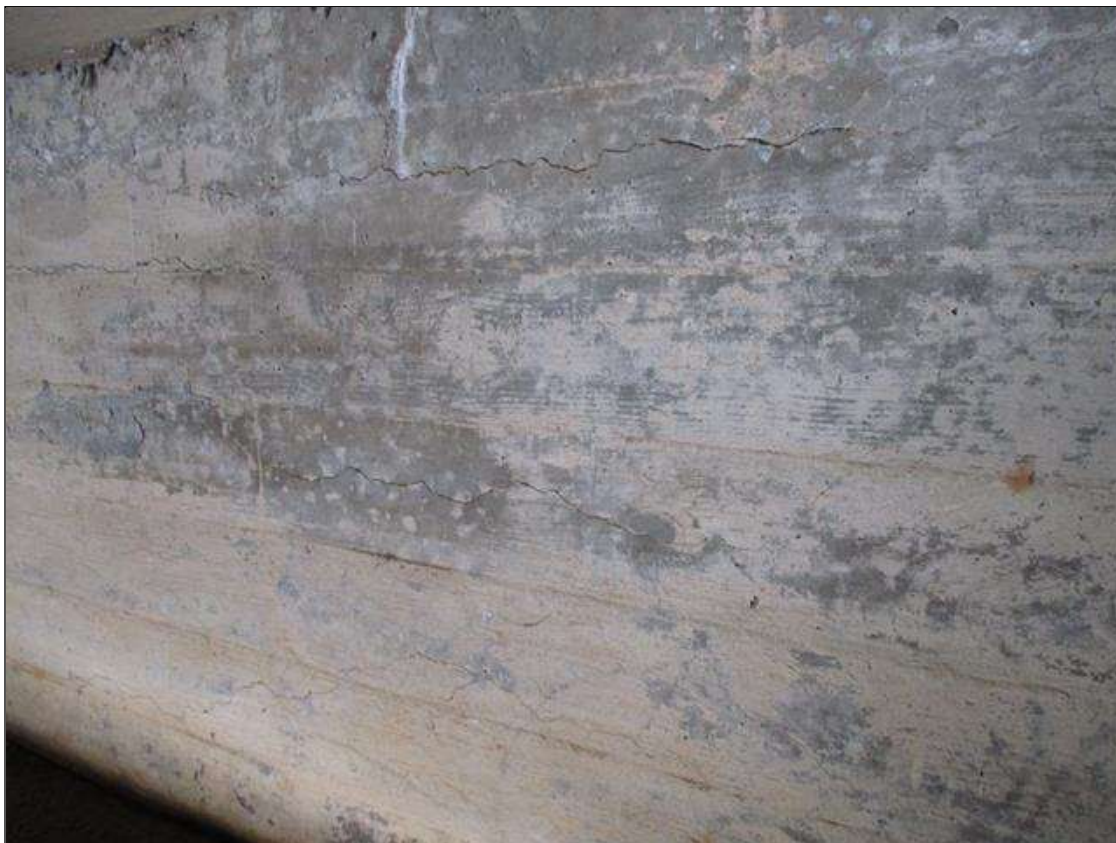
End Bent 2 Abutment: MULTIPLE HORZ. CRACKS UP TO 1/16TH IN WIDE THRU OUT END BENT BACKWALL AT OUTSIDE FACES.

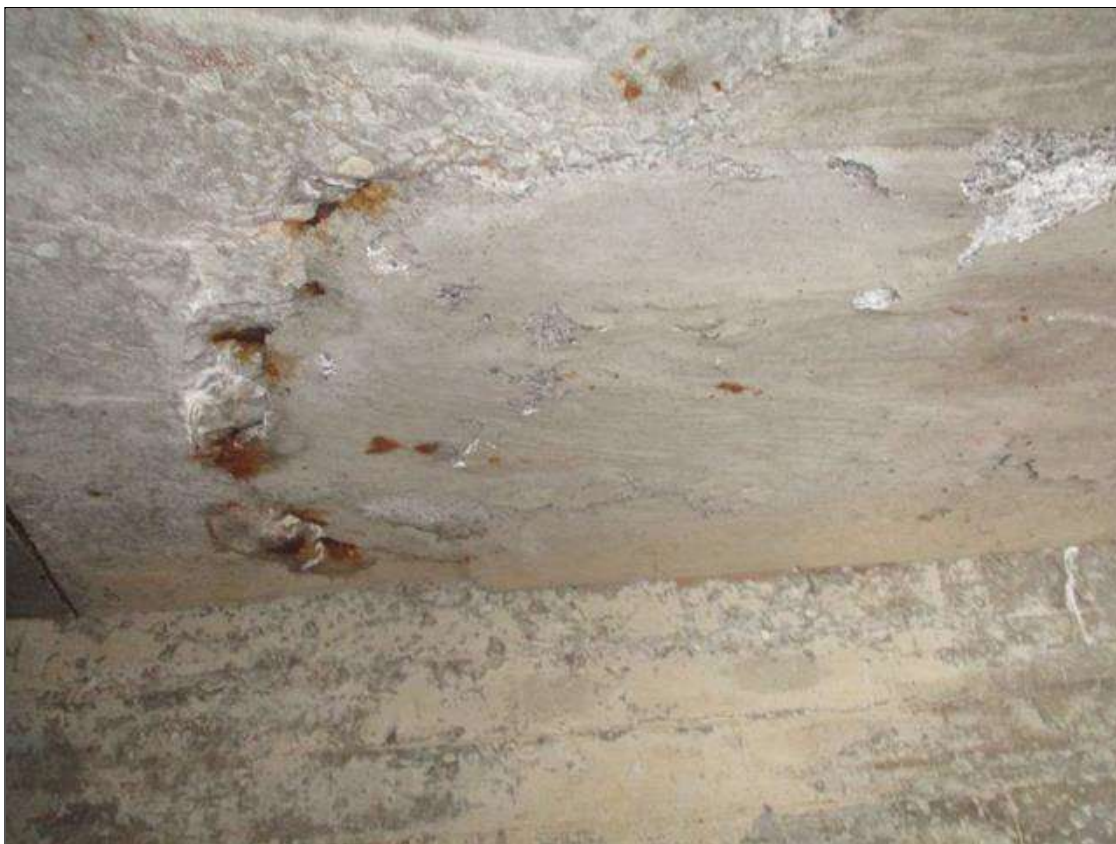
Span 4 Deck: 5 SQ FT AREA OF POORLY PATCHED AREA UNDER BAY 1 WITH SPALLS UP TO 4 IN DIAMETER WITH EXPOSED REBAR. NO SECTION LOSS IN THE EXPOSED REBAR.

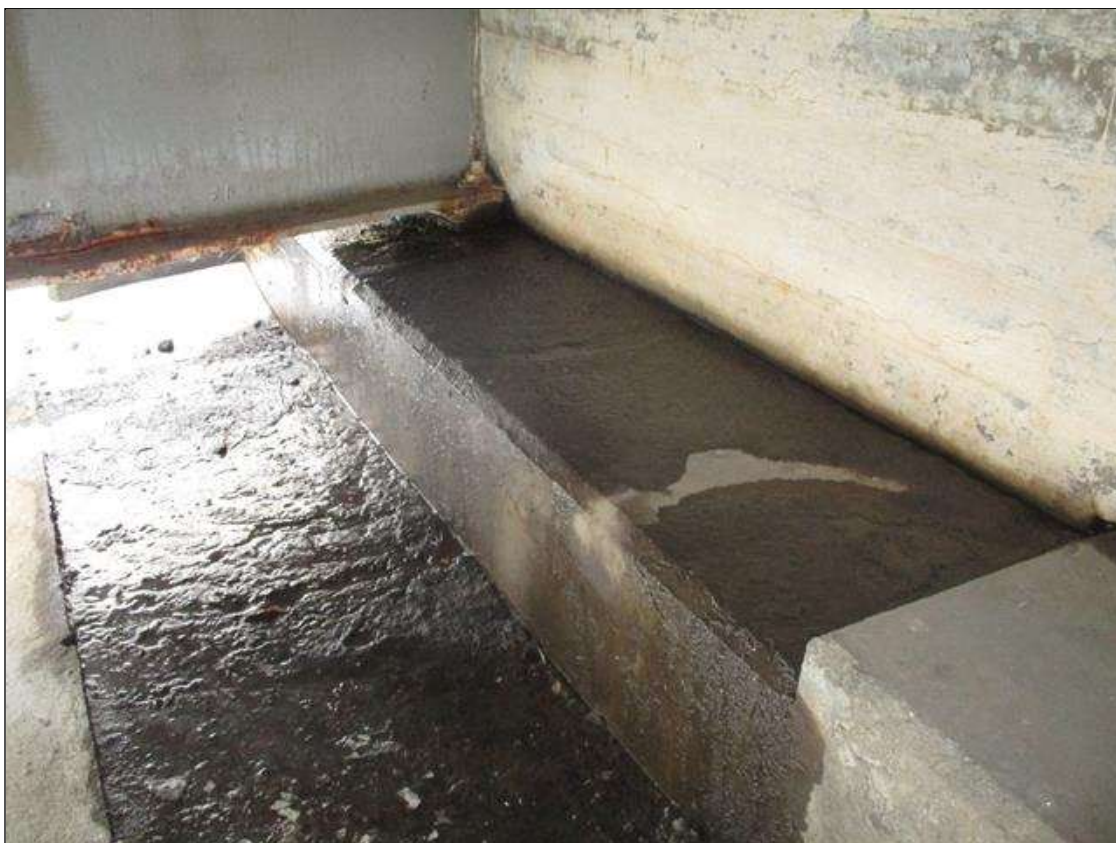
ACTIVE WATER LEAKAGE ON TOP OF BRIDGE SEAT AT BEAM 1 SPAN 4 AT END BENT 2

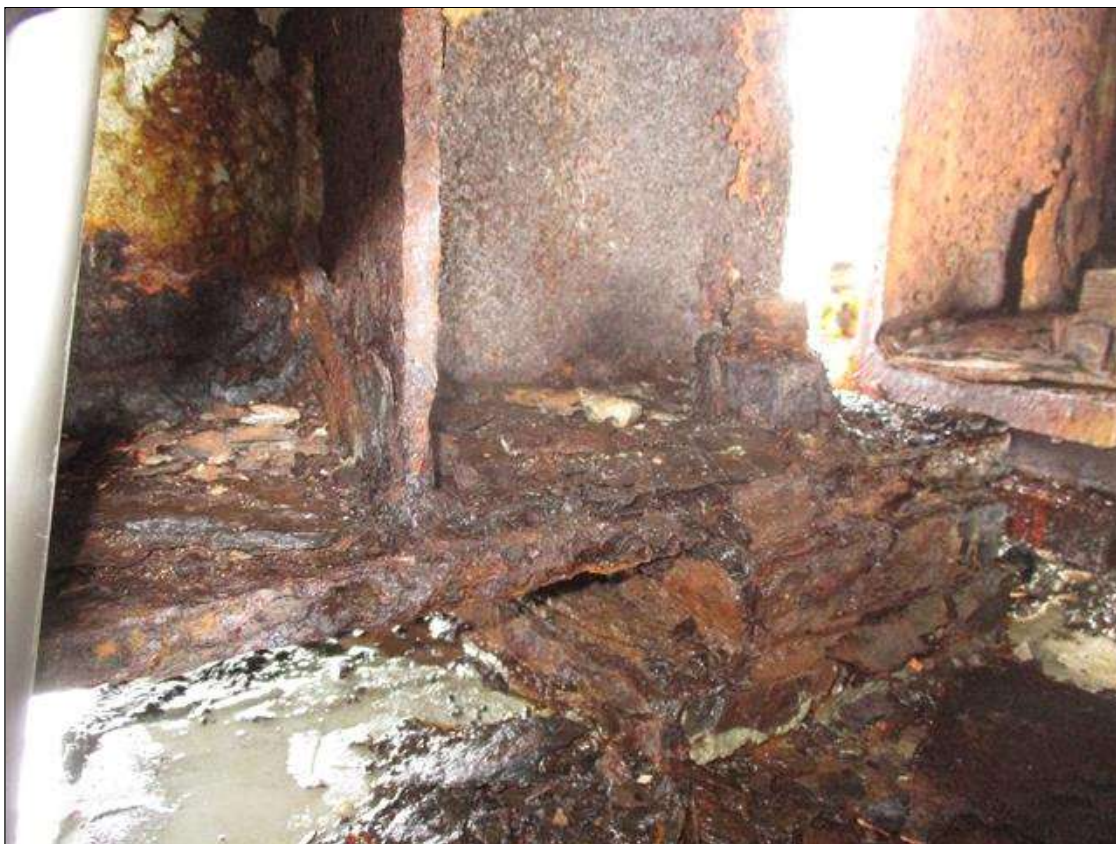
Span 1 Beam 1: BTM FLANGE SECTION LOSS (47% SL, 7/16IN SL, 1/2IN REMAIN) FULL WIDTH & WEB PITTING (9/16IN REMAIN) X 3IN HIGH FOR 3FT AT FAR END. (PAR)

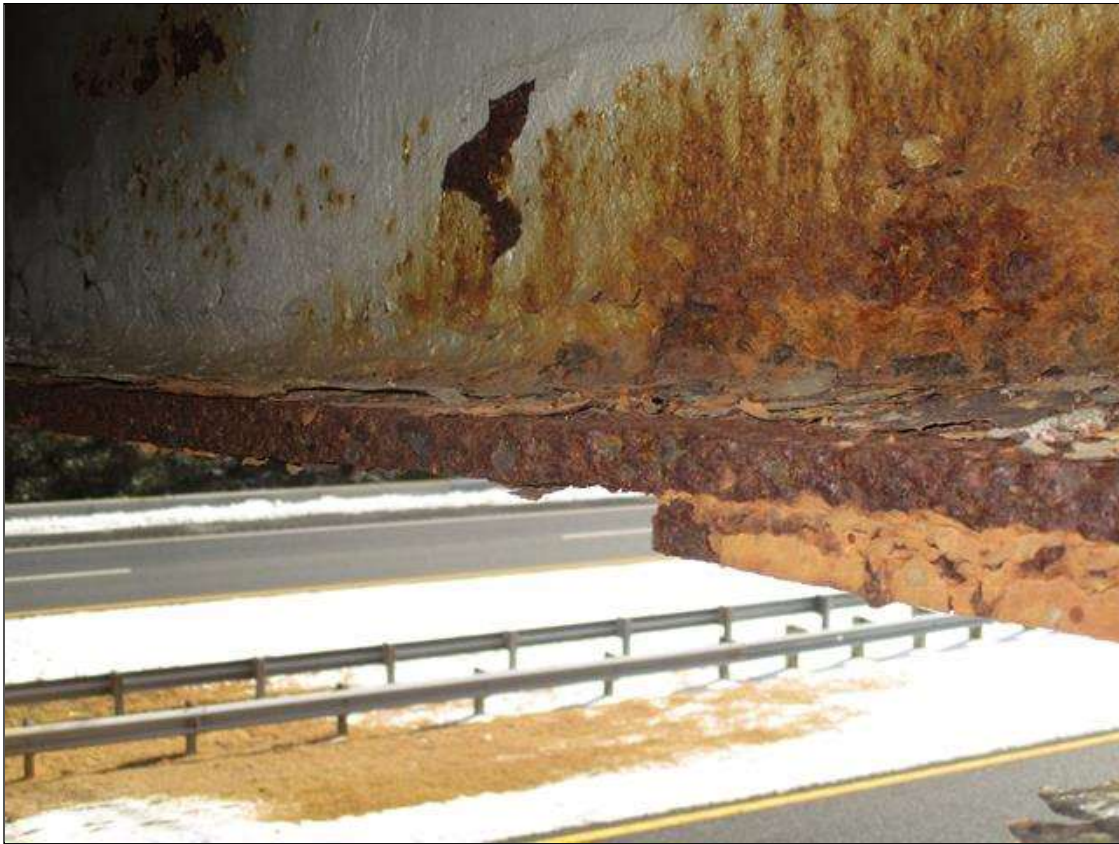
Span 2 Beam 8: BTM FLANGE SECTION LOSS (27% SL, 1/4IN SL, 11/16IN REMAIN) FULL WIDTH FOR 1FT STARTING AT 1FT FROM NEAR END AFTER REPAIR PLATE. (PAR)

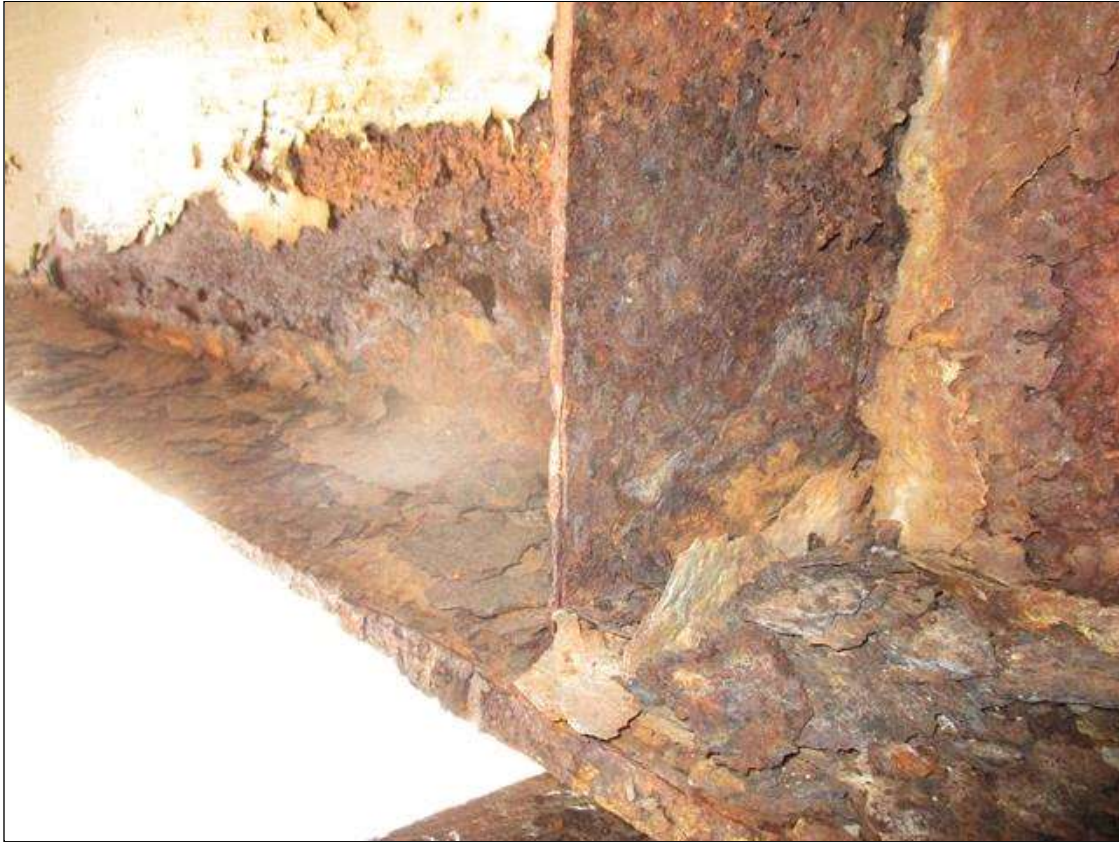
Span 2 Beam 9: BTM FLANGE SECTION LOSS (50% SL, 1/4IN REMAIN AT LEFT SIDE & 1/2IN REMAIN AT RIGHT SIDE) & WEB SECTION LOSS (1/2IN REMAIN) X 8IN HIGH FOR 4FT AT NEAR END. STIFFENER SECTION LOSS (1/4IN REMAIN) 7IN HIGH X FULL WIDTH TO LEFT SIDE STIFFENER AT NEAR END (PAR)
