NC DEPARTMENT OF TRANSPORTATION
 DIVISION OF HIGHWAYS
 STRUCTURE MANAGEMENT UNIT

ATTENTION: **PAR SUBMITTED**

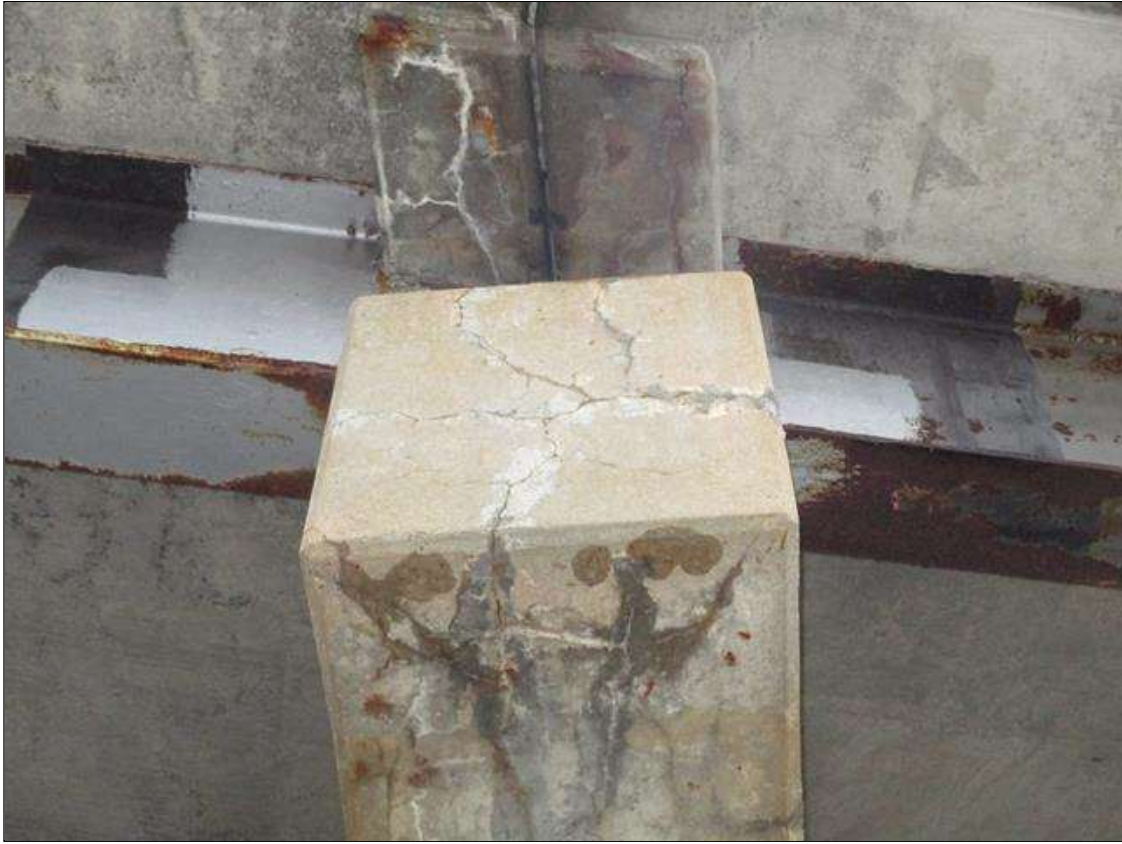
Span 4 Deck: 2X SPALL (UP TO 1.5FT X 8IN X 3IN) WEST/ EXPOSED REBAR TO LEFT SIDE OVERHANG HAUNCH & BTM OF DECK OVER BENT 3. 90% SECTION REMAINING IN THE EXPOSED REBAR. (PAR)

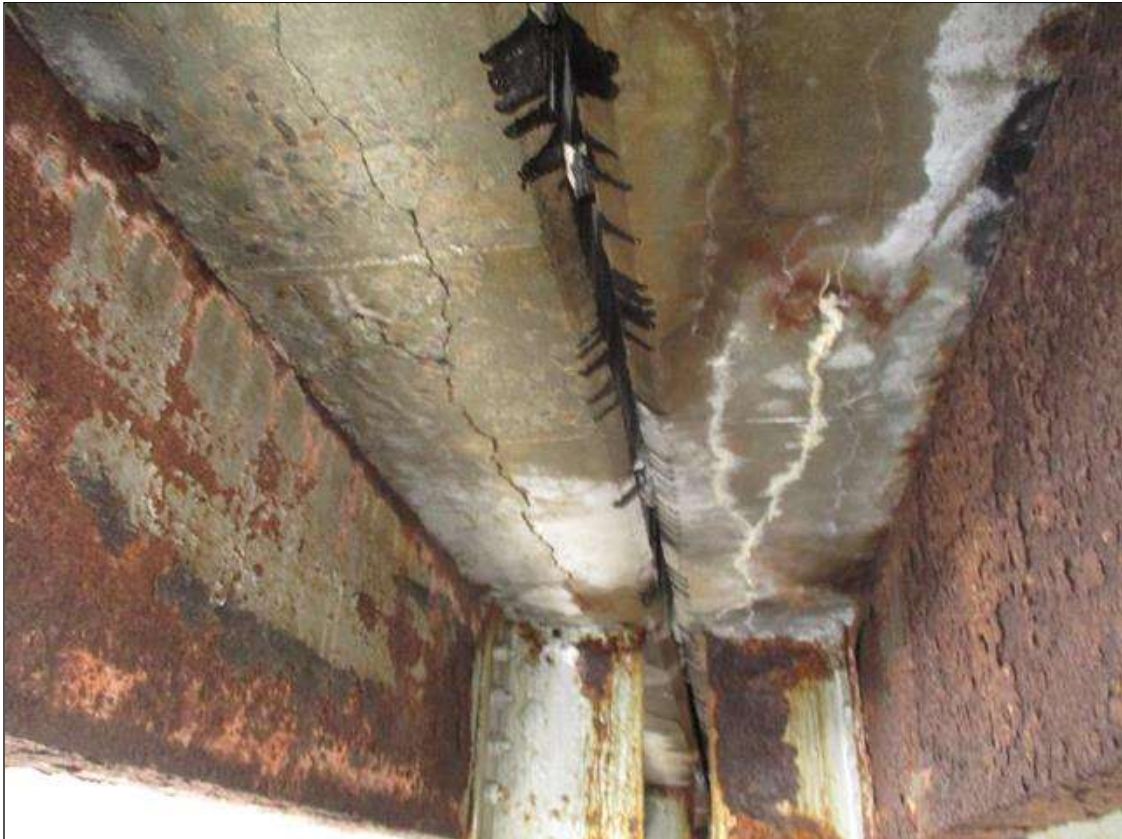
Span 4 Deck: TRANSVERSE CRACKING UP TO 1/4 IN WIDE FOR FULL WIDTH IN BAY 8 AND 9 WITH DELAMINATED AREA SURROUNDING THE CRACK UP TO 4 IN WIDE

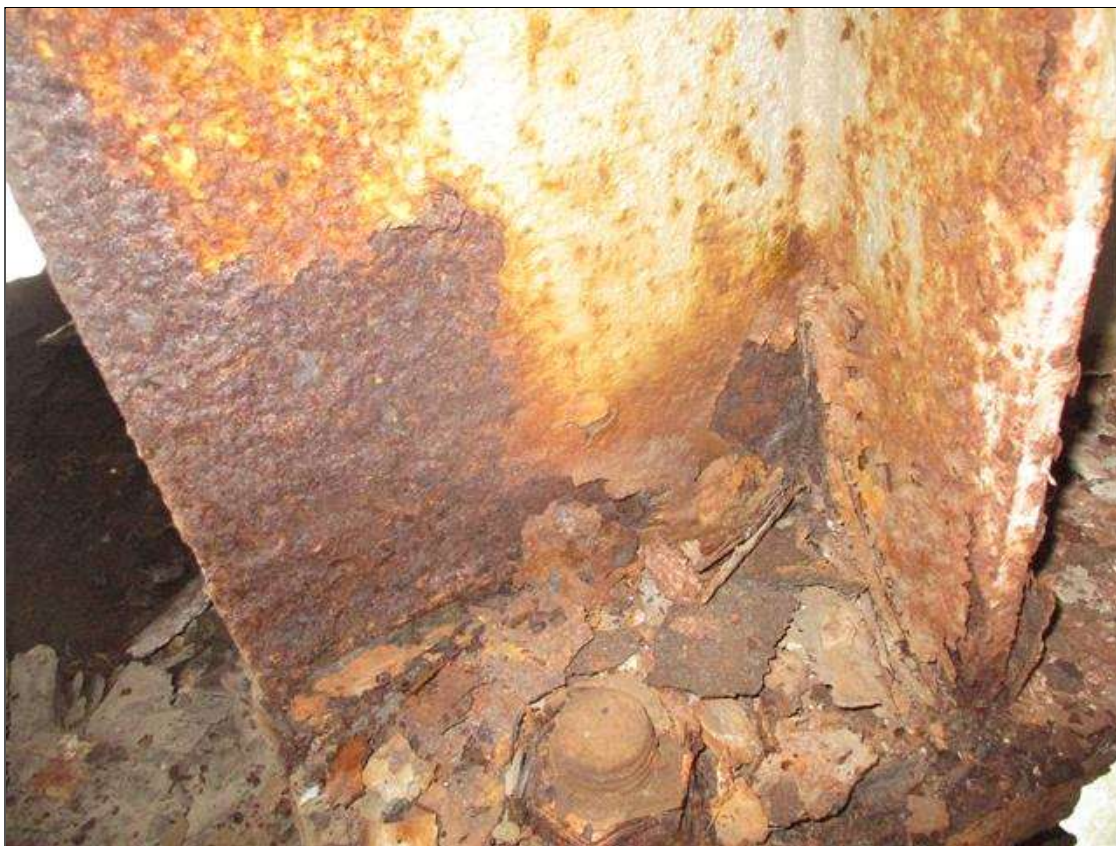
Span 4 Beam 3: WEB SECTION LOSS (40% SL, 1/4IN SL, 3/8IN REMAIN) X UP TO FULL HEIGHT FOR 10IN AT NEAR END. (PAR)

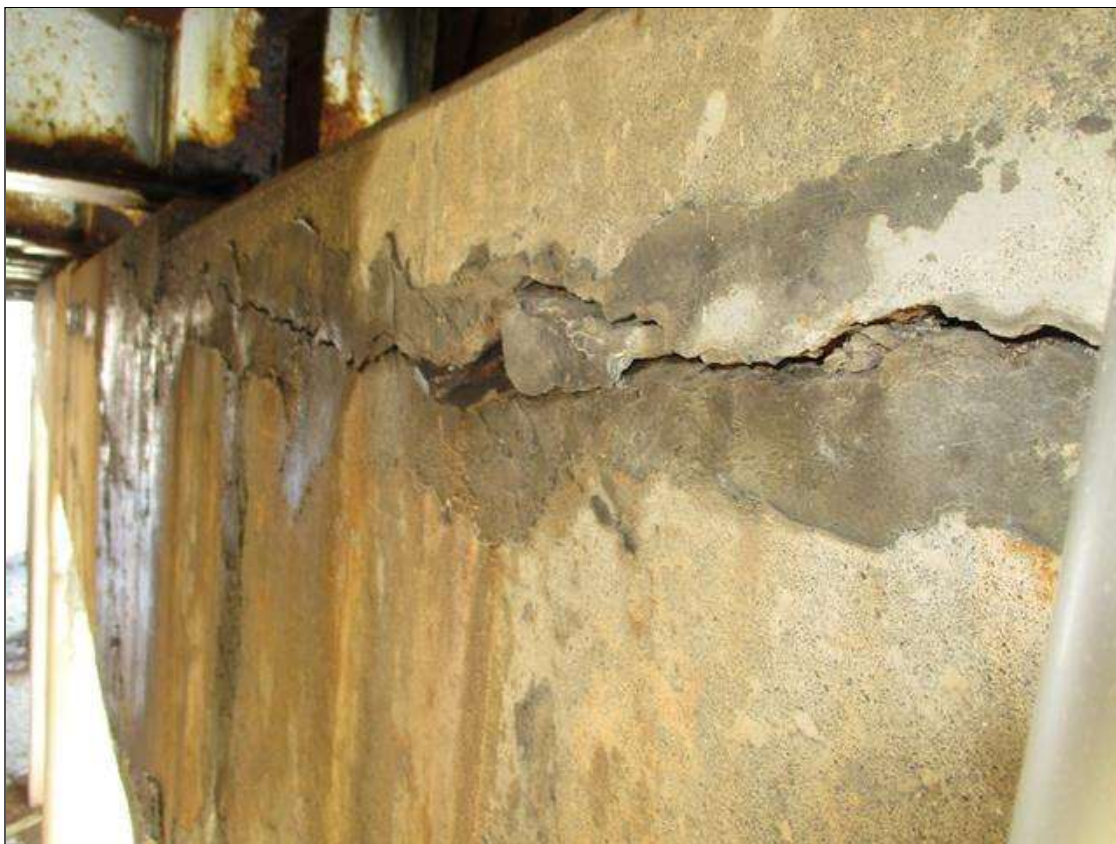
Bent 1 Cap 1: HORZ. & MAP CRACKING (UP TO 1/8IN) WEST/ EFFLO. & RUSTING STAINING THRU OUT ALL FACES OF CAP, CRACKING BECOMES WIDER AT RIGHT END OF CAP. 5FT HORZ. OPEN CRACKING WEST/ DELAM (6IN X 6IN) TO NEAR TOP CORNER OF CAP IN BAY 9.

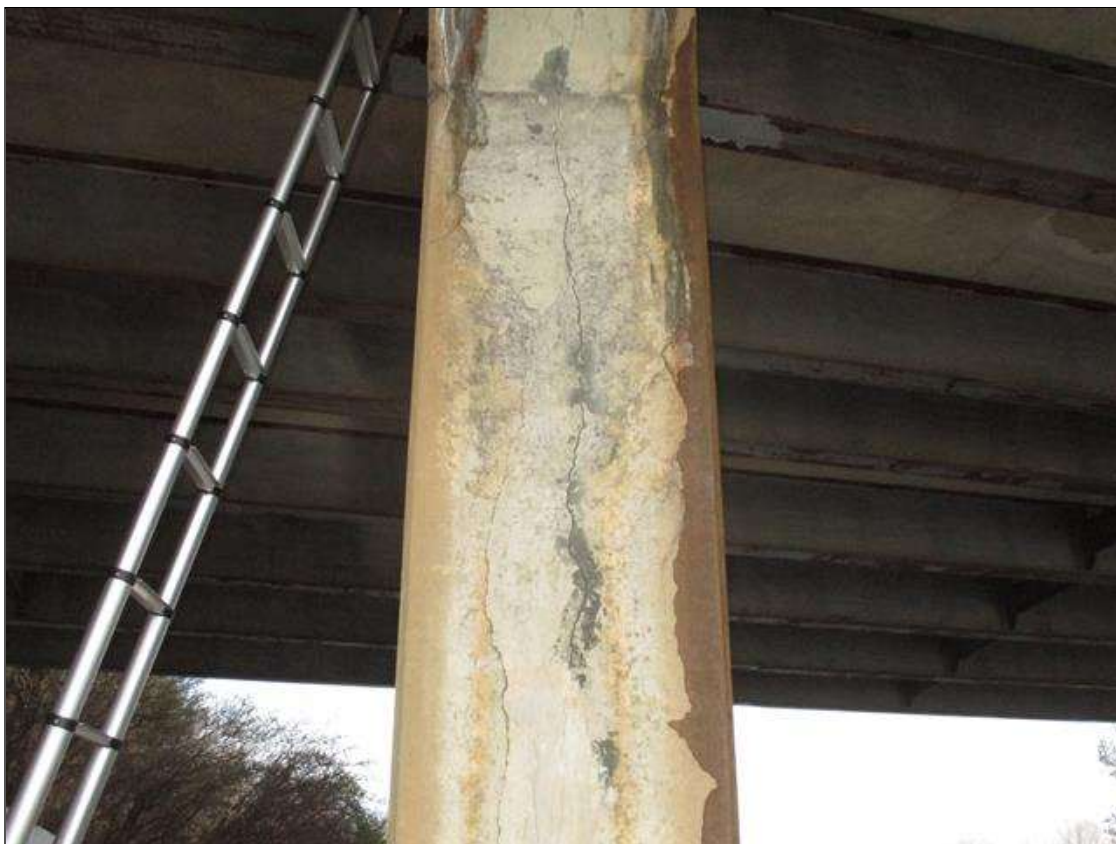
Bent 1 Pile 3: PATCHED AREA UNSOUND ALONG SOUTH FACE FOR 2/3 OF TOTAL HEIGHT

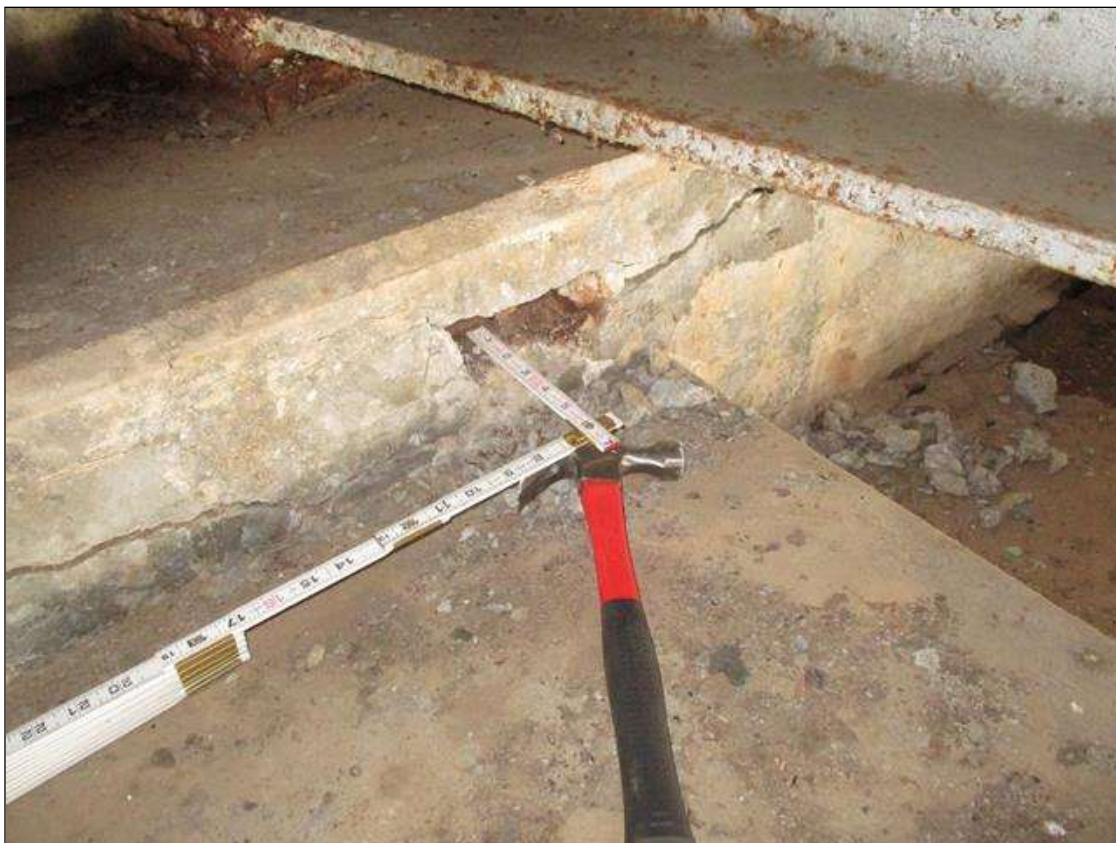
End Bent 2 Cap 1: SPALL WITH EXPOSED REBAR UP TO 9 IN LONG X 5" HIGH X 2.5" DEEP UNDER GIRDER 8. EXPOSED REBAR HAS NO SECTION LOSS

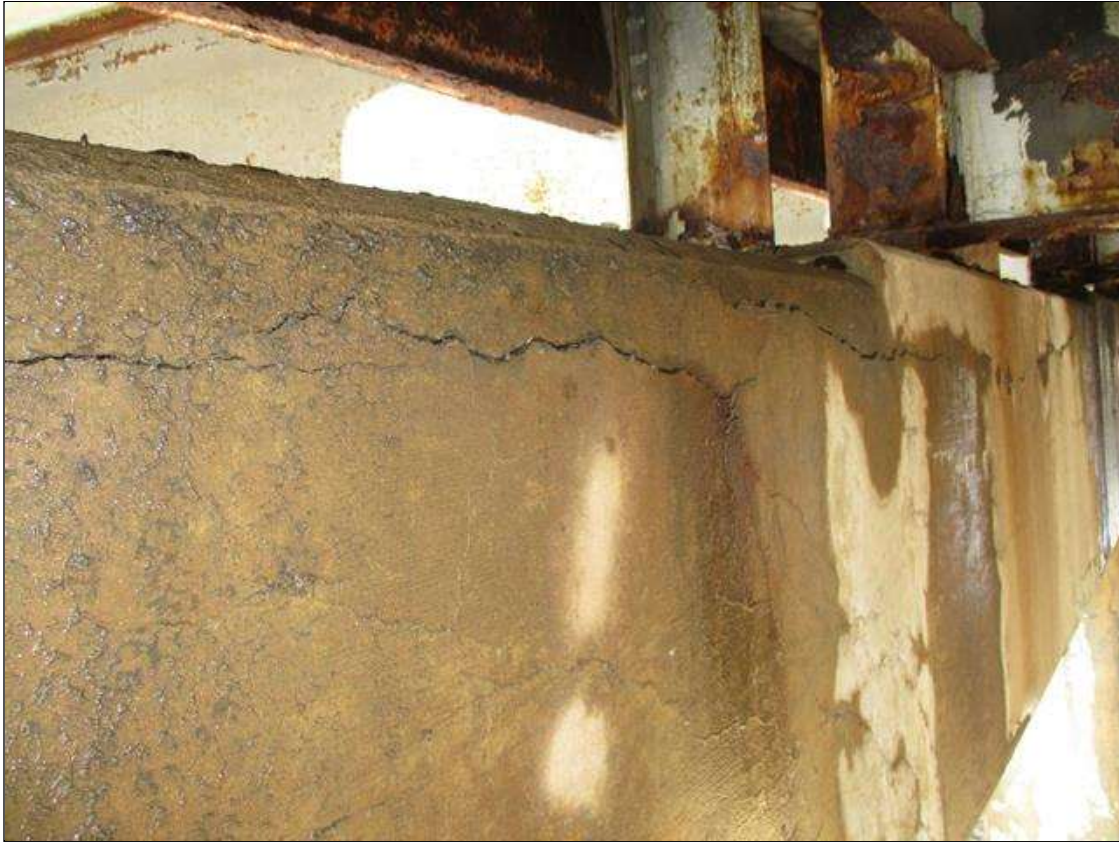
Bent 3 Cap 1: HORZ. & MAP CRACKING (UP TO 3/16IN) WEST/ EFFLO. & RUSTING STAINING THRU OUT ALL FACES OF CAP. HORZ. CRACKING (UP TO 1/8IN) WEST/ EDGE DELAM TO BTM OF CAP THRU OUT.

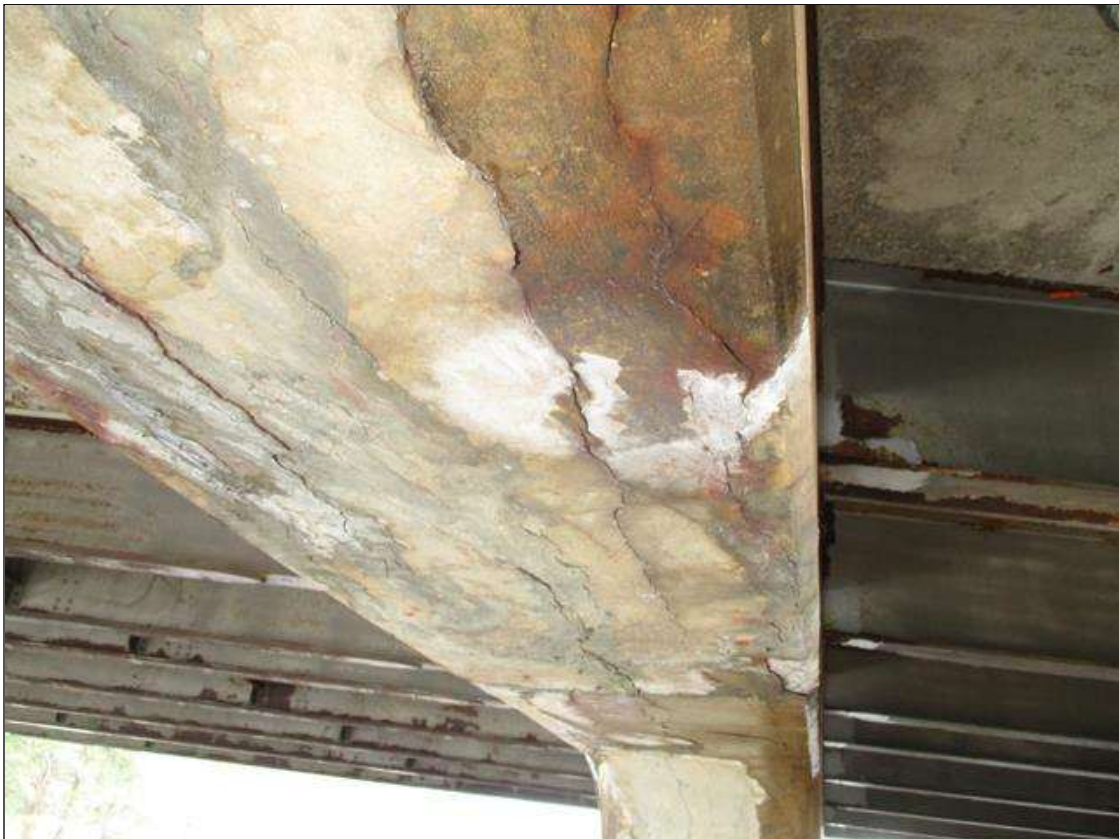
Bent 3 Cap 1: LONGITUDINAL CRACKING UP TO 3/16 IN WIDE WITH SURROUNDING DELAMS ON THE UNDERSIDE OF CAP BETWEEN PILES 3 AND 4

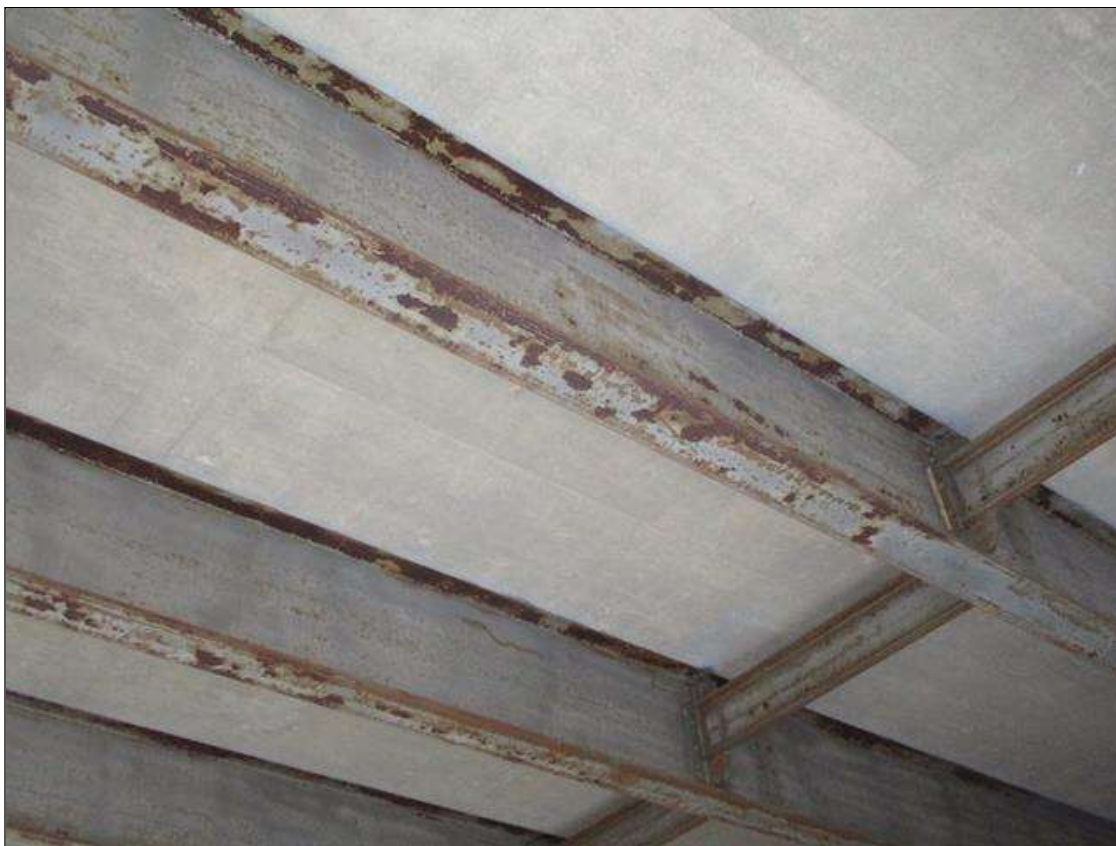
Span 1 Beam 2: SURFACE CORROSION & FRECKLE RUST THRU OUT LENGTH OF BEAM, MOSTLY AT FLANGES.

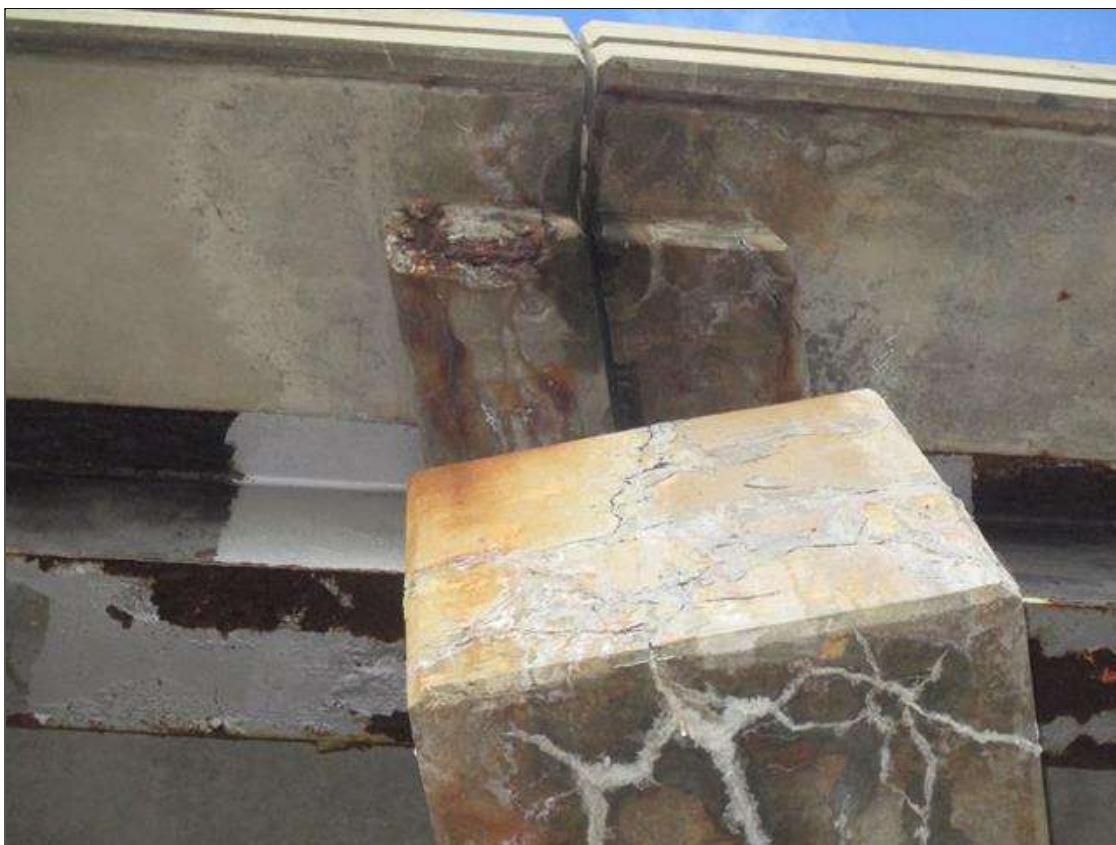
Span 2 Deck: SPALL (1FT X 8IN X 2IN) WEST/ EXPOSED REBAR TO RIGHT SIDE OVERHANG HAUNCH OVER BENT 2. UP TO 90% SECTION REMAINING IN THE EXPOSED REBAR. (PAR)

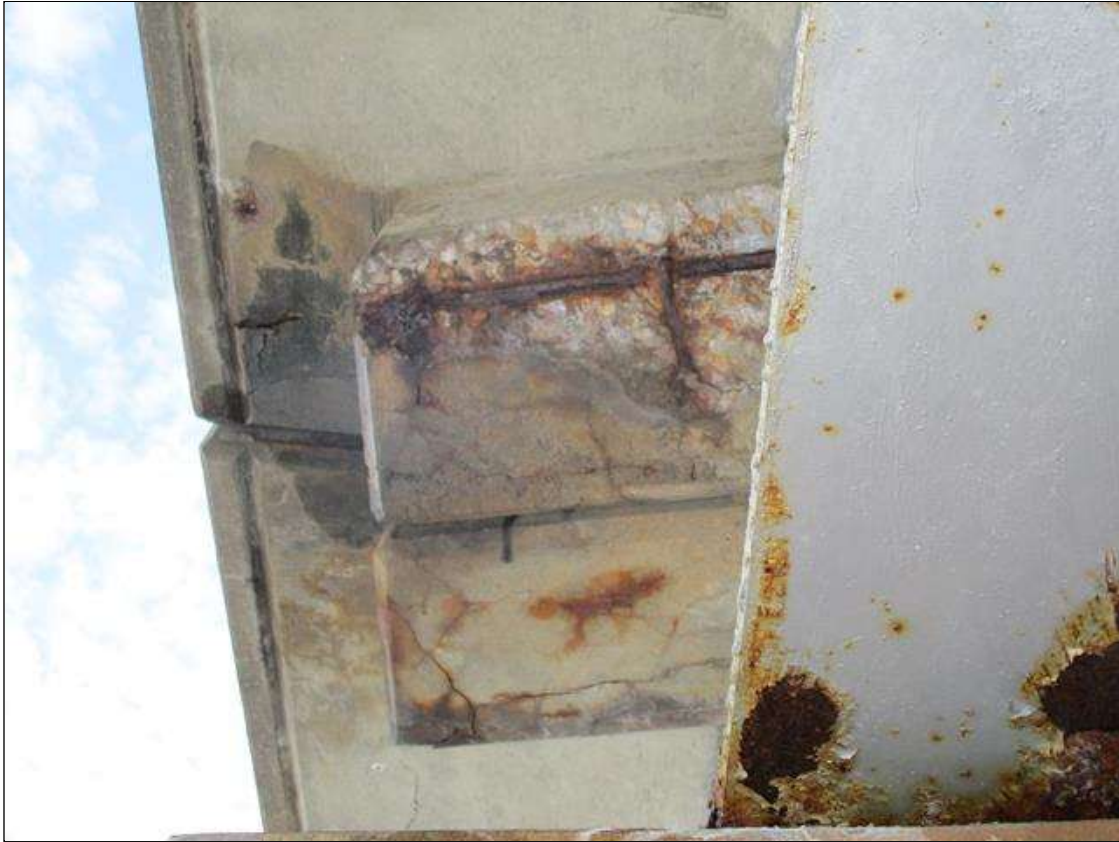
Span 2 Deck: SPALL (2FT X 8IN X 2IN) WEST/ EXPOSED REBAR TO LEFT SIDE OVERHANG HAUNCH OVER BENT 2. UP TO 90% SECTION REMAINING IN THE EXPOSED REBAR (PAR)

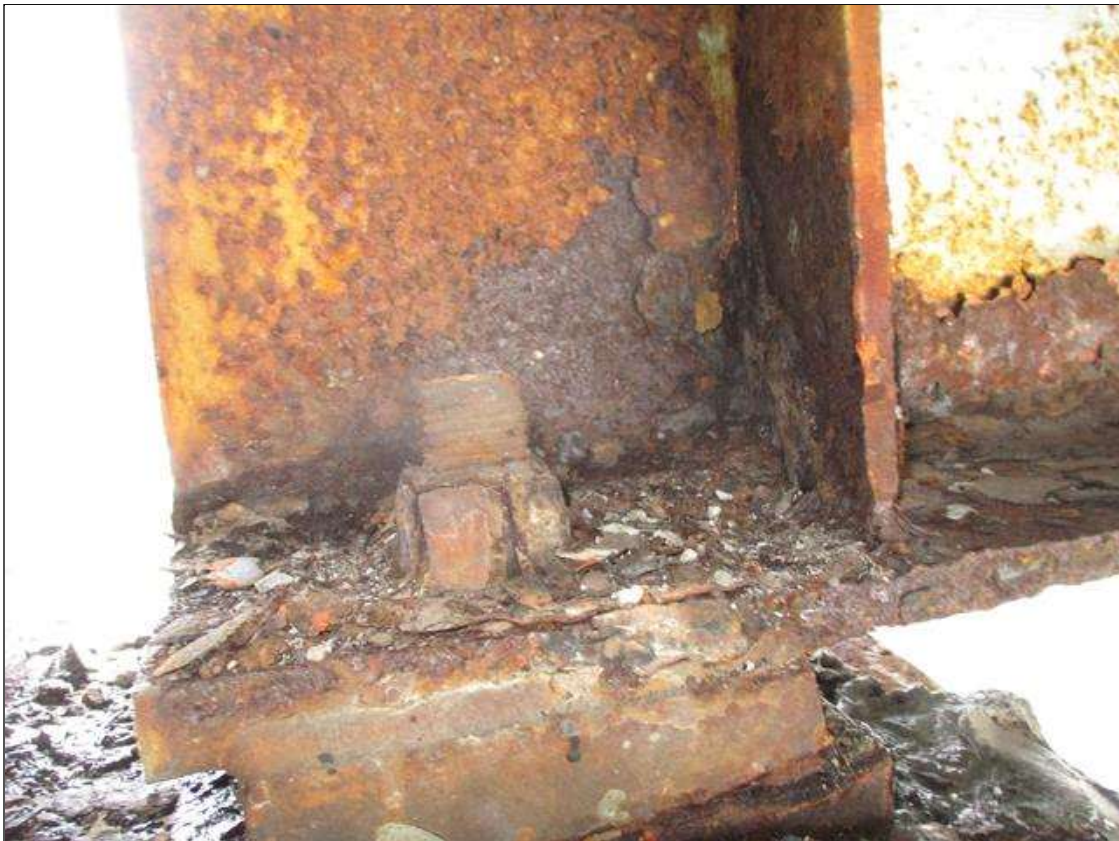
Span 2 Beam 1: BTM FLANGE SECTION LOSS (40% SL, 3/8IN SL, 9/16IN REMAIN) FULL WIDTH & WEB PITTING (9/16IN REMAIN) X 4IN HIGH FOR 4FT AT NEAR END. (PAR)

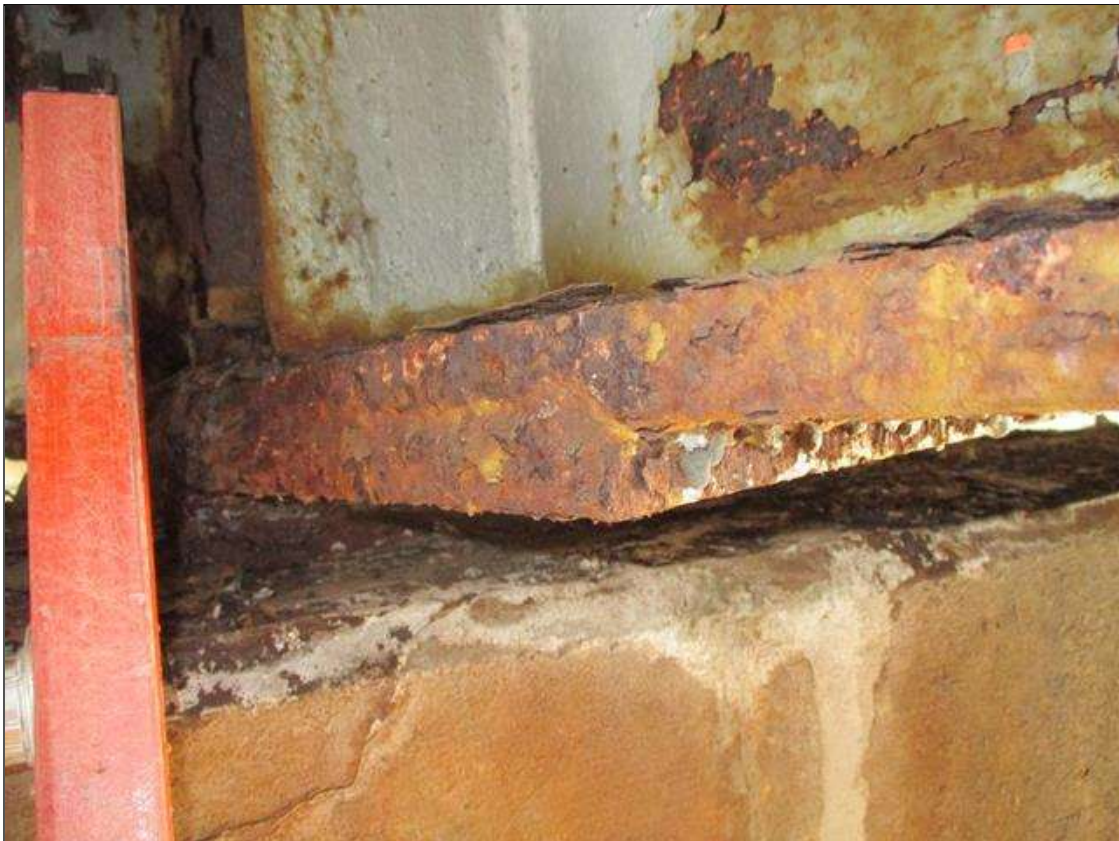
Span 2 Beam 8: BTM MINOR FLANGE SECTION LOSS IS FULL WIDTH FOR 1FT STARTING AT 1FT FROM FAR END AFTER REPAIR PLATE.

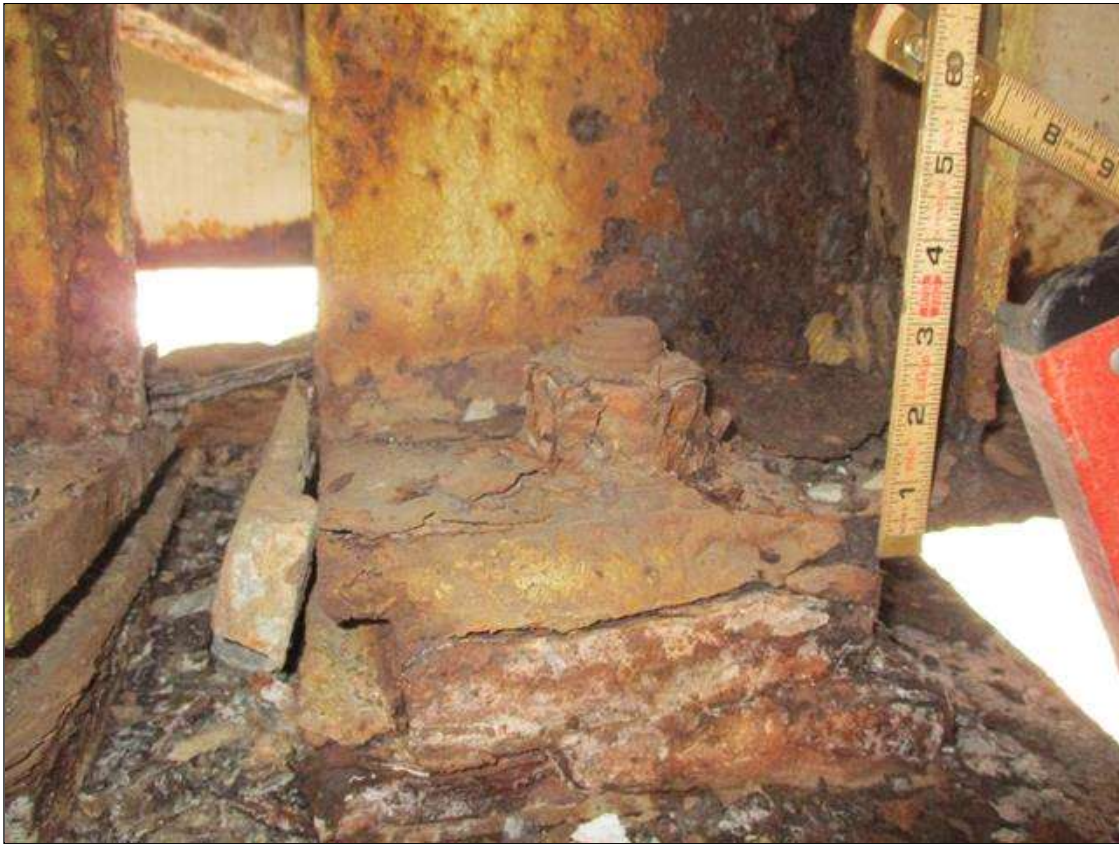
Span 2 Beam 9: BTM FLANGE SECTION LOSS (66% SL, 5/8IN SL, 5/16IN REMAIN) FULL WIDTH & WEB PITTING (9/16IN REMAIN) X 3IN HIGH FOR 2FT AT FAR END. (PAR)

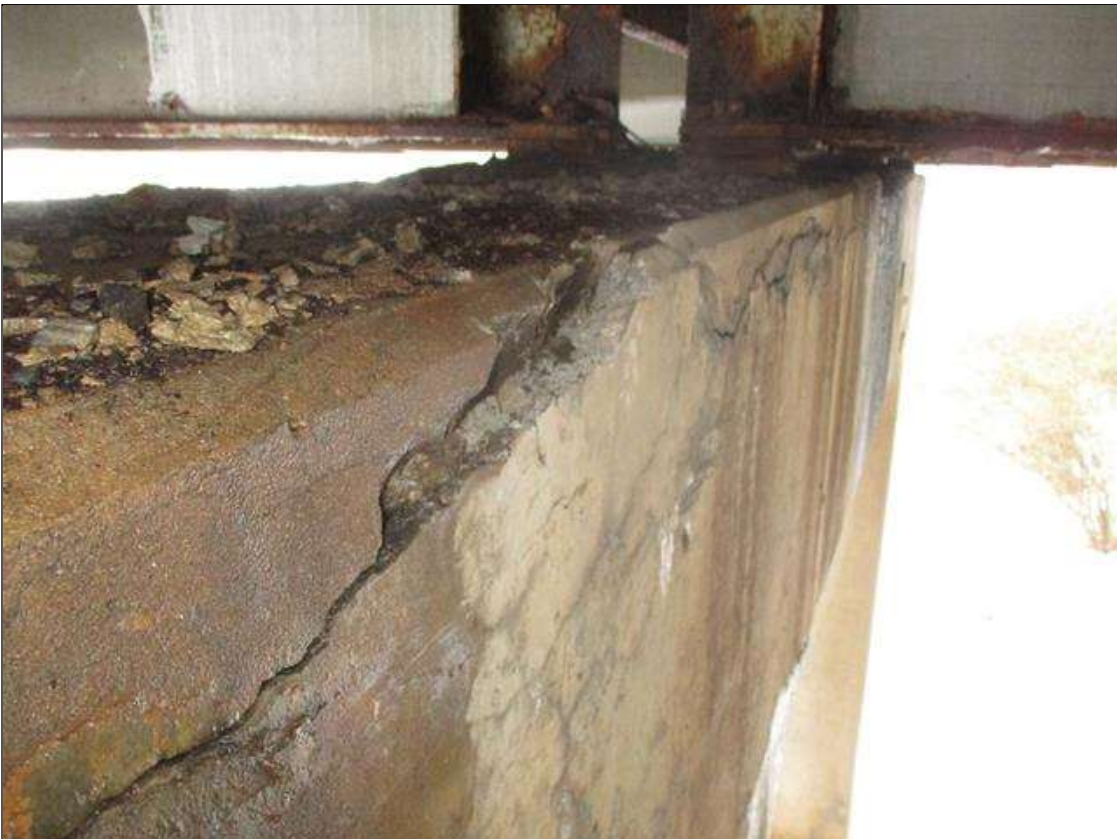
Bent 3 Cap1: DELAMINATED AND SPALLED AREA UP TO 5 FT LONG X 3 HIGH X 2 IN DEEP WITH NO EXPOSED REBAR IN THE TOP FAR FACE BELOW BAY 2 WITH HORIZONTAL CRACKS UP TO 3/16 IN WIDE

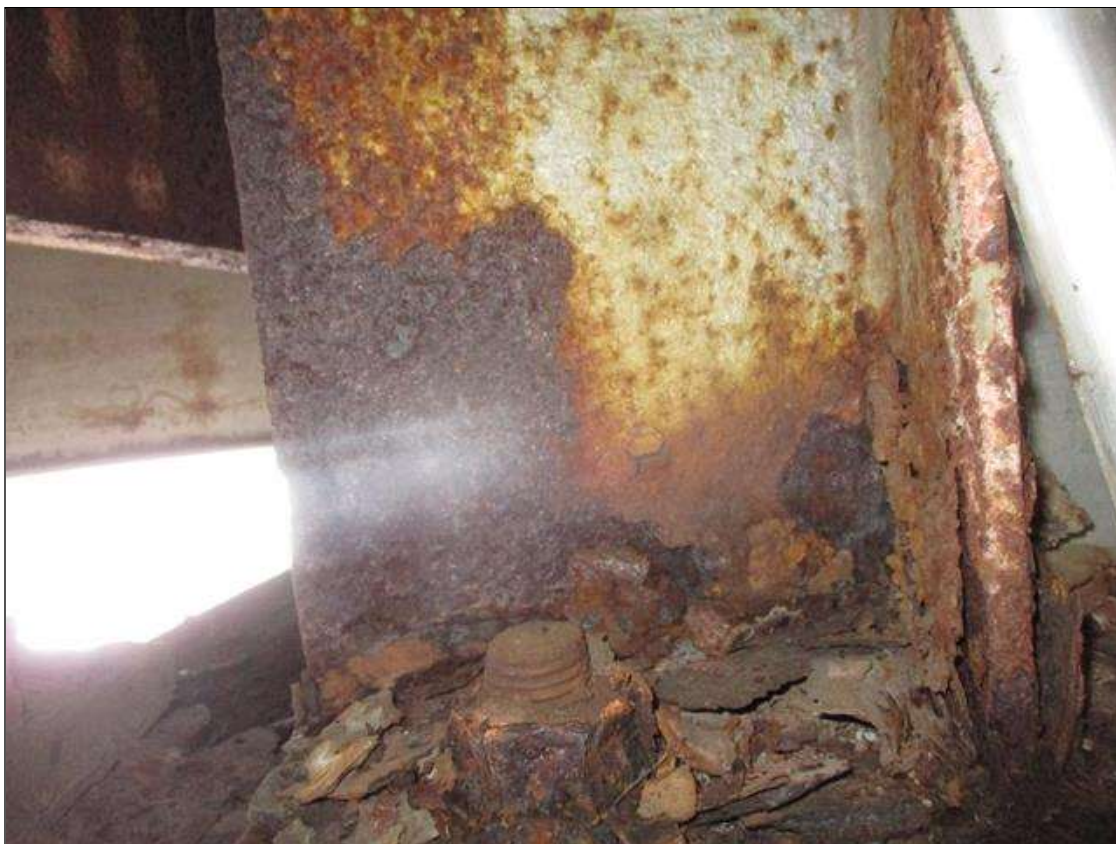
Span 4 Beam 2: BTM FLANGE & FULL HEIGHT WEB SCALING AT NEAR END OF BEAM

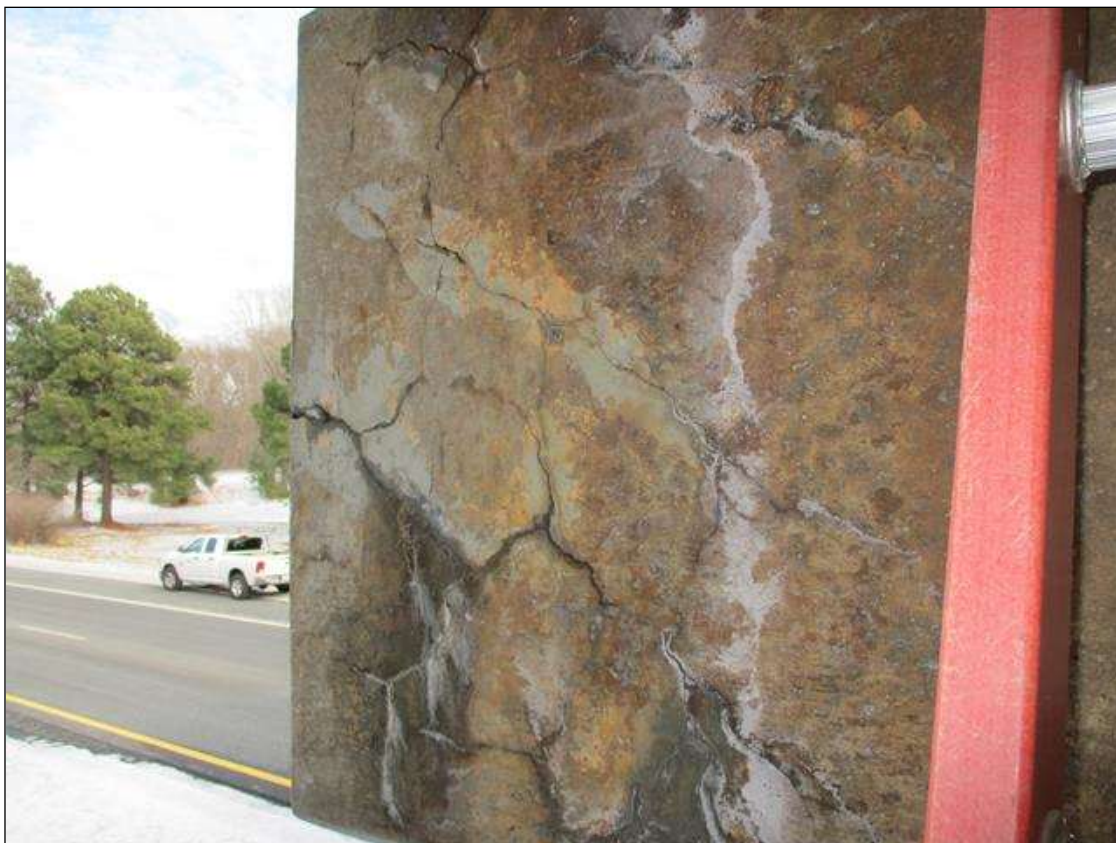
Bent 2 Cap 1: HORZ. & MAP CRACKING (UP TO 1/8IN) WEST/ EFFLO. & RUSTING STAINING THRU OUT ALL FACES OF CAP

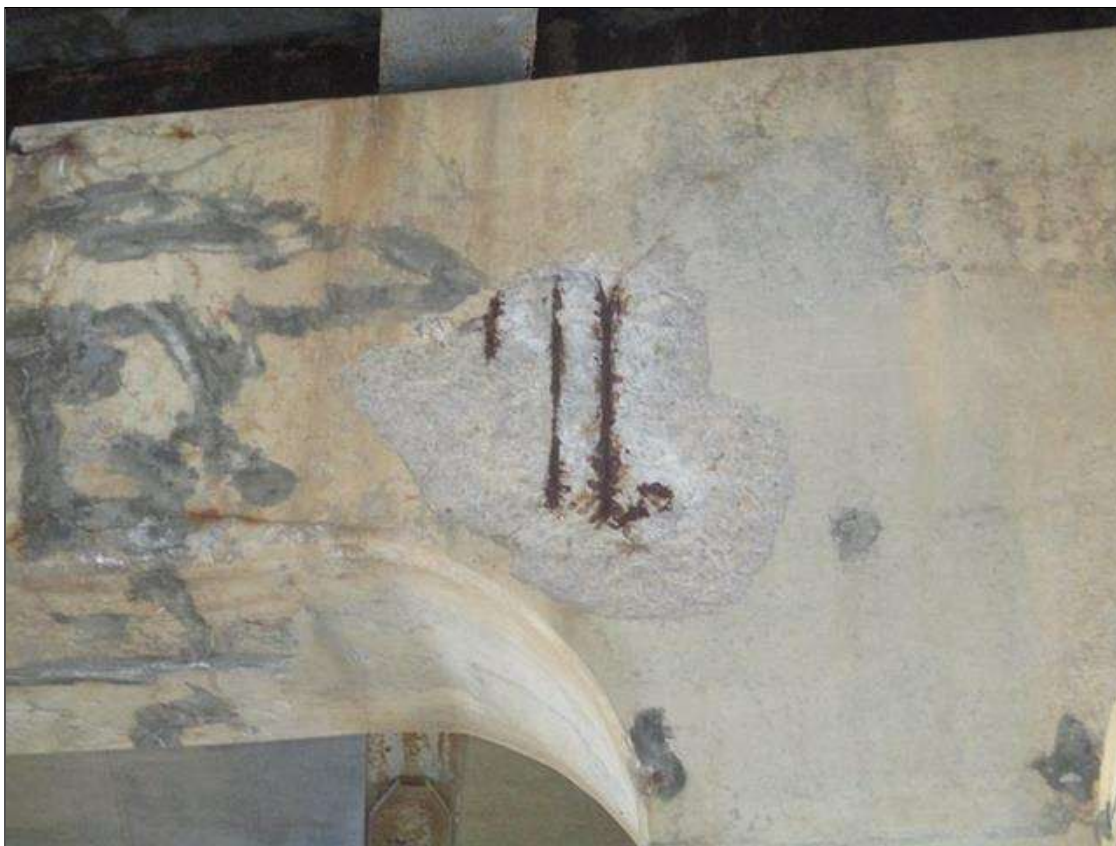
Bent 2 Cap 1: SPALL (3FT X 2FT X 2IN) WEST/ EXPOSED REBAR TO NEAR FACE OF COLUMN OVER COLUMN 3 (PAR)

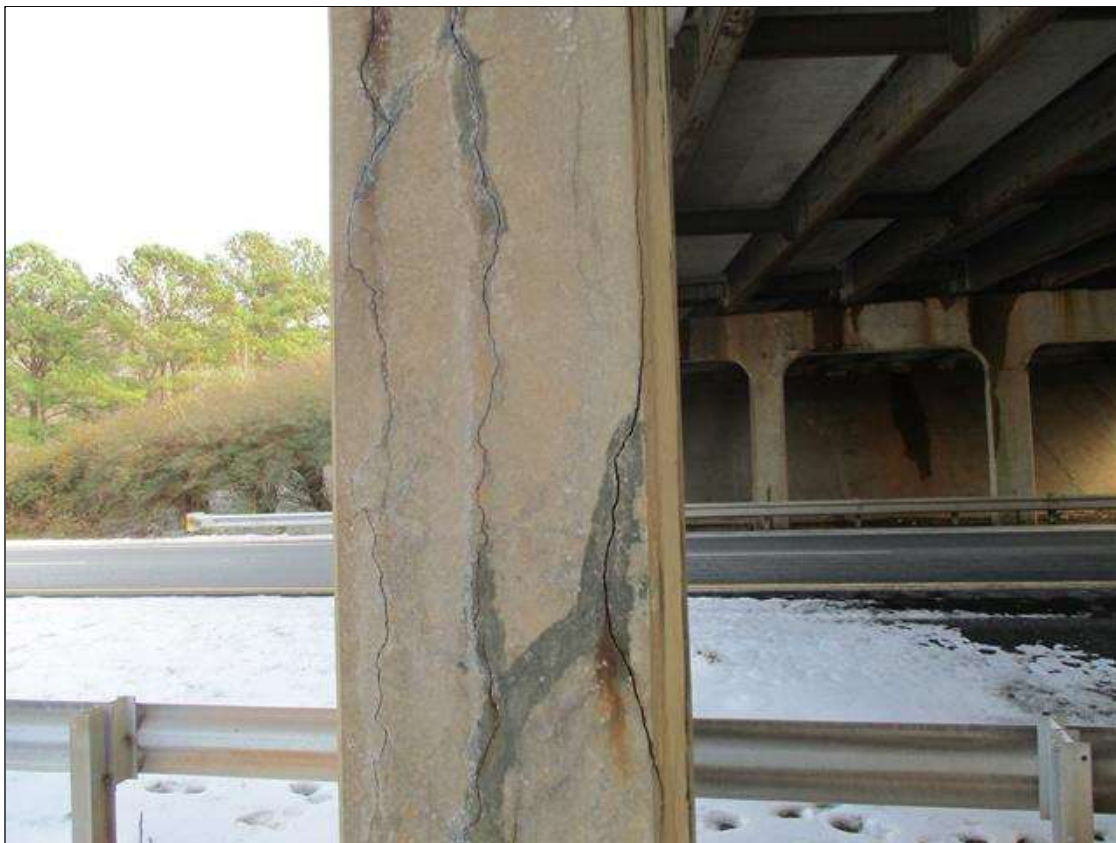
Bent 2 Pile 1: FULL HEIGHT VERTICAL OPEN CRACKING (UP TO 3/16IN) TO ALL FACES OF COLUMN.

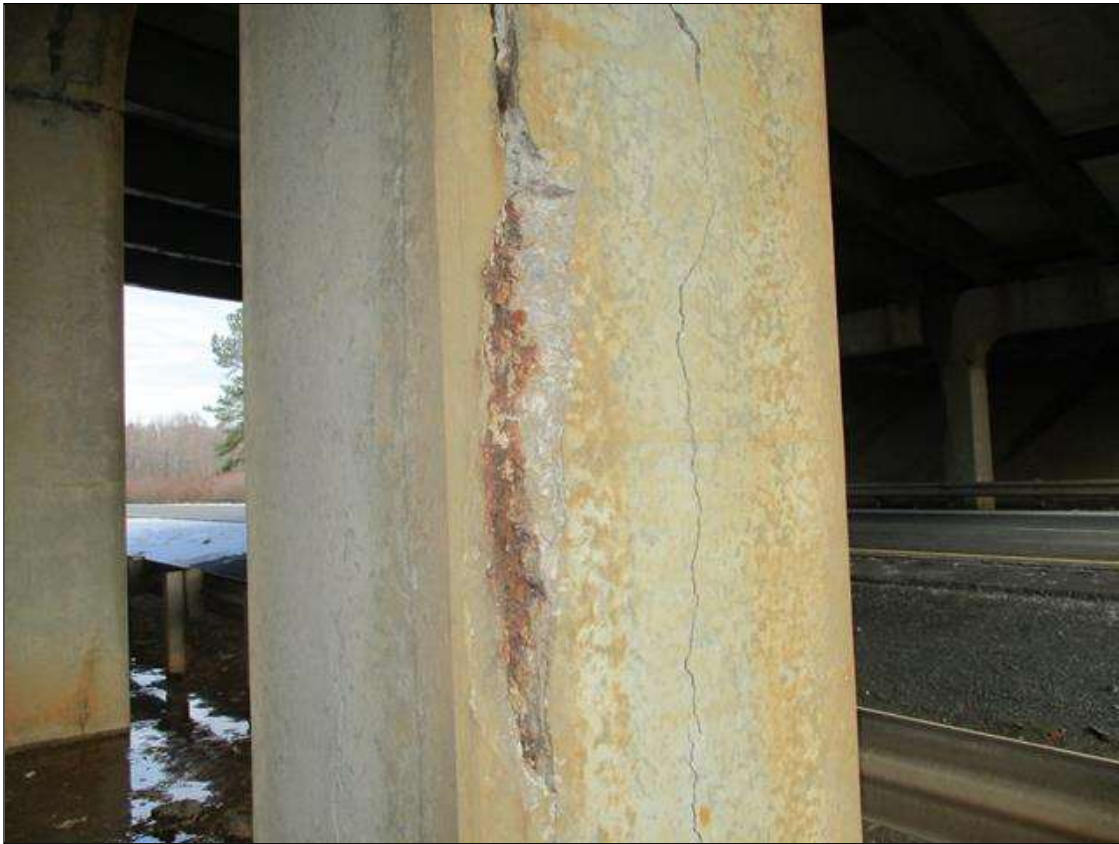
Bent 2 Pile 4: SPALL WITH EXPOSED REBAR IN THE SOUTH FACE OF COLUMN UP TO 4 FT HIGH X 5 IN WIDE X 2.5 IN DEEP STARTING 3 FT FROM GROUND LINE. UP TO 80% SECTION REMAINING ON THE EXPOSED REBAR. COLUMN IS DELAMINATED ABOVE THE SPALL FOR THE REMAINDER OF THE COLUMN HEIGHT

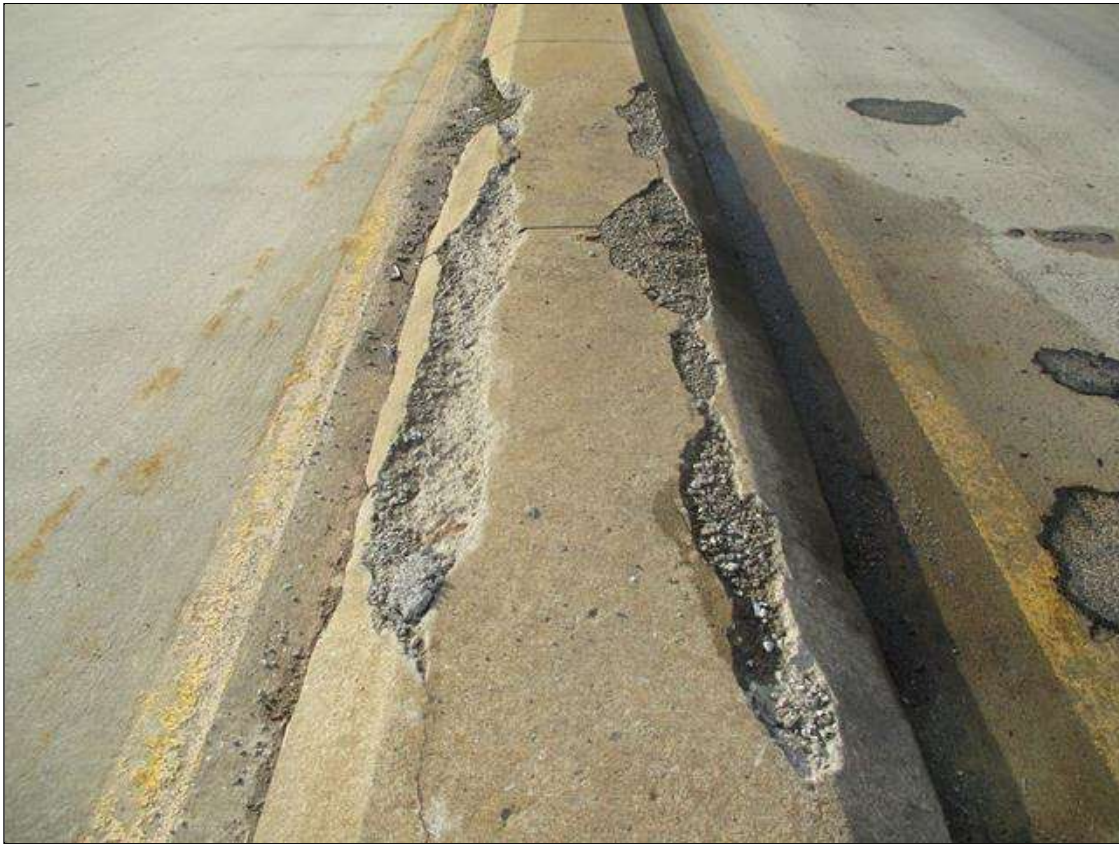
Span 2 Deck: 2X SPALLING (UP TO 17FT X 1FT WIDE X 6IN) DEEP TO RIGHT & LEFT SIDES OF MEDIAN AT FAR END. SPALL (2FT X 10IN X 6IN DEEP) TO RIGHT SIDE OF MEDIAN AT 1/3 SPAN (SIMILAR AT 2/3 SPAN).

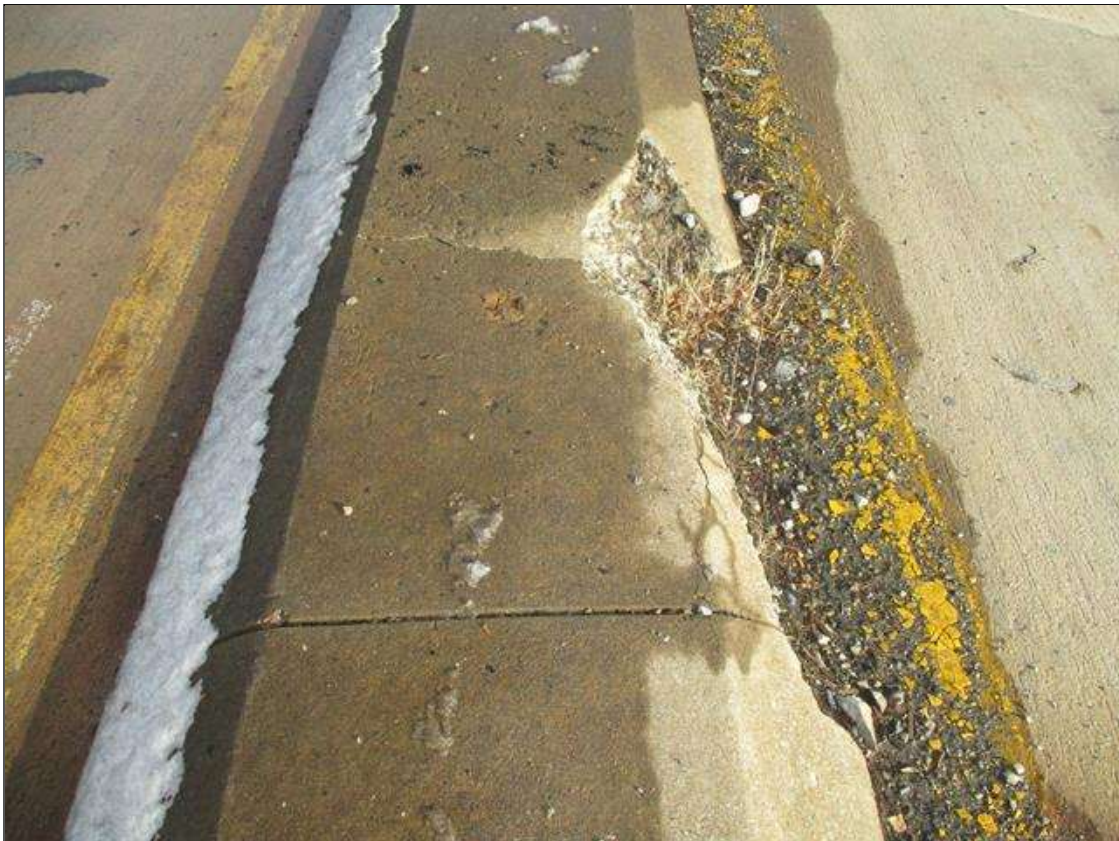
Span 4 Deck: SPALL(6FT X 12IN X 6IN DEEP) TO RIGHT SIDE OF MEDIAN, 15FT FROM FAR END. SPALL (15FT X 4IN X 4IN) TP LEFT EDGE OF MEDIAN AT FAR END.

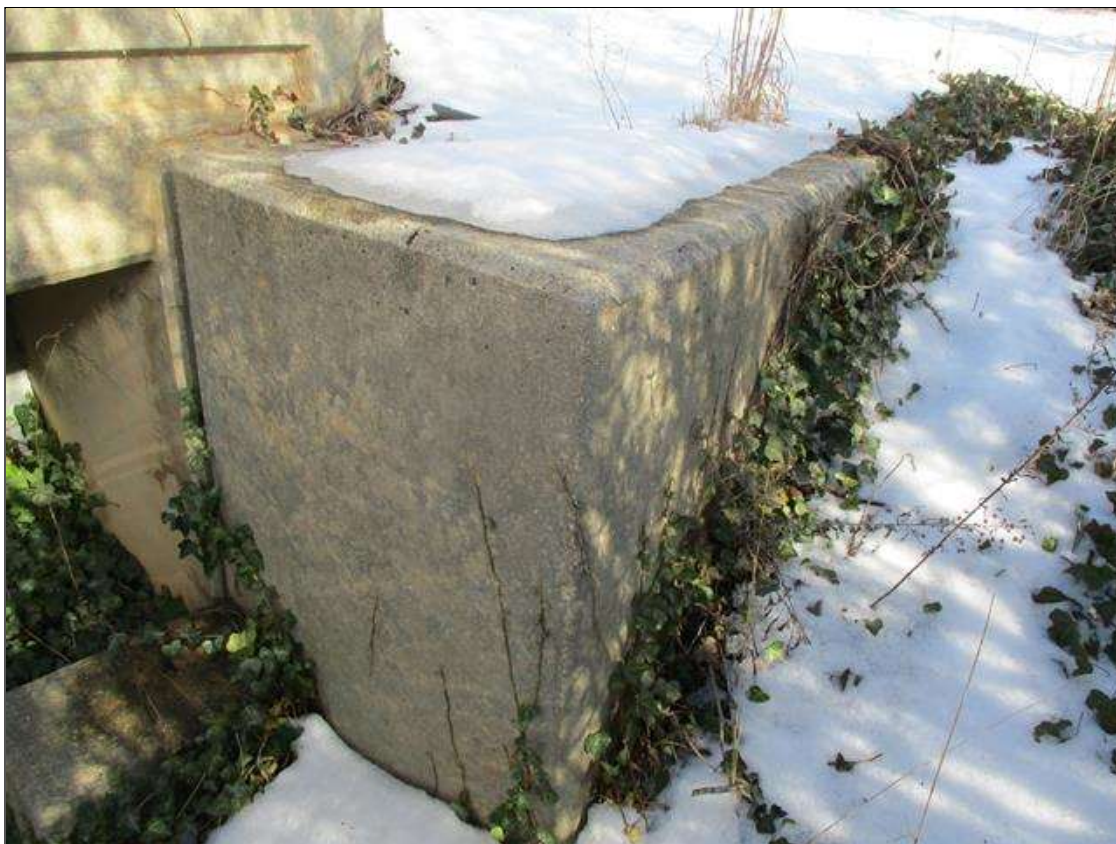
SOME MINOR EFFLOR AT SOUTHEAST WINGWALL, TYPICAL
