NC DEPARTMENT OF TRANSPORTATION
 DIVISION OF HIGHWAYS
 STRUCTURE MANAGEMENT UNIT

ATTENTION: **PAR SUBMITTED**

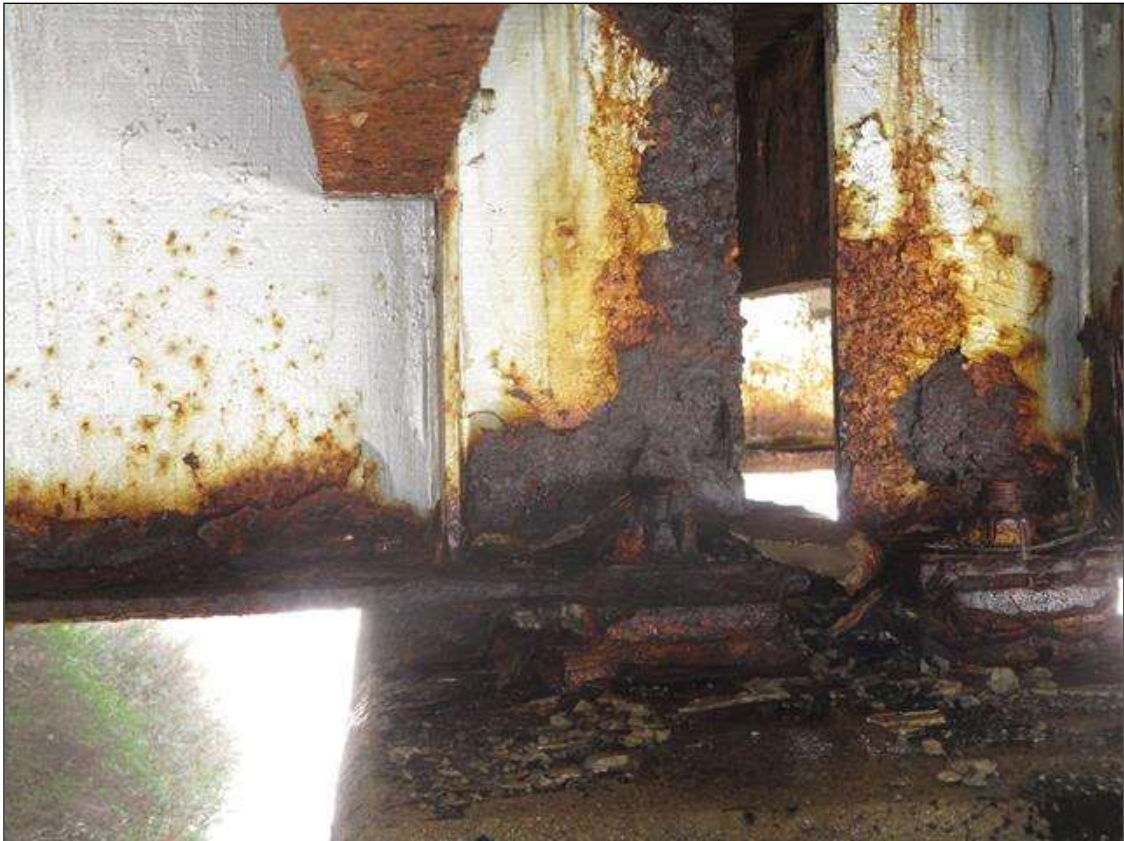
TYPICAL BEARING AT BENT

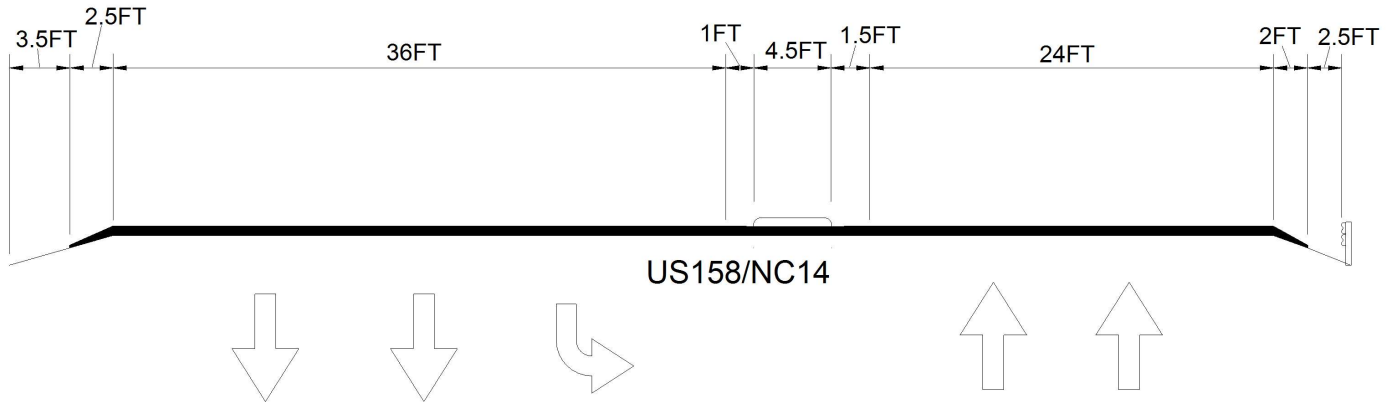
Left Lanes			
Roadway	36ft Wide	3 Paved Lanes	West Bound
Right Shoulder	6ft Wide	2.5ft Paved	3.5ft Unpaved
Left Shoulder	1ft Wide	1ft Paved	
Right Guardrail			
Left Guardrail			
Median	4.5ft Wide	0.5ft High	
Right Lanes			
Roadway	24ft Wide	2 Paved Lanes	East Bound
Left Shoulder	1.5ft Wide	1.5ft Paved	
Right Shoulder	4.5ft Wide	2ft Paved	2.5ft Unpaved
Left Guardrail			
Right Guardrail	4.5ft from road

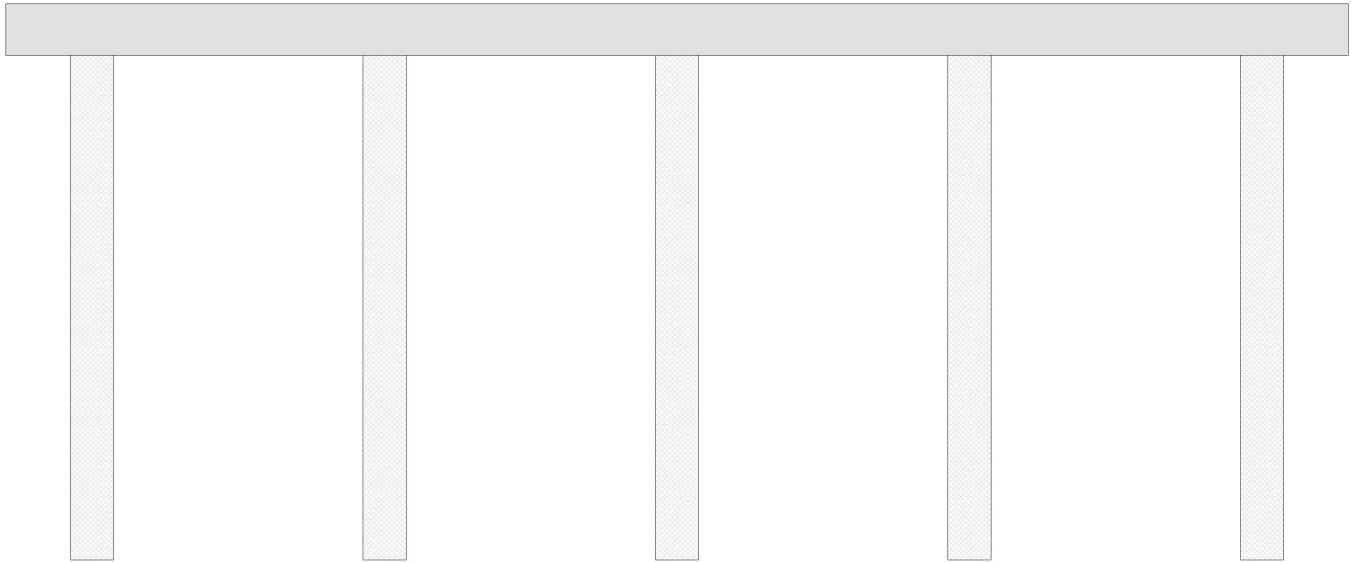
Cap Information			Material Cast-in-Place Concrete							
Length	Width	Height	Left Overhang	Right Overhang	Left Beam to End of Cap.	Right Beam to End of Cap.				
78.000 ft.	2.500 ft.	3.000 ft.	5.000 ft.	5.000 ft.	1.000 ft.	1.000 ft.				
Subcap Information			Material							
Length	Width	Height	Left Overhang	Right Overhang	Left Pile to Splice.					
Sill Information			Material							
Length	Width	Height								
Pile #	Material	Spacing	Width/Dia.	Height	Length	Orientation	Driven?	Replacement?	Removed?	Collar?
1	Concrete	17 ft.	2.5 ft.	2.5 ft.		Vertical	No	No	No	No
2	Concrete	17 ft.	2.5 ft.	2.5 ft.		Vertical	No	No	No	No
3	Concrete	17 ft.	2.5 ft.	2.5 ft.		Vertical	No	No	No	No
4	Concrete	17 ft.	2.5 ft.	2.5 ft.		Vertical	No	No	No	No
5	Concrete		2.5 ft.	2.5 ft.		Vertical	No	No	No	No
VERIFIED BY ED ON 1/19/22										
Bent/Abutment #: 1			Similar Bents: 2, 3
