STATE OF NORTH CAROLINA

DEPARTMENT OF TRANSPORTATION

BENT 3

S3-15

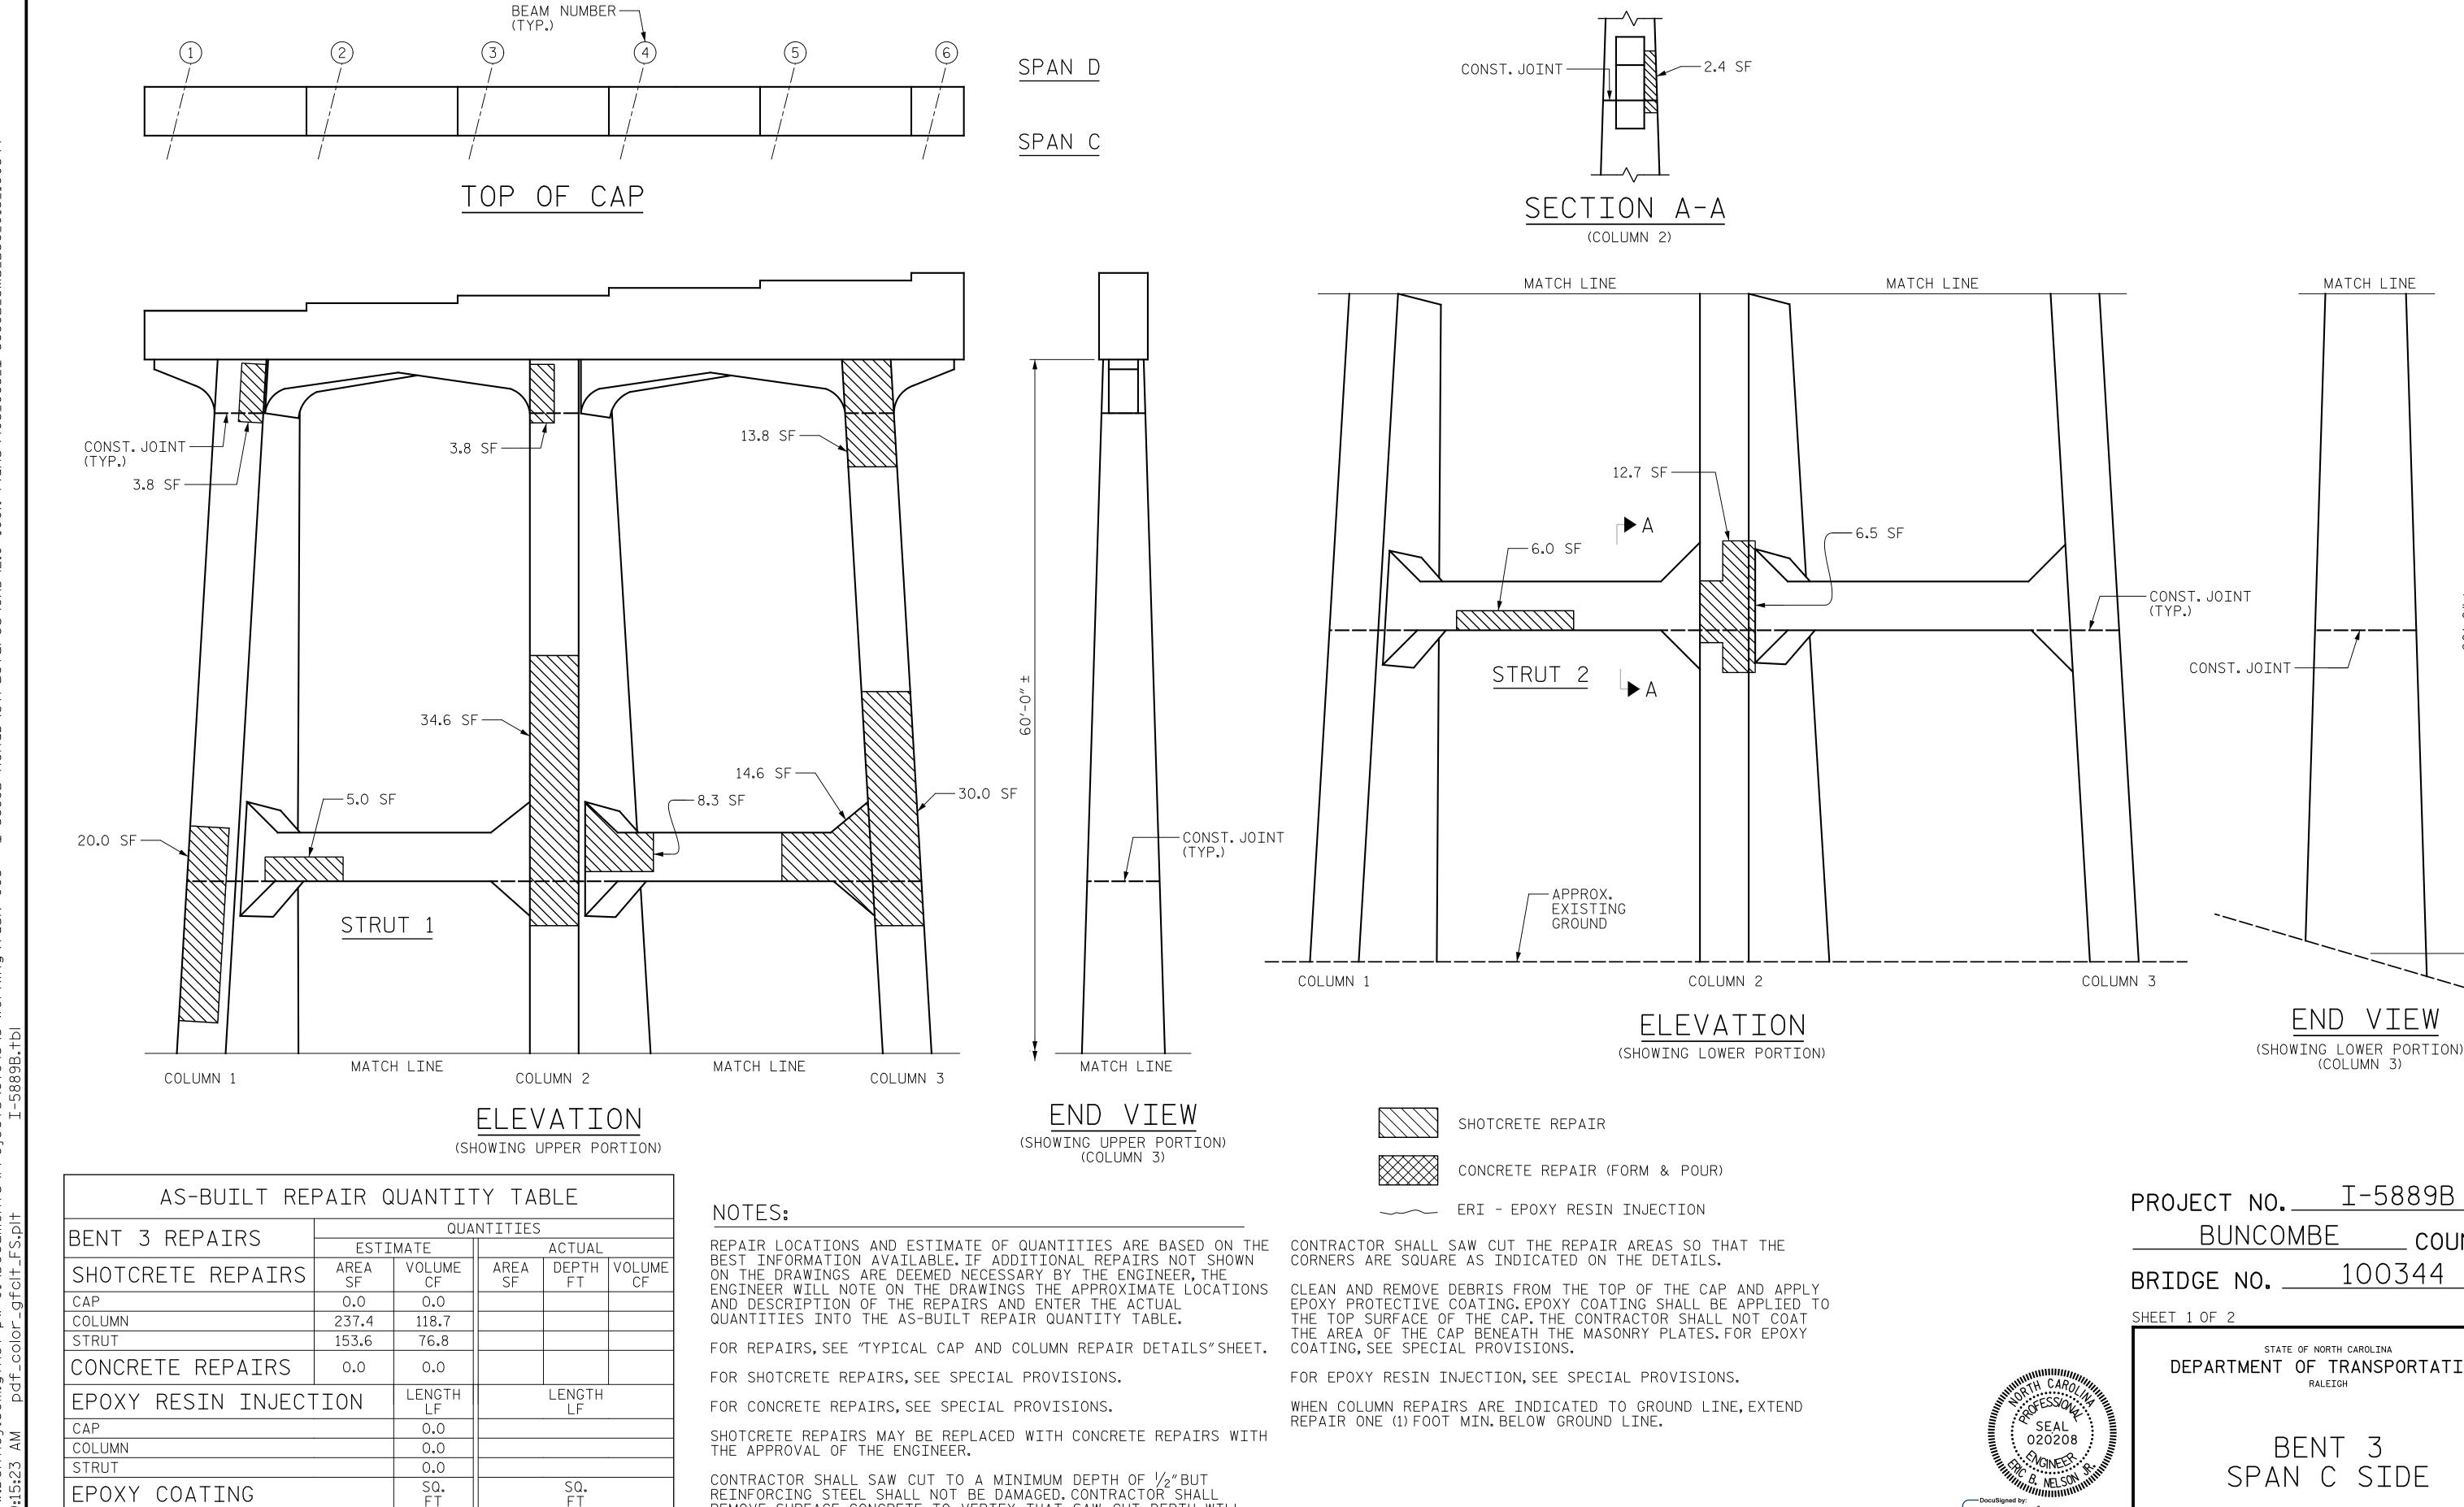
VALUES IN CHART REPRESENT ESTIMATED REPAIR TOTALS AFTER REMOVAL

OF UNSOUND CONCRETE, MINIMUM OF 1" BEHIND REBAR AND MINIMUM OF 2" CLEARANCE TO SAWCUT. FOR REPAIR DETAILS, SEE "TYPICAL CAP AND

REMOVE SURFACE CONCRETE TO VERIFY THAT SAW CUT DEPTH WILL

NOT DAMAGE EXISTING REINFORCING STEEL.
