Structure Safety Report

2 Year Complete Topside and Underwater Element Inspection

INSPECTION DATE: 01/03/2022

DIVISION: 6 COUNTY: COLUMBUS STRUCTURE NUMBER: 230372 FREQUENCY: 24 MONTHS

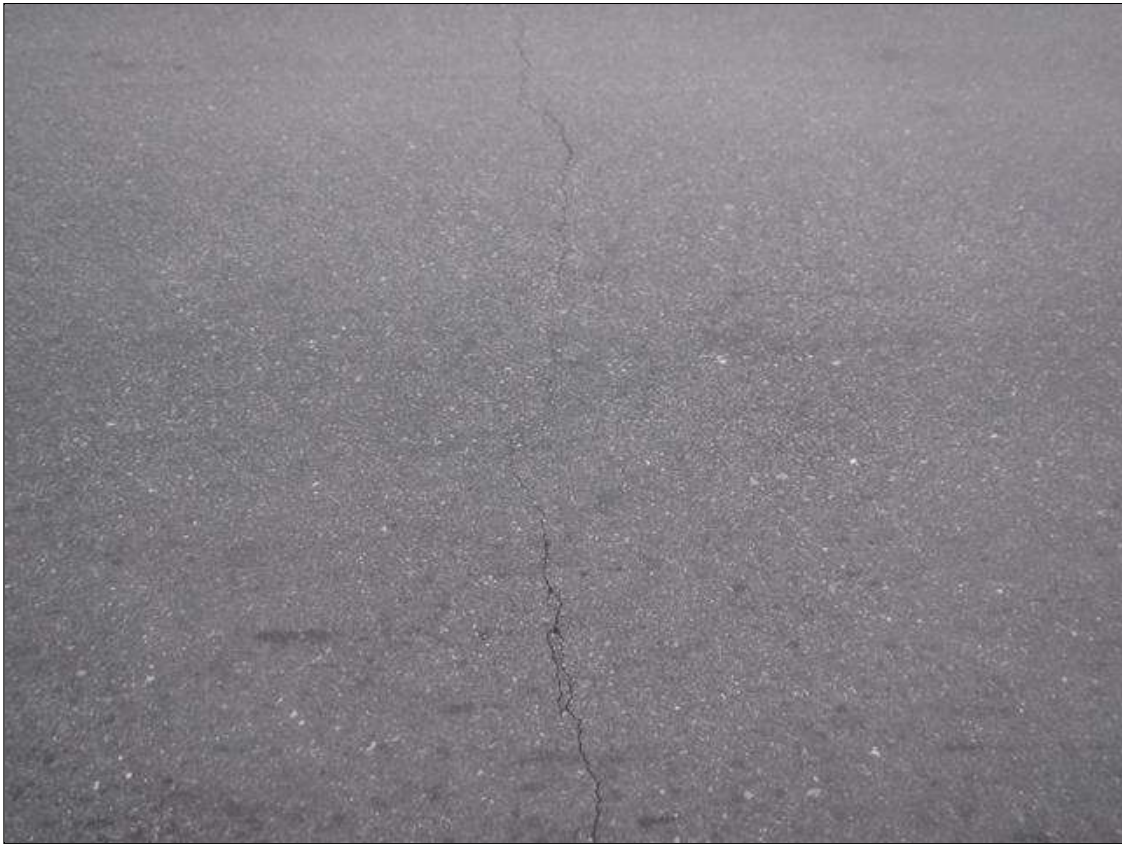
Item	General Comments and Misc Items	Grade	F	Maint Code		Qty. 0
Details	CRACKING IN AWS UP TO 1/8"					
Item	Portion of structure in > 3' of water (Y or N)	Grade	Y	Maint Code		Qty. 0
Details	MAX. DEPTH- 10.4'

CRACKING IN AWS UP TO 1/8"

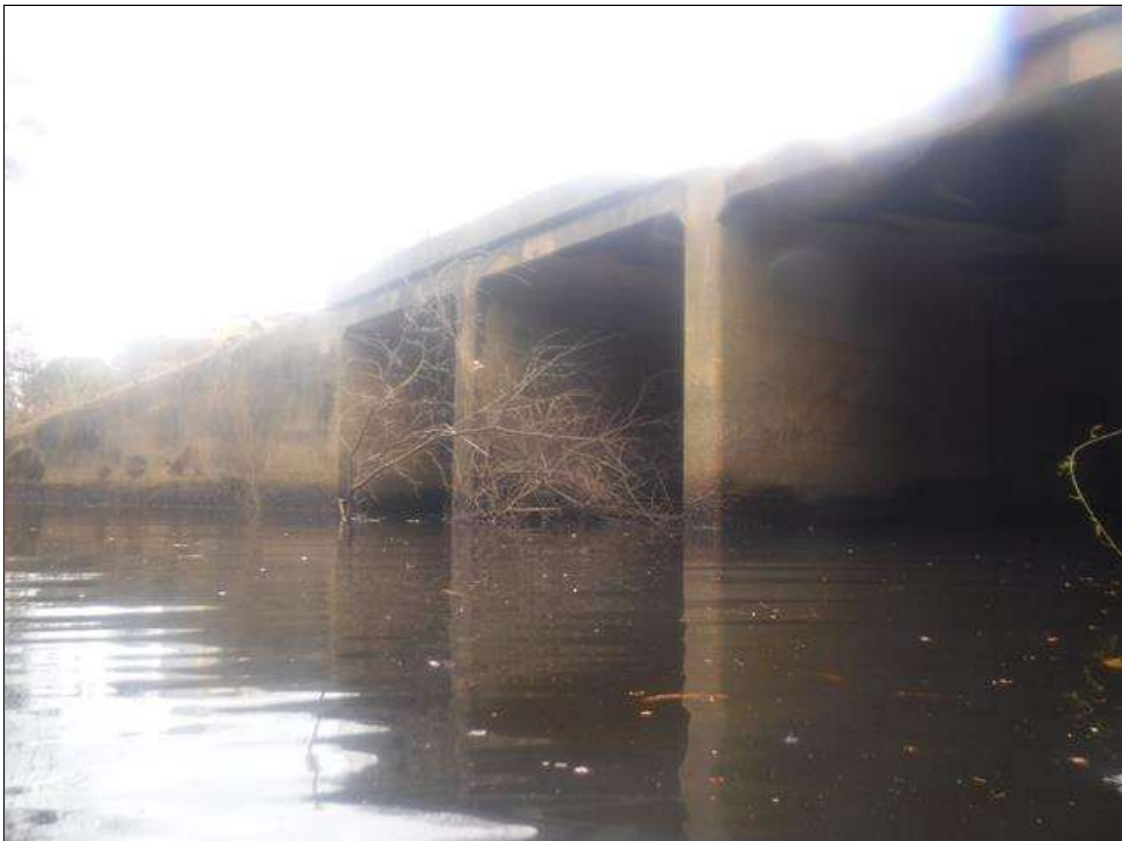
Item	Drift	Grade	F	Maint Code	3366	Qty. 50
Details	RANDOM LOGS AND BRANCHES ALONG THE M/L UP TO 5' AW/L. UP TO 4" DIAMETER.					
Item	Scour	Grade	P	Maint Code		Qty. 0
Details	SCOUR AT THE UP/DOWN STREAM ENDS OF THE CULVERT. (SEE ELEMENT DEFECTS AND SCOUR SKETCH FOR DETAILS)					
	FOOTING EXPOSURES AT ALL WINGS: SW WING- 2'V EXPOSURE AT THE C/L NW WING- 2.3'V EXPOSURE AT THE C/L SE WING- 0.8'V EXPOSURE AT THE C/L NE WING- 2'V EXPOSURE AT THE C/L

BARREL 2- DRIFT

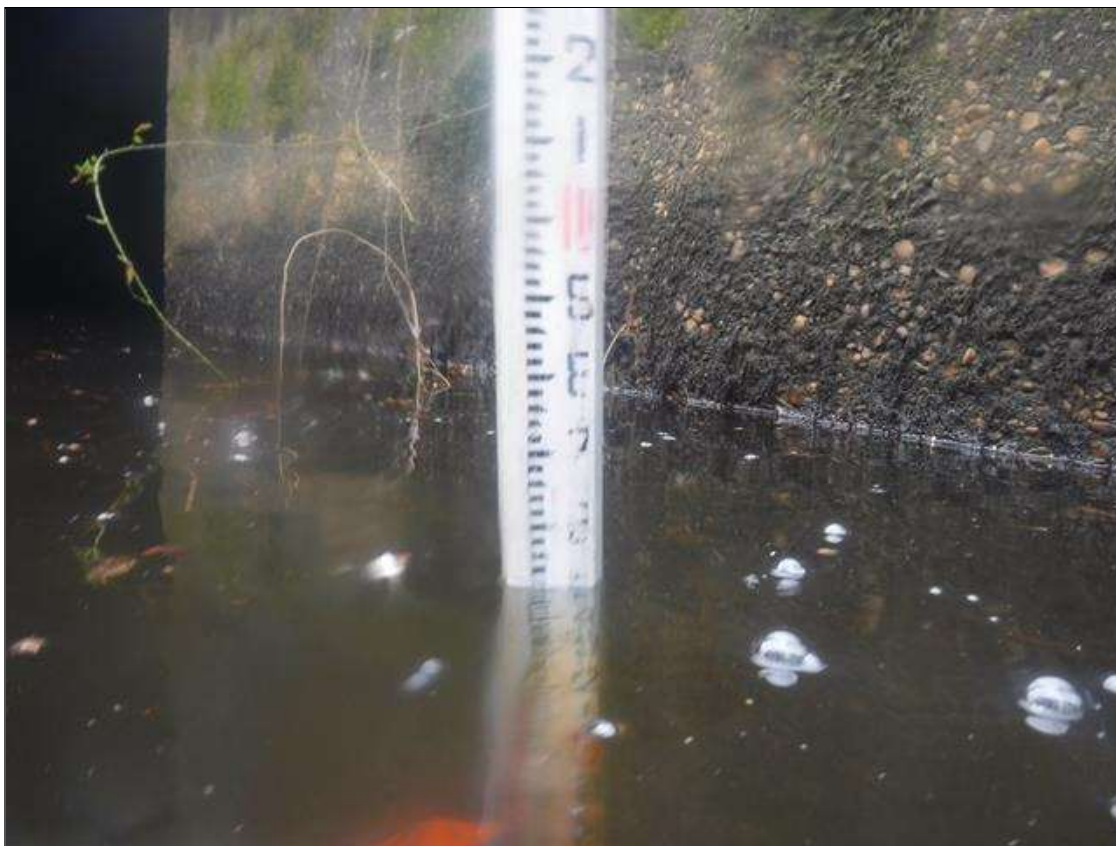
Priority Level	Defect Type	Quantity	Defect Description
2		60	SCOURING ON THE SW WING, 2'V AT THE C/L.(PAR) NW WING, 2.3'V AT THE C/L (PAR) NE WING, 2'V AT THE C/L (PAR) SE WING, 0.8' AT THE C/L (PAR)

SCOUR AT SW WING (PAR)

3350	Maint R C Wings and Walls	SF	60	SCOURING ON THE SW WING, 2'V AT THE C/L.(PAR) NW WING, 2.3'V AT THE C/L (PAR) NE WING, 2'V AT THE C/L (PAR) SE WING, 0.8' AT THE C/L (PAR)

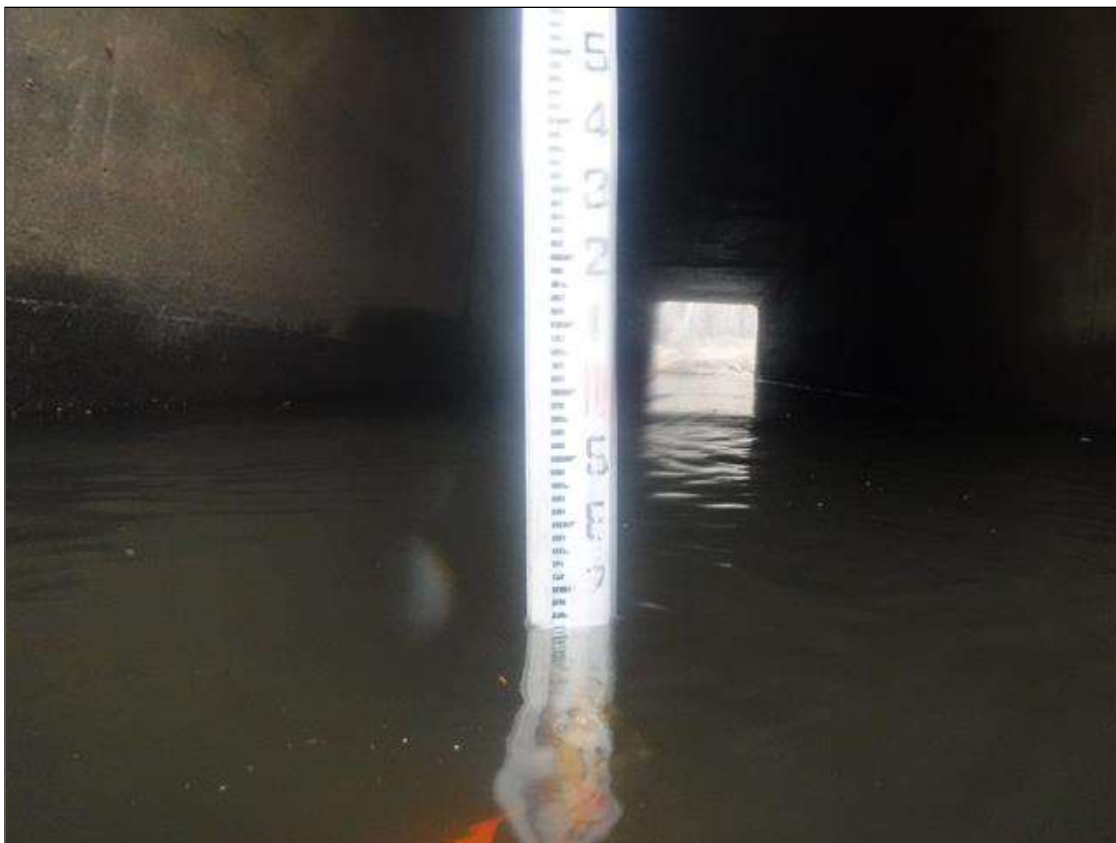
Priority Level	Defect Type	Quantity	Defect Description
2	Delamination/Spall	5	Span 1 Culvert Section 1: 5 AREAS OF SPALLS- 6' LONG X 8" WIDE X 1" DEEP (PAR)
2	Scour	1	Span 1 Culvert Section 1: UPSTREAM CURTAIN WALL EXPOSURE 2.2' VERT (PAR)

Span 1 Culvert Section 1: UPSTREAM CURTAIN WALL EXPOSURE 2.2' VERT (PAR)

3370	Maintenance and Repair of NBIS Pipes and Culverts	LF	1	Span 1 Culvert Section 1: UPSTREAM CURTAIN WALL EXPOSURE 2.2' VERT (PAR)

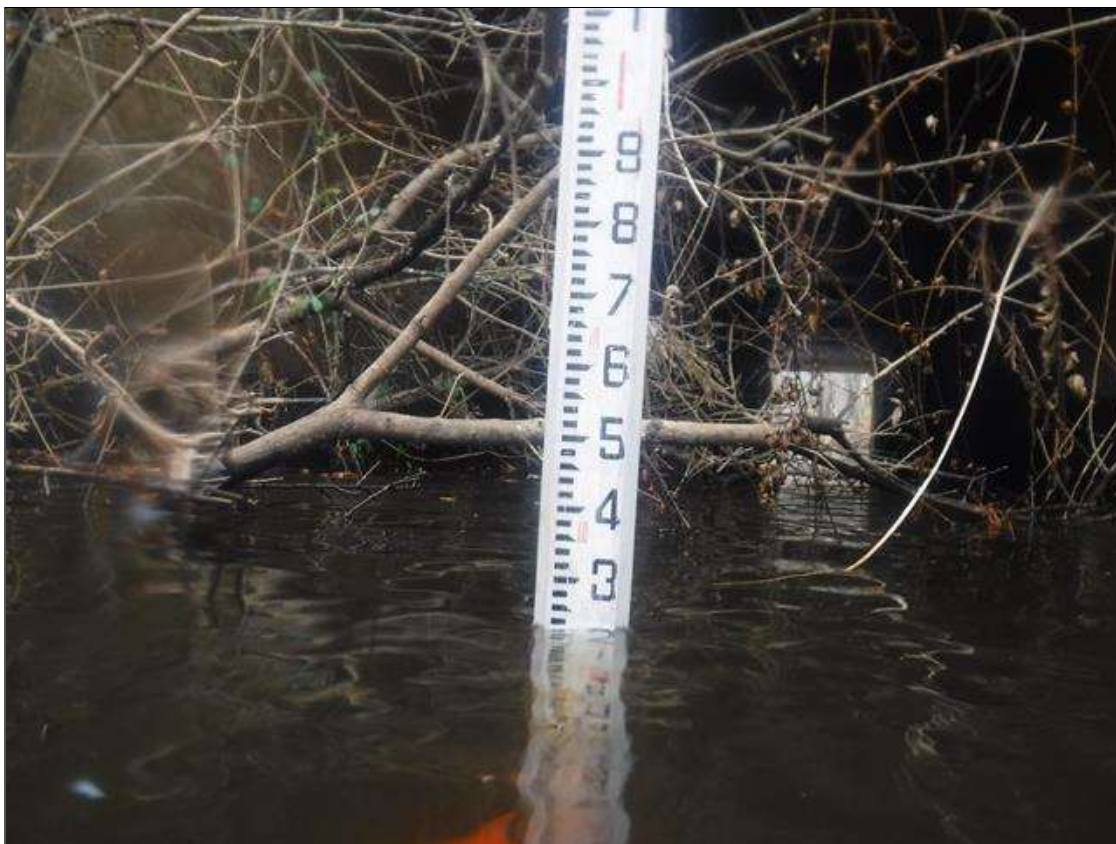
Priority Level	Defect Type	Quantity	Defect Description
2	Exposed Rebar	6	Span 2 Culvert Section 1: REBAR EXPOSED, SECTION LOSS DUE TO SPALLS ON INTERIOR WALL 2, 15' FROM EAST END. (PAR)
2	Scour	2	Span 2 Culvert Section 1: UPSTREAM CURTAIN WALL EXPOSURE 2.7' WITH 0.5' VERT. BELOW CURTAINWALL WITH PROBE TO 0.5'. DOWNSTREAM CURTAIN WALL EXPOSURE 1.1' VERT. (PAR)

Span 2 Culvert Section 1: UPSTREAM CURTAIN WALL EXPOSURE 2.7' WITH 0.5' VERT. BELOW CURTAINWALL WITH PROBE TO 0.5'. DOWNSTREAM CURTAIN WALL EXPOSURE 1.1' VERT. (PAR)

3370	Maintenance and Repair of NBIS Pipes and Culverts	LF	2	Span 2 Culvert Section 1: UPSTREAM CURTAIN WALL EXPOSURE 2.7' WITH 0.5' VERT. BELOW CURTAINWALL WITH PROBE TO 0.5'. DOWNSTREAM CURTAIN WALL EXPOSURE 1.1' VERT. (PAR)

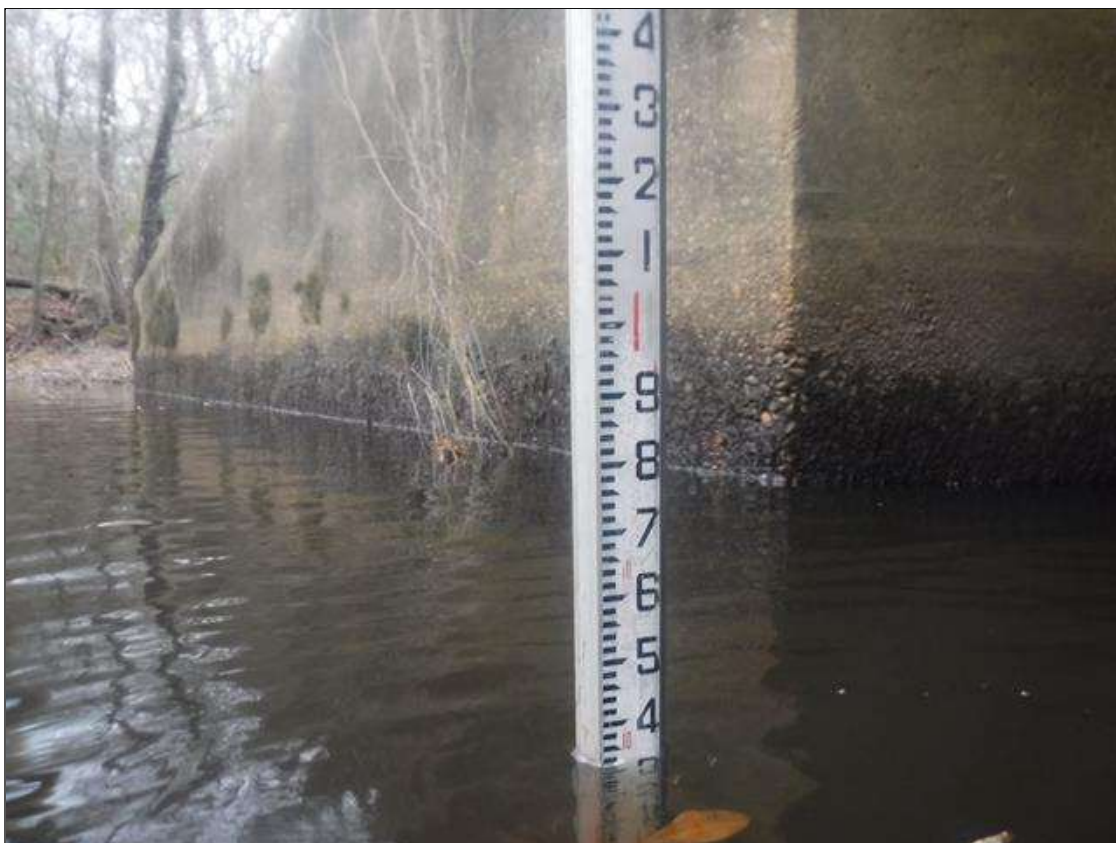
Priority Level	Defect Type	Quantity	Defect Description
2	Exposed Rebar	2	Span 3 Culvert Section 1: REBAR EXPOSED, SECTION LOSS DUE TO SPALLS ON TOP SLAB. (PAR)
2	Scour	2	Span 3 Culvert Section 1: UPSTREAM CURTAIN WALL EXPOSURE 3.0' VERT. WITH 0.5' VERT. BELOW CURTAINWALL X 0.5' PROBE. (PAR)

Span 3 Culvert Section 1: UPSTREAM CURTAIN WALL EXPOSURE 3.0' VERT. WITH 0.5' VERT. BELOW CURTAINWALL X 0.5' PROBE. (PAR)

3370	Maintenance and Repair of NBIS Pipes and Culverts	LF	2	Span 3 Culvert Section 1: UPSTREAM CURTAIN WALL EXPOSURE 3.0' VERT. WITH 0.5' VERT. BELOW CURTAINWALL X 0.5' PROBE. (PAR)

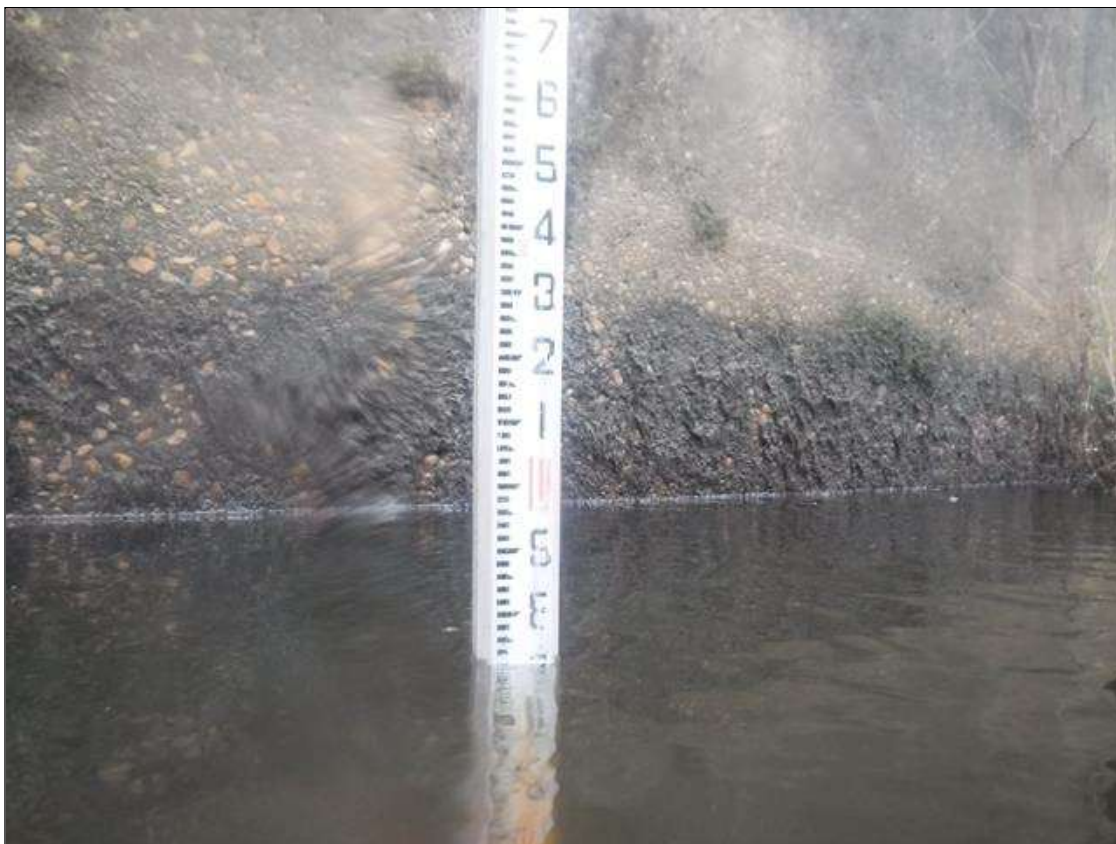
NW WING SCOUR (PAR)

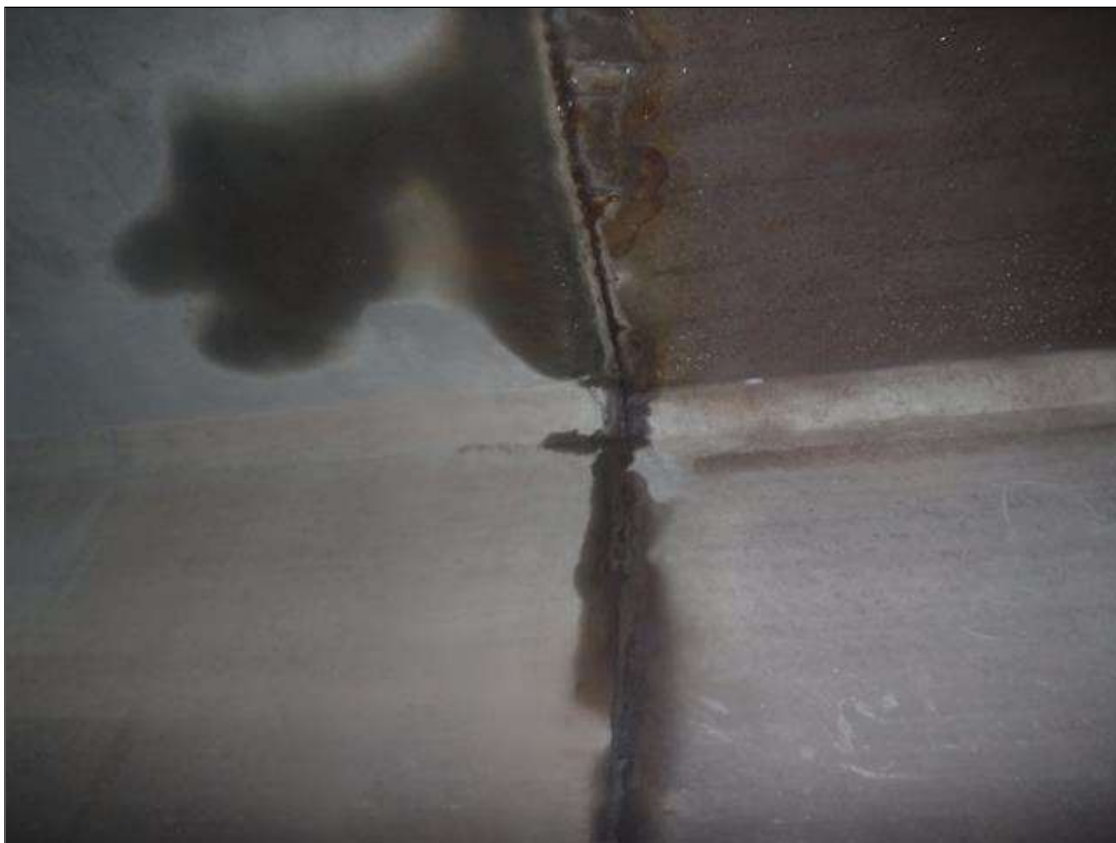
Span 1 Culvert Section 1: CONSTRUCTION JOINTS OPEN TO 1/16" WITH EFFLORESCENCE/WATER LEAKAGE (ALL BARRELS SIMILIAR)

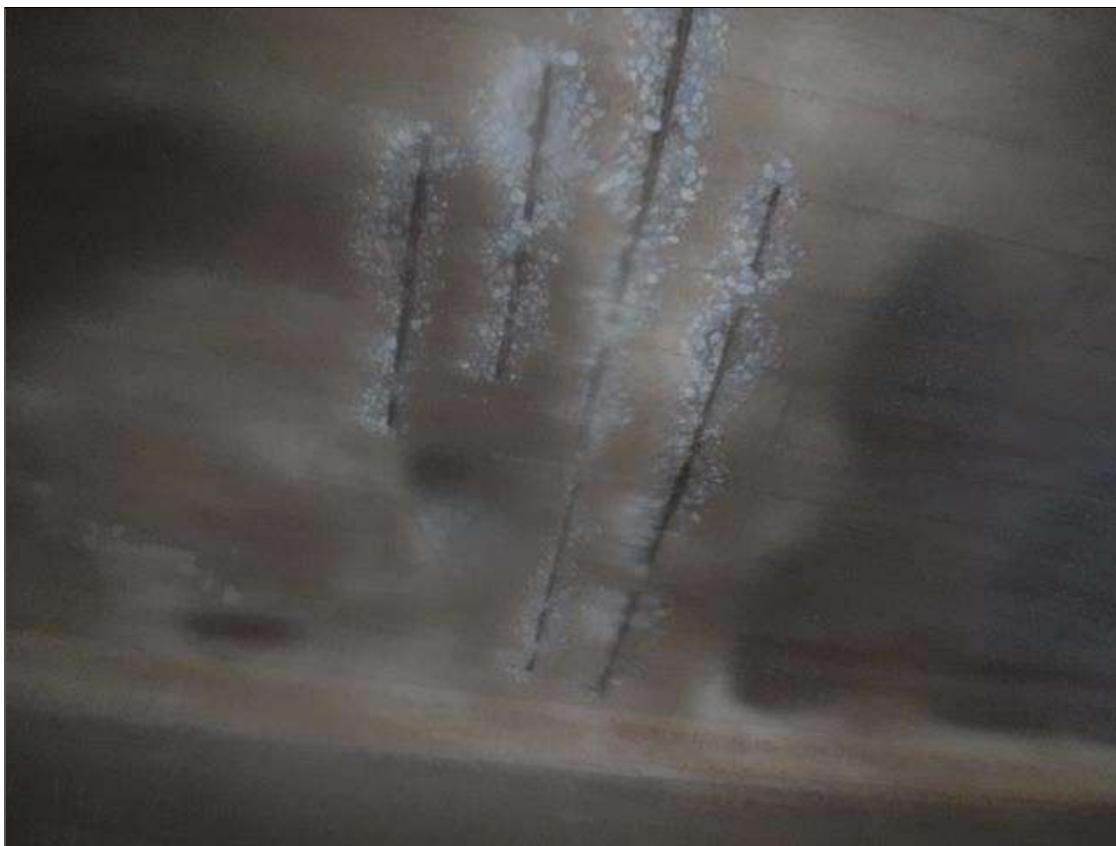
Element Number	Defect Type	Defect Description	CS	CS Qty	Maint Qty
241	Delamination/Spall	5 AREAS OF SPALLS- 6' LONG X 8" WIDE X 1" DEEP (PAR)	3	5	5 Feet
241	Efflorescence/Rust Staining	CONSTRUCTION JOINTS OPEN TO 1/16" WITH EFFLORESCENCE/WATER LEAKAGE (ALL BARRELS SIMILIAR)	3	2	Feet
241	Exposed Rebar	REBAR EXPOSED, SECTION LOSS DUE TO SPALLS	3	5	5 Feet
241	Scour	UPSTREAM CURTAIN WALL EXPOSURE 2.2' VERT (PAR)	3	1	1 Feet
241	Abrasion/Wear (PSC/RC)	COARSE AGGREGATE EXPOSED TO 1/4"	2	63	Feet

Span 1 Culvert Section 1: 5 AREAS OF SPALLS- 6' LONG X 8" WIDE X 1" DEEP (PAR)

3370	Maintenance and Repair of NBIS Pipes and Culverts	LF	5	Span 1 Culvert Section 1: 5 AREAS OF SPALLS- 6' LONG X 8" WIDE X 1" DEEP (PAR)

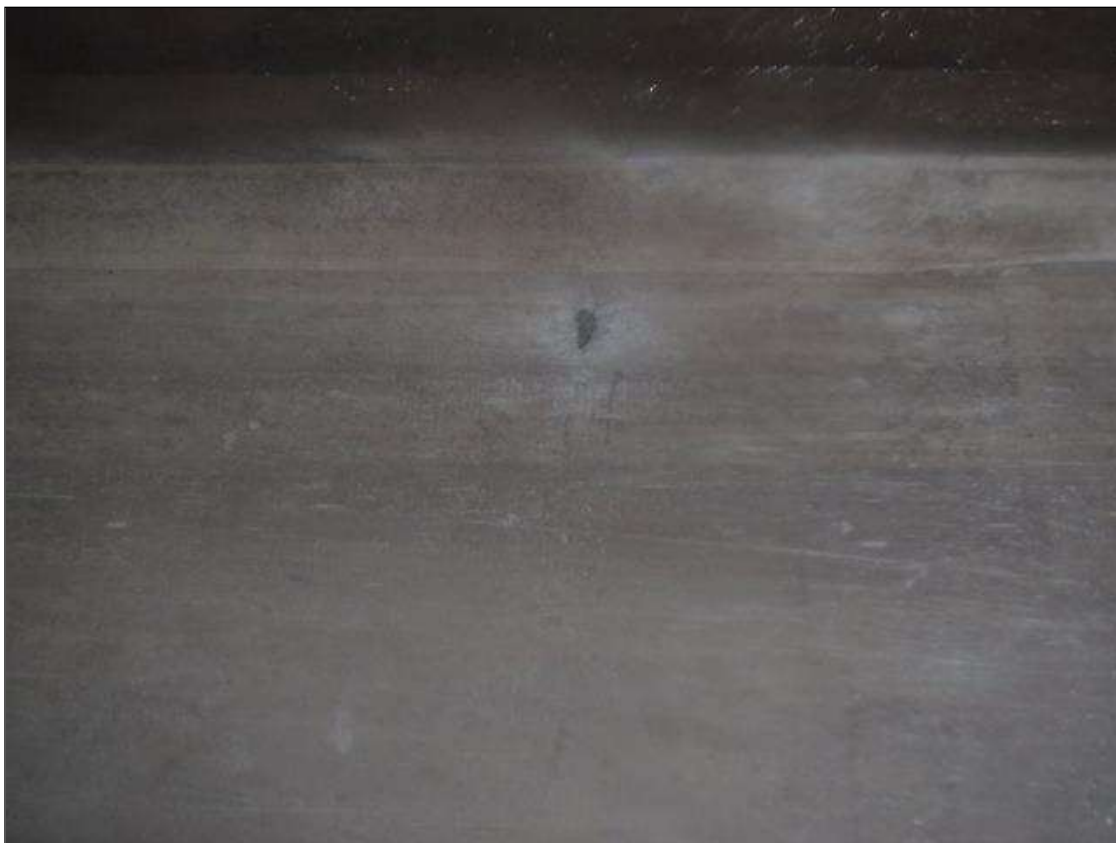
Span 2 Culvert Section 1: REBAR EXPOSED, SECTION LOSS DUE TO SPALLS ON INTERIOR WALL 2, 15' FROM EAST END. (PAR)

3370	Maintenance and Repair of NBIS Pipes and Culverts	LF	6	Span 2 Culvert Section 1: REBAR EXPOSED, SECTION LOSS DUE TO SPALLS ON INTERIOR WALL 2, 15' FROM EAST END. (PAR)

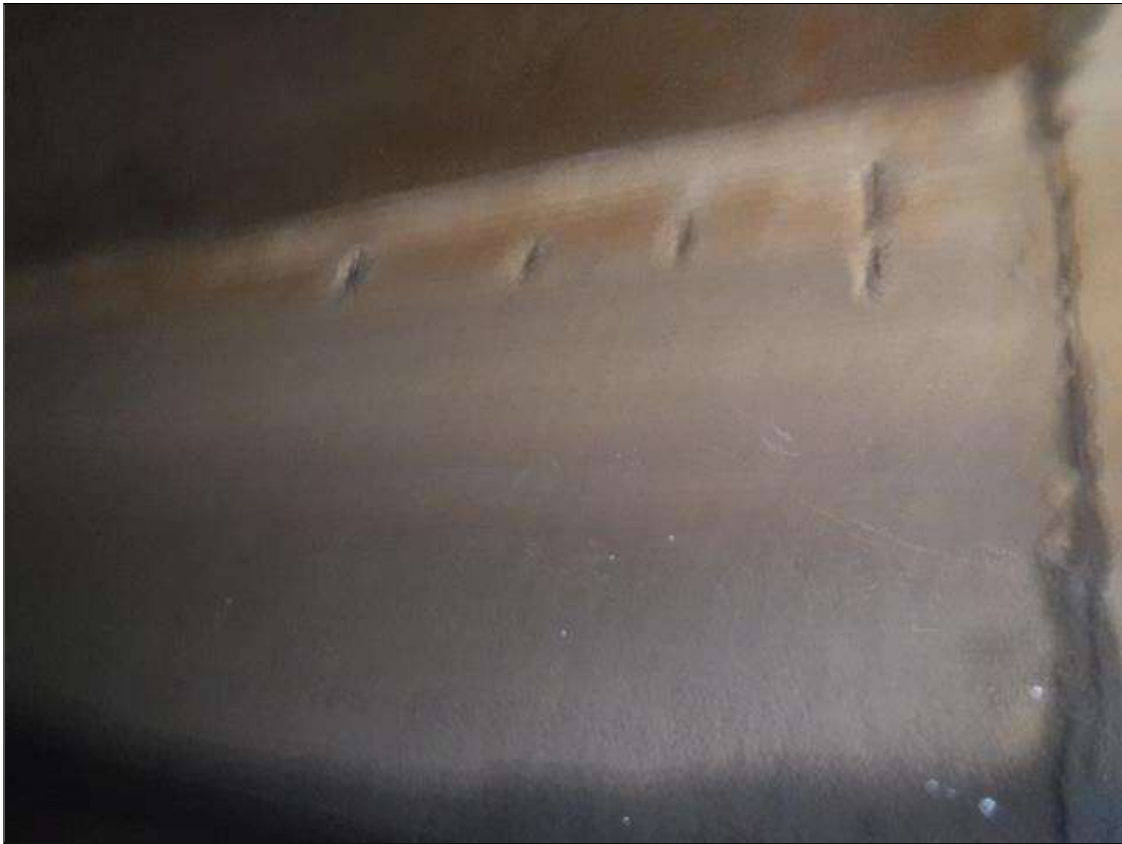
Element Number	Defect Type	Defect Description	CS	CS Qty	Maint Qty
241	Delamination/Spall	TOP SLAB SPALLS NEAR C/L- 9' LONG X 8" WIDE X 1" DEEP. SPALL ON INTERIOR WALL 1, 20' FROM WEST END.	3	9	9 Feet
241	Exposed Rebar	REBAR EXPOSED, SECTION LOSS DUE TO SPALLS ON INTERIOR WALL 2, 15' FROM EAST END. (PAR)	3	6	6 Feet
241	Scour	UPSTREAM CURTAIN WALL EXPOSURE 2.7' WITH 0.5' VERT. BELOW CURTAINWALL WITH PROBE TO 0.5'. DOWNSTREAM CURTAIN WALL EXPOSURE 1.1' VERT. (PAR)	3	2	2 Feet
241	Abrasion/Wear (PSC/RC)	COARSE AGGREGATE EXPOSED TO 1/4"	2	58	Feet
241	Efflorescence/Rust Staining	CONSTRUCTION JOINTS OPEN TO 1/16" WITH EFFLORESCENCE/WATER LEAKAGE	2	2	Feet

Span 2 Culvert Section 1: TOP SLAB SPALLS NEAR C/L- 9' LONG X 8" WIDE X 1" DEEP. SPALL ON INTERIOR WALL 1, 20' FROM WEST END.

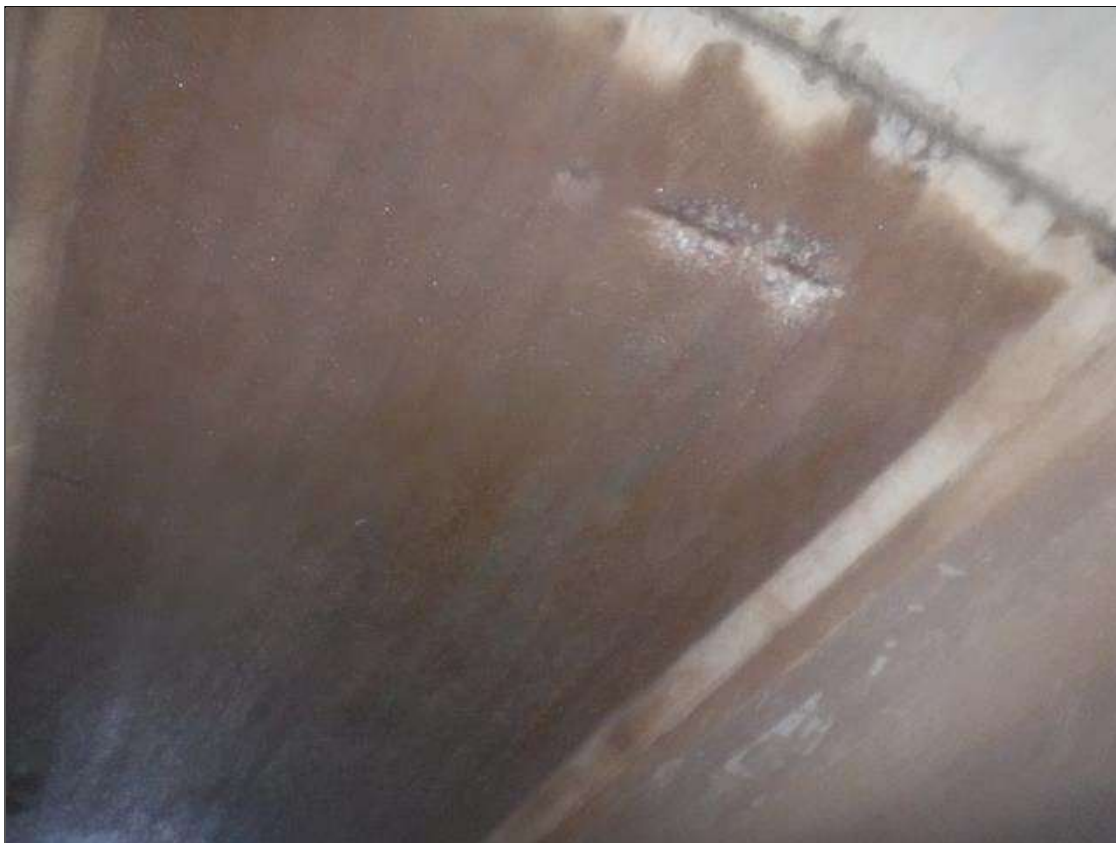
Span 3 Culvert Section 1: REBAR EXPOSED, SECTION LOSS DUE TO SPALLS ON TOP SLAB. (PAR)

3370	Maintenance and Repair of NBIS Pipes and Culverts	LF	2	Span 3 Culvert Section 1: REBAR EXPOSED, SECTION LOSS DUE TO SPALLS ON TOP SLAB. (PAR)

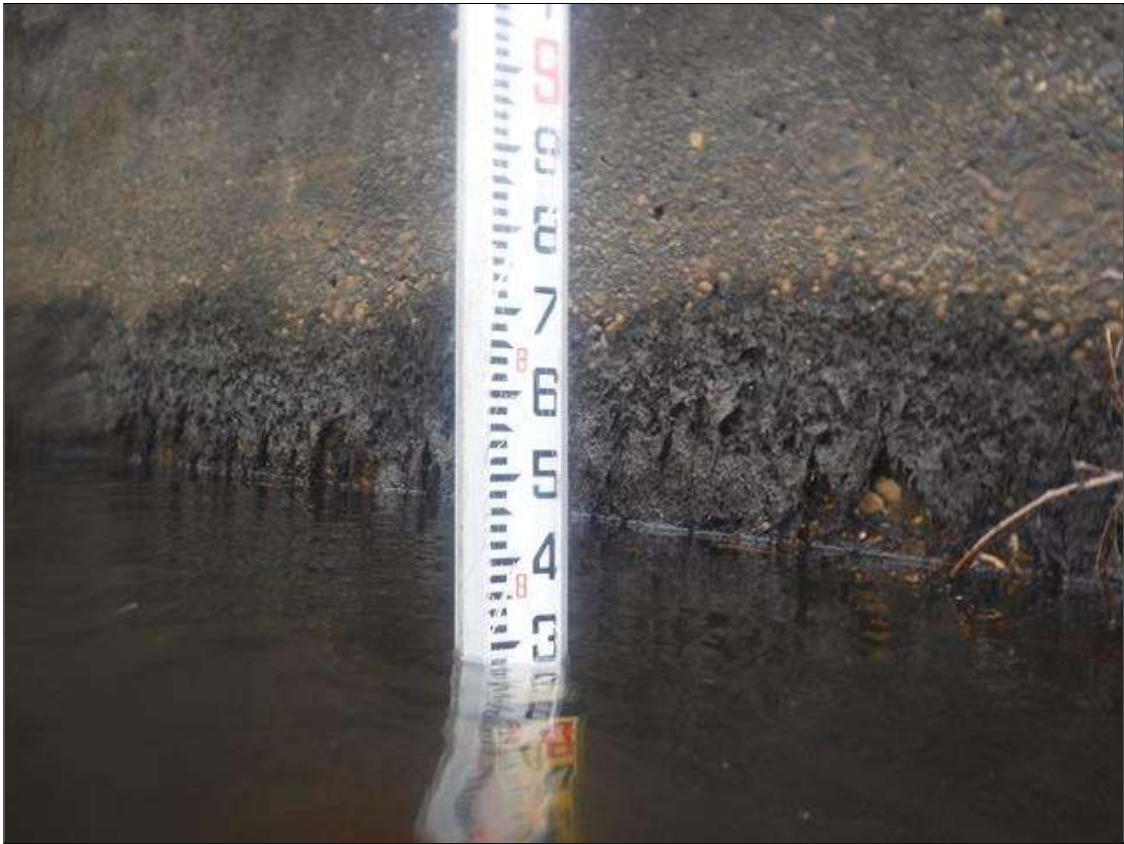
NE WING, SCOUR (PAR)

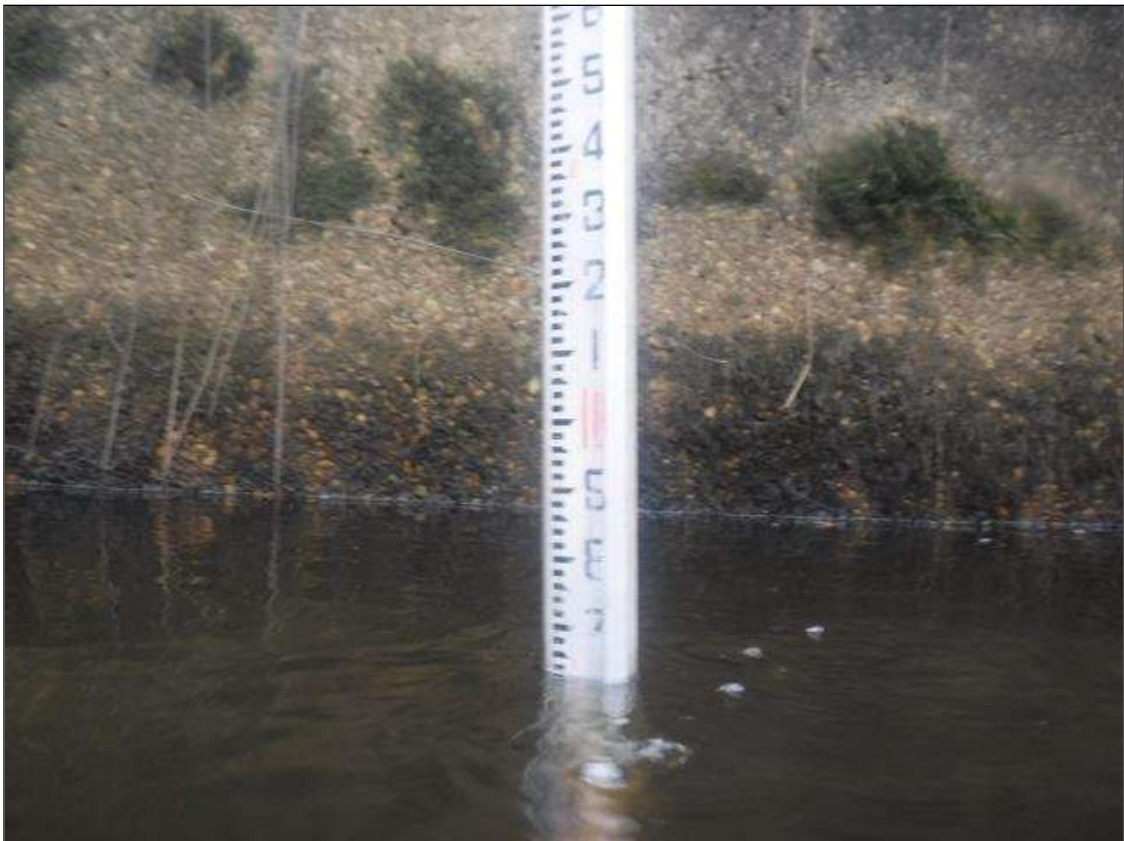
SE WING, SCOUR (PAR)

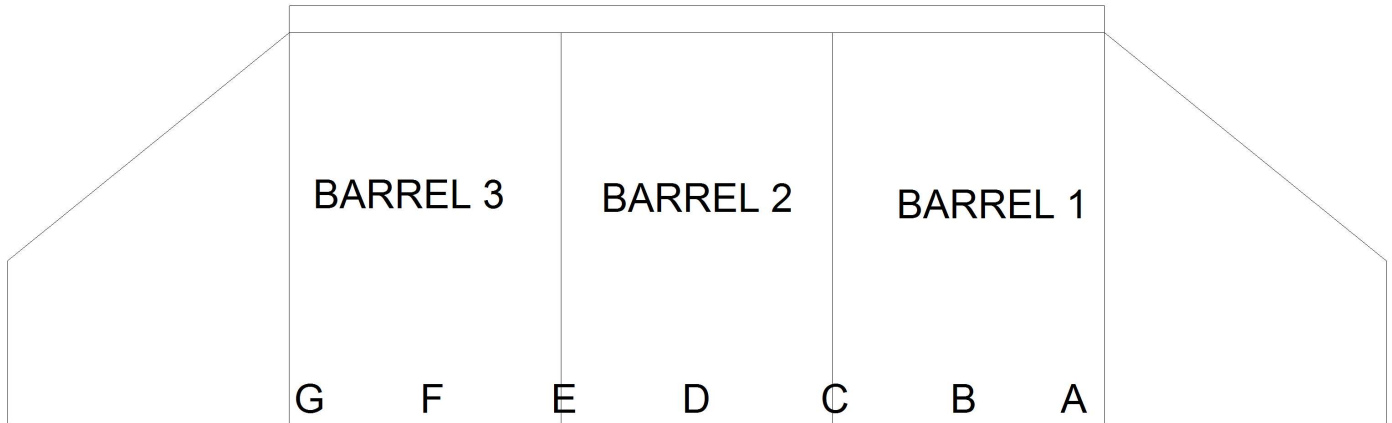
Title
SCOUR DETAIL

STATION	VERTICAL	HORIZONTAL
A	1.9'	
B	2.5'	
C	2.6'	
D	3.2'	0.5' probe
E	3.0'	0.5' probe
F	3.0'	0.5' probe
G	3.0'	0.5' probe

STATION	VERTICAL	HORIZONTAL
A	1.8'	
B	2.2'	
C	2.6'	
D	2.7'	0.5' PROBE
E	1.6'	0.5' PROBE
F	3'	0.5' PROBE
G	3'	0.5' PROBE
