NC DEPARTMENT OF TRANSPORTATION  
 DIVISION OF HIGHWAYS  
 STRUCTURE MANAGEMENT UNIT

# Structure Safety Report

## 2 Year Complete Topside and Underwater Element Inspection

DIVISION: 6 COUNTY: COLUMBUS STRUCTURE NUMBER: 230374 FREQUENCY: 24 MONTHS

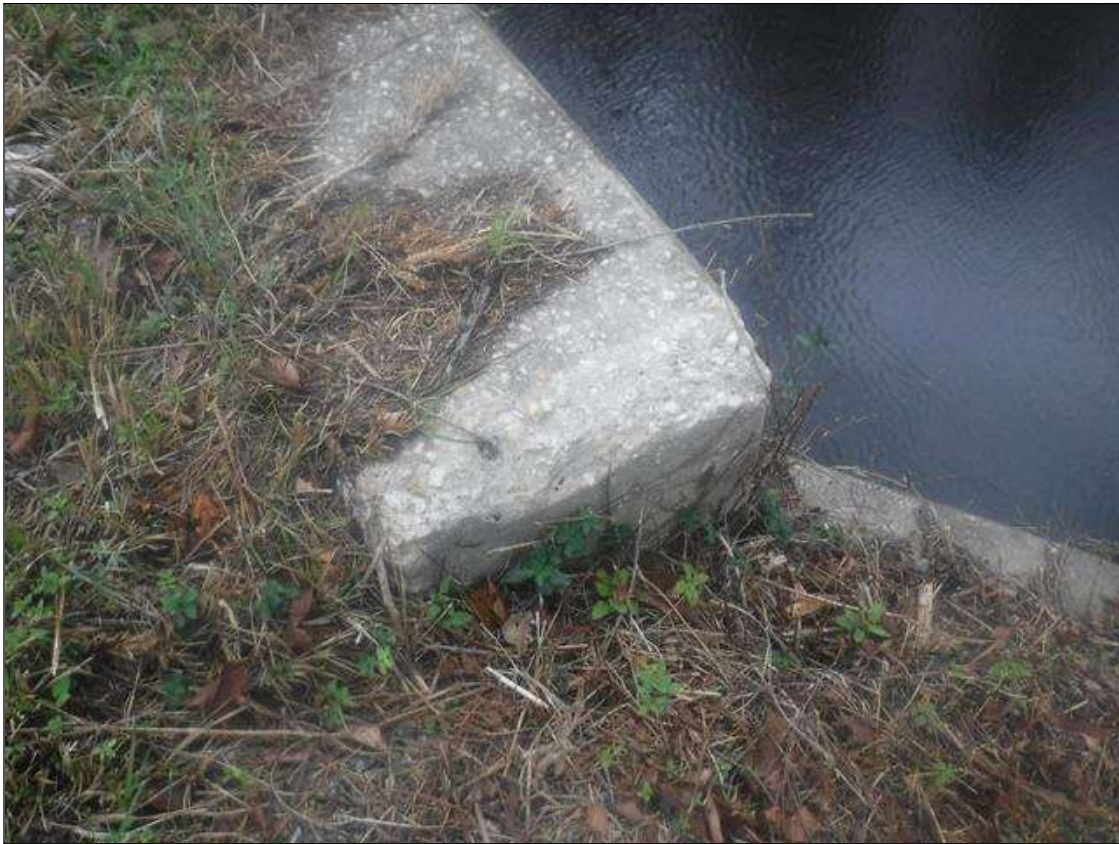
Item	Other Equipment Used	Grade	Y	Maint Code	Qty.	0
Details	DRYSUIT, LIGHT, AGA, OTS, SCUBA SDM, 6', 20 MINUTES					
Item	Headwalls	Grade	F	Maint Code	4675	Qty. 4
Details	MOWER DAMAGE AT THE END OF THE HEADWALLS. SPALL ON THE WEST HEADWALL OVER BARREL 1. 1'L X 5"W X 1.5"DEEP SPALL ON EAST HEADWALL, S. END. 4"V X 14"W X 1/2" DEEP. SPALL ON WEST HEADWALL, S. END. 4"V X 14"W X 1/2" DEEP.

SPALL ON EAST HEADWALL, SOUTH END

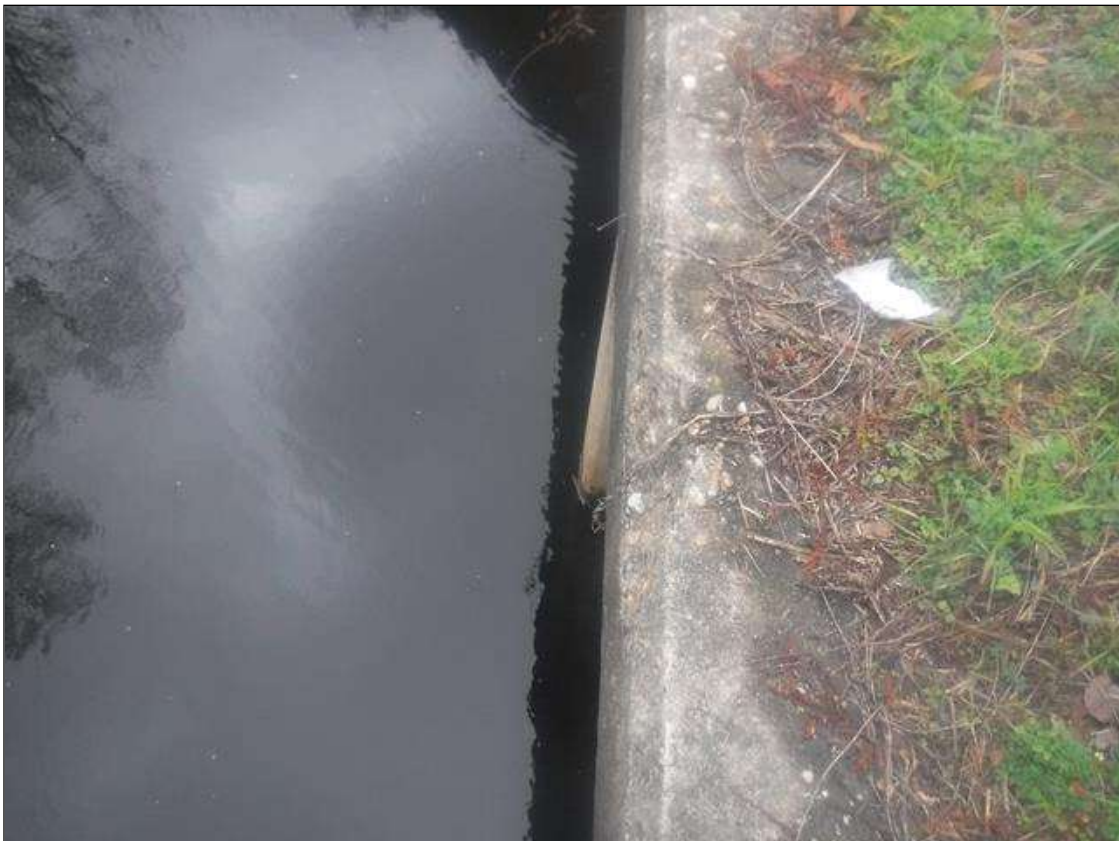
SPALL ON WEST HEADWALL, OVER BARREL 1

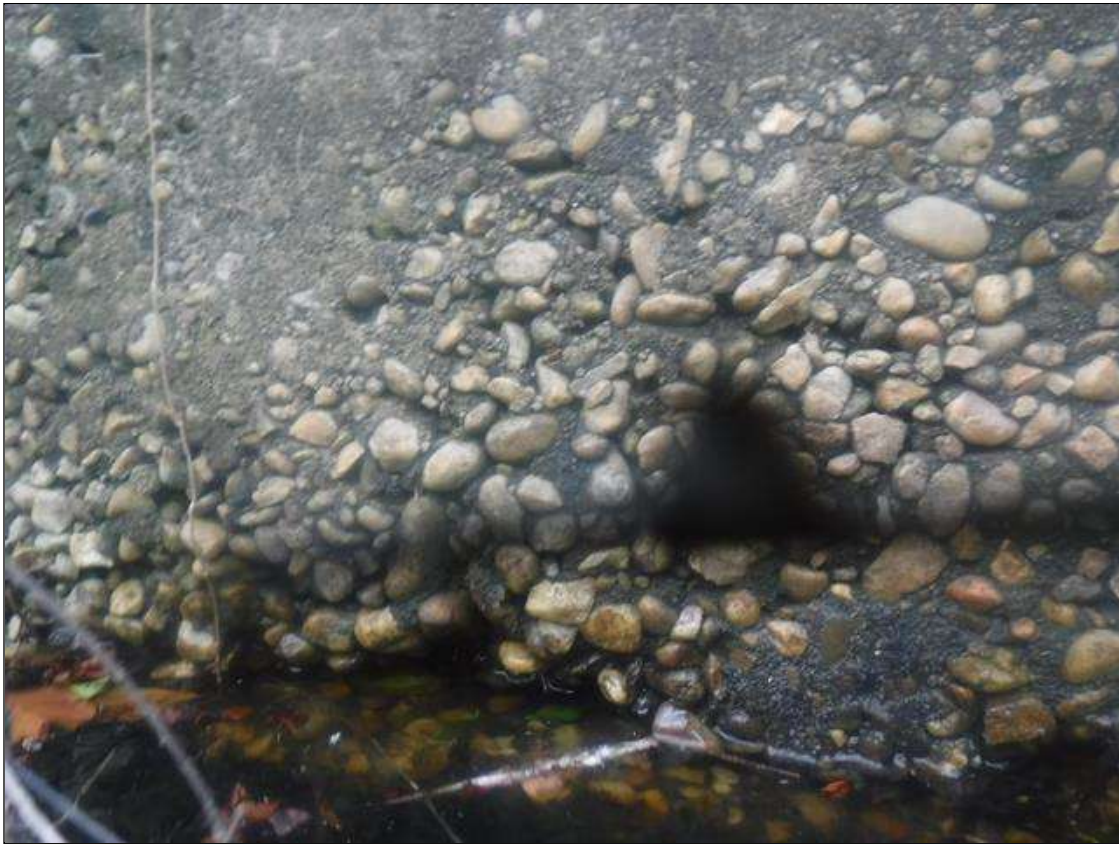
Item	Wingwalls	Grade	F	Maint Code	3350	Qty. 60
Details	COARSE AGGREGATE EXPOSED TO 1/4" DEEP ON ALL WINGS. VOID ON THE SE WING. 3"V X 1'W X 2"DEEP					
Item	General Comments and Misc Items	Grade		Maint Code	Qty.	0
Details	MISSING 1 DELINEATOR AT THE NW CORNER (PAR)

COARSE AGGREGATE EXPOSED ON WING (ALL WINGS SIMILIAR)

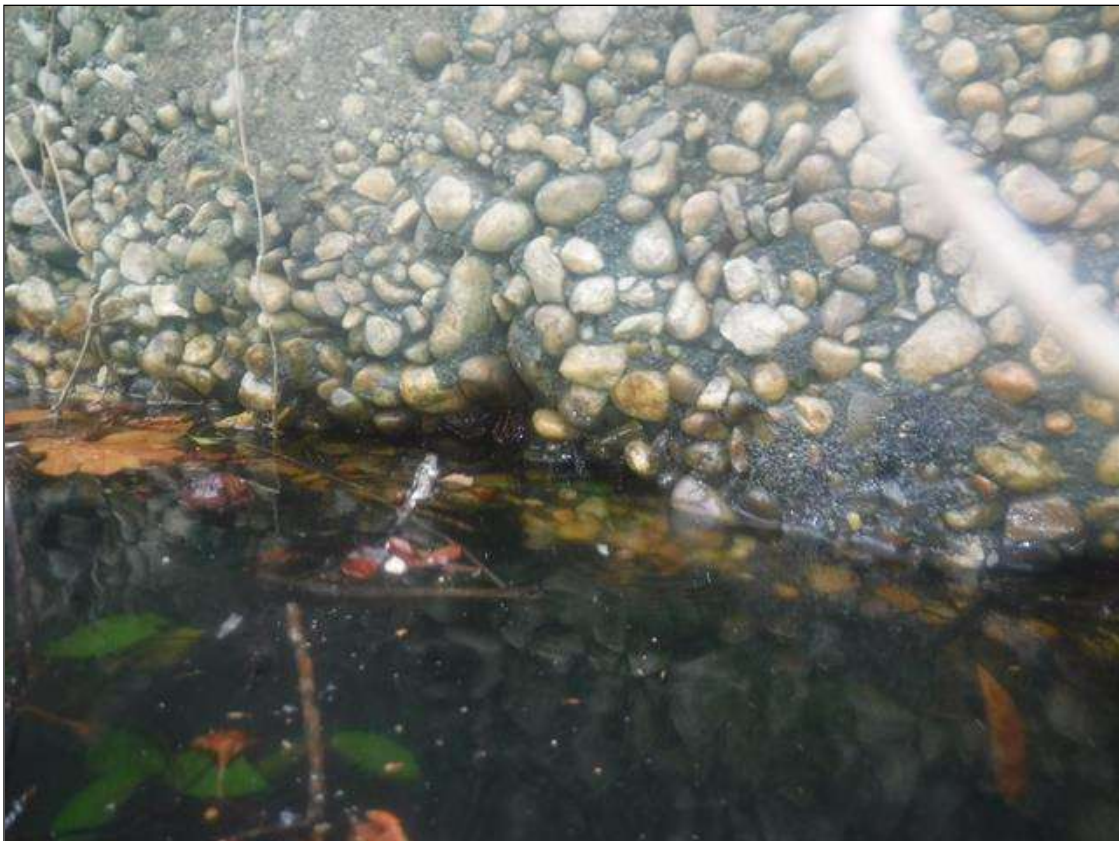
VOID ON THE SE WINGWALL. 3"V X 1"W X 2"DEEP

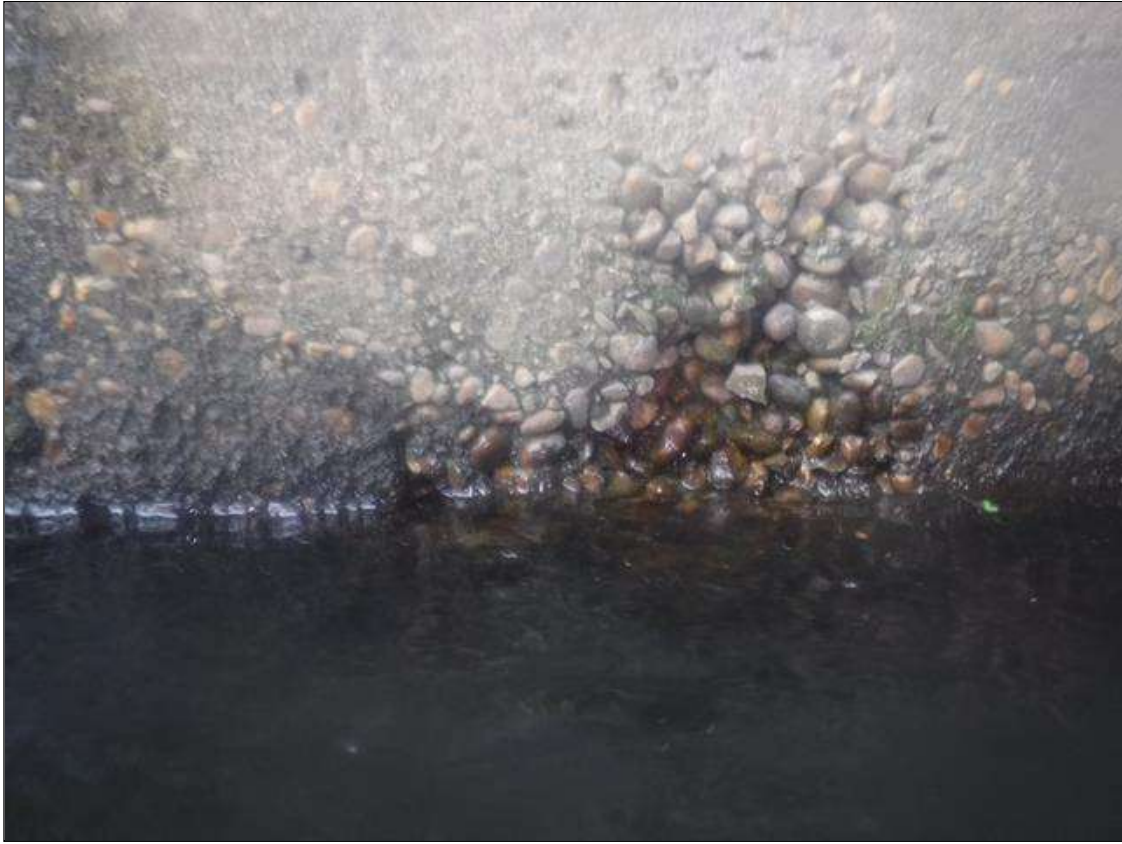
Element Number	Defect Type	Defect Description	CS	CS Qty	Maint Qty	
241	Delamination/Spall	VOID ON THE EXTERIOR WALL. 8" DIAMETER X 2" DEEP. 1' FROM THE EAST END/ 5.5' ABOVE BOTTOM SLAB	3	1	1	Feet
241	Abrasion/Wear (PSC/RC)	COARSE AGGREGATE EXPOSED TO 1/4" BOTTOM SLAB UP 6'	2	45		Feet
241	Cracking (RC and Other)	H/L VERTICAL CRACK ON INTERIOR WALL NEAR C/L	2	1		Feet

Span 1 Culvert Section 1: VOID ON THE EXTERIOR WALL. 8" DIAMETER X 2" DEEP. 1' FROM THE EAST END/  
5.5' ABOVE BOTTOM SLAB

MMS Code	Element Name	Defect Name	Recommended Quantity
3370	Reinforced Concrete Culvert	Delamination/Spall	1 Feet

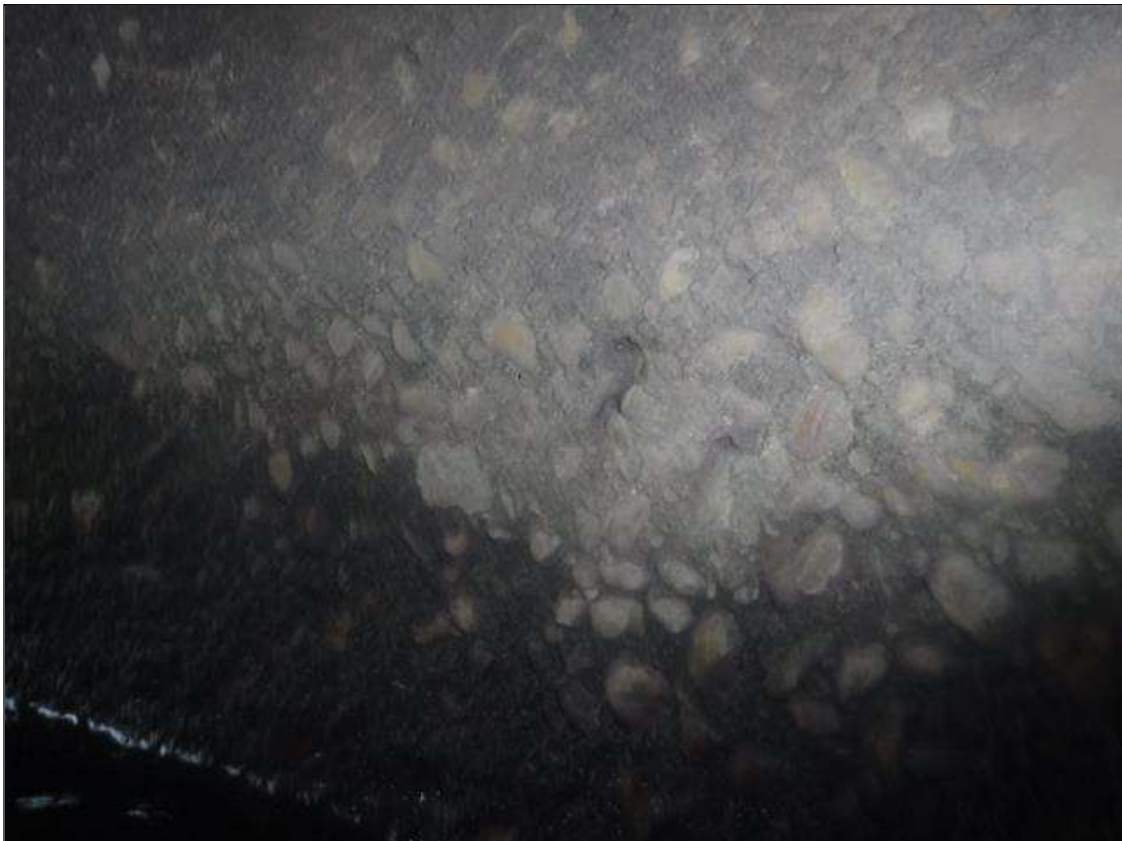
COARSE AGGREGATE EXPOSED ON BARREL WALL (ALL BARRELS SIMILIAR)

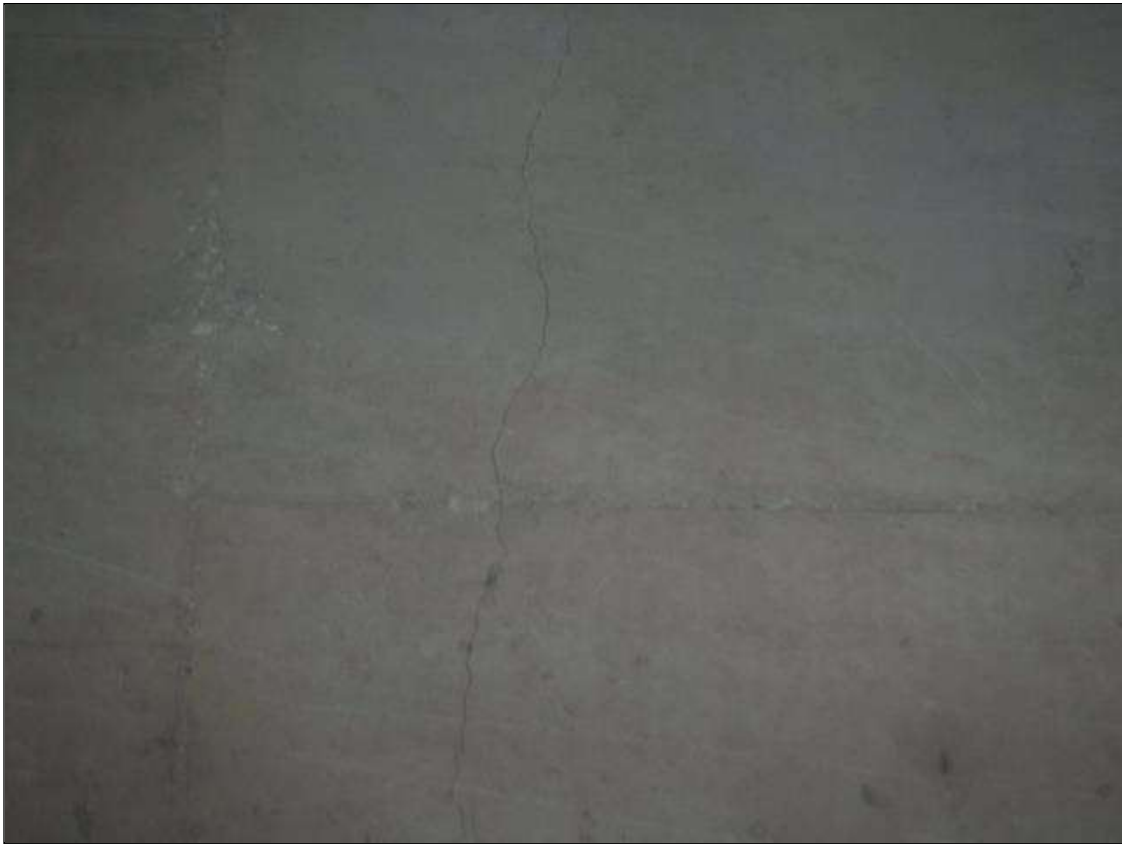
Span 1 Culvert Section 1: H/L VERTICAL CRACK ON INTERIOR WALL NEAR C/L

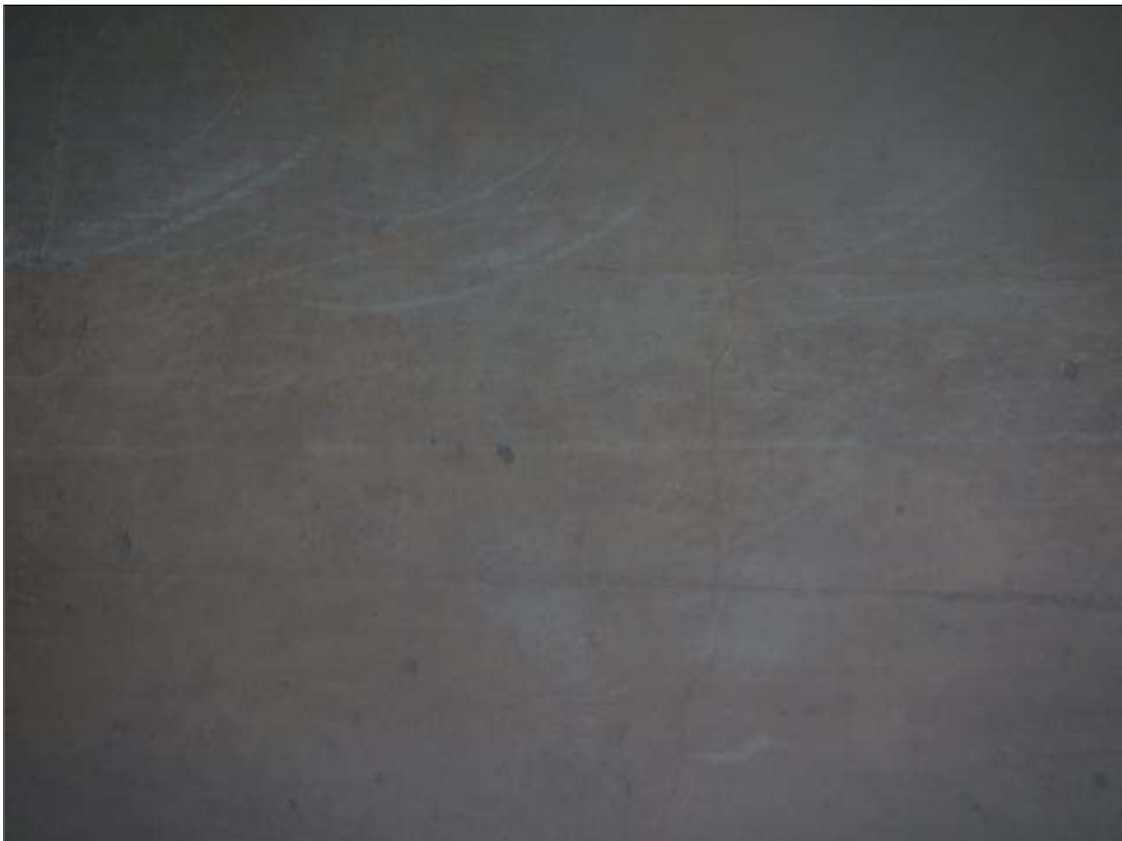
Span 2 Culvert Section 1: H/L VERTICAL CRACKING ON INTERIOR WALL NEAR C/L
