NC DEPARTMENT OF TRANSPORTATION  
 DIVISION OF HIGHWAYS  
 STRUCTURE MANAGEMENT UNIT

ATTENTION: **PRIORITY ACTION REQUESTS; SIGN NOTICED  
 ISSUED FOR (2) MISSING DELINEATORS**

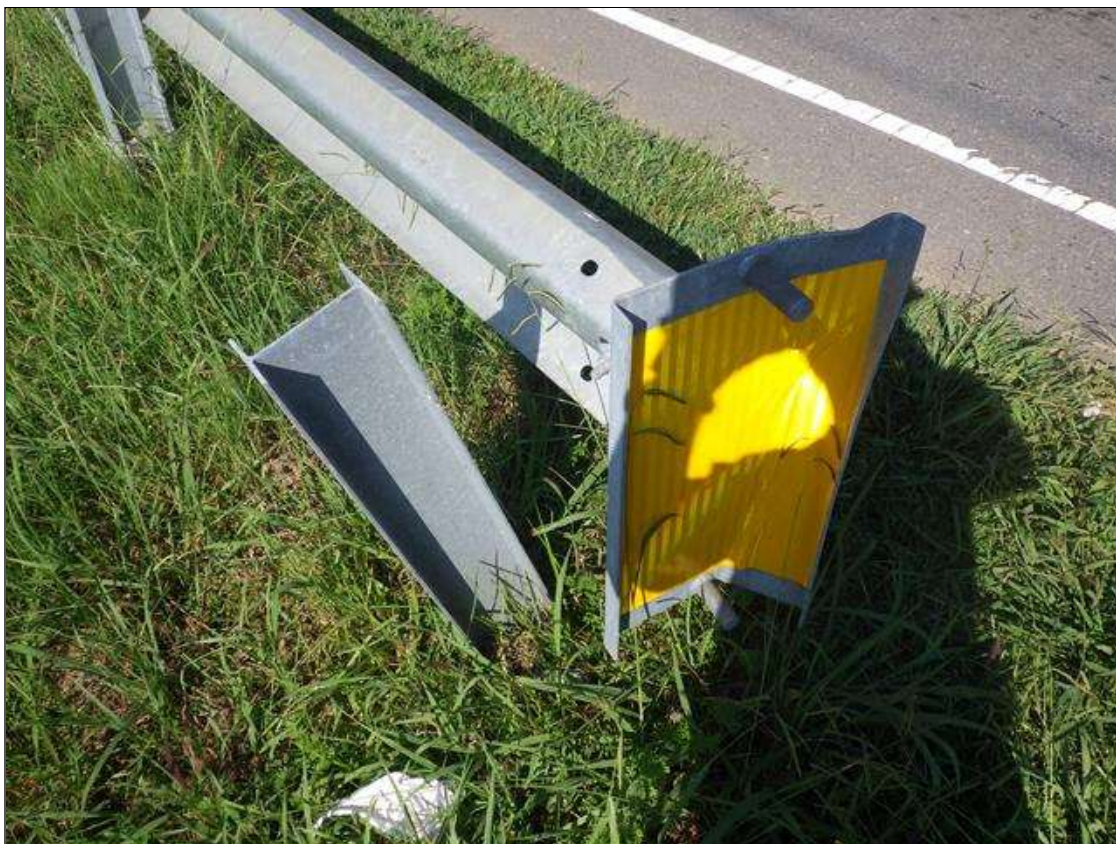
1 FOOT LONG IMPACT DAMAGE TO THE SOUTHEAST GUARDRAIL END TREATMENT WITH THE END POST DETACHED (PRIORITY ACTION REQUEST)

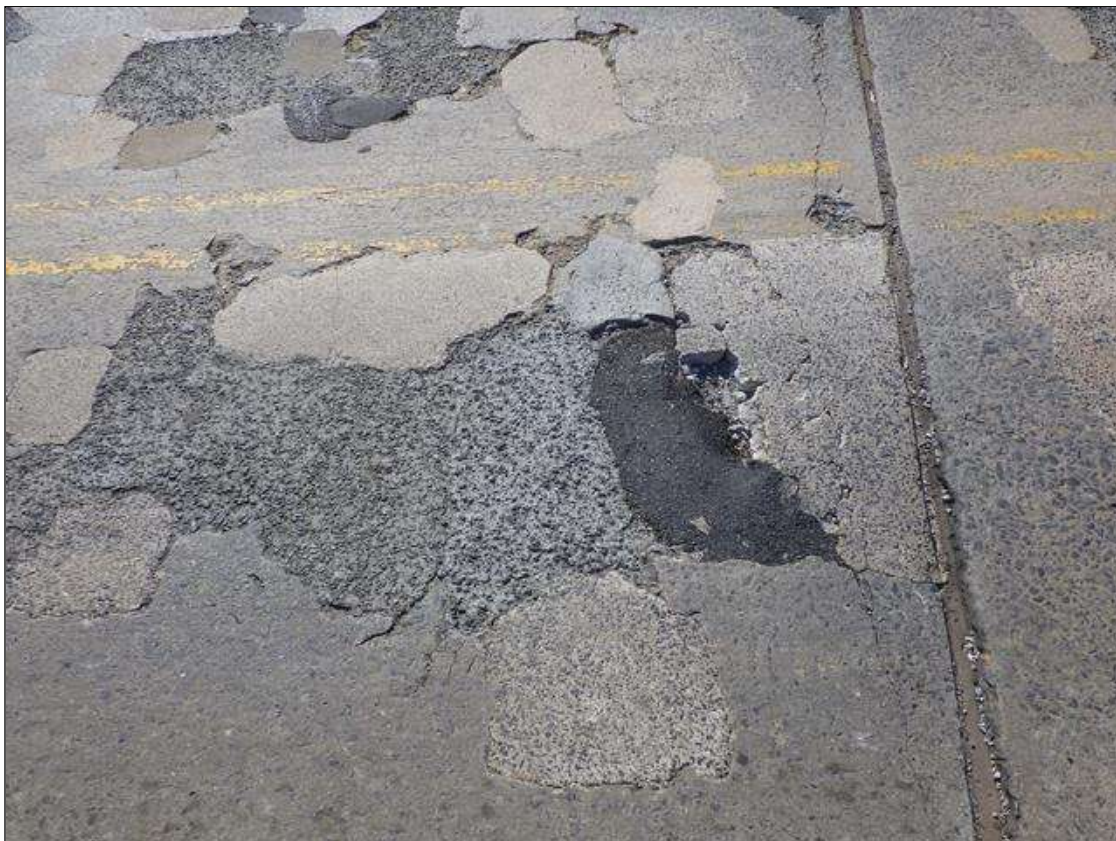
Span 2 Deck: 6 FEET 7 INCHES LONG X 4 FEET WIDE SPALLED AND DELAMINATED PATCHED AREA WITH EXPOSED REINFORCEMENT IN THE WESTBOUND LANE AT BENT 1 (PRIORITY ACTION REQUEST)

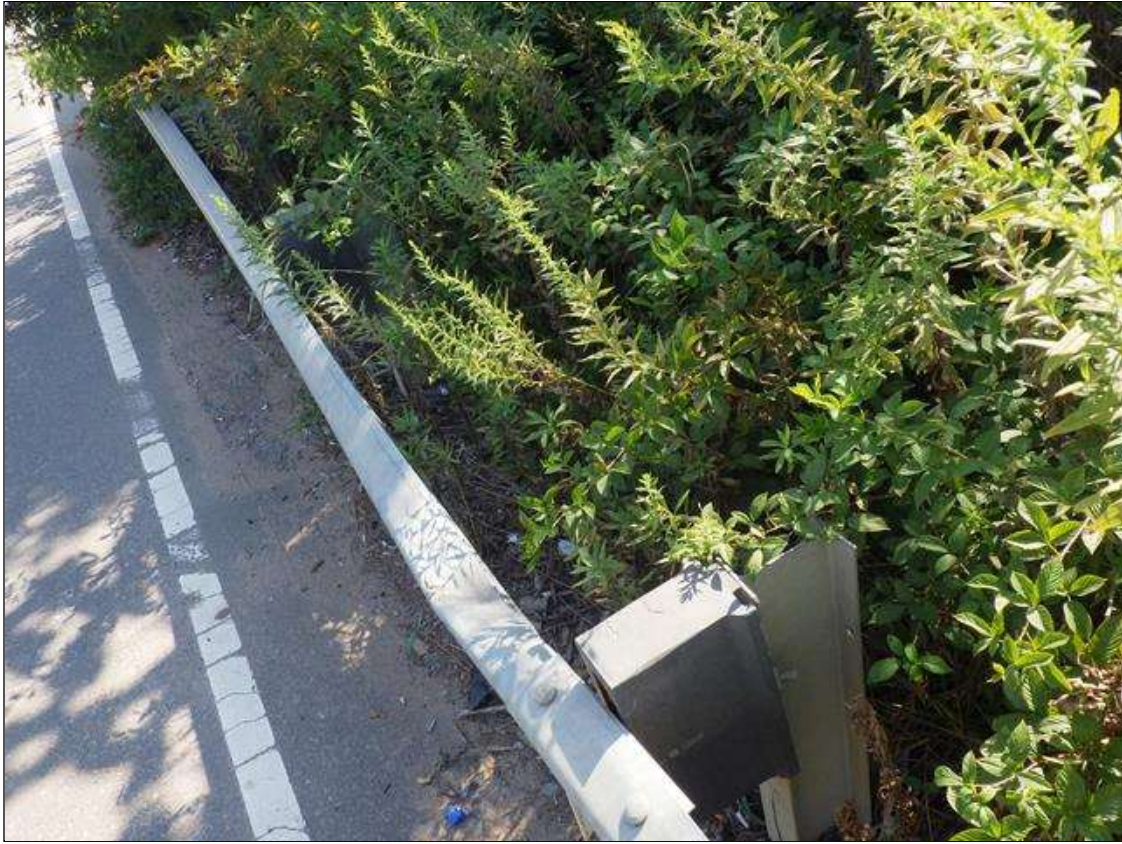
7 FEET LONG AREA OF IMPACT DAMAGE TO THE SOUTHEAST GUARDRAIL WITH POST 8 DETACHED, 30 FEET FROM END BENT 2 (PRIORITY ACTION REQUEST)

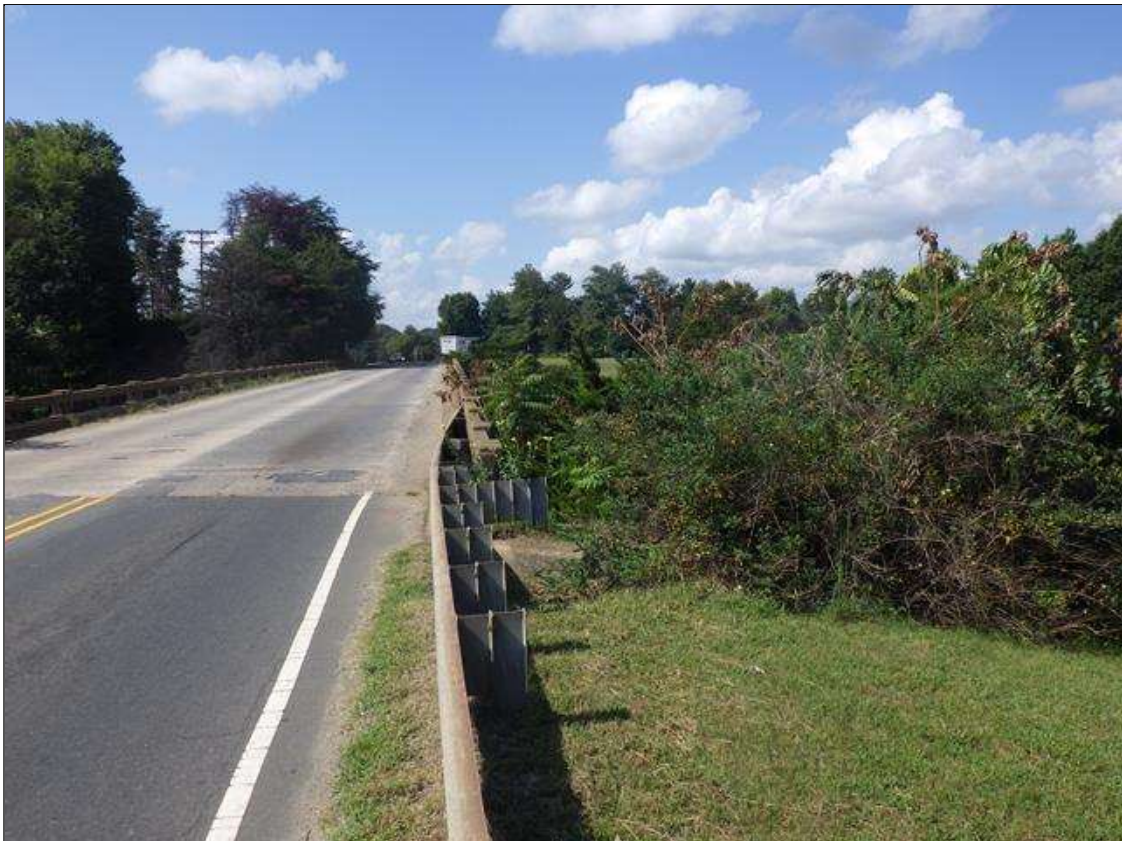
NORTHEAST DELINEATOR IS MISSING (PRIORITY ACTION REQUEST)

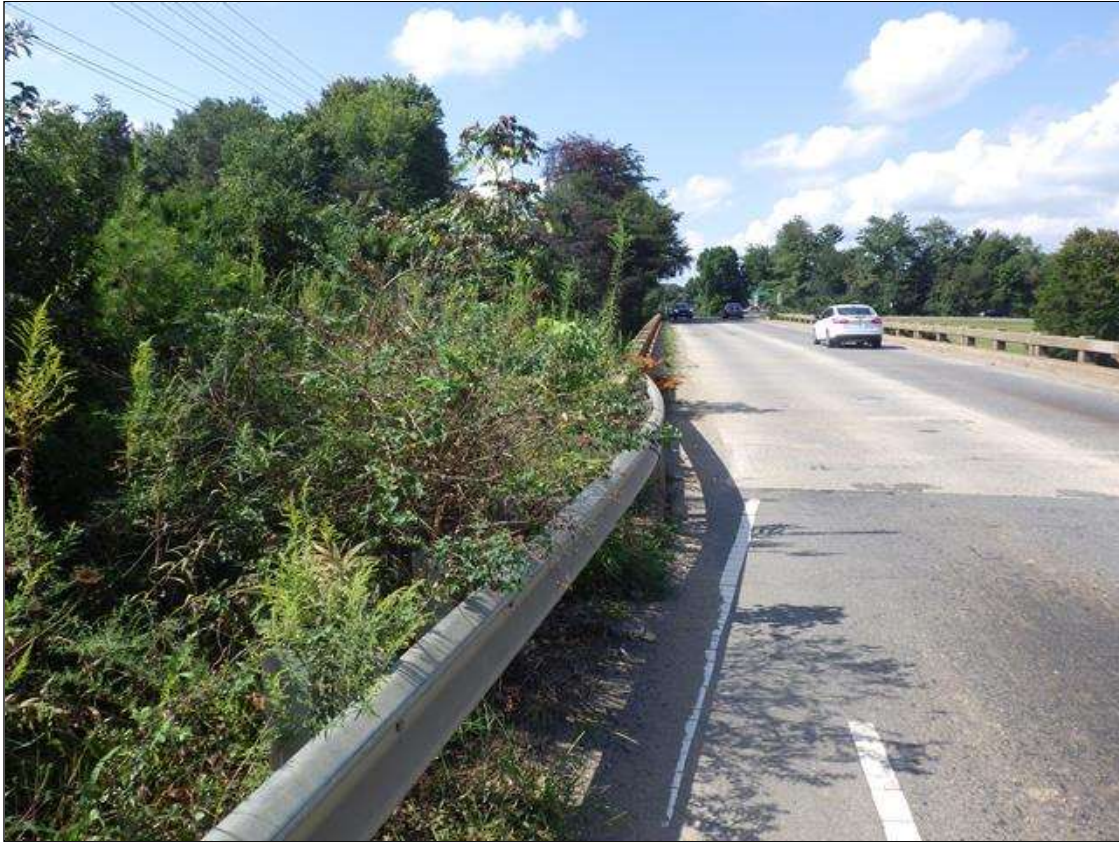
SOUTHEAST DELINEATOR IS MISSING (PRIORITY ACTION REQUEST)

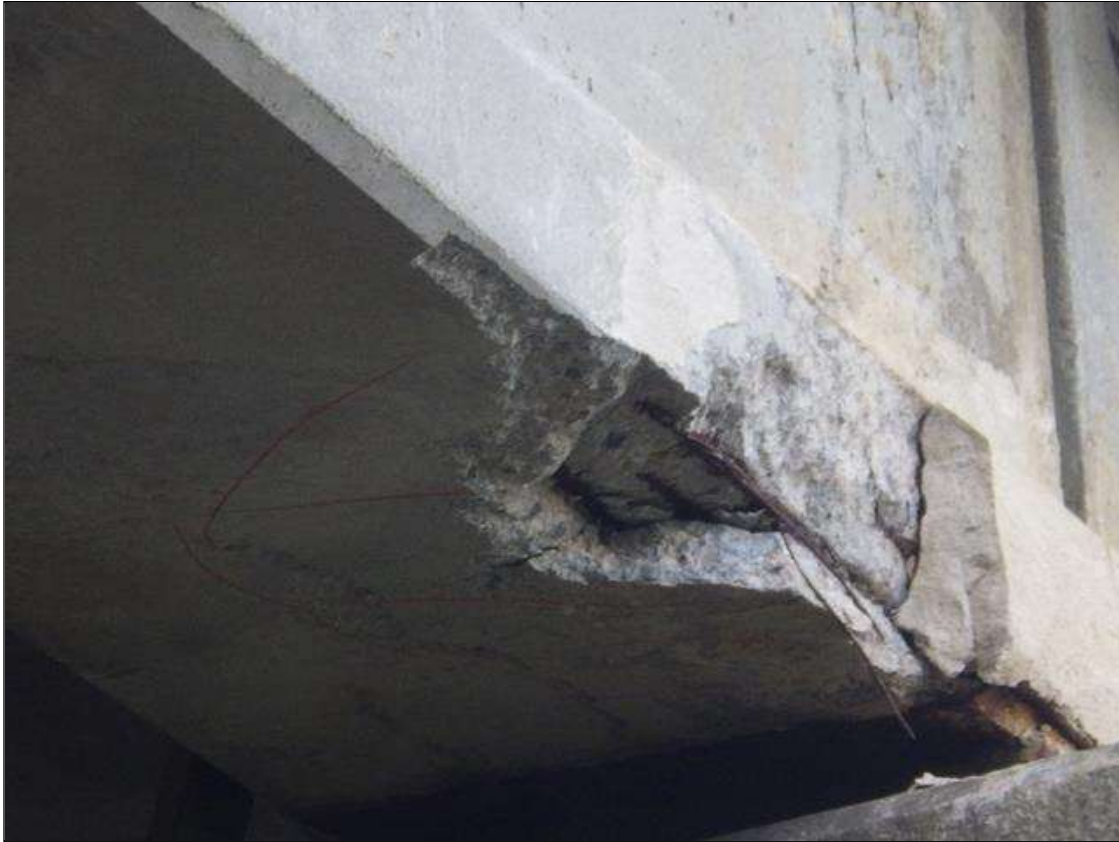
Span 4 Beam 1: 4 FEET LONG X 1 FOOT 2 INCHES WIDE X 7 INCHES HIGH X 2 INCHES DEEP SPALLED AND DELAMINATED PATCHED AREA IN THE LEFT BOTTOM FLANGE WITH (3) EXPOSED PRESTRESSING STRANDS, (1) STRAND SEVERED (PRIORITY ACTION REQUEST)

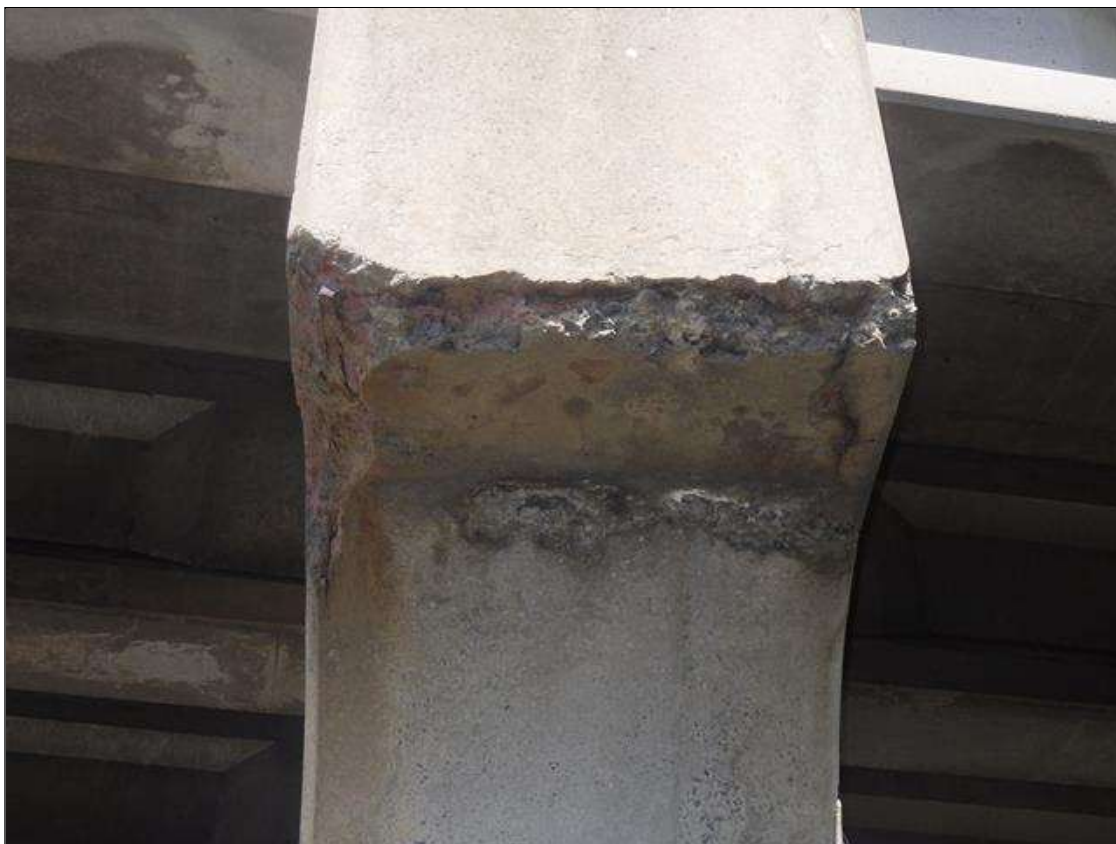
Bent 3 Cap 1: 2 FEET LONG X 3 FEET 3 INCHES WIDE X 2 INCHES HIGH SPALLED AREA WITH EXPOSED MAIN REINFORCEMENT IN THE UNDERSIDE OF THE SOUTH OVERHANG (PRIORITY ACTION REQUEST)

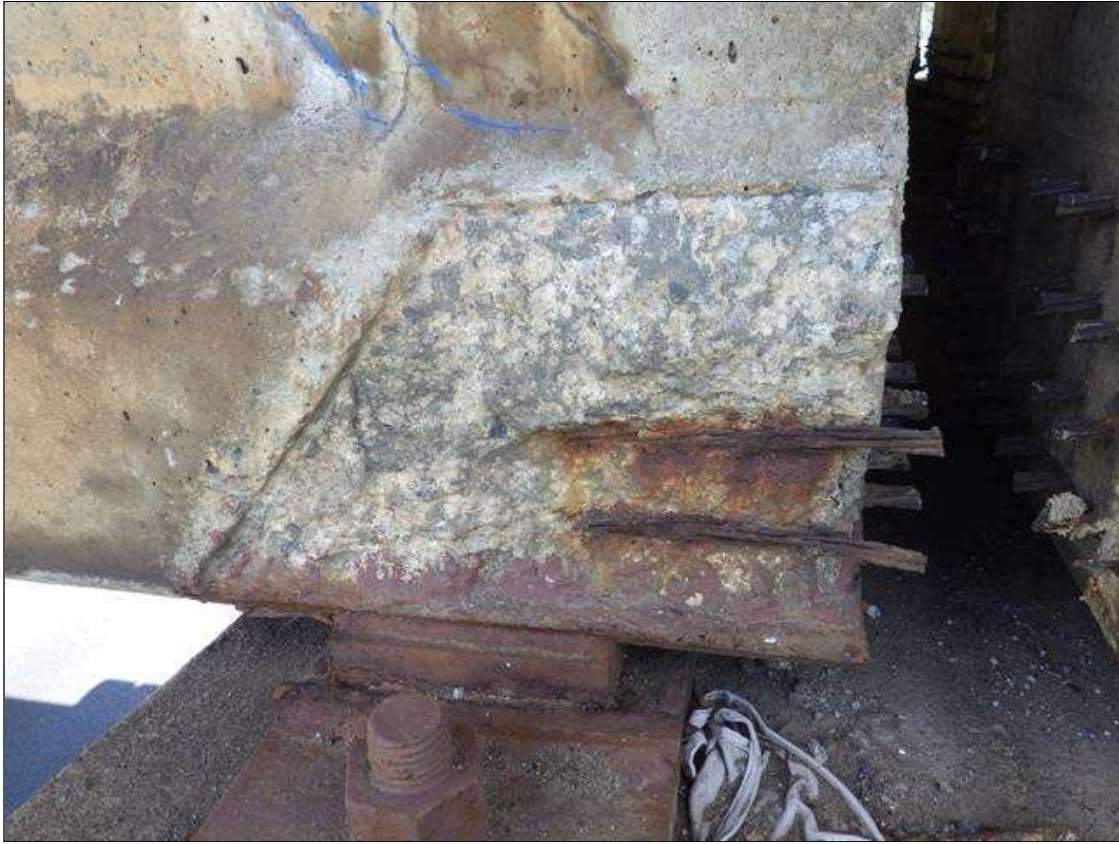
Span 3 Beam 1: 1 FOOT 2 INCHES LONG X 10 INCHES HIGH X 3 INCHES WIDE SPALLED AREA WITH (2) EXPOSED PRESTRESSING STRANDS IN THE LEFT BOTTOM FLANGE AT BENT 2 (PRIORITY ACTION REQUEST)

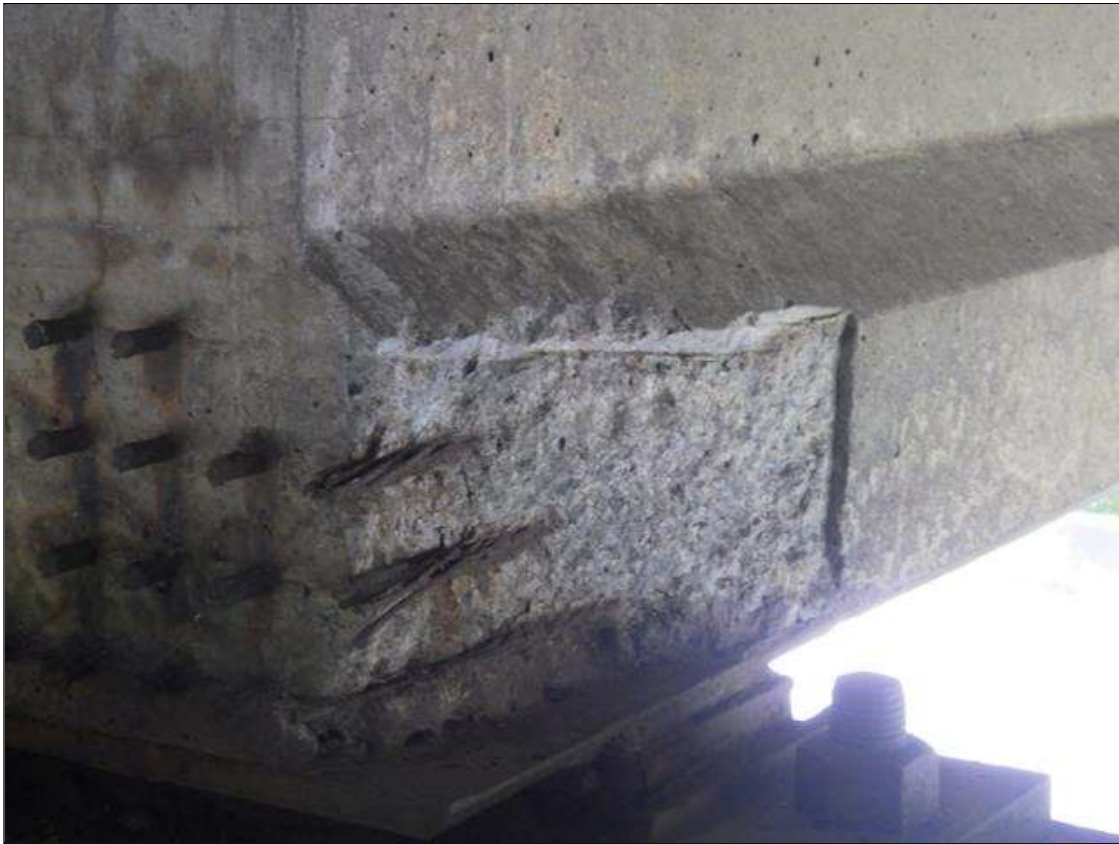
Span 2 Beam 2: 1 FOOT 3 INCHES LONG X 8 INCHES HIGH X 4 INCHES WIDE SPALLED AREA WITH (3) EXPOSED PRESTRESSING STRANDS IN THE LEFT BOTTOM FLANGE AT BENT 2 (PRIORITY ACTION REQUEST)

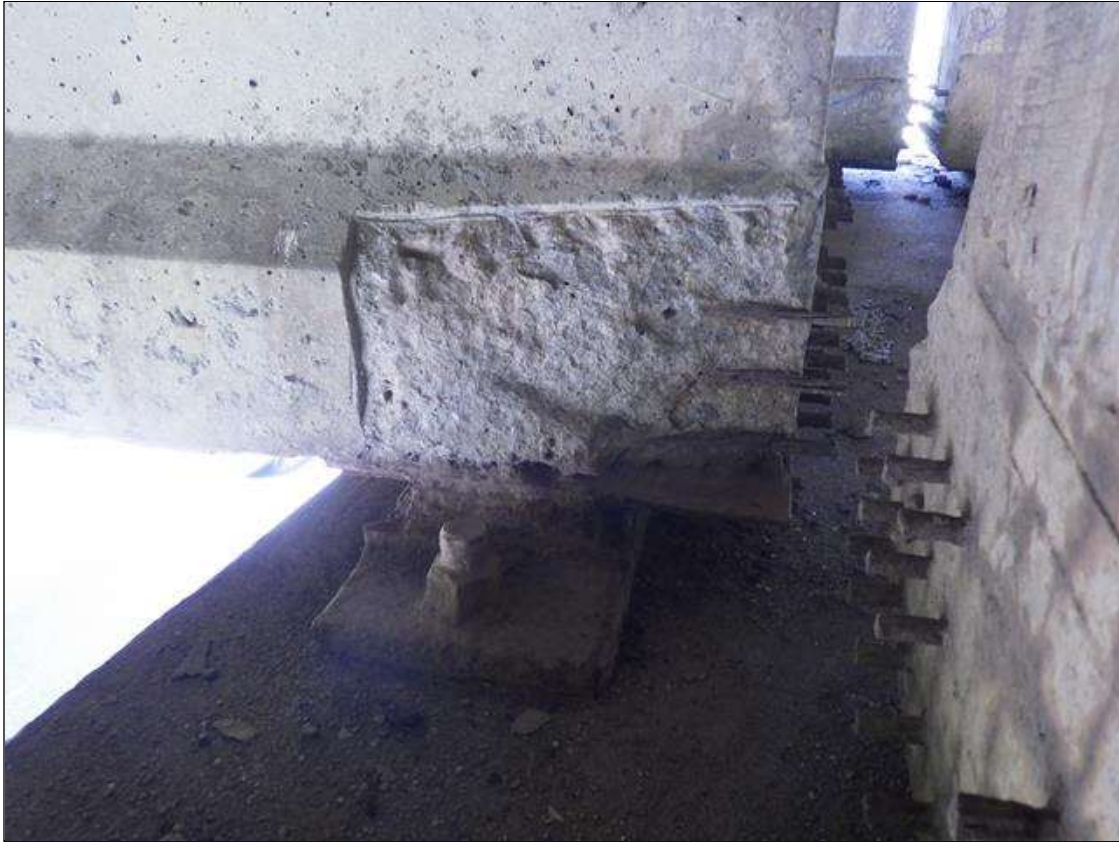
Span 2 Beam 2: 1 FOOT 2 INCHES LONG X 9 INCHES HIGH X 3 INCHES WIDE SPALLED AREA WITH (3) EXPOSED PRESTRESSING STRANDS IN THE RIGHT BOTTOM FLANGE AT BENT 2 (PRIORITY ACTION REQUEST)

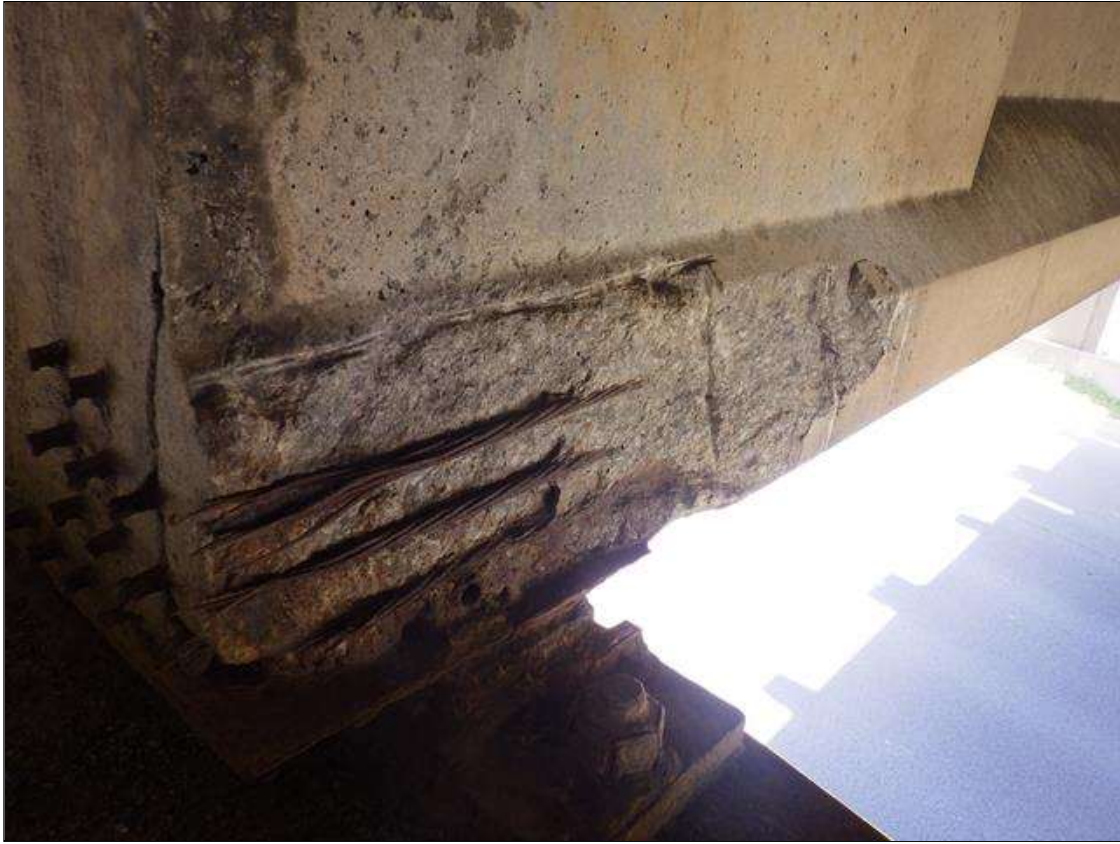
Span 2 Beam 3: 2 FOOT 8 INCHES LONG X 10 INCHES HIGH X 4 INCHES WIDE SPALLED AREA WITH (3) EXPOSED PRESTRESSING STRANDS IN THE LEFT BOTTOM FLANGE AT BENT 2 (PRIORITY ACTION REQUEST)

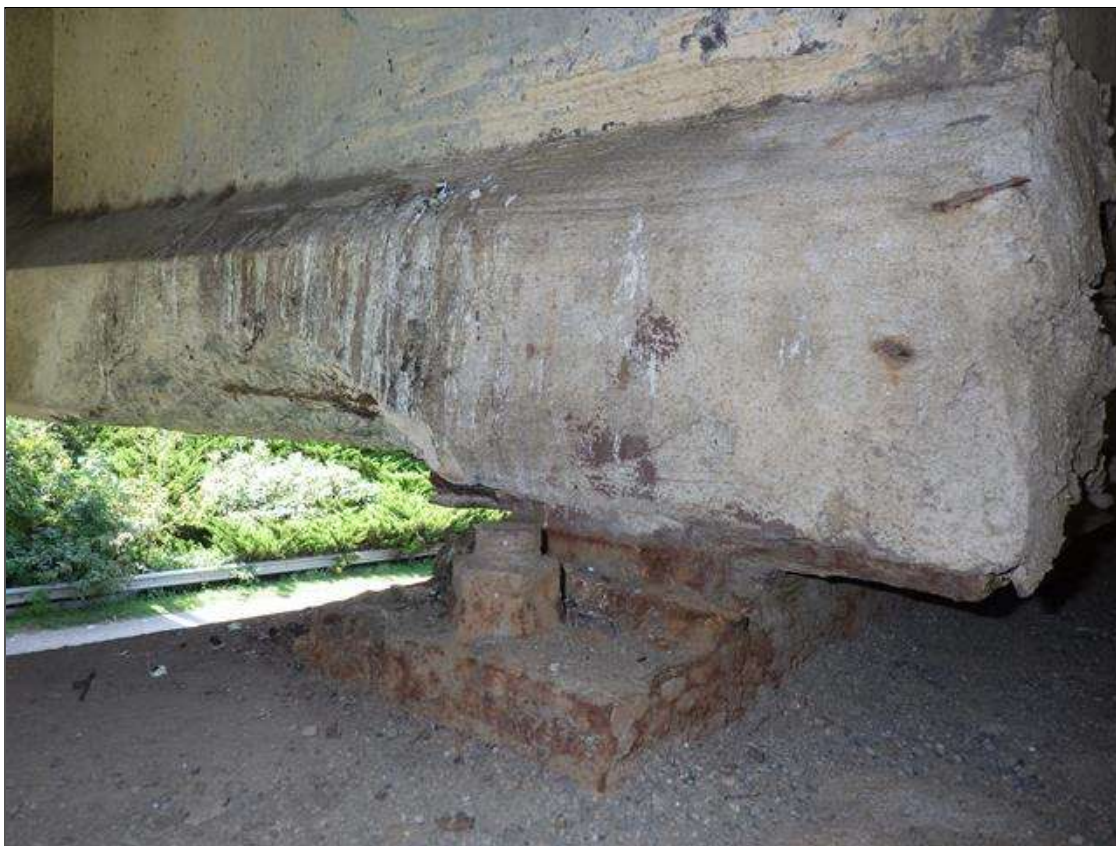
Span 2 Beam 3: 3 FOOT LONG X 10 INCHES HIGH X 10 INCHES WIDE SPALLED AREA WITH (1) EXPOSED PRESTRESSING STRAND IN THE RIGHT BOTTOM FLANGE AT BENT 2 (PRIORITY ACTION REQUEST)

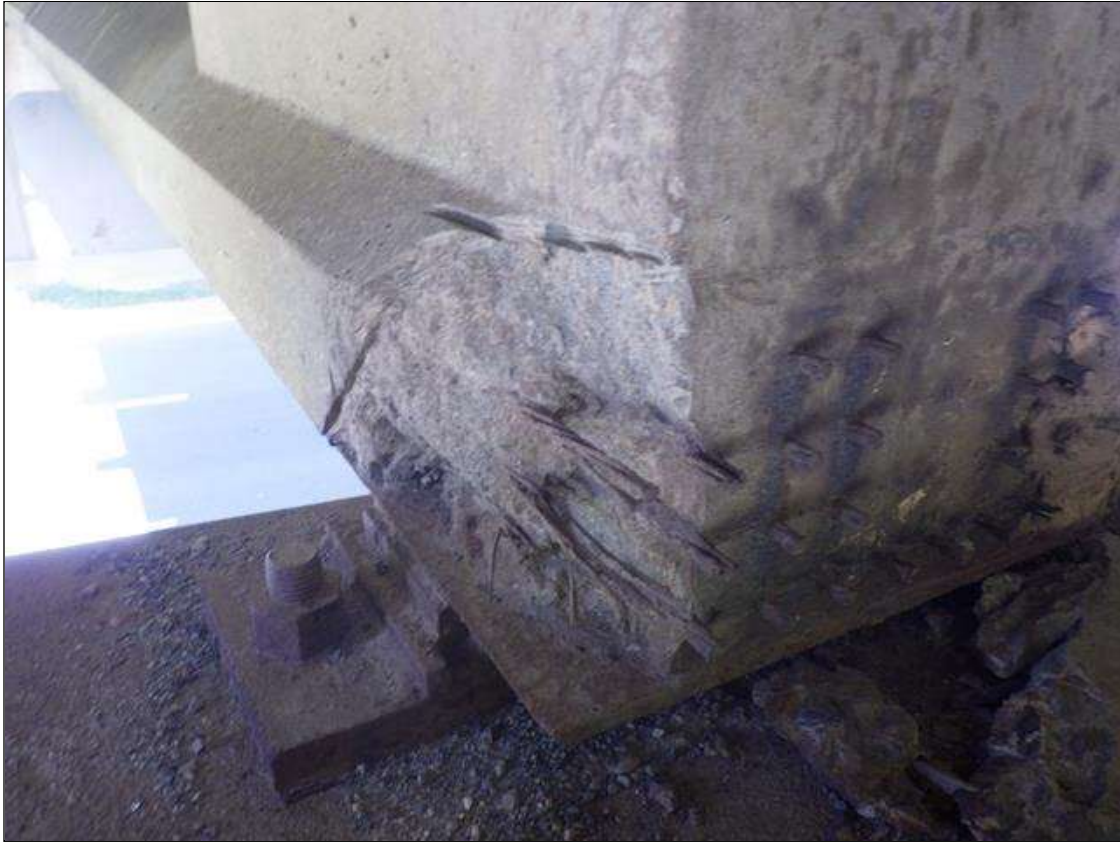
Span 2 Beam 4: 1 FOOT 4 INCHES LONG X 10 INCHES HIGH X 4 INCHES WIDE SPALLED AREA WITH (5) EXPOSED PRESTRESSING STRANDS IN THE RIGHT BOTTOM FLANGE AT BENT 2 (PRIORITY ACTION REQUEST)

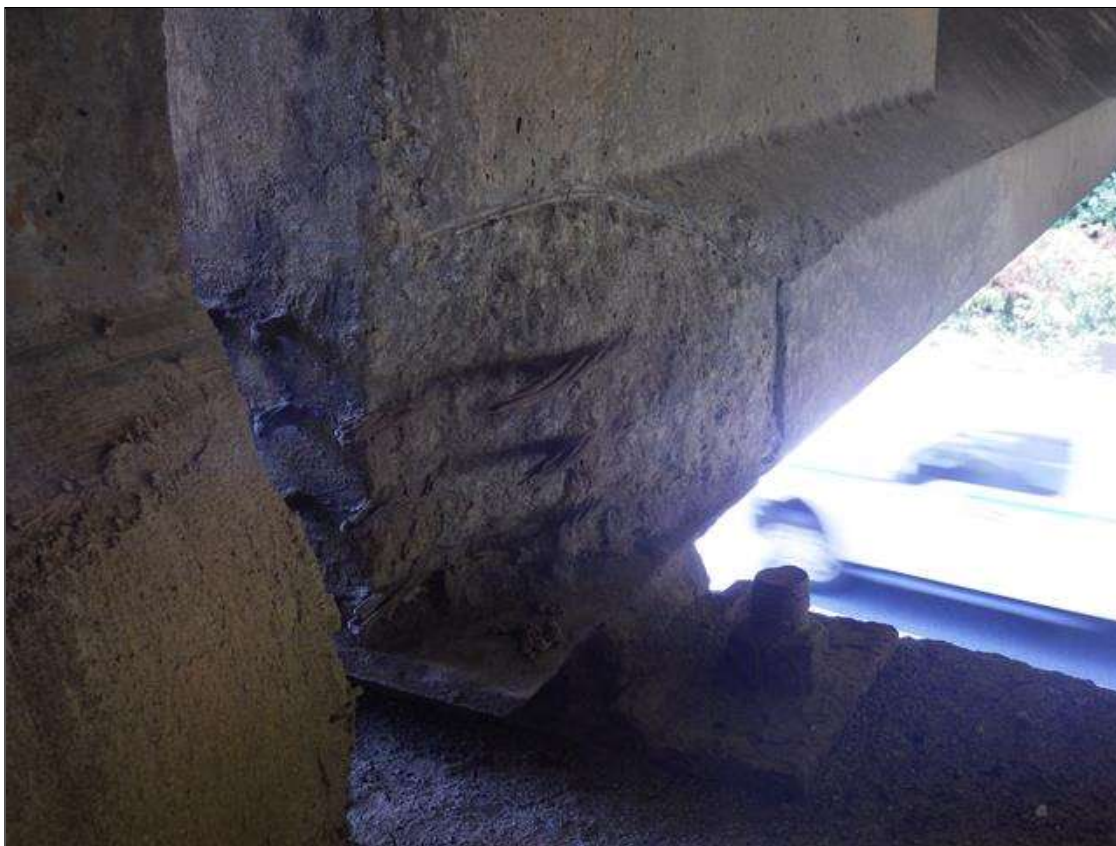
Span 2 Beam 5: 1 FOOT 4 INCHES LONG X 10 INCHES HIGH X 4 INCHES WIDE SPALLED AREA WITH (6) EXPOSED PRESTRESSING STRANDS IN THE LEFT BOTTOM FLANGE AT BENT 2 (PRIORITY ACTION REQUEST)

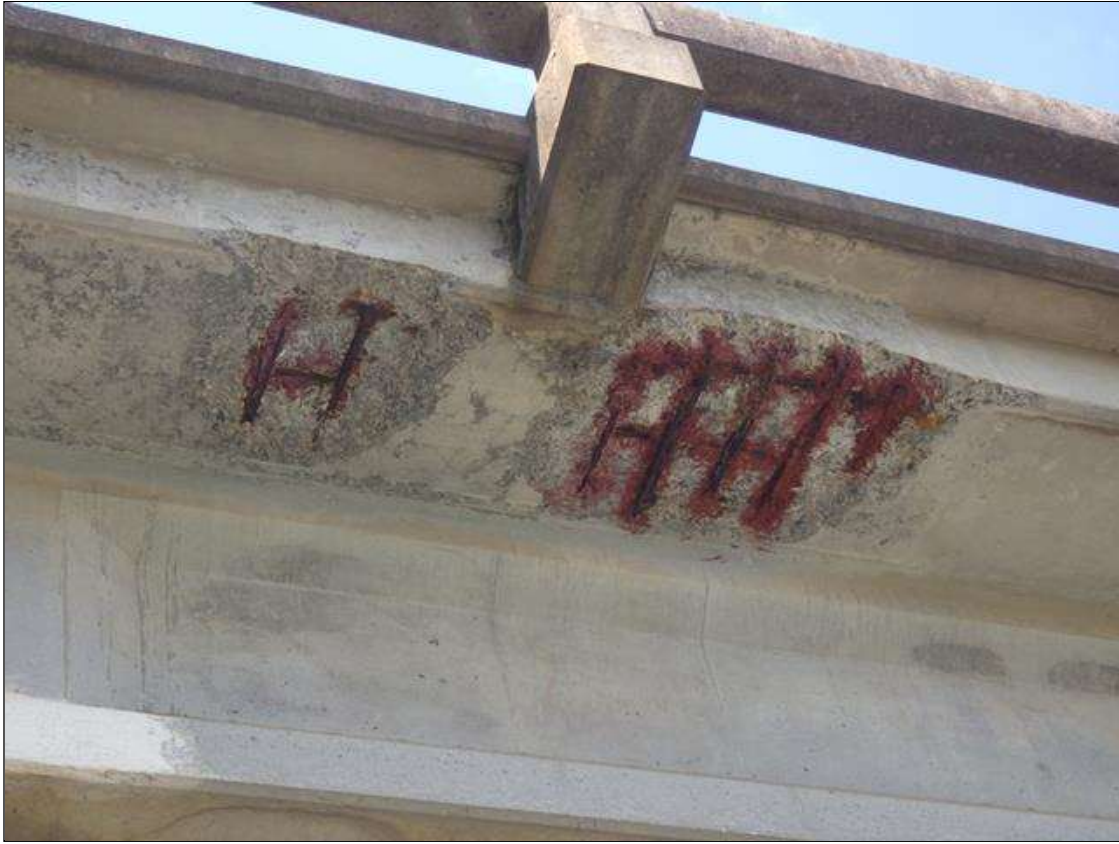
Span 2 Deck: INTERMITTENT 10 FEET LONG X 2 FEET 6 INCHES WIDE X 6 INCHES HIGH SPALLED AREA WITH EXPOSED REINFORCEMENT (10 PERCENT SECTION LOSS TO REBAR) IN THE UNDERSIDE OF THE SOUTH OVERHANG, 7 FEET FROM BENT 1 AND ABOVE THE MERGE LANE (PRIORITY ACTION REQUEST)

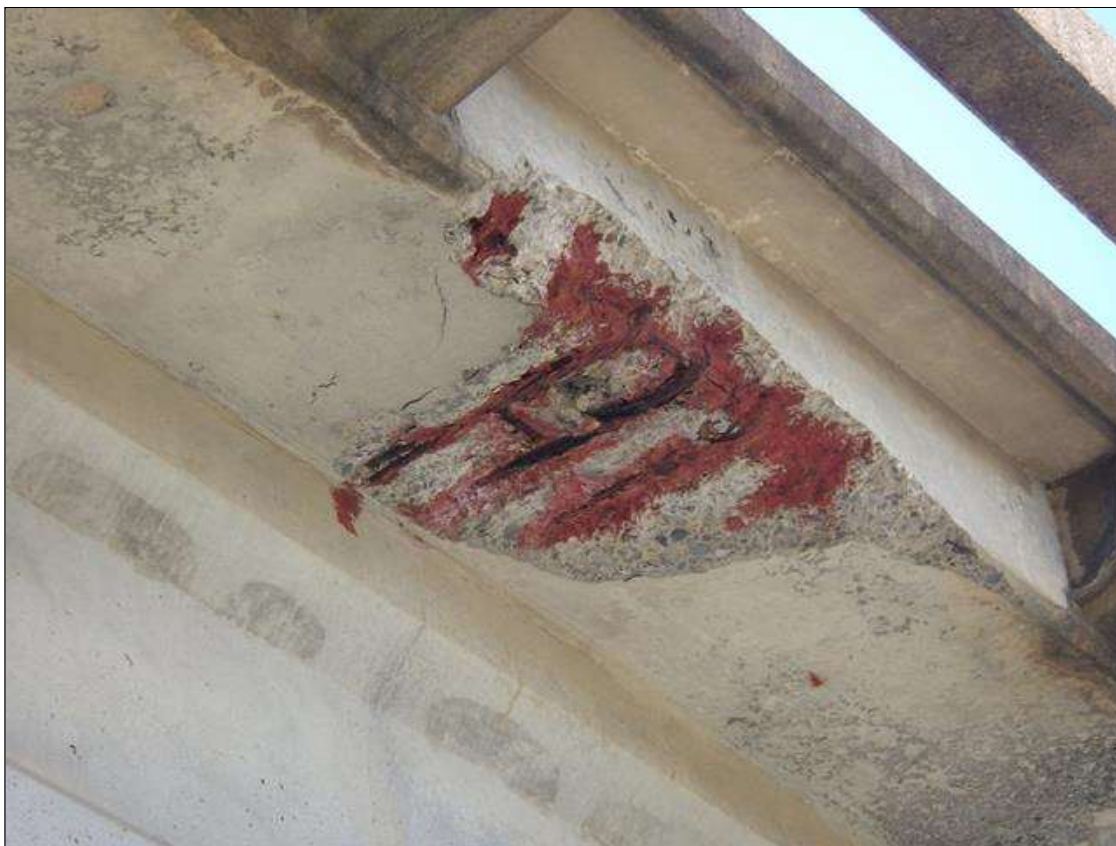
Span 2 Deck: 6 FEET LONG X 2 FEET 6 INCHES WIDE X 6 INCHES HIGH SPALLED AREA WITH EXPOSED REINFORCEMENT (10 PERCENT SECTION LOSS TO REBAR) IN THE UNDERSIDE OF THE SOUTH OVERHANG, ABOVE THE RIGHT SOUTHBOUND LANE (PRIORITY ACTION REQUEST)

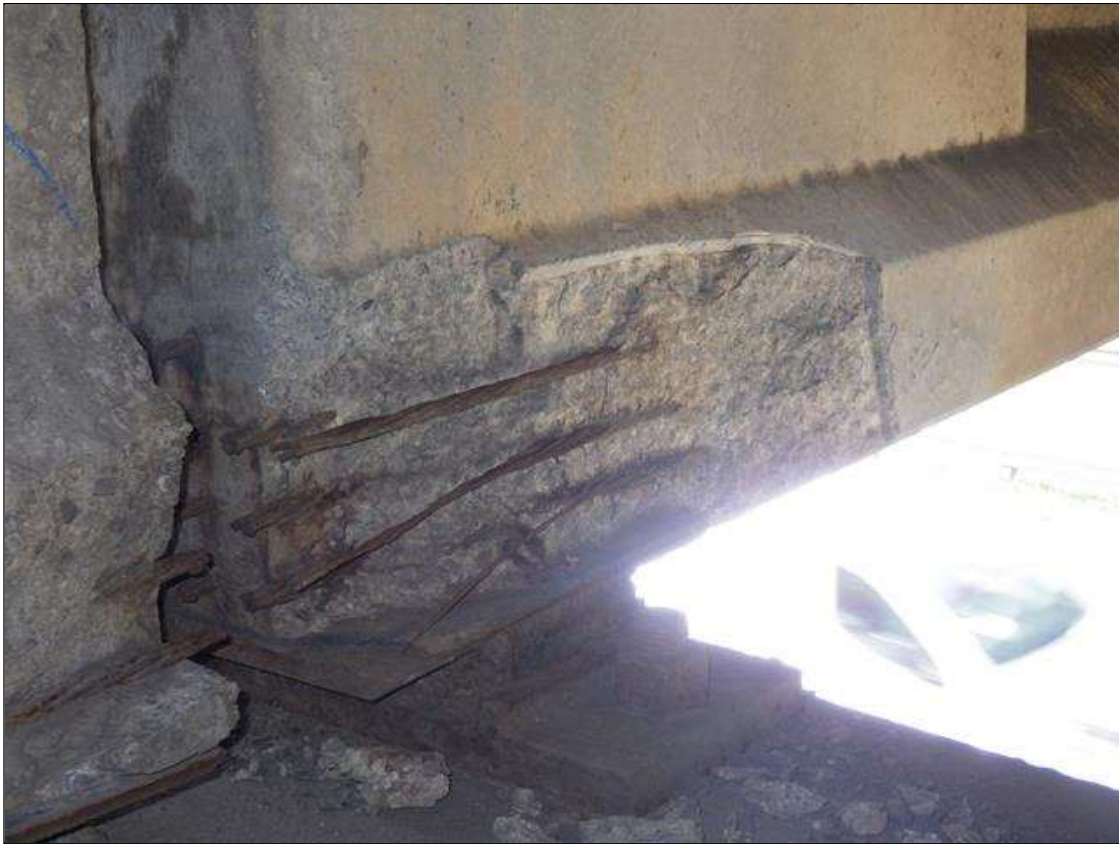
Span 2 Beam 1: 2 FEET 3 INCHES LONG X 10 INCHES HIGH X 4 INCHES WIDE SPALLED AREA WITH (6) EXPOSED PRESTRESSING STRANDS IN THE RIGHT BOTTOM FLANGE AT BENT 1 (PRIORITY ACTION REQUEST)

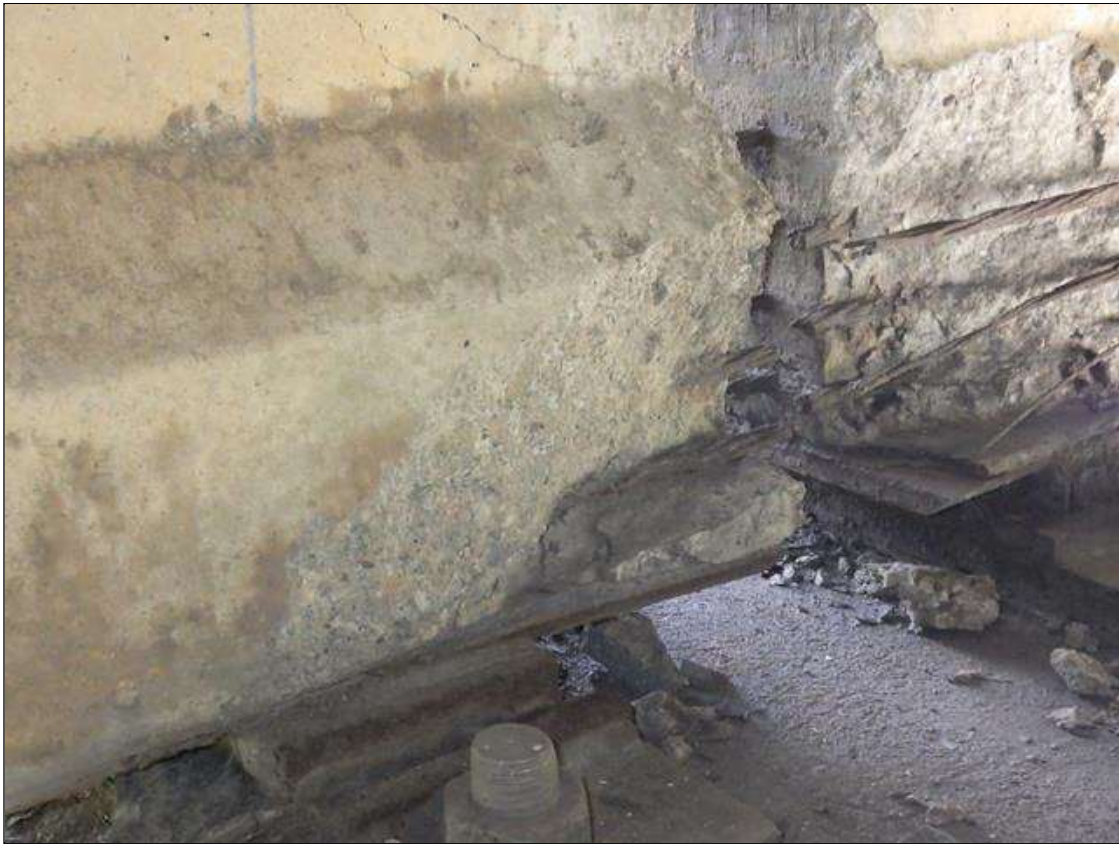
Span 1 Beam 1: 1 FOOT LONG X 8 INCHES HIGH X 3 INCHES WIDE SPALLED AREA WITH (2) EXPOSED PRESTRESSING STRANDS IN THE RIGHT BOTTOM FLANGE AT BENT 1 (PRIORITY ACTION REQUEST)

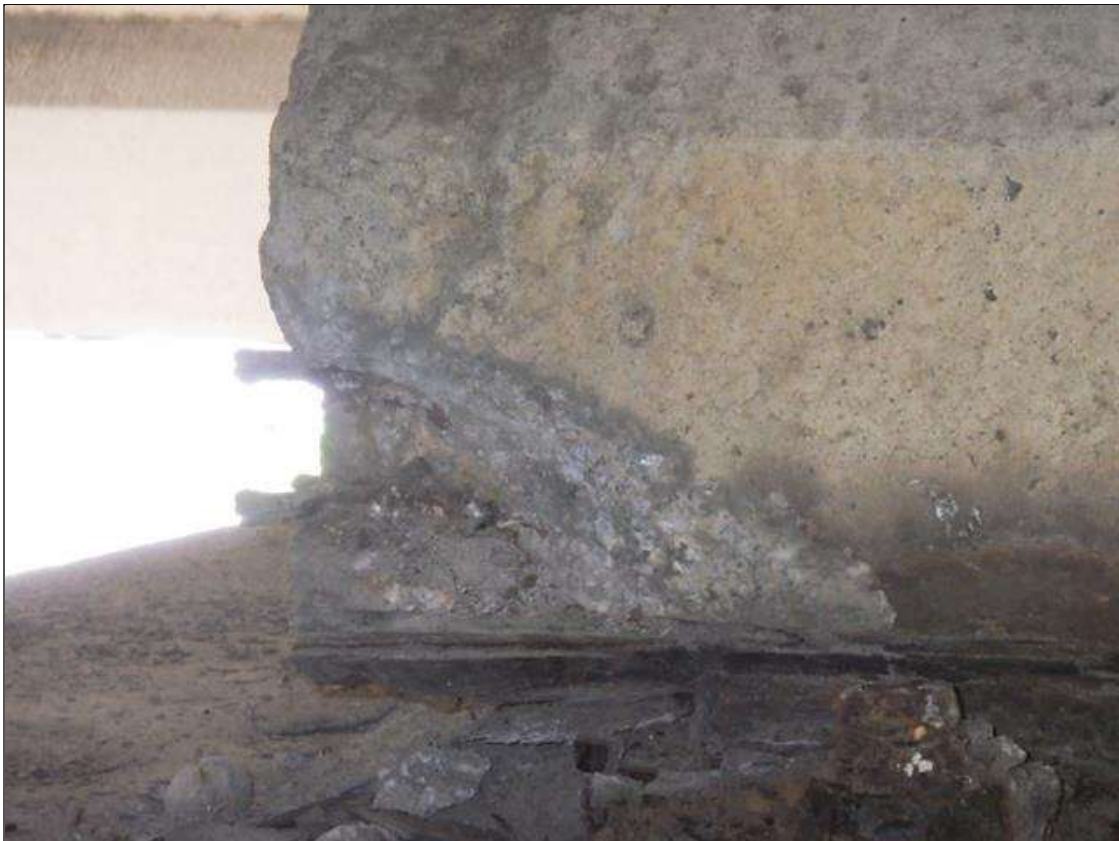
Span 1 Beam 2: 9 INCHES LONG X 4 INCHES HIGH X 3 INCHES WIDE SPALLED AREA WITH (2) EXPOSED PRESTRESSING STRANDS IN THE LEFT BOTTOM FLANGE AT BENT 1 (PRIORITY ACTION REQUEST)

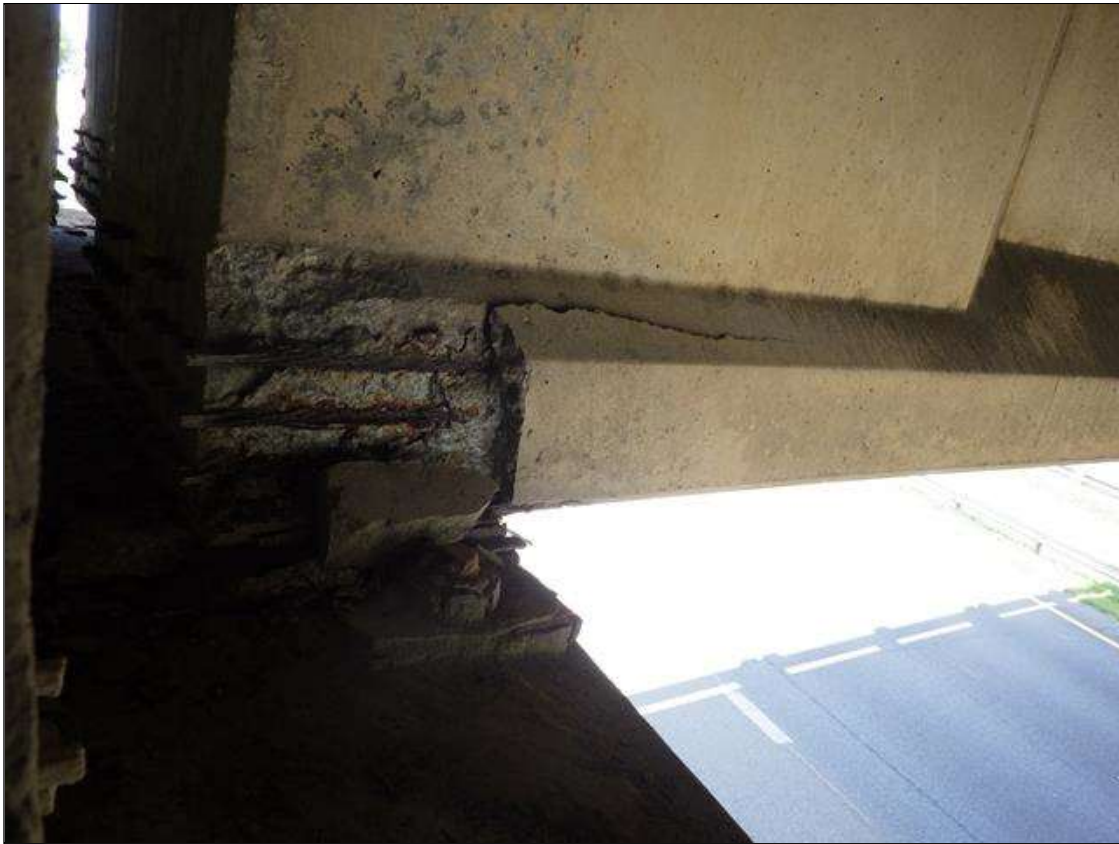
Span 2 Beam 2: 2 FEET 6 INCHES LONG X 10 INCHES HIGH X 3 INCHES WIDE SPALLED AREA WITH (3) EXPOSED PRESTRESSING STRANDS IN THE RIGHT BOTTOM FLANGE AT BENT 1 (PRIORITY ACTION REQUEST)

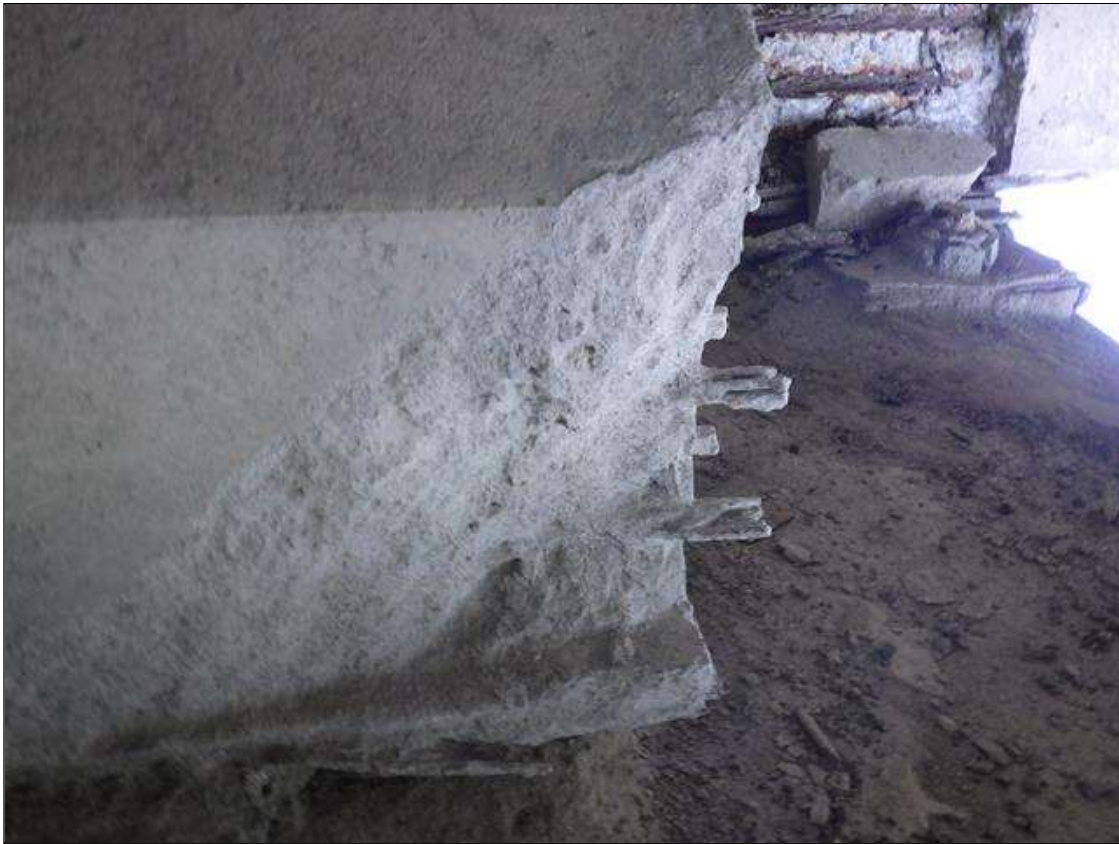
Span 1 Beam 2: 9 INCHES LONG X 7 INCHES HIGH X 4 INCHES WIDE SPALLED AREA WITH (2) EXPOSED PRESTRESSING STRANDS IN THE RIGHT BOTTOM FLANGE AT BENT 1 (PRIORITY ACTION REQUEST)

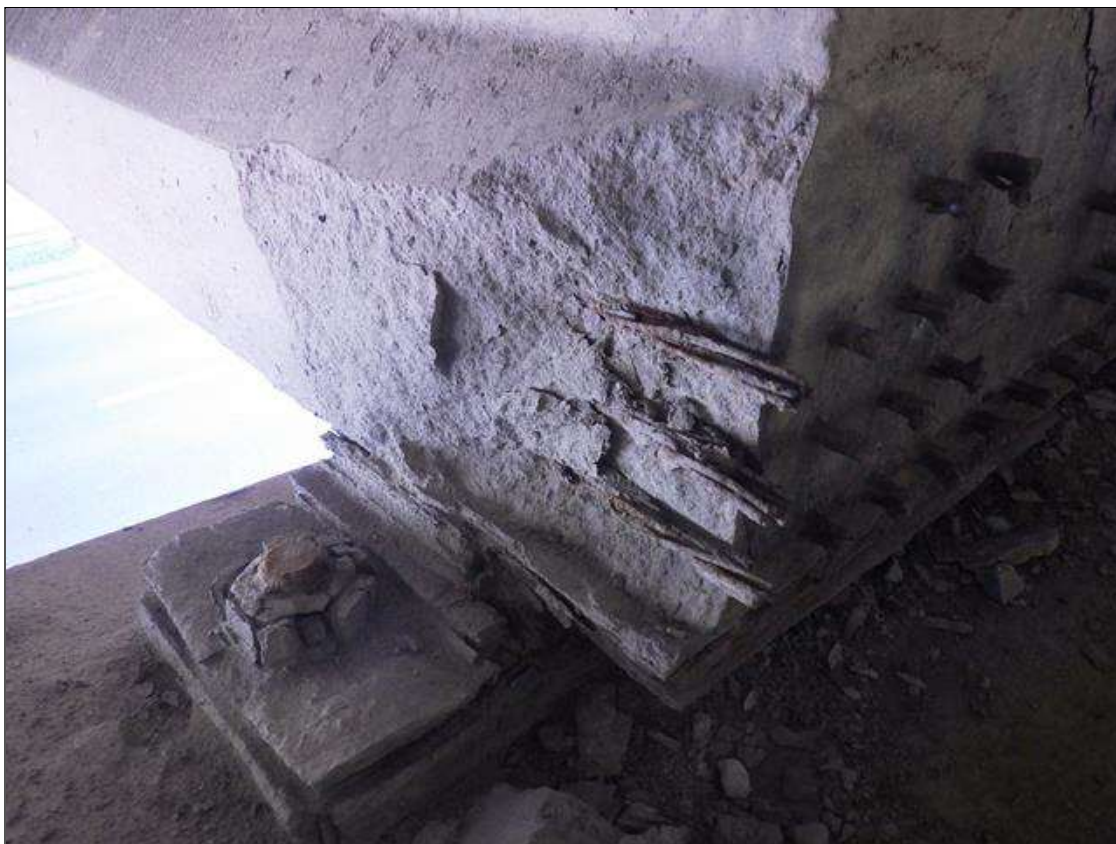
Span 2 Beam 3: 1 FEET 2 INCHES LONG X 10 INCHES HIGH X 2 INCHES WIDE SPALLED AREA WITH (2) EXPOSED PRESTRESSING STRANDS IN THE LEFT BOTTOM FLANGE AT BENT 1 (PRIORITY ACTION REQUEST)

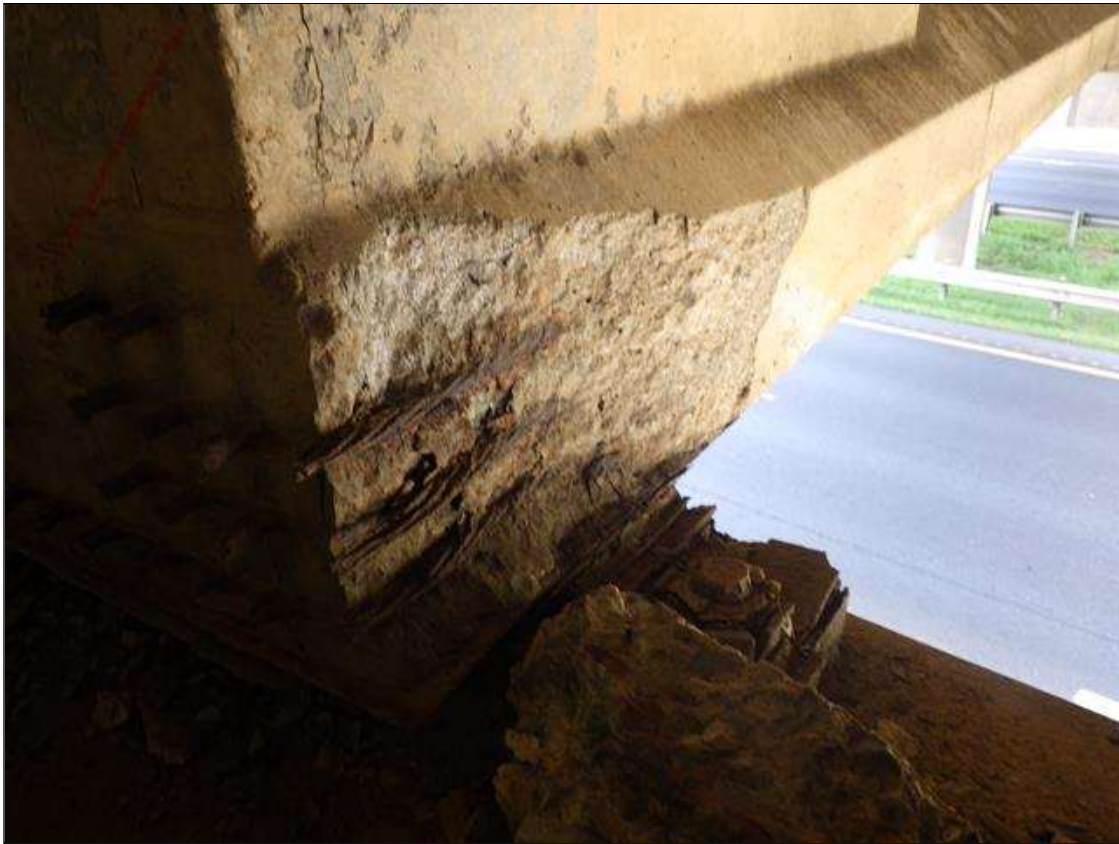
Span 2 Beam 3: 1 FEET 9 INCHES LONG X 10 INCHES HIGH X 2 INCHES WIDE SPALLED AREA WITH (3) EXPOSED PRESTRESSING STRANDS IN THE RIGHT BOTTOM FLANGE AT BENT 1 (PRIORITY ACTION REQUEST)
