NC DEPARTMENT OF TRANSPORTATION  
 DIVISION OF HIGHWAYS  
 STRUCTURE MANAGEMENT UNIT

ATTENTION: **PRIORITY ACTION REQUESTS; SIGN NOTICED  
 ISSUED FOR (2) MISSING DELINEATORS**

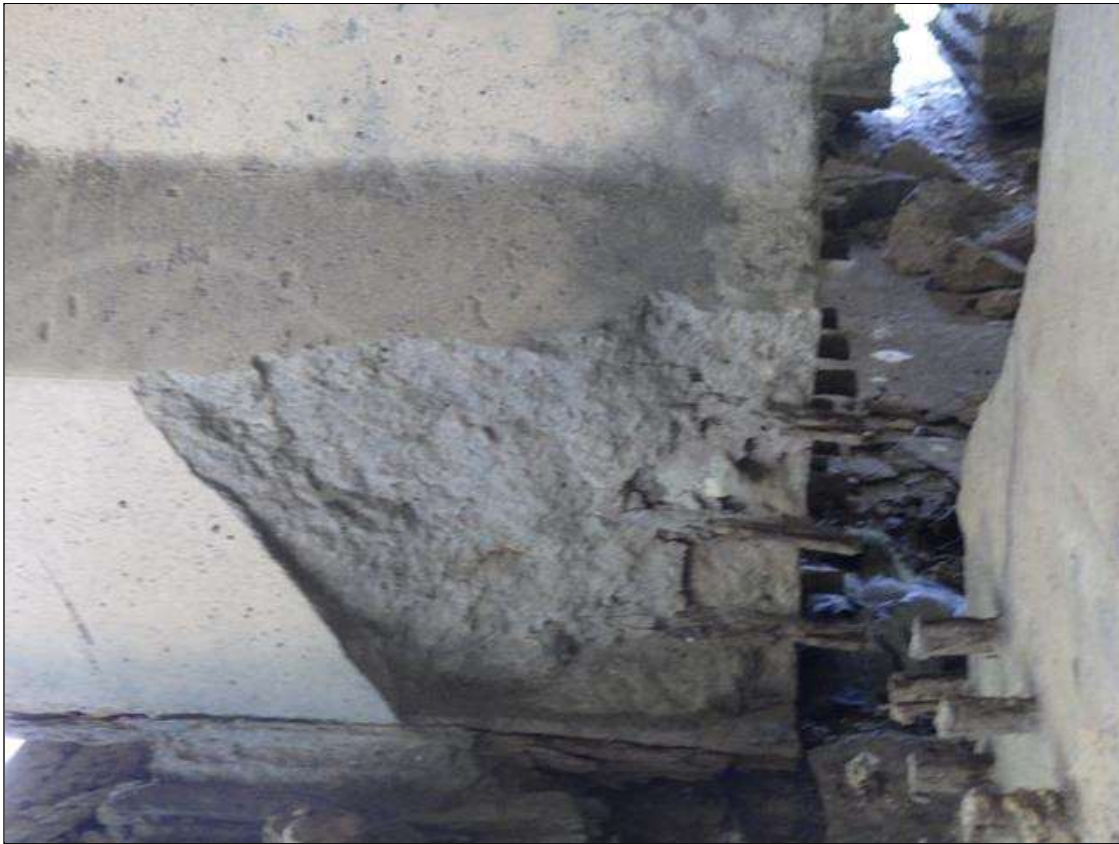
Span 2 Beam 4: 1 FOOT LONG X 10 INCHES HIGH X 2 INCHES WIDE SPALLED AREA WITH (3) EXPOSED PRESTRESSING STRANDS IN THE LEFT BOTTOM FLANGE AT BENT 1 (PRIORITY ACTION REQUEST)

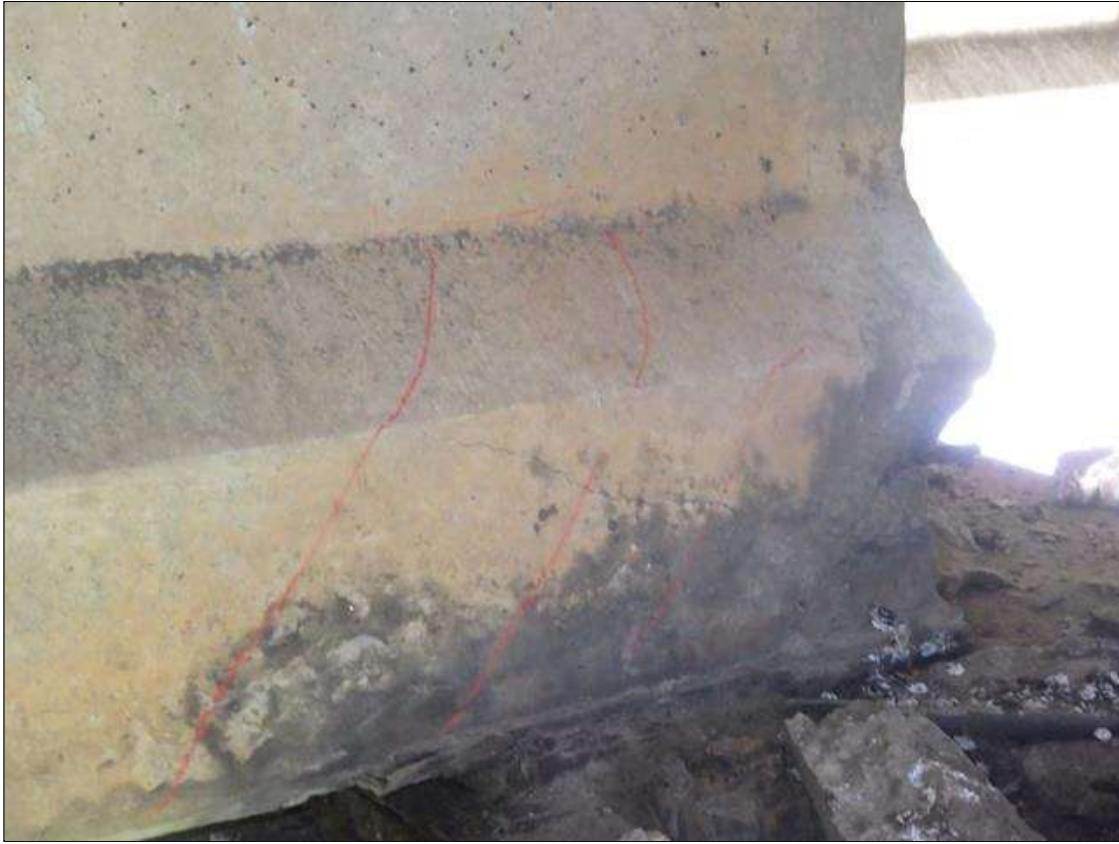
Span 1 Beam 3: 1 FOOT 6 INCHES LONG X 10 INCHES HIGH X 3 INCHES WIDE SPALLED AND DELAMINATED AREA WITH (2) EXPOSED PRESTRESSING STRANDS IN THE RIGHT BOTTOM FLANGE AT BENT 1 (PRIORITY ACTION REQUEST)

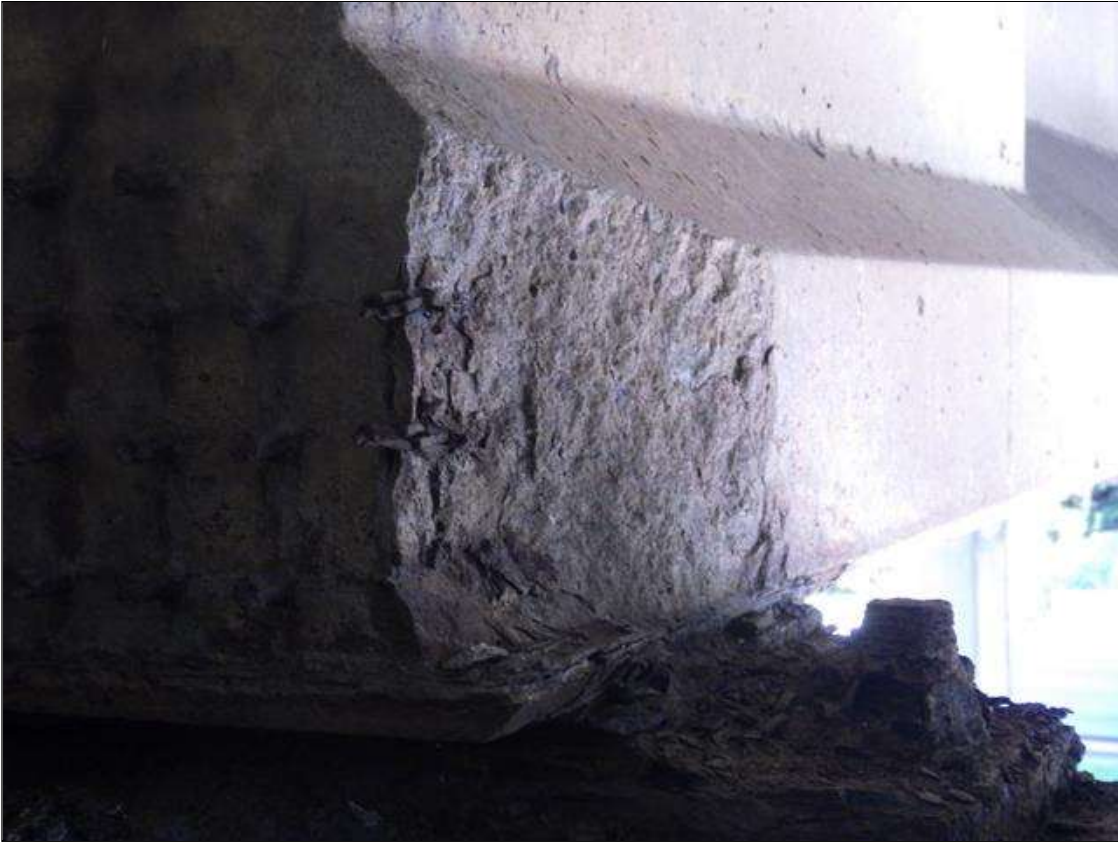
Span 2 Beam 4: 10 INCHES LONG X 10 INCHES HIGH X 2 INCHES WIDE SPALLED AREA WITH (3) EXPOSED PRESTRESSING STRANDS IN THE RIGHT BOTTOM FLANGE AT BENT 1 (PRIORITY ACTION REQUEST)

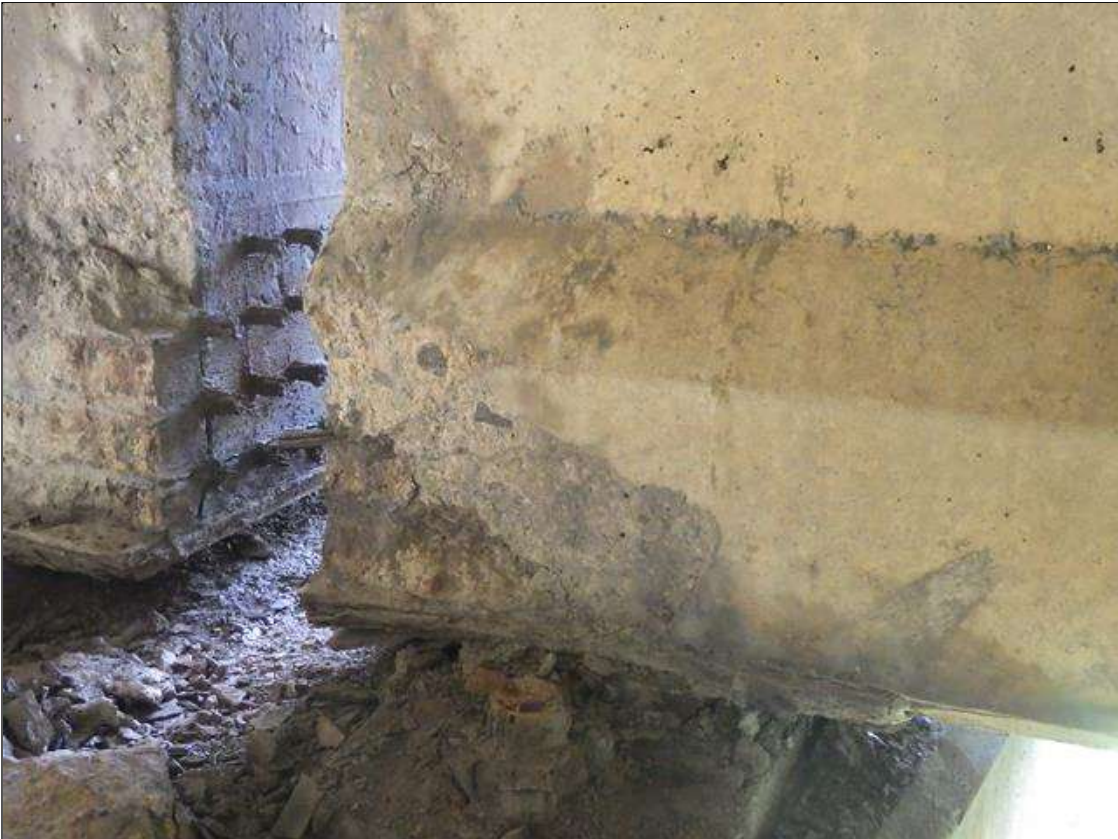
Span 1 Beam 4: 1 FOOT LONG X 9 INCHES HIGH X 2 INCHES WIDE SPALLED AREA WITH (2) EXPOSED PRESTRESSING STRANDS IN THE LEFT BOTTOM FLANGE AT BENT 1 (PRIORITY ACTION REQUEST)

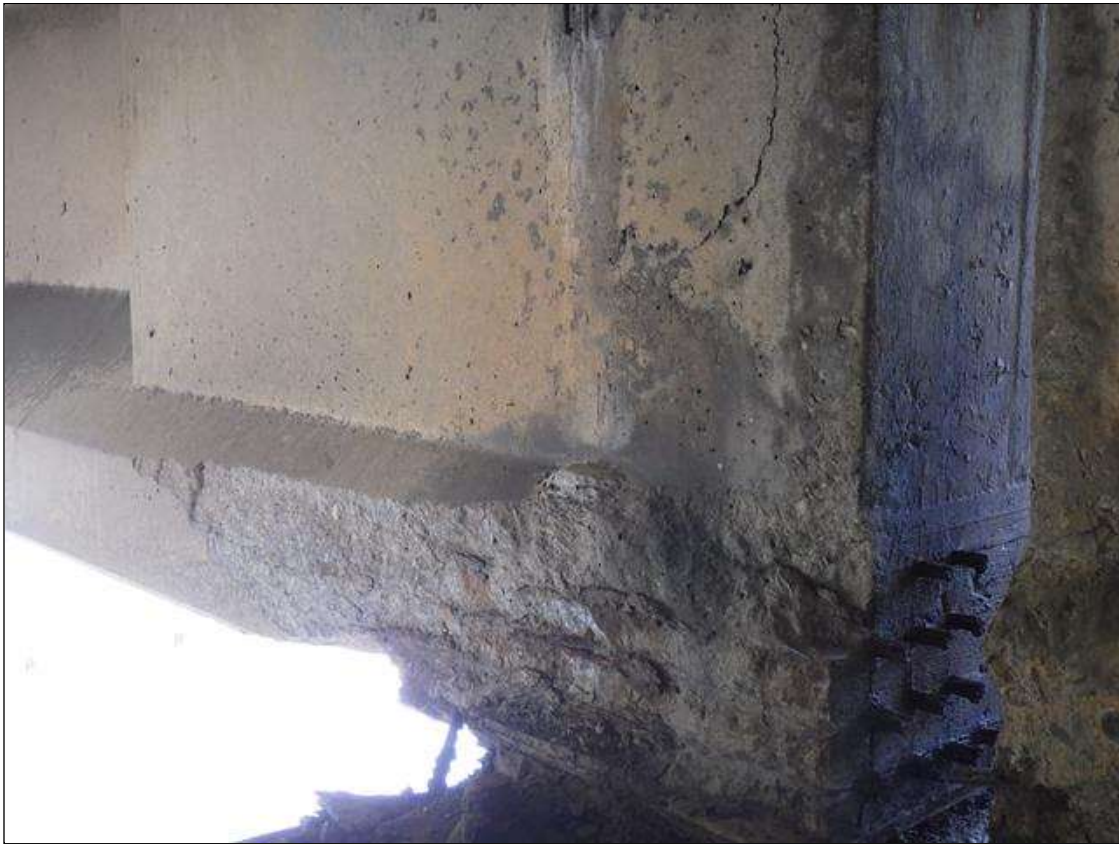
Span 2 Beam 5: 3 FEET 4 INCHES LONG X FULL HEIGHT X 4 INCHES WIDE SPALLED AND DELAMINATED AREA WITH (2) EXPOSED PRESTRESSING STRANDS IN THE LEFT BOTTOM FLANGE AND WEB AT BENT 1 (PRIORITY ACTION REQUEST)

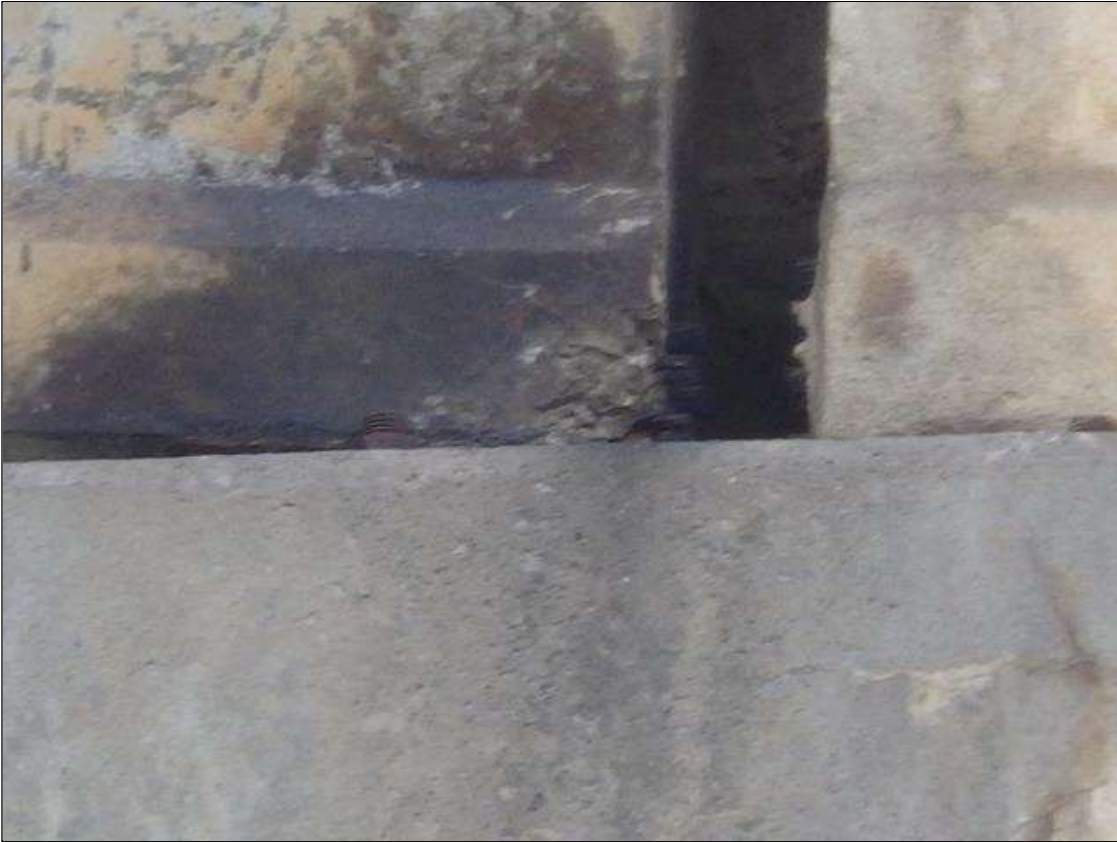
Span 1 Beam 4: 9 INCHES LONG X 5 INCHES HIGH X 3 INCHES WIDE SPALLED AREA WITH (1) EXPOSED PRESTRESSING STRAND IN THE RIGHT BOTTOM FLANGE AT BENT 1 (PRIORITY ACTION REQUEST)

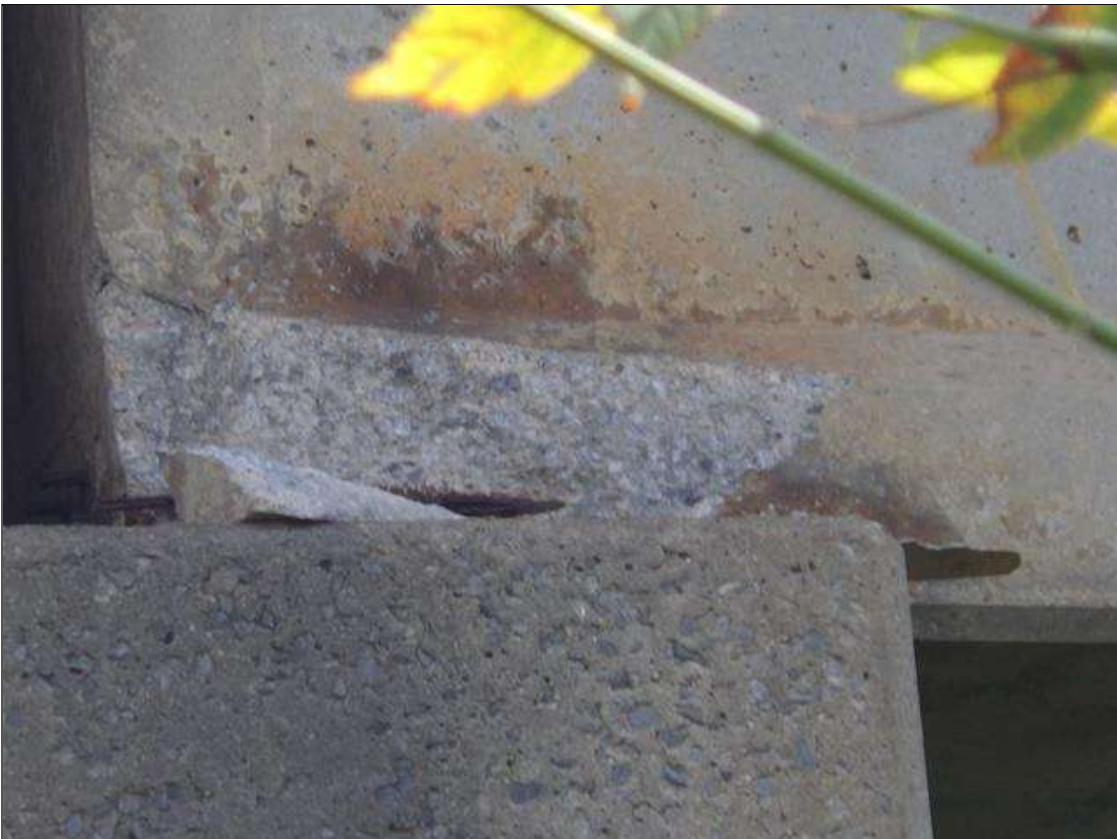
Span 1 Beam 1: 1 FOOT 8 INCHES LONG X 10 INCHES HIGH X 4 INCHES WIDE SPALLED AREA WITH (1) EXPOSED PRESTRESSING STRAND IN THE LEFT BOTTOM FLANGE AT BENT 1 (PRIORITY ACTION REQUEST)

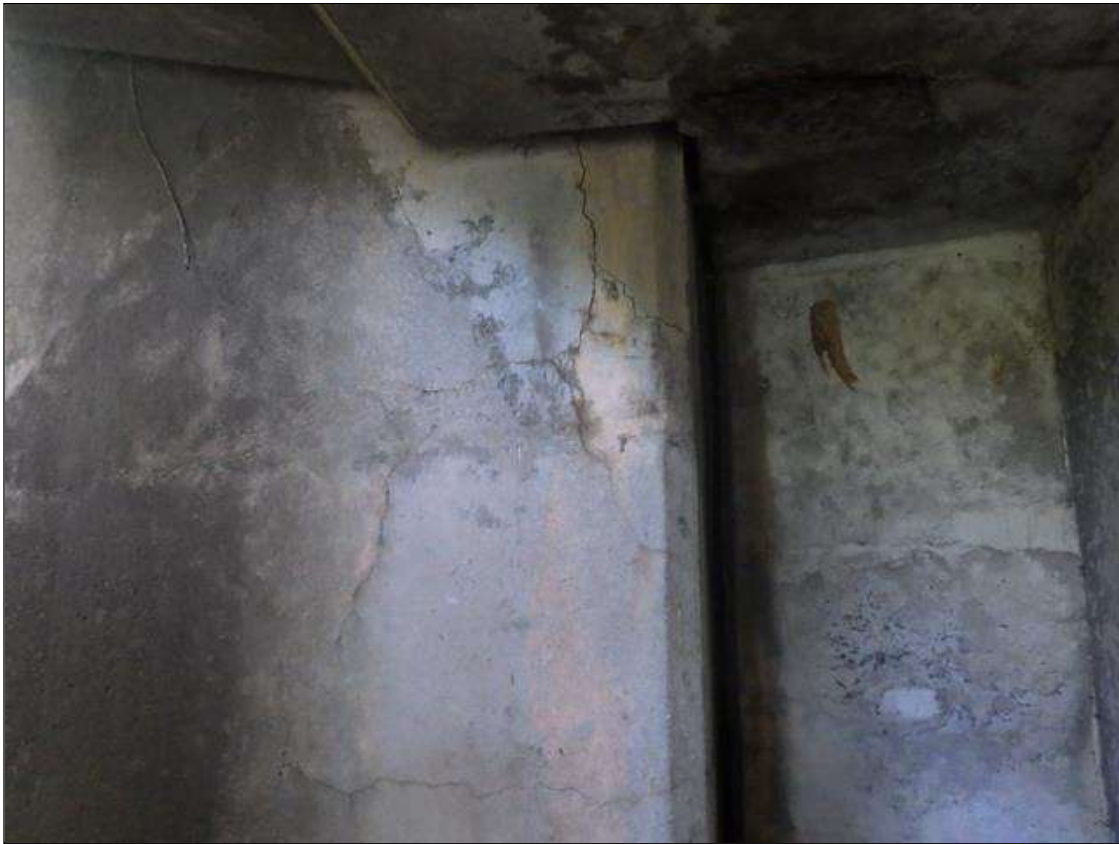
INTERMITTENT FULL HEIGHT X 5 INCHES LONG X 1 FOOT WIDE DELAMINATED AREA IN THE NORTHEAST WING WALL BELOW THE SOUTH OVERHANG

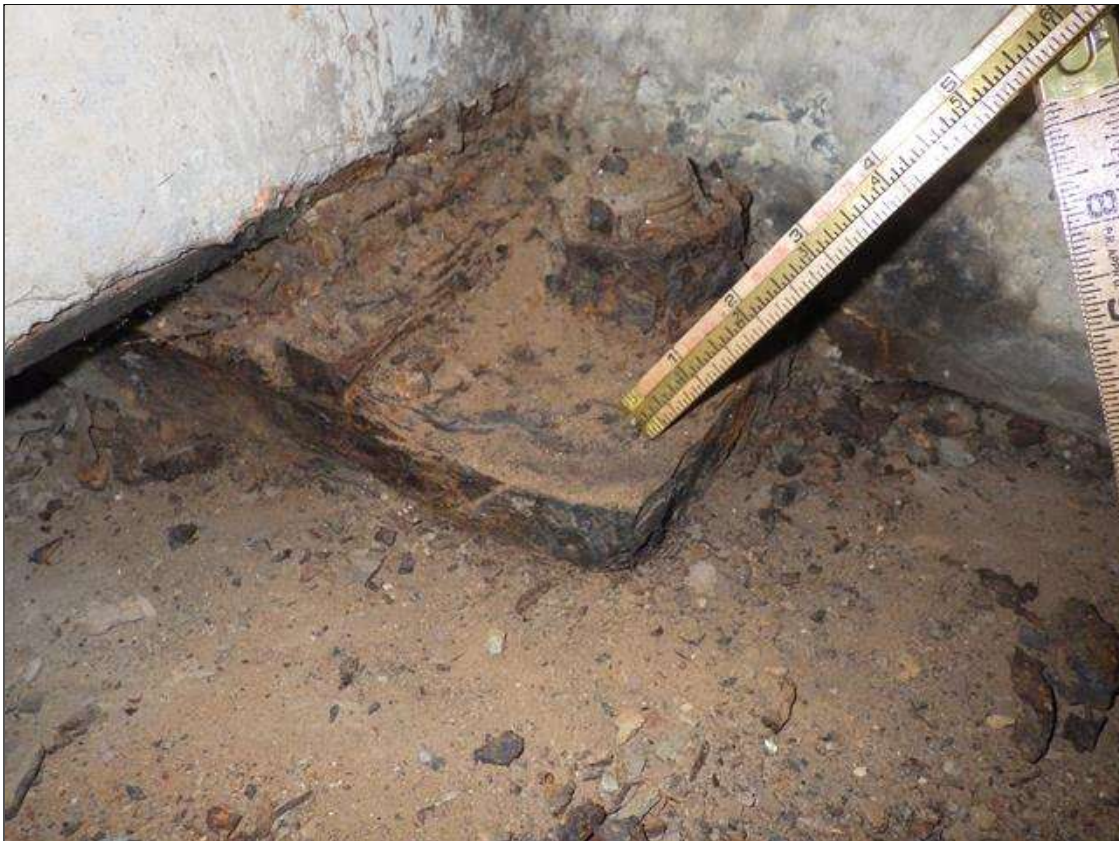
Span 4 Far Bearing: ACTIVE CORROSION THROUGHOUT THE GIRDER 1 BEARING WITH 1/16 INCH SECTION LOSS (LESS THAN 25 PERCENT SECTION LOSS)

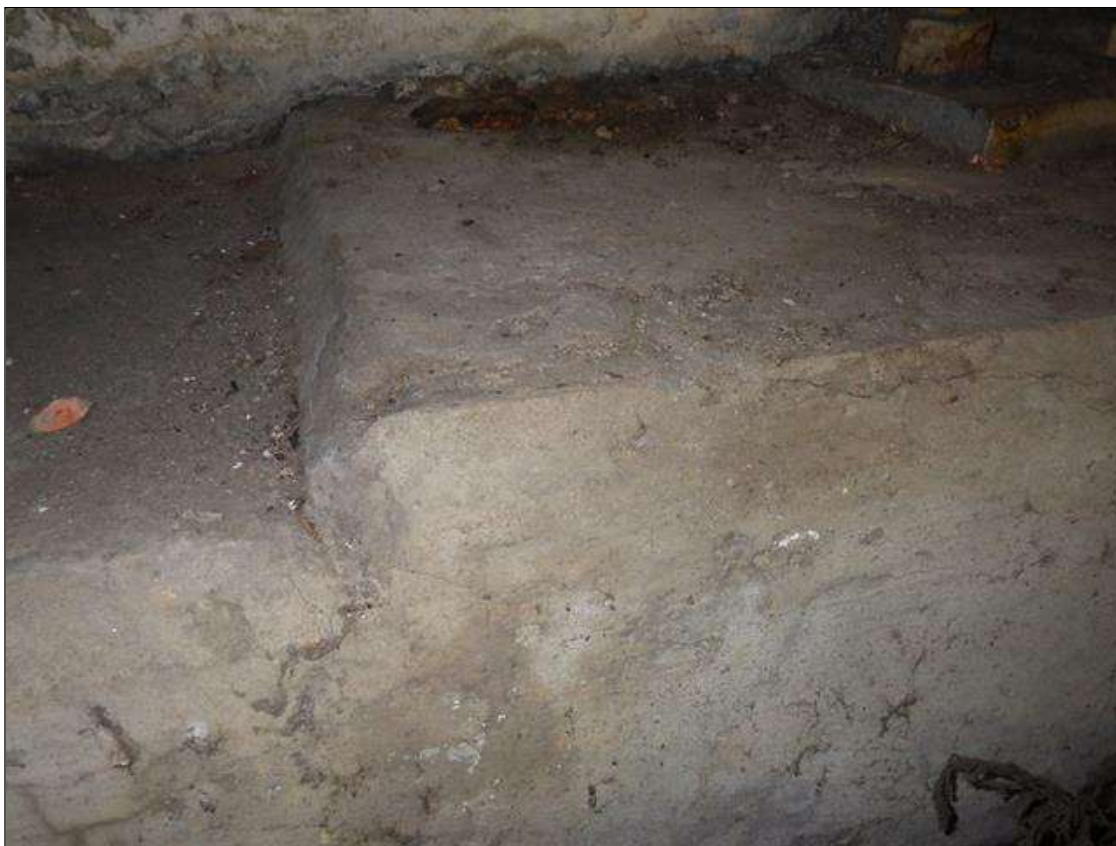
End Bent 2 Cap 1: (2) 7 FEET LONG X 1/16 INCH WIDE LONGITUDINAL CRACKS IN THE CAP BELOW BAY 1

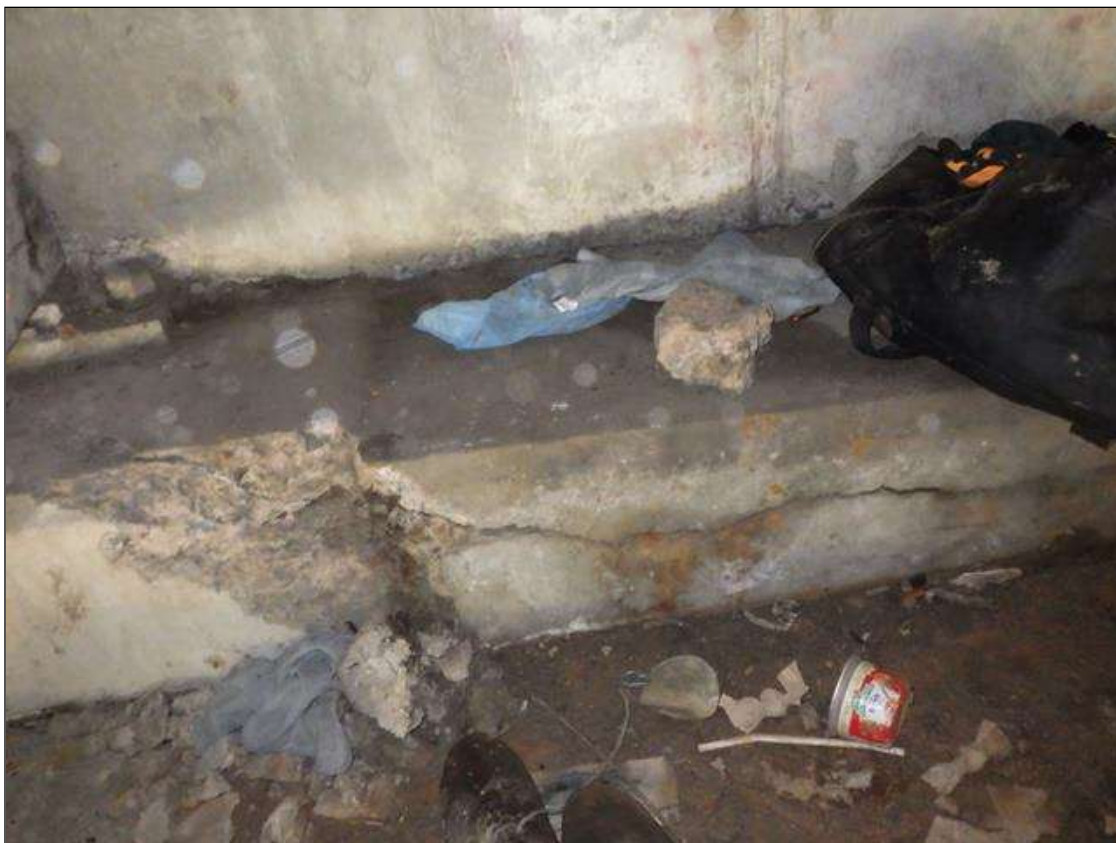
End Bent 2 Cap 1: 5 FEET 9 INCHES LONG X 1 FOOT HIGH X 1 FOOT WIDE SPALLED AND DELAMINATED AREA WITH EXPOSED REINFORCEMENT IN THE CAP BELOW BAY 3

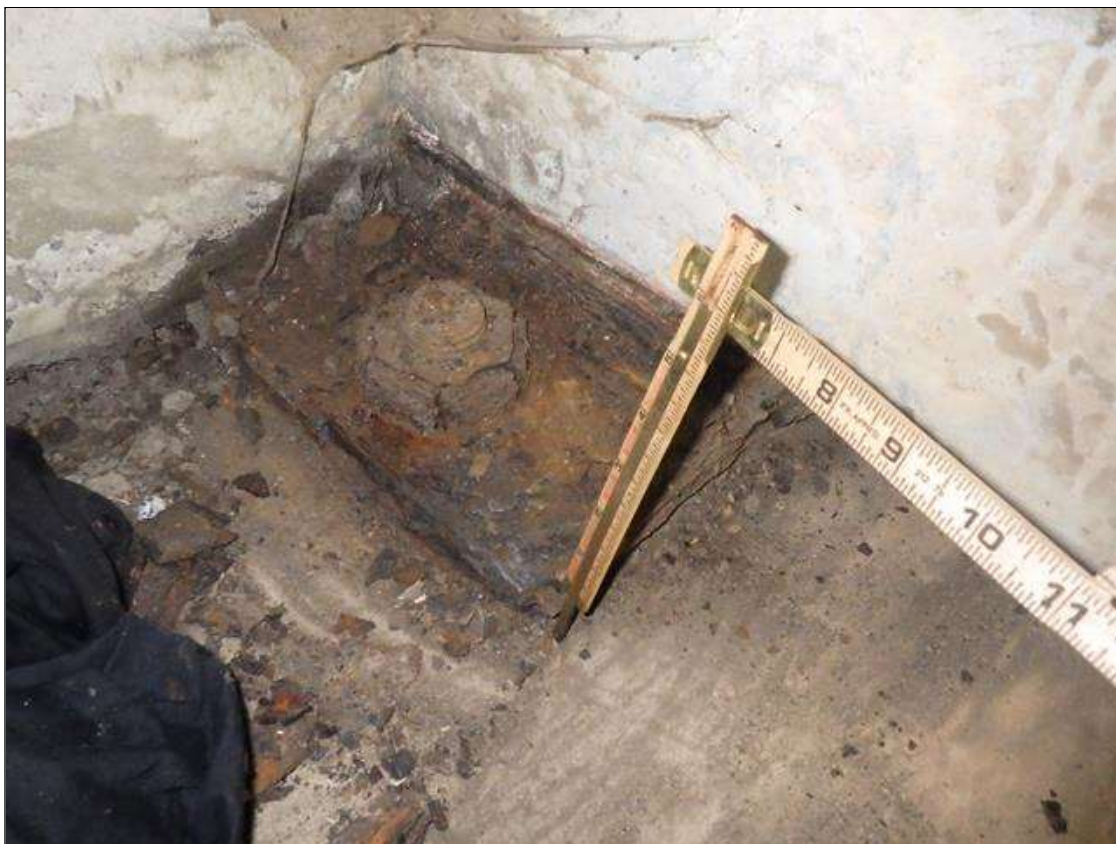
Span 4 Far Bearing: ACTIVE CORROSION THROUGHOUT THE GIRDER 4 BEARING WITH 1/16 INCH SECTION LOSS (LESS THAN 25 PERCENT SECTION LOSS)

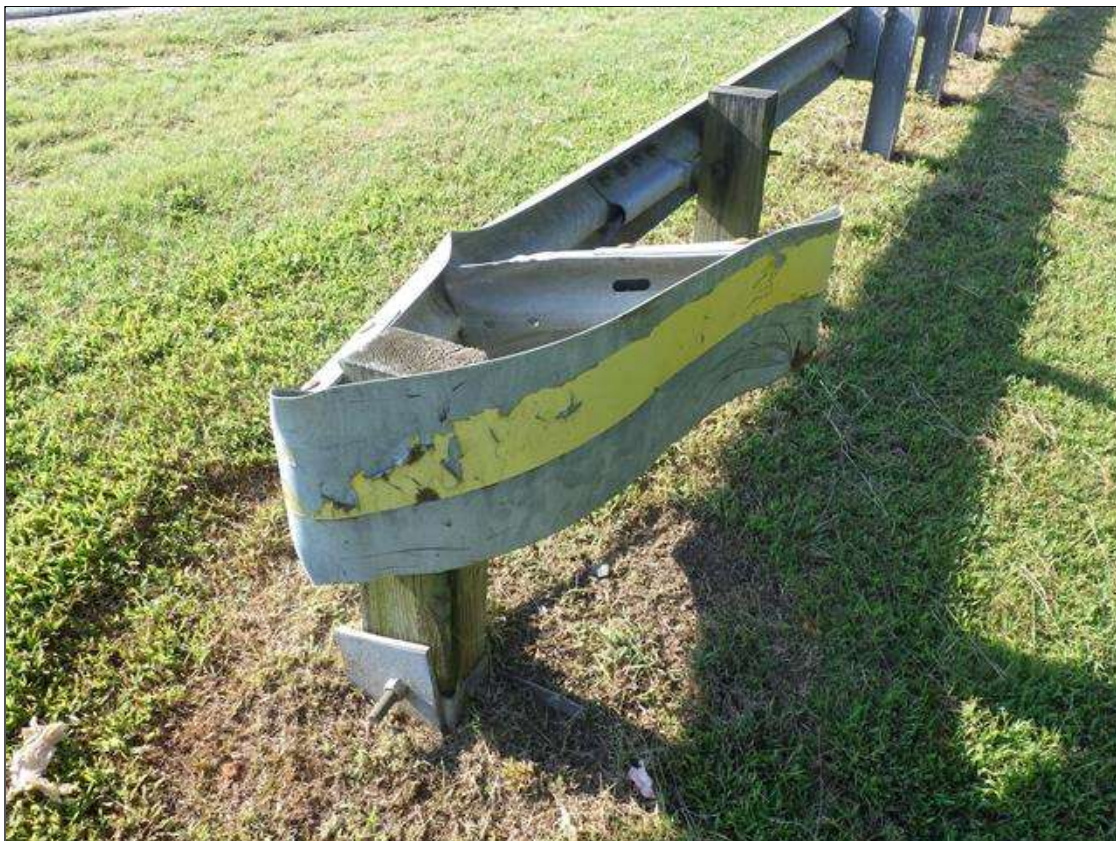
2 FEET LONG IMPACT DAMAGE TO THE NORTHEAST GUARDRAIL END TREATMENT

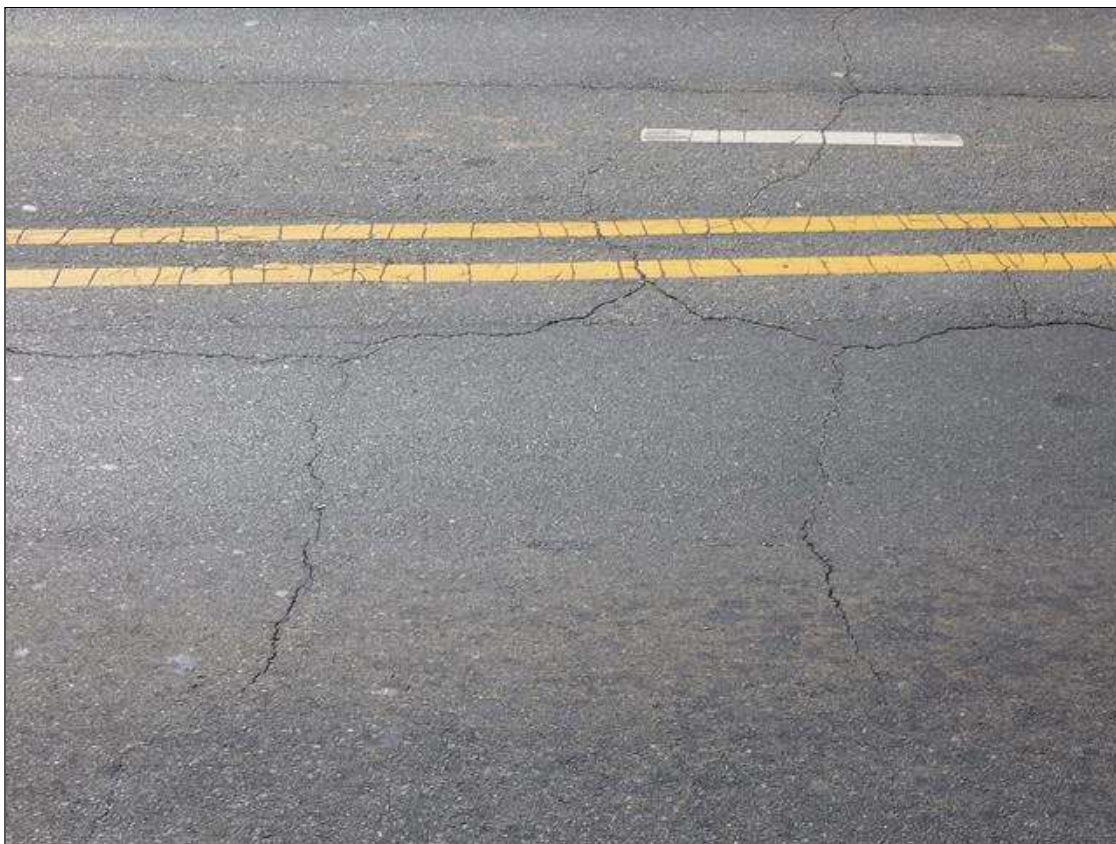
GREATER THAN 50 FEET LONG X INTERMITTENT FULL WIDTH MAP CRACKING UP TO 1/4 INCH WIDE IN THE EAST APPROACH ASPHALT WEARING SURFACE AT END BENT 2 (WEST APPROACH SIMILAR)

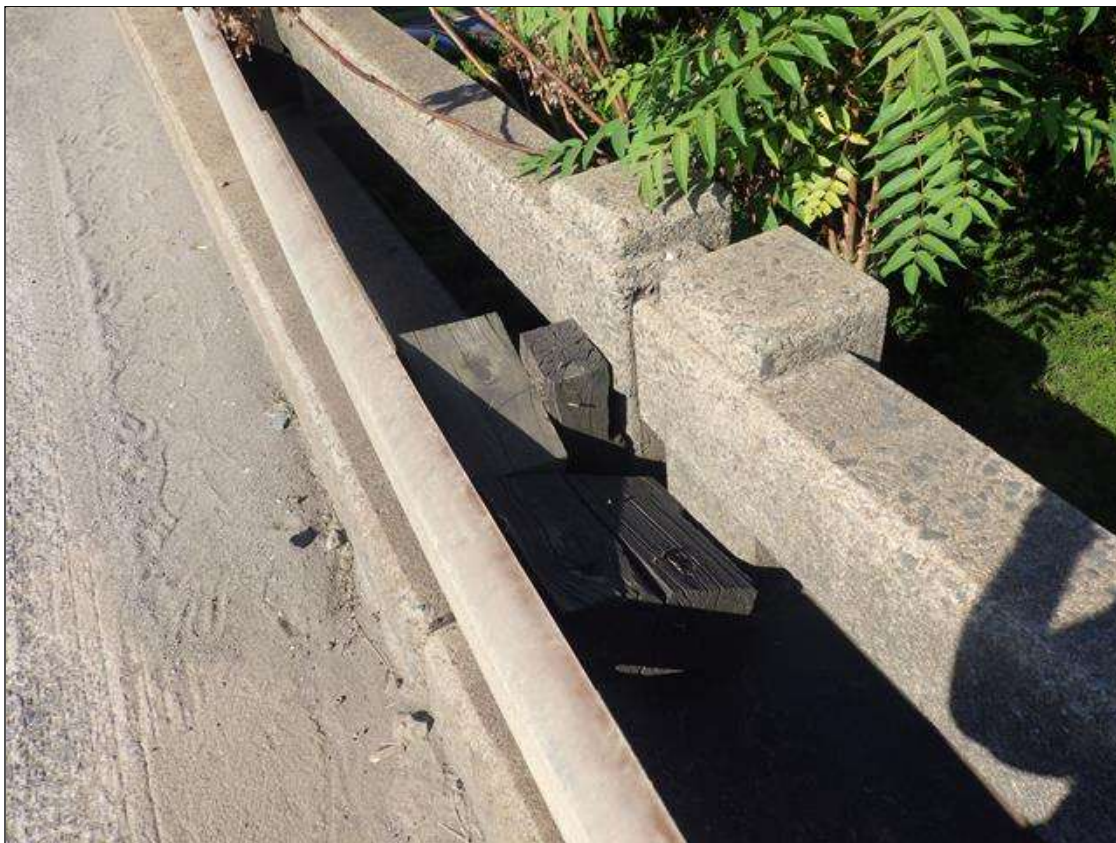
IMPACT DAMAGE TO THE NORTHEAST GUARDRAIL SPACER BLOCKS, 8 FEET FROM END BENT 2

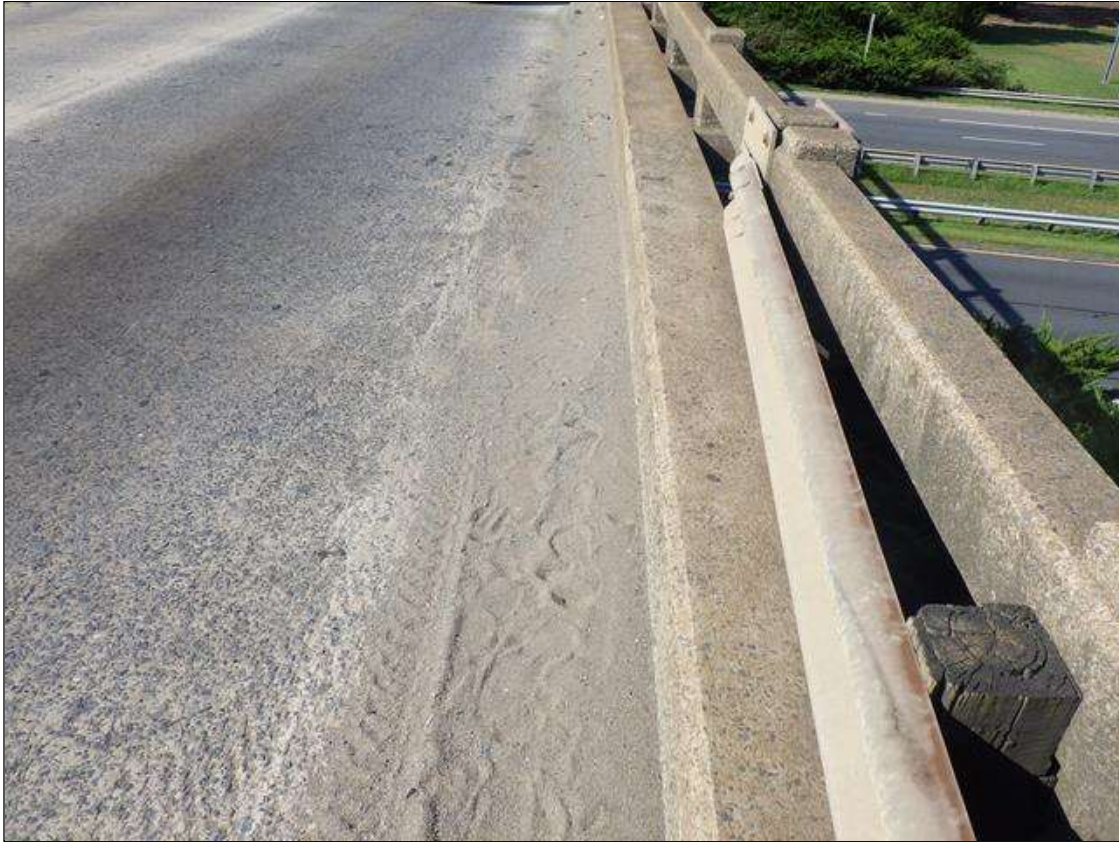
FULL LENGTH X UP TO 2 FEET WIDE DEBRIS BUILD-UP ALONG THE NORTH AND SOUTH BRIDGE RAILS

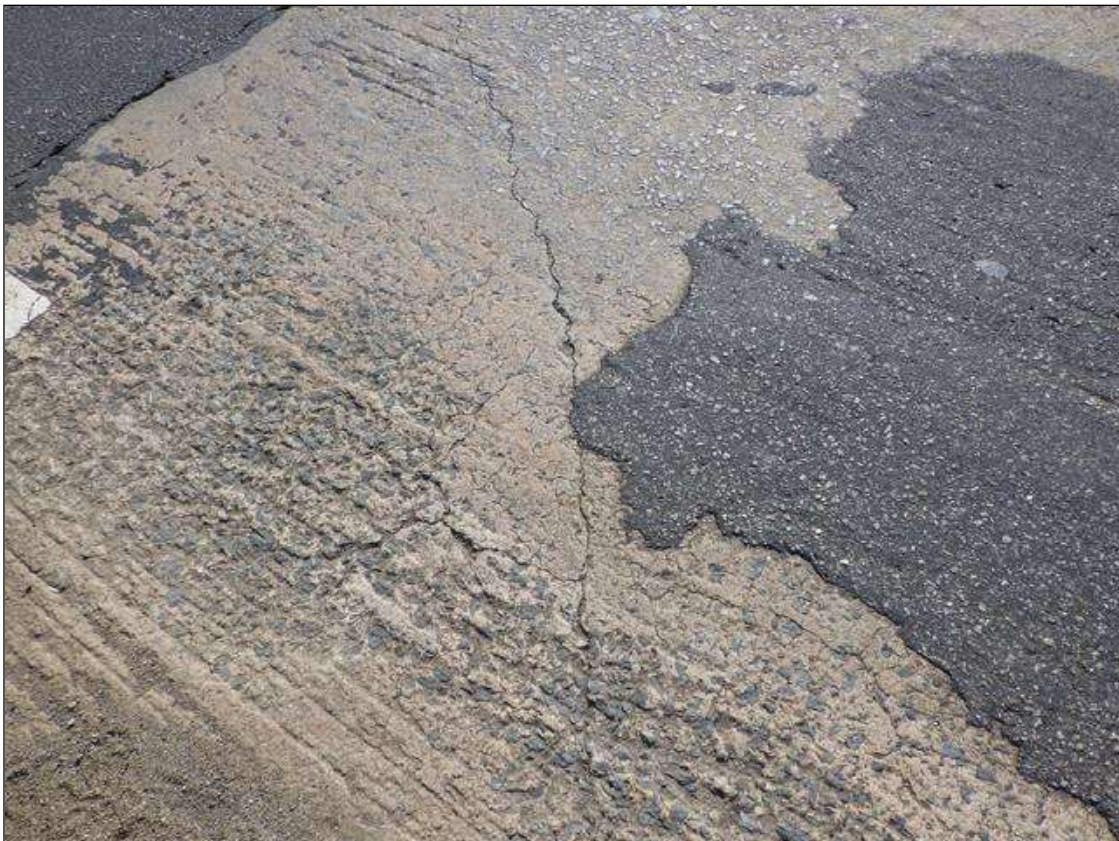
Span 4 Deck: 6 FEET 6 INCHES LONG X UP TO 1/8 INCH WIDE DIAGONAL CRACK IN THE WESTBOUND LANE AT END BENT 2

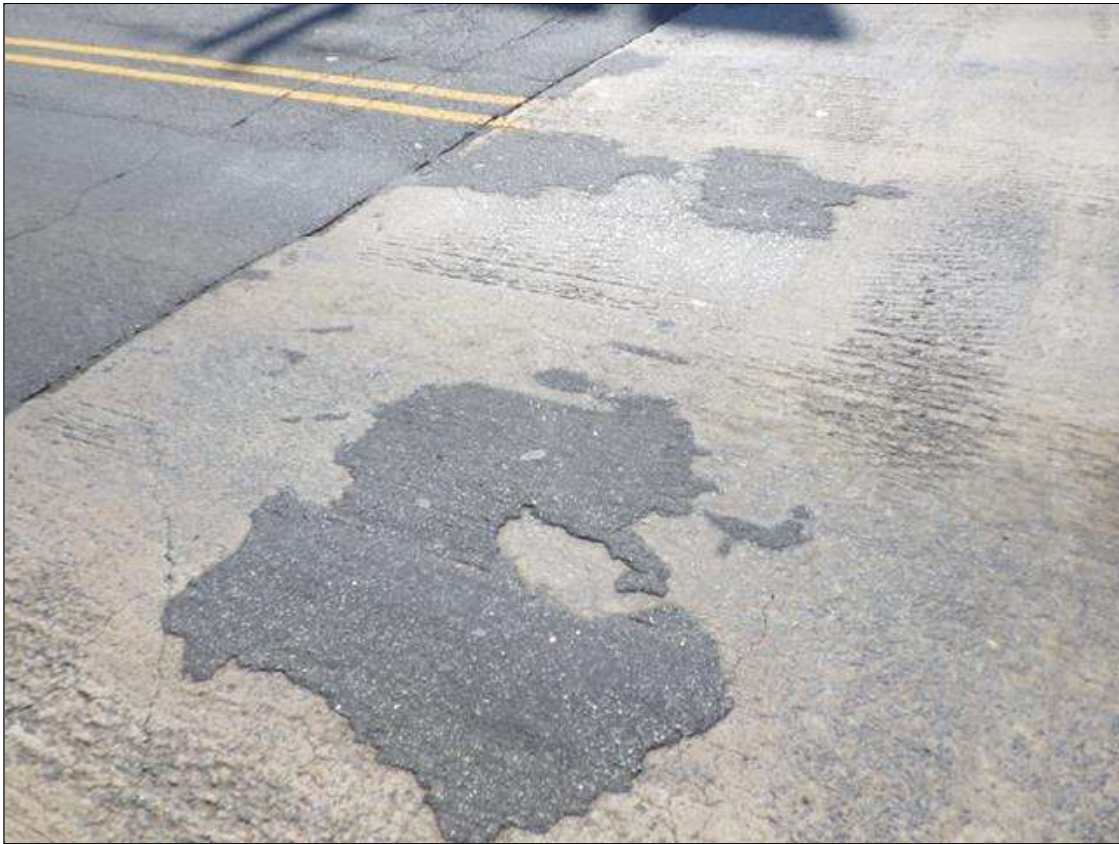
Span 4 Deck: (3) PATCHED AREAS UP TO 4 FEET 3 INCHES LONG X 4 FEET 8 INCHES WIDE IN THE WESTBOUND LANE AT END BENT 2

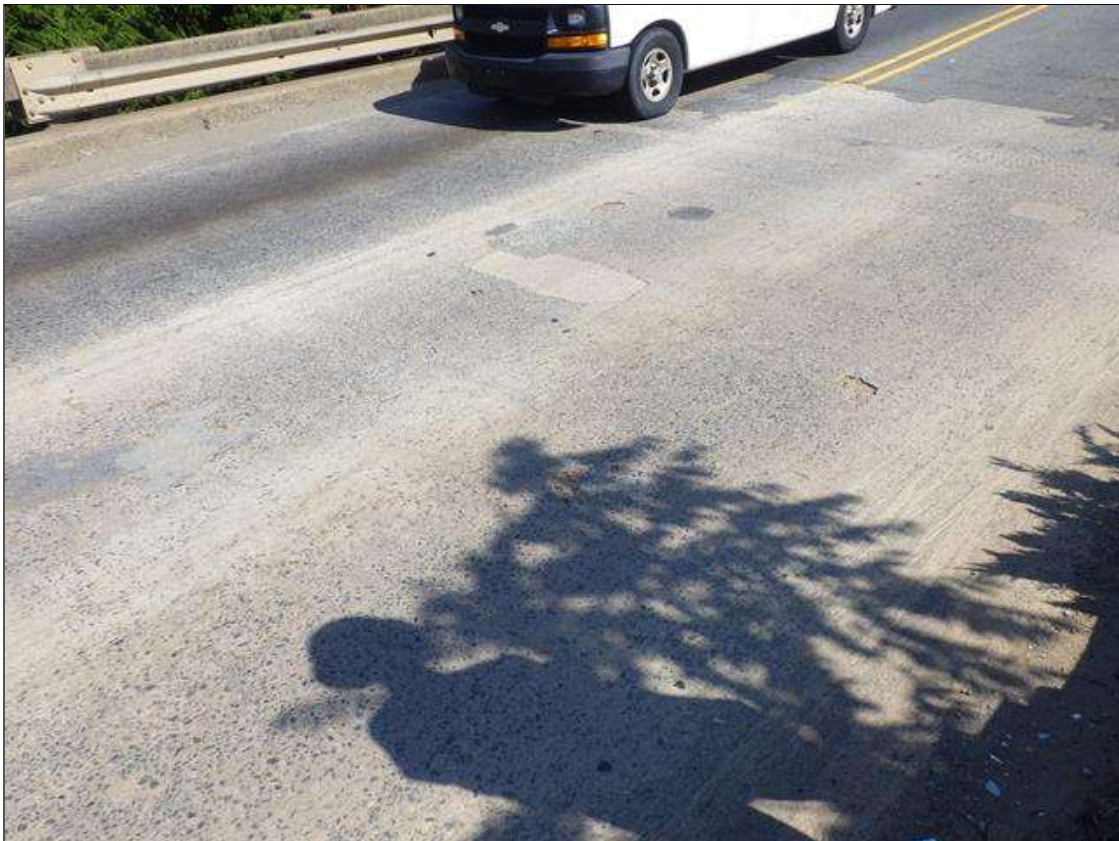
Span 4 Deck: (8) SPALLED AND DELAMINATED PATCHED AREAS UP TO 2 FEET 6 INCHES LONG X 2 FEET 6 INCHES WIDE X 1 INCH DEEP IN THE EASTBOUND LANE

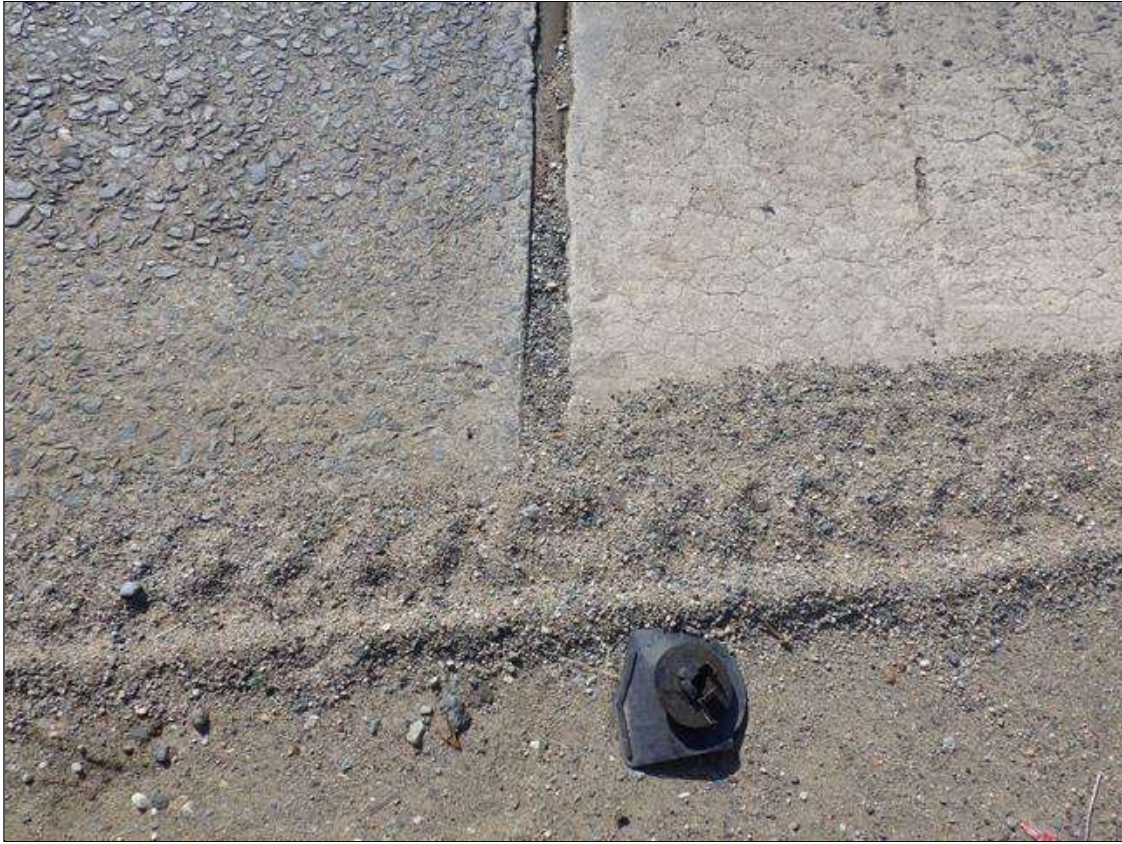
Span 4 Expansion Joint 3: FULL LENGTH LOOSE DEBRIS ACCUMULATION ALONG THE JOINT (OTHER JOINTS SIMILAR)

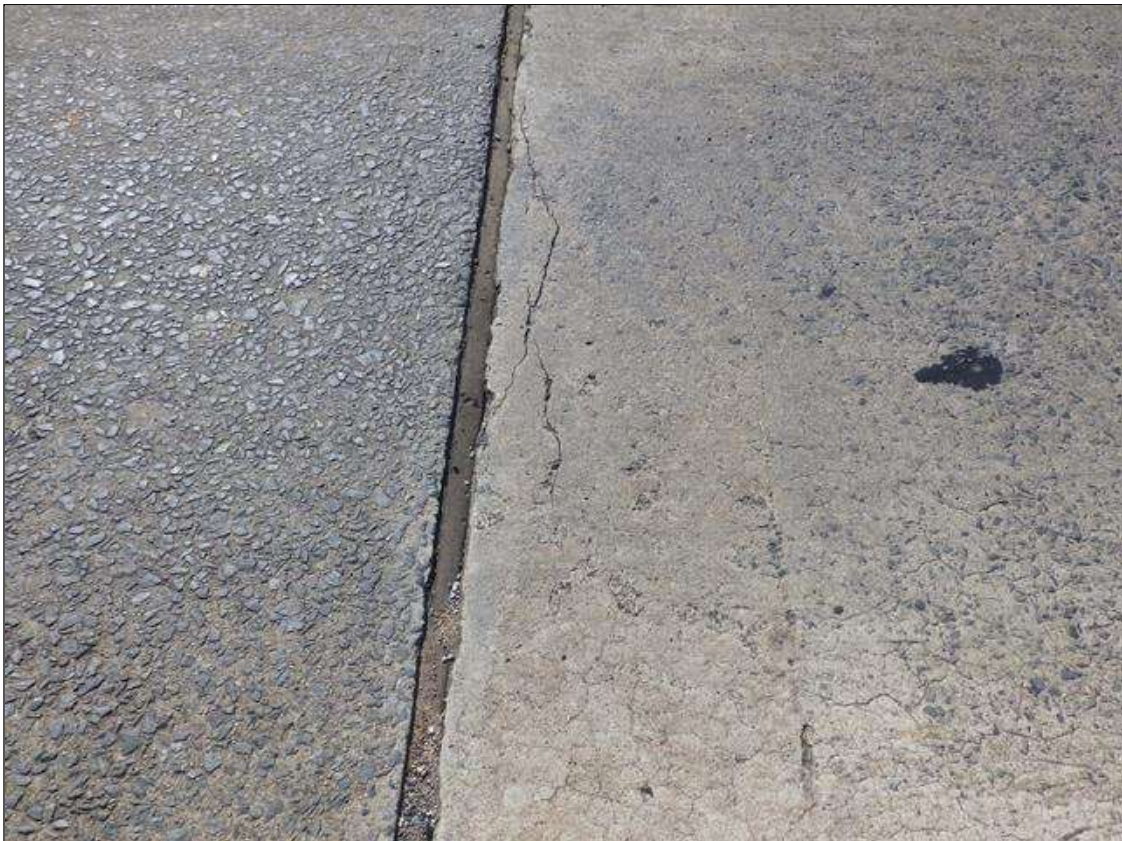
Span 3 Deck: INTERMITTENT 9 FEET WIDE X 6 INCHES LONG DELAMINATED AREA IN THE WESTBOUND LANE AT BENT 3

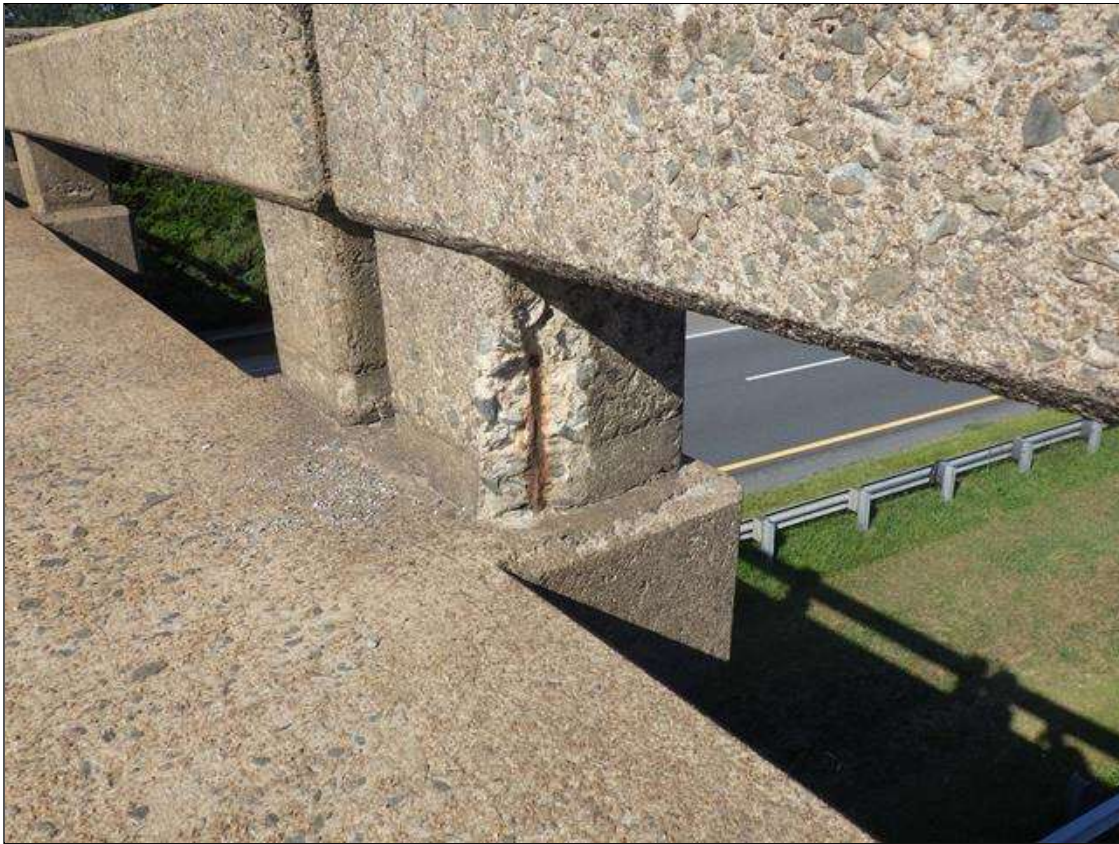
Span 3 Left Bridge Rail: (2) SPALLS UP TO 7 INCHES HIGH X 3 INCHES LONG X 1 INCH WIDE WITH EXPOSED REINFORCEMENT, (1) IN POST 1 AND (1) IN POST 4 (POST 4 SHOWN)

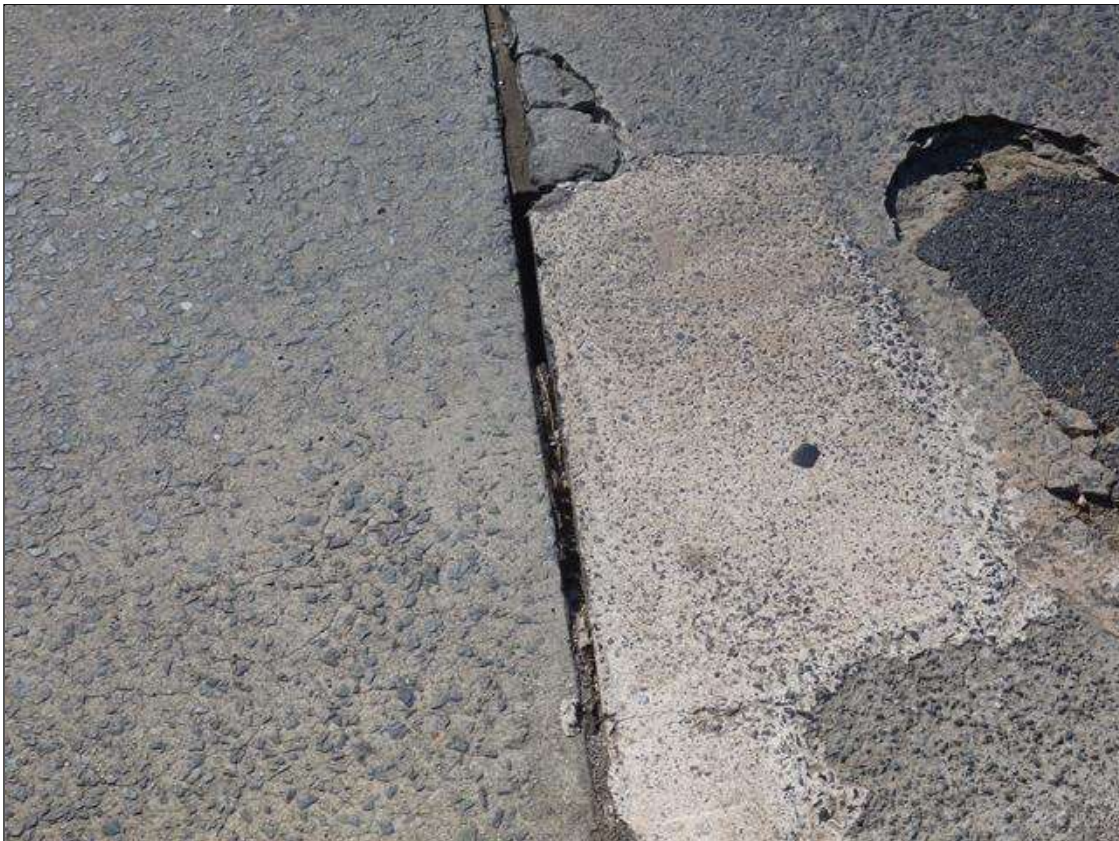
Span 3 Expansion Joint 2: 3 FEET LONG X FULL DEPTH MISSING JOINT MATERIAL IN THE WESTBOUND LANE
