NC DEPARTMENT OF TRANSPORTATION  
 DIVISION OF HIGHWAYS  
 STRUCTURE MANAGEMENT UNIT

ATTENTION: **PRIORITY ACTION REQUESTS; SIGN NOTICED  
 ISSUED FOR (2) MISSING DELINEATORS**

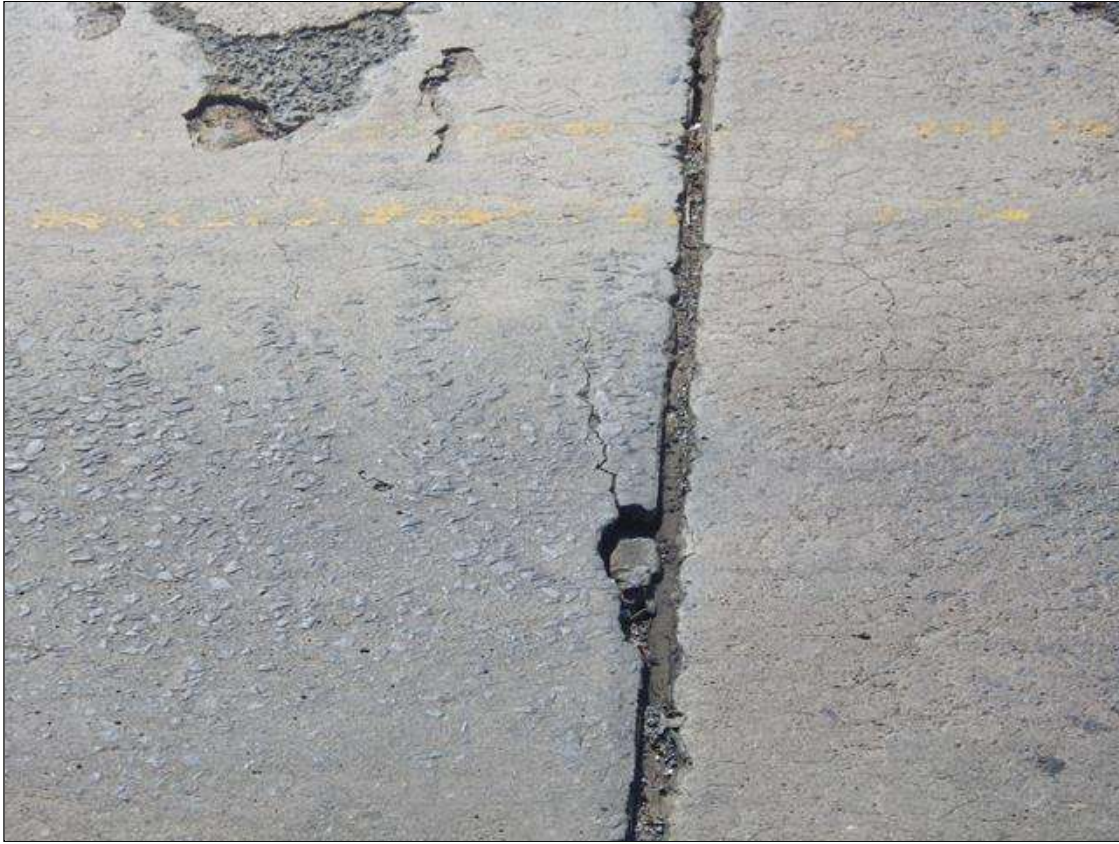
Span 3 Deck: 2 FEET 9 INCHES WIDE X 3 INCHES LONG X 1 1/2 INCHES DEEP SPALLED AND DELAMINATED AREA IN THE WESTBOUND LANE AT BENT 2

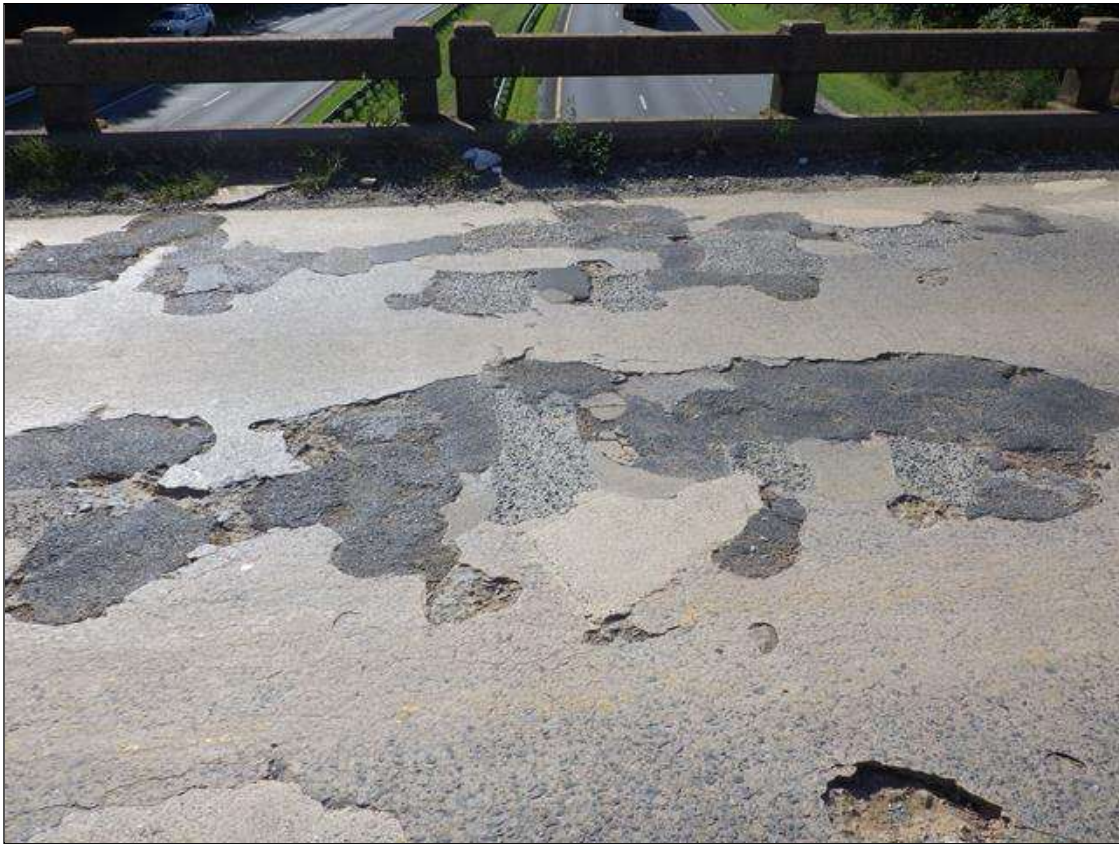
Span 2 Deck: INTERMITTENT FULL LENGTH X INTERMITTENT FULL WIDTH X UP TO 1 1/2 INCHES DEEP DELAMINATIONS, SPALLS, AND FAILED PATCHES THROUGHOUT THE DECK WITH 30 PERCENT OF DECK AREA AFFECTED

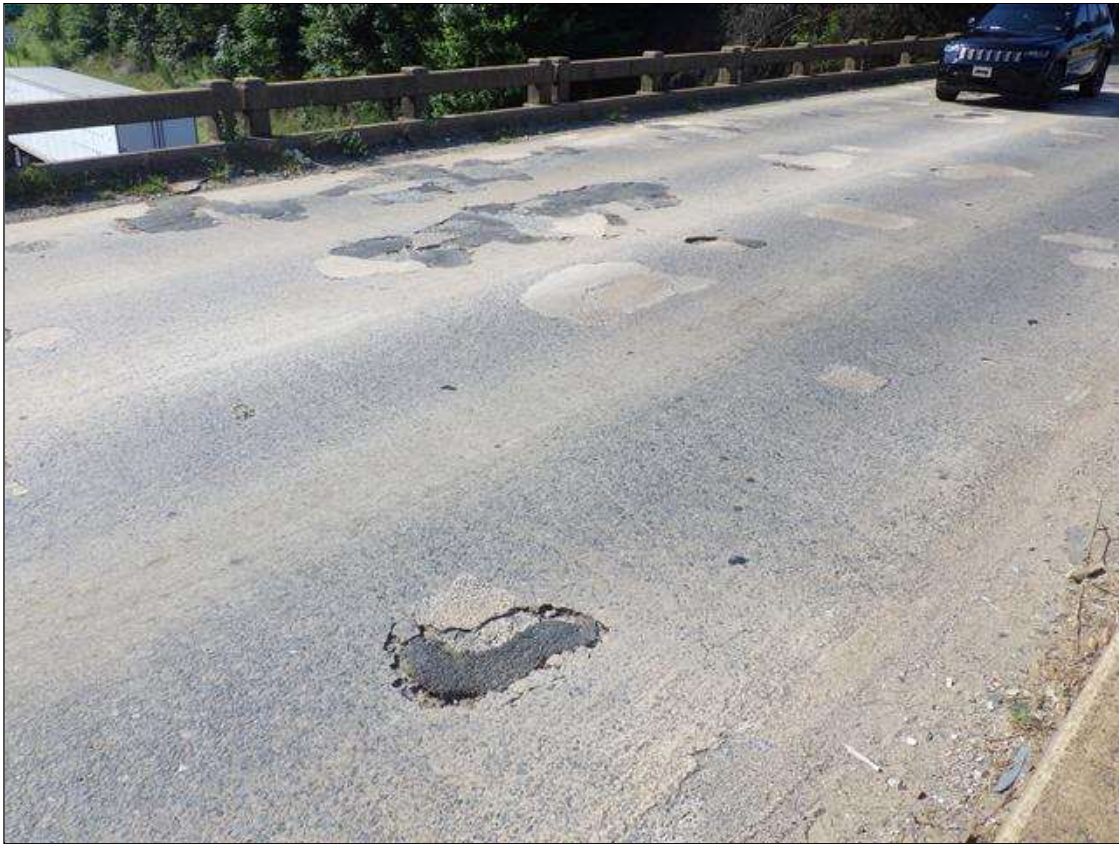
Span 2 Deck: INTERMITTENT FULL LENGTH X INTERMITTENT FULL WIDTH X UP TO 1 1/2 INCHES DEEP DELAMINATIONS, SPALLS, AND FAILED PATCHES THROUGHOUT THE DECK WITH 30 PERCENT OF DECK AREA AFFECTED

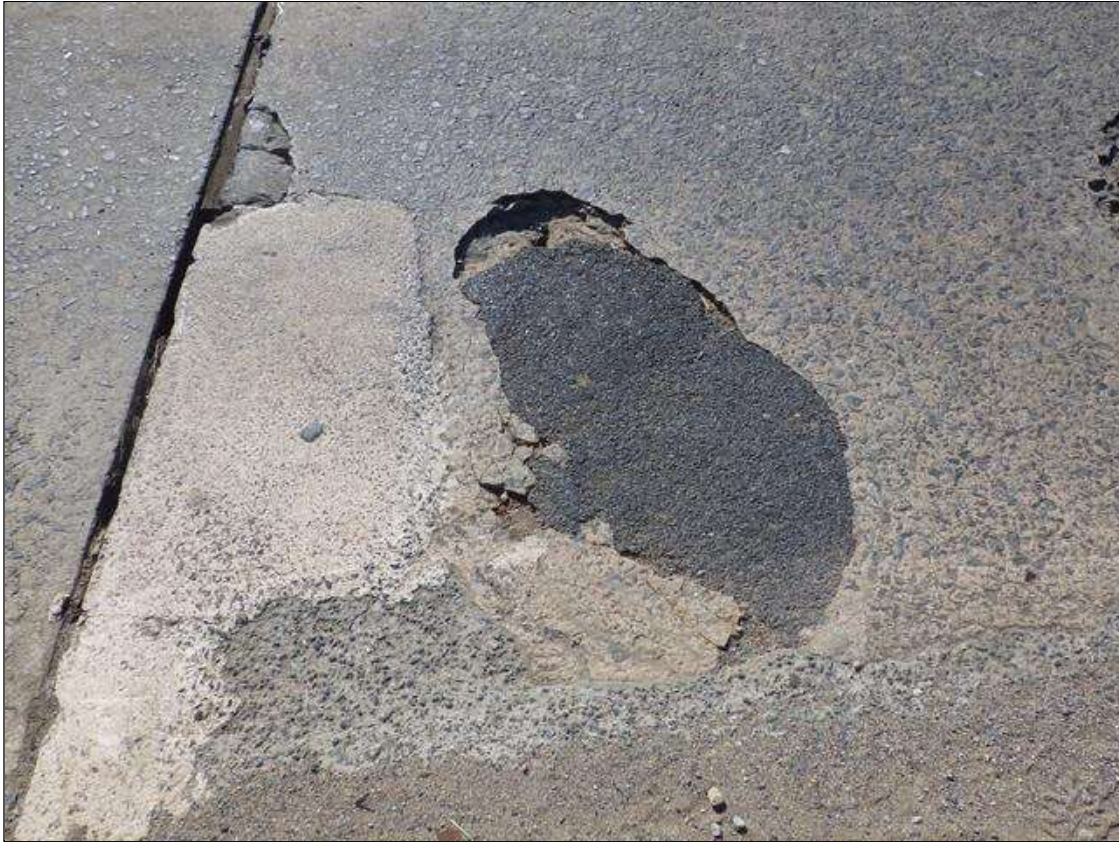
Span 2 Deck: INTERMITTENT FULL LENGTH X INTERMITTENT FULL WIDTH X UP TO 1 1/2 INCHES DEEP DELAMINATIONS, SPALLS, AND FAILED PATCHES THROUGHOUT THE DECK WITH 30 PERCENT OF DECK AREA AFFECTED

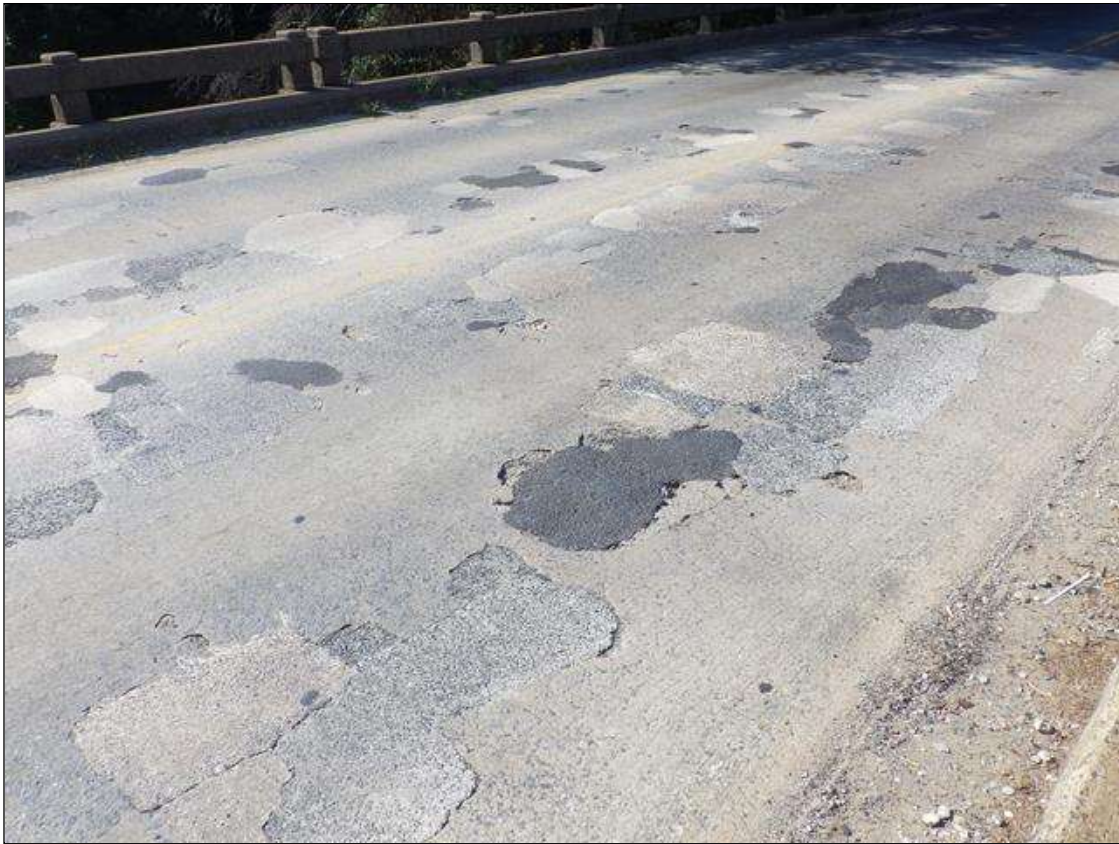
Span 1 Deck: INTERMITTENT FULL LENGTH X INTERMITTENT FULL WIDTH X UP TO 1 1/2 INCHES DEEP DELAMINATIONS, SPALLS, AND FAILED PATCHES THROUGHOUT THE DECK WITH 30 PERCENT OF DECK AREA AFFECTED

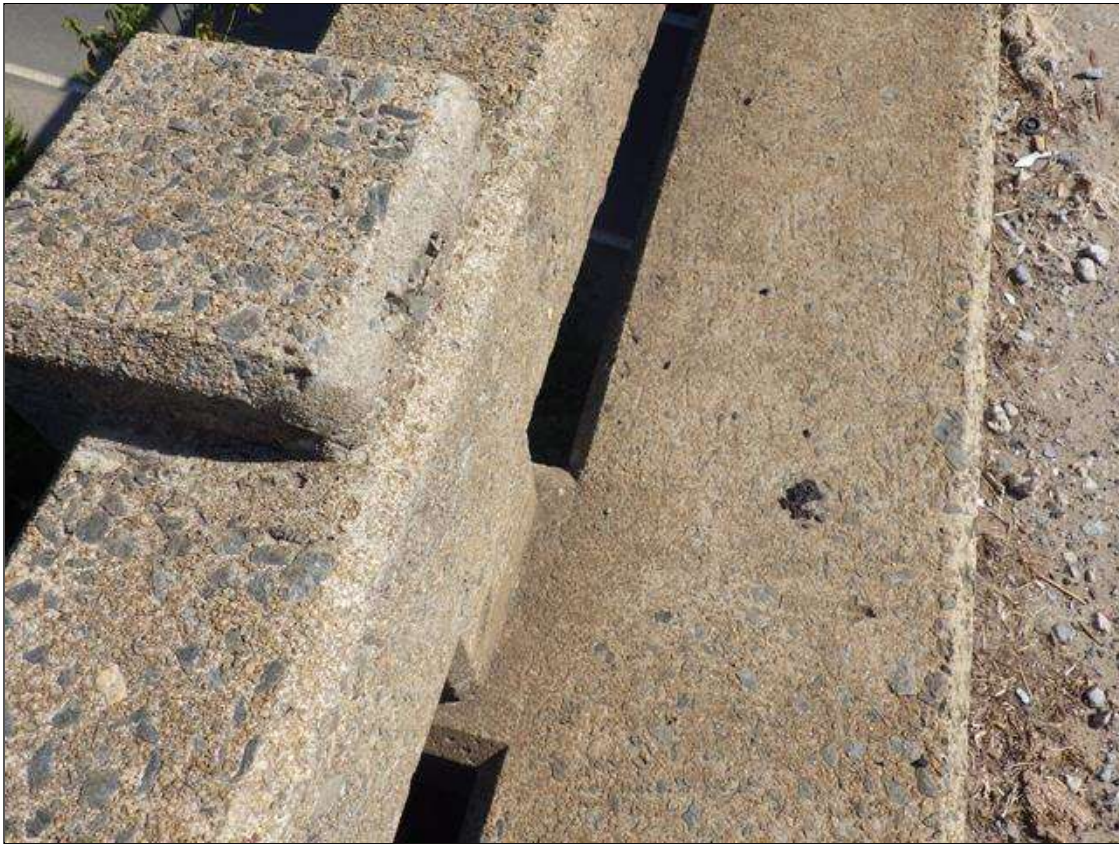
Span 1 Left Bridge Rail: EXPOSED SURFACE COARSE AGGREGATE THROUGHOUT THE RAIL AND CURB (OTHERS SIMILAR)

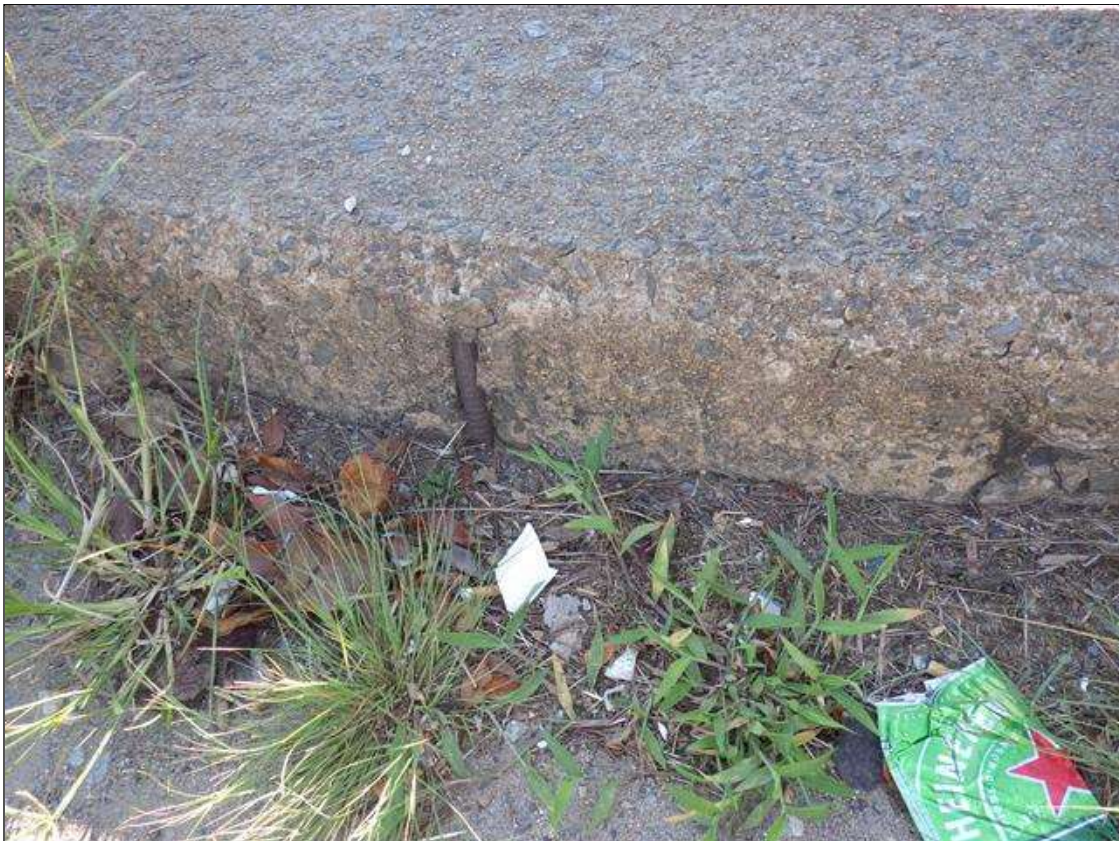
Span 1 Right Bridge Rail: (4) SPALLED AREAS UP TO 6 INCHES HIGH X 2 INCHES LONG X 1/2 INCH DEEP WITH EXPOSED REINFORCEMENT IN THE CURB

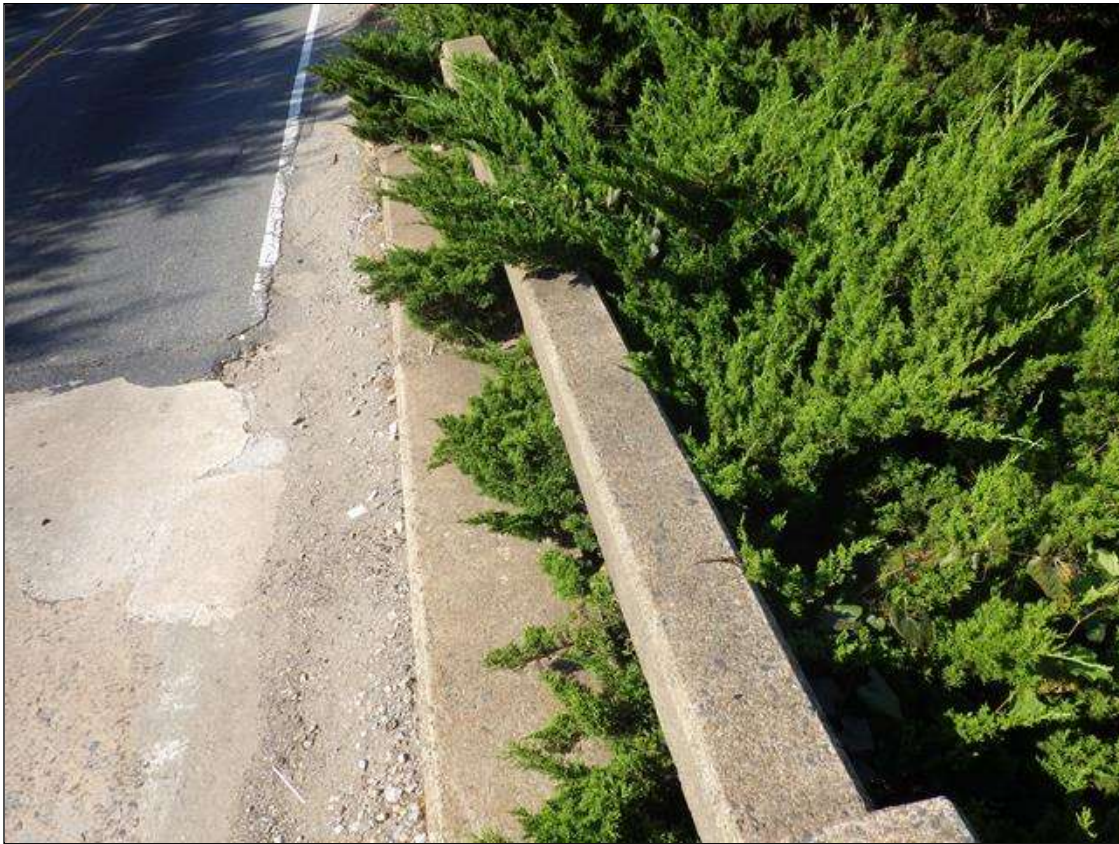
25 FEET LONG X 3 FEET HIGH X 2 FEET WIDE VEGETATION GROWTH THROUGH THE NORTH BRIDGE RAIL AT END BENT 1

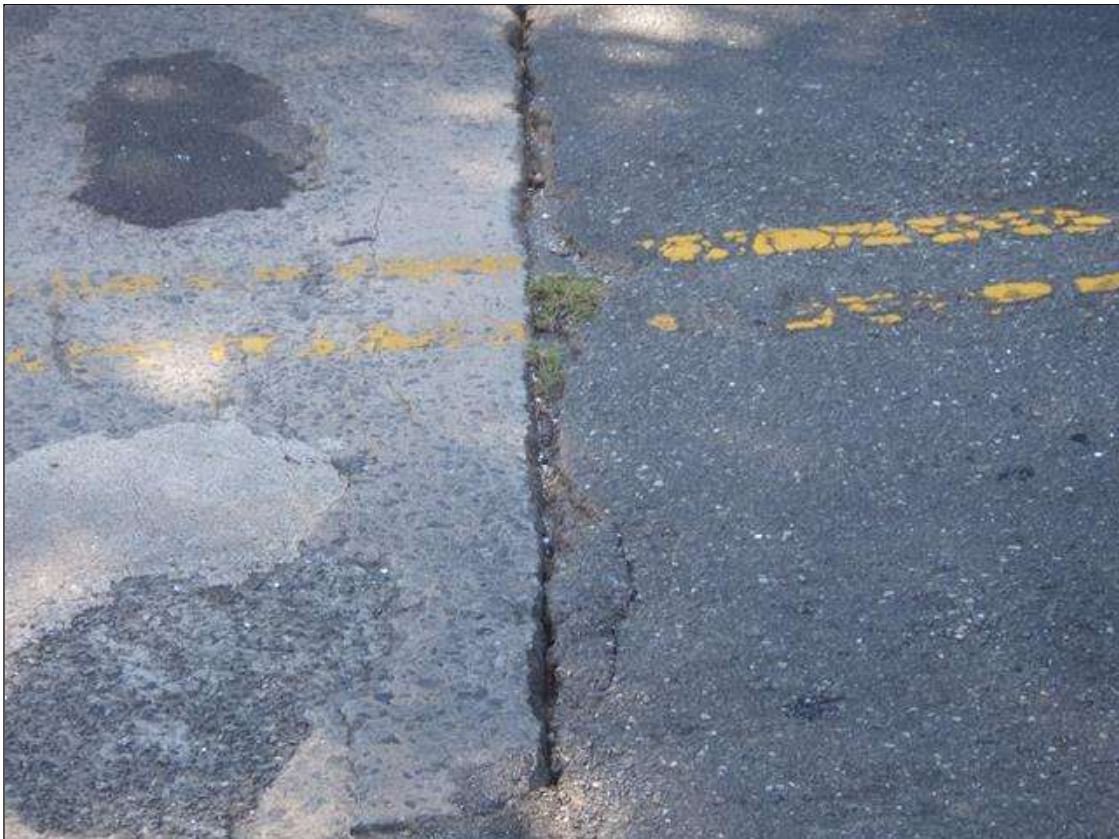
5 INCHES LONG X 15 FEET WIDE X 2 INCHES DEEP SPALLED AND DELAMINATED AREA IN THE WEST APPROACH ASPHALT WEARING SURFACE AT END BENT 1

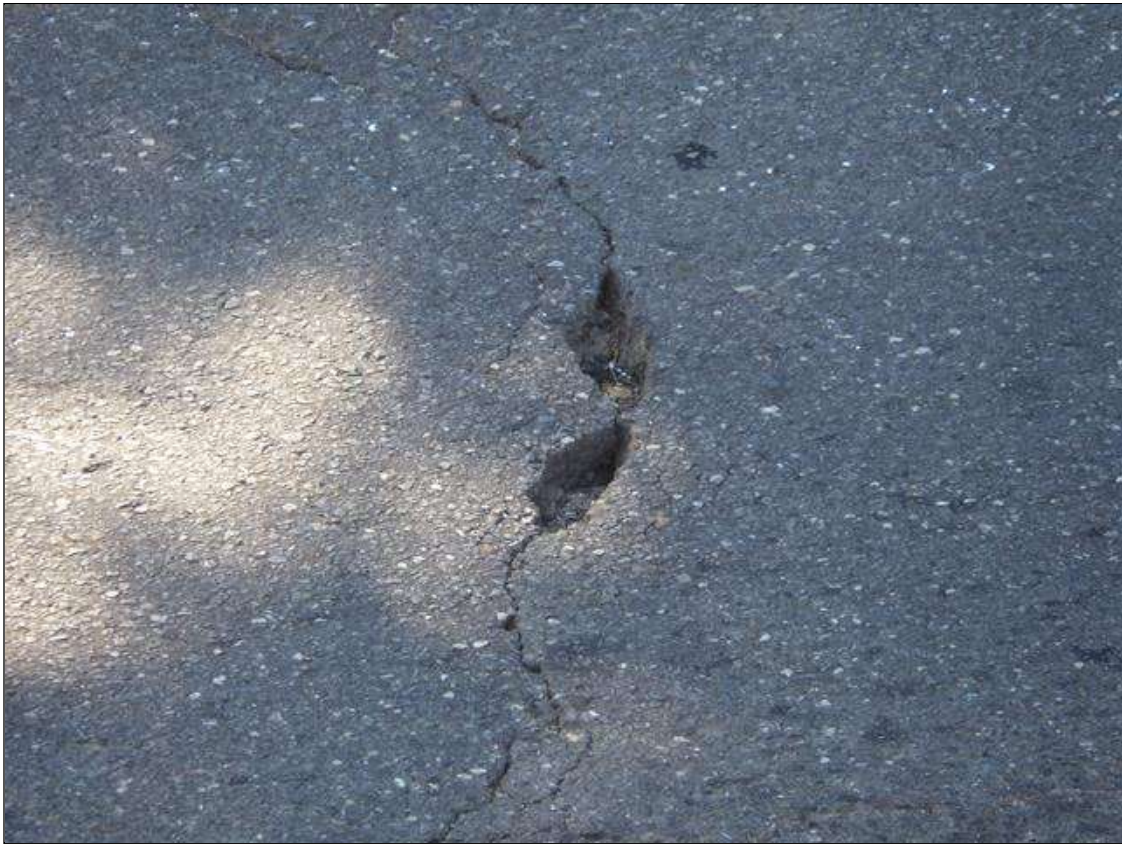
1 FOOT 4 INCHES WIDE X 3 INCHES LONG X 2 INCHES DEEP SPALLED AREA IN THE WEST APPROACH ASPHALT WEARING SURFACE, 8 FEET FROM END BENT 1

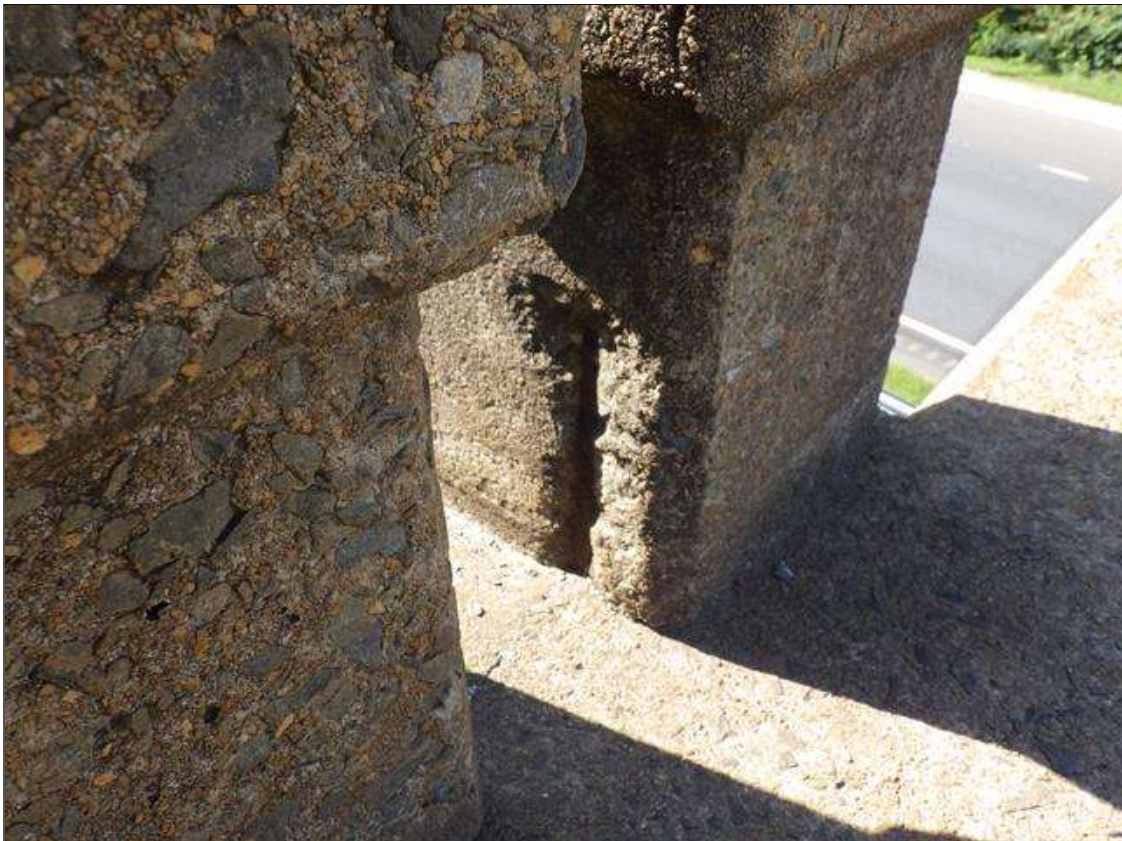
Span 3 Right Bridge Rail: (2) SPALLS UP TO 8 INCHES HIGH X 1 INCH WIDE X 1/2 INCH DEEP WITH EXPOSED REINFORCEMENT, (1) IN POST 3 AND (1) IN POST 4

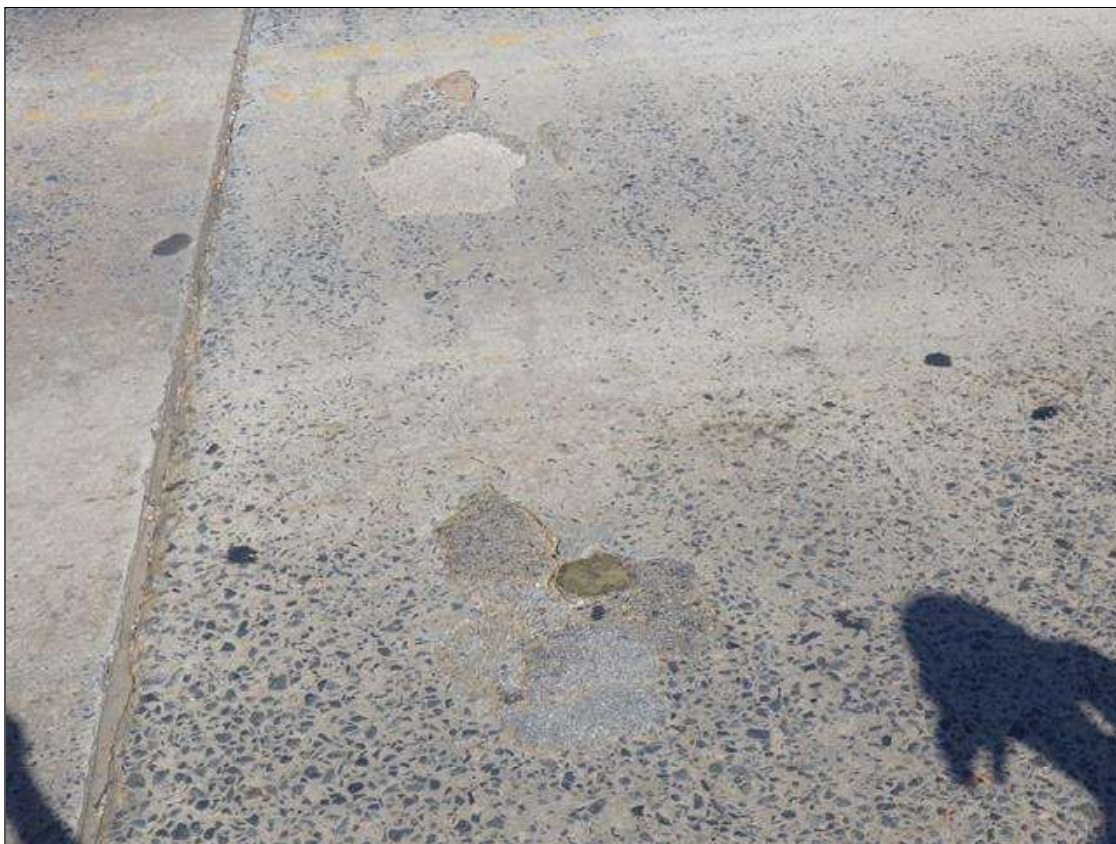
Span 3 Deck: 1 FOOT 4 INCHES LONG X 2 FEET 2 INCHES WIDE X 1 INCH DEEP SPALLED AND DELAMINATED PATCHED AREA IN THE EASTBOUND LANE, 2 FEET FROM BENT 2

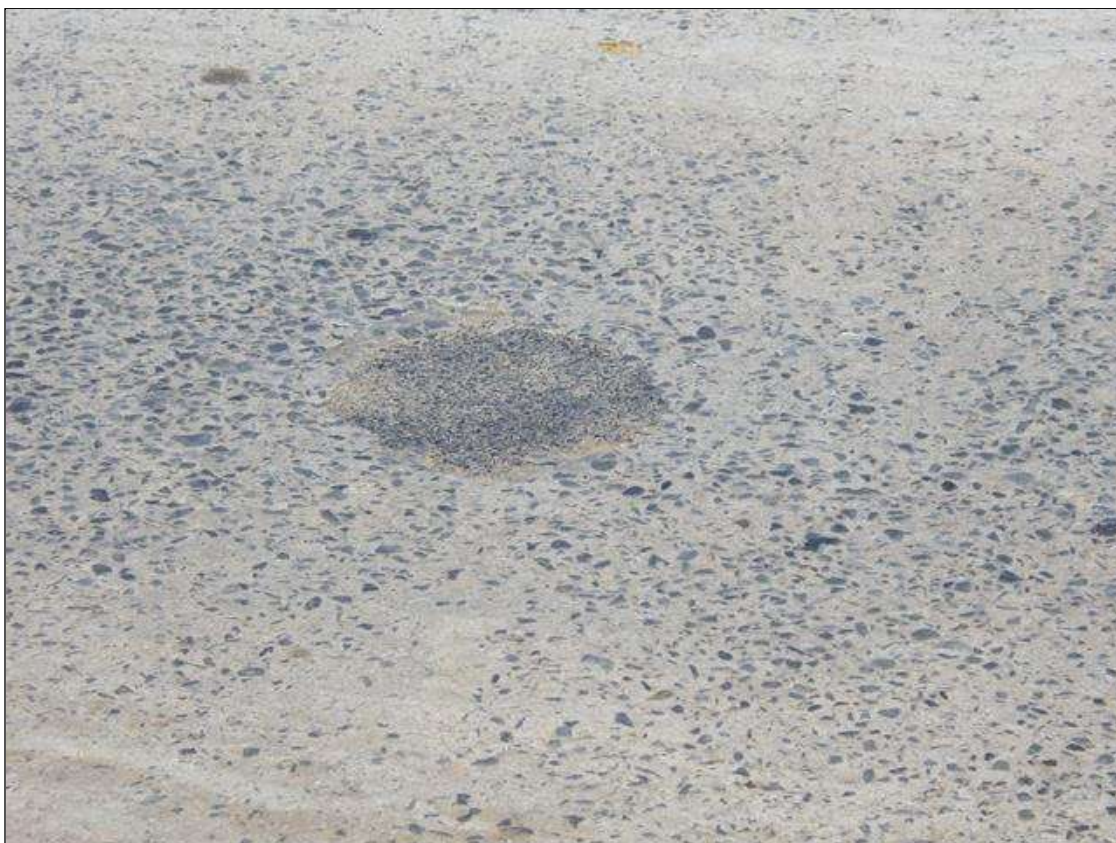
Span 3 Deck: 1 FOOT DIAMETER PATCHED AREA IN THE EASTBOUND LANE, 8 FEET FROM BENT 3

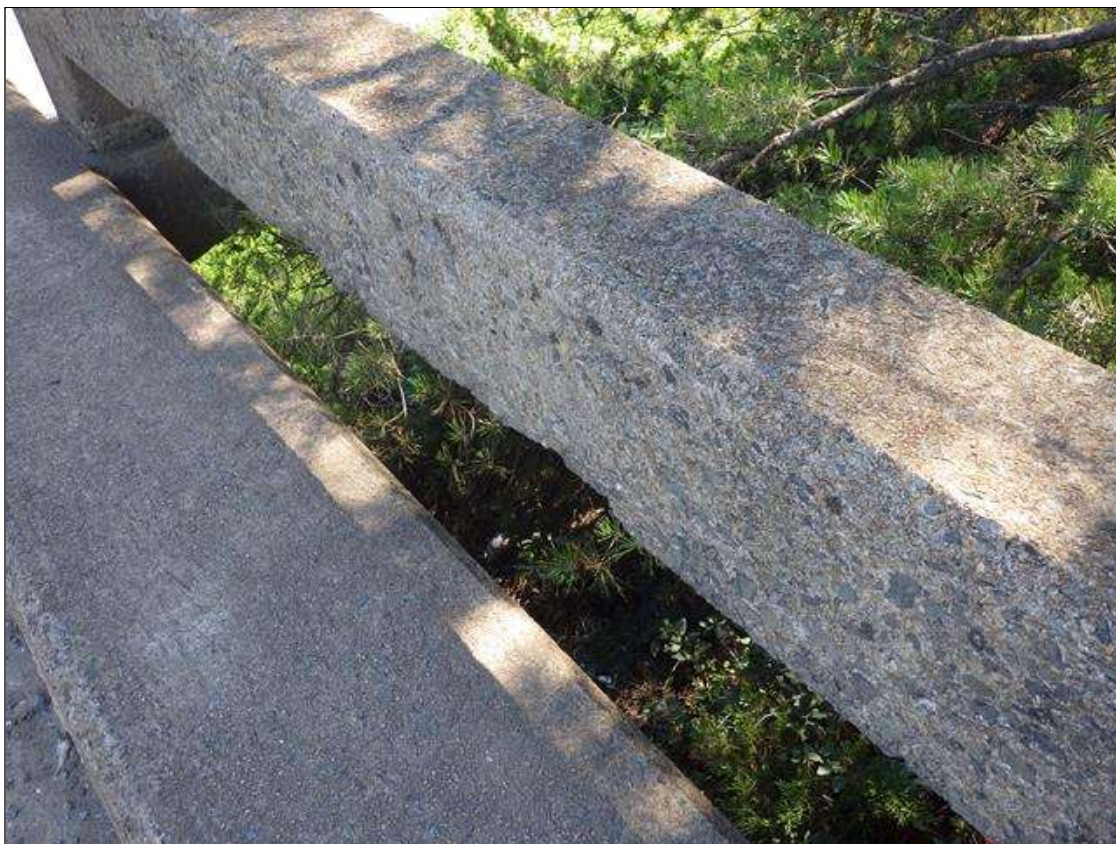
Span 4 Left Bridge Rail: INTERMITTENT 3 FEET 6 INCHES LONG X 3 INCHES HIGH X 1 INCH WIDE SPALLED AREA IN THE RAIL BETWEEN POST 3 AND POST 4

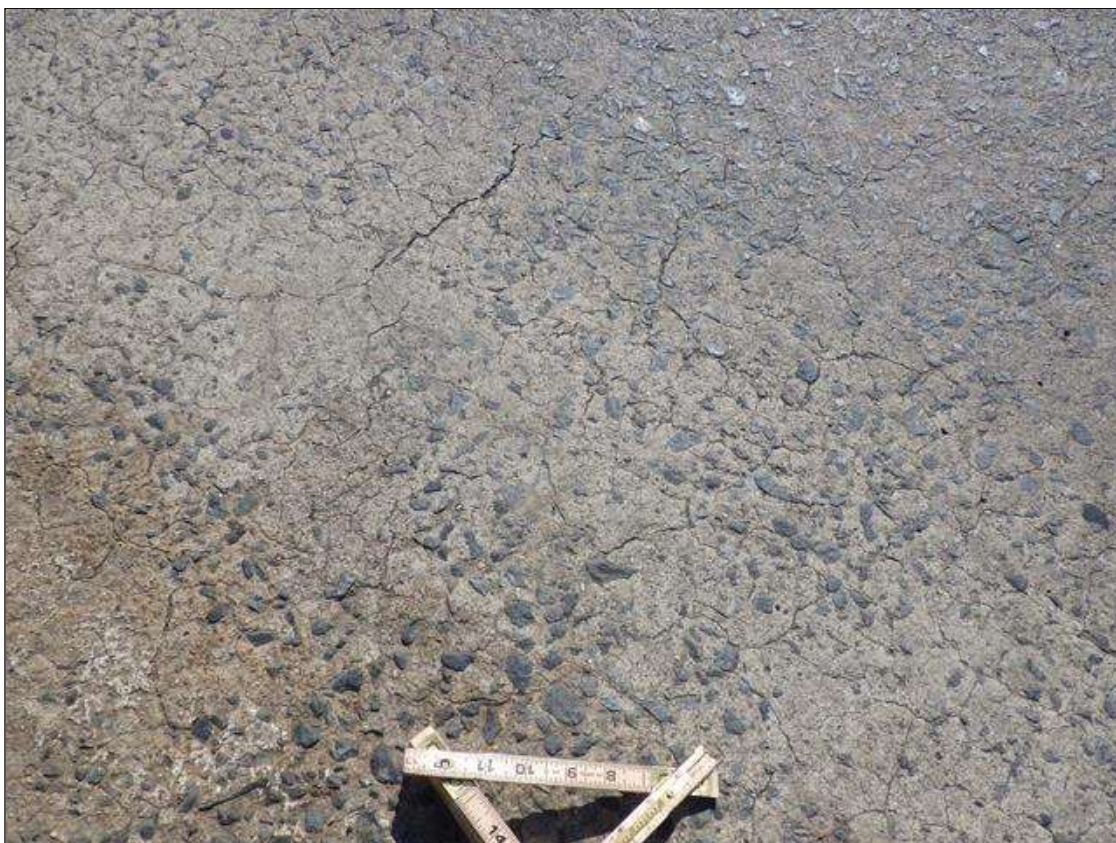
Span 1 Deck: FULL LENGTH X FULL WIDTH MAP CRACKING UP TO 1/8 INCH WIDE THROUGHOUT THE TOP OF THE DECK

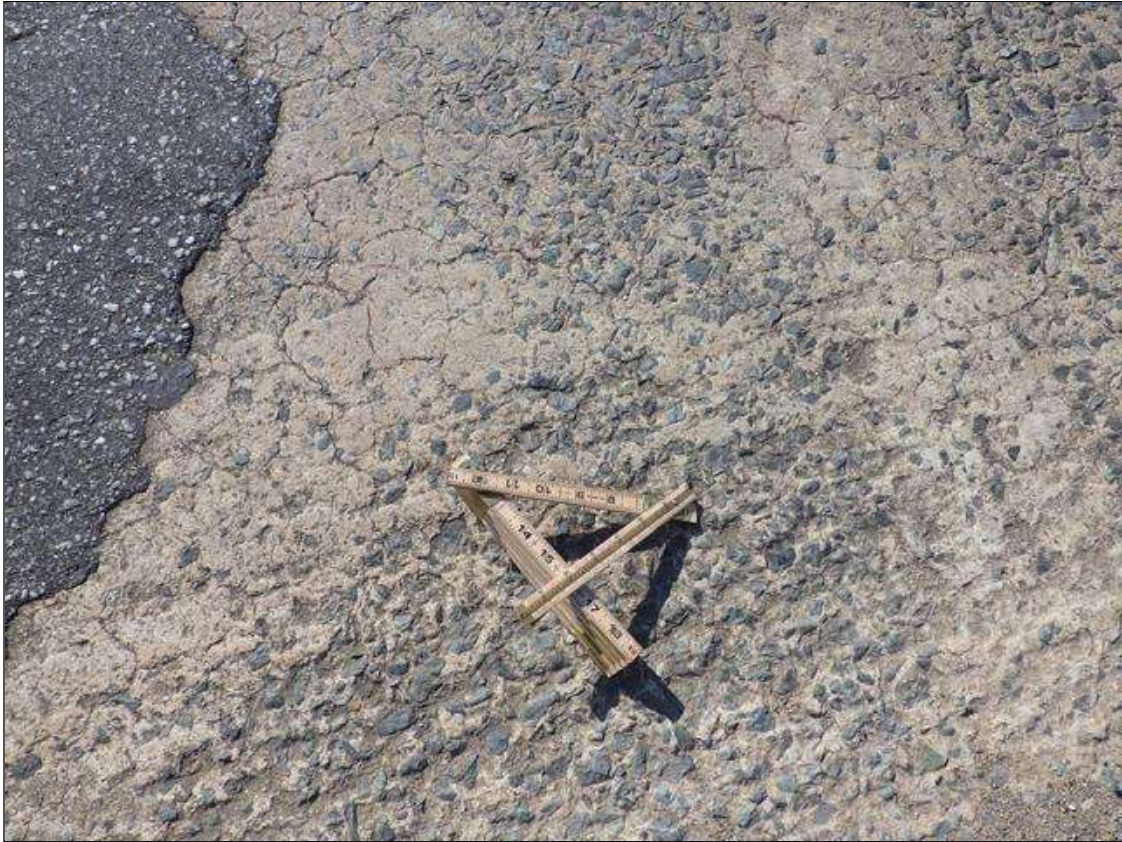
Span 4 Deck: FULL LENGTH X FULL WIDTH MAP CRACKING UP TO 1/16 INCH WIDE THROUGHOUT THE TOP OF THE DECK WITH EXPOSED SURFACE COARSE AGGREGATE (OTHERS SIMILAR)

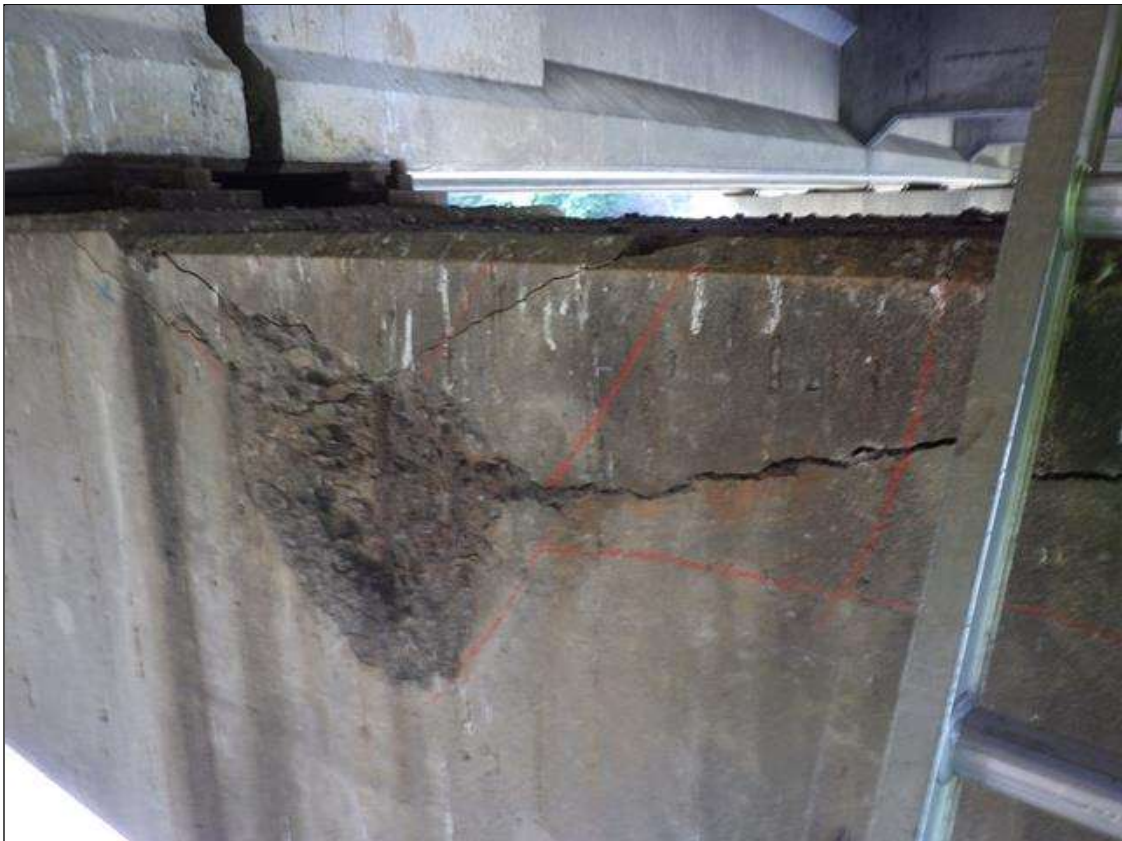
Bent 3 Cap 1: DELAMINATED AND SPALLED AREA UP TO 6 FEET X 1 FOOT 8 INCHES HIGH X 1 FOOT WIDE X 2 INCHES DEEP IN THE EAST FACE AND TOP FACE BELOW BAY 1

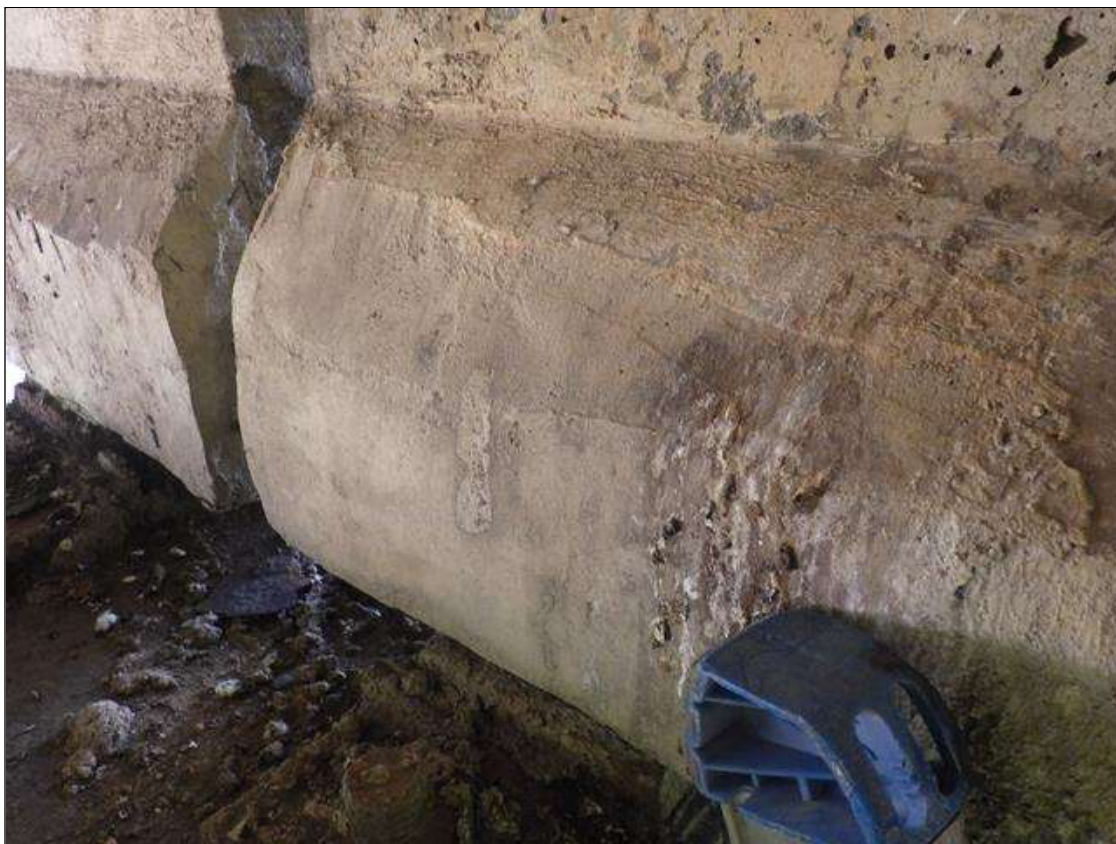
Span 4 Beam 1: PATCHED AREA UP TO 1 FOOT LONG X 9 INCHES HIGH X 3 INCHES WIDE IN THE RIGHT BOTTOM FLANGE AT BENT 3

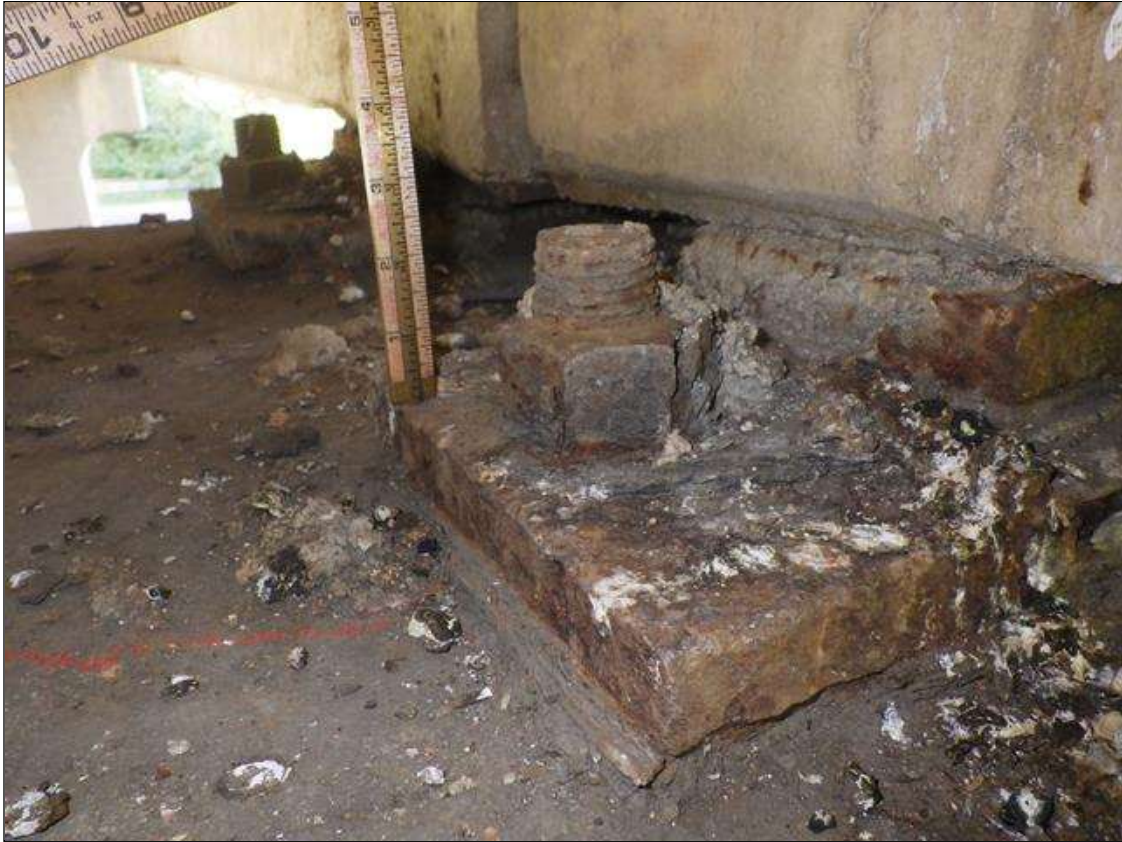
Span 4 Beam 1 - Near Bearing: ACTIVE CORROSION THROUGHOUT THE GIRDER 1 BEARING WITH 1/16 INCH SECTION LOSS (LESS THAN 25 PERCENT SECTION LOSS)

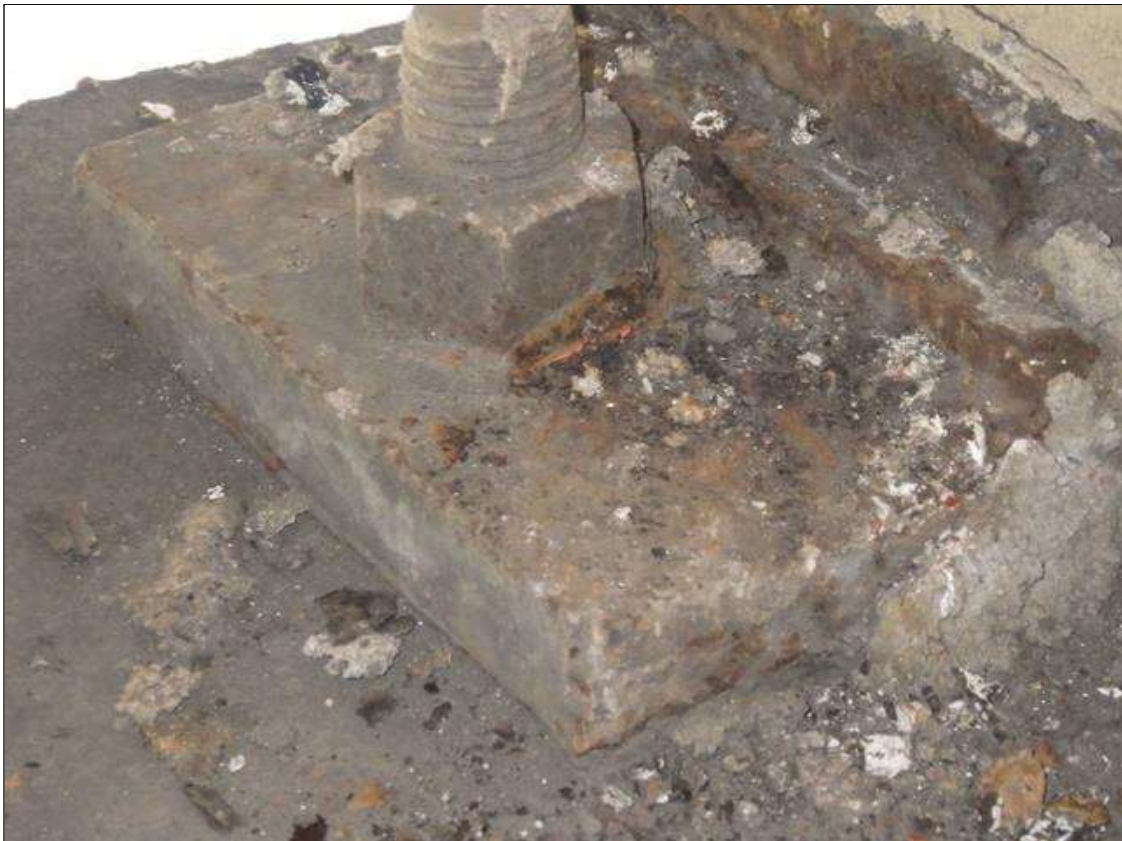
Span 3 Beam 1 - Far Bearing: SURFACE RUST THROUGHOUT THE GIRDER 1 BEARING

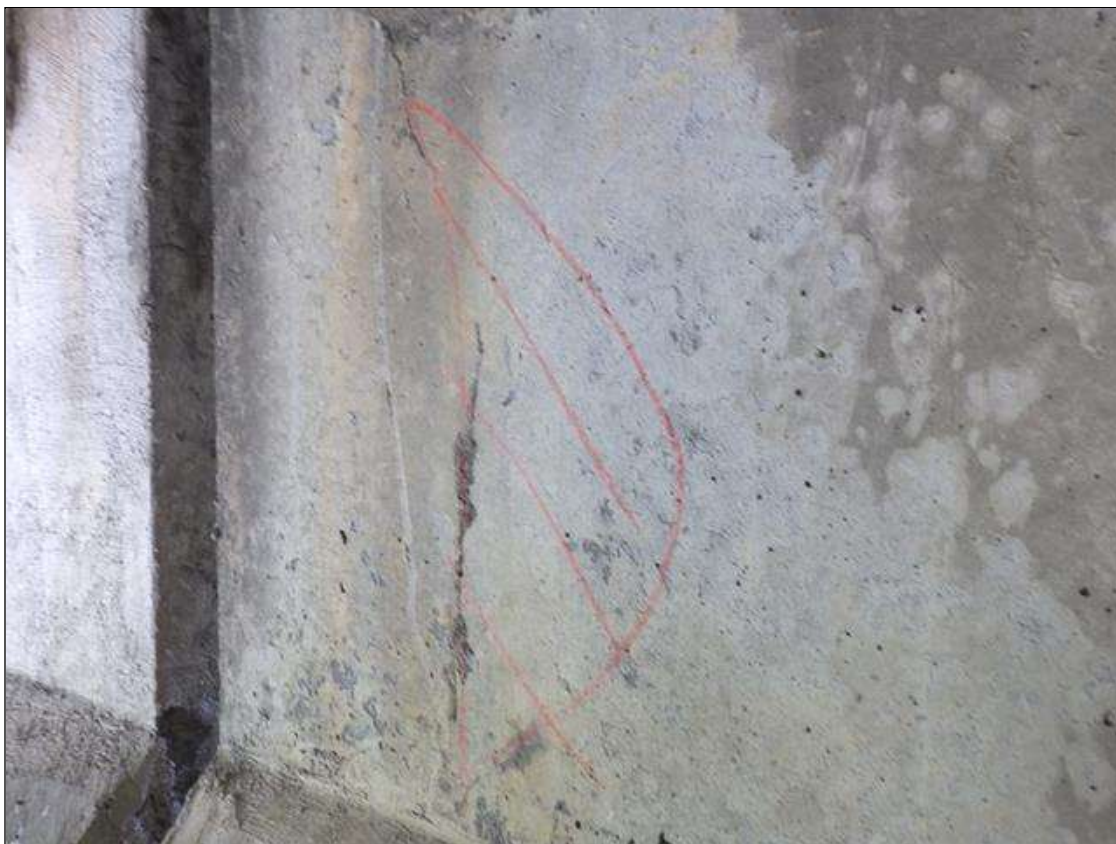
Span 4 Beam 1: DELMINATED AREA UP TO 6 INCHES LONG X 1 FOOT 4 INCHES HIGH IN THE RIGHT WEB, 6 INCHES FROM THE END OF GIRDER AT BENT 3

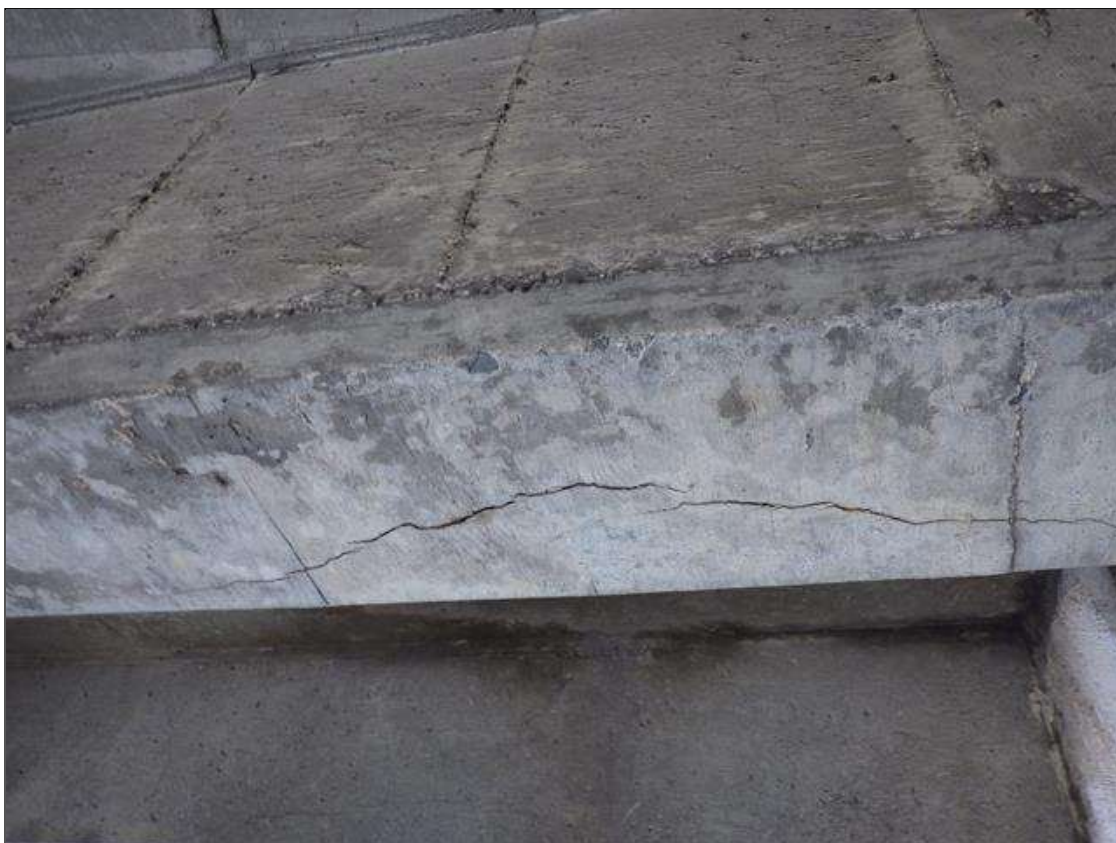
Span 4 Beam 1: LONGITUDINAL CRACK UP TO INTERMITTENT FULL WIDTH X 1/16 INCH WIDE IN BAY 1 END DIAPHRAGM AT BENT 3

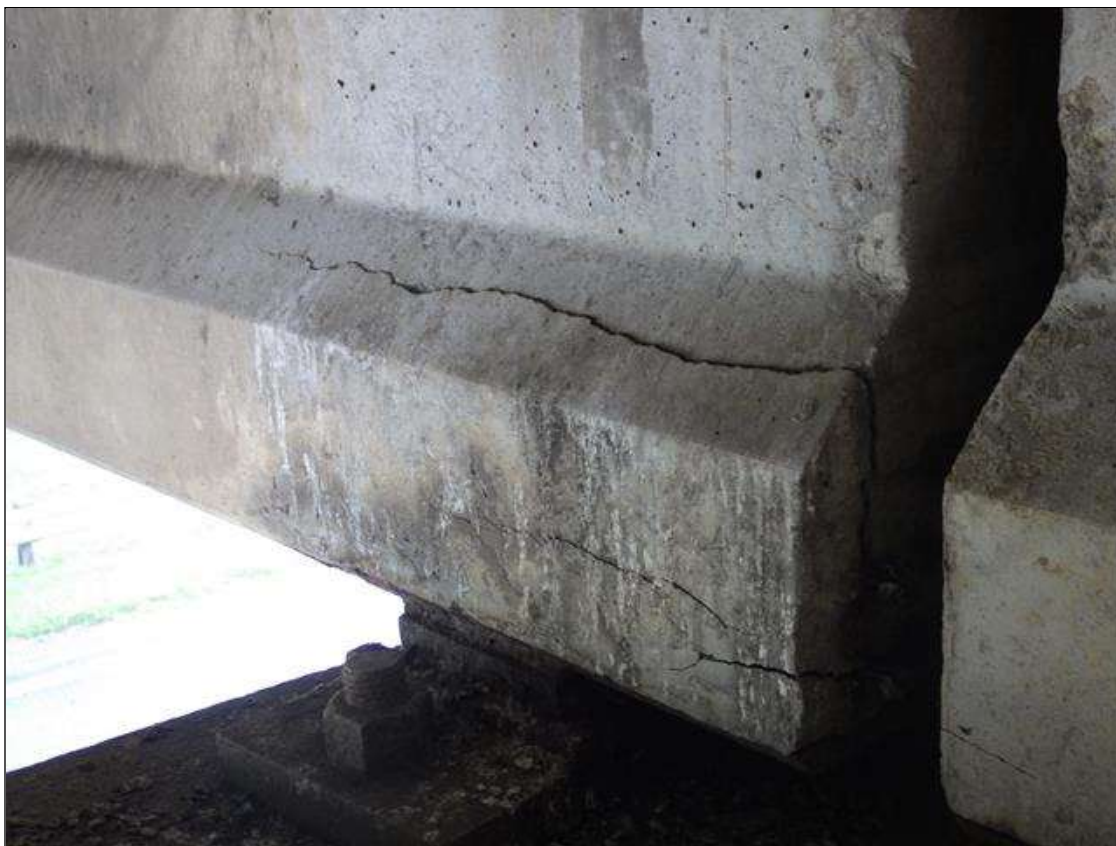
Span 3 Beam 2: DELAMINATED AREA UP TO 2 FEET LONG X 9 INCHES HIGH X 2 INCHES WIDE IN THE RIGHT BOTTOM FLANGE AT BENT 3
