NC DEPARTMENT OF TRANSPORTATION  
 DIVISION OF HIGHWAYS  
 STRUCTURE MANAGEMENT UNIT

ATTENTION: **PRIORITY ACTION REQUESTS; SIGN NOTICED  
 ISSUED FOR (2) MISSING DELINEATORS**

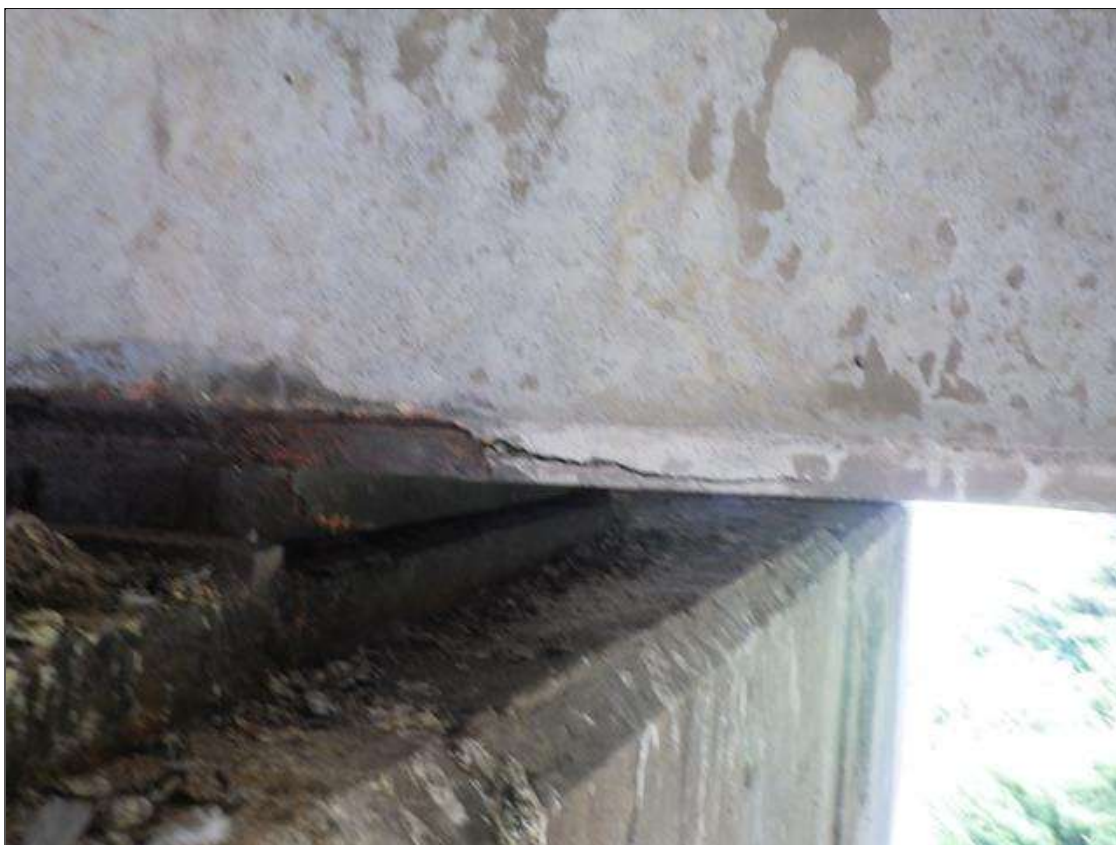
Span 4 Beam 2: LONGITUDINAL CRACKS UP TO 6 INCHES LONG X 1/16 INCH WIDE IN THE RIGHT BOTTOM FLANGE AND LEFT BOTTOM FLANGE ADJACENT TO THE EMBEDDED PLATE AT BENT 3

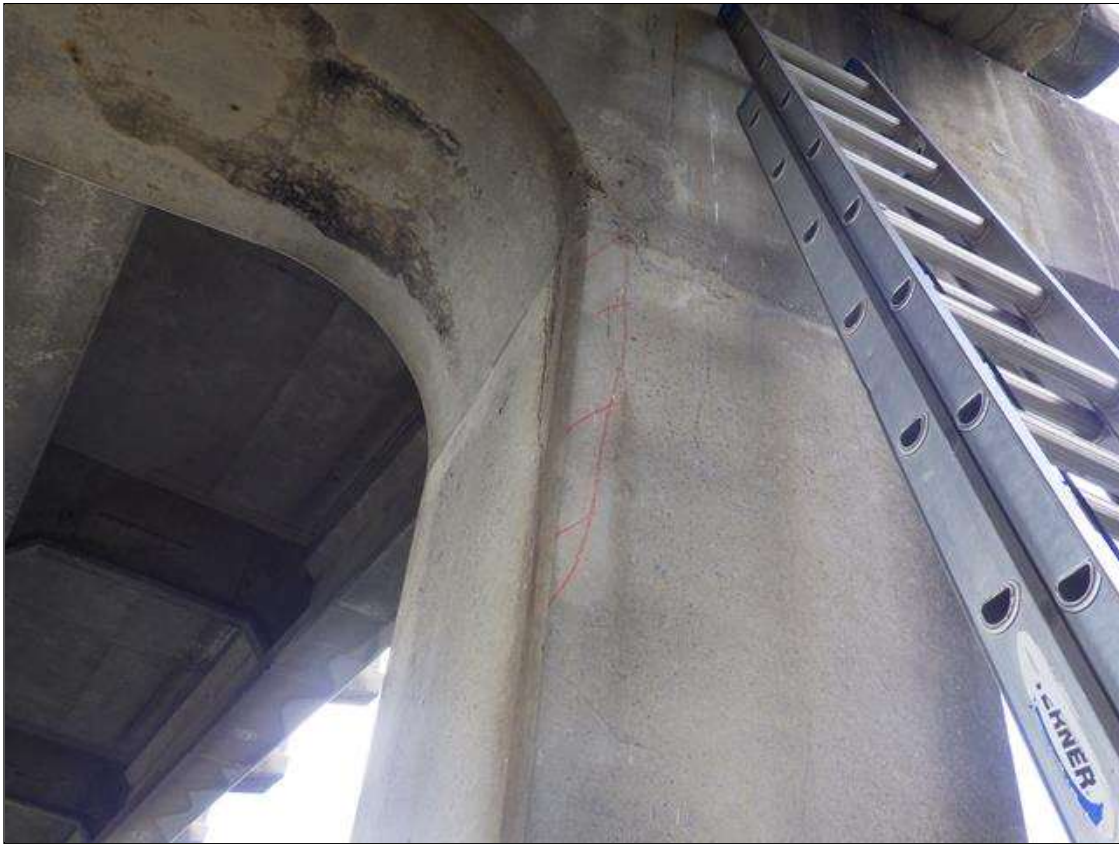
Bent 3 Pile 1: DELAMINATED AREA UP TO 3 FEET 4 INCHES HIGH X 4 INCHES LONG X 5 INCHES WIDE IN THE SOUTHEAST CORNER ADJACENT TO BOTTOM OF CAP

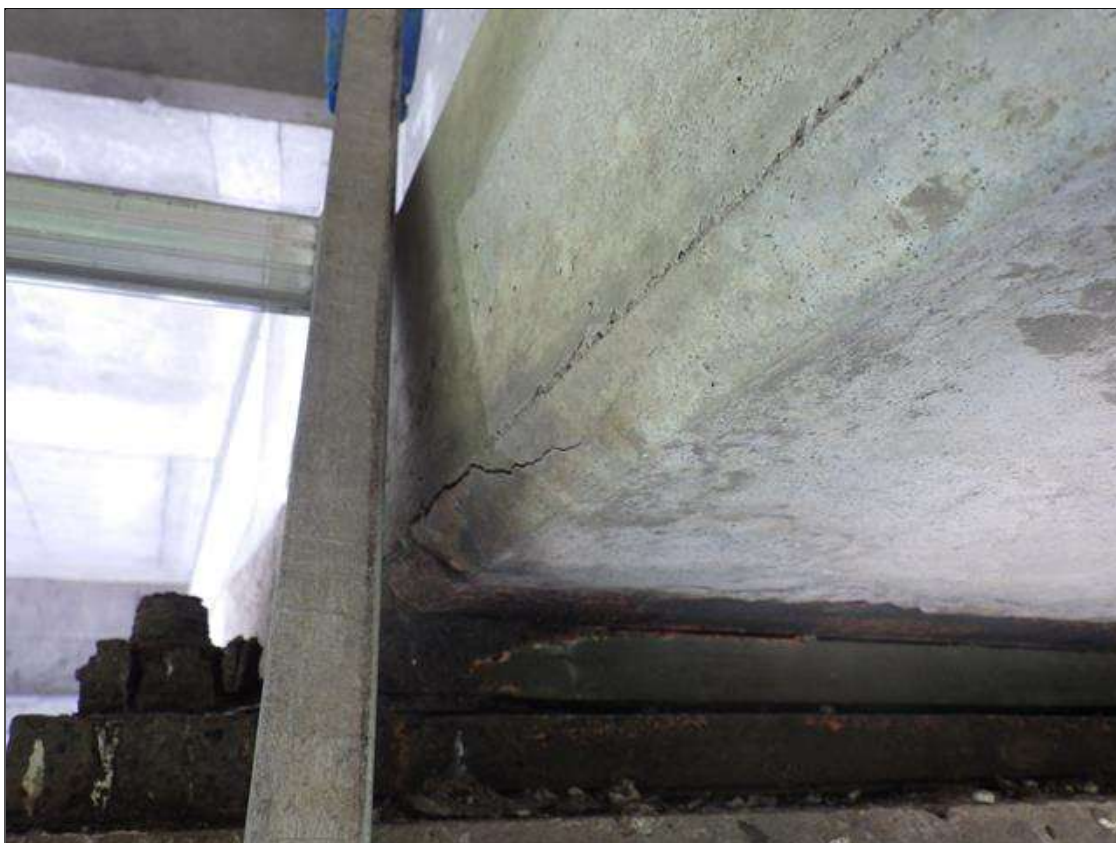
Span 4 Beam 3: LONGITUDINAL CRACK UP TO 6 INCHES LONG X 1/16 INCH WIDE IN THE RIGHT BOTTOM FLANGE ADJACENT TO THE EMBEDDED PLATE AT BENT 3

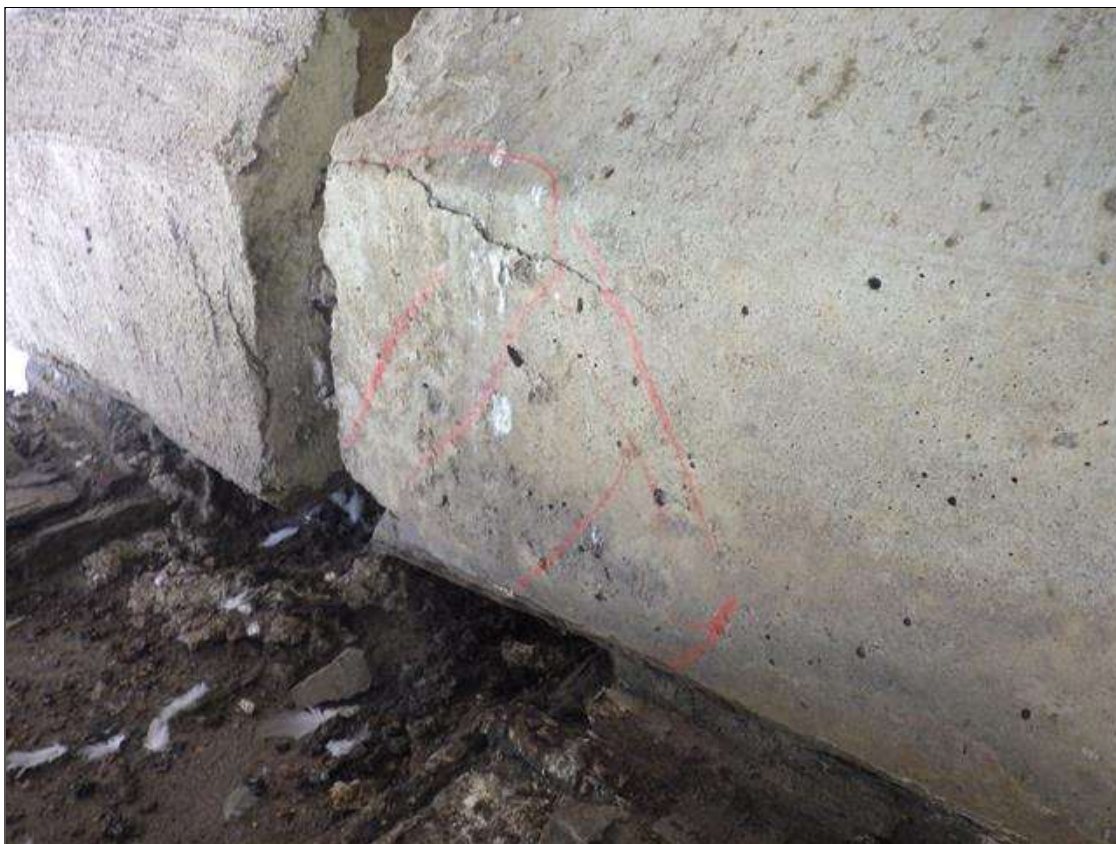
Span 4 Beam 3: DELAMINATED AREA UP TO 8 INCHES LONG X 8 INCHES HIGH IN THE RIGHT BOTTOM FLANGE AT BENT 3

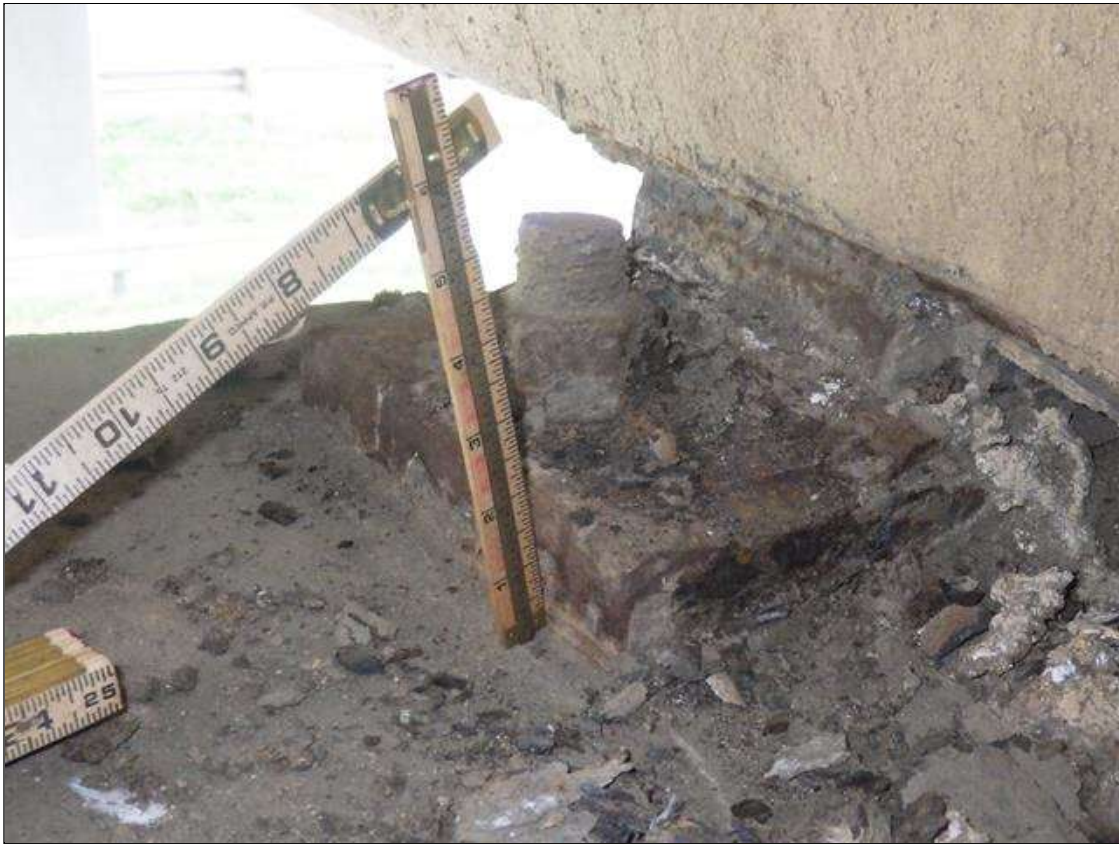
Span 3 Beam 3 - Far Bearing: ACTIVE CORROSION THROUGHOUT THE GIRDER 3 BEARING WITH 1/16 INCH SECTION LOSS (LESS THAN 25 PERCENT SECTION LOSS)

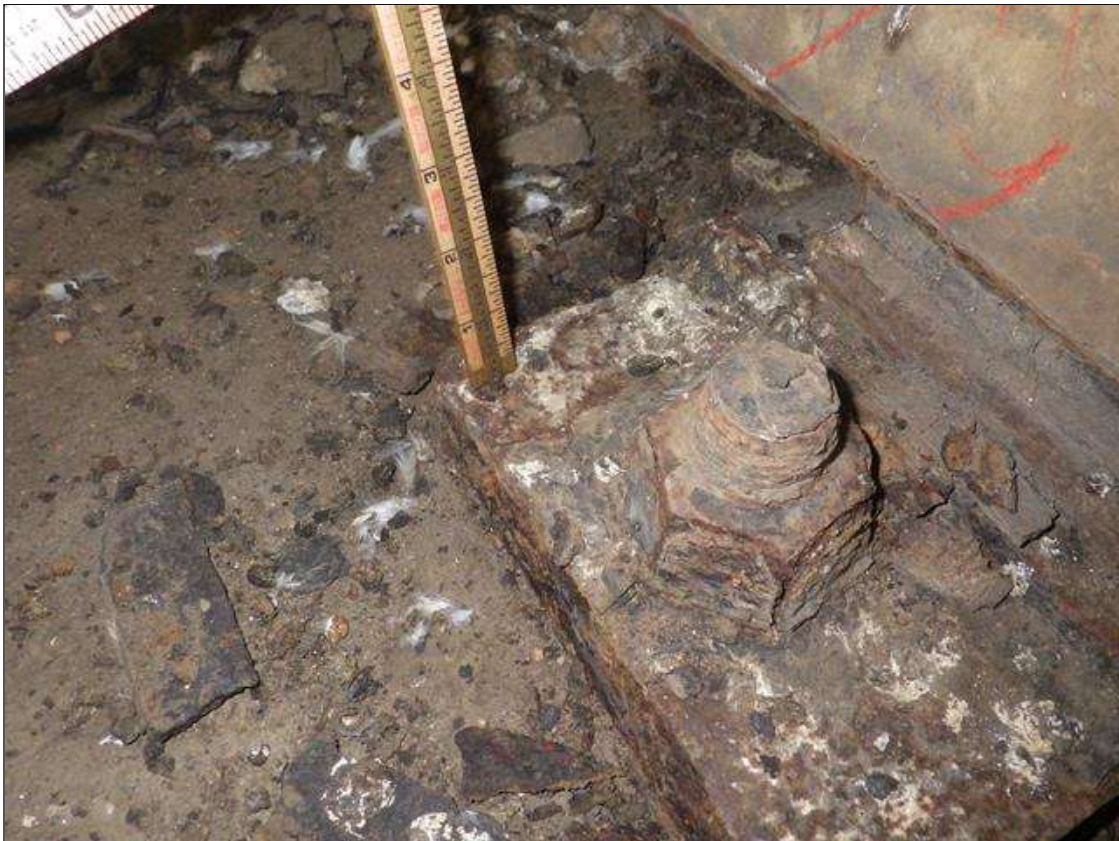
Span 4 Beam 3 - Near Bearing: ACTIVE CORROSION THROUGHOUT THE GIRDER 3 BEARING WITH 1/16 INCH SECTION LOSS (LESS THAN 25 PERCENT SECTION LOSS)

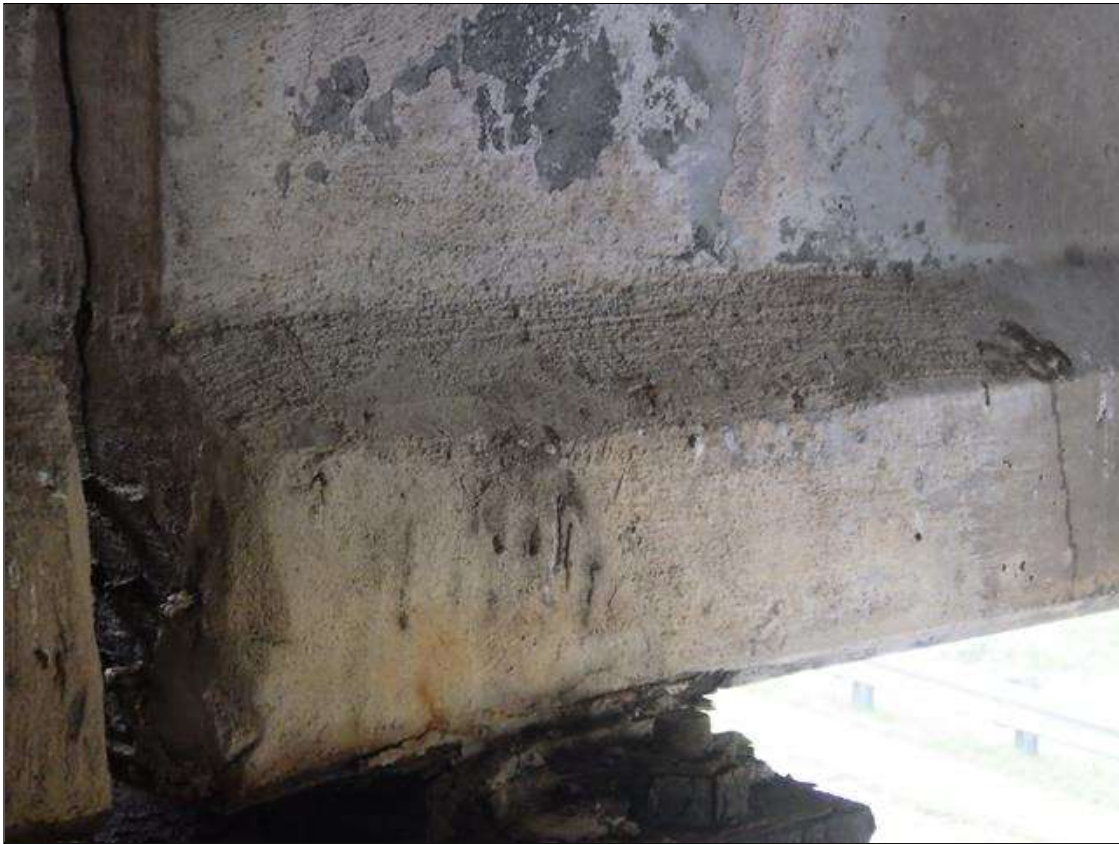
Span 3 Beam 4: PATCHED AREA UP TO 2 FEET LONG X 10 INCHES HIGH X 3 INCHES WIDE IN THE LEFT BOTTOM FLANGE AT BENT 3

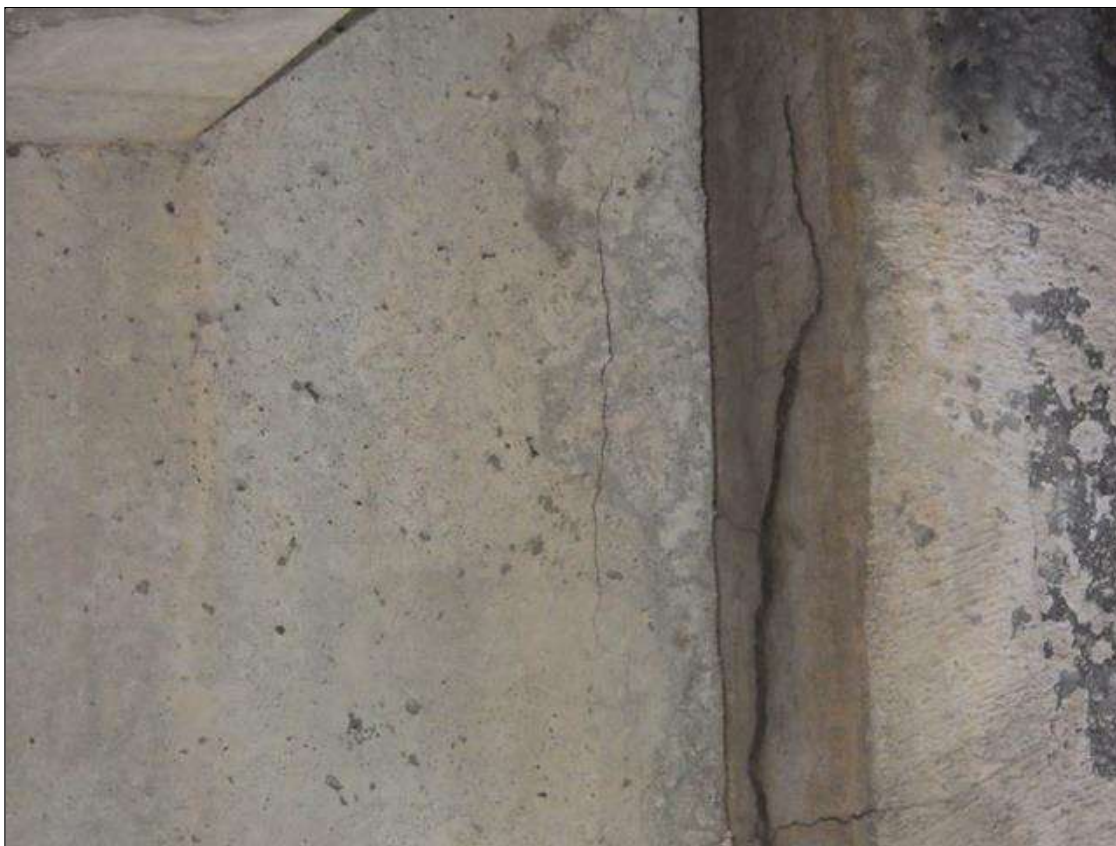
Span 4 Beam 4: VERTICAL CRACK UP TO 1 FOOT HIGH X 1/32 INCH WIDE IN THE LEFT WEB, 2 INCHES FROM END OF GIRDER AT BENT 3

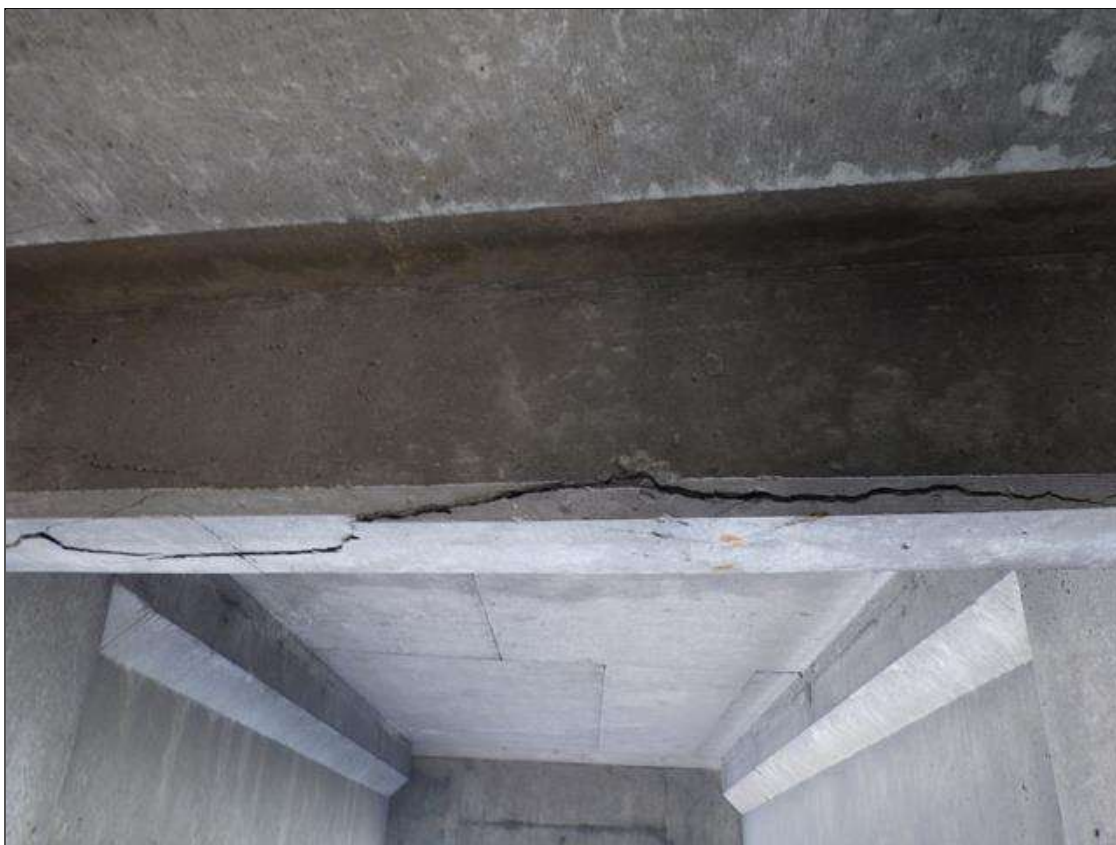
Span 3 Beam 2: DELAMINATED AREA UP TO FULL WIDTH X 10 INCHES LONG X 2 INCHES HIGH IN BAY 2 END DIAPHRAGM AT BENT 3

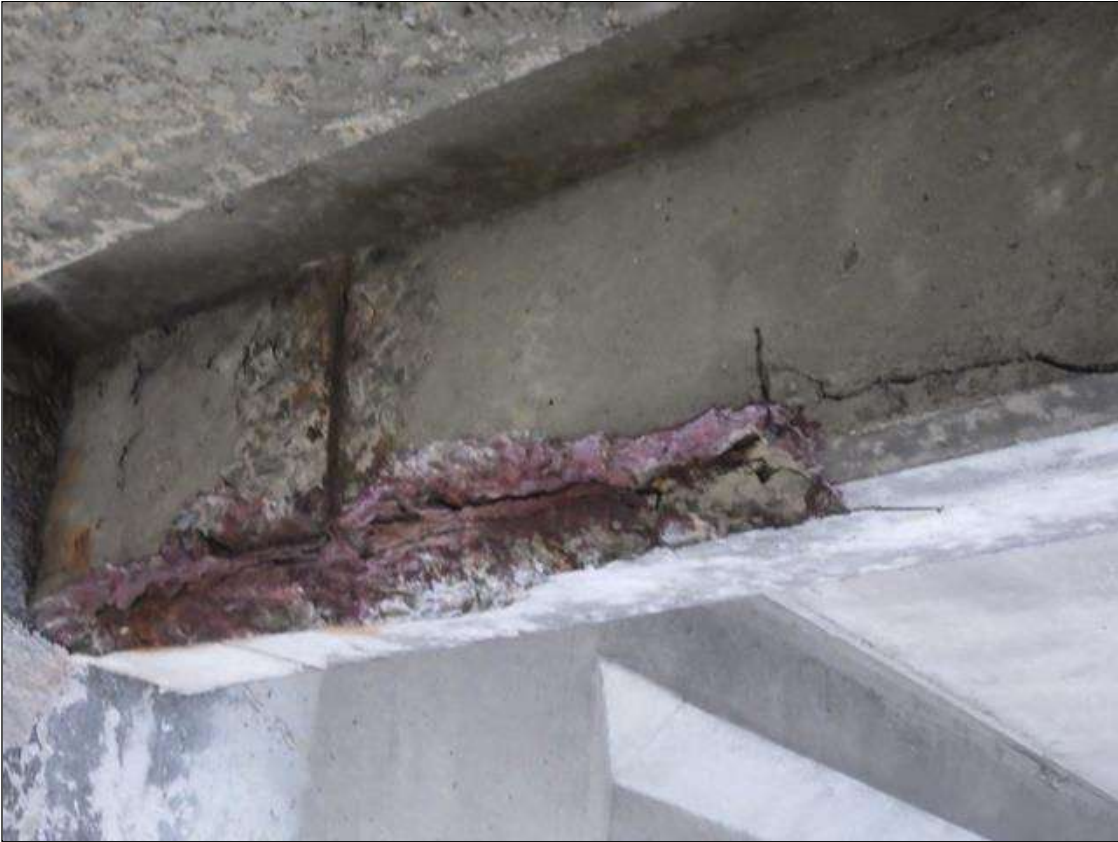
Span 3 Beam 3: DELAMINATED AND SPALLED AREA UP TO 5 FEET LONG X FULL HEIGHT X 5 INCHES WIDE WITH EXPOSED REINFORCEMENT IN BAY 3 END DIAPHRAGM AT BENT 3

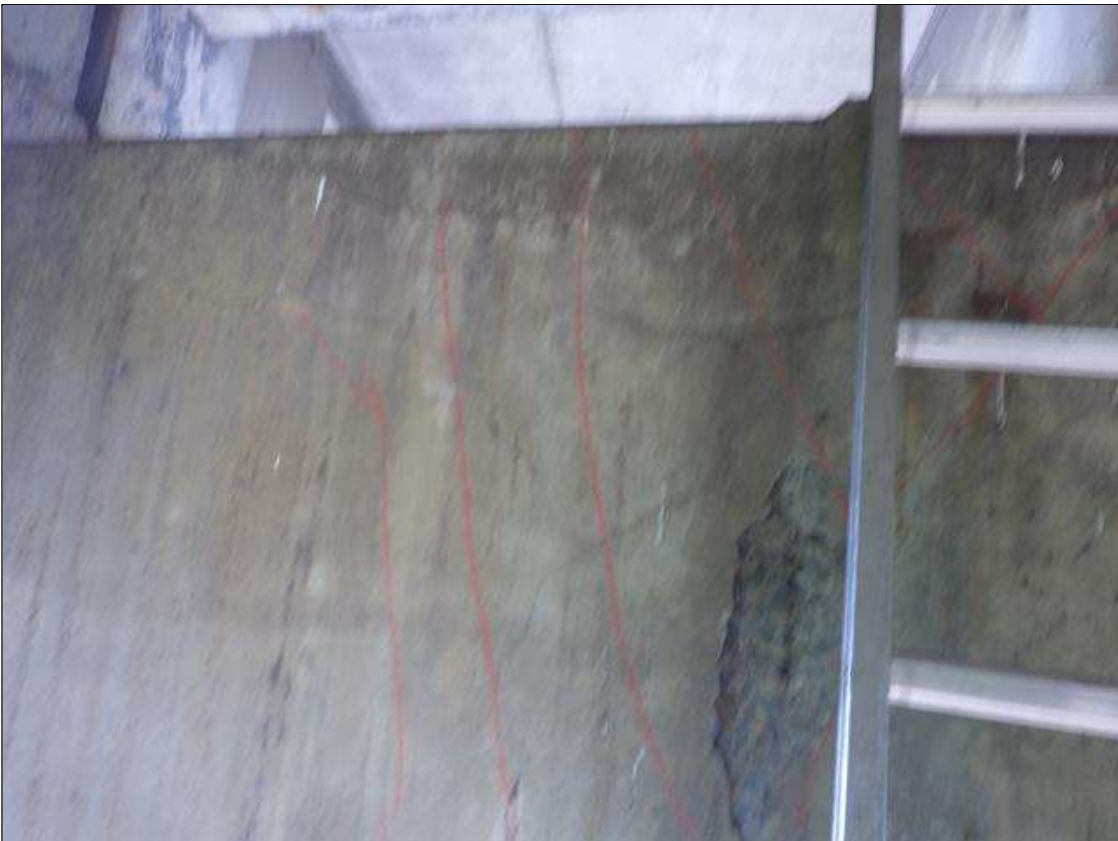
Bent 3 Cap 1: DELMINATED AND SPALLED AREA UP TO INTERMITTENT 9 FEET LONG X 3 FEET 1 INCH HIGH X 1 INCHES DEEP IN THE EAST FACE BELOW BAY 3 TO SOUTH OVERHANG

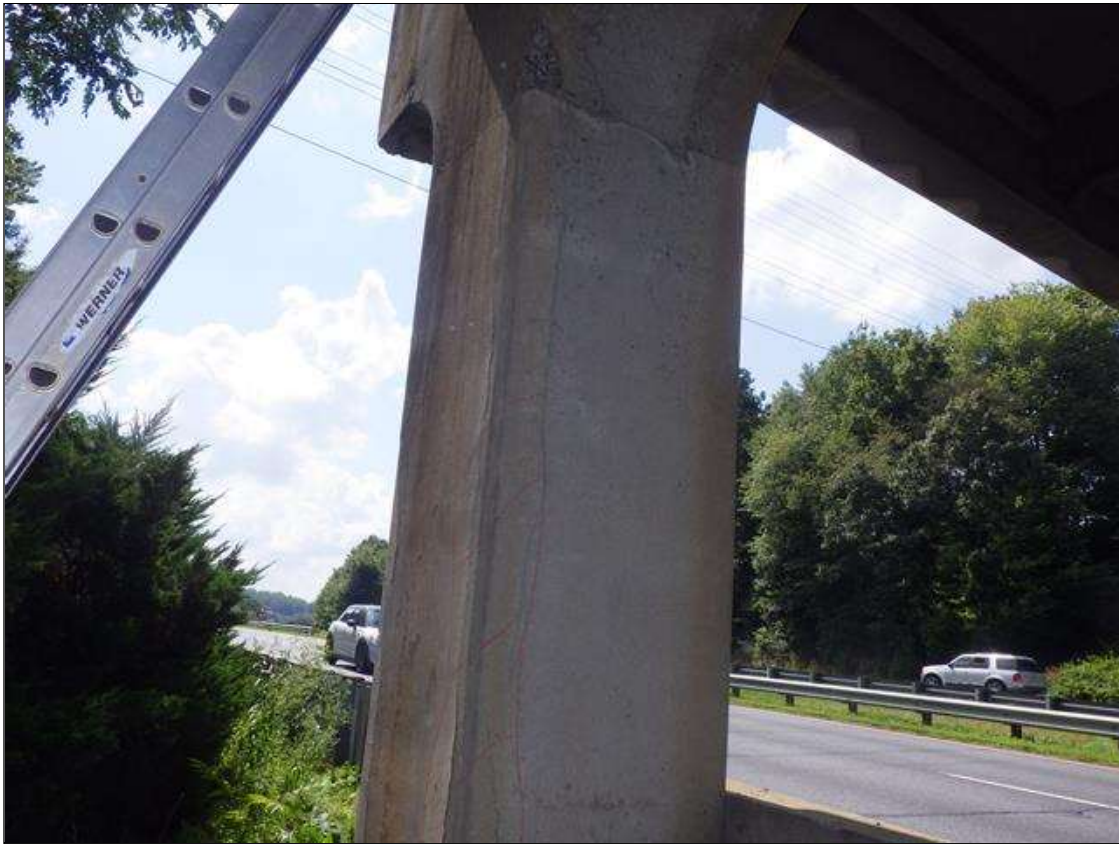
Bent 3 Pile 2: DELAMINATED AND SPALLED AREA UP TO FULL HEIGHT X 11 INCHES LONG X 9 INCHES WIDE IN THE NORTHEAST CORNER

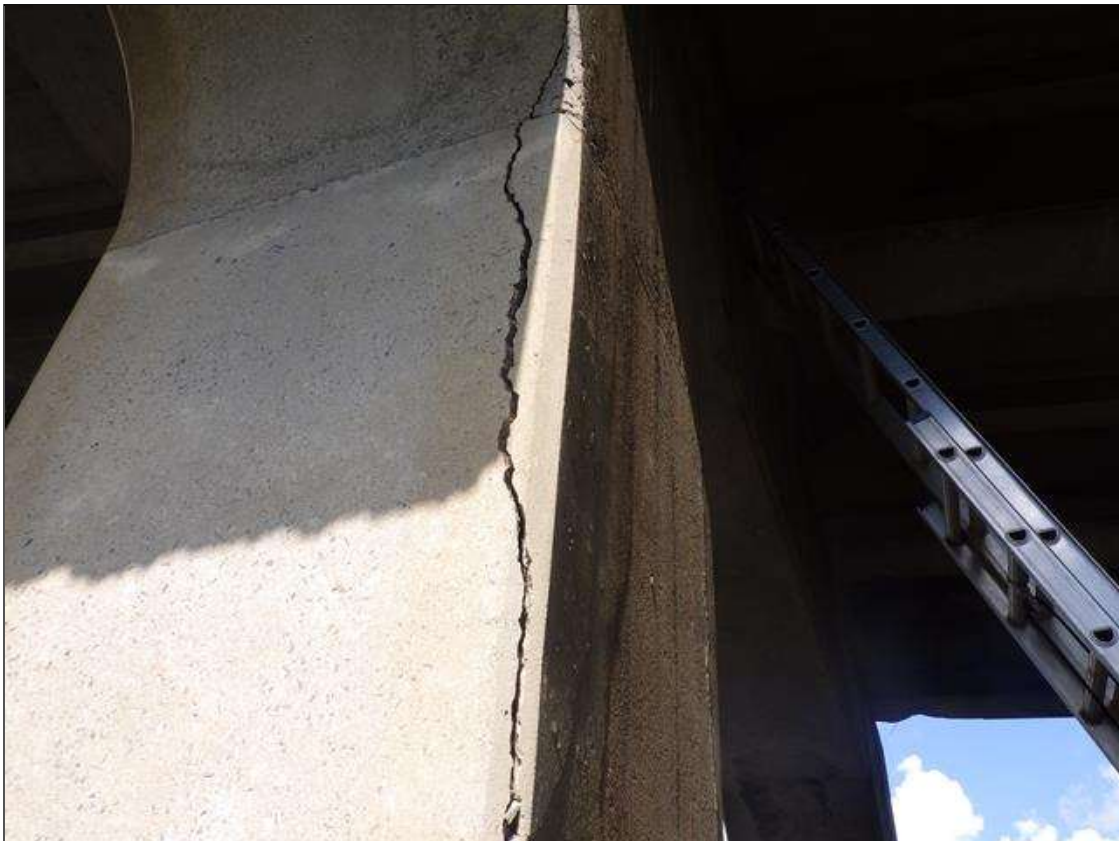
Bent 3 Pile 2: DELAMINATED AND SPALLED AREA UP TO FULL HEIGHT X 11 INCHES LONG X 9 INCHES WIDE WITH EXPOSED REINFORCEMENT IN THE SOUTHEAST CORNER

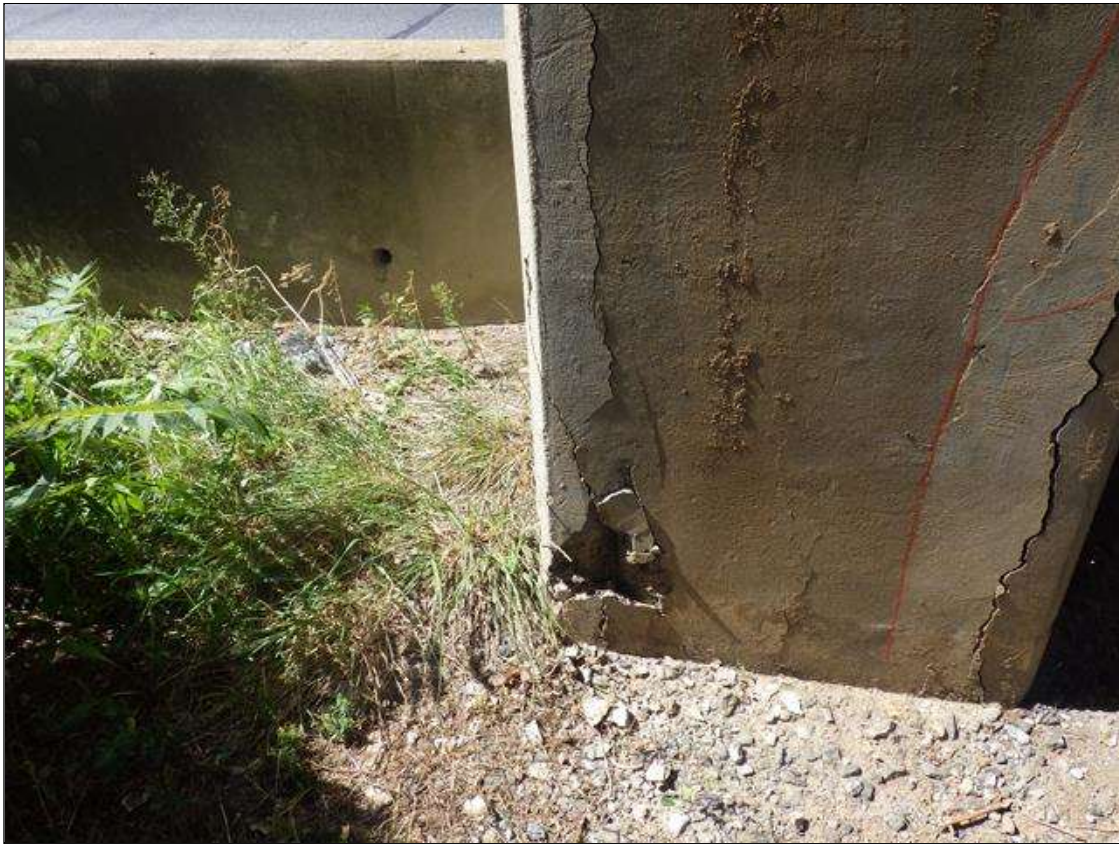
Bent 3 Pile 2: DELAMINATED AND SPALLED AREA UP TO FULL HEIGHT X 11 INCHES LONG X 9 INCHES WIDE WITH EXPOSED REINFORCEMENT IN THE SOUTHEAST CORNER

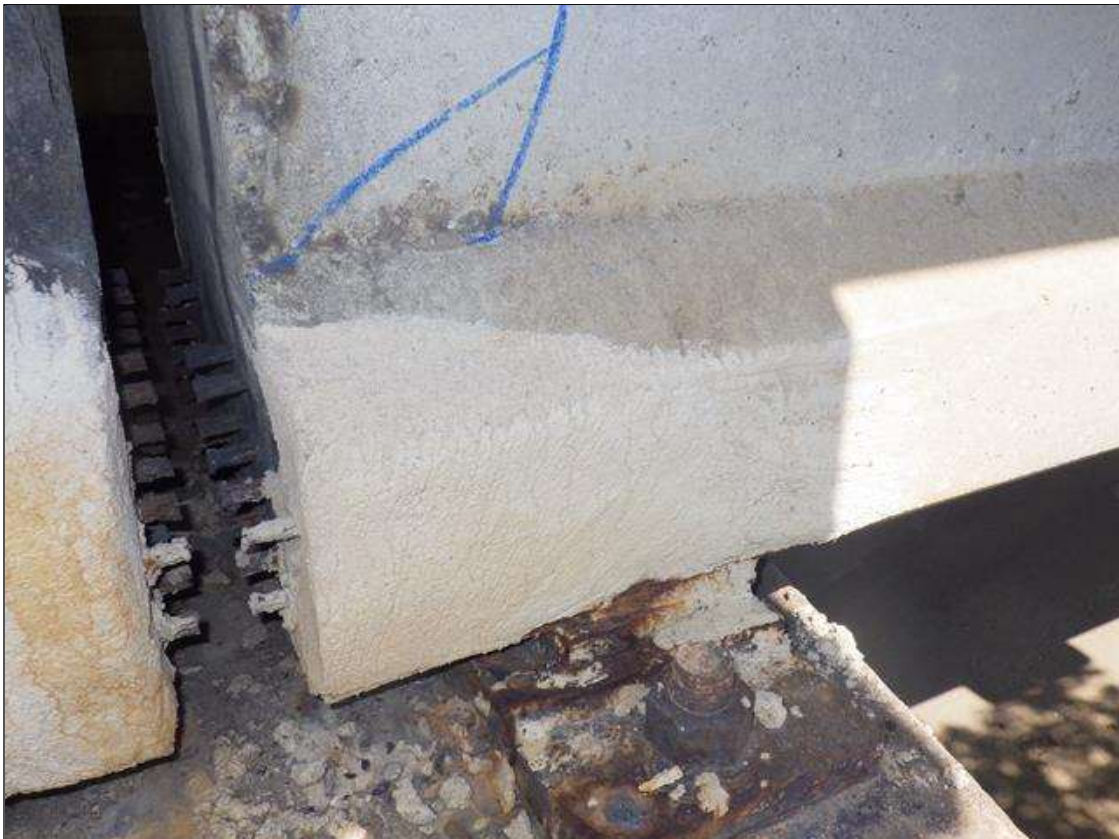
Span 4 Beam 4: PATCHED AREA UP TO 1 FOOT LONG X 10 INCHES HIGH X 3 INCHES WIDE IN THE BOTTOM RIGHT FLANGE AT BENT 3

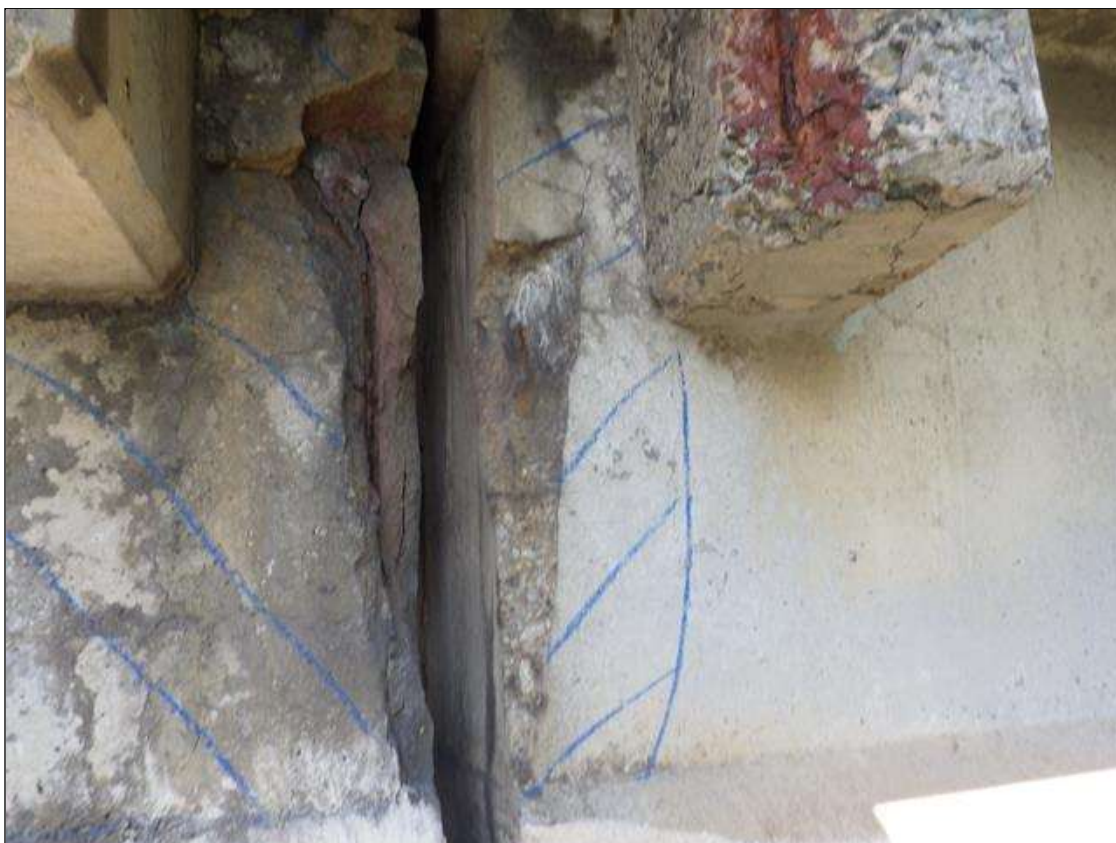
Span 4 Beam 4: DELAMINATED AND SPALLED AREA UP TO 8 INCHES LONG X FULL HEIGHT X 3 INCHES WIDE IN THE RIGHT SIDE OF THE WEB AT BENT 3

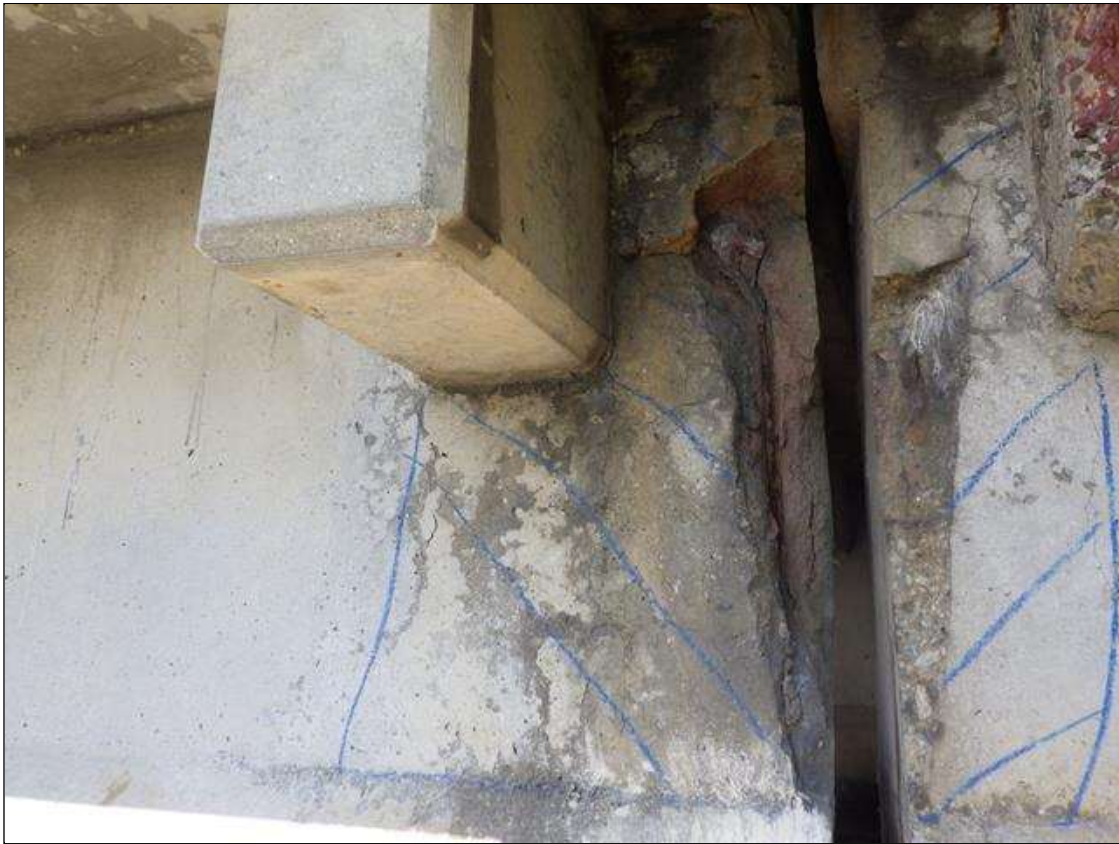
Span 3 Beam 4: DELAMINATED AND SPALLED AREA UP TO 1 FOOT 9 INCHES LONG X FULL HEIGHT X FULL WIDTH IN THE RIGHT SIDE OF THE WEB AND EAST FACE WITH EXPOSED EMBEDDED PLATE AT BENT 3

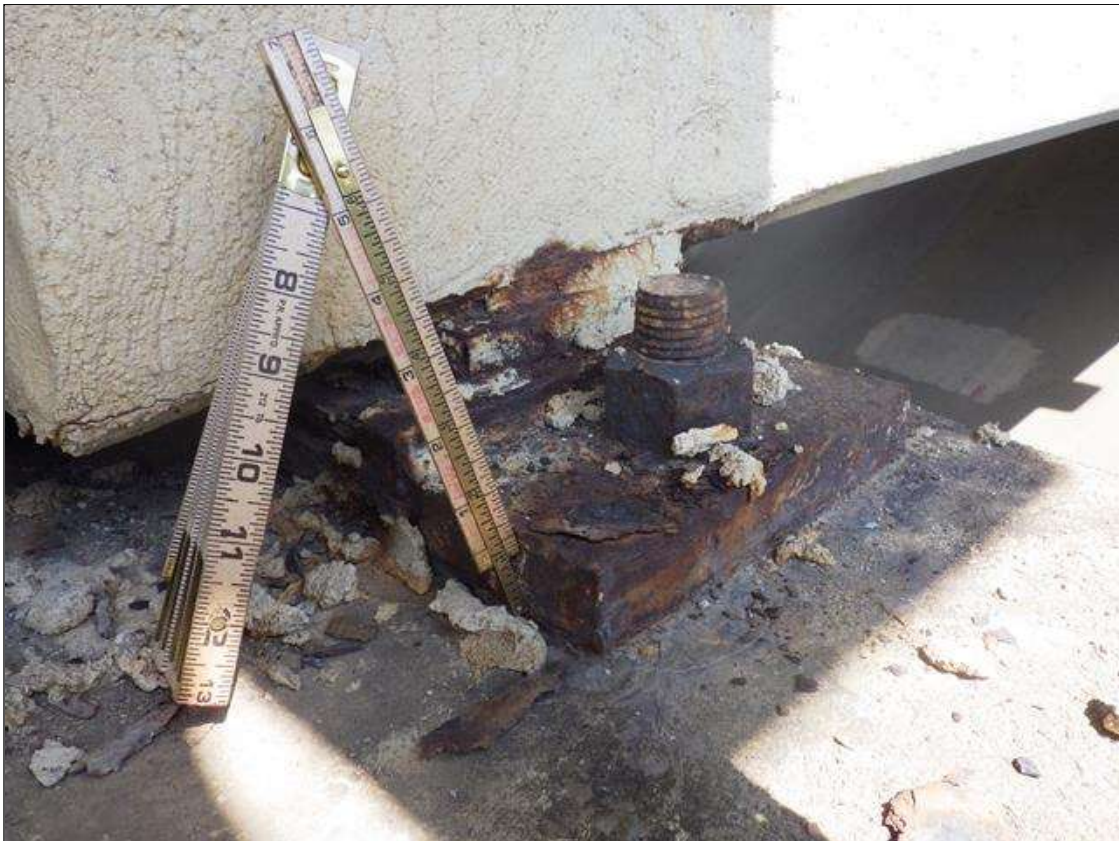
Span 4 Beam 4 - Near Bearing: ACTIVE CORROSION THROUGHOUT THE GIRDER 4 BEARING WITH 1/32 INCH SECTION LOSS

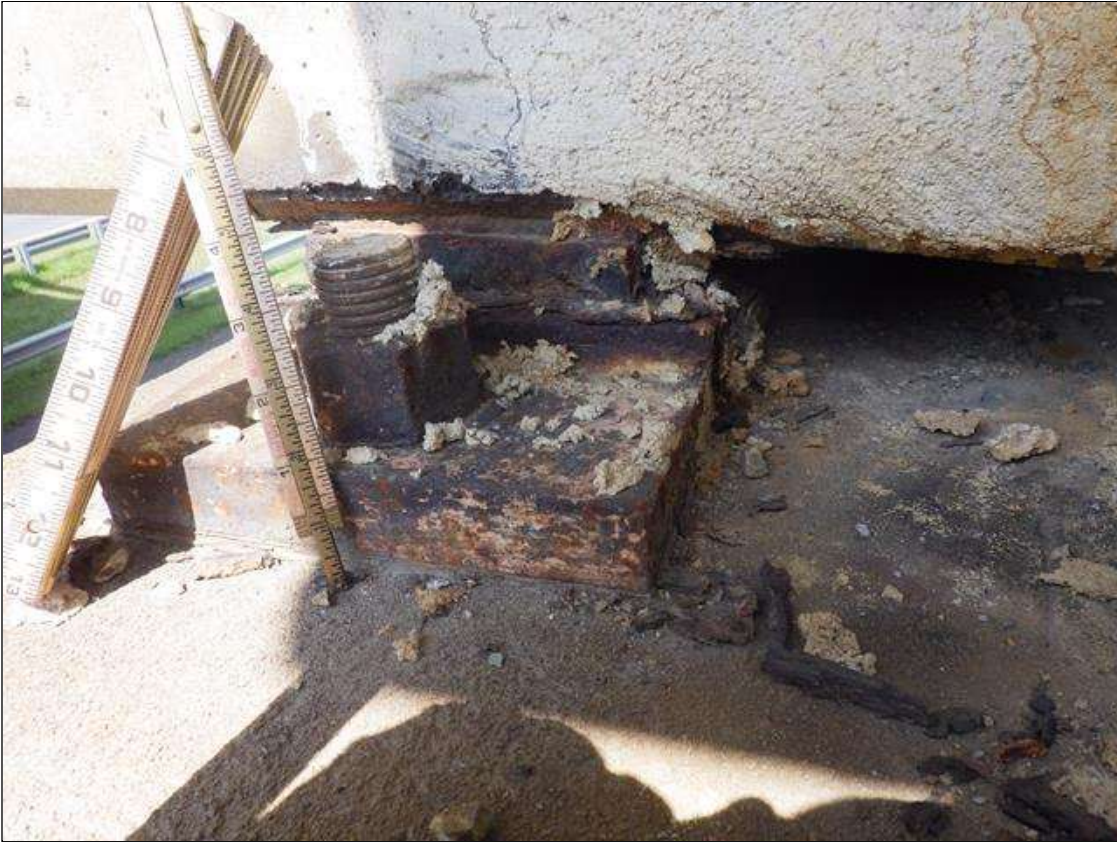
Span 3 Beam 4 - Far Bearing: ACTIVE CORROSION THROUGHOUT THE GIRDER 4 BEARING WITH 1/32 INCH SECTION LOSS

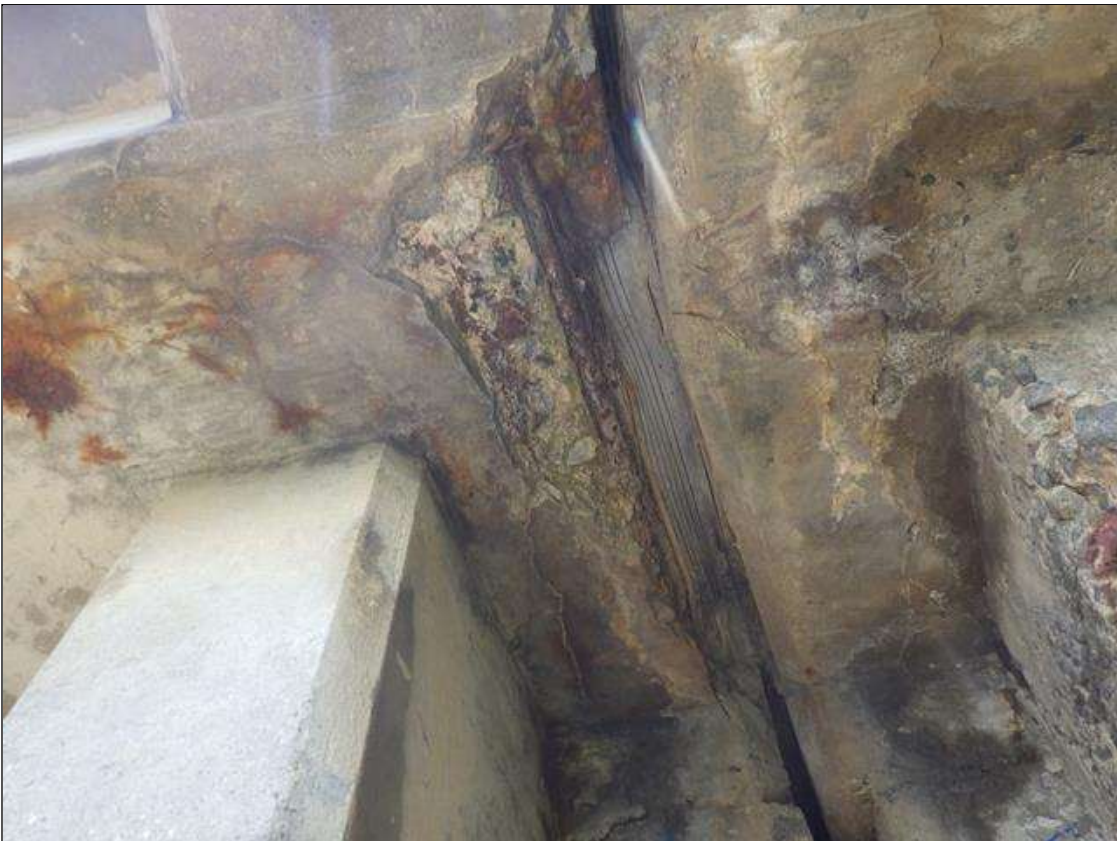
Span 3 Deck: SPALLED AREA UP TO 8 INCHES LONG X 2 FEET WIDE X 4 INCHES DEEP WITH EXPOSED REINFORCEMENT IN THE SOUTH OVERHANG AT BENT 3

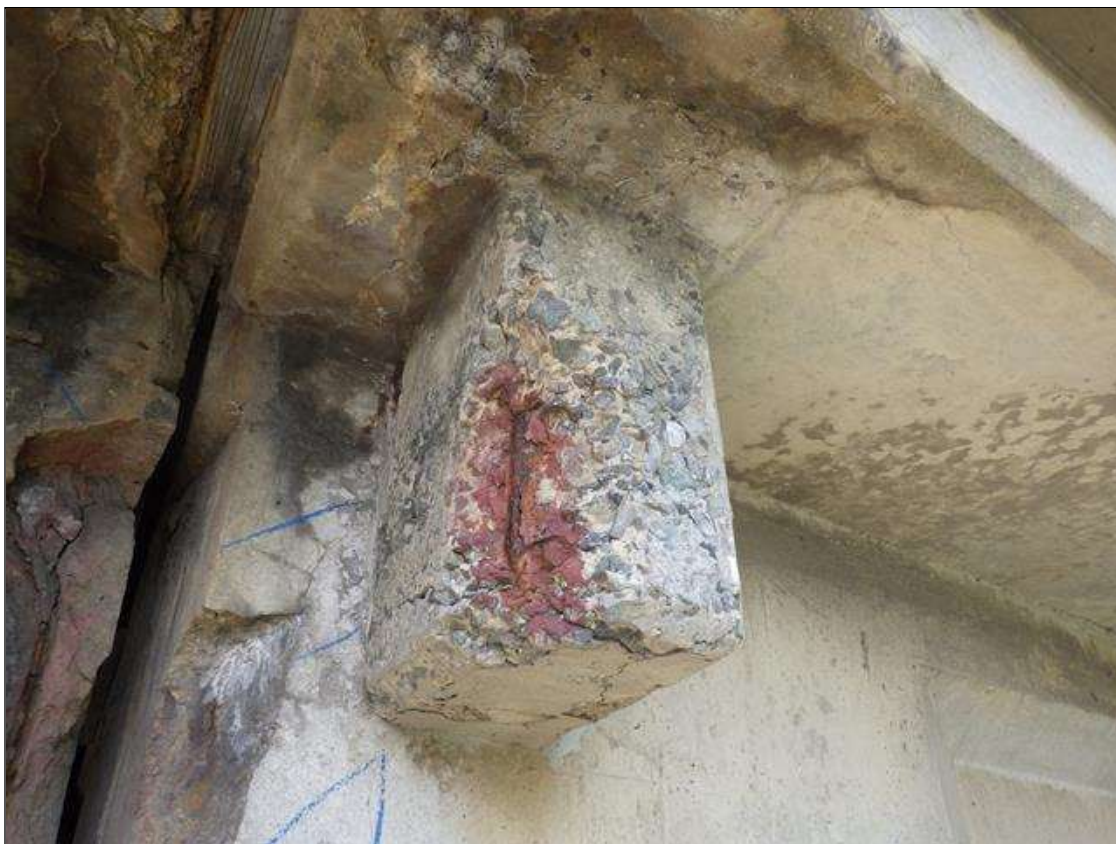
Span 4 Beam 4: DELAMINATED AND SPALLED AREA UP TO FULL LENGTH X FULL WIDTH X FULL HEIGHT WITH EXPOSED REINFORCEMENT IN THE SOUTH OVERHANG END DIAPHRAGM AT BENT 3

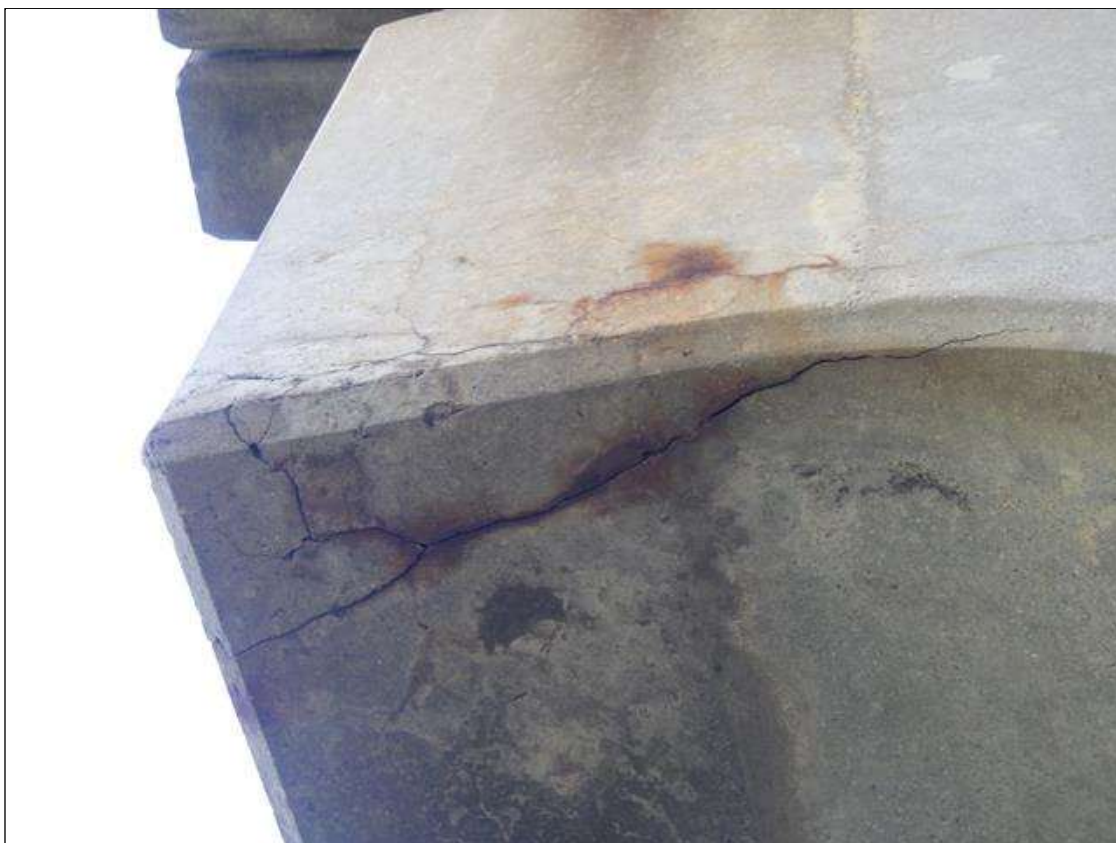
Bent 3 Cap 1: DELAMINATED AREA UP TO 2 FEET LONG X 1 FOOT HIGH X 8 INCHES WIDE WITH RUST STAINING IN THE WEST FACE AND UNDERSIDE AT THE SOUTH END

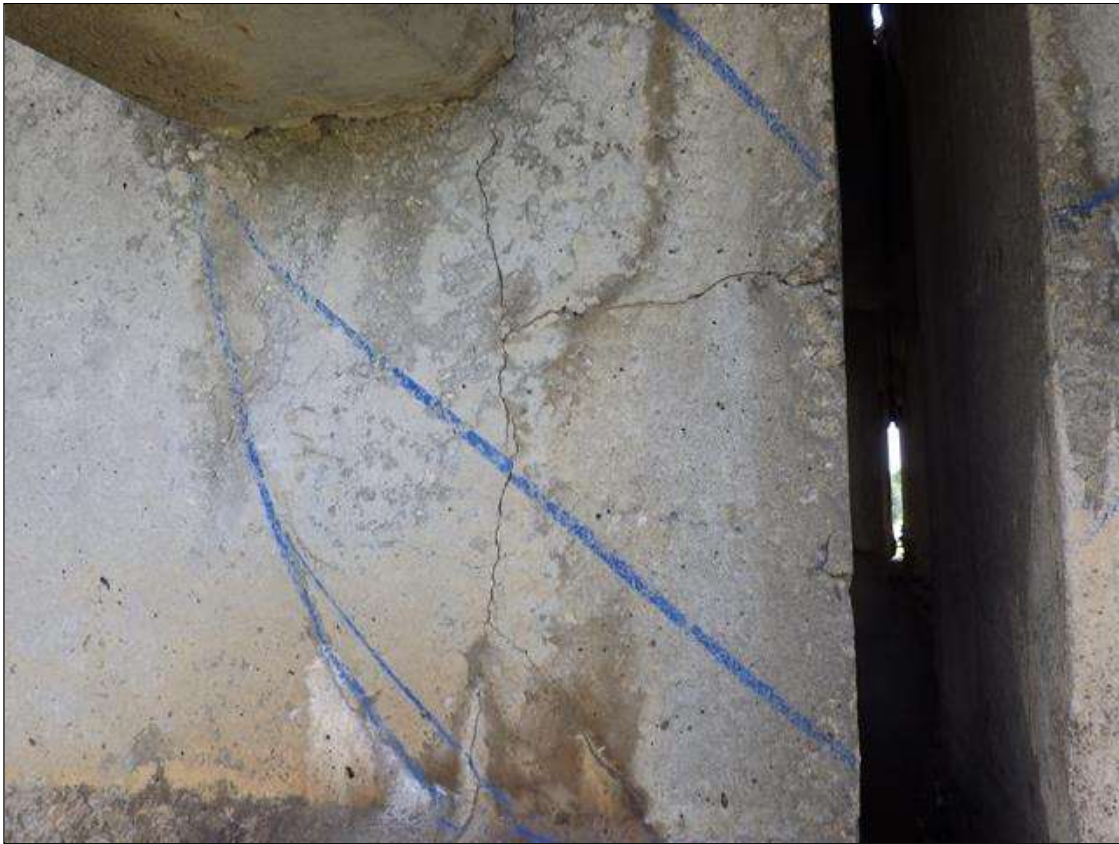
Span 3 Beam 1: DELAMINATED AREA UP TO 1 FOOT 3 INCHES LONG X FULL HEIGHT X FULL WIDTH IN THE LEFT SIDE OF WEB AT BENT 2
