NC DEPARTMENT OF TRANSPORTATION  
 DIVISION OF HIGHWAYS  
 STRUCTURE MANAGEMENT UNIT

ATTENTION: **PRIORITY ACTION REQUESTS; SIGN NOTICED  
 ISSUED FOR (2) MISSING DELINEATORS**

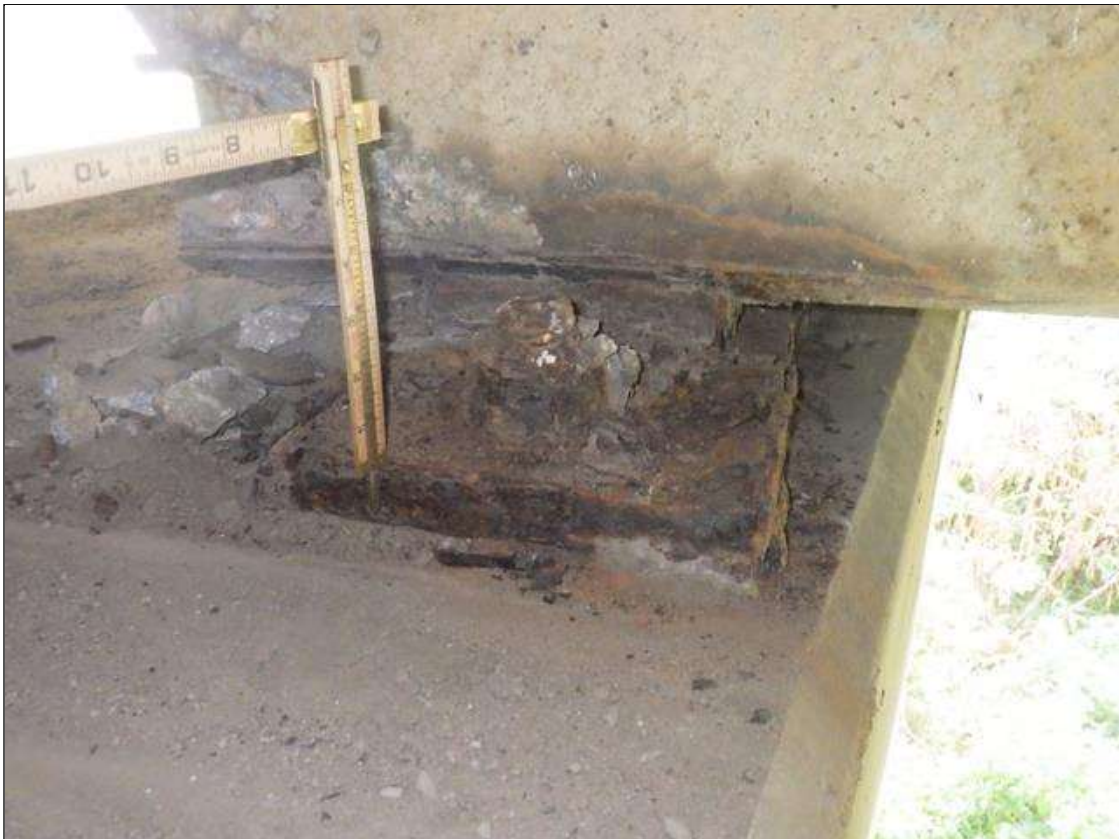
Span 1 Beam 2 - Far Bearing: ACTIVE CORROSION UP TO FULL PERIMETER X FULL HEIGHT WITH 1/32 INCH SECTION LOSS THROUGHOUT GIRDER 2 BEARING

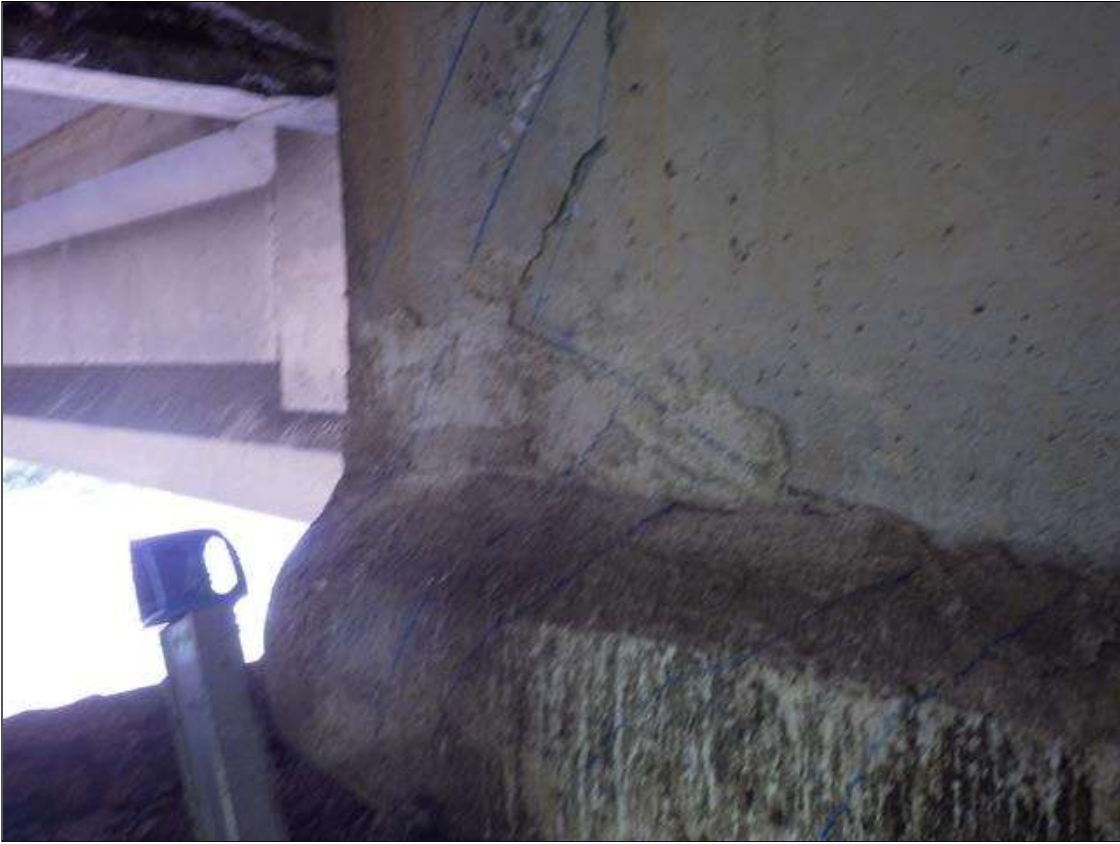
Span 1 Beam 3: DELAMINATED PATCH AREA UP TO 1 FOOT 9 INCHES LONG X FULL HEIGHT X 9 INCHES WIDE IN THE LEFT FACE OF THE WEB AND BOTTOM FLANGE AT BENT 1

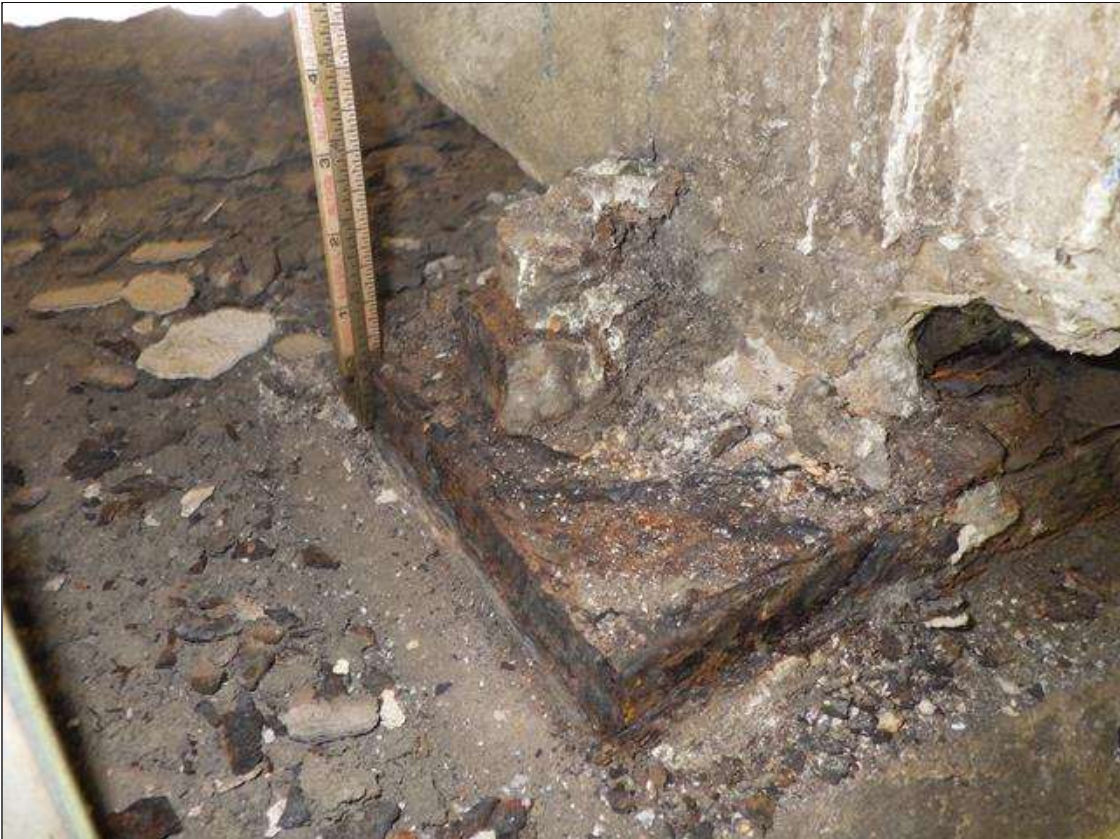
Span 1 Beam 3 - Far Bearing: ACTIVE CORROSION UP TO FULL PERIMETER X FULL HEIGHT WITH 1/16 INCH SECTION LOSS THROUGHOUT GIRDER 3 BEARING

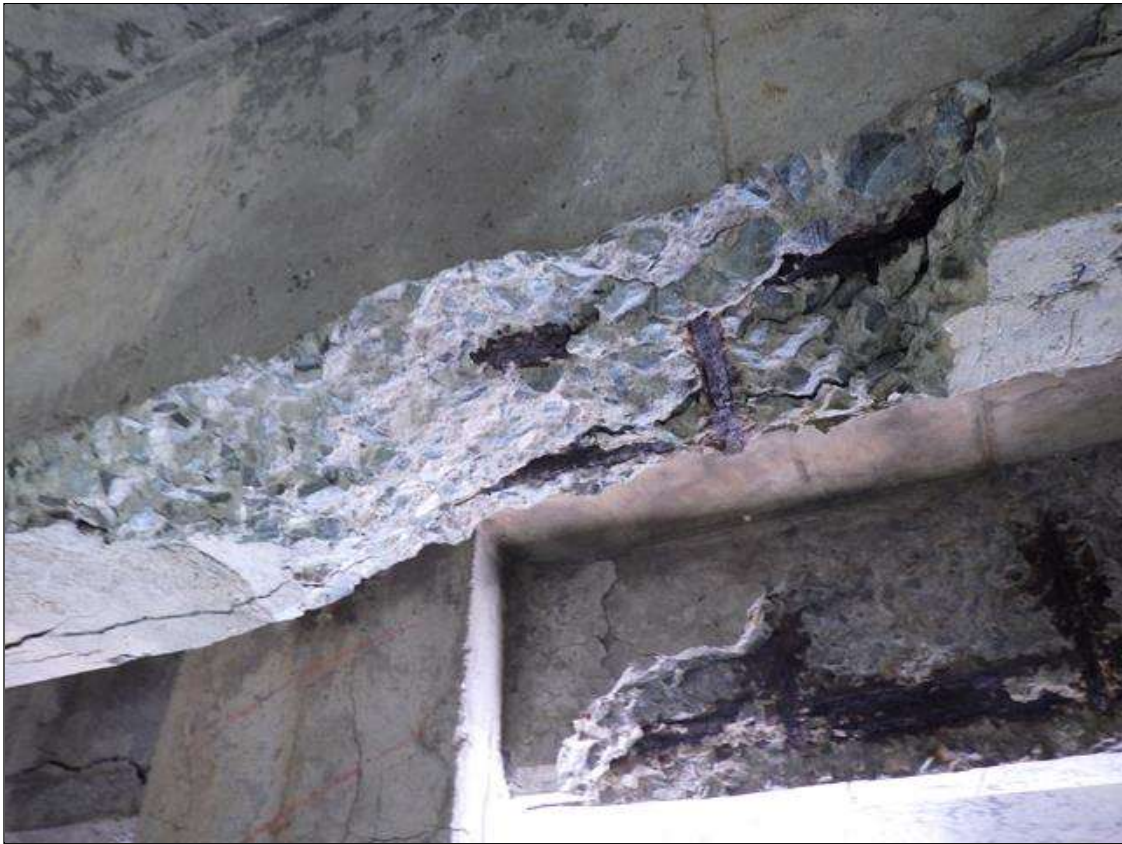
Span 1 Beam 2: DELAMINATED AND SPALLED AREA UP TO FULL LENGTH X FULL WIDTH X FULL HEIGHT WITH EXPOSED REINFORCEMENT IN BAY 2 END DIAPHRAGM AT BENT 1

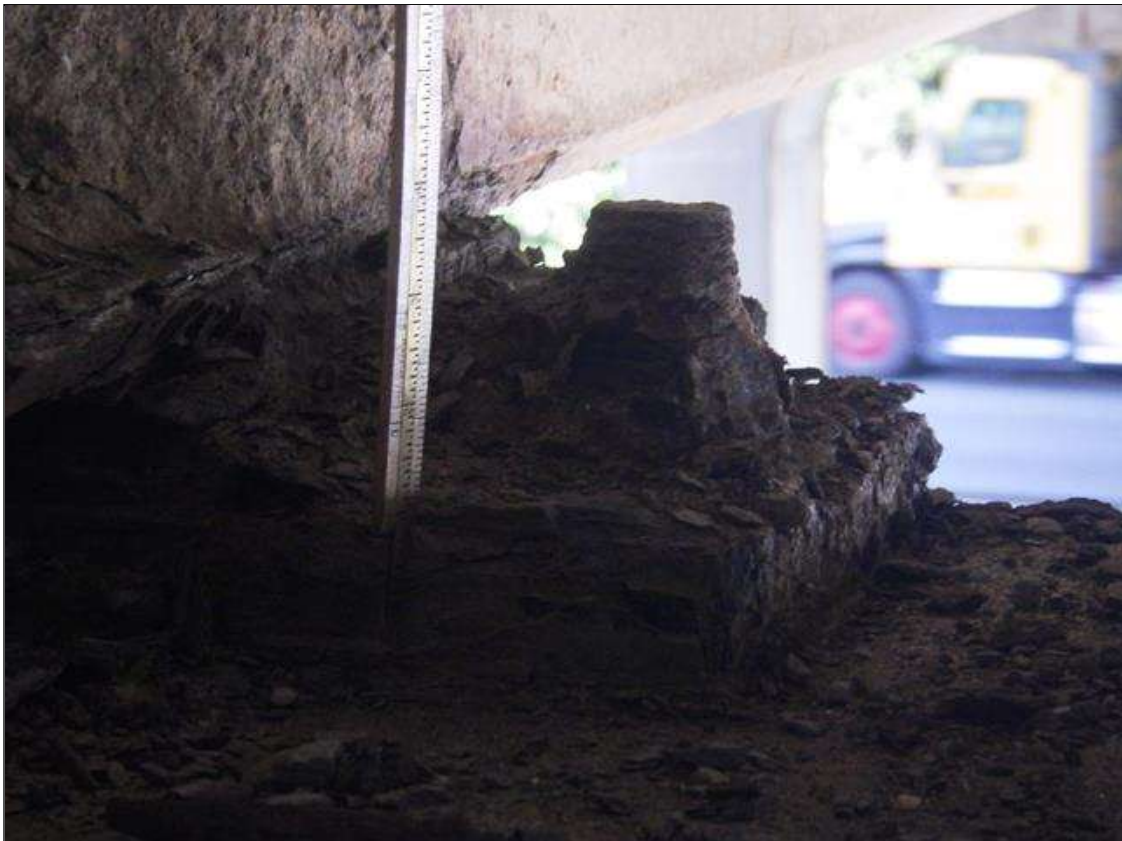
Span 1 Beam 4 - Far Bearing: ACTIVE CORROSION UP TO FULL PERIMETER X FULL HEIGHT WITH 1/16 INCH SECTION LOSS THROUGHOUT GIRDER 4 BEARING

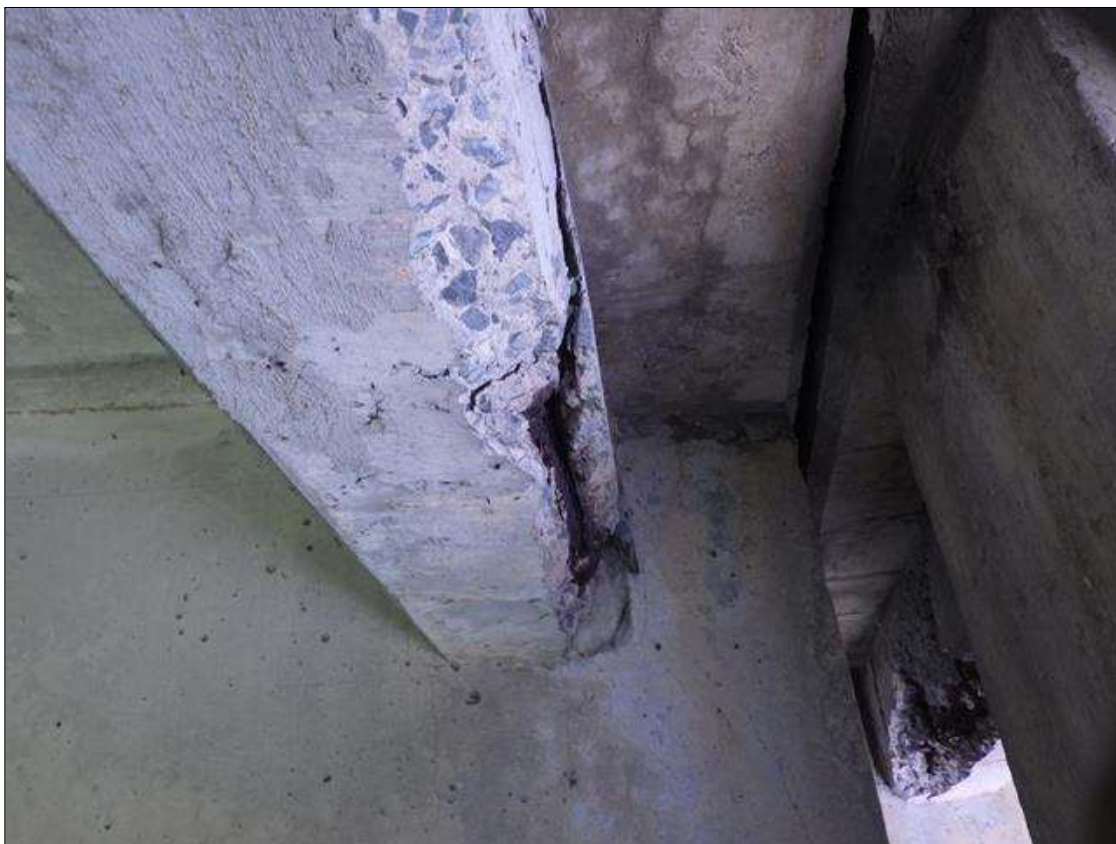
Span 1 Beam 3: DELAMINATED AND SPALLED AREA UP TO FULL LENGTH X FULL WIDTH X 4 INCHES HIGH WITH EXPOSED REINFORCEMENT IN BAY 3 END DIAPHRAGM AT BENT 1

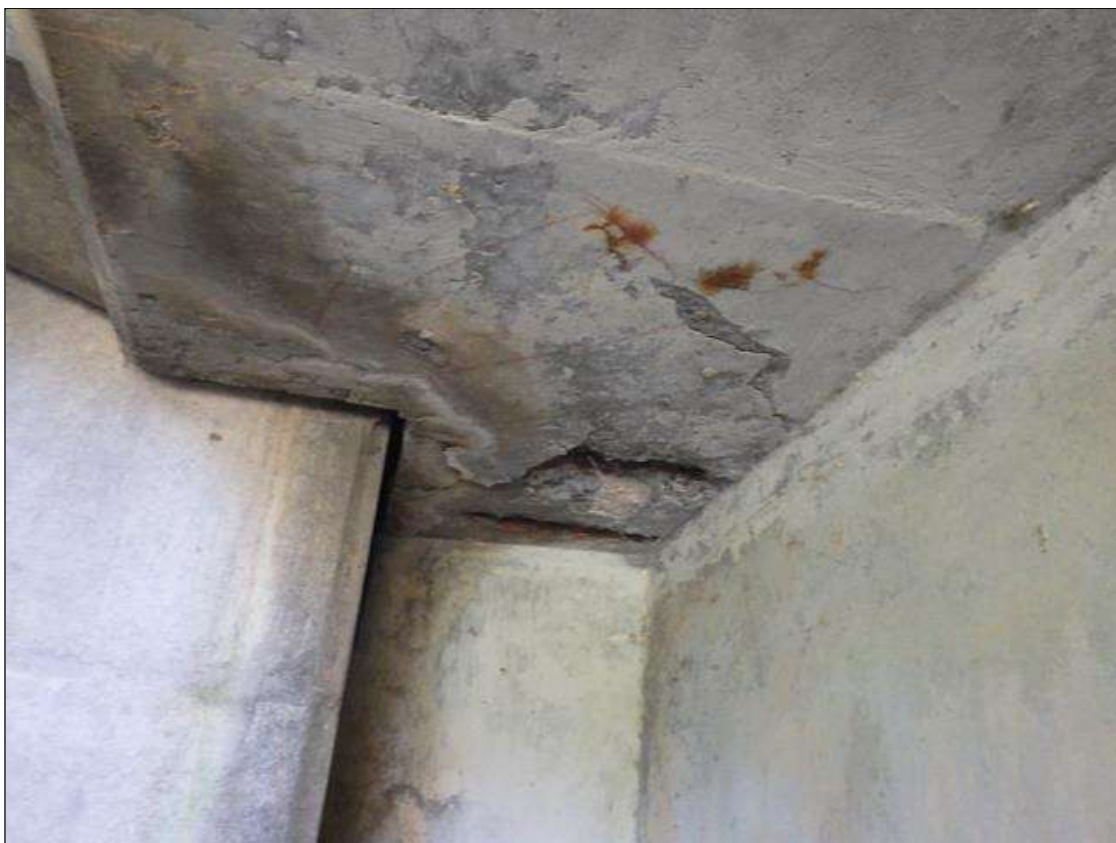
Span 1 Deck: DELAMINATED AND SPALLED AREA UP TO 2 FEET LONG X 2 FEET WIDE X 2 INCHES DEEP WITH EXPOSED REINFORCEMENT IN THE UNDERSIDE OF THE SOUTH OVERHANG AT END BENT 1

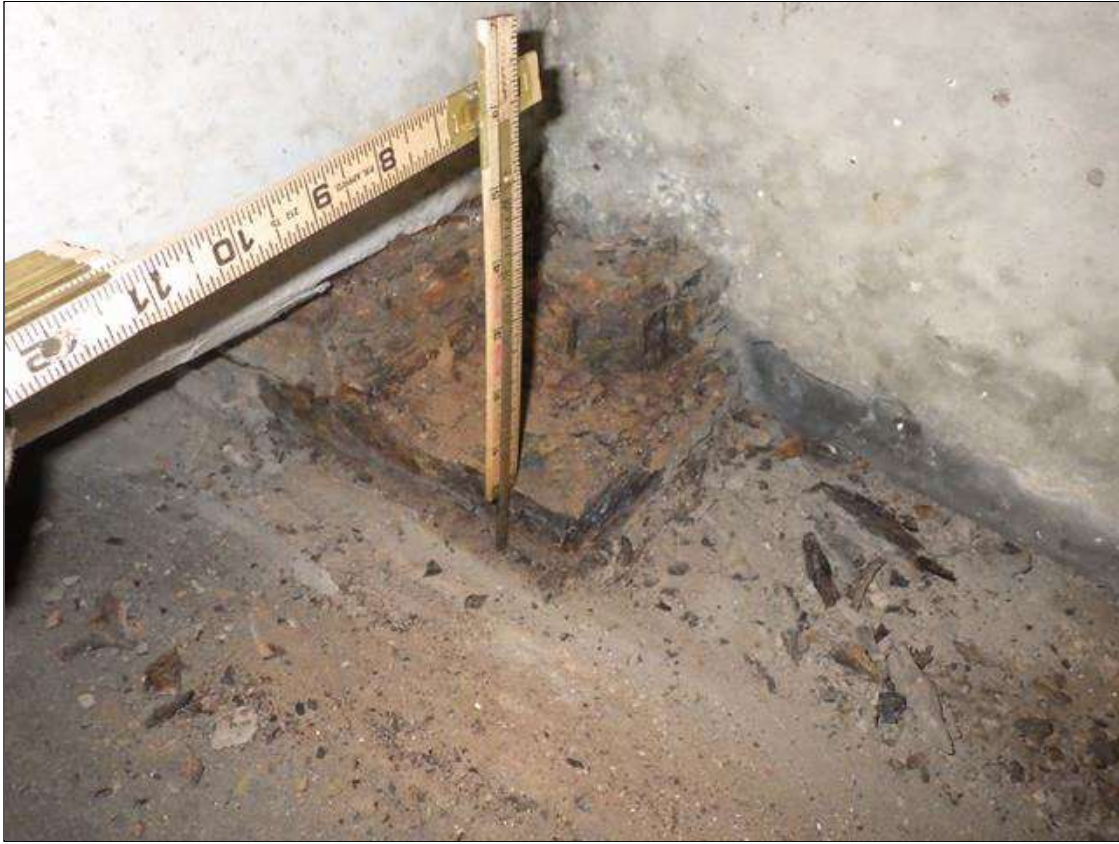
Span 1 Beam 4 - Near Bearing: ACTIVE CORROSION UP TO FULL PERIMETER X FULL HEIGHT WITH 1 1/4 INCHES REMAINING (GREATER THAN OR EQUAL TO 1/16 INCH SECTION LOSS AND LESS THAN 25 PERCENT SECTION LOSS) THROUGHOUT GIRDER 4 BEARING

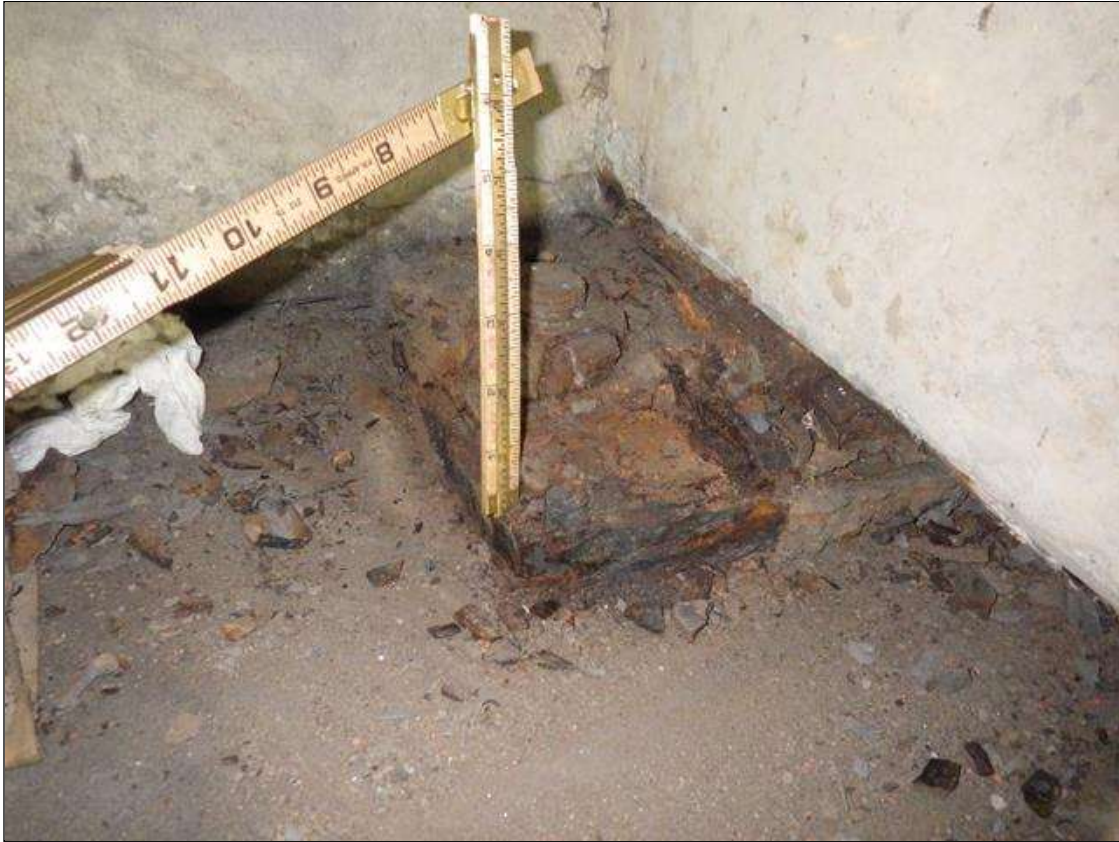
Span 1 Beam 1 - Near Bearing: ACTIVE CORROSION UP TO FULL PERIMETER X FULL HEIGHT WITH 1 1/4 INCHES REMAINING (GREATER THAN OR EQUAL TO 1/16 INCH SECTION LOSS AND LESS THAN 25 PERCENT SECTION LOSS) THROUGHOUT GIRDER 1 BEARING

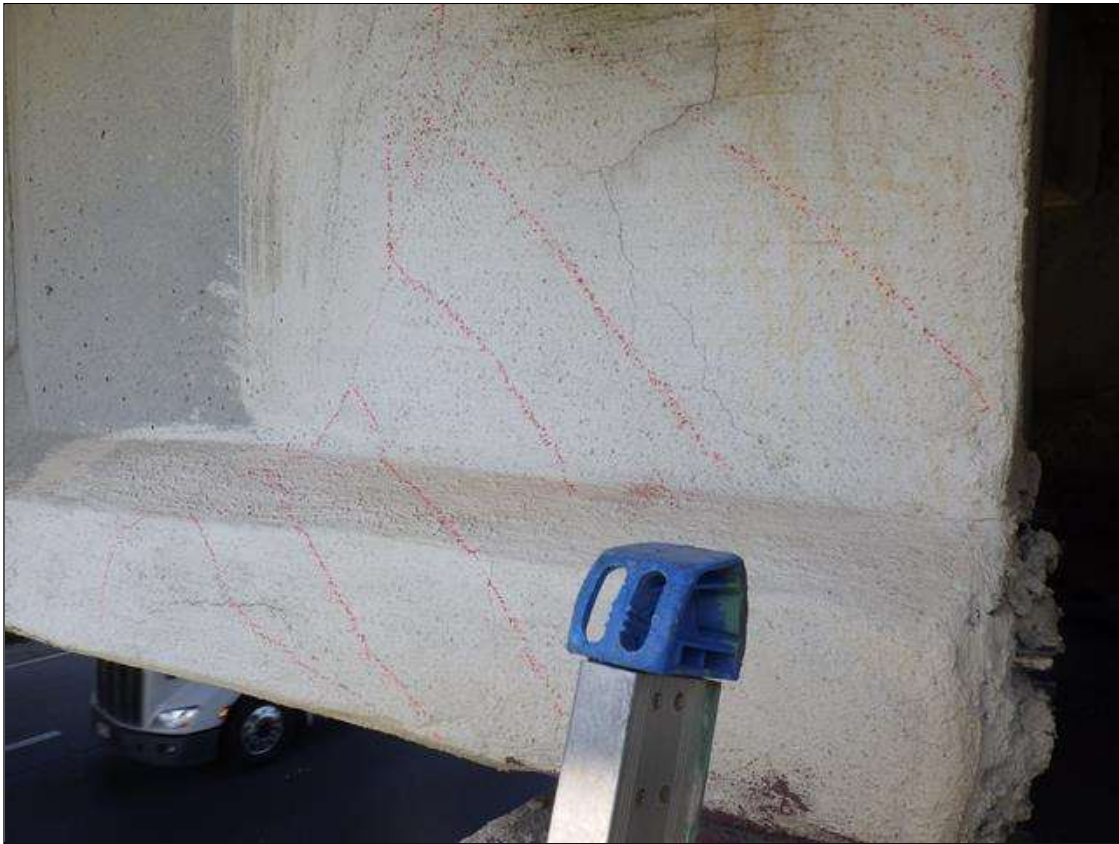
Span 2 Beam 5: DELAMINATED PATCH AREA UP TO 3 FEET 11 INCHES LONG X 2 FEET 5 INCHES HIGH X 9 INCHES WIDE IN THE RIGHT FACE OF THE WEB AND BOTTOM FLANGE AT BENT 2

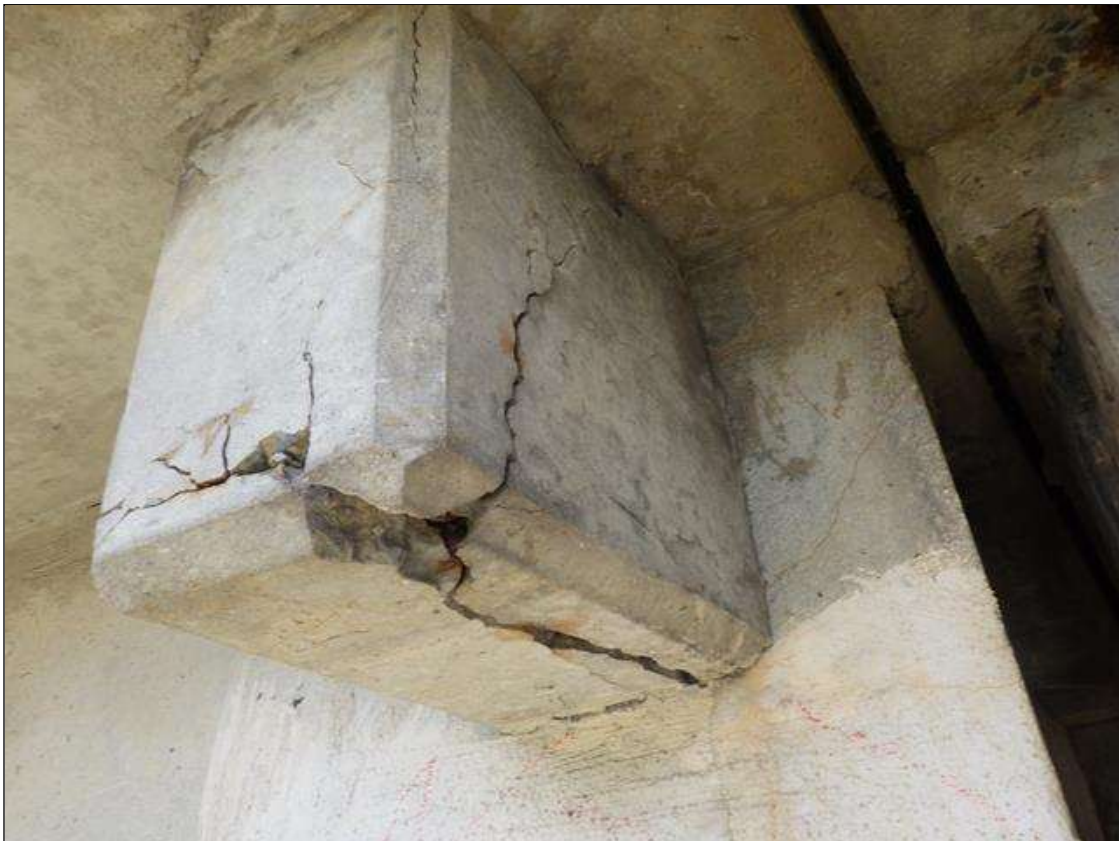
Span 2 Beam 5: DELAMINATED AND SPALLED AREA UP TO FULL LENGTH X FULL WIDTH X FULL HEIGHT WITH EXPOSED REINFORCEMENT IN THE END DIAPHRAGM BELOW THE SOUTH OVERHANG AT BENT 2

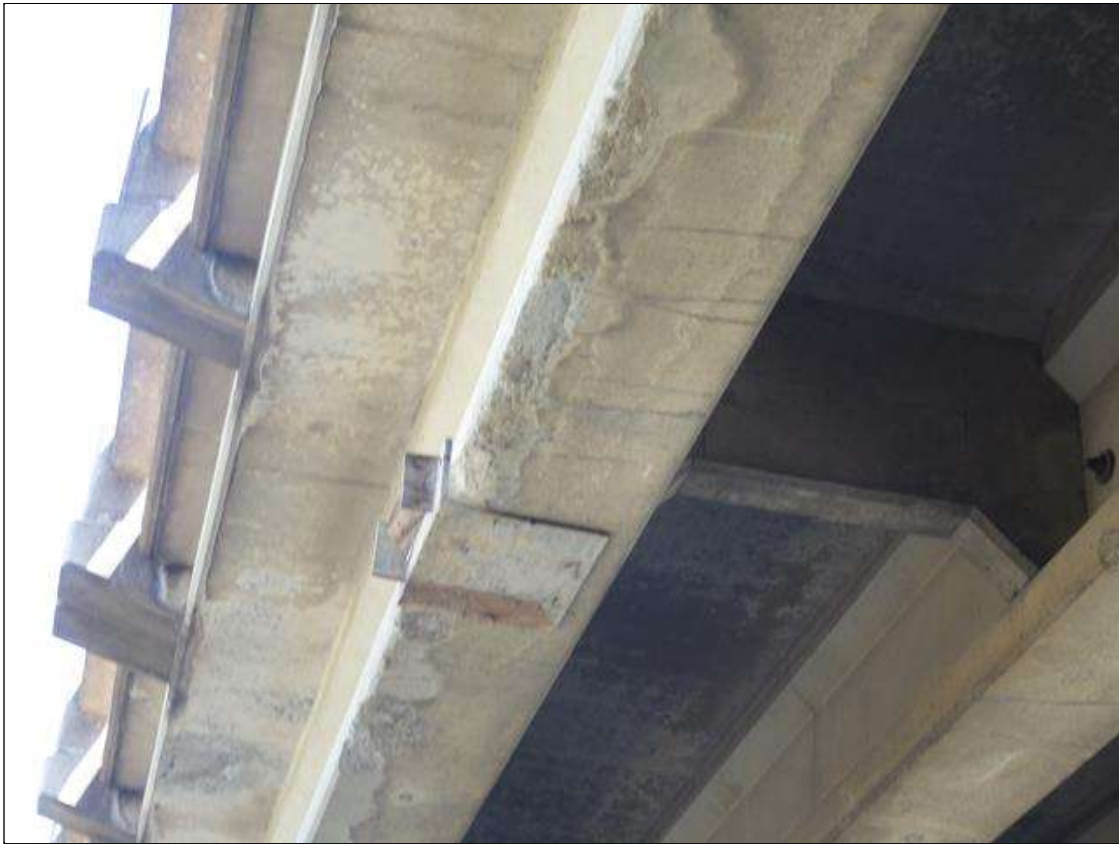
Span 2 Beam 1: SPALLED AREA UP TO INTERMITTENT 19 FEET LONG X 4 INCHES HIGH X 8 INCHES WIDE IN THE LEFT BOTTOM FLANGE, 12 FEET FROM BENT 1

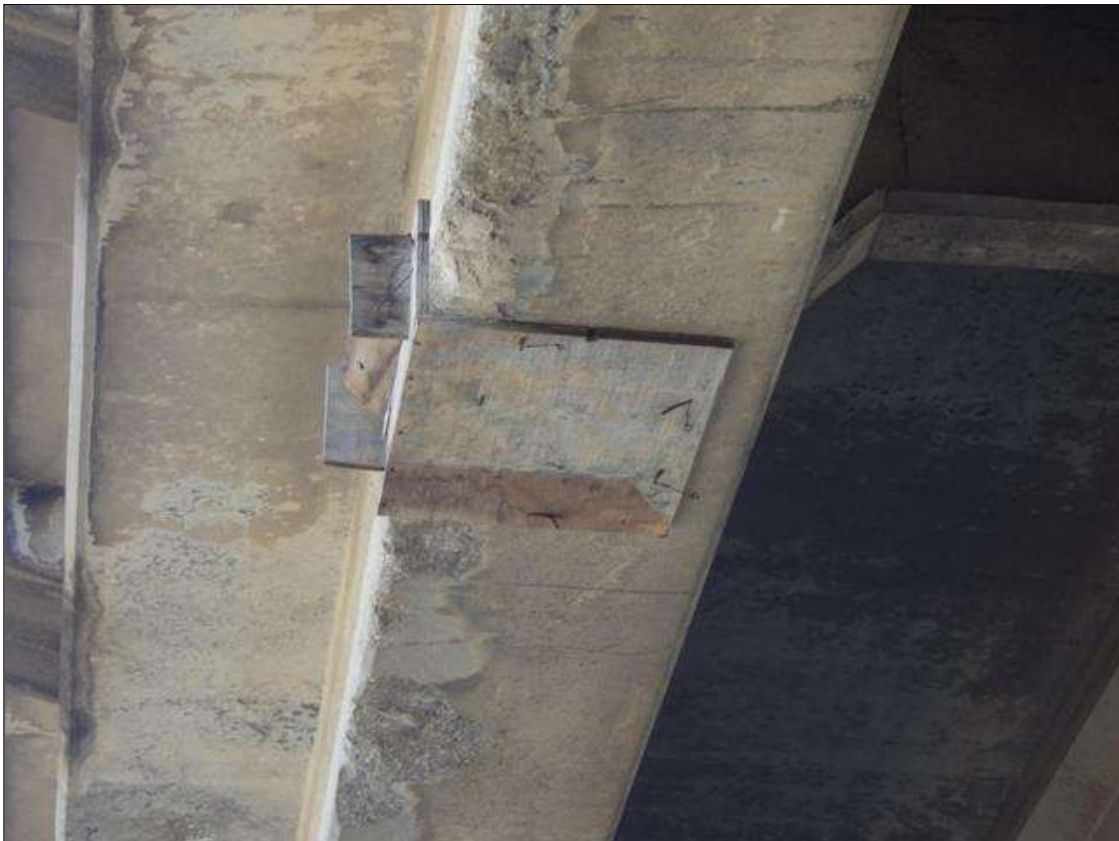
Span 2 Beam 2: (2) SPALLED AREAS UP TO 1 FOOT LONG X 4 INCHES WIDE X 3 INCHES HIGH IN THE LEFT BOTTOM FLANGE ABOVE THE MERGE ON RAMP LANE

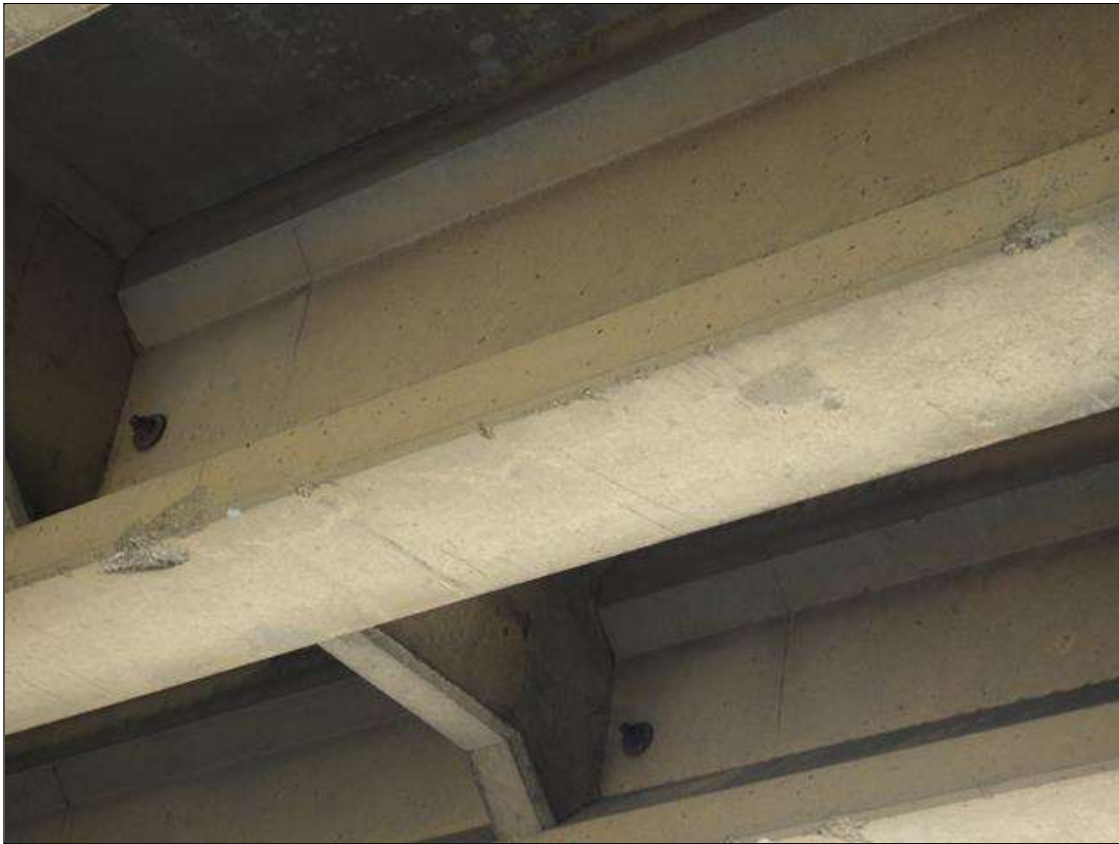
Span 2 Beam 3: (2) SPALLED AREAS UP TO 1 FOOT LONG X 4 INCHES WIDE X 4 INCHES HIGH IN THE LEFT BOTTOM FLANGE ABOVE THE MERGE ON RAMP LANE

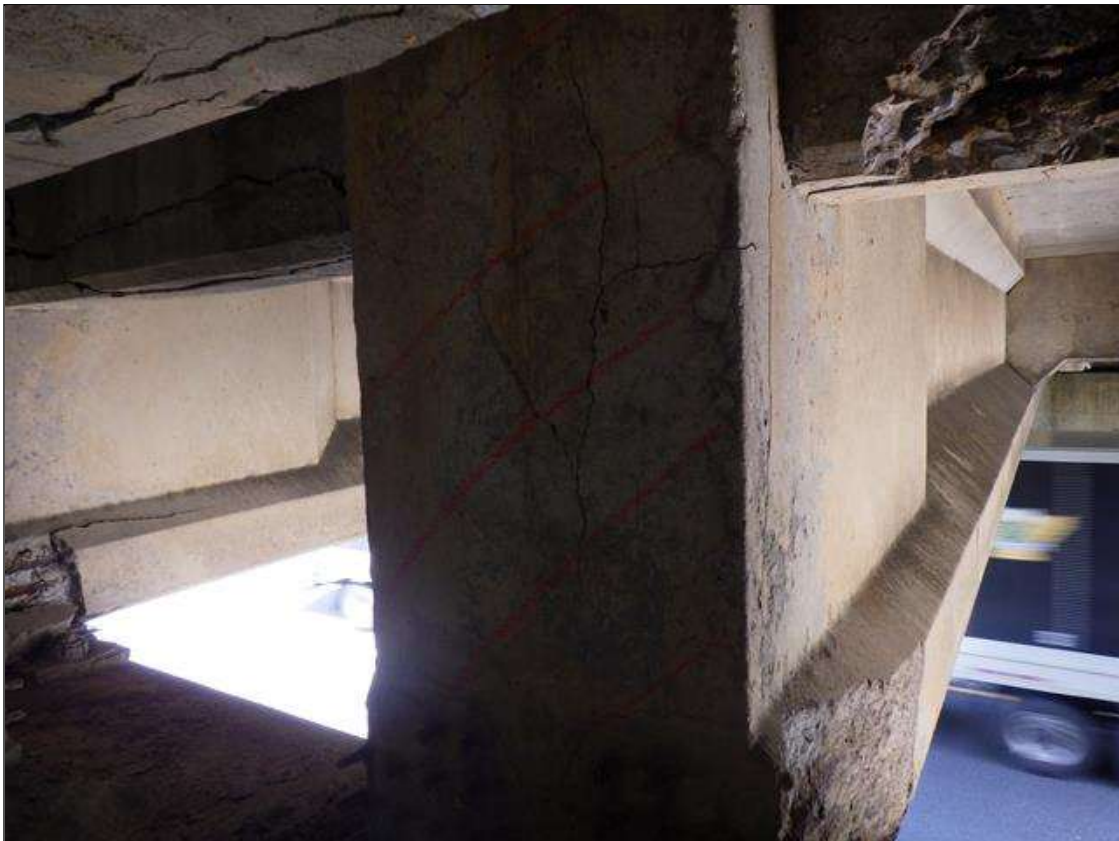
Span 2 Beam 3: DELAMINATED AREA UP TO 2 INCHES LONG X FULL HEIGHT X FULL WIDTH IN THE WEST FACE OF THE WEB AND FLANGES AT BENT 1

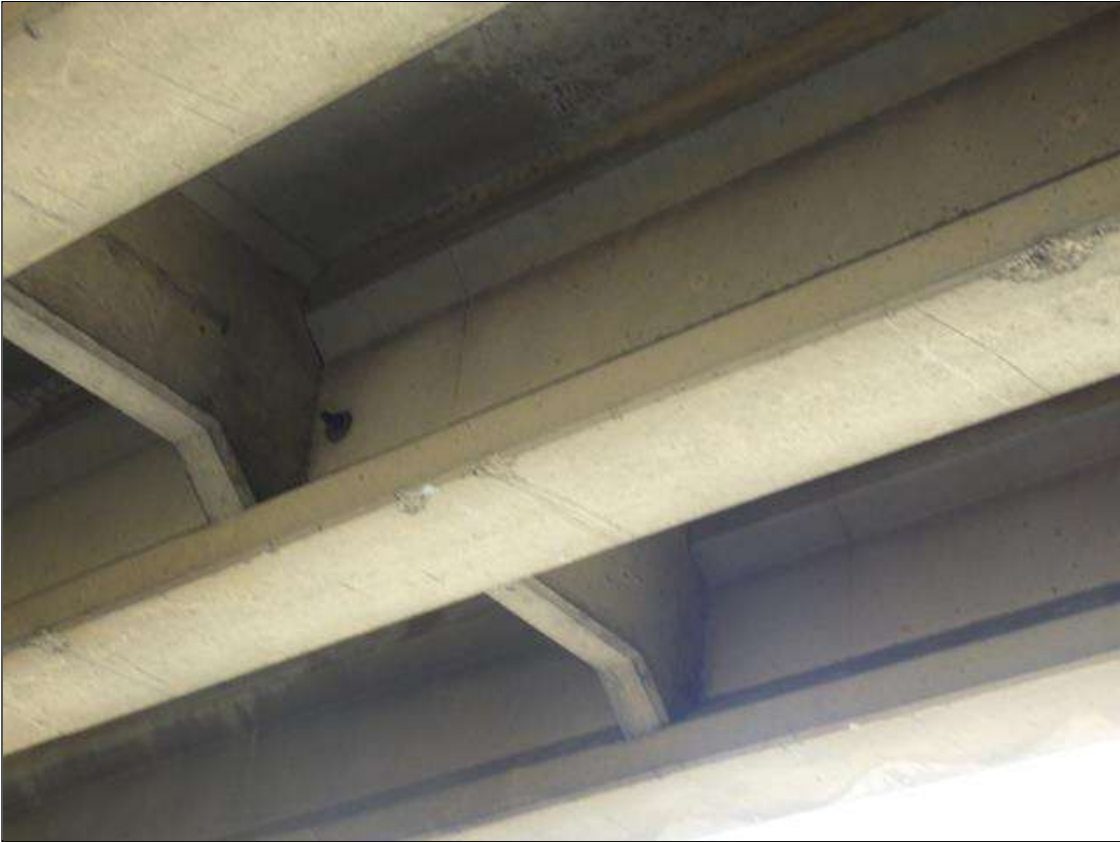
Span 2 Beam 4: (4) SPALLED AREAS UP TO 10 INCHES LONG X 4 INCHES WIDE X 2 INCHES HIGH IN THE LEFT BOTTOM FLANGE ABOVE THE RIGHT SOUTHBOUND THRU LANE

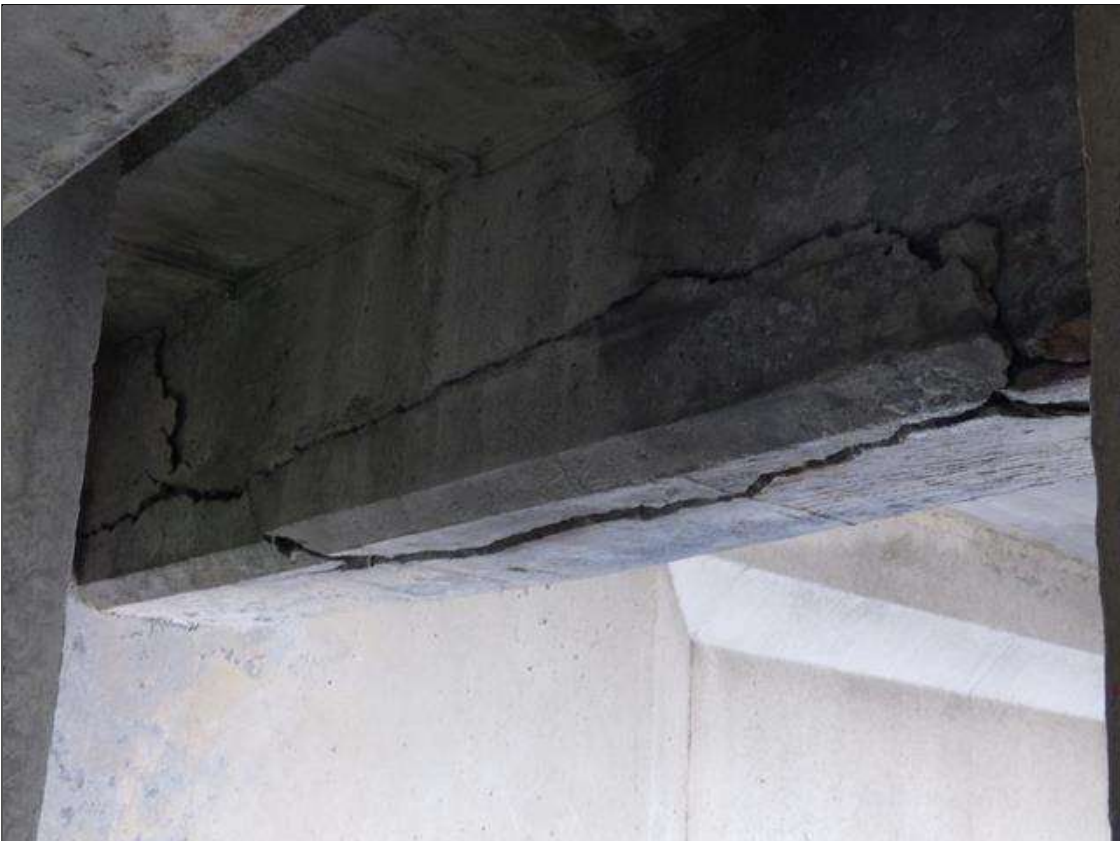
Span 2 Beam 2: DELAMINATED UP TO FULL LENGTH X FULL WIDTH X FULL HEIGHT IN BAY 2 END DIAPHRAGM AT BENT 1

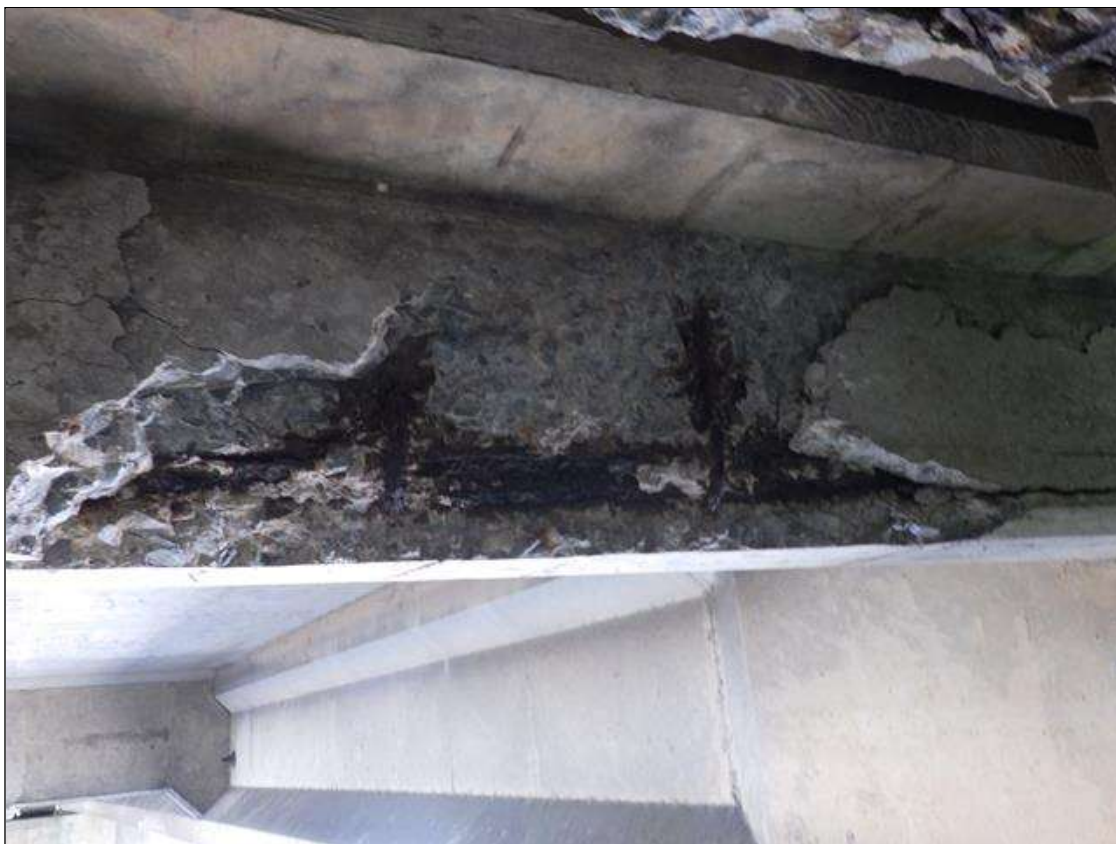
Span 2 Beam 3: DELAMINATED AND SPALLED AREA UP TO FULL LENGTH X FULL WIDTH X FULL HEIGHT WITH EXPOSED REINFORCEMENT IN BAY 3 END DIAPHRAGM AT BENT 1

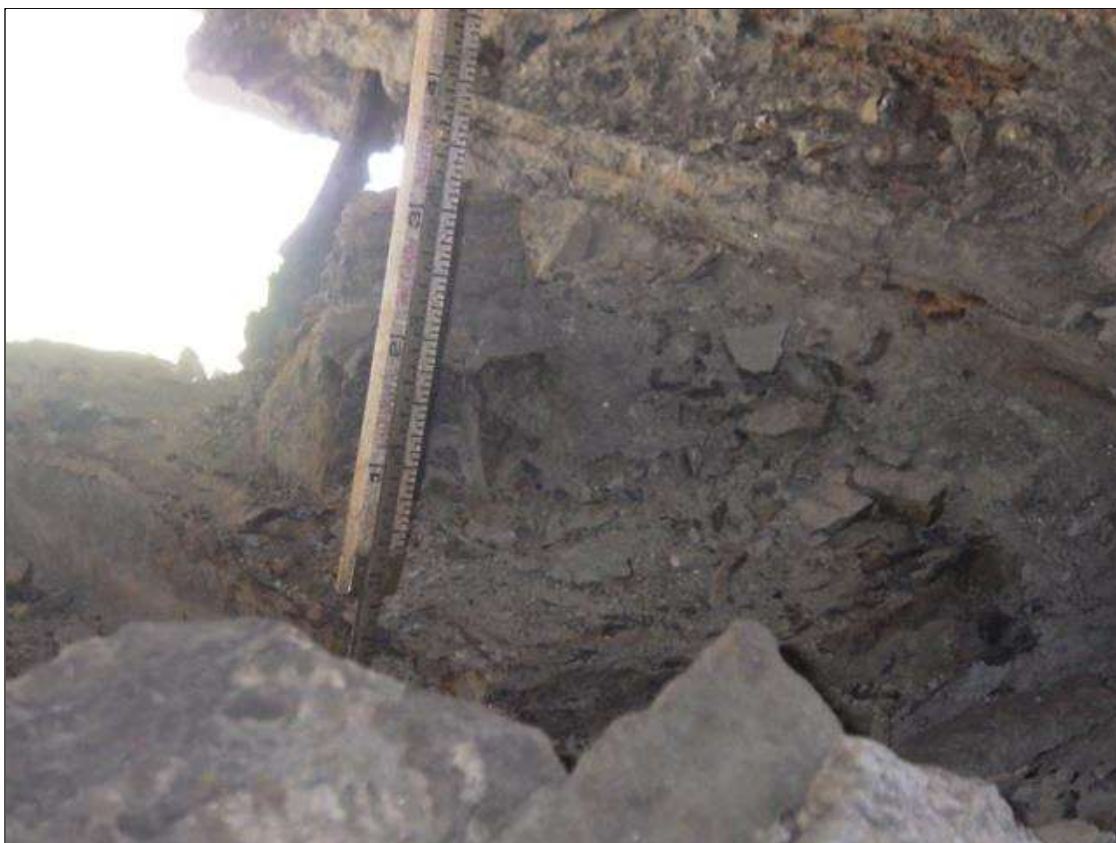
Span 2 Beam 5 - Near Bearing: ACTIVE CORROSION UP TO FULL PERIMETER X FULL HEIGHT WITH 1/16 INCH SECTION LOSS THROUGHOUT GIRDER 5 BEARING

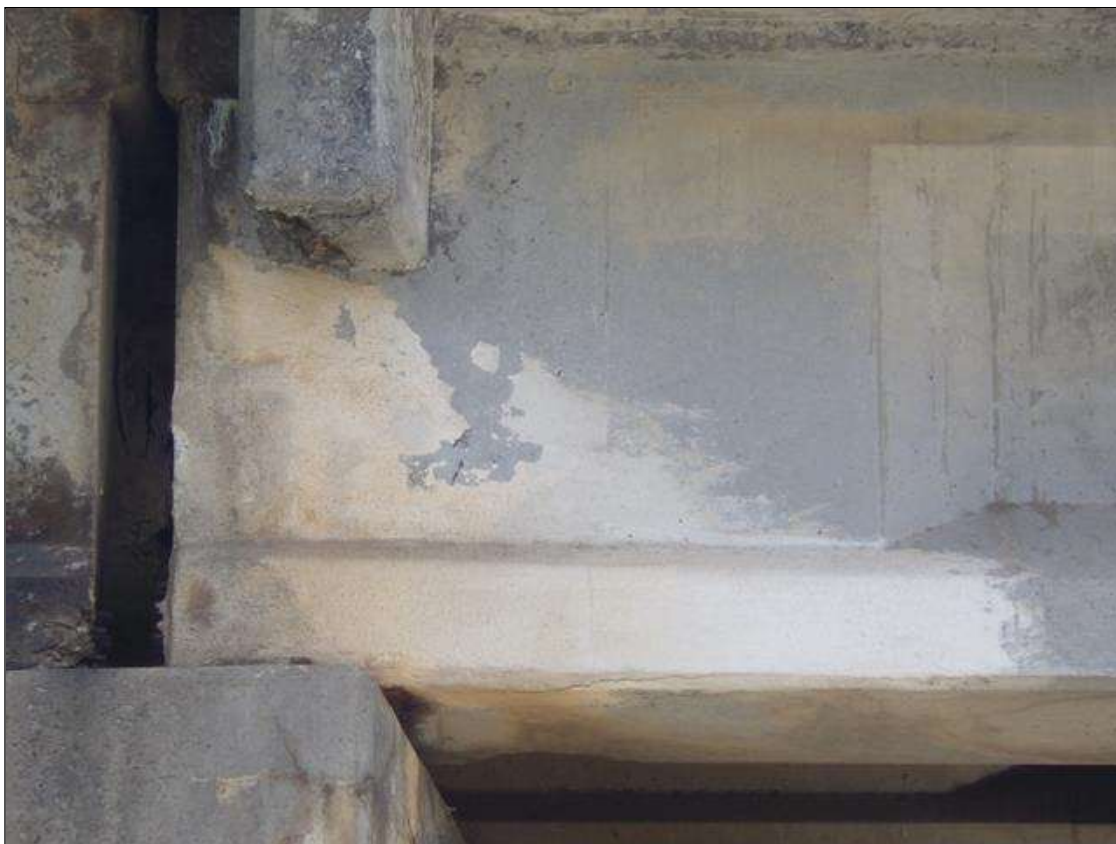
Span 2 Beam 2: PATCHED AREA UP TO 4 FEET LONG X 2 FEET 10 INCHES LONG X 3 INCHES WIDE IN THE RIGHT FACE OF THE WEB AND BOTTOM FLANGE AT BENT 1

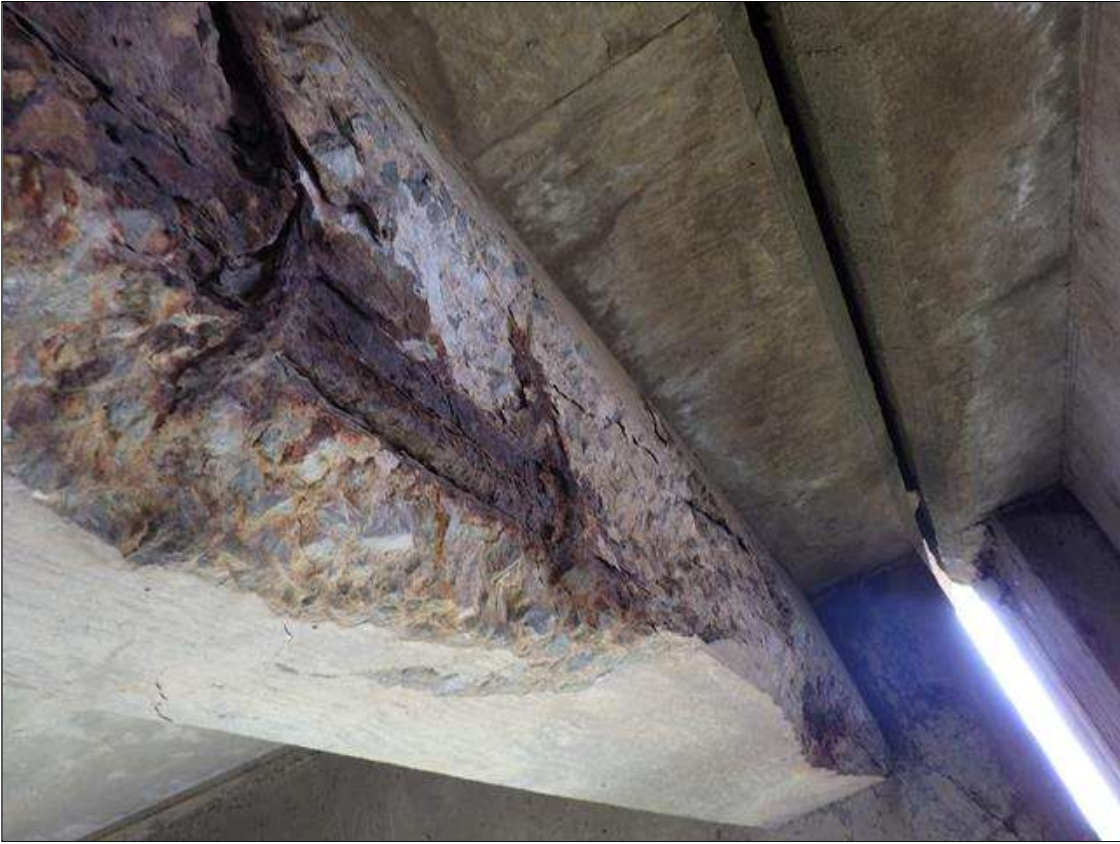
Span 3 Beam 3: SPALLED AREA UP TO FULL LENGTH X 6 INCHES WIDE X FULL HEIGHT WITH EXPOSED REINFORCEMENT IN BAY 3 END DIAPHRAGM AT BENT 2

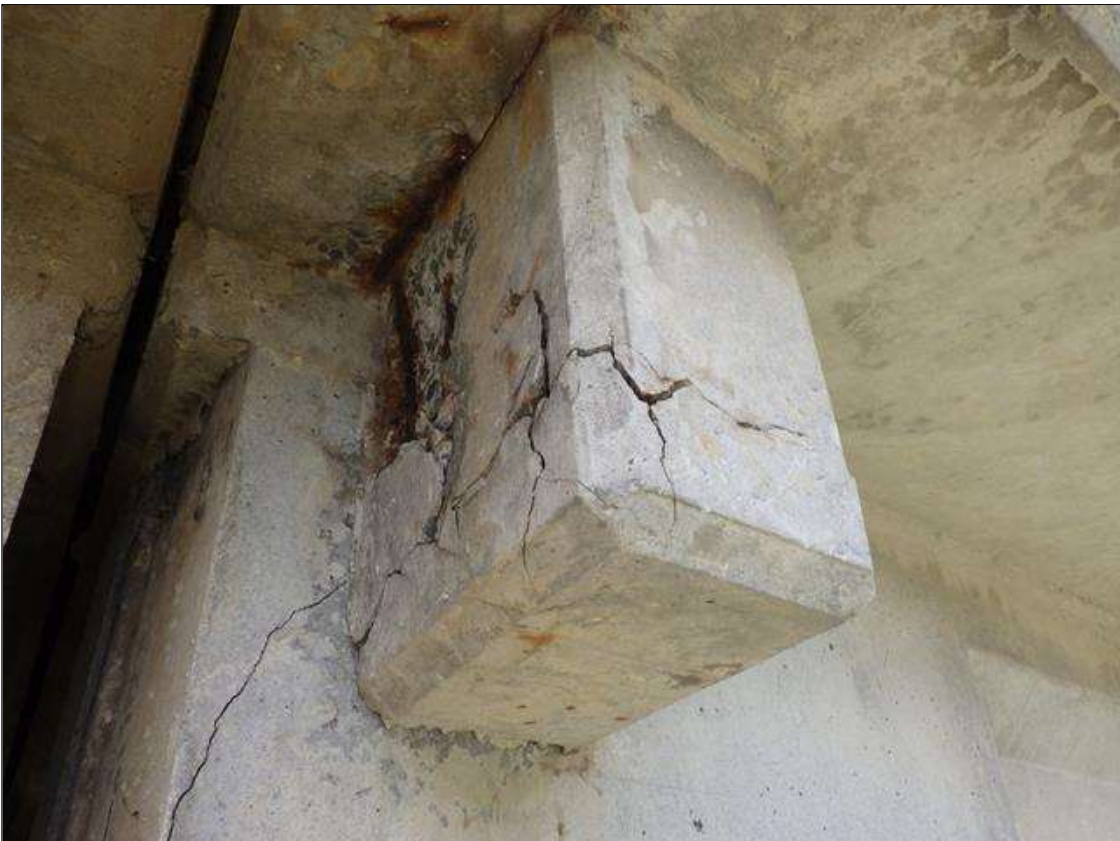
Span 3 Beam 4: DELAMINATED AND SPALLED AREA UP TO FULL LENGTH X FULL WIDTH X FULL HEIGHT WITH EXPOSED REINFORCEMENT IN THE END DIAPHRAGM BELOW THE SOUTH OVERHANG AT BENT 2

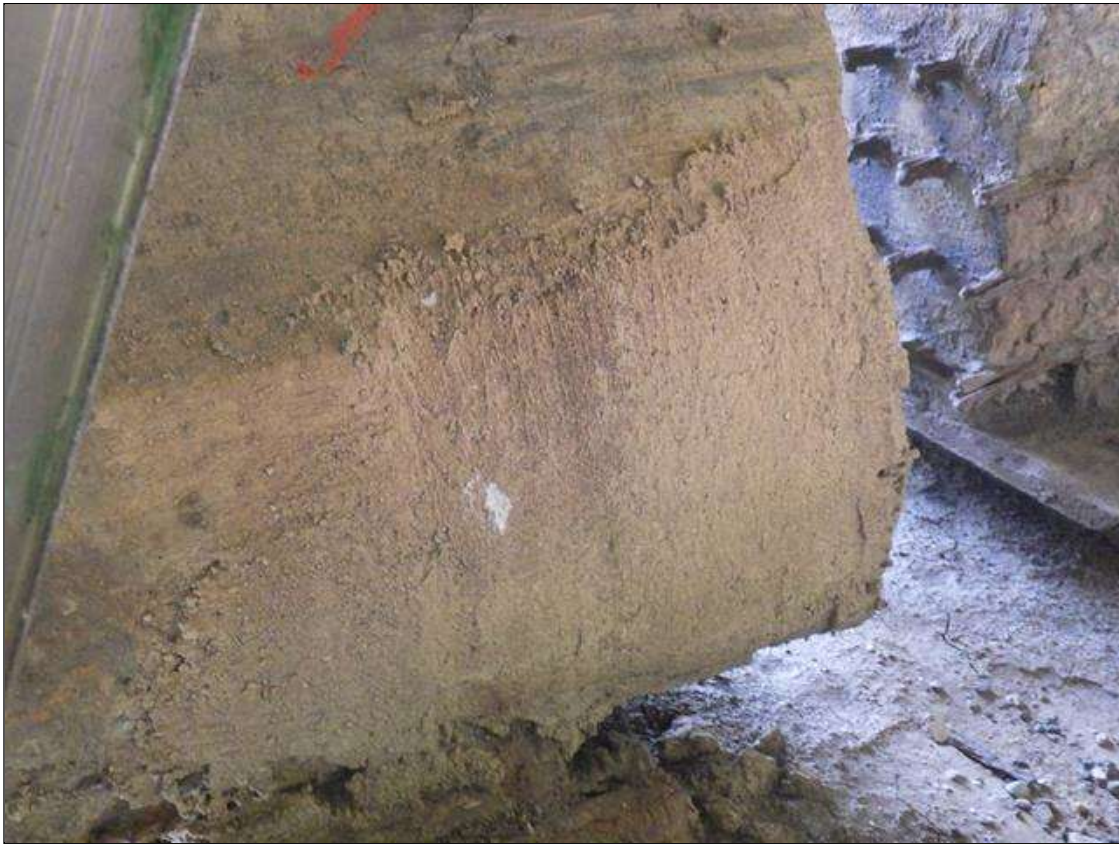
Span 3 Beam 4: PATCHED AREA UP TO 1 FOOT LONG X 10 INCHES HIGH X 3 INCHES WIDE IN THE LEFT BOTTOM FLANGE AT BENT 2
