NC DEPARTMENT OF TRANSPORTATION  
 DIVISION OF HIGHWAYS  
 STRUCTURE MANAGEMENT UNIT

ATTENTION: **PRIORITY ACTION REQUESTS; SIGN NOTICED  
 ISSUED FOR (2) MISSING DELINEATORS**

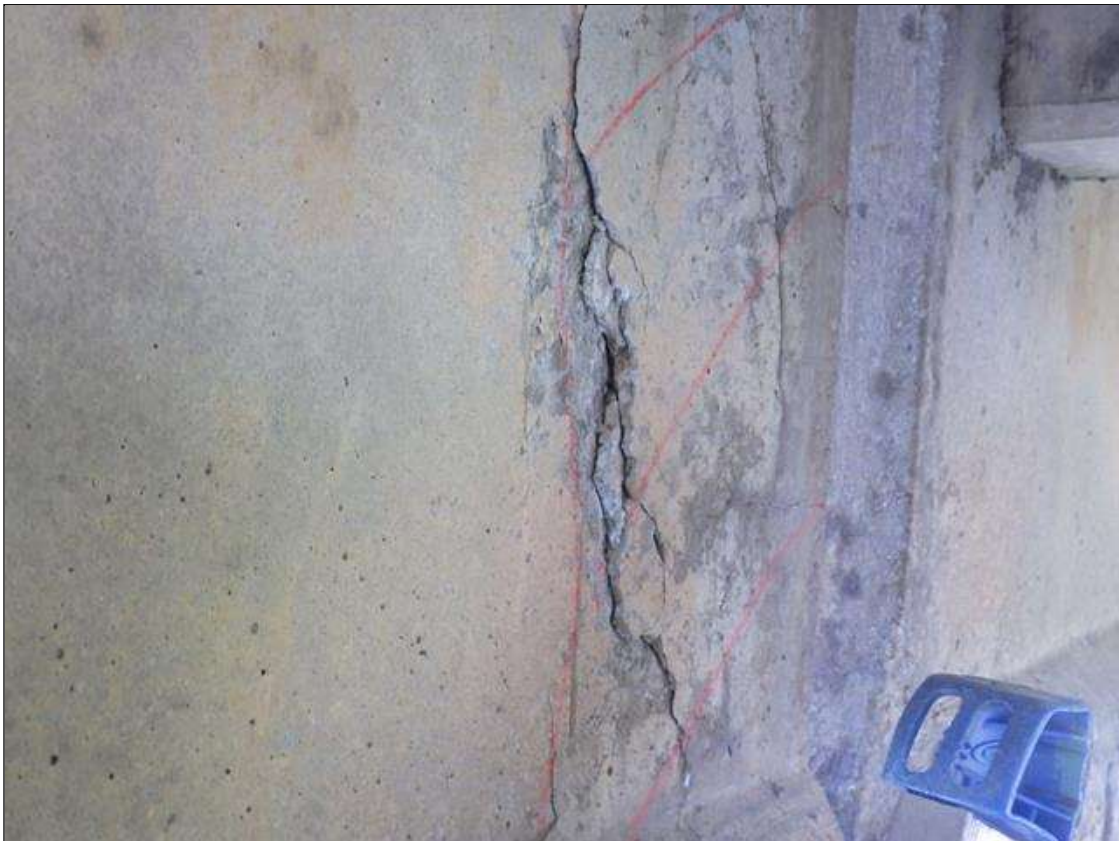
Span 3 Beam 4: DELAMINATED AND SPALLED AREA UP TO 1 FOOT 2 INCHES LONG X FULL HEIGHT X 1 INCH DEEP IN THE LEFT FACE OF THE WEB AT BENT 2

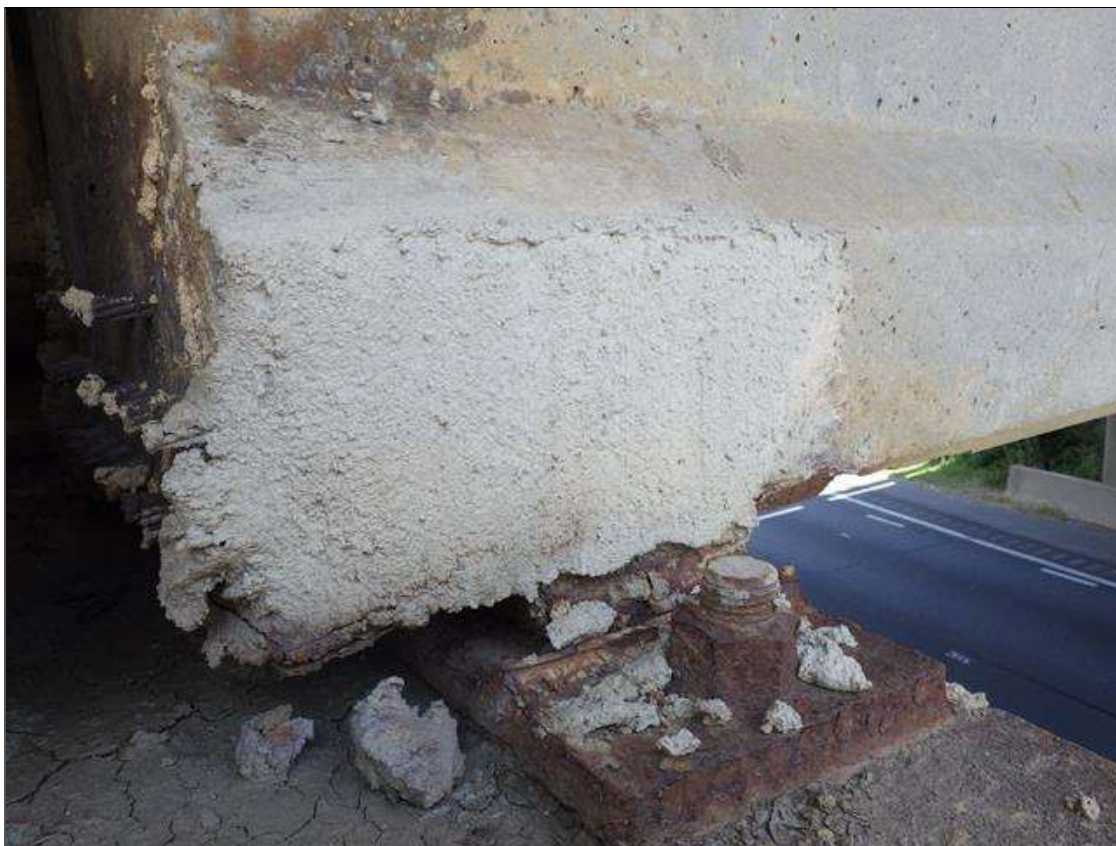
Span 3 Beam 4: PATCHED AREA UP TO 1 FOOT 4 INCHES LONG X 10 INCHES HIGH X 3 INCHES WIDE IN THE RIGHT BOTTOM FLANGE AT BENT 2

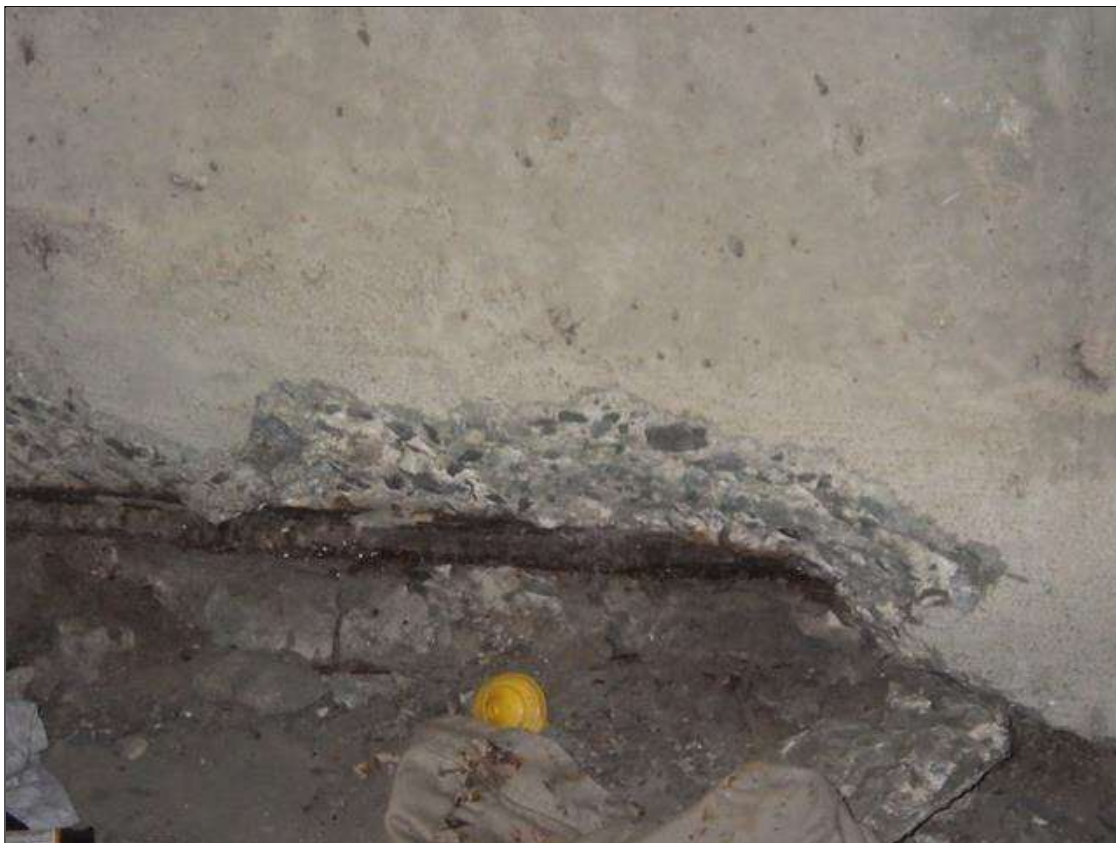
End Bent 1 Abutment: SPALLED AREA UP TO 2 FEET LONG X 6 INCHES HIGH X 3 INCHES DEEP WITH EXPOSED REINFORCEMENT IN BAY 1

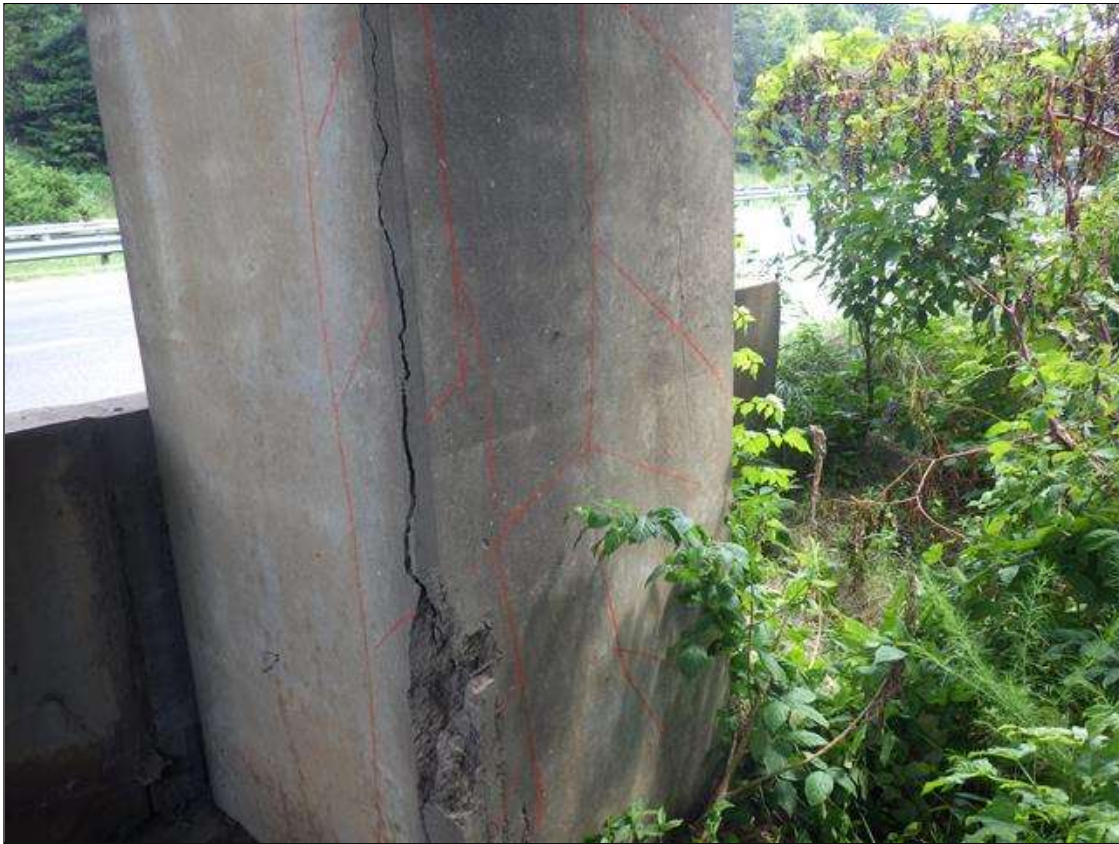
**Bent 1 Pile 2: DELAMINATED AND SPALLED AREA UP TO FULL HEIGHT X FULL LENGTH X 1 FOOT 2 INCHES WIDE IN THE WEST, NORTH, AND SOUTH FACES**

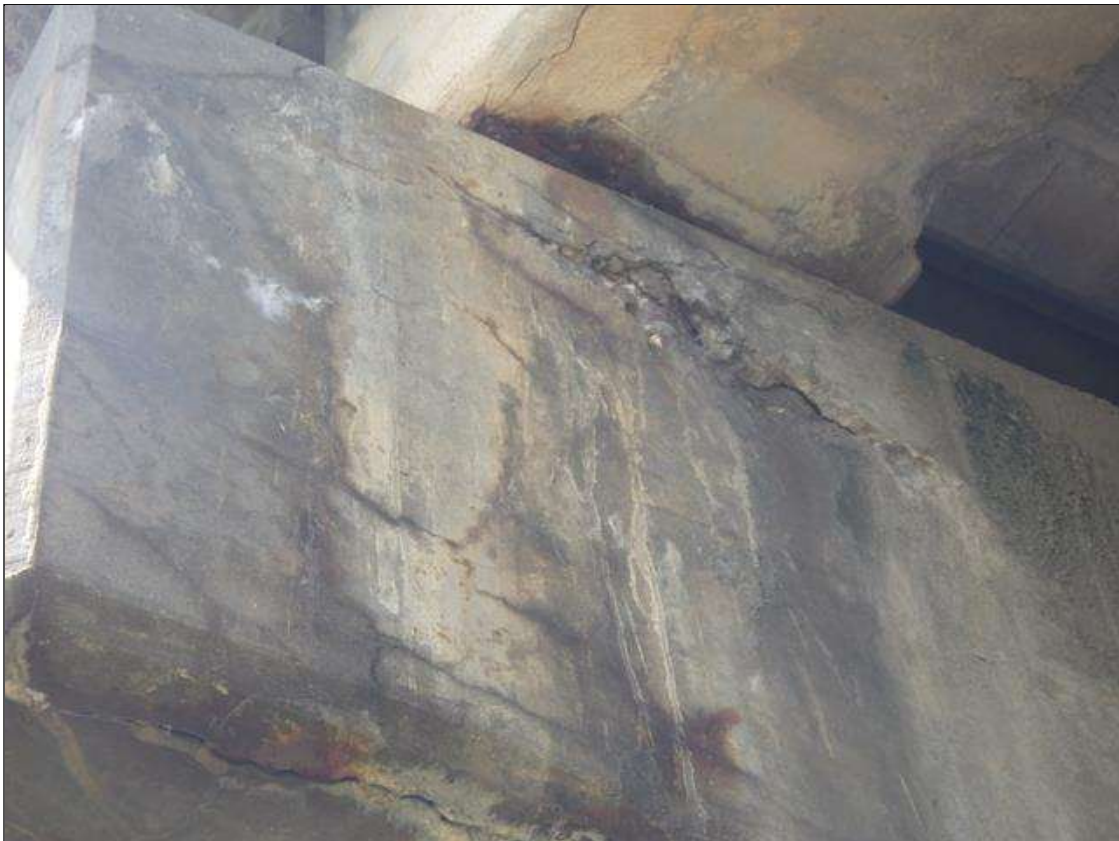
**Bent 1 Cap 1: DELAMINATED AND SPALLED AREA UP TO 3 FEET LONG X FULL HEIGHT X FULL WIDTH WITH EXPOSED REINFORCEMENT AND EFFLORESCENCE IN THE EAST AND SOUTH FACES**

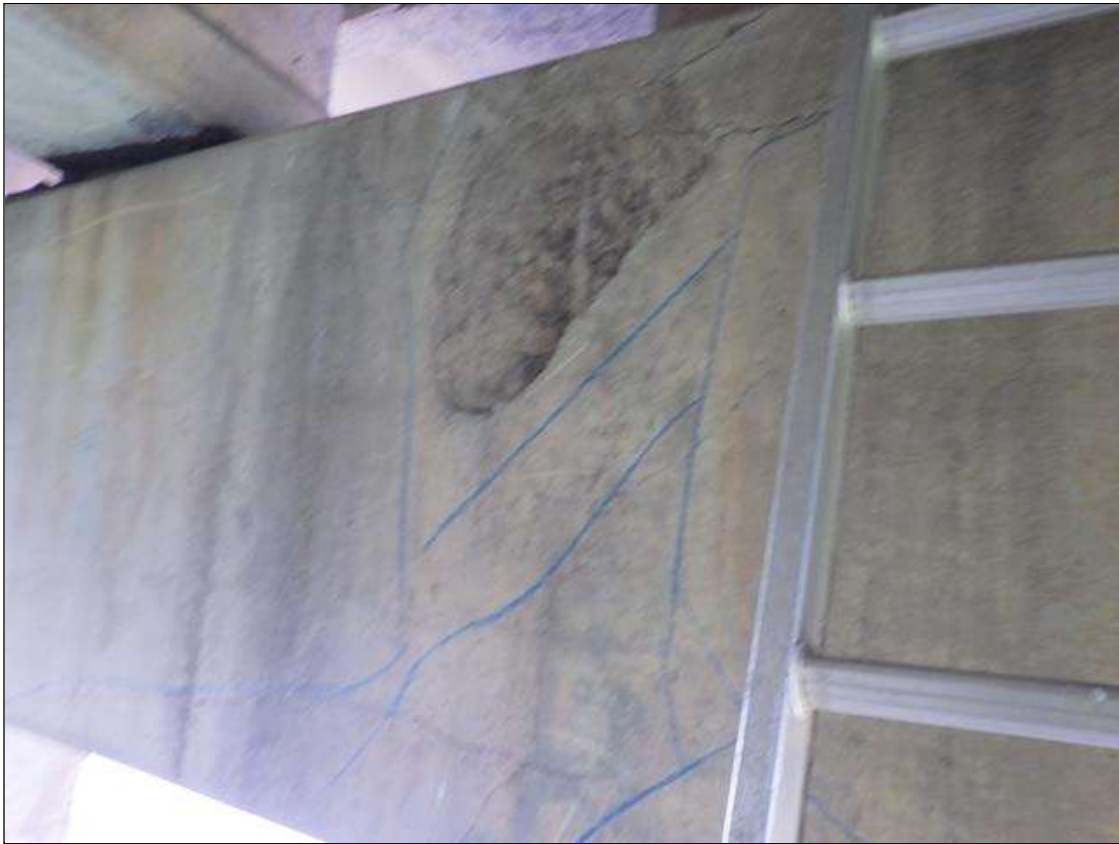
Bent 1 Cap 1: DELAMINATED AND SPALLED AREA UP TO 2 INCHES LONG X FULL HEIGHT X FULL WIDTH WITH EXPOSED REINFORCEMENT IN THE UNDERSIDE AND WEST FACES BELOW BAY 2

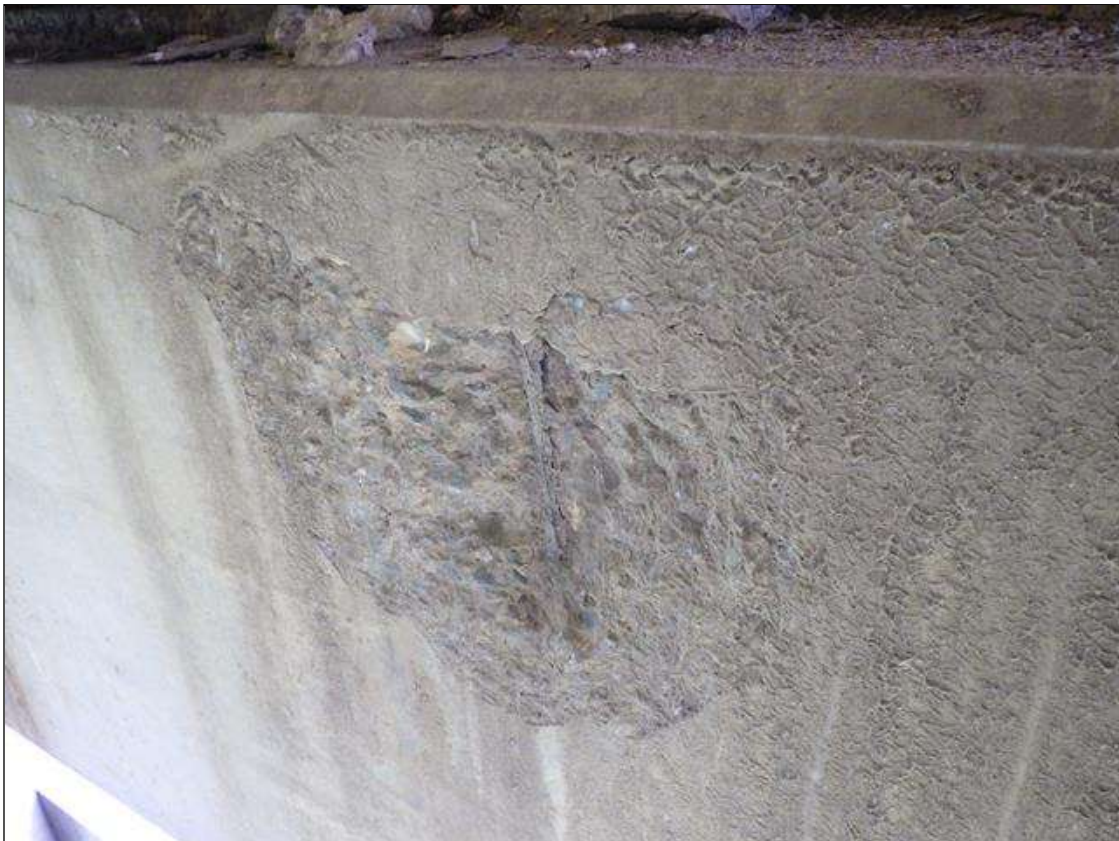
Bent 1 Cap 1: DELAMINATED AND SPALLED AREA UP TO 3 FEET LONG X 1 FOOT 4 INCHES HIGH X 1 INCH DEEP WITH EXPOSED REINFORCEMENT IN THE WEST FACE BELOW BAY 3

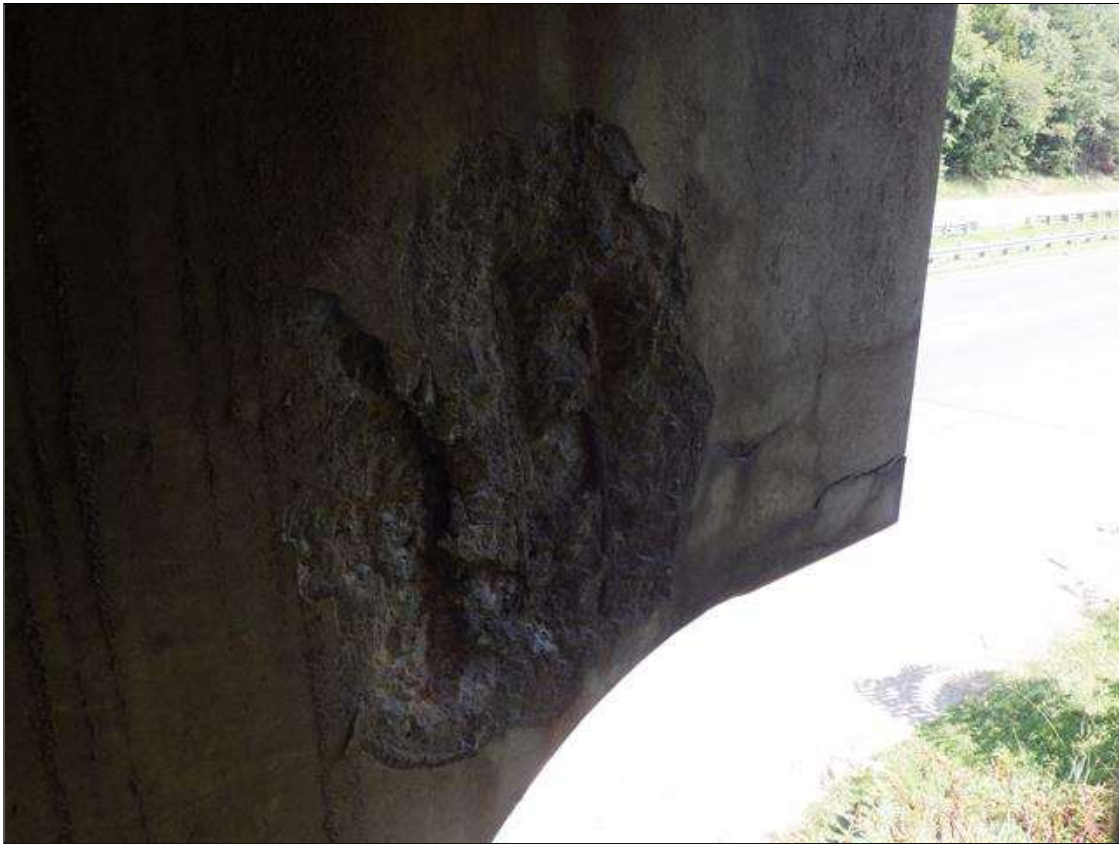
Bent 1 Cap 1: DELAMINATED AND SPALLED AREA UP TO 3 FEET 7 INCHES LONG X 2 FEET 3 INCHES HIGH X 2 INCH DEEP WITH EXPOSED REINFORCEMENT IN THE WEST FACE BELOW GIRDER 4

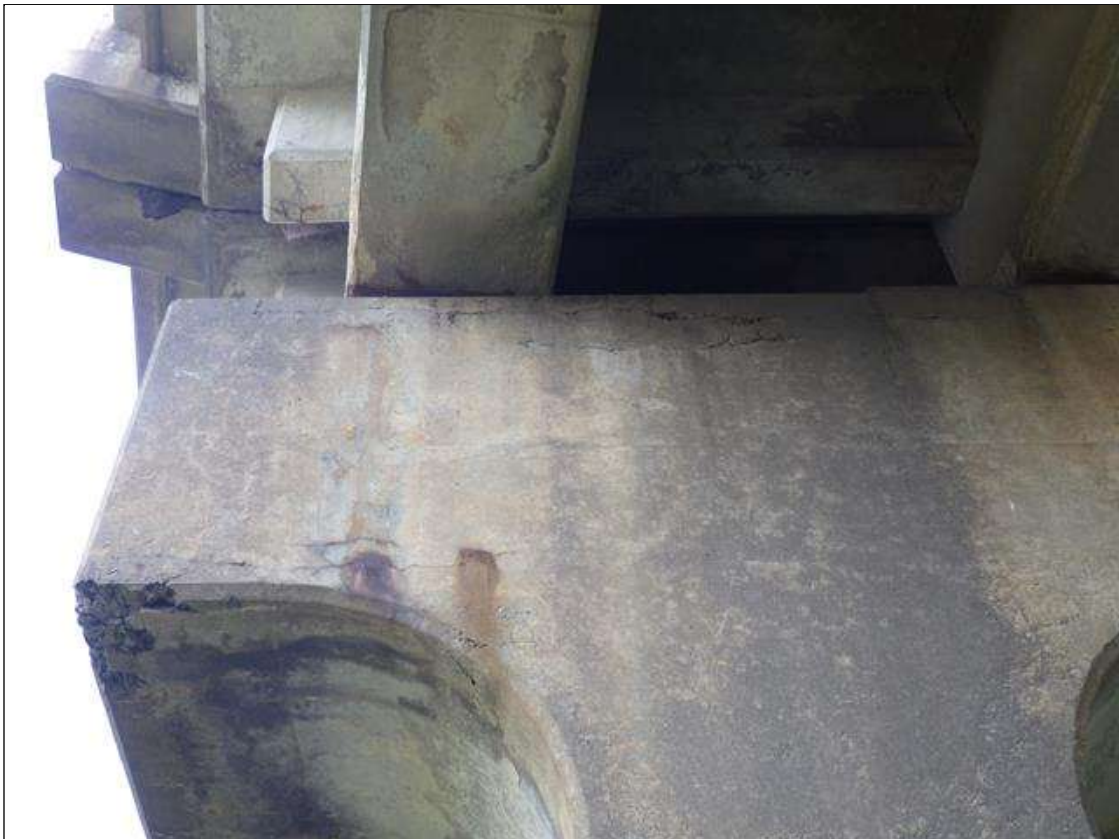
Bent 2 Cap 1: DELAMINATED AREA UP TO INTERMITTENT 7 FEET LONG X INTERMITTENT FULL HEIGHT X 1 FOOT WIDE WITH RUST STAINING IN THE UNDERSIDE AND WEST FACES BELOW GIRDER 1

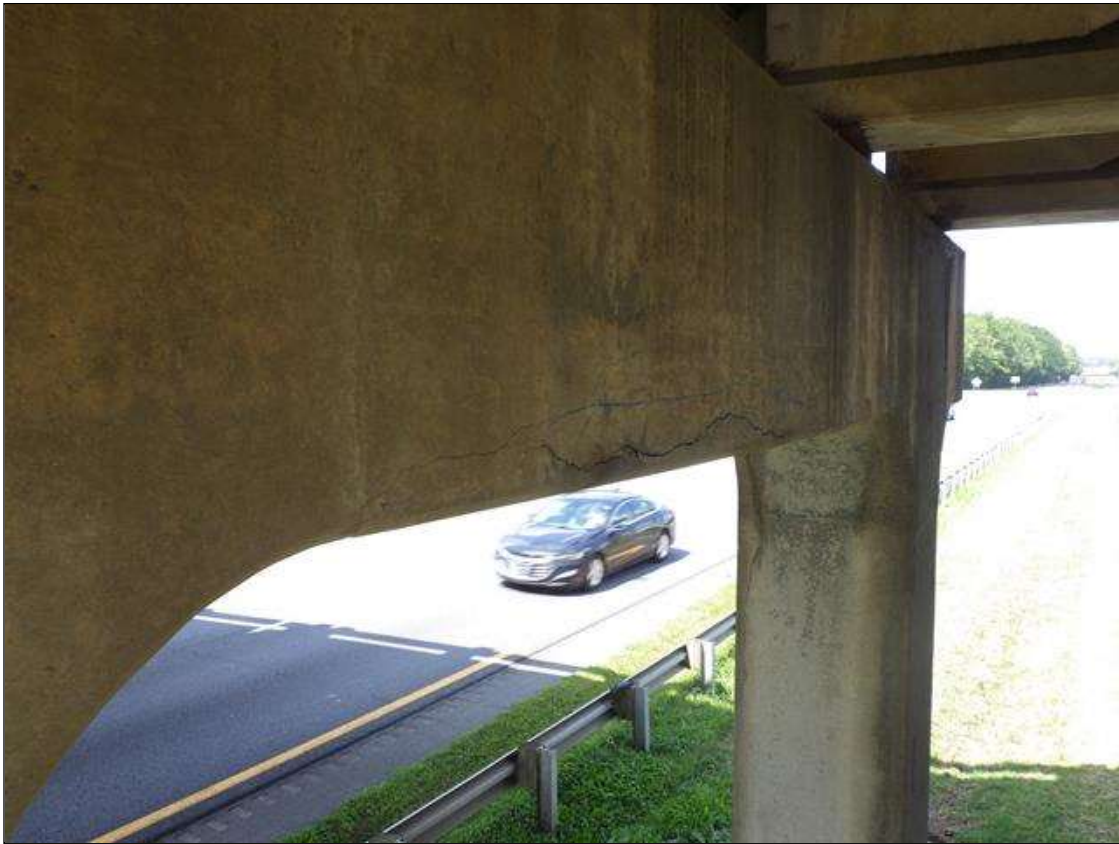
Bent 2 Cap 1: DELAMINATED AREA UP TO 13 FEET LONG X FULL WIDTH X 1 FOOT 6 INCHES HIGH WITH EFFLORESCENCE IN THE UNDERSIDE AND EAST FACES BETWEEN COLUMNS 1 AND 2

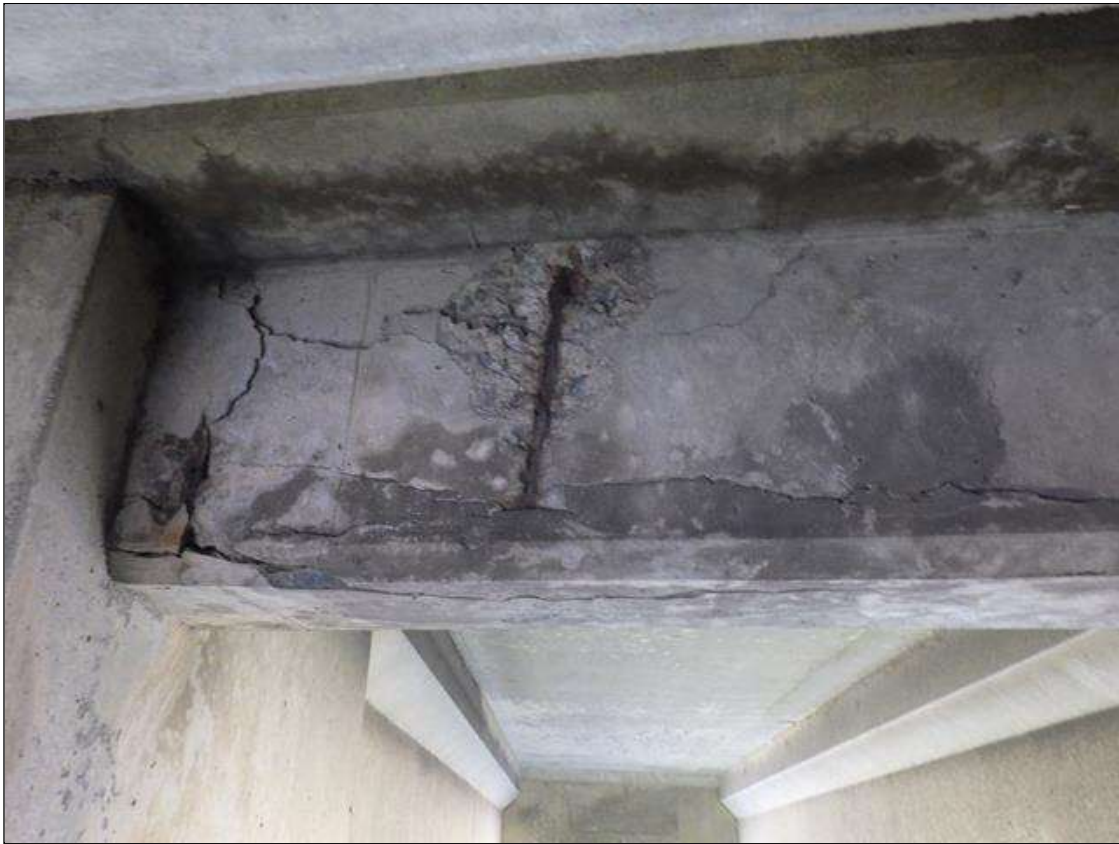
Span 2 Beam 2: DELAMINATED AND SPALLED AREA UP TO FULL LENGTH X FULL WIDTH X FULL HEIGHT WITH EXPOSED REINFORCEMENT IN BAY 2 END DIAPHRAGM AT BENT 2

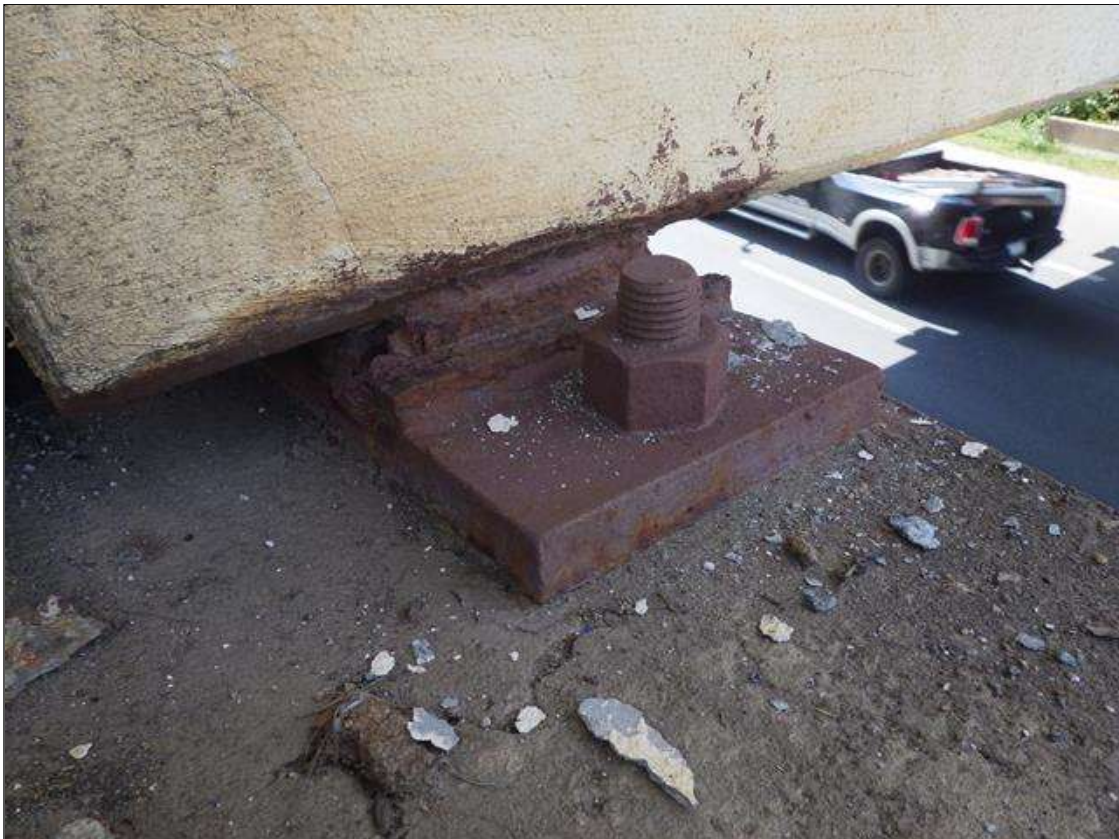
Span 2 Beam 1 - Far Bearing: ARRESTED SURFACE RUST UP TO FULL PERIMETER X FULL HEIGHT THROUGHOUT GIRDER 1 BEARING

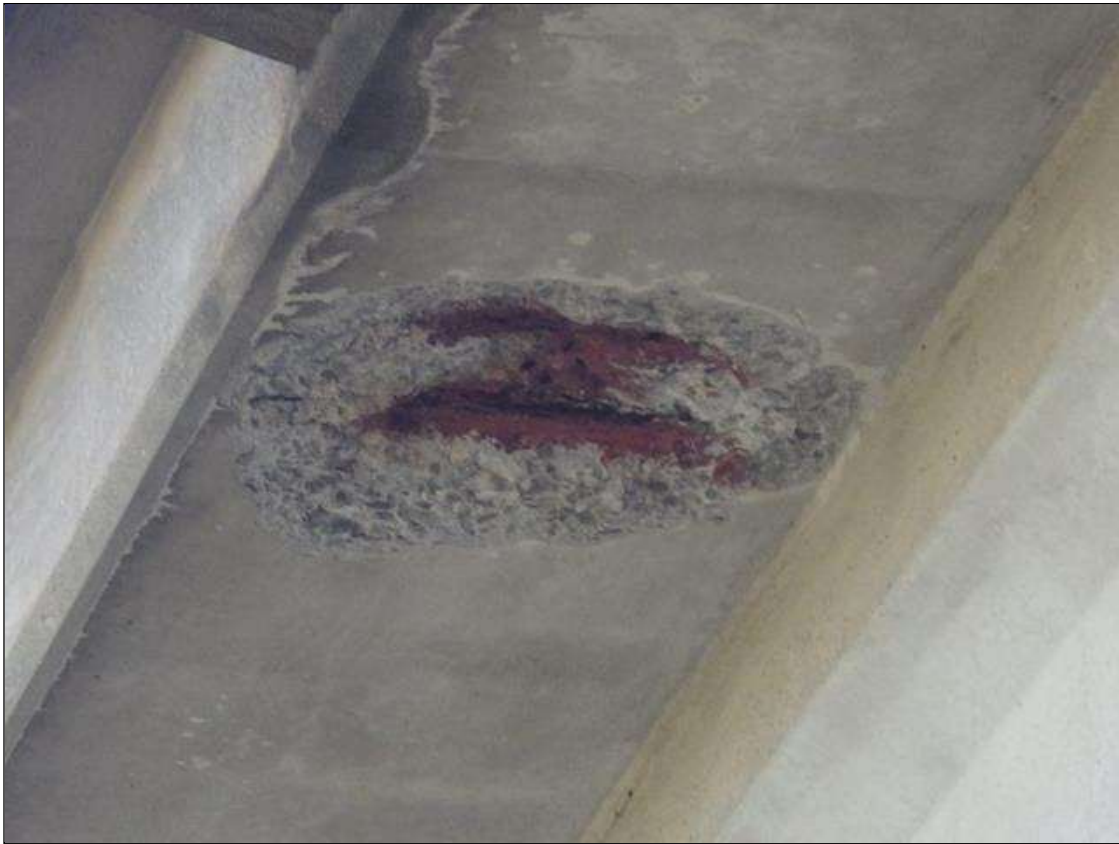
Span 3 Deck: SPALLED AREA UP TO 2 FEET DIAMETER X 2 INCHES DEEP WITH PAINTED EXPOSED REINFORCEMENT IN THE UNDERSIDE OF THE NORTH OVERHANG ABOVE THE RIGHT NORTHBOUND LANE

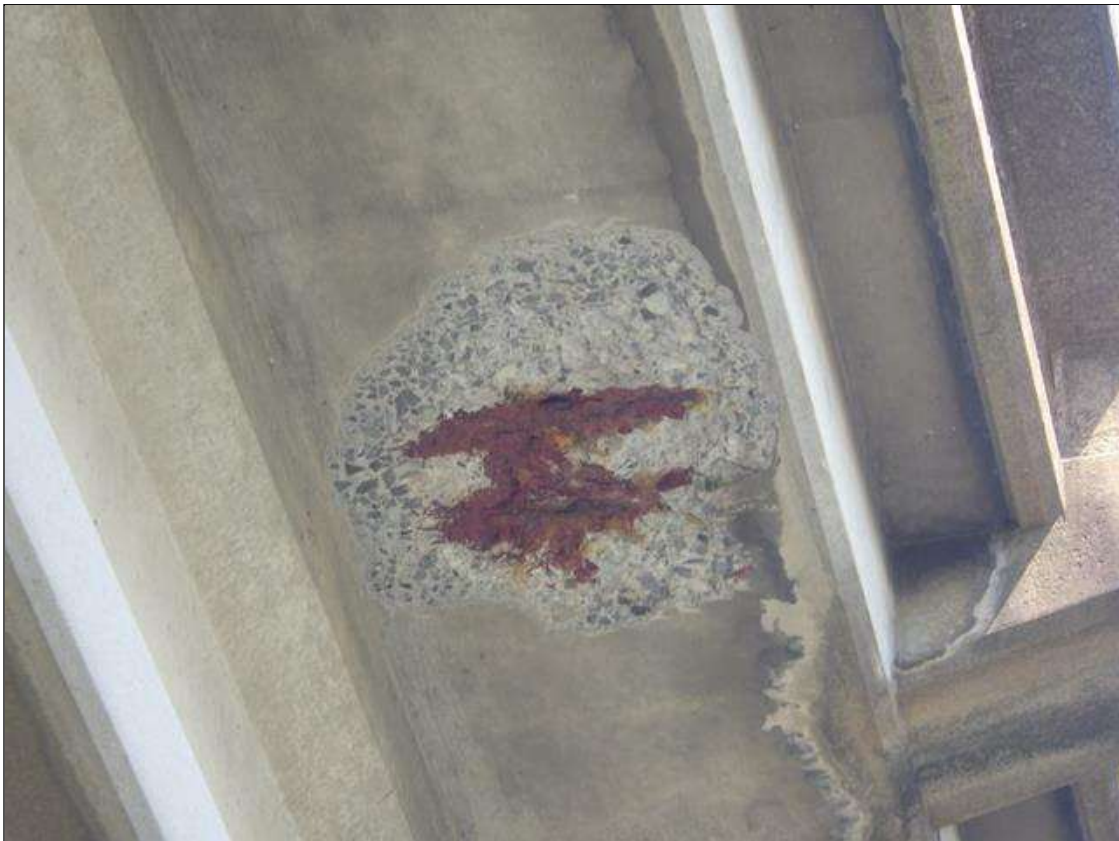
Span 3 Deck: SPALLED AREA UP TO 2 FEET DIAMETER X 2 INCHES DEEP WITH PAINTED EXPOSED REINFORCEMENT IN THE UNDERSIDE OF THE SOUTH OVERHANG ABOVE THE LEFT NORTHBOUND LANE

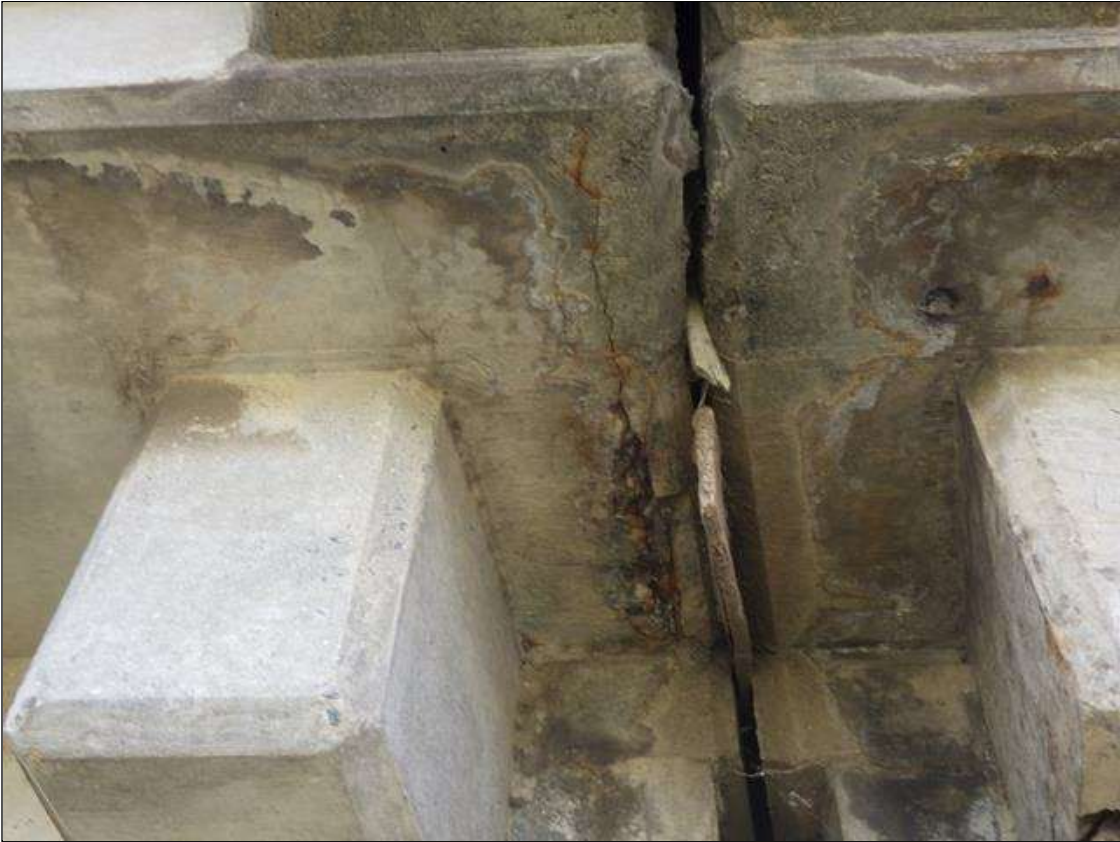
Span 3 Deck: DELAMINATED AND SPALLED AREA UP TO 3 INCHES LONG X 2 FEET WIDE X 1 INCH DEEP WITH EXPOSED REINFORCEMENT IN THE UNDERSIDE OF THE NORTH OVERHANG AT BENT 2

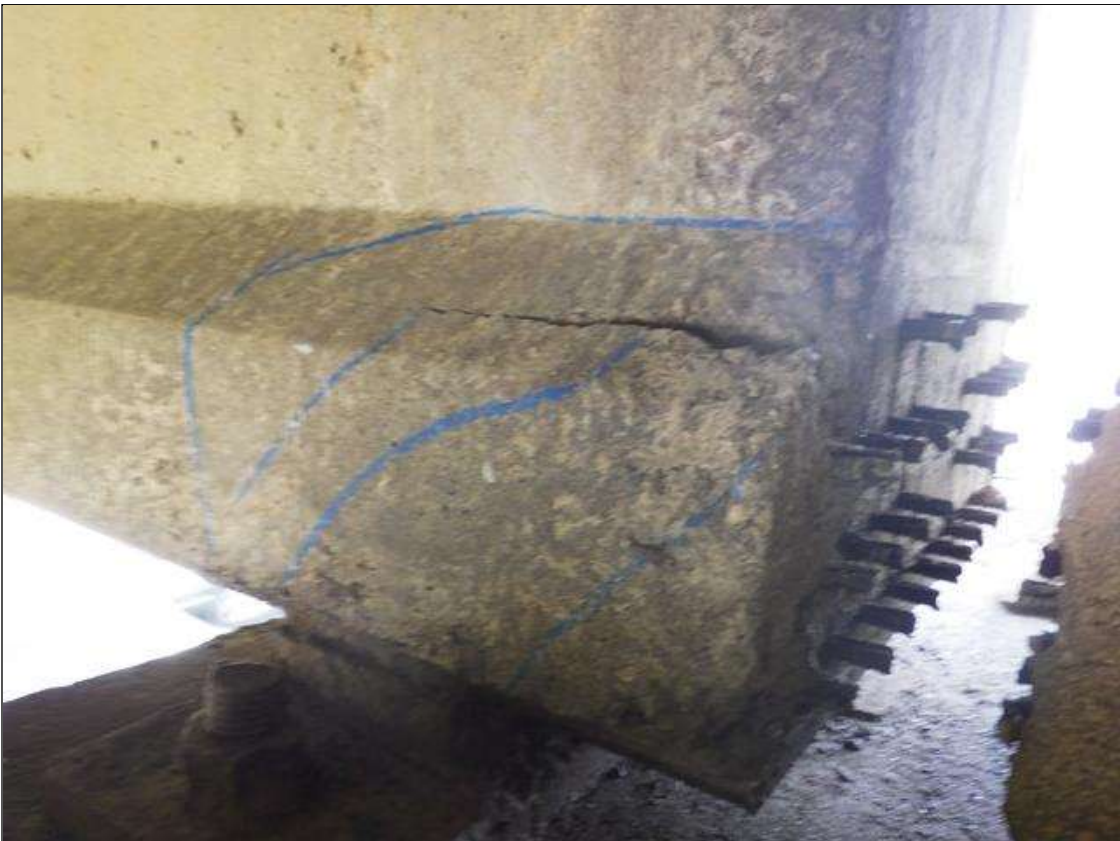
Span 3 Beam 3: PATCHED AREA UP TO 1 FOOT LONG X 10 INCHES HIGH X 3 INCHES WIDE IN THE RIGHT BOTTOM FLANGE AT BENT 2

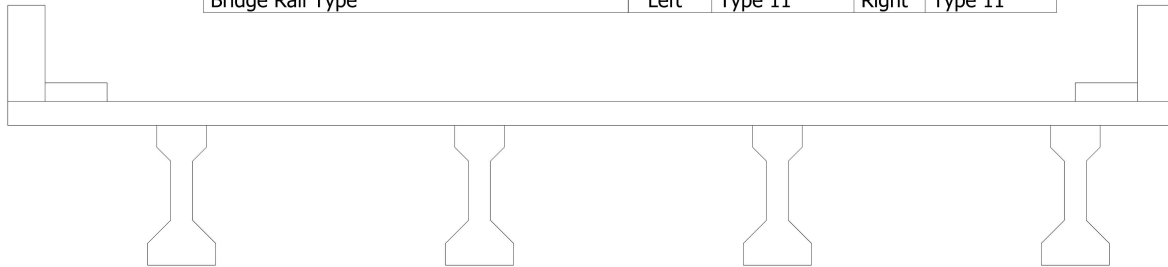
Measurements for Span #	1	Similar Span #	3, 4
Deck Thickness	7.75in	Left Overhang	4.667ft
Top of Rail to Bottom of Beam (Avg)	6.979ft	Right Overhang	4.667ft

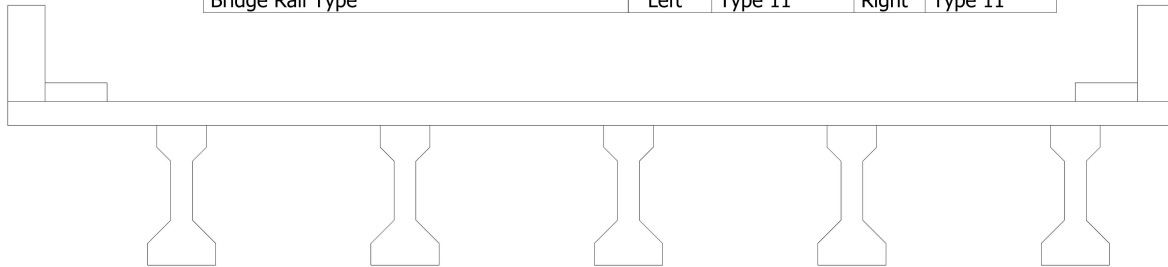
Measurements for Span #	2		
Deck Thickness	7.75in	Left Overhang	4.667ft
Top of Rail to Bottom of Beam (Avg)	6.979ft	Right Overhang	4.667ft
