NC DEPARTMENT OF TRANSPORTATION
 DIVISION OF HIGHWAYS
 STRUCTURE MANAGEMENT UNIT

ATTENTION: **PROMPT ACTION REQUEST; HYDRAPLATFORM USED; NEW REPAIRS; OUT-TO-OUT REVISED;**

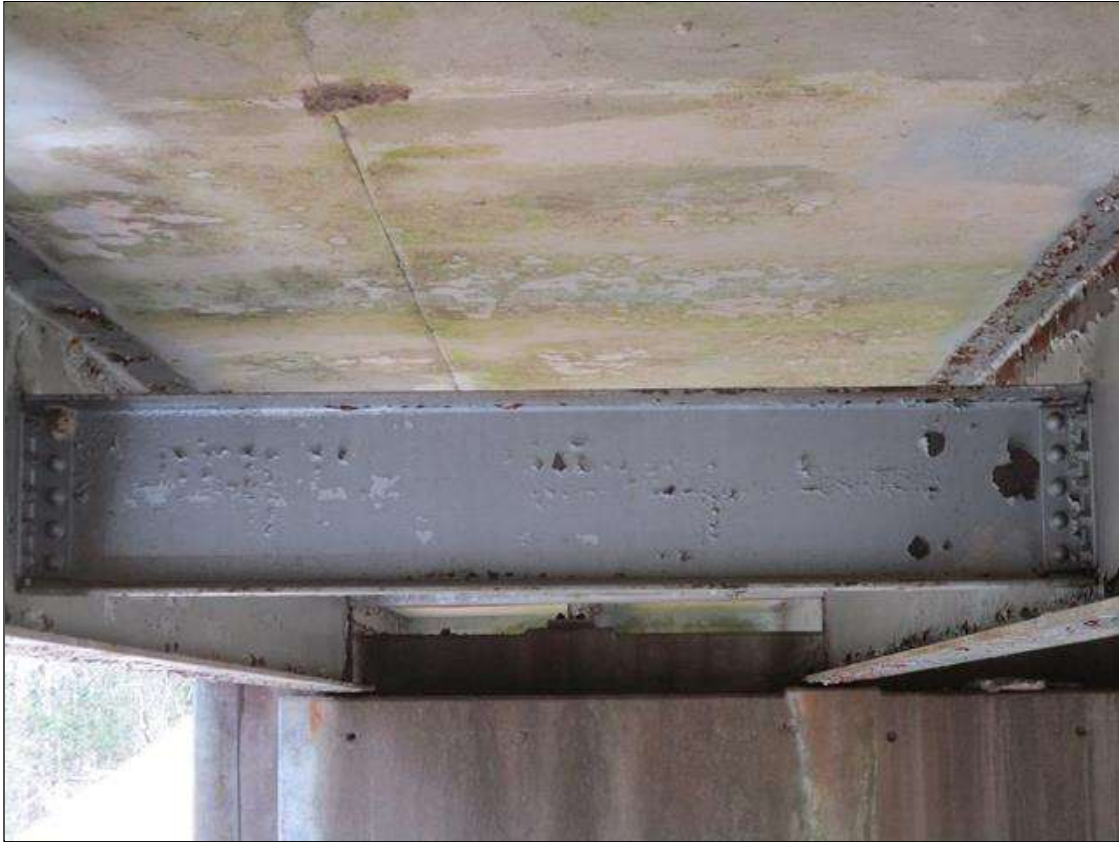
STEEL DIAPHRAGMS: FRECKLED CORROSION AND SCATTERED CORROSION IN AREAS OF PROTECTIVE COATING FAILURE

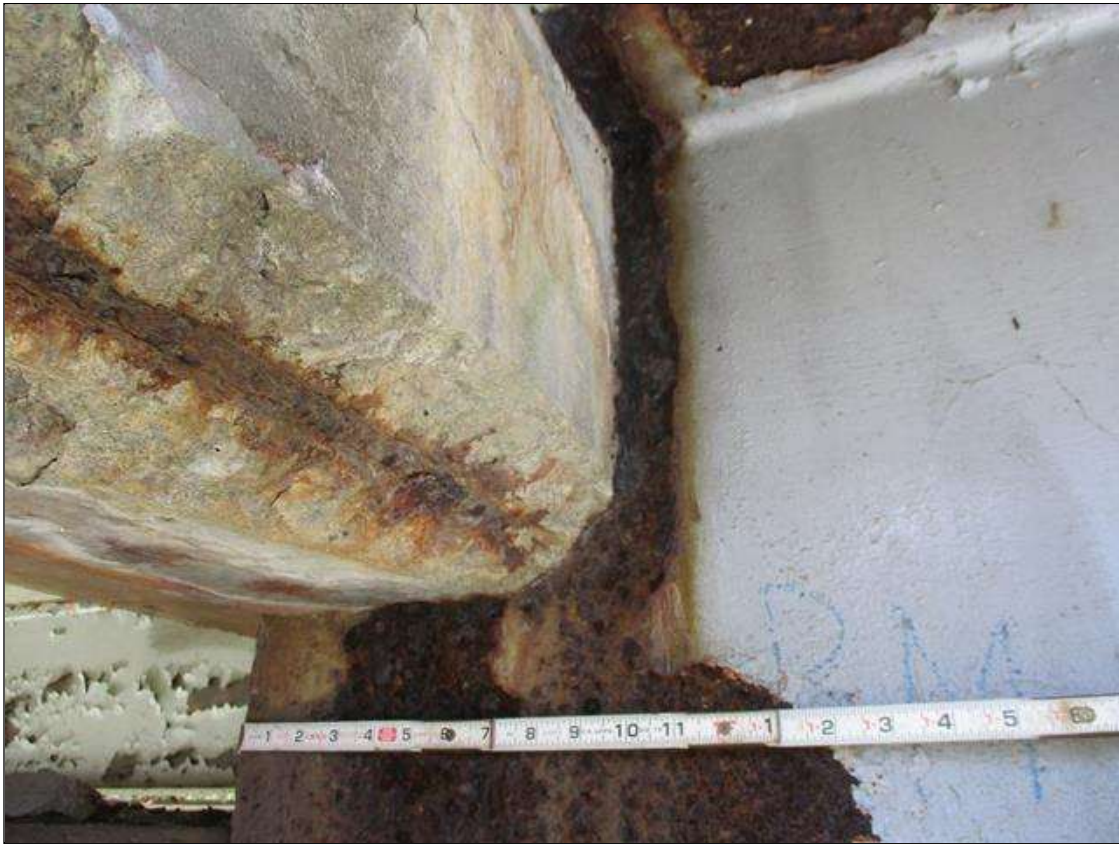
Span 8 Beam 1: [PROMPT ACTION REQUEST] BEAM END AT BENT 8, THERE IS AN APPROXIMATELY 1" WIDE BAND OF CORROSION THAT WRAPS THE REINFORCED CONCRETE DIAPHRAGM, APPROXIMATELY 5/16" SECTION LOSS [AVERAGE 1/8" REMAINS] FOR APPROXIMATELY 10" LONG.

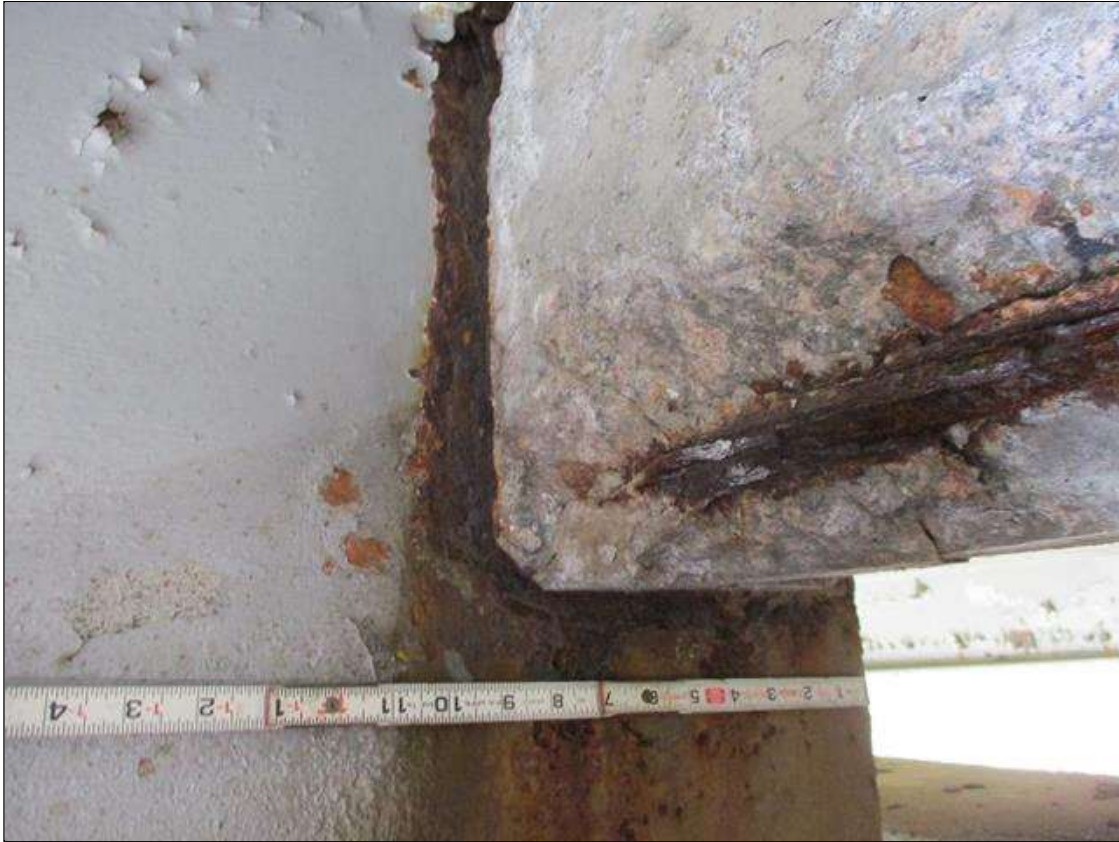
Span 8 Beam 2: [PROMPT ACTION REQUEST] BEAM END AT BENT 8, THERE IS AN APPROXIMATELY 1" WIDE BAND OF CORROSION THAT WRAPS THE REINFORCED CONCRETE DIAPHRAGM, APPROXIMATELY 3/16" SECTION LOSS [AVERAGE 1/4" REMAINS] FOR APPROXIMATELY 10" LONG.

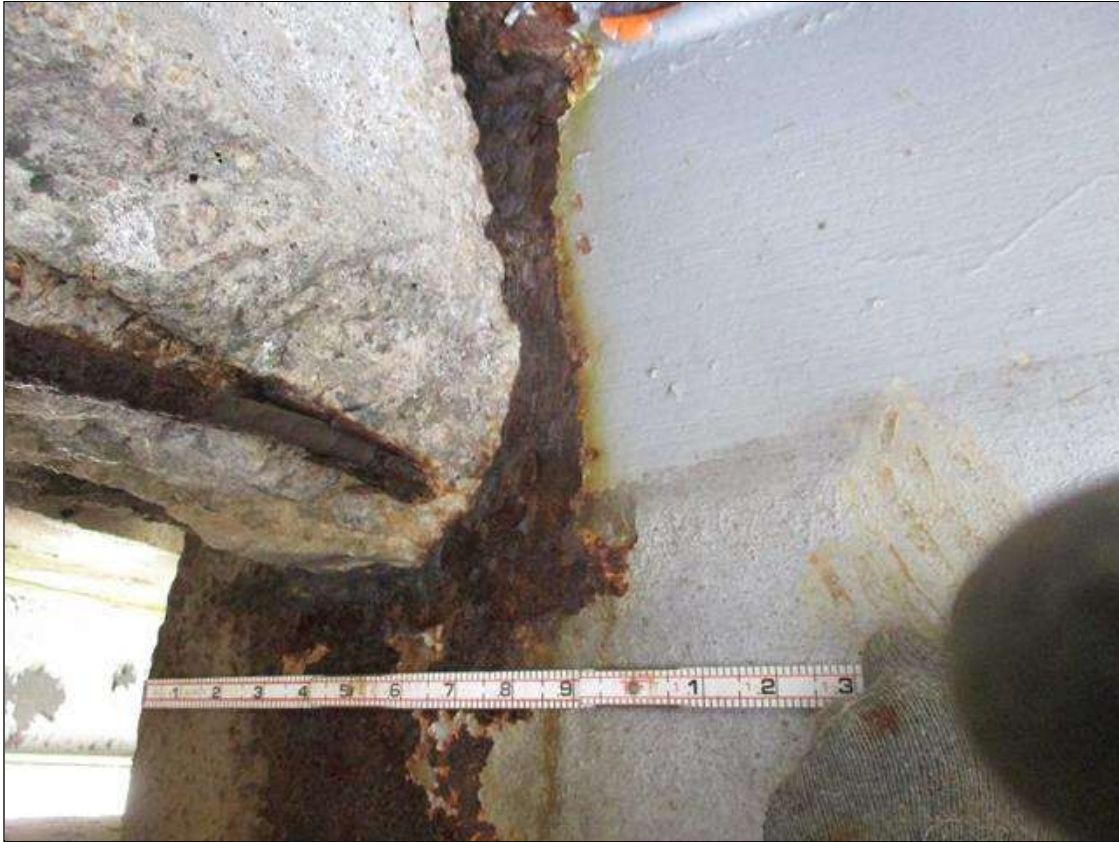
Span 8 Beam 3: [PROMPT ACTION REQUEST] BEAM END AT BENT 8, THERE IS AN APPROXIMATELY 2" WIDE BAND OF CORROSION THAT WRAPS THE REINFORCED CONCRETE DIAPHRAGM, APPROXIMATELY 1/4" SECTION LOSS [AVERAGE 3/16" REMAINS] FOR APPROXIMATELY 10" LONG.

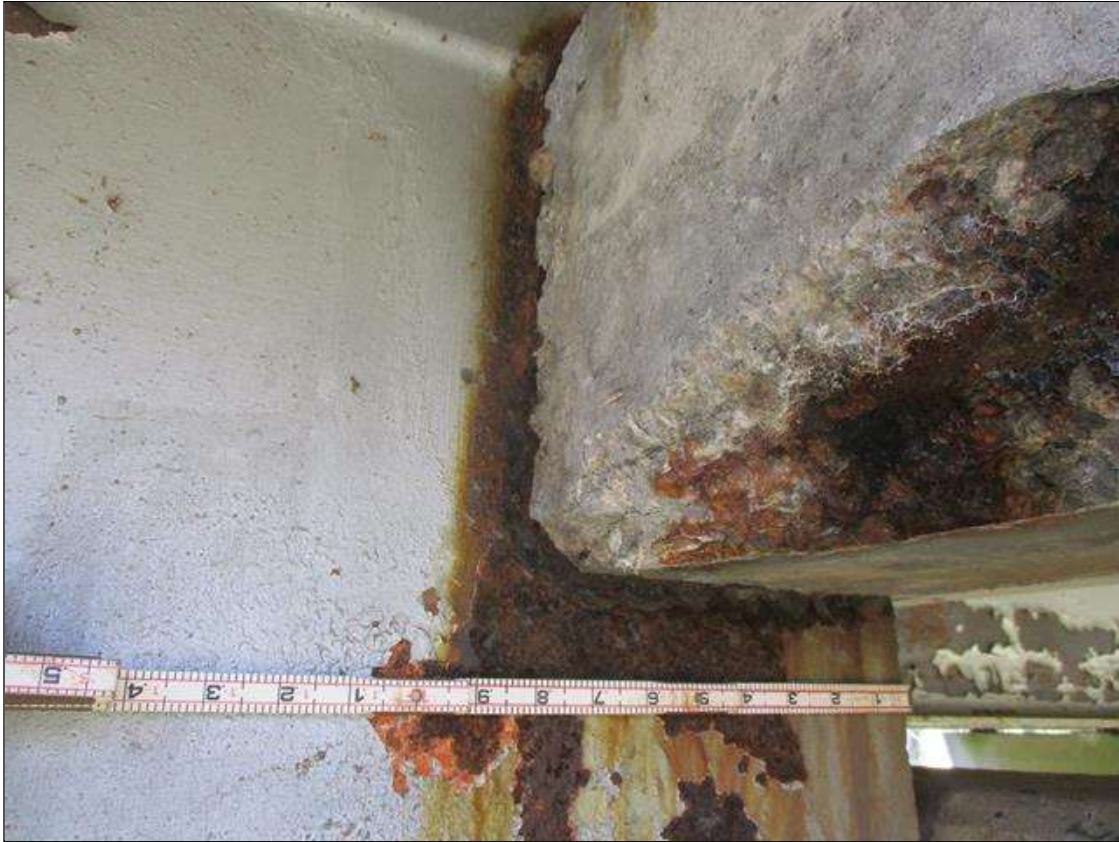
Span 8 Beam 4: [PROMPT ACTION REQUEST] BEAM END AT BENT 8, THERE IS AN APPROXIMATELY 1" WIDE BAND OF CORROSION THAT WRAPS THE REINFORCED CONCRETE DIAPHRAGM, APPROXIMATELY 1/4" SECTION LOSS [AVERAGE 3/16" REMAINS] FOR APPROXIMATELY 10" LONG.

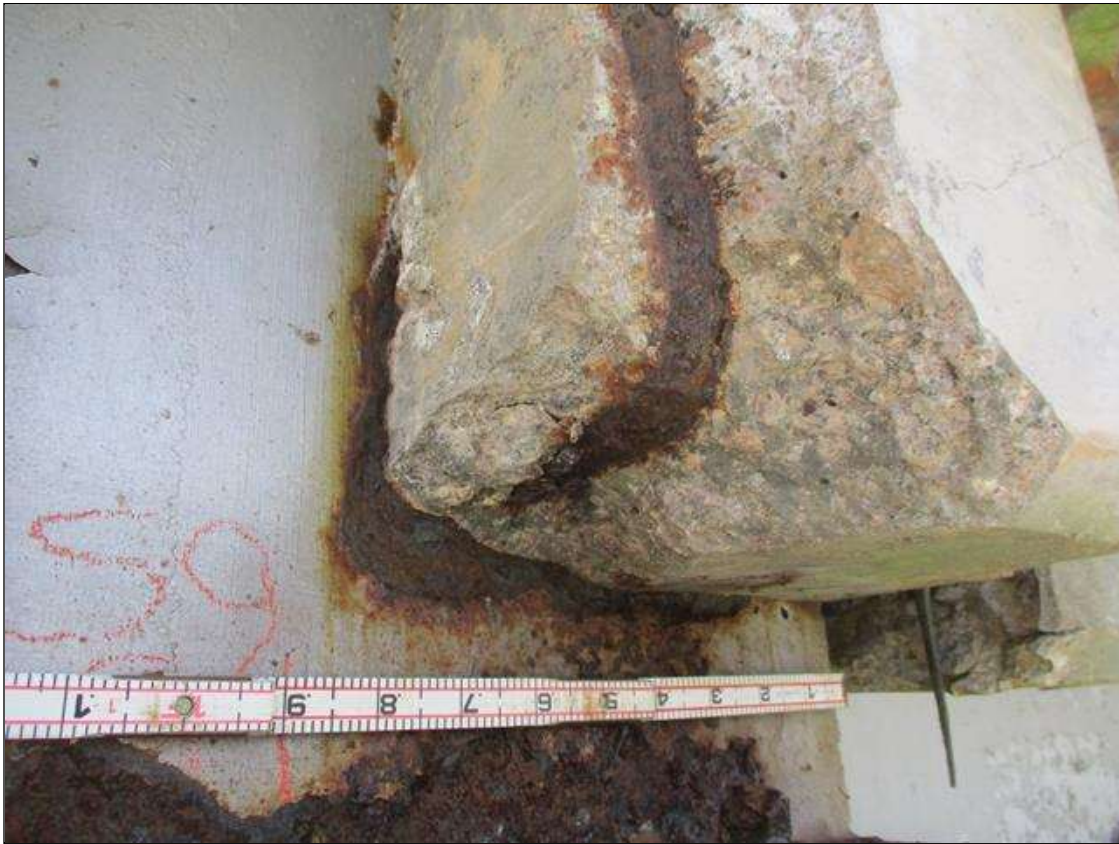
Span 9 Beam 1: [PROMPT ACTION REQUEST] BEAM END AT BENT 8, THERE IS AN APPROXIMATELY 1" WIDE BAND OF CORROSION THAT WRAPS THE REINFORCED CONCRETE DIAPHRAGM, APPROXIMATELY 3/16" SECTION LOSS [AVERAGE 3/16" REMAINS] FOR APPROXIMATELY 10" LONG.

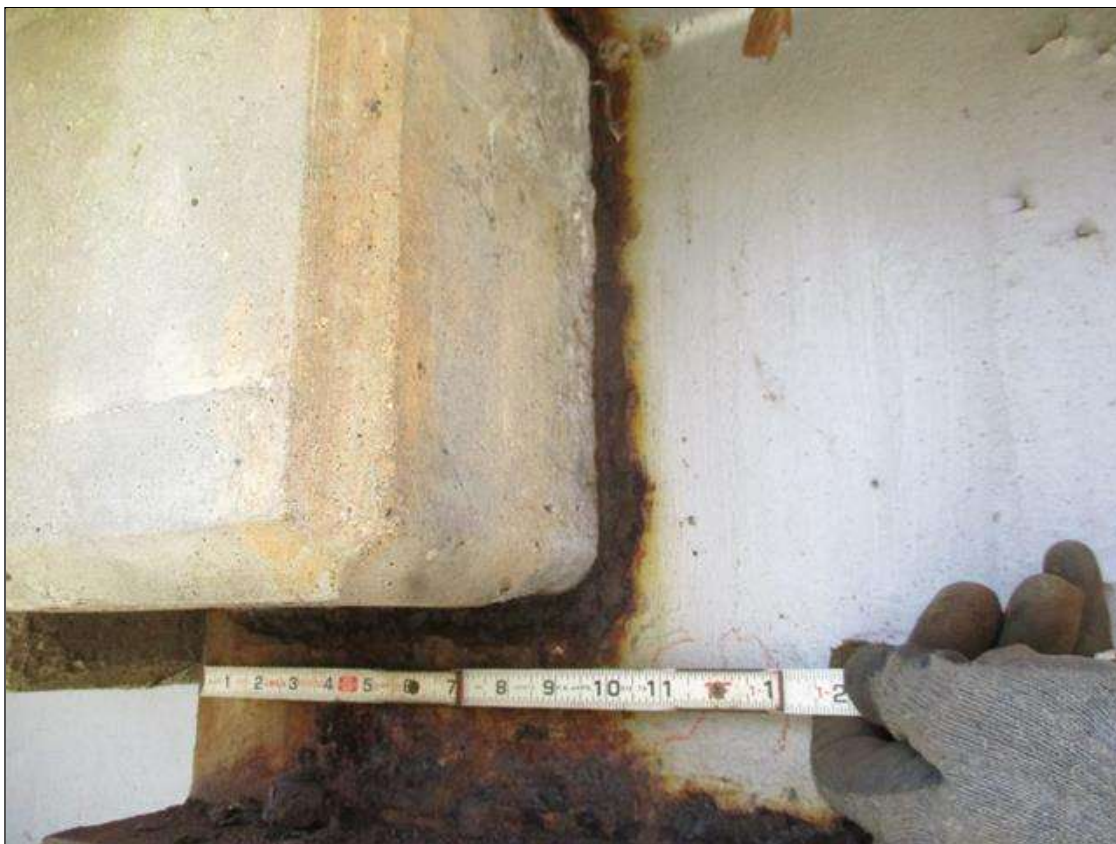
Span 9 Beam 6: [PROMPT ACTION REQUEST] BEAM END AT BENT 8, THERE IS AN APPROXIMATELY 1" WIDE BAND OF CORROSION THAT WRAPS THE REINFORCED CONCRETE DIAPHRAGM, APPROXIMATELY 3/16" SECTION LOSS [AVERAGE 3/16" REMAINS] FOR APPROXIMATELY 10" LONG.

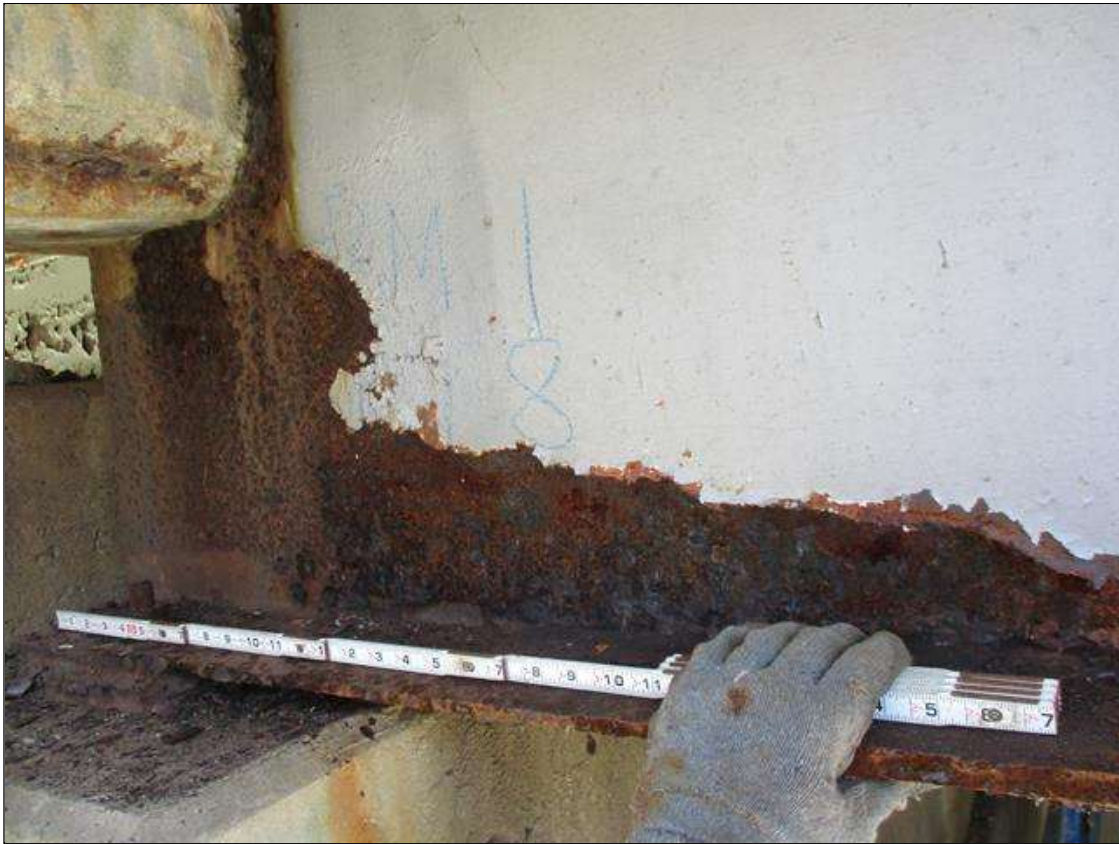
Span 8 Beam 1: [PROMPT ACTION REQUEST] BEAM END AT BENT 8, WEB, FULL HEIGHT, CORROSION WITH APPROXIMATELY 1/8" SECTION LOSS [AVERAGE 5/16" REMAINS] FOR 10" LONG, THEN IN THE LOWER 5" OF THE WEB, CORROSION WITH APPROXIMATELY 1/8" SECTION LOSS [AVERAGE 5/16" REMAINS] FOR 18" LONG.

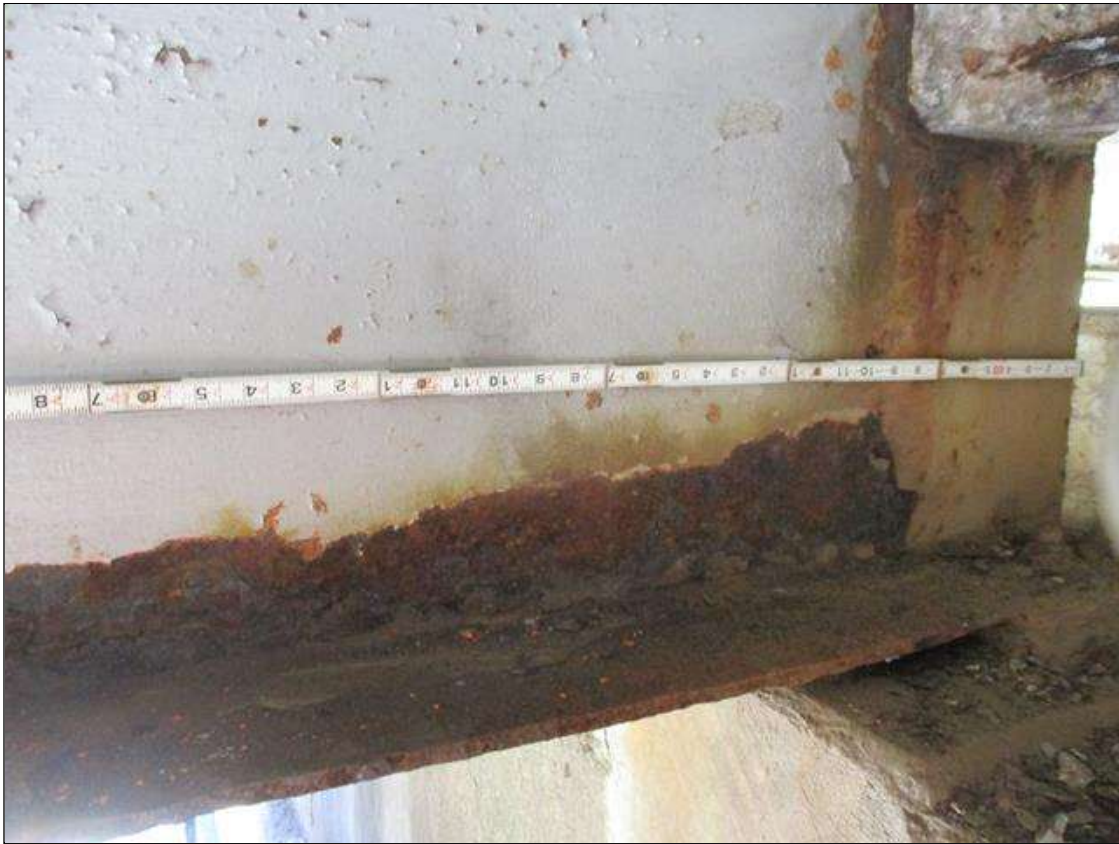
Span 8 Beam 2: [PROMPT ACTION REQUEST] 8" OUT FROM THE BEAM END AT BENT 8, IN THE LOWER 4" OF THE WEB, CORROSION WITH APPROXIMATELY 3/16" SECTION LOSS [AVERAGE 1/4" REMAINS] FOR 30" LONG.

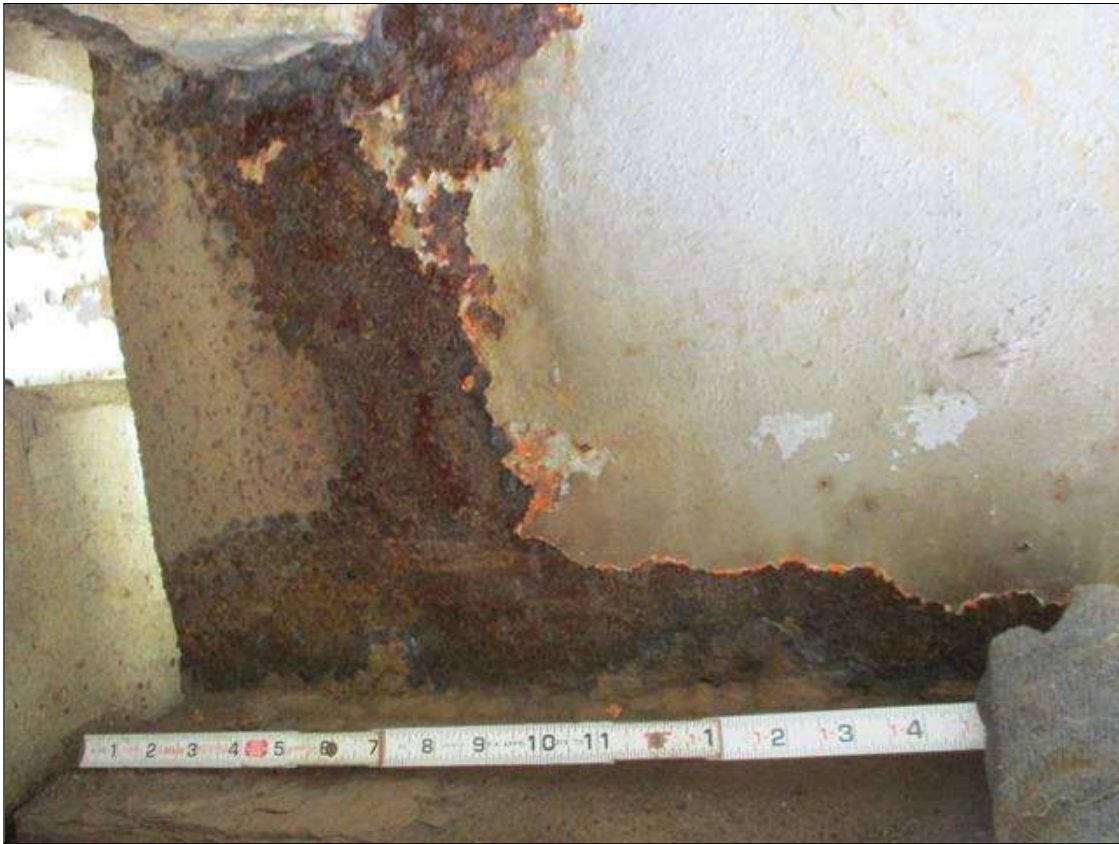
Span 8 Beam 3: [PROMPT ACTION REQUEST] BEAM END AT BENT 8, WEB, FULL HEIGHT, CORROSION WITH APPROXIMATELY 3/16" SECTION LOSS [AVERAGE 1/4" REMAINS] FOR 10" LONG

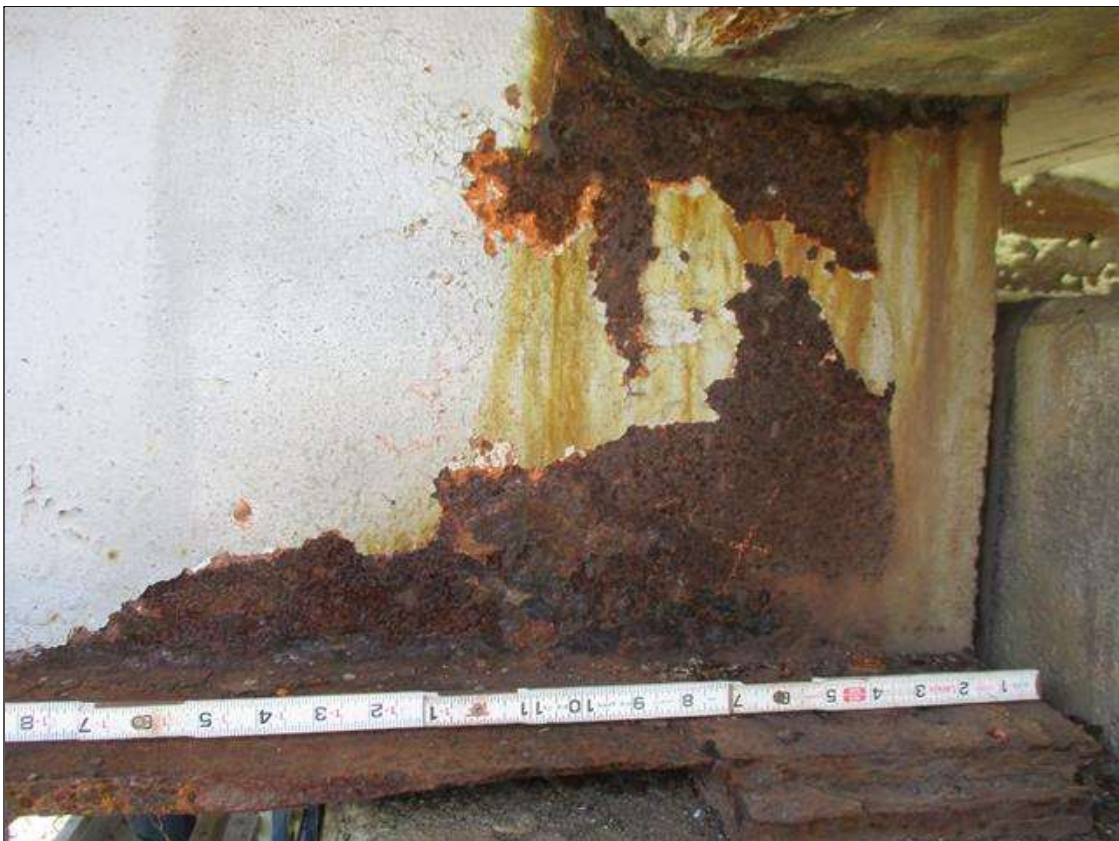
Span 8 Beam 4: [PROMPT ACTION REQUEST] BEAM END AT BENT 8, WEB, LOWER 3", CORROSION WITH APPROXIMATELY 1/8" SECTION LOSS [AVERAGE 5/16" REMAINS] FOR 18" LONG

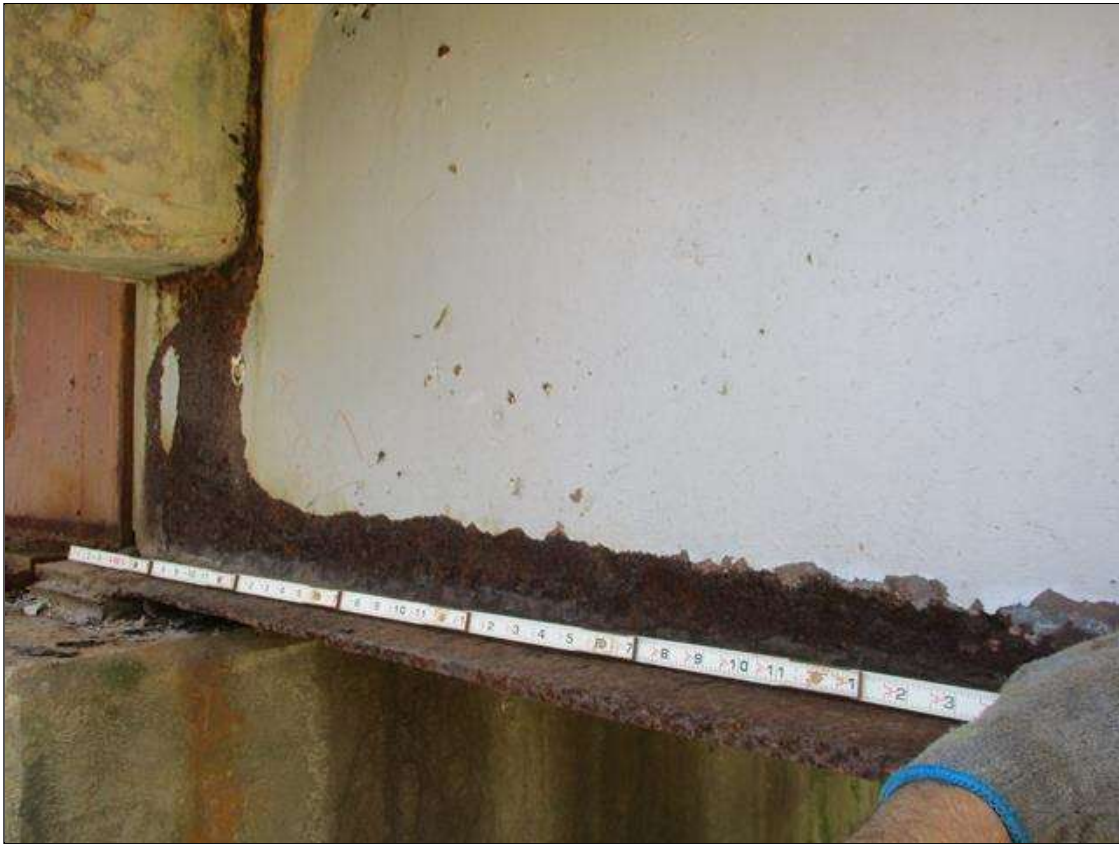
Span 8 Beam 4: [PROMPT ACTION REQUEST] BEAM END AT BENT 7, WEB, FULL HEIGHT, CORROSION WITH APPROXIMATELY 1/4" SECTION LOSS [AVERAGE 3/16" REMAINS] FOR 9" LONG, THEN IN THE LOWER 2" OF THE WEB, APPROXIMATELY 1/4" SECTION LOSS [AVERAGE 3/16" REMAINS] FOR 30" LONG

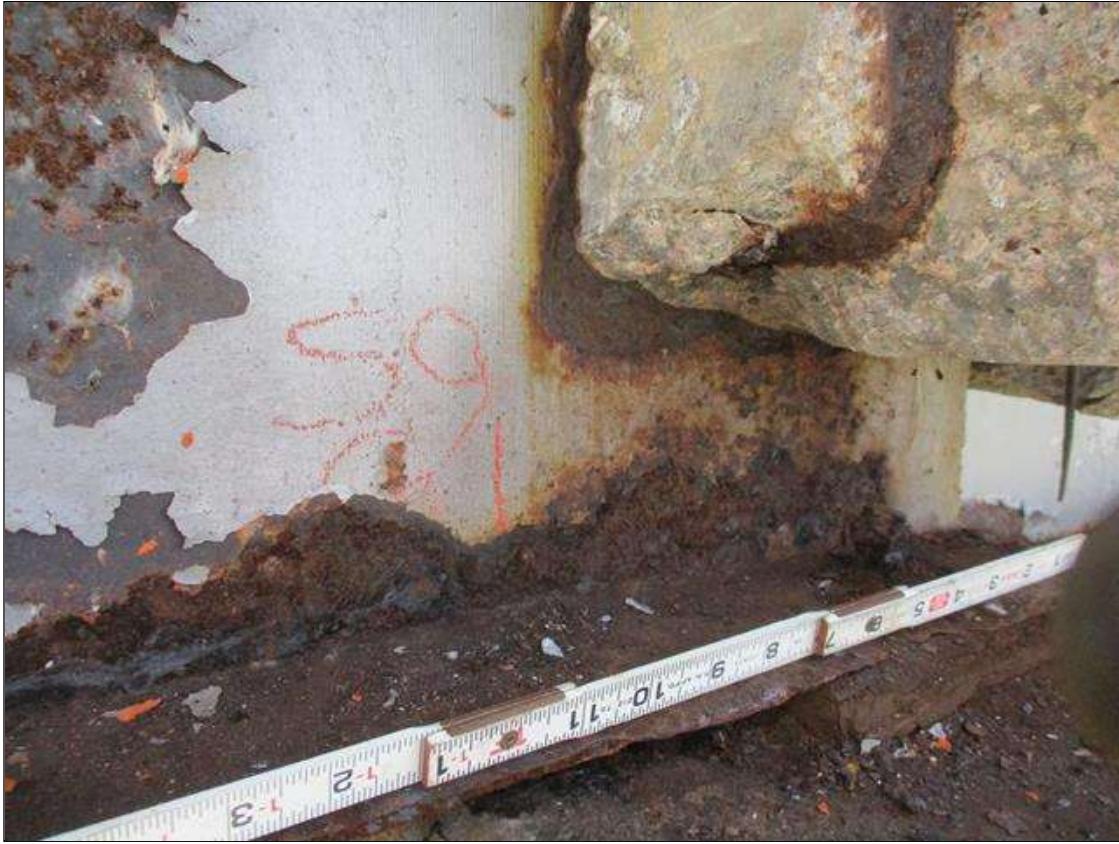
Span 9 Beam 1: [PROMPT ACTION REQUEST] BEAM END AT BENT 8, WEB, LOWER 2", CORROSION WITH APPROXIMATELY 1/8" SECTION LOSS [AVERAGE 1/4" REMAINS] FOR 12" LONG

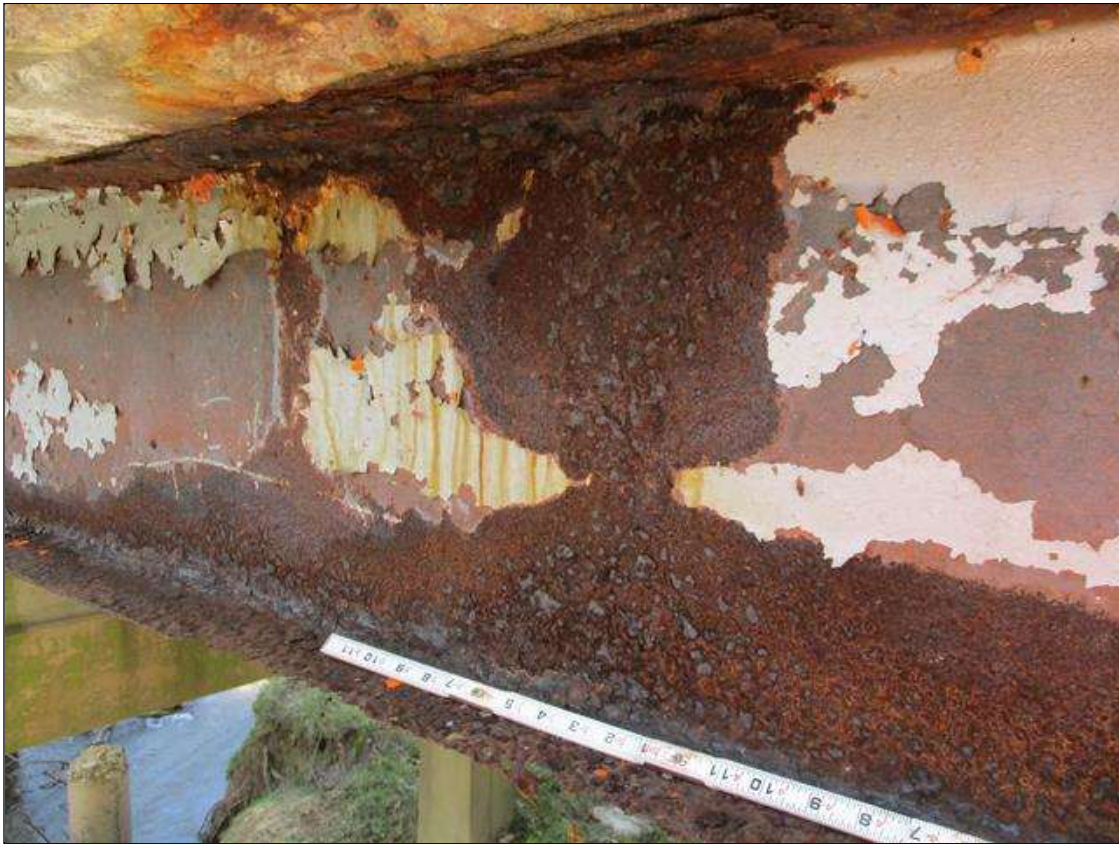
Span 9 Beam 6: [PROMPT ACTION REQUEST] APPROXIMATELY 5.5' OUT FROM THE BEAM END AT BENT 9, WEB, FULL HEIGHT, CORROSION WITH APPROXIMATELY 5/16" SECTION LOSS [AVERAGE 1/8" REMAINS] FOR 3" LONG. APPROXIMATELY 2' OUT FROM THE BEAM END AT BENT 9, WEB, LOWER AND UPPER 1", CORROSION WITH APPROXIMATELY 5/16" SECTION LOSS [AVERAGE 1/8" REMAINS] FOR 12" LONG.

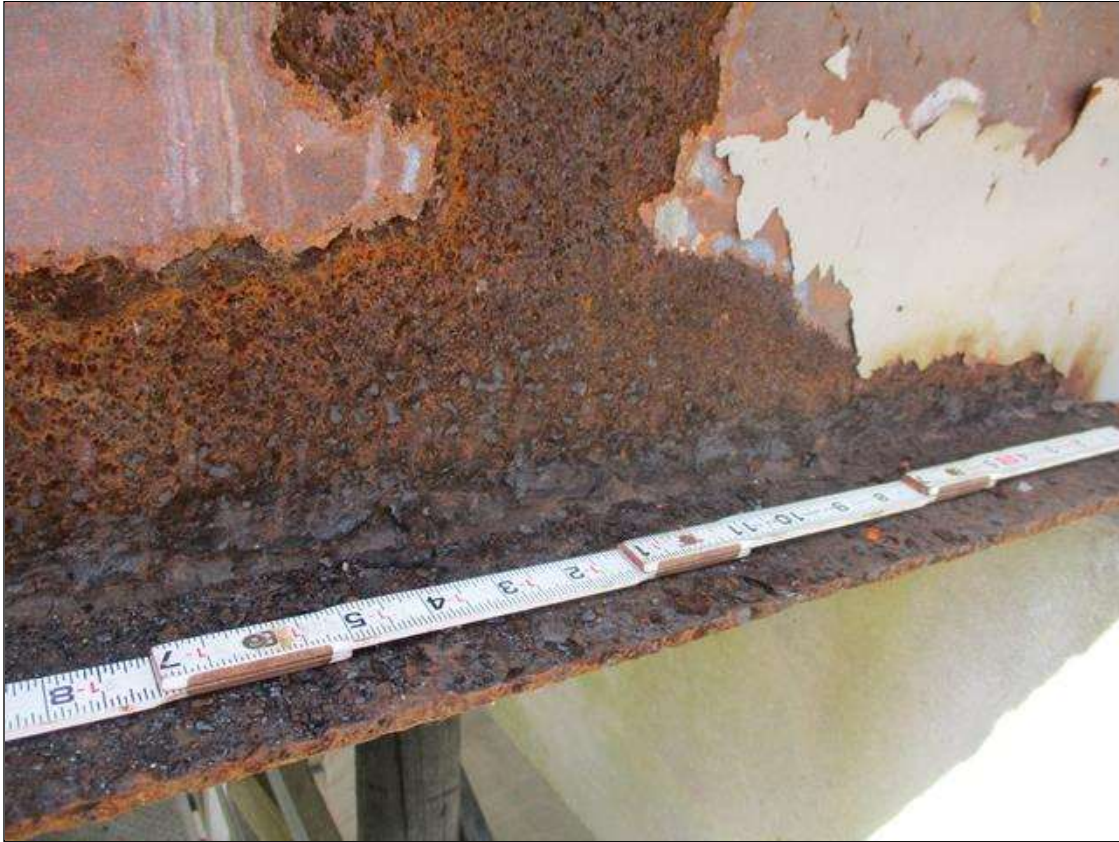
Span 9 Beam 6: [PROMPT ACTION REQUEST] APPROXIMATELY 5.5' OUT FROM THE BEAM END AT BENT 9, WEB, FULL HEIGHT, CORROSION WITH APPROXIMATELY 5/16" SECTION LOSS [AVERAGE 1/8" REMAINS] FOR 3" LONG. APPROXIMATELY 2' OUT FROM THE BEAM END AT BENT 9, WEB, LOWER AND UPPER 1", CORROSION WITH APPROXIMATELY 5/16" SECTION LOSS [AVERAGE 1/8" REMAINS] FOR 12" LONG.

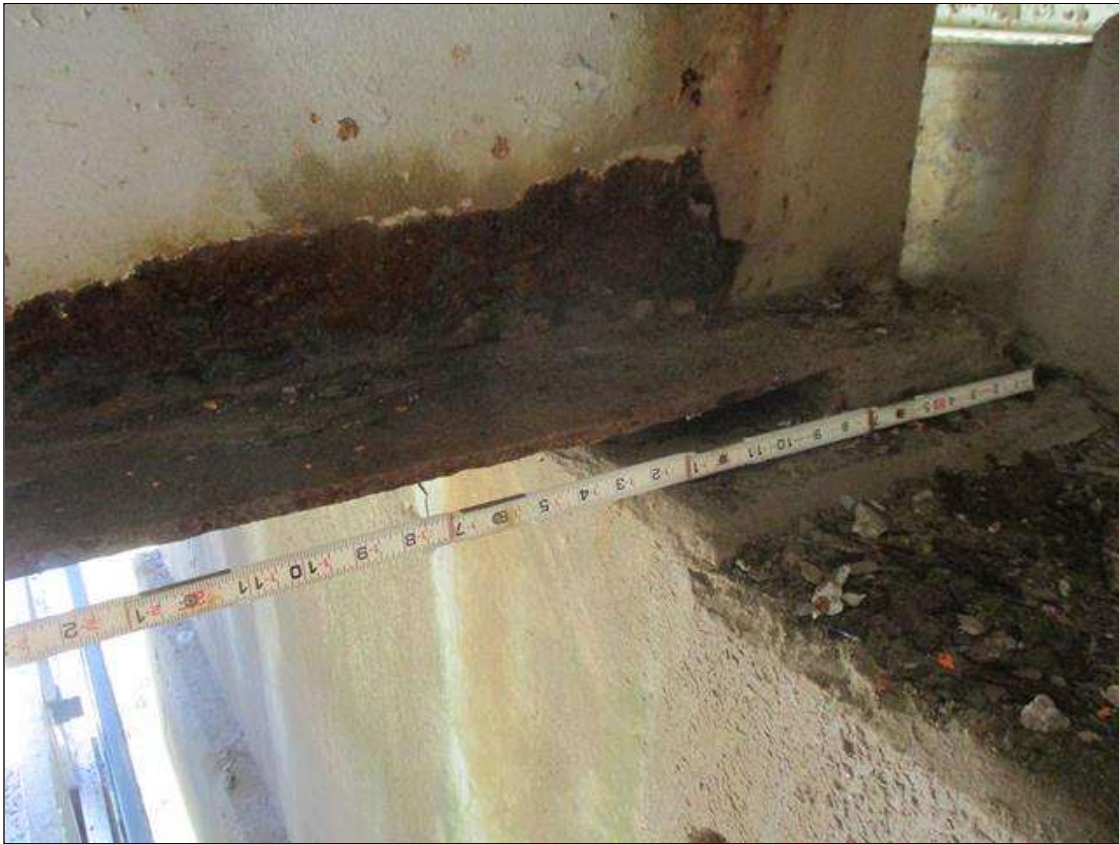
Span 8 Beam 2: [PROMPT ACTION REQUEST] BEAM END AT BENT 8, LOWER FLANGE, CORROSION WITH APPROXIMATELY 3/8" SECTION LOSS [AVERAGE 1/4" REMAINS] FOR APPROXIMATELY 1' LONG, THEN 1/4" SECTION LOSS [AVERAGE 3/8" REMAINS] FOR 2' LONG.

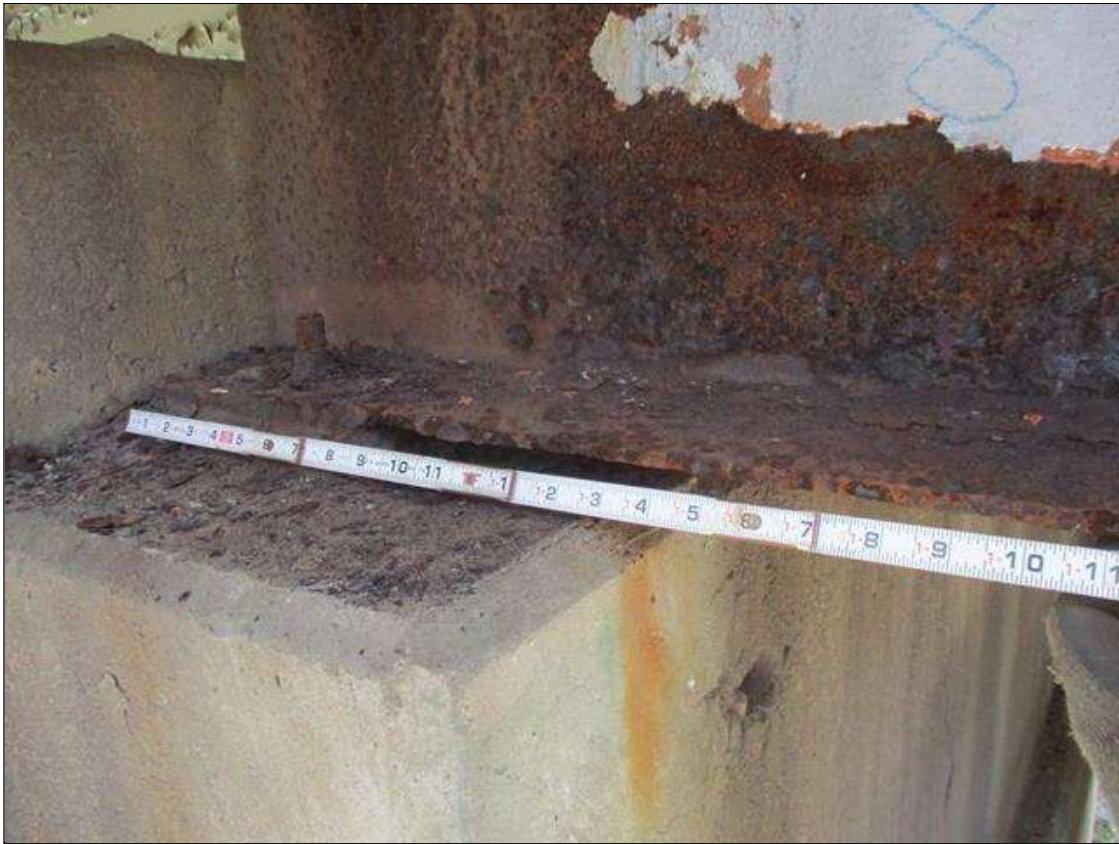
Span 8 Beam 1: [PROMPT ACTION REQUEST] BEAM END AT BENT 8, LOWER FLANGE, CORROSION WITH APPROXIMATELY 5/16" SECTION LOSS [AVERAGE 5/16" REMAINS] FOR APPROXIMATELY 2' LONG

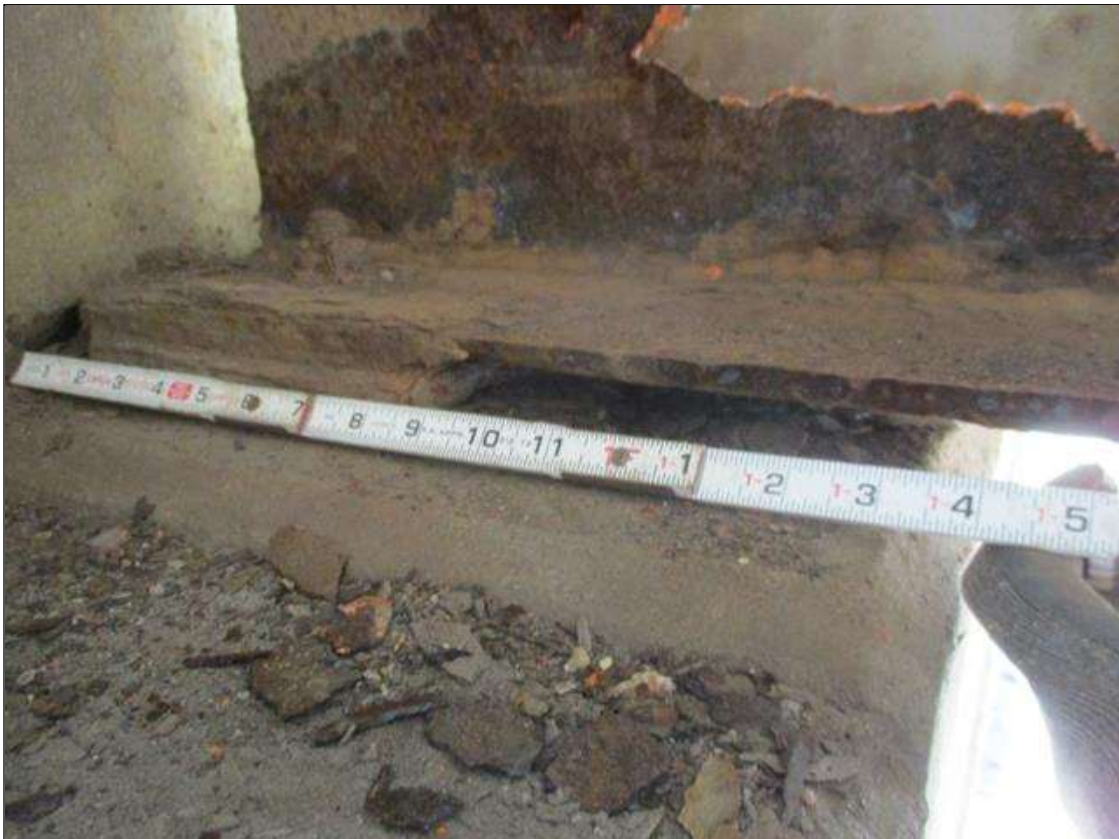
Span 8 Beam 3: [PROMPT ACTION REQUEST] BEAM END AT BENT 8, LOWER FLANGE, CORROSION WITH APPROXIMATELY 5/16" SECTION LOSS [AVERAGE 5/16" REMAINS] FOR APPROXIMATELY 1.5' LONG.

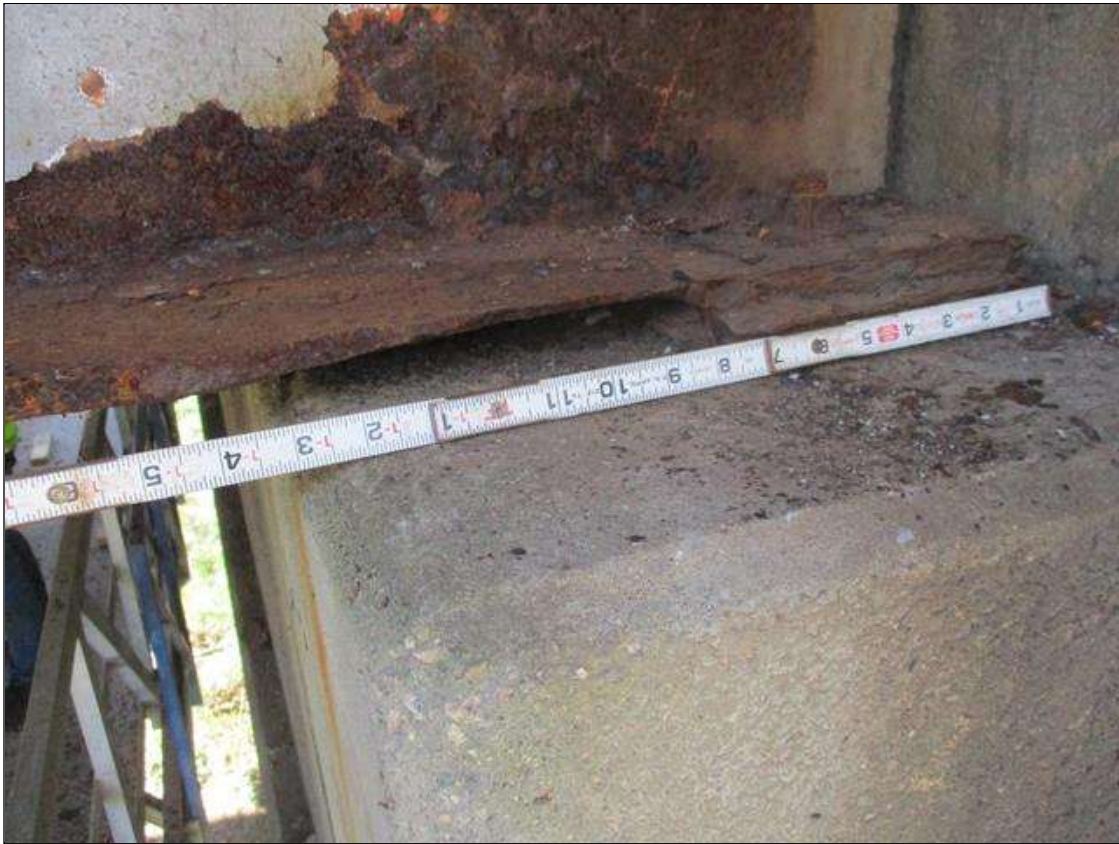
Span 8 Beam 4: [PROMPT ACTION REQUEST] BEAM END AT BENT 8, LOWER RIGHT FLANGE, CORROSION WITH APPROXIMATELY 3/8" SECTION LOSS [AVERAGE 1/4" REMAINS] FOR APPROXIMATELY 1' LONG.

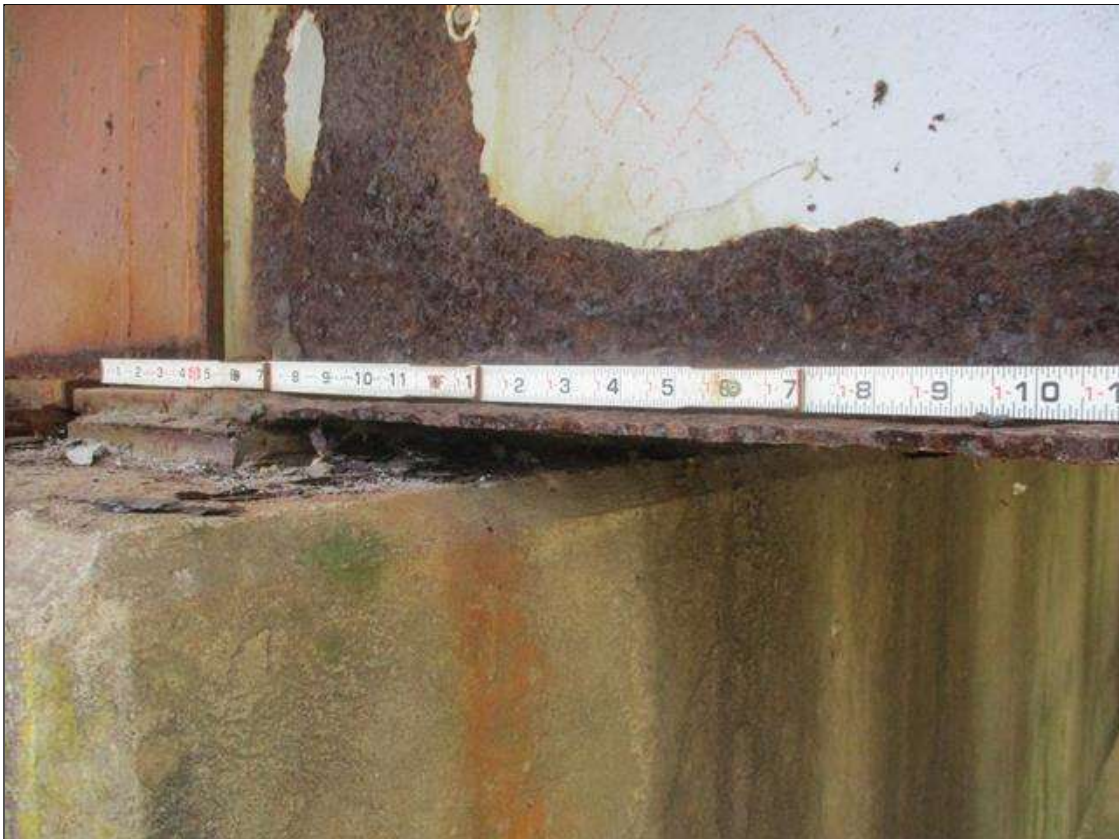
Span 8 Beam 4: [PROMPT ACTION REQUEST] BEAM END AT BENT 7, LOWER FLANGE, CORROSION WITH APPROXIMATELY 3/8" SECTION LOSS [AVERAGE 1/4" REMAINS] FOR APPROXIMATELY 2' LONG.

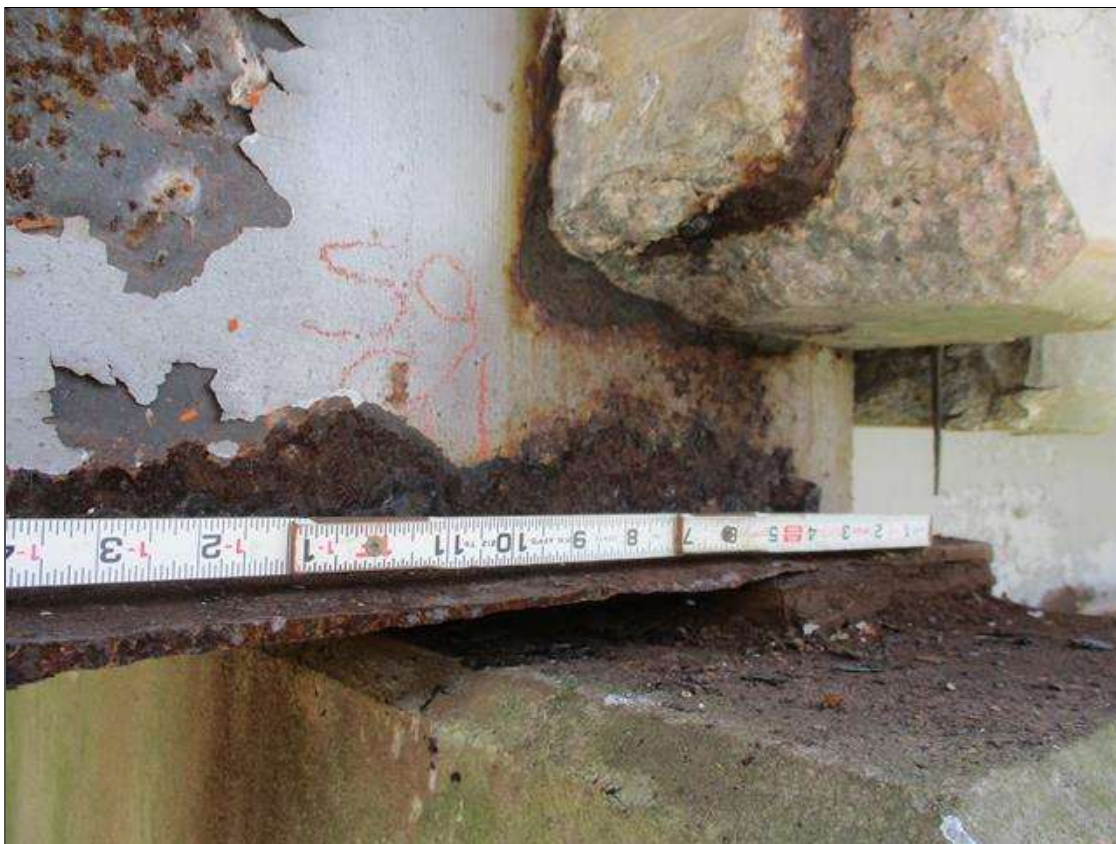
Span 9 Beam 1: [PROMPT ACTION REQUEST] BEAM END AT BENT 8, LOWER LEFT FLANGE, CORROSION WITH APPROXIMATELY 5/16" SECTION LOSS [AVERAGE 1/8" REMAINS] FOR APPROXIMATELY 15" LONG.

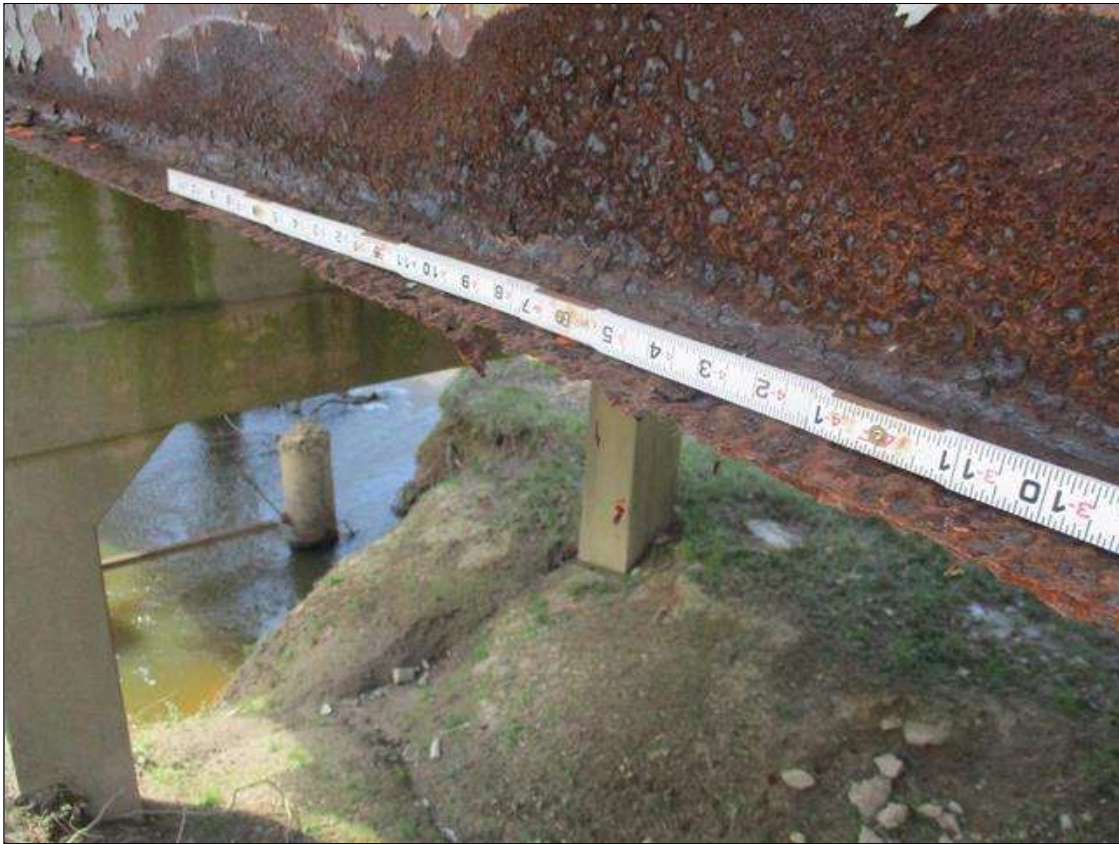
Span 9 Beam 6: [PROMPT ACTION REQUEST] BEAM END AT BENT 9, LOWER RIGHT FLANGE, CORROSION WITH APPROXIMATELY 1/4" SECTION LOSS [AVERAGE 3/16" REMAINS] FOR APPROXIMATELY 3' LONG, THEN AT 4' OUT, CORROSION WITH UP TO 3/8" SECTION LOSS [AVERAGE 1/16" REMAINS] WITH KNIFE EDGING AND CORROSION HOLES FOR APPROXIMATELY 3' LONG.

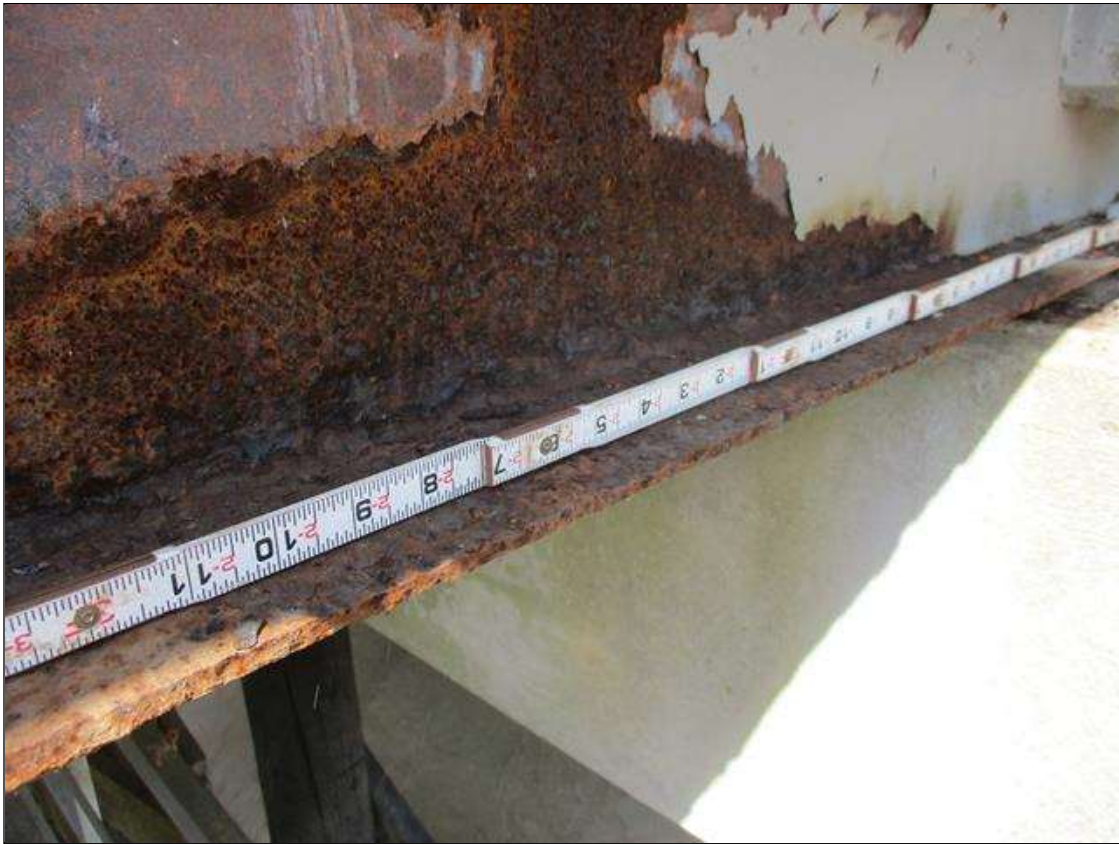
Span 9 Beam 6: [PROMPT ACTION REQUEST] BEAM END AT BENT 9, LOWER RIGHT FLANGE, CORROSION WITH APPROXIMATELY 1/4" SECTION LOSS [AVERAGE 3/16" REMAINS] FOR APPROXIMATELY 3' LONG, THEN AT 4' OUT, CORROSION WITH UP TO 3/8" SECTION LOSS [AVERAGE 1/16" REMAINS] WITH KNIFE EDGING AND CORROSION HOLES FOR APPROXIMATELY 3' LONG.
