NC DEPARTMENT OF TRANSPORTATION
 DIVISION OF HIGHWAYS
 STRUCTURE MANAGEMENT UNIT

ATTENTION: **PROMPT ACTION REQUEST; HYDRAPLATFORM USED; NEW REPAIRS; OUT-TO-OUT REVISED;**

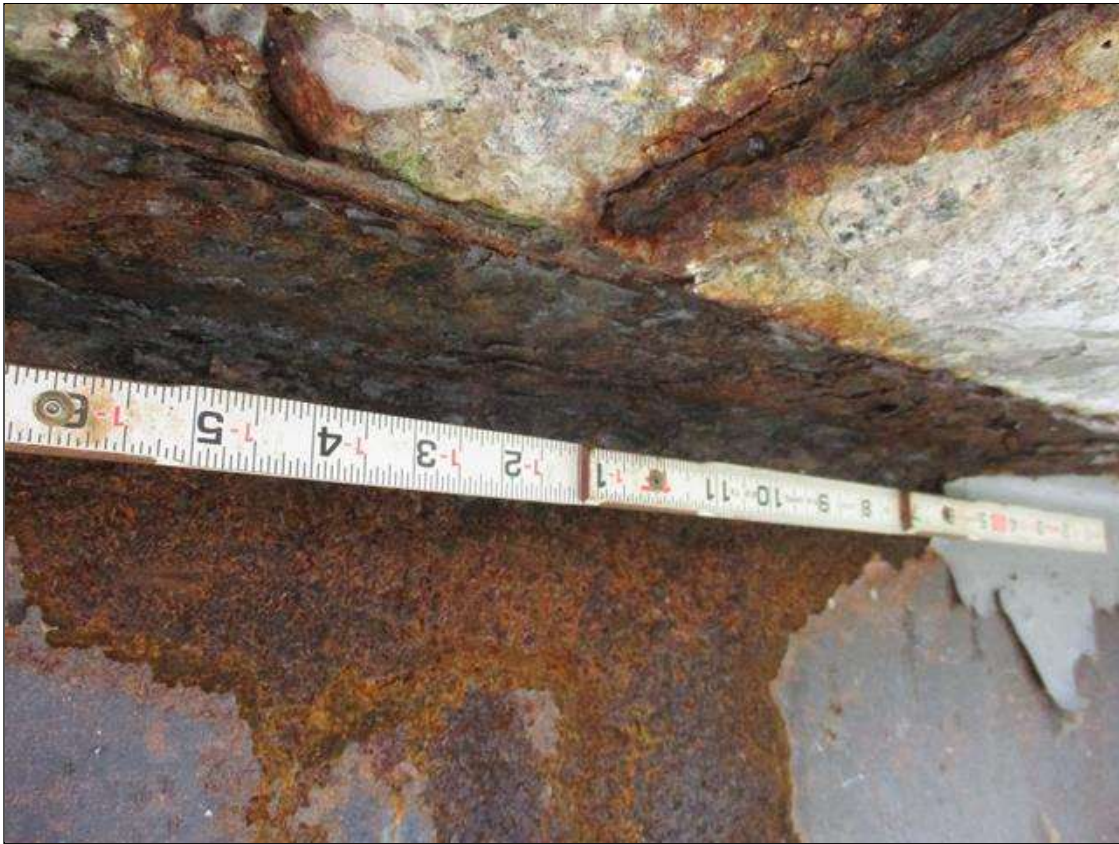
Span 9 Beam 6: [PROMPT ACTION REQUEST] BEAM END AT BENT 9, UPPER RIGHT FLANGE, CORROSION WITH APPROXIMATELY 1/4" SECTION LOSS [AVERAGE 3/16" REMAINS] FOR APPROXIMATELY 7' LONG.

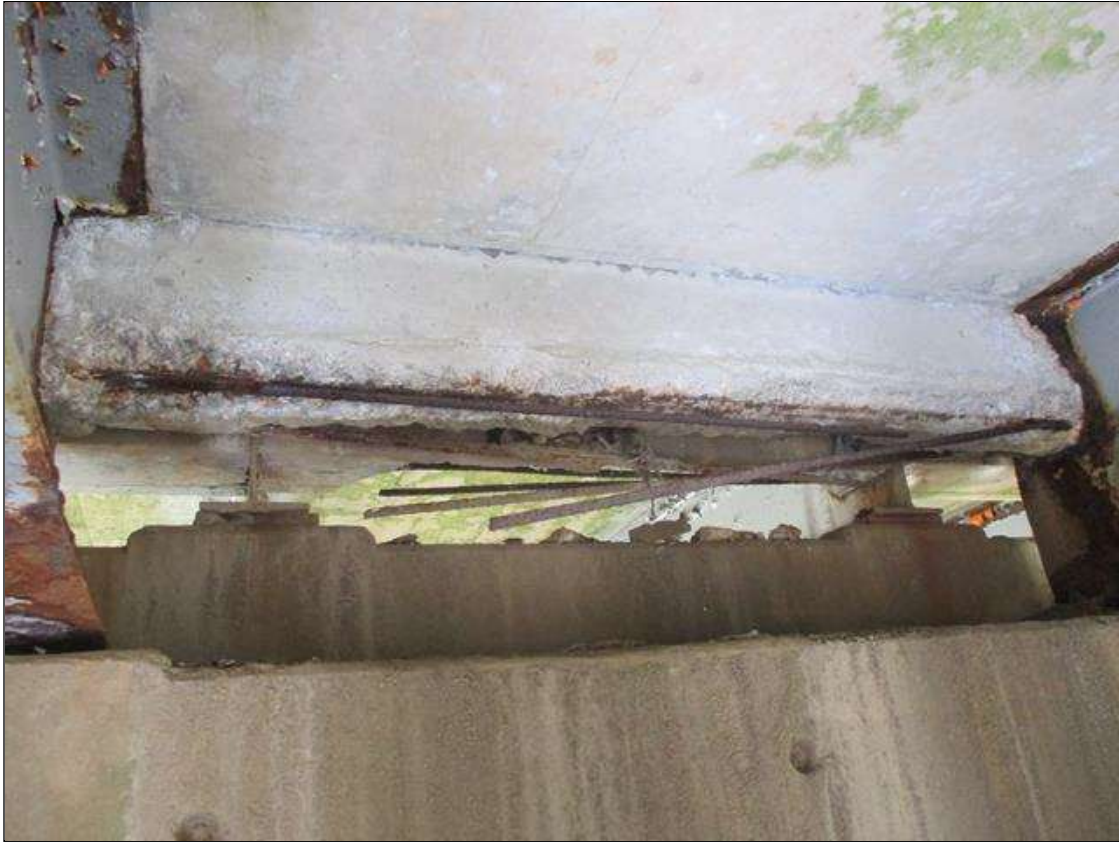
Span 8 Beam 2: [PROMPT ACTION REQUEST] BAY 2 AT BENT 8, REINFORCED CONCRETE DIAPHRAGM, SPALLING WITH EXPOSED REBAR [APPROXIMATELY 6' LONG X 1' WIDE X UP TO 4" DEEP]. THE REBAR IS DELAMINATED FROM THE CONCRETE AND HAS SURFACE CORROSION AND PITTING UP TO 1/16" DEEP.

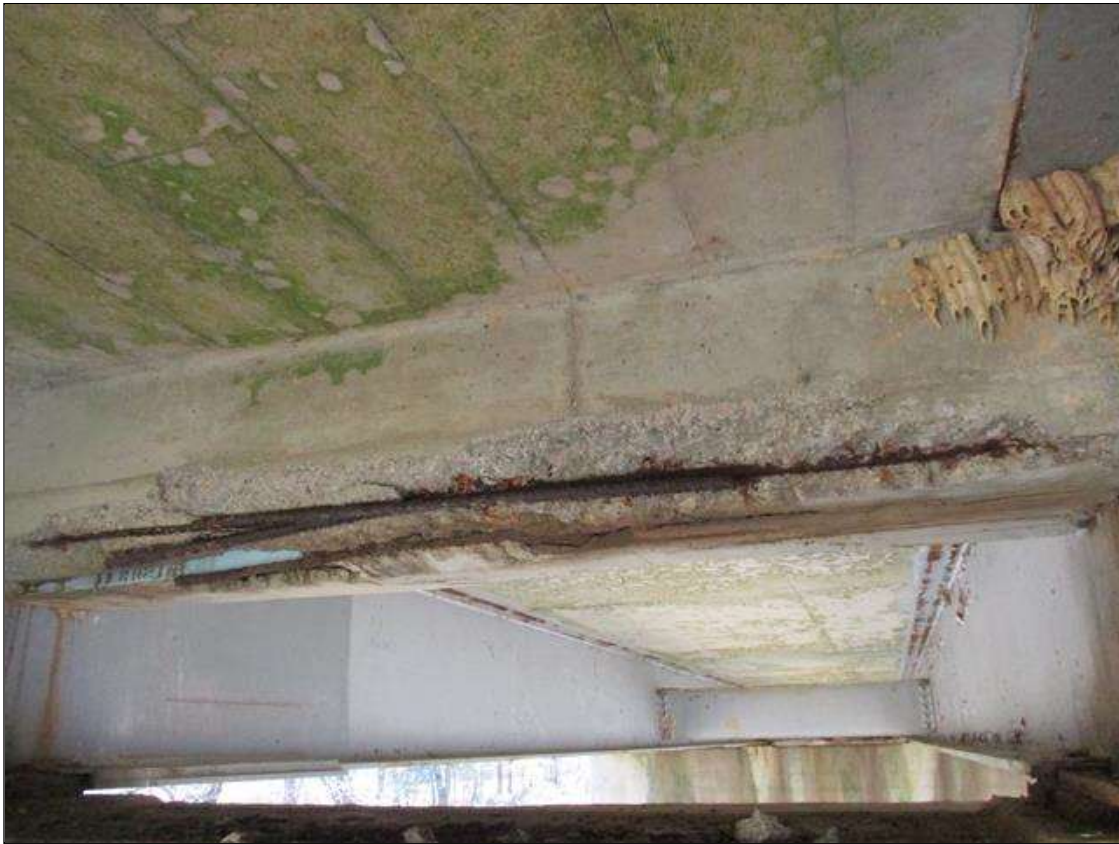
Span 8 Beam 2: [PROMPT ACTION REQUEST] BAY 2 AT BENT 7, REINFORCED CONCRETE DIAPHRAGM, SPALLING WITH EXPOSED REBAR [APPROXIMATELY 5' LONG X 10" WIDE X UP TO 3" DEEP]. THE REBAR IS DELAMINATED FROM THE CONCRETE AND HAS SURFACE CORROSION AND PITTING UP TO 1/16" DEEP.

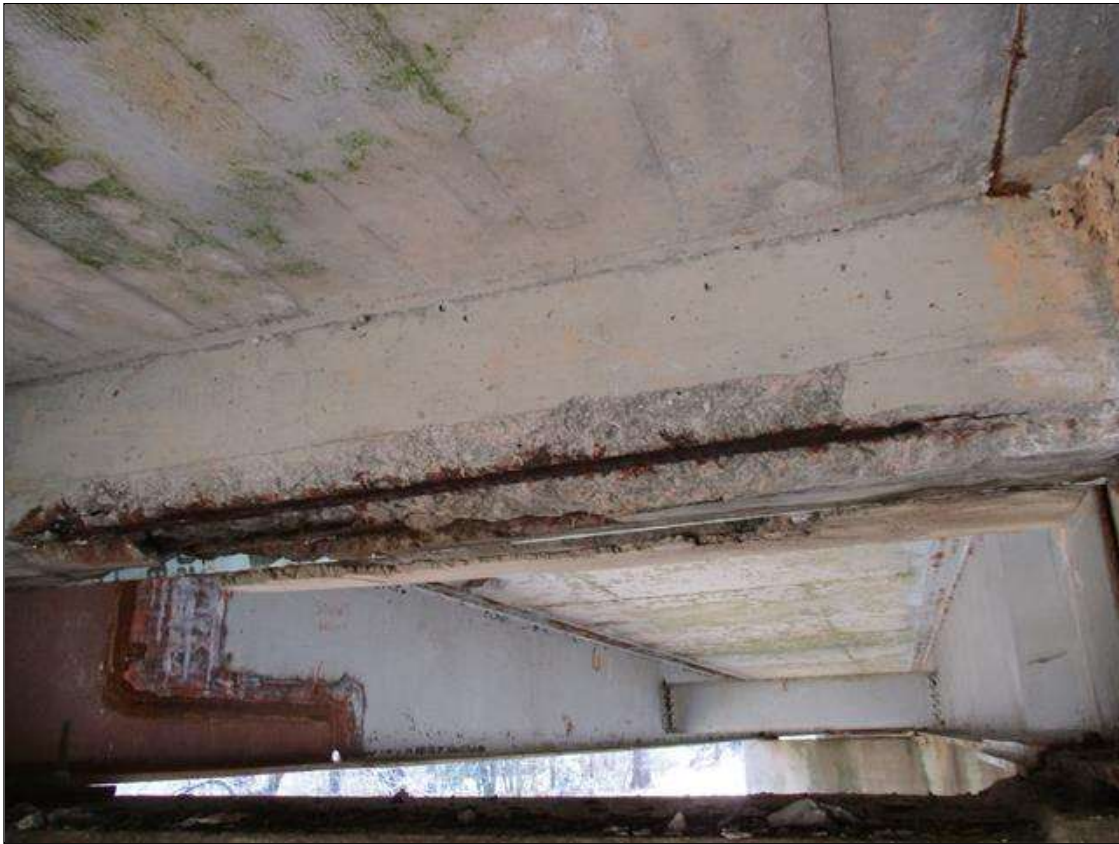
Span 8 Beam 2: [PROMPT ACTION REQUEST] BAY 3 AT BENT 7, REINFORCED CONCRETE DIAPHRAGM, SPALLING WITH EXPOSED REBAR [APPROXIMATELY 5' LONG X 10" WIDE X UP TO 3" DEEP]. THE REBAR IS DELAMINATED FROM THE CONCRETE AND HAS SURFACE CORROSION AND PITTING UP TO 1/16" DEEP.

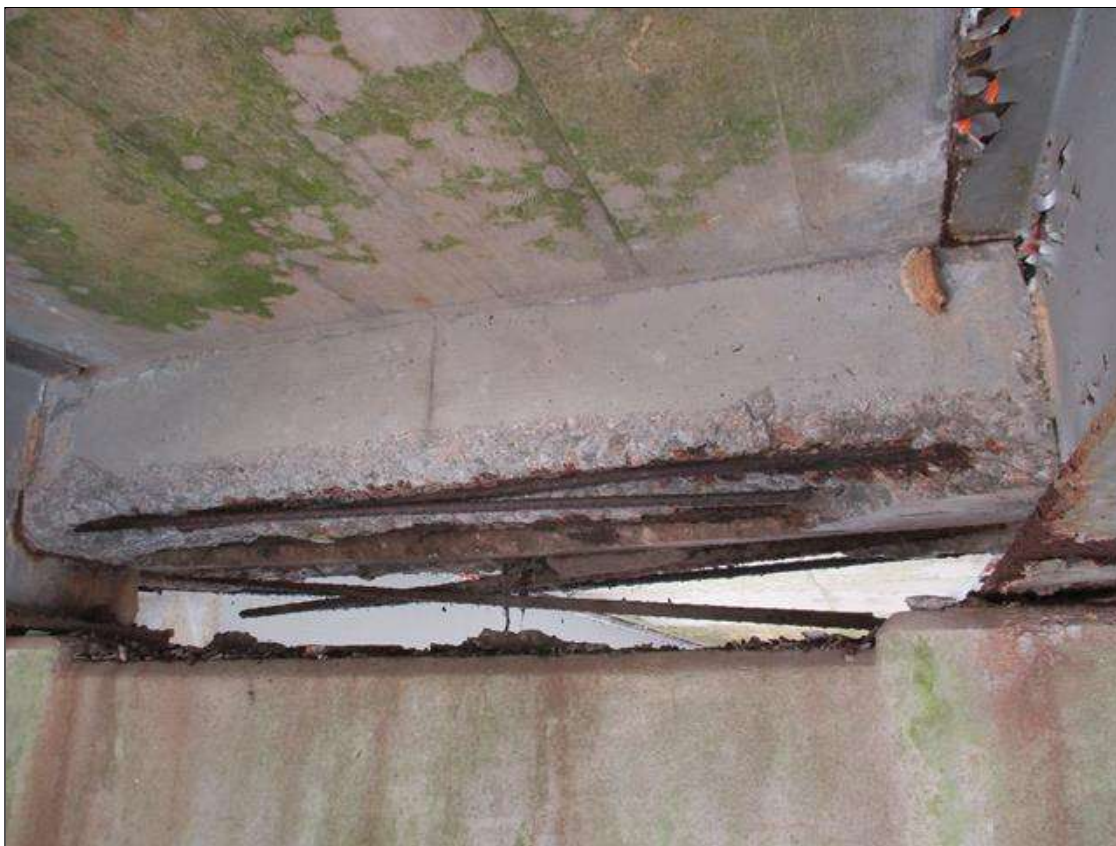
Span 9 Beam 3: [PROMPT ACTION REQUEST] BAY 3 AT BENT 8, REINFORCED CONCRETE DIAPHRAGM, SPALLING WITH EXPOSED REBAR [APPROXIMATELY 5' LONG X 9" WIDE X UP TO 3" DEEP]. THE REBAR IS DELAMINATED FROM THE CONCRETE AND HAS SURFACE CORROSION AND PITTING UP TO 1/16" DEEP.

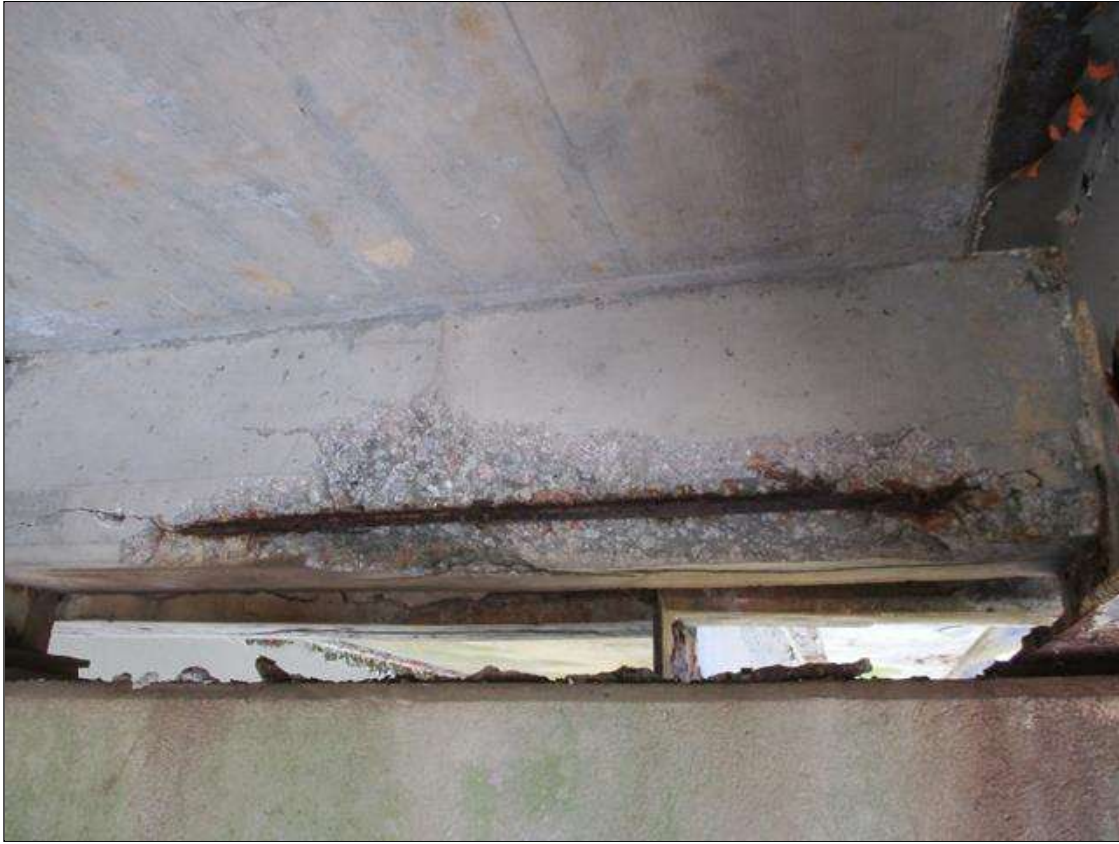
Span 9 Beam 3: [PROMPT ACTION REQUEST] BAY 2 AT BENT 8, REINFORCED CONCRETE DIAPHRAGM, SPALLING WITH EXPOSED REBAR [APPROXIMATELY 4' LONG X 10" WIDE X UP TO 3" DEEP]. THE REBAR IS DELAMINATED FROM THE CONCRETE AND HAS SURFACE CORROSION AND PITTING UP TO 1/16" DEEP.

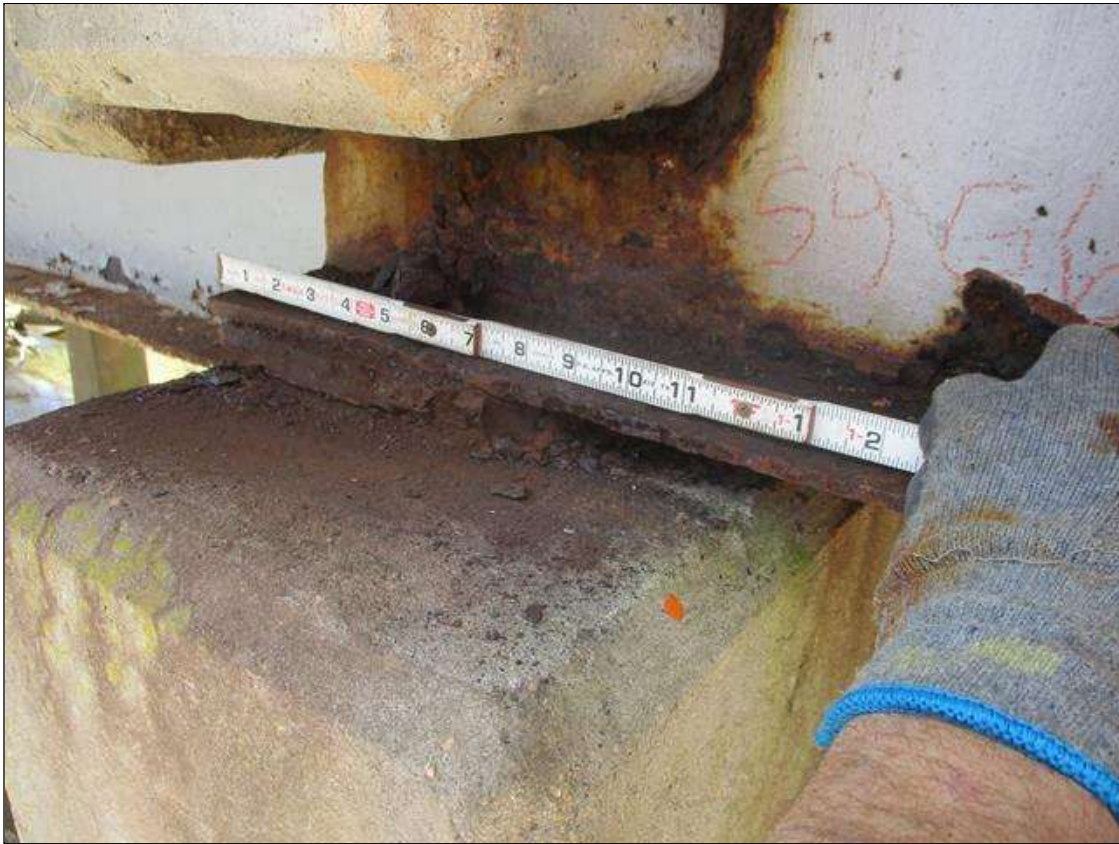
Span 9 Beam 6: [PROMPT ACTION REQUEST] APPROXIMATELY 8" OUT FROM THE BEAM END AT BENT 8, LOWER RIGHT FLANGE, CORROSION WITH APPROXIMATELY 3/16" SECTION LOSS [AVERAGE 1/4" REMAINS] FOR APPROXIMATELY 1' LONG.

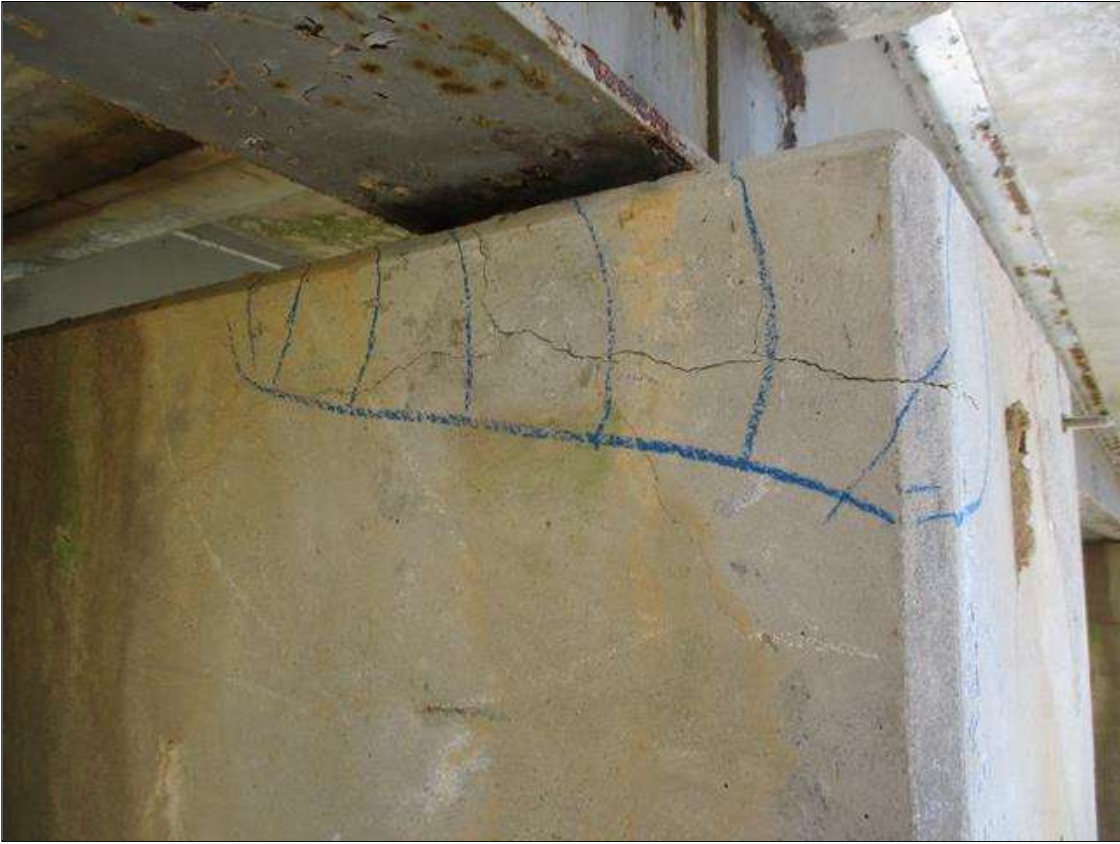
Bent 7 Cap 1: NORTH FACE, LEFT END, TOP CORNER, APPROXIMATELY 2 SQUARE FEET MAP CRACKING TO 1/32" WIDE WITH ASSOCIATED DELAMINATION

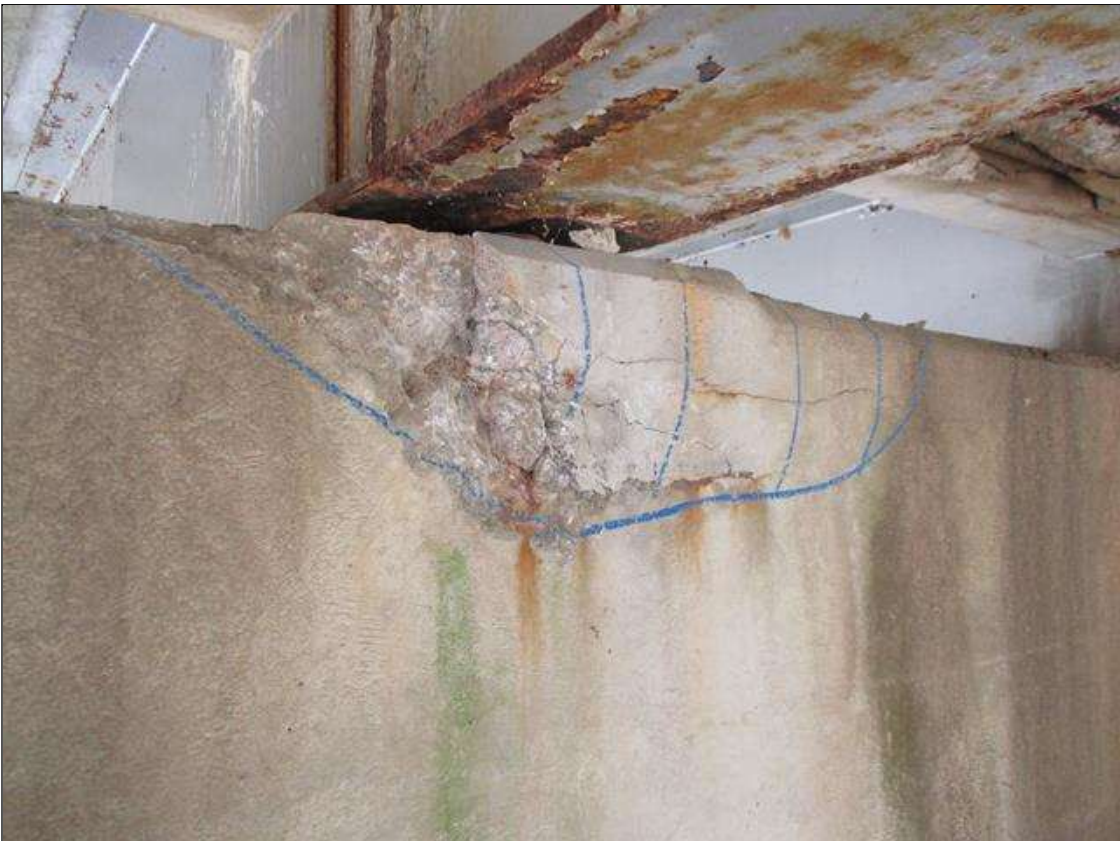
Bent 7 Cap 1: NORTH FACE AT BEAM 3, APPROXIMATELY 2 SQUARE FEET OF SPALLING AND MAP CRACKING TO 1/32" WIDE WITH ASSOCIATED DELAMINATION

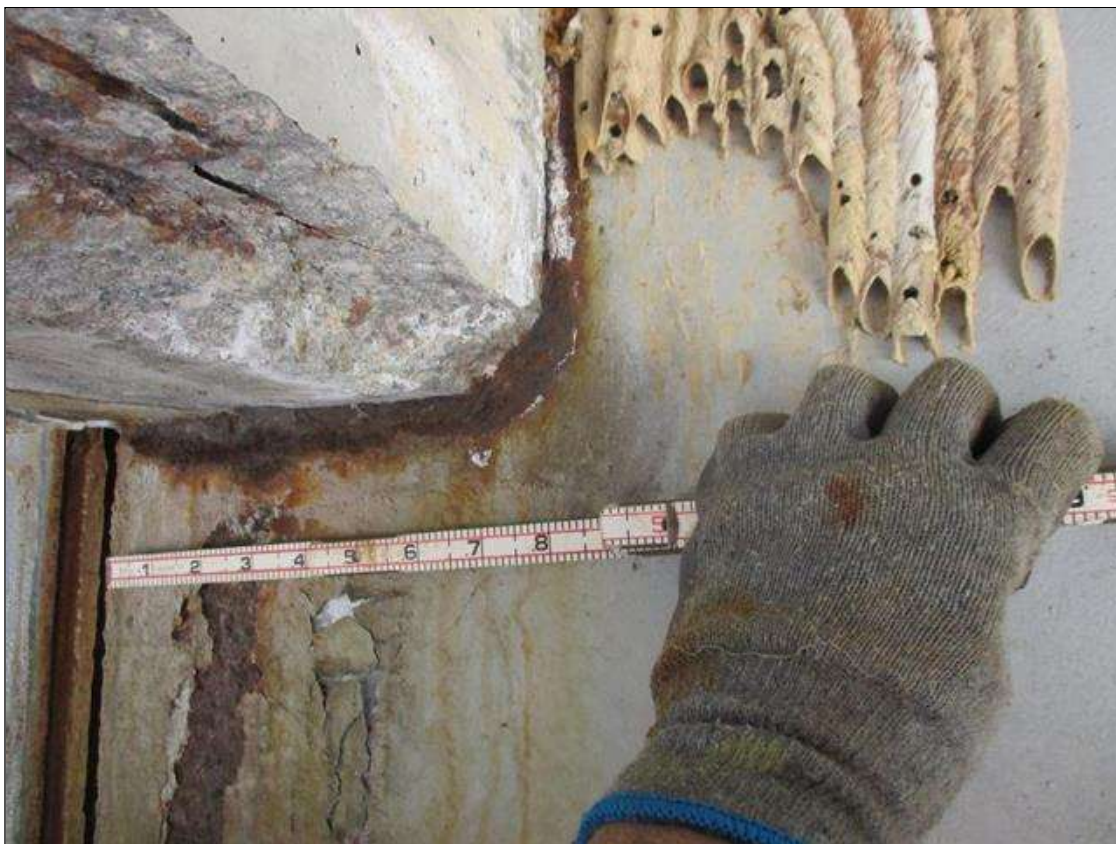
Span 8 Beam 3: [PROMPT ACTION REQUEST] BEAM END AT BENT 7, THERE IS AN APPROXIMATELY 1" WIDE BAND OF CORROSION THAT WRAPS THE REINFORCED CONCRETE DIAPHRAGM, APPROXIMATELY 1/4" SECTION LOSS [AVERAGE 3/16" REMAINS] FOR APPROXIMATELY 10" LONG.

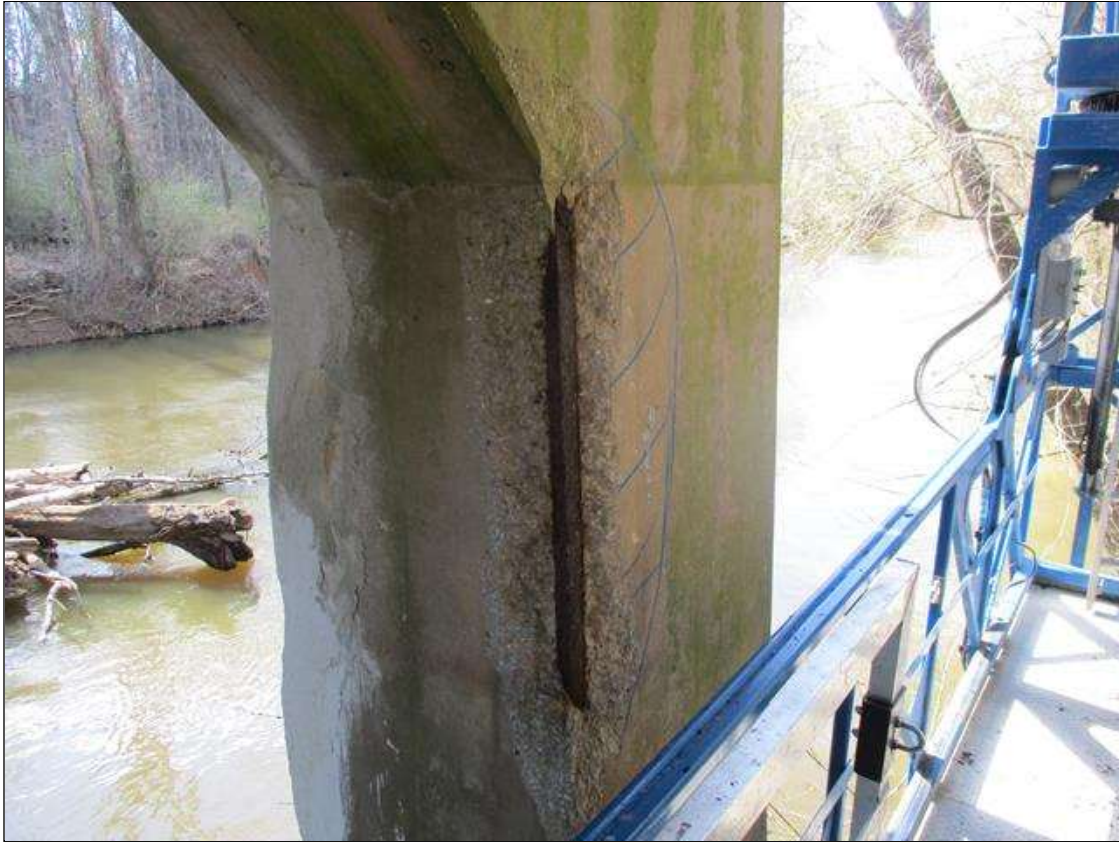
Bent 7 Pile 1: [PROMPT ACTION REQUEST] 4' X 6" X 7" SPALL WITH EXPOSED REBAR ON NORTHEAST CORNER, NO MEASURABLE SECTION LOSS, WITH APPROXIMATELY 3 SQUARE FEET ASSOCIATED DELAMINATION

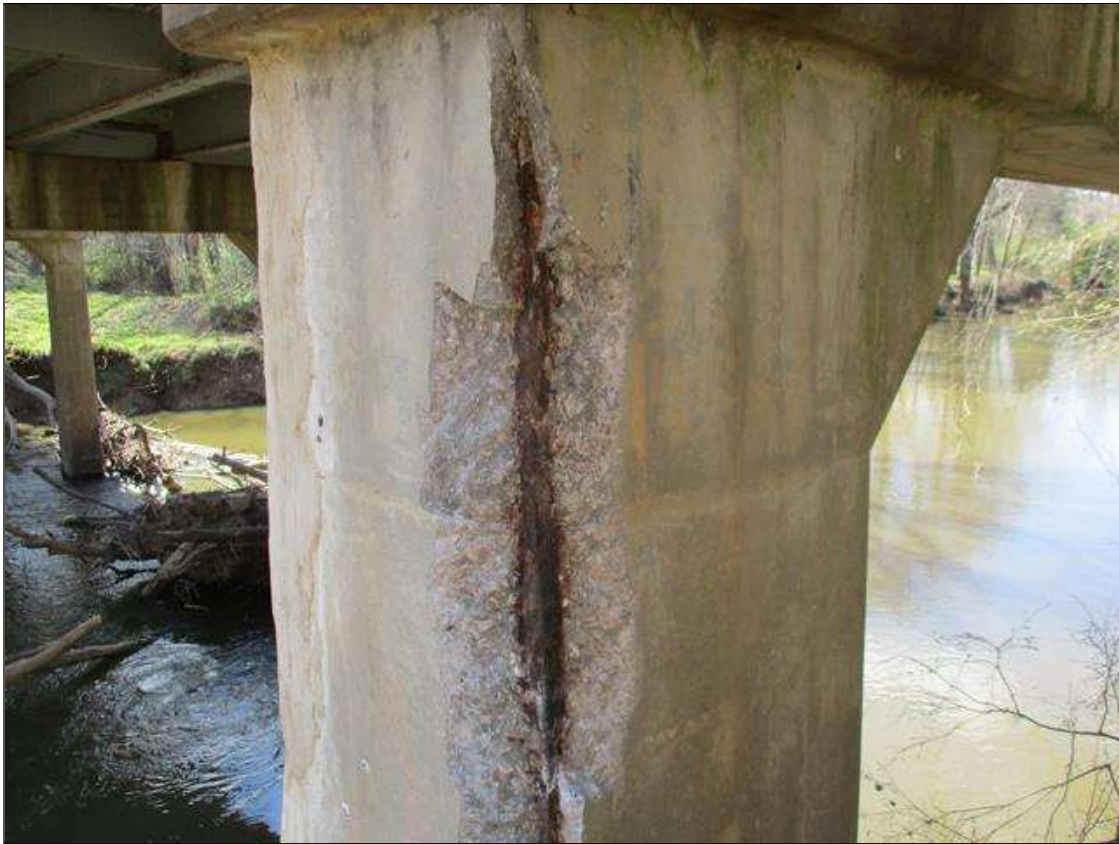
Bent 7 Pile 2: [PROMPT ACTION REQUEST] NORTHEAST CORNER, SPALLING WITH EXPOSED REBAR UP TO 2" DEEP, VERTICAL CRACKING TO 1/8" WIDE AND ASSOCIATED DELAMINATION [TOTAL AREA APPROXIMATELY 8' LONG X 1' WIDE]

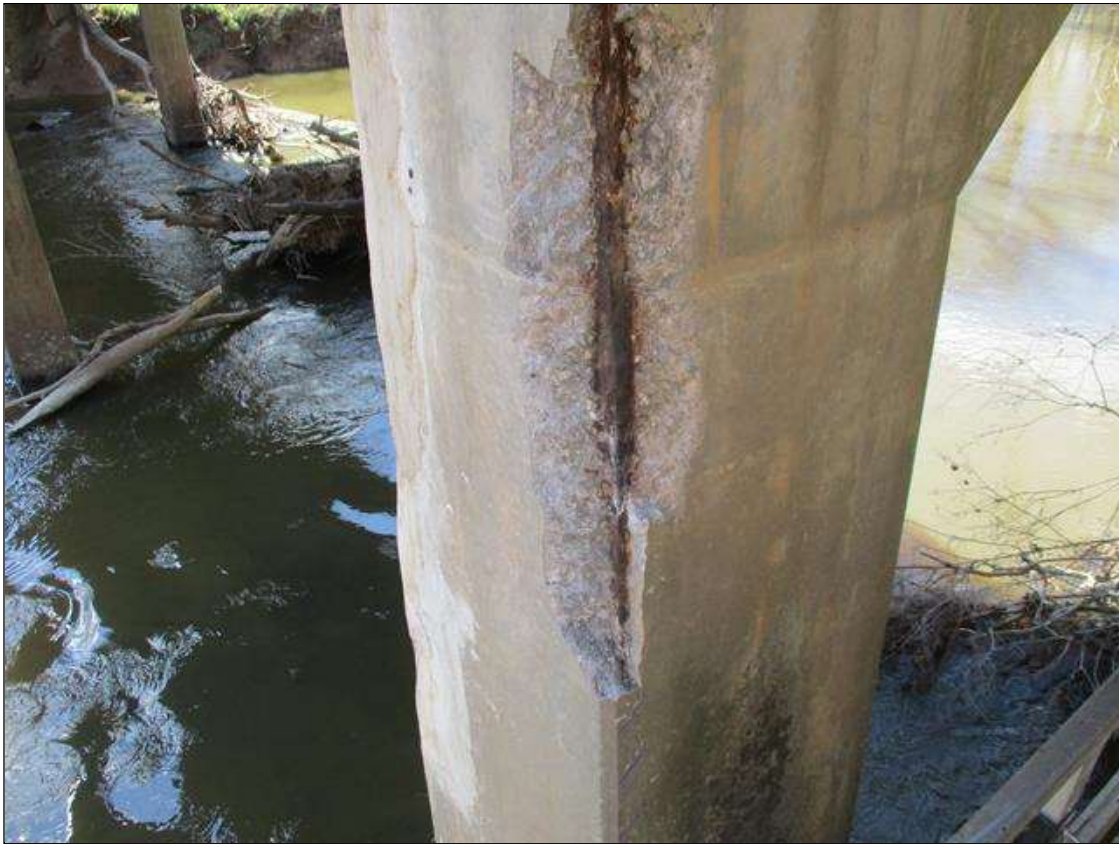
Bent 7 Pile 2: [PROMPT ACTION REQUEST] NORTHEAST CORNER, SPALLING WITH EXPOSED REBAR UP TO 2" DEEP, VERTICAL CRACKING TO 1/8" WIDE AND ASSOCIATED DELAMINATION [TOTAL AREA APPROXIMATELY 8' LONG X 1' WIDE]

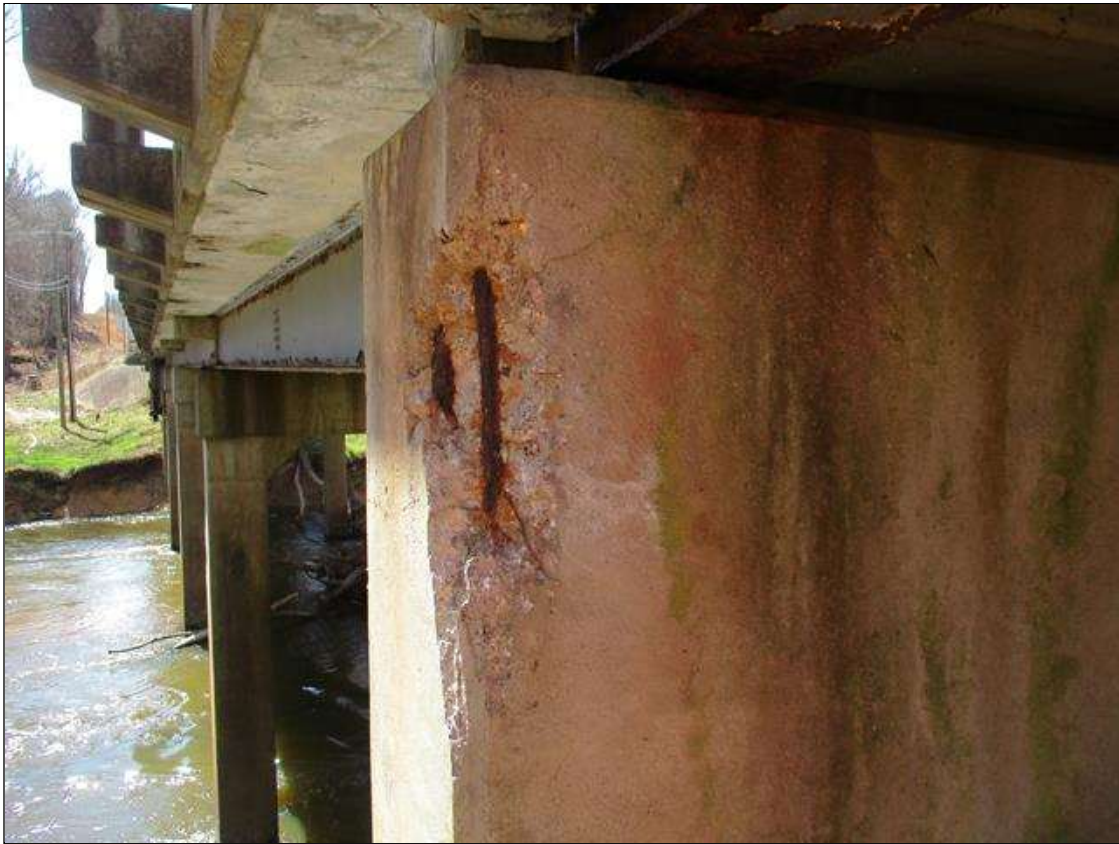
Bent 8 Cap 1: 18" X 7" X 3" DEEP SPALL WITH EXPOSED REBAR ON NORTHEAST CORNER

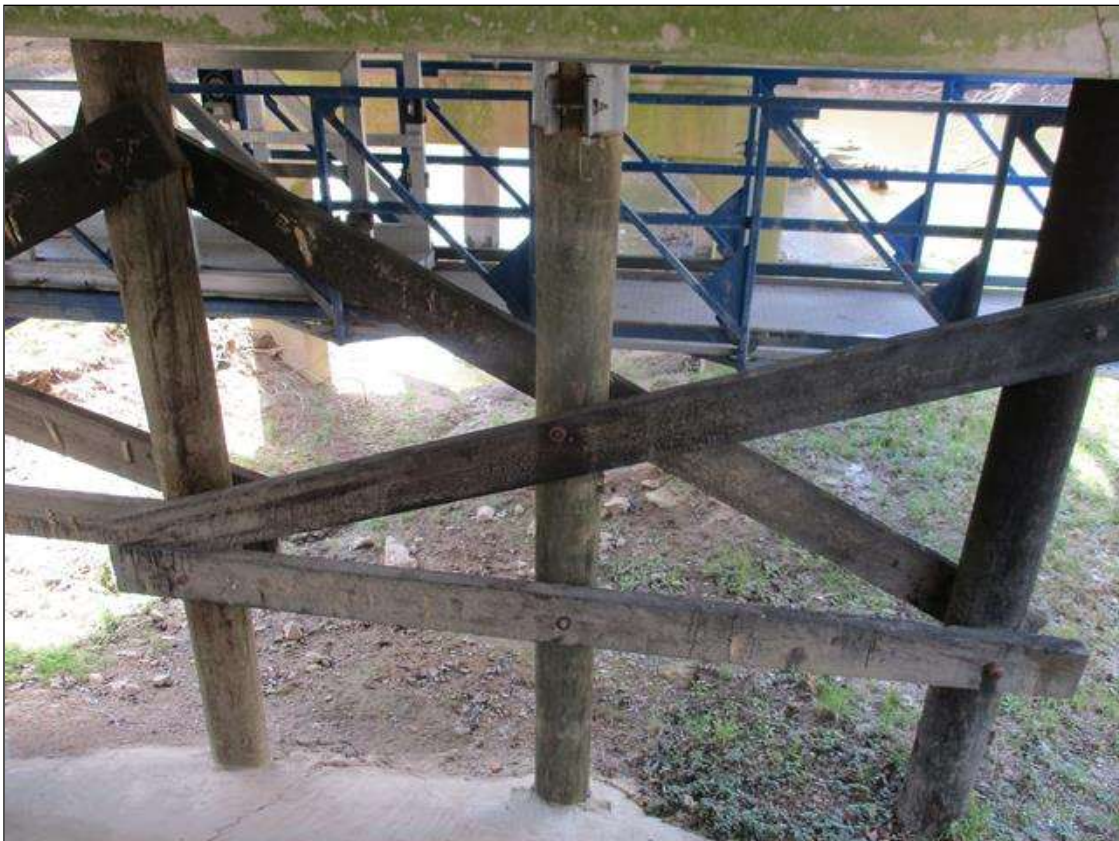
Bent 9 Pile 2: [NEW REPAIR] PILE SPLICED USING STEEL COLLARS [APPROXIMATELY 12' LONG]

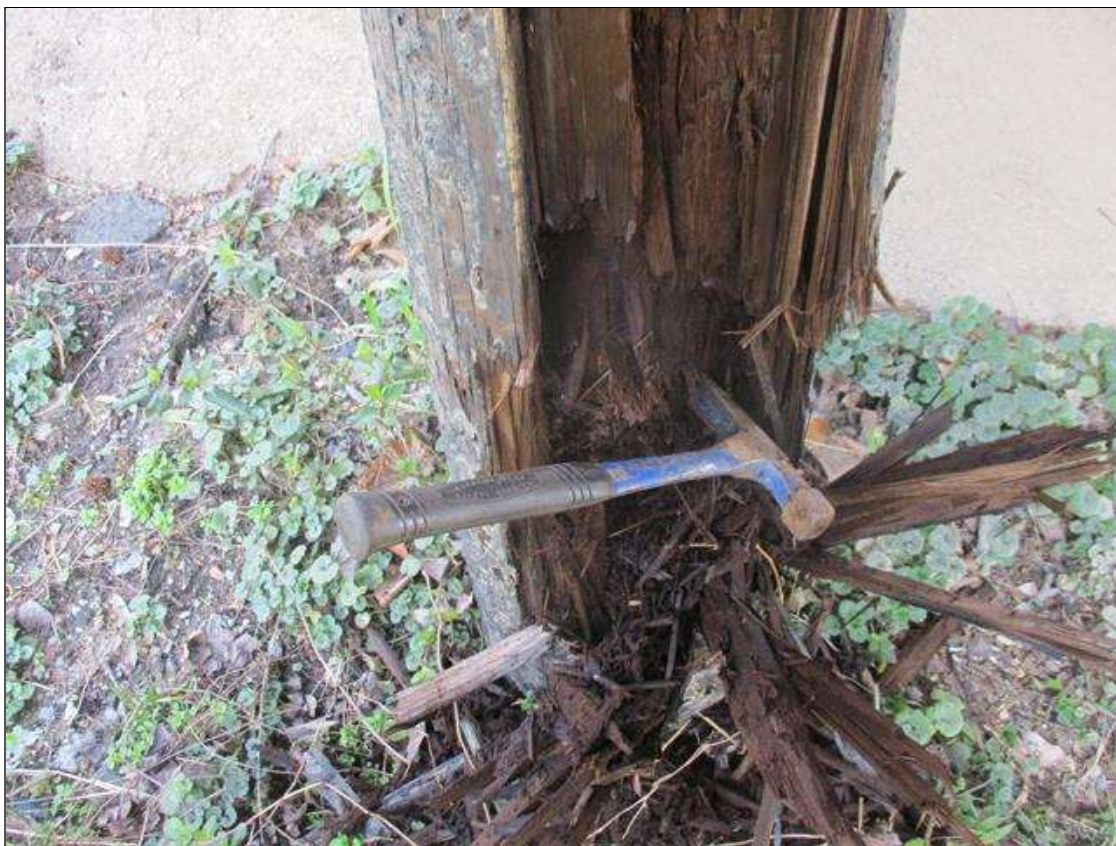
Bent 9 Pile 1: [PROMPT ACTION REQUEST] AT THE GROUNDLINE, DECAY AND SECTION LOSS WITH APPROXIMATELY 4" CORE REMAINING FOR APPROXIMATELY 4' HIGH

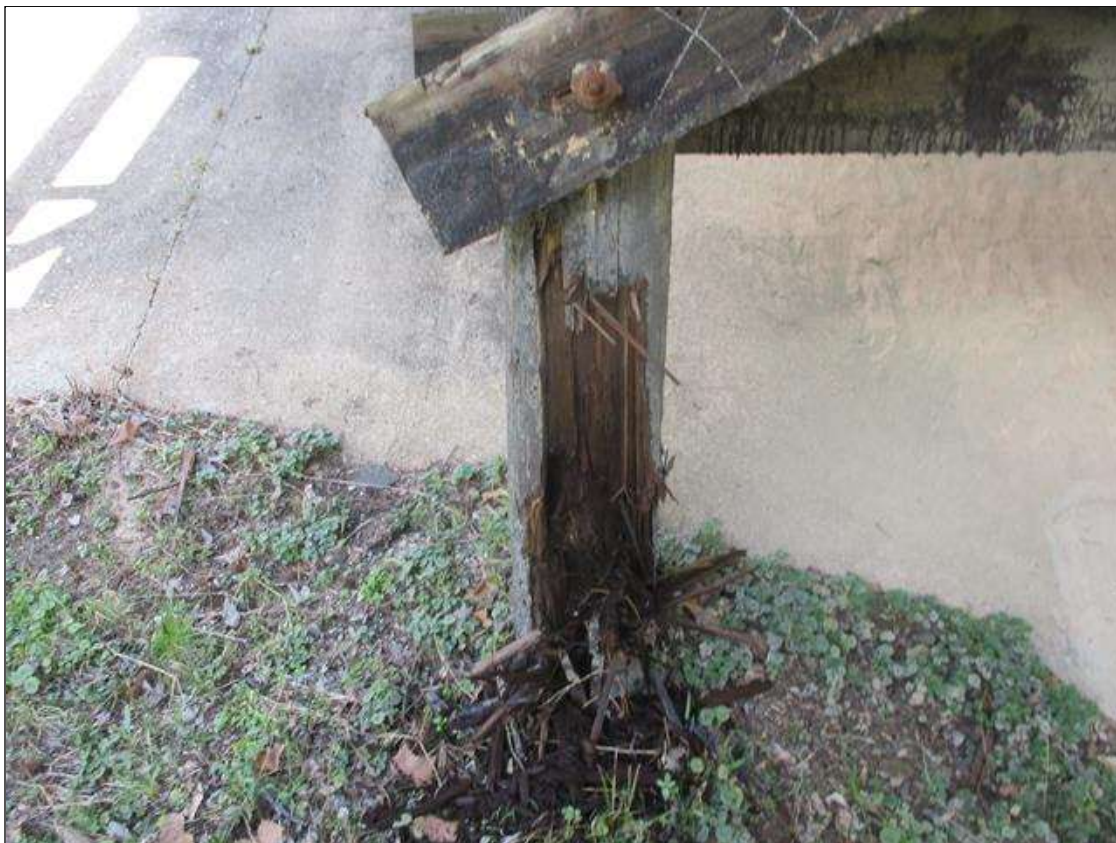
Bent 9 Pile 1: [PROMPT ACTION REQUEST] AT THE GROUNDLINE, DECAY AND SECTION LOSS WITH APPROXIMATELY 4" CORE REMAINING FOR APPROXIMATELY 4' HIGH

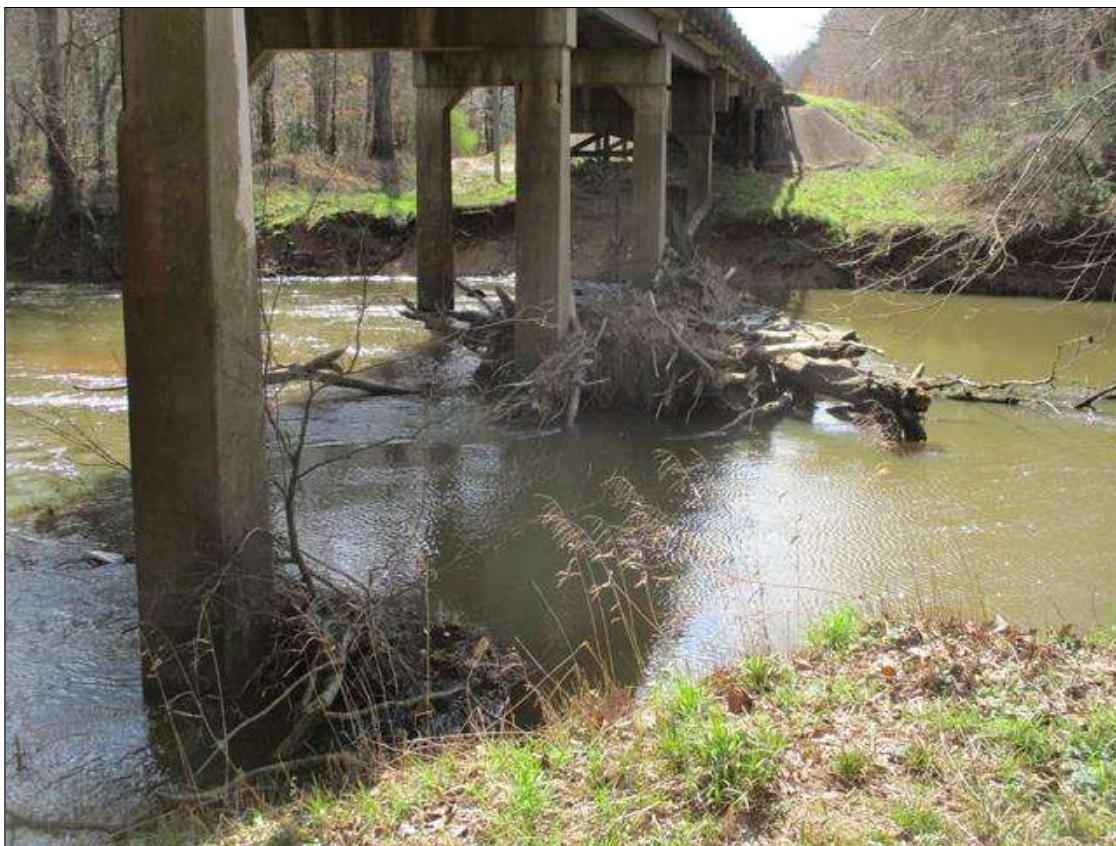
UPSTREAM OF BENTS 4-7, DRIFT COLLECTED [APPROXIMATELY 120 CUBIC YARDS TOTAL]

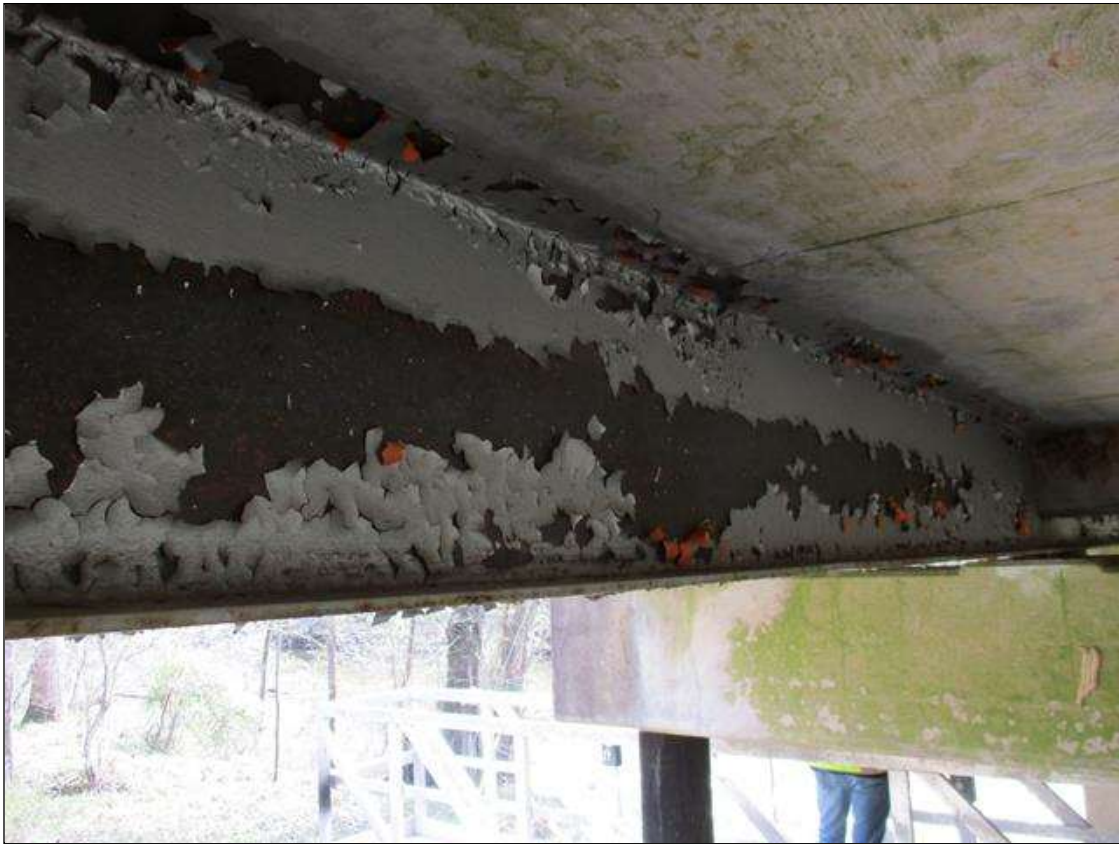
SUPERSTRUCTURE: VIEW OF TYPICAL PROTECTIVE COATING FAILURE

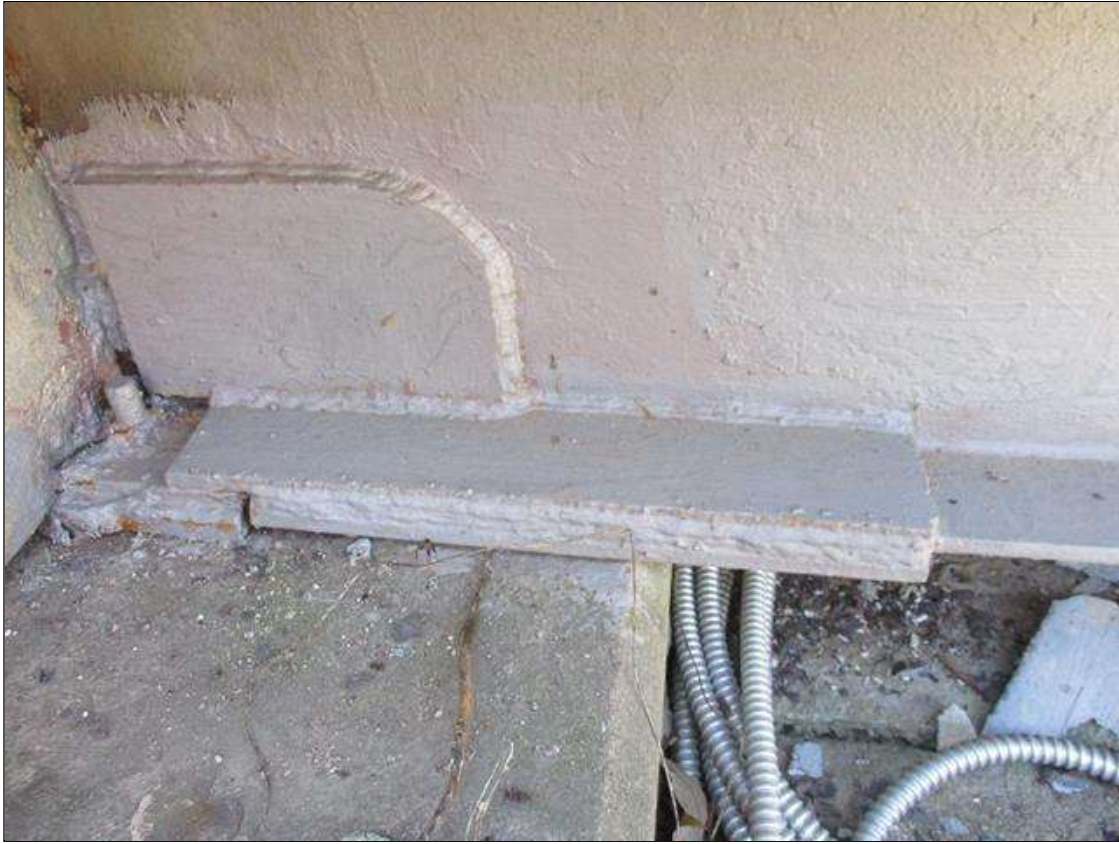
Span 1 Beam 6: [NEW REPAIR] BEAM END AT END BENT 1, PLATES HAVE BEEN WELDED TO BOTH SIDES OF THE WEB [10" LONG] AND ON THE UPPER AND LOWER SIDES OF THE LOWER FLANGE [18" LONG] IN THE AREAS OF PAST SECTION LOSS.

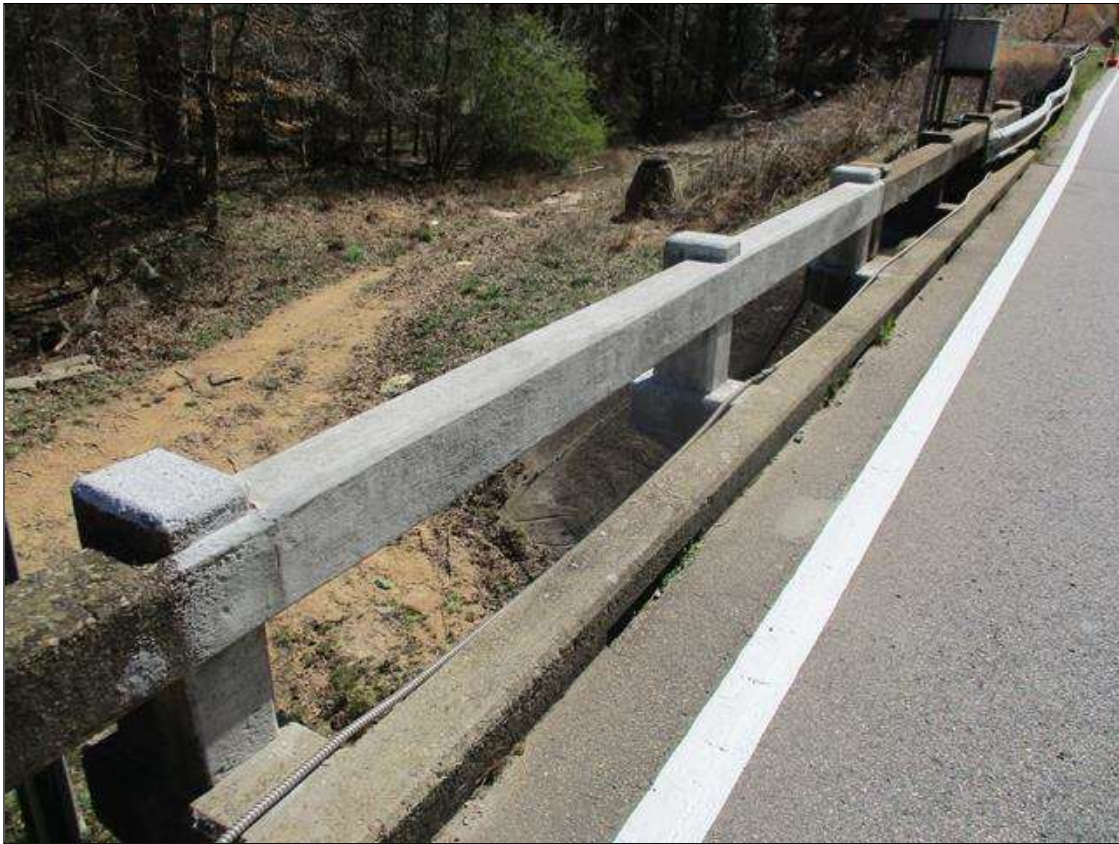
Span 2 Right Bridge Rail: APPROXIMATELY 12' OF SOUND PATCHING

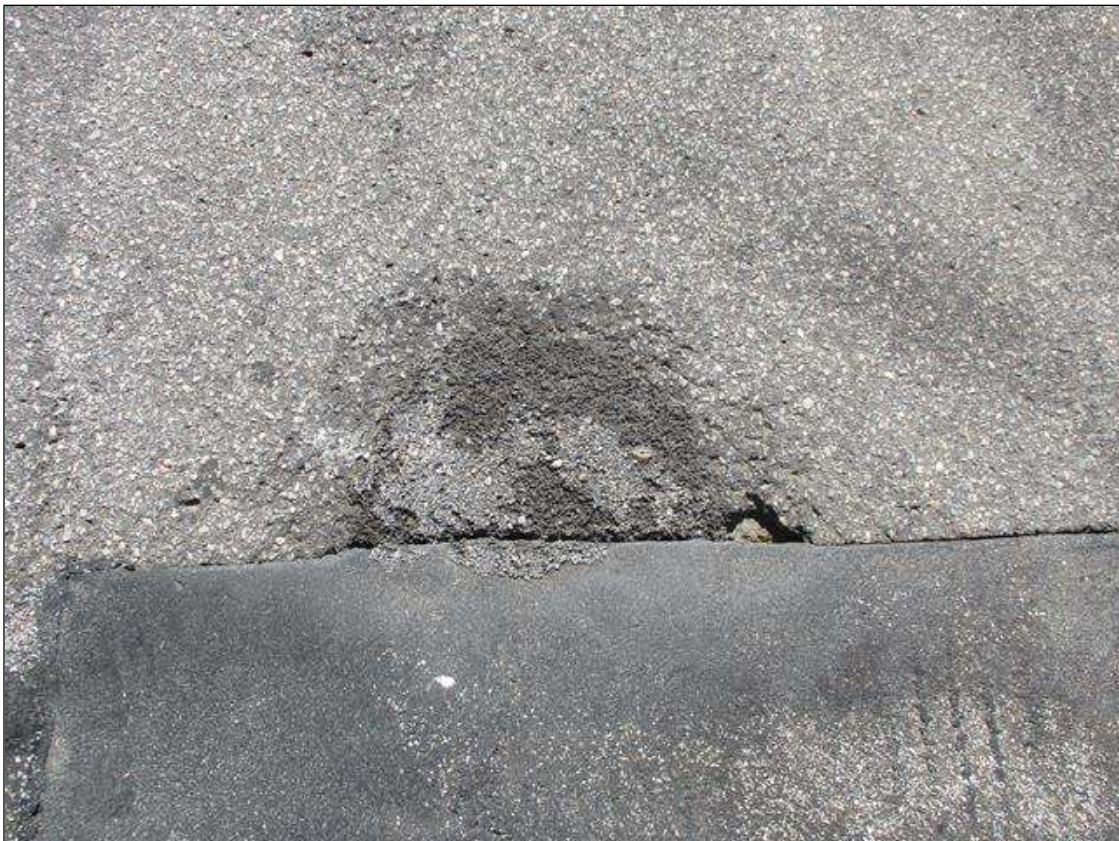
Span 2 Wearing Surface: LEFT LANE AT BENT 2, APPROXIMATELY 2 SQUARE FEET UNSOUND PATCHING [COLD PATCH]

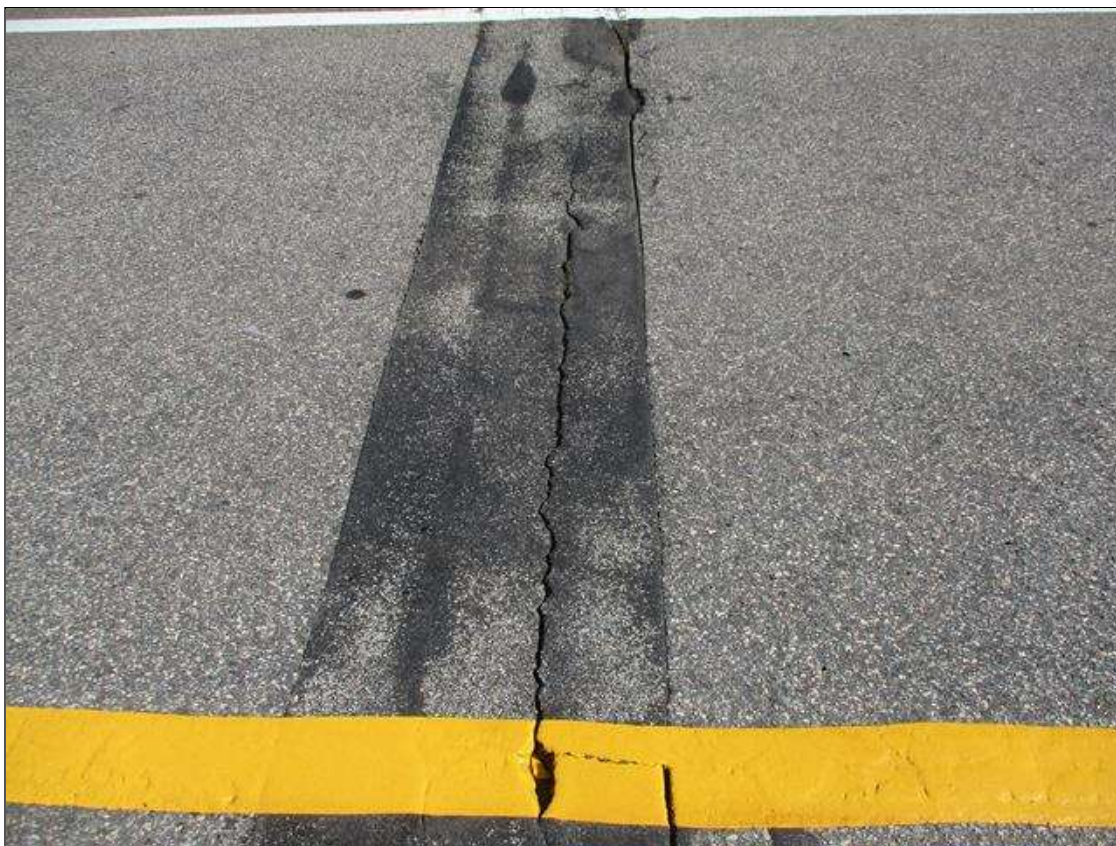
Expansion Joint : SCATTERED ALONG THE LENGTH, LONGITUDINAL CRACKING TO 2" WIDE
