NC DEPARTMENT OF TRANSPORTATION
 DIVISION OF HIGHWAYS
 STRUCTURE MANAGEMENT UNIT

ATTENTION: **PROMPT ACTION REQUEST; HYDRAPLATFORM USED; NEW REPAIRS; OUT-TO-OUT REVISED;**

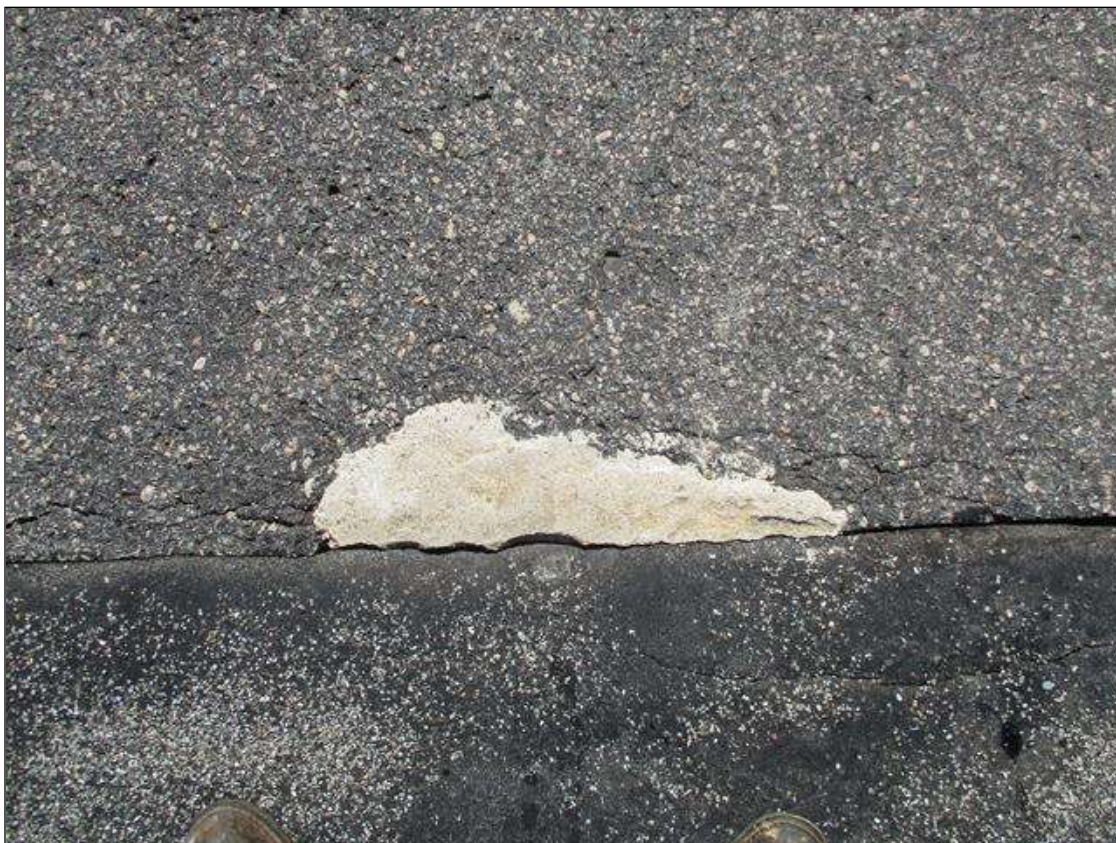
Span 5 Wearing Surface: RIGHT LANE AT BENT 5, APPROXIMATELY 1 SQUARE FEET SOUND PATCHING

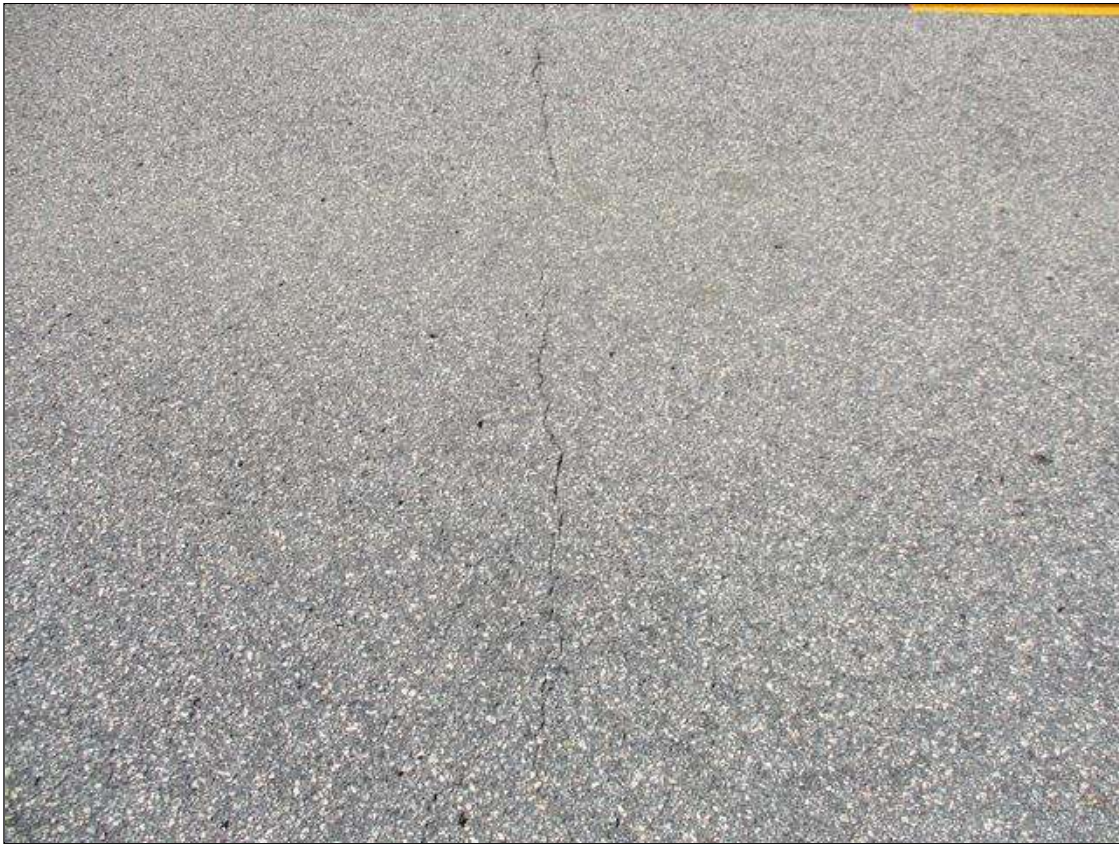
Span 5 Wearing Surface: SCATTERED LONGITUDINAL CRACKING TO 3/16" WIDE

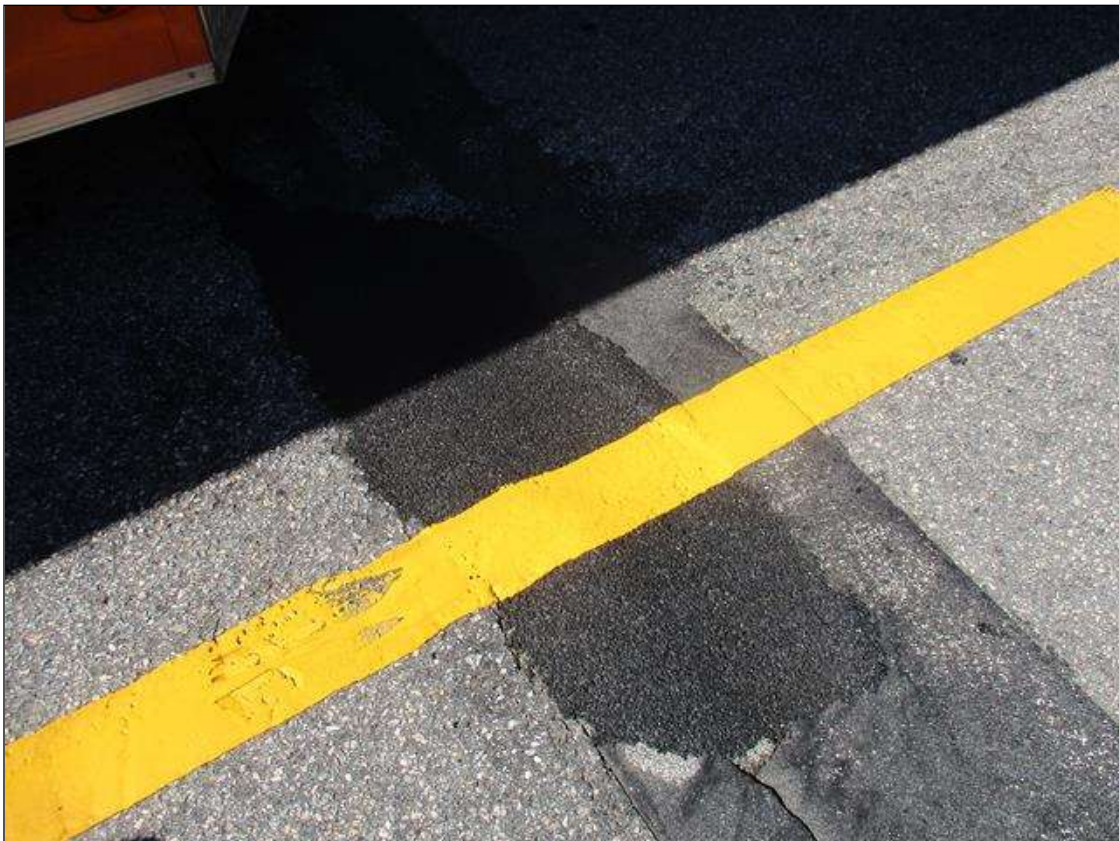
Expansion Joint : SCATTERED 1/2" LONGITUDINAL CRACKING AND APPROXIMATELY 4 SQUARE FEET UNSOUND PATCHING [COLD PATCH]

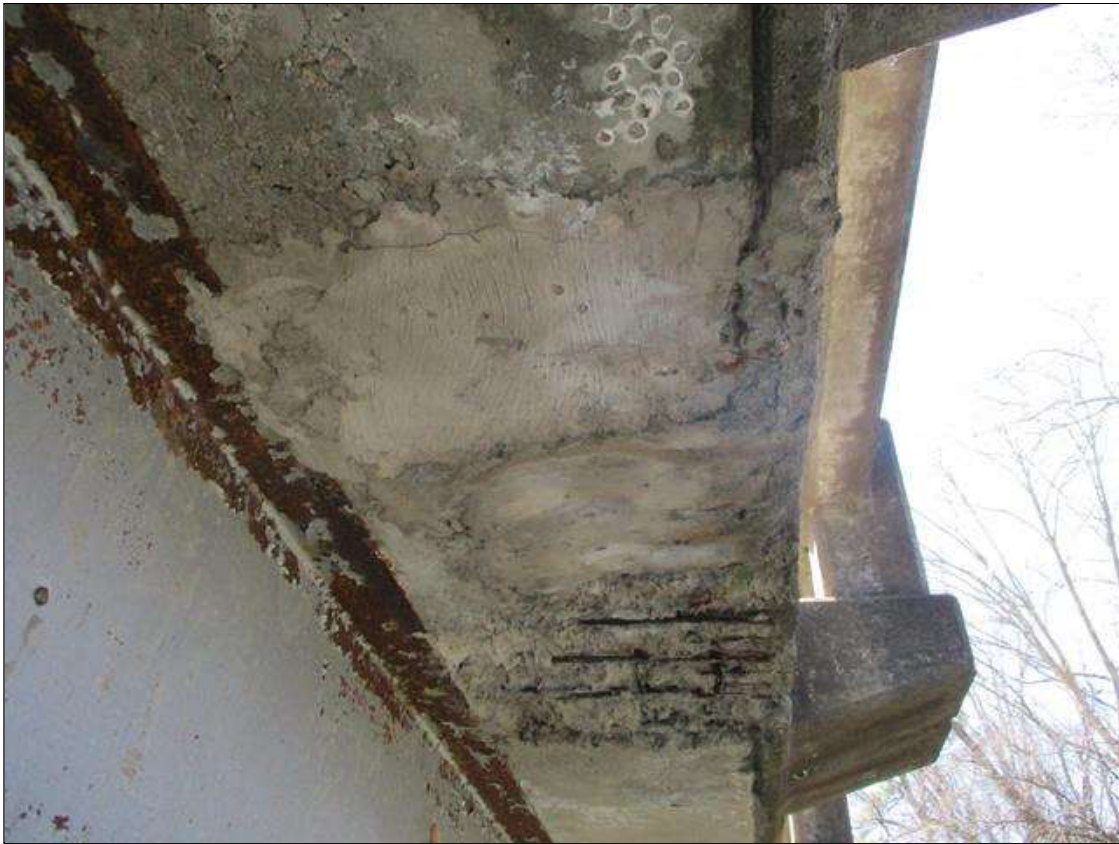
Span 5 Deck: [PROMPT ACTION REQUEST] 5' X 2' X 3" DEEP SPALLING WITH HEAVILY DECAYED REBAR [SECTION LOSS UP TO 100%] IN LEFT OVERHANG AT 7' FROM BENT 5

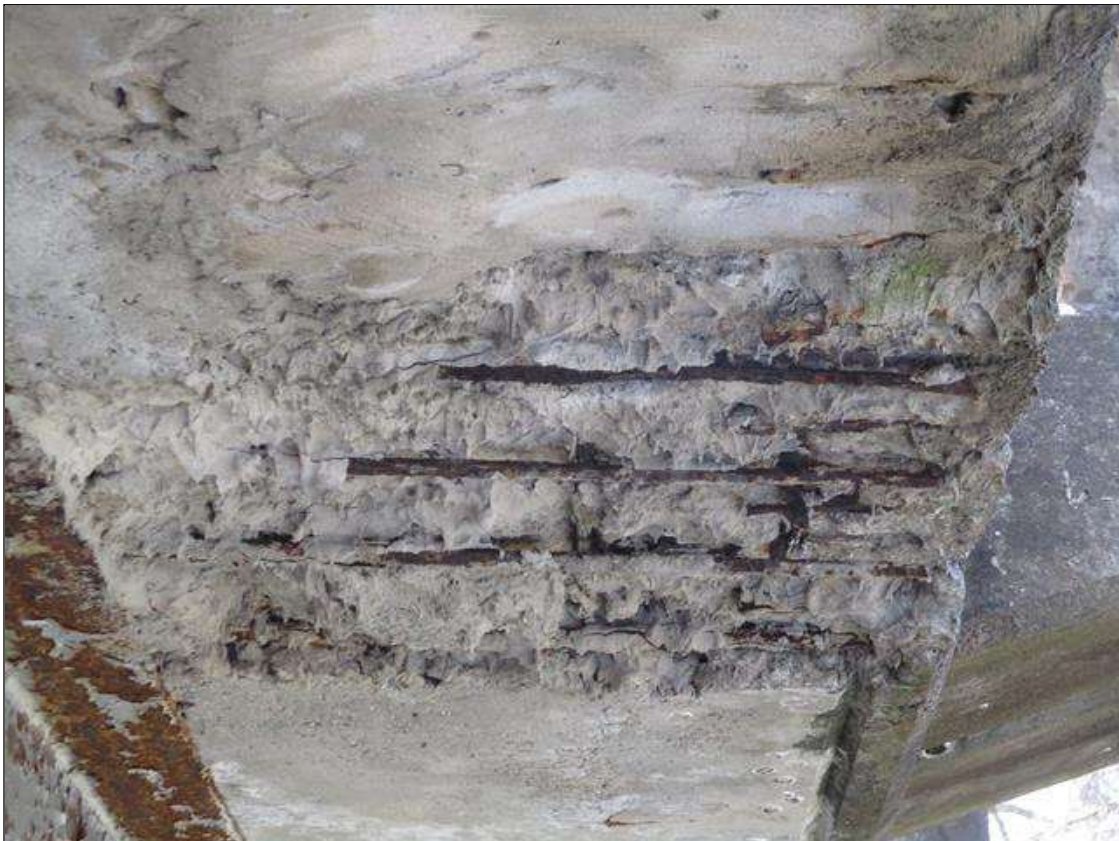
Span 5 Deck: [PROMPT ACTION REQUEST] 5' X 2' X 3" DEEP SPALLING WITH HEAVILY DECAYED REBAR [SECTION LOSS UP TO 100%] IN LEFT OVERHANG AT 7' FROM BENT 5

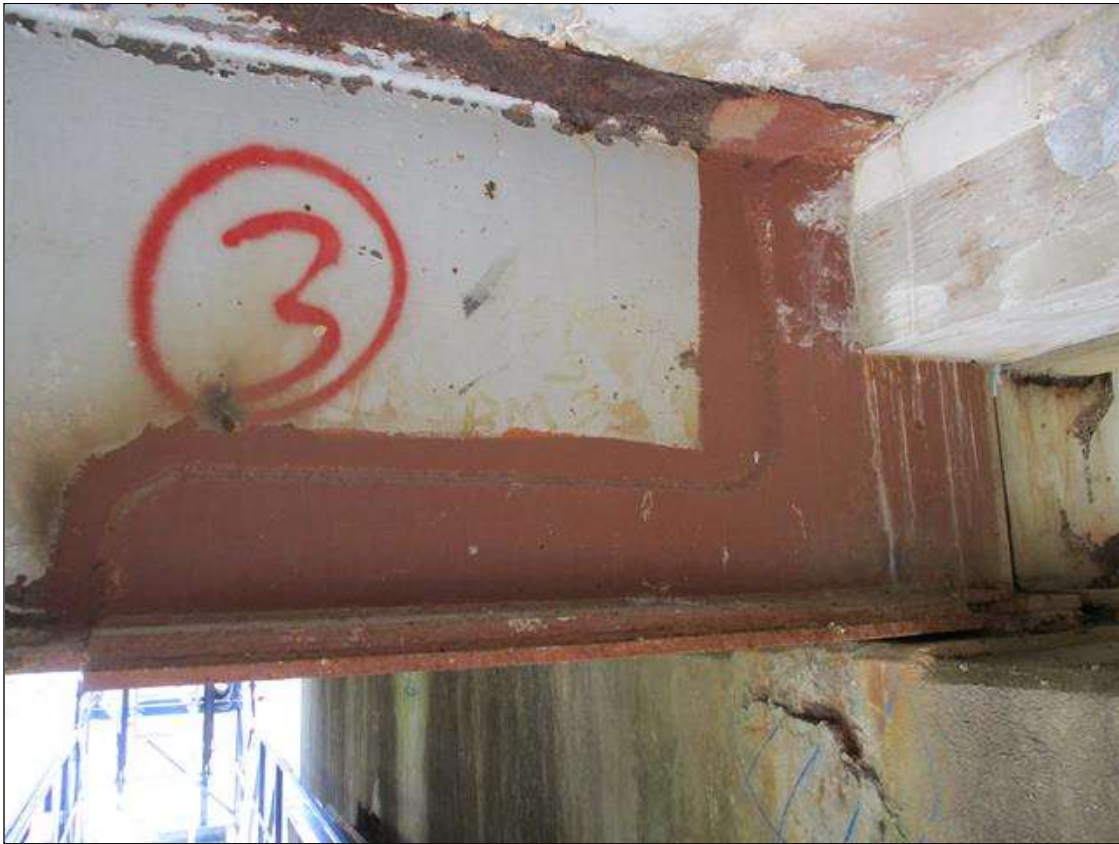
Span 5 Beam 3: [NEW REPAIR] BEAM END AT BENT 5, PLATES HAVE BEEN WELDED TO BOTH SIDES OF THE WEB [4' LONG X UP TO FULL HEIGHT] AND ON THE UPPER AND LOWER SIDES OF THE LOWER FLANGE [4' LONG X 1' WIDE] IN THE AREAS OF PAST SECTION LOSS.

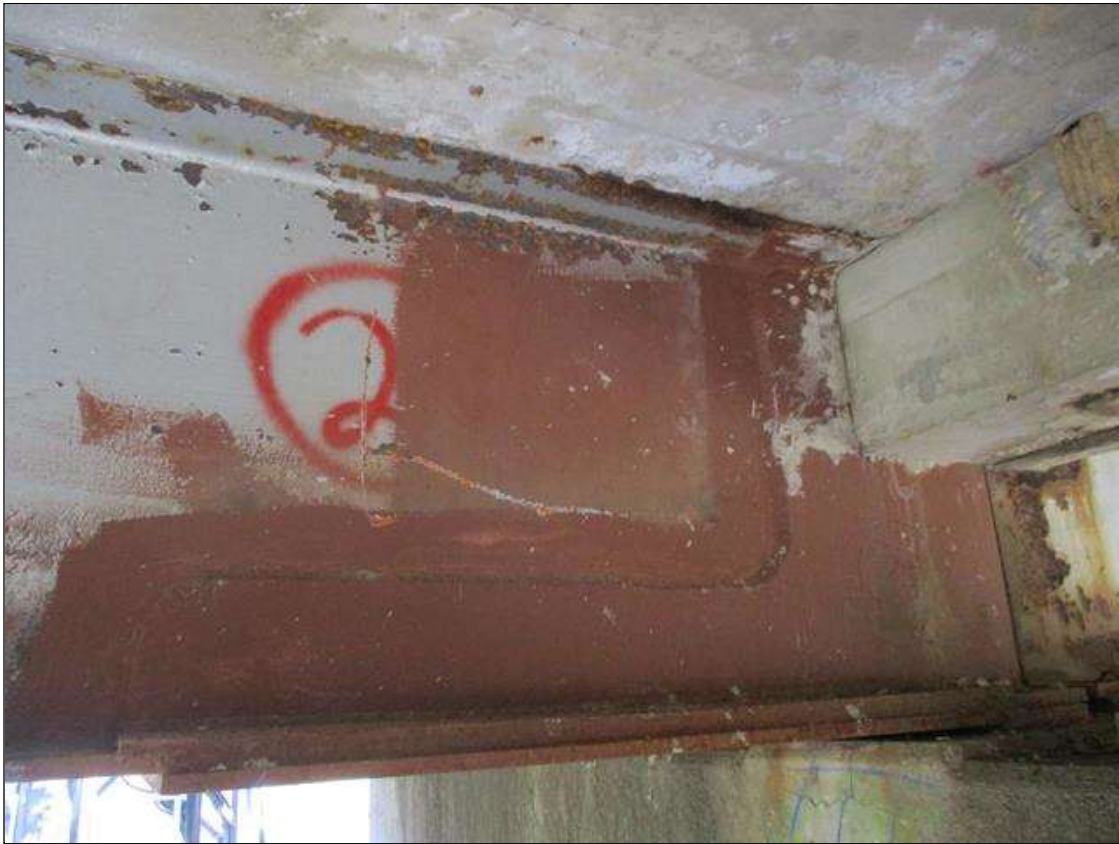
Span 5 Beam 2: [NEW REPAIR] BEAM END AT BENT 5, PLATES HAVE BEEN WELDED TO BOTH SIDES OF THE WEB [4' LONG X UP TO FULL HEIGHT] AND ON THE UPPER AND LOWER SIDES OF THE LOWER FLANGE [4' LONG X 1' WIDE] IN THE AREAS OF PAST SECTION LOSS.

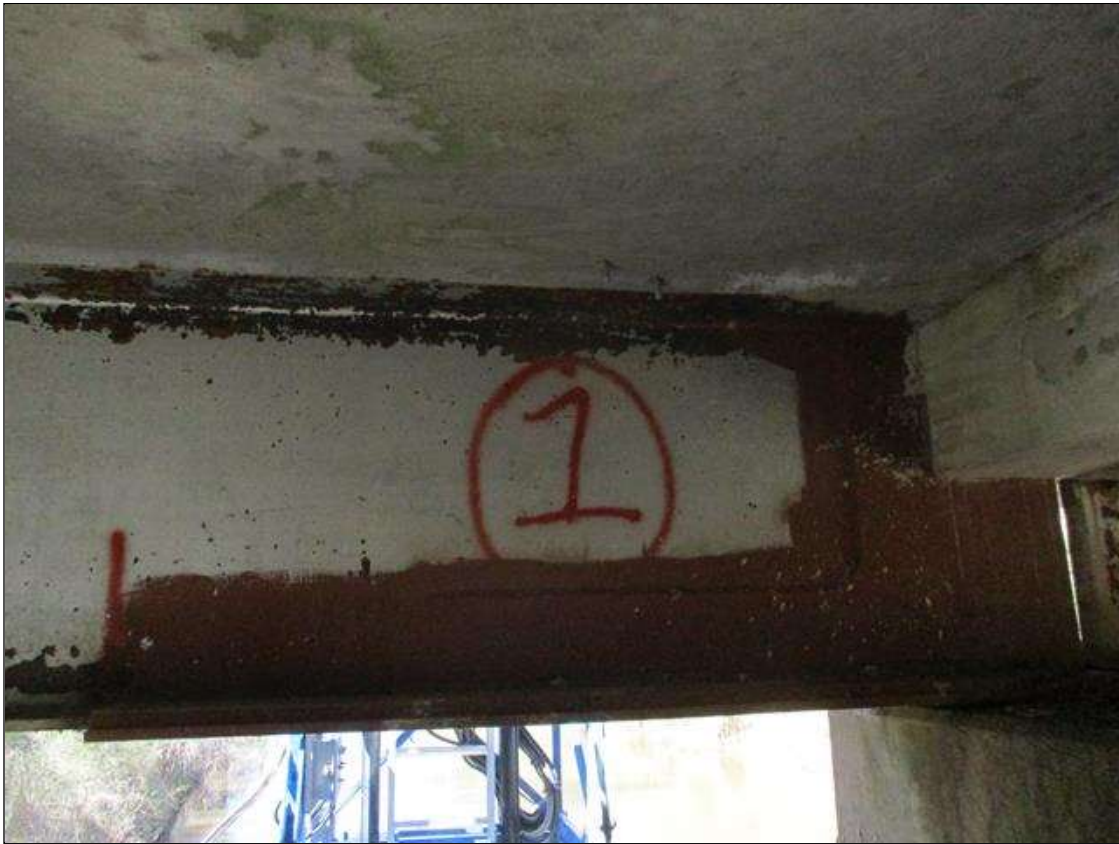
Span 5 Beam 1: [NEW REPAIR] BEAM END AT BENT 5, PLATES HAVE BEEN WELDED TO BOTH SIDES OF THE WEB [4' LONG X UP TO FULL HEIGHT] AND ON THE UPPER AND LOWER SIDES OF THE LOWER FLANGE [5.33' LONG X 1' WIDE] IN THE AREAS OF PAST SECTION LOSS.

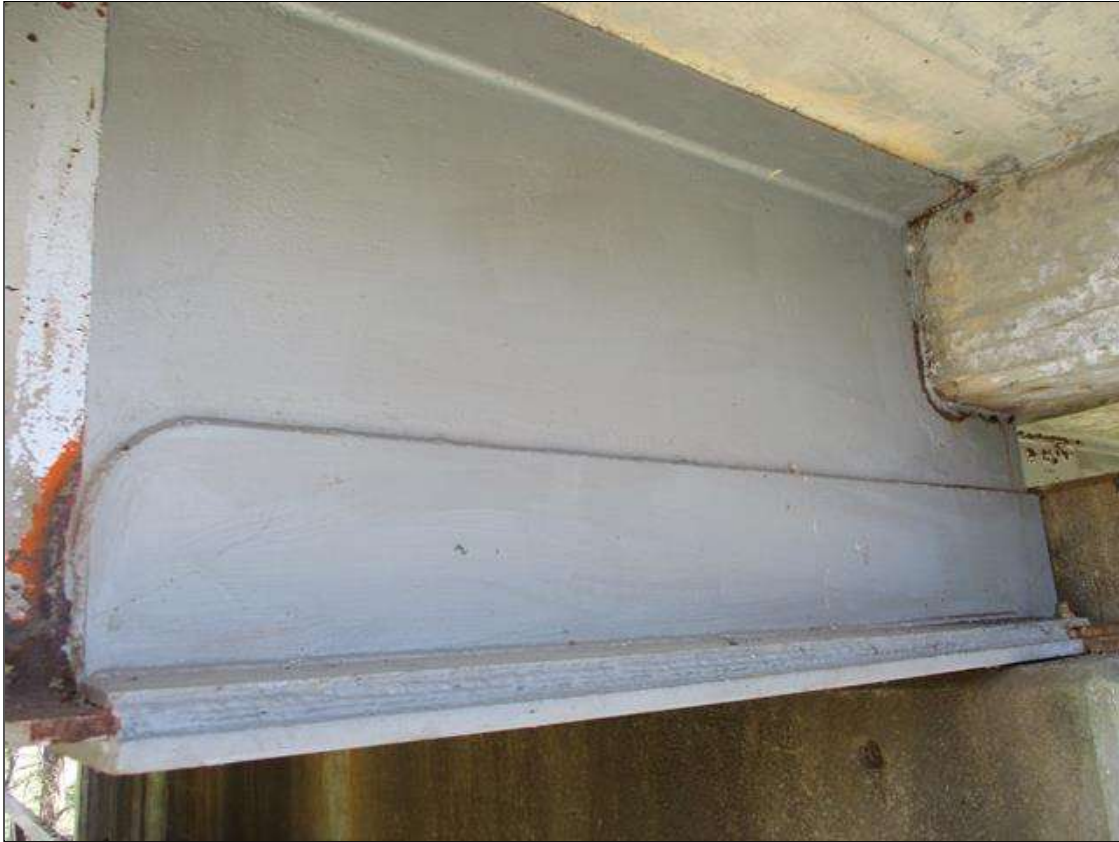
Span 5 Beam 1: [NEW REPAIR] BEAM END AT BENT 4, PLATES HAVE BEEN WELDED TO BOTH SIDES OF THE WEB [4.67' LONG X 6" HIGH] AND ON THE UPPER AND LOWER SIDES OF THE LOWER FLANGE [4.67' LONG X 1' WIDE] IN THE AREAS OF PAST SECTION LOSS.

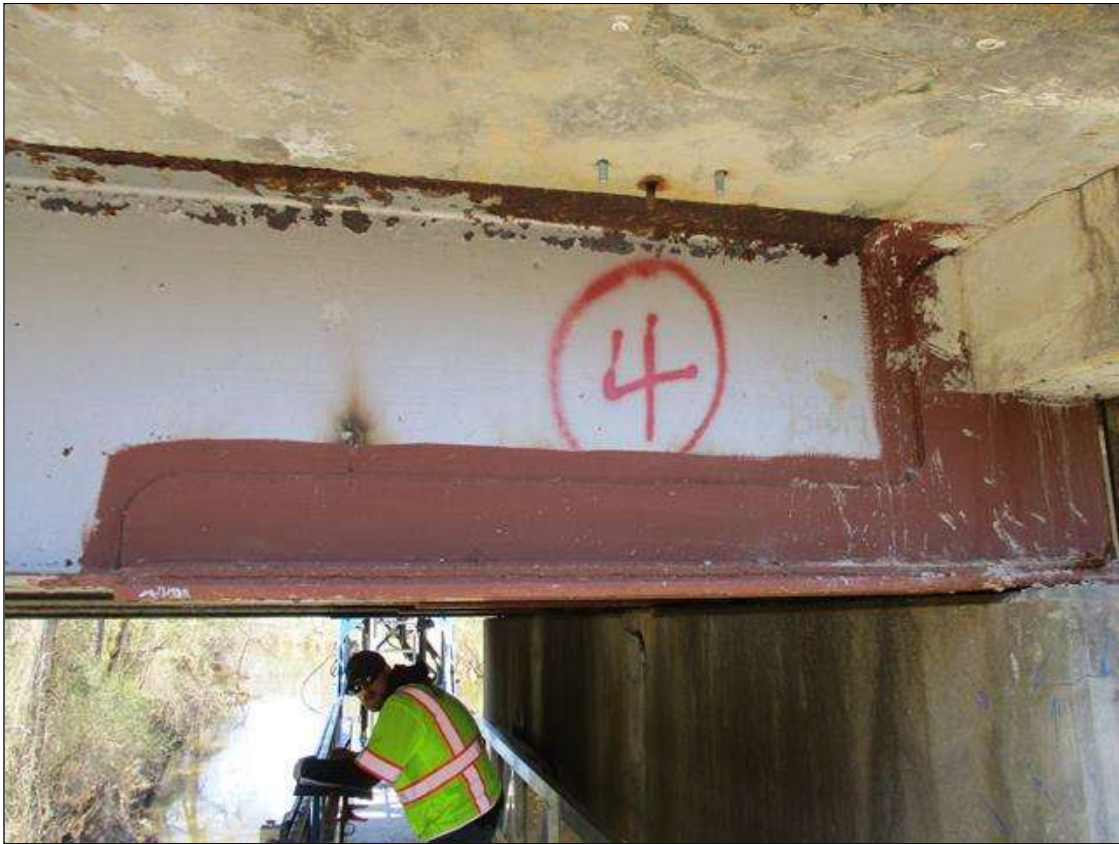
Span 5 Beam 4: [NEW REPAIR] BEAM END AT BENT 5, PLATES HAVE BEEN WELDED TO BOTH SIDES OF THE WEB [6' LONG X UP TO FULL HEIGHT] AND ON THE UPPER AND LOWER SIDES OF THE LOWER FLANGE [6' LONG X 1' WIDE] IN THE AREAS OF PAST SECTION LOSS.

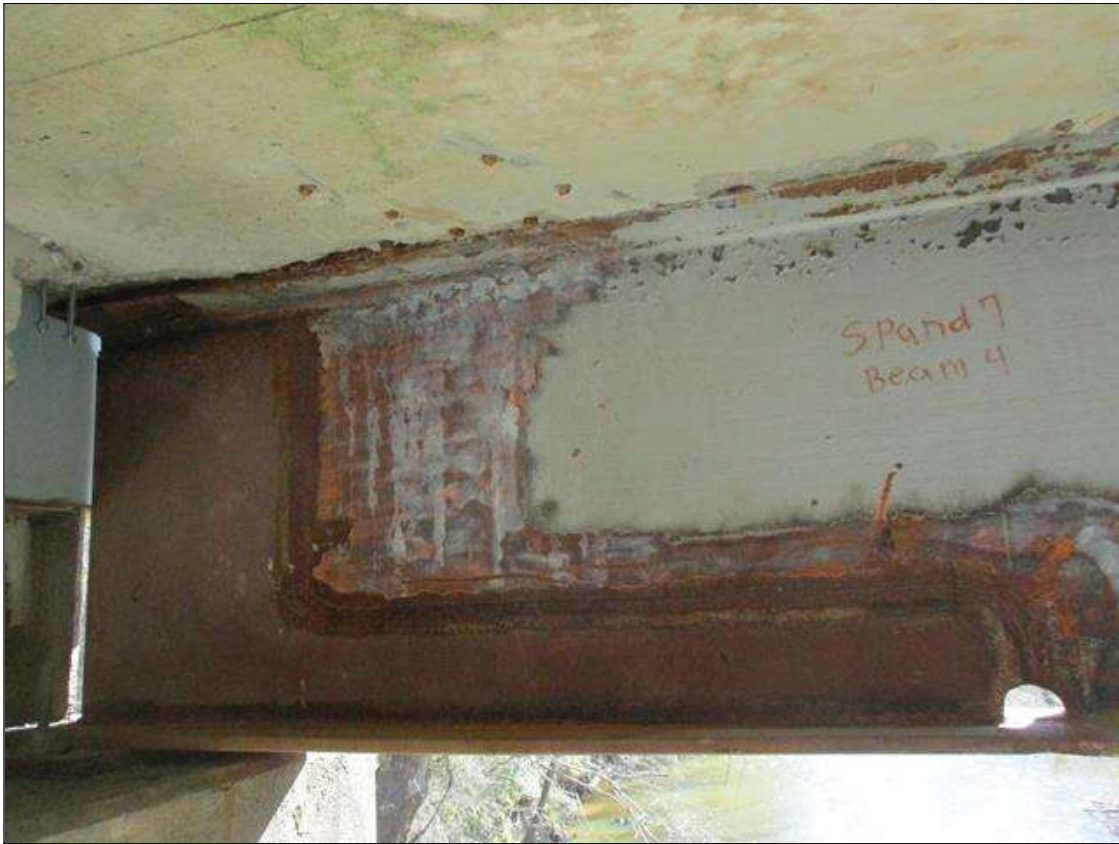
Span 7 Beam 4: [NEW REPAIR] BEAM END AT BENT 7, BEAM END HAS BEEN SECTIONED [4.5' LONG X UP TO 26" HIGH]

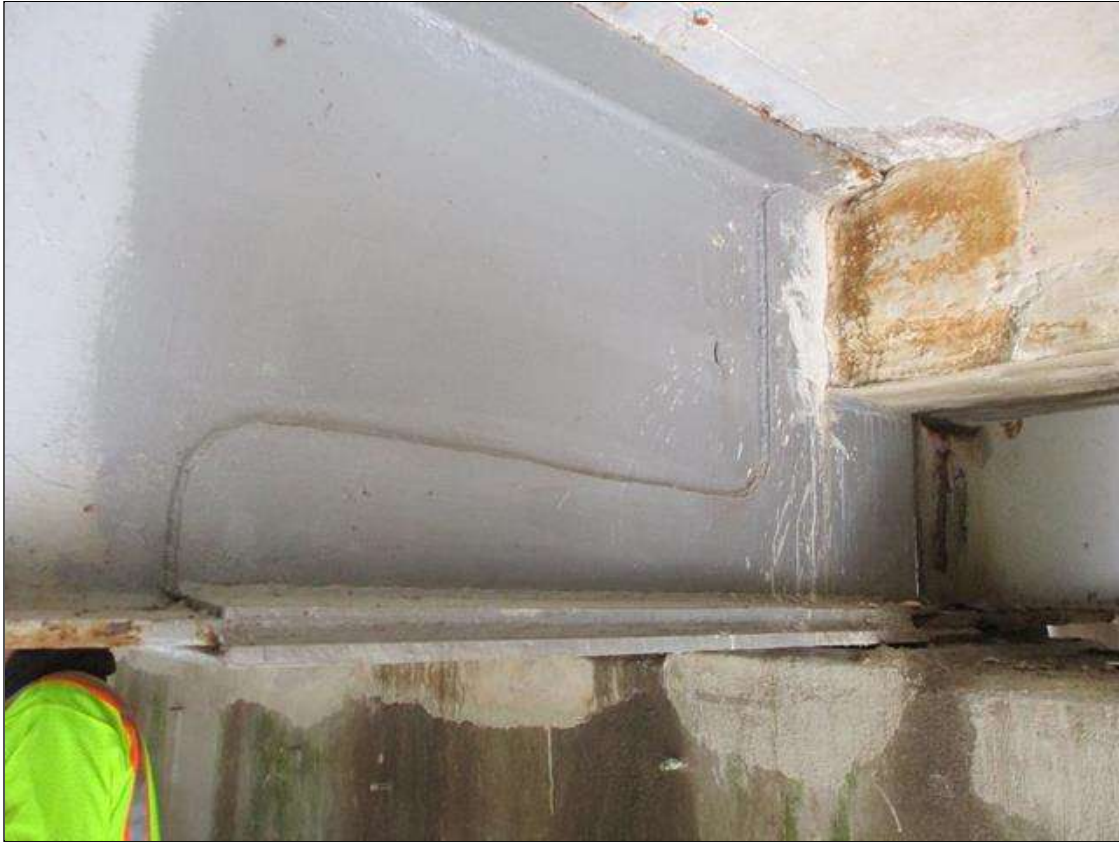
Span 7 Beam 3: [NEW REPAIR] BEAM END AT BENT 7, PLATES HAVE BEEN WELDED TO BOTH SIDES OF THE WEB [4' LONG X UP TO FULL HEIGHT] AND ON THE UPPER AND LOWER SIDES OF THE LOWER FLANGE [3.33' LONG X 11-3/4" WIDE] IN THE AREAS OF PAST SECTION LOSS.

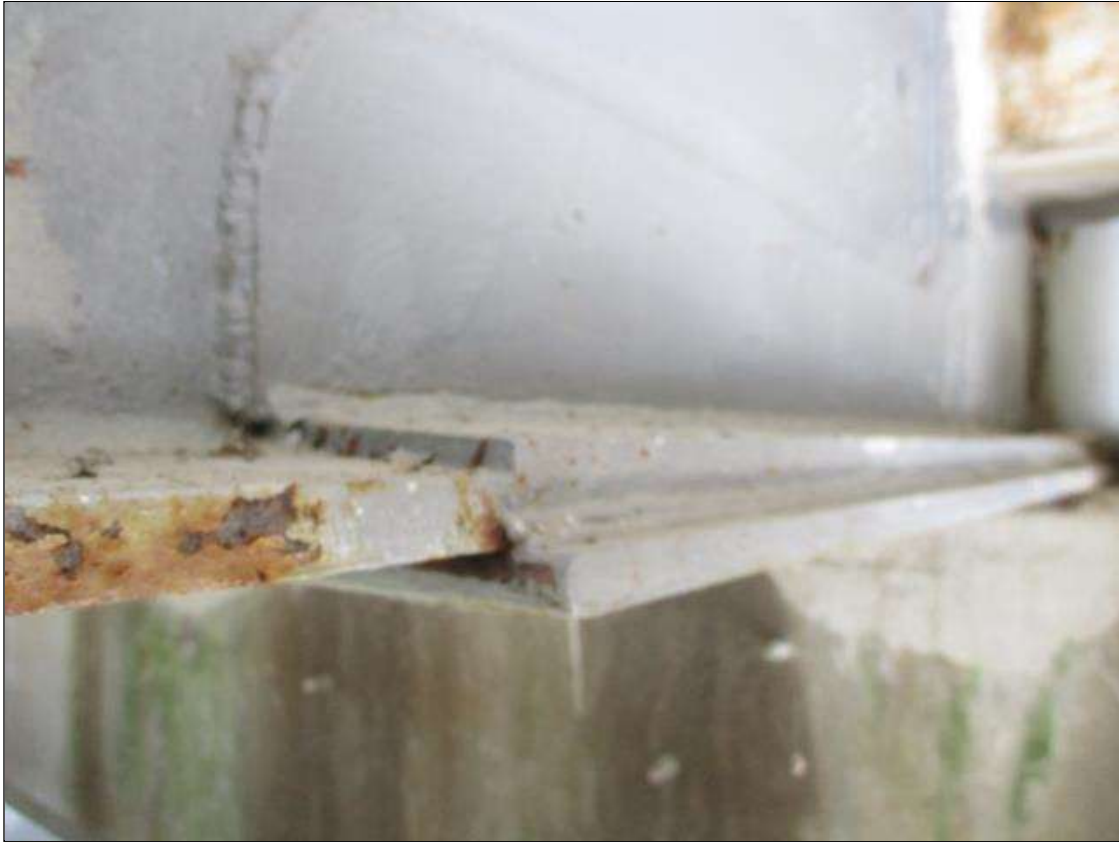
[NEW REPAIR] BEAM END AT BENT 7, PLATES HAVE BEEN WELDED TO BOTH SIDES OF THE WEB [4' LONG X UP TO FULL HEIGHT] AND ON THE UPPER AND LOWER SIDES OF THE LOWER FLANGE [3.33' LONG X 11-3/4" WIDE] IN THE AREAS OF PAST SECTION LOSS. [TYPICAL FOR THIS REPAIR]

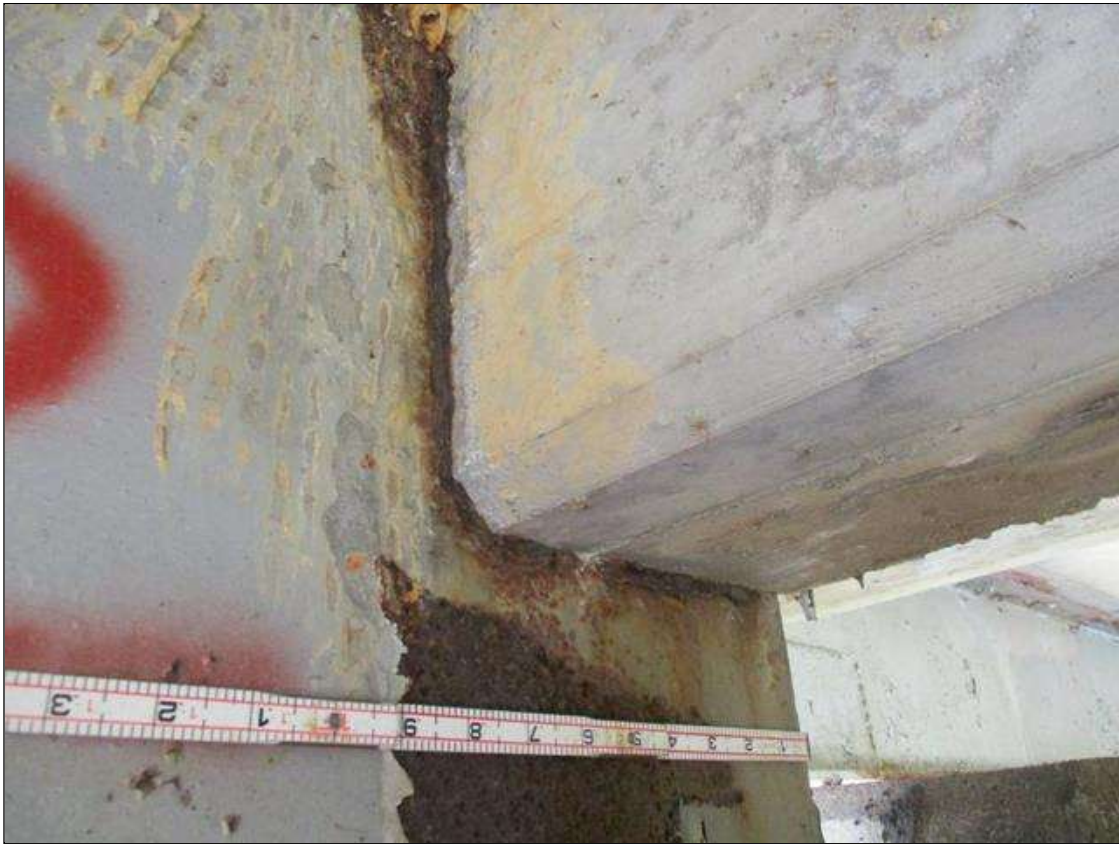
Span 5 Beam 4: [PROMPT ACTION REQUEST] BEAM END AT BENT 4, THERE IS AN APPROXIMATELY 1" WIDE BAND OF CORROSION THAT WRAPS THE REINFORCED CONCRETE DIAPHRAGM, APPROXIMATELY 1/8" SECTION LOSS [AVERAGE 5/16" REMAINS] FOR APPROXIMATELY 10" LONG.

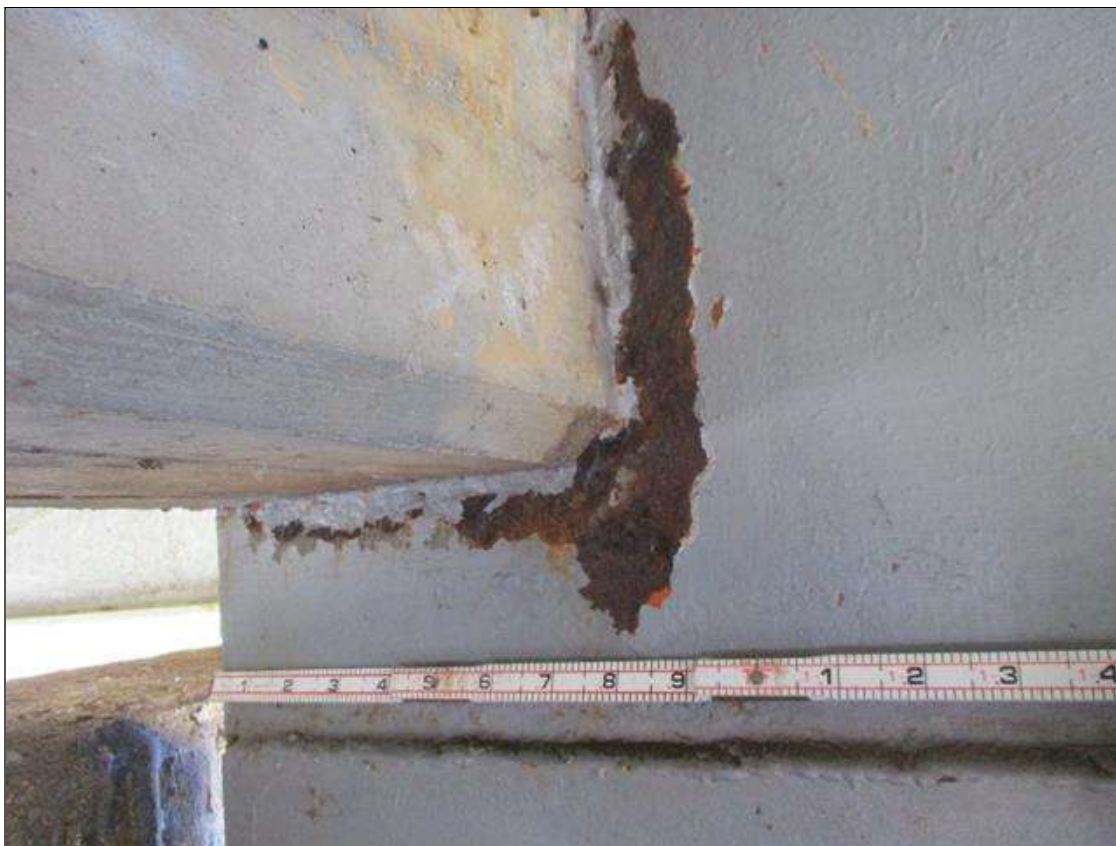
Span 5 Beam 1: [PROMPT ACTION REQUEST] BEAM END AT BENT 4, THERE IS AN APPROXIMATELY 1" WIDE BAND OF CORROSION THAT WRAPS THE REINFORCED CONCRETE DIAPHRAGM, APPROXIMATELY 1/4" SECTION LOSS [AVERAGE 3/16" REMAINS] FOR APPROXIMATELY 10" LONG.

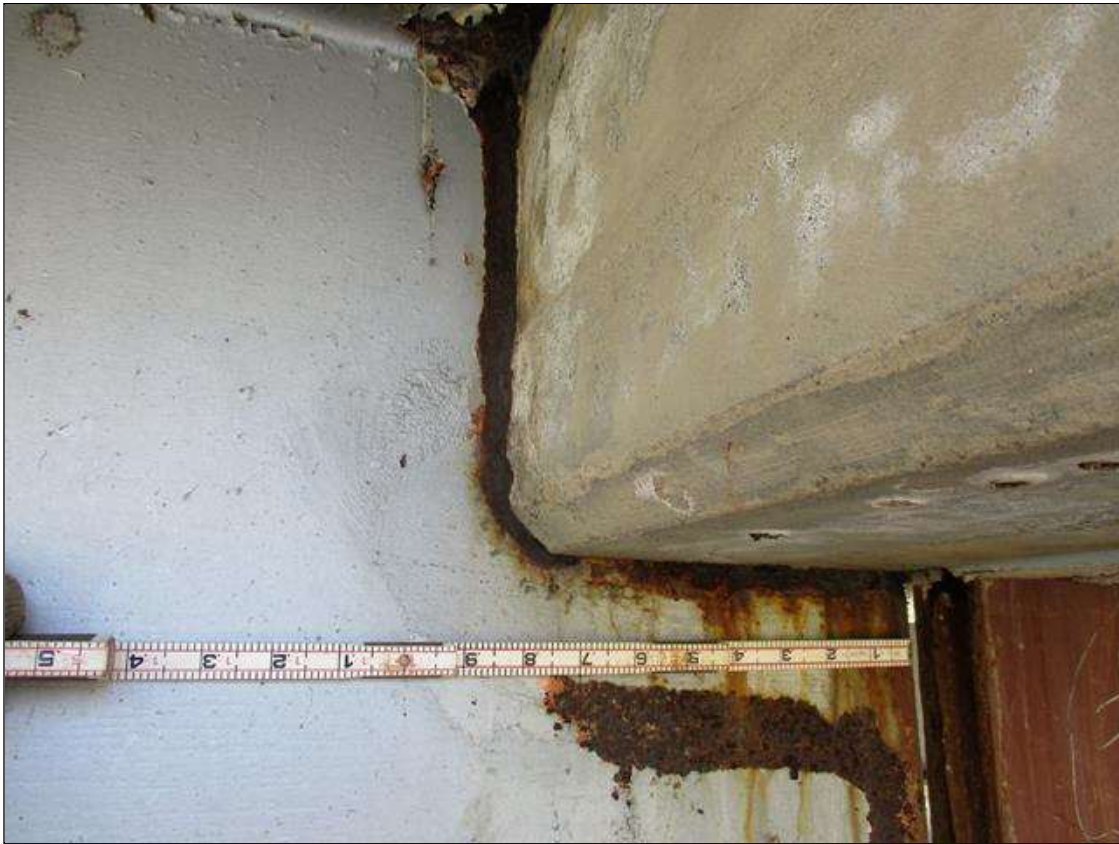
Span 6 Beam 1: [PROMPT ACTION REQUEST] BEAM END AT BENT 5, THERE IS AN APPROXIMATELY 1" WIDE BAND OF CORROSION THAT WRAPS THE REINFORCED CONCRETE DIAPHRAGM, APPROXIMATELY 3/16" SECTION LOSS [AVERAGE 1/4" REMAINS] FOR APPROXIMATELY 10" LONG.

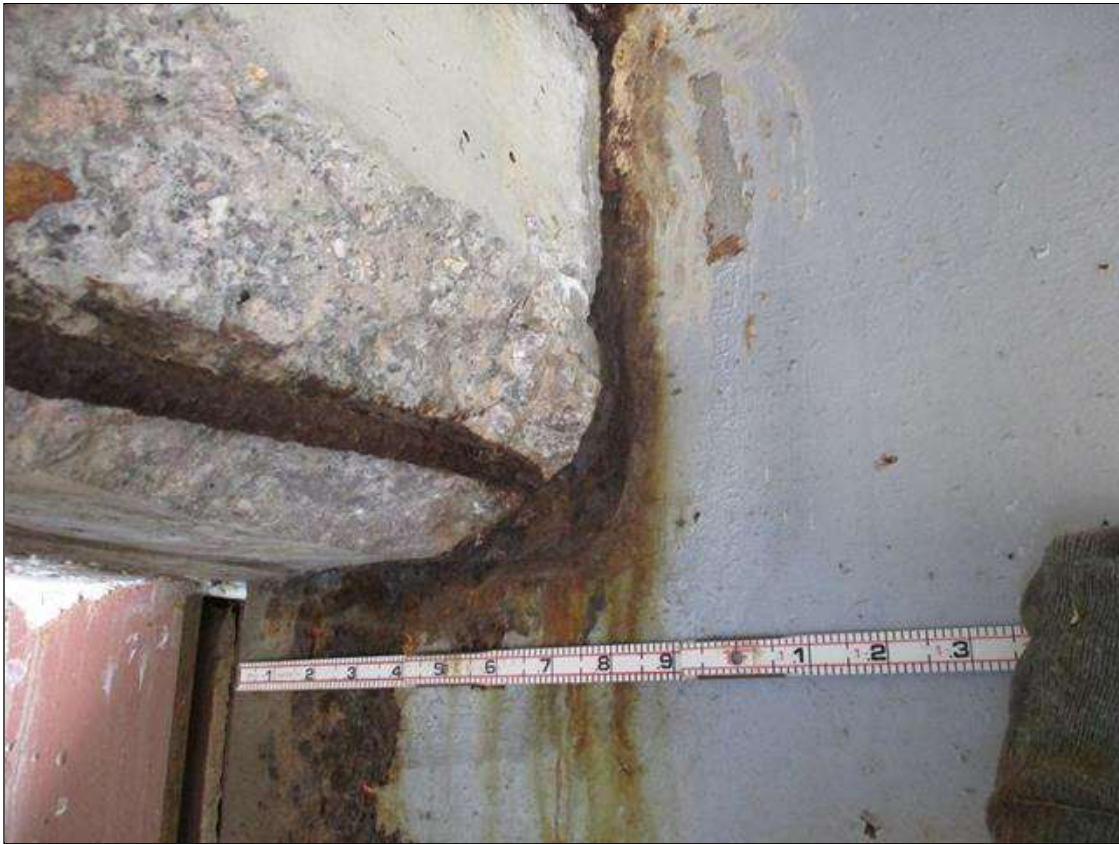
Span 6 Beam 2: [PROMPT ACTION REQUEST] BEAM END AT BENT 5, THERE IS AN APPROXIMATELY 2" WIDE BAND OF CORROSION THAT WRAPS THE REINFORCED CONCRETE DIAPHRAGM, APPROXIMATELY 3/16" SECTION LOSS [AVERAGE 1/4" REMAINS] FOR APPROXIMATELY 10" LONG.

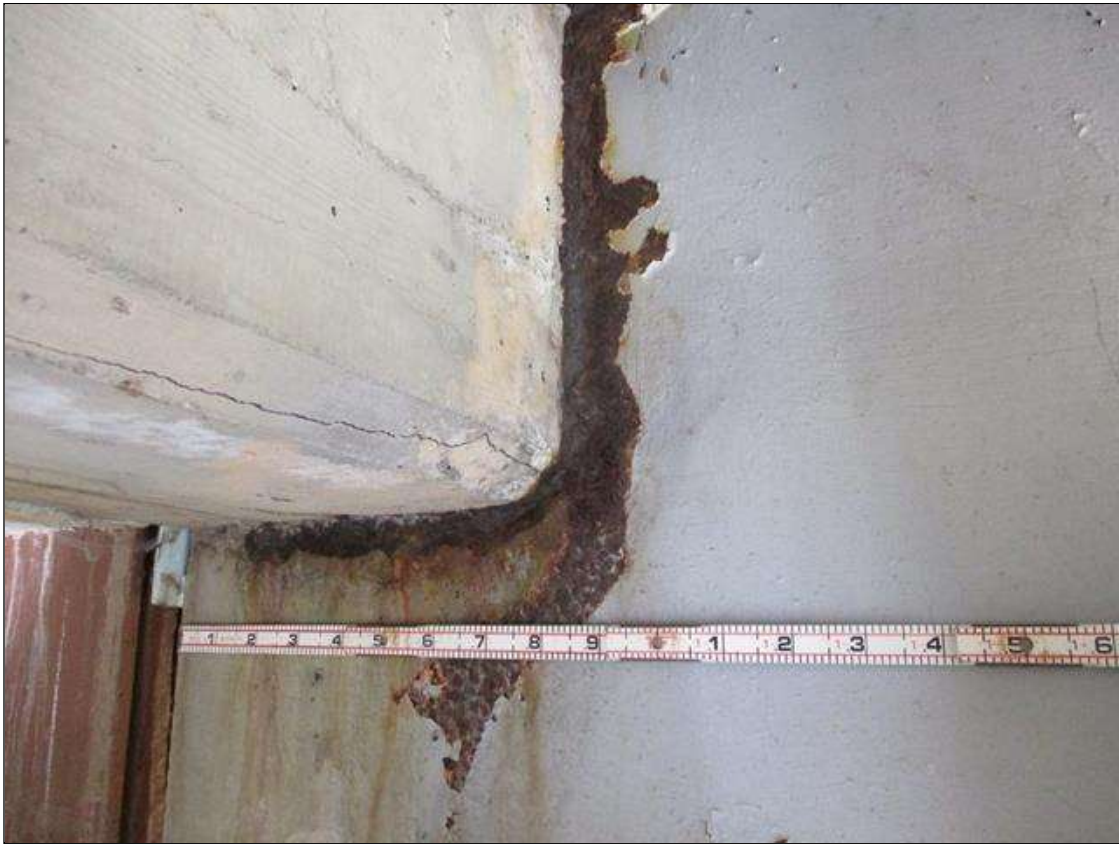
Span 6 Beam 3: [PROMPT ACTION REQUEST] BEAM END AT BENT 5, THERE IS AN APPROXIMATELY 1" WIDE BAND OF CORROSION THAT WRAPS THE REINFORCED CONCRETE DIAPHRAGM, APPROXIMATELY 1/4" SECTION LOSS [AVERAGE 3/16" REMAINS] FOR APPROXIMATELY 10" LONG.

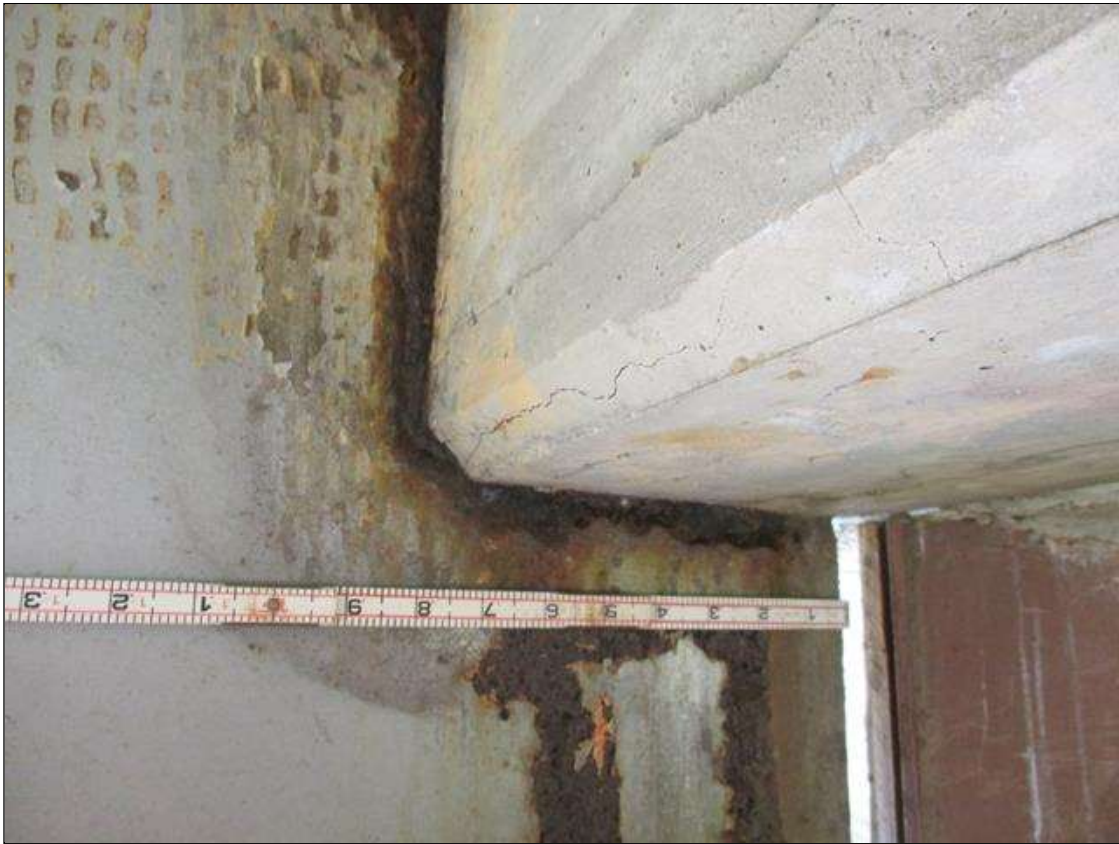
Span 6 Beam 4: [PROMPT ACTION REQUEST] BEAM END AT BENT 5, THERE IS AN APPROXIMATELY 1" WIDE BAND OF CORROSION THAT WRAPS THE REINFORCED CONCRETE DIAPHRAGM, APPROXIMATELY 1/8" SECTION LOSS [AVERAGE 5/16" REMAINS] FOR APPROXIMATELY 10" LONG.

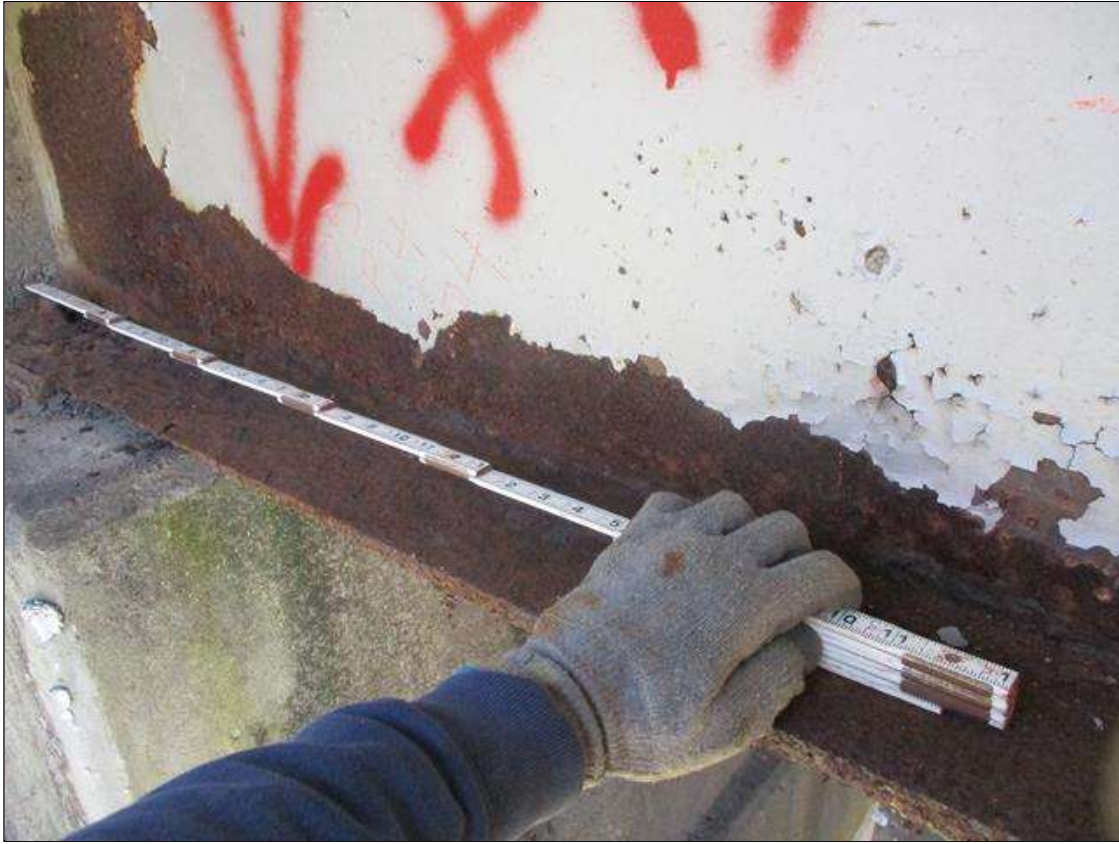
Span 5 Beam 4: [PROMPT ACTION REQUEST] 8" OUT FROM THE BEAM END AT BENT 4, IN THE LOWER 3" OF THE WEB, CORROSION WITH APPROXIMATELY 5/16" SECTION LOSS [AVERAGE 1/8" REMAINS] FOR 30" LONG.

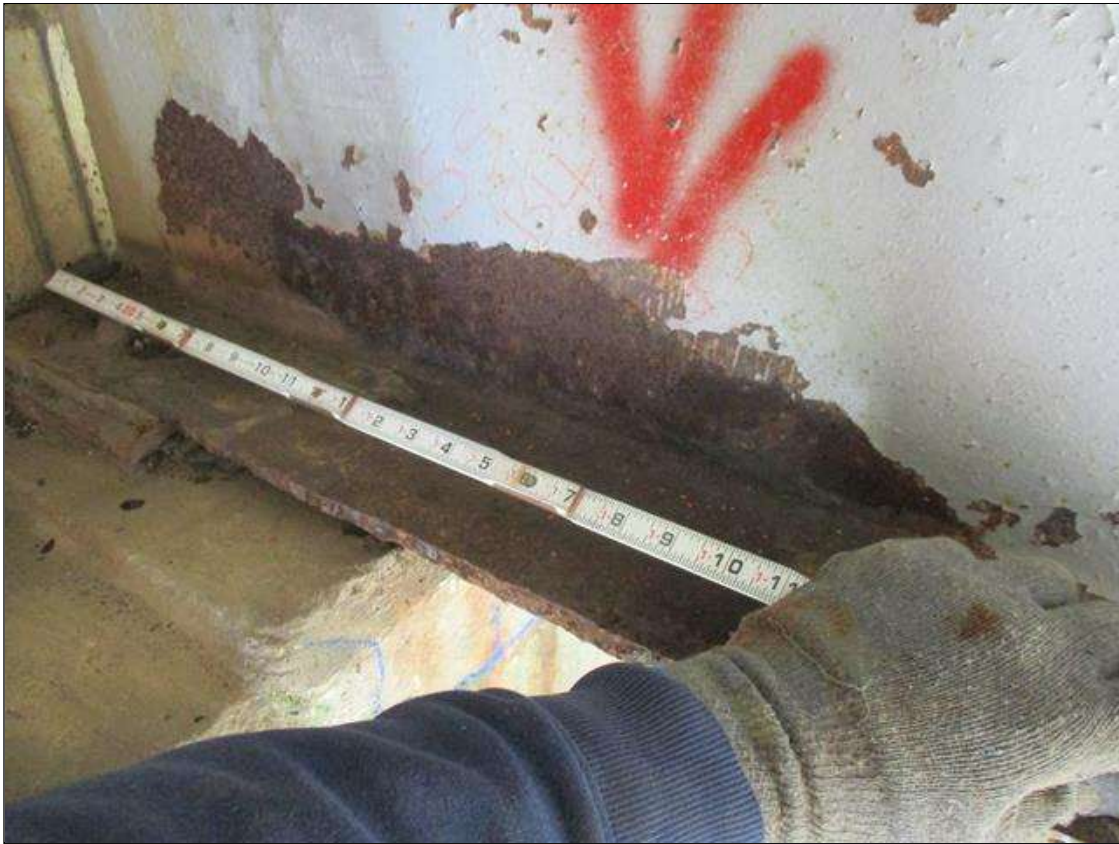
Span 5 Beam 3: [PROMPT ACTION REQUEST] 8" OUT FROM THE BEAM END AT BENT 4, IN THE LOWER 2" OF THE WEB, CORROSION WITH APPROXIMATELY 3/16" SECTION LOSS [AVERAGE 1/4" REMAINS] FOR 12" LONG.

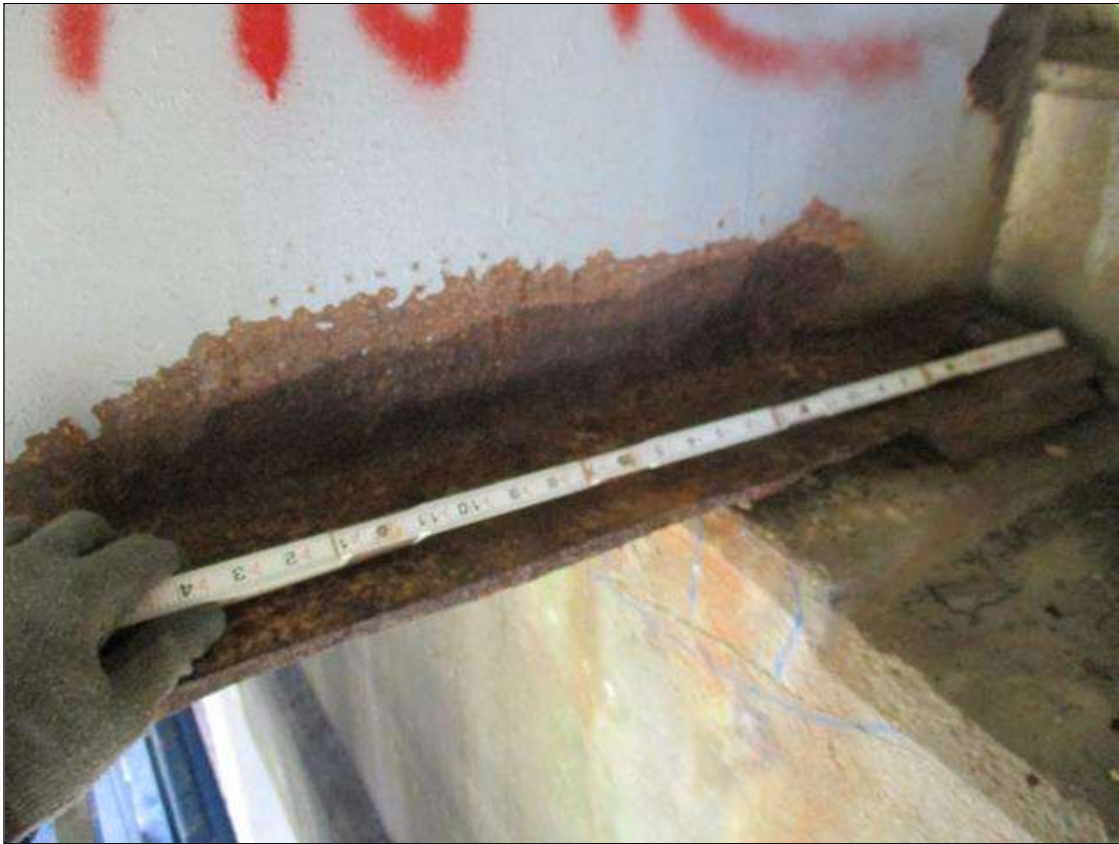
Span 5 Beam 2: [PROMPT ACTION REQUEST] 8" OUT FROM THE BEAM END AT BENT 4, IN THE LOWER 3" OF THE WEB, CORROSION WITH APPROXIMATELY 3/16" SECTION LOSS [AVERAGE 1/4" REMAINS] FOR 18" LONG.

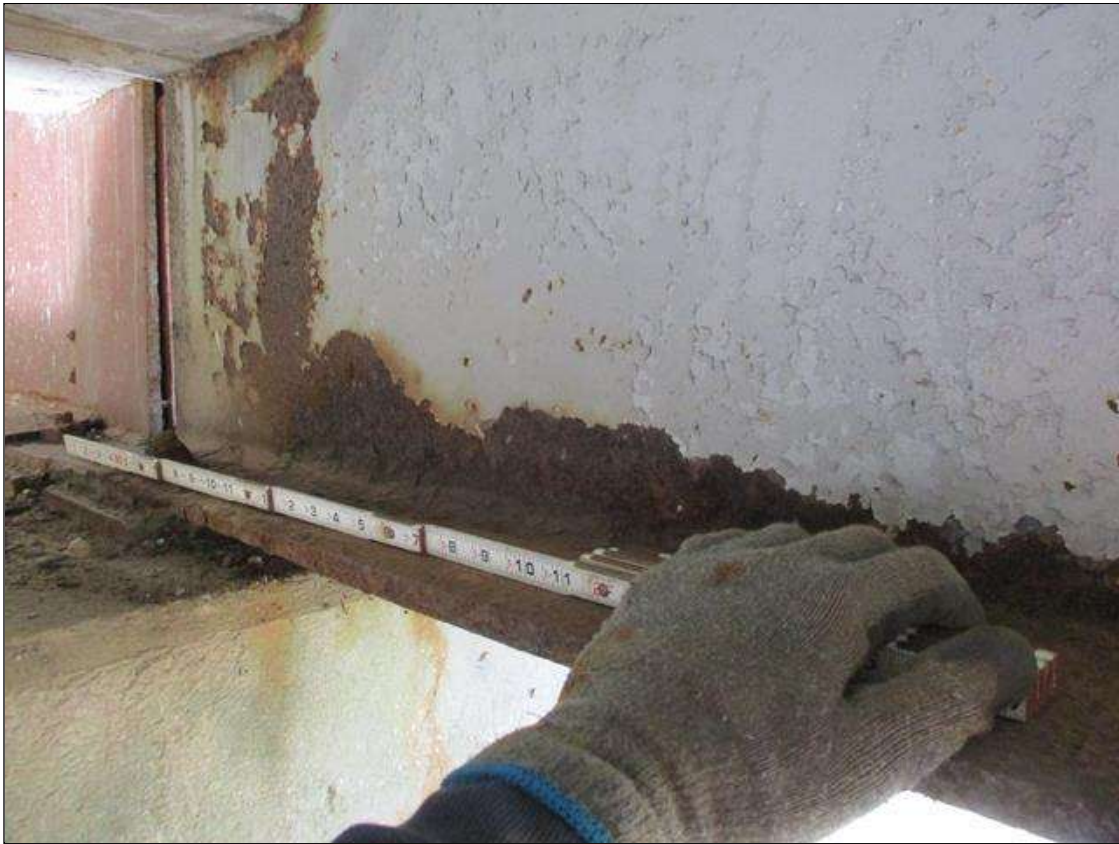
Span 6 Beam 1: [PROMPT ACTION REQUEST] BEAM END AT BENT 5, IN THE LOWER 2" OF THE WEB, CORROSION WITH APPROXIMATELY 1/8" SECTION LOSS [AVERAGE 5/16" REMAINS] FOR 24" LONG.
