NC DEPARTMENT OF TRANSPORTATION
 DIVISION OF HIGHWAYS
 STRUCTURE MANAGEMENT UNIT

ATTENTION: **PROMPT ACTION REQUEST; HYDRAPLATFORM USED; NEW REPAIRS; OUT-TO-OUT REVISED;**

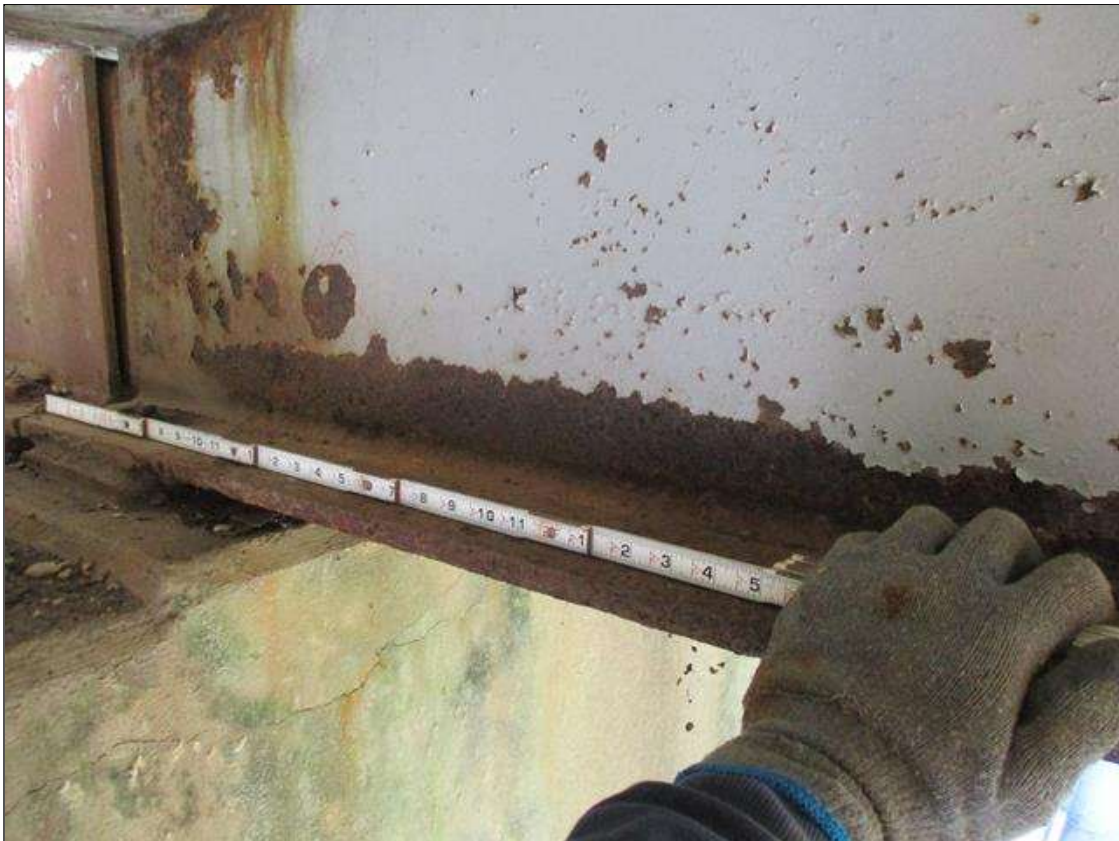
Span 6 Beam 2: [PROMPT ACTION REQUEST] BEAM END AT BENT 5, IN THE LOWER 3" OF THE WEB, CORROSION WITH APPROXIMATELY 1/8" SECTION LOSS [AVERAGE 5/16" REMAINS] FOR 30" LONG.

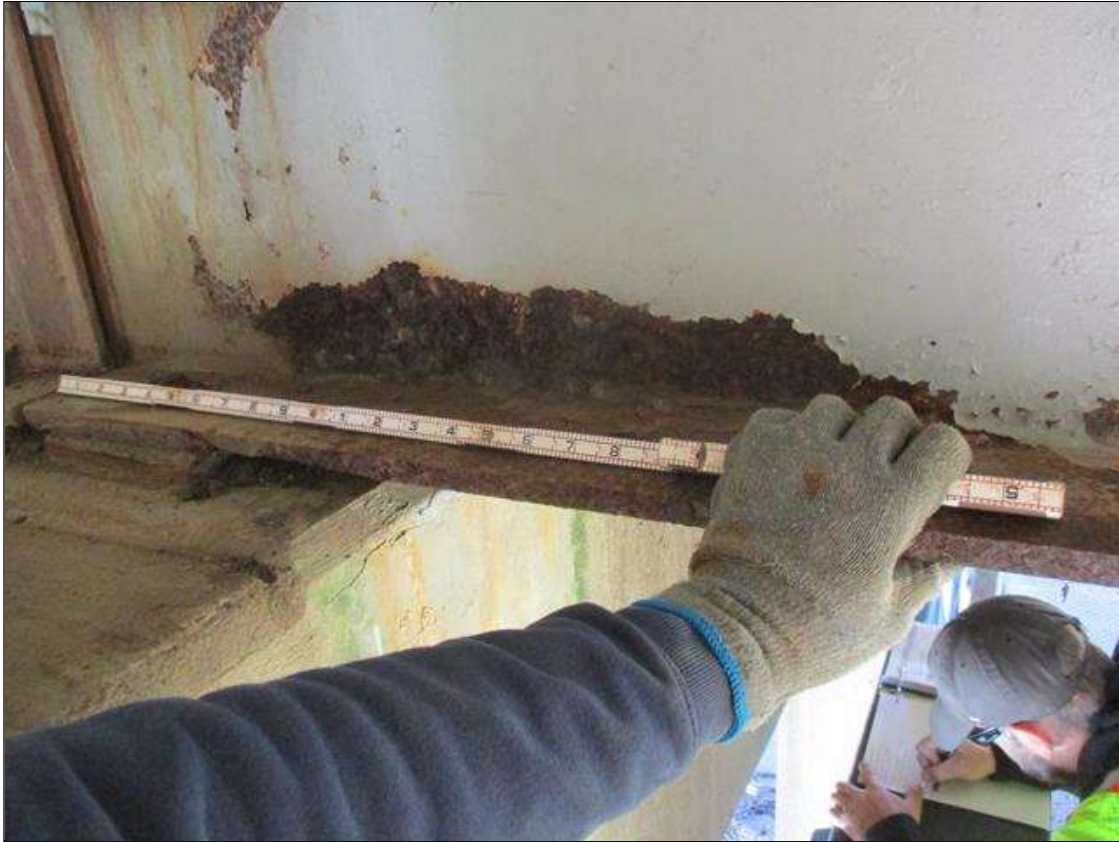
Span 6 Beam 3: [PROMPT ACTION REQUEST] 8" OUT FROM THE BEAM END AT BENT 5, IN THE LOWER 2" OF THE WEB, CORROSION WITH APPROXIMATELY 1/4" SECTION LOSS [AVERAGE 3/16" REMAINS] FOR 18" LONG.

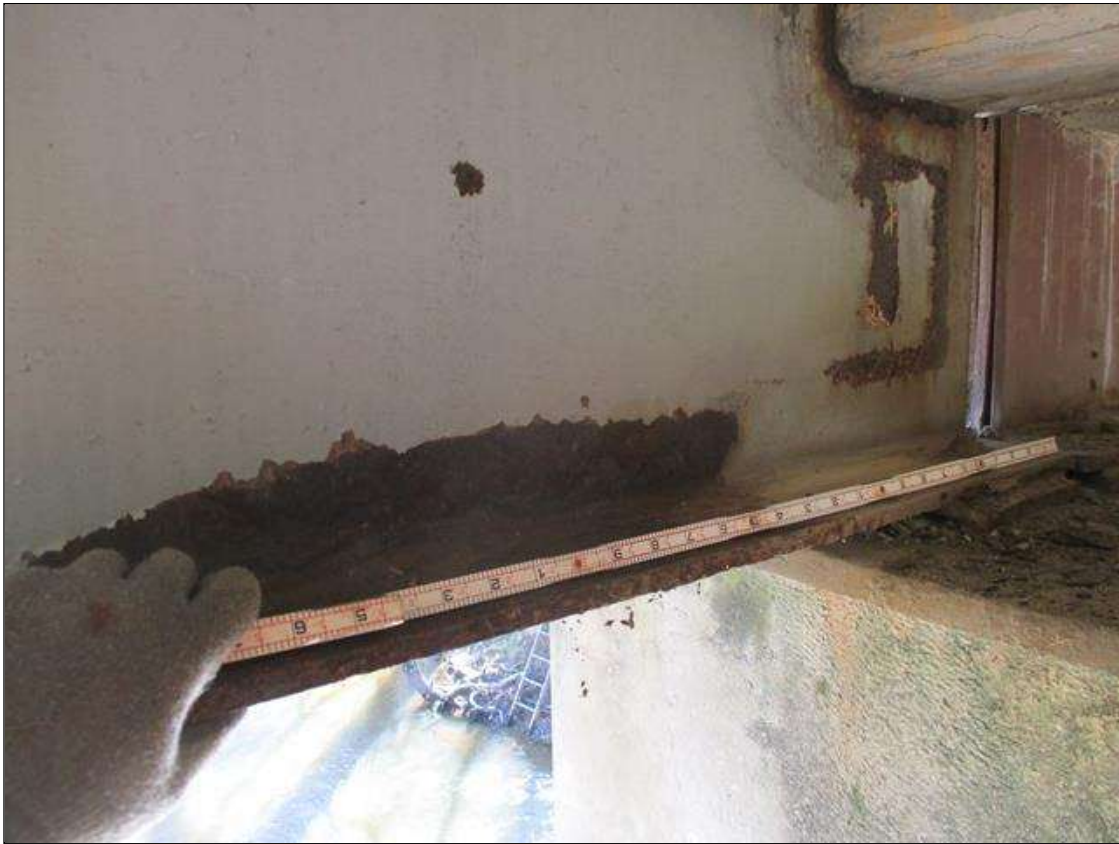
Span 6 Beam 4: [PROMPT ACTION REQUEST] 15" OUT FROM THE BEAM END AT BENT 5, IN THE LOWER 2" OF THE WEB, CORROSION WITH APPROXIMATELY 1/8" SECTION LOSS [AVERAGE 5/16" REMAINS] FOR 18" LONG.

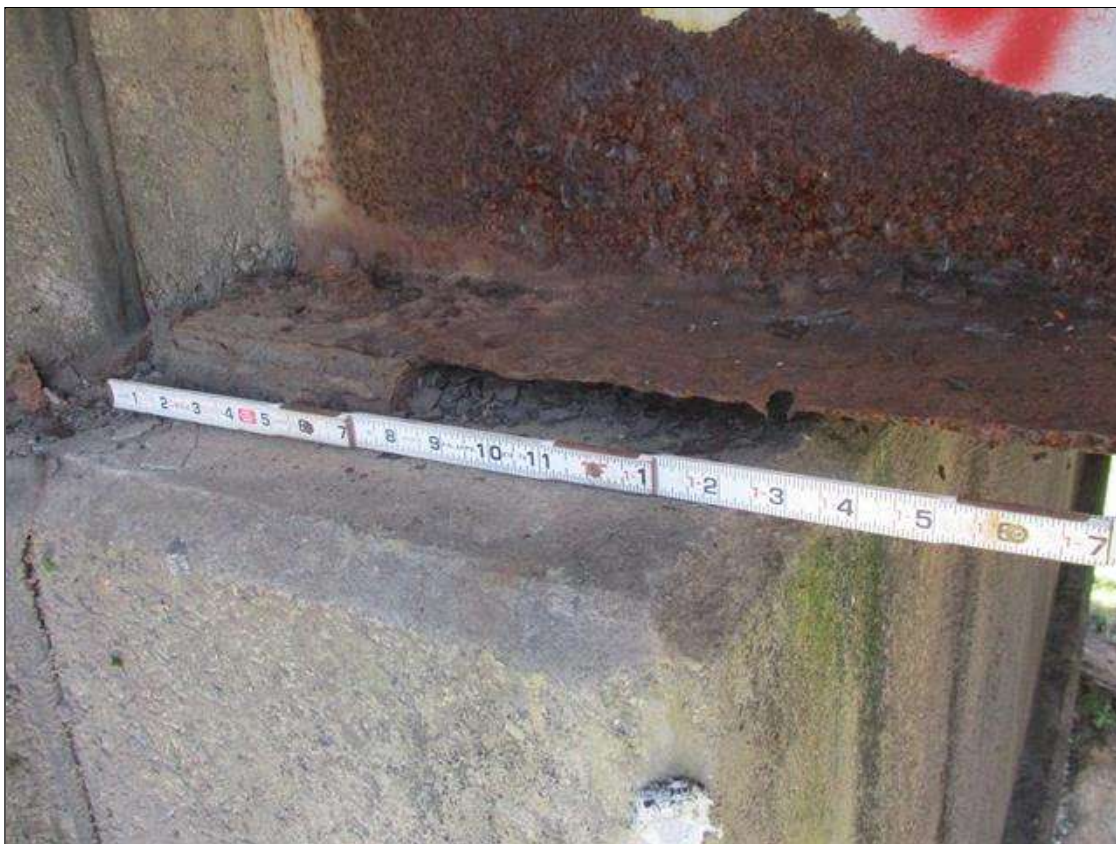
Span 5 Beam 4: [PROMPT ACTION REQUEST] BEAM END AT BENT 4, LOWER FLANGE, CORROSION WITH APPROXIMATELY 1/2" SECTION LOSS [AVERAGE 1/8" REMAINS] WITH KNIFE EDGING FOR APPROXIMATELY 15" LONG, THEN TAPERING TO FULL SECTION OVER THE NEXT 2' LONG

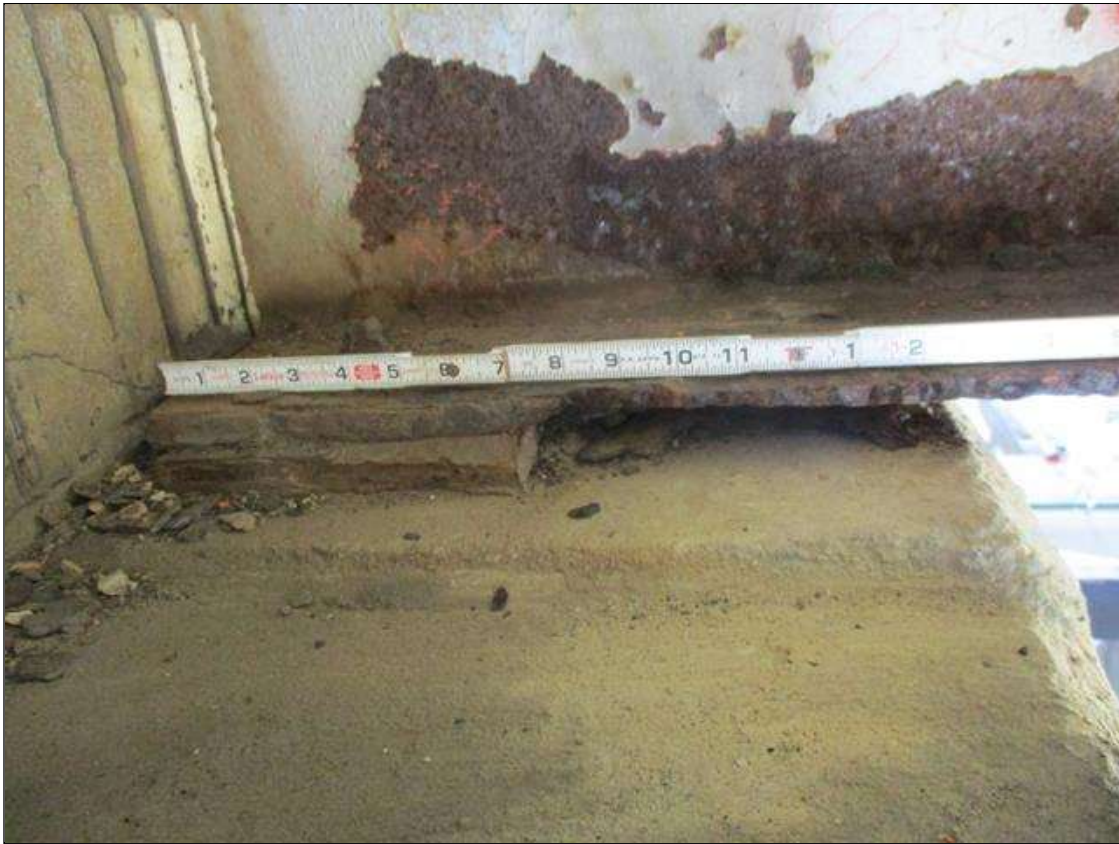
Span 5 Beam 3: [PROMPT ACTION REQUEST] BEAM END AT BENT 4, LOWER FLANGE, CORROSION WITH APPROXIMATELY 5/16" SECTION LOSS [AVERAGE 5/16" REMAINS] FOR APPROXIMATELY 15" LONG

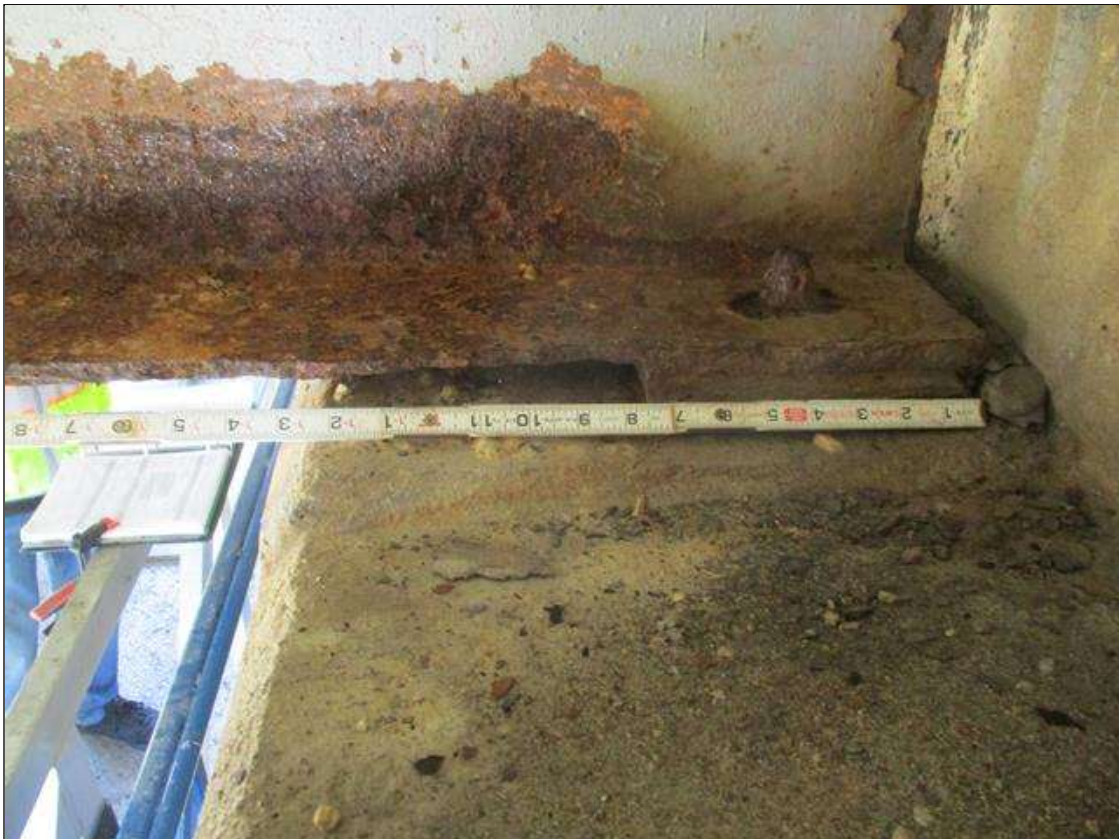
Span 5 Beam 2: [PROMPT ACTION REQUEST] BEAM END AT BENT 4, LOWER FLANGE, CORROSION WITH APPROXIMATELY 5/16" SECTION LOSS [AVERAGE 5/16" REMAINS] FOR APPROXIMATELY 18" LONG

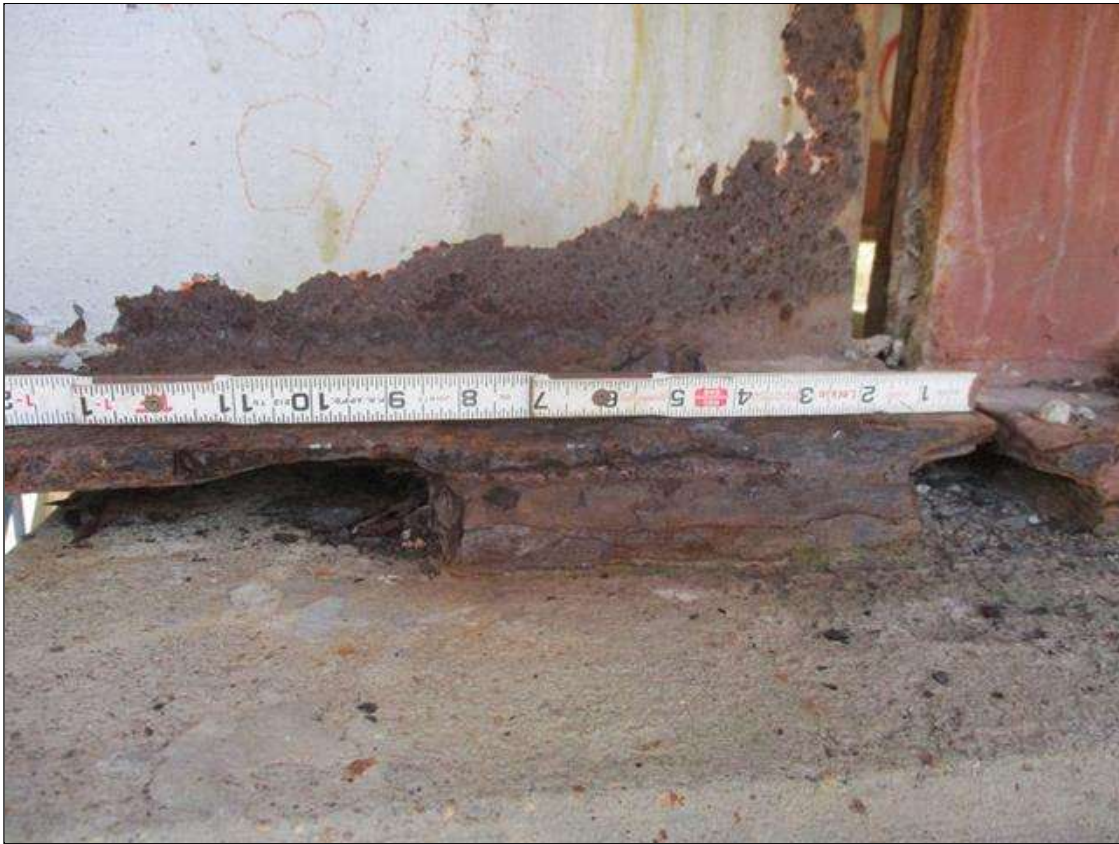
Span 6 Beam 1: [PROMPT ACTION REQUEST] BEAM END AT BENT 5, LOWER FLANGE, CORROSION WITH APPROXIMATELY 3/8" SECTION LOSS [AVERAGE 1/4" REMAINS] FOR APPROXIMATELY 12" LONG

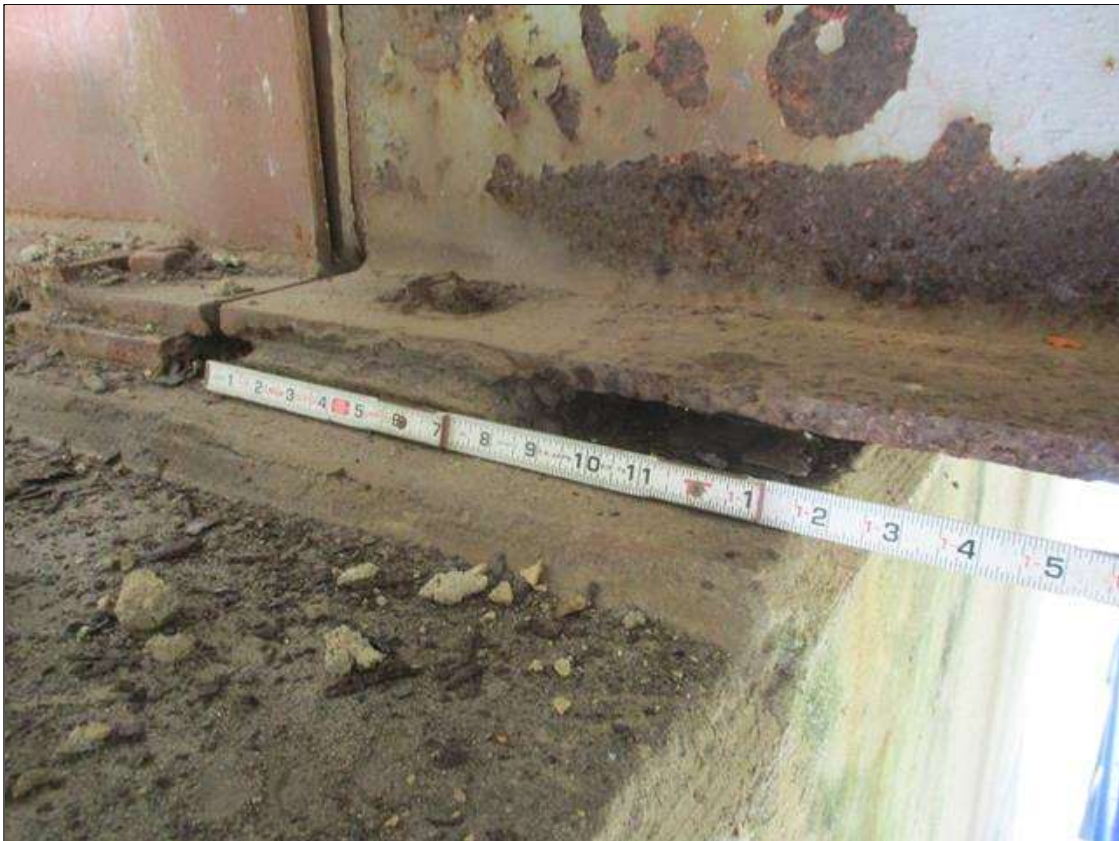
Span 6 Beam 2: [PROMPT ACTION REQUEST] BEAM END AT BENT 5, LOWER FLANGE, CORROSION WITH APPROXIMATELY 1/8" SECTION LOSS [AVERAGE 1/2" REMAINS] FOR APPROXIMATELY 12" LONG

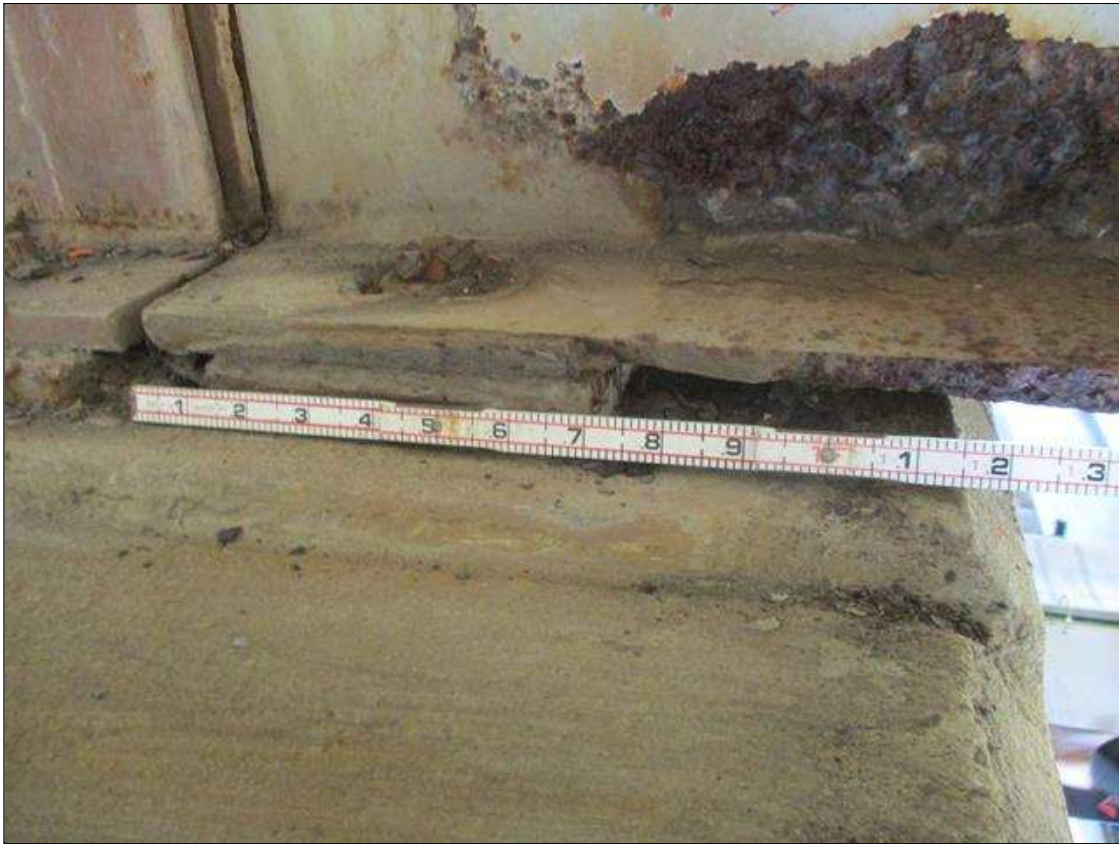
Span 6 Beam 3: [PROMPT ACTION REQUEST] BEAM END AT BENT 5, LOWER FLANGE, CORROSION WITH APPROXIMATELY 3/16" SECTION LOSS [AVERAGE 7/16" REMAINS] FOR APPROXIMATELY 12" LONG

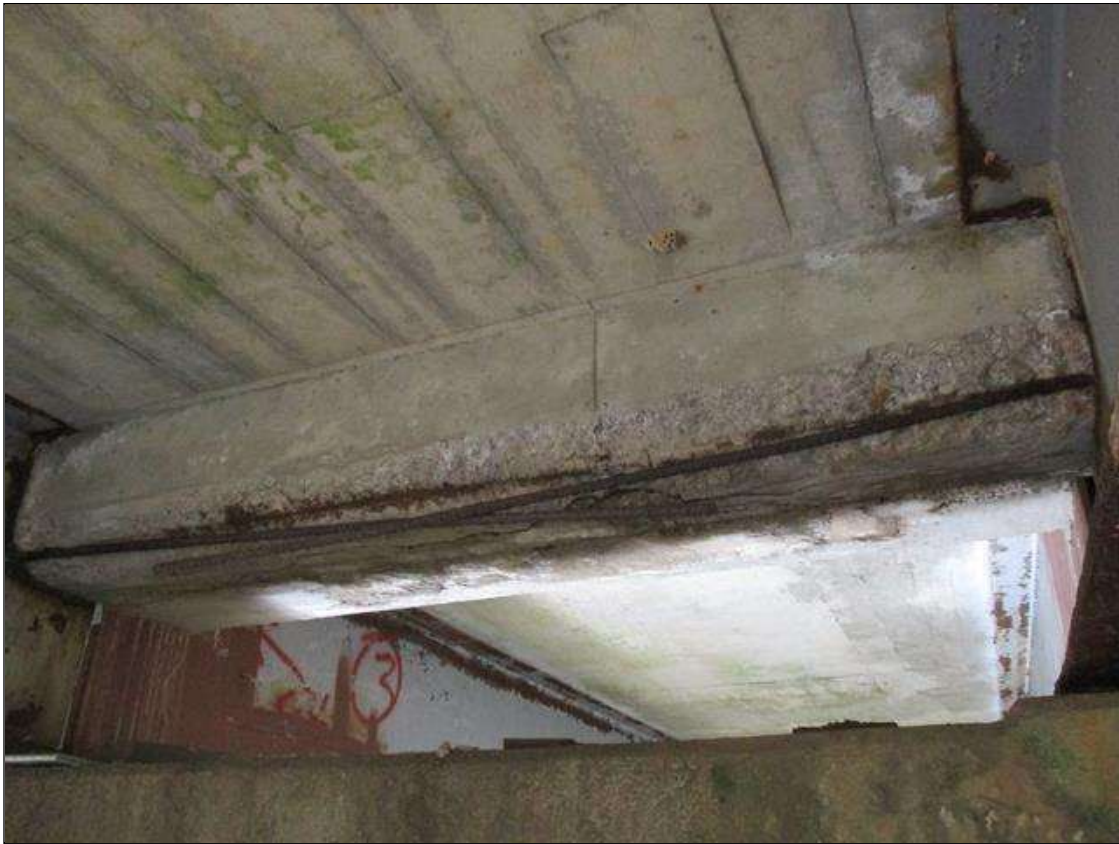
Span 6 Beam 2: [PROMPT ACTION REQUEST] BAY 2 AT BENT 5, REINFORCED CONCRETE DIAPHRAGM, SPALLING WITH EXPOSED REBAR [APPROXIMATELY 6' LONG X 12" WIDE X UP TO 2" DEEP] WITH DELAMINATED REBAR, WHICH HAS SURFACE CORROSION AND PITTING UP TO 1/8" DEEP

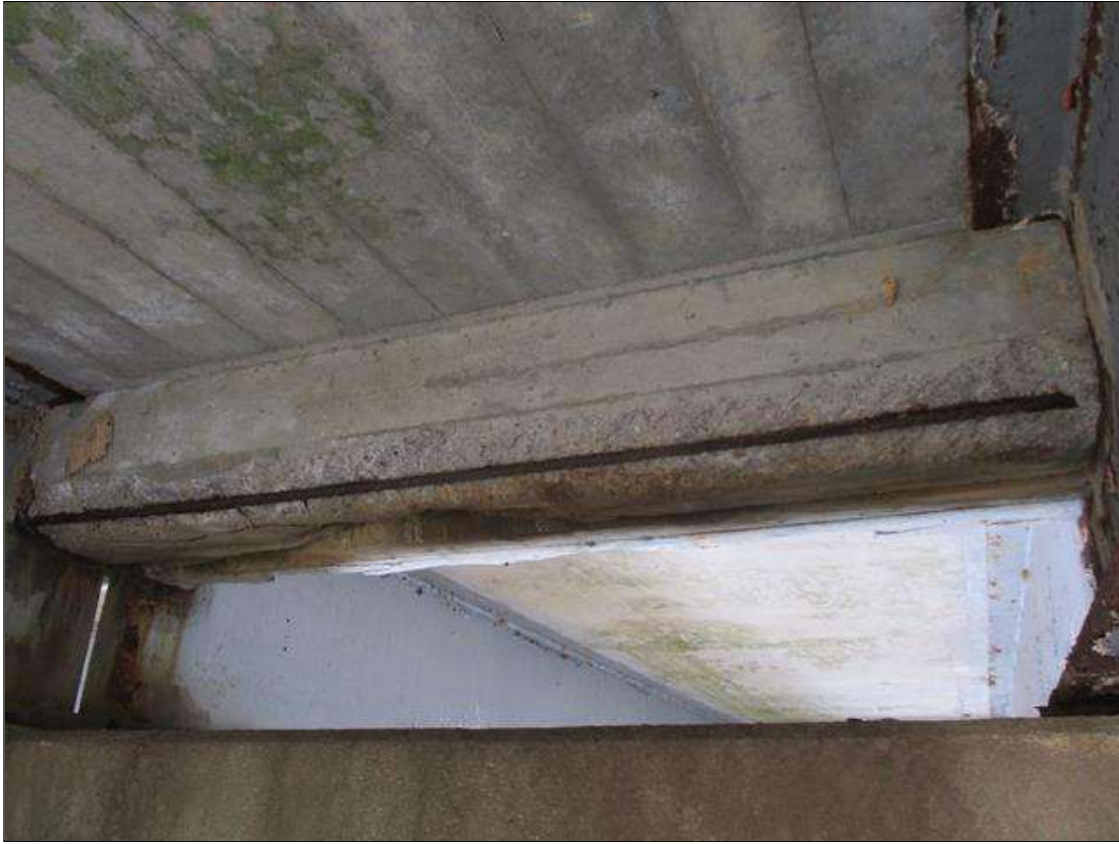
Span 7 Beam 1: [PROMPT ACTION REQUEST] BAY 1 AT BENT 6, REINFORCED CONCRETE DIAPHRAGM, SPALLING WITH EXPOSED REBAR [APPROXIMATELY 6' LONG X 12" WIDE X UP TO 2" DEEP] WITH DELAMINATED REBAR, WHICH HAS SURFACE CORROSION AND PITTING UP TO 1/8" DEEP

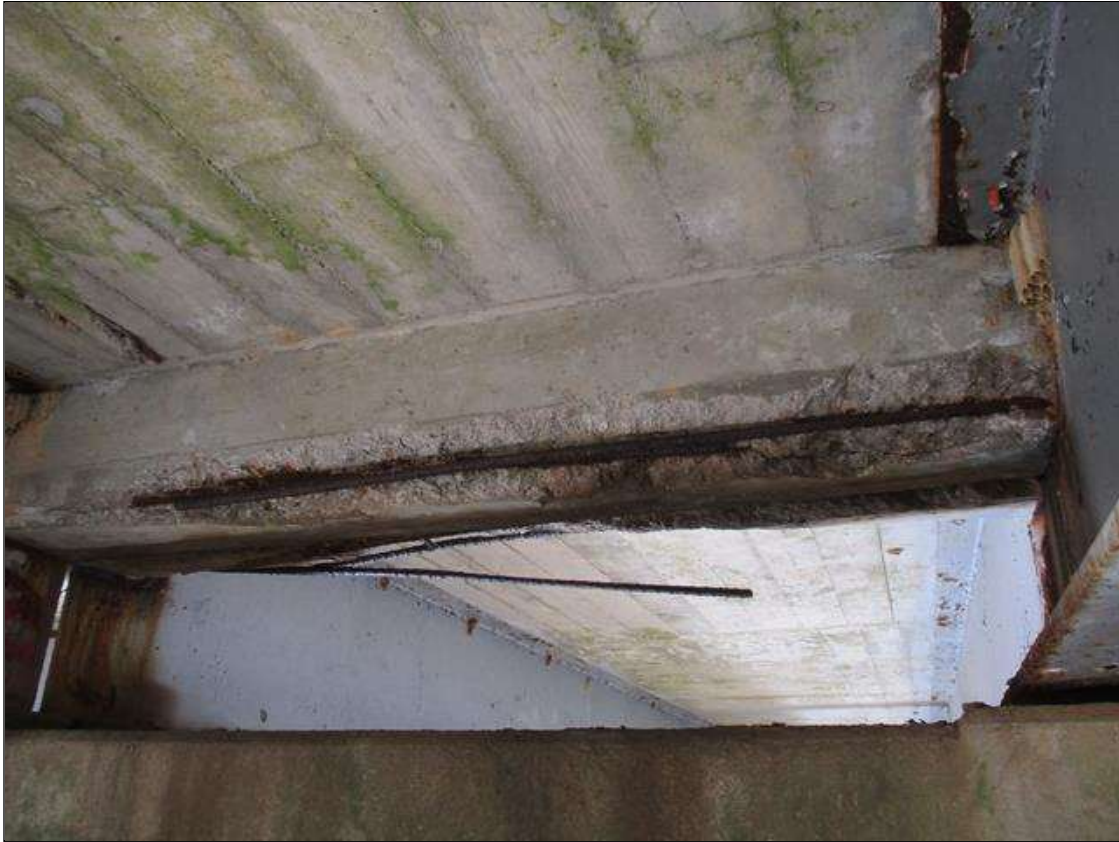
Span 7 Beam 2: [PROMPT ACTION REQUEST] BAY 2 AT BENT 6, REINFORCED CONCRETE DIAPHRAGM, SPALLING WITH EXPOSED REBAR [APPROXIMATELY 6' LONG X 12" WIDE X UP TO 3" DEEP] WITH DELAMINATED REBAR, WHICH HAS SURFACE CORROSION AND PITTING UP TO 1/8" DEEP

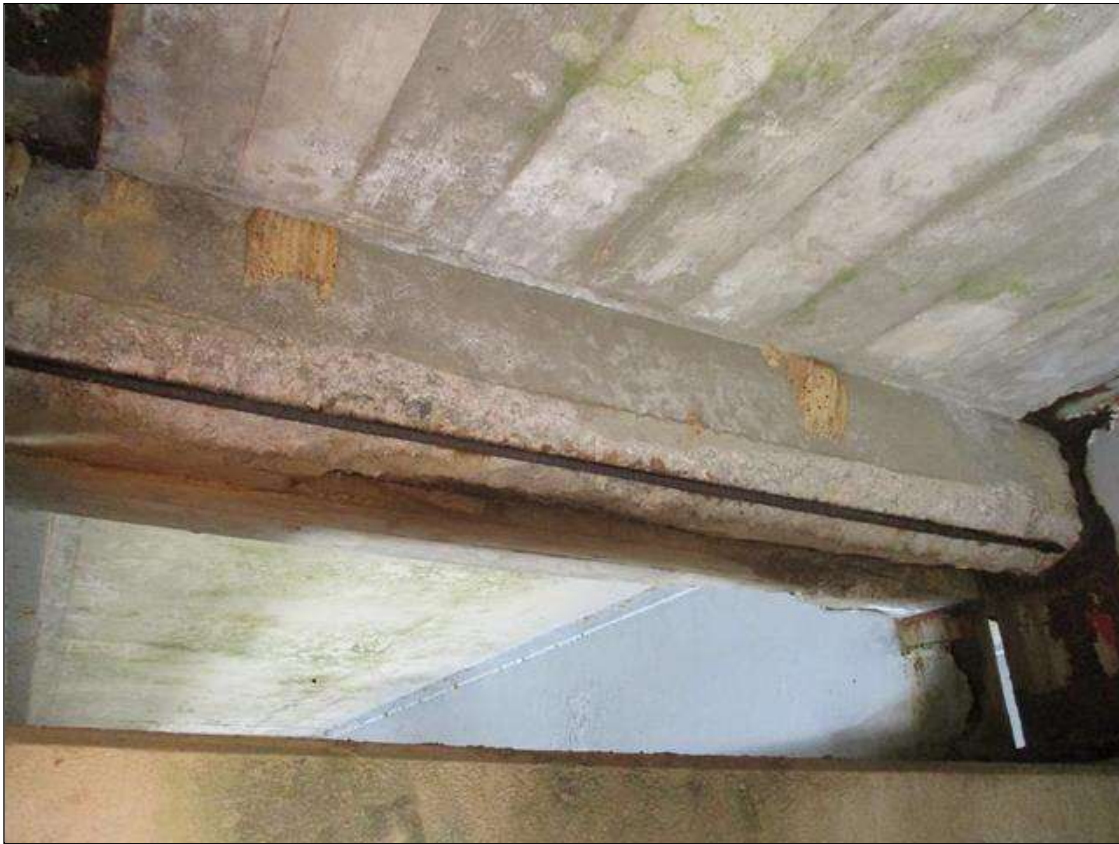
Span 7 Beam 3: [PROMPT ACTION REQUEST] BAY 3 AT BENT 6, REINFORCED CONCRETE DIAPHRAGM, SPALLING WITH EXPOSED REBAR [APPROXIMATELY 6' LONG X 12" WIDE X UP TO 3" DEEP] WITH DELAMINATED REBAR, WHICH HAS SURFACE CORROSION AND PITTING UP TO 1/8" DEEP THROUGHOUT WITH AREAS OF SECTION LOSS UP TO 90%

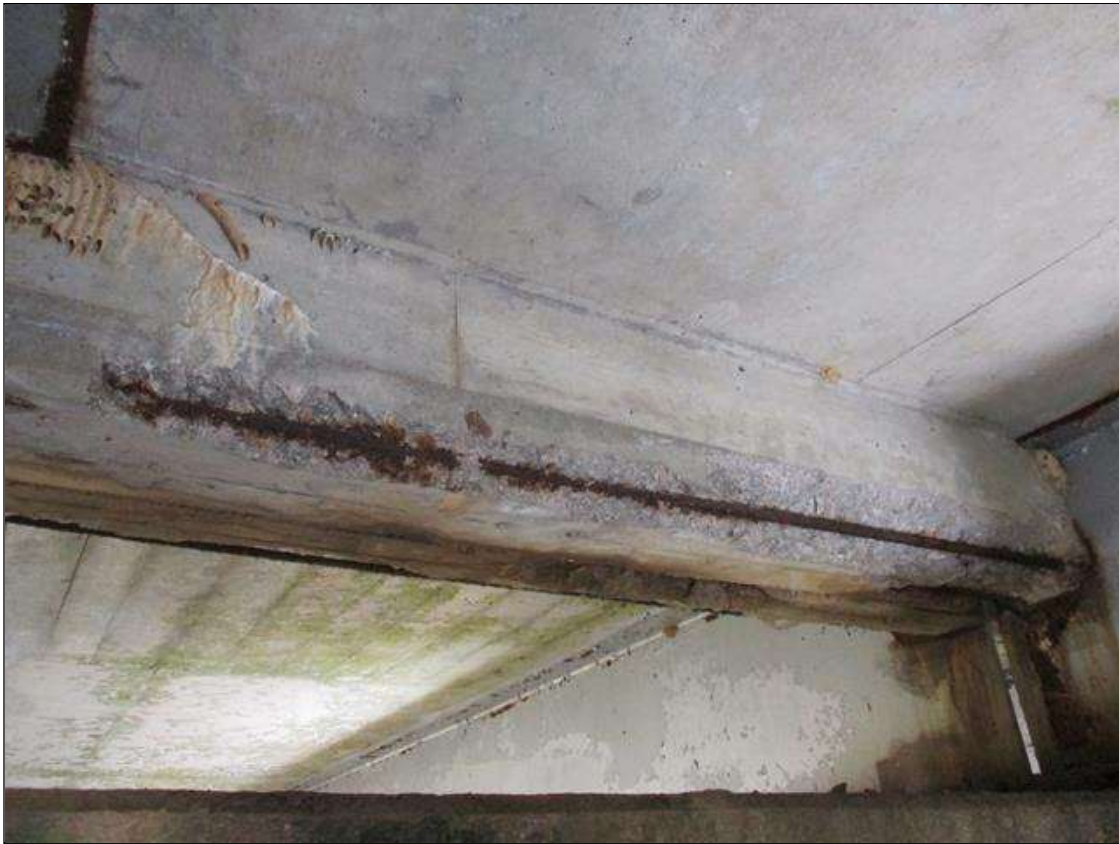
Span 5 Beam 1: [PROMPT ACTION REQUEST] BAY 1 AT BENT 5, REINFORCED CONCRETE DIAPHRAGM, SPALLING WITH EXPOSED REBAR [APPROXIMATELY 6' LONG X 8" WIDE X UP TO 2" DEEP] WITH DELAMINATED REBAR, WHICH HAS SURFACE CORROSION AND PITTING UP TO 1/8" DEEP

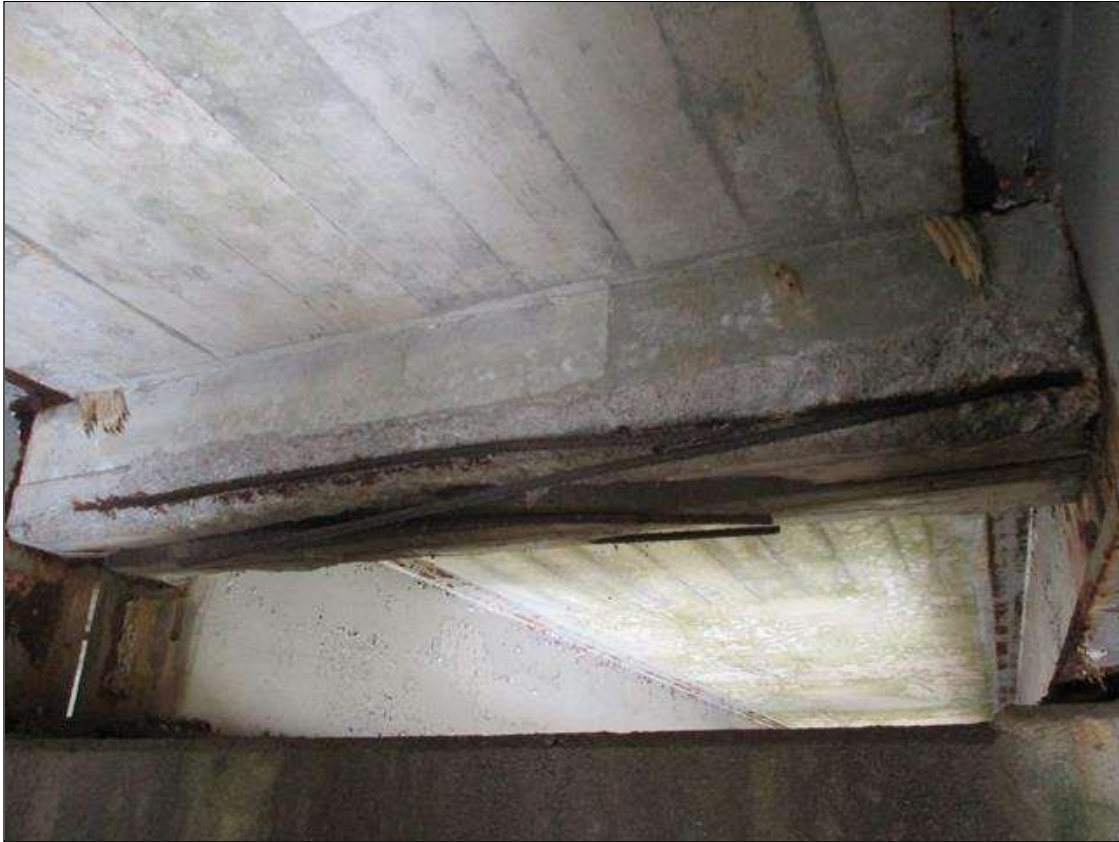
Span 5 Beam 2: [PROMPT ACTION REQUEST] BAY 2 AT BENT 5, REINFORCED CONCRETE DIAPHRAGM, SPALLING WITH EXPOSED REBAR [APPROXIMATELY 6' LONG X 12" WIDE X UP TO 3" DEEP] WITH DELAMINATED REBAR, WHICH HAS SURFACE CORROSION AND PITTING UP TO 1/8" DEEP

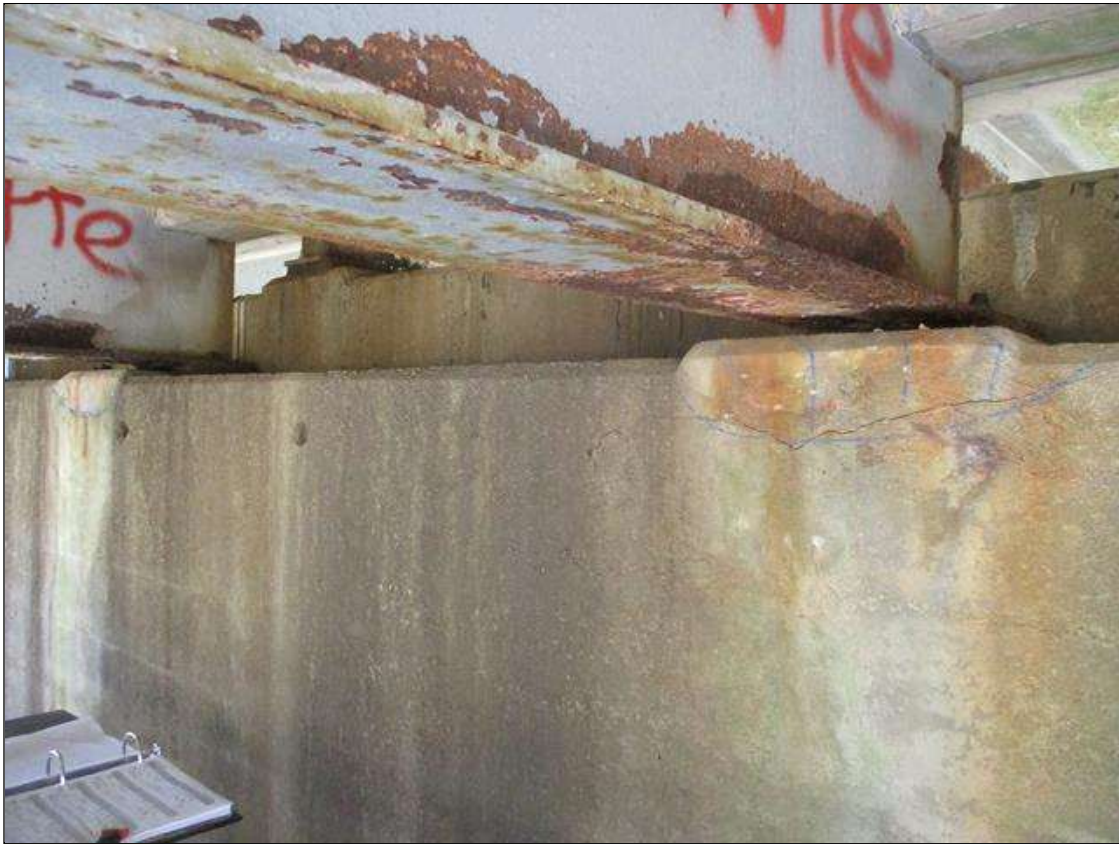
Bent 4 Cap 1: NORTH FACE AT BEAMS 2 & 3, (2) AREAS OF MAP CRACKING TO 1/8" WIDE WITH ASSOCIATED DELAMINATION

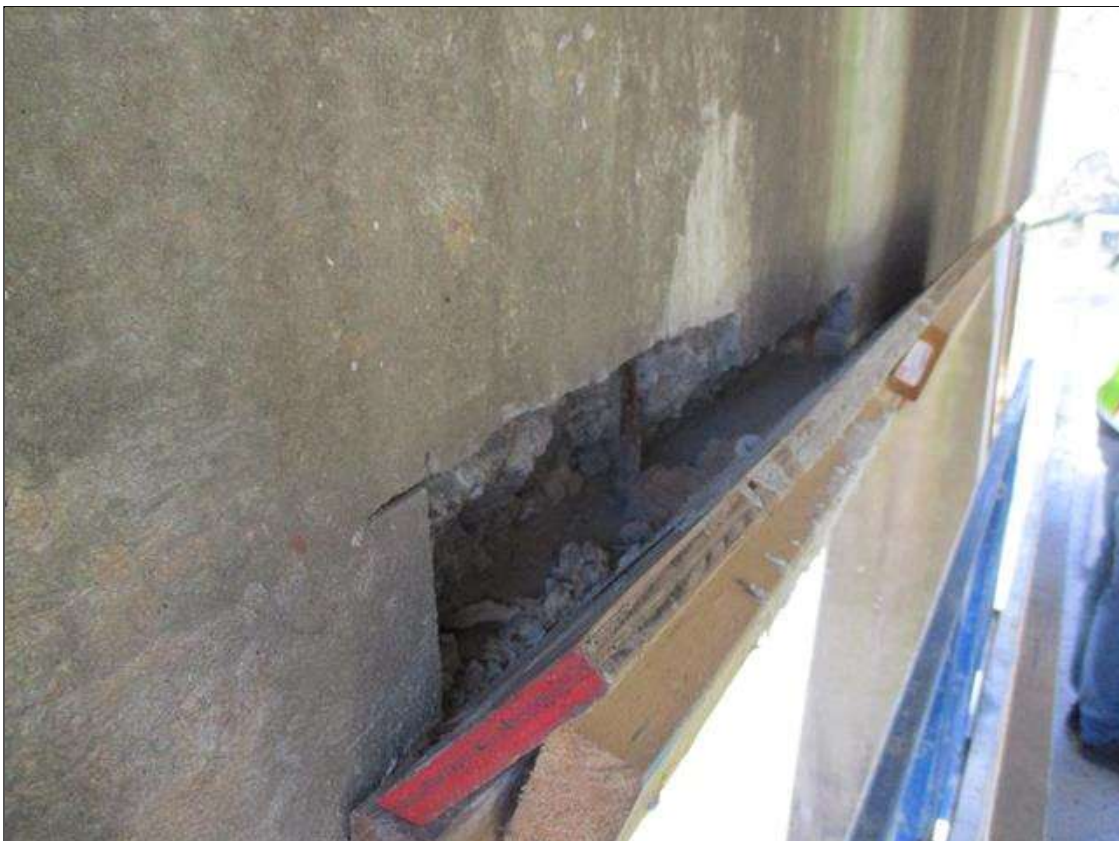
Bent 5 Cap 1: 2.67' X 9" X 5 1/2" DEEP SPALL WITH EXPOSED REBAR ON SOUTH FACE

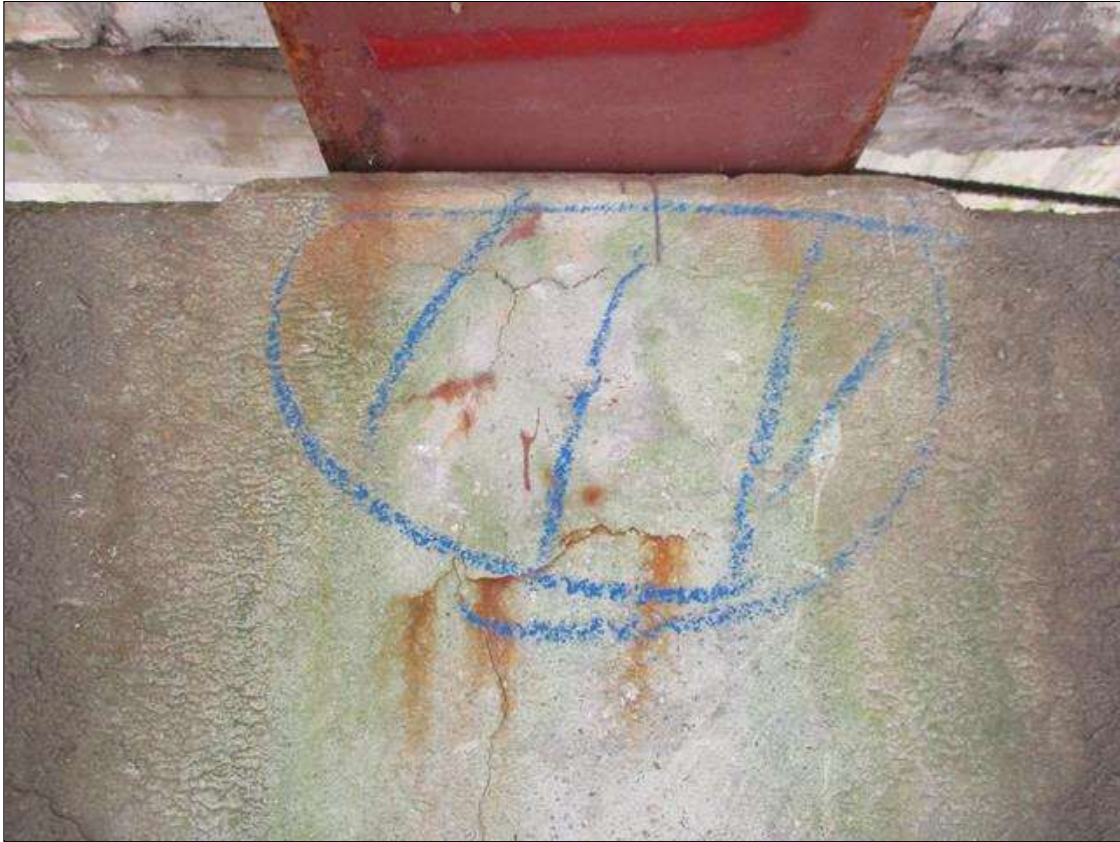
Bent 5 Cap 1: SOUTH FACE AT BEAM 2, TOP, APPROXIMATELY 1 SQUARE FEET MAP CRACKING TO 1/16" WIDE WITH ASSOCIATED DELAMINATION

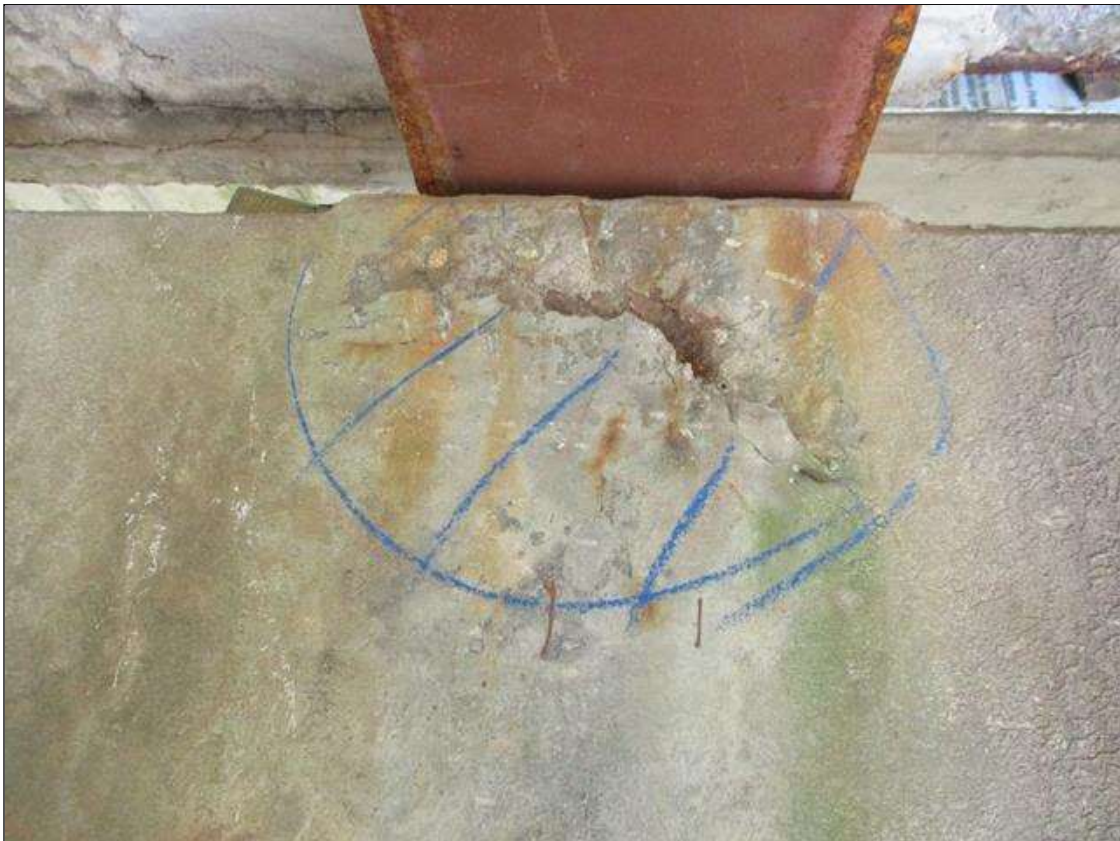
Bent 5 Cap 1: SOUTH FACE AT BEAM 3, TOP, APPROXIMATELY 1.5 SQUARE FEET MAP CRACKING TO 1/16" WIDE WITH ASSOCIATED DELAMINATION

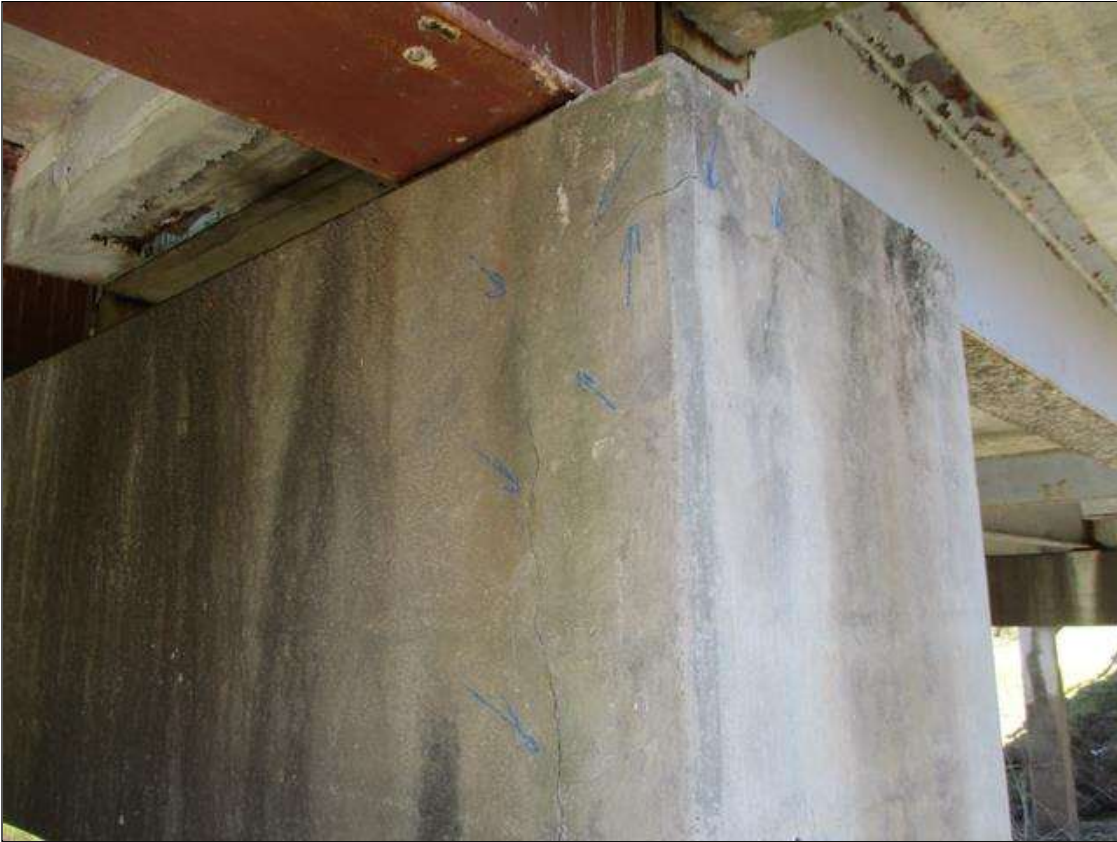
Bent 5 Cap 1: SOUTH FACE, RIGHT END, FULL HEIGHT MAP CRACKING TO 1/16" WIDE, EXTENDS BACK INTO THE EAST FACE UP TO 1'

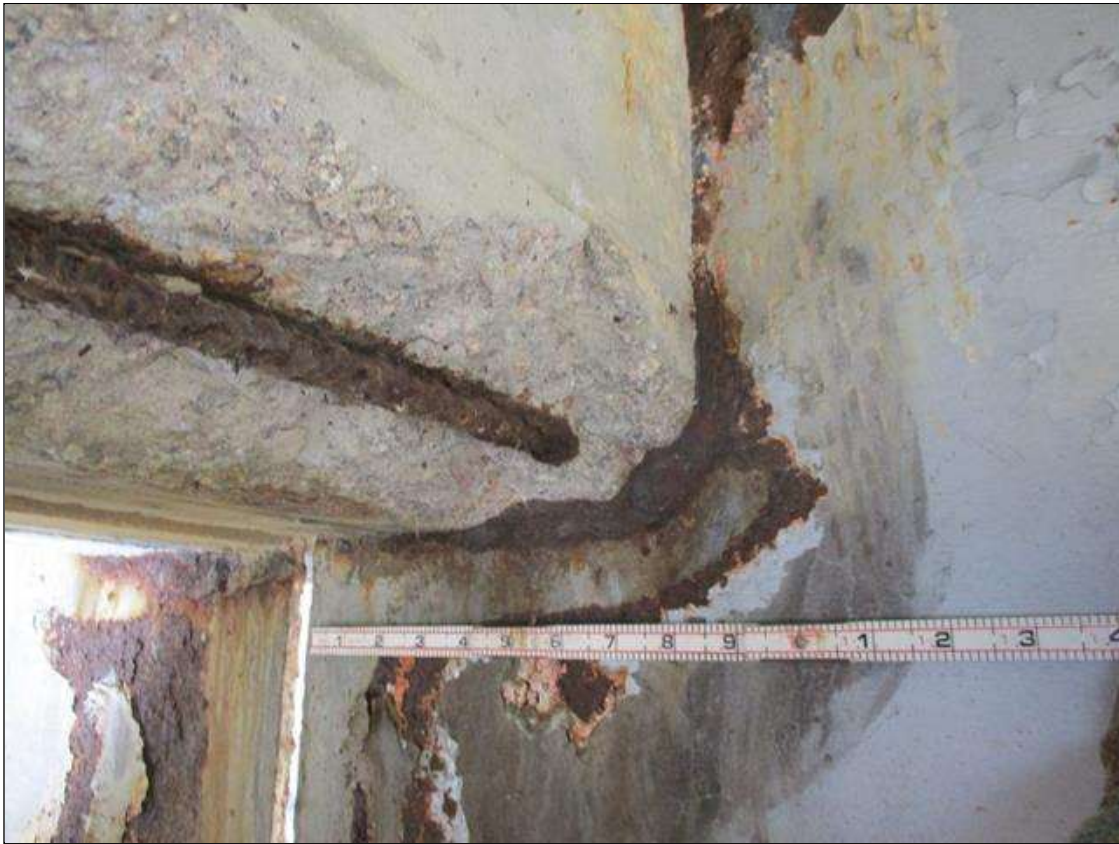
Span 7 Beam 1: [PROMPT ACTION REQUEST] BEAM END AT BENT 6, THERE IS AN APPROXIMATELY 1" WIDE BAND OF CORROSION THAT WRAPS THE REINFORCED CONCRETE DIAPHRAGM, APPROXIMATELY 3/16" SECTION LOSS [AVERAGE 1/4" REMAINS] FOR APPROXIMATELY 10" LONG.

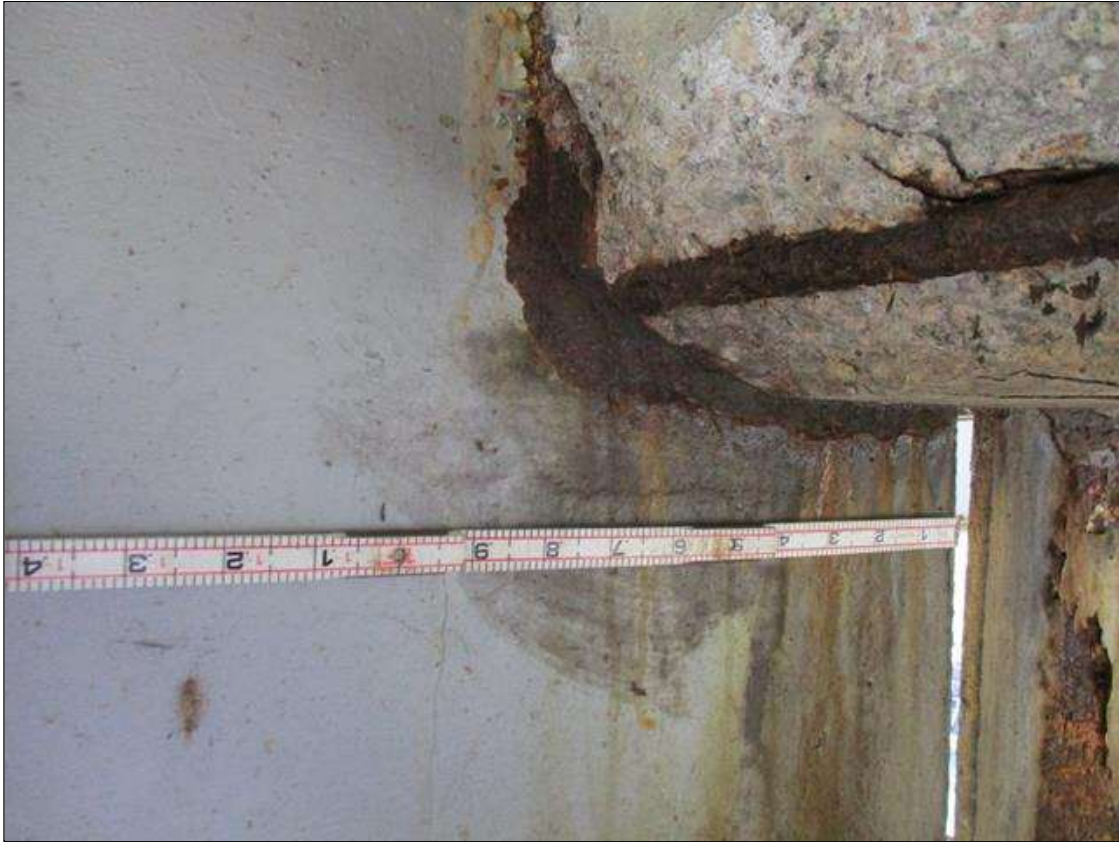
Span 7 Beam 2: [PROMPT ACTION REQUEST] BEAM END AT BENT 6, THERE IS AN APPROXIMATELY 1" WIDE BAND OF CORROSION THAT WRAPS THE REINFORCED CONCRETE DIAPHRAGM, APPROXIMATELY 3/16" SECTION LOSS [AVERAGE 1/4" REMAINS] FOR APPROXIMATELY 10" LONG.

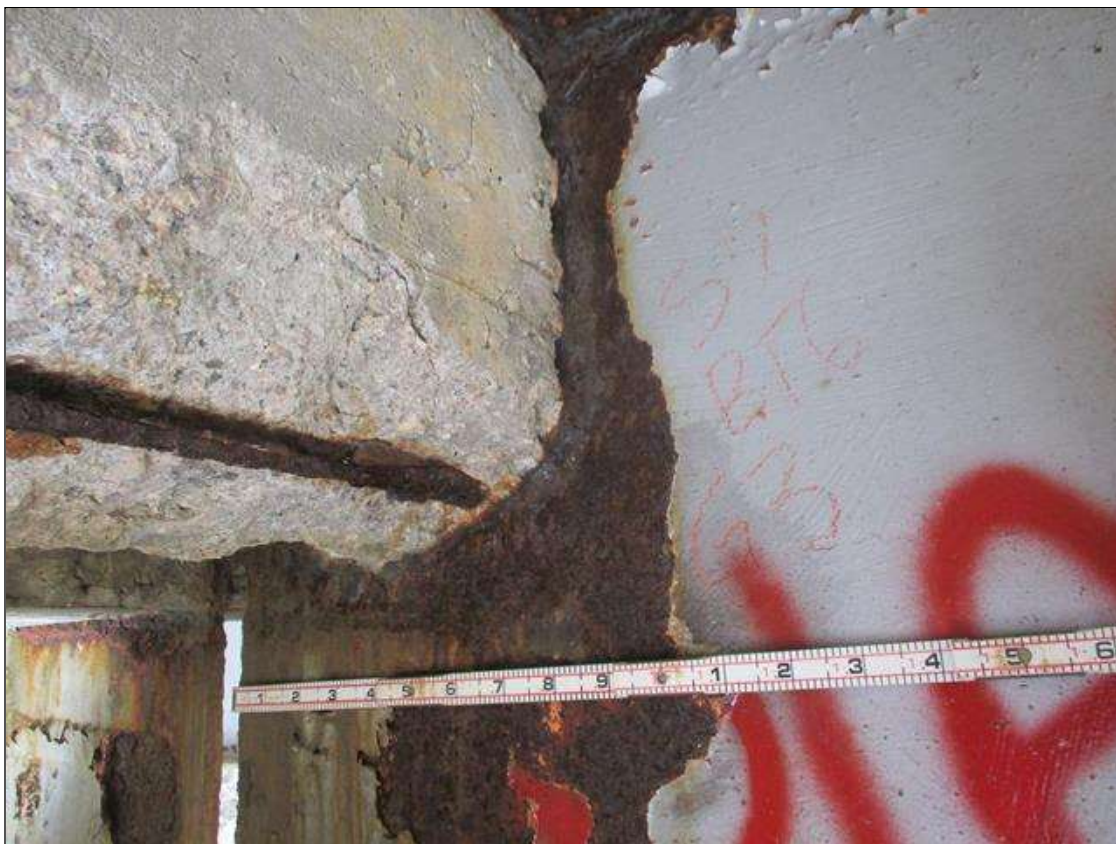
Span 7 Beam 3: [PROMPT ACTION REQUEST] BEAM END AT BENT 6, THERE IS AN APPROXIMATELY 2" WIDE BAND OF CORROSION THAT WRAPS THE REINFORCED CONCRETE DIAPHRAGM, APPROXIMATELY 1/4" SECTION LOSS [AVERAGE 3/16" REMAINS] FOR APPROXIMATELY 10" LONG.
