NC DEPARTMENT OF TRANSPORTATION
 DIVISION OF HIGHWAYS
 STRUCTURE MANAGEMENT UNIT

ATTENTION: **PROMPT ACTION REQUEST; HYDRAPLATFORM USED; NEW REPAIRS; OUT-TO-OUT REVISED;**

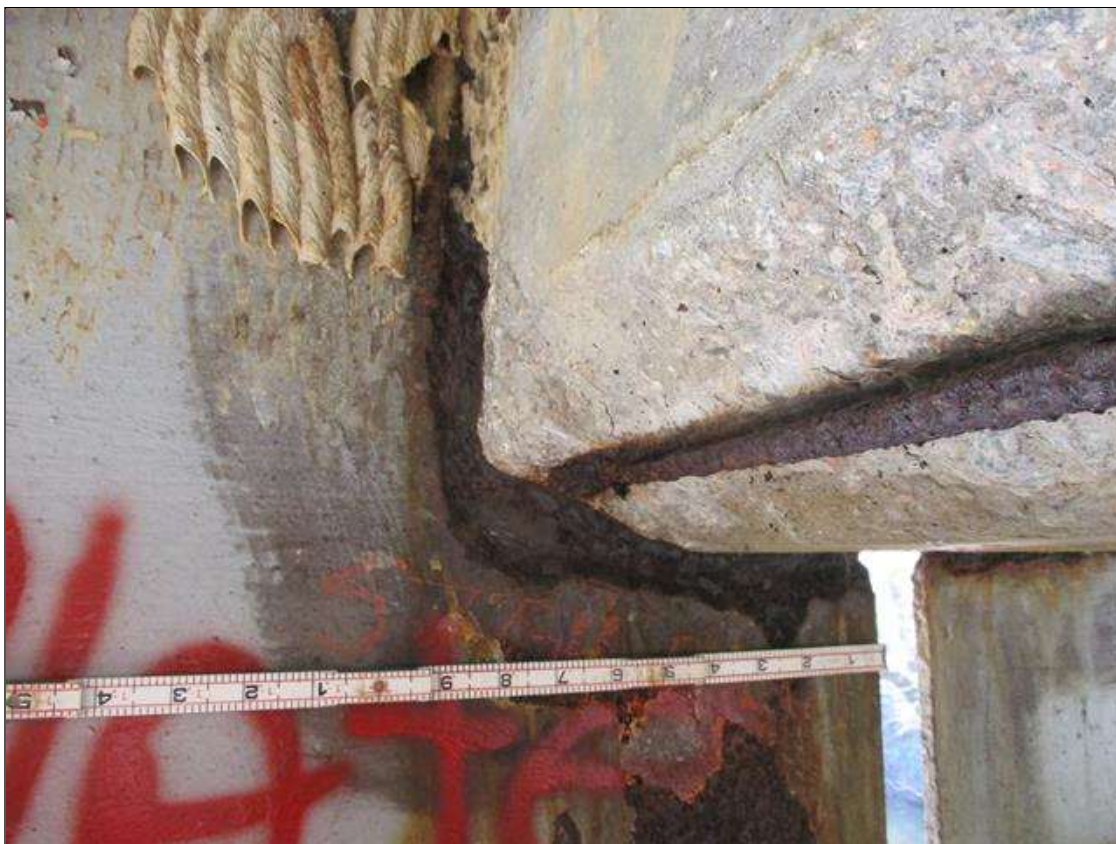
Span 7 Beam 4: [PROMPT ACTION REQUEST] BEAM END AT BENT 6, THERE IS AN APPROXIMATELY 2" WIDE BAND OF CORROSION THAT WRAPS THE REINFORCED CONCRETE DIAPHRAGM, APPROXIMATELY 3/8" SECTION LOSS [AVERAGE 1/16" REMAINS] FOR APPROXIMATELY 10" LONG.

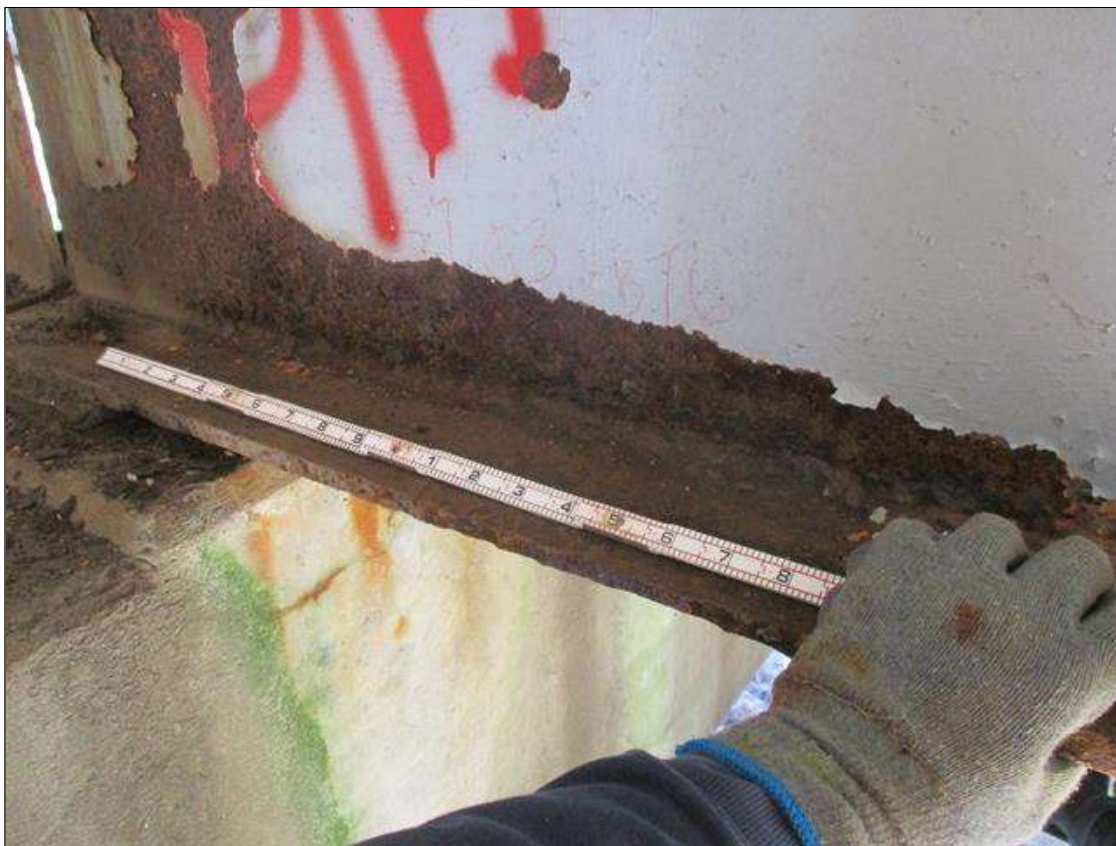
Span 7 Beam 3: [PROMPT ACTION REQUEST] 8" OUT FROM THE BEAM END AT BENT 6, IN THE LOWER 2" OF THE WEB, CORROSION WITH APPROXIMATELY 3/16" SECTION LOSS [AVERAGE 1/4" REMAINS] FOR 24" LONG.

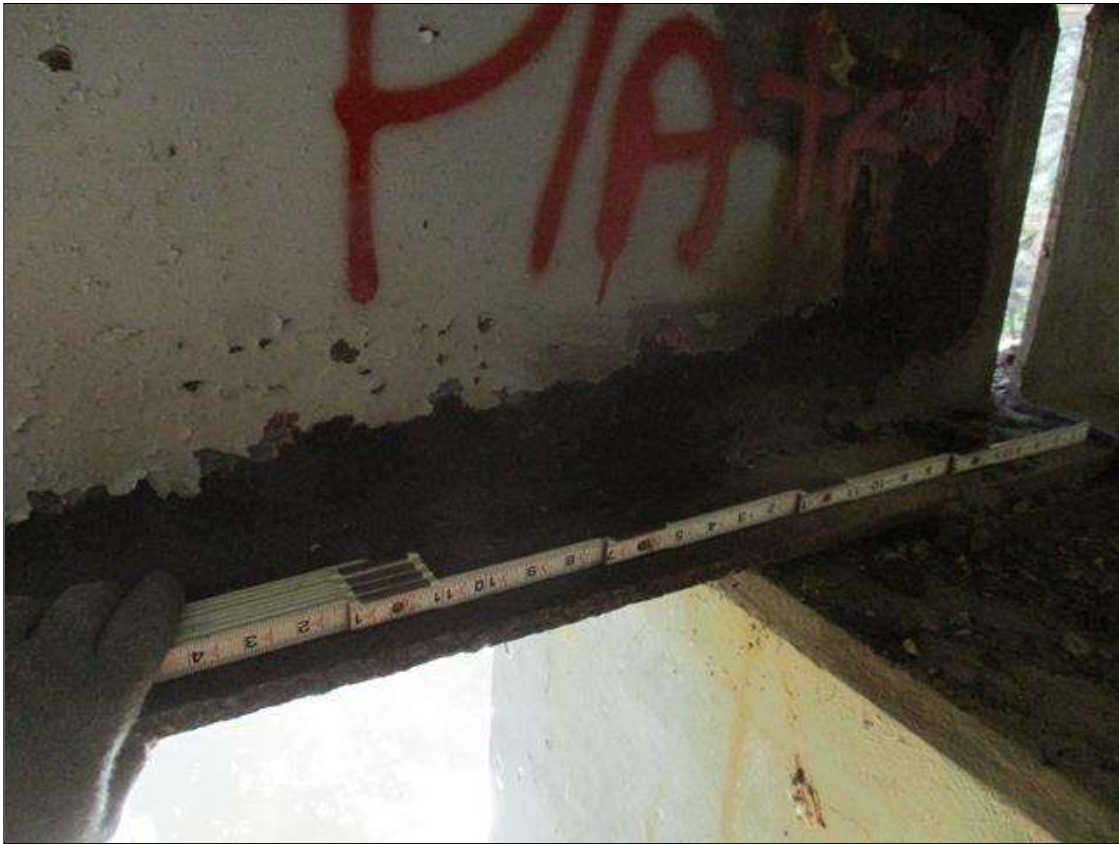
Span 7 Beam 4: [PROMPT ACTION REQUEST] 12" OUT FROM THE BEAM END AT BENT 6, IN THE LOWER 2" OF THE WEB, CORROSION WITH APPROXIMATELY 3/16" SECTION LOSS [AVERAGE 1/4" REMAINS] FOR 18" LONG.

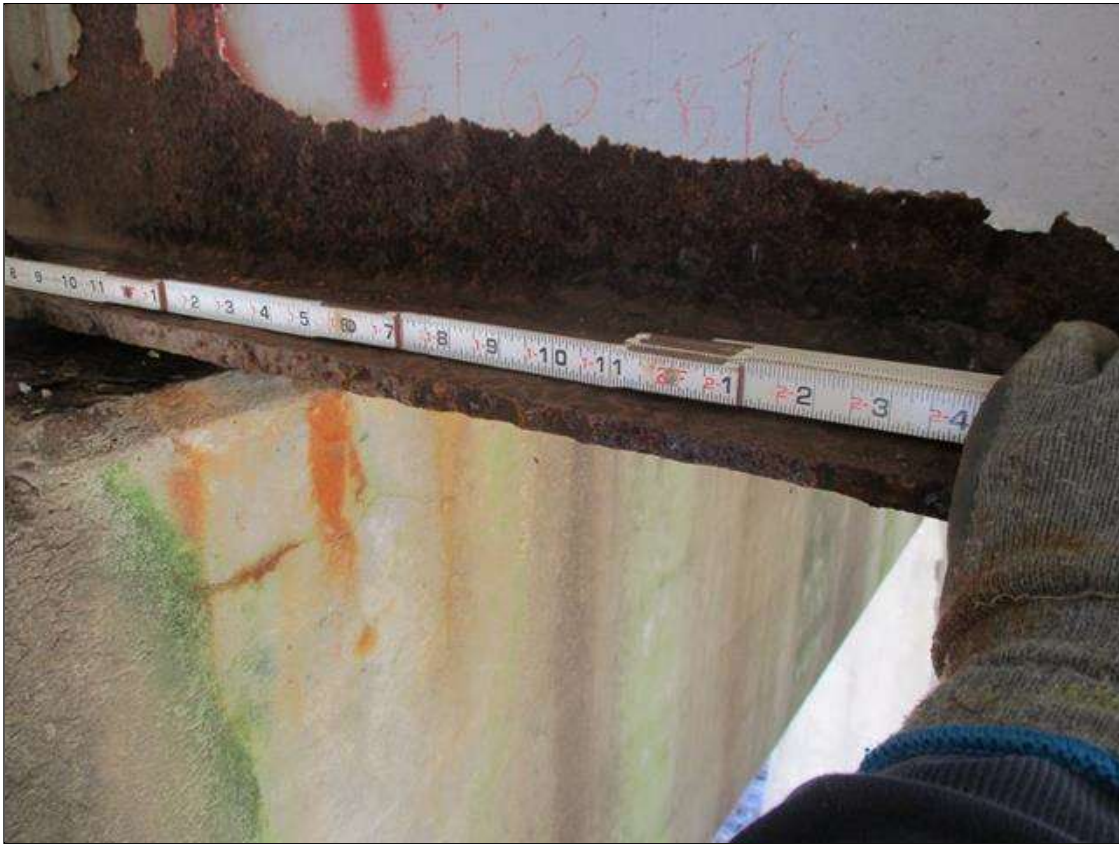
Span 7 Beam 3: [PROMPT ACTION REQUEST] BEAM END AT BENT 6, LOWER RIGHT FLANGE, CORROSION WITH APPROXIMATELY 5/16" SECTION LOSS [AVERAGE 5/16" REMAINS] FOR APPROXIMATELY 24" LONG

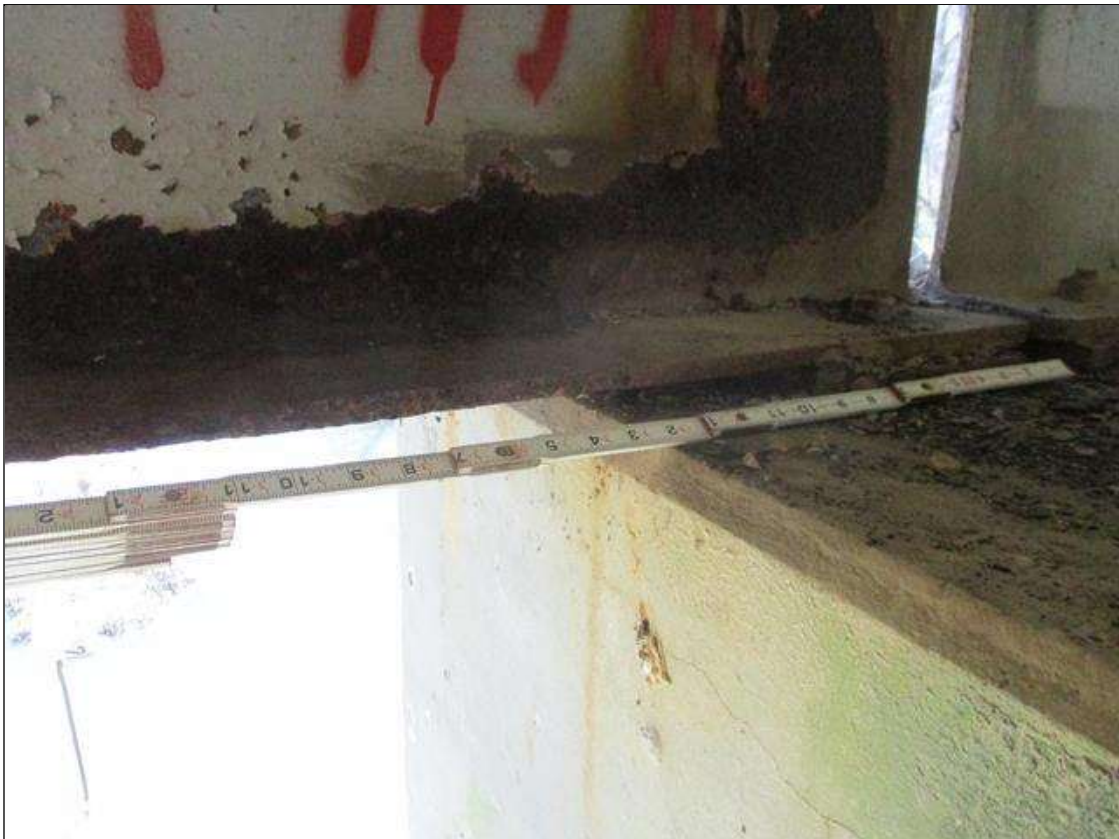
Span 7 Beam 4: [PROMPT ACTION REQUEST] BEAM END AT BENT 6, LOWER FLANGE, CORROSION WITH APPROXIMATELY 3/16" SECTION LOSS [AVERAGE 7/16" REMAINS] FOR APPROXIMATELY 12" LONG

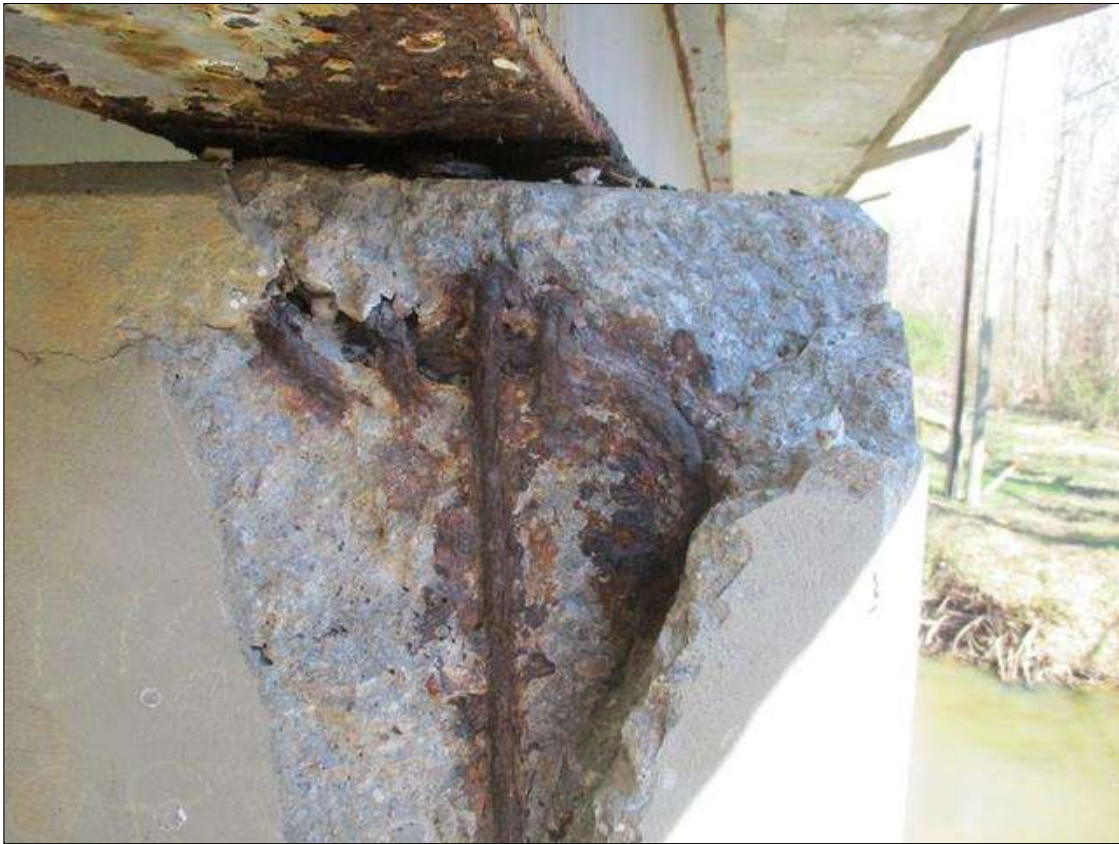
Bent 6 Cap 1: [PROMPT ACTION REQUEST] SOUTH FACE, RIGHT END, SPALLING WITH EXPOSED REBAR [APPROXIMATELY 2' LONG X FULL HEIGHT X UP TO 7" BACK X 3" DEEP]; SURFACE CORROSION AND PITTING TO 1/16" ON THE REBAR

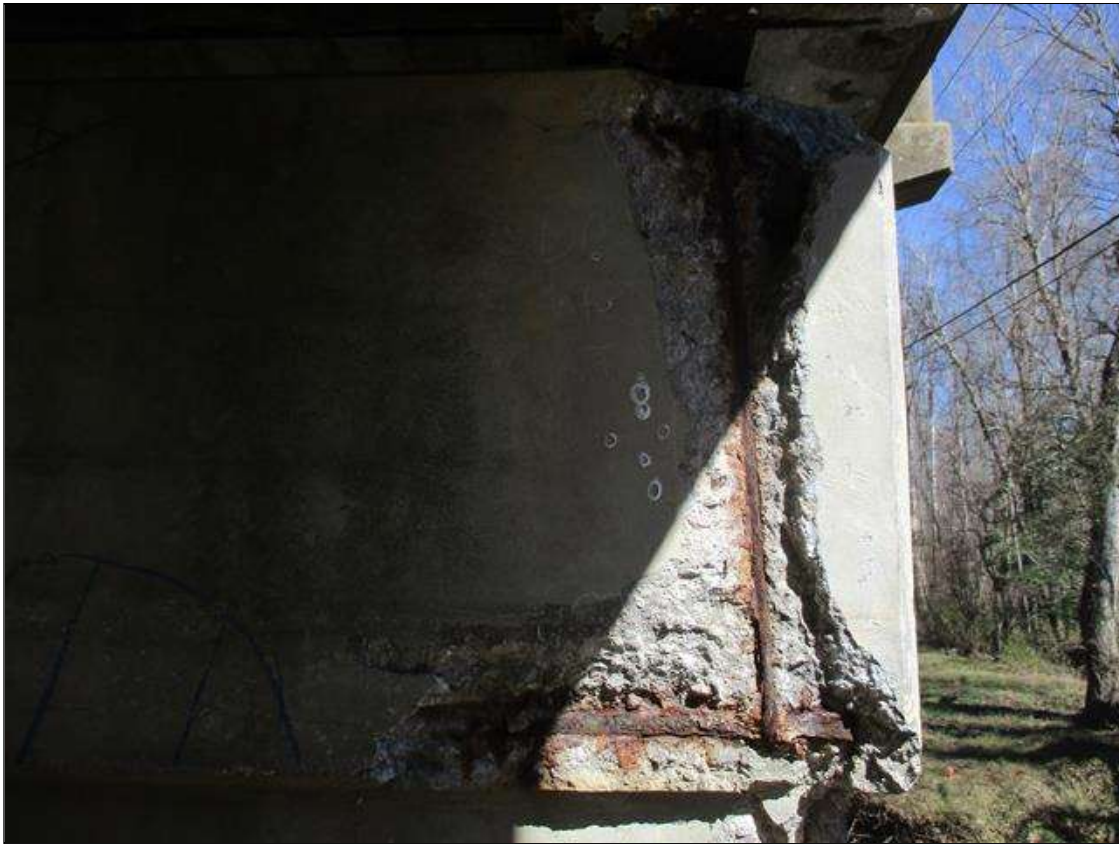
Bent 6 Cap 1: [PROMPT ACTION REQUEST] SOUTH FACE, RIGHT END, SPALLING WITH EXPOSED REBAR [APPROXIMATELY 2' LONG X FULL HEIGHT X UP TO 7" BACK X 3" DEEP]; SURFACE CORROSION AND PITTING TO 1/16" ON THE REBAR

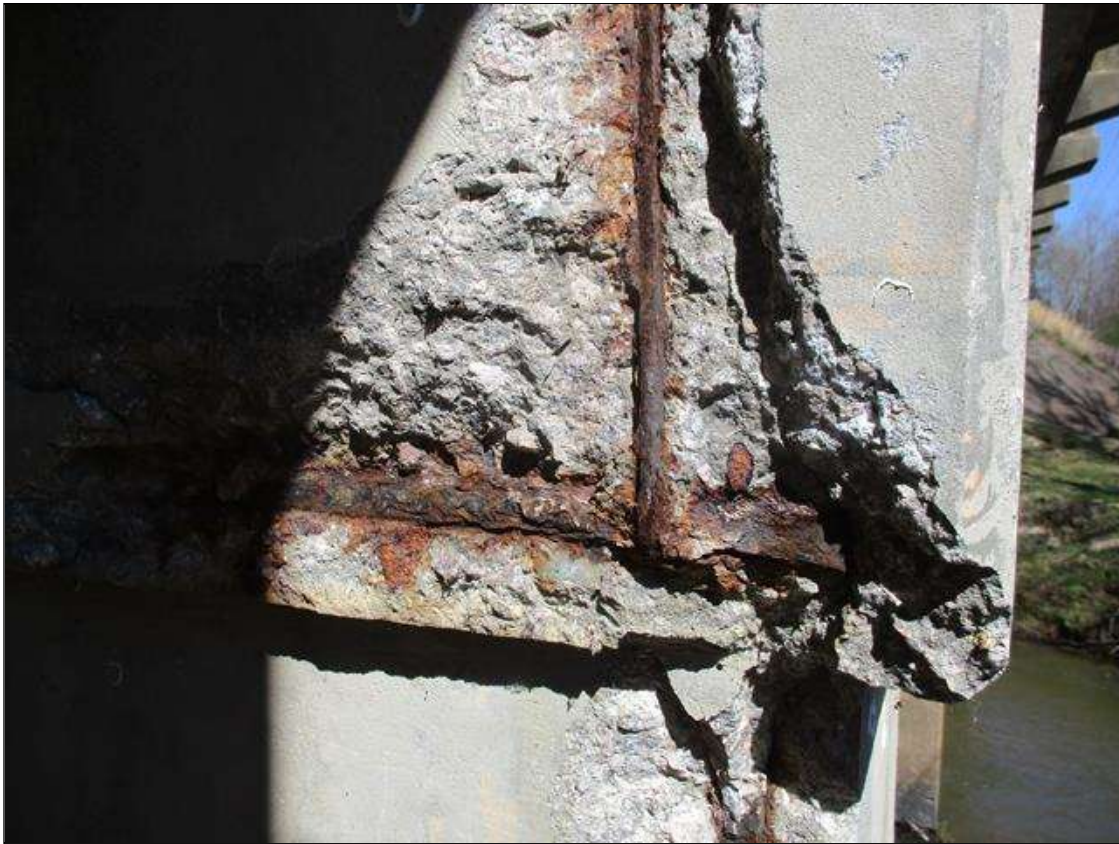
Bent 6 Cap 1: [PROMPT ACTION REQUEST] SOUTH FACE, RIGHT END, SPALLING WITH EXPOSED REBAR [APPROXIMATELY 2' LONG X FULL HEIGHT X UP TO 7" BACK X 3" DEEP]; SURFACE CORROSION AND PITTING TO 1/16" ON THE REBAR

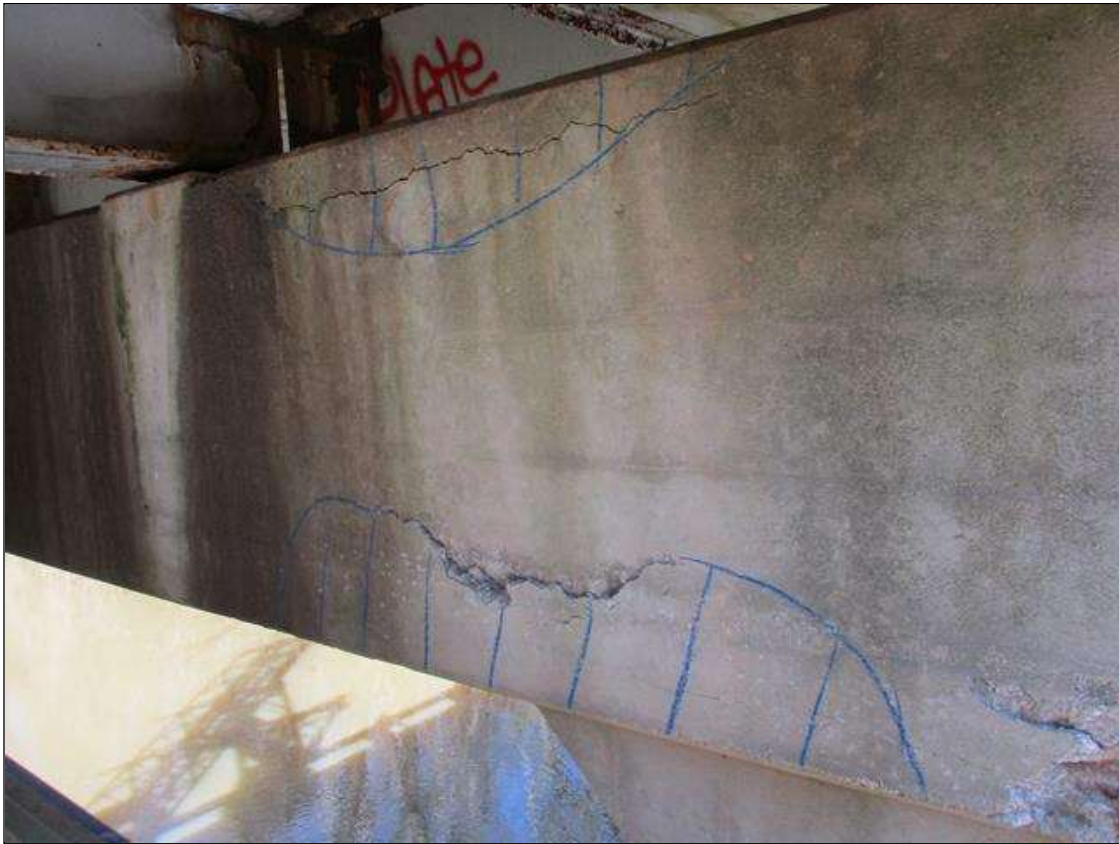
Bent 6 Cap 1: SOUTH FACE AT BAY 3, UPPER AND LOWER 12" OF THE CAP FACE, MAP CRACKING TO 1/8" WIDE WITH APPROXIMATELY 6 SQUARE FEET OF ASSOCIATED DELAMINATION

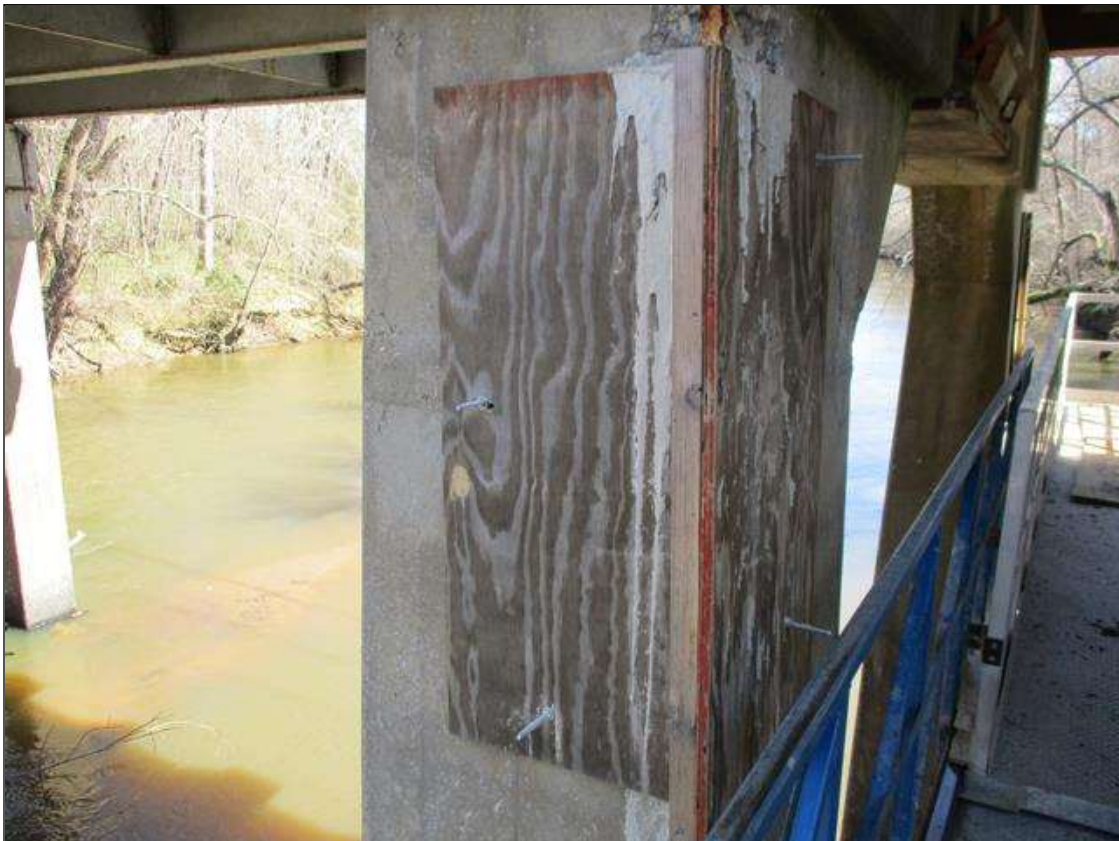
Bent 5 Pile 1: SOUND PATCHING --> [FORMERLY 2.75' X 7" X 6" DEEP SPALL WITH EXPOSED REBAR]

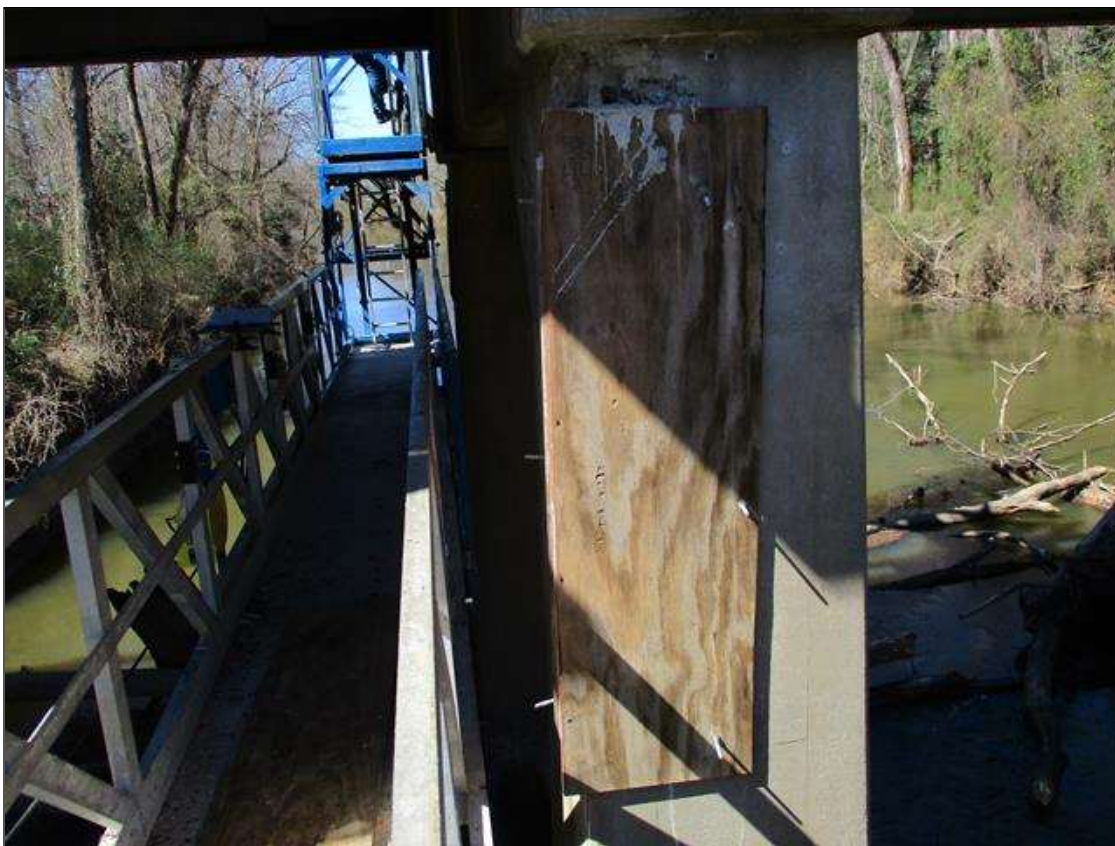
Bent 5 Pile 2: SOUND PATCHING --> [FORMERLY 4' X 10" X 9" DEEP SPALL WITH EXPOSED REBAR]

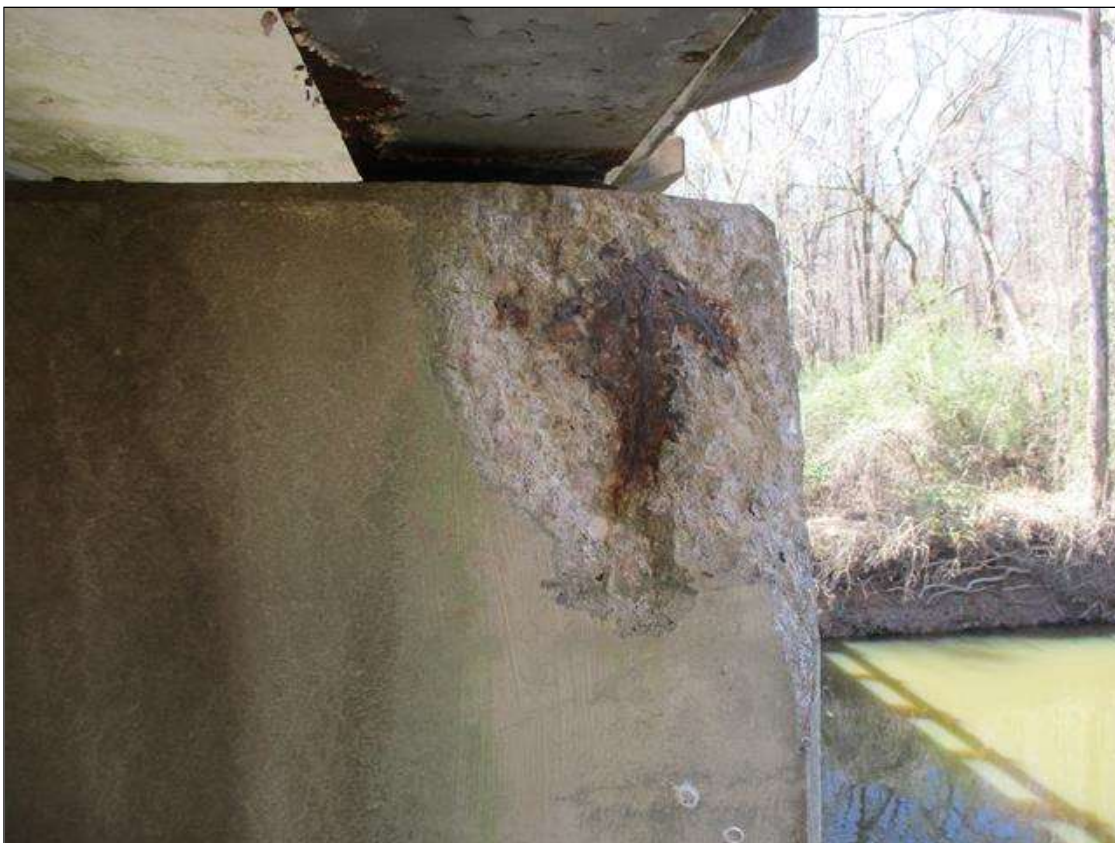
Bent 6 Cap 1: [PROMPT ACTION REQUEST] 19" X 14" X 5" DEEP SPALL WITH EXPOSED REBAR ON NORTH FACE UNDER GIRDER 1

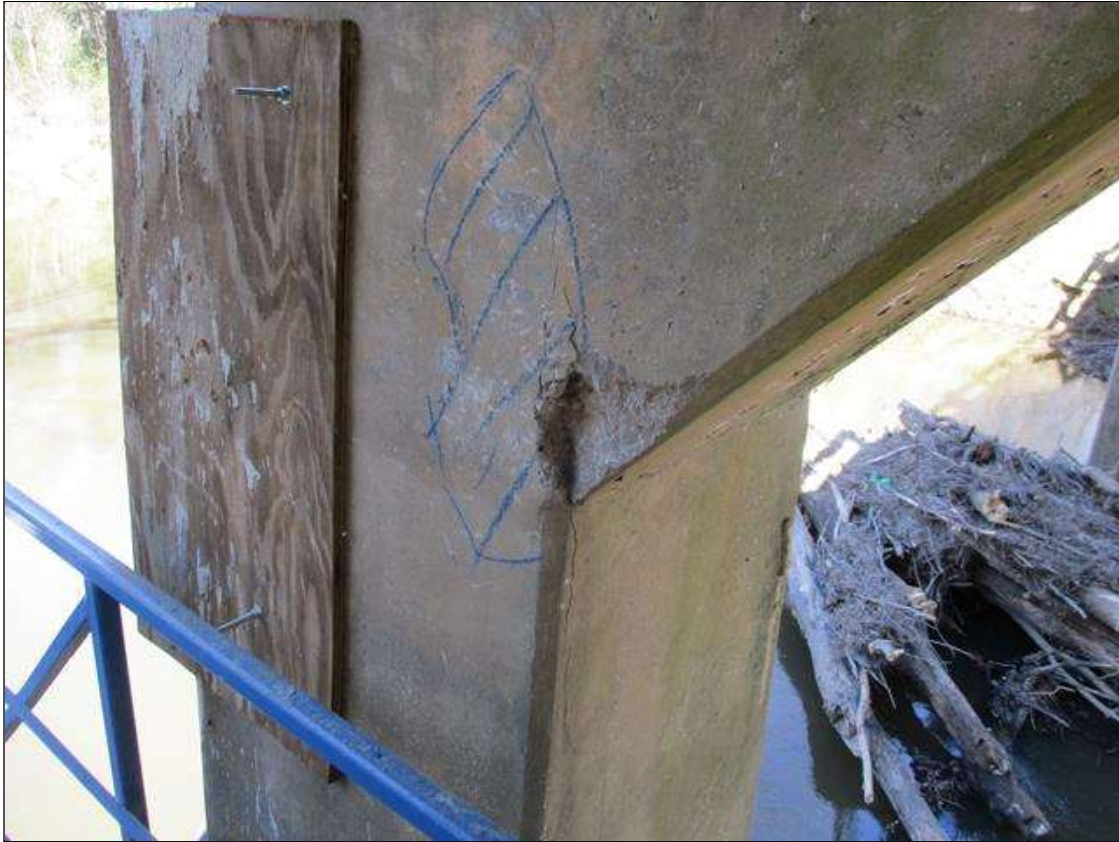
Bent 5 Pile 1: AT THE HAUNCH, APPROXIMATELY 2 SQUARE FEET MAP CRACKING TO 1/16" WIDE WITH ASSOCIATED DELAMINATION AND SPALLING TO 2" DEEP

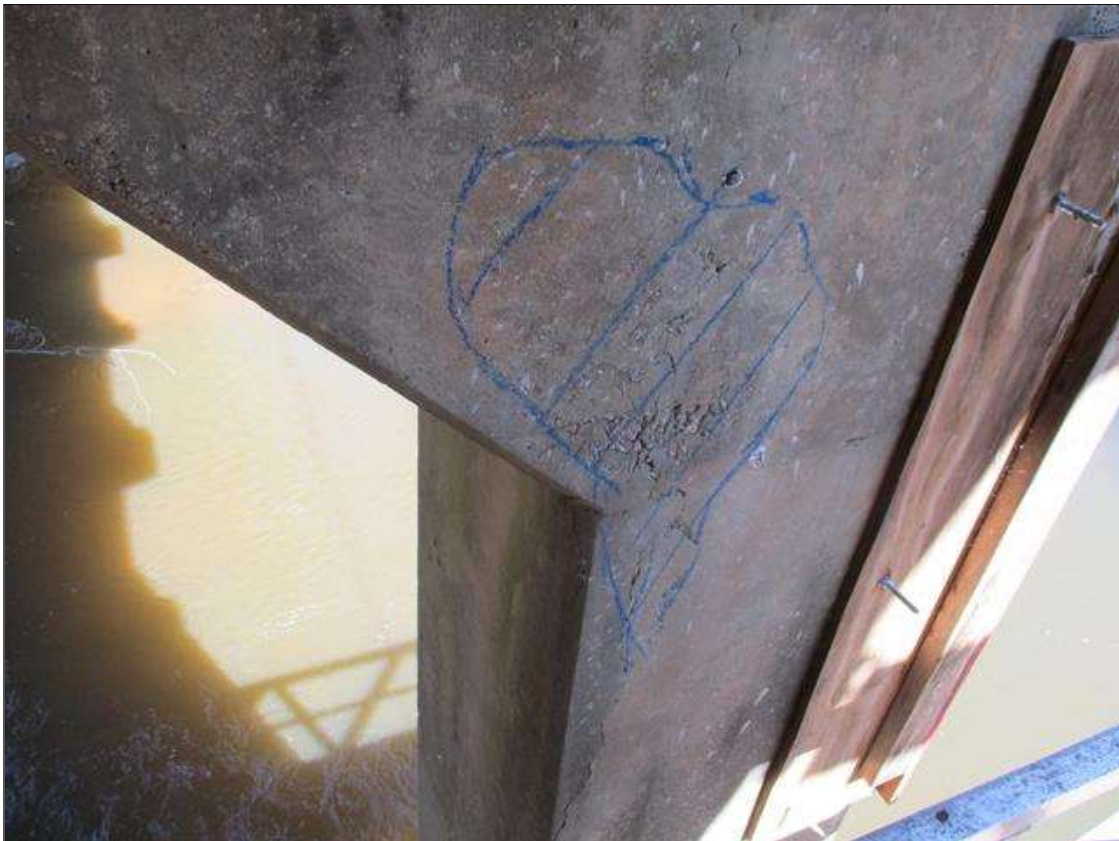
Bent 5 Pile 2: AT THE HAUNCH, APPROXIMATELY 3 SQUARE FEET MAP CRACKING TO 1/16" WIDE AND VERTICAL CRACKING TO 1/8" WIDE WITH ASSOCIATED DELAMINATION

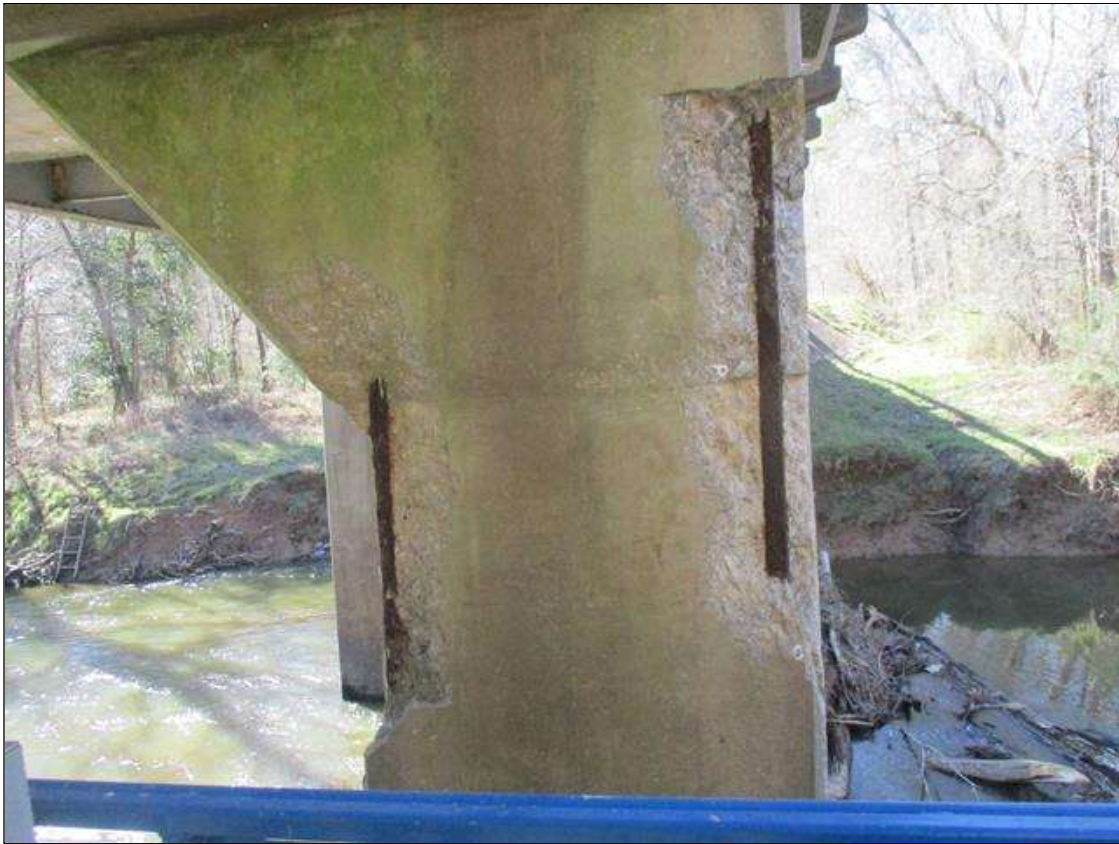
Bent 6 Pile 1: [PROMPT ACTION REQUEST] 2 - UP TO 3' X 10" X 2" DEEP SPALL WITH EXPOSED REBAR ON NORTH FACE [NO MEASURABLE SECTION LOSS]

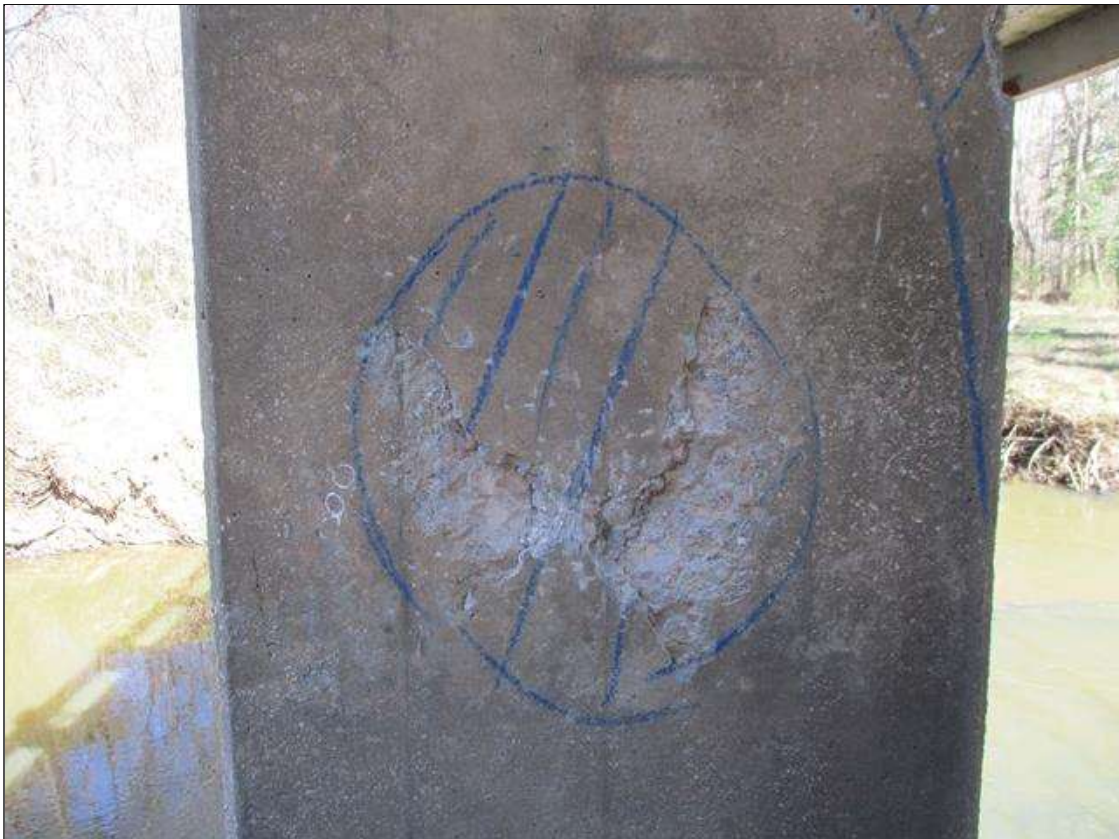
Bent 6 Pile 1: AT 5' DOWN FROM THE CAP, APPROXIMATELY 3 SQUARE FEET MAP CRACKING TO 1/16" WIDE WITH ASSOCIATED SPALLIN TO 1" DEEP AND DELAMINATION

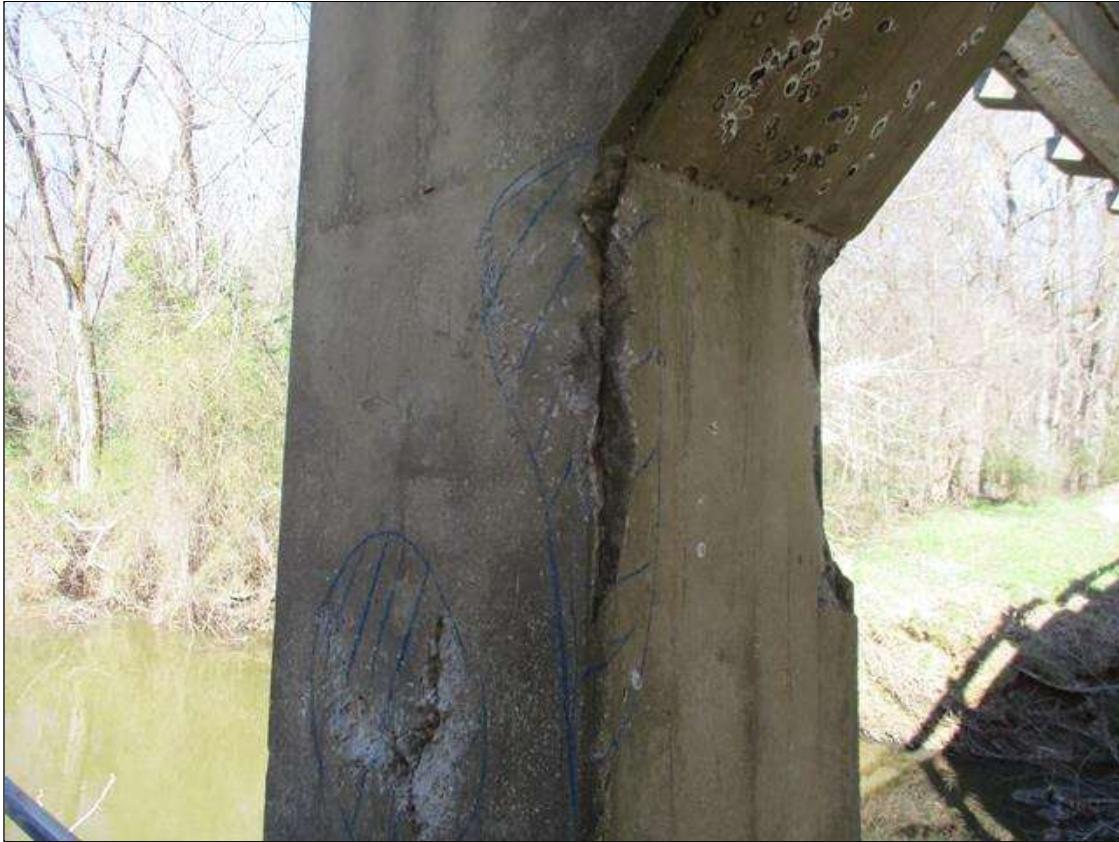
Bent 6 Pile 1: AT 4' DOWN FROM THE CAP, APPROXIMATELY 3 SQUARE FEET MAP CRACKING TO 1/16" WIDE WITH ASSOCIATED SPALLIN TO 2" DEEP AND DELAMINATION

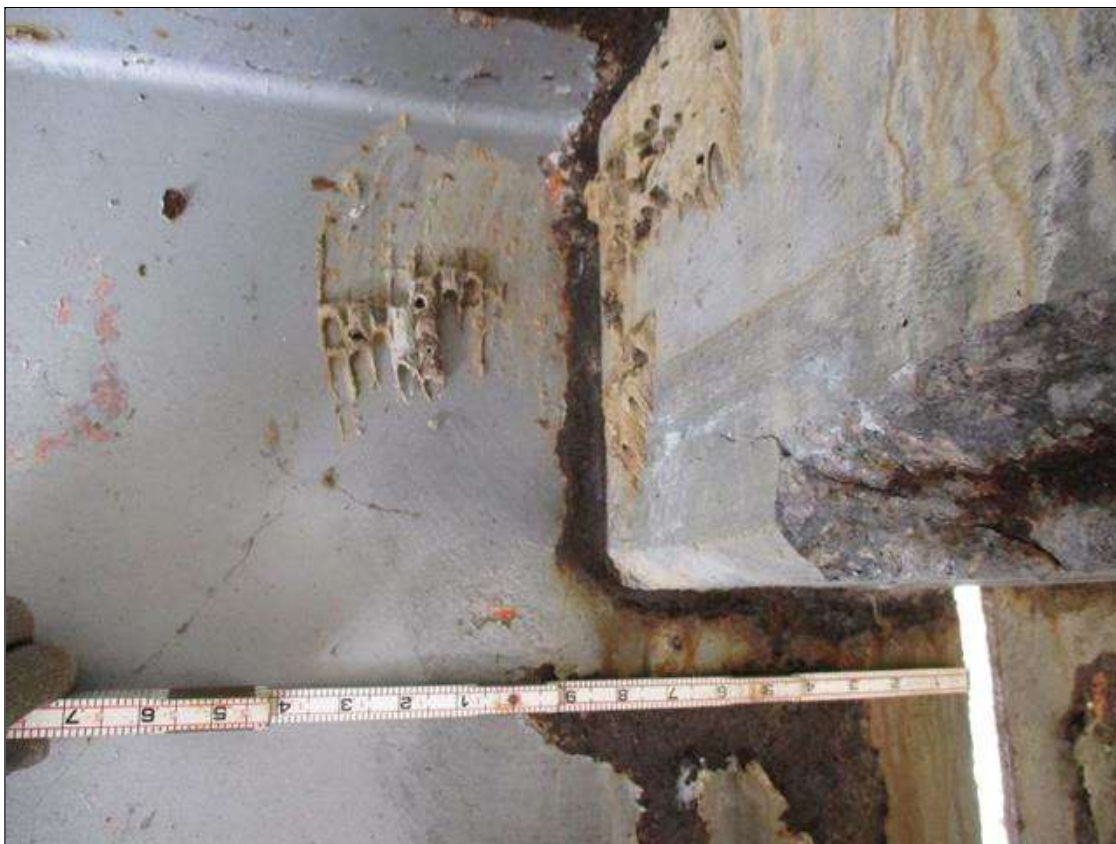
Span 5 Beam 1: [PROMPT ACTION REQUEST] BEAM END AT BENT 5, THERE IS AN APPROXIMATELY 1" WIDE BAND OF CORROSION THAT WRAPS THE REINFORCED CONCRETE DIAPHRAGM, APPROXIMATELY 1/4" SECTION LOSS [AVERAGE 3/16" REMAINS] FOR APPROXIMATELY 10" LONG.

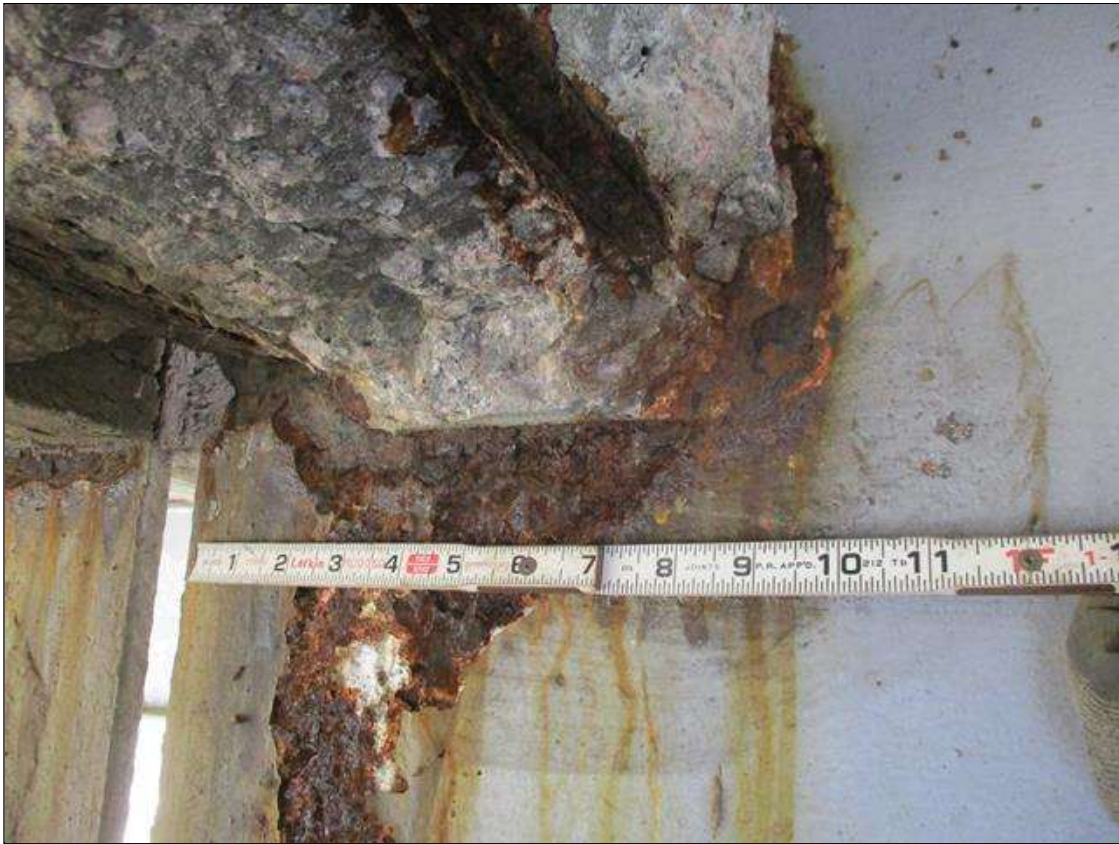
Span 5 Beam 2: [PROMPT ACTION REQUEST] BEAM END AT BENT 5, THERE IS AN APPROXIMATELY 1" WIDE BAND OF CORROSION THAT WRAPS THE REINFORCED CONCRETE DIAPHRAGM, APPROXIMATELY 1/4" SECTION LOSS [AVERAGE 3/16" REMAINS] FOR APPROXIMATELY 10" LONG.

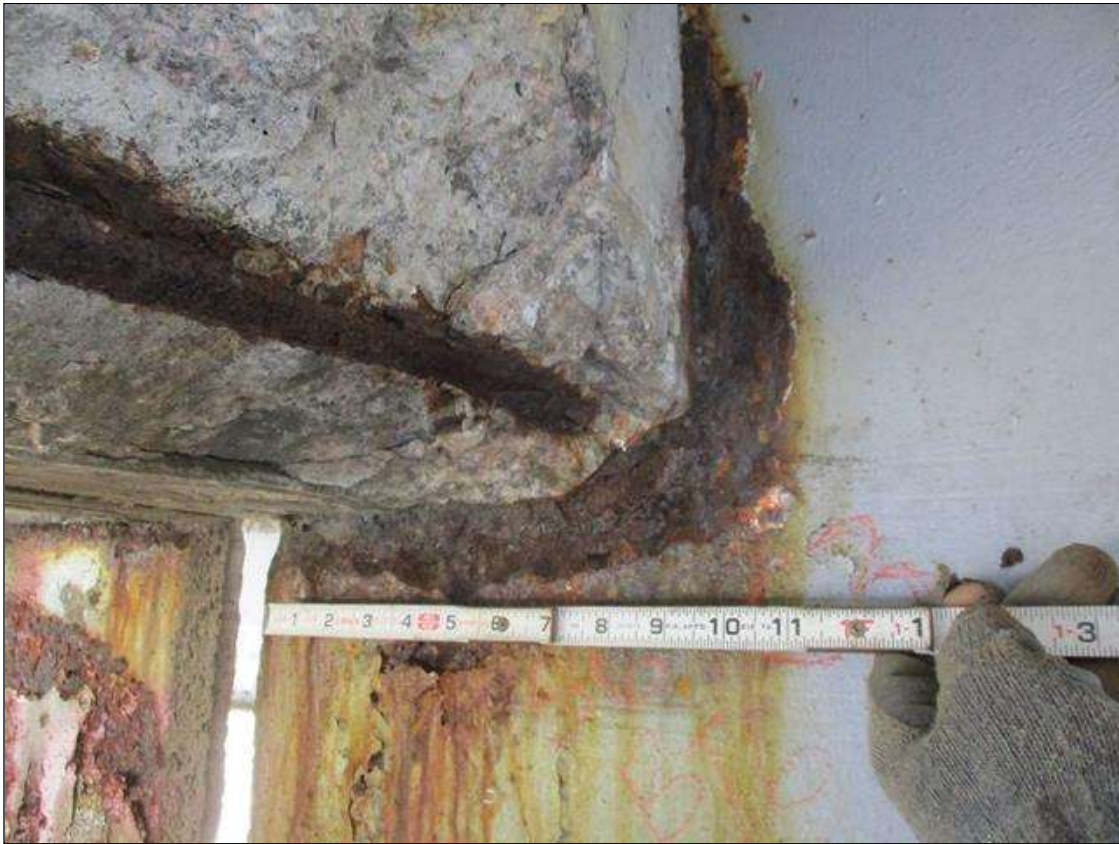
Span 5 Beam 3: [PROMPT ACTION REQUEST] BEAM END AT BENT 5, THERE IS AN APPROXIMATELY 2" WIDE BAND OF CORROSION THAT WRAPS THE REINFORCED CONCRETE DIAPHRAGM, APPROXIMATELY 5/16" SECTION LOSS [AVERAGE 1/8" REMAINS] FOR APPROXIMATELY 10" LONG.

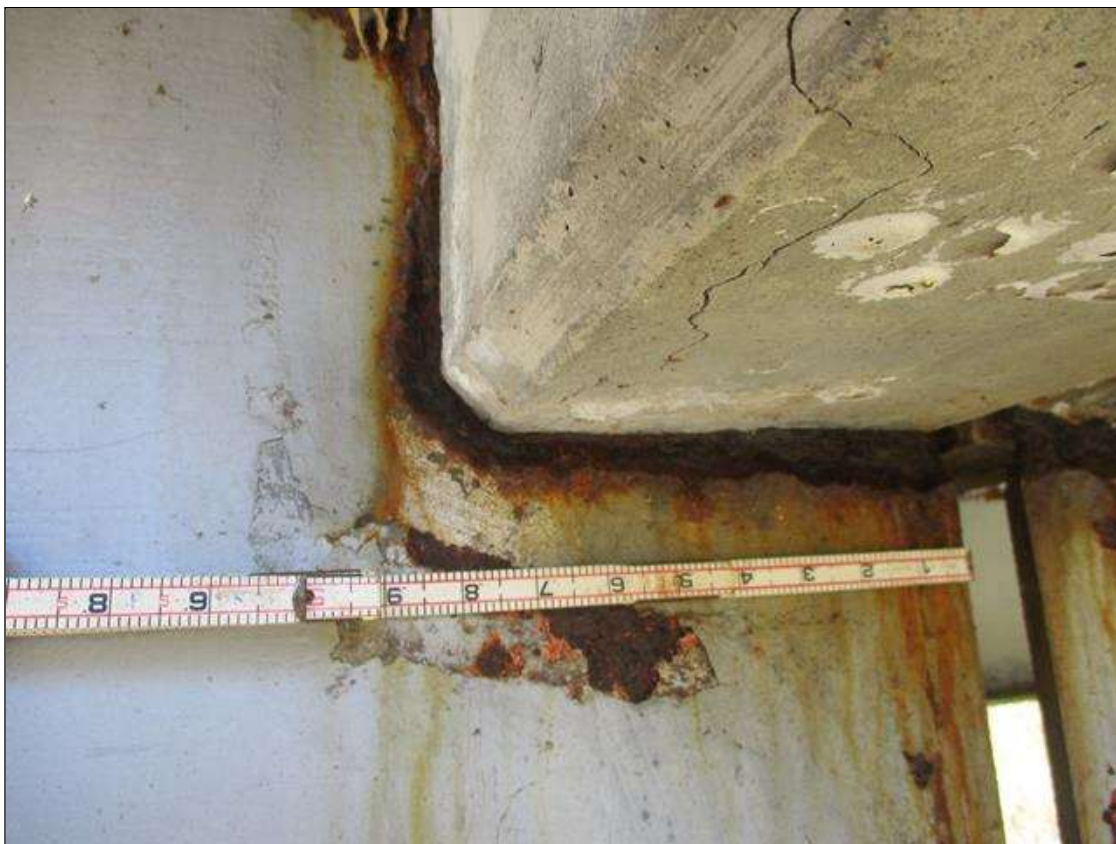
Span 5 Beam 4: [PROMPT ACTION REQUEST] BEAM END AT BENT 5, THERE IS AN APPROXIMATELY 1" WIDE BAND OF CORROSION THAT WRAPS THE REINFORCED CONCRETE DIAPHRAGM, APPROXIMATELY 1/4" SECTION LOSS [AVERAGE 3/16" REMAINS] FOR APPROXIMATELY 10" LONG.

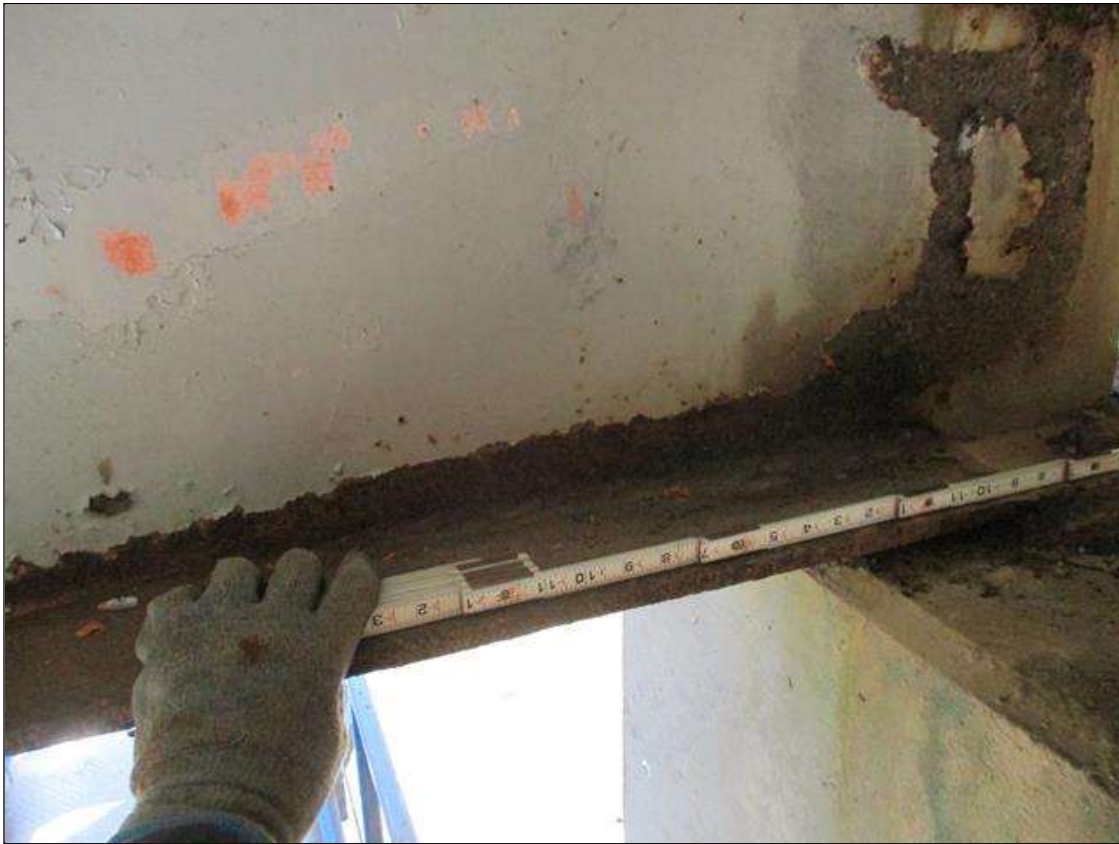
Span 5 Beam 1: [PROMPT ACTION REQUEST] 8" OUT FROM THE BEAM END AT BENT 5, IN THE LOWER 2" OF THE WEB, CORROSION WITH APPROXIMATELY 3/16" SECTION LOSS [AVERAGE 1/4" REMAINS] FOR 18" LONG.

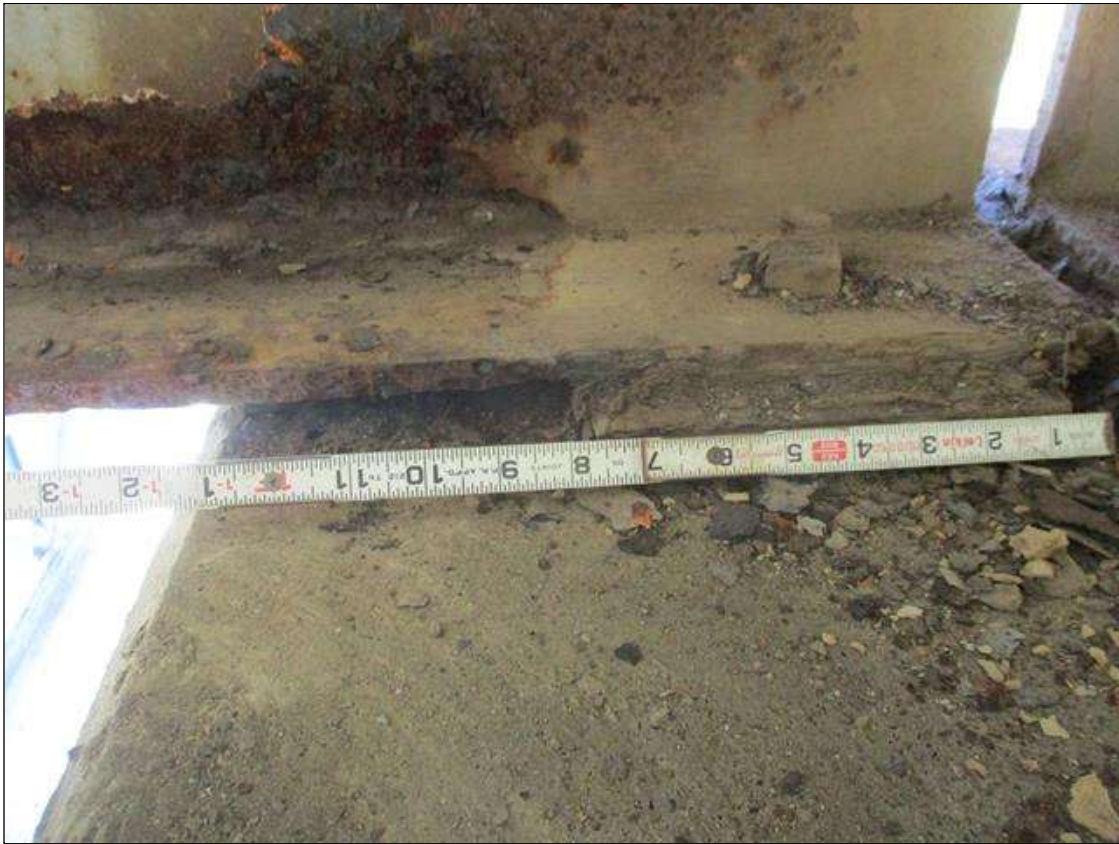
Span 5 Beam 1: [PROMPT ACTION REQUEST] BEAM END AT BENT 5, LOWER FLANGE, CORROSION WITH APPROXIMATELY 3/16" SECTION LOSS [AVERAGE 7/16" REMAINS] FOR APPROXIMATELY 10" LONG
