NC DEPARTMENT OF TRANSPORTATION
 DIVISION OF HIGHWAYS
 STRUCTURE MANAGEMENT UNIT

ATTENTION: **PROMPT ACTION REQUEST; HYDRAPLATFORM USED; NEW REPAIRS; OUT-TO-OUT REVISED;**

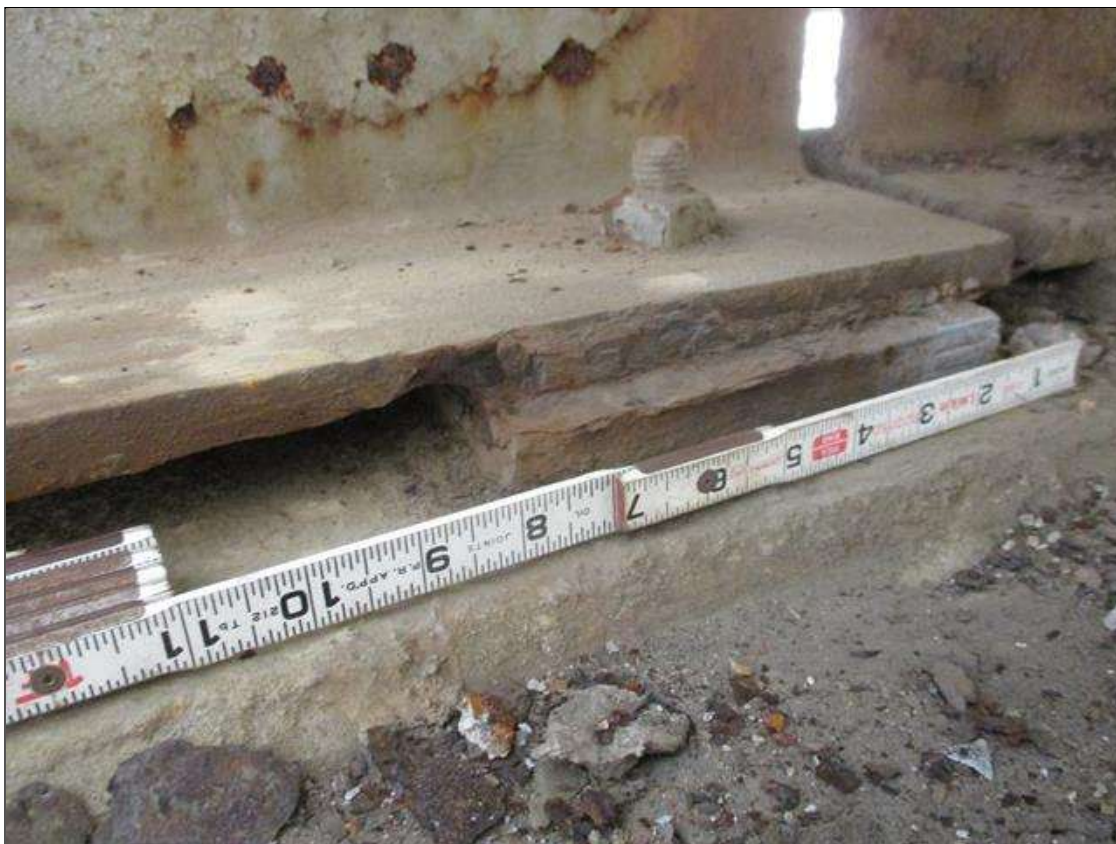
Span 5 Beam 3: [PROMPT ACTION REQUEST] 8" OUT FROM THE BEAM END AT BENT 5, LOWER FLANGE, CORROSION WITH APPROXIMATELY 1/4" SECTION LOSS [AVERAGE 3/8" REMAINS] FOR APPROXIMATELY 4" LONG

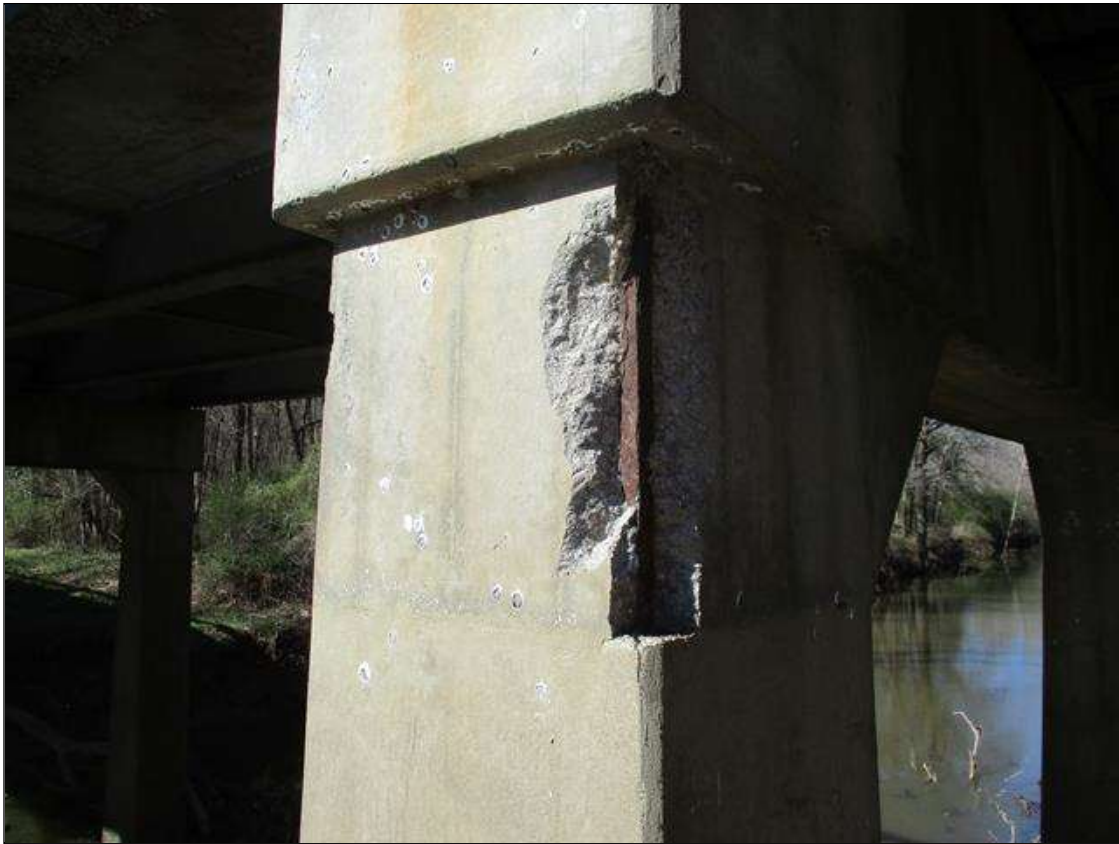
Bent 6 Pile 2: [PROMPT ACTION REQUEST] ON SOUTHEAST AND NORTHEAST CORNERS, SPALLING WITH EXPOSED REBAR [UP TO 2' LONG X 8" WIDE X 2" DEEP], NO MEASURABLE SECTION LOSS

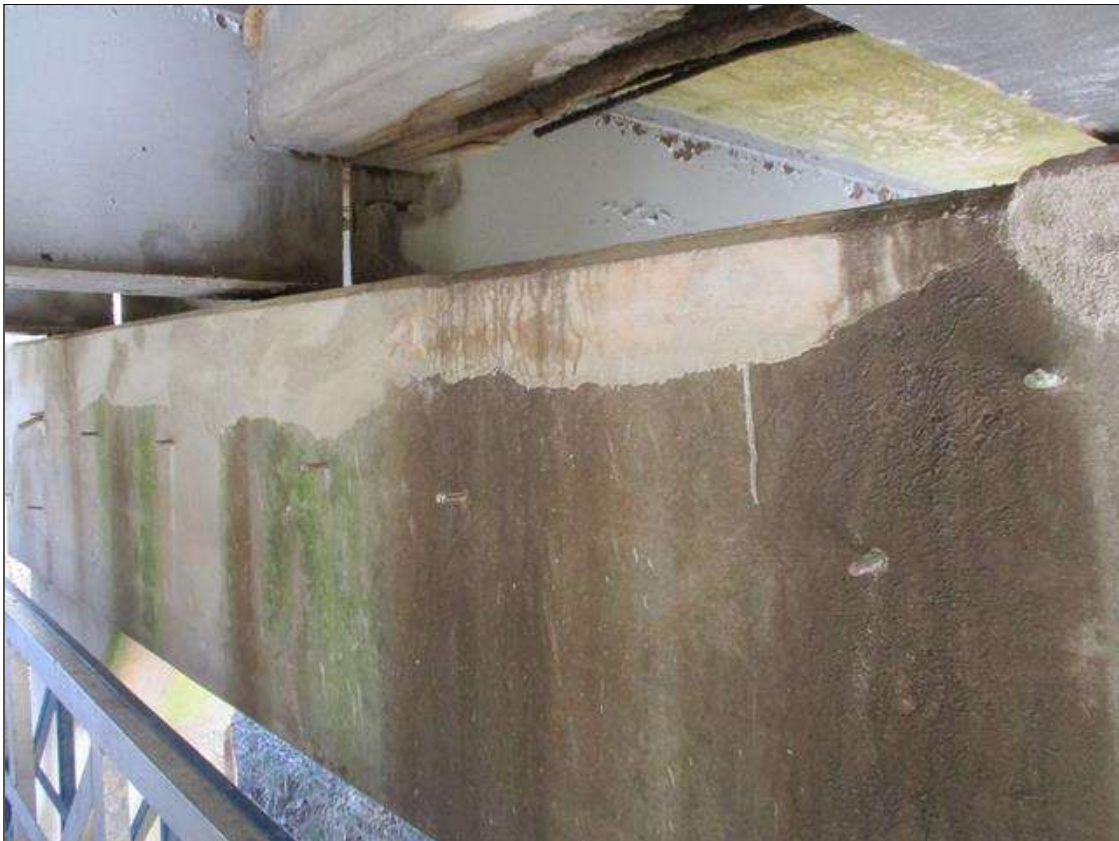
Bent 7 Cap 1: [NEW REPAIR] SOUND PATCHING - SOUTH FACE AT THE TOP OF THE CAP

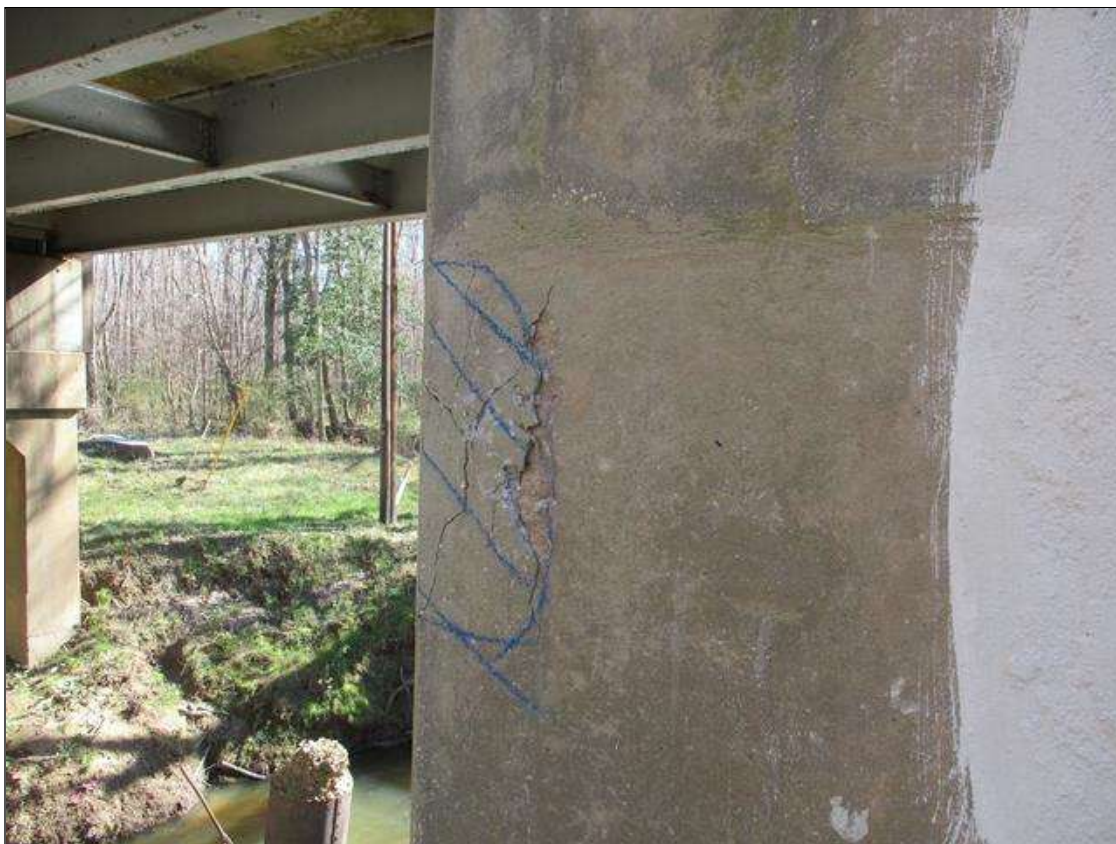
Bent 7 Pile 1: LEFT SIDE, APPROXIMATELY 2' DOWN FROM THE CAP, APPROXIMATELY 1 SQUARE FEET MAP CRACKING TO 1/8" WIDE WITH ASSOCIATED DELAMINATION AND SPALLING TO 3/4" DEEP

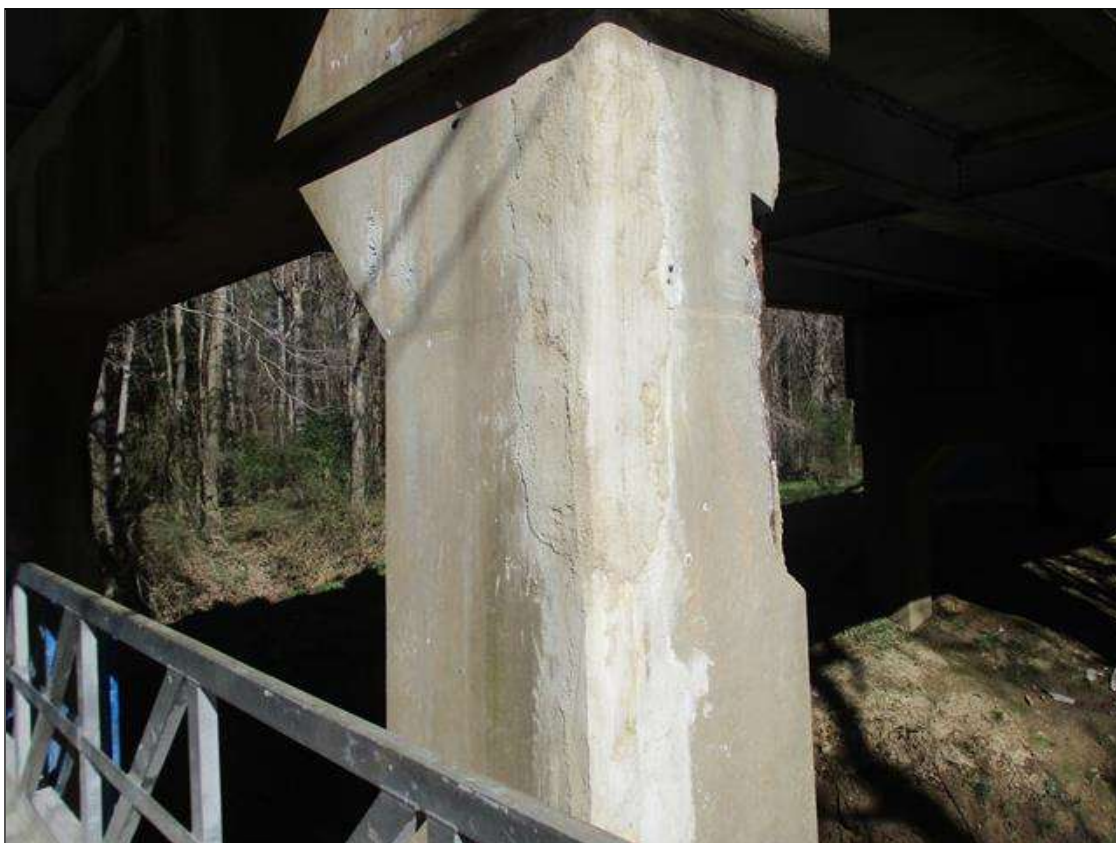
Bent 7 Pile 2: [NEW REPAIR] SOUND PATCHING --> FORMERLY 3.5' X 7" X 8" SPALL WITH EXPOSED REBAR ON SOUTHEAST CORNER

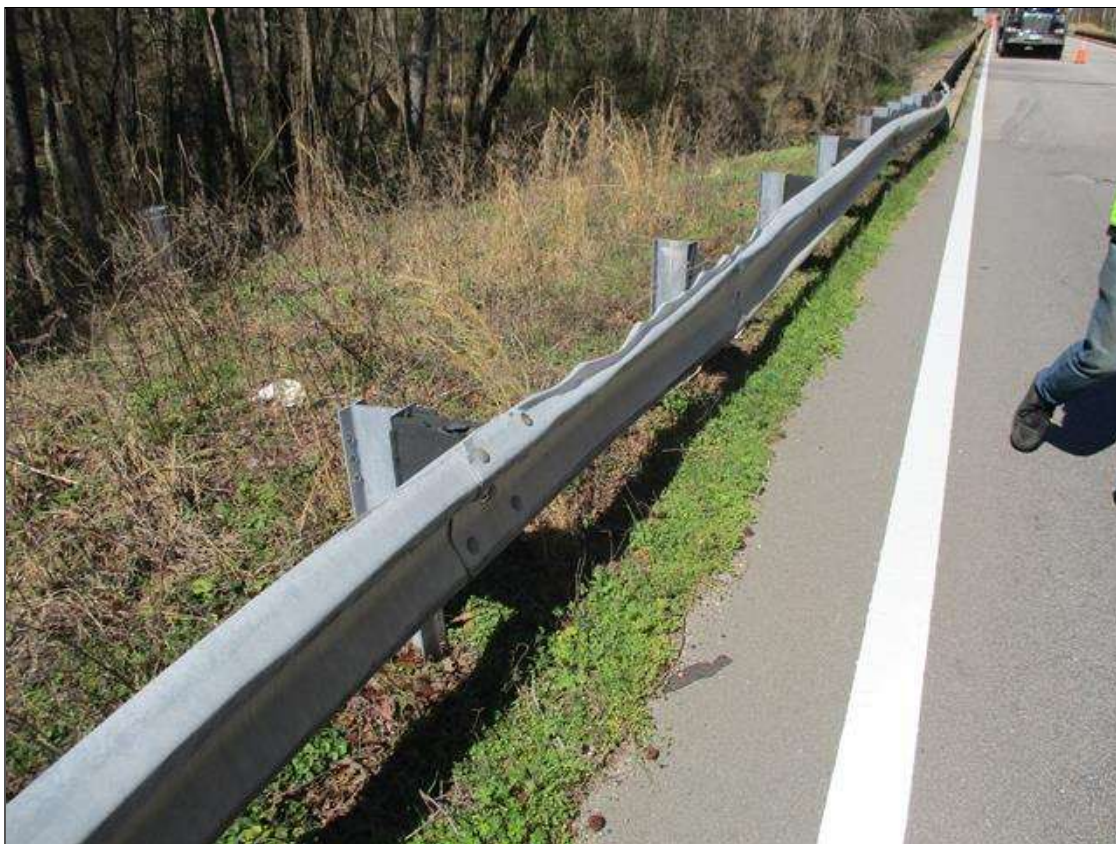
GUIDERAIL AT THE APPROACHES HAS BEEN "RUBBED" IN SCATTERED LOCATIONS, BUT IS GENERALLY SECURE AND FUNCTIONING.

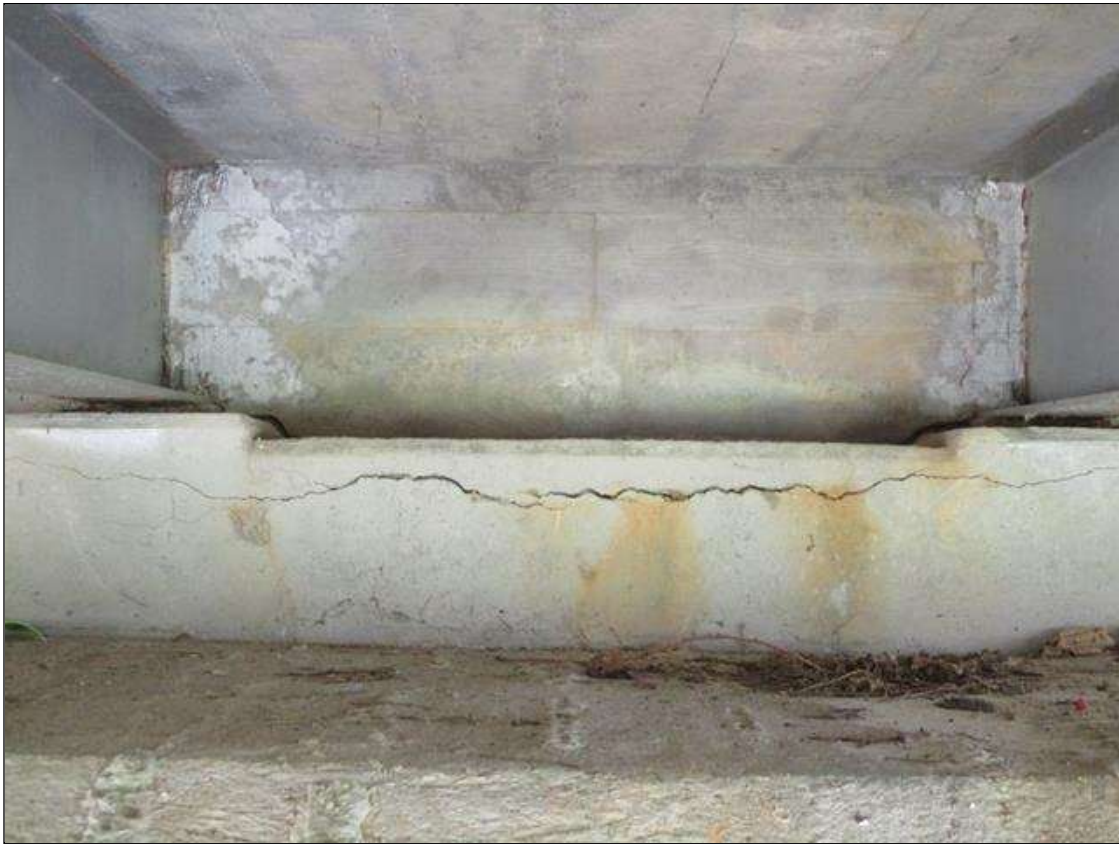
End Bent 1 Cap 1: CAP FACE AT BAY 2, UP TO 1/4" HORIZONTAL CRACKING

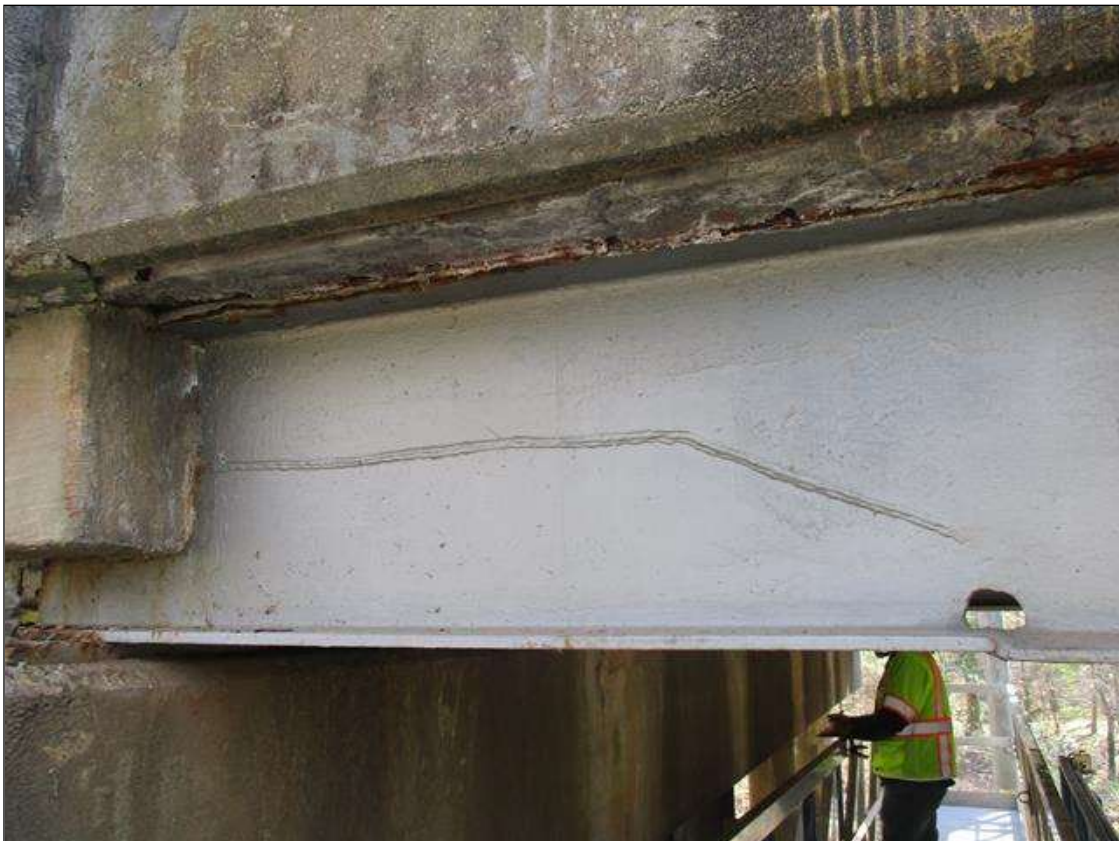
Span 1 Beam 1: [NEW REPAIR] BEAM END AT BENT 2 HAS BEEN SECTIONED, APPROXIMATELY 4' LONG X 7.5" WIDE X UP TO 8" HIGH

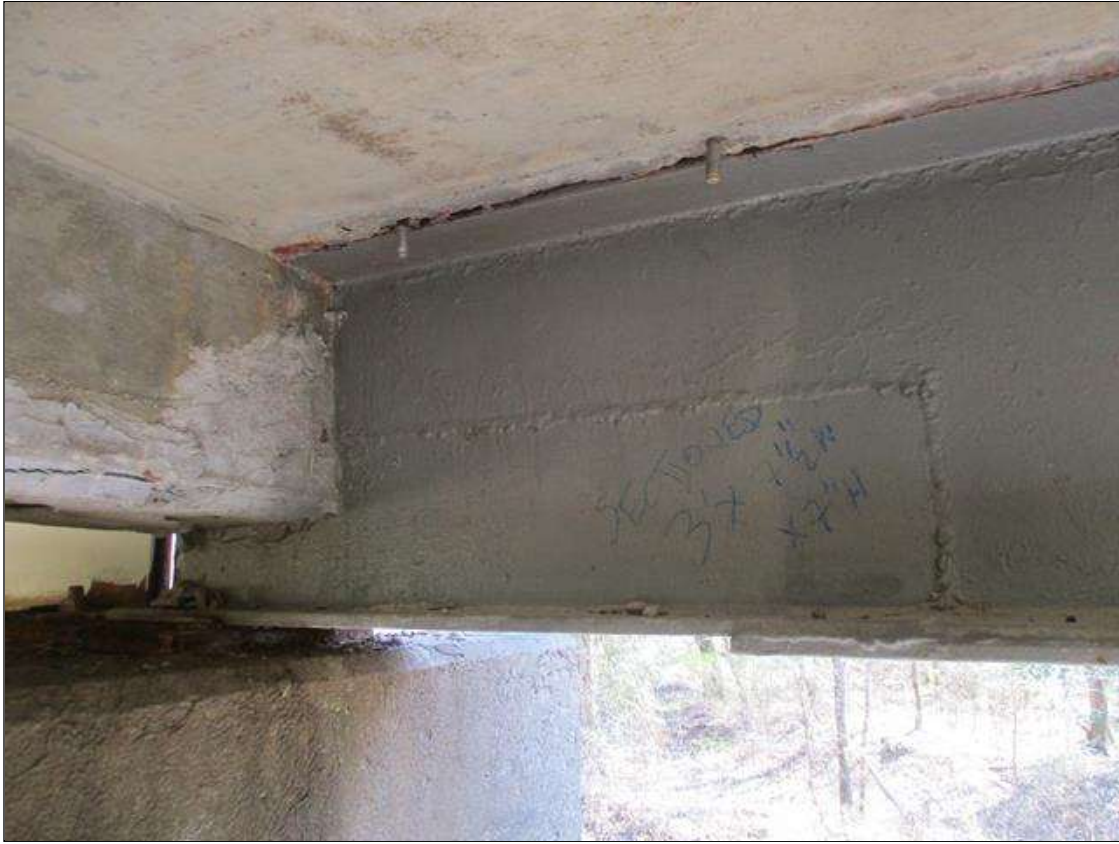
Span 1 Beam 6: [NEW REPAIR] BEAM END AT BENT 2 HAS BEEN SECTIONED, APPROXIMATELY 3' LONG X 7.5" WIDE X UP TO 7" HIGH

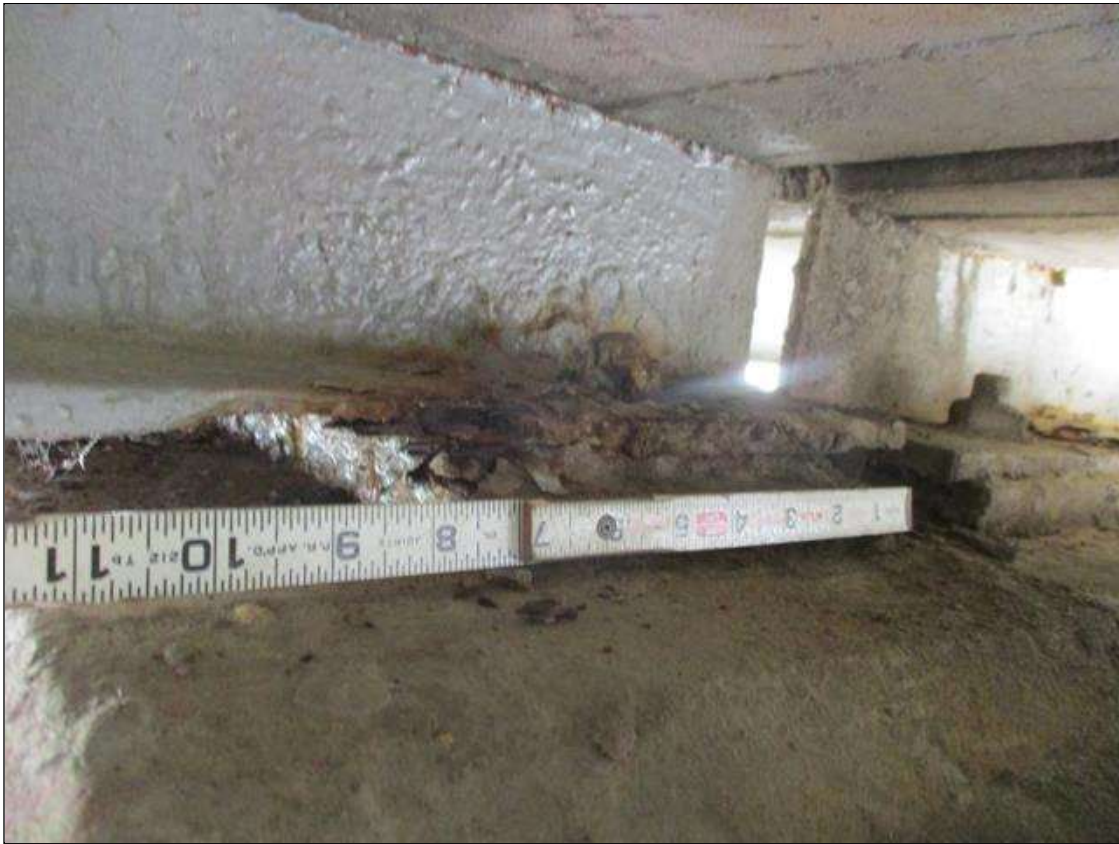
Span 1 Beam 2: [PROMPT ACTION REQUEST] APPROXIMATELY 6" OUT FROM THE BEAM END AT BENT 2, LOWER FLANGE, CORROSION WITH APPROXIMATELY 3/16" SECTION LOSS [AVERAGE 3/16" REMAINS] FOR APPROXIMATELY 3" LONG

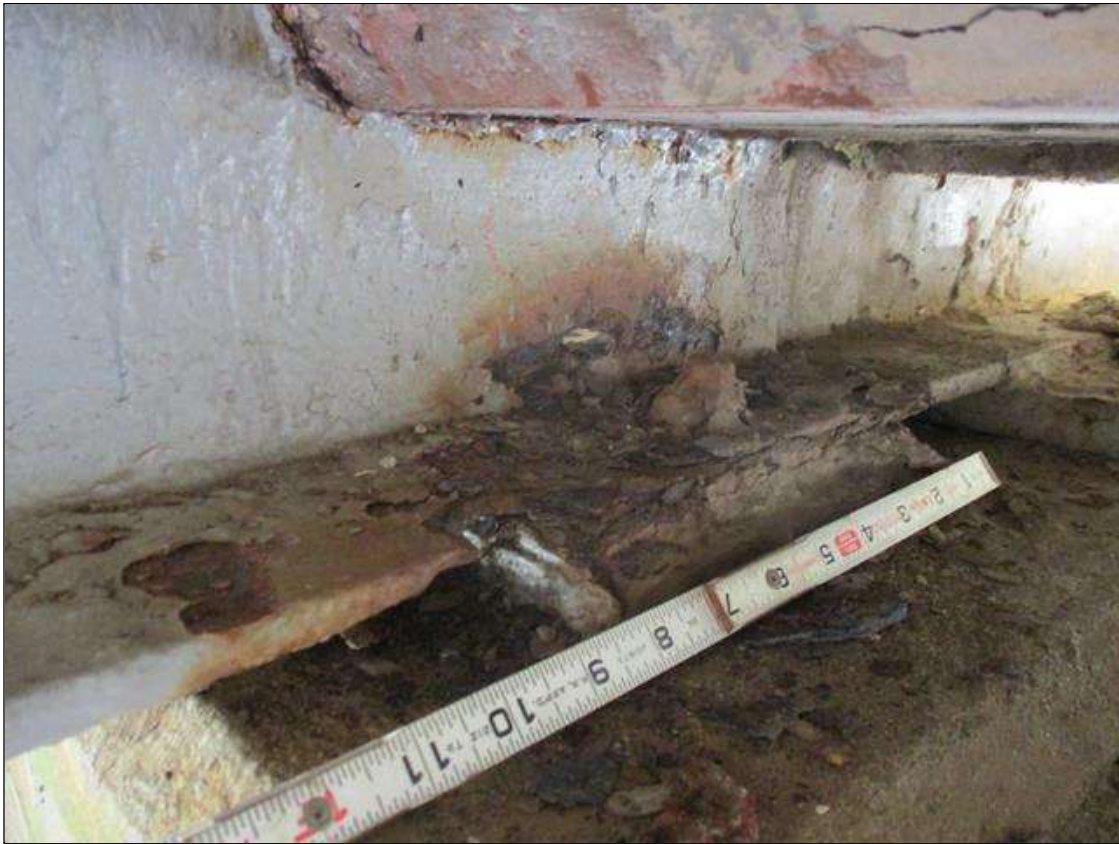
Span 1 Beam 3: [PROMPT ACTION REQUEST] BEAM END AT BENT 2, LOWER LEFT FLANGE, CORROSION WITH APPROXIMATELY 1/4" SECTION LOSS [AVERAGE 1/8" REMAINS] FOR APPROXIMATELY 11" LONG, AND LOWER RIGHT FLANGE, CORROSION WITH 100% SECTION LOSS FOR APPROXIMATELY 11" LONG

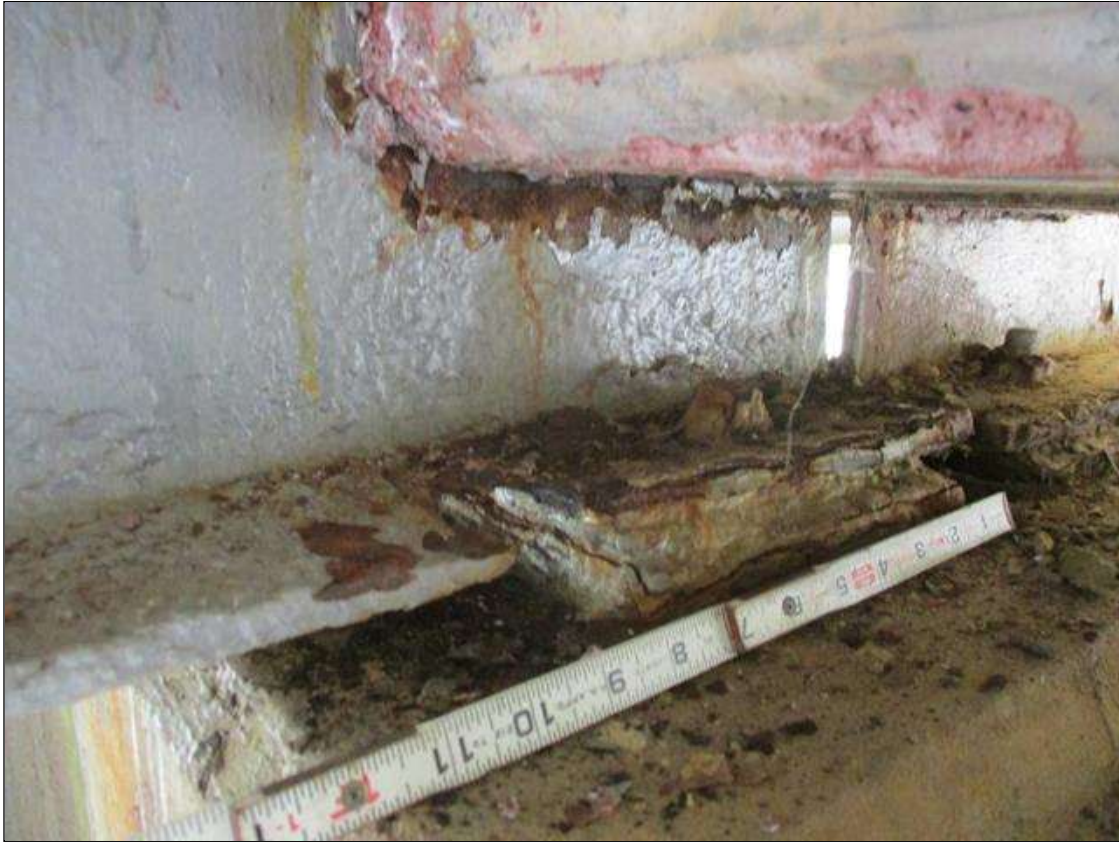
Span 1 Beam 4: [PROMPT ACTION REQUEST] BEAM END AT BENT 2, LOWER LEFT FLANGE, CORROSION WITH APPROXIMATELY 1/4" SECTION LOSS [AVERAGE 1/8" REMAINS] FOR APPROXIMATELY 11" LONG, AND LOWER RIGHT FLANGE, CORROSION WITH 100% SECTION LOSS FOR APPROXIMATELY 11" LONG

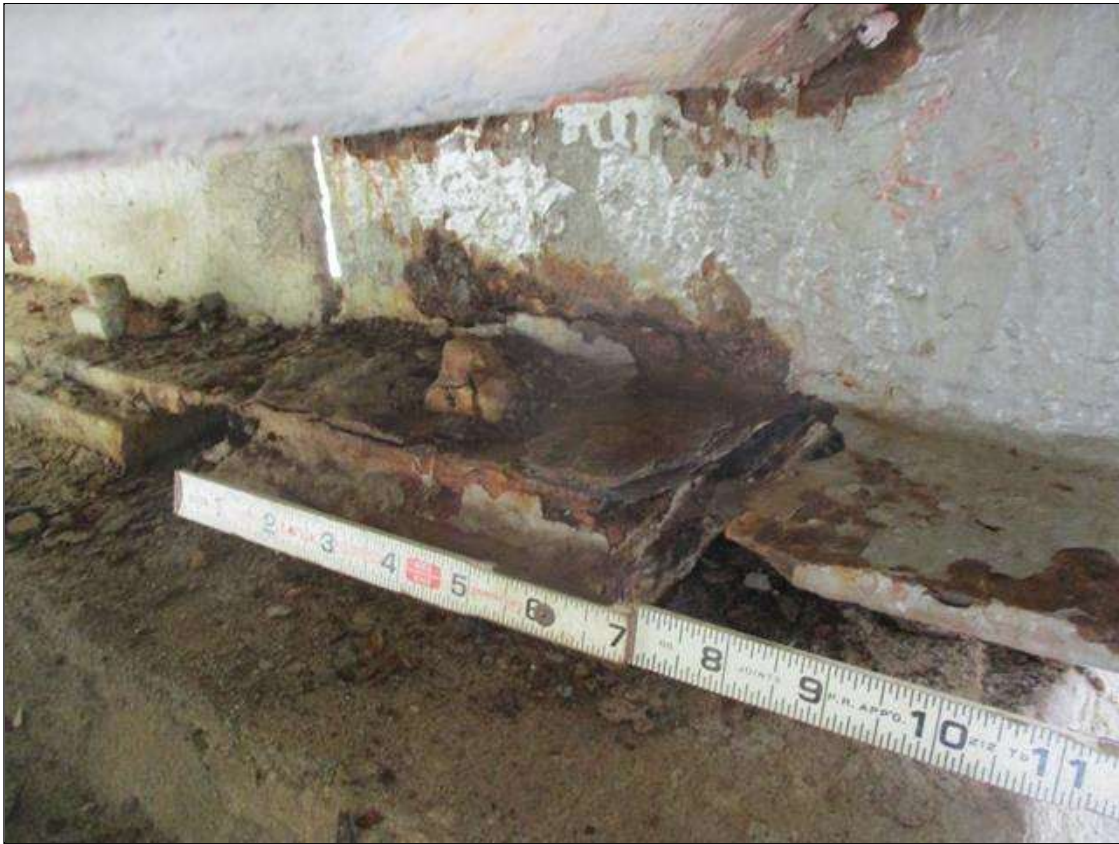
Span 1 Beam 5: [PROMPT ACTION REQUEST] BEAM END AT BENT 2, LOWER FLANGE, CORROSION WITH 100% SECTION LOSS FOR APPROXIMATELY 8" LONG

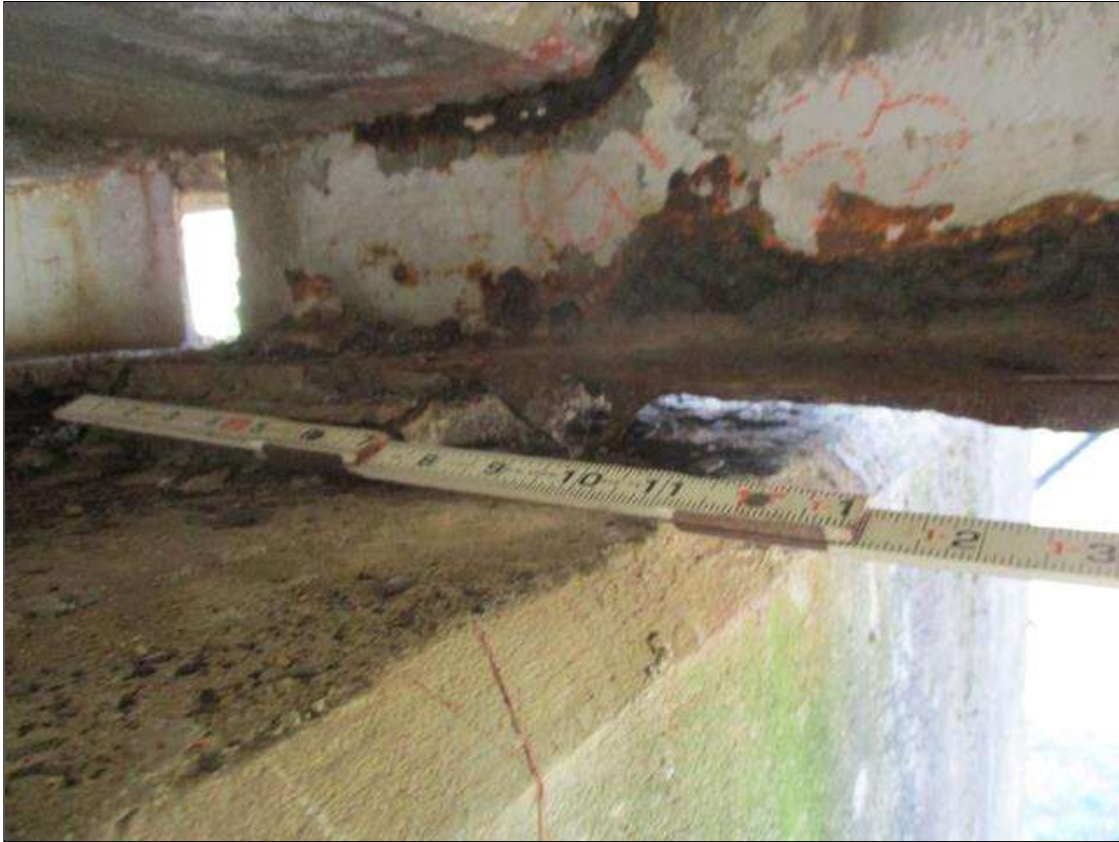
Span 3 Beam 1: [PROMPT ACTION REQUEST] APPROXIMATELY 6" OUT FROM THE BEAM END AT BENT 2, LOWER FLANGE, CORROSION WITH 100% SECTION LOSS FOR APPROXIMATELY 5" LONG, THEN TAPERING TO FULL SECTION OVER THE NEXT 5" [AVERAGE 3/16" REMAINS]

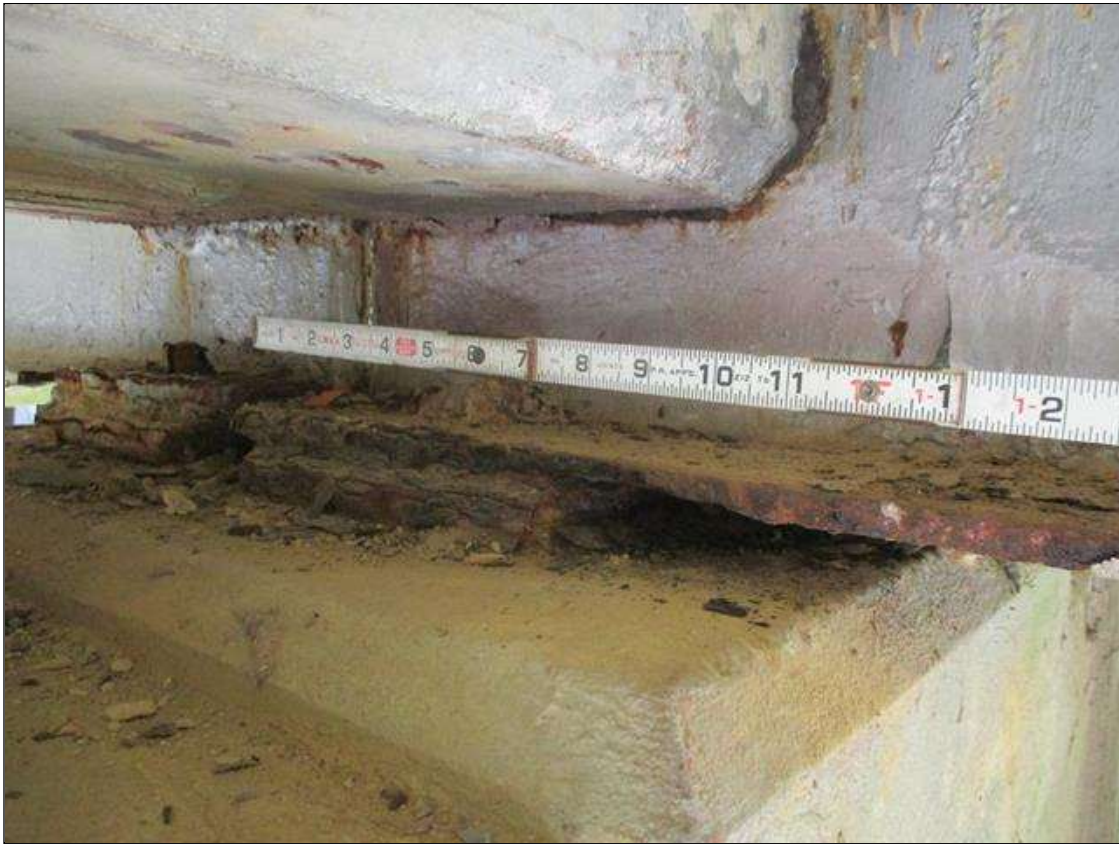
Span 3 Beam 4: [PROMPT ACTION REQUEST] APPROXIMATELY 6" OUT FROM THE BEAM END AT BENT 2, LOWER RIGHT FLANGE, CORROSION WITH APPROXIMATELY 1/8" SECTION LOSS [AVERAGE 1/4" REMAINS] FOR APPROXIMATELY 4" LONG

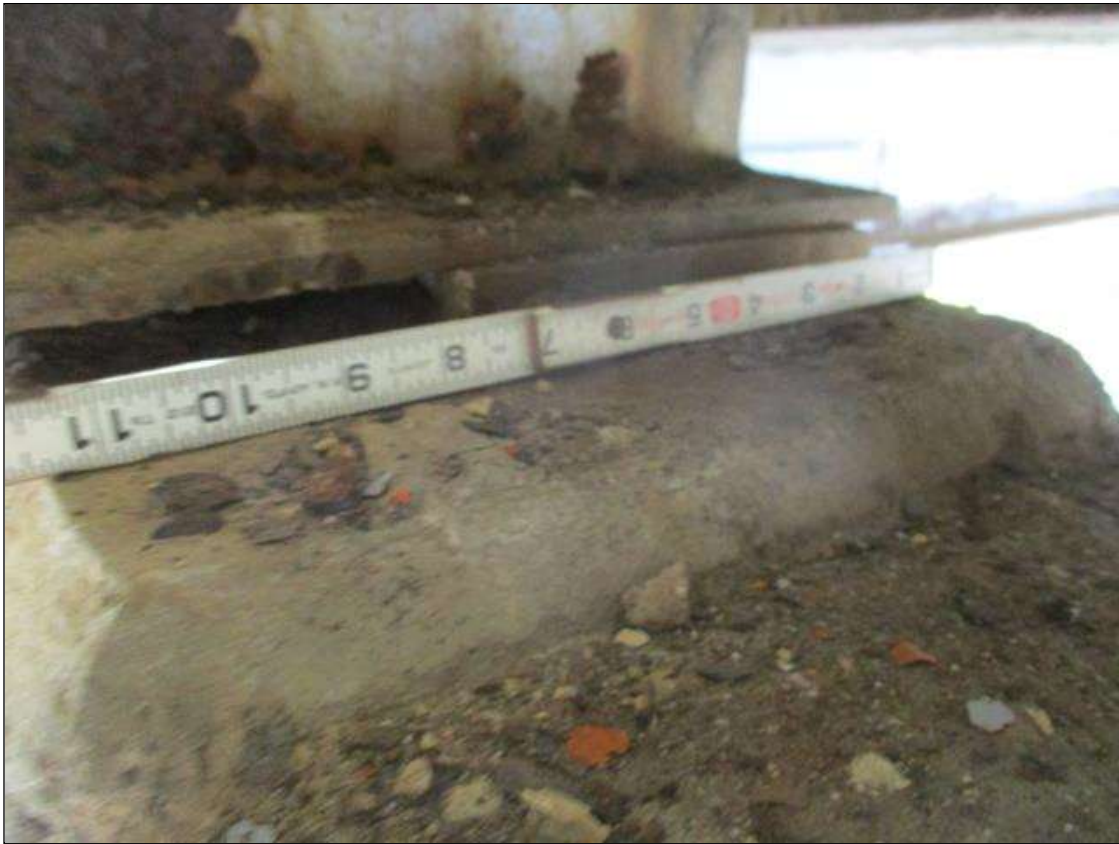
Span 3 Beam 2: [PROMPT ACTION REQUEST] APPROXIMATELY 8" OUT FROM THE BEAM END AT BENT 4, LOWER FLANGE, CORROSION WITH APPROXIMATELY 1/8" SECTION LOSS [AVERAGE 1/4" REMAINS] FOR APPROXIMATELY 4" LONG

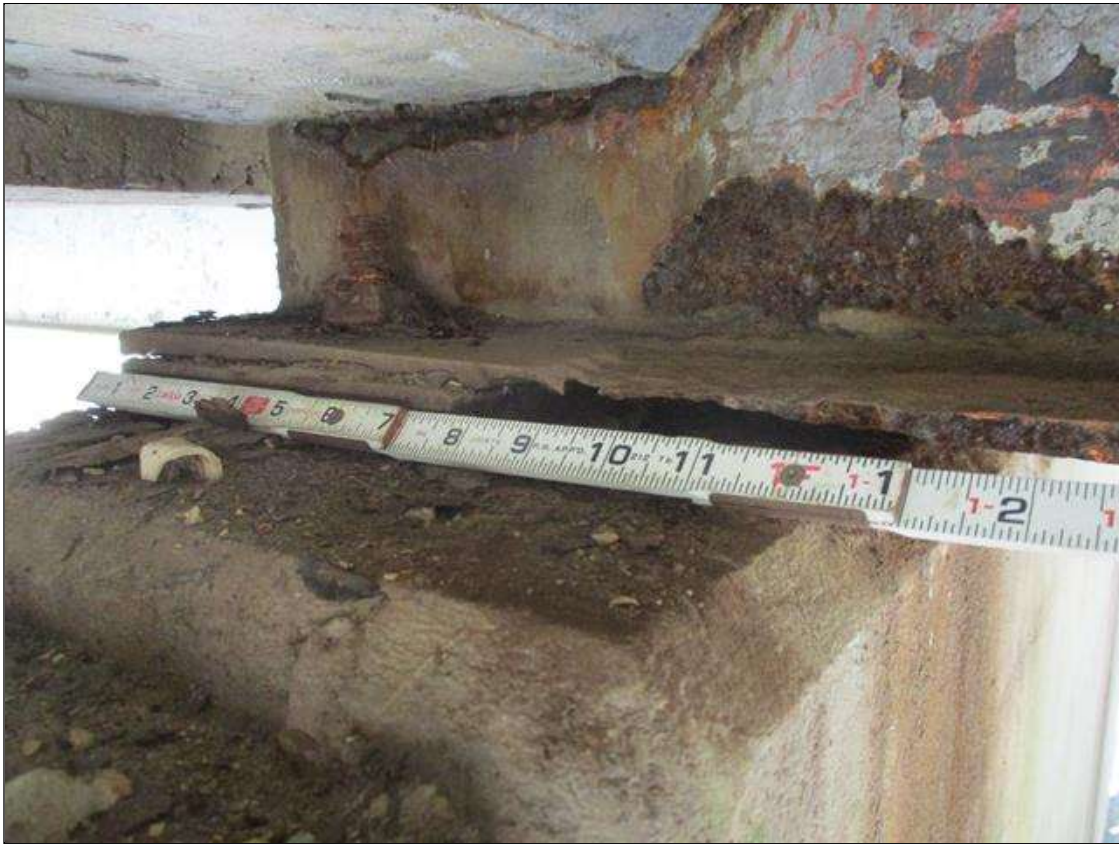
Span 3 Beam 3: [PROMPT ACTION REQUEST] BEAM END AT BENT 4, LOWER FLANGE, CORROSION WITH APPROXIMATELY 1/4" SECTION LOSS [AVERAGE 1/8" REMAINS] FOR APPROXIMATELY 12" LONG

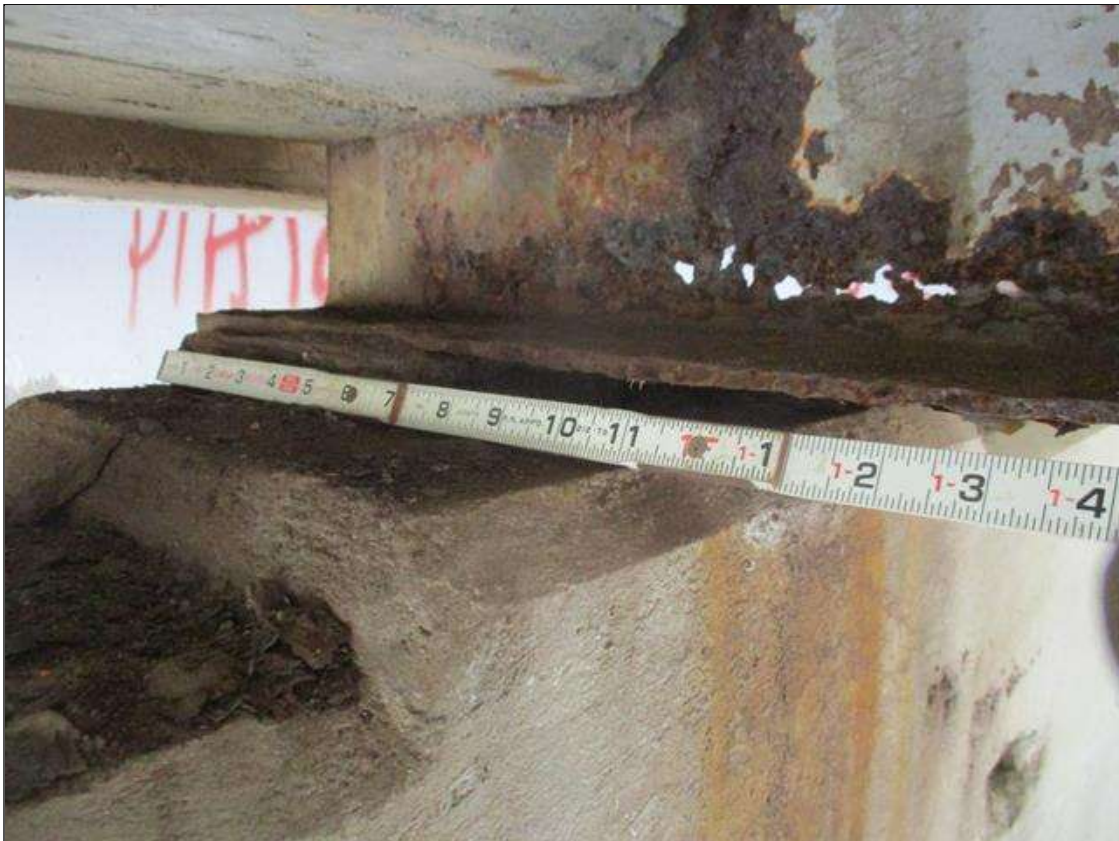
Span 3 Beam 4: [PROMPT ACTION REQUEST] BEAM END AT BENT 4, LOWER FLANGE, CORROSION WITH APPROXIMATELY 3/16" SECTION LOSS [AVERAGE 3/16" REMAINS] FOR APPROXIMATELY 20" LONG

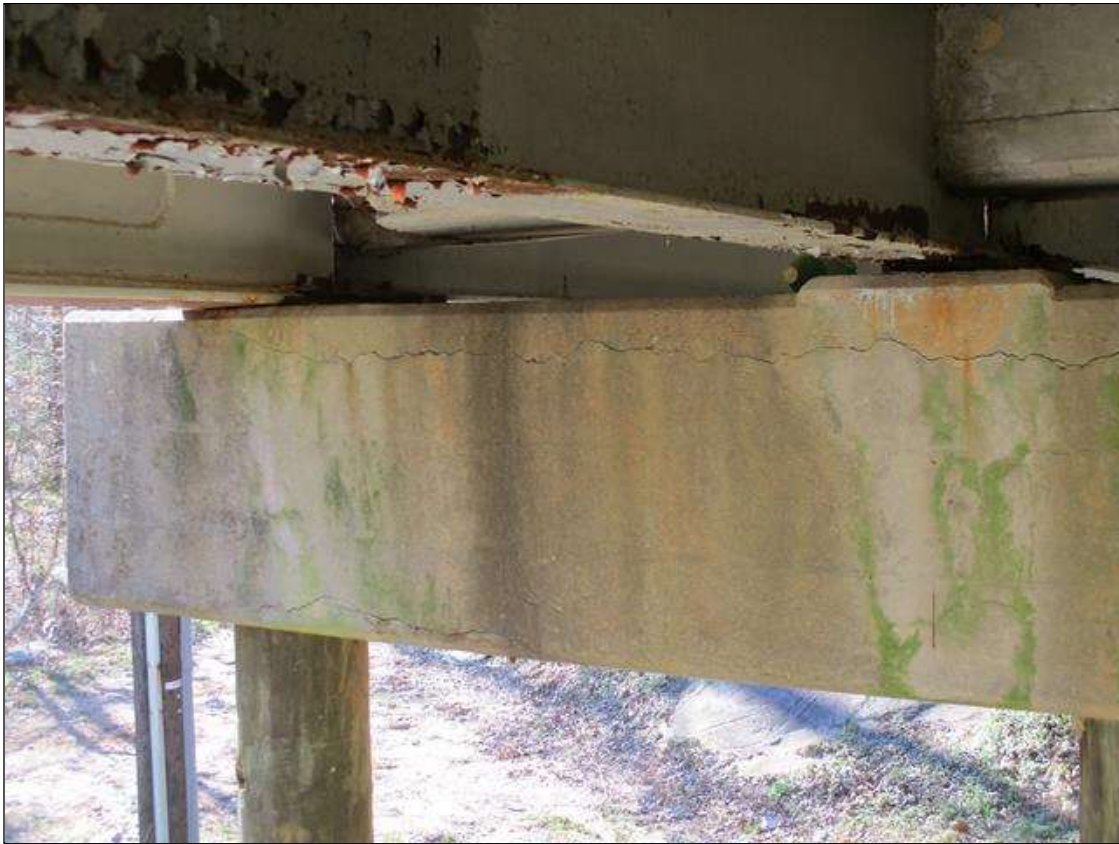
Bent 2 Cap 1: NORTH FACE, APPROXIMATELY 4" DOWN FROM THE TOP BETWEEN BEAMS 2-6, HORIZONTAL CRACKING TO 3/16" WIDE WITH ASSOCIATED DELAMINATION ABOVE, AND LOWER 6" OF THE NORTH FACE, SCATTERED HORIZONTAL CRACKING TO 1/16" WIDE

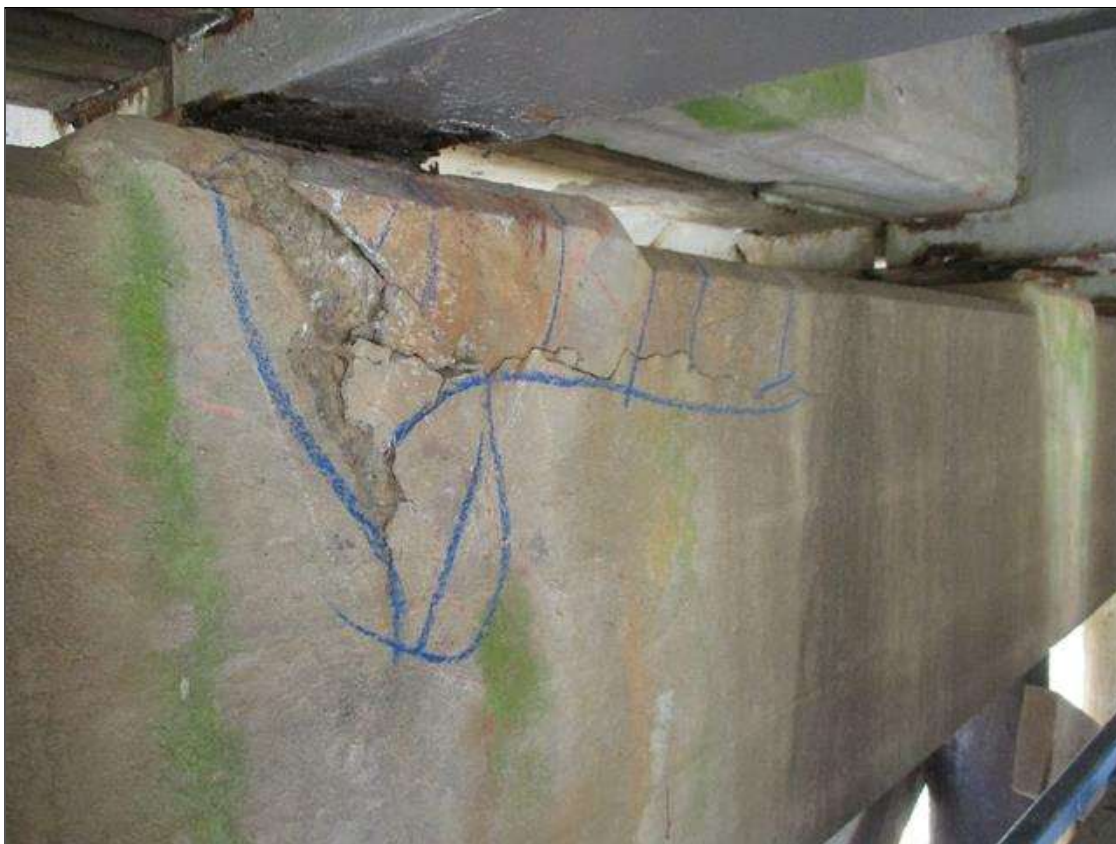
Bent 2 Cap 1: SOUTH FACE AT BEAM 2, TOP 10" OF THE CAP, APPROXIMATELY 2 SQUARE FEET OF MAP CRACKING TO 1/8" WIDE WITH ASSOCIATED DELAMINATION AND SPALLING TO 3/4" DEEP

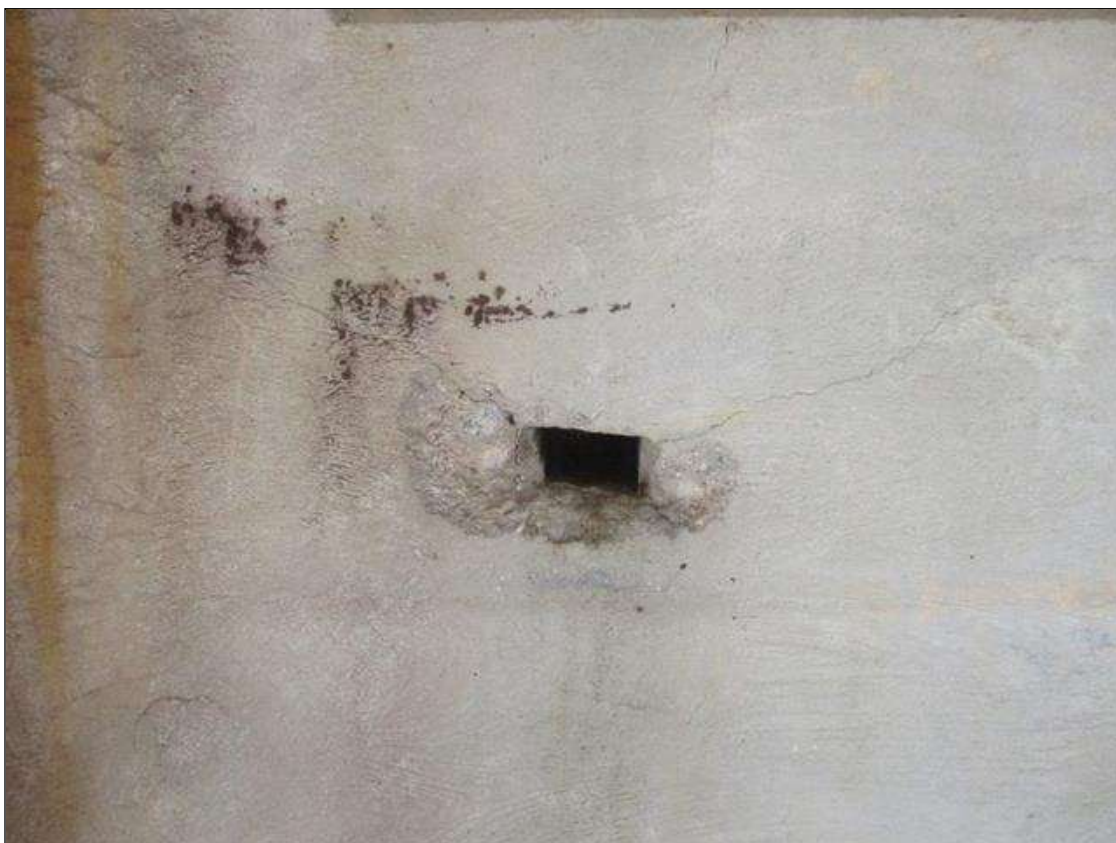
Bent 4 Cap 1: 6" X 4" X 1" DEEP SPALL ON SOUTH FACE UNDER BAY 4

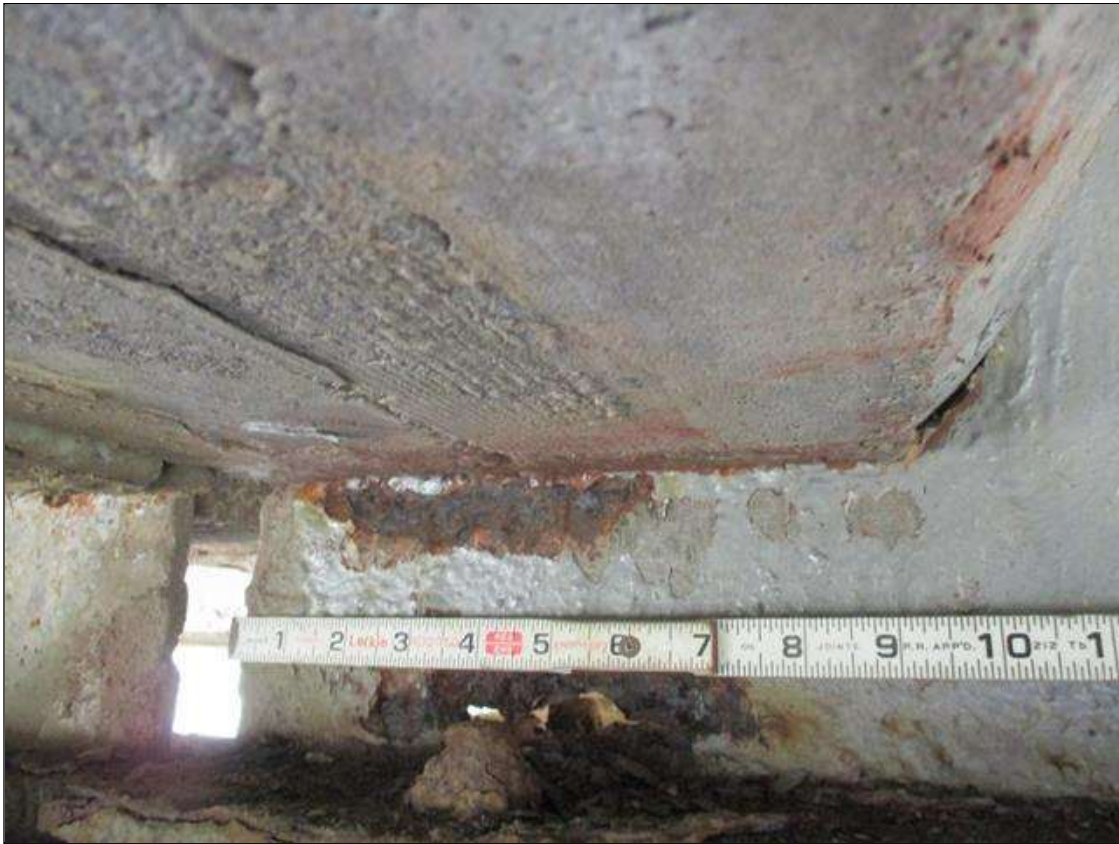
Span 1 Beam 3: [PROMPT ACTION REQUEST] BEAM END AT BENT 2, THERE IS AN APPROXIMATELY 1" WIDE BAND OF CORROSION THAT WRAPS THE REINFORCED CONCRETE DIAPHRAGM, APPROXIMATELY 3/16" SECTION LOSS [AVERAGE 1/8" REMAINS] FOR APPROXIMATELY 5" LONG.

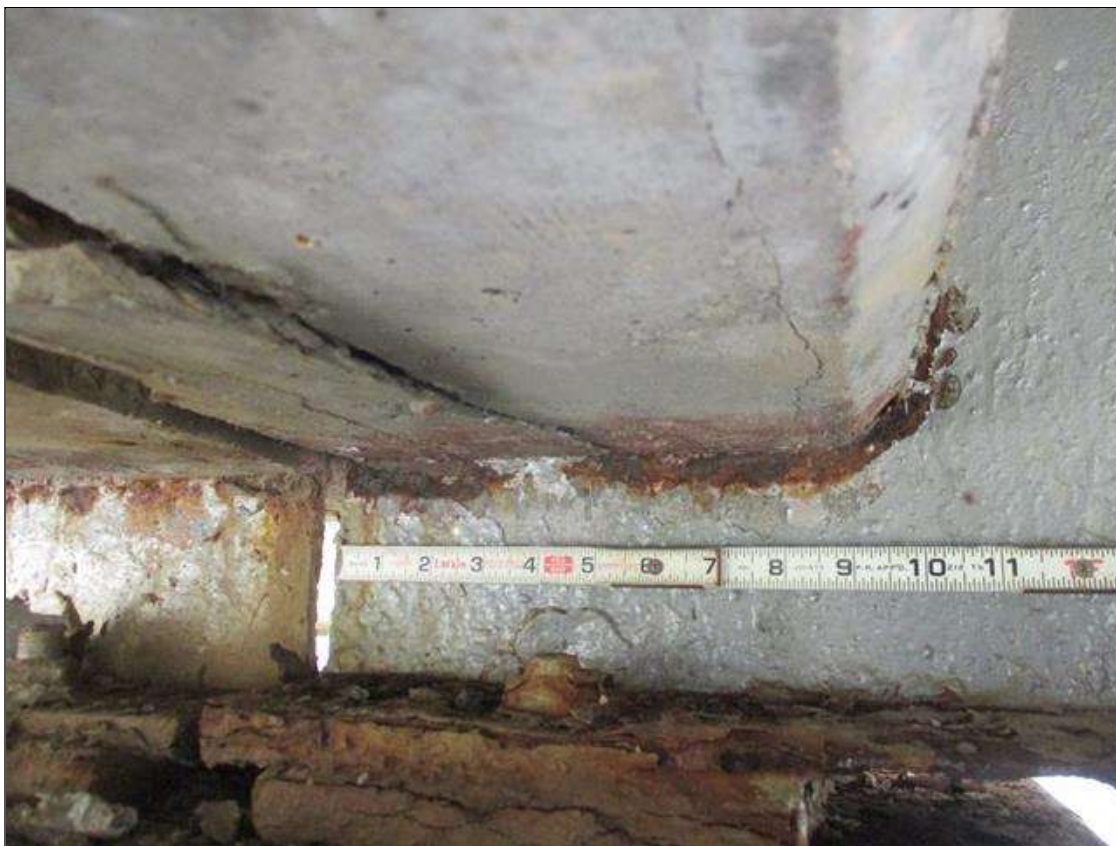
Span 1 Beam 4: [PROMPT ACTION REQUEST] BEAM END AT BENT 2, THERE IS AN APPROXIMATELY 1" WIDE BAND OF CORROSION THAT WRAPS THE REINFORCED CONCRETE DIAPHRAGM, 100% SECTION LOSS FOR APPROXIMATELY 2" LONG, THEN APPROXIMATELY 1/8" SECTION LOSS [AVERAGE 3/16" REMAINS] FOR APPROXIMATELY 8" LONG.
