NC DEPARTMENT OF TRANSPORTATION
 DIVISION OF HIGHWAYS
 STRUCTURE MANAGEMENT UNIT

ATTENTION: **PROMPT ACTION REQUEST; HYDRAPLATFORM USED; NEW REPAIRS; OUT-TO-OUT REVISED;**

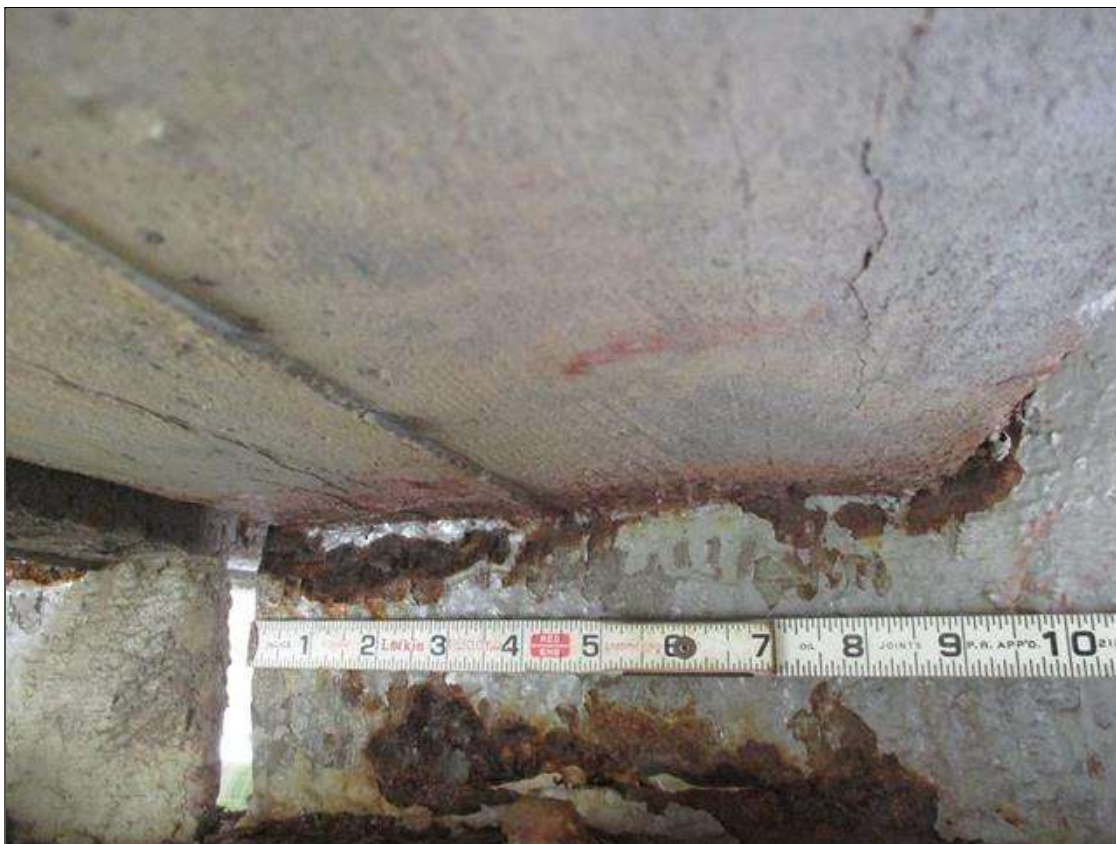
Span 1 Beam 5: [PROMPT ACTION REQUEST] BEAM END AT BENT 2, THERE IS AN APPROXIMATELY 1" WIDE BAND OF CORROSION THAT WRAPS THE REINFORCED CONCRETE DIAPHRAGM, APPROXIMATELY 3/16" SECTION LOSS [AVERAGE 1/8" REMAINS] FOR APPROXIMATELY 3" LONG.

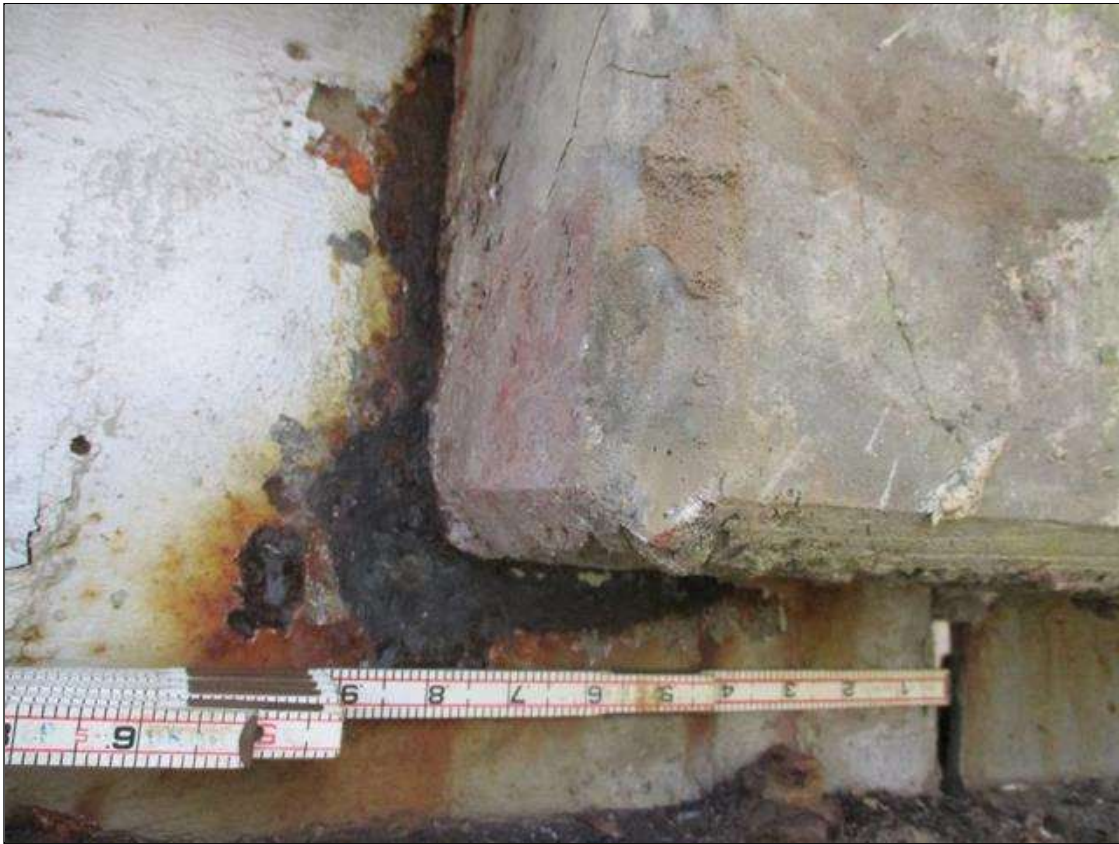
Span 3 Beam 1: [PROMPT ACTION REQUEST] APPROXIMATELY 5" OUT FROM THE BEAM END AT BENT 2, THERE IS AN APPROXIMATELY 1" WIDE BAND OF CORROSION THAT WRAPS THE REINFORCED CONCRETE DIAPHRAGM, 100% SECTION LOSS FOR APPROXIMATELY 5" LONG.

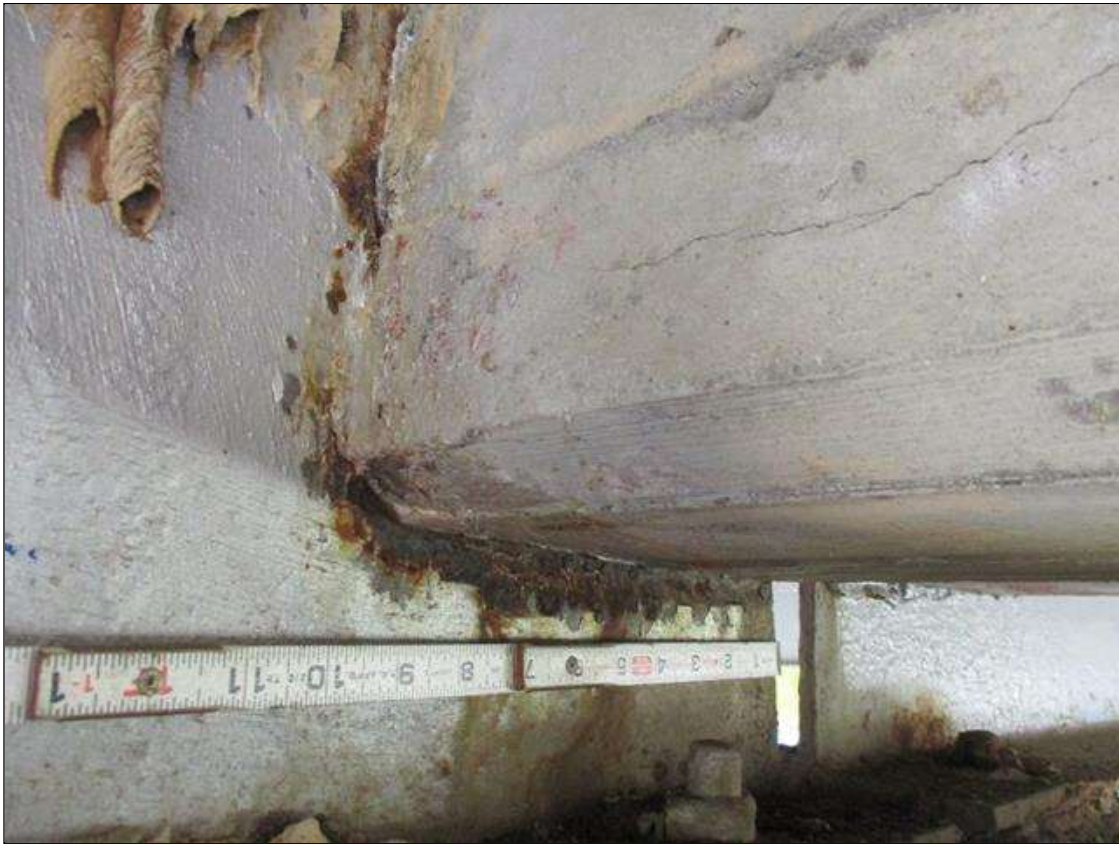
Span 3 Beam 2: [PROMPT ACTION REQUEST] BEAM END AT BENT 2, THERE IS AN APPROXIMATELY 1" WIDE BAND OF CORROSION THAT WRAPS THE REINFORCED CONCRETE DIAPHRAGM, APPROXIMATELY 1/4" SECTION LOSS [AVERAGE 1/16" REMAINS] FOR APPROXIMATELY 10" LONG.

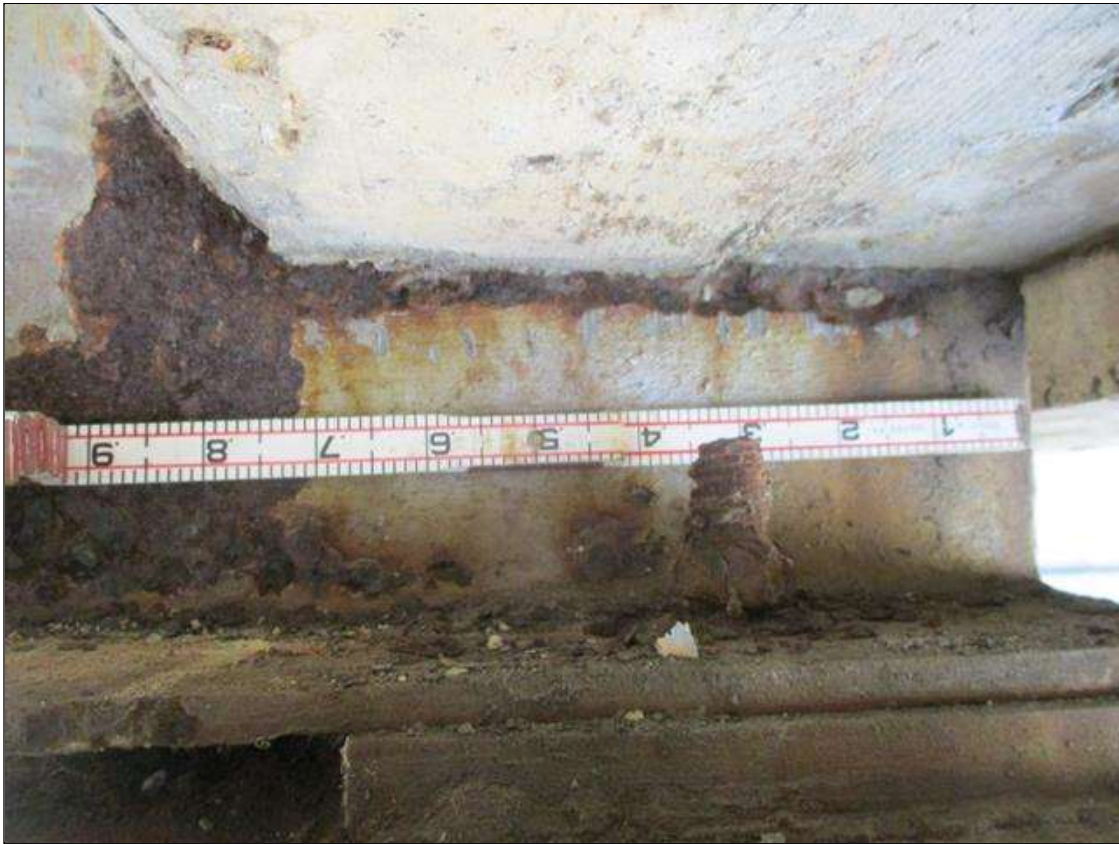
Span 3 Beam 2: [PROMPT ACTION REQUEST] APPROXIMATELY 1" OUT FROM THE BEAM END AT BENT 4, THERE IS AN APPROXIMATELY 1" WIDE BAND OF CORROSION THAT WRAPS THE REINFORCED CONCRETE DIAPHRAGM, 100% SECTION LOSS FOR APPROXIMATELY 1" LONG, THEN APPROXIMATELY 1/8" SECTION LOSS [AVERAGE 3/16" REMAINS] FOR APPROXIMATELY 8" LONG.

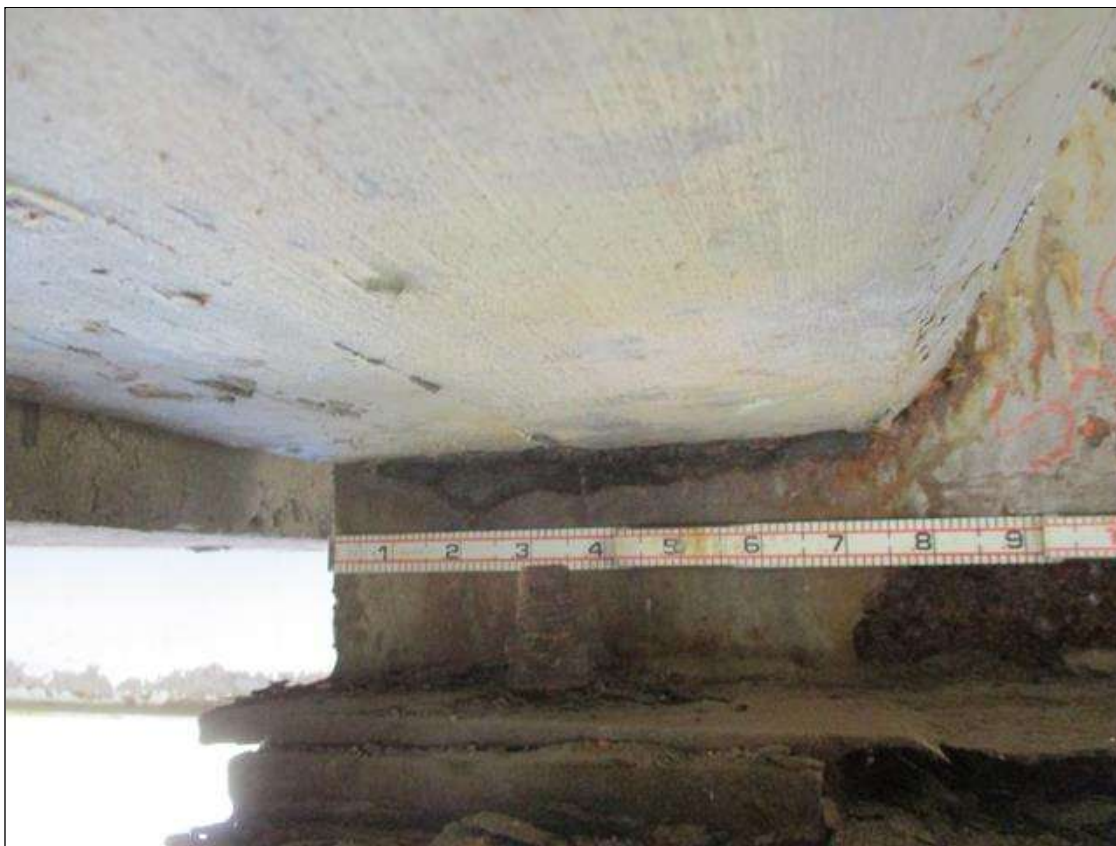
Span 3 Beam 3: [PROMPT ACTION REQUEST] APPROXIMATELY 1" OUT FROM THE BEAM END AT BENT 4, THERE IS AN APPROXIMATELY 1" WIDE BAND OF CORROSION THAT WRAPS THE REINFORCED CONCRETE DIAPHRAGM, APPROXIMATELY 3/16" SECTION LOSS [AVERAGE 1/8" REMAINS] FOR APPROXIMATELY 9" LONG.

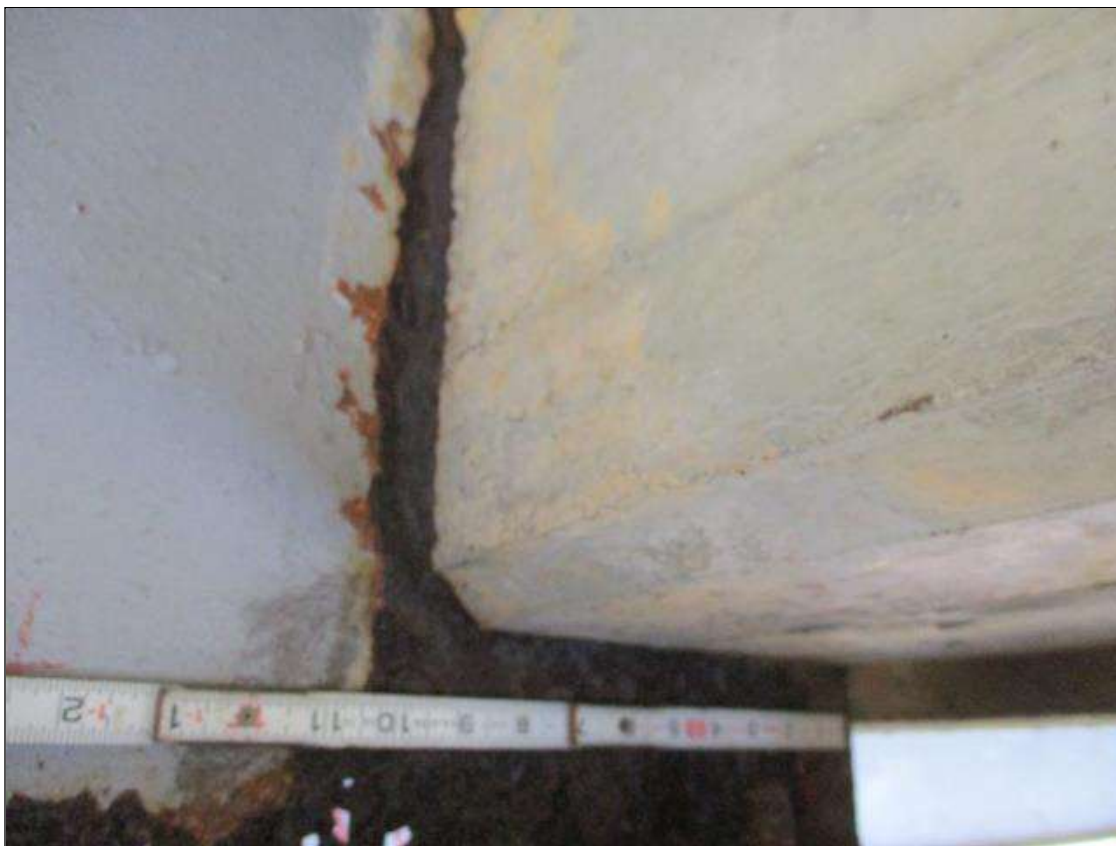
Span 3 Beam 4: [PROMPT ACTION REQUEST] APPROXIMATELY 5" OUT FROM THE BEAM END AT BENT 4, THERE IS AN APPROXIMATELY 1" WIDE BAND OF CORROSION THAT WRAPS THE REINFORCED CONCRETE DIAPHRAGM, APPROXIMATELY 3/16" SECTION LOSS [AVERAGE 1/8" REMAINS] FOR APPROXIMATELY 5" LONG.

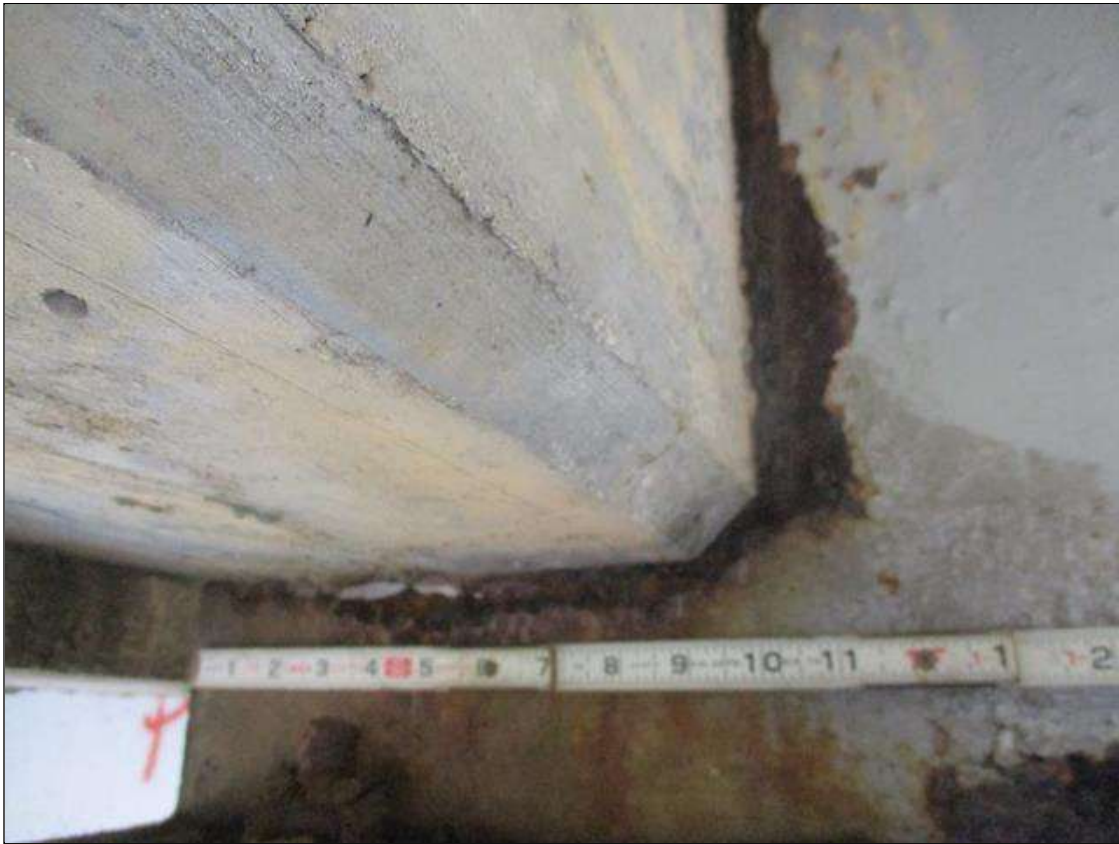
Span 3 Beam 5: [PROMPT ACTION REQUEST] APPROXIMATELY 1" OUT FROM THE BEAM END AT BENT 4, THERE IS AN APPROXIMATELY 1" WIDE BAND OF CORROSION THAT WRAPS THE REINFORCED CONCRETE DIAPHRAGM, 100% SECTION LOSS FOR APPROXIMATELY 4" LONG, THEN APPROXIMATELY 3/16" SECTION LOSS [AVERAGE 1/8" REMAINS] FOR APPROXIMATELY 5" LONG.

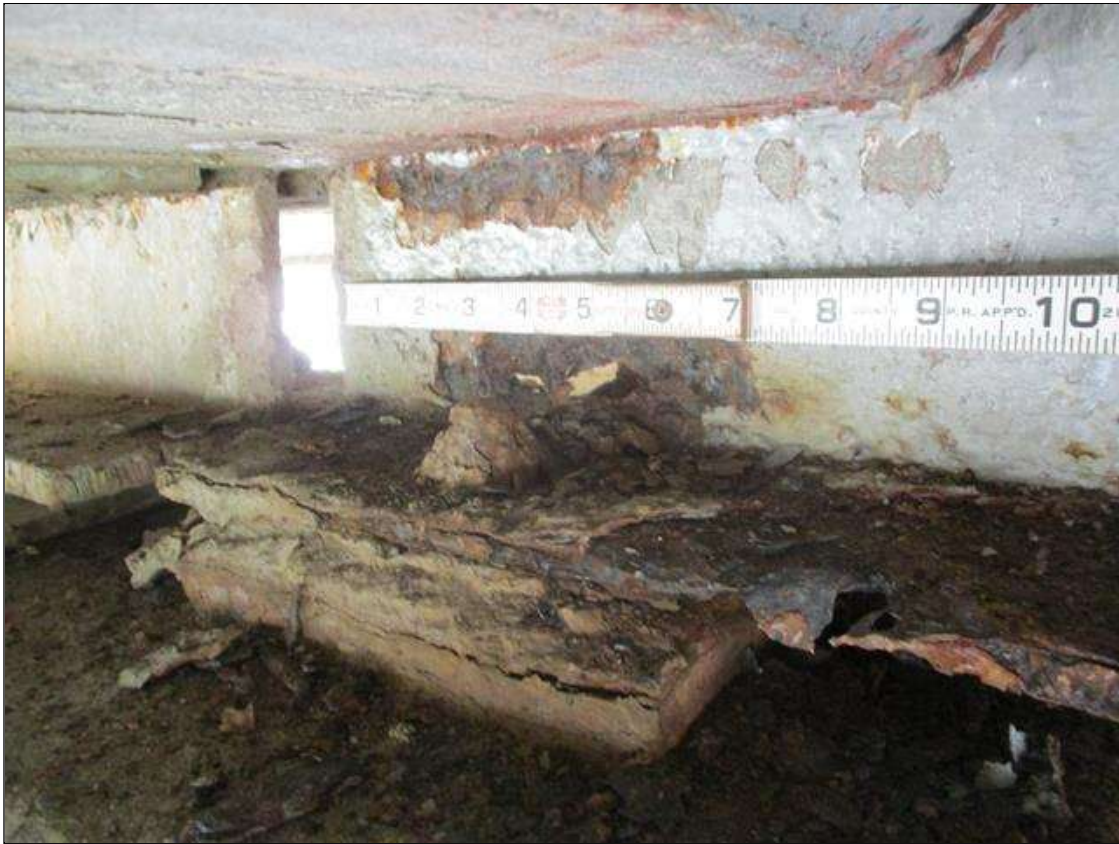
Span 1 Beam 3: [PROMPT ACTION REQUEST] APPROXIMATELY 2" OUT FROM THE BEAM END AT BENT 2, IN THE LOWER 1" OF THE WEB, CORROSION WITH 100% SECTION LOSS FOR APPROXIMATELY 4" LONG.

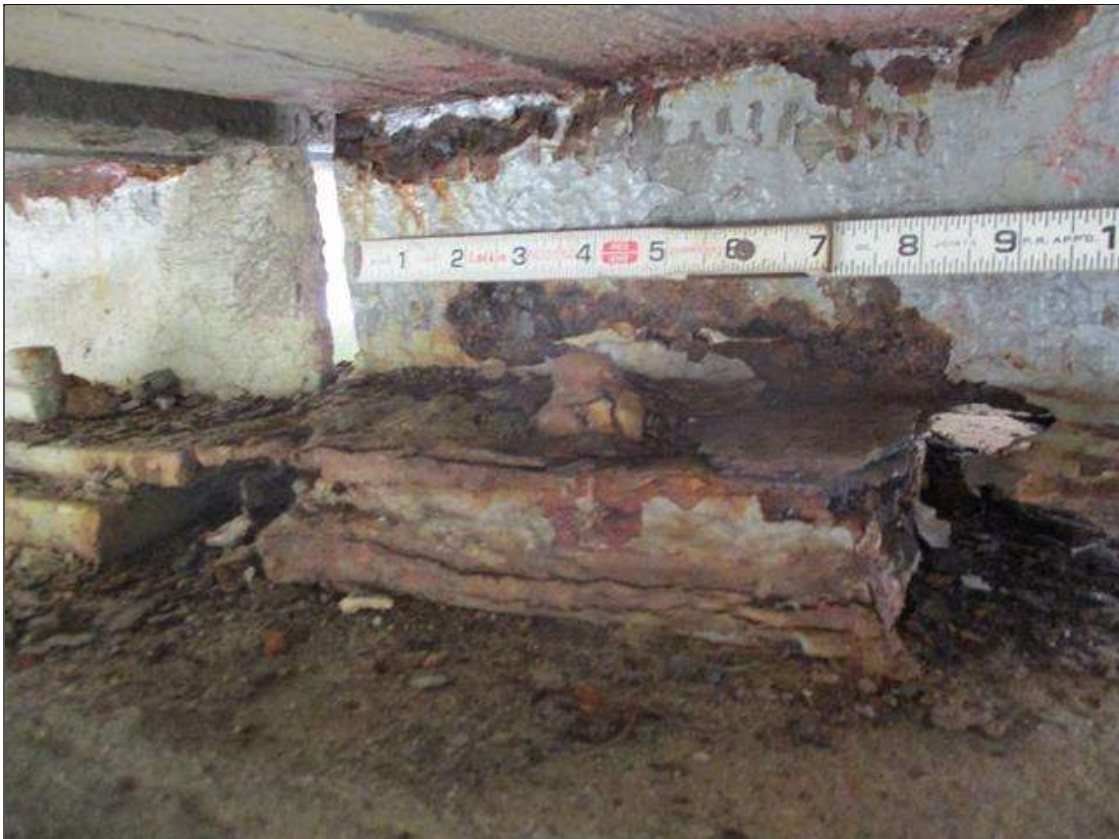
Span 1 Beam 5: [PROMPT ACTION REQUEST] APPROXIMATELY 2" OUT FROM THE BEAM END AT BENT 2, IN THE LOWER 1" OF THE WEB, CORROSION WITH 100% SECTION LOSS FOR APPROXIMATELY 5" LONG.

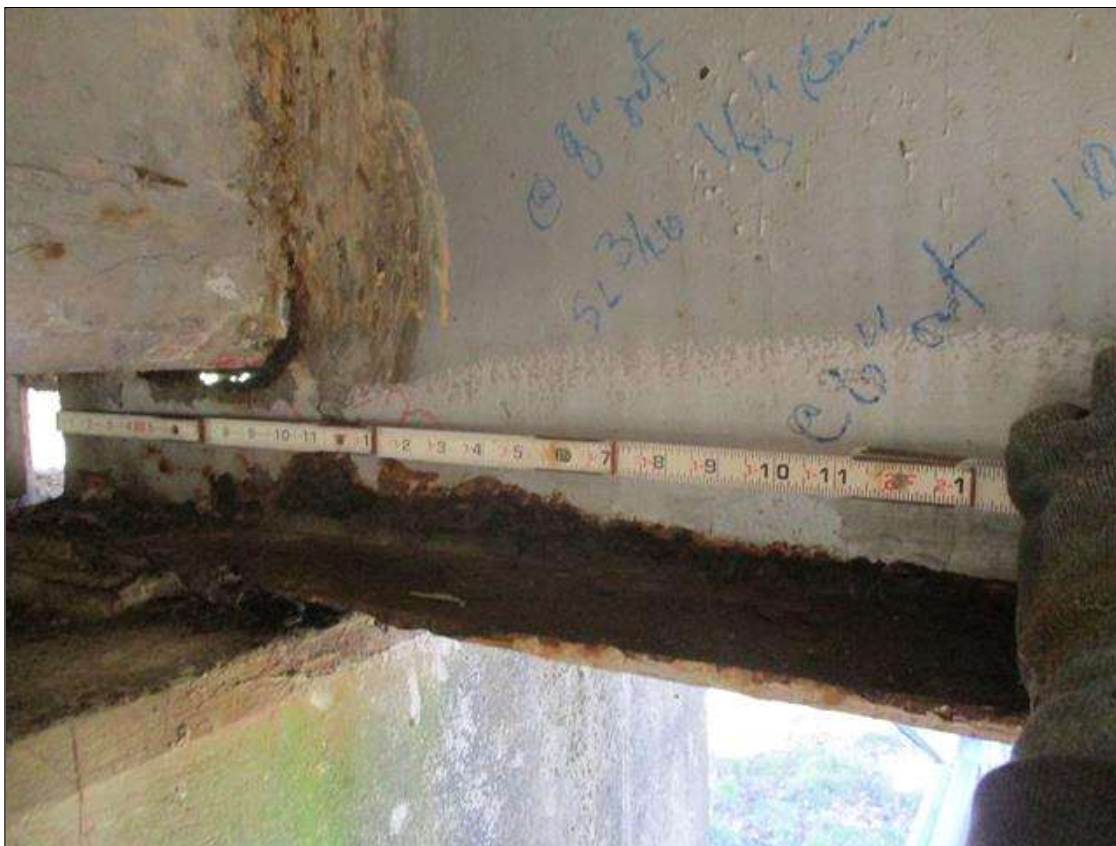
Span 3 Beam 1: [PROMPT ACTION REQUEST] APPROXIMATELY 8" OUT FROM THE BEAM END AT BENT 2, IN THE LOWER 1" OF THE WEB, CORROSION WITH APPROXIMATELY 3/16" SECTION LOSS [AVERAGE 1/8" REMAINS] FOR APPROXIMATELY 18" LONG.

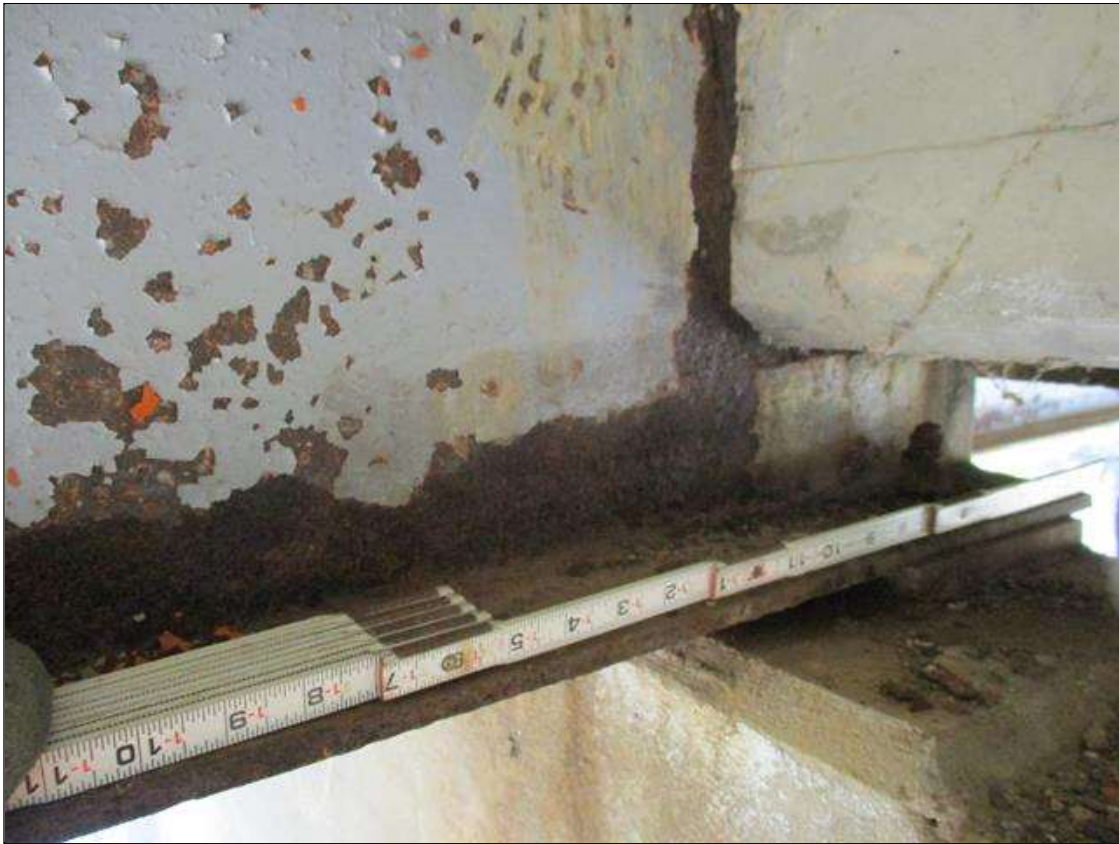
Span 3 Beam 2: [PROMPT ACTION REQUEST] APPROXIMATELY 10" OUT FROM THE BEAM END AT BENT 4, IN THE LOWER 1" OF THE WEB, CORROSION WITH APPROXIMATELY 1/8" SECTION LOSS [AVERAGE 3/16" REMAINS] FOR APPROXIMATELY 15" LONG.

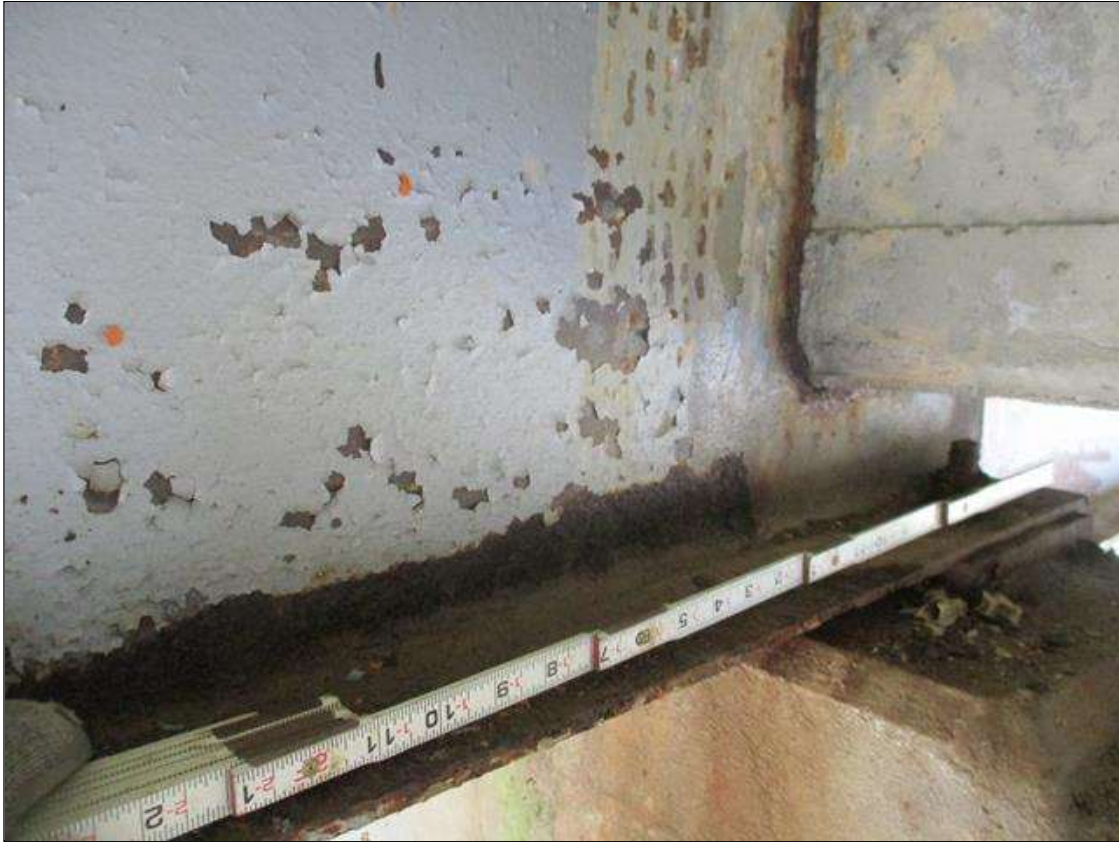
Span 3 Beam 3: [PROMPT ACTION REQUEST] APPROXIMATELY 10" OUT FROM THE BEAM END AT BENT 4, IN THE LOWER 2" OF THE WEB, CORROSION WITH APPROXIMATELY 1/8" SECTION LOSS [AVERAGE 3/16" REMAINS] FOR APPROXIMATELY 12" LONG.

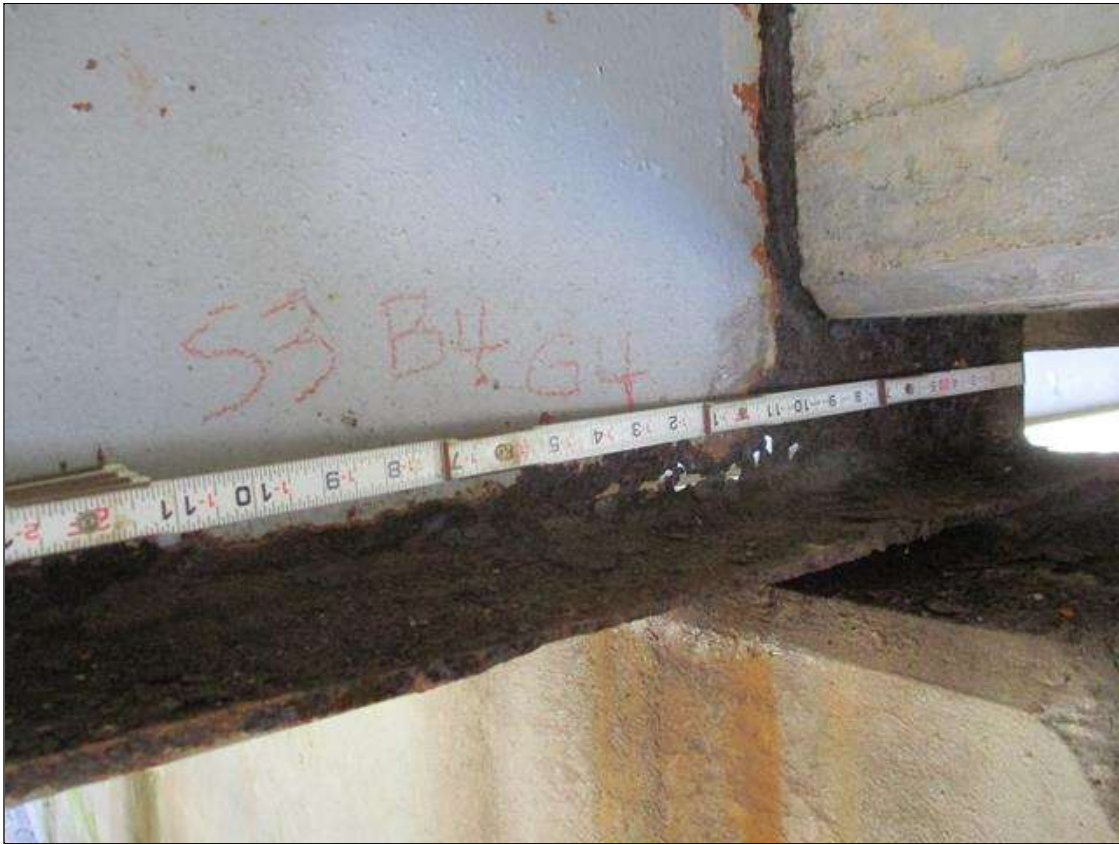
Span 3 Beam 4: [PROMPT ACTION REQUEST] APPROXIMATELY 6" OUT FROM THE BEAM END AT BENT 4, IN THE LOWER 2" OF THE WEB, CORROSION WITH APPROXIMATELY 1/8" SECTION LOSS [AVERAGE 3/16" REMAINS] FOR APPROXIMATELY 3" LONG, THEN 100% SECTION LOSS FOR APPROXIMATELY 6" LONG, THEN APPROXIMATELY 3/16" SECTION LOSS [AVERAGE 1/8" REMAINS] FOR APPROXIMATELY 12" LONG

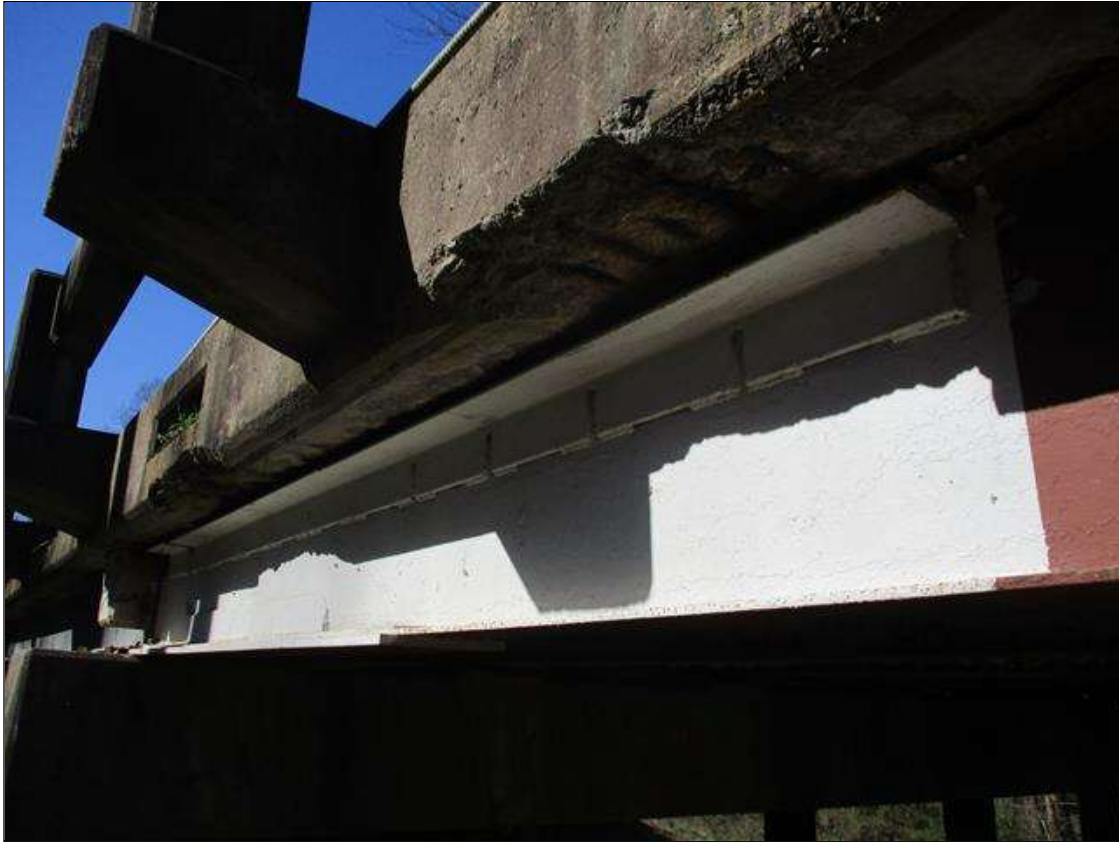
Span 3 Beam 6: [NEW REPAIR] BEAM END AT BENT 2, PLATES HAVE BEEN WELDED TO BOTH SIDES OF THE LOWER WEB [APPROXIMATELY 84" LONG X UP TO 14" HIGH X 3/8" THICK]; AND THE LOWER FLANGE [APPROXIMATELY 91" LONG X 10" WIDE X 3/4" THICK]; AND THE UPPER RIGHT FLANGE [APPROXIMATELY 134" LONG X 4" WIDE]

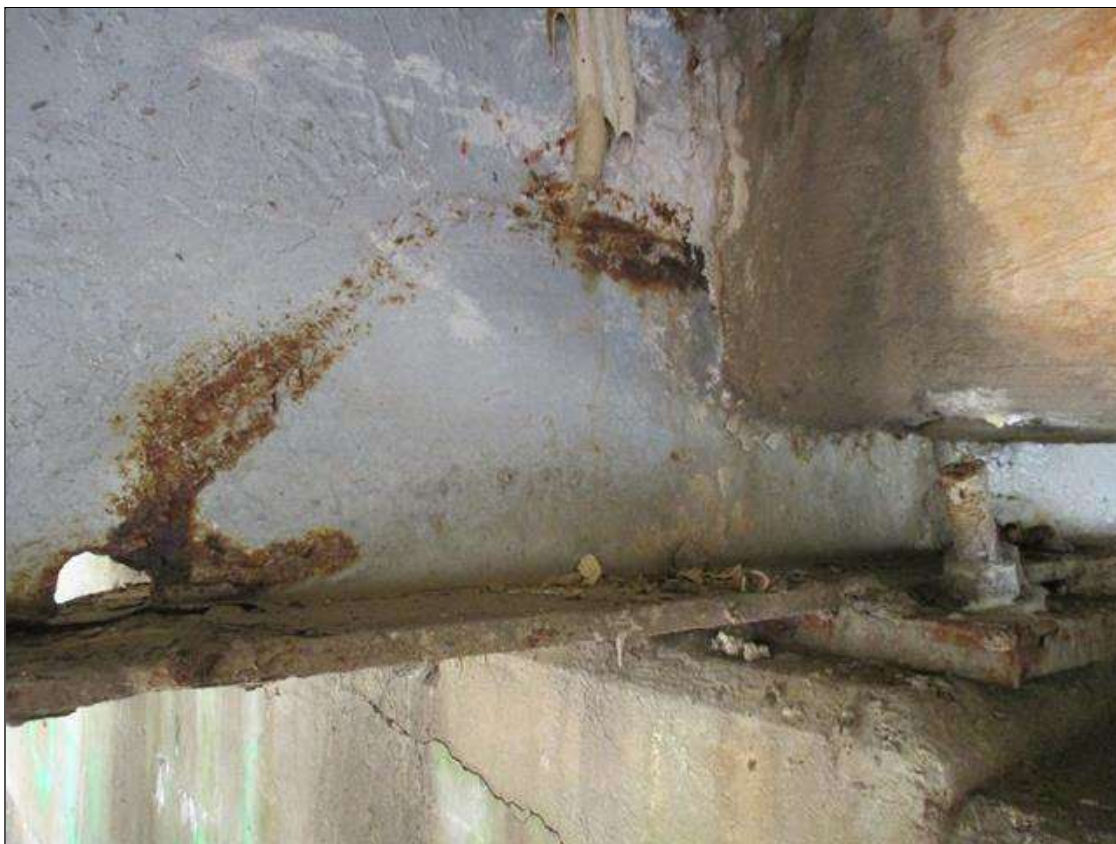
Span 3 Beam 3: [NEW REPAIR] BEAM END AT BENT 2 HAS BEEN SECTIONED, APPROXIMATELY 2' LONG X 7.5" WIDE X UP TO 8" HIGH

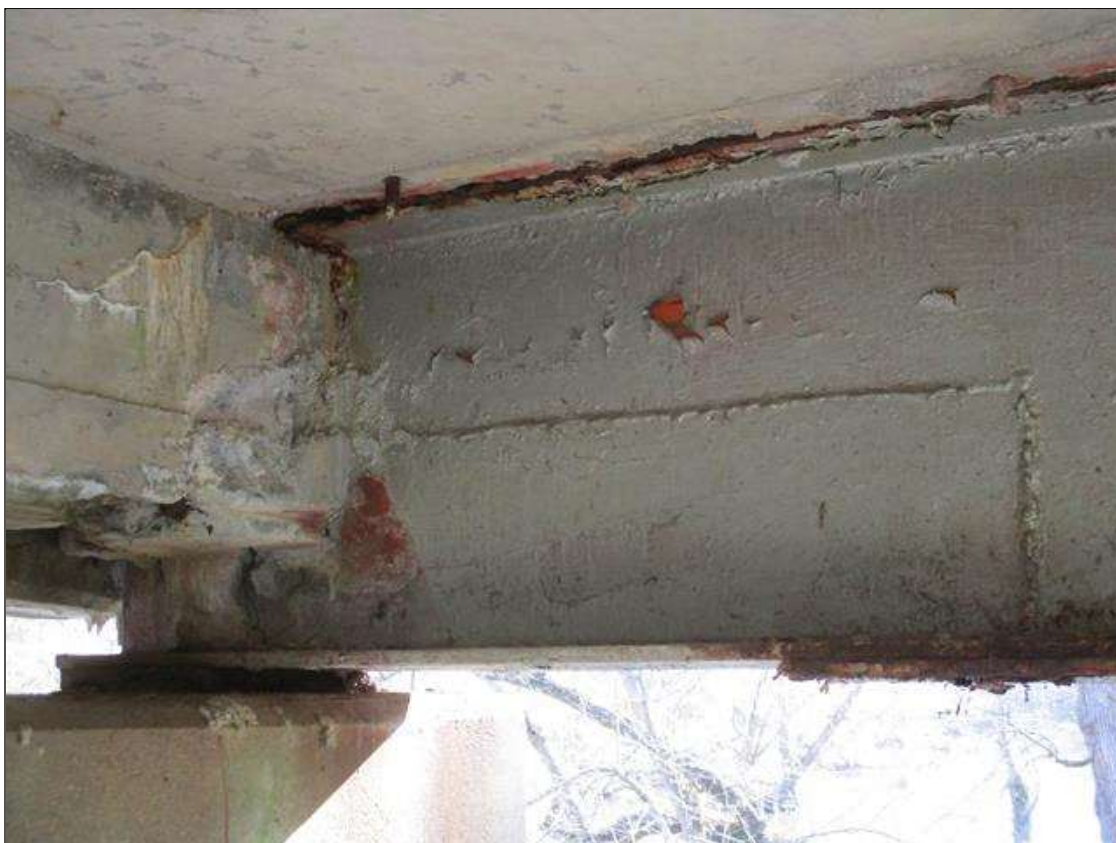
Span 4 Beam 6: [NEW REPAIR] BEAM END AT BENT 4 HAS BEEN SECTIONED, APPROXIMATELY 3' LONG X 7.5" WIDE X UP TO 7" HIGH

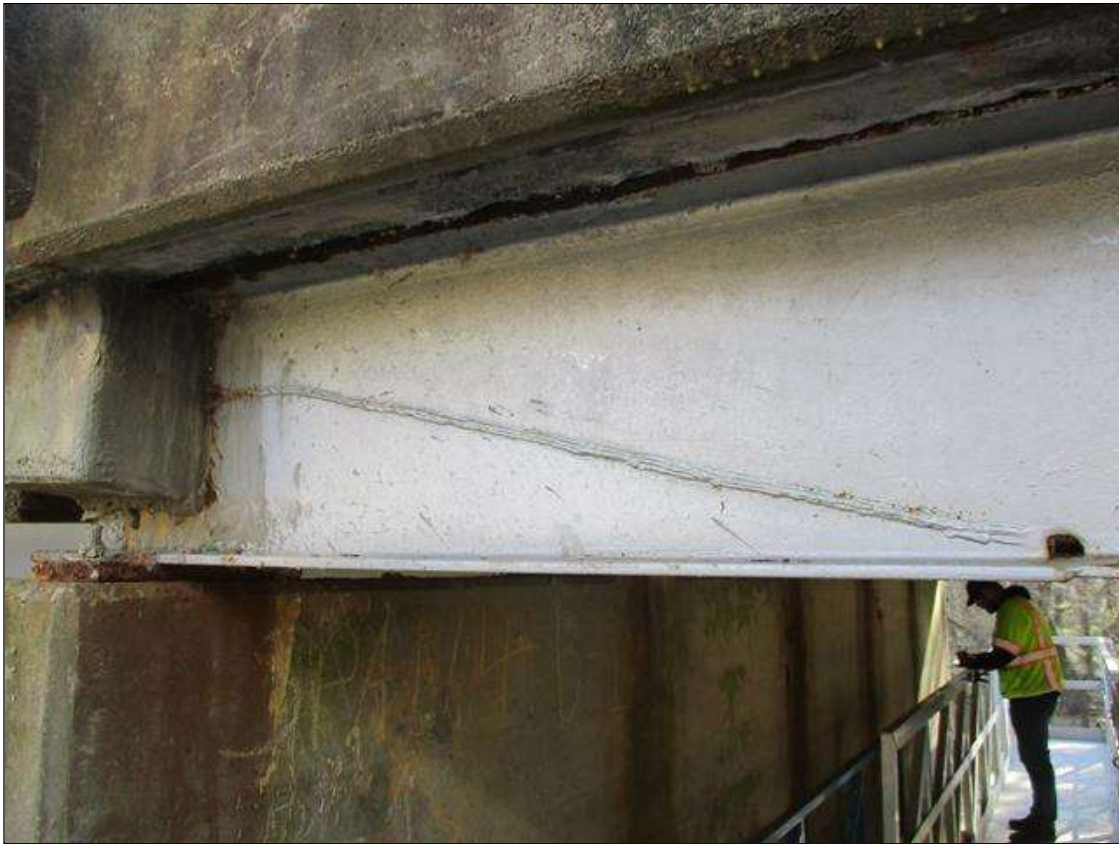
Span 4 Beam 1: [NEW REPAIR] BEAM END AT BENT 4 HAS BEEN SECTIONED, APPROXIMATELY 4.5' LONG X 7.5" WIDE X UP TO 9" HIGH

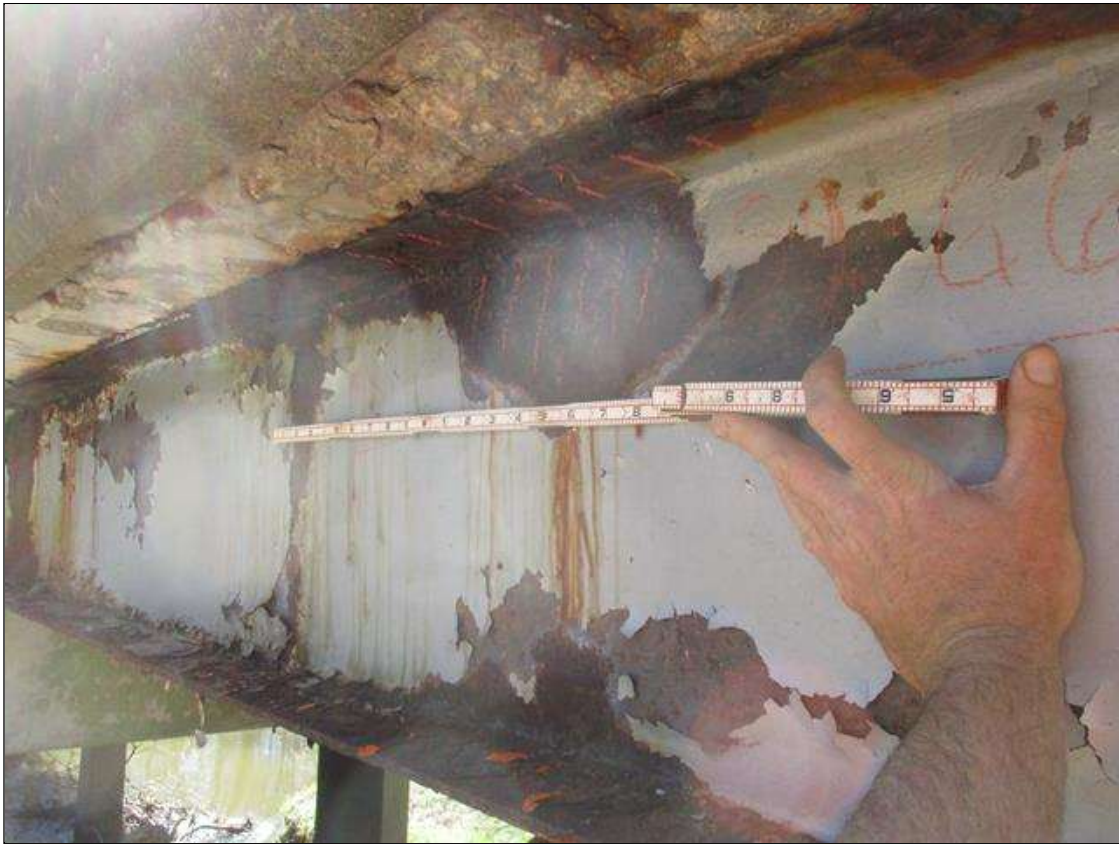
Span 9 Beam 6: [PROMPT ACTION REQUEST] 5/16" SECTION LOSS (1/8" REMAINING) ON TOP RIGHT FLANGE FOR HALF FLANGE WIDTH FOR 5' STARTING 10' FROM BENT 9 IN SPAN 10 WITH SCATTERED SECTION LOSS TO 1/8" [AVERAGE 3/16" REMAINING] IN THE UPPER AND LOWER 3" OF THE WEB AT THIS LOCATION

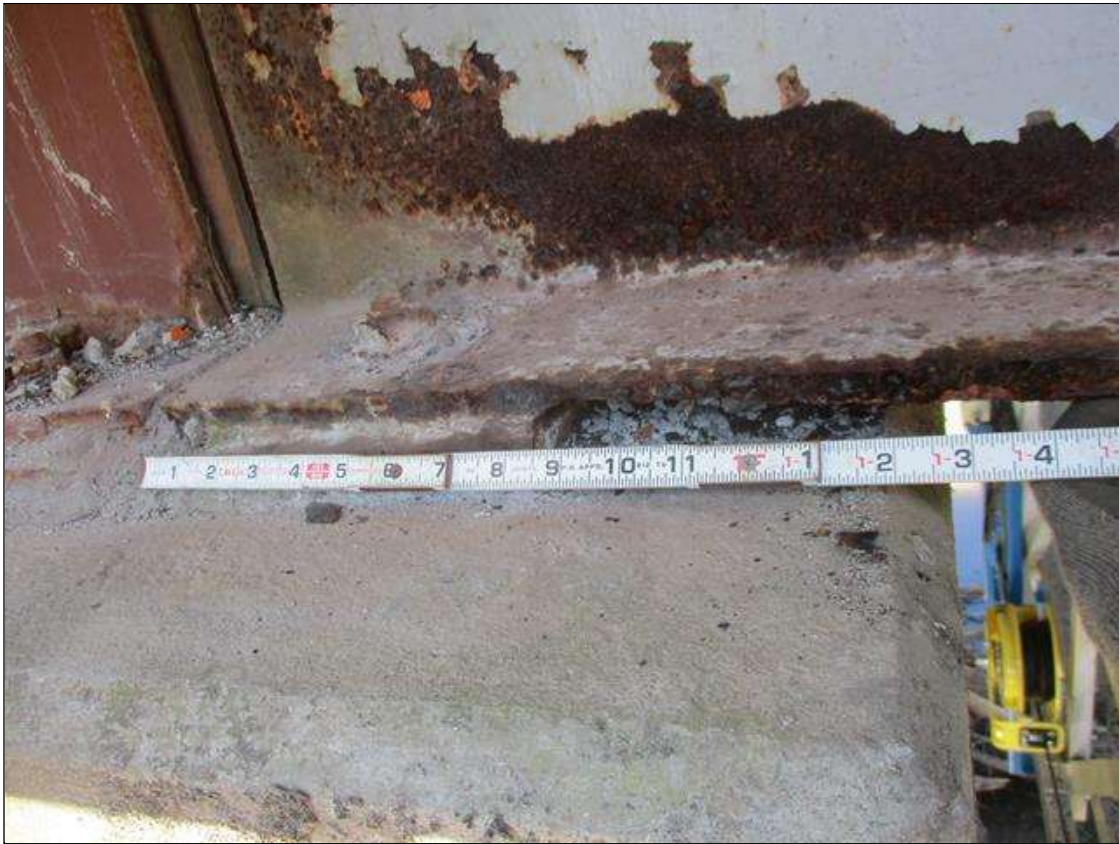
Span 6 Beam 4: [PROMPT ACTION REQUEST] BEAM END AT BENT 5, LOWER FLANGE, CORROSION WITH APPROXIMATELY 5/16" SECTION LOSS [AVERAGE 5/16" REMAINS] FOR APPROXIMATELY 12" LONG

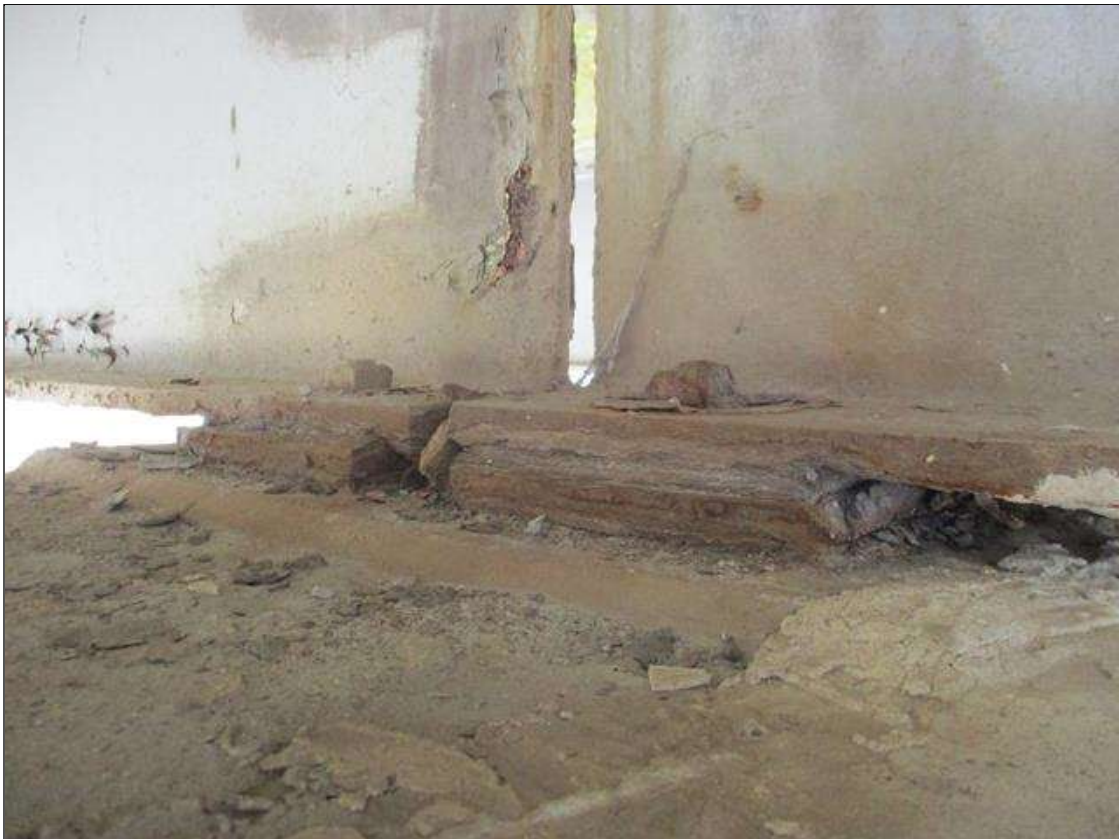
TYPICAL BEARING SURFACE CORROSION

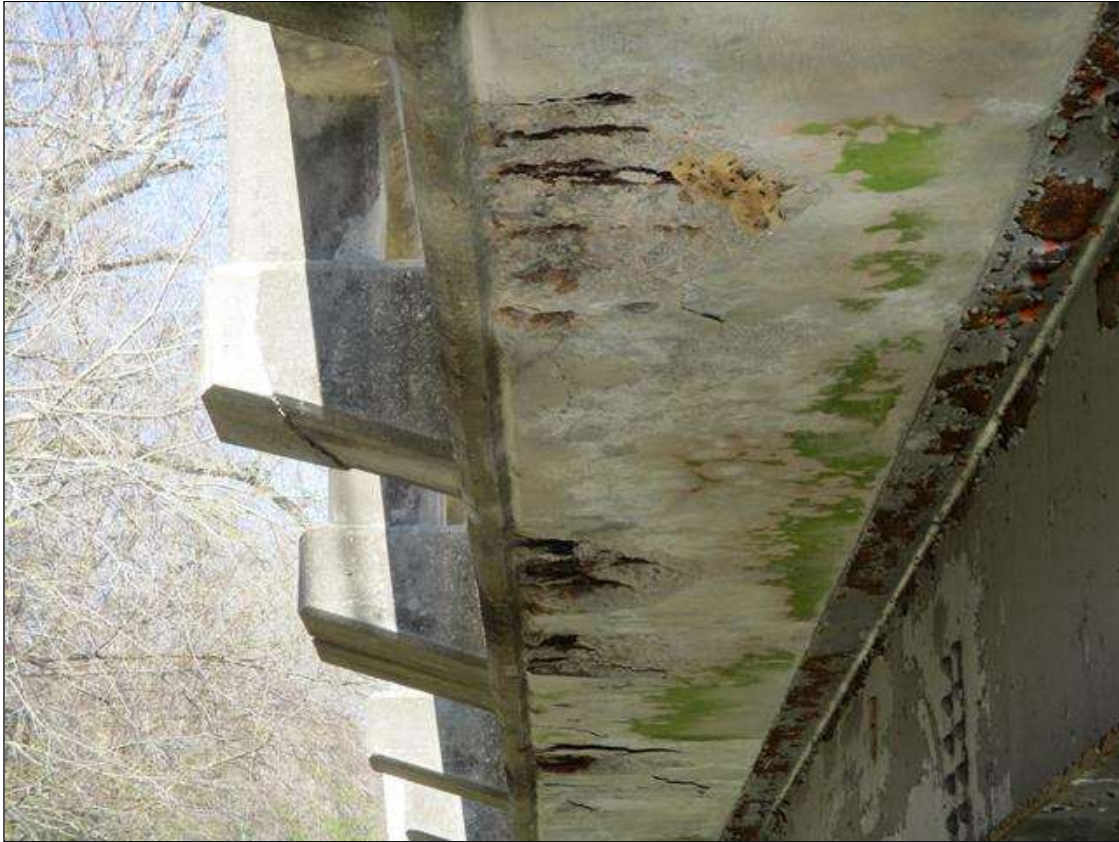
REINFORCED CONCRETE DECK OVERHANGS: VIEW OF TYPICAL SCATTERED SPALLING WITH EXPOSED REBAR AND DELAMINATION

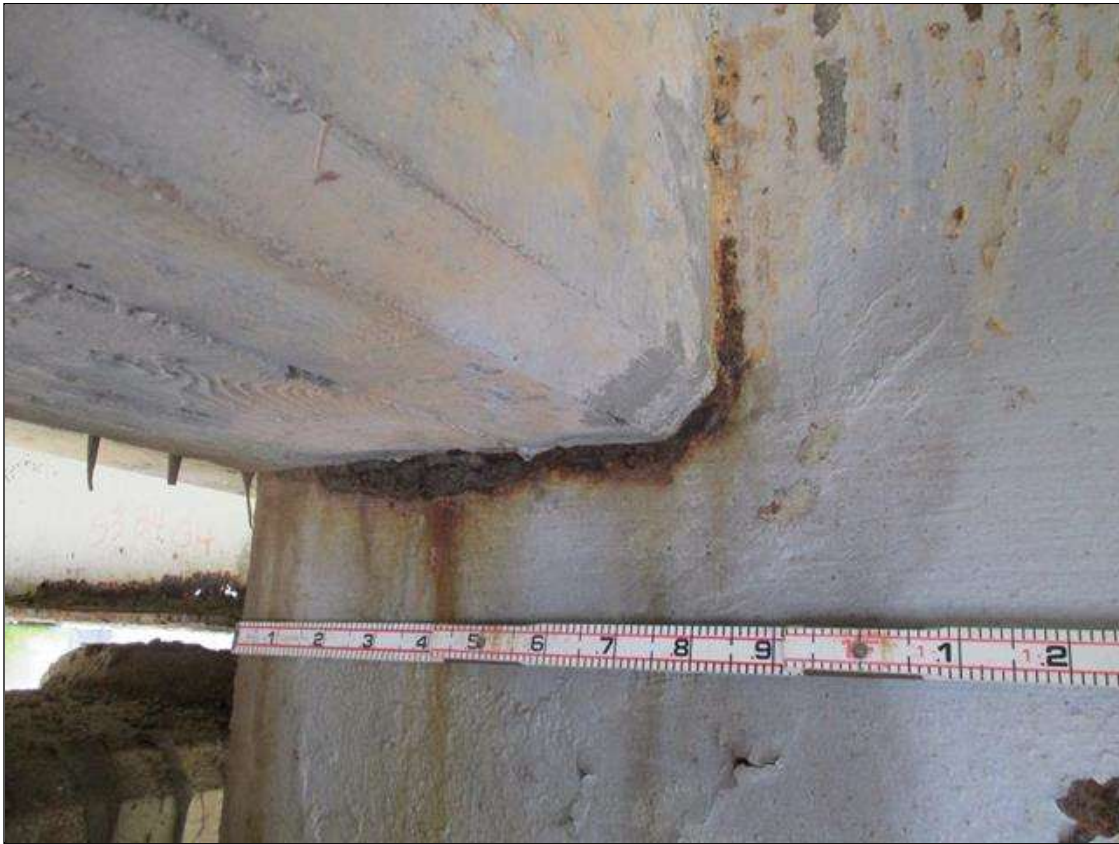
Span 5 Beam 2: [PROMPT ACTION REQUEST] BEAM END AT BENT 4, THERE IS AN APPROXIMATELY 1" WIDE BAND OF CORROSION THAT WRAPS THE REINFORCED CONCRETE DIAPHRAGM, APPROXIMATELY 1/8" SECTION LOSS [AVERAGE 5/16" REMAINS] FOR APPROXIMATELY 10" LONG.

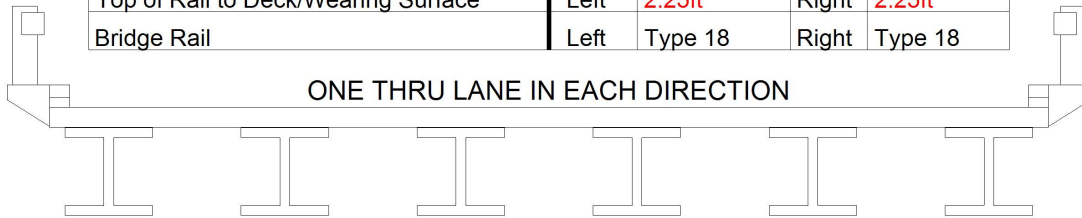
Measurements for Spans	1 thru 4, 9 and 10		
Deck Thickness	0.5	Left Overhang	2.916 *
Top of Rail to Bottom of Beam	4.33	Right Overhang	2.916 *

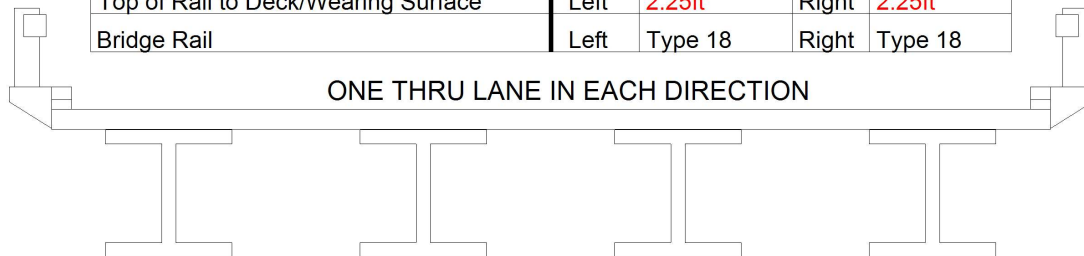
Measurements for Spans	5 thru 8		
Deck Thickness	0.5	Left Overhang	4.458 *
Top of Rail to Bottom of Beam	5.167	Right Overhang	4.458 *
