NC DEPARTMENT OF TRANSPORTATION
 DIVISION OF HIGHWAYS
 STRUCTURE MANAGEMENT UNIT

ATTENTION: **PROMPT ACTION REQUEST; HYDRAPLATFORM USED; NEW REPAIRS; OUT-TO-OUT REVISED;**

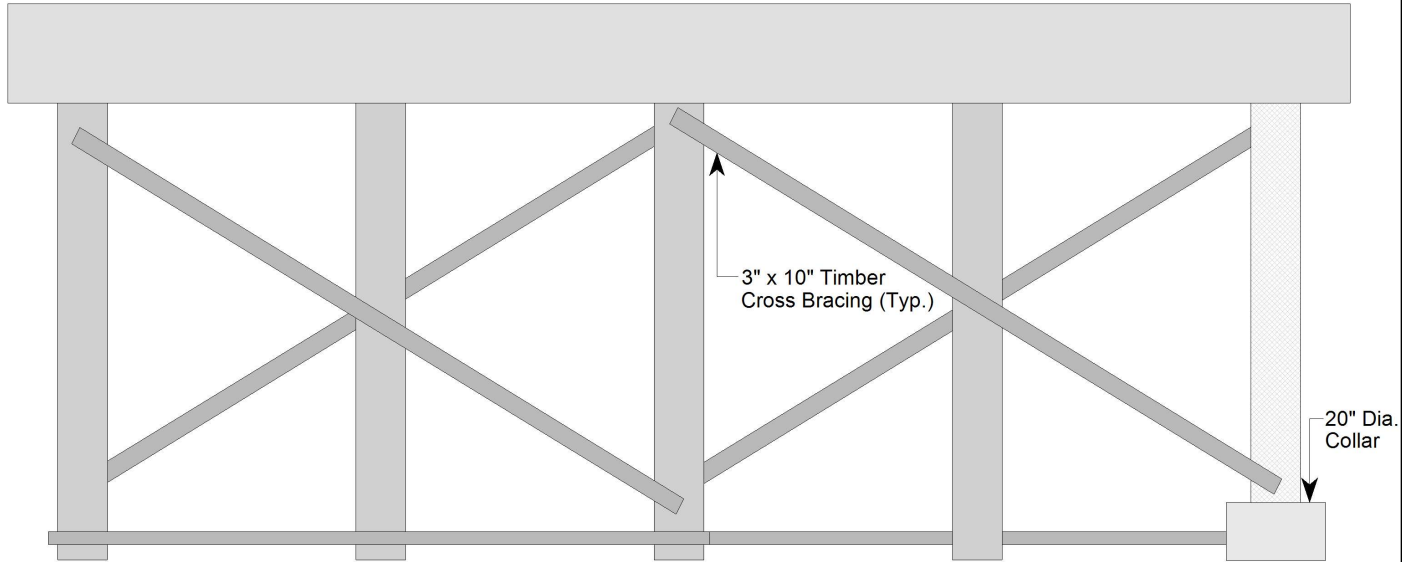
Cap Information			Material Cast-in-Place Concrete							
Length	Width	Height	Left Overhang	Right Overhang	Left Beam to End of Cap.	Right Beam to End of Cap.				
27.0 ft.	2.25 ft.	2.0 ft.	1.5 ft.	1.5 ft.	1.667 ft.	1.667 ft.				
Subcap Information			Material							
Length	Width	Height	Left Overhang	Right Overhang	Left Pile to Splice.					
Sill Information			Material							
Length	Width	Height								
Pile #	Material	Spacing	Width/Dia.	Height	Length	Orientation	Driven?	Replacement?	Removed?	Collar?
1	Timber	6.0 ft.	1.0 ft.			Vertical	Yes	No	No	No
2	Timber	6.0 ft.	1.0 ft.			Vertical	Yes	No	No	No
3	Timber	6.0 ft.	1.0 ft.			Vertical	Yes	No	No	No
4	Timber	6.0 ft.	1.0 ft.			Vertical	Yes	No	No	No
5	Timber		1.0 ft.			Vertical	Yes	Yes	No	Yes
Bent: 1			Similar Bents: 2, 3 and 9
