BRIDGES: 640044, 640045, 640058, 640059

PROJECT NO. I-6039

NEW HANOVER COUNTY

**CONCRETE RESTORATION DETAILS
SUBSTRUCTURE**

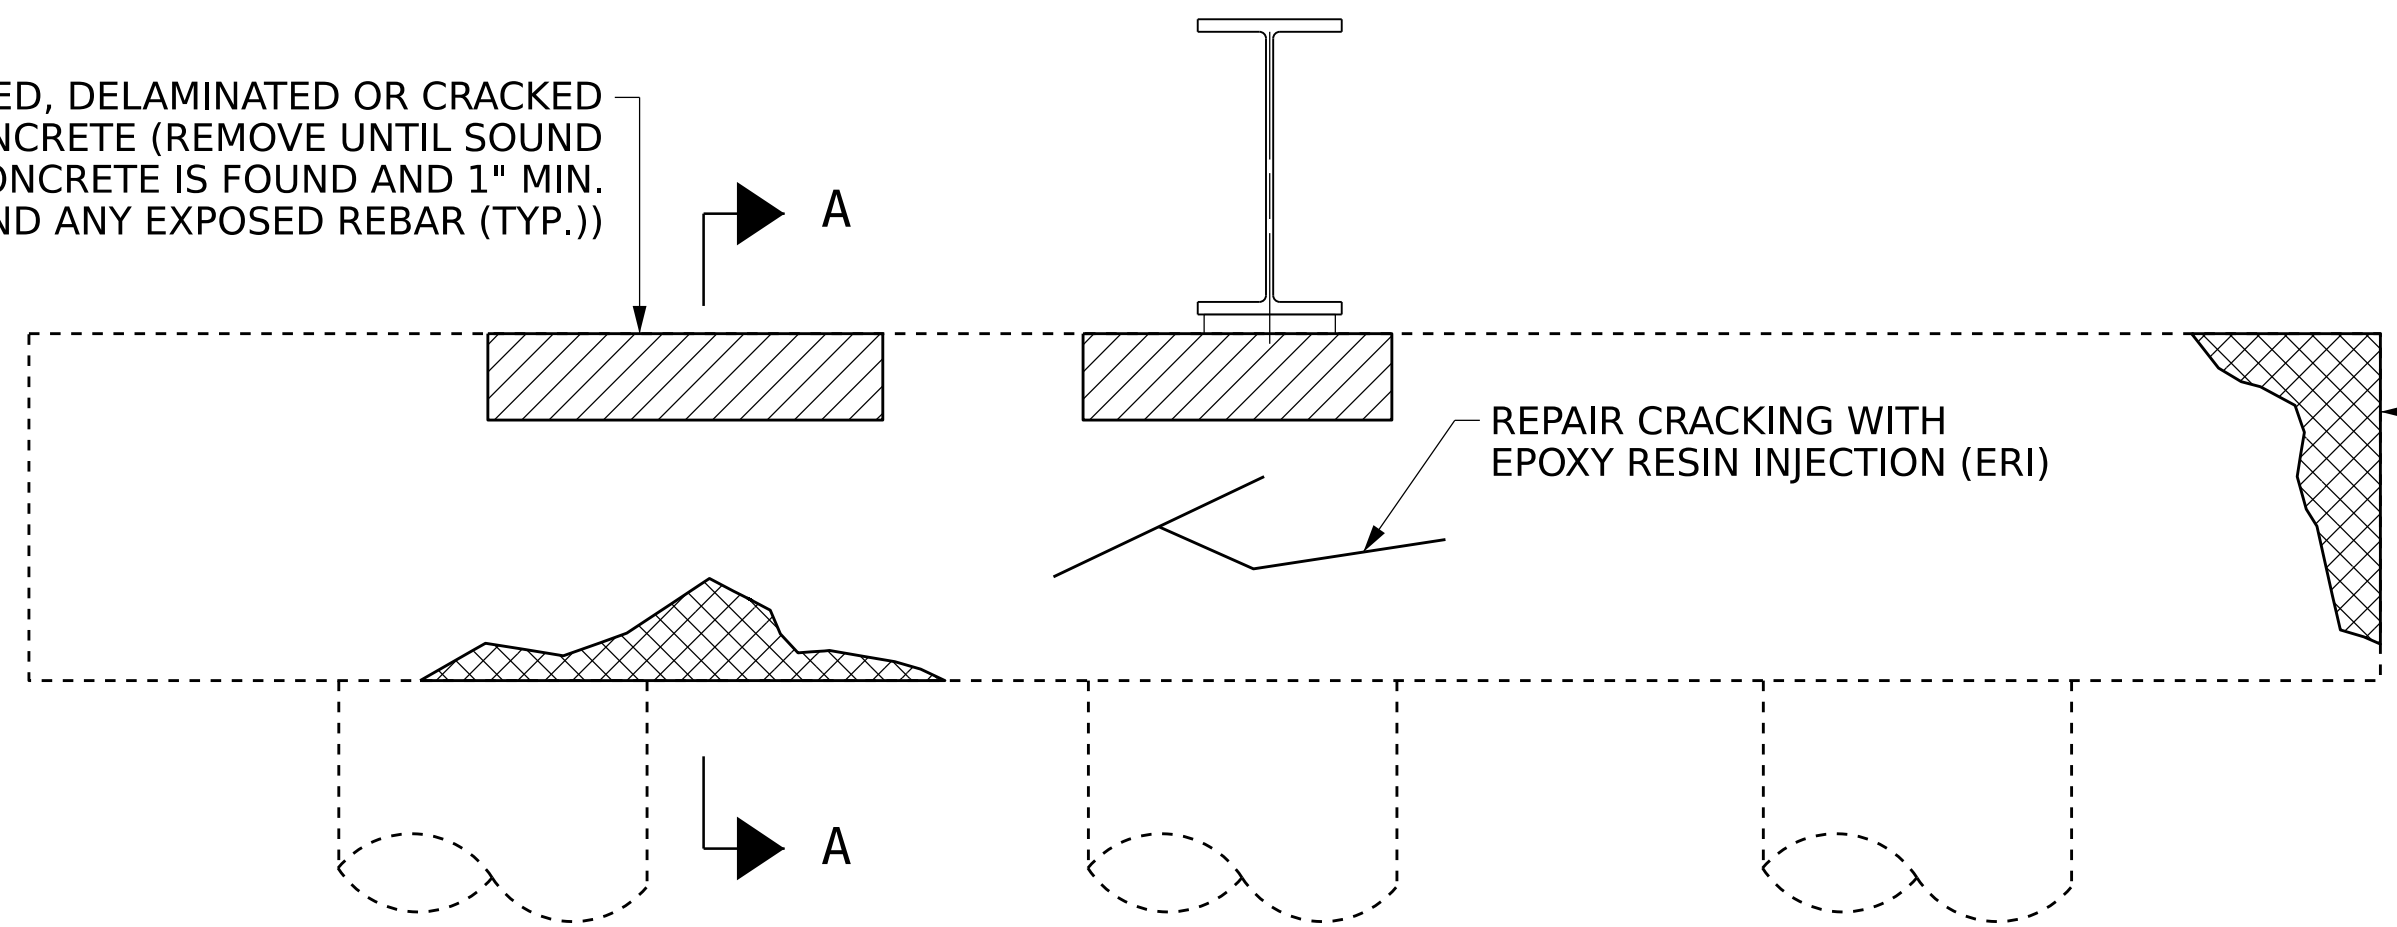
BENT CAP REPAIRS

SPALLED, DELAMINATED OR CRACKED CONCRETE (REMOVE UNTIL SOUND CONCRETE IS FOUND AND 1" MIN. BEHIND ANY EXPOSED REBAR (TYP.))

REPAIR CRACKING WITH EPOXY RESIN INJECTION (ERI)

REPAIR ALL SPALLED, DELAMINATED OR CRACKED CONCRETE AREAS NOT OCCURRING AT BEAM BEARING AREAS PER PLANS AND PER THE ENGINEER USING SHOTCRETE REPAIRS OR CONCRETE REPAIRS (SEE NOTES)
