NC DEPARTMENT OF TRANSPORTATION
 DIVISION OF HIGHWAYS
 STRUCTURE MANAGEMENT UNIT

ATTENTION: PRIORITY ACTION REQUEST ISSUED; HYDRA-PLATFORM USED

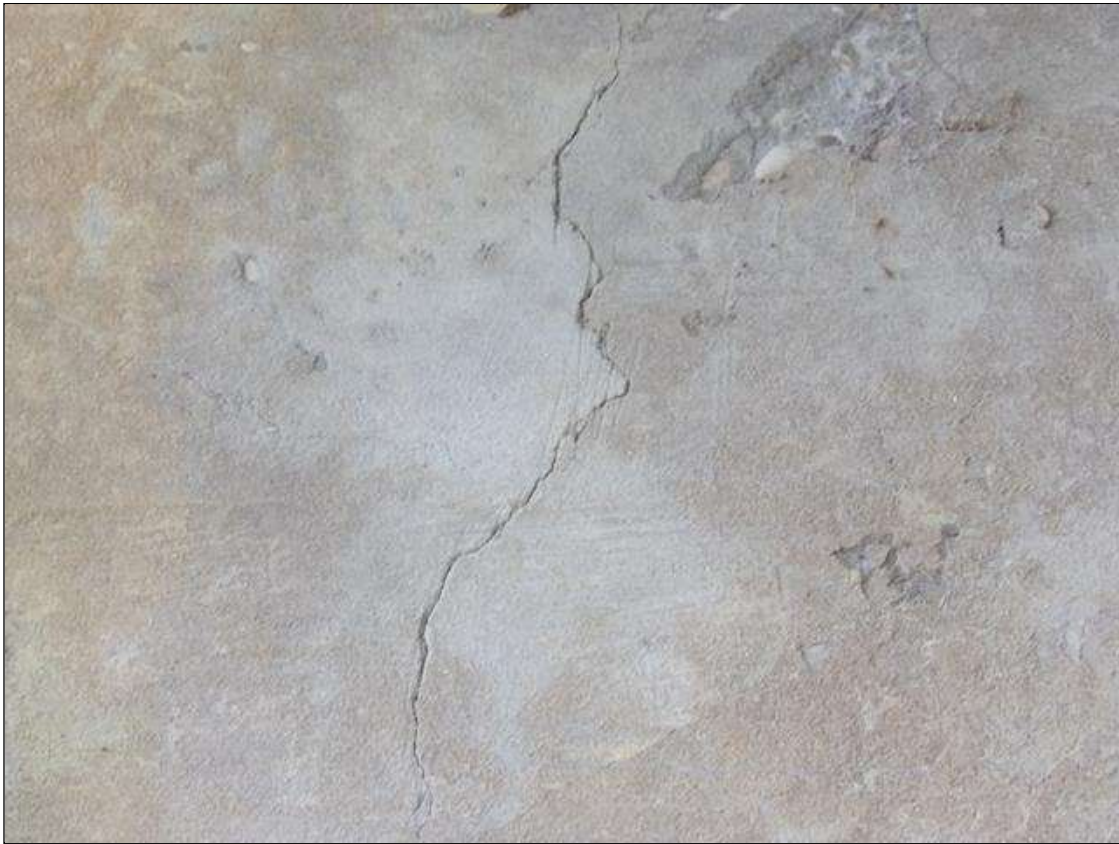
Bent 2 Cap 1: UP TO 1/32" WIDE VERTICAL AND DIAGONAL CRACKS UP TO 2' LONG THROUGHOUT BOTH FACES

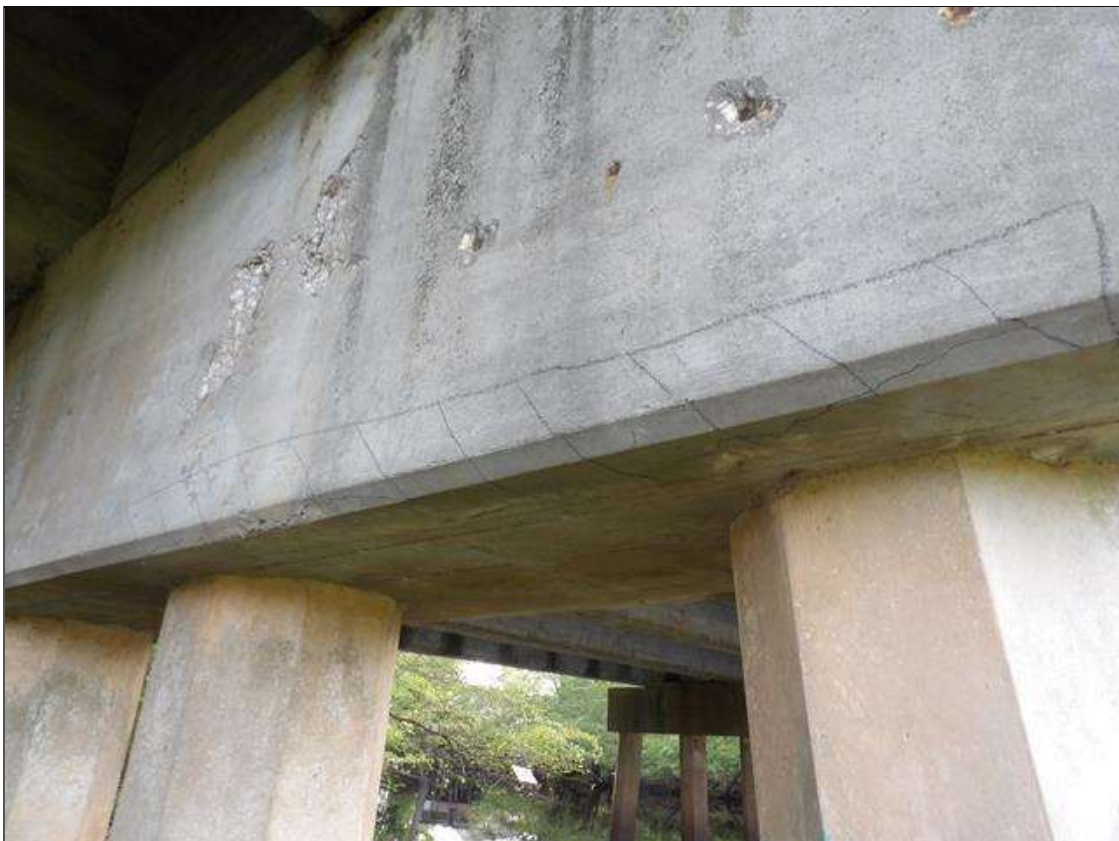
Bent 2 Cap 1: DELAMINATION ON NEAR FACE AT BOTTOM OF CAP 4' LONG X 6" HIGH.

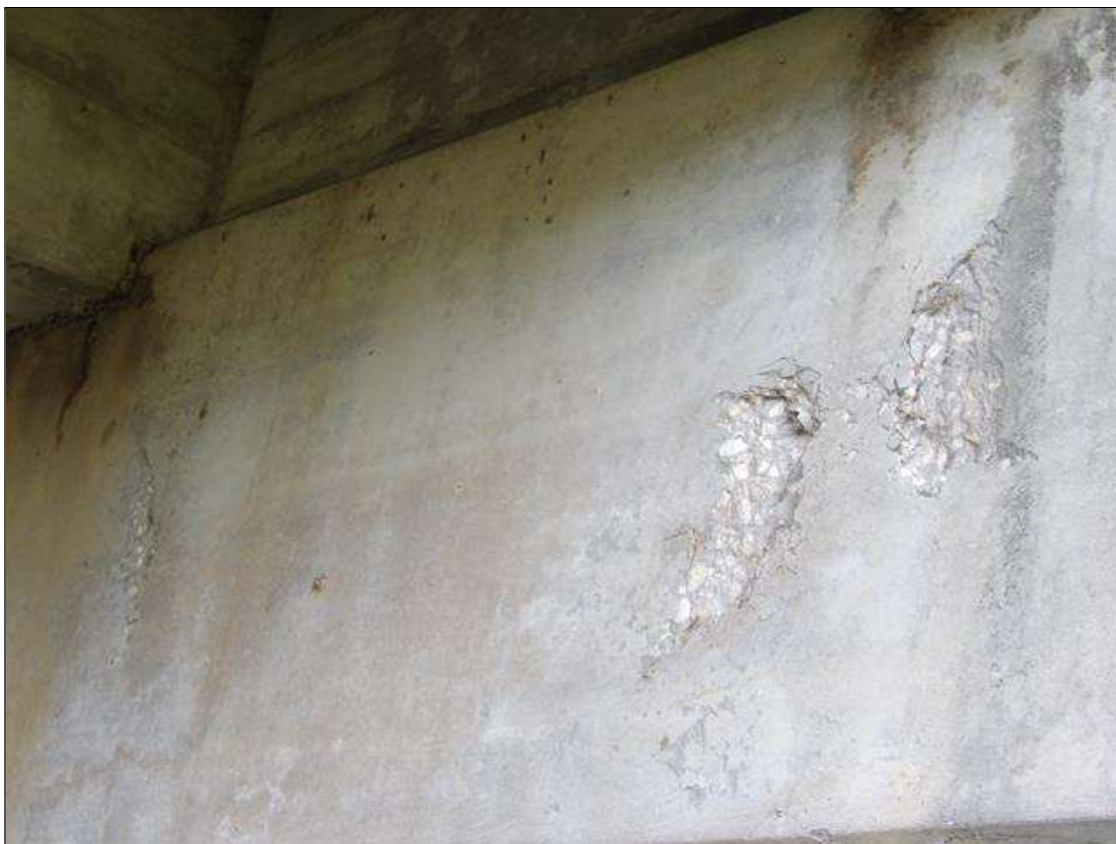
Bent 2 Cap 1: NEAR FACE, (6) SPALLS UP TO 12" LONG X 4" WIDE X 1" DEEP UNDER BEAMS 4 AND 5.

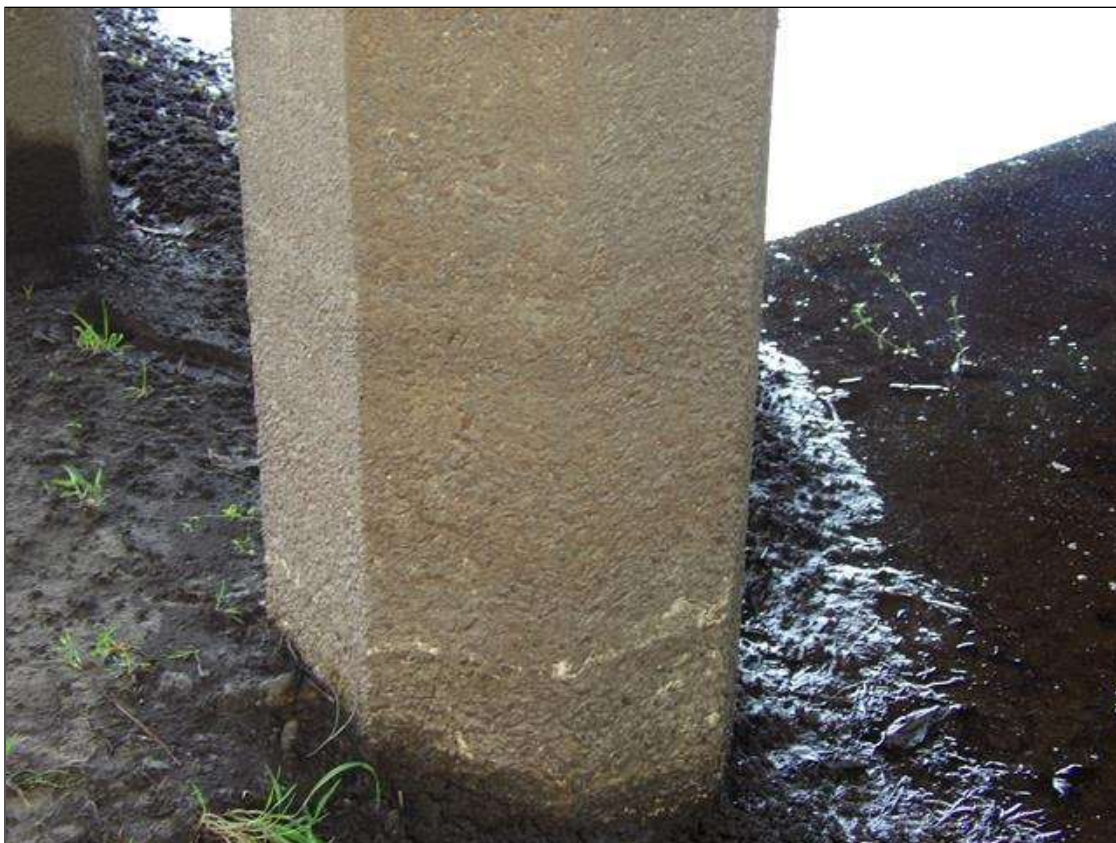
Typical minor abrasion in piles up to 3' high on all faces, Bent 2 Pile 3 shown

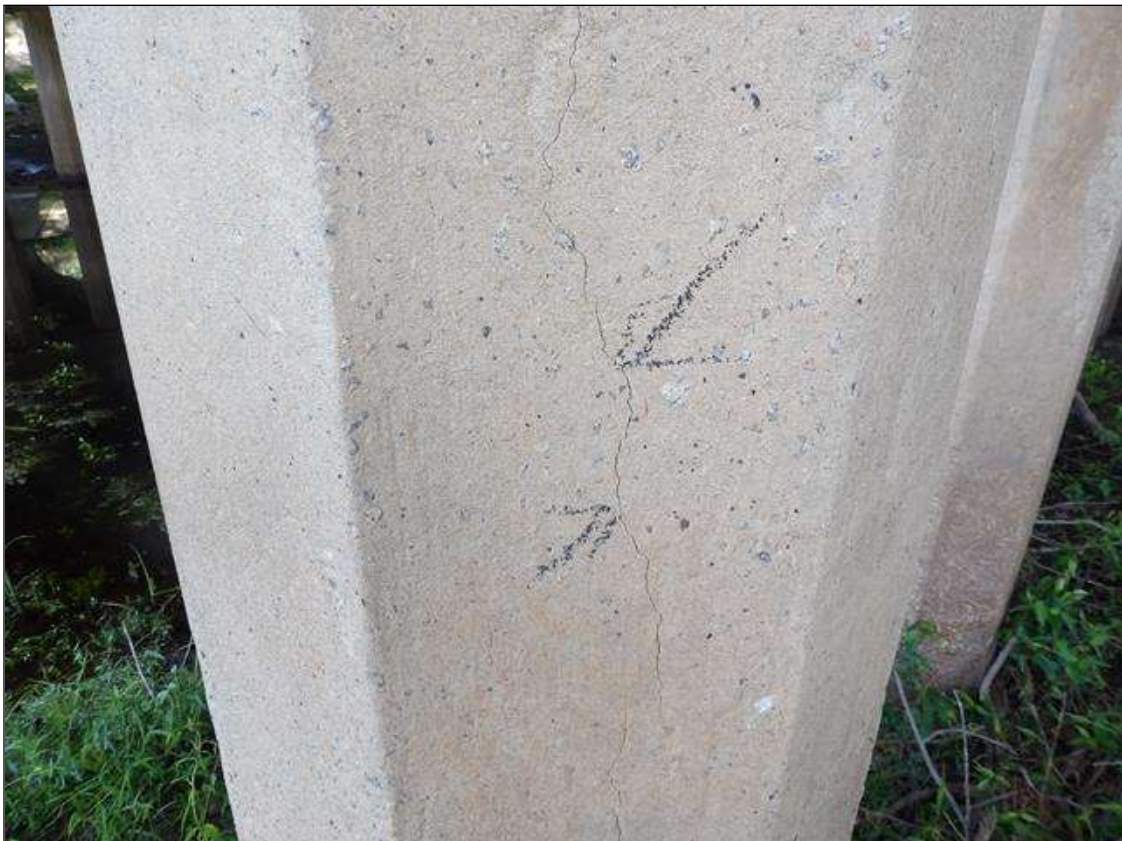
Typical vertical hairline crack on Piles, Bent 2 Pile 7 shown

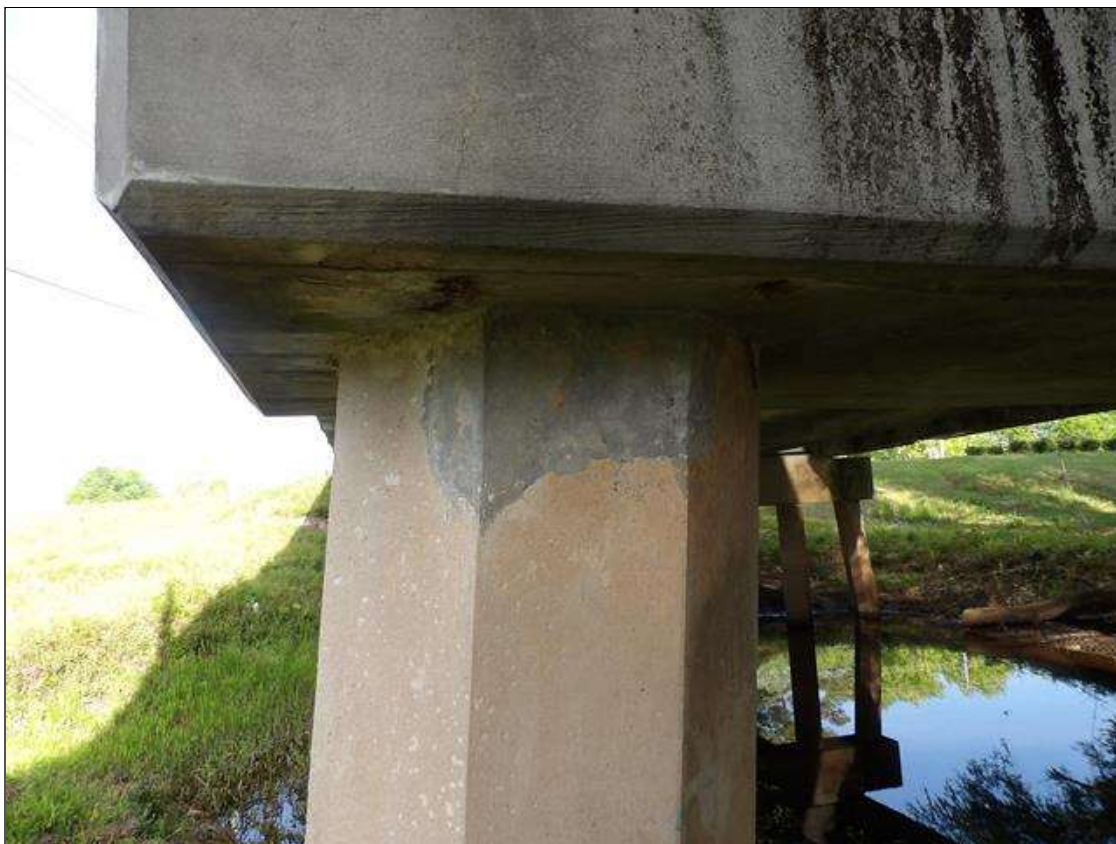
Bent 2 Pile 8: 1' x 8" SOUND PATCH AT TOP OF PILE ON EAST FACE

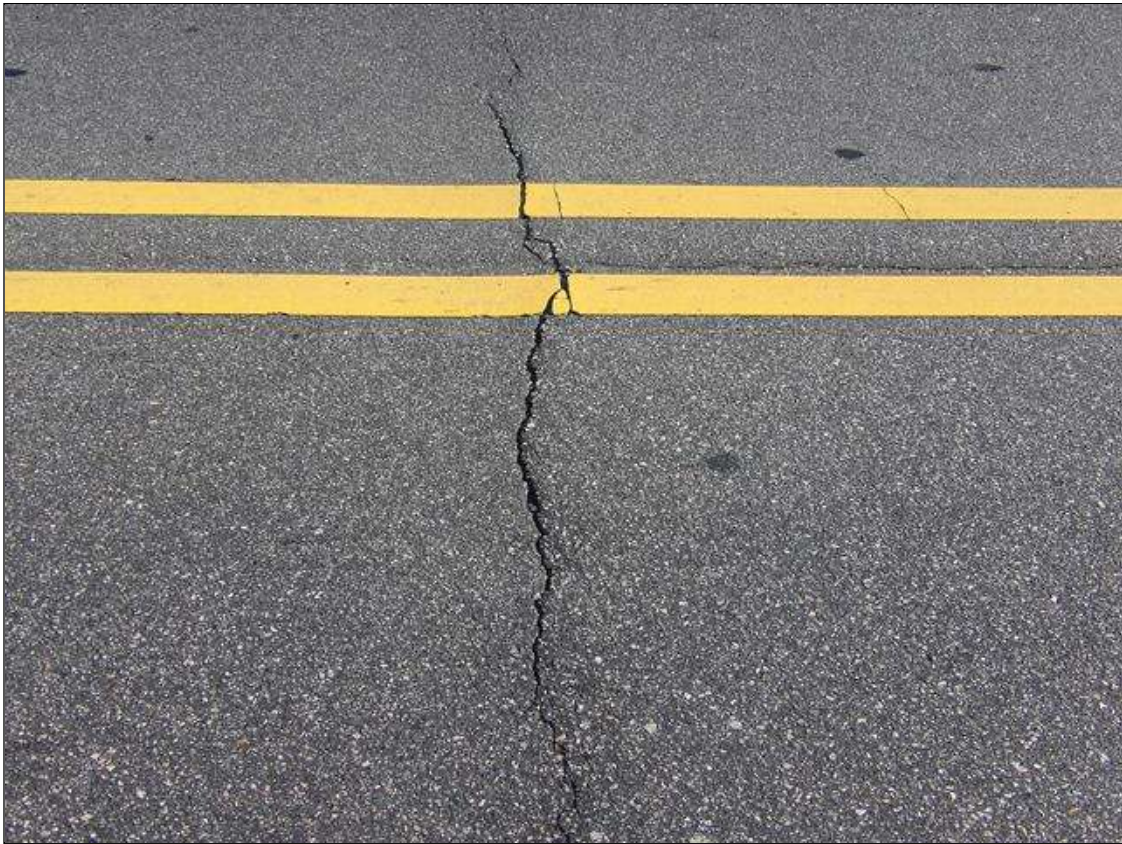
TYPICAL TRANSVERSE CRACK IN WEARING SURFACE FULL LENGTH X UP TO 1/4" WIDE, OVER ABUTMENT 1 SHOWN

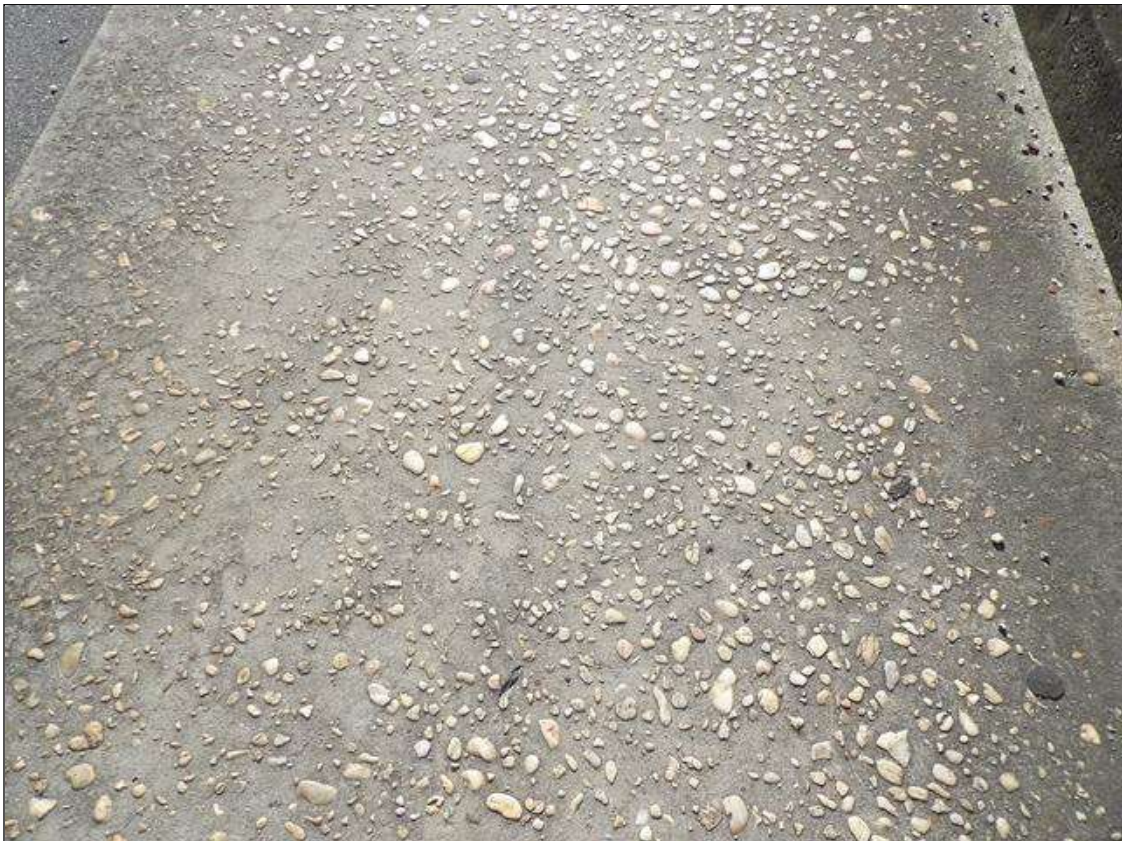
Typical minor abrasion on sidewalks, Span 1 right sidewalk shown

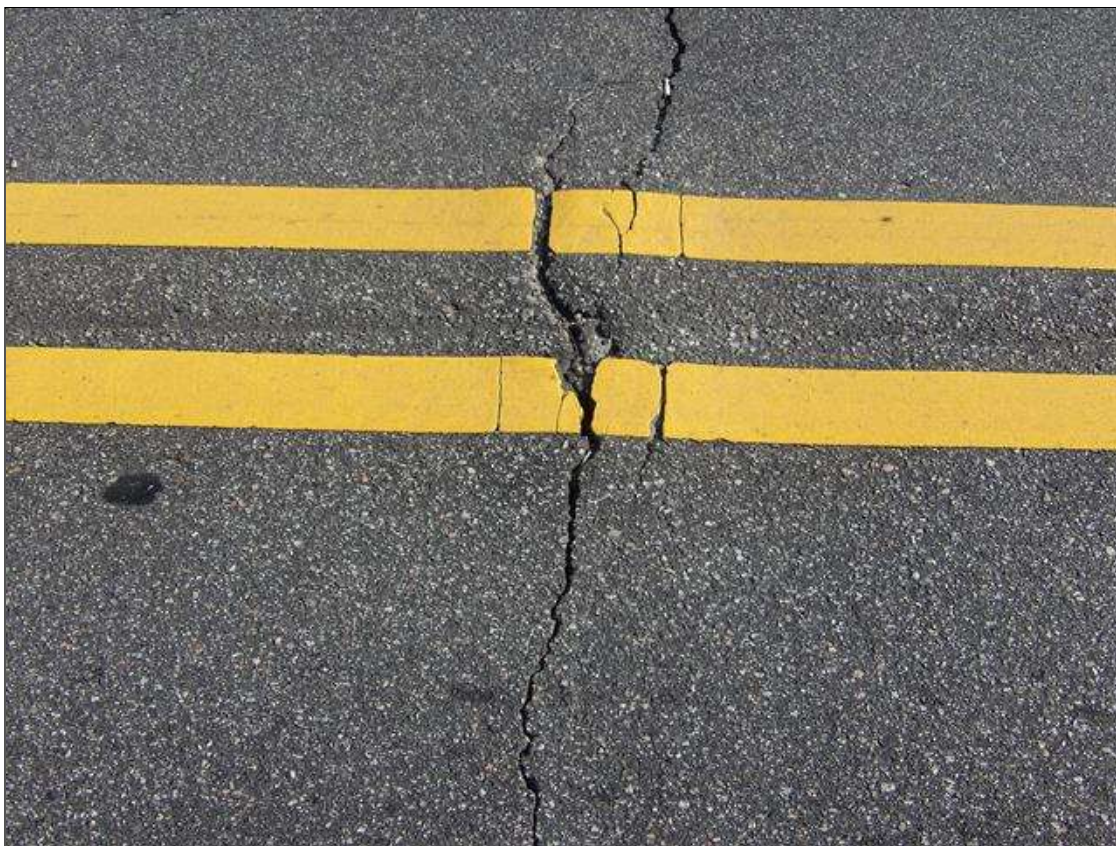
TYPICAL TRANSVERSE CRACKS UP TO FULL WIDTH X 1/2" WIDE, OVER BENT 3 SHOWN

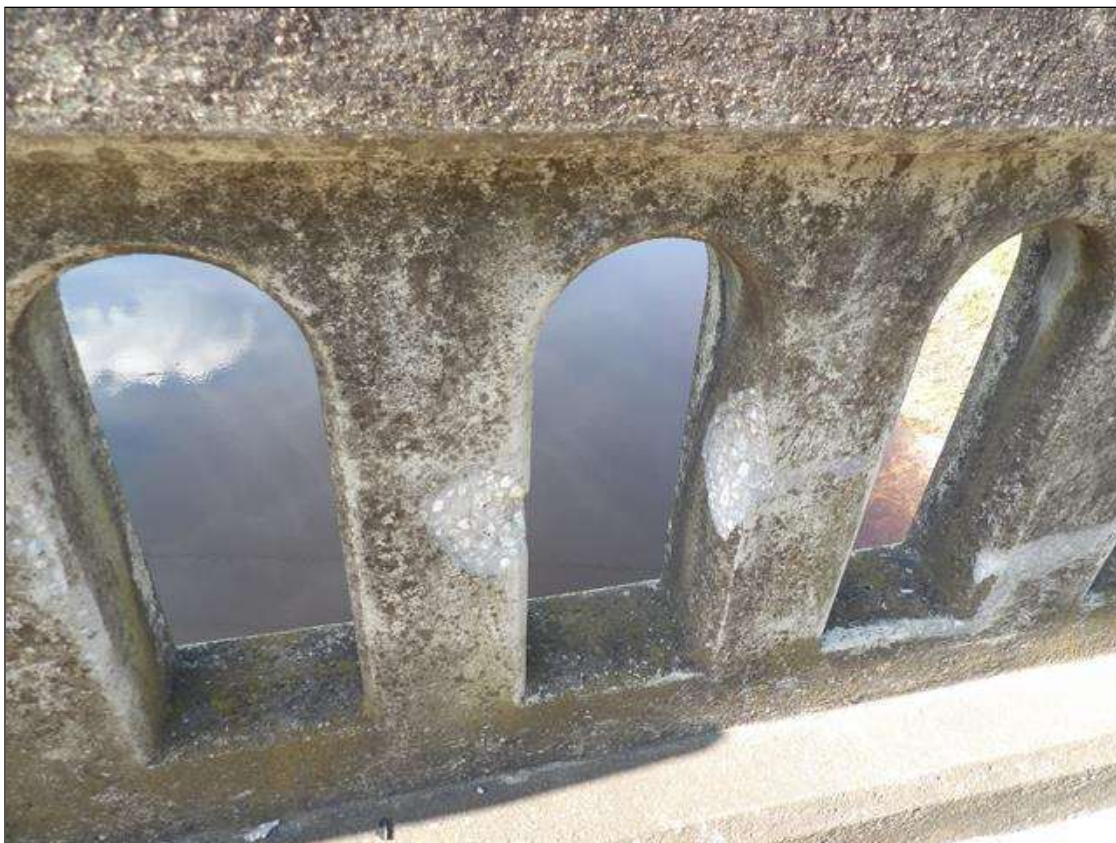
Span 3 Right Bridge Rail: 2 SPALLS LOCATED 6' BEFORE BENT 3, 4" DIAMETER EACH UP TO 1" DEEP

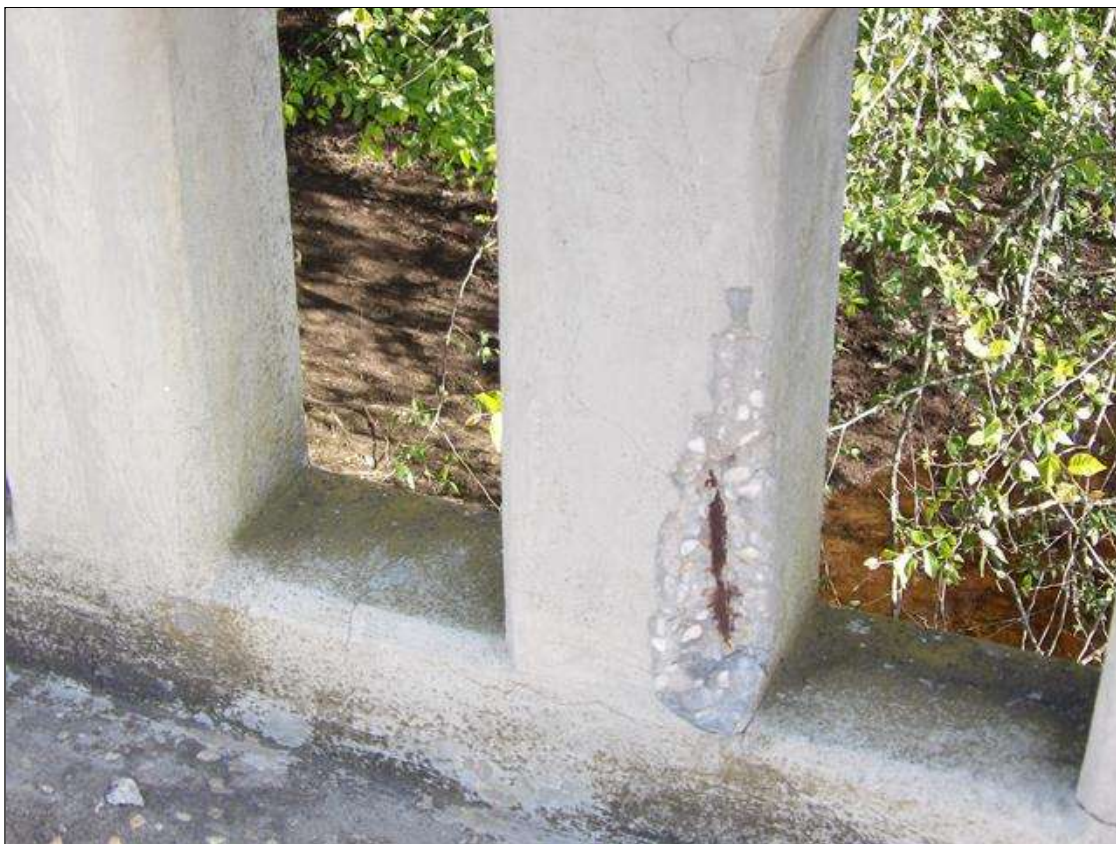
Span 3 Left Bridge Rail: SPALL ON 2ND POST FROM BENT 3, SOUTH FACE, 3" LONG X 12" HIGH X 2" DEEP WITH EXPOSED REBAR WITH NO SECTION LOSS

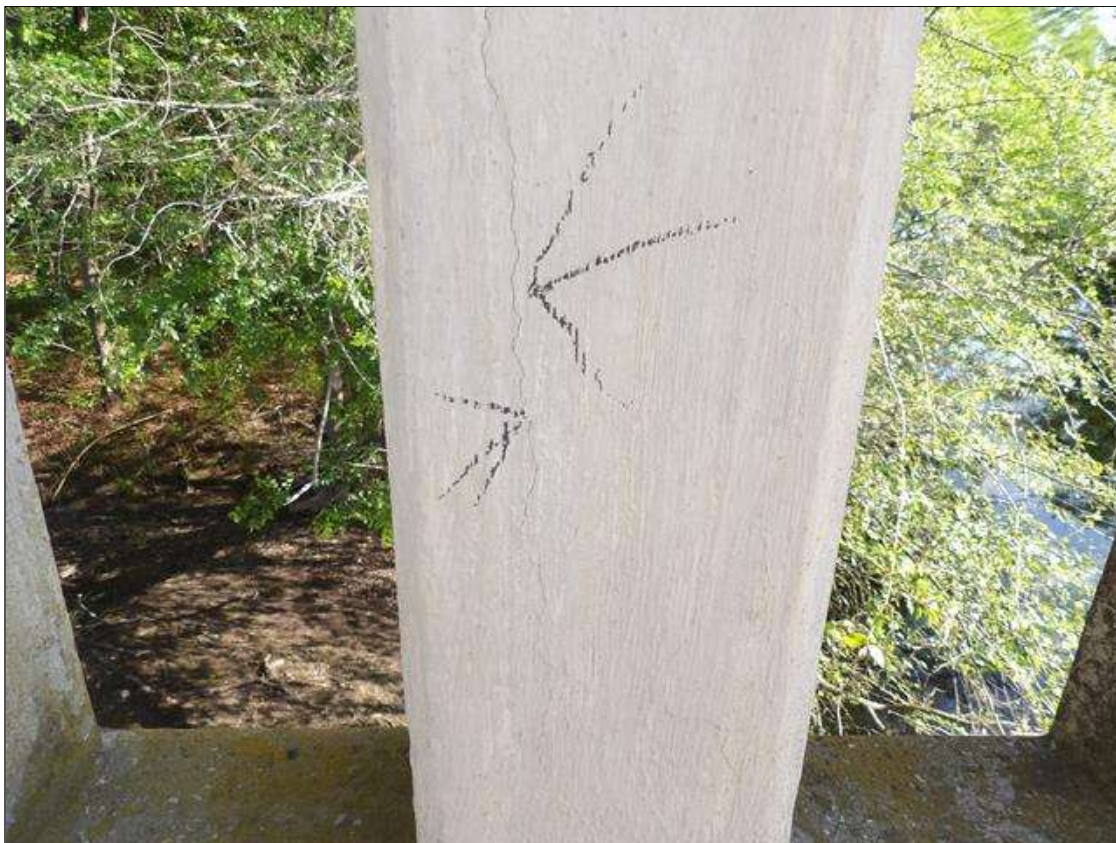
Span 3 Left Bridge Rail: HAIRLINE CRACKS IN LEFT RAIL POSTS AT VARIOUS LOCATIONS THROUGHOUT

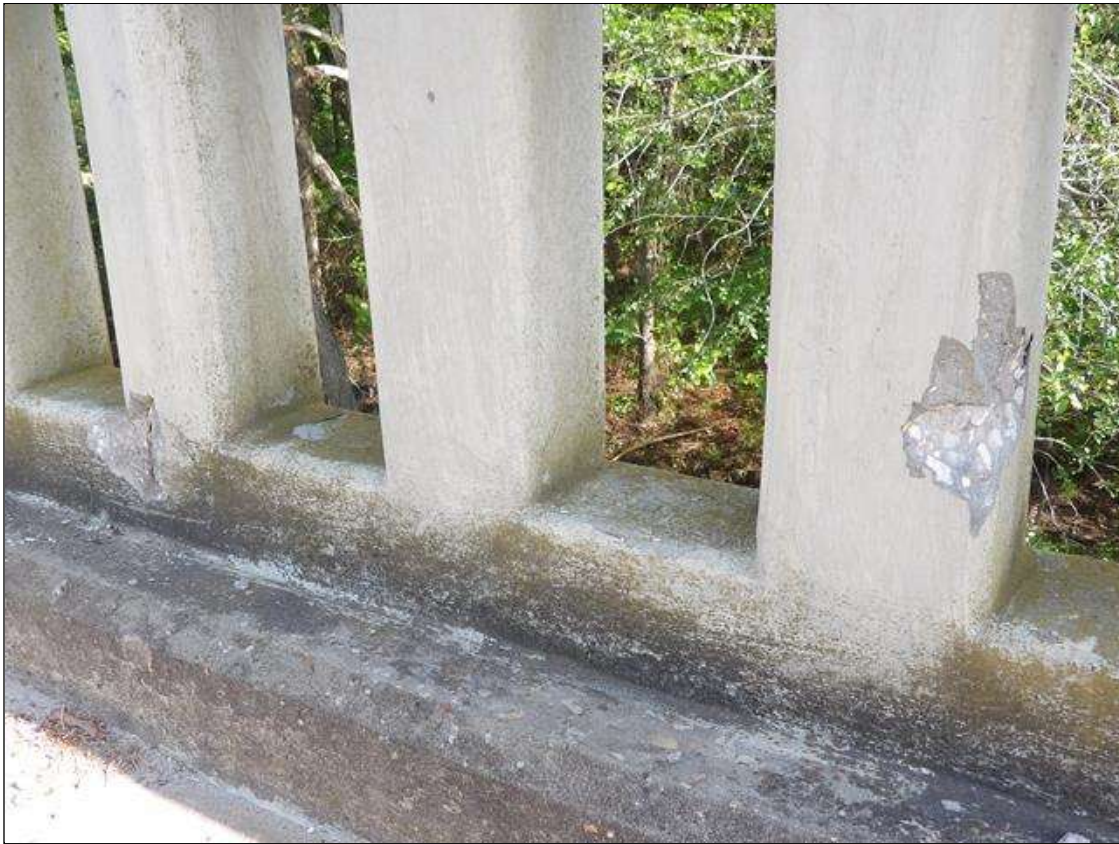
Span 3 Left Bridge Rail: (2) SPALLS UP TO 6" DIA. X 2" DEEP WITH EXPOSED REBAR WITH NO MEASURABLE SECTION LOSS IN RAIL POSTS

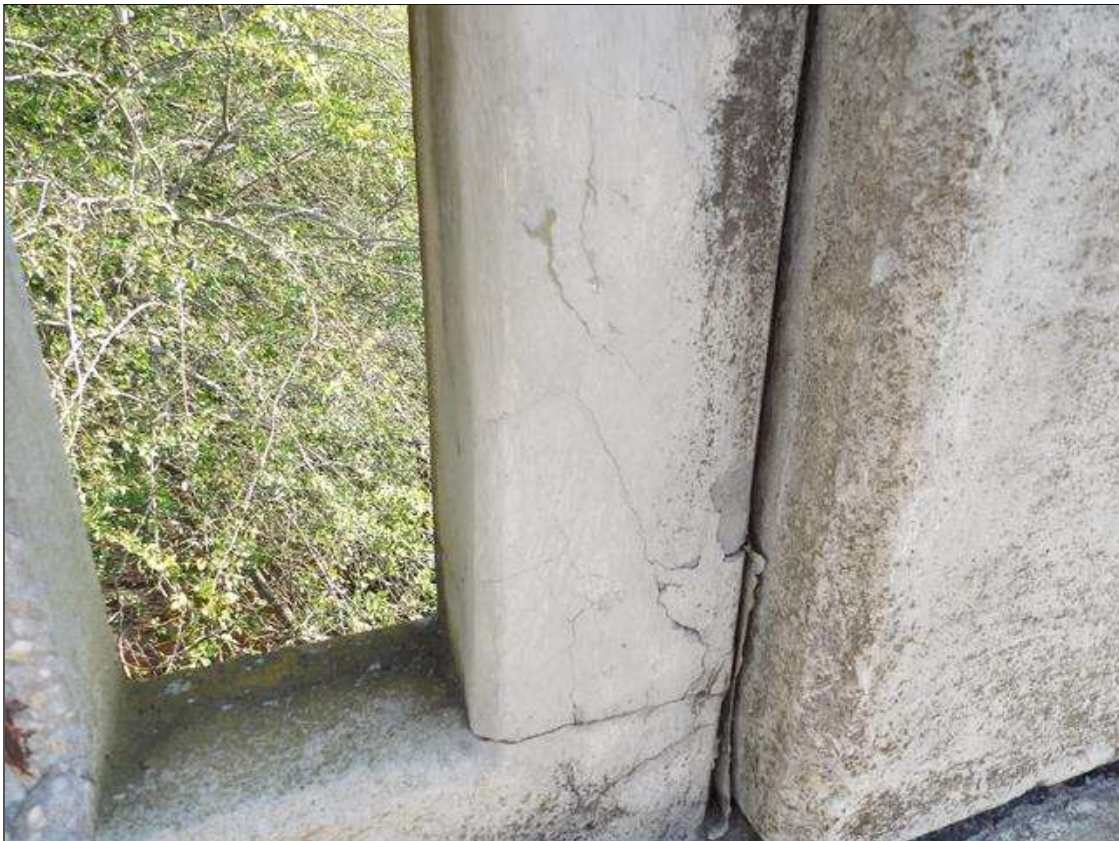
Span 3 Left Bridge Rail: UNSOUND PATCH ON LAST POST OF SPAN 3 LEFT RAIL. FULL FACE OF POST

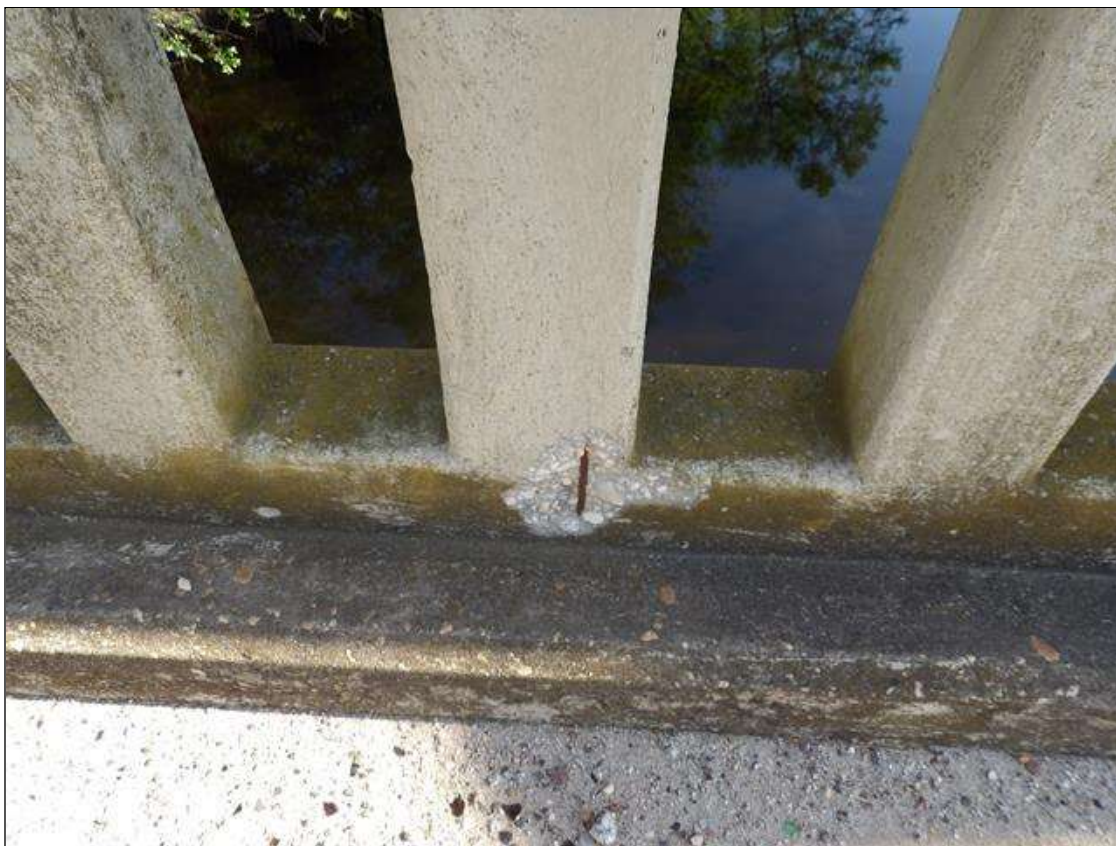
Span 4 Left Bridge Rail: 6" DIAMETER X 1" DEEP SPALL WITH EXPOSED REBAR WITH NO SECTION LOSS. LOCATED AT MIDSPAN LEFT RAIL SPAN 4

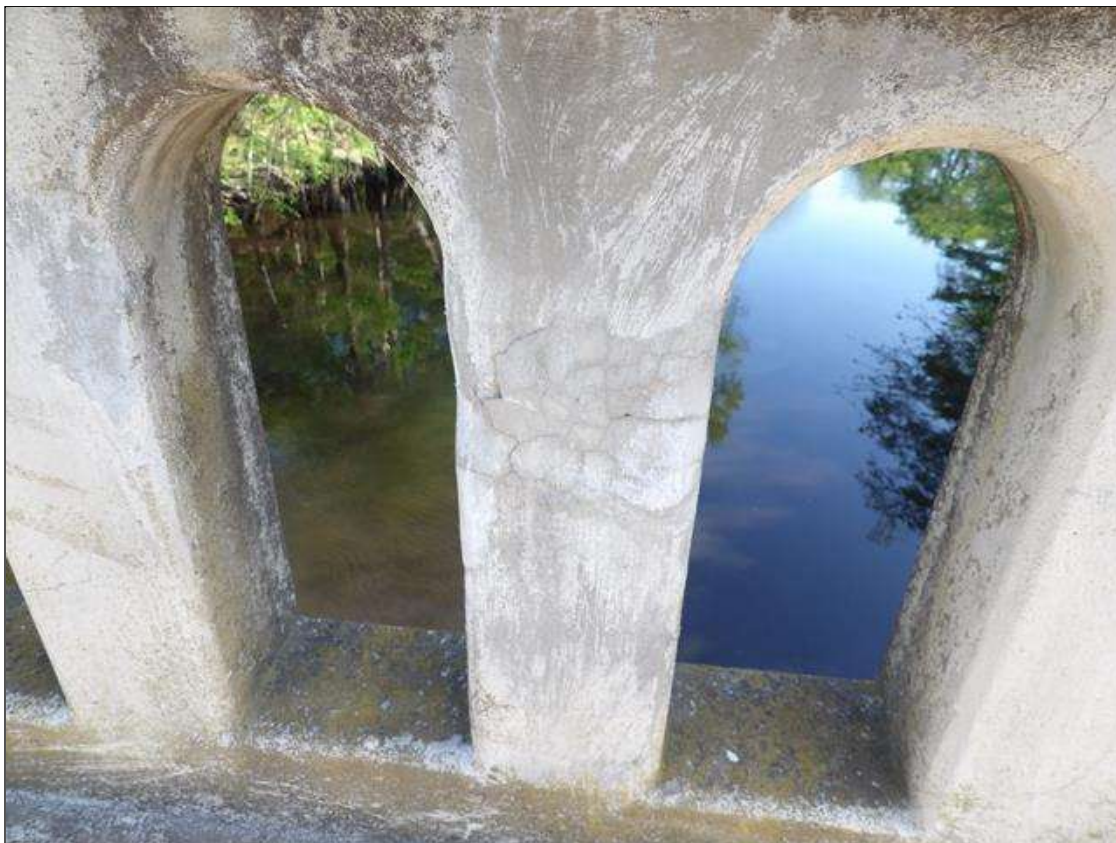
Span 5 Left Bridge Rail: 4TH POST FROM BENT 5 UNSOUND PATCH ON TOP HALF OF INTERIOR FACE. PATCH IS DELAMINATED.

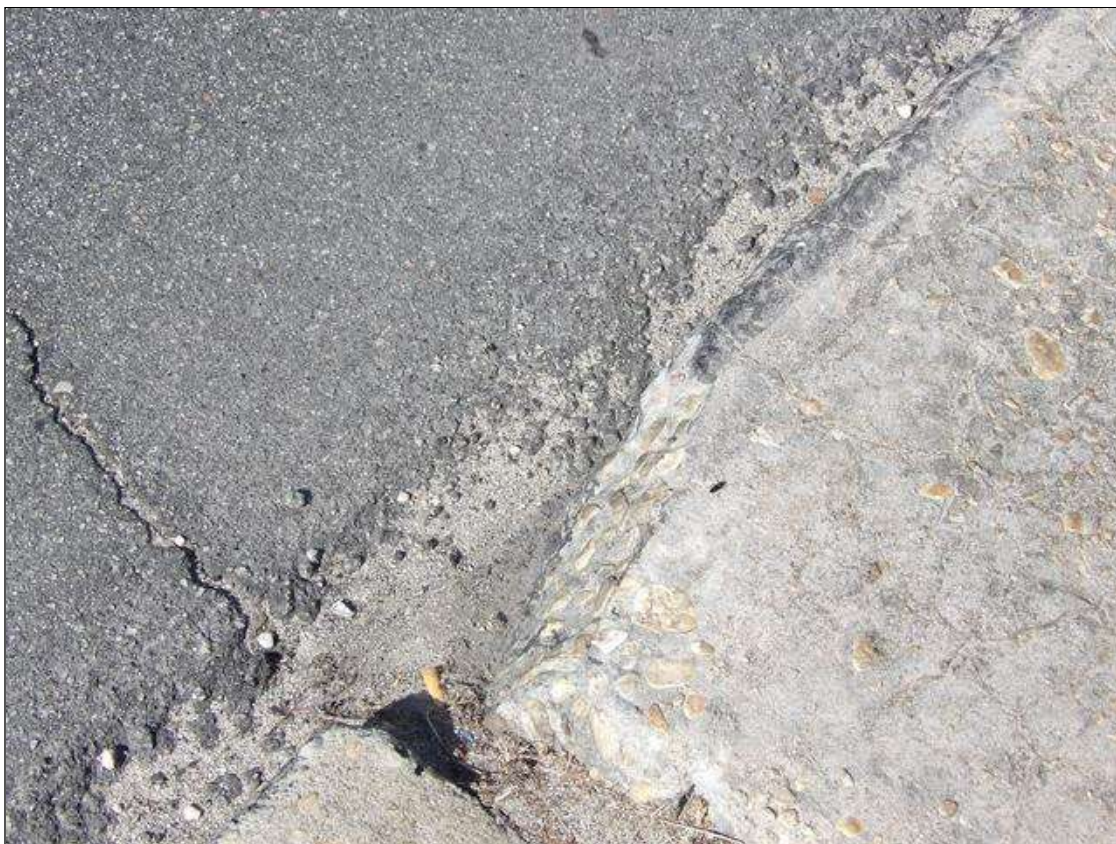
SIDEWALK AT EAST END, OVER END BENT 2, CORNER SPALL 8" X 6" X 1" DEEP

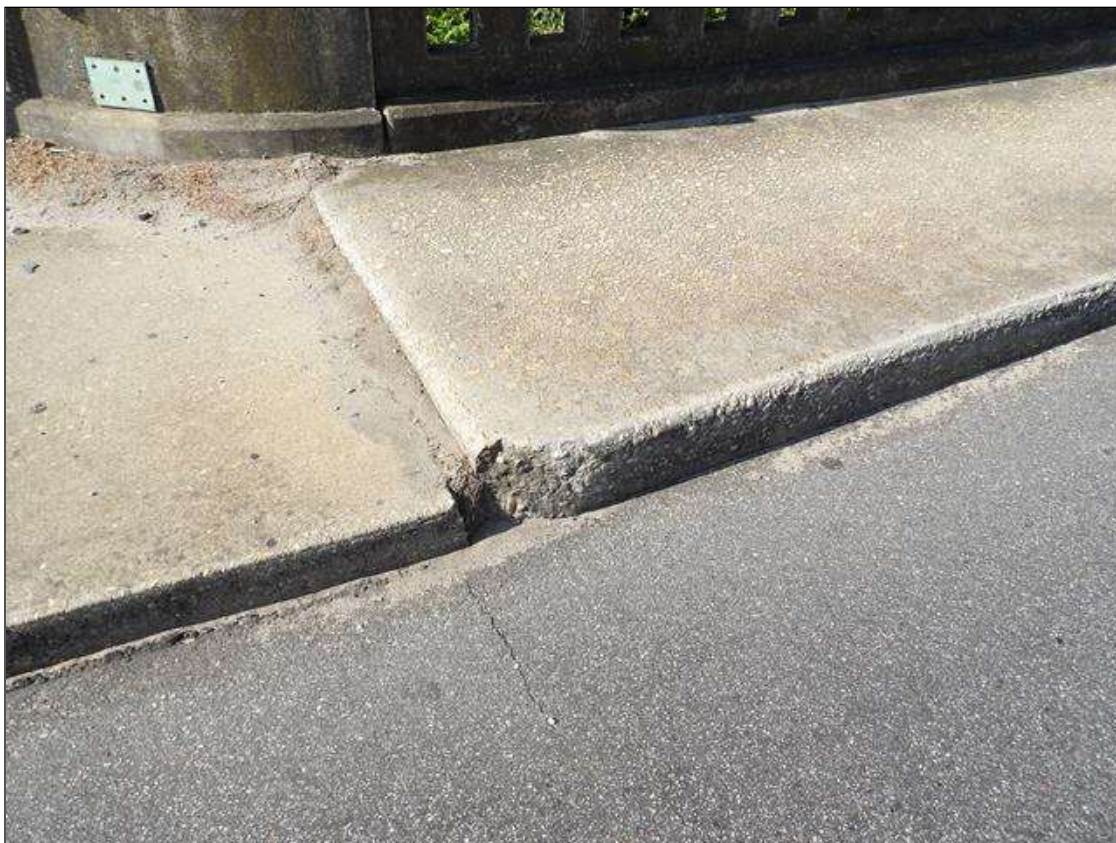
RIGHT SIDEWALK EAST END CORNER SPALL 9" X 7" X UP TO 3" DEEP

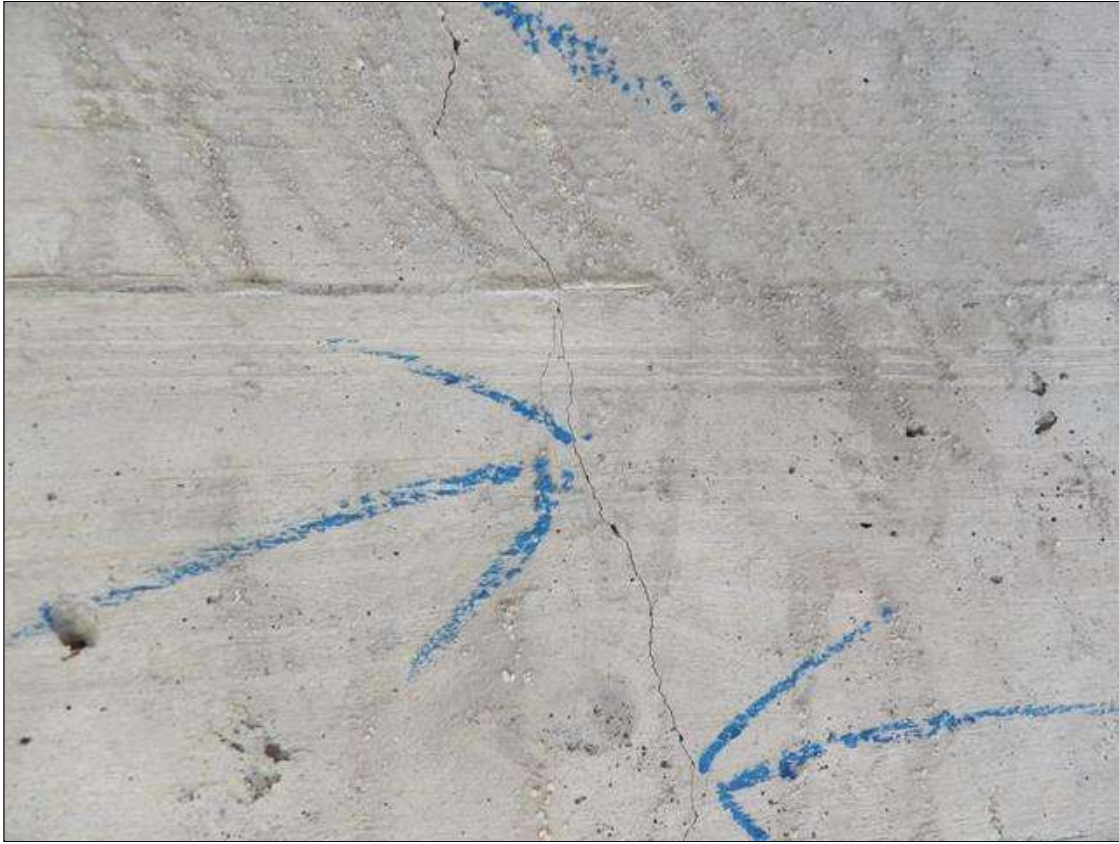
TYPICAL HAIRLINE VERTICAL CRACKS IN THE WEB AREA THROUGHOUT THE LENGTH OF THE BEAMS, SPAN 1 BEAM 5 SHOWN.

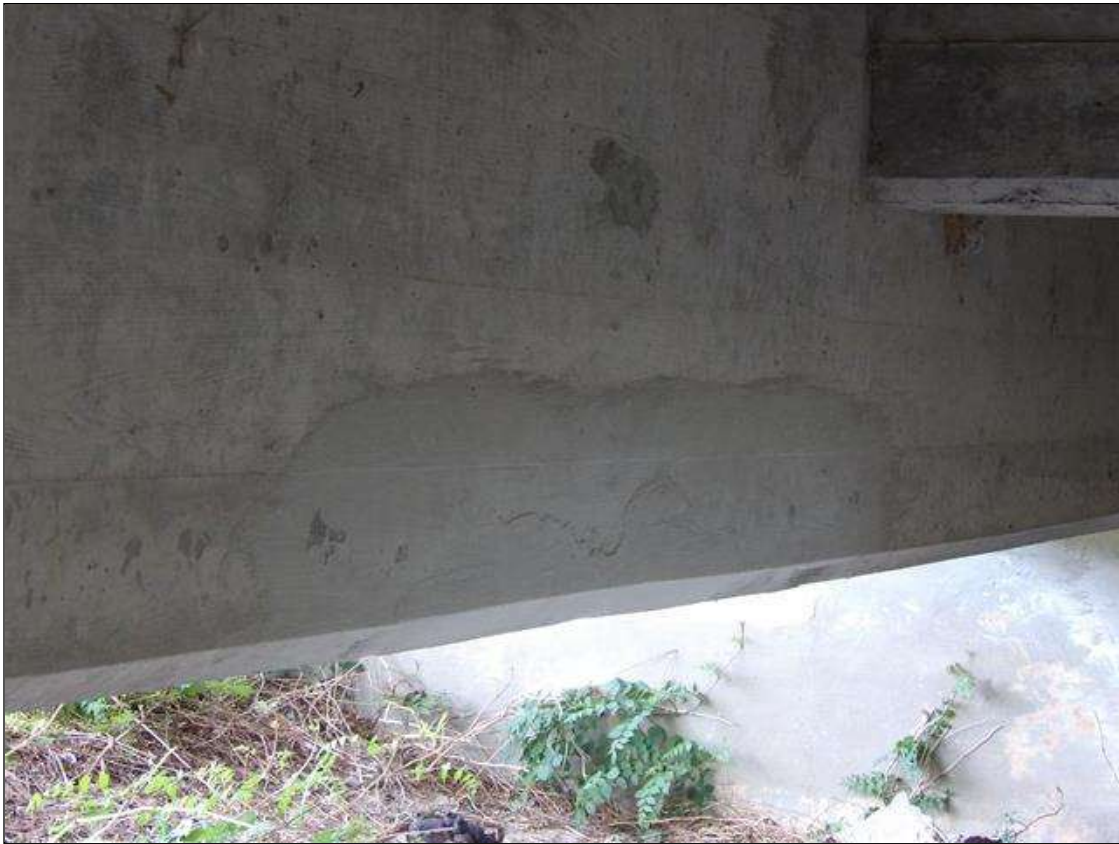
Span 1 Beam 5: 4.5' X 16" AREA PATCH 10' FROM END BENT 1. ON INTERIOR FACE OF WEB EXTENDING ON FULL WIDTH OF BOTTOM FLANGE AND EXTENDING 3" ON EXTERIOR FACE WITH 6" DIAMETER AREA OF DELAMINATION WITH HAIRLINE MAP CRACKING THROUGHOUT PATCH

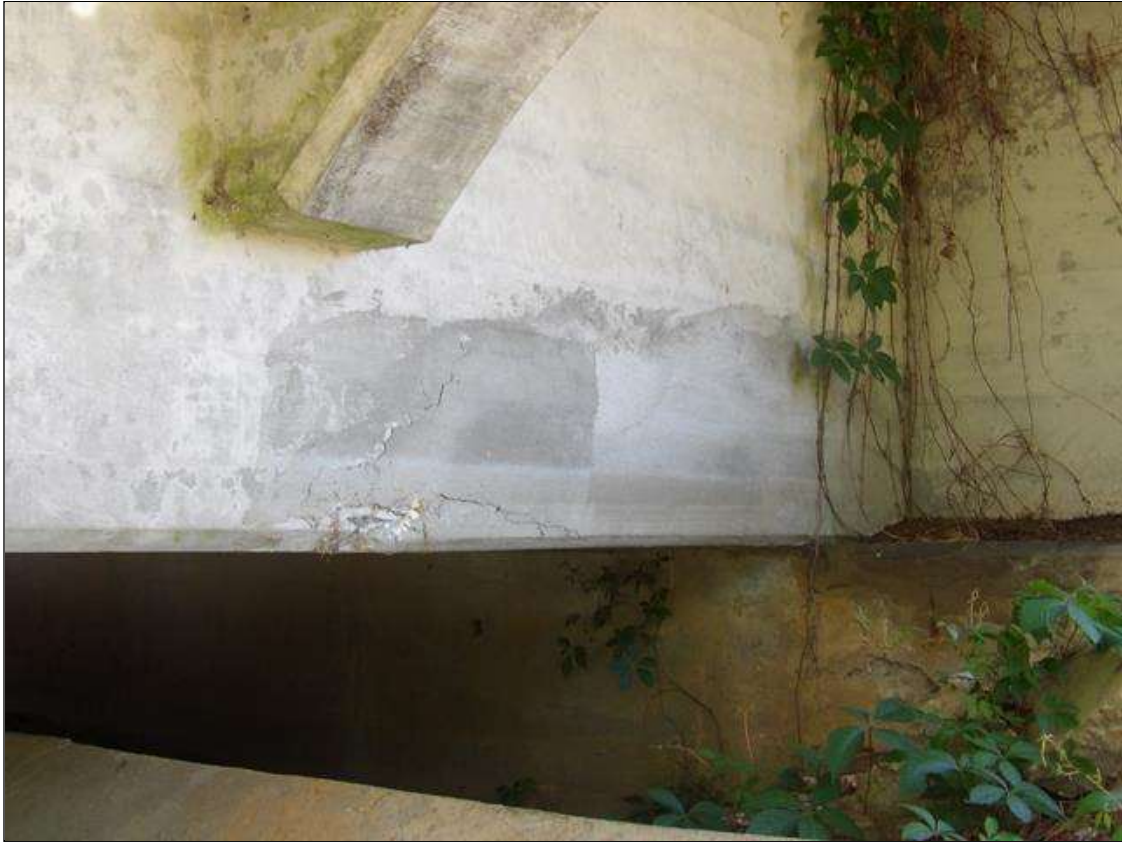
Span 1 Beam 1: LARGE FAILING PATCH 15' LONG X 2' WIDE ON LEFT BOTTOM FACE 18" FROM END BENT 1

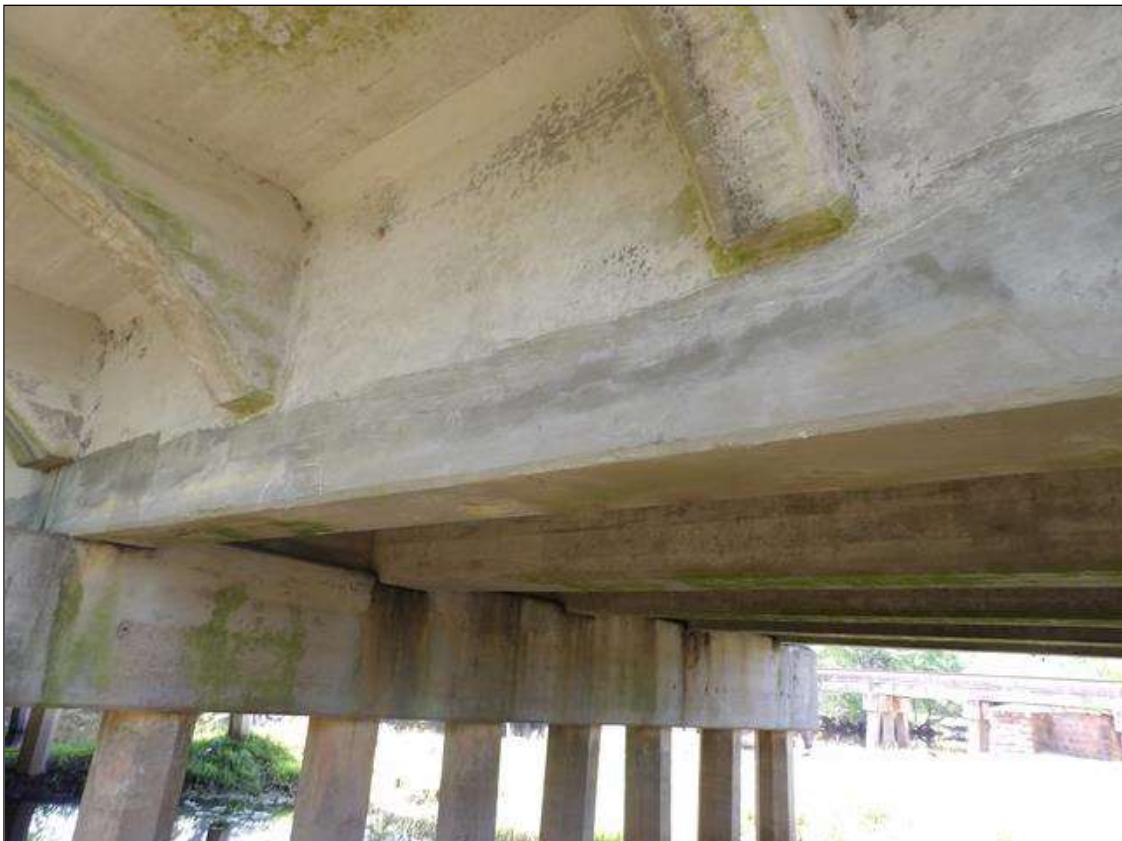
Span 1 Beam 1: 12' FROM BENT 1. FAILING PATCH 8' LONG X FULL BEAM WIDTH ON THE BOTTOM OF THE BEAM AND BOTH FACES.

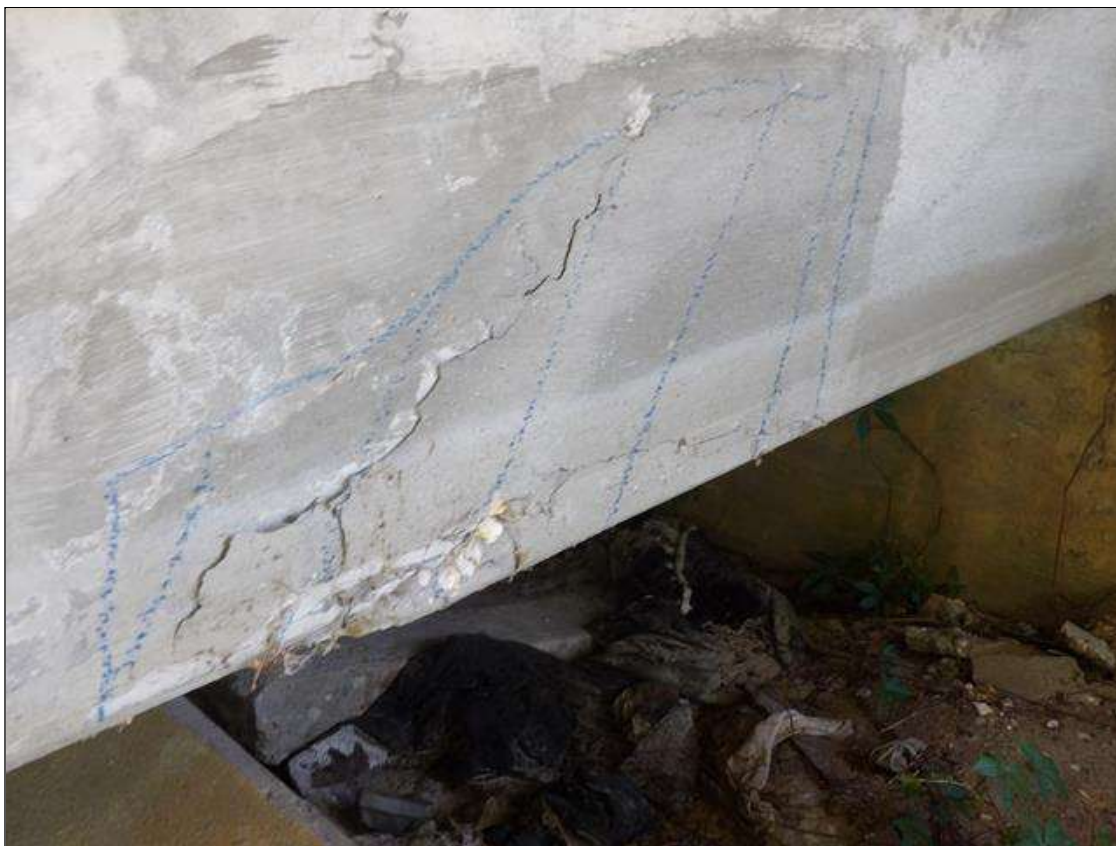
Span 1 Beam 1: 5' FROM END BENT 1, BOTTOM LEFT CORNER DELAMINATION 3' X 2' AREA

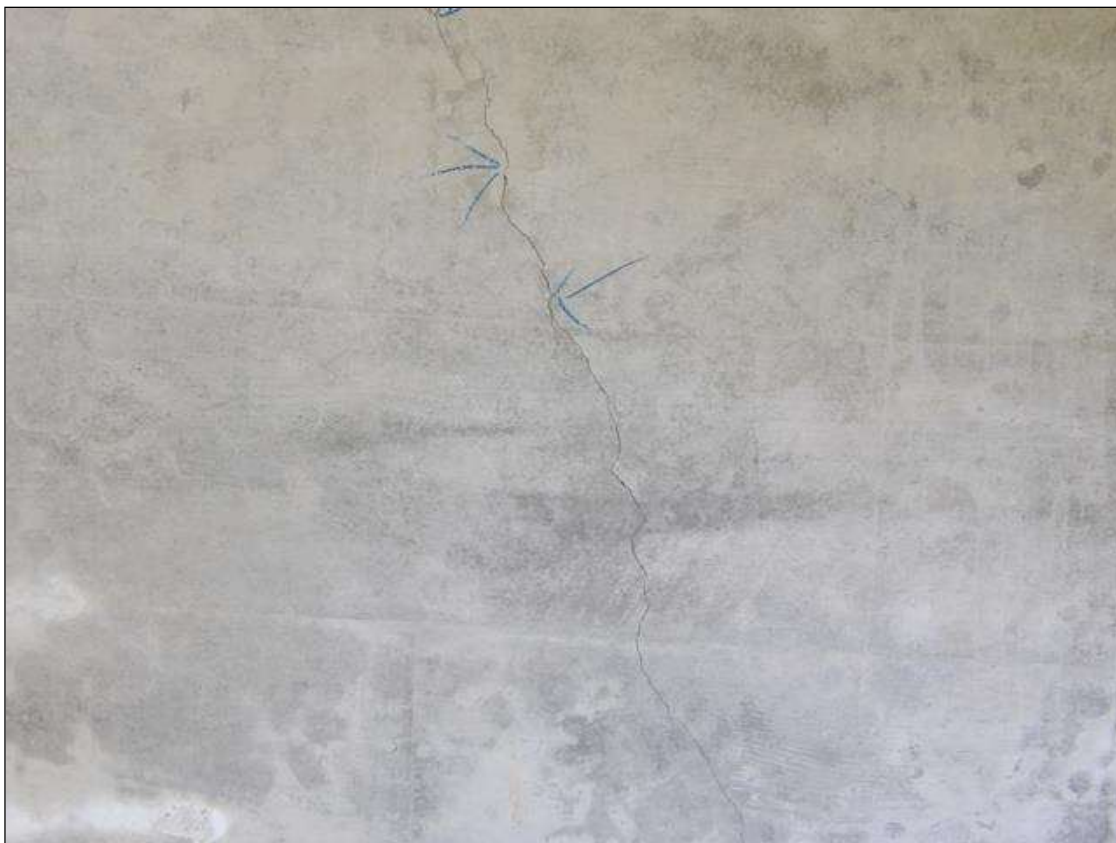
TYPICAL HAIRLINE DIAGONAL CRACKS ON WEB OF BEAM, SPAN 1 BEAM 1 SHOWN
