NC DEPARTMENT OF TRANSPORTATION
 DIVISION OF HIGHWAYS
 STRUCTURE MANAGEMENT UNIT

ATTENTION: PRIORITY ACTION REQUEST ISSUED; HYDRA-PLATFORM USED

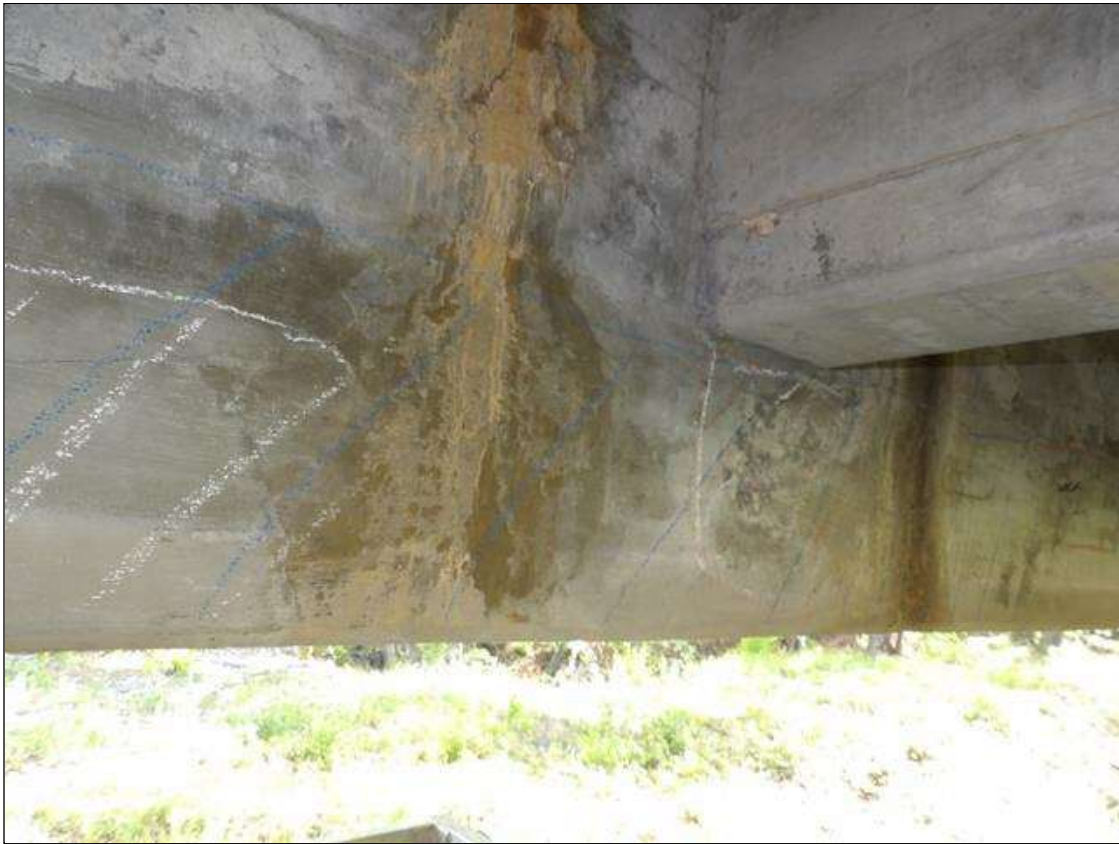
Span 1 Beam 1: 12' LONG X UP TO 2' WIDE AREA OF DELAMINATION IN RIGHT FACE NEAR MIDSPAN

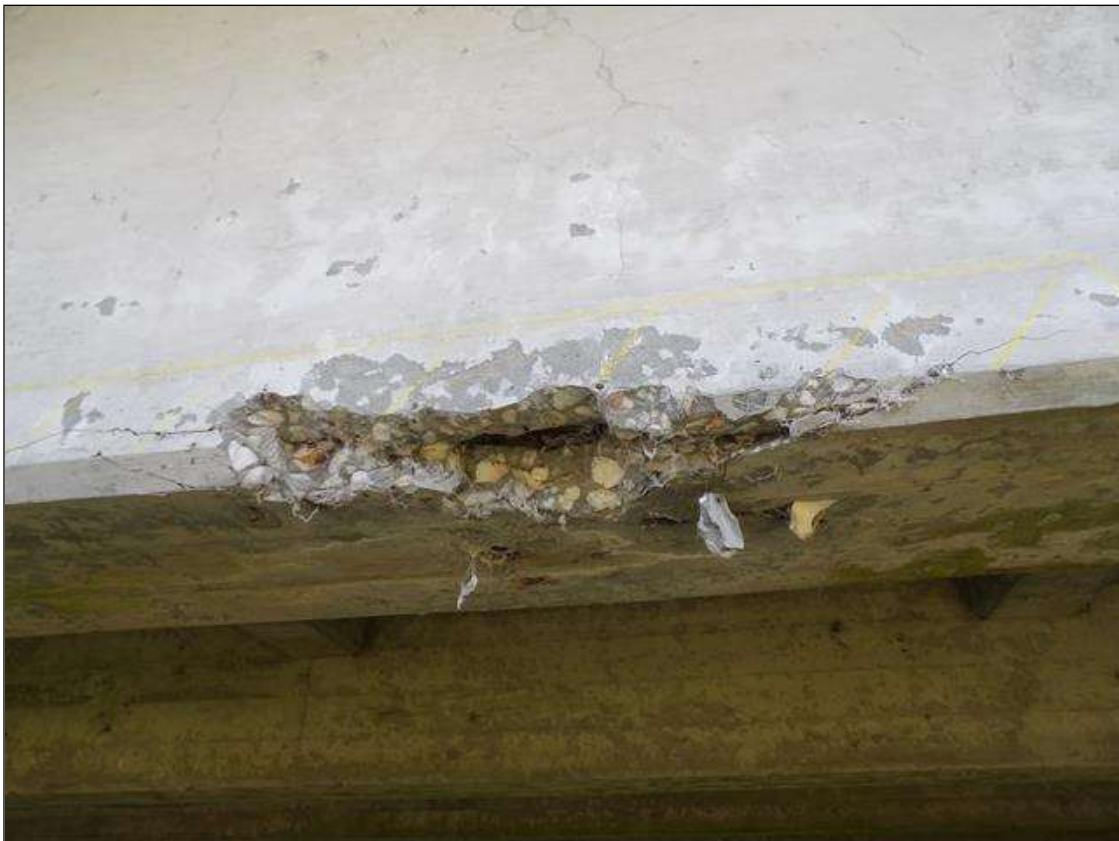
Span 1 Beam 5: PAR - 9' FROM BENT 1, BOTTOM OF BEAM BOTH SIDES, SPALL AND DELAMINATION 5' LONG X 6" HIGH X 3" DEEP WITH EXPOSED REBAR WITH MINOR SECTION LOSS

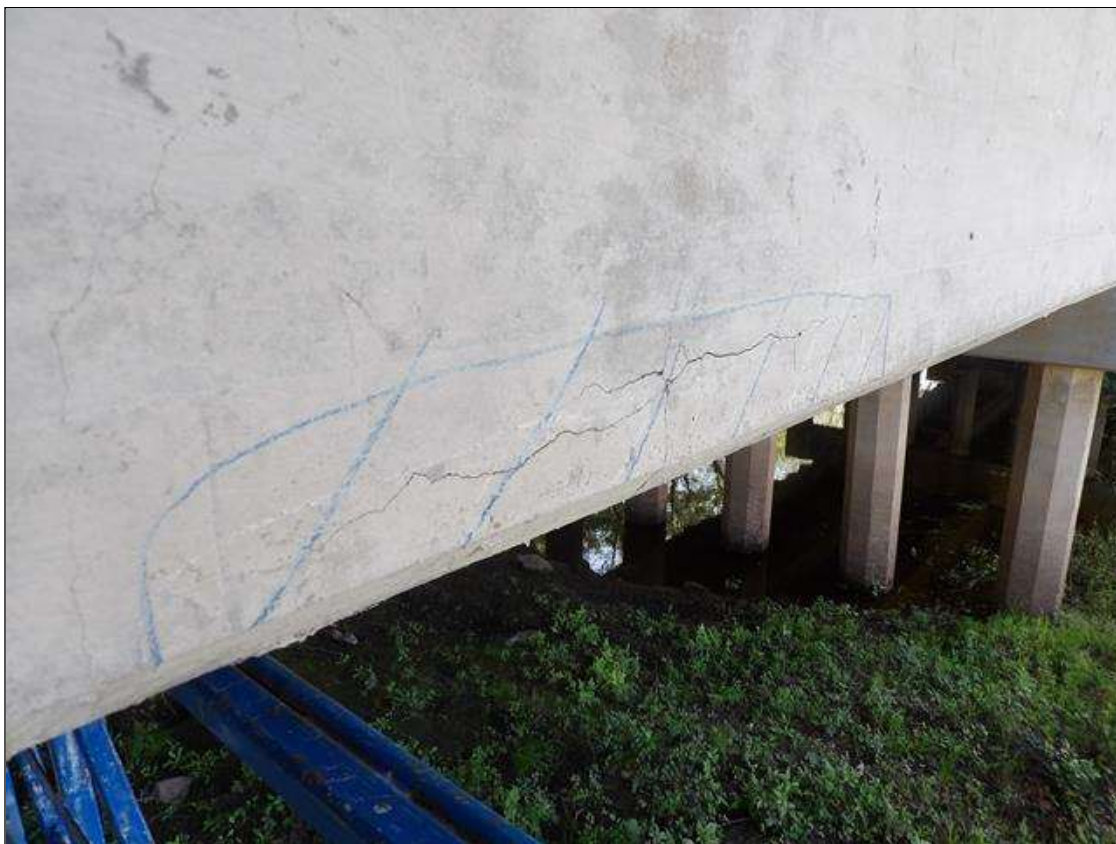
Span 1 Beam 5: 21' FROM END BENT 1, RIGHT SIDE 20" LONG X 3" DELAMINATION

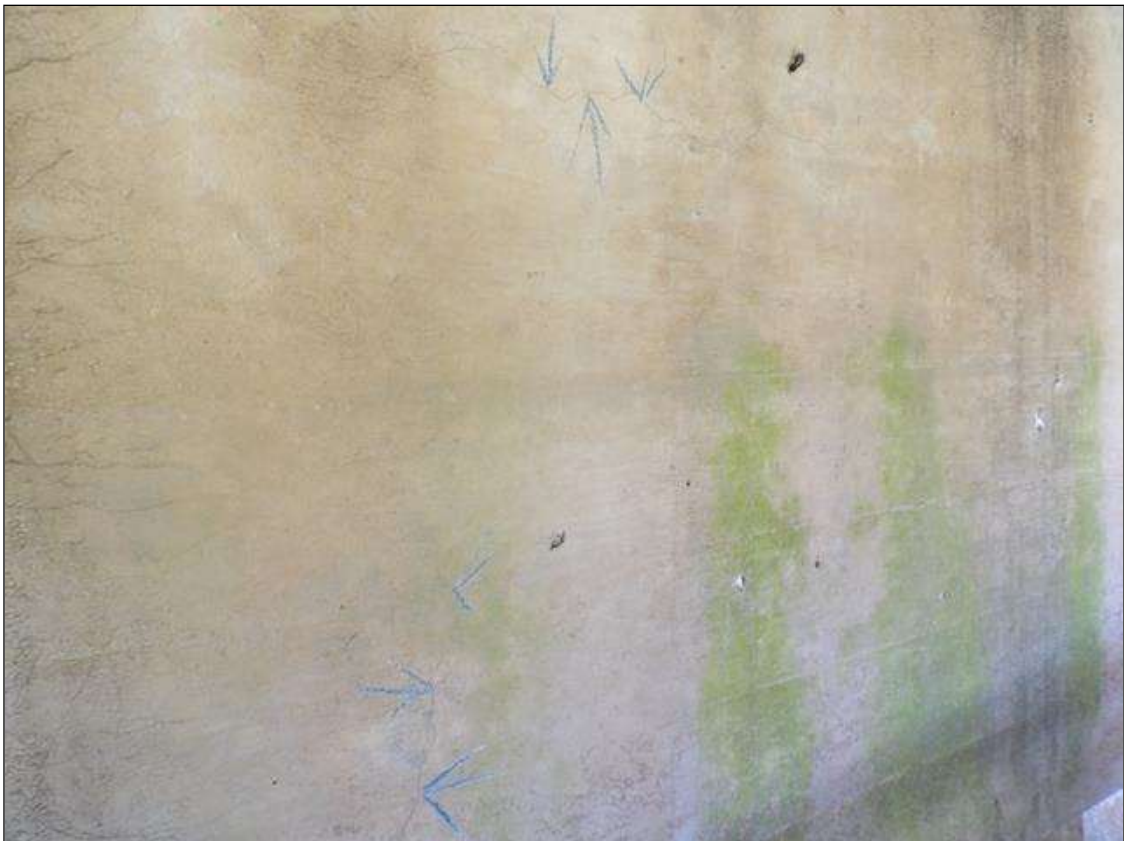
TYPICAL HAIRLINE TO 1/32" VERTICAL/HORIZONTAL CRACKS IN CAP, BENT 1 CAP SHOWN

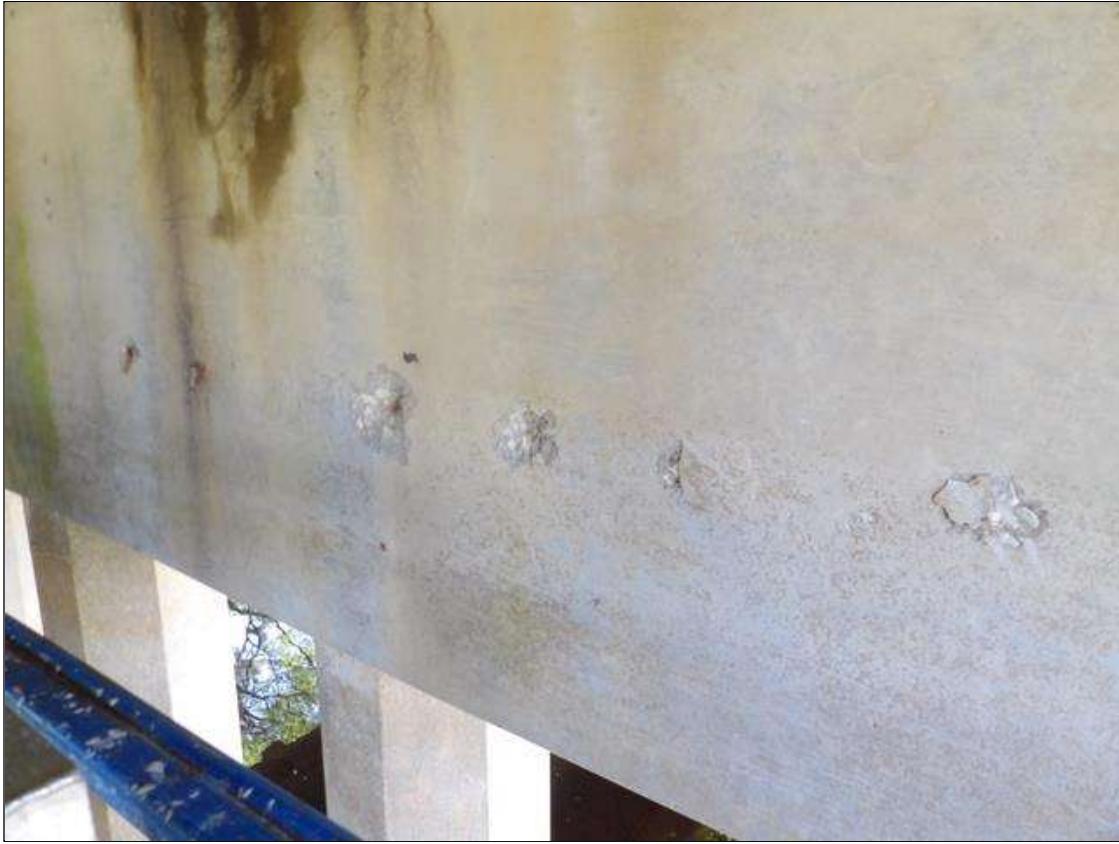
Bent 1 Cap 1: (15) UP TO 5" DIAMETER X 1" DEEP ROUND POP OUT SPALLS WITH EXPOSED REBAR WITH NO MEASURABLE SECTION LOSS ON WEST FACE

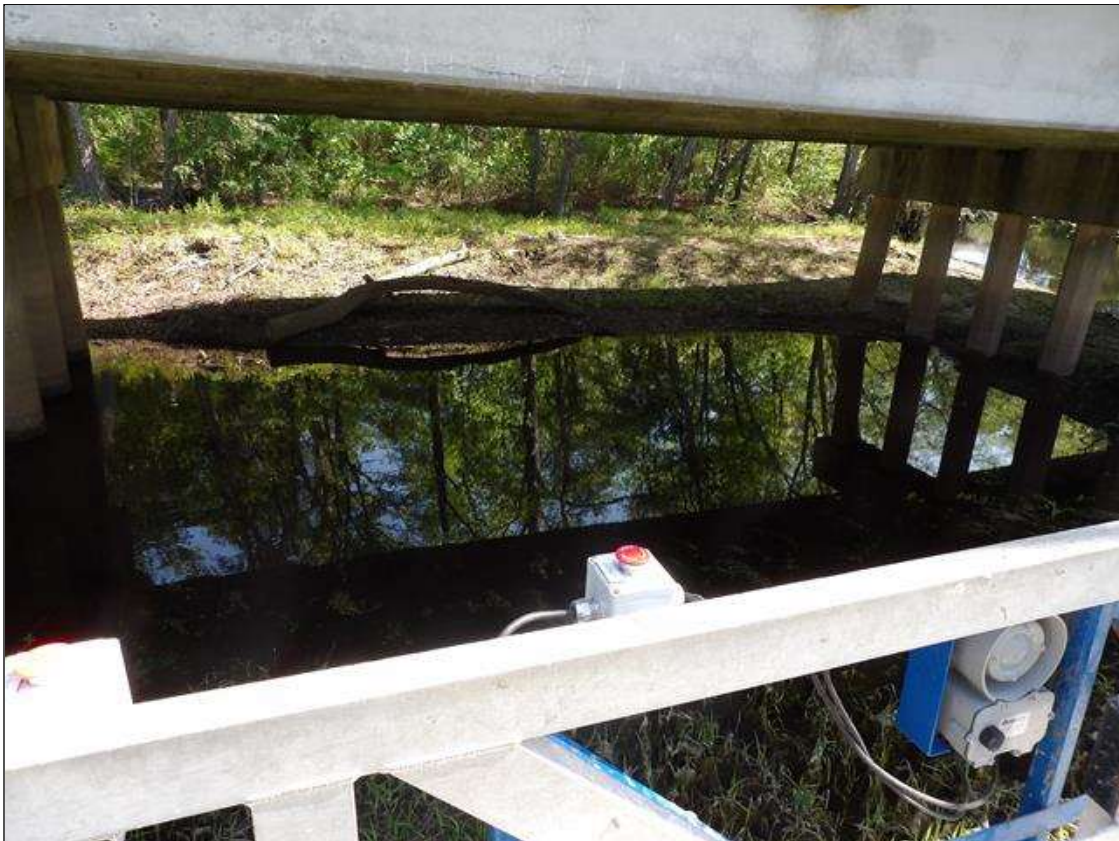
SPAN 2 FULL LENGTH X FULL WIDTH X 2' DEEP SCOUR HOLE WITH STANDING WATER

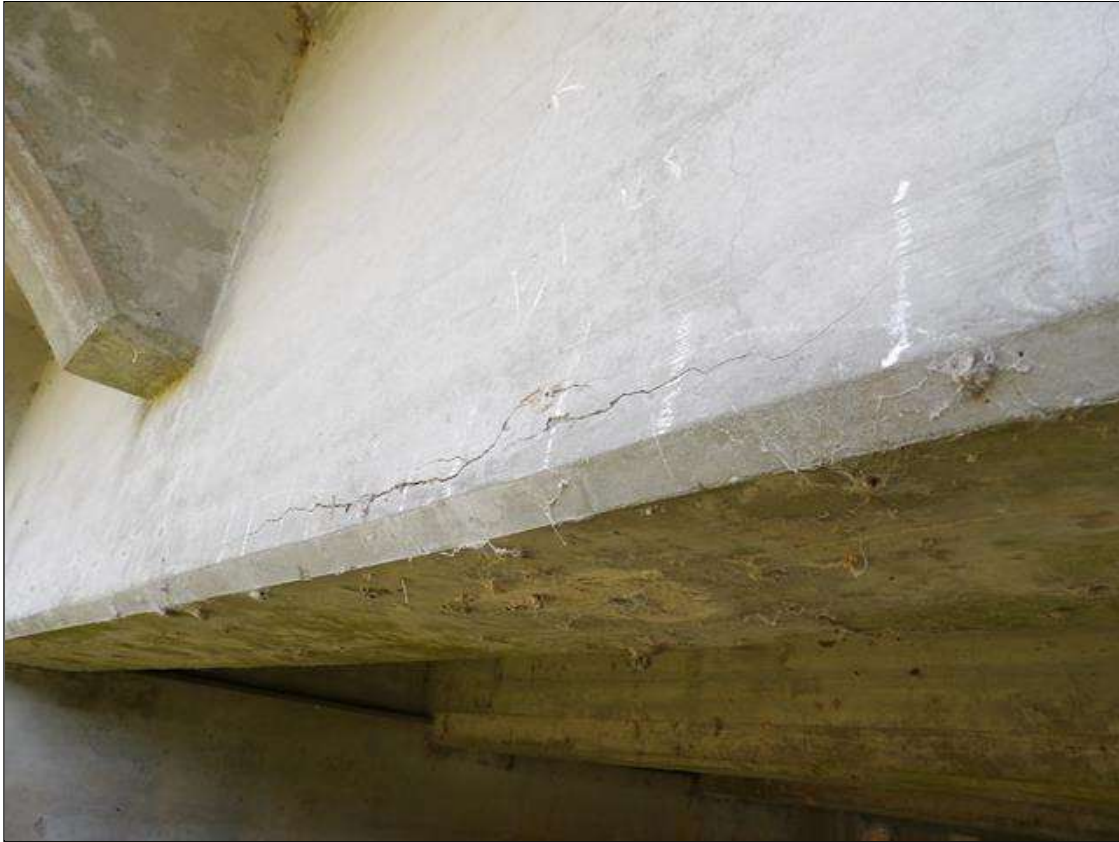
Span 2 Beam 5: 9' FROM BENT 1. 2' LONG X 5" HIGH AREA OF DELAMINATION WITH ASSOCIATED CRACKING
IN RIGHT BOTTOM FACE

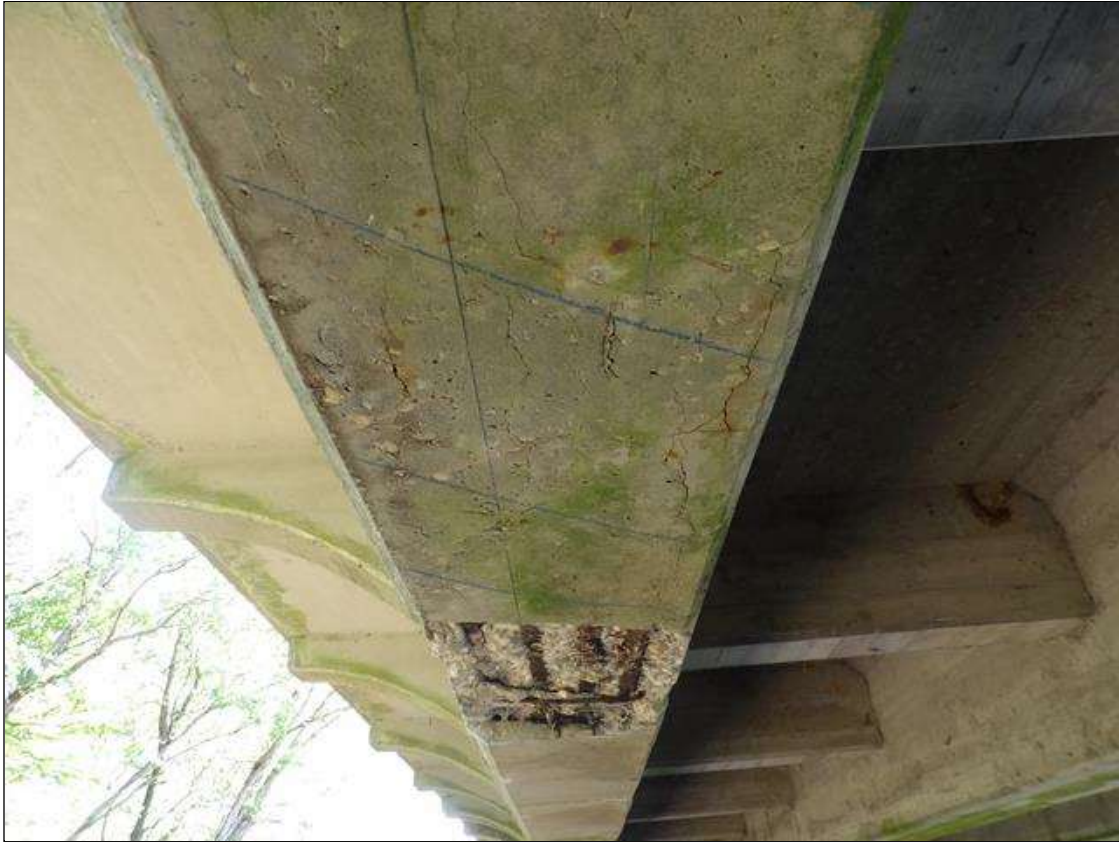
Span 2 Beam 1: PAR -- 12' LONG X FULL WIDTH OF BOTTOM FLANGE EXTENDING 3" ON BOTH FACES AREA OF DELAMINATION WITH 2' LONG X FULL WIDTH X 3" DEEP SPALL WITH EXPOSED REBAR WITH MINIOR SECTION LOSS STARTING 2' FROM BENT 1

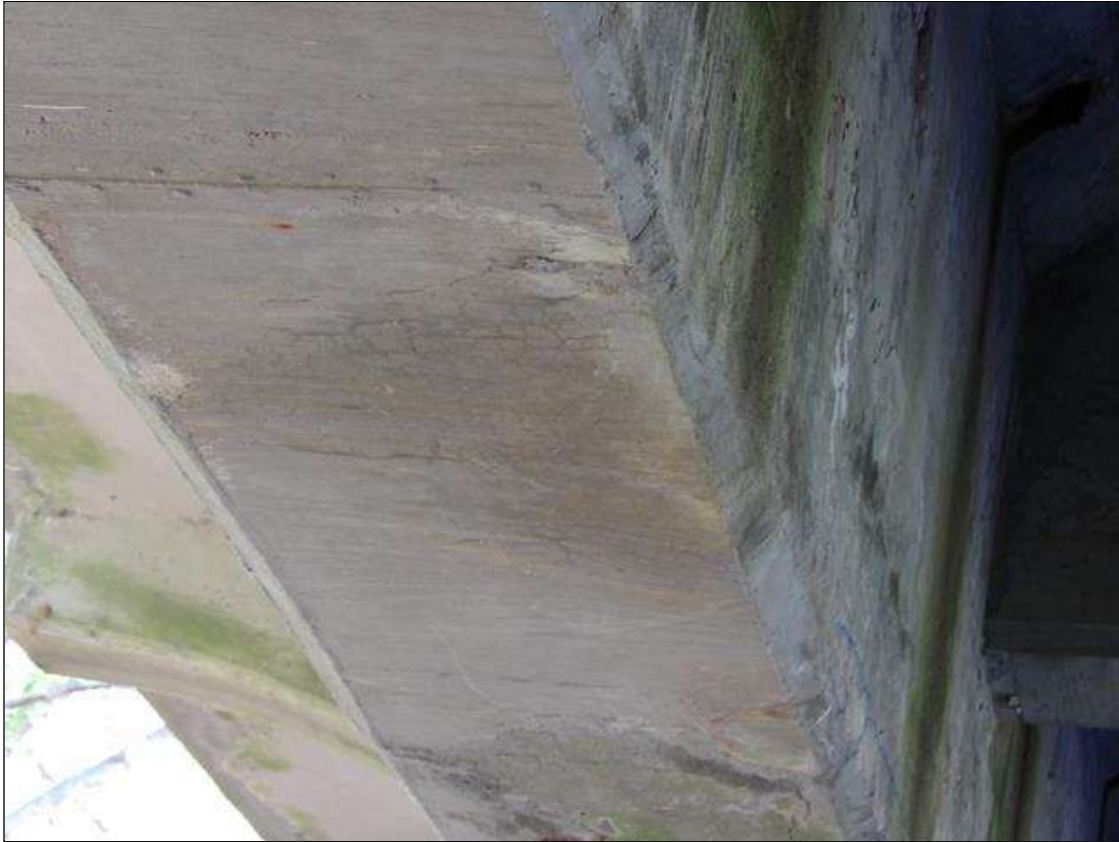
Span 2 Beam 1: SOUND PATCHED AREAS ON THE BOTTOM OF THE BEAM INTERMITTENT THROUGHOUT SPAN EXTENDING 16" FROM BOTTOM OF BEAM ON INTERIOR AND EXTERIOR FACES

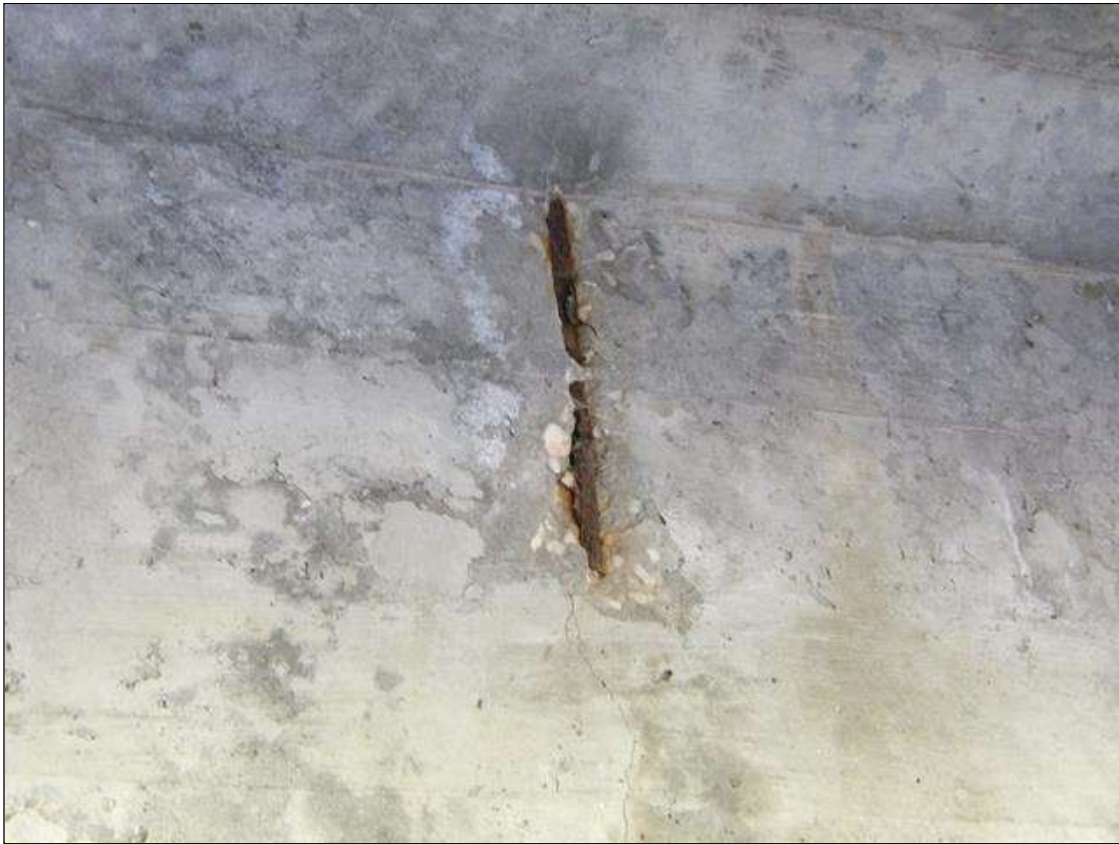
Span 2 Beam 1: 1' LONG X 3" WIDE X 1" DEEP SPALL WITH EXPOSED REBAR WITH NO MEASURABLE SECTION LOSS IN RIGHT FACE NEAR MIDSPAN

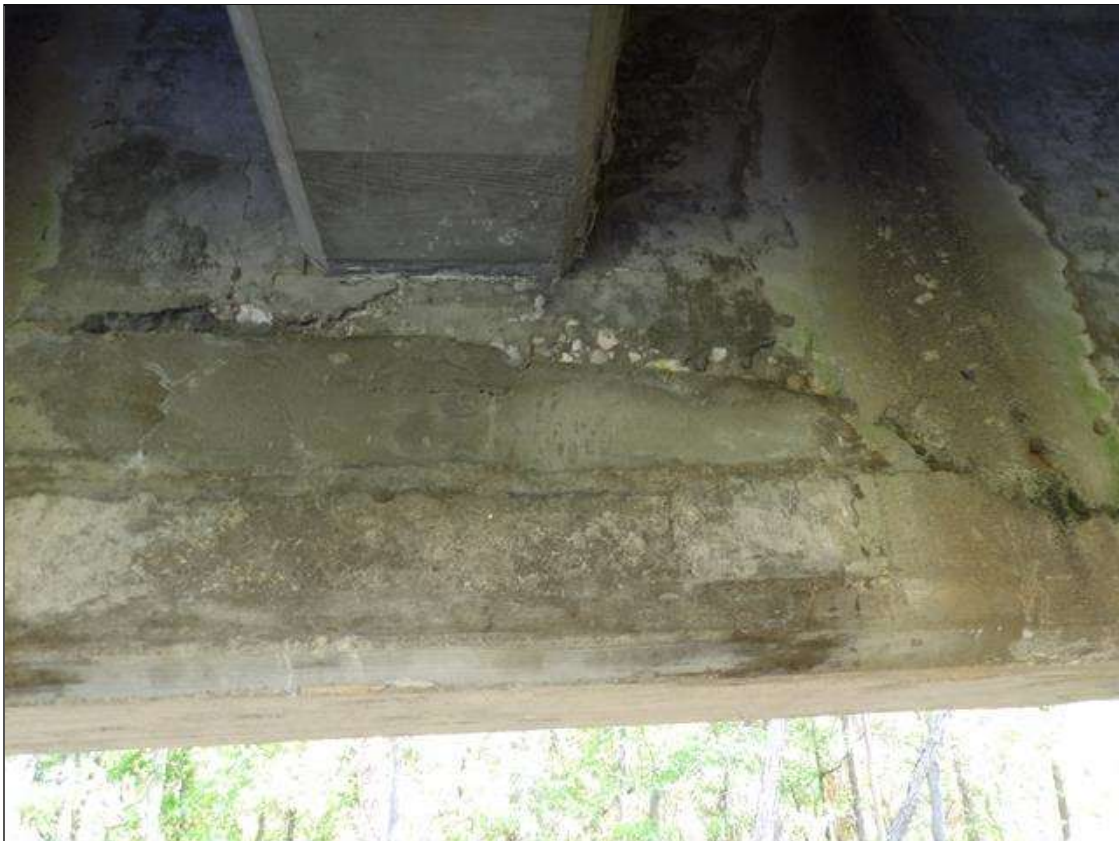
Span 2 Beam 1: PATCHED AREAS ON BOTH FACES THROUGHOUT THE LENGTH OF THE BEAM ARE BEGINNING TO FAIL AND SHOW DELAMINATION

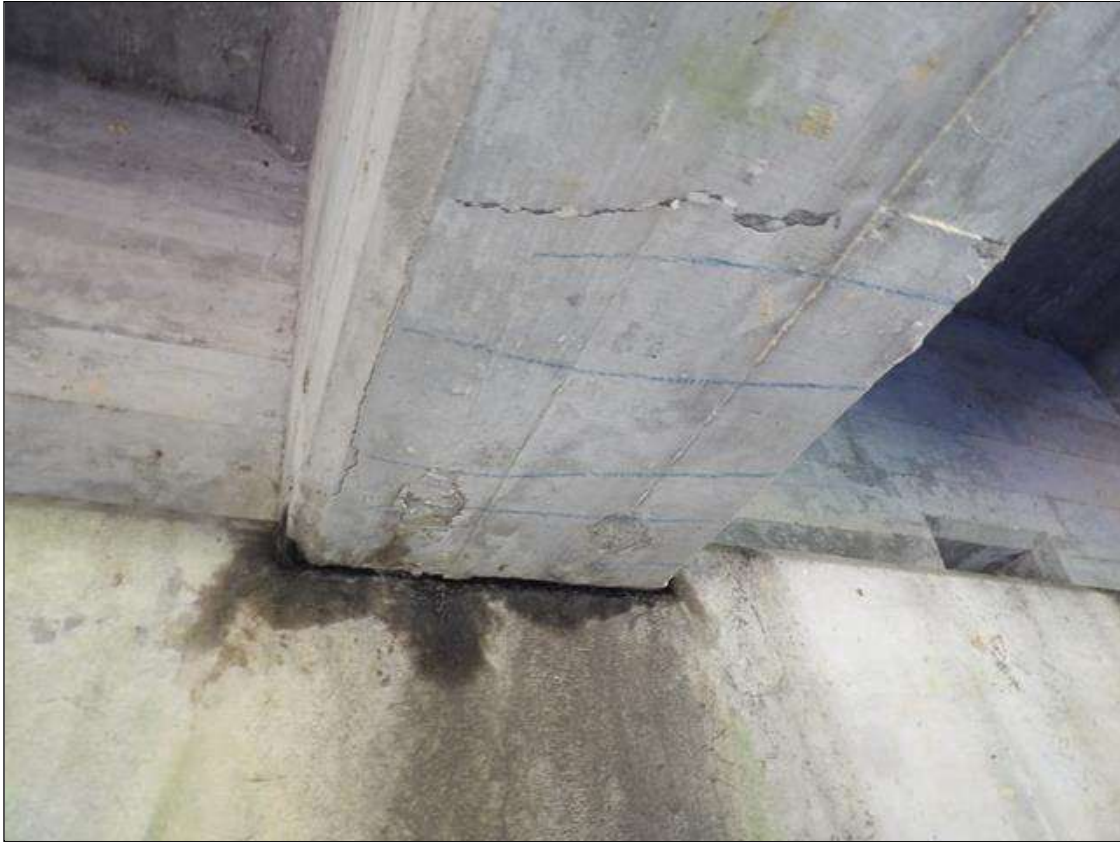
Span 2 Beam 2: 2' LONG X FULL WIDTH AREA OF DELAMINATION IN BOTTOM FACE AT BENT 2

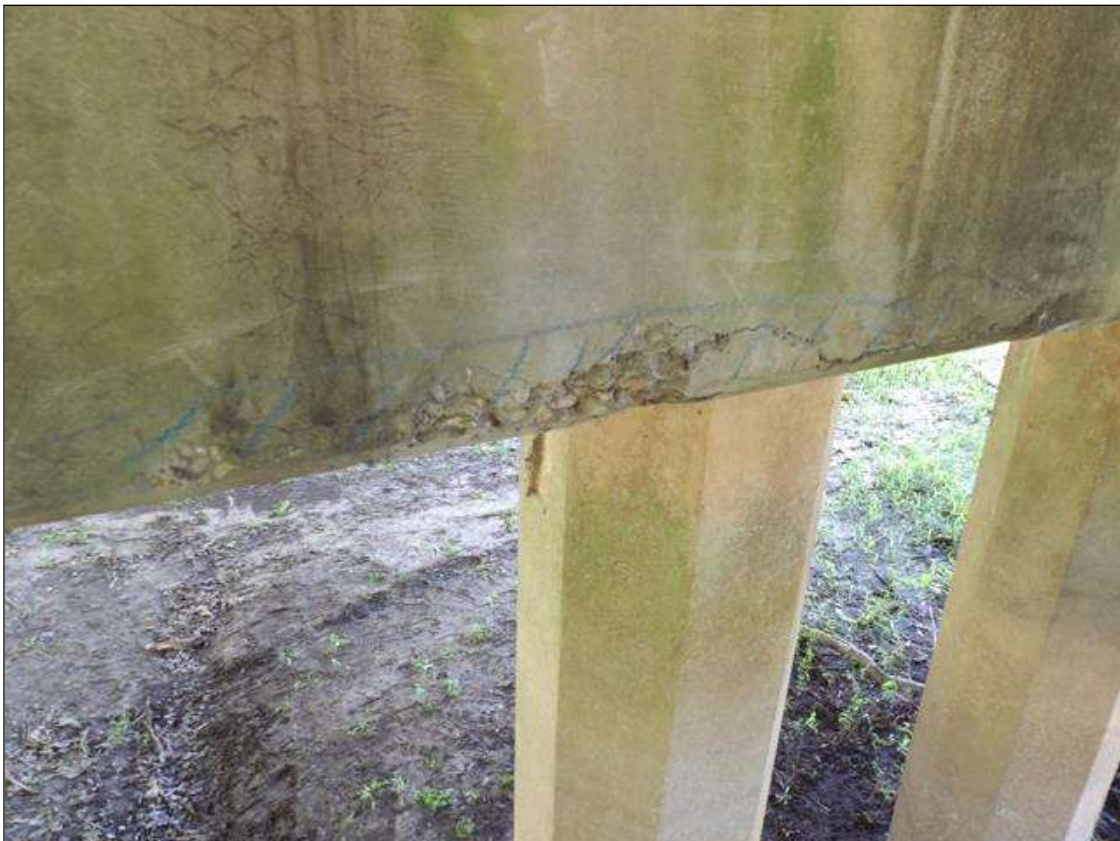
Bent 2 Cap 1: 2' LONG X 4" HIGH DELAMINATION WITH DETERIORATED CONCRETE AND CRACKS UNDER BEAM 2

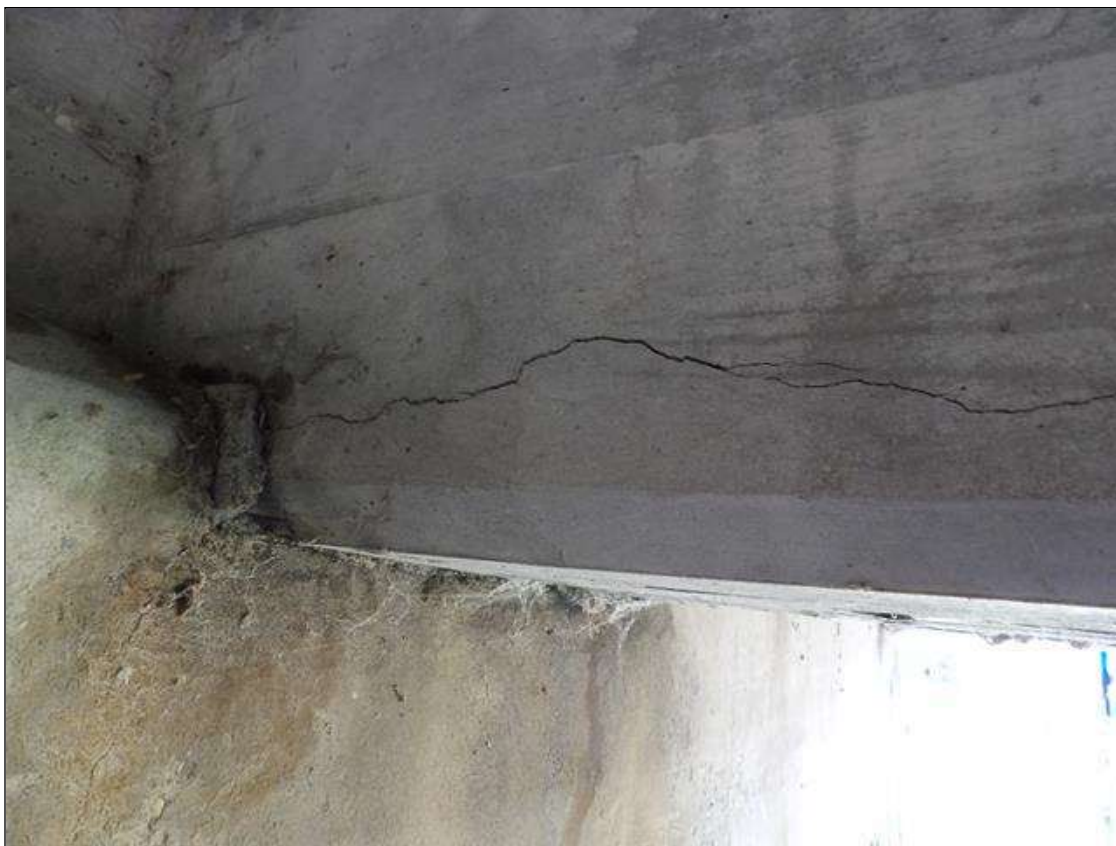
Span 2 Beam 4: 1/8" WIDE X 1' LONG HORIZONTAL CRACK ON BOTTOM LEFT FACE AT BENT 2

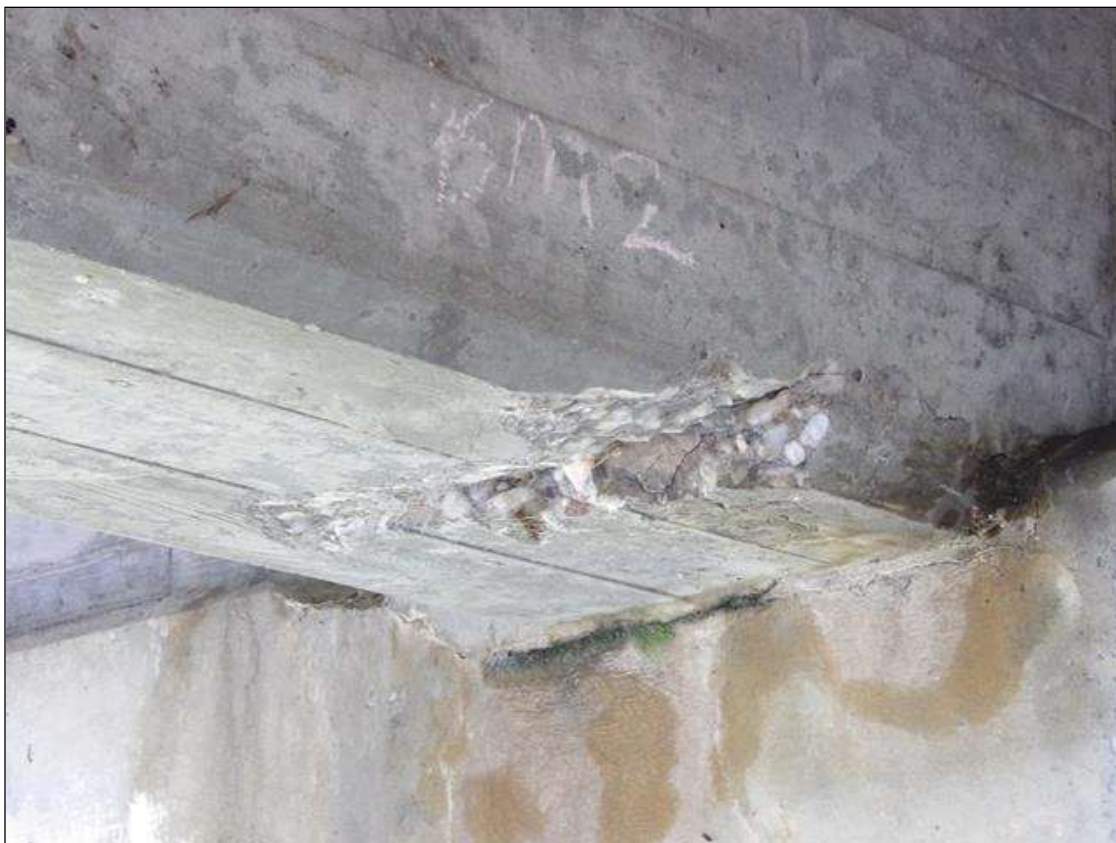
Span 3 Beam 4: 1' LONG X 8" WIDE X 2" DEEP SPALL IN BOTTOM FACE AT BENT 2

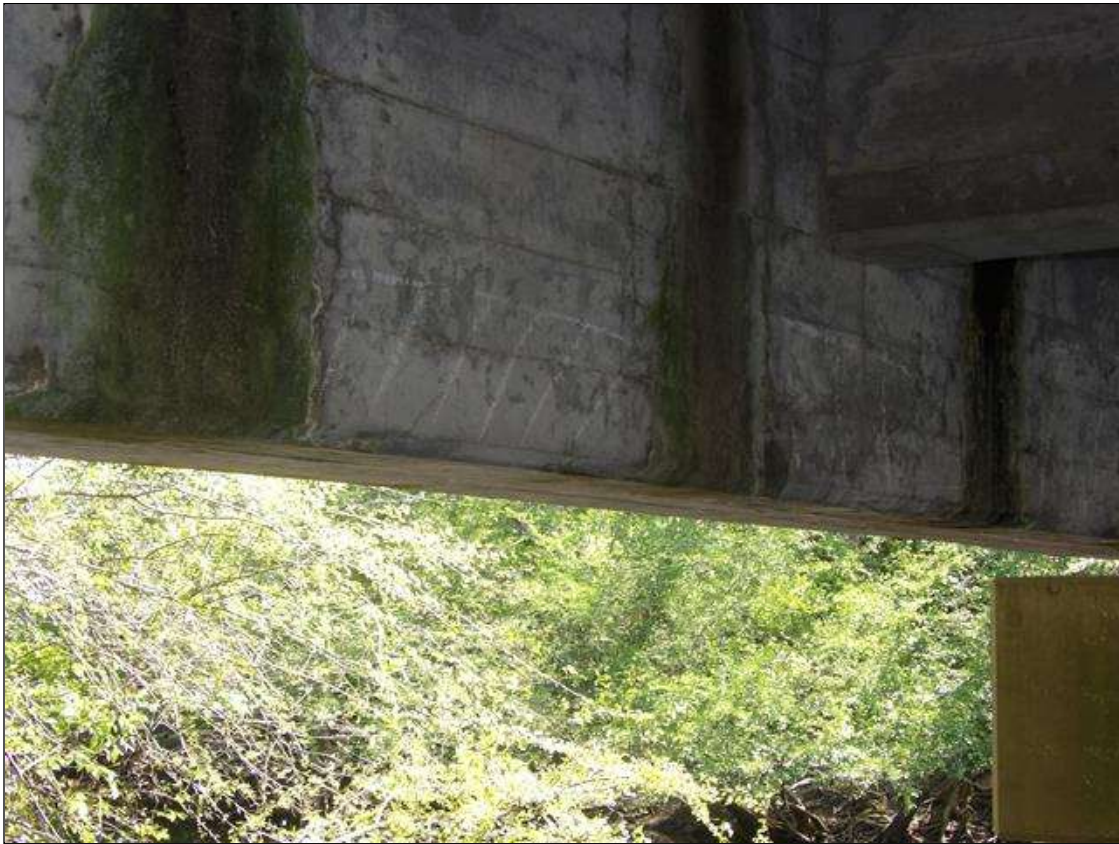
Span 3 Beam 1: 25' LONG X 8" WIDE ON BOTTOM FACE AND EXTENDING UP TO 2' HIGH ON WEB AREA OF DELAMINATION IN RIGHT FACE STARTING 4' FROM PIER 3

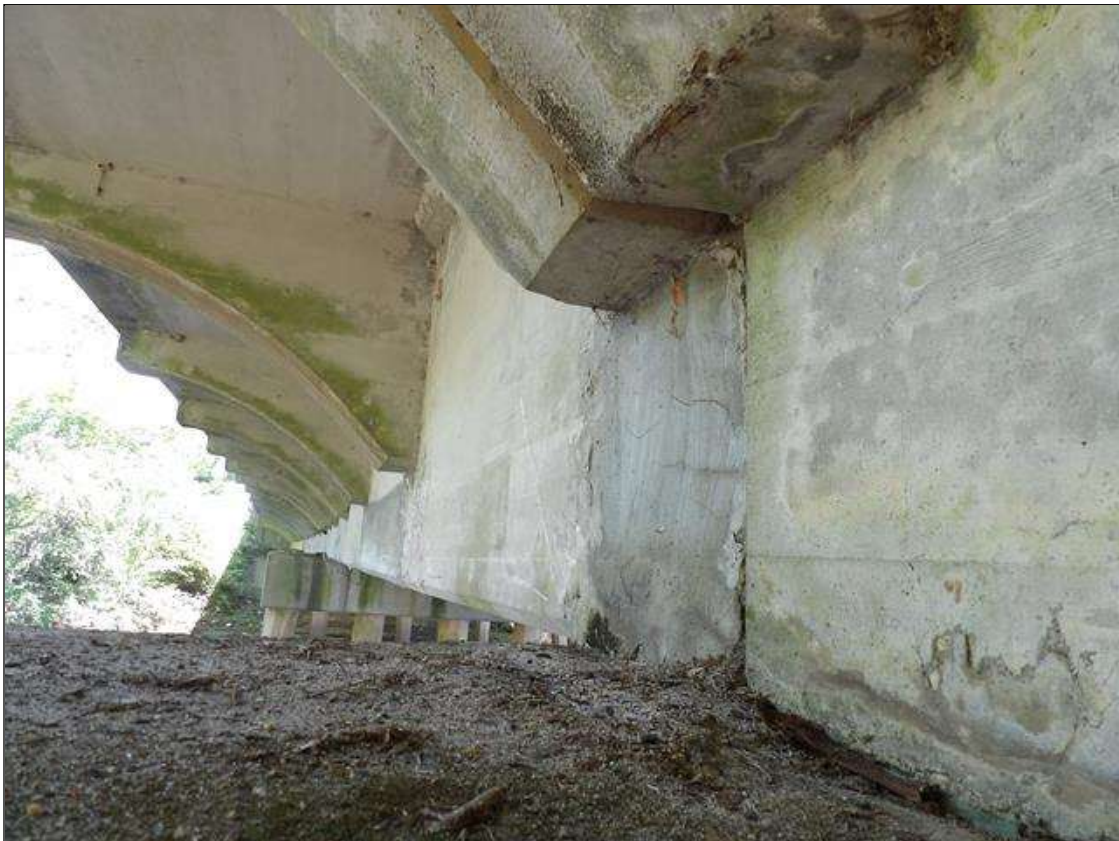
Span 4 Beam 1: 1' HIGH X 1' WIDE SOUND PATCHED AREA AT BENT 3 WITH HAIRLINE HORIZONTAL CRACKING

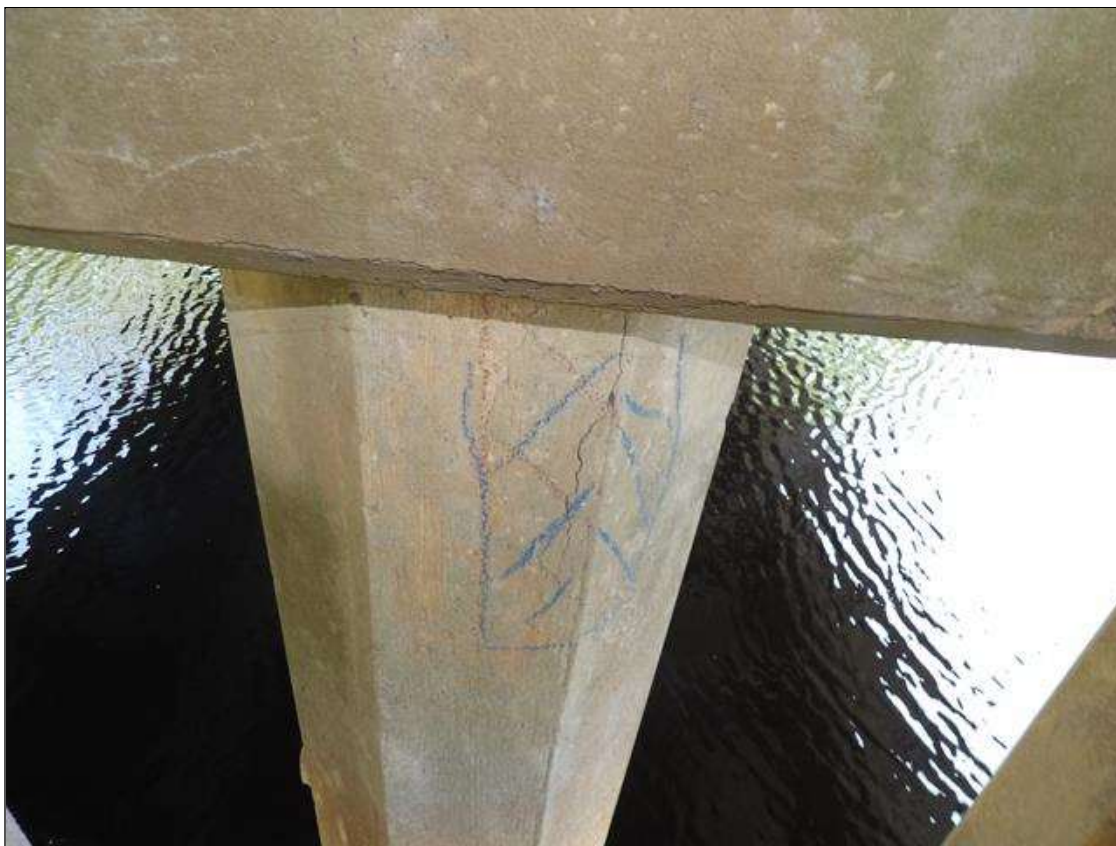
Bent 3 Pile 5: 20" LONG X 16" WIDE AREA OF DELAMINATION ON THE WEST FACE AT TOP OF PILE

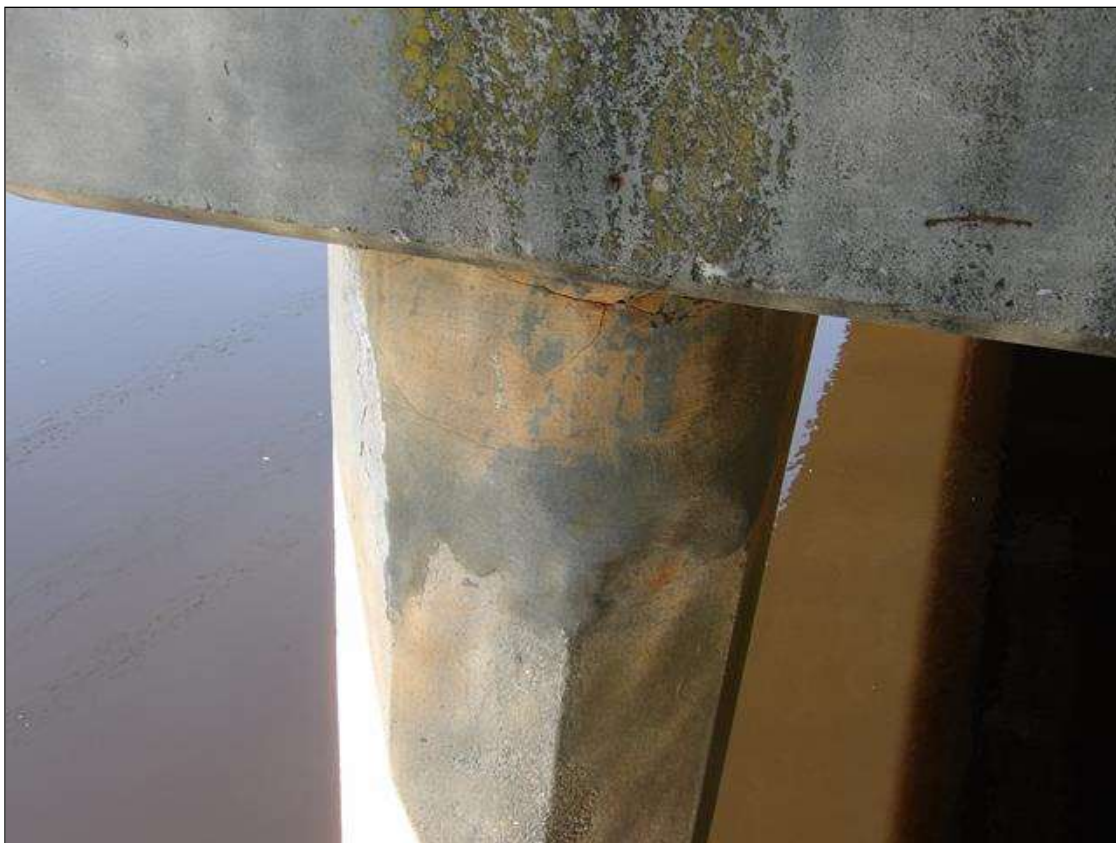
Bent 3 Pile 8: SOUND PATCH WITH HORIZONTAL CRACKS AT TOP OF PILE EAST FACE

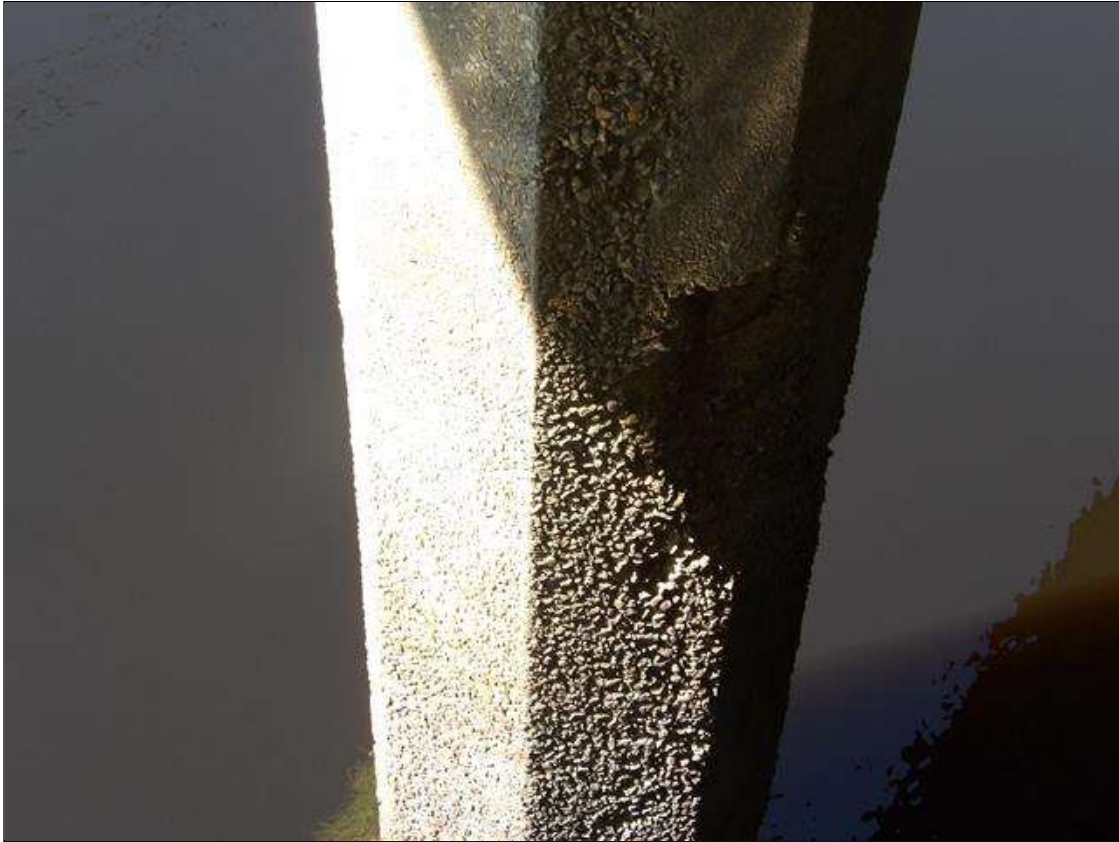
Bent 3 Pile 8: 5' BELOW THE CAP, 3' LONG X 12" WIDE X 2" DEEP WITH EXPOSED REBAR WITH NO MEASURABLE SECTION LOSS

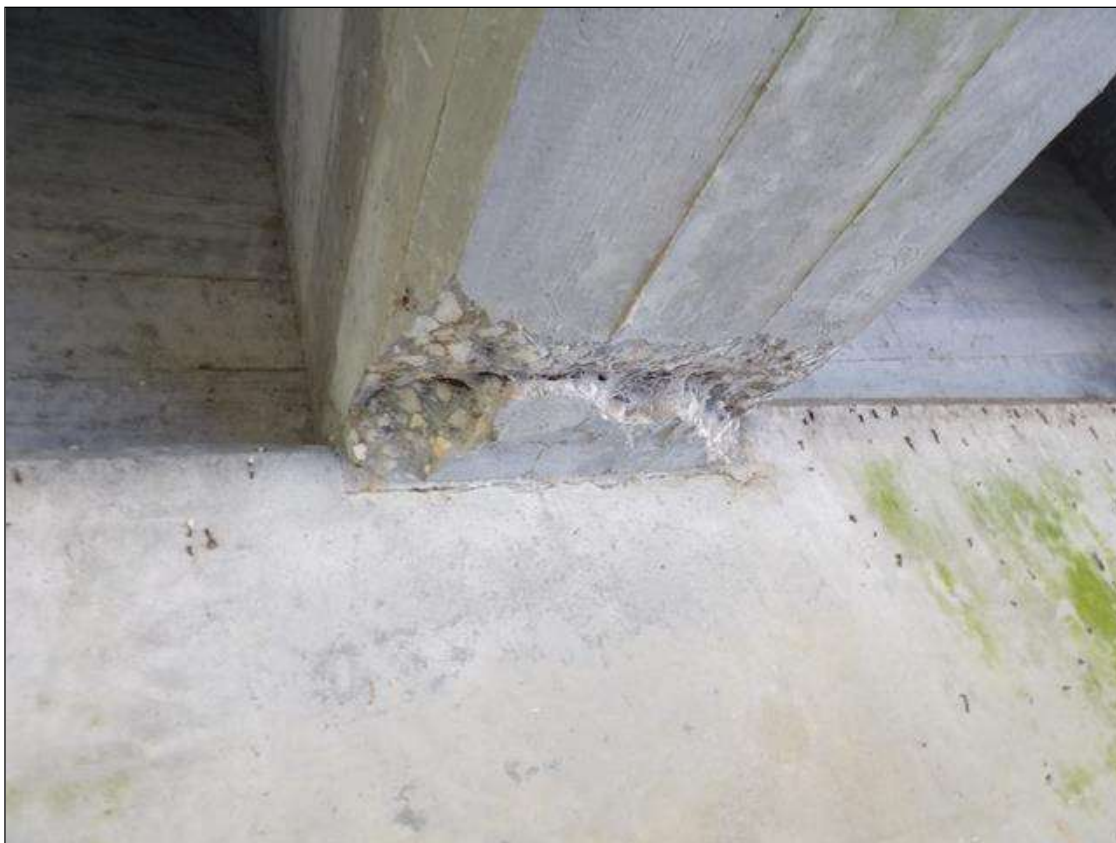
Span 4 Beam 3: 8" LONG X FULL WIDTH X 2" DEEP SPALL WITH NO EXPOSED REBAR IN BOTTOM FLANGE AT BENT 4

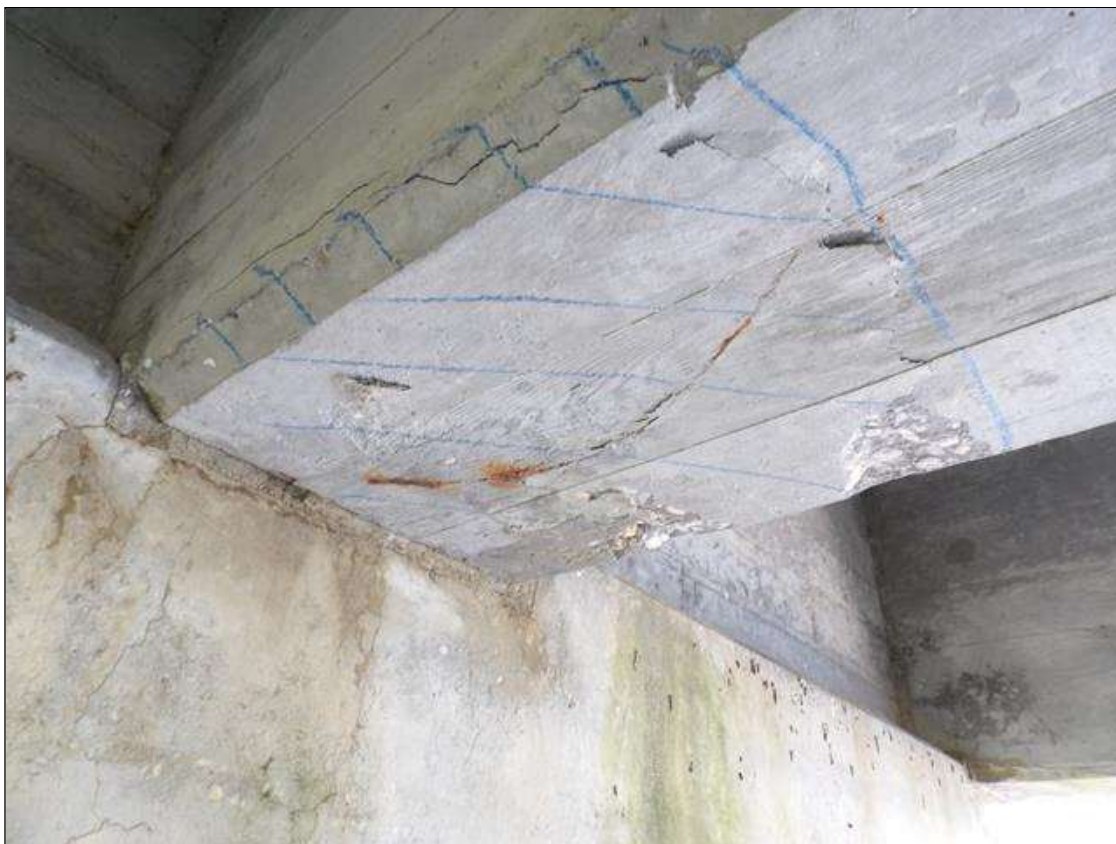
Span 4 Beam 4: 1.5' LONG X FULL WIDTH AREA OF DELAMINATION IN BOTTOM FLANGE AT BENT 4

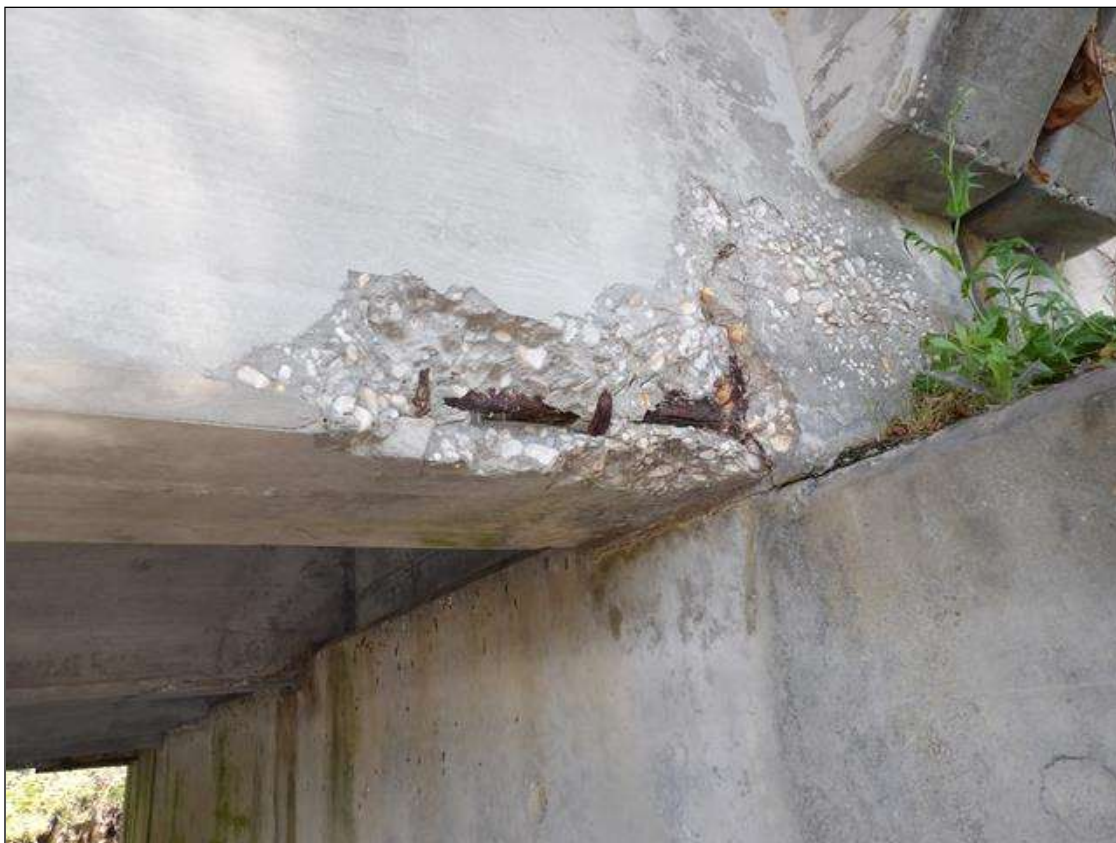
Span 4 Beam 5: PAR --- 2' LONG X UP TO 1' HIGH X 3" DEEP SPALL WITH EXPOSED REBAR WITH MINOR SECTION LOSS IN RIGHT FACE FACE OF WEB AT BENT 4
