NC DEPARTMENT OF TRANSPORTATION
 DIVISION OF HIGHWAYS
 STRUCTURE MANAGEMENT UNIT

ATTENTION: PRIORITY ACTION REQUEST ISSUED; HYDRA-PLATFORM USED

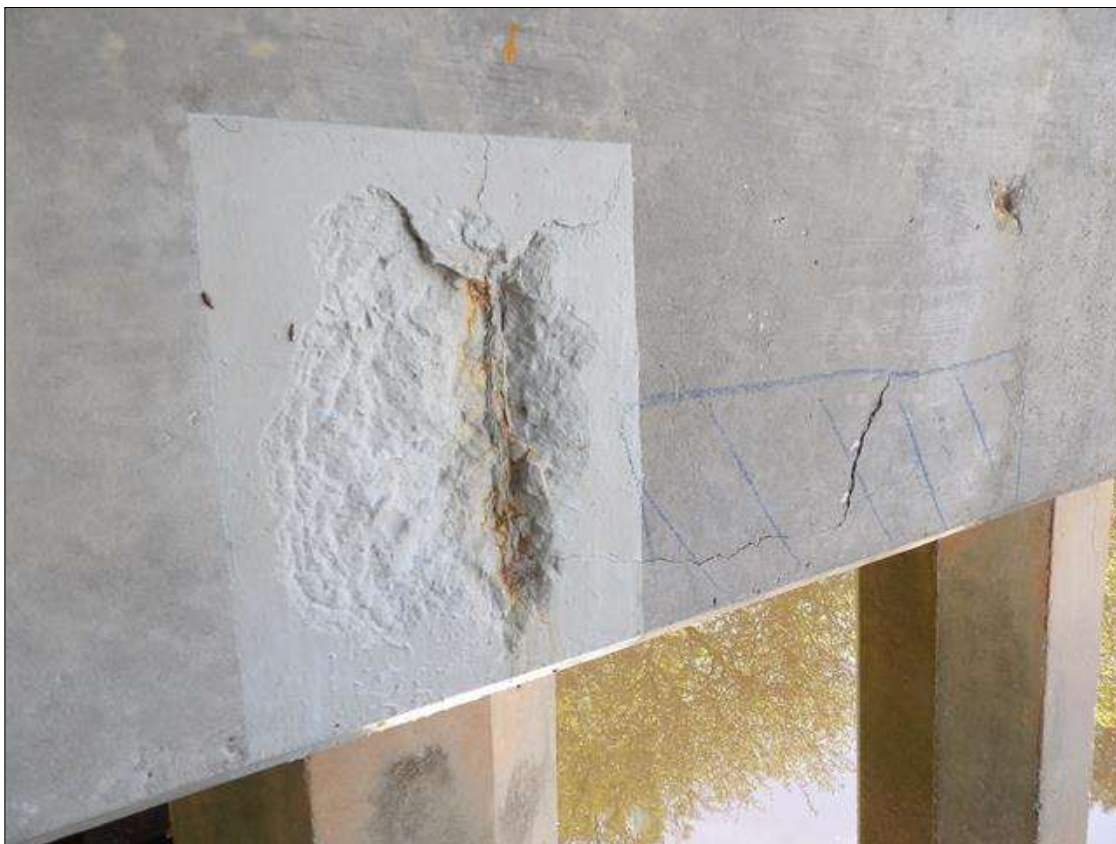
Bent 4 Cap 1: WEST FACE BELOW BEAM 5, 12" HIGH X 18" WIDE X 2" DEEP SPALL WITH EXPOSED REBAR. AREA HAS BEEN COATED AND STEEL IS NOT CORRODED. ADJACENT 24" X 16" DELAMINATION

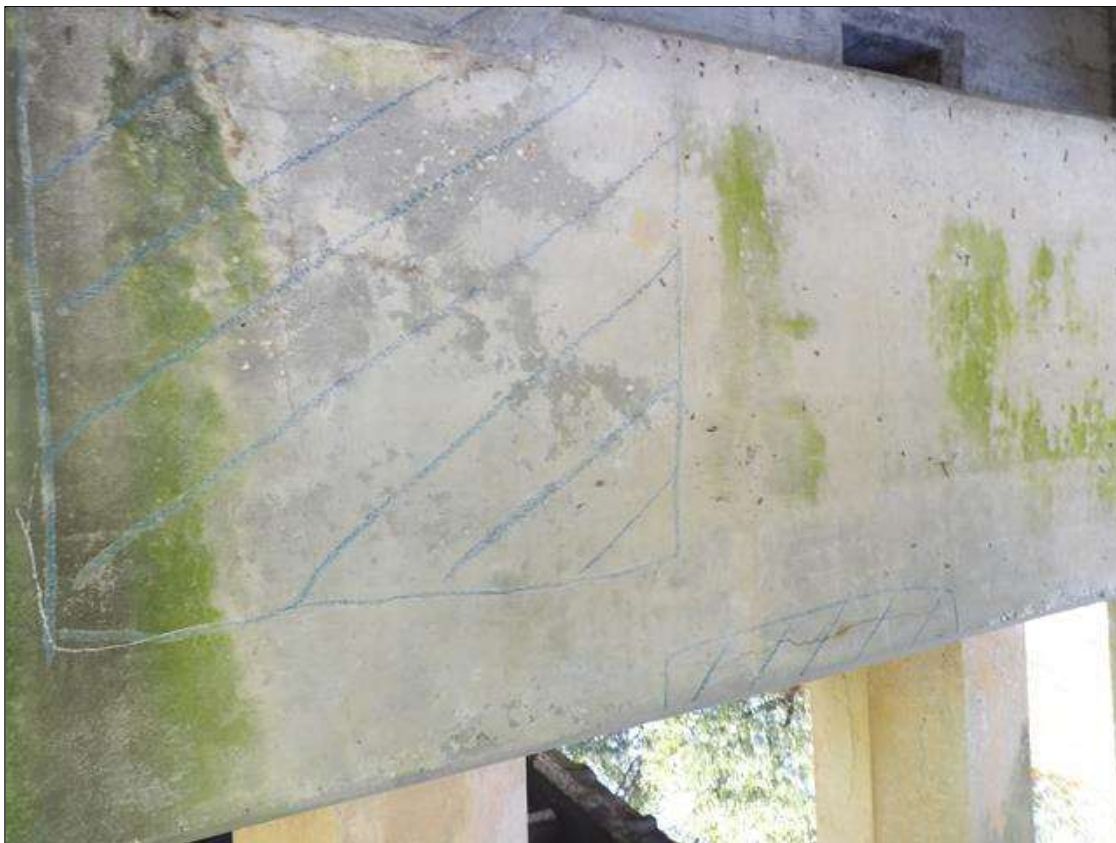
Bent 4 Cap 1: (2) AREAS OF DELAMINATION IN WEST FACE OF CAP IN BAY 2, UP TO 3' LONG X 3' WIDE

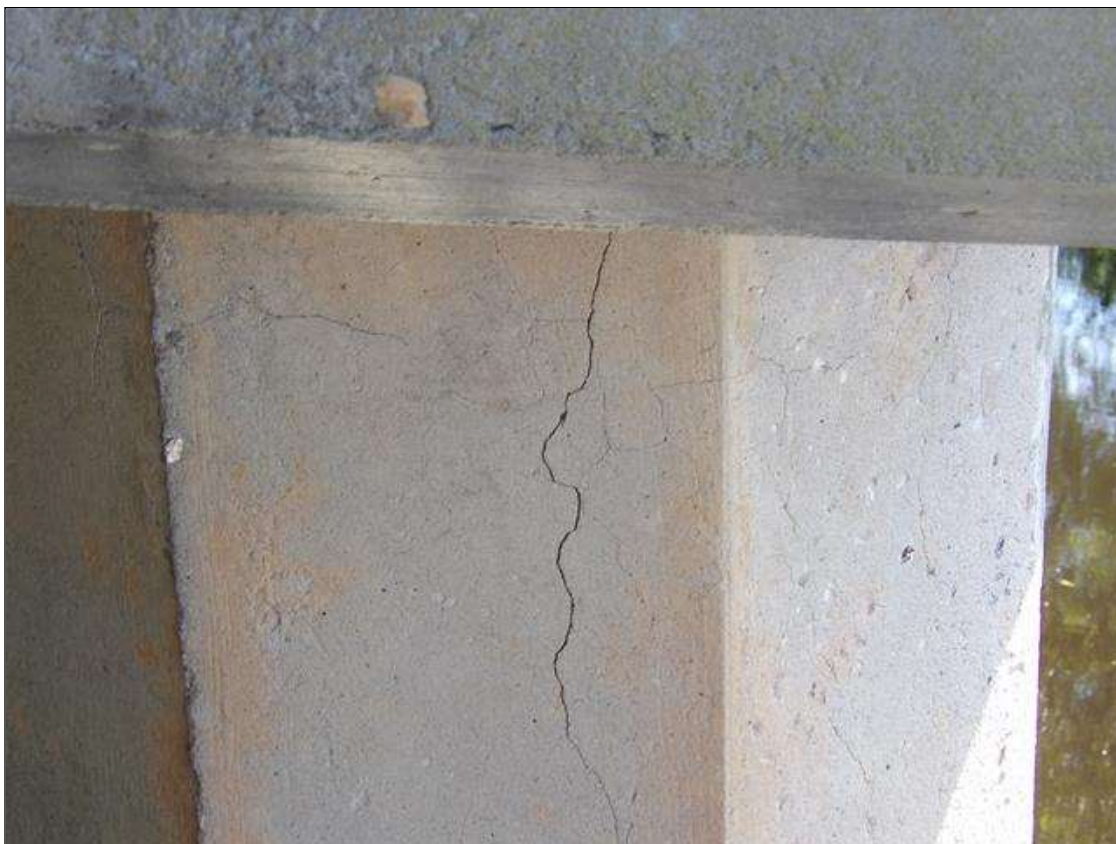
Bent 4 Pile 8: 1' LONG X 1/16" WIDE VERTICAL CRACK IN WEST FACE OF PILE AT CAP

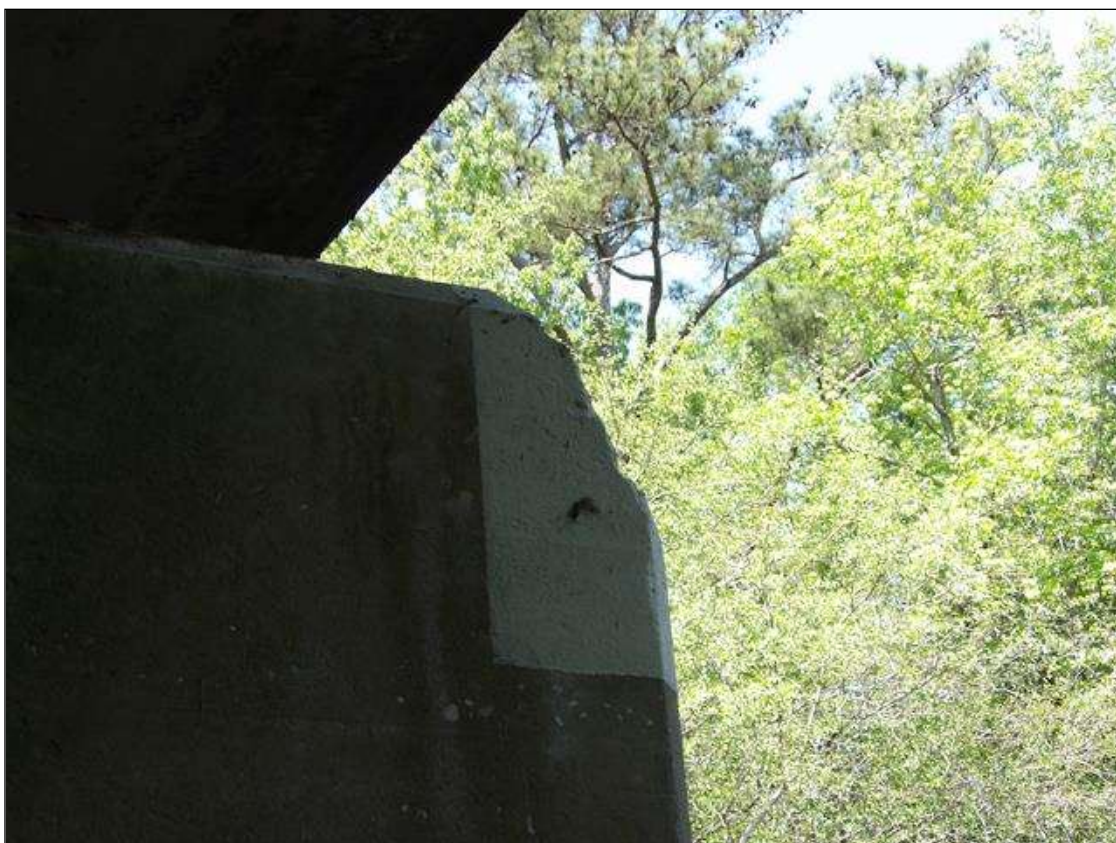
Bent 4 Cap 1: CORNER SPALL ON LEFT END TOP, 1' LONG X 10" WIDE X 3" DEEP, PREVIOUSLY COATED AREA

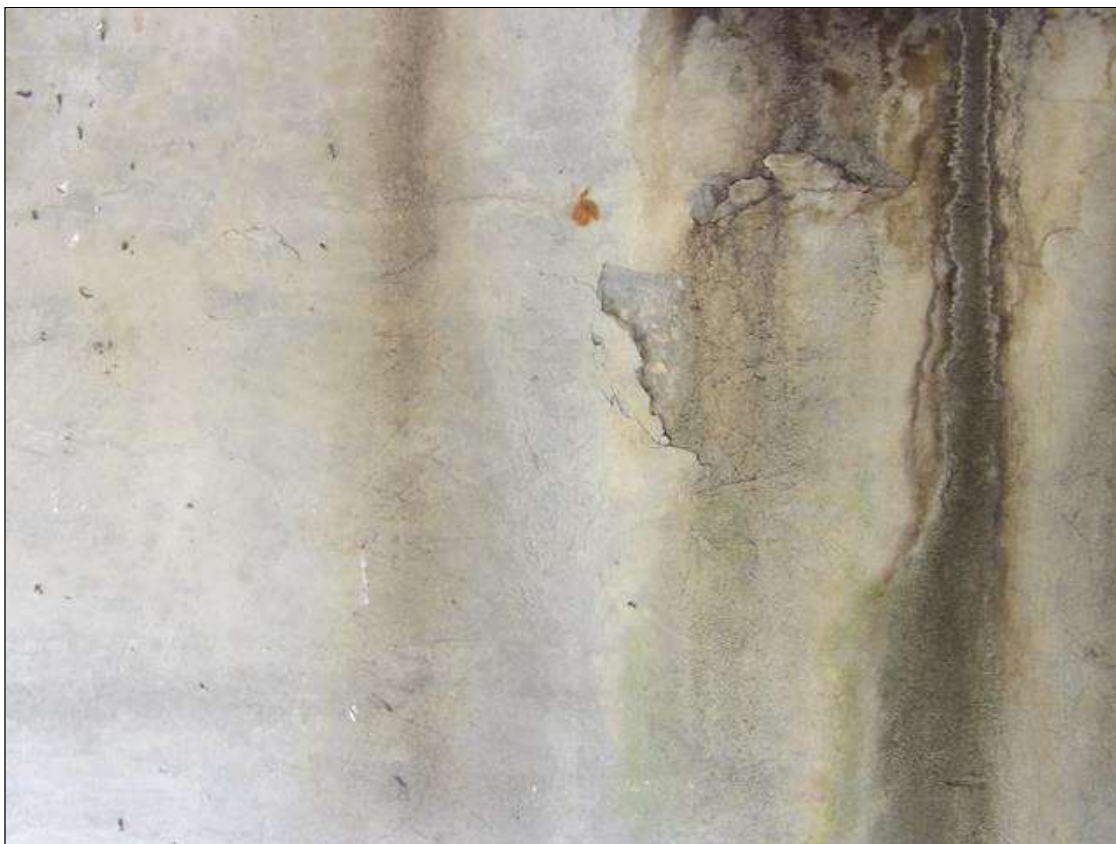
Bent 4 Cap 1: 3' LONG X 1.5' AREA OF DELMINATION WITH DETERIORATING CONCRETE IN EAST FACE BELOW BEAM 4

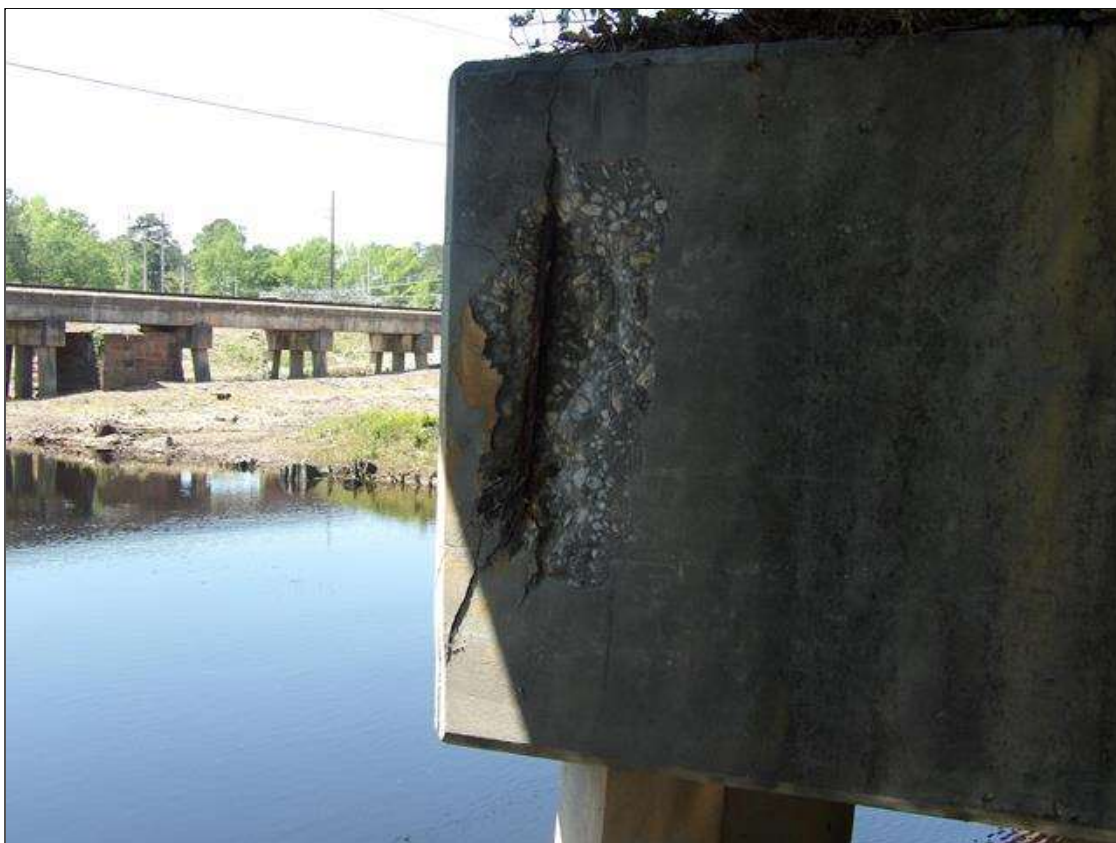
Bent 4 Cap 1: PAR -- SPALL 36" HIGH X 16" WIDE X 2.5" DEEP SPALL WITH EXPOSED REBAR WITH MINOR SECTION LOSS

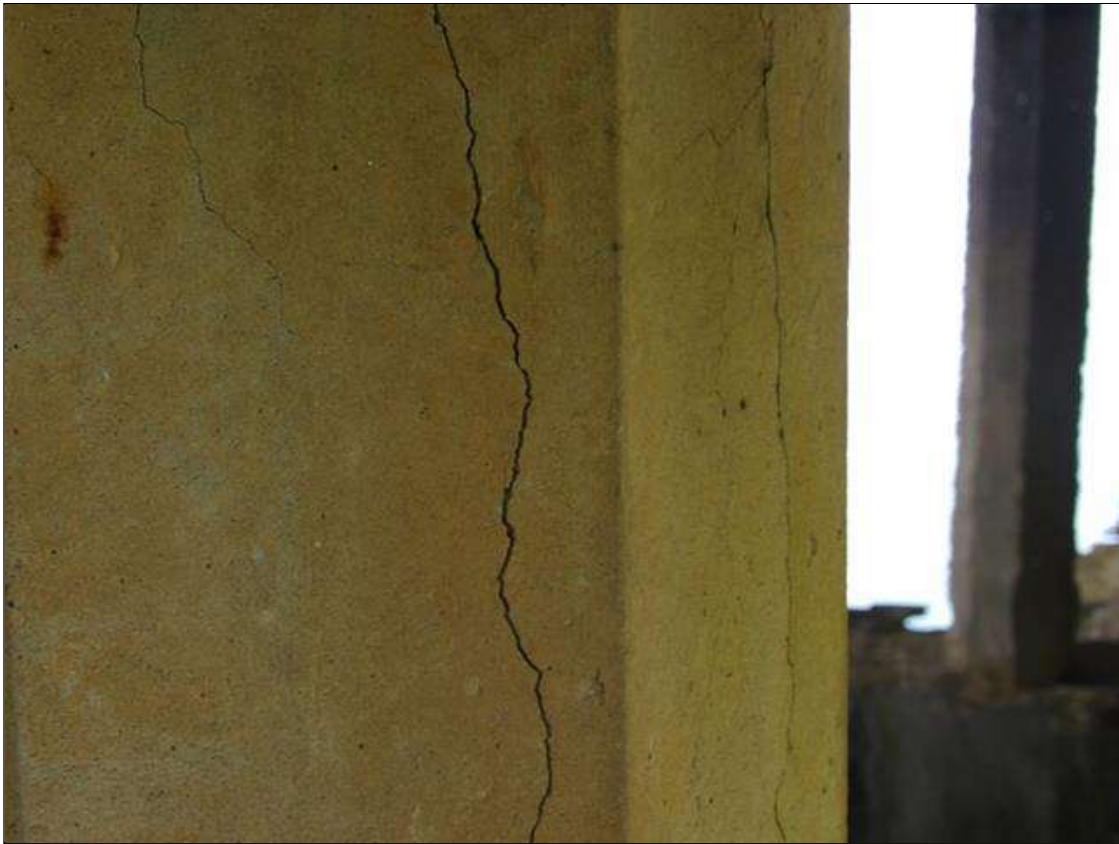
Bent 4 Pile 4: (2) UP TO 2' LONG X 1/16" WIDE VERTICAL CRACKS IN NORTH AND NORTHEAST FACE OF PILE AT TOP

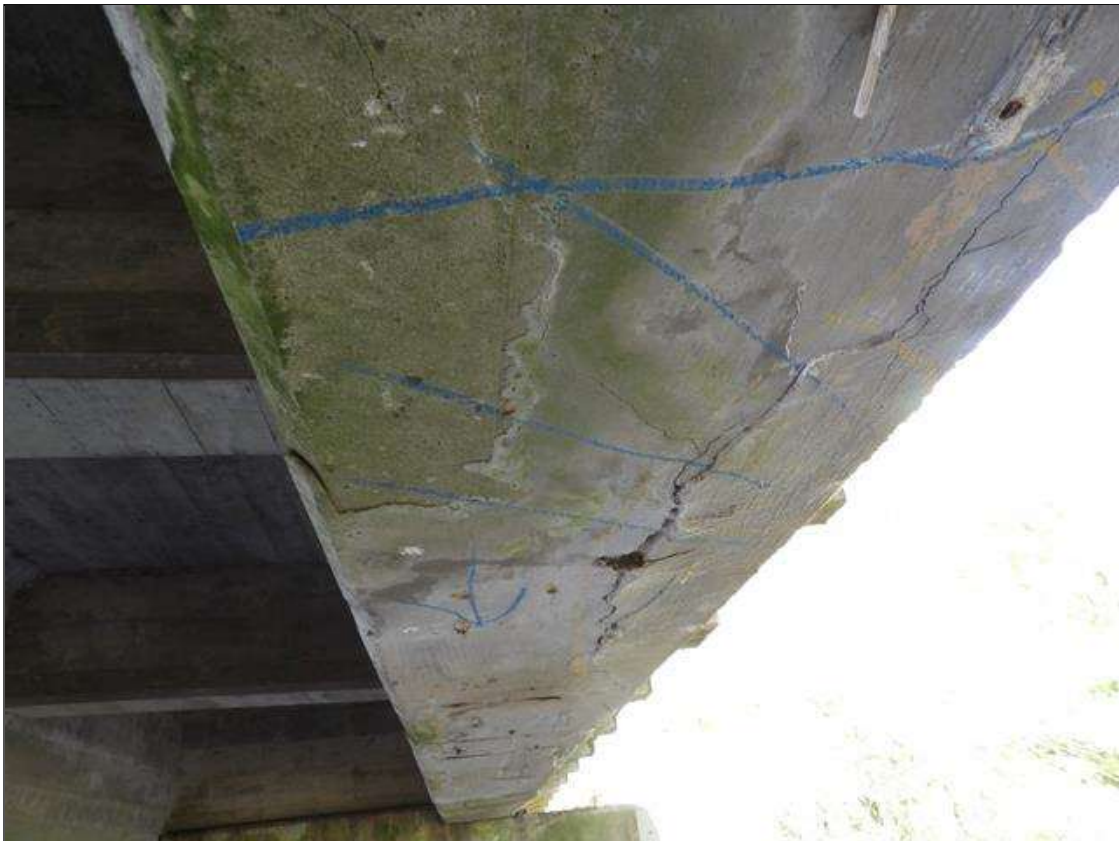
Span 5 Beam 1: 20' LONG X FULL WIDTH AREA OF DELAMINATION IN BOTTOM FLANGE EXTENDING UP TO 2' IN BOTH FACES OF WEB, STARTING 3' FROM BENT 4

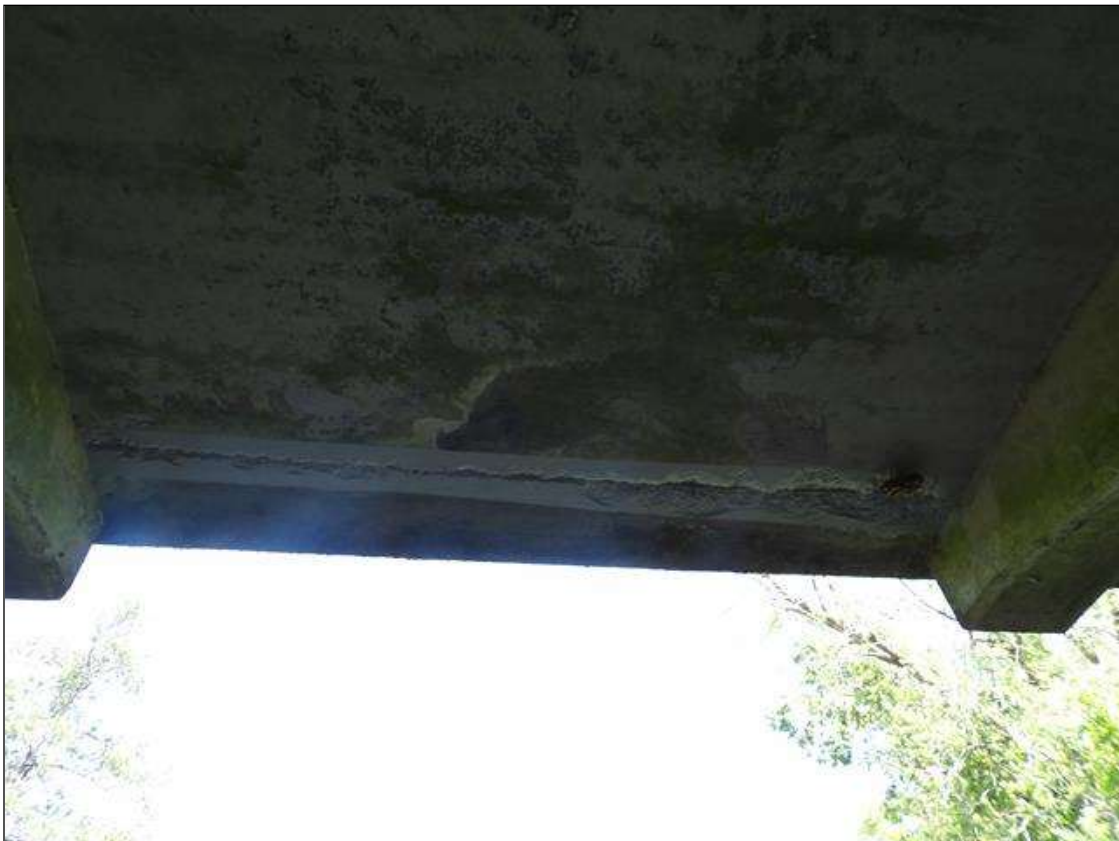
Span 5 Deck: 6' LONG X 7" WIDE X 1" DEEP SPALL WITH EXPOSED REBAR IN DECK UNDERSIDE LEFT OVERHANG. AREA HAS BEEN PAINTED OVER

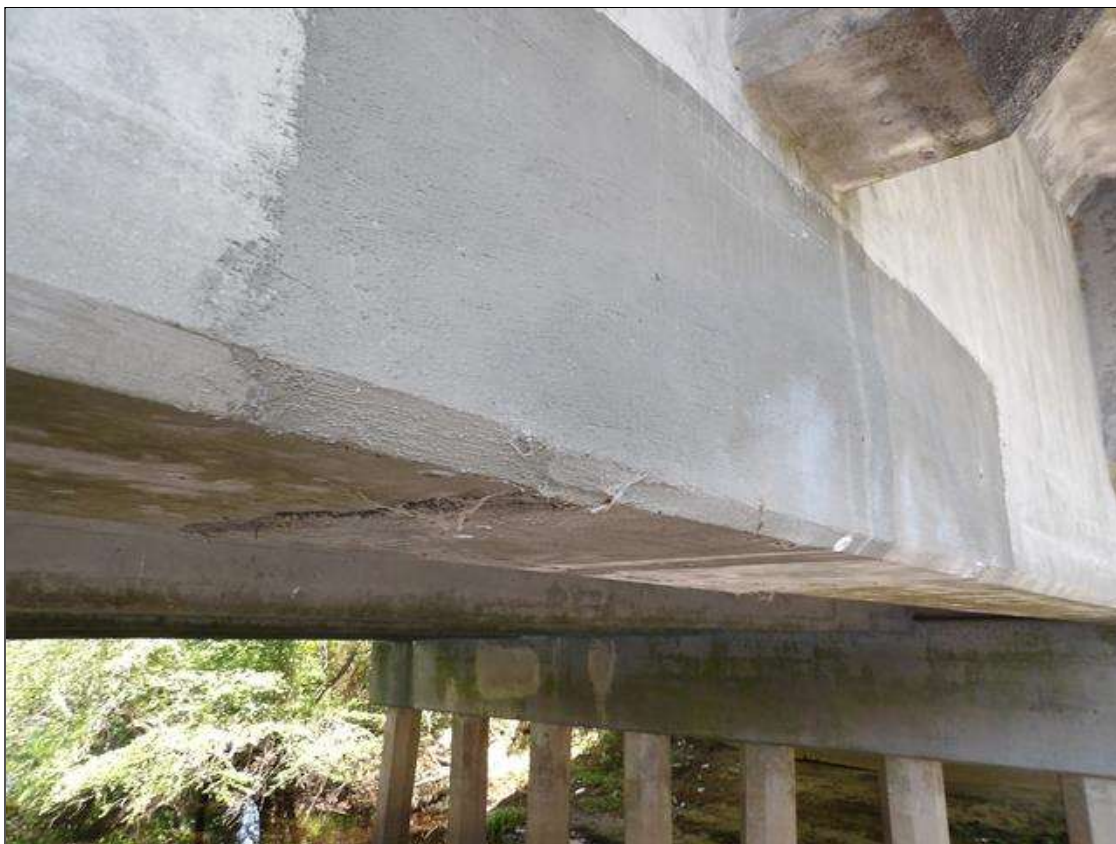
Span 5 Beam 5: 2.5' LONG X FULL WIDTH OF BOTTOM FLANGE SOUND PATCH AREA EXTENDING UP TO 1' ON BOTH FACES OF WEB, NEAR MIDSPAN

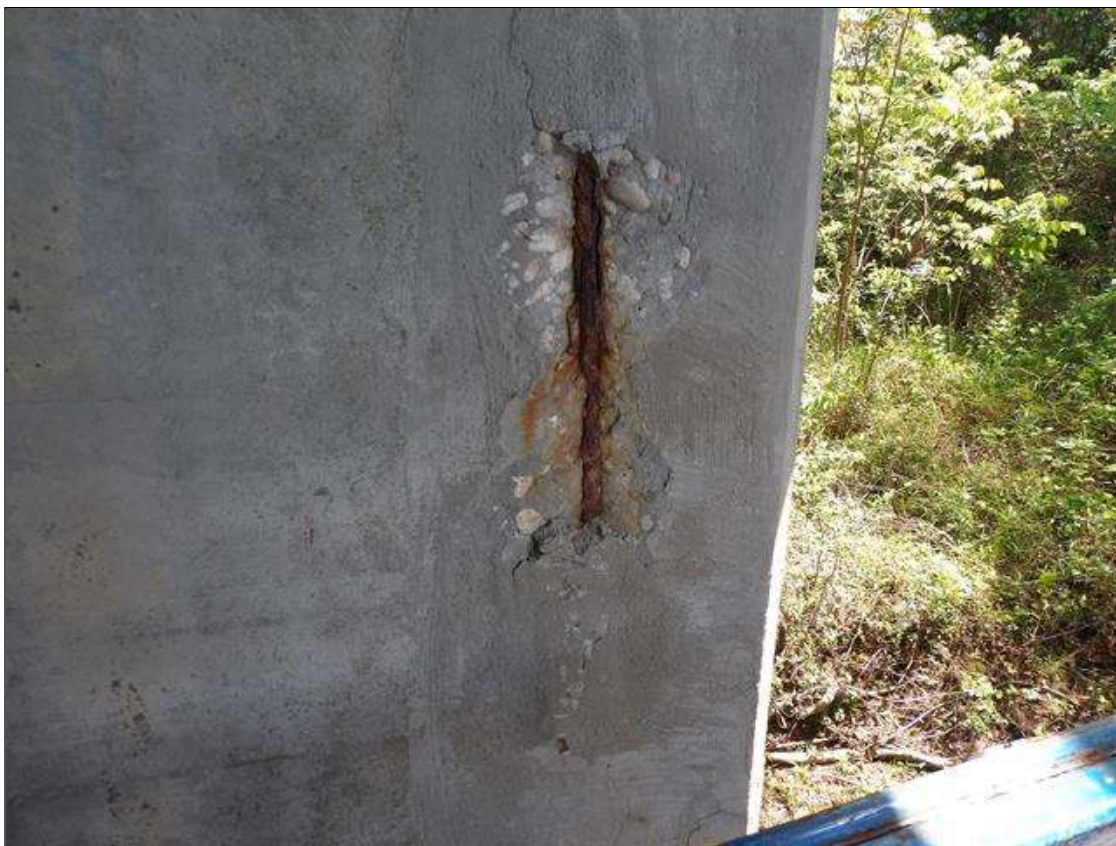
Bent 5 Cap 1: PAR -- 8" LONG X 15" HIGH X 1" DEEP SPALL WITH EXPOSED REBAR WITH MINOR SECTION LOSS ON WEST FACE AT PILE 8

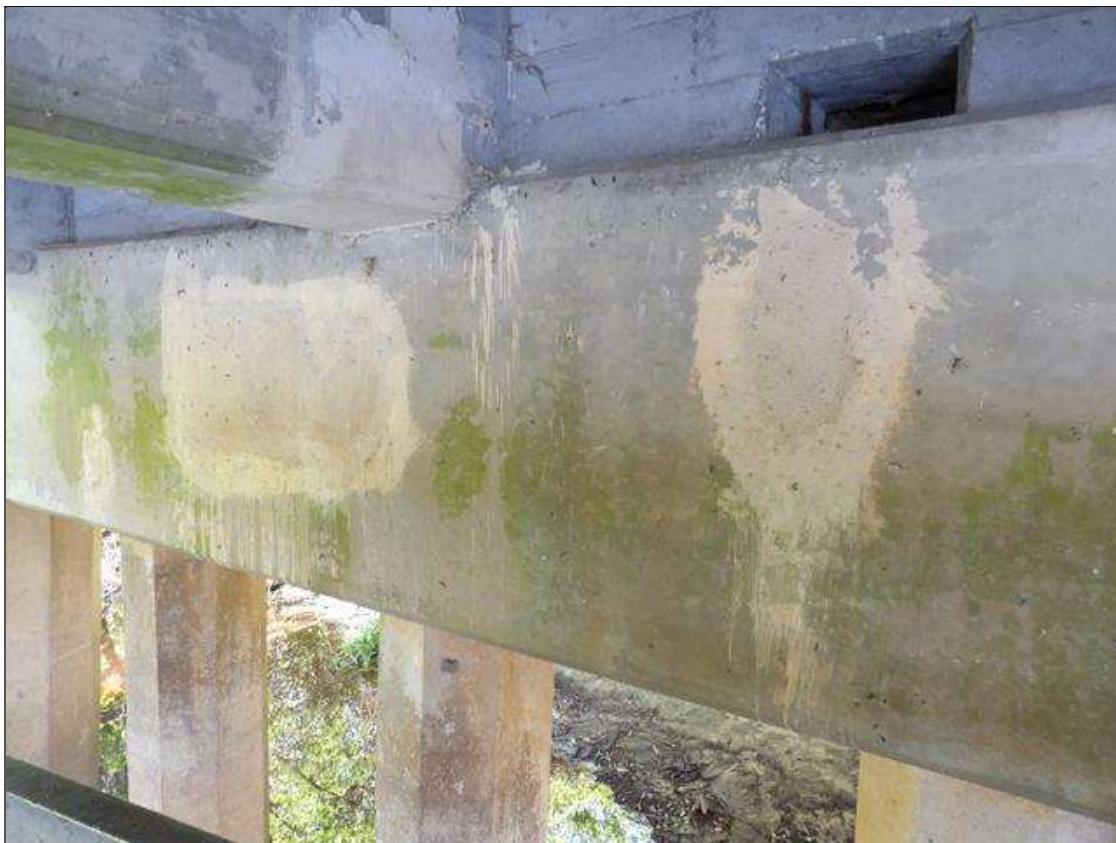
Bent 5 Cap 1: (3) UP TO 3' LONG X 2' HIGH SOUND PATCHES IN WEST FACE AT VARIOUS LOCATIONS

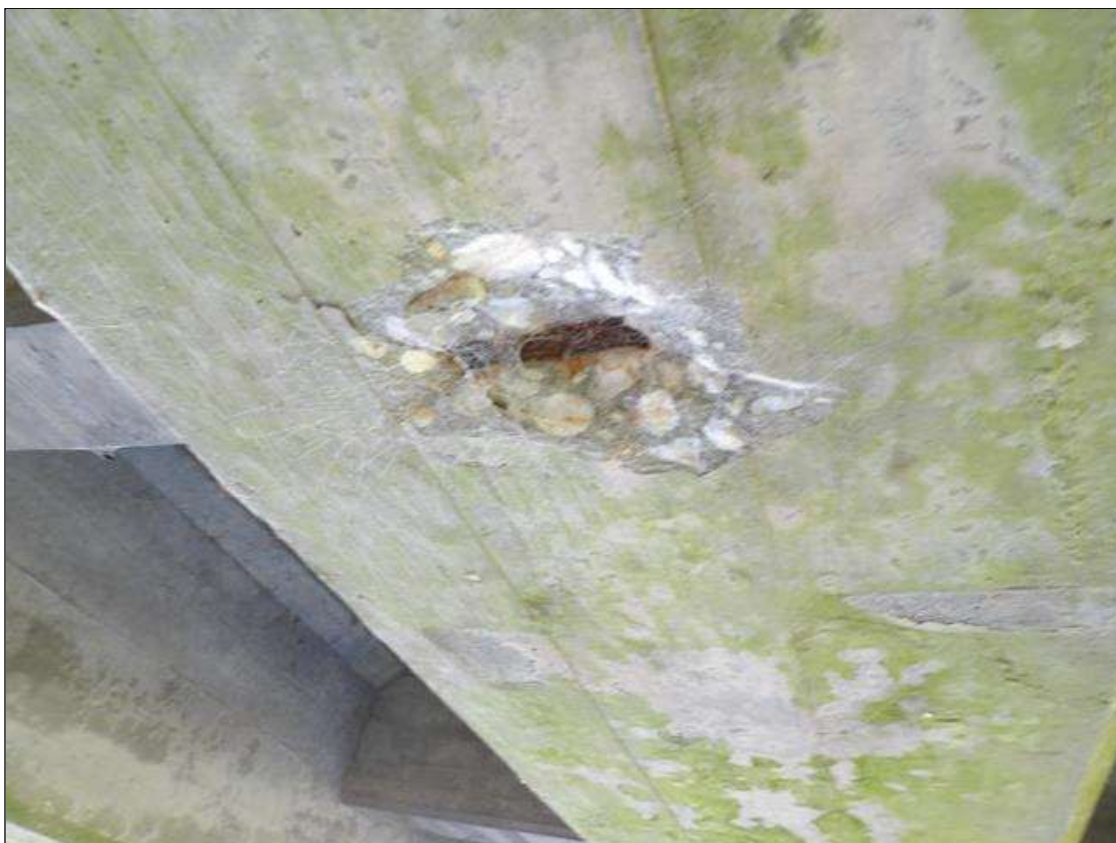
Span 5 Beam 2: (2) 5" DIA. X 1" DEEP SPALLS WITH EXPOSED REBAR IN BOTTOM FLANGE AT 5' AND 10' FROM PIER 5

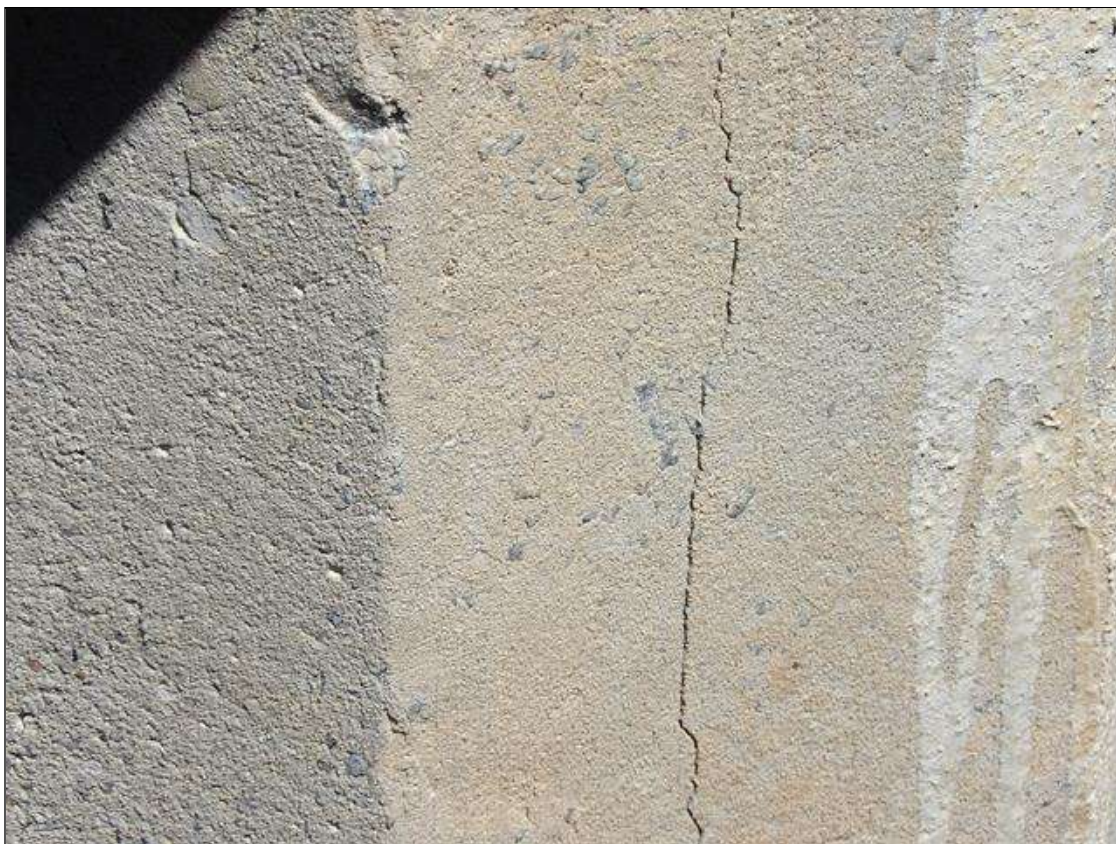
Bent 5 Pile 8: 4' LONG X UP TO 1/16" WIDE VERTICAL CRACK ON SOUTH FACE AT TOP

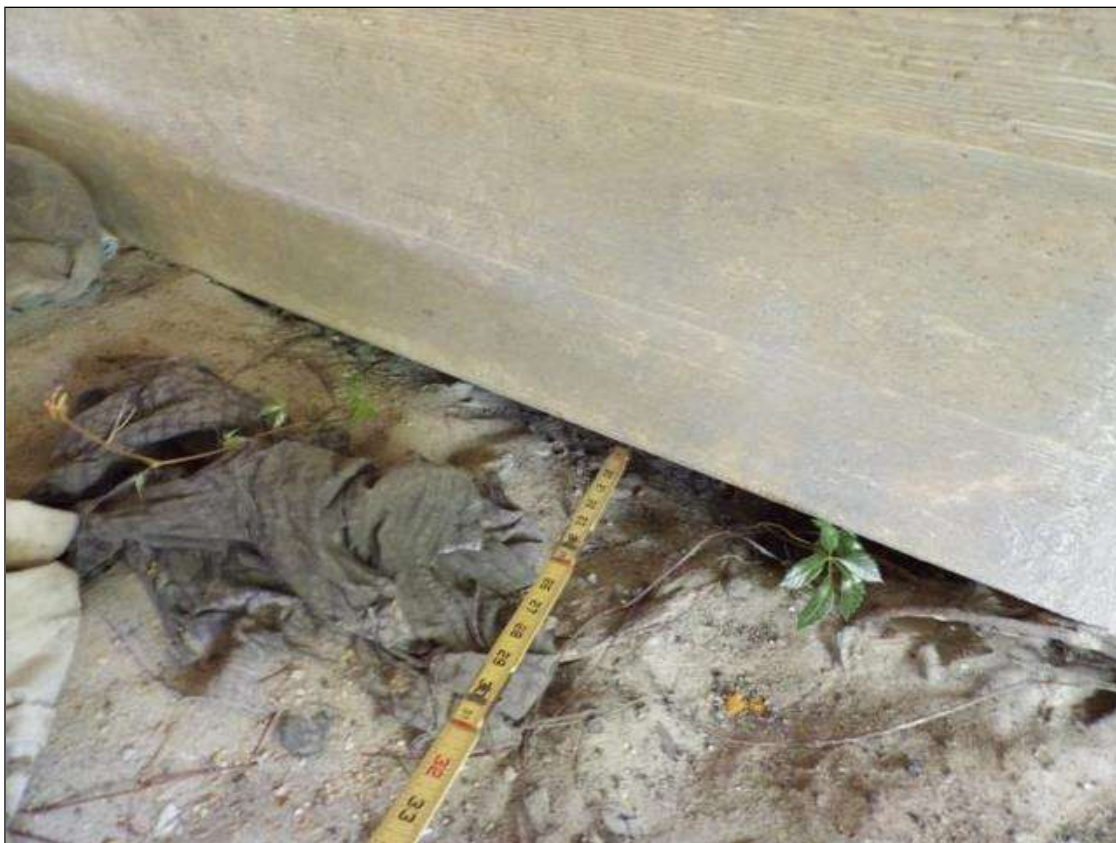
END BENT 1 SLOPE PROTECTION BERM, BELOW BAY 1, CAP 2' WIDE X 6" HIGH X UP TO 21" DEEP VOID CAUSED BY AN ANIMAL

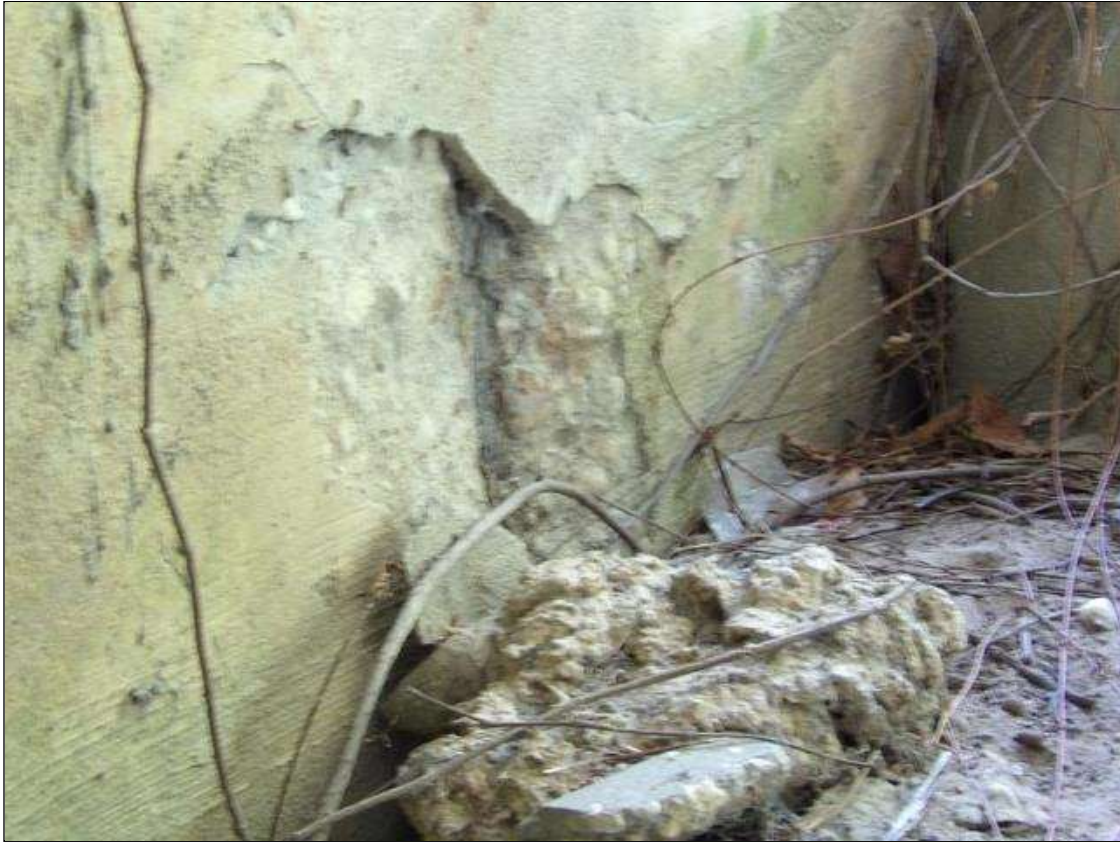
End Bent 1 Cap 1: PAR -- SPALL 16" X UP TO 12" X UP TO 1" DEEP UNDER LEFT OVERHANG WITH EXPOSED REBAR 5" LONG

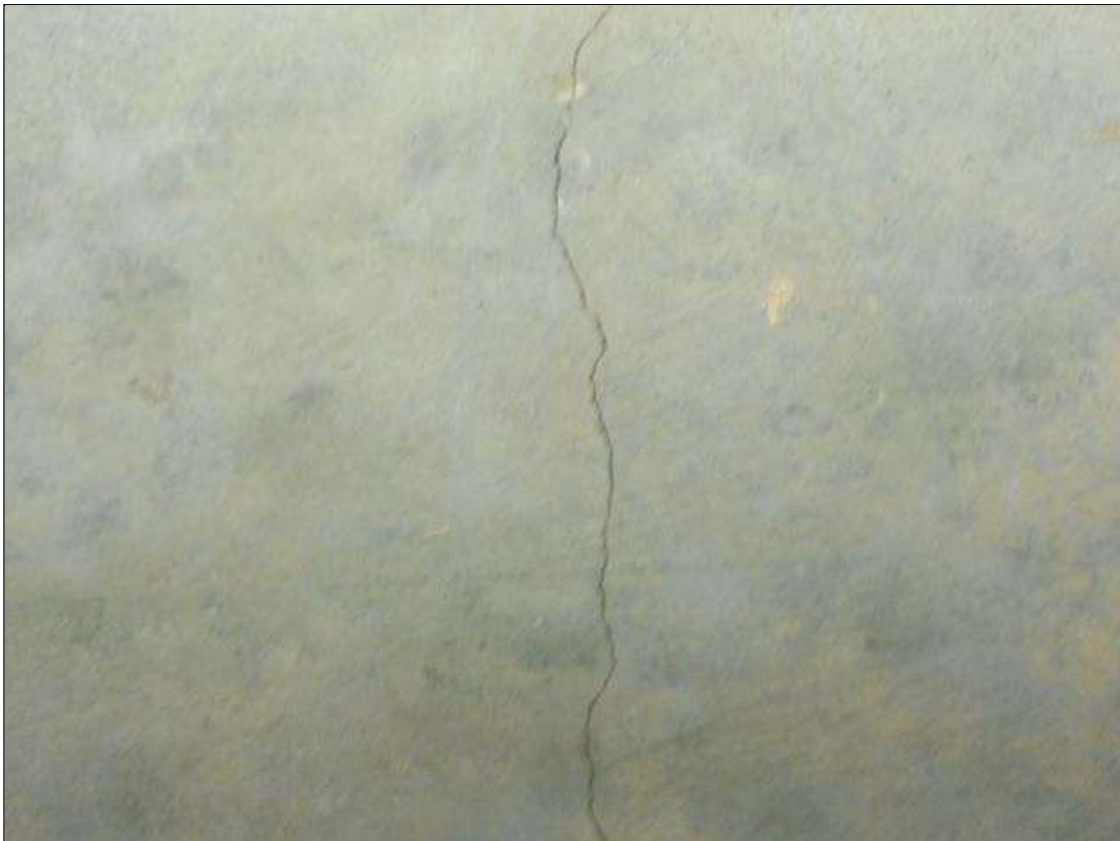
End Bent 1 Cap 1: 2 FULL HEIGHT X HAIRLINE TO 1/32" WIDE VERTICAL CRACKS AT BAY 2 AND 3

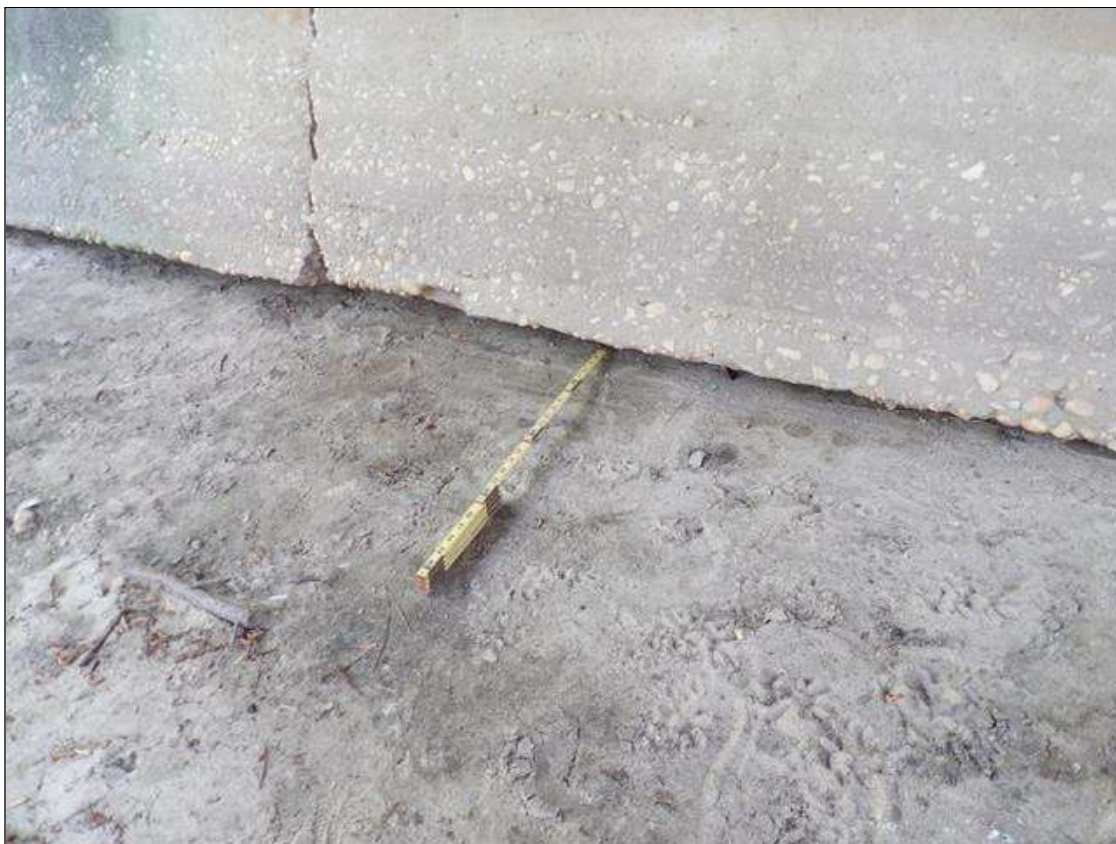
PAR -- 10' X 5" HIGH X 9" DEEP WASHOUT AND UNDERMINING OF THE SLOPE PROTECTION AT ABUTMENT 2

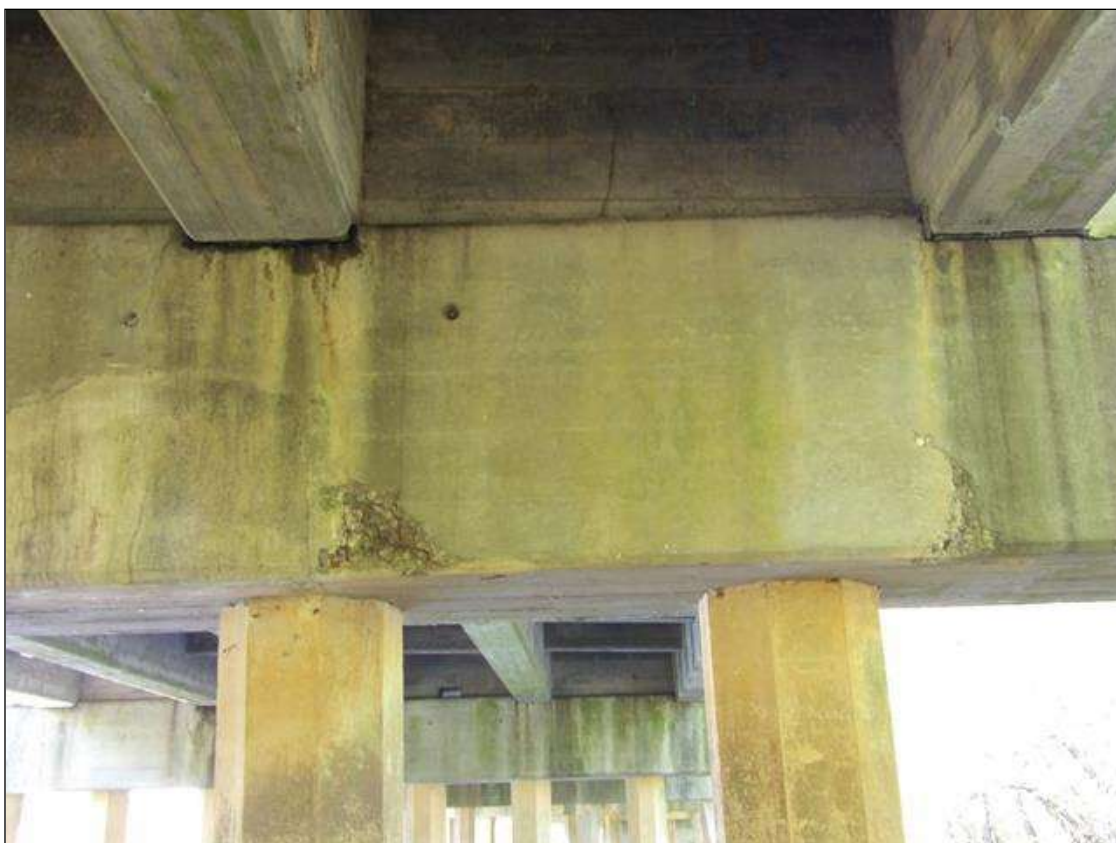
Bent 5 Cap 1: (2) UP TO 12" HIGH X 12" LONG X 3" DEEP SPALLS WITH NO EXPOSED REBAR ON EAST FACE UNDER BAY 1

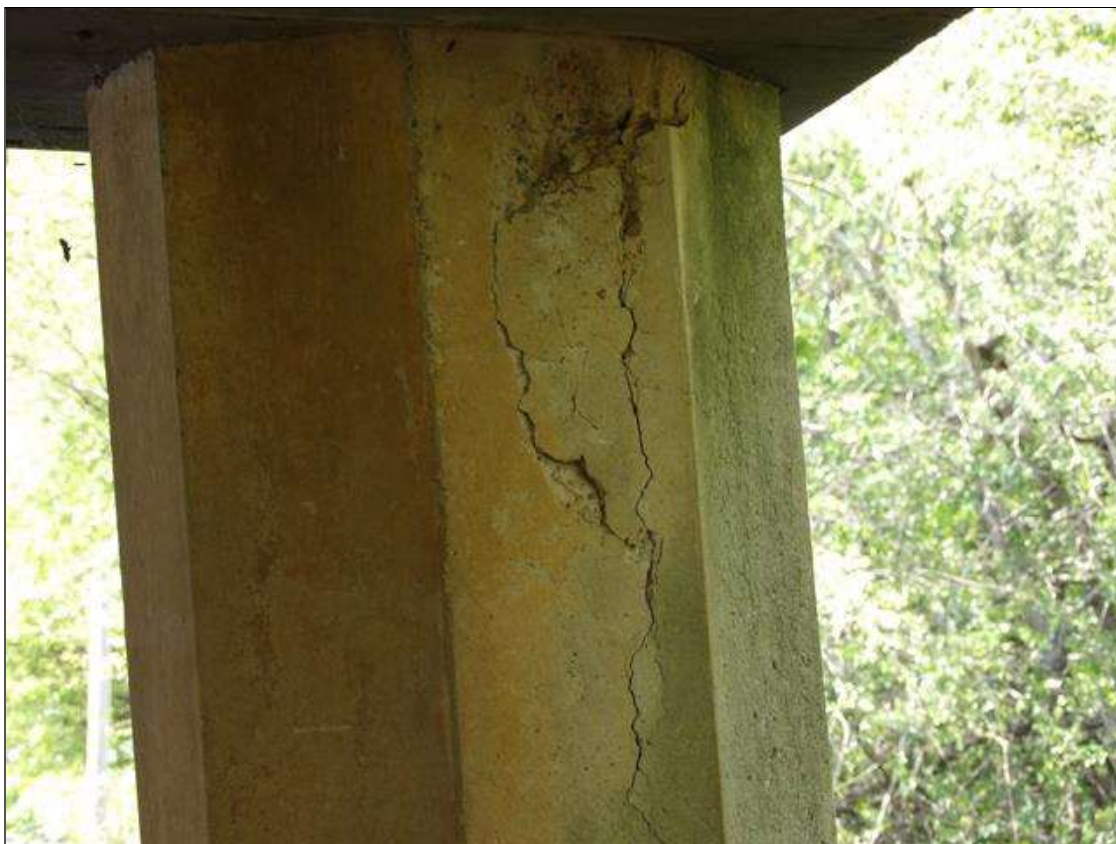
Bent 5 Pile 1: 3' LONG X 4" WIDE AREA OF DELAMINATION EAST FACE AT TOP

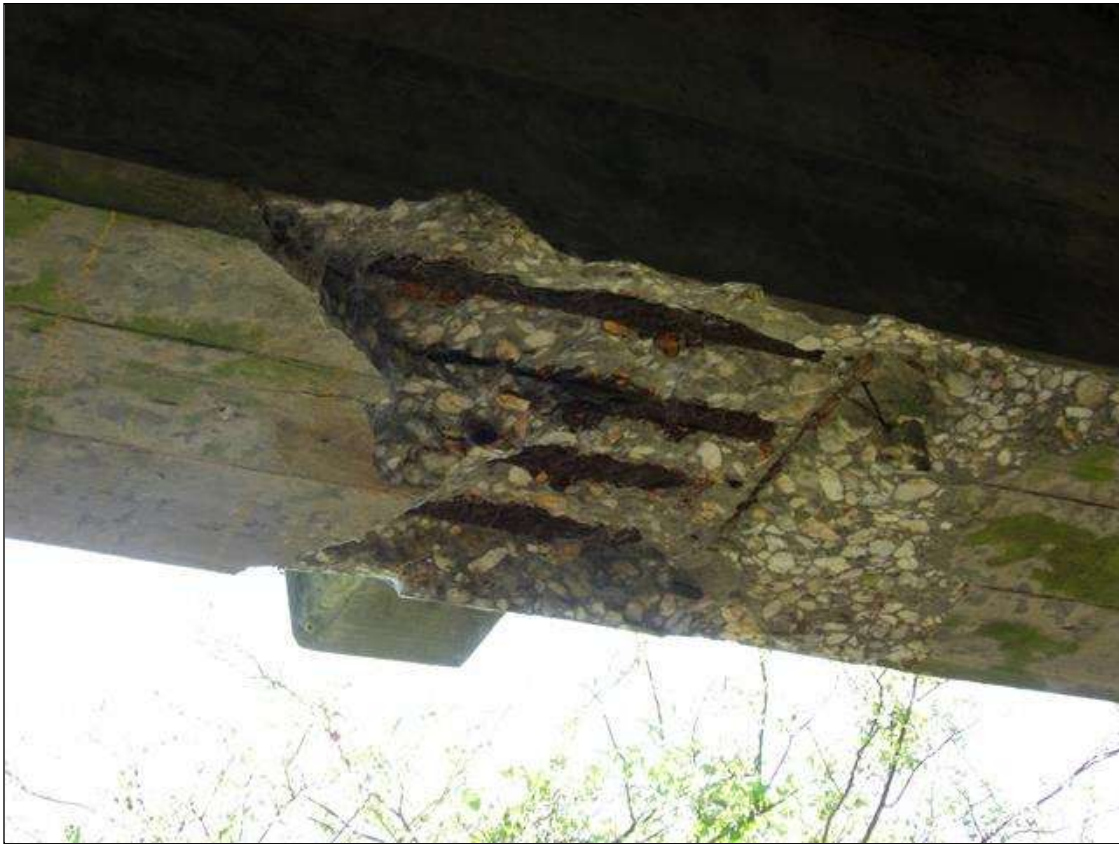
Span 6 Beam 5: PAR -- 20" LONG X FULL BOTTOM WIDTH X 3" DEEP SPALL WITH EXPOSED REBAR WITH MINOR SECTION LOSS IN BOTTOM OF FLANGE 10' FROM BENT 6

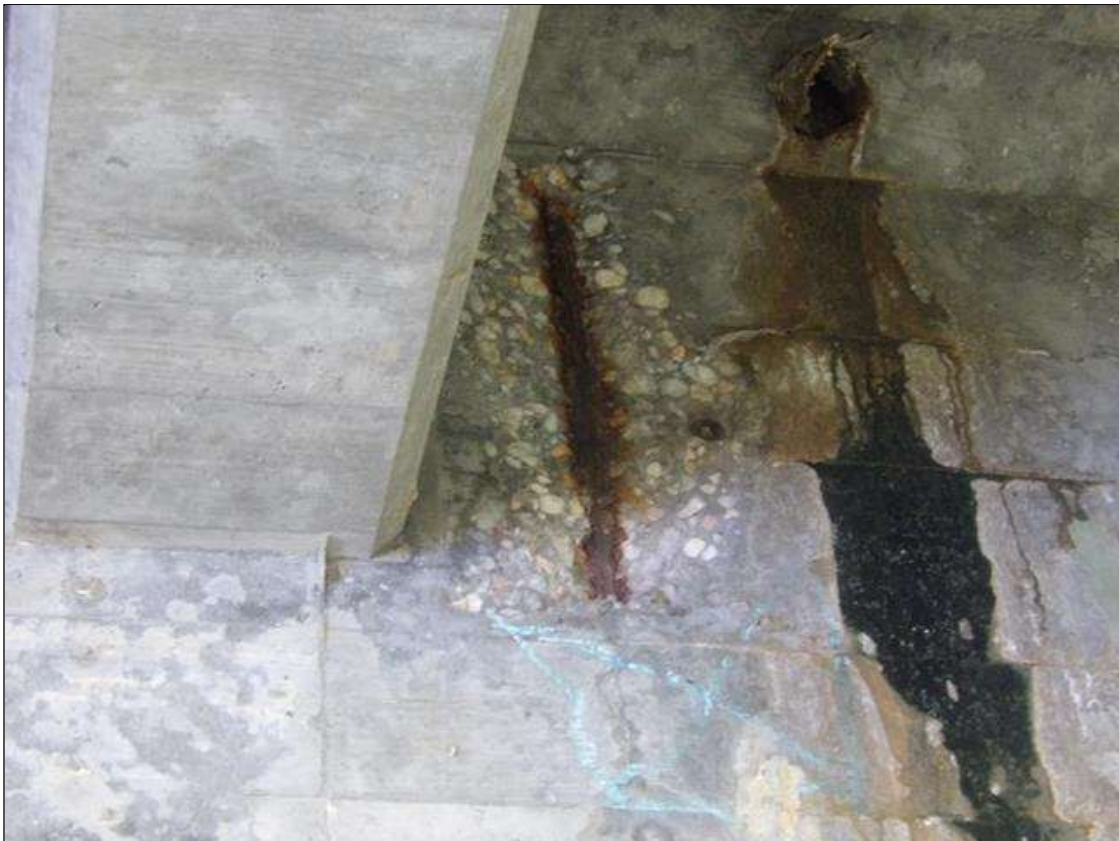
Span 6 Beam 1: PAR -- 20" LONG X 12" WIDE X 1" DEEP SPALL WITH EXPOSED REBAR WITH MINOR SECTION LOSS AND 10" DIA. AREA OF DELAMINATION BELOW SPALL, IN RIGHT FACE AT DIAPHRAGM

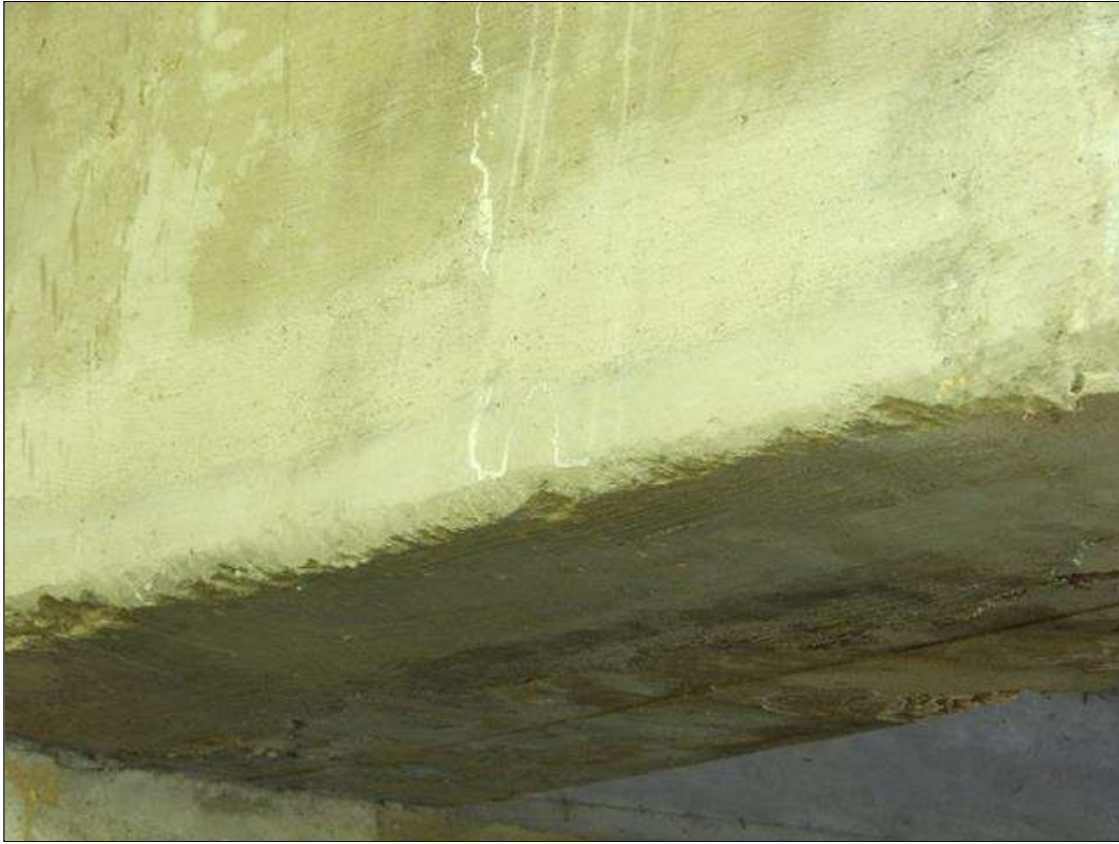
Span 6 Beam 1: 4' LONG X 5" SOUND PATCH ON LEFT FACE OF BEAM LOCATED 5' FROM END BENT 2

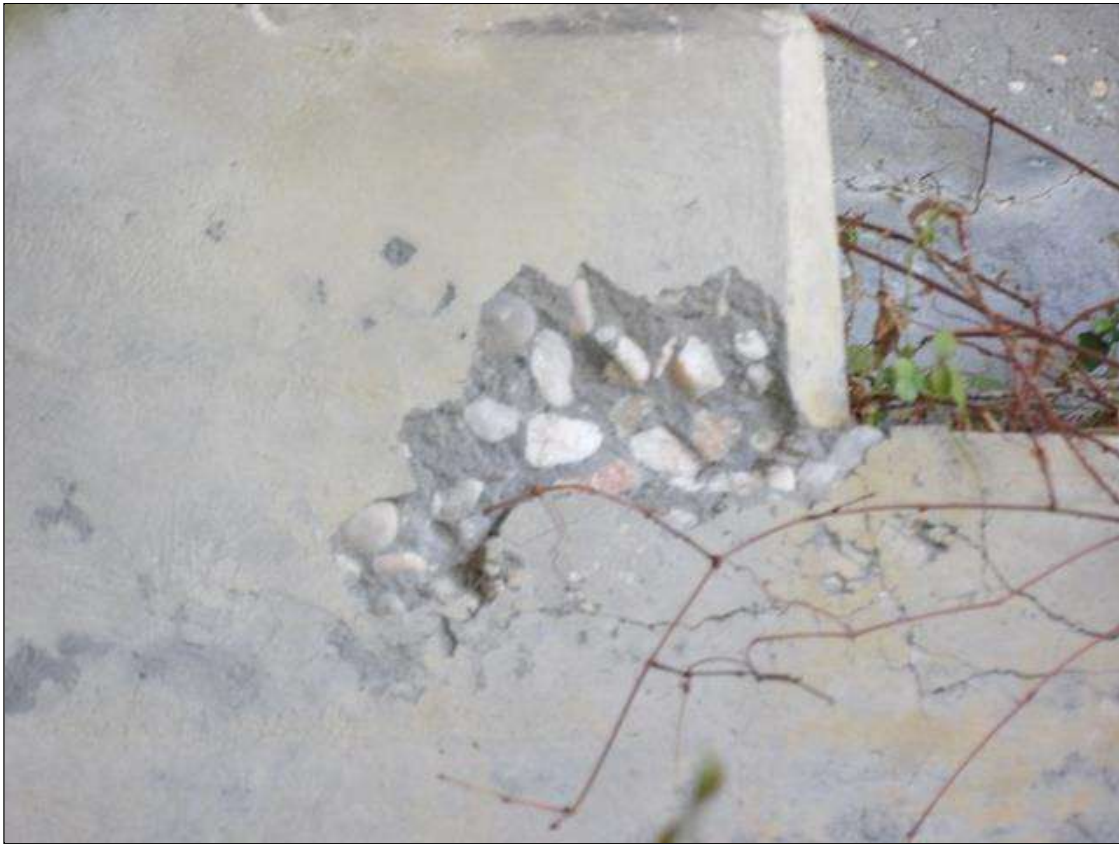
End Bent 2 Cap 1: 3" HIGH X 4" LONG X 1" DEEP SPALL, NO EXPOSED REBAR AT BEAM 5
