NC DEPARTMENT OF TRANSPORTATION
 DIVISION OF HIGHWAYS
 STRUCTURE MANAGEMENT UNIT

ATTENTION: PRIORITY ACTION REQUEST ISSUED; HYDRA-PLATFORM USED

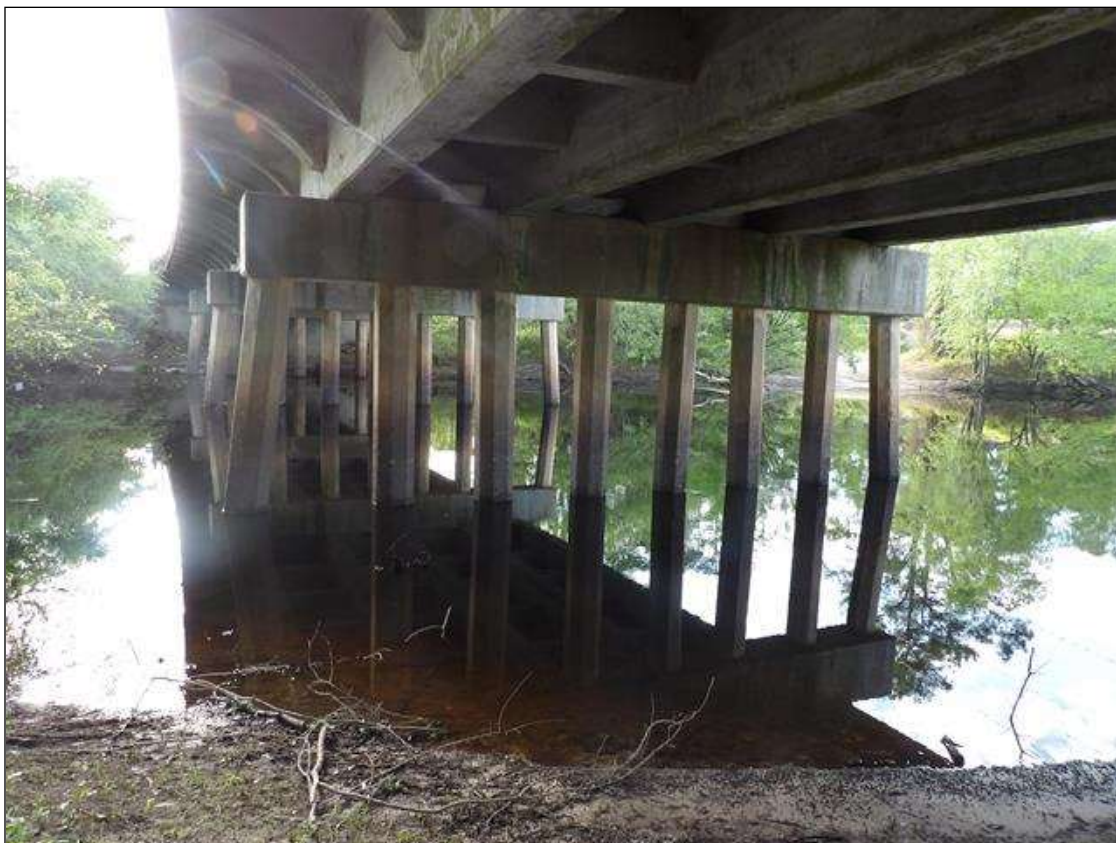
Pier 3 shown, all others similar

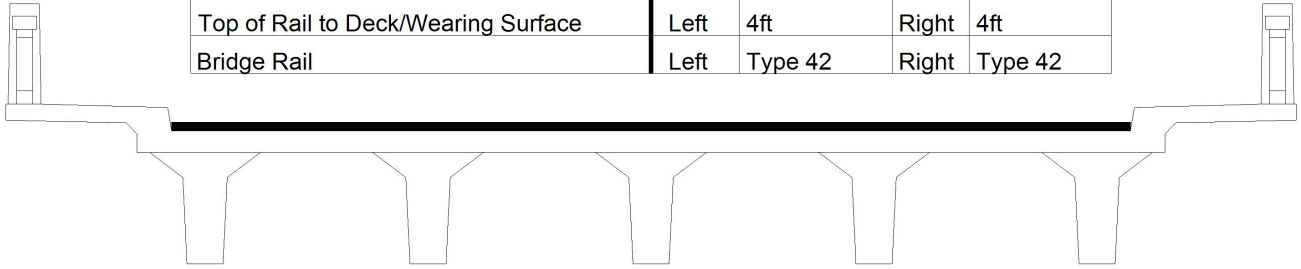
Measurements for Span #	1	ALL SPANS ARE SIMILAR	
Deck Thickness	0.625	Left Overhang	6.25
Top of Rail to Bottom of Beam	8.125	Right Overhang	6.25

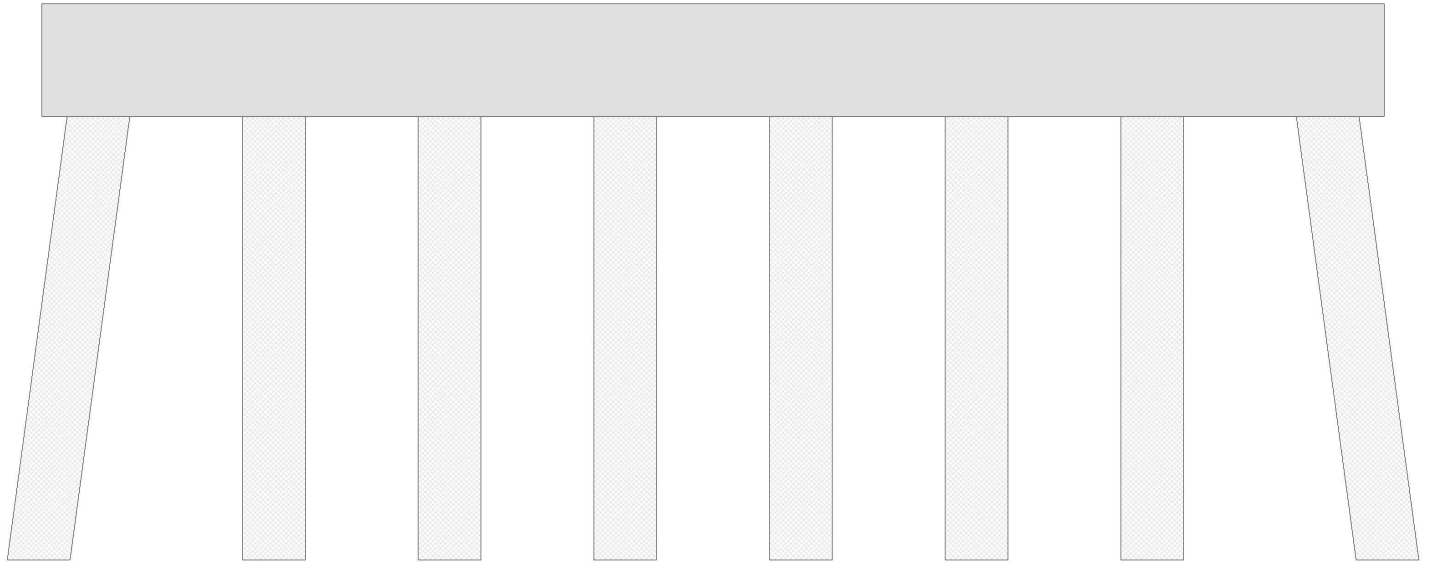
Cap Information			Material Cast-in-Place Concrete							
Length	Width	Height	Left Overhang	Right Overhang	Left Beam to End of Cap.	Right Beam to End of Cap.
