B-5981 PROJECT NO.____ **DUPLIN** __ COUNTY

BRIDGE NO. 300017

DECK UNDERSIDE REPAIR SPAN A

SHEET NO. REVISIONS S2-10 NO. BY: DATE: DATE: DOCUMENT NOT CONSIDERED FINAL UNLESS ALL SIGNATURES COMPLETED

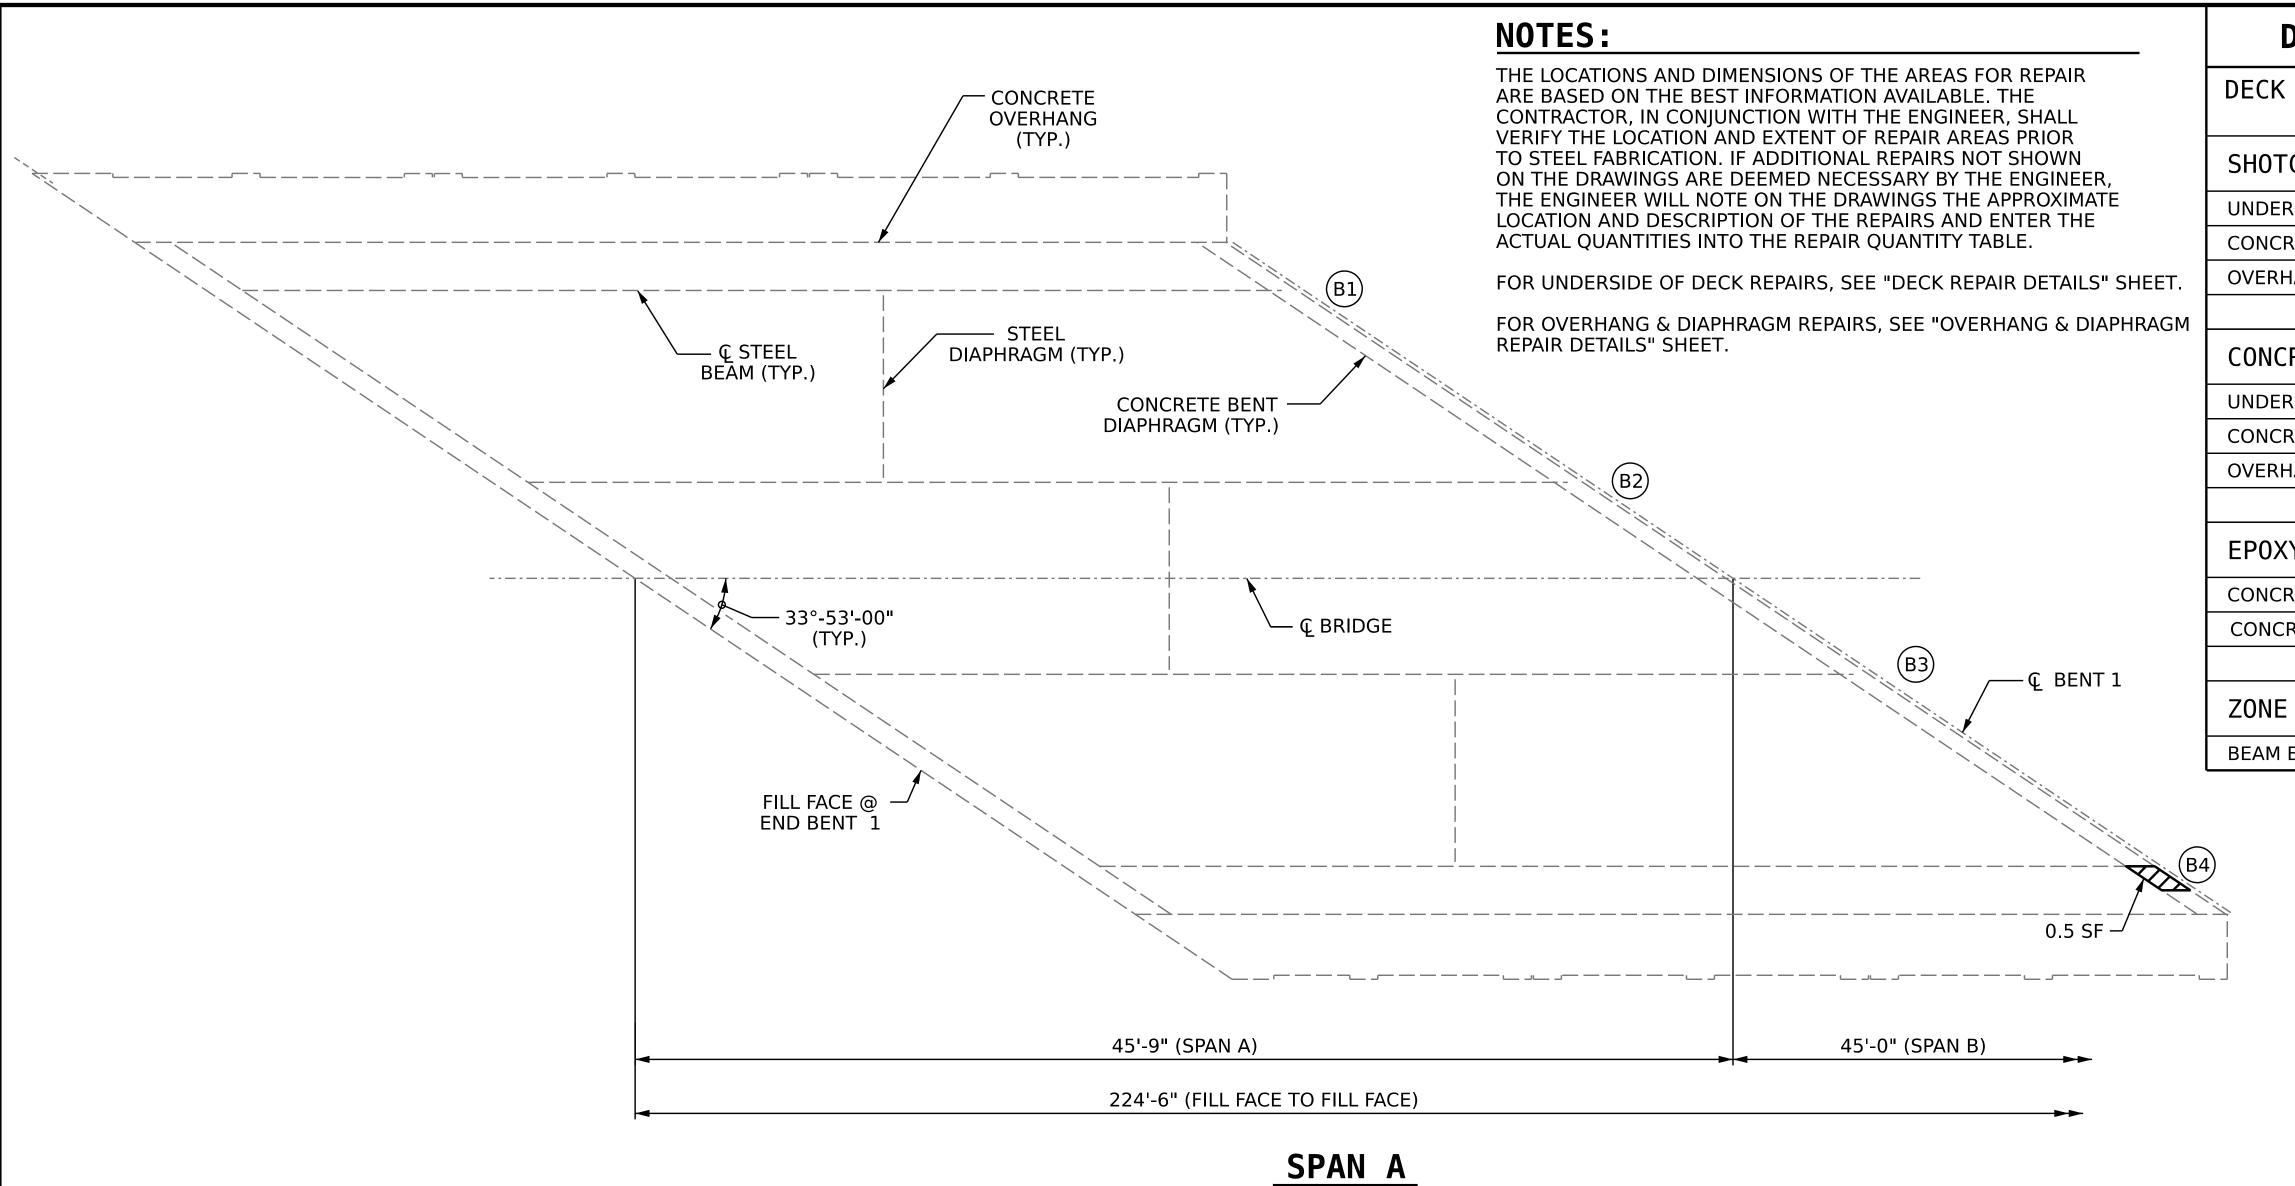
DECK UNDERSIDE	REPAIR	QUANT	ITY TAI	BLE	
DEC	DECK UNDERSIDE REPAIRS	QUANTITIES				
	SPAN A	ESTIN	ESTIMATE		UAL	
SHO	OTCRETE REPAIRS	AREA SF	VOLUME CF	AREA SF	VOLUME CF	
UNE	DERSIDE OF DECK	0	0			
CON	ICRETE DIAPHRAGM	0.5	0.4			
OVE	RHANG	0	0			
1						
	NCRETE REPAIRS	AREA SF	VOLUME CF	AREA SF	VOLUME CF	
UNE	DERSIDE OF DECK	0	0			
CON	ICRETE DIAPHRAGM	0	0			
OVE	RHANG	0	0			
EPO	OXY RESIN INJECTION	LINEAR FT		LINEAR FT		
CON	ICRETE DIAPHRAGM	0				
COI	NCRETE OVERHANG	0				
ZOI	NE PAINTING		AREA SF		AREA SF	
BEA	M ENDS		225.4

LIMITS OF ZONE PAINTING

VALUES IN CHART REPRESENT ESTIMATED REPAIR TOTALS AFTER REMOVAL OF UNSOUND CONCRETE, MIN. OF 1" BEHIND REBAR AND MIN. 2" CLEAR TO SAWCUT. SEE REPAIR DETAILS.

(SEE SHEETS S2-26, S2-27 AND S2-28 FOR BEAM REPAIR DETAILS AND DIMENSIONS.)
