B-5981 PROJECT NO. ____

DUPLIN

BRIDGE NO. 300017

DECK UNDERSIDE REPAIR SPAN C

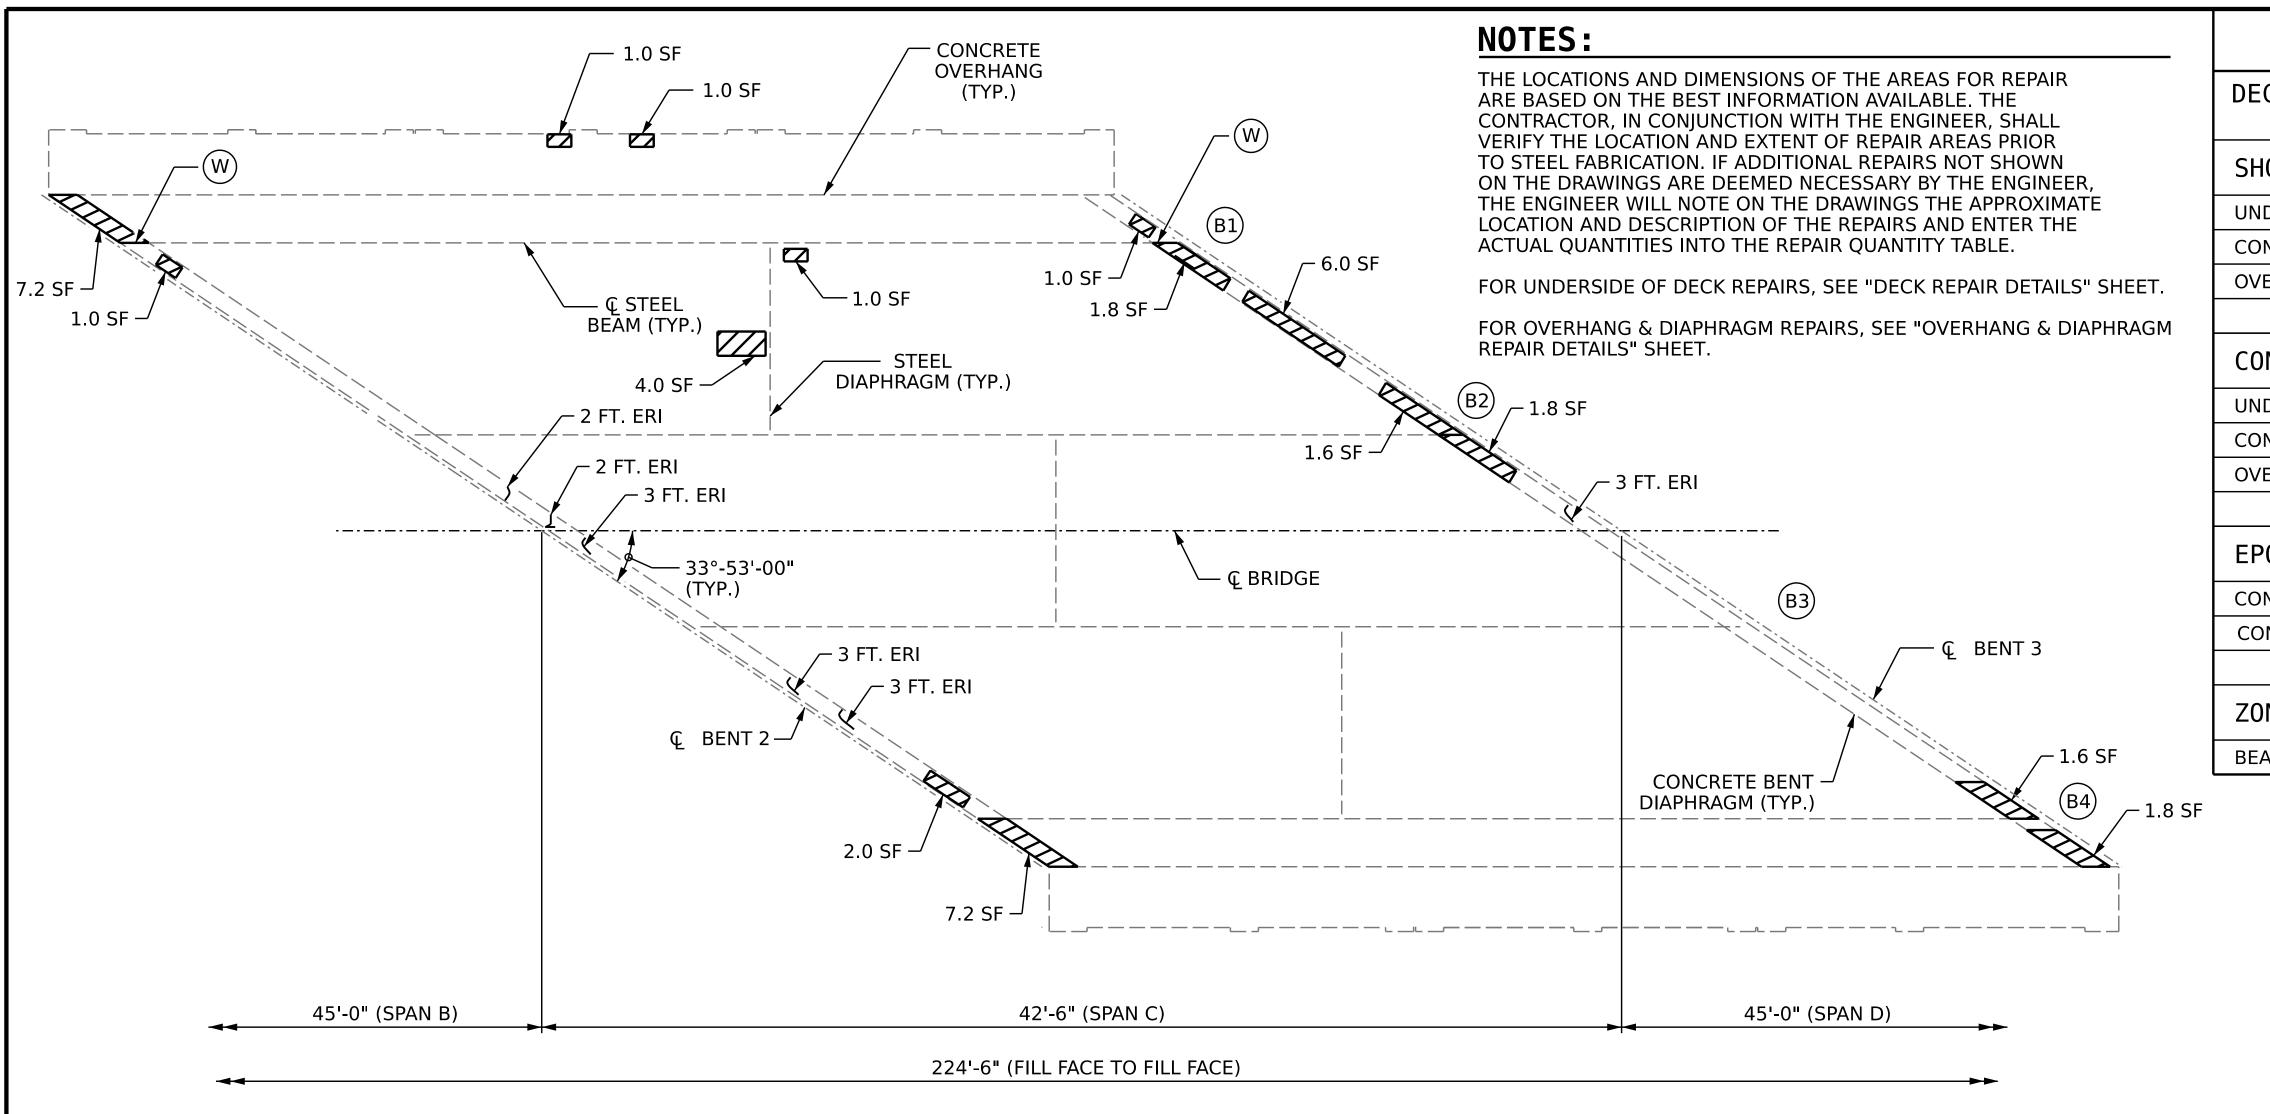
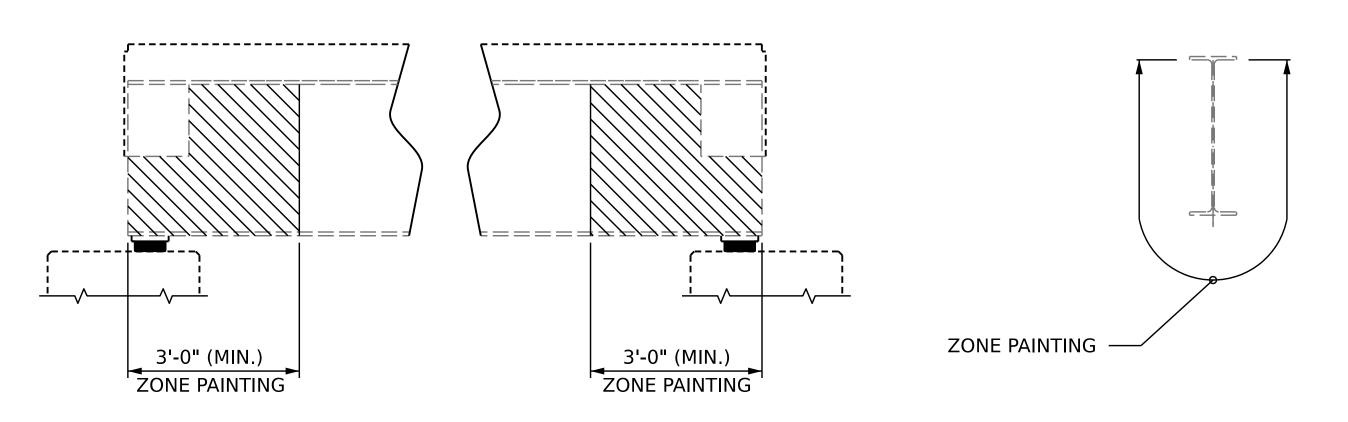
ANTICIPATED STEEL REPAIR LOCATIONS							
REPAIR TYPE	BEAM	LOCATION	DIM. "A"	DIM. "B''	DIM. "C"	DIM. "D''	
W	1	BENT 2	18"	16"			
W	1	BENT 3	15"	15"

VALUES IN CHART REPRESENT ESTIMATED REPAIR TOTALS AFTER REMOVAL OF UNSOUND CONCRETE, MIN. OF 1" BEHIND REBAR AND MIN. 2" CLEAR TO SAWCUT. SEE REPAIR DETAILS.

(SEE SHEETS S2-26, S2-27 AND S2-28 FOR BEAM REPAIR DETAILS AND DIMENSIONS.)
