PROJECT NO. **B-5981**  
**DUPLIN** COUNTY  
 BRIDGE NO. **300017**  
 SHEET 3 OF 6

STATE OF NORTH CAROLINA  
 DEPARTMENT OF TRANSPORTATION  
 RALEIGH  
**SUBSTRUCTURE REPAIR  
 BENT 2**

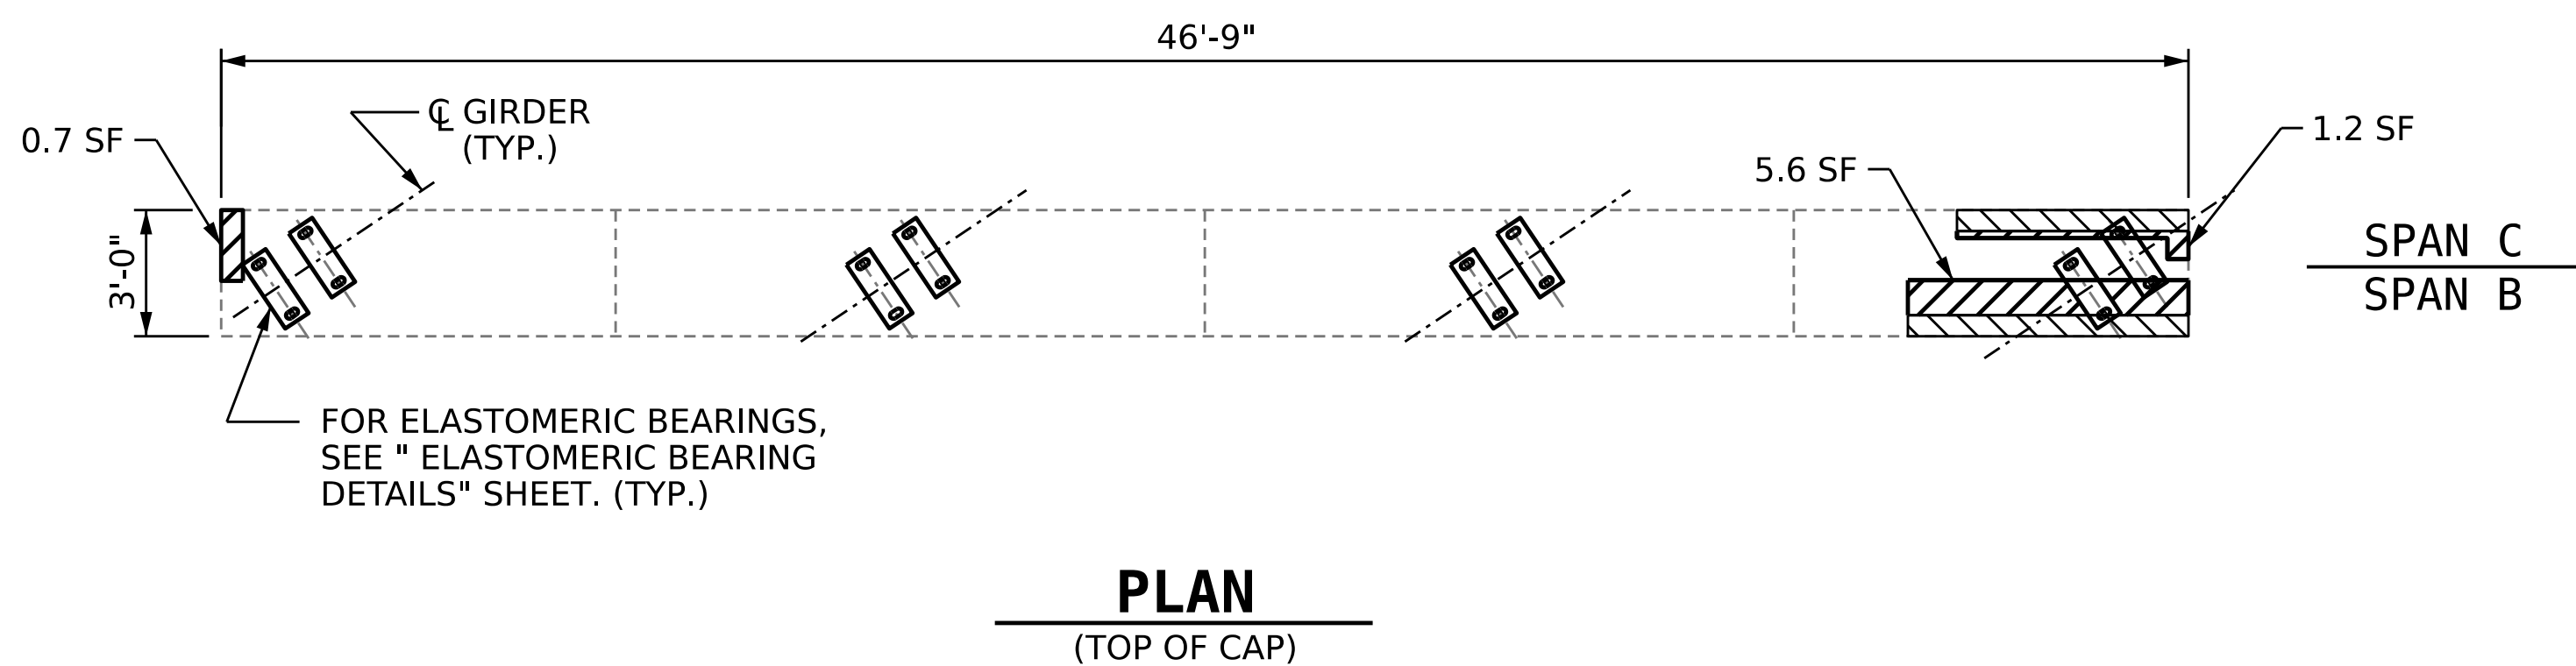
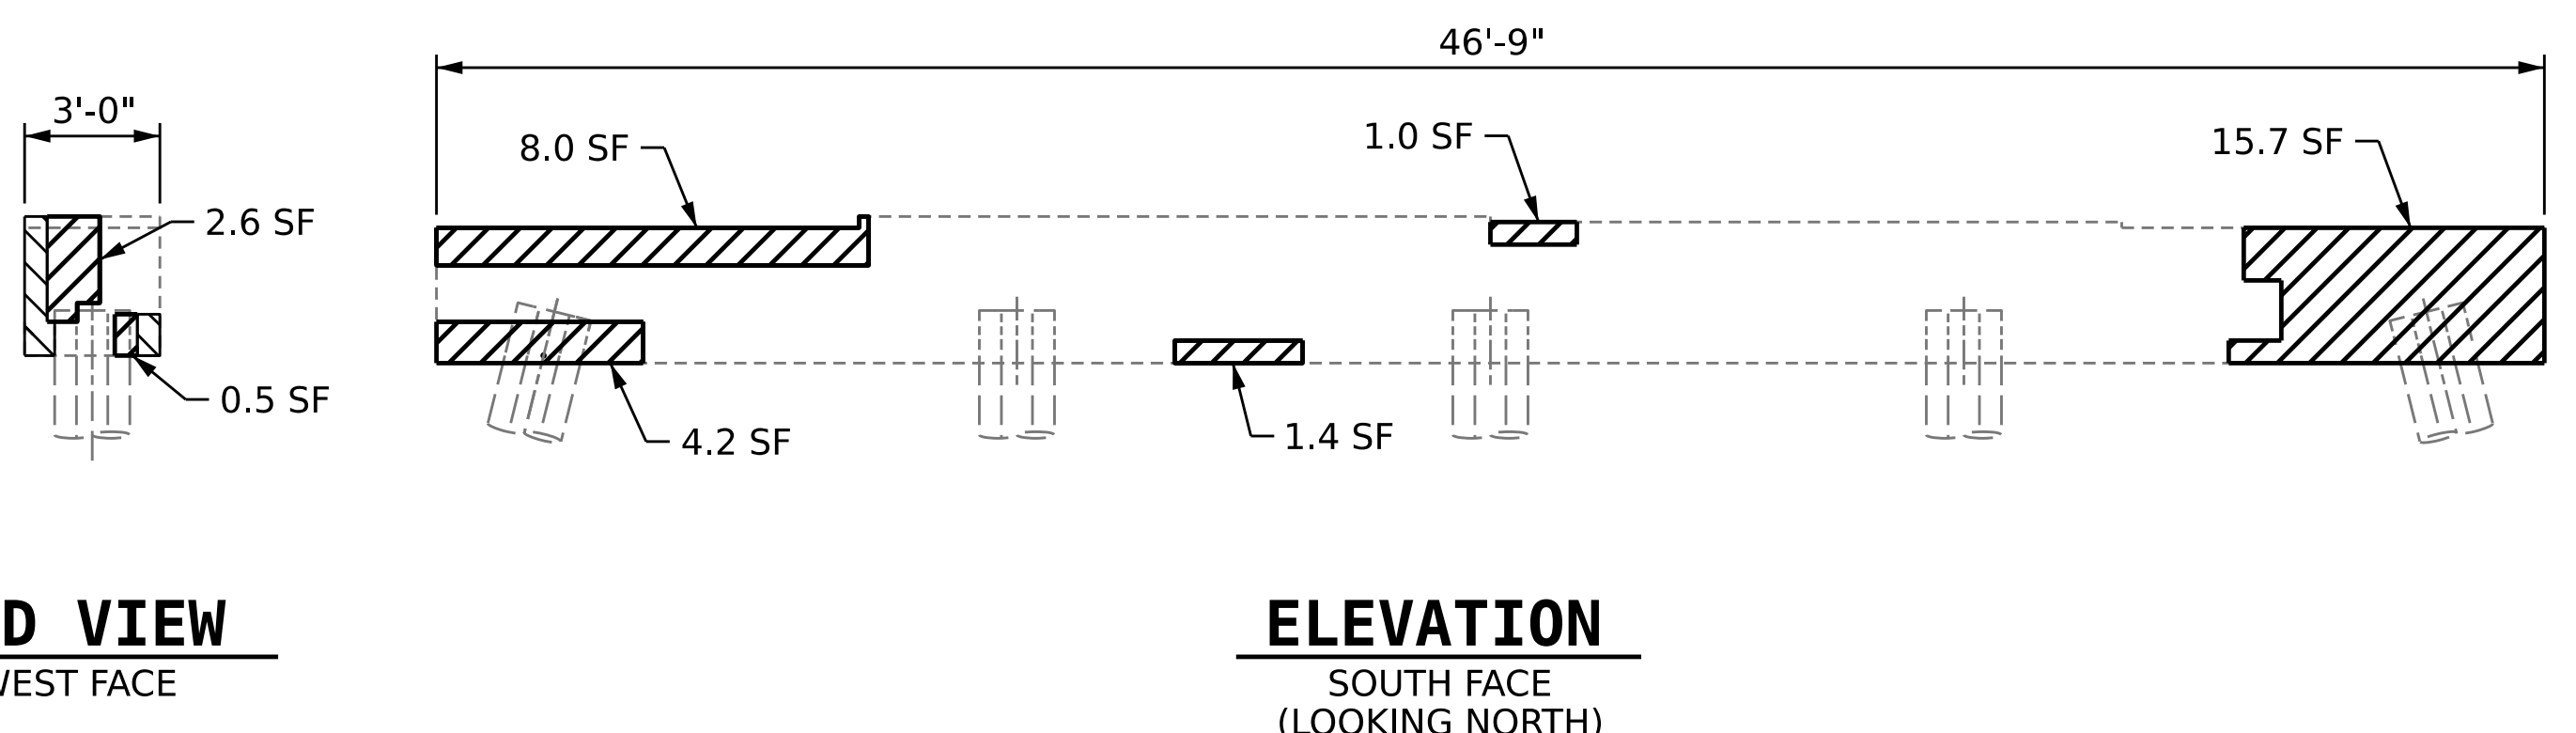
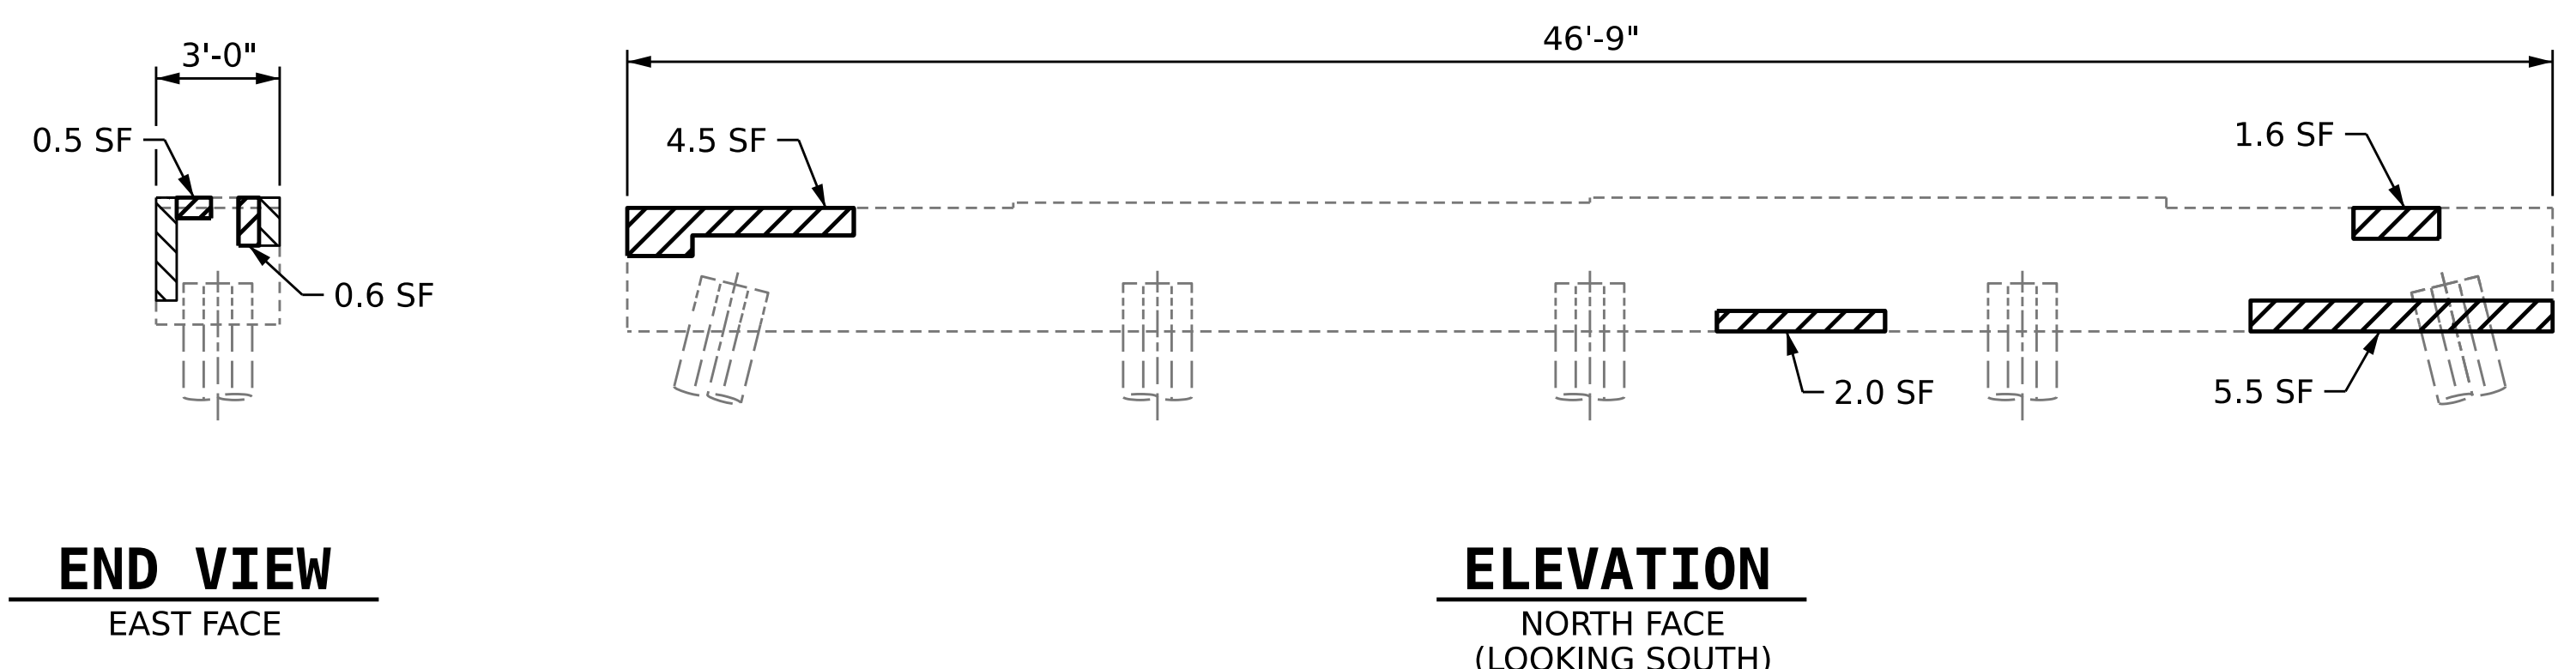
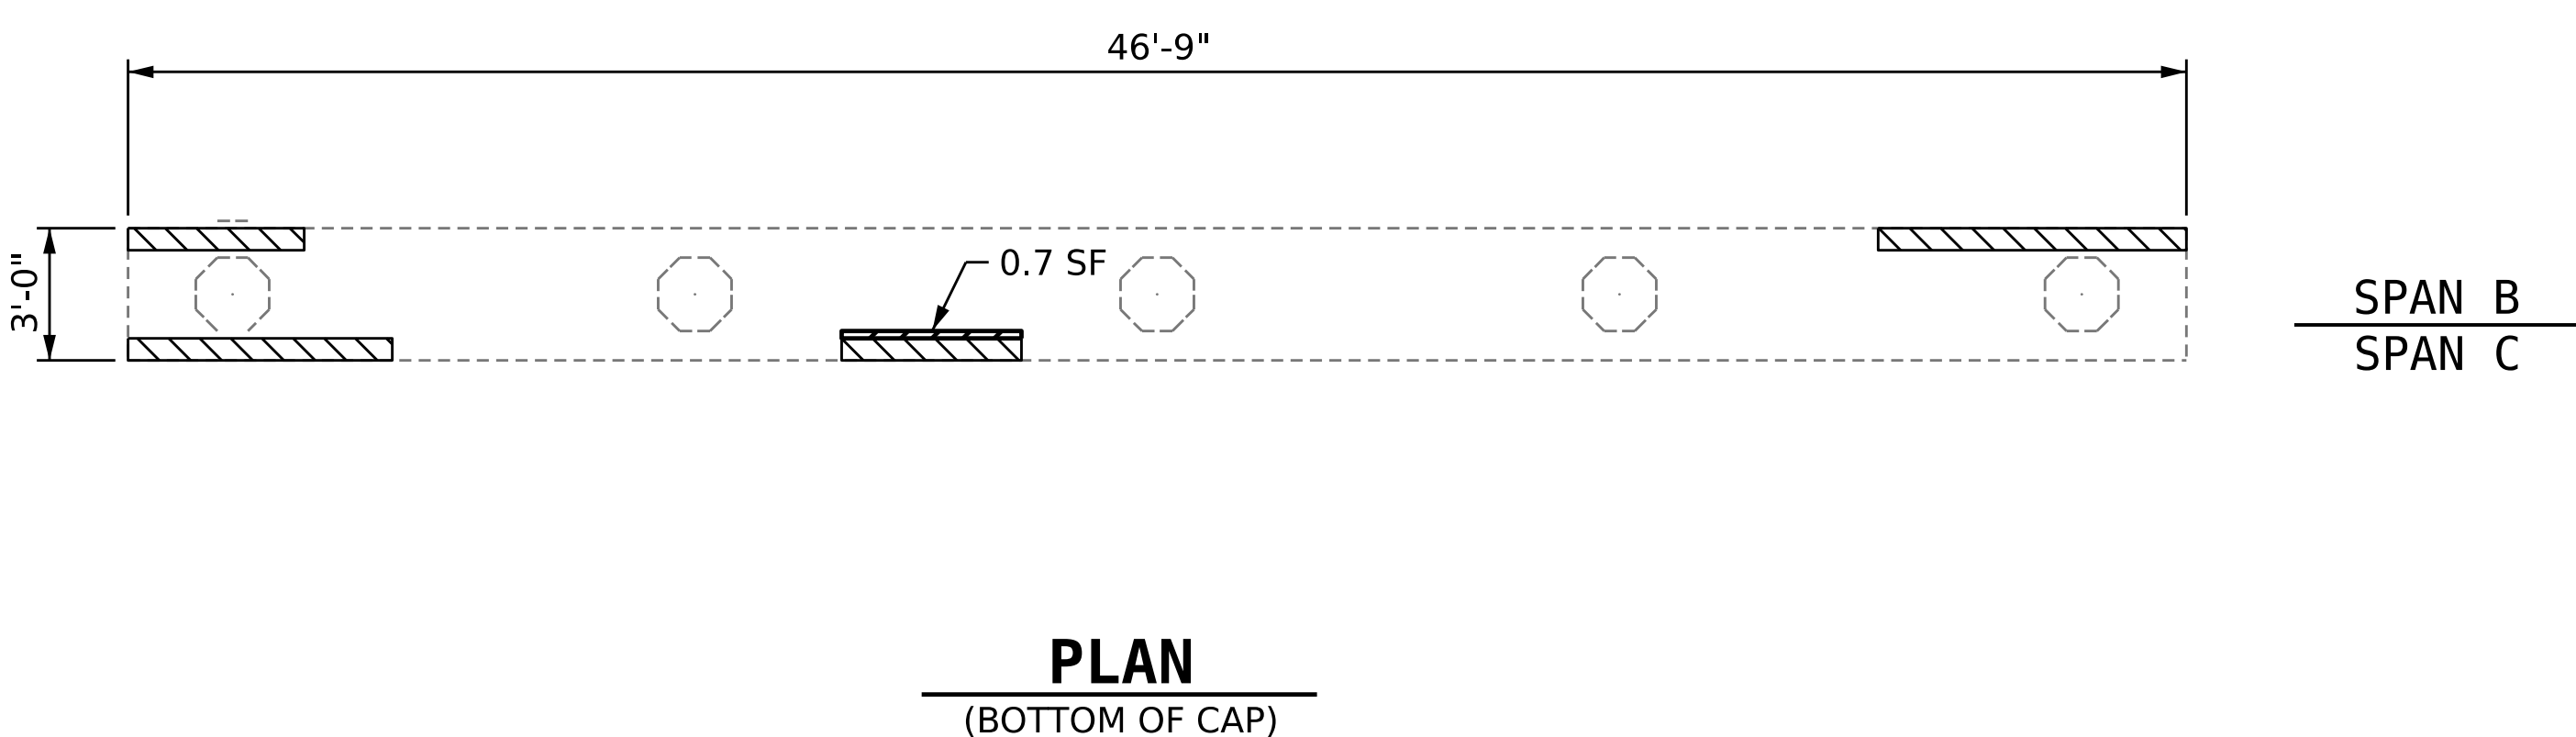
SUBSTRUCTURE REPAIR QUANTITY TABLE				
REPAIRS - BENT 2	QUANTITIES			
	ESTIMATE		ACTUAL	
SHOTCRETE REPAIRS	AREA SF	VOLUME CF	AREA SF	VOLUME CF
CAP	56.3	28.2		
COLUMN	0	0		
CONCRETE REPAIRS	AREA SF	VOLUME CF	AREA SF	VOLUME CF
CAP	0	0		
COLUMN	0	0		
EPOXY RESIN INJECTION		LINEAR FT		LINEAR FT
CAP		0		
COLUMN		0		
EPOXY COATING		AREA SF		AREA SF
CAP		130.5

VALUES IN CHART REPRESENT ESTIMATED REPAIR TOTALS AFTER REMOVAL OF UNSOUND CONCRETE, MIN. OF 1" BEHIND REBAR AND MIN. 2" CLEAR TO SAWCUT. SEE REPAIR DETAILS.

CLEAN AND REMOVE DEBRIS FROM THE TOP OF THE CAP AND APPLY EPOXY PROTECTIVE COATING. EPOXY COATING SHALL BE APPLIED TO THE TOP SURFACE OF THE CAP AFTER ELASTOMERIC BEARINGS AND ANCHOR BOLTS ARE INSTALLED. THE CONTRACTOR SHALL NOT COAT THE AREA OF THE CAP BENEATH THE BEARINGS.

FOR REPAIR DETAILS, SEE "TYPICAL CAP AND COLUMN REPAIR DETAILS" SHEET.
