December 9, 2020

**Subject: Removal Site Evaluation Report
Davidson Community Asbestos
Davidson, Mecklenburg County, North Carolina
EPA Contract No.: 68HE0519D0006
Task Order / Task Order Line Item No.: 68HE0419F0097 / 97-005**

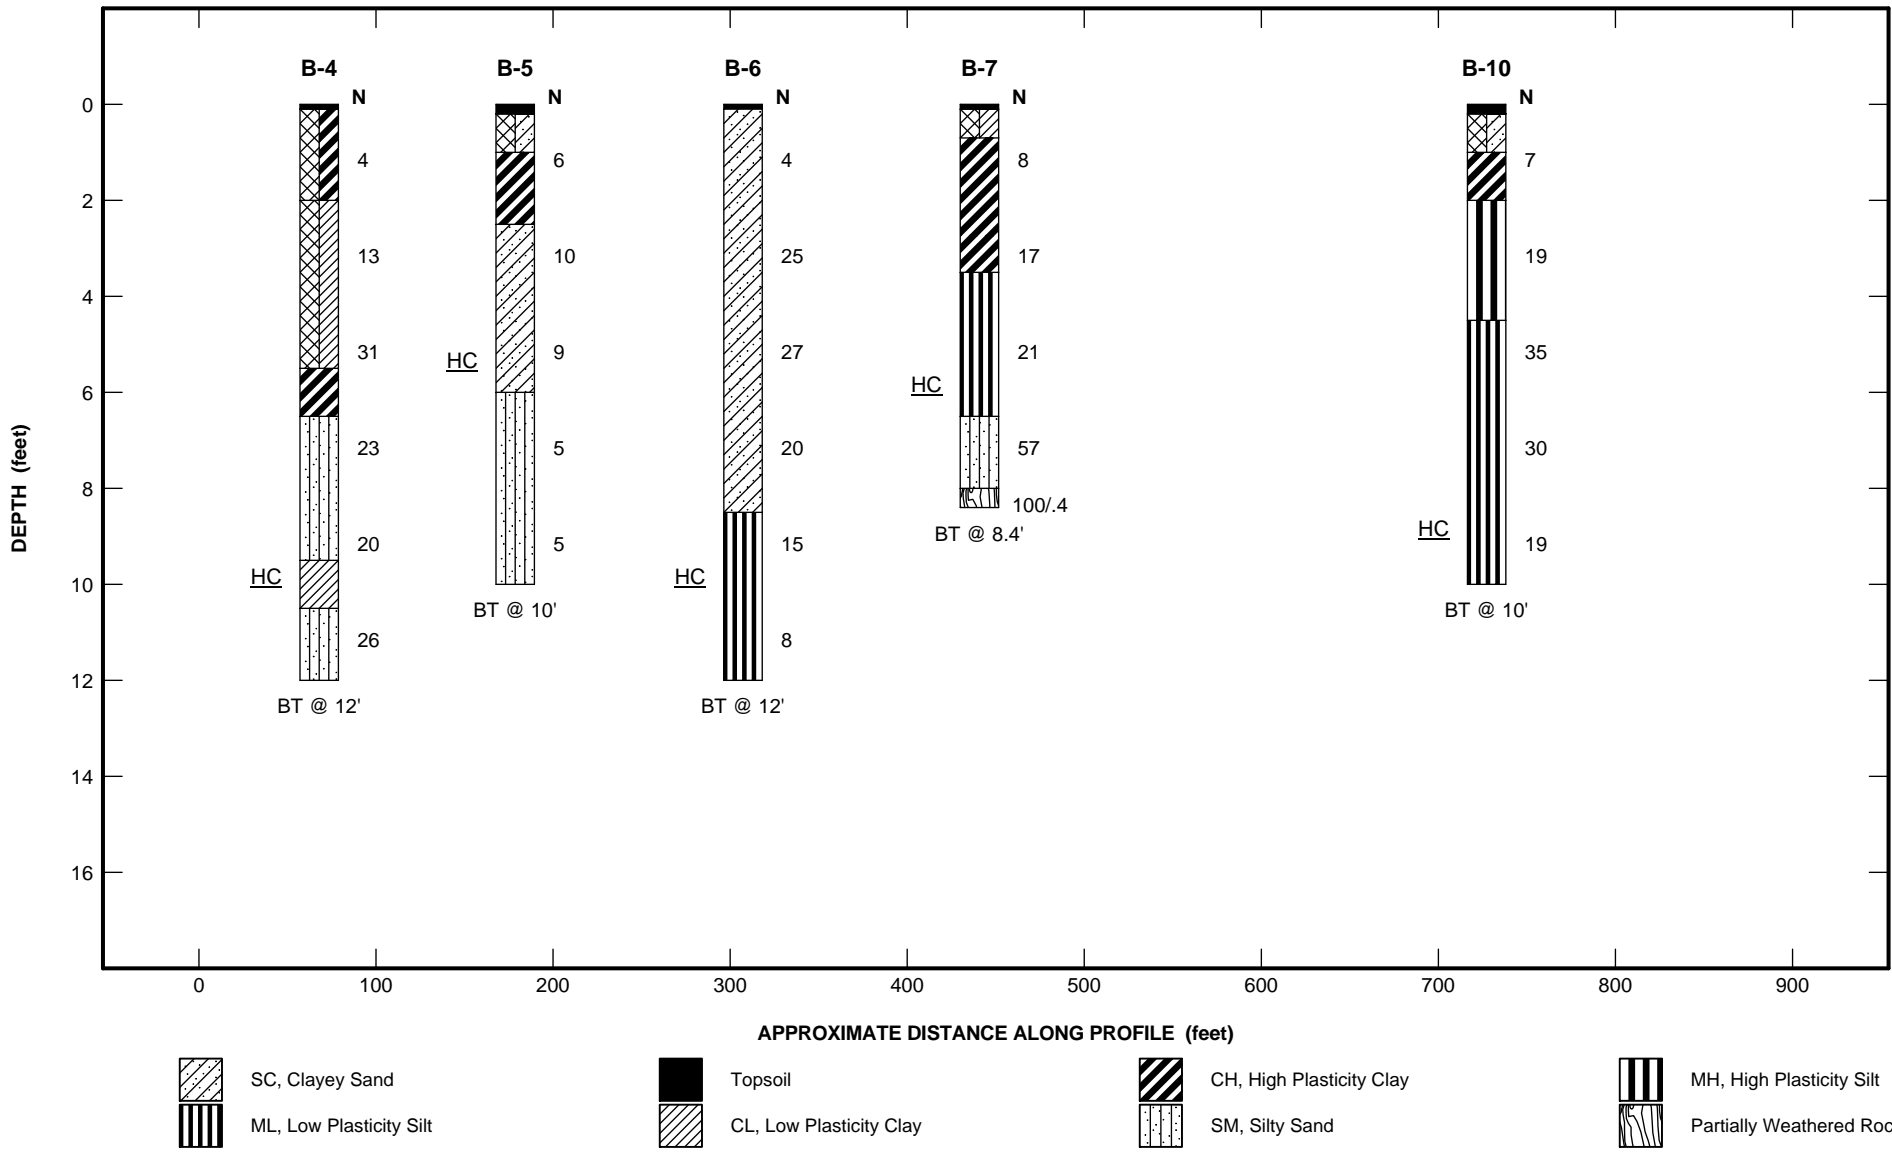
Figure
3

N = Standard Penetration Test resistance value (blows per foot). The depicted stratigraphy is shown for illustrative purposes only. The actual subsurface conditions will vary between boring locations.
