BRIDGE INSPECTION REPORT

INSPECTION TYPE: Routine Inspection

COUNTY JOHNSTON BRIDGE NUMBER 500050 INSPECTION CYCLE 2 YRS
 ROUTE NC210 ACROSS MIDDLE CREEK M.P. 0

INSPECTION TYPE Routine Inspection
 BRIDGE NO. 500050 COUNTY JOHNSTON ROUTE NC210 OVER MIDDLE CREEK
 STRUCTURE TYPE REINFORCED CONCRETE FLOOR ON I-BEAMS
 ROUTE ORIENTATION W - E SPANS 1@34';2@33.917';1@34'

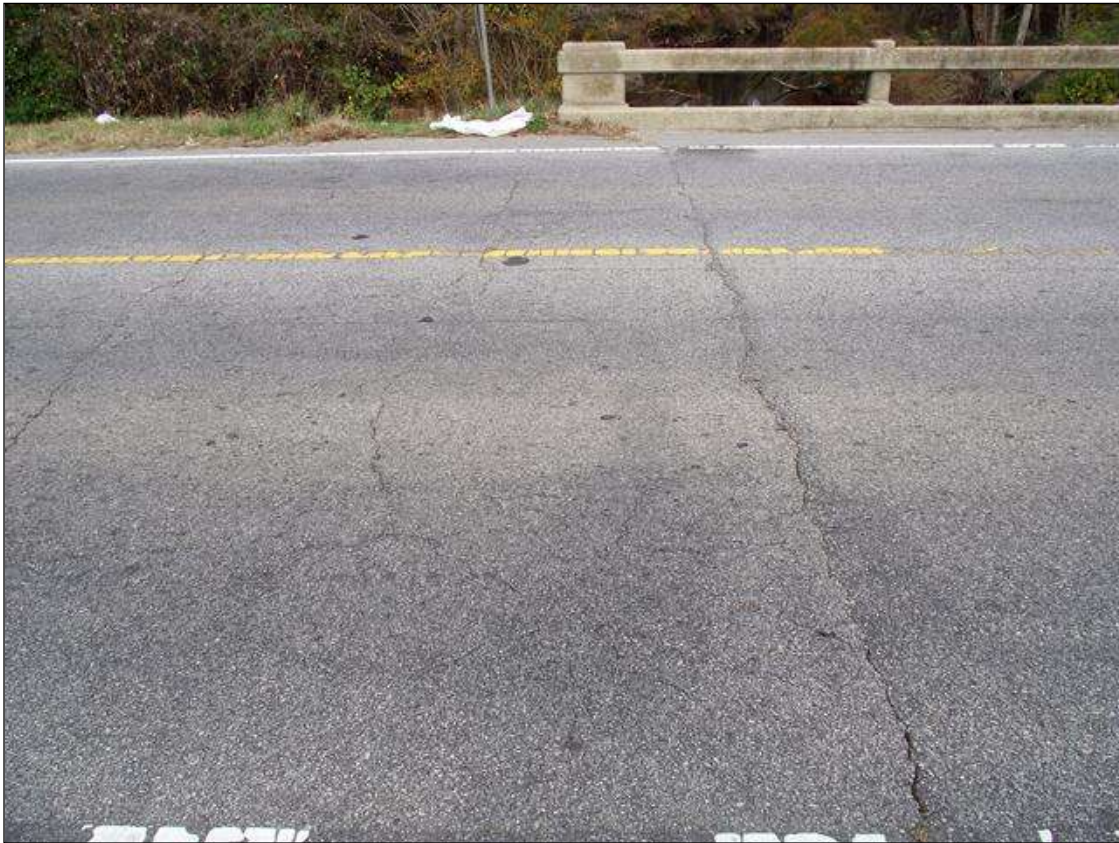
TRANSVERSE CRACK IN WEARING SURFACE OVER END BENT 1

MMS Code	Description of Function	Unit	Quantity	Remarks	Est. Cost
2816	Asphalt Surface Repair or Replacement	SY	140	APPROACHES ARE CRACKED AND SETTLED.	
3376	Clean/Wash Bridge Decks	SF	560	DIRT, VEGETATION, AND DEBRIS ALONG CURBS.

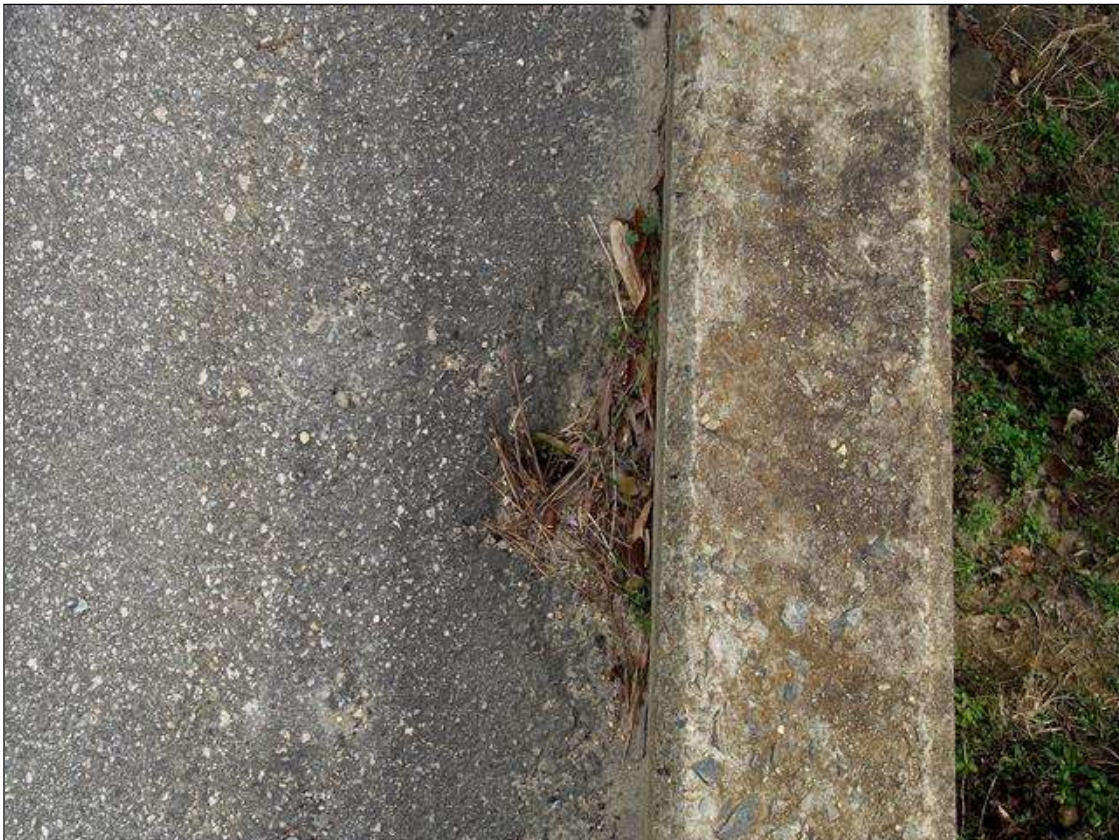
16	F	DRAINAGE SYSTEM 50 PERCENT OF THE DECK DRAINS ARE CLOGGED.	
36a	F	CONCRETE CAPS ABUTMENT 1 RANDOM HAIRLINE VERTICAL CRACKS IN FACES . 7 INCH LONG CRACK WITH DELAMINATION AND EFFLORESCENCE UNDER BEAM NO. 12 AT ABUTMENT NO. 1 . BENT 1 SPAN 1 SIDE OF CAP AT BENT NO. 1 SPALLED 6 IN. X 6 IN. X 1 IN. DEEP WITH REBAR EXPOSED UNDER BAY 6 . 1/8 IN. WIDE LONGITUDINAL CRACK 18 IN. LONG IN SPAN 1 SIDE FACE OF CAP BAY 3 AT BOTTOM CORNER. BENT 2 1/16 IN. WIDE LONGITUDINAL CRACK 3 FT. LONG IN FACE OF CAP SPAN 3 SIDE OF BENT 2 CAP UNDER BEAM 12 BENT 3 SPAN 3 SIDE FACE OF BENT 3 CAP UNDER BEAM 9 IS SPALL HAS BEEN REPAIRED. HAIRLINE X 2 FT. LONGITUDINAL CRACK IN SPAN 3 SIDE BAY 3. HAIRLINE MAP CRACKING ON BOTTOM OF BENT NO. 3 CAP OTHERS SIMILAR . END BENT 2 1/32 IN WIDE VERTICAL CRACKS IN FACE OF CAP .

DRAINS CLOGGED ALONG THE RIGHT SIDE CURBLINE- LEFT SIDE SIMILAR

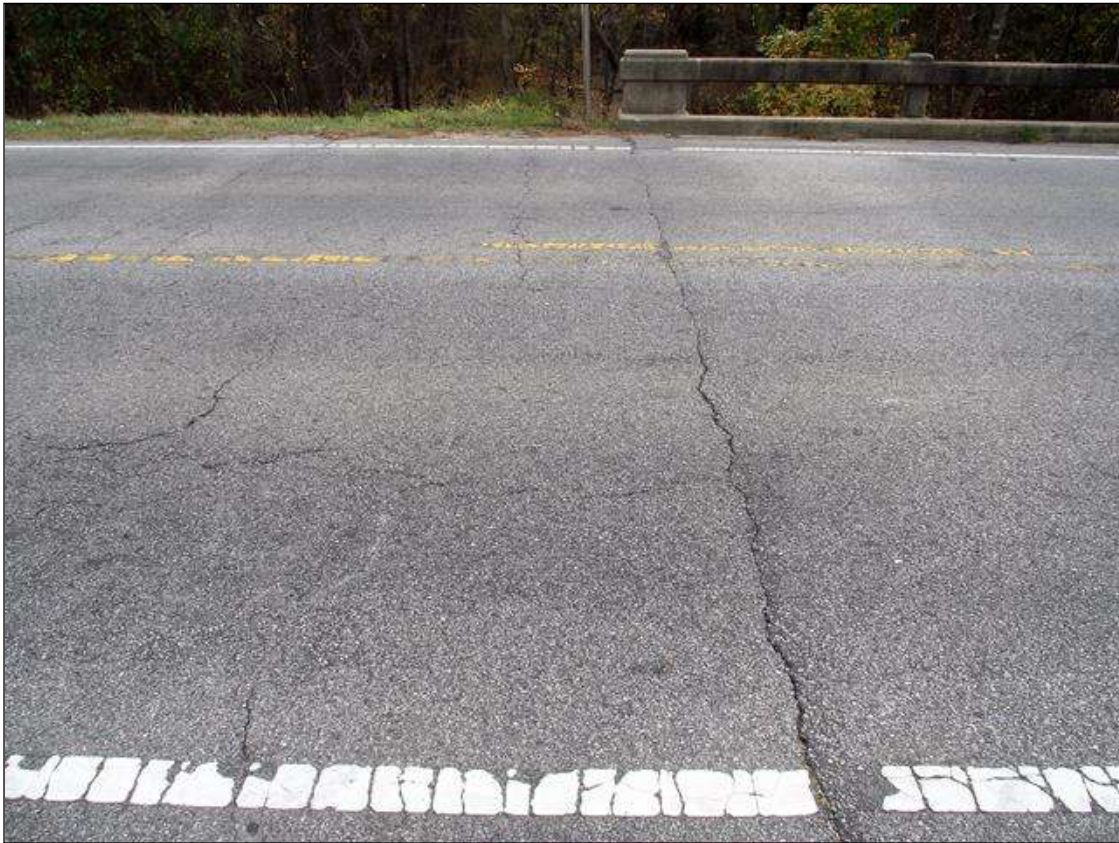
Bridge I&A Form 1(82)H State of North Carolina Dept. of Transportation Division of Highways		FIELD INSPECTION REPORT <u>Bridge Inspeccion & Analysis</u>	
Team Leader WILLIS C MAY			
Assisted By WTW			
Item No.	Grade		
36b	F	CONCRETE COLUMNS ABRASION WITH EXPOSED COARSE AGGREGATE ALONG FLOWLINE. RANDOM HAIRLINE VERTICAL CRACKS IN COLUMNS. BENT 3 SPALL WITH REBAR EXPOSED 17 INCHES LONG IN FILLET ON LEFT SIDE OF COLUMN NO. 1 BENT NO. 3 . VERTICAL 1/32 INCH CRACKS IN LEFT SIDE OF COLOMNN NO. 2 BENT 3.	
36c	F	CONCRETE PILES ABRASION WITH EXPOSED COARSE AGGREGATE ALONG FLOWLINE OF BENT 1 AND BENT 2. BENT 1 SPALL WITH REBAR EXPOSED 7 INCHES LONG ON SPAN 1 SIDE FACE OF PILE 2 AT BENT NO. 1 .	
50	F	APPROACH ROADWAY CONDITION TRANSVERSE AND MAP CRACKS IN BOTH APPROACHES WITH 1/2 IN. SETTLEMENT AT END BENTS.

TRANSVERSE CRACK IN WEARING SURFACE OVER END BENT 2 AND IN APPROACH 2

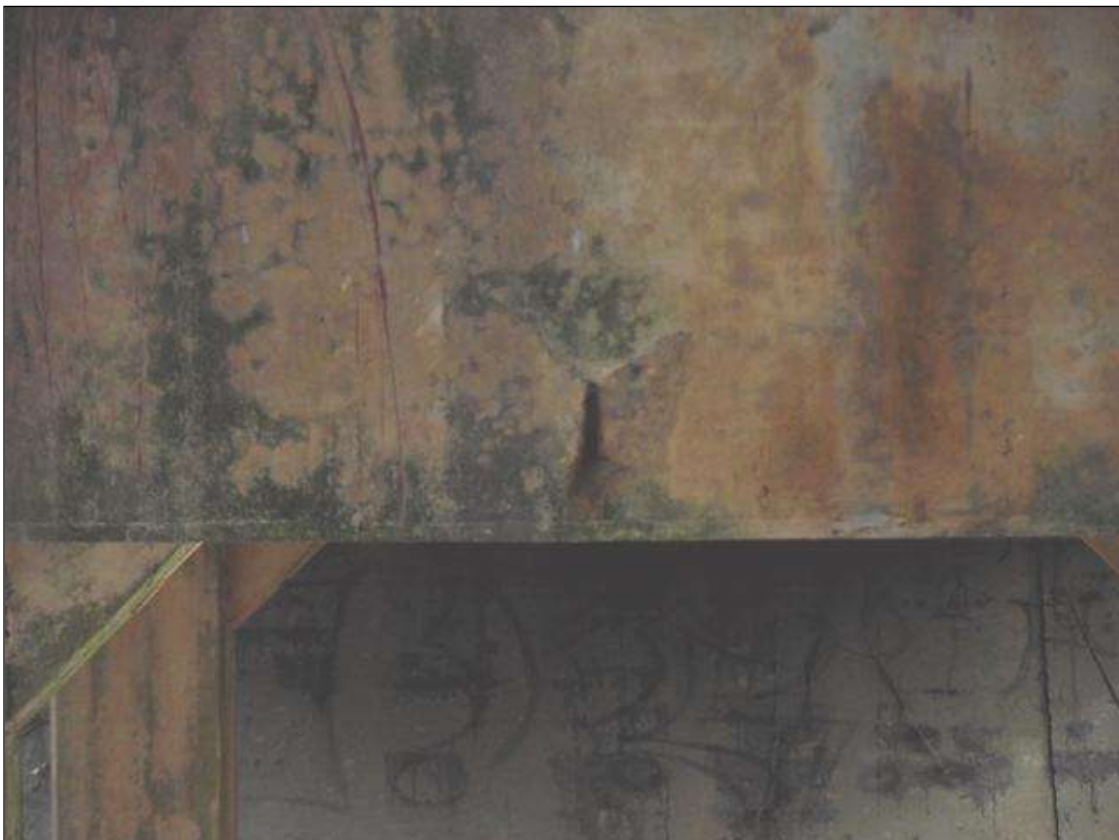
SPALL WITH EXPOSED REBAR IN FACE OF CAP AT BENT 1 SPAN 1 UNDER BAY 6

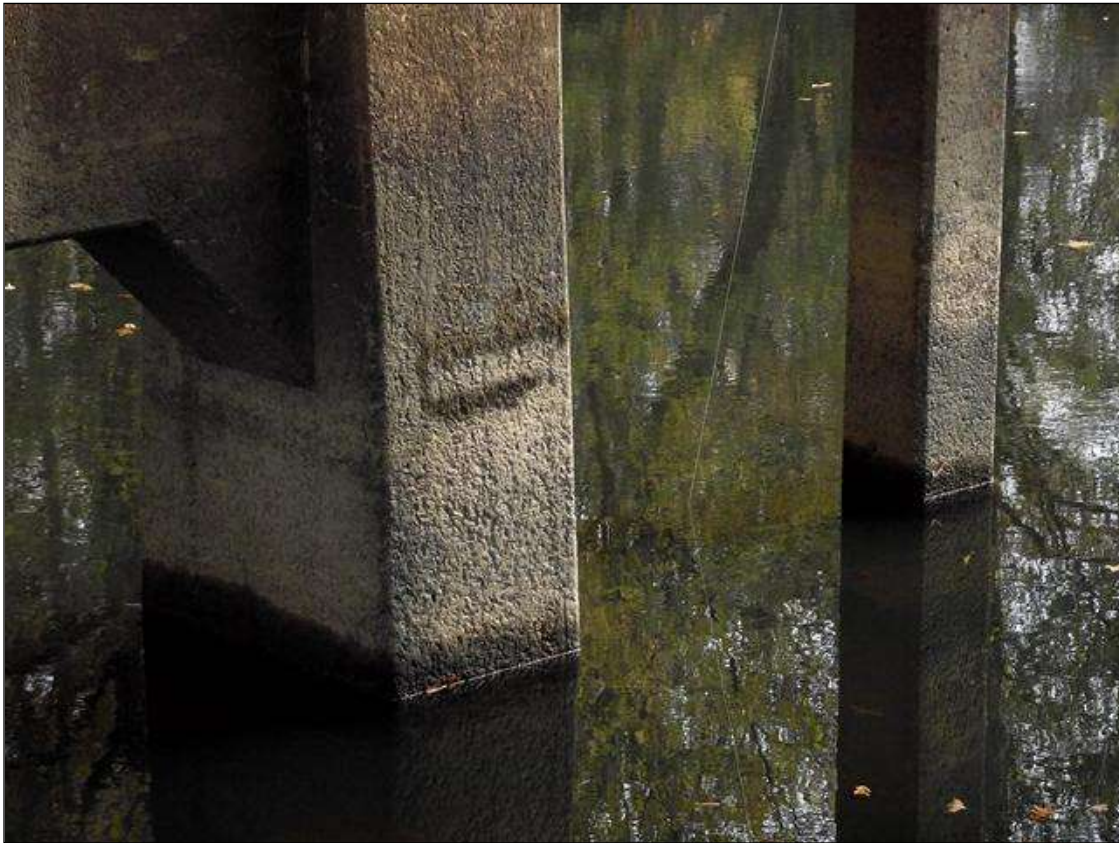
WATER ABRASION WITH EXPOSED AGGREGATE IN THE FLOWZONE OF BENT COLUMNS

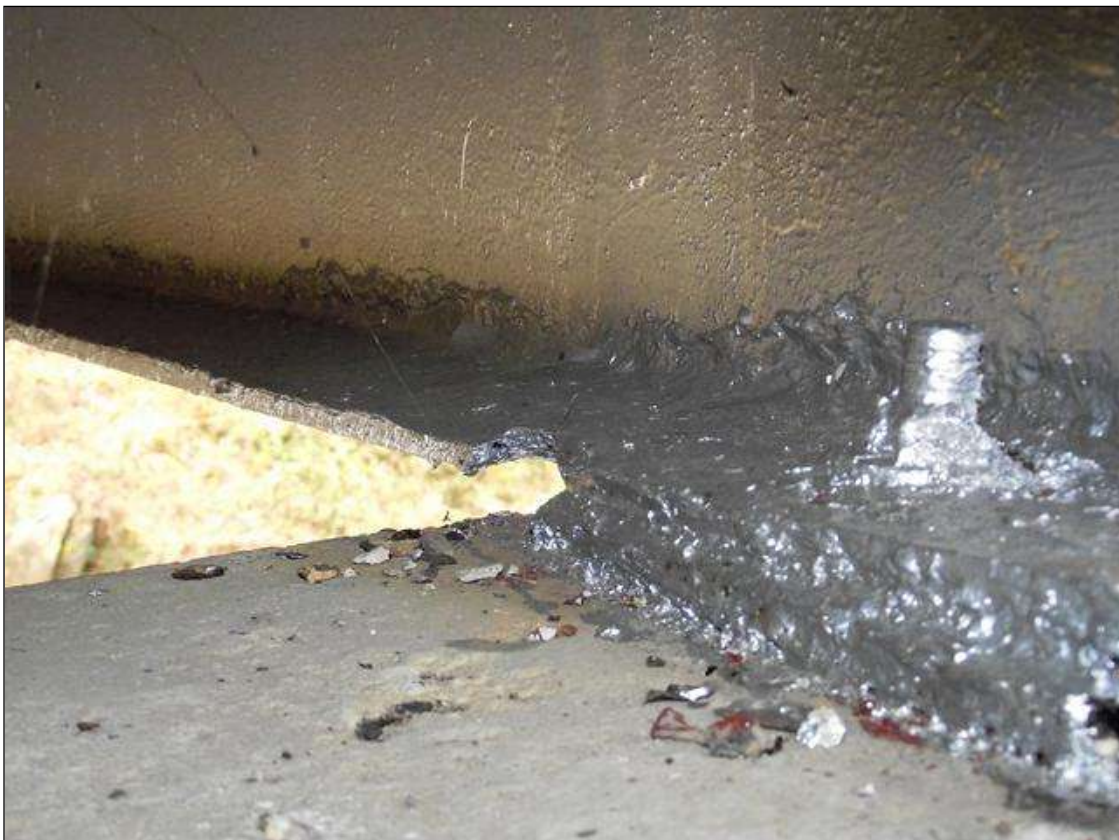
Item No.	Grade		
10A	NO	BEAM 7 RIGHT BOTTOM FLANGE HAS SECTION LOSS WITH 3/8 IN. REMAINING 24 IN. LONG IN END OVER BENT 3 . BEAM 8 RIGHT BOTTOM FLANGE HAS SECTION LOSS WITH 3/8 IN. REMAINING 24 IN. LONG IN END OVER BENT 3 . BEAM NO. 13 AT END BENT 2 HAS SECTION LOSS WITH 3/16 INCH REMAINING , RANDOM SPOTS OF 1/16 IN. SECTION LOSS THE FULL LENGTH OF BOTTOM FLANGE, AND 1/8 IN. SECTION LOSS IN BOTTOM FLANGE 18 IN LONG AT 2/3 POINT. NO CURVED GIRDERS.	
13	F	END DIAPHRAGMS BENT NO. 1 BAY 10 DIAPHRAGM CRACKED IN SPAN 1 AT BENT 1. DIAPHRAGM SPALLED WITH REBAR EXPOSED IN BAY 3,7,8 AND 9 IN SPAN NO. 1 AT BENT 1. BENT 3 DIAPHRAGM AT BENT NO. 3 SPALLED IN BAY 6 AND 7 IN SPAN NO. 3 .	
15	F	BEARING ASSEMBLIES BEARING ASSEMBLIES HAVE BEEN CLEANED AND PAINTED. BEARINGS AT BENT 3 HAVE 1/16 IN. SECTION LOSS IN FACES . MISSING ANCHOR BOLT NUTS AT RIGHT SIDE OF BEAM 12 SPAN 3 BENT 3 AND LEFT SIDE OF BEAM 13 SPAN 4 AT END BENT 2.

SECTION LOSS IN THE RIGHT SIDE BOTTOM FLANGE OF BEAM 1 IN SPAN 2 OVER BENT 1

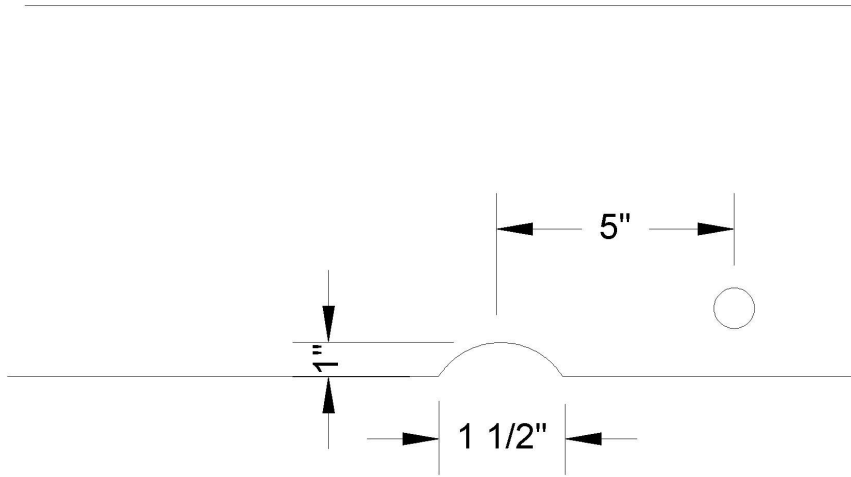
Title CONDITION 2		Description CONDITION 2	
Bridge No: 500050	Drawn By: WCM	Date: 11/20/2009	File Name: S0014003801

RT BOTTOM FLANGE OF BEAM 1 SPAN 2 AT BENT 2

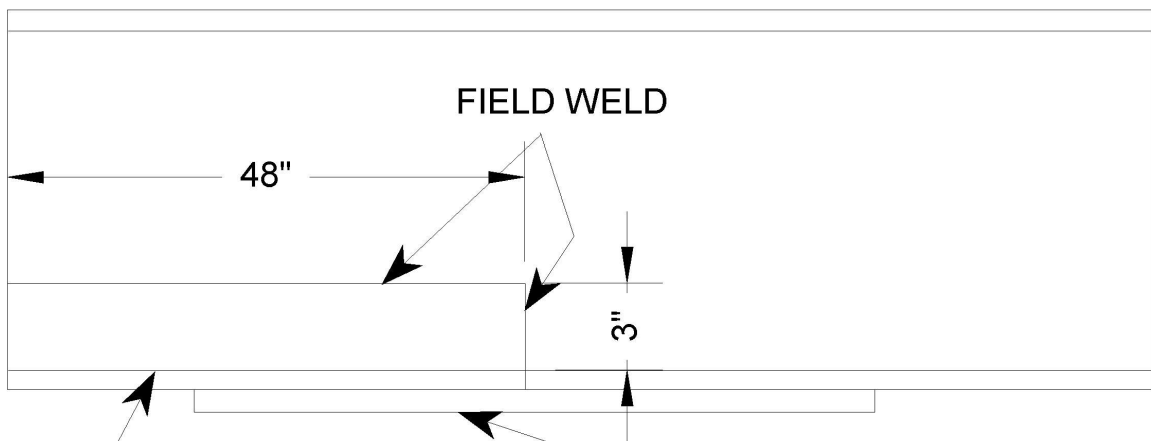
Title REPAIR		Description REPAIR TO BEAMS 9,10,11 SPAN 3	
Bridge No: 500050	Drawn By: WCM	Date: 11/20/2009	File Name: S0014003799

BEAMS 9,10,11 OF SPAN 3 BENT 3 END

1/2" x 10" x 48" COVER PLATE ADDED OVER JOINT

WEB AND BOTTOM FLANGE HAVE BEEN REPLACED

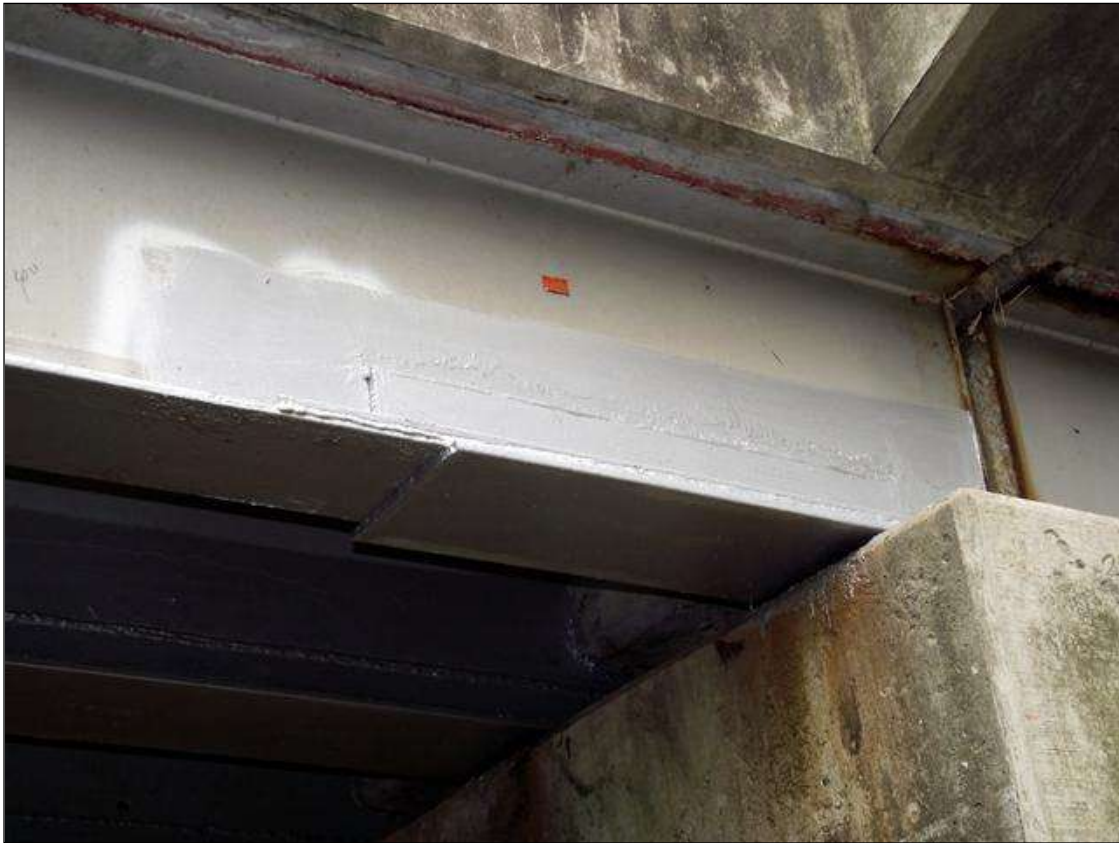
PLATE REPAIR AT THE END OF BEAM 13 OVER BENT 3 SPAN 3 SIDE - OTHER REPAIRS SIMILAR THROUGHOUT STRUCTURE

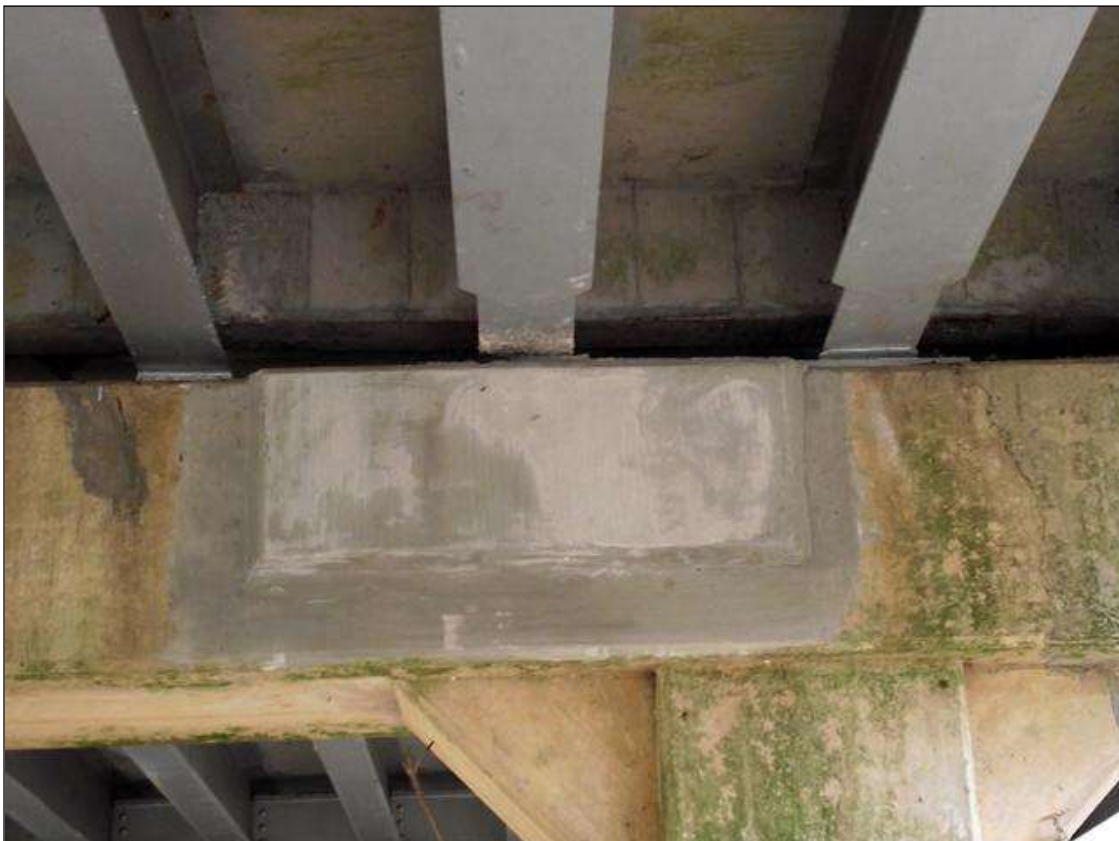
SPALL WITH EXPOSED REBAR IN FACE OF CAP AT BENT 3 SPAN 3 SIDE UNDER BAY 9 REPAIRED

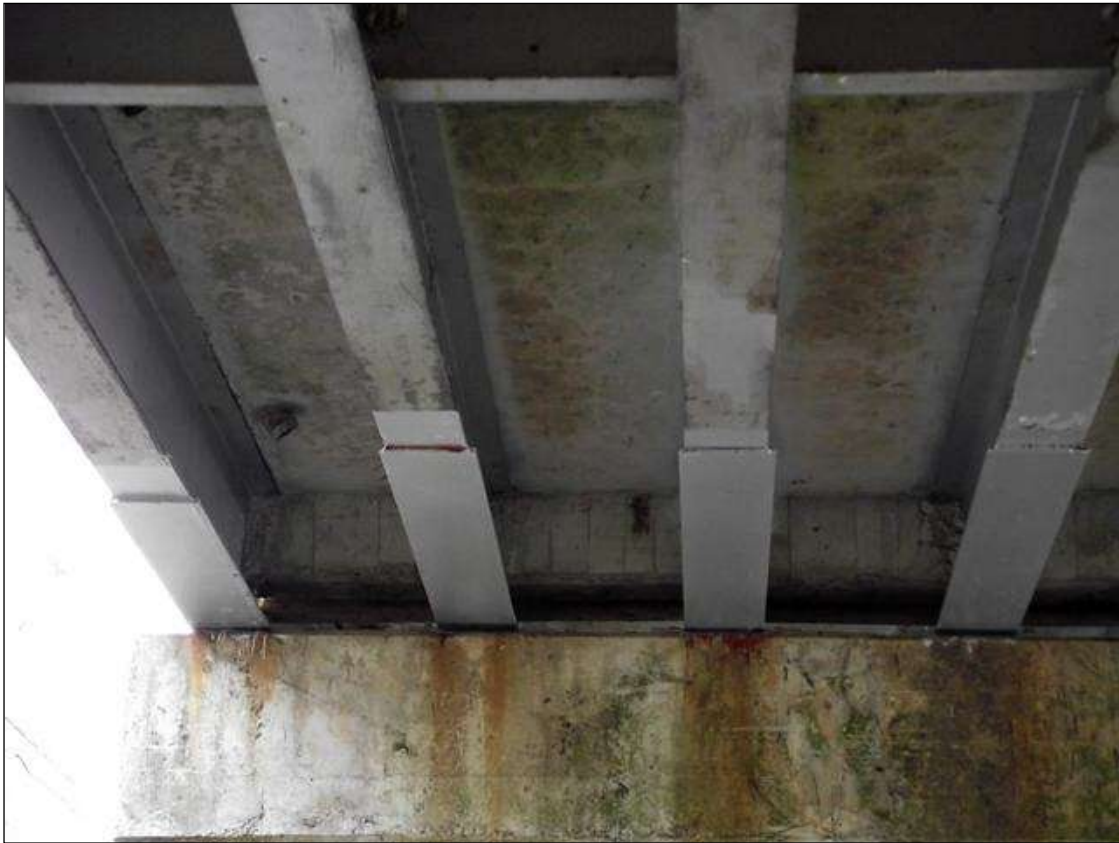
PLATE REPAIRS AT THE ENDS OF BEAMS 1-4 IN SPAN 1 OVER BENT 1

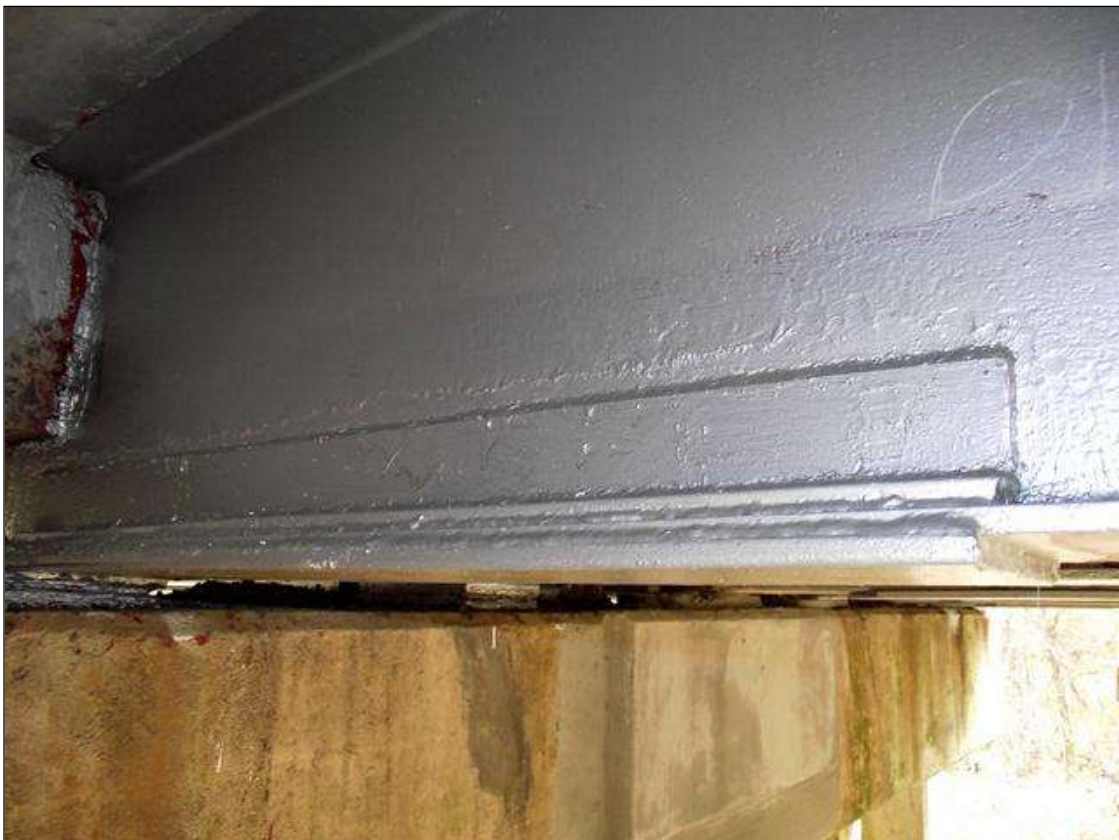
PLATE REPAIR DETAIL FOR BEAM 7 OVER BENT 3 SPAN 3 SIDE - OTHER REPAIRS SIMILAR AT THIS BENT
