NC DEPARTMENT OF TRANSPORTATION
 DIVISION OF HIGHWAYS
 STRUCTURE MANAGEMENT UNIT

ATTENTION: **Priority Action Request, Changes to Structure Data**

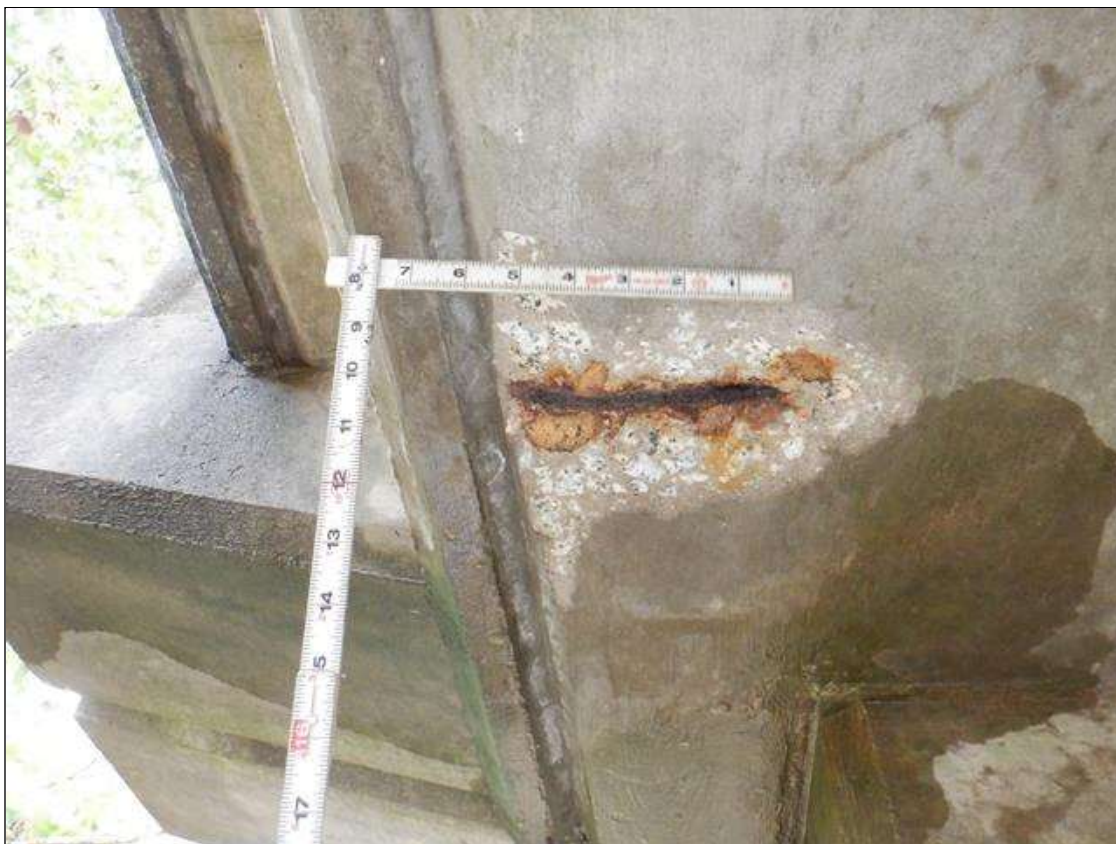
Span 1 Deck: underside West overhang at bent 1, spall [8in x 3in x 1/2in deep] with exposed rusted reinforcing [loss < 1/16in]

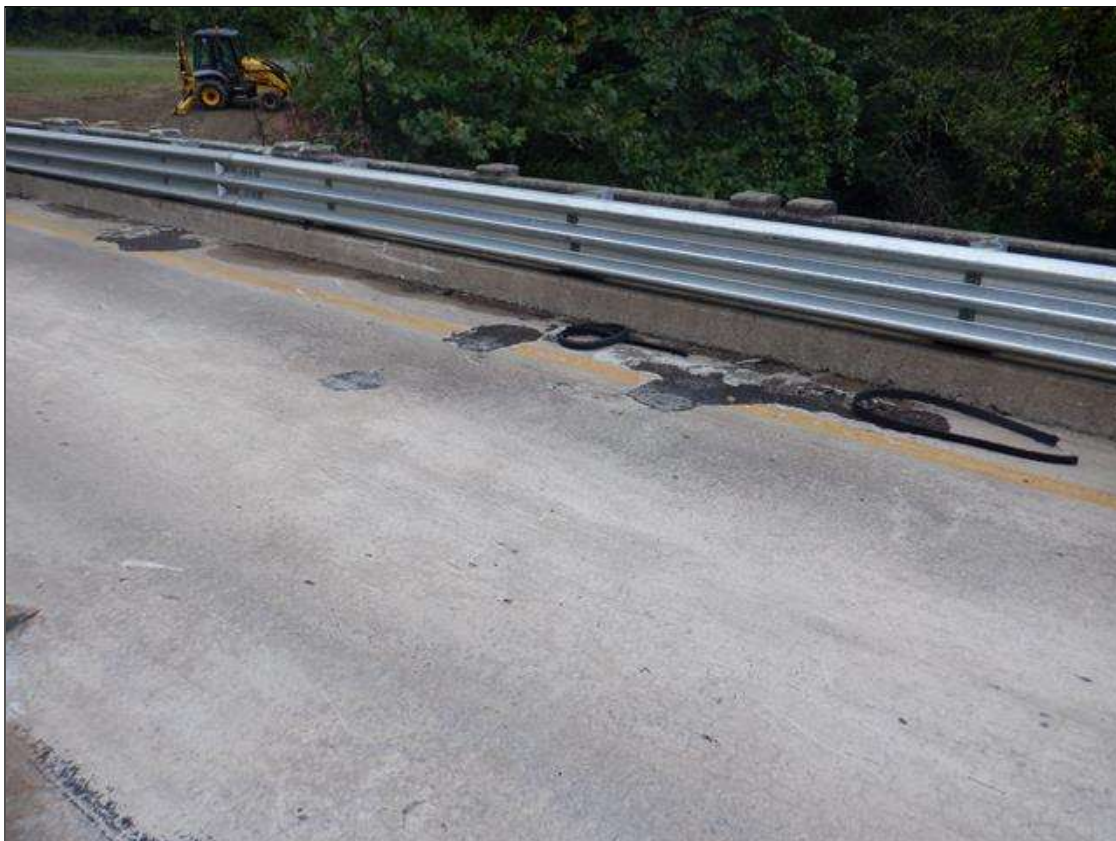
Span 2 Deck: at West shoulder 30ft from bent 2, sound patch [1ft-4in x 1ft-4in]

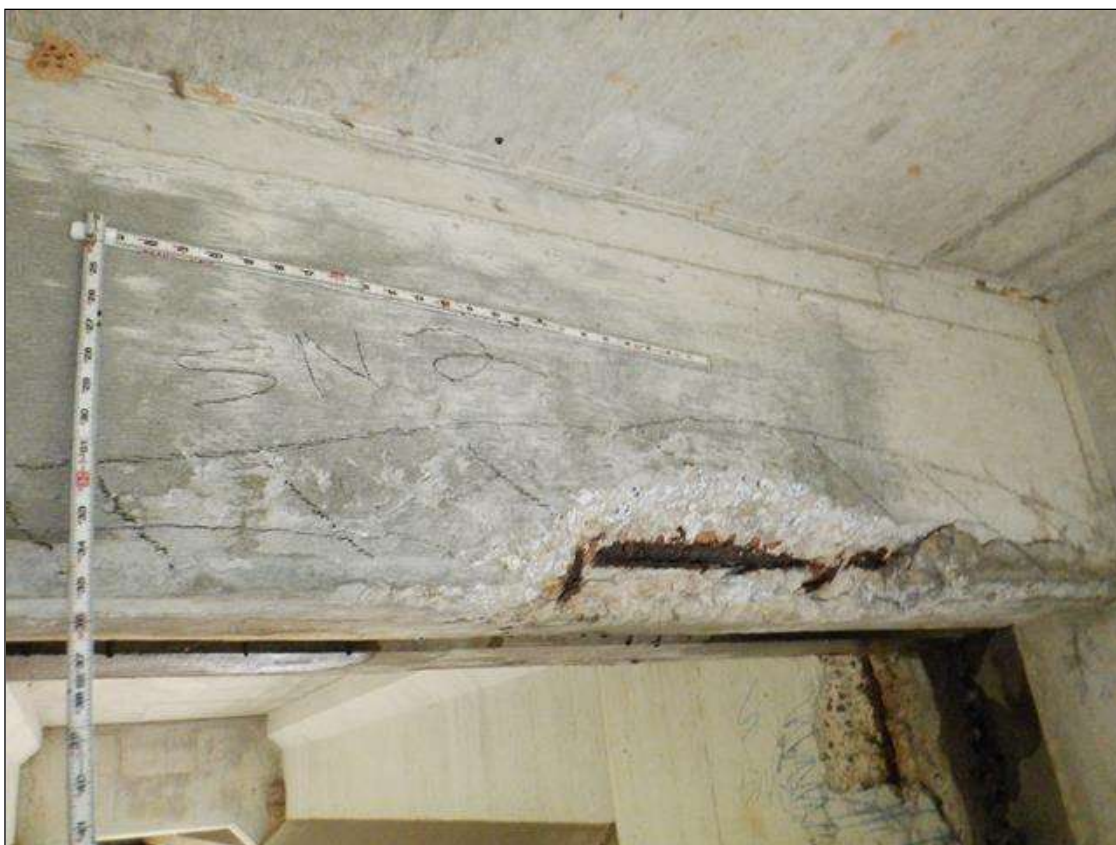
end diaphragm in bay 2 at bent 2, spall [5ft x 1ft x 4in deep] with exposed rusted reinforcing [loss up to 1/8in]

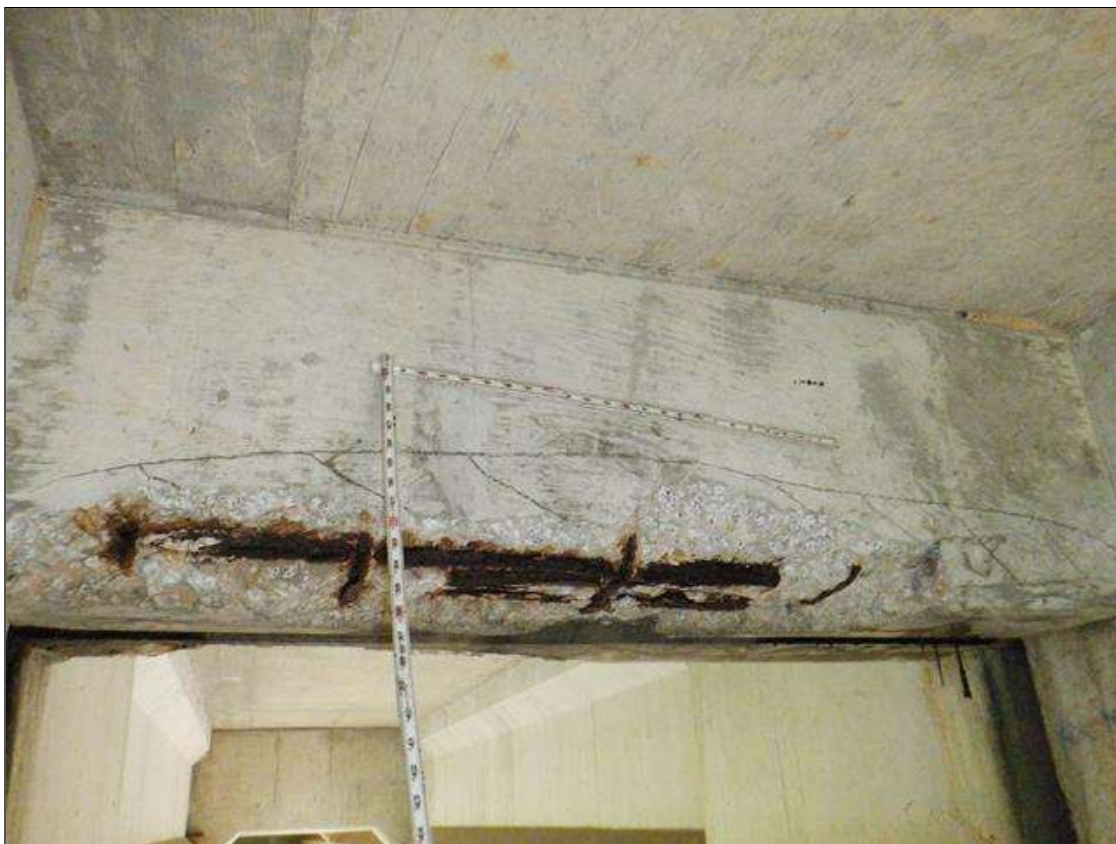
end diaphragm in bay 3 at bent 2, spall [5ft x 1ft x 4in deep] with exposed rusted reinforcing [loss up to 1/8in]

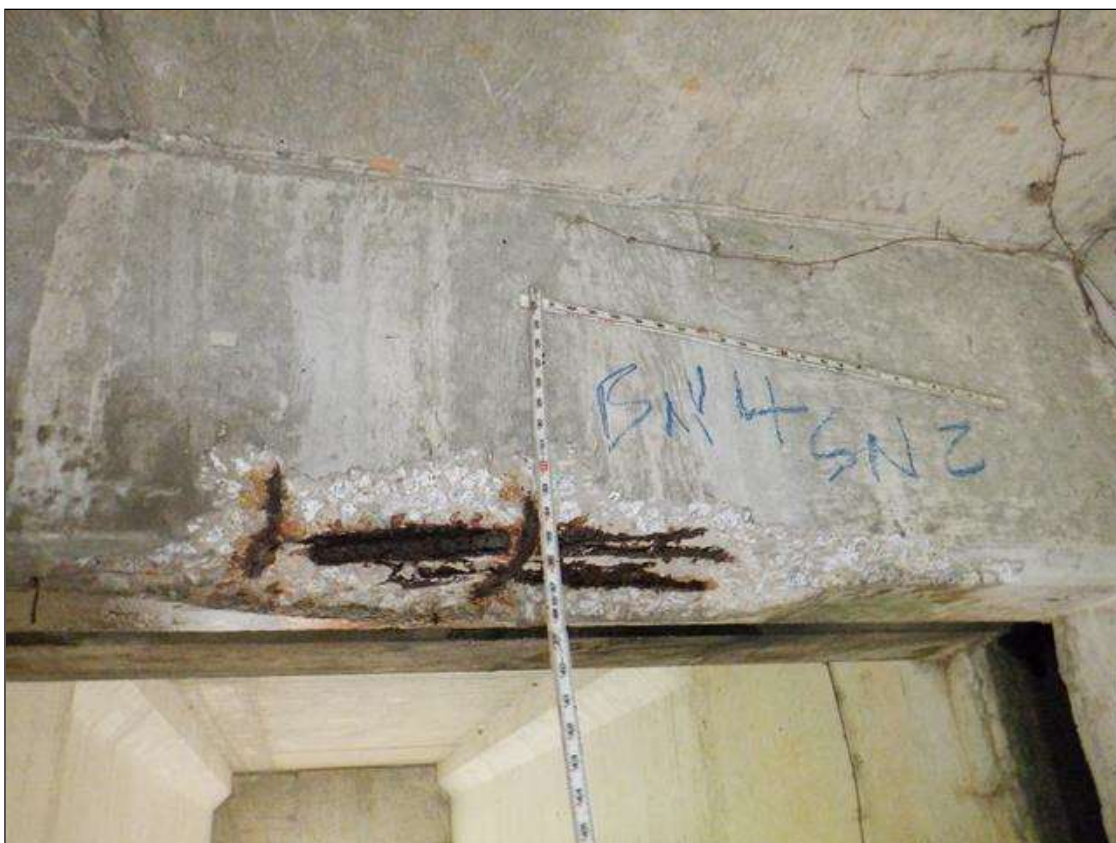
end diaphragm in bay 4 at bent 2, spall [5ft x 1ft x 4in deep] with exposed rusted reinforcing [loss up to 1/8in]

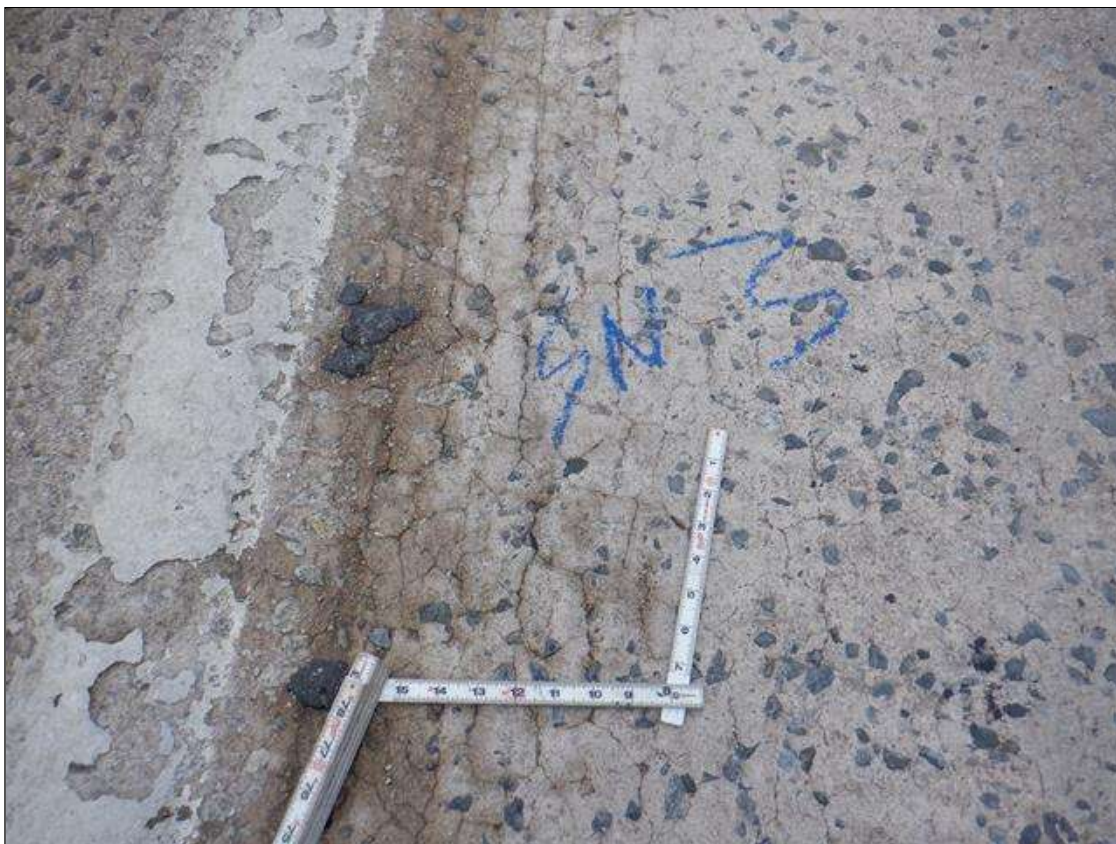
Span 3 Deck: throughout span, map cracking [up to 0.03in]

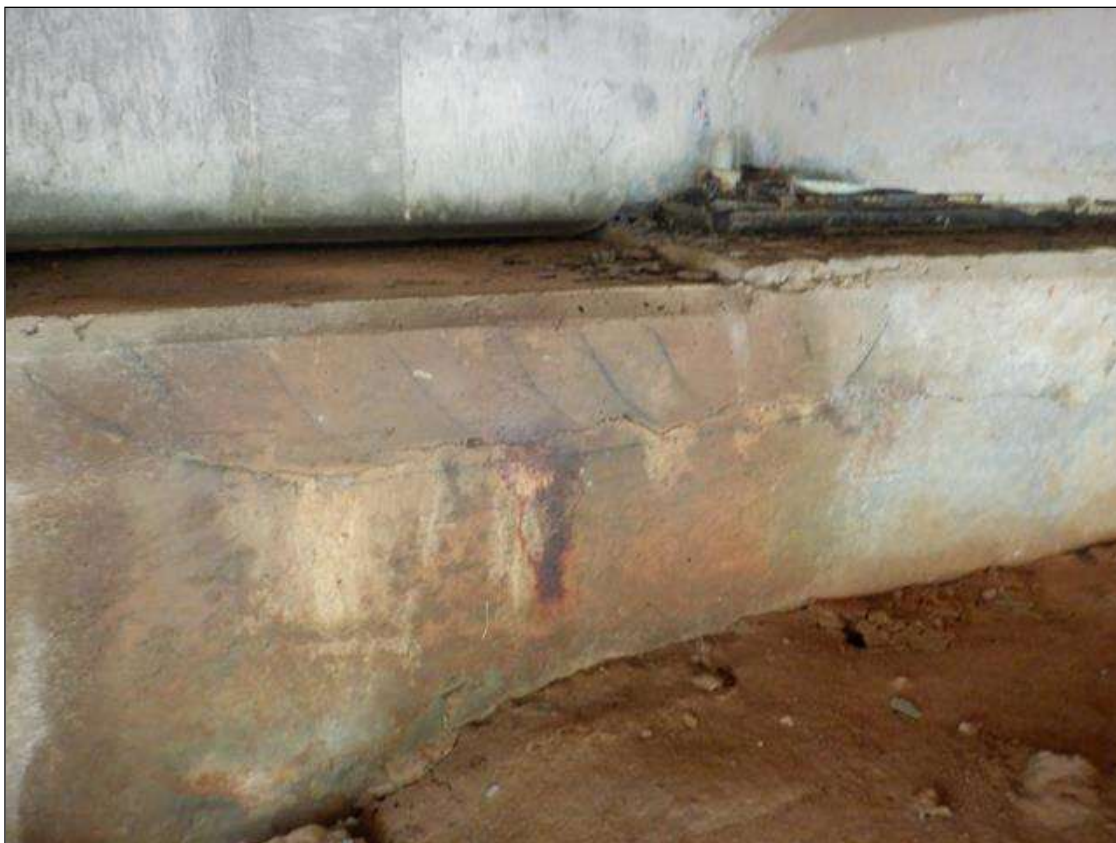
End Bent 1 Cap 1: below girder 4, delamination [3ft x 7in]

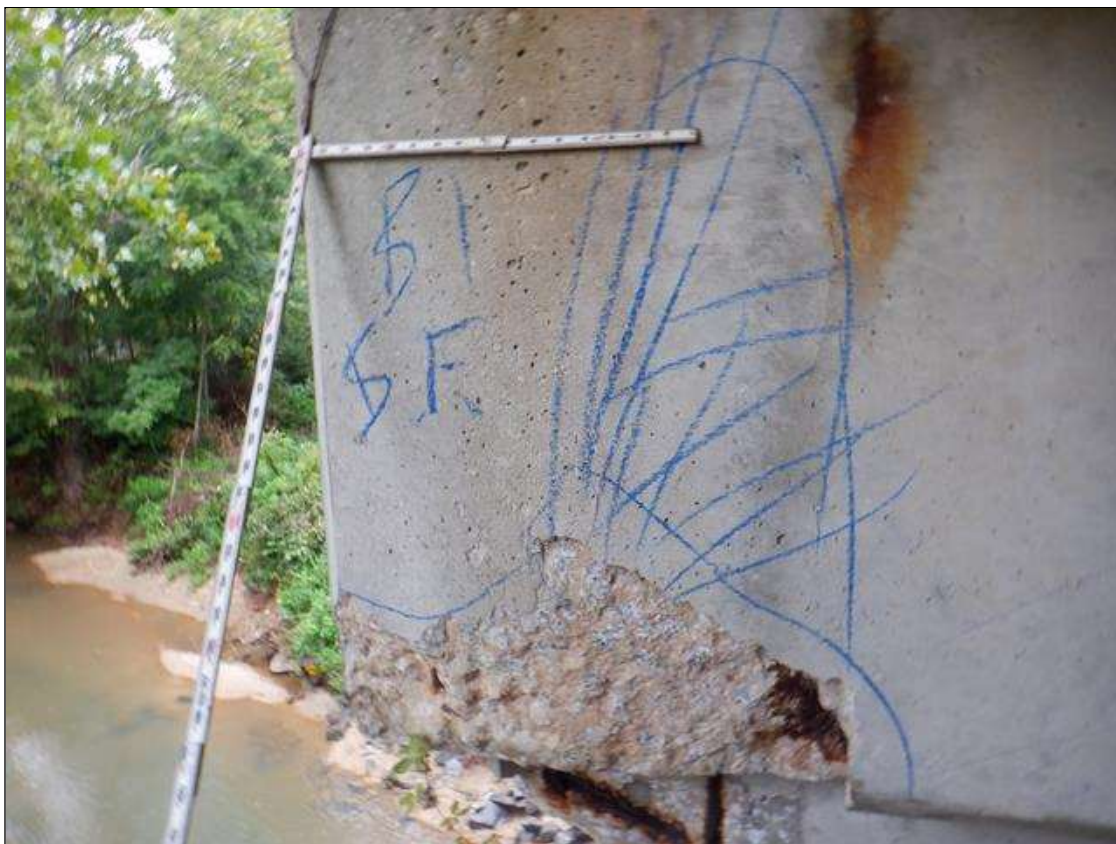
Bent 1 Cap 1: South face below West overhang, spall [40in x 27in x 3in deep] with exposed rusted reinforcing [loss up to 1/8in]

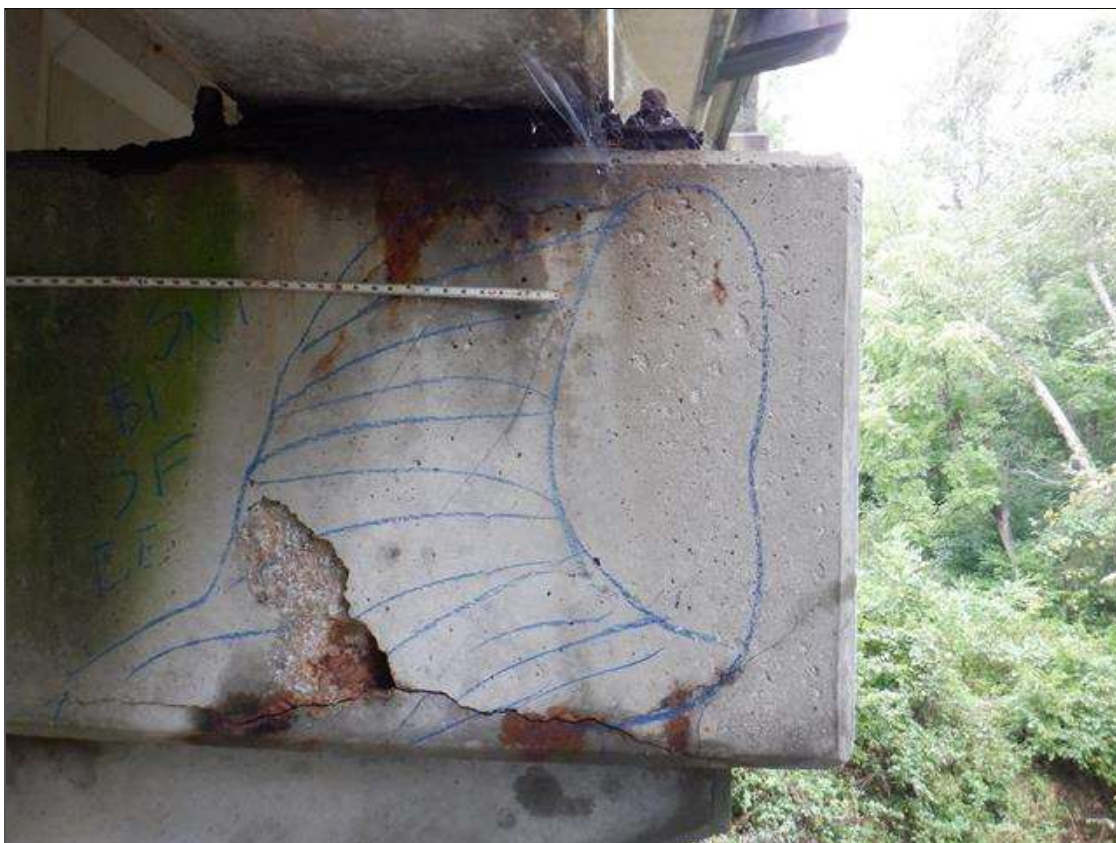
Bent 1 Cap 1: South face below girder 5, spall [40in x 30in x 1-1/4in deep] with exposed rusted reinforcing [loss up to 1/16in]

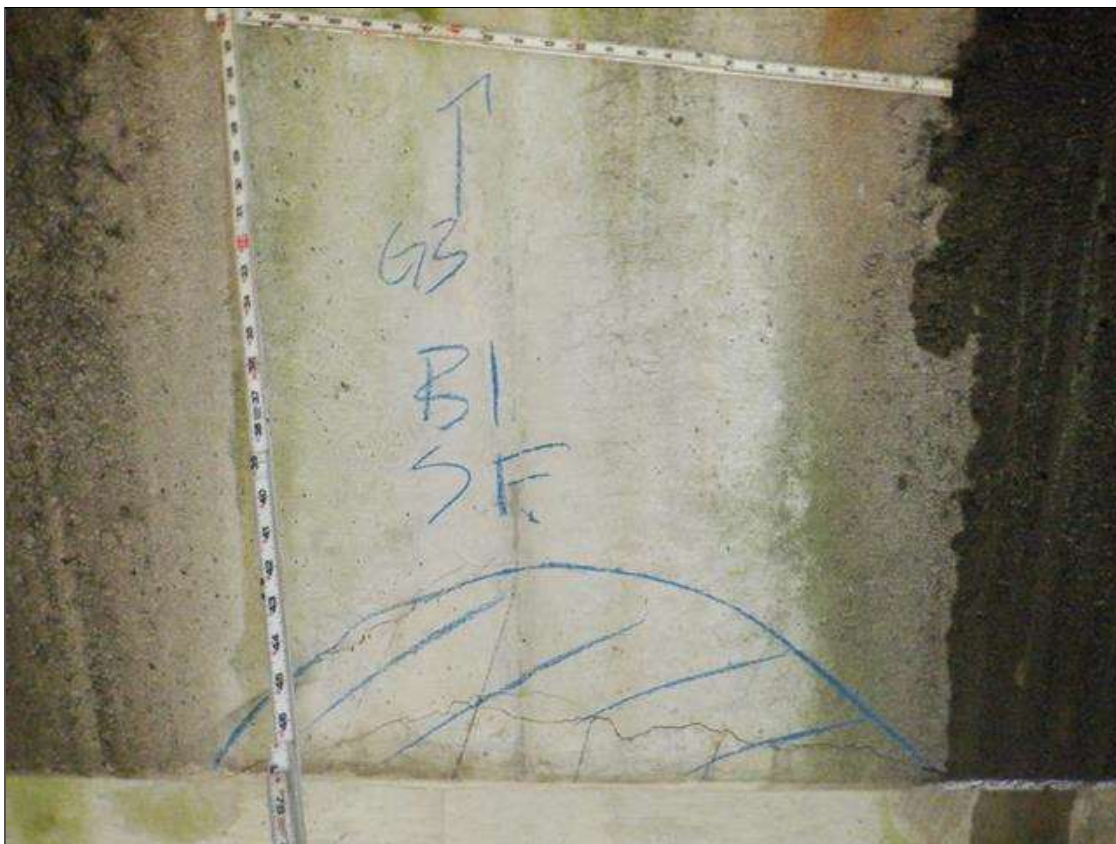
Bent 1 Cap 1: South face below girder 3 at bottom edge, delamination [30in x 10in]

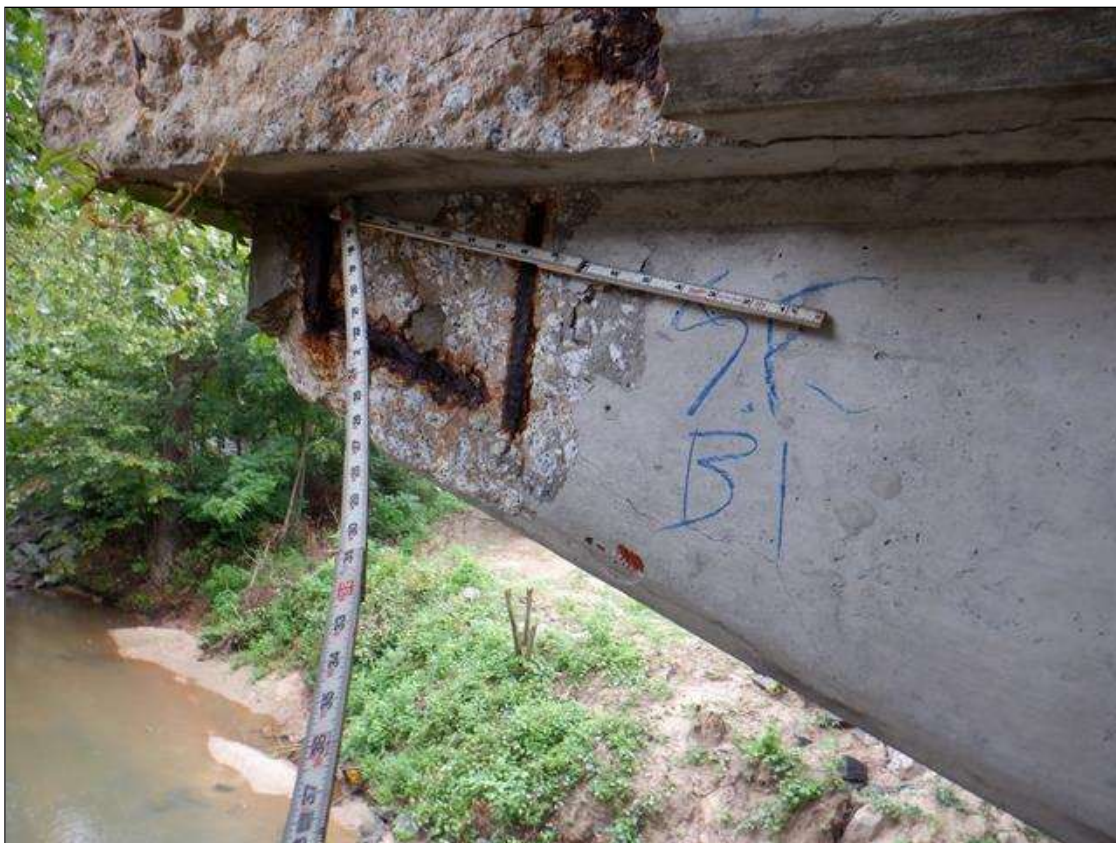
Bent 1: South face of West corbel adjacent to column 1, spall [16in x 10in x 2in deep] with exposed rusted reinforcing [loss up to 1/8in]

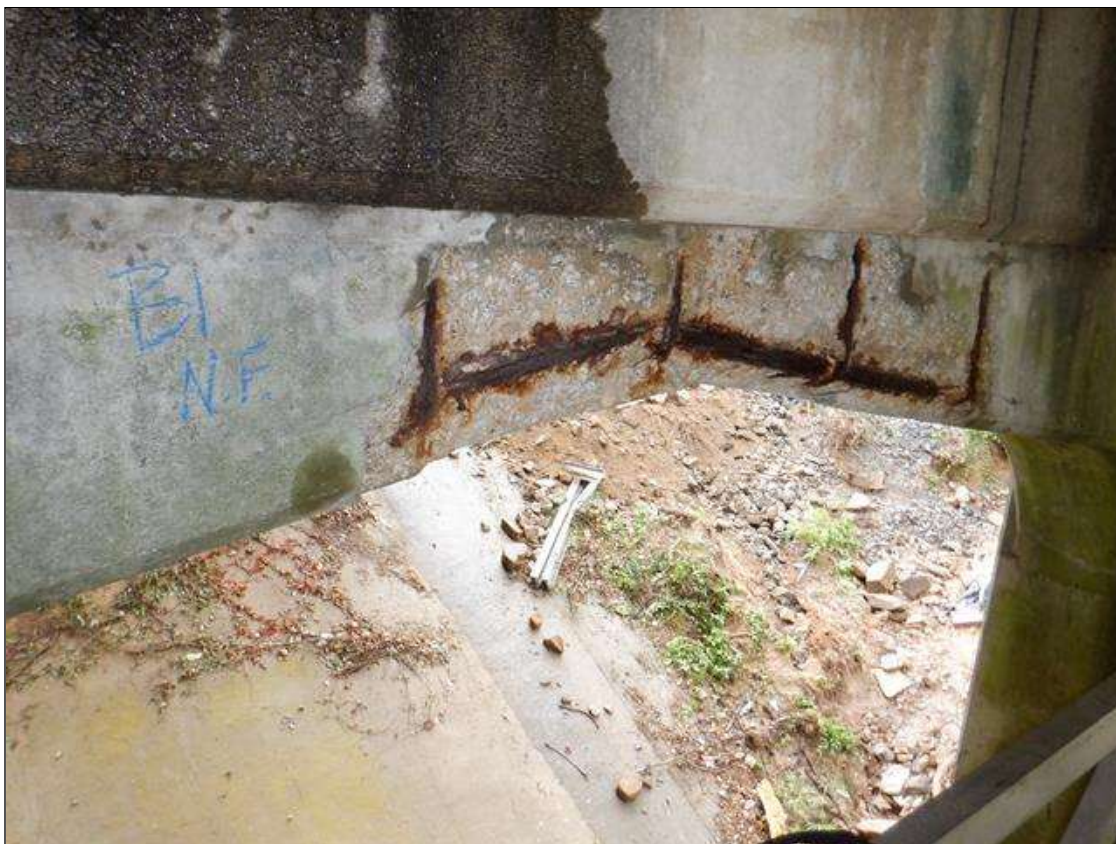
Bent 1: North face of center corbel below girder 3, spall/delamination [75in x 12in x 6in deep] with exposed rusted reinforcing [up to 100% loss]

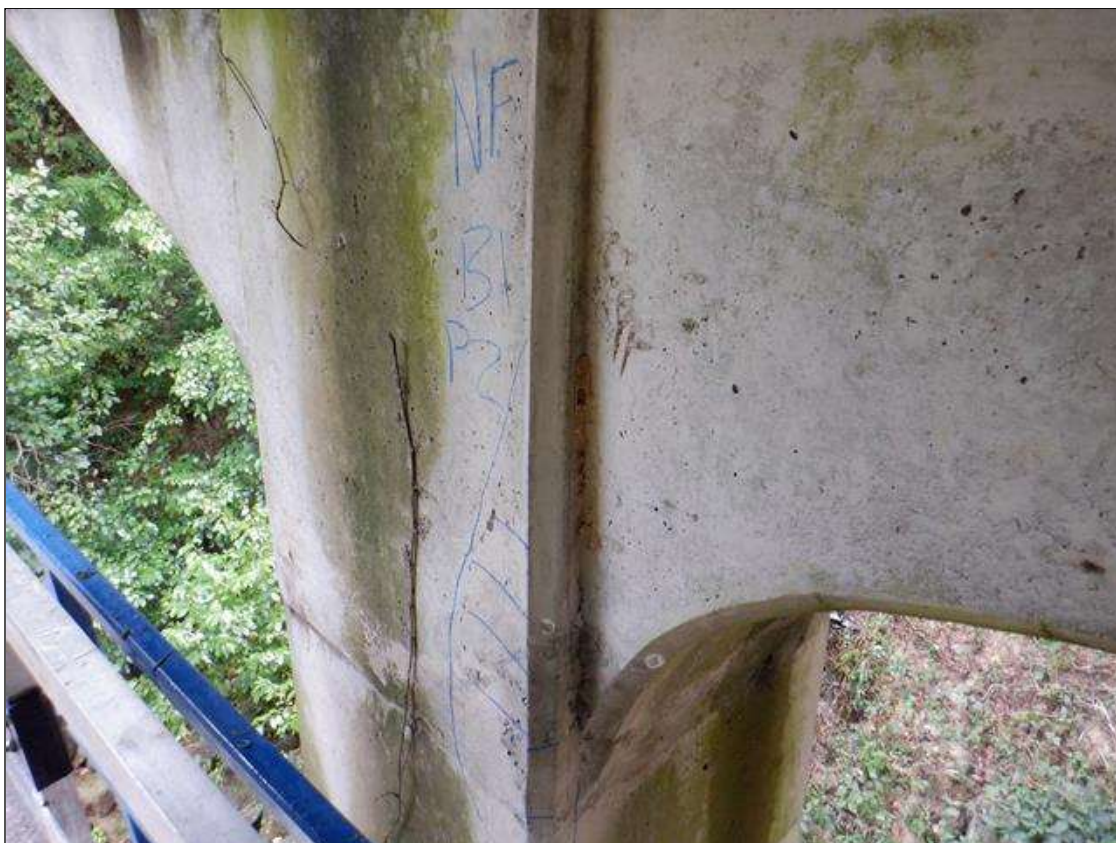
Bent 1 Pile 2: Northwest corner adjacent to corbel, delamination [20in x 7in]

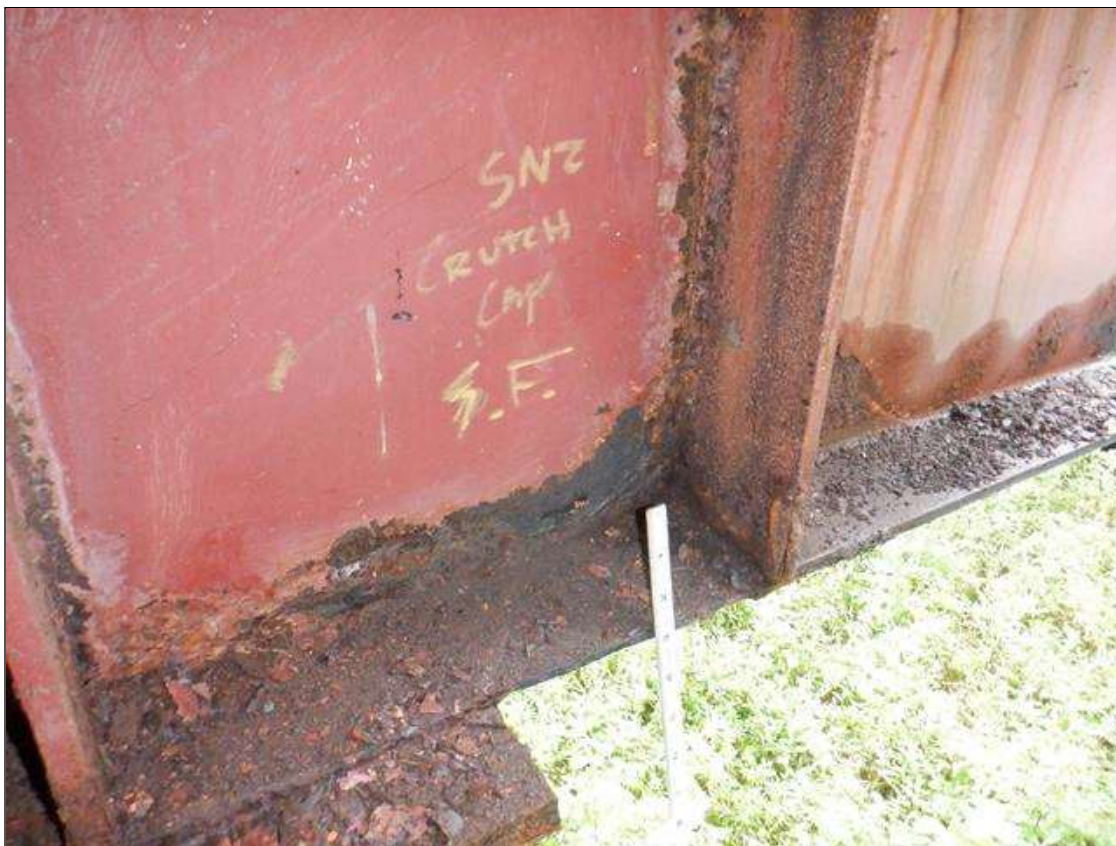
Bent 1 Cap 1: [PAR] below beam 5, active corrosion with section loss, bottom flange [16in x full width - 5/16in avg rem]; top flange [20in x full width - 7/16in avg rem]; lower web [16in x up to 2in - 1/4in avg rem]; web adjacent to East stiffener [full height x 1in - 1/4in avg rem]

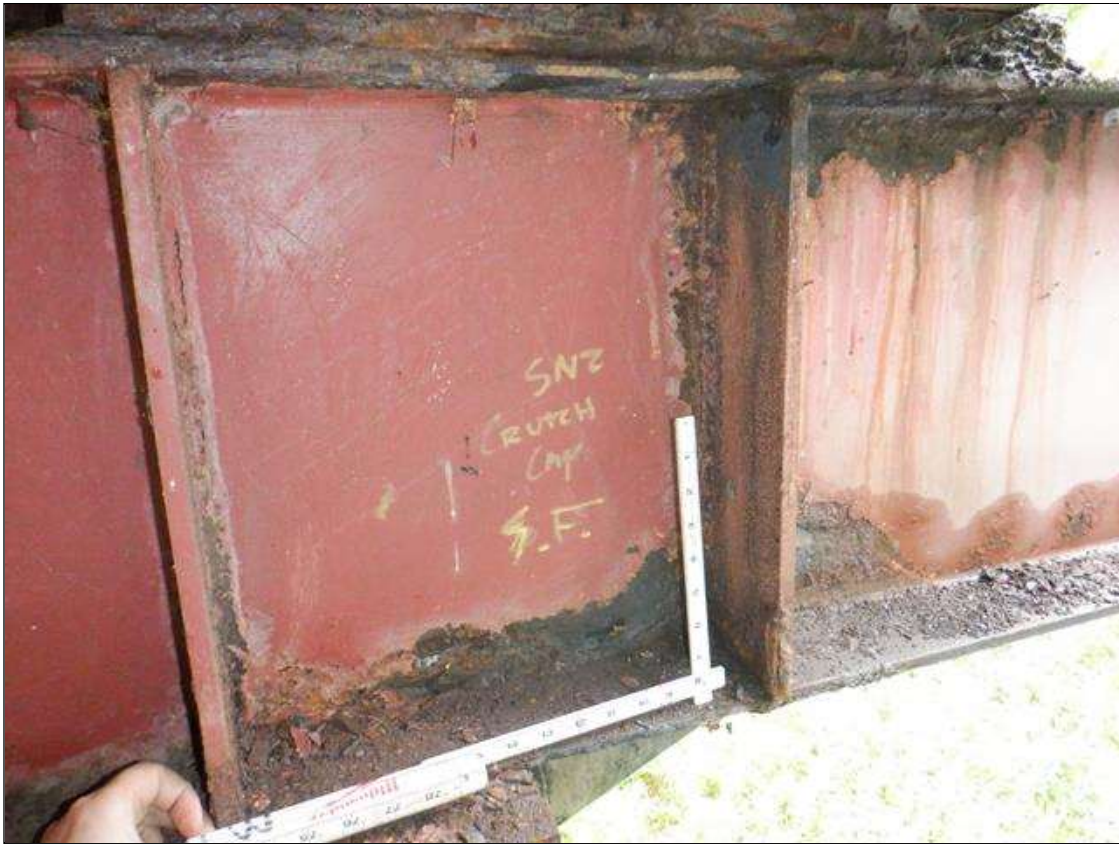
Bent 1 Cap 1: [PAR] below beam 5, active corrosion with section loss, bottom flange [16in x full width - 5/16in avg rem]; top flange [20in x full width - 7/16in avg rem]; lower web [16in x up to 2in - 1/4in avg rem]; web adjacent to East stiffener [full height x 1in - 1/4in avg rem]

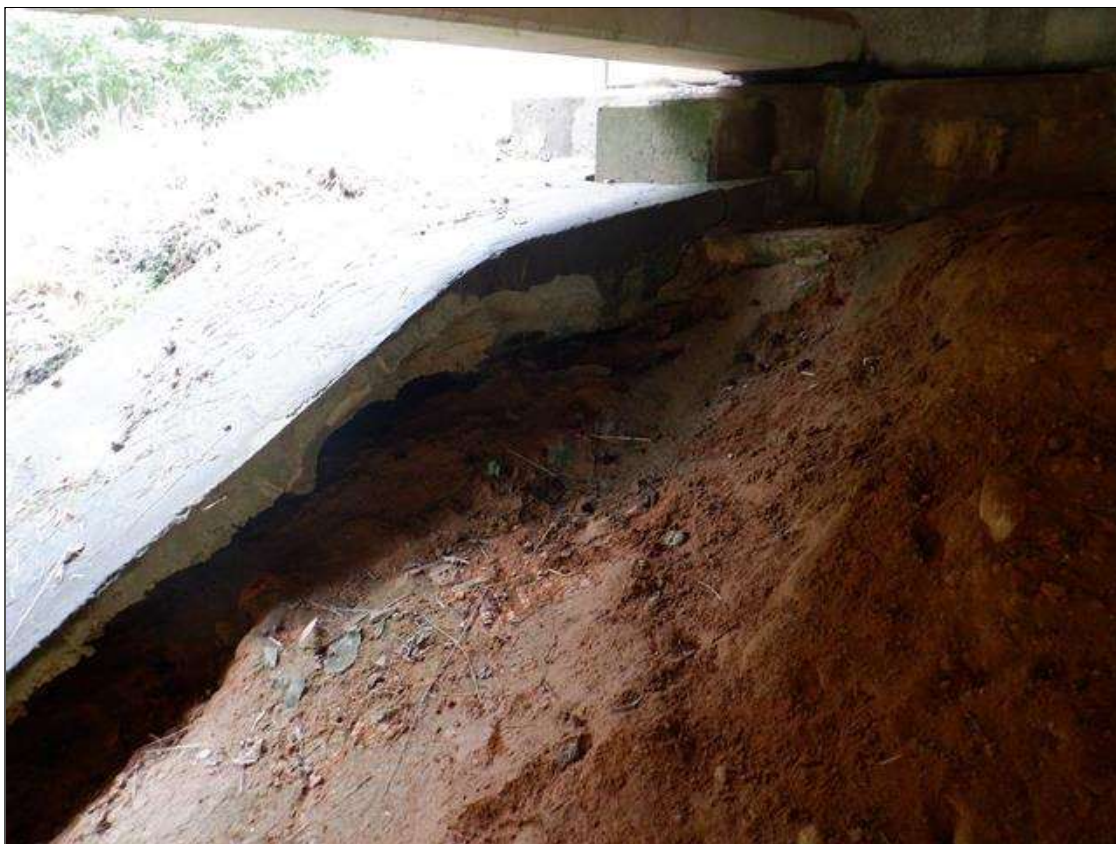
Slope Protection: below concrete gutter below span 1 East overhang, erosion [full length x 2ft x 3ft deep]

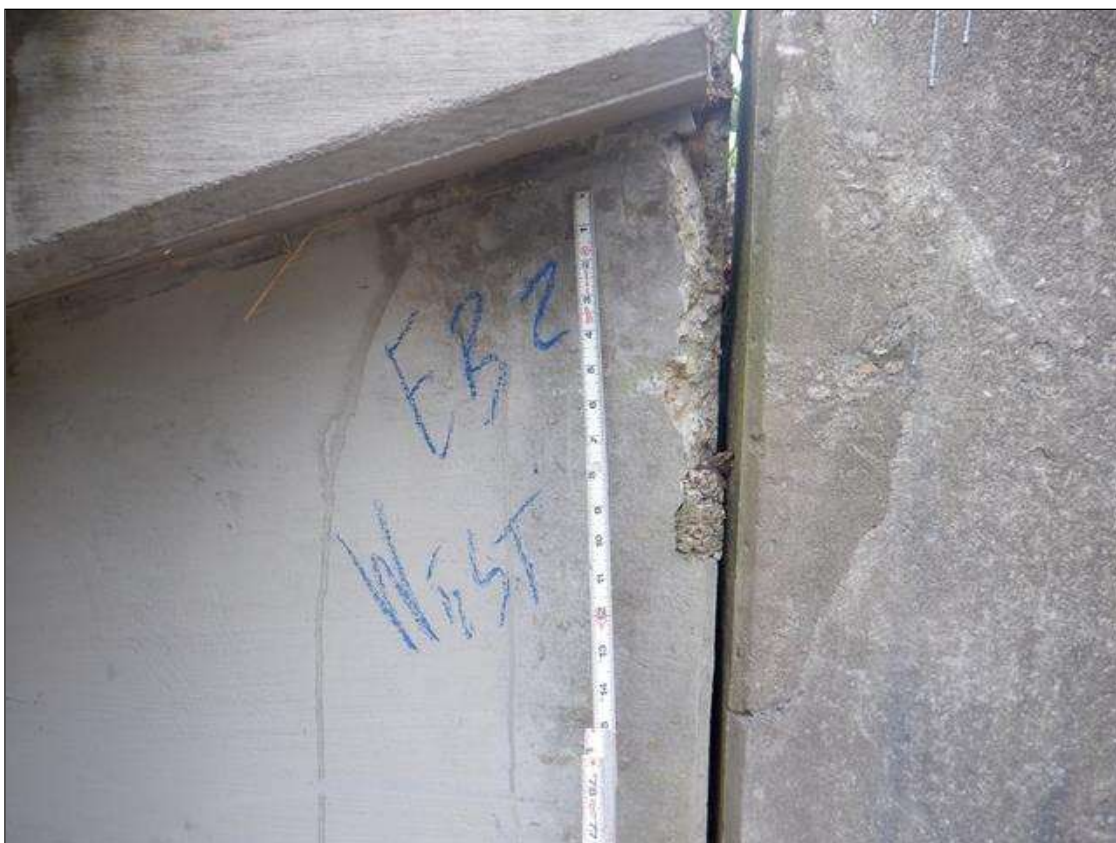
End bent 2 backwall: at West end, spall [12in x 4in x 1-1/2in deep]

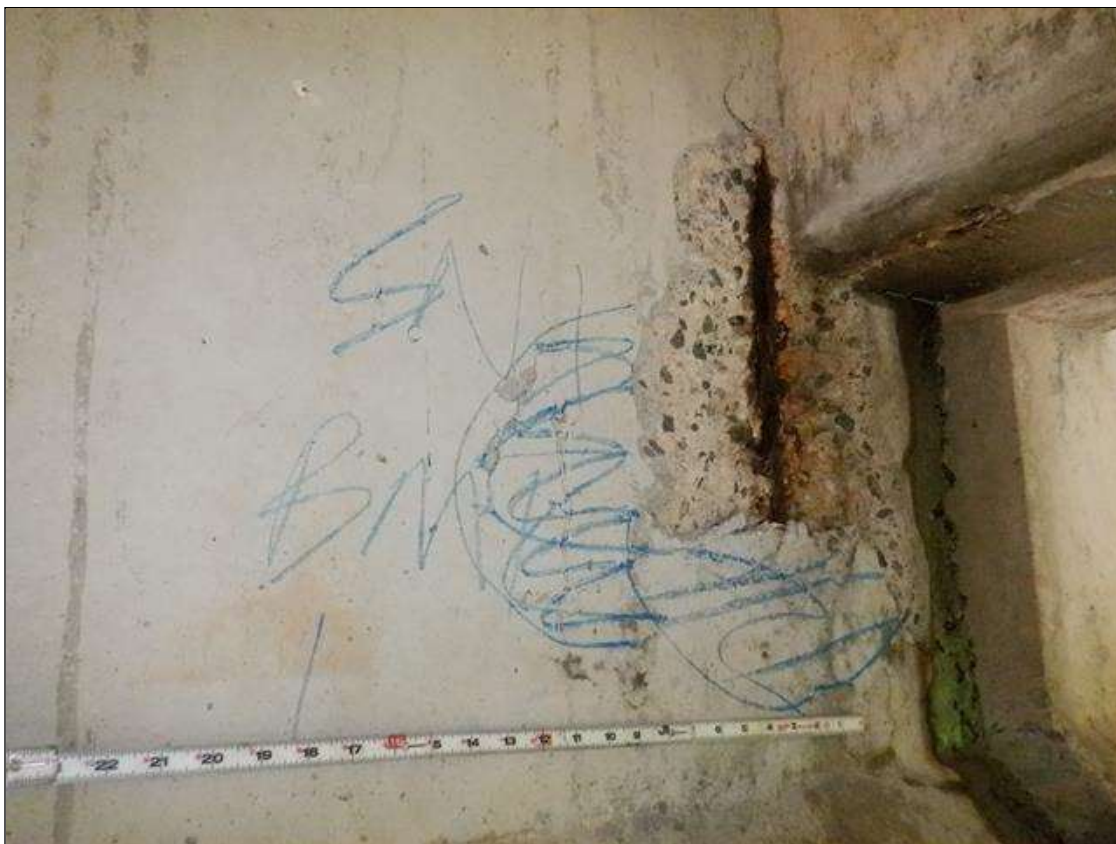
Span 1 Beam 1: [PAR] East face at far end, spall [18in x 21in x 1in deep] with exposed rusted reinforcing [up to 1/8in]

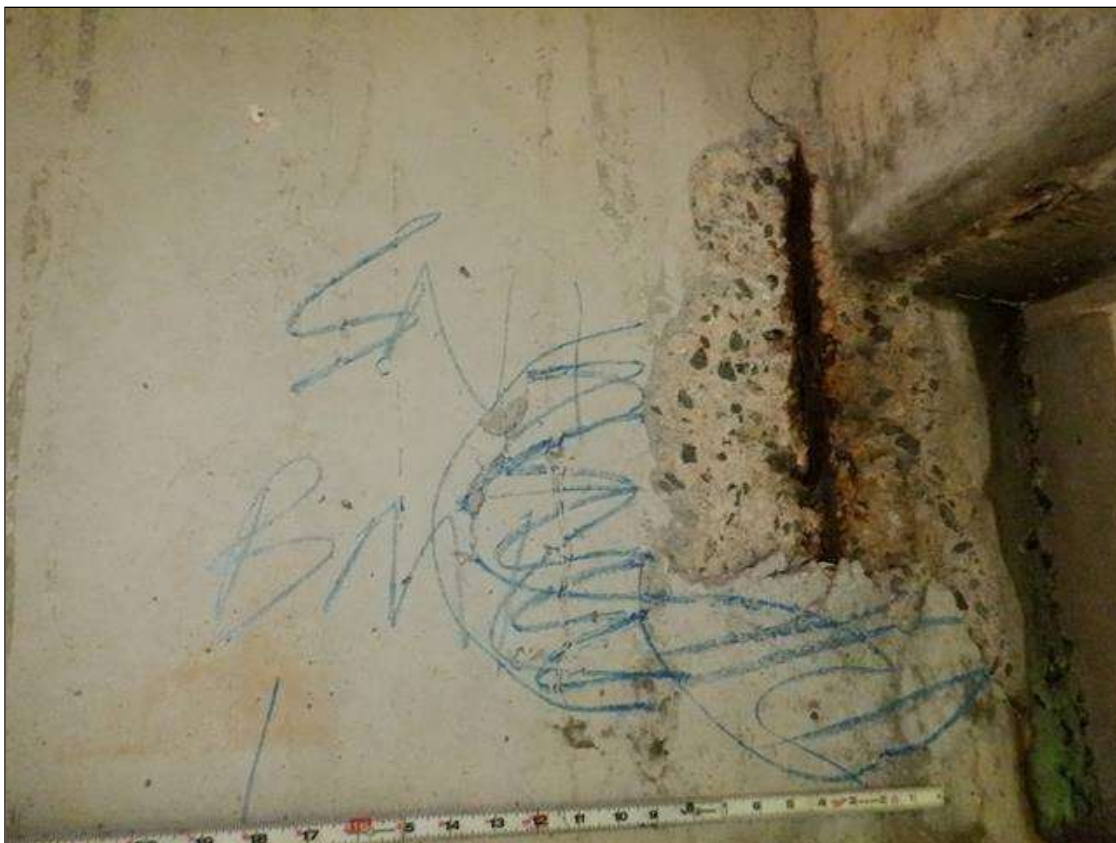
Span 1 Beam 1: [PAR] East face at far end, spall [18in x 21in x 1in deep] with exposed rusted reinforcing [up to 1/8in]

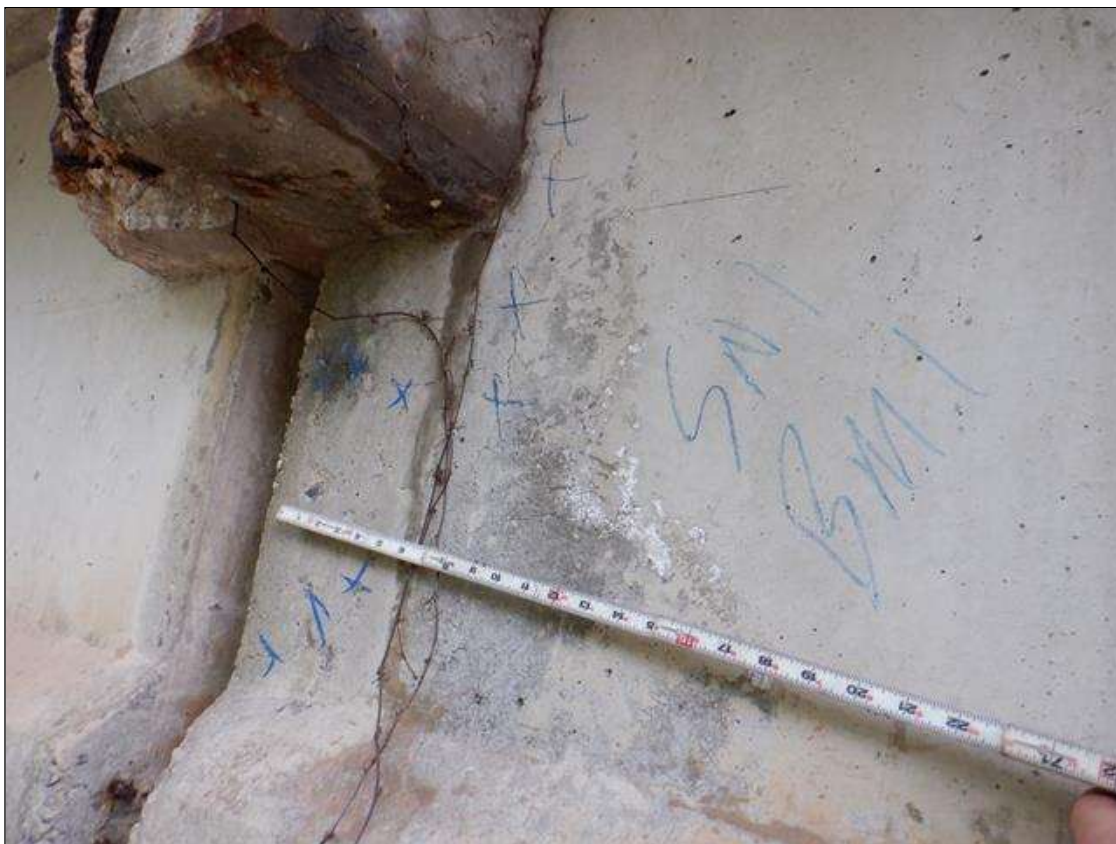
Span 1 Beam 1: West face at far end, multiple horizontal, vertical, and diagonal cracks [up to 18in x up to 0.004in]

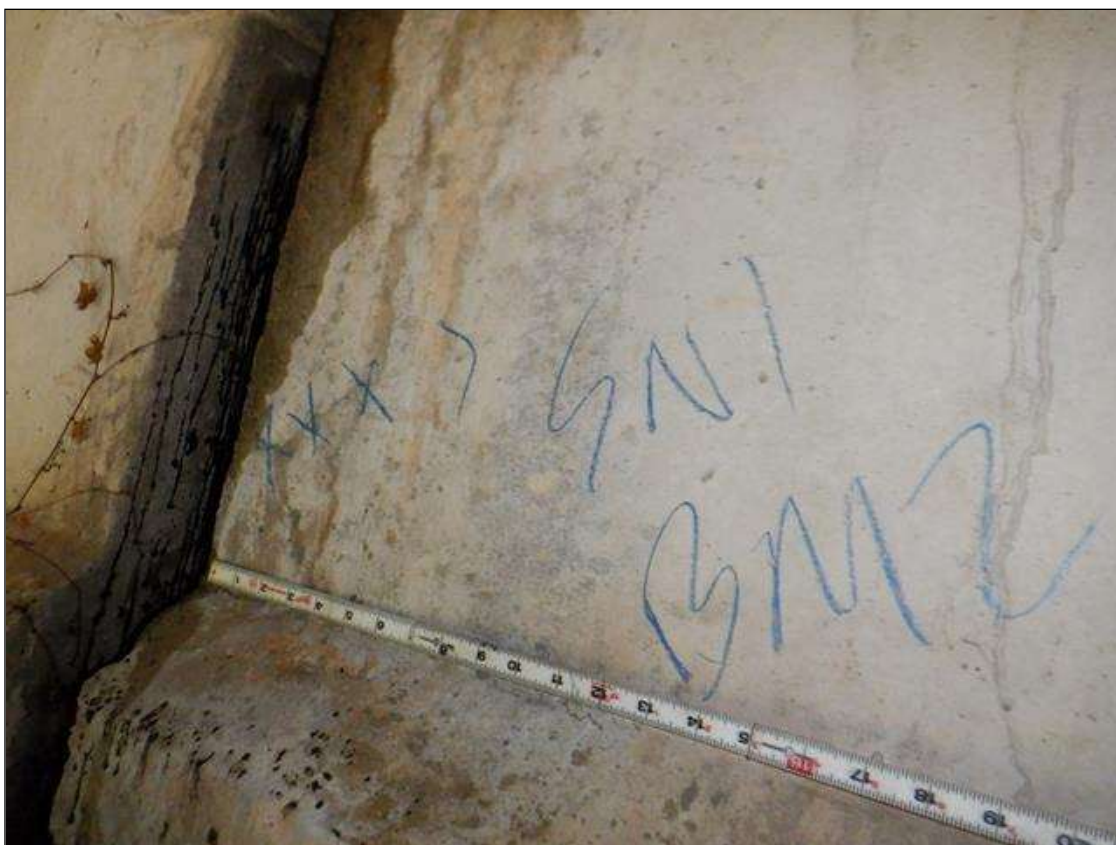
Span 1 Beam 2: West face at far end, diagonal crack [8in x 0.009in]

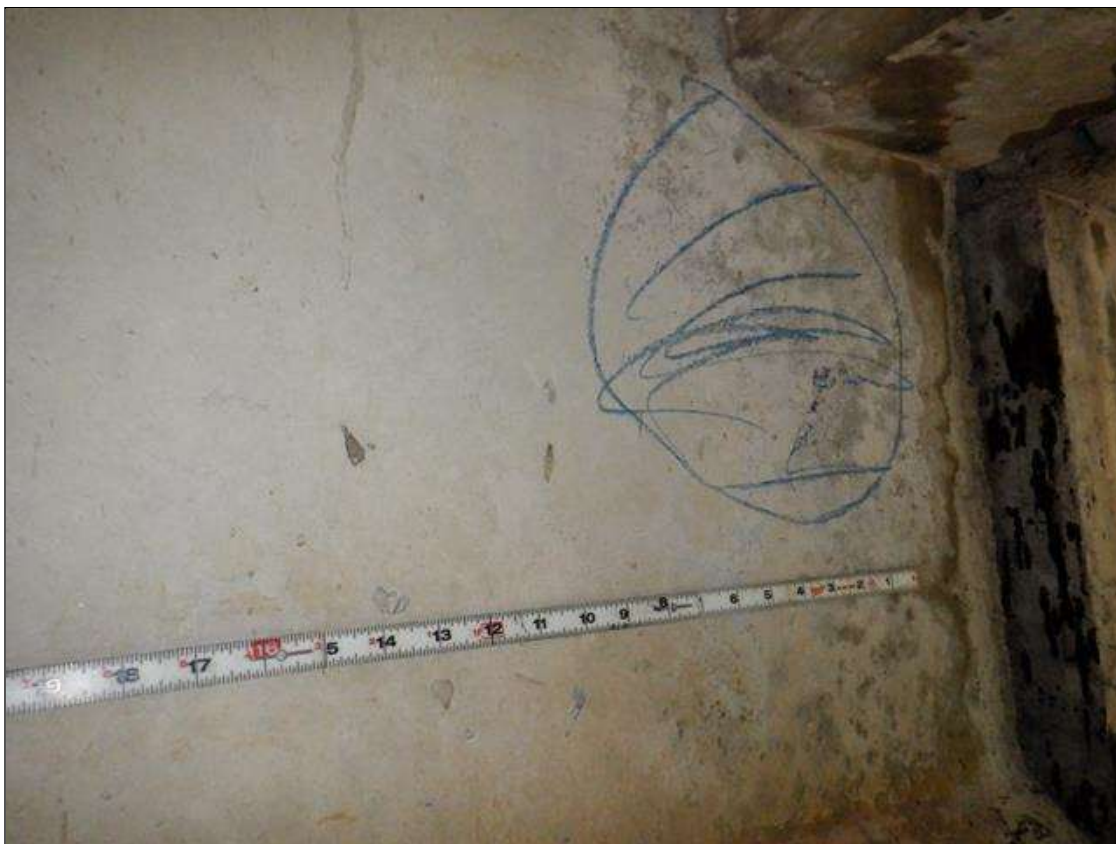
Span 1 Beam 2: East face at far end, delamination [12in diameter]

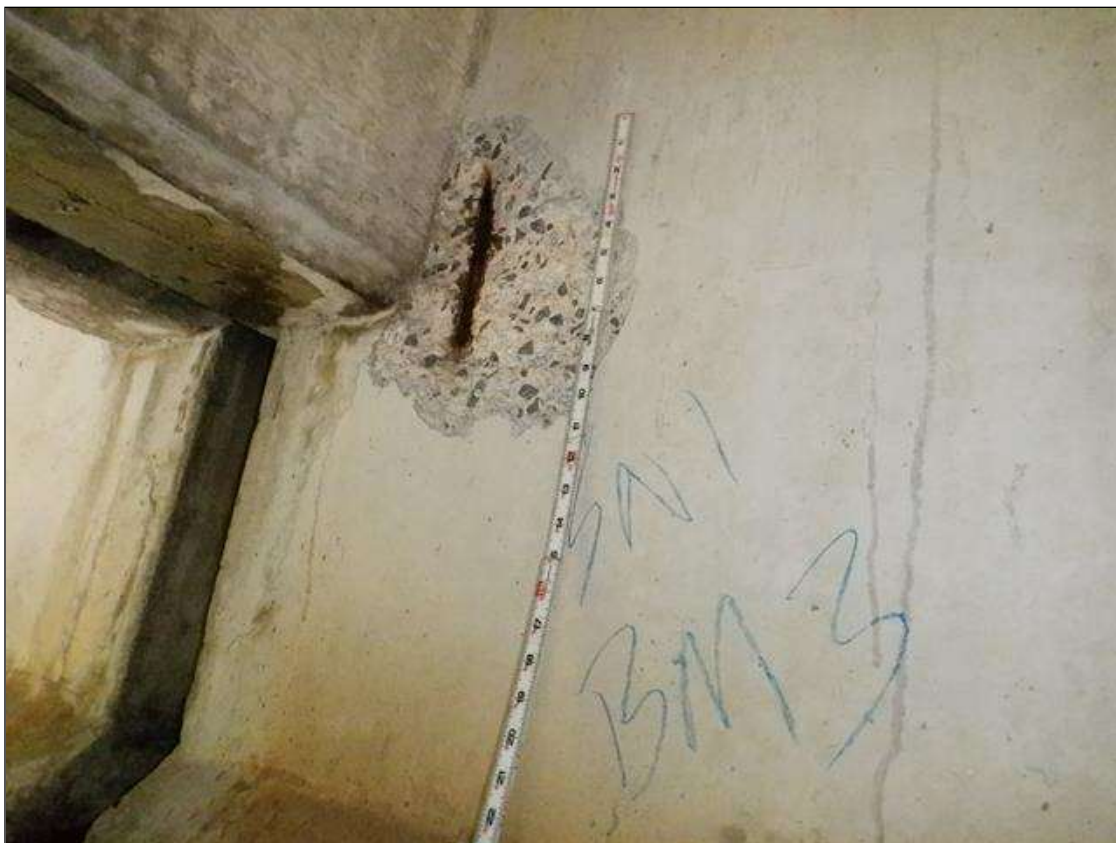
Span 1 Beam 3: [PAR] West face at far end, spall [13in x 10in x 1in deep] with exposed rusted reinforcing [up to 1/8in]
