NC DEPARTMENT OF TRANSPORTATION
 DIVISION OF HIGHWAYS
 STRUCTURE MANAGEMENT UNIT

ATTENTION: **Priority Action Request, Changes to Structure Data**

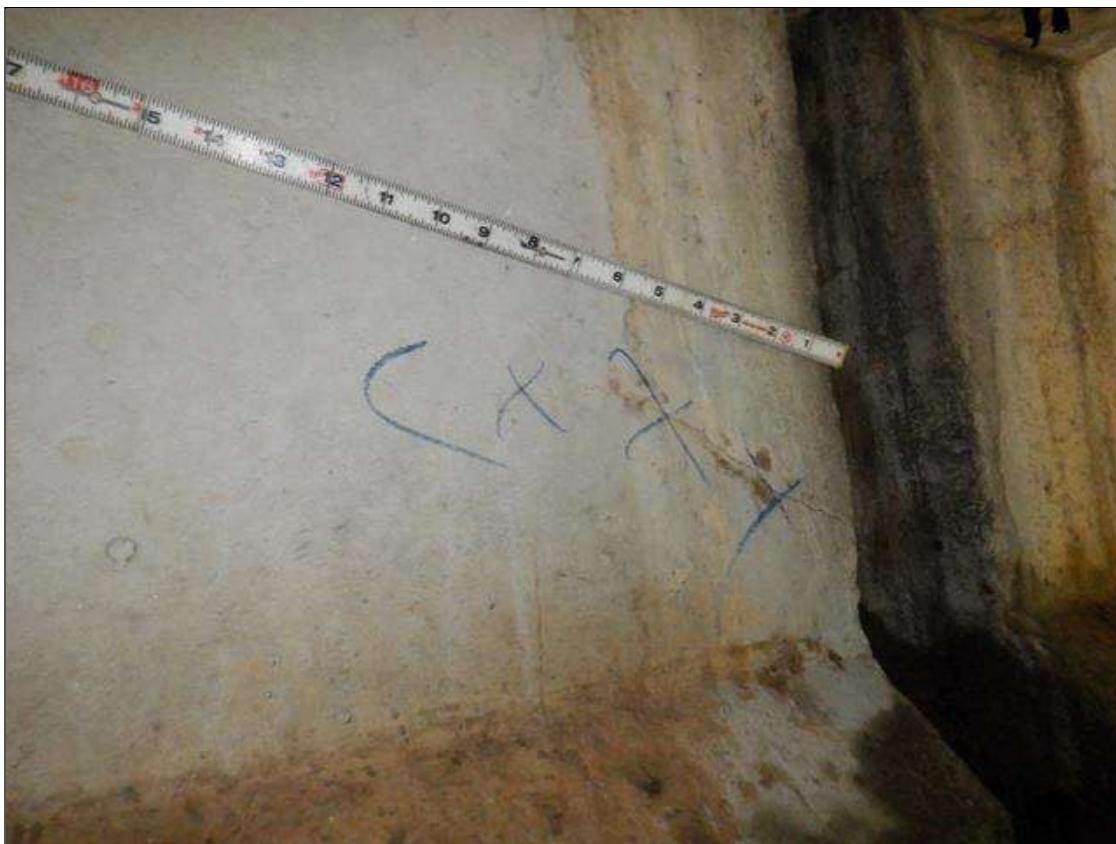
Span 1 Beam 3: East face at far end, diagonal crack [12in x up to 0.004in]

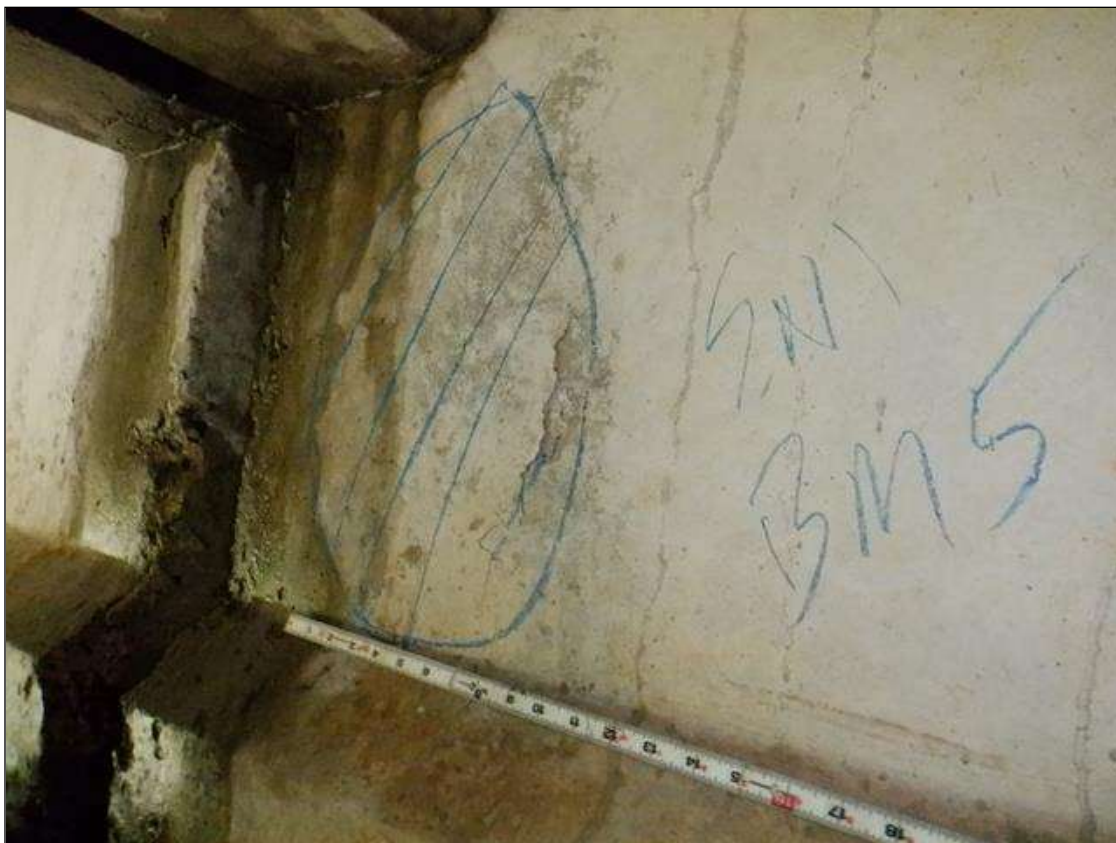
Span 1 Beam 5: West face at far end, delamination [11in x 15in]

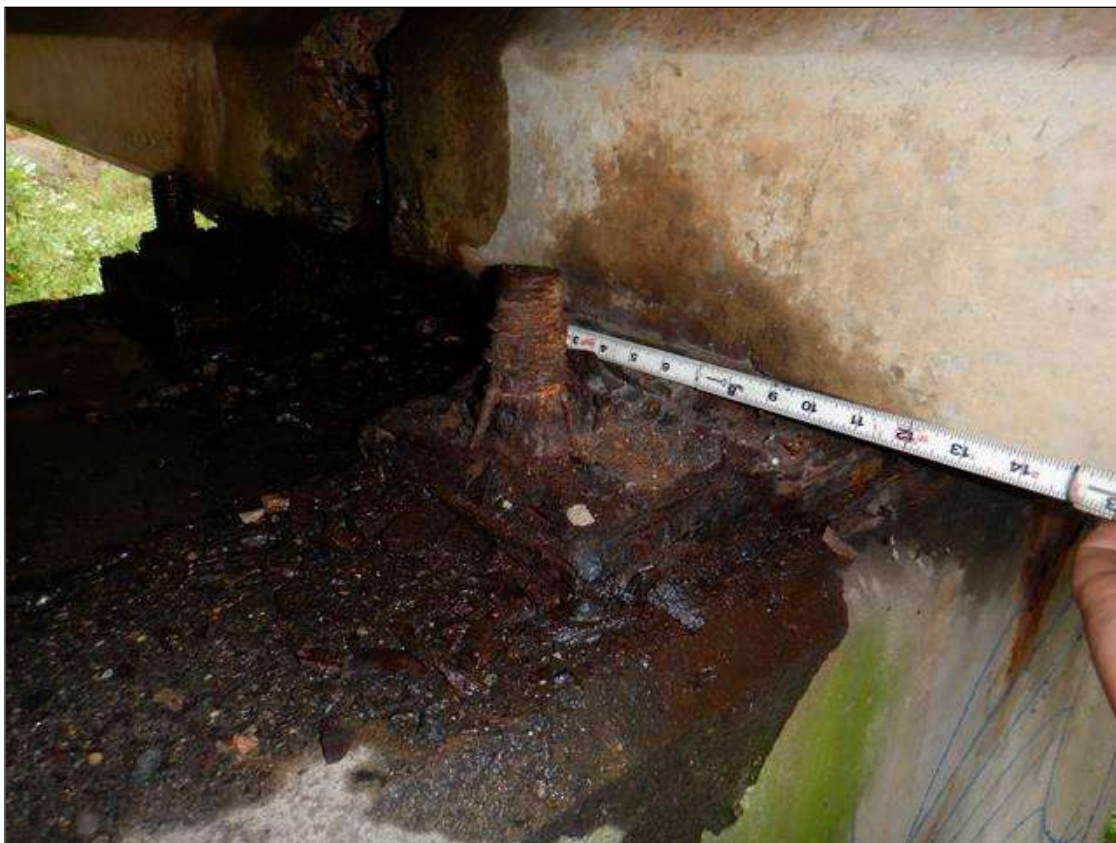
Span 1 Beam 5 Far Bearing: active corrosion with section loss [up to 1/4in] with section loss on anchor bolts & nuts [up to 50%]

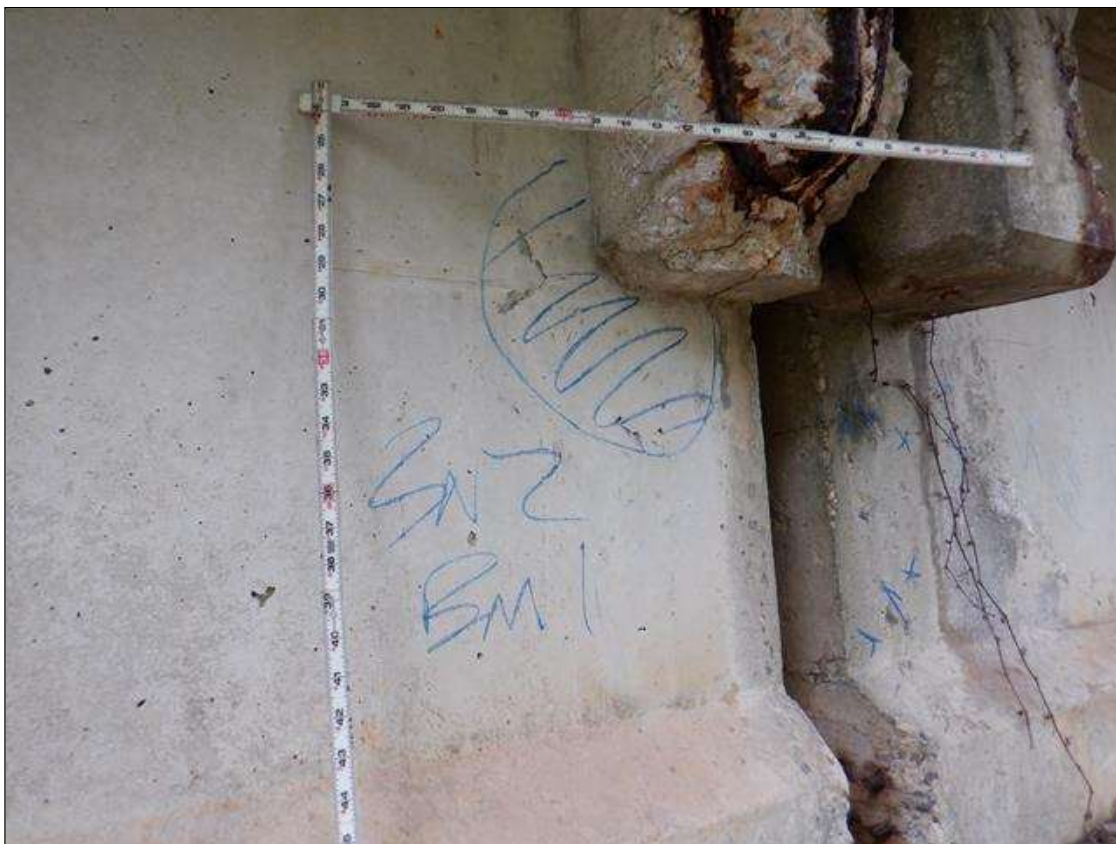
Span 2 Beam 1: West face at near end, delamination [11in x 10in]

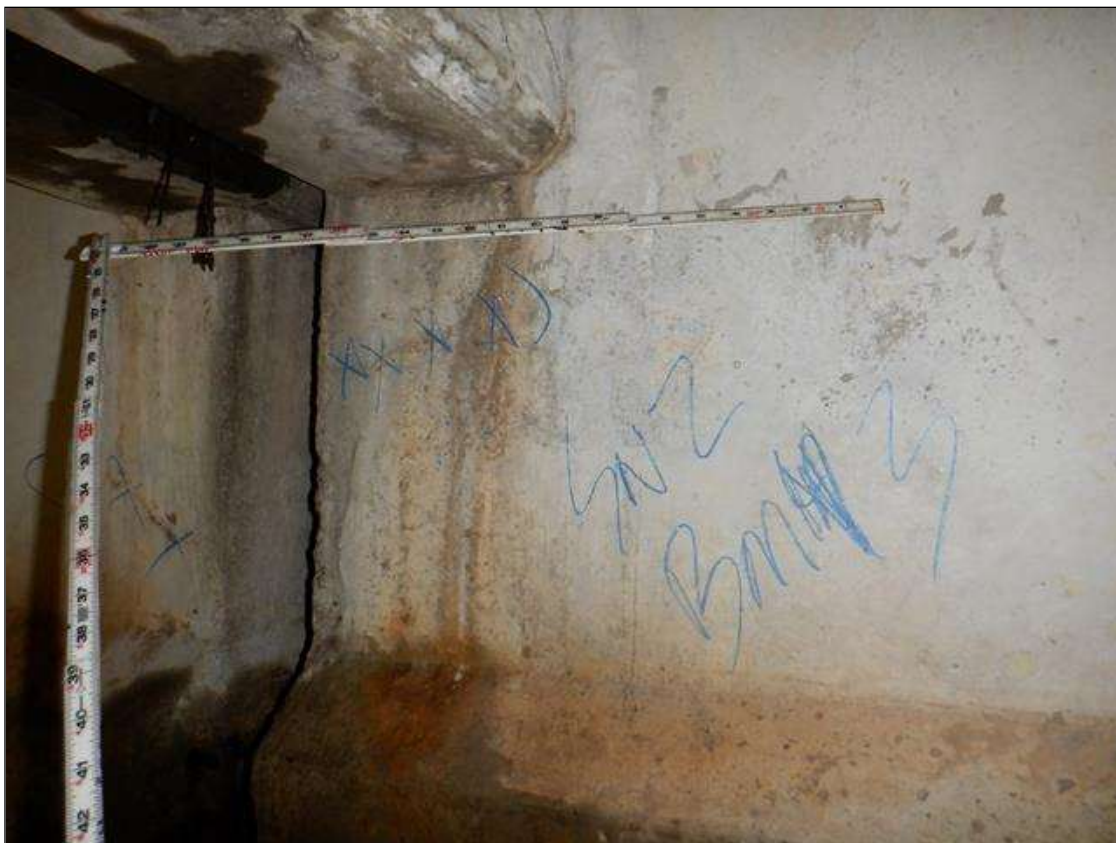
Span 2 Beam 3: West face at near end, three [3] horizontal cracks [up to 10in x hairline]

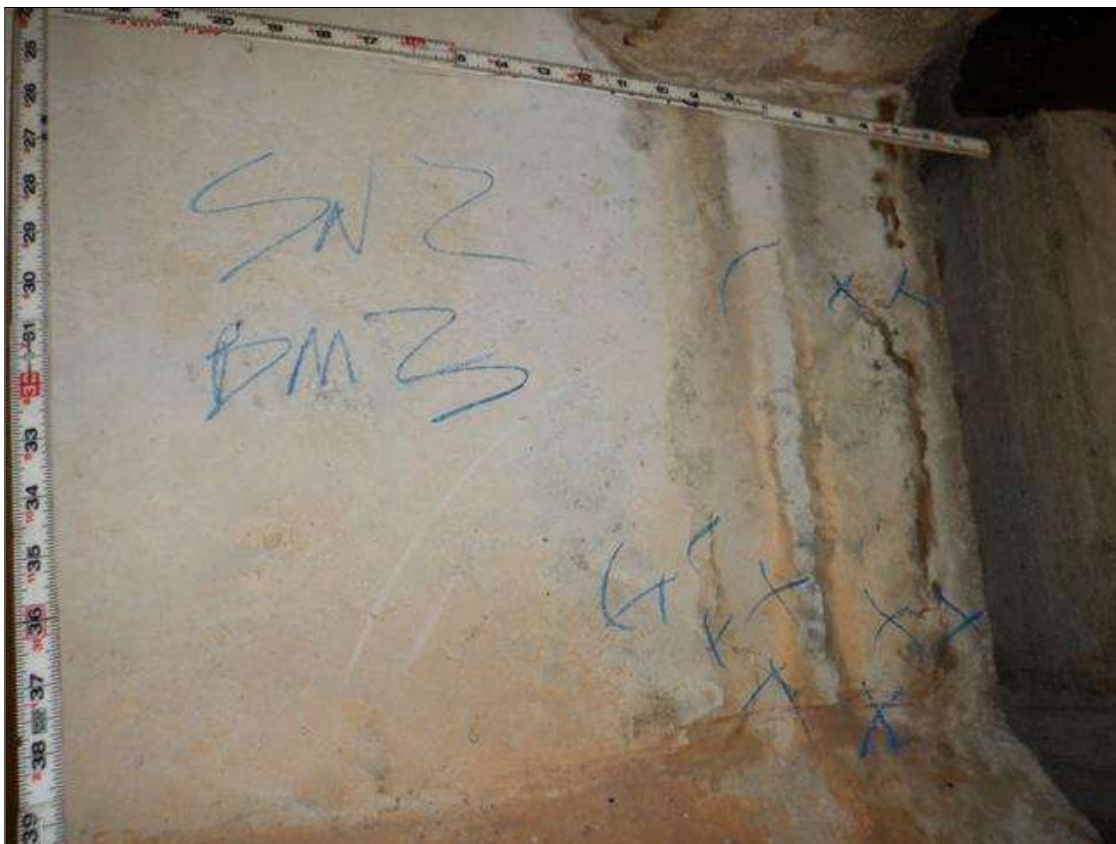
Span 2 Beam 3: East face at near end, horizontal crack [9in x hairline]

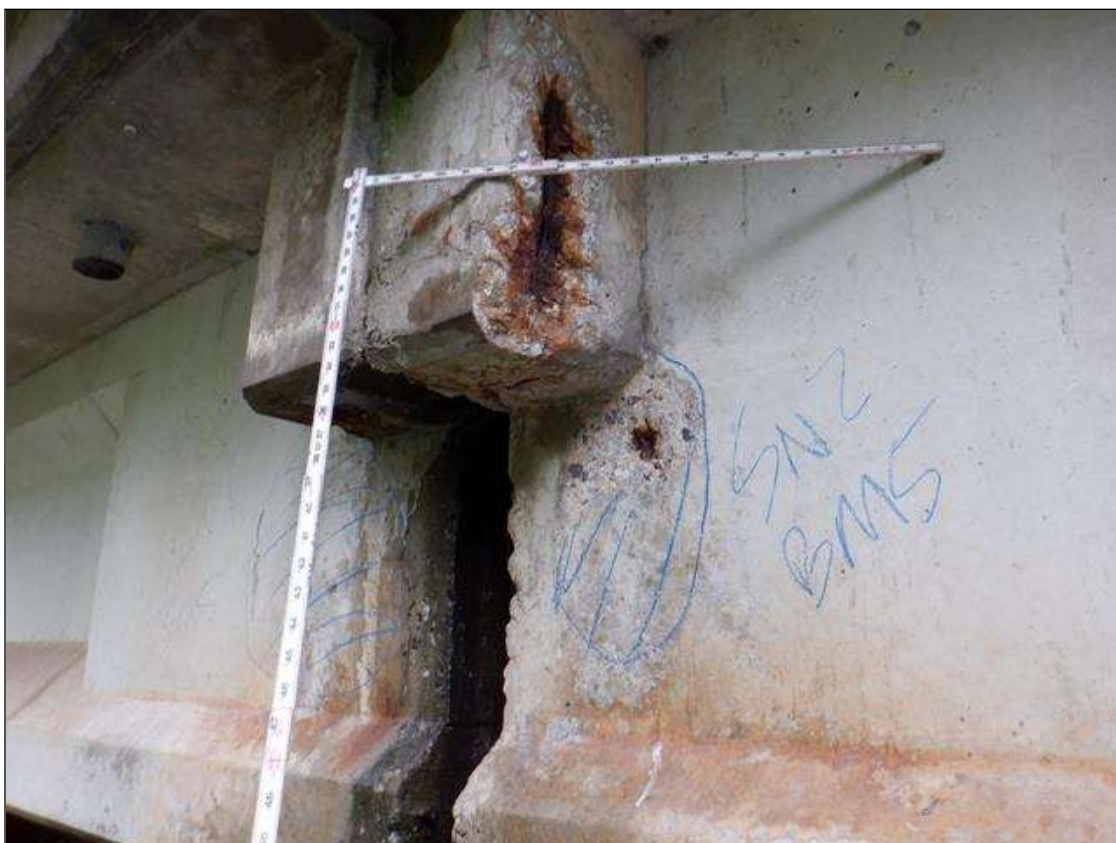
Span 2 Beam 5: East face at near end, spall/delamination [8in x 12in x up to 1in deep] with exposed rusted reinforcing [loss up to 1/16in]

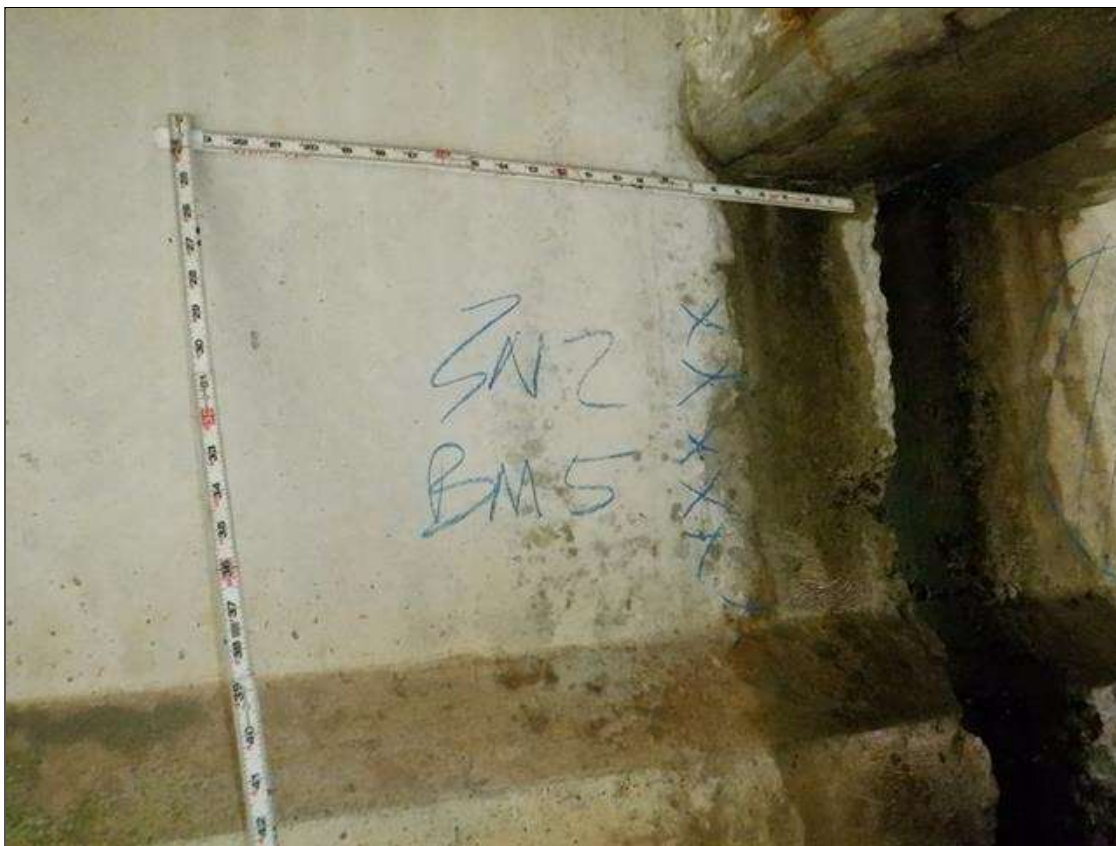
Span 2 Beam 5: West face at near end, vertical crack [14in x hairline]

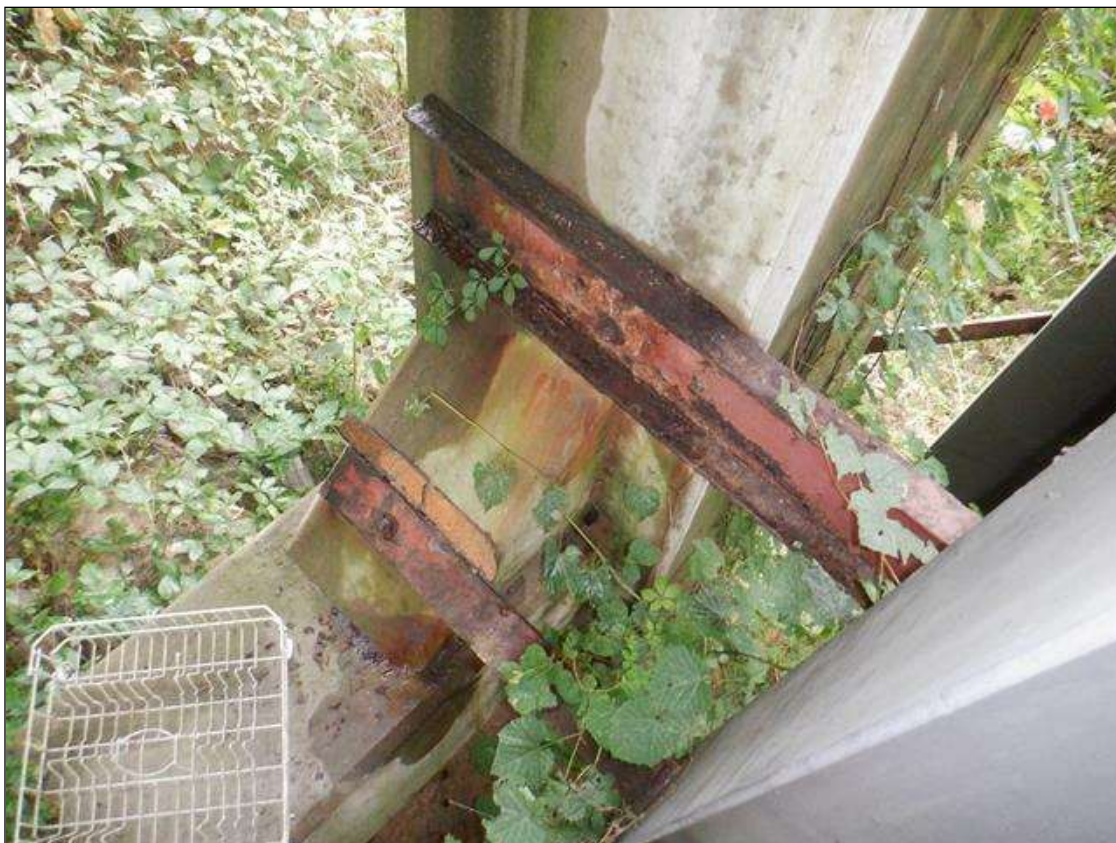
Crutch Bent: at metal angles and bracing attaching crutch bent to original bent 2, active corrosion with section loss [up to 1/8in]

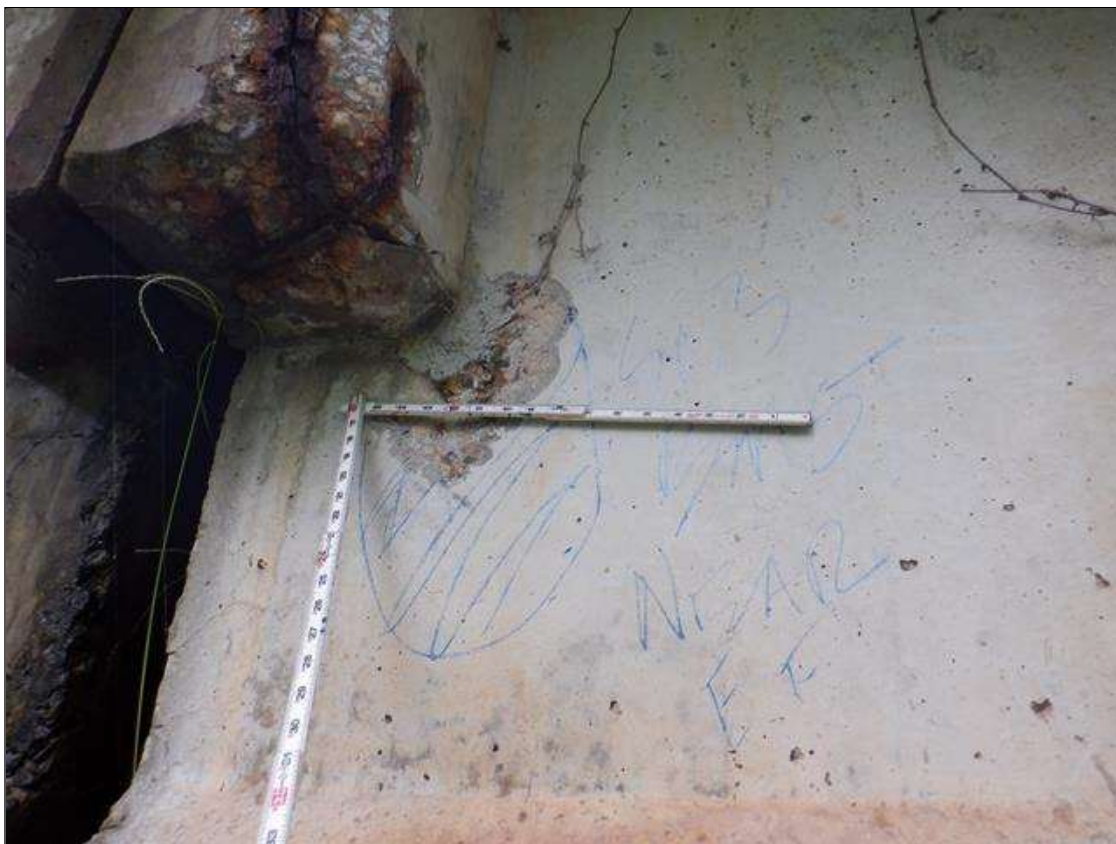
Span 3 Beam 5: East face at near end, spall/delamination [15in x 9in x 1/2in deep]

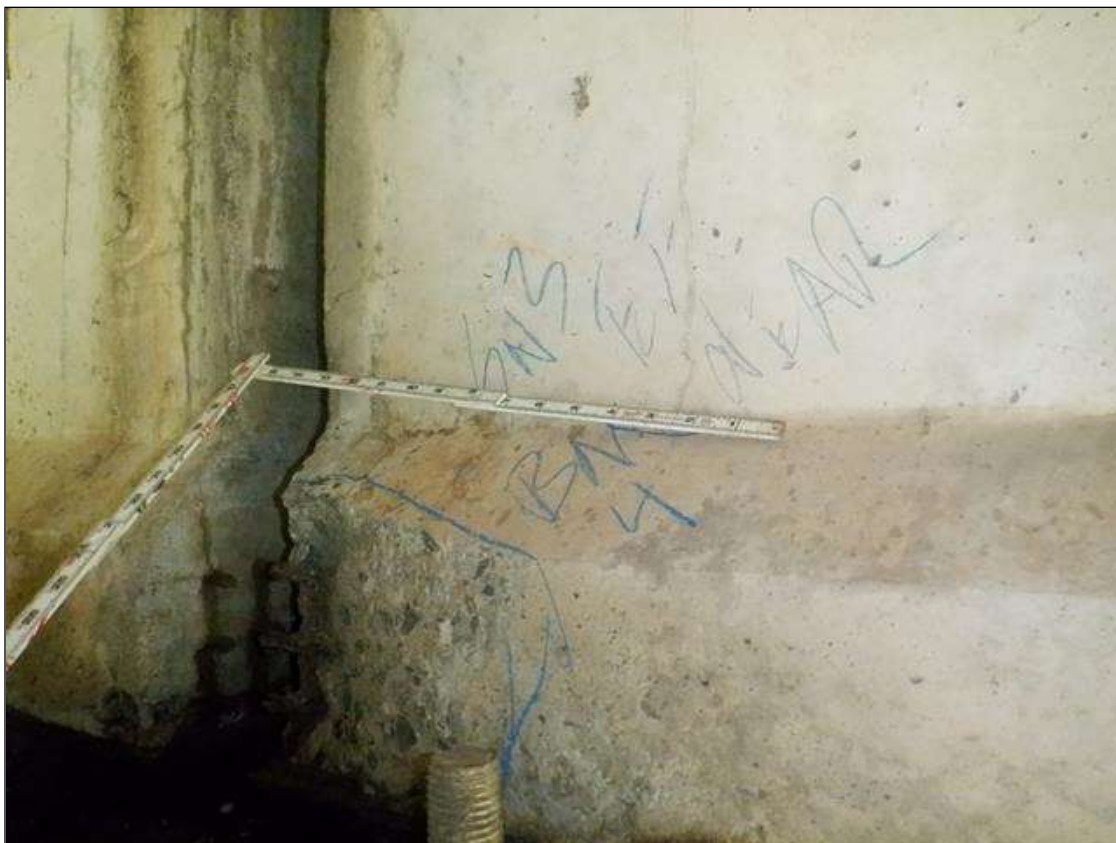
Span 3 Beam 4: [PAR] East face bottom flange at near end, spall [8in x 10in x 2in deep], with three [3] exposed prestress strands [loss up to 1/16in]

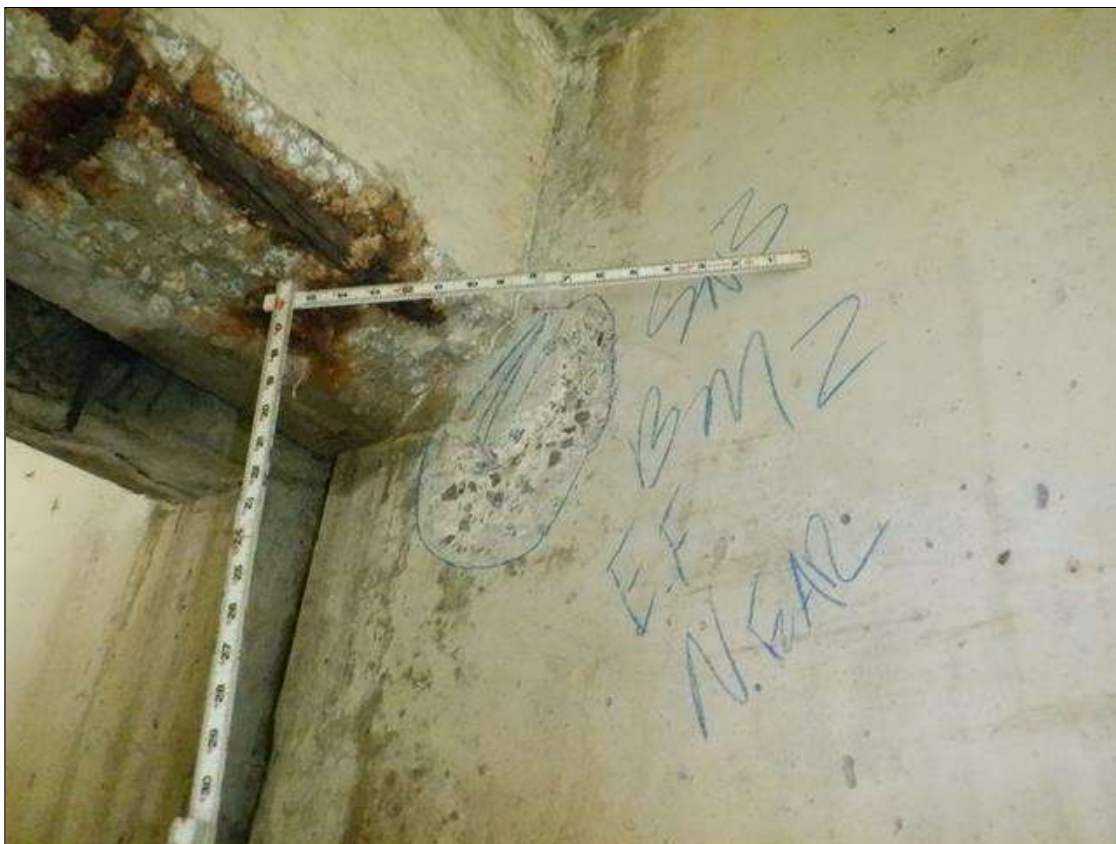
Span 3 Beam 2: East face at near end, spall/delamination [8in x 10in x 3/4in deep]

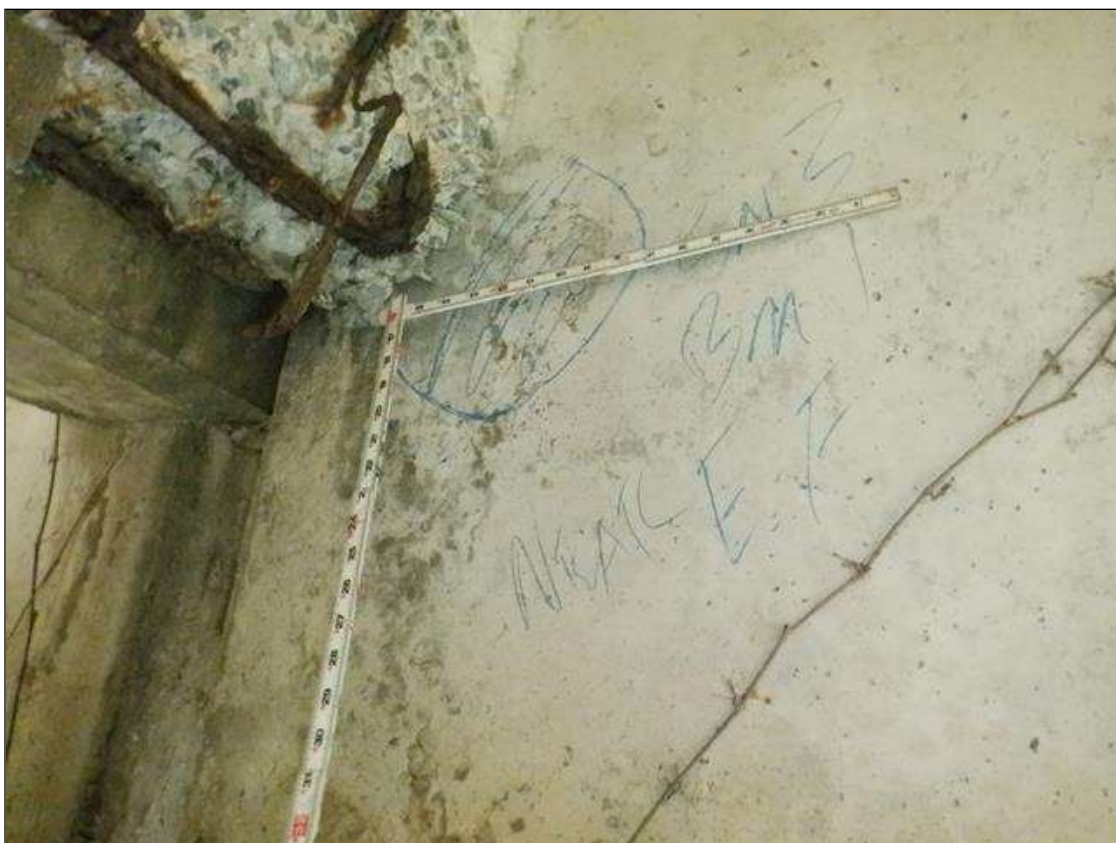
Span 3 Beam 1: East face at near end, delamination [10in diameter]

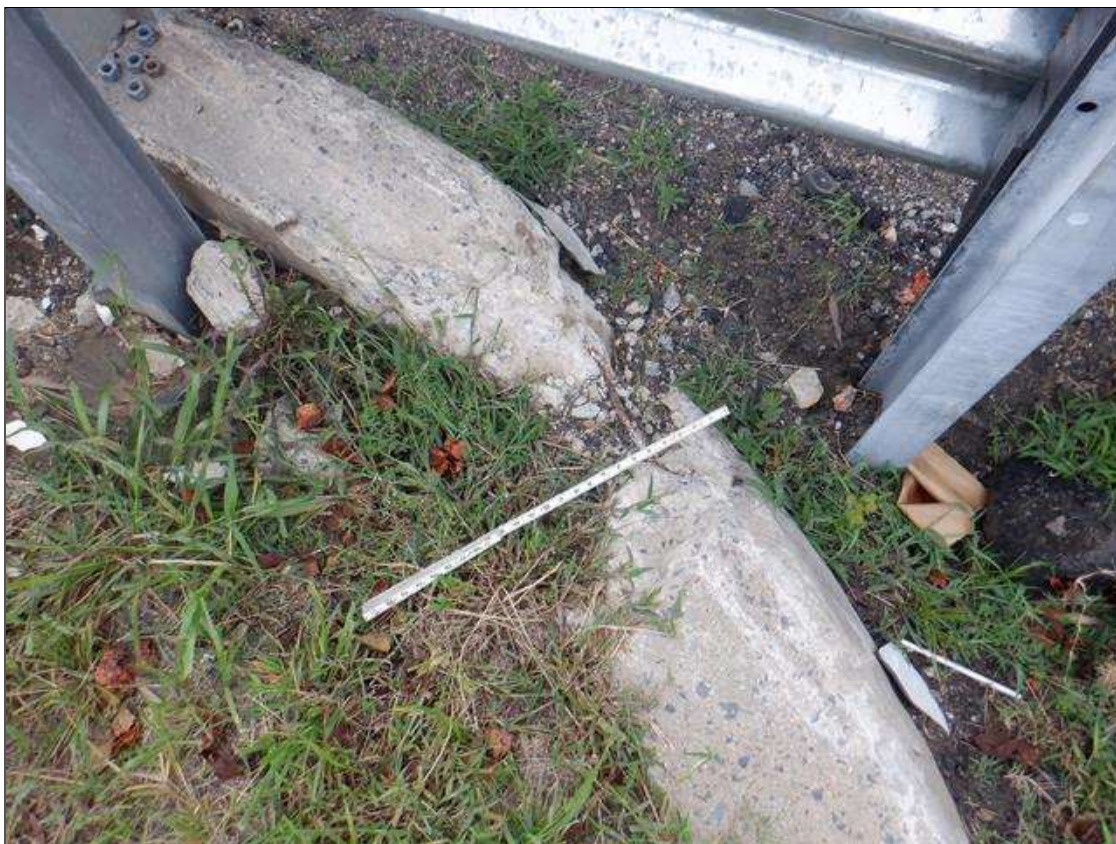
Southwest approach curb: vehicular impact damage [full length x full width x full depth] with exposed rusted reinforcing [loss < 1/16in]

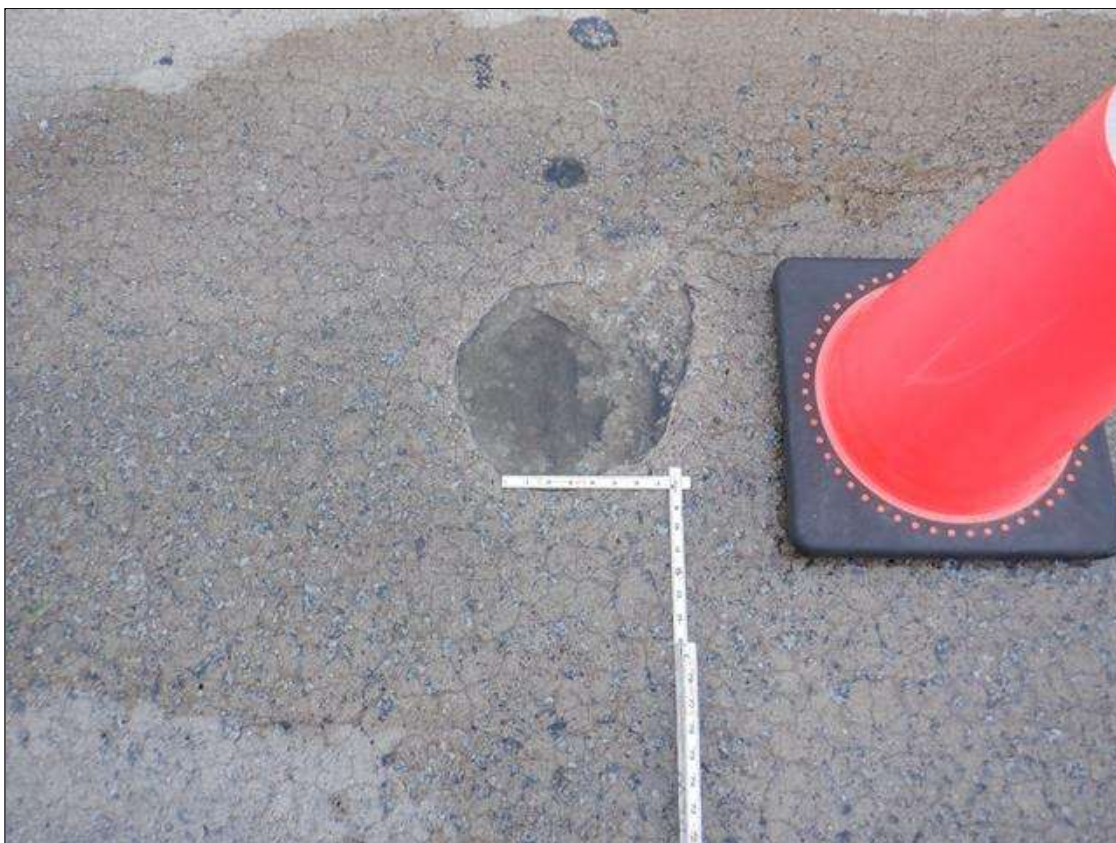
Span 1 Deck: centerline of roadway near midspan, spall [10in diameter x 1in deep] with exposed rusted reinforcing [no loss]

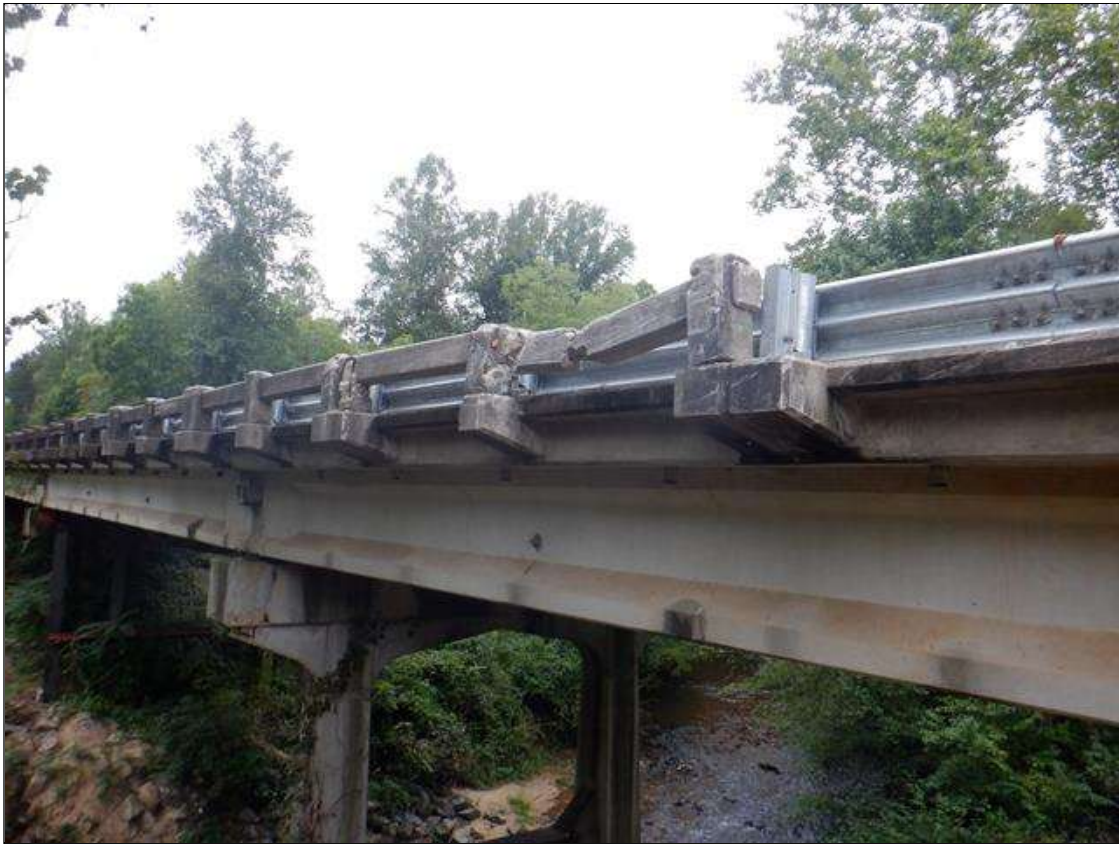
Span 1 Left Bridge Rail: [PAR] at near end, vehicular impact damage [2/3 of length missing], repair crew onsite at time of inspection

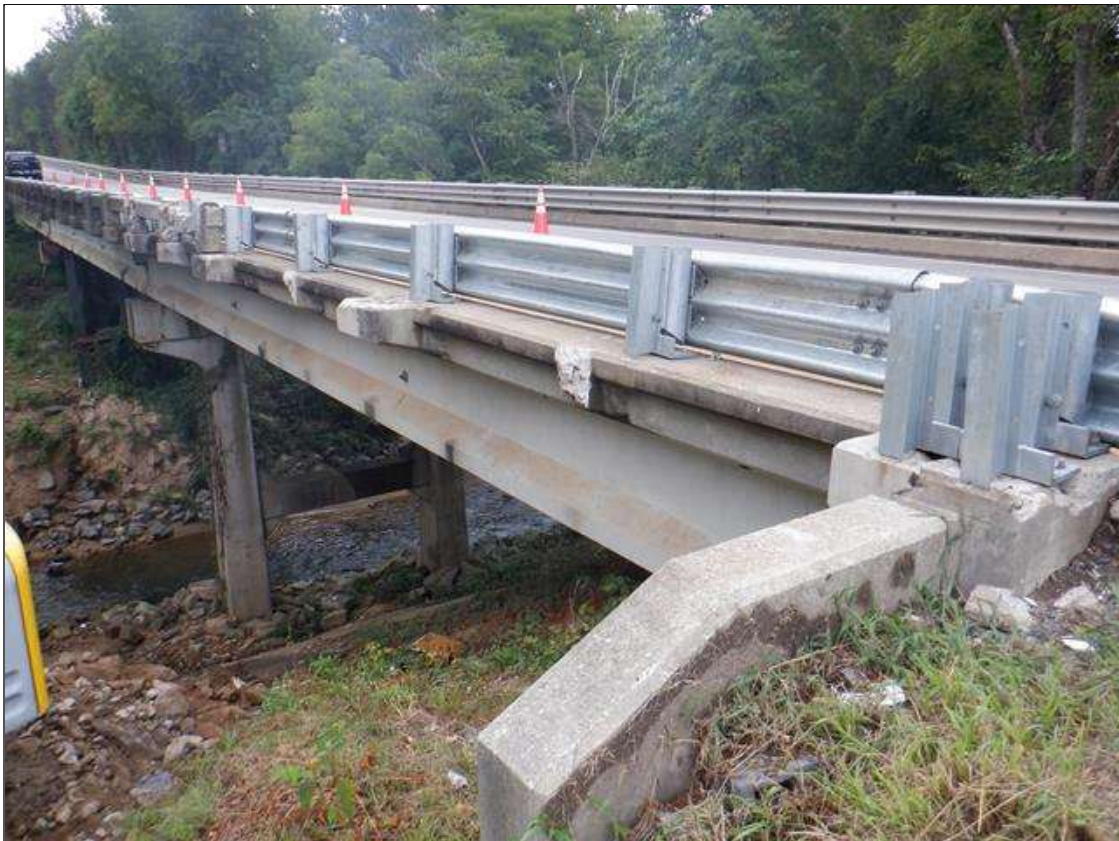
Span 1 Left Bridge Rail: [PAR] at near end, vehicular impact damage [2/3 of length missing], repair crew onsite at time of inspection

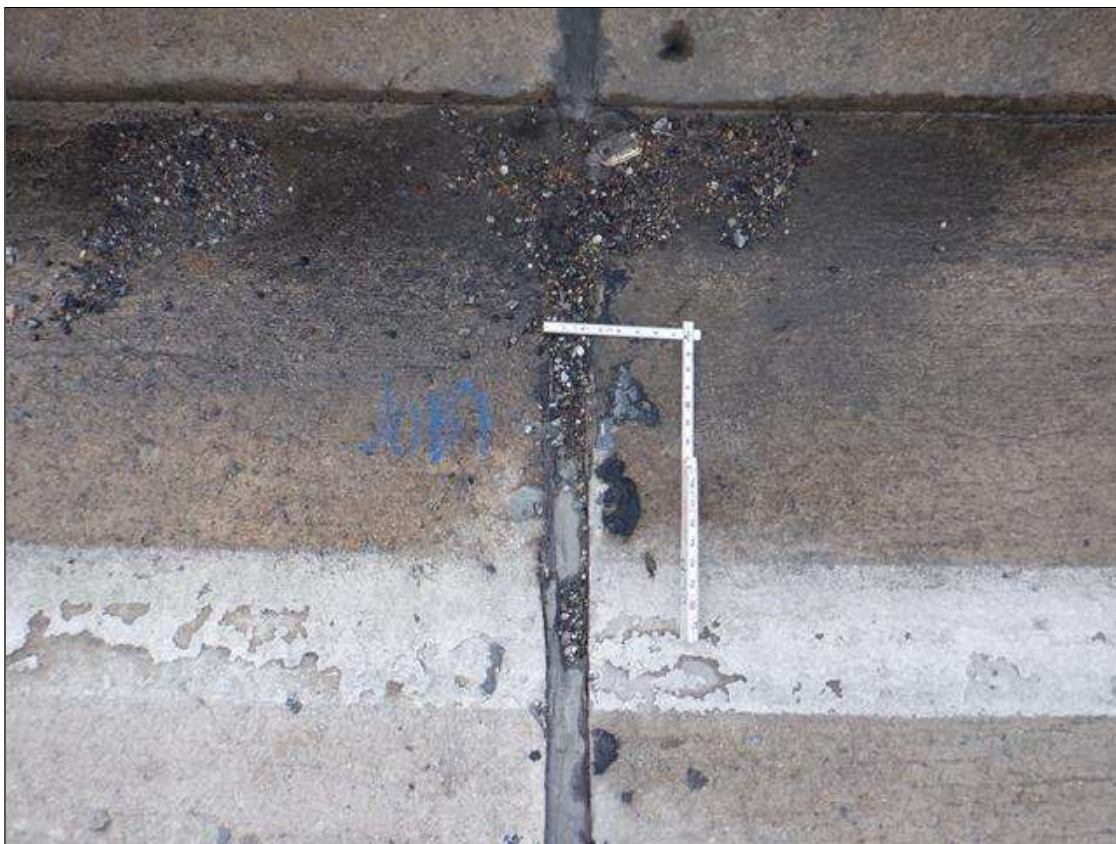
Expansion Joint : at both shoulders, debris impaction [up to 3ft, free movement]

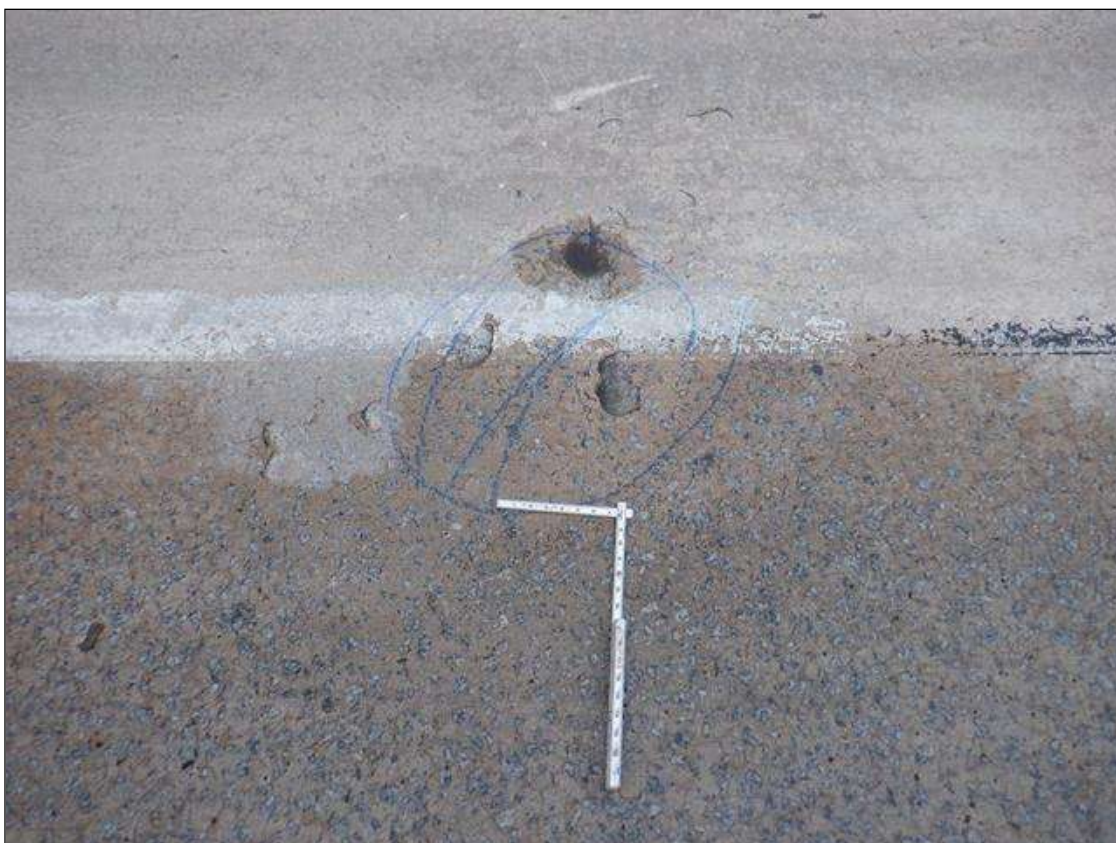
Span 2 Deck: at left lane near midspan, two [2] spall/delaminations [up to 2ft diameter x 1in deep]

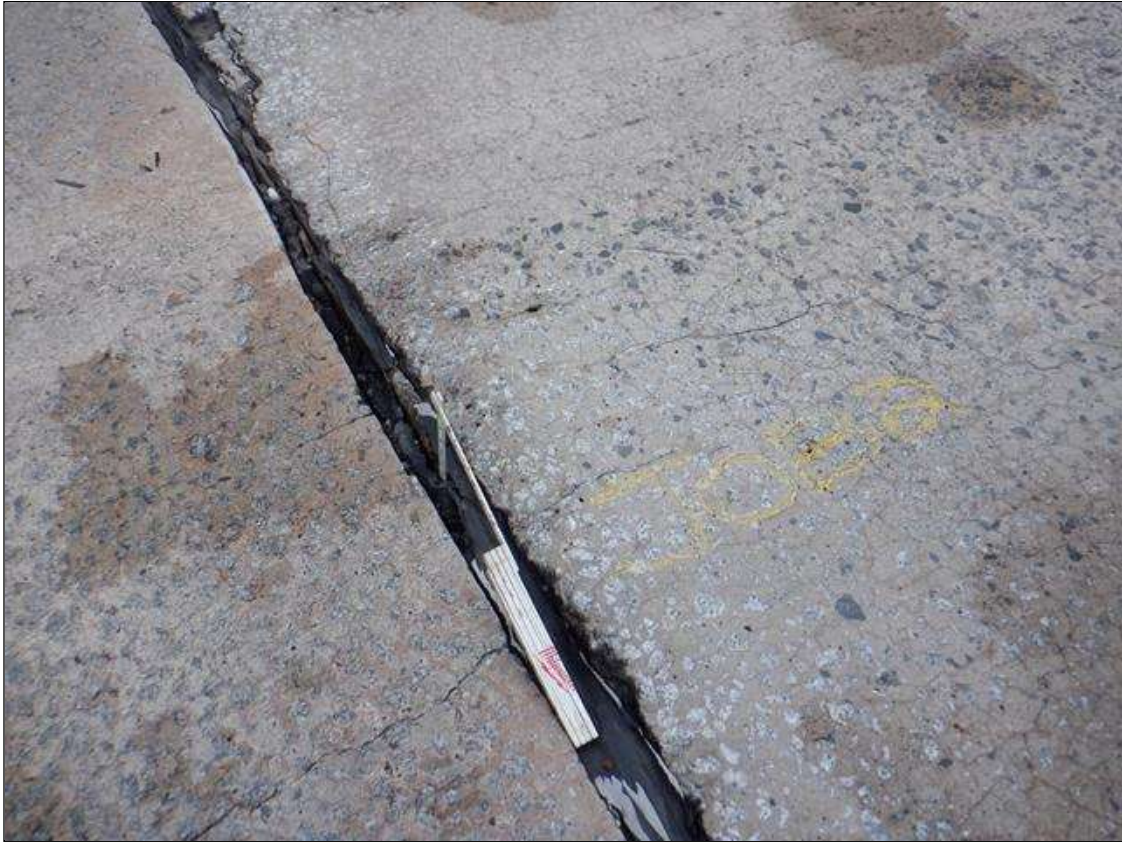
Expansion Joint : along length, areas of seal adhesion failure [full depth]

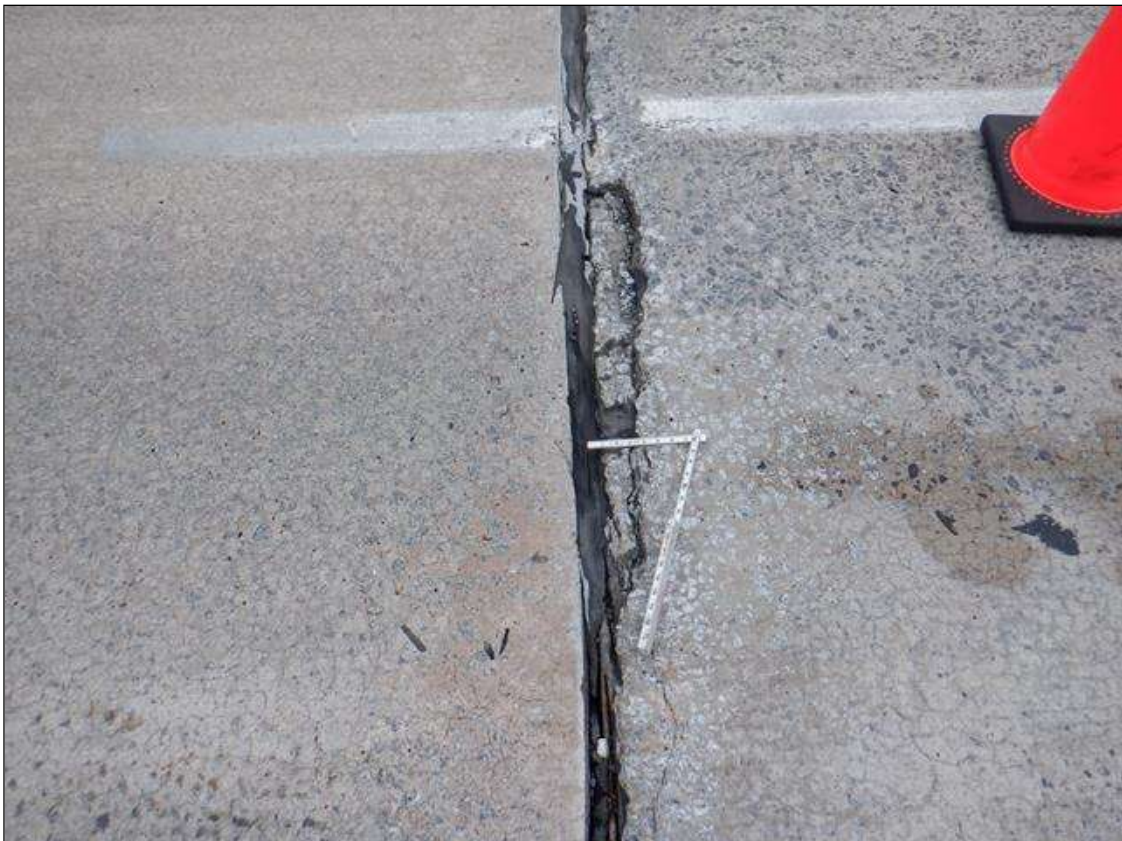
Span 3 Deck: [PAR] adjacent to joint over bent 2, spall/delamination [3ft x 5in x 2-1/2in deep]

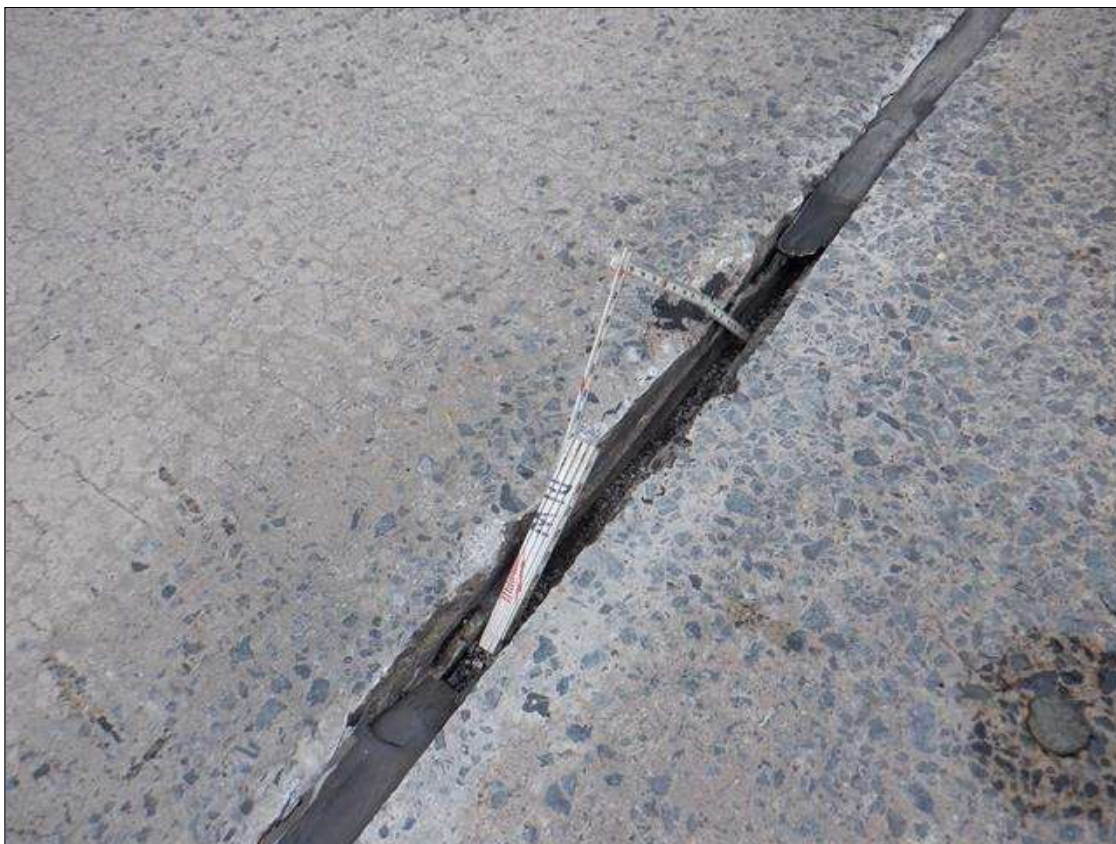
Expansion Joint : along length, areas of seal adhesion failure [full depth]

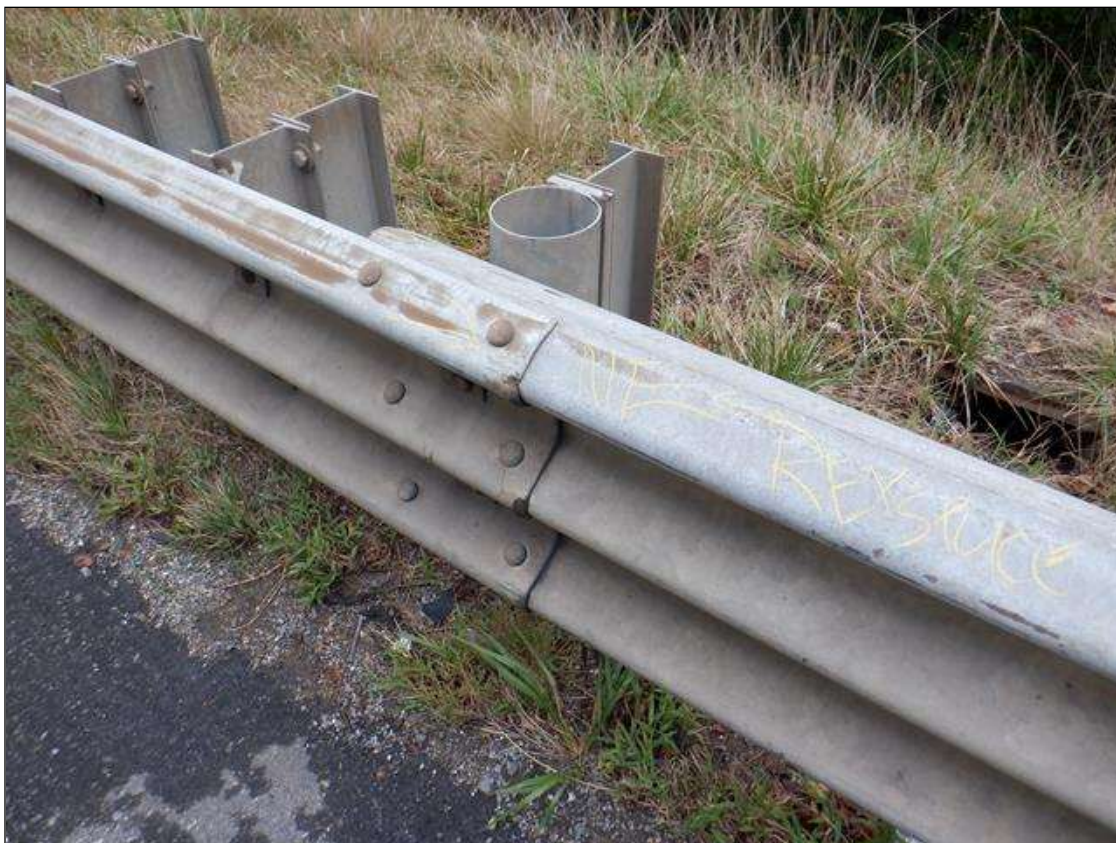
[PAR] splices at North approach slab, reversed and facing traffic

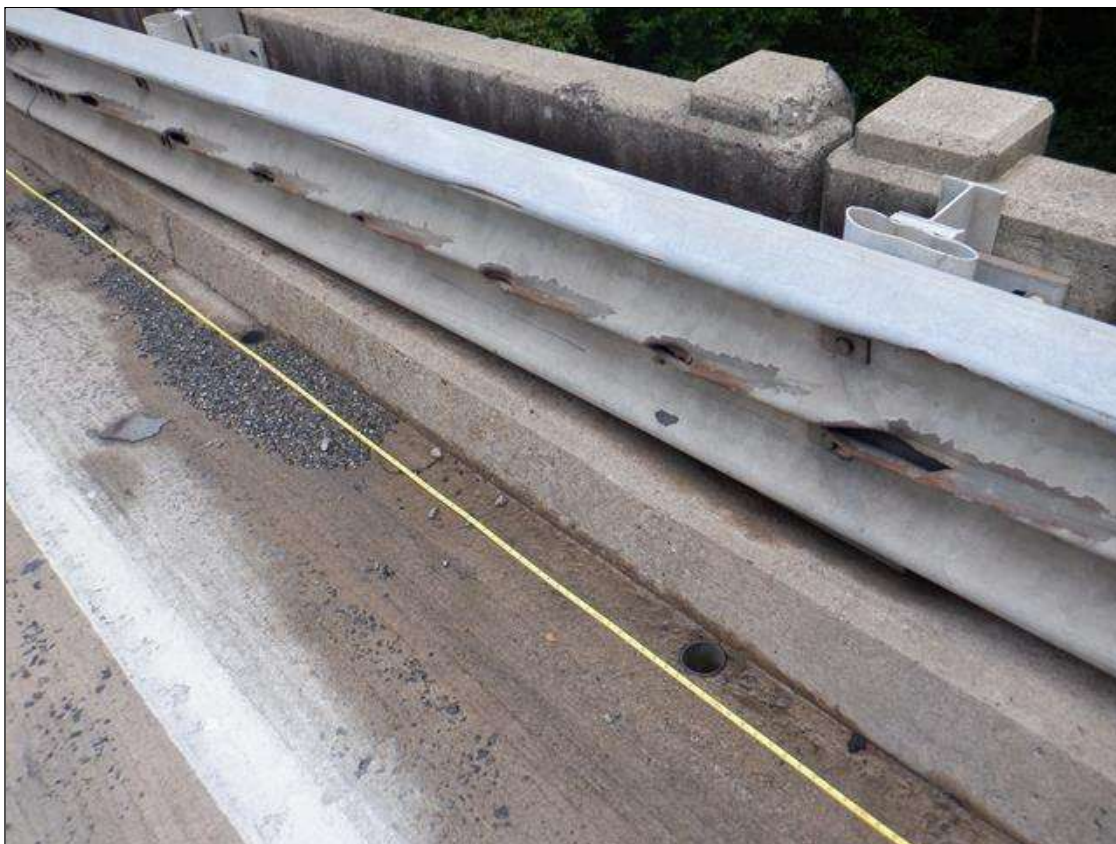
Span 3 Right Bridge Rail: along length, vehicular impact damage [23ft] with scrapes and gauges
