NC DEPARTMENT OF TRANSPORTATION
 DIVISION OF HIGHWAYS
 STRUCTURE MANAGEMENT UNIT

ATTENTION: **Priority Action Request, Changes to Structure Data**

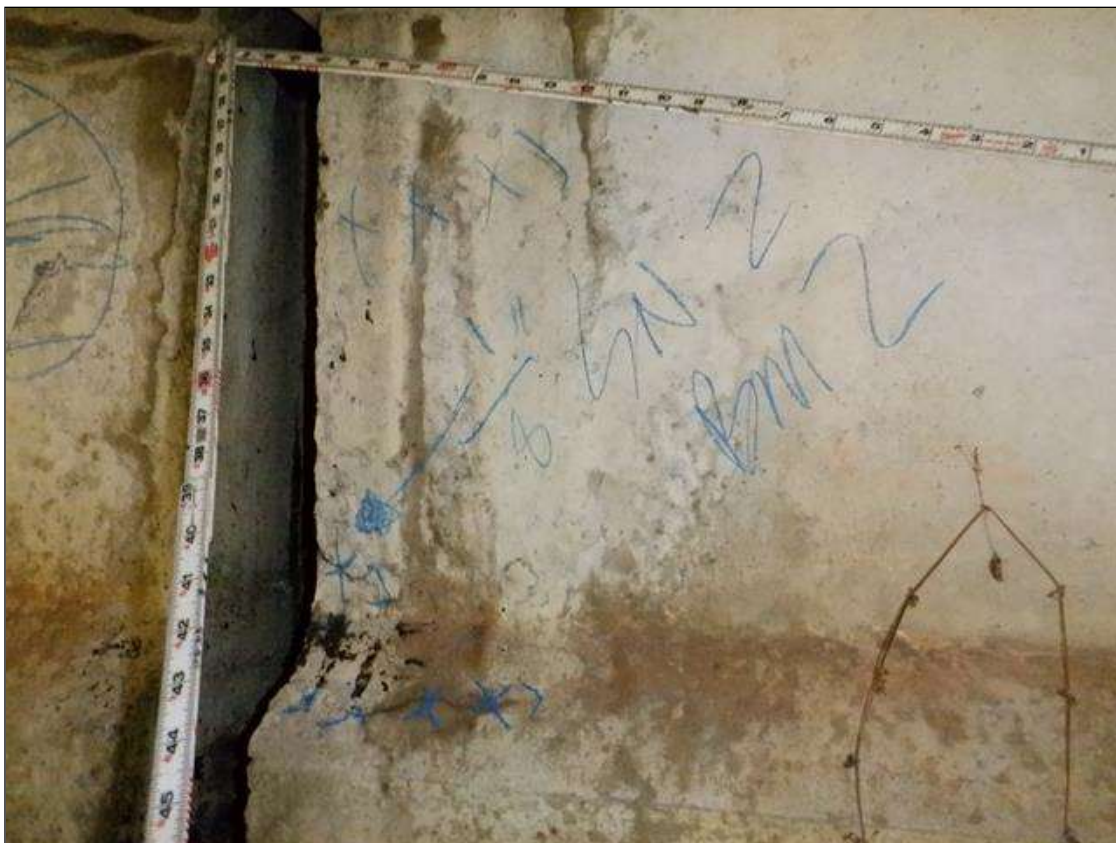
Span 2 Beam 2: [PAR] East face at near end, horizontal crack [3in x 1/8in]

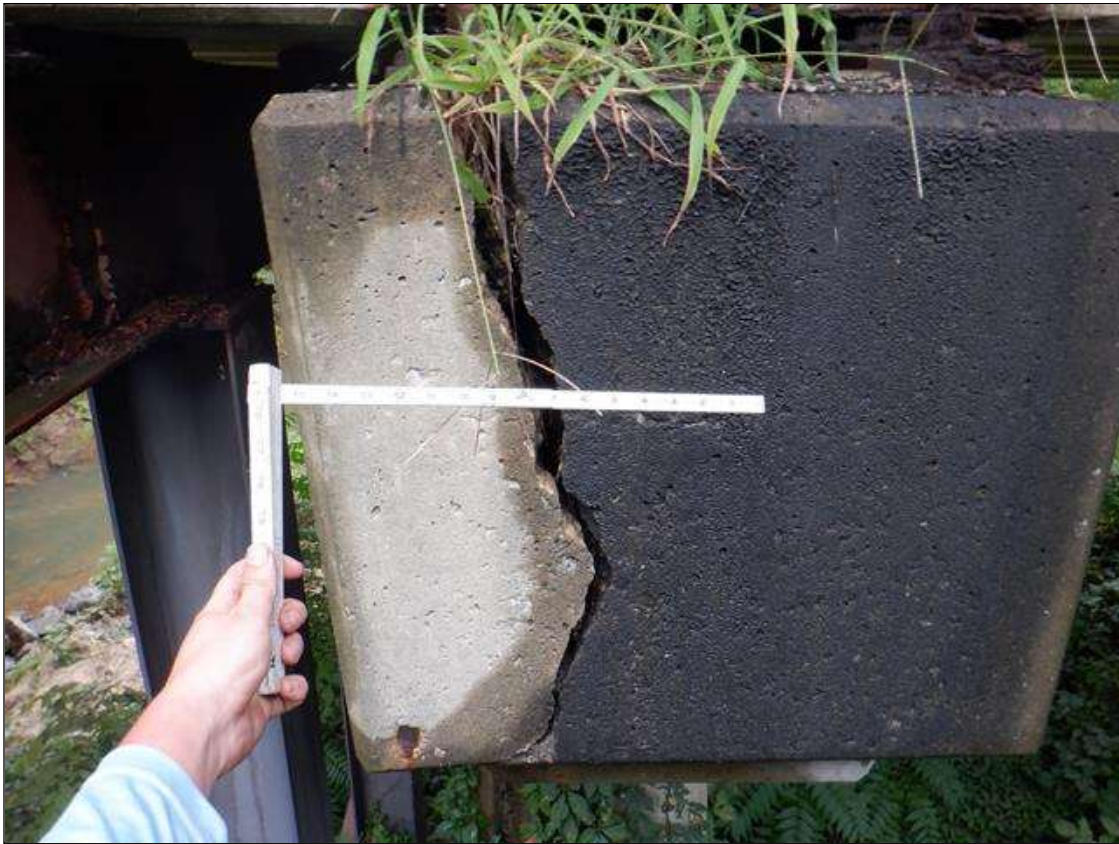
Bent 2 Cap 1: [PAR] along length, vertical crack [full height x up to 2-1/4in] traveling through all original bearing area; intermittently along length, delamination [up to full height]; along length multiple cracks [up to 20ft x up to 1/8in] with rust stain and efflorescence buildup; along top of South face, multiple spalls [6ft x 6in x 8in deep] with exposed primary and secondary rebar [up to 50% loss]; a replacement/crutch has been placed adjacent to original cap with the new bearing area 28in South of original; wood blocks have been placed in all bays over original bent 2 as additional support at concrete diaphragms

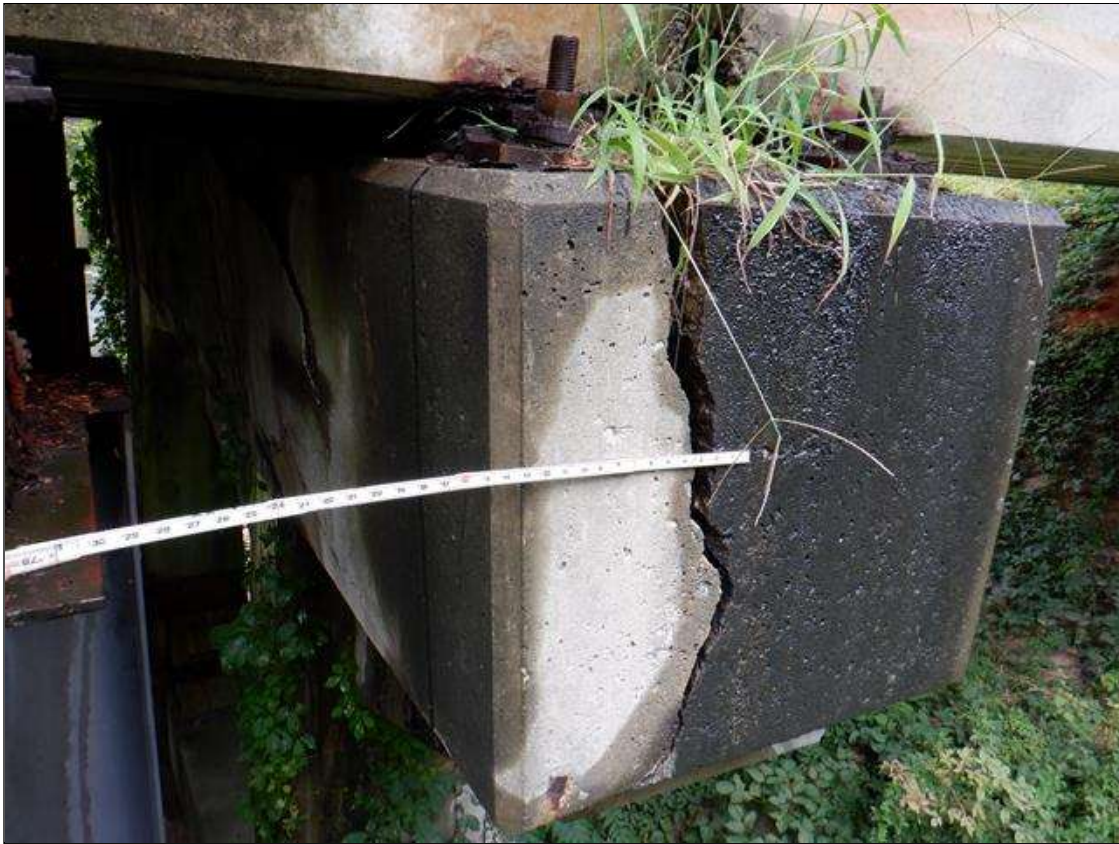
Bent 2 Cap 1: [PAR] along length, vertical crack [full height x up to 2-1/4in] traveling through all original bearing area; intermittently along length, delamination [up to full height]; along length multiple cracks [up to 20ft x up to 1/8in] with rust stain and efflorescence buildup; along top of South face, multiple spalls [6ft x 6in x 8in deep] with exposed primary and secondary rebar [up to 50% loss]; a replacement/crutch has been placed adjacent to original cap with the new bearing area 28in South of original; wood blocks have been placed in all bays over original bent 2 as additional support at concrete diaphragms

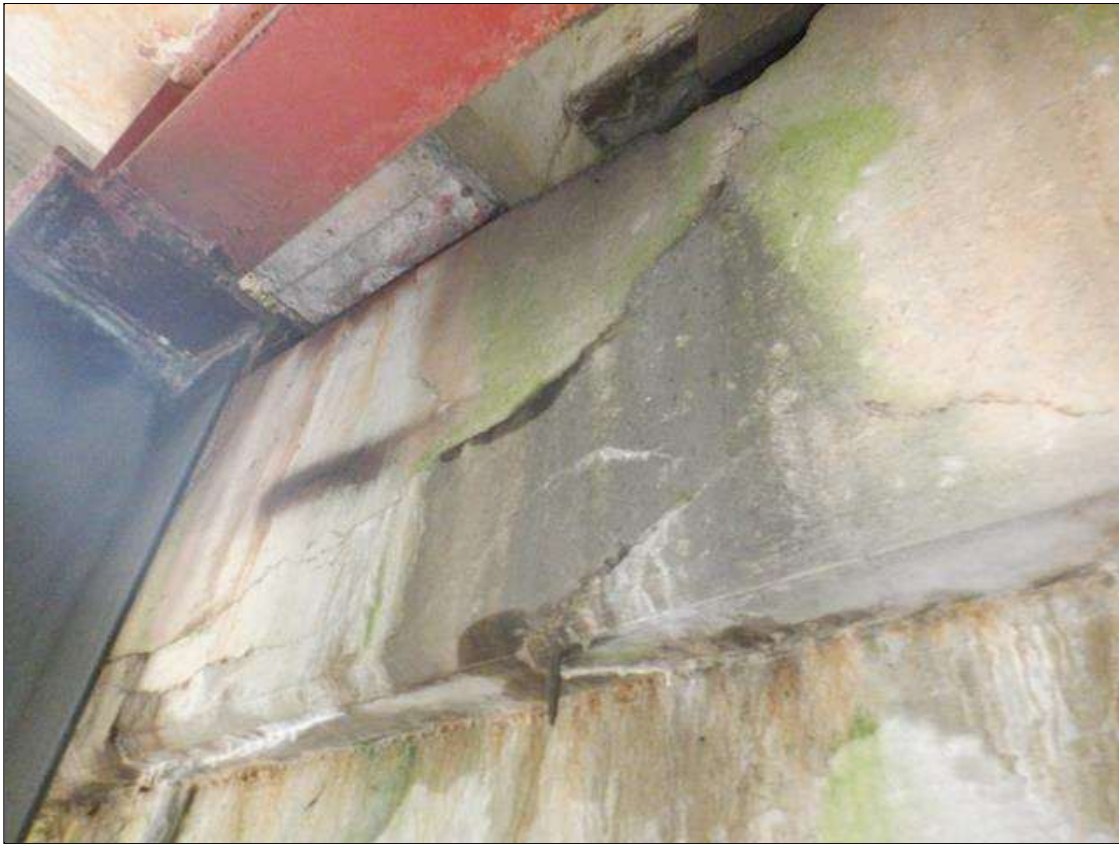
Bent 2 Cap 1: [PAR] along length, vertical crack [full height x up to 2-1/4in] traveling through all original bearing area; intermittently along length, delamination [up to full height]; along length multiple cracks [up to 20ft x up to 1/8in] with rust stain and efflorescence buildup; along top of South face, multiple spalls [6ft x 6in x 8in deep] with exposed primary and secondary rebar [up to 50% loss]; a replacement/crutch has been placed adjacent to original cap with the new bearing area 28in South of original; wood blocks have been placed in all bays over original bent 2 as additional support at concrete diaphragms

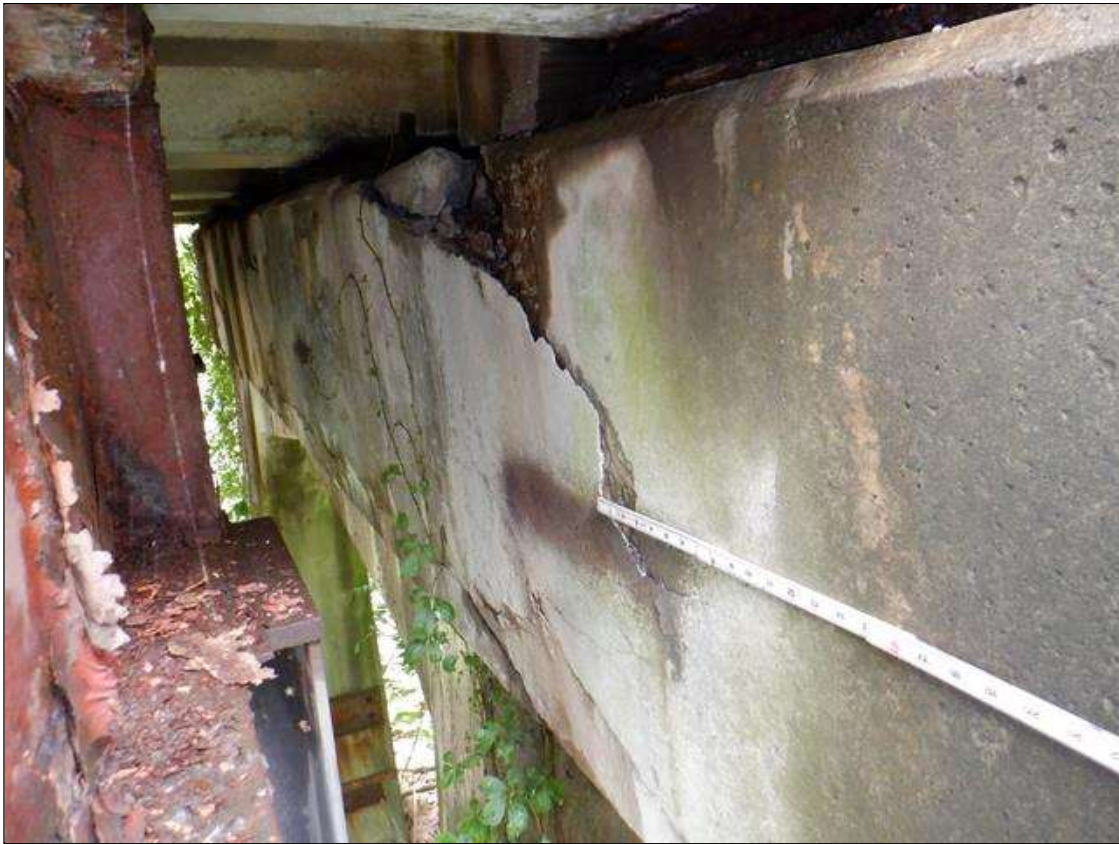
Bent 2 Cap 1: [PAR] along length, vertical crack [full height x up to 2-1/4in] traveling through all original bearing area; intermittently along length, delamination [up to full height]; along length multiple cracks [up to 20ft x up to 1/8in] with rust stain and efflorescence buildup; along top of South face, multiple spalls [6ft x 6in x 8in deep] with exposed primary and secondary rebar [up to 50% loss]; a replacement/crutch has been placed adjacent to original cap with the new bearing area 28in South of original; wood blocks have been placed in all bays over original bent 2 as additional support at concrete diaphragms

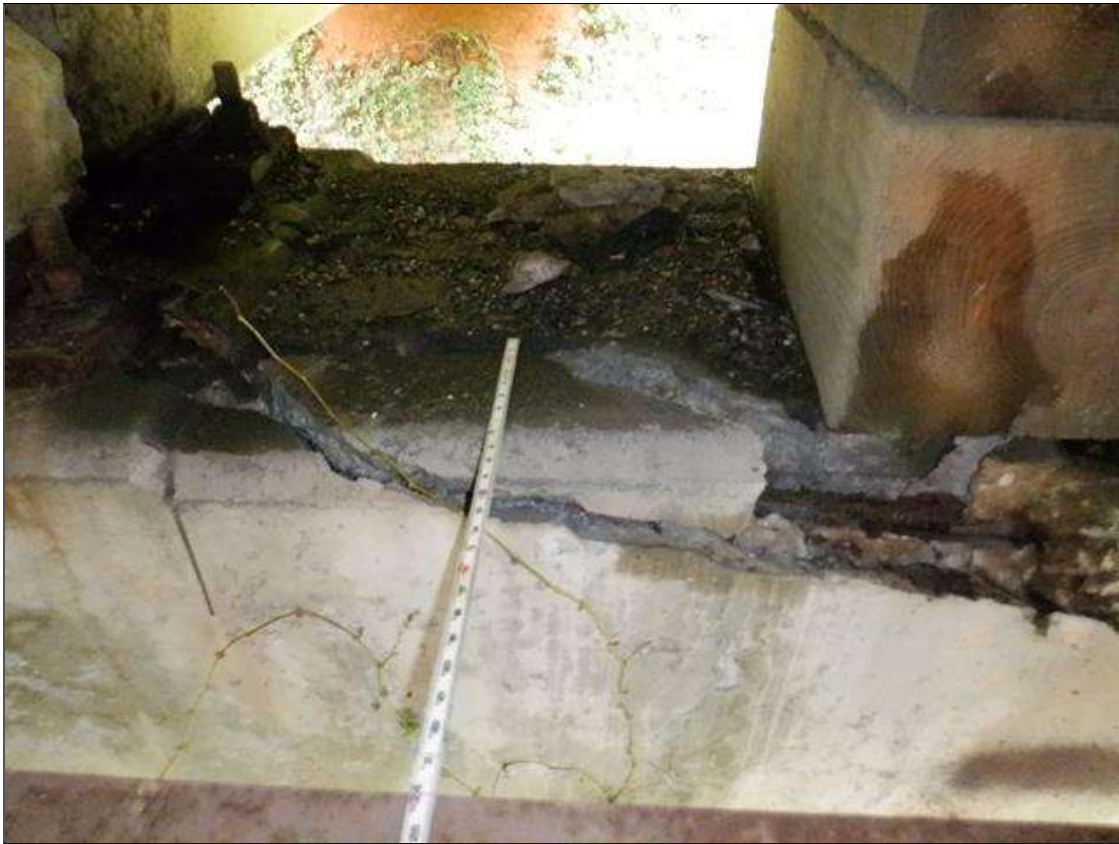
Bent 2 Cap 1: [PAR] along length, vertical crack [full height x up to 2-1/4in] traveling through all original bearing area; intermittently along length, delamination [up to full height]; along length multiple cracks [up to 20ft x up to 1/8in] with rust stain and efflorescence buildup; along top of South face, multiple spalls [6ft x 6in x 8in deep] with exposed primary and secondary rebar [up to 50% loss]; a replacement/crutch has been placed adjacent to original cap with the new bearing area 28in South of original; wood blocks have been placed in all bays over original bent 2 as additional support at concrete diaphragms

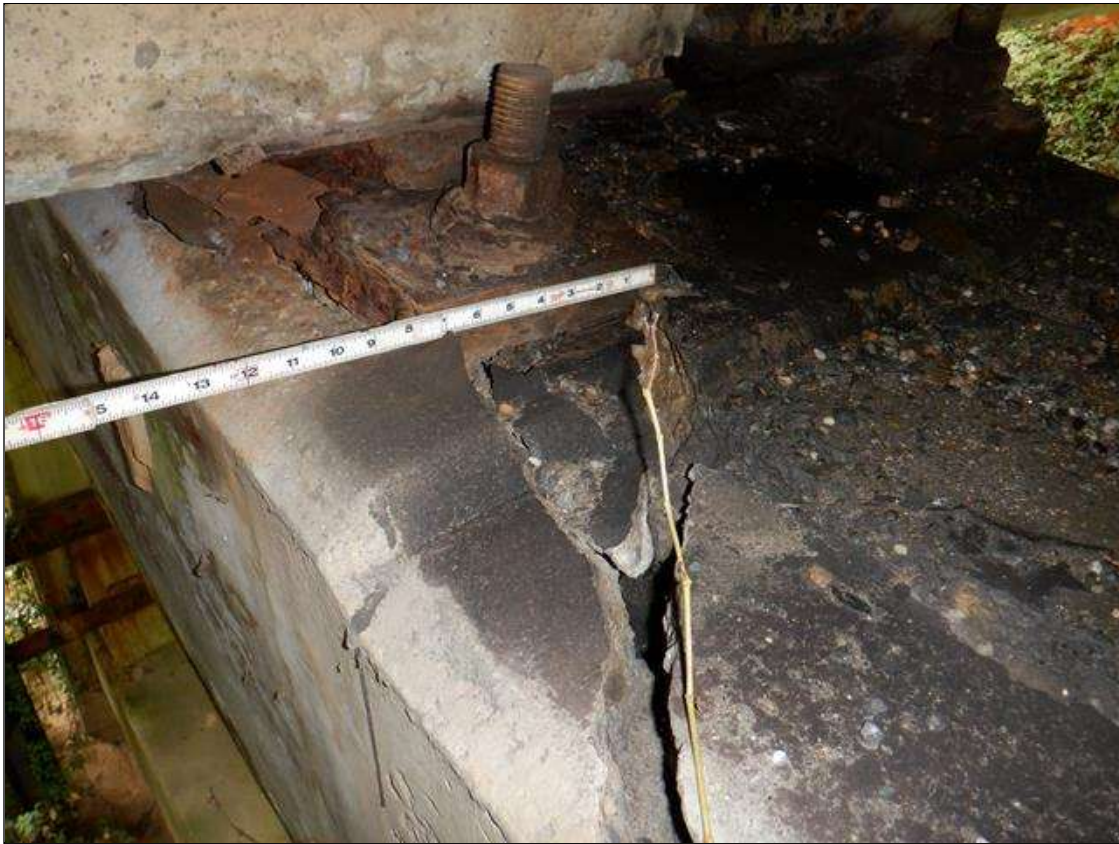
Bent 2 Cap 1: [PAR] along length, vertical crack [full height x up to 2-1/4in] traveling through all original bearing area; intermittently along length, delamination [up to full height]; along length multiple cracks [up to 20ft x up to 1/8in] with rust stain and efflorescence buildup; along top of South face, multiple spalls [6ft x 6in x 8in deep] with exposed primary and secondary rebar [up to 50% loss]; a replacement/crutch has been placed adjacent to original cap with the new bearing area 28in South of original; wood blocks have been placed in all bays over original bent 2 as additional support at concrete diaphragms

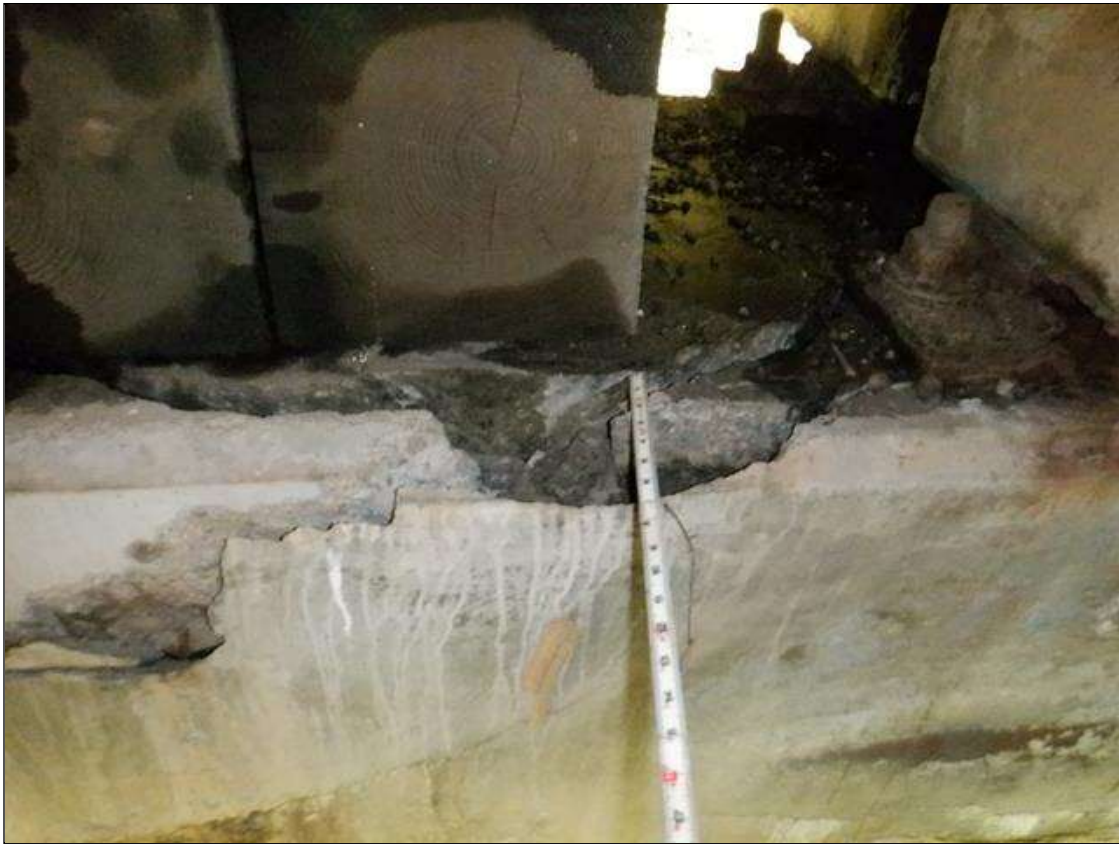
Bent 2 Cap 1: [PAR] along length, vertical crack [full height x up to 2-1/4in] traveling through all original bearing area; intermittently along length, delamination [up to full height]; along length multiple cracks [up to 20ft x up to 1/8in] with rust stain and efflorescence buildup; along top of South face, multiple spalls [6ft x 6in x 8in deep] with exposed primary and secondary rebar [up to 50% loss]; a replacement/crutch has been placed adjacent to original cap with the new bearing area 28in South of original; wood blocks have been placed in all bays over original bent 2 as additional support at concrete diaphragms

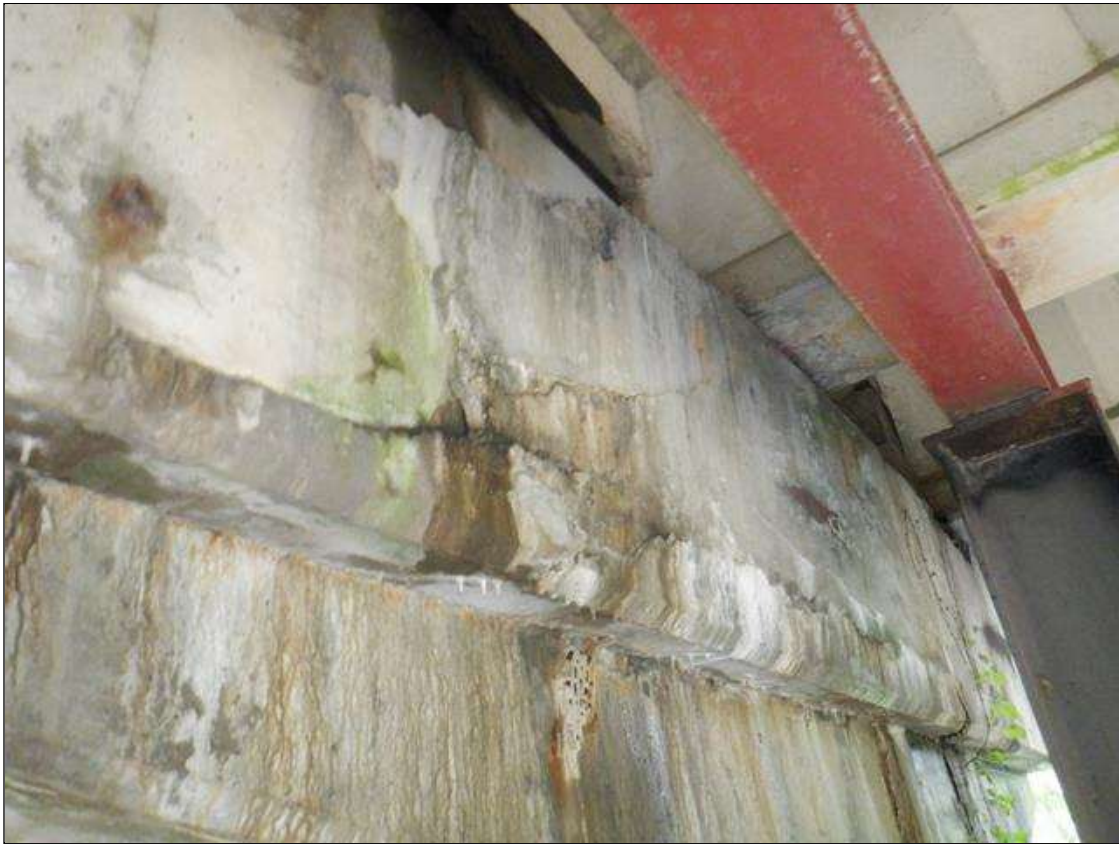
Bent 2 Cap 1: [PAR] along length, vertical crack [full height x up to 2-1/4in] traveling through all original bearing area; intermittently along length, delamination [up to full height]; along length multiple cracks [up to 20ft x up to 1/8in] with rust stain and efflorescence buildup; along top of South face, multiple spalls [6ft x 6in x 8in deep] with exposed primary and secondary rebar [up to 50% loss]; a replacement/crutch has been placed adjacent to original cap with the new bearing area 28in South of original; wood blocks have been placed in all bays over original bent 2 as additional support at concrete diaphragms

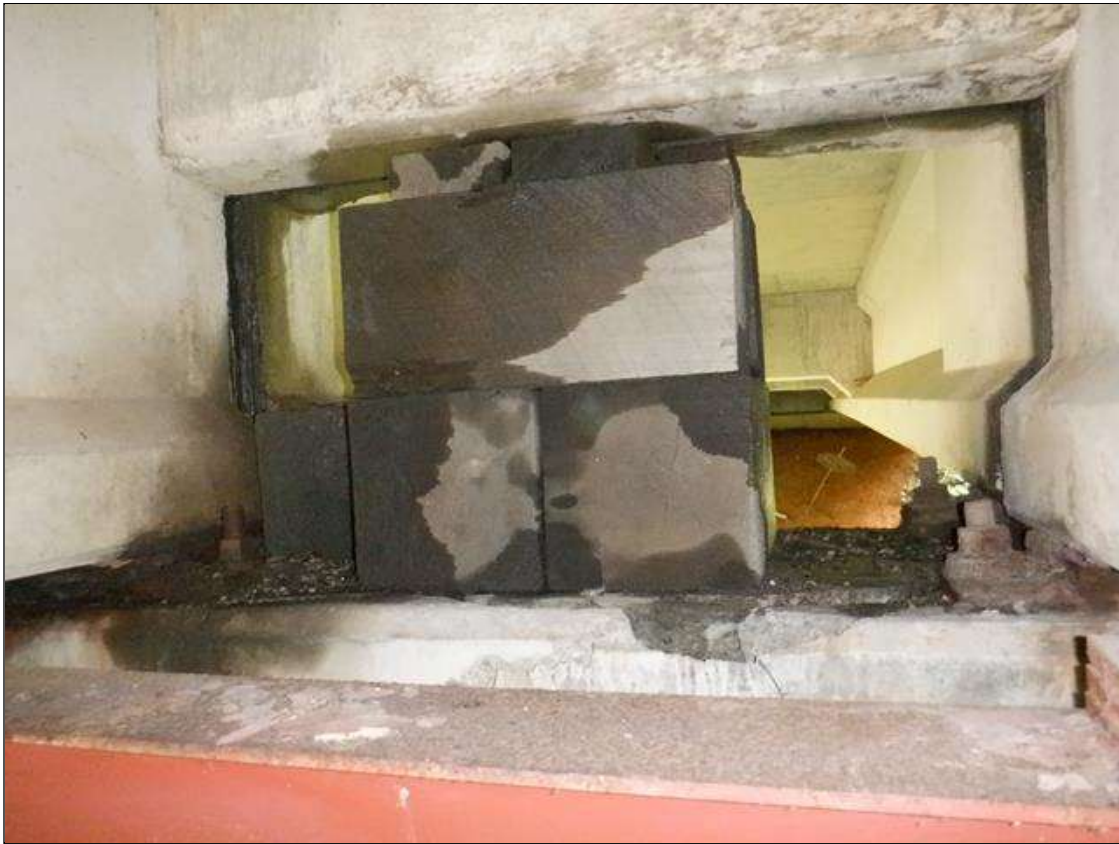
Bent 2 Cap 1: [PAR] along length, vertical crack [full height x up to 2-1/4in] traveling through all original bearing area; intermittently along length, delamination [up to full height]; along length multiple cracks [up to 20ft x up to 1/8in] with rust stain and efflorescence buildup; along top of South face, multiple spalls [6ft x 6in x 8in deep] with exposed primary and secondary rebar [up to 50% loss]; a replacement/crutch has been placed adjacent to original cap with the new bearing area 28in South of original; wood blocks have been placed in all bays over original bent 2 as additional support at concrete diaphragms

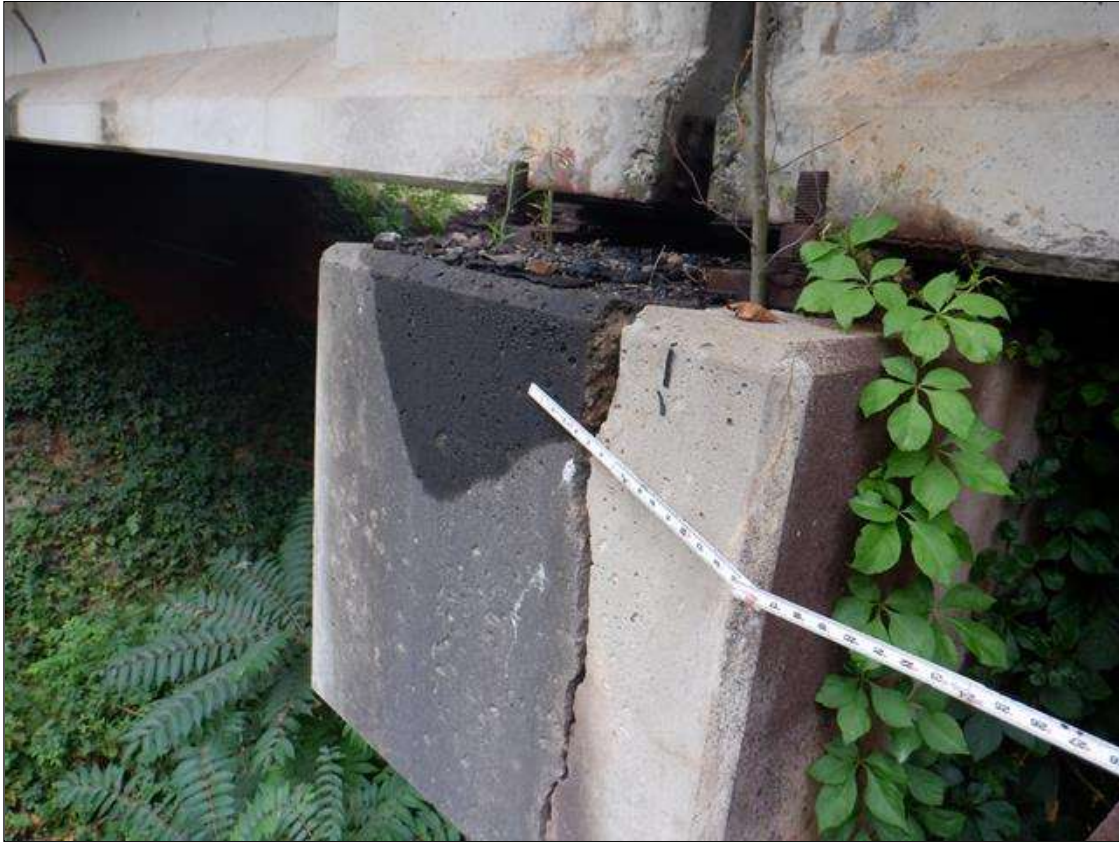
Bent 2 Cap 1: [PAR] along length, vertical crack [full height x up to 2-1/4in] traveling through all original bearing area; intermittently along length, delamination [up to full height]; along length multiple cracks [up to 20ft x up to 1/8in] with rust stain and efflorescence buildup; along top of South face, multiple spalls [6ft x 6in x 8in deep] with exposed primary and secondary rebar [up to 50% loss]; a replacement/crutch has been placed adjacent to original cap with the new bearing area 28in South of original; wood blocks have been placed in all bays over original bent 2 as additional support at concrete diaphragms

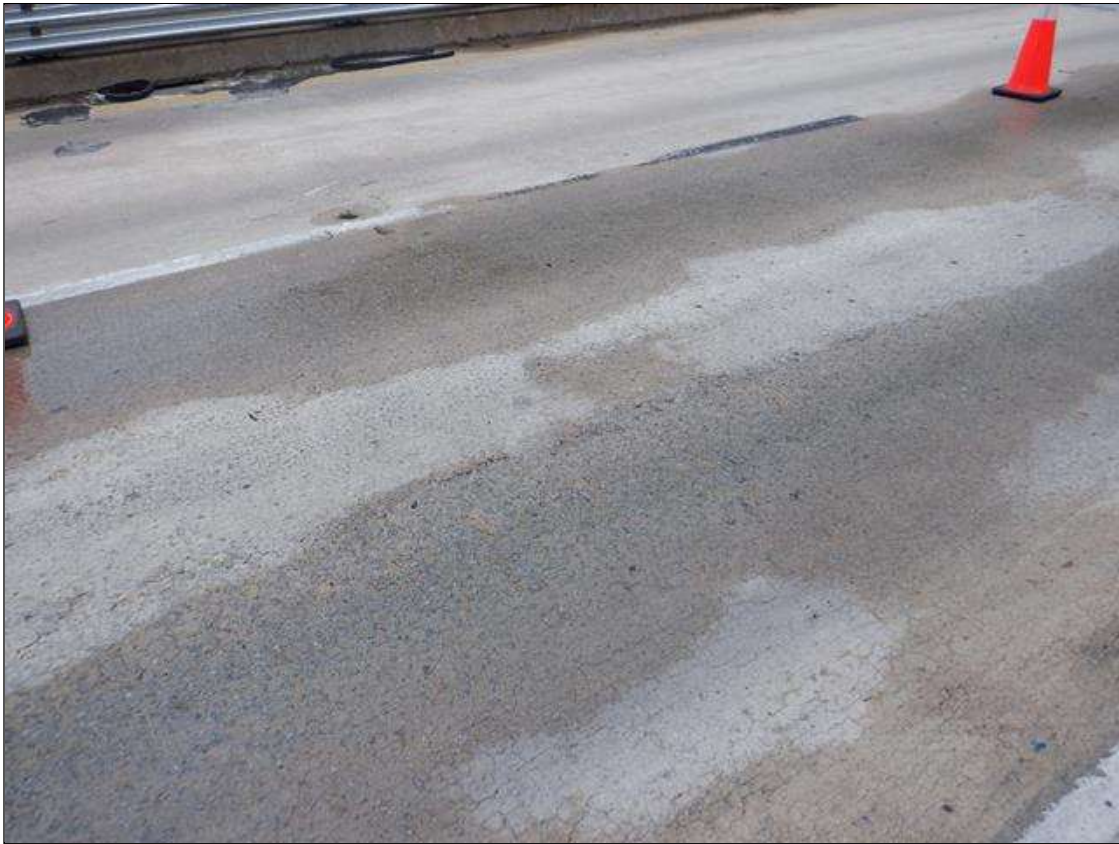
typical wearing surface

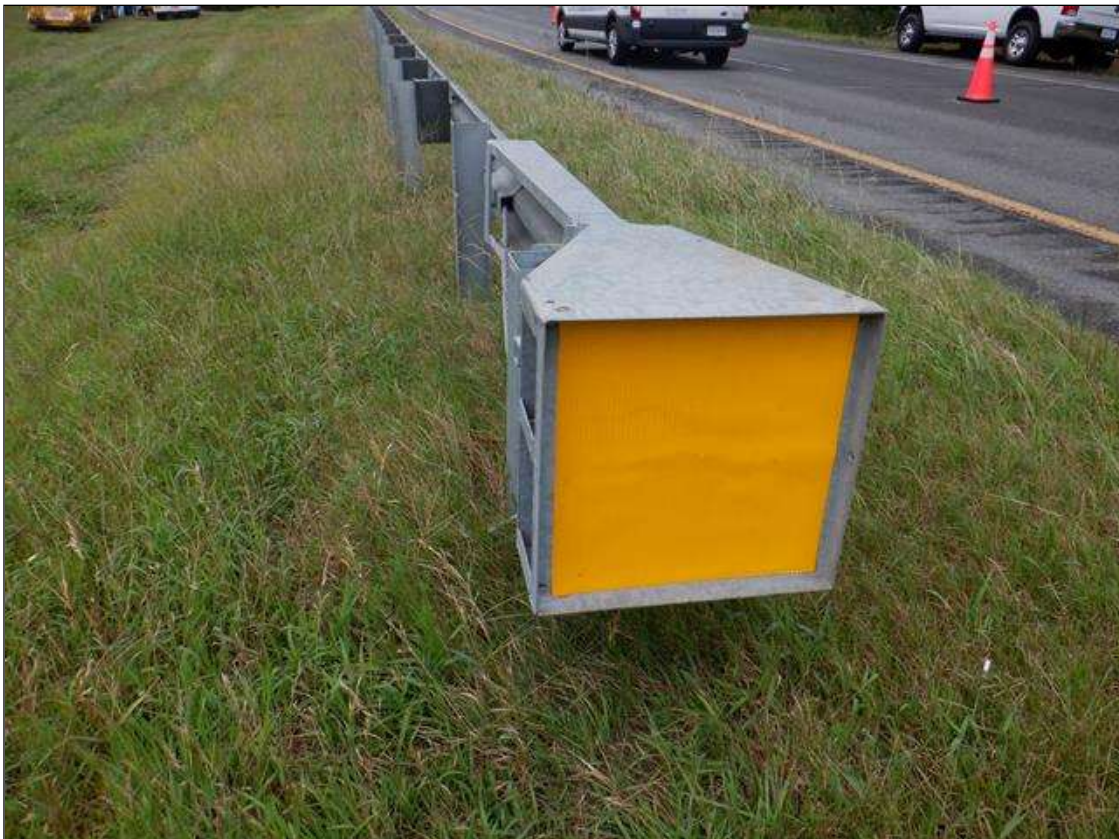
typical guardrail end treatment

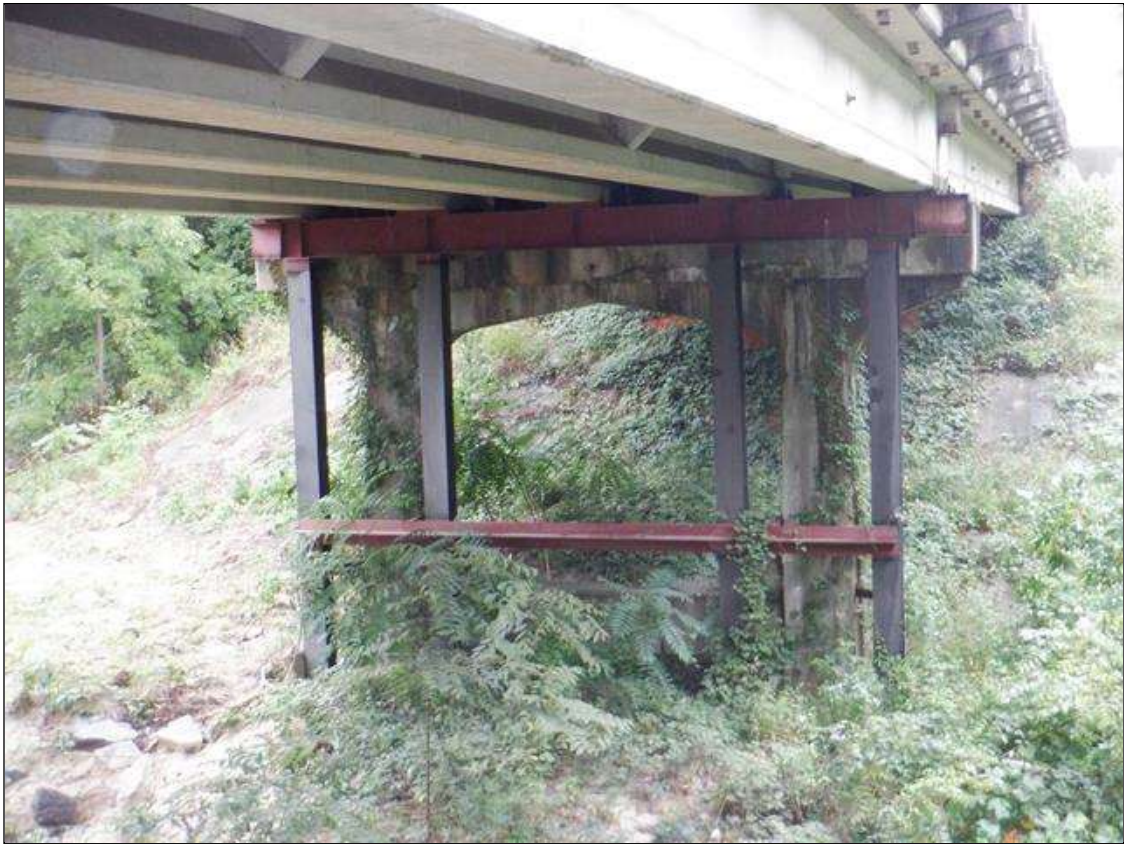
Bent 2 & Crutch Bent Profile

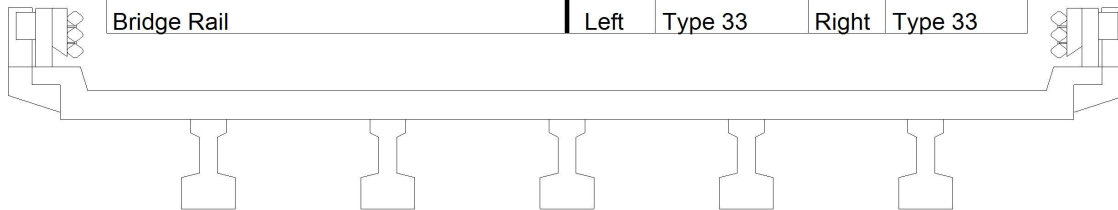
Measurements for Span #	1		
Deck Thickness	0.833ft*	Left Overhang	4.208ft
Top of Rail to Bottom of Beam	6.917ft	Right Overhang	4.208ft

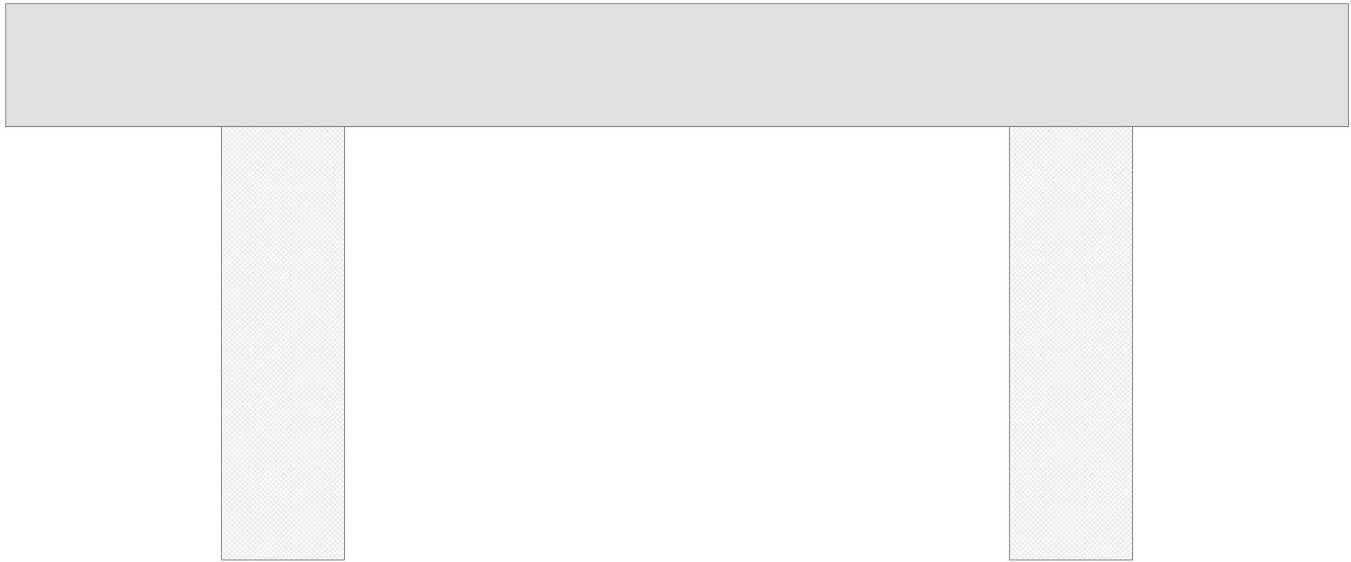
Cap Information			Material Cast-in-Place Concrete						
Length	Width	Height	Left Overhang	Right Overhang	Left Beam to End of Cap.	Right Beam to End of Cap.			
29.167 ft.	3.000 ft.	2.750 ft.	6.000 ft.	6.000 ft.	2.083 ft.	2.083 ft.			
Subcap Information			Material						
Length	Width	Height	Left Overhang	Right Overhang	Left Pile to Splice.				
Sill Information			Material						
Length	Width	Height							
Pile #	Material	Spacing	Width/Dia.	Length	Orientation	Driven?	Replacement?	Removed?	Collar?
1	Concrete	17.167 ft.	2.750 ft. X 3.000 ft.		Vertical	No	No	No	No
2	Concrete		2.750 ft. X 3.000 ft.		Vertical	No	No	No	No
Bent #: 1			Similar Bent #: 2
