NC DEPARTMENT OF TRANSPORTATION
 DIVISION OF HIGHWAYS
 STRUCTURE MANAGEMENT UNIT

ATTENTION: **Priority Action Requested**
Snooper Recommended next Inspection

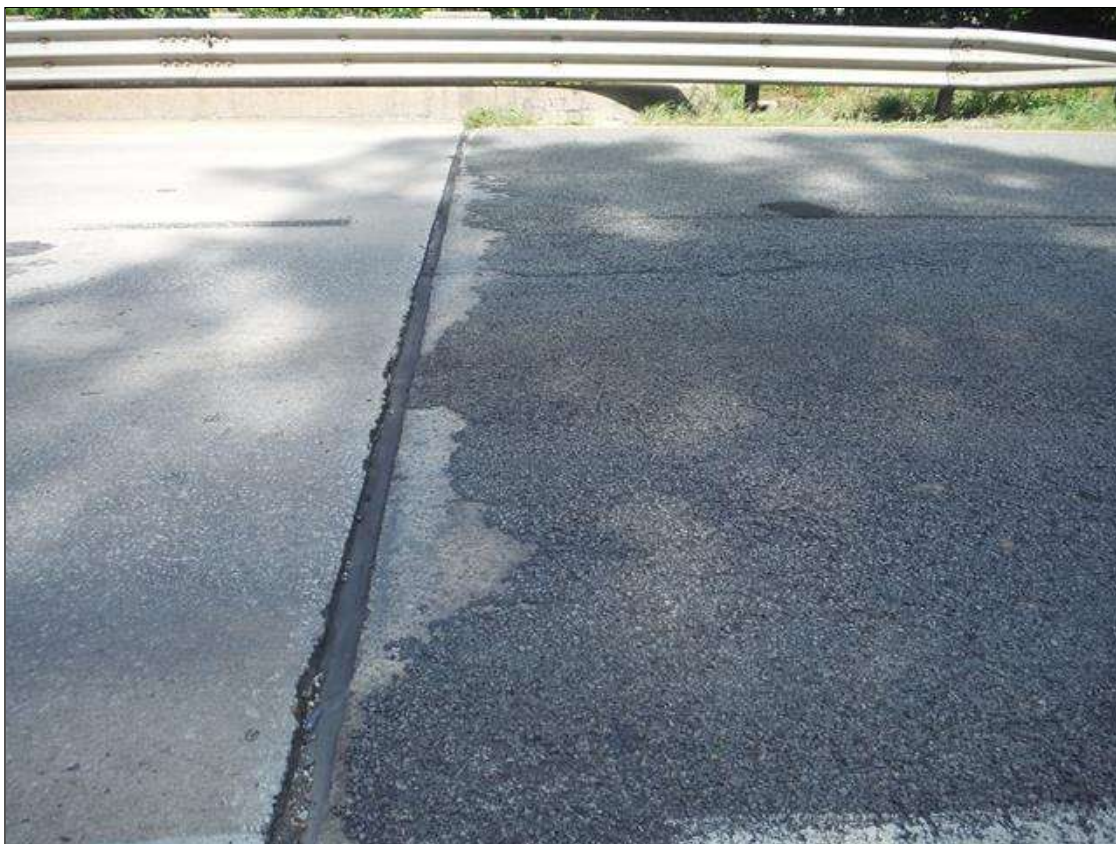
Approach 1: full width by 2ft of missing asphalt wearing surface at joint

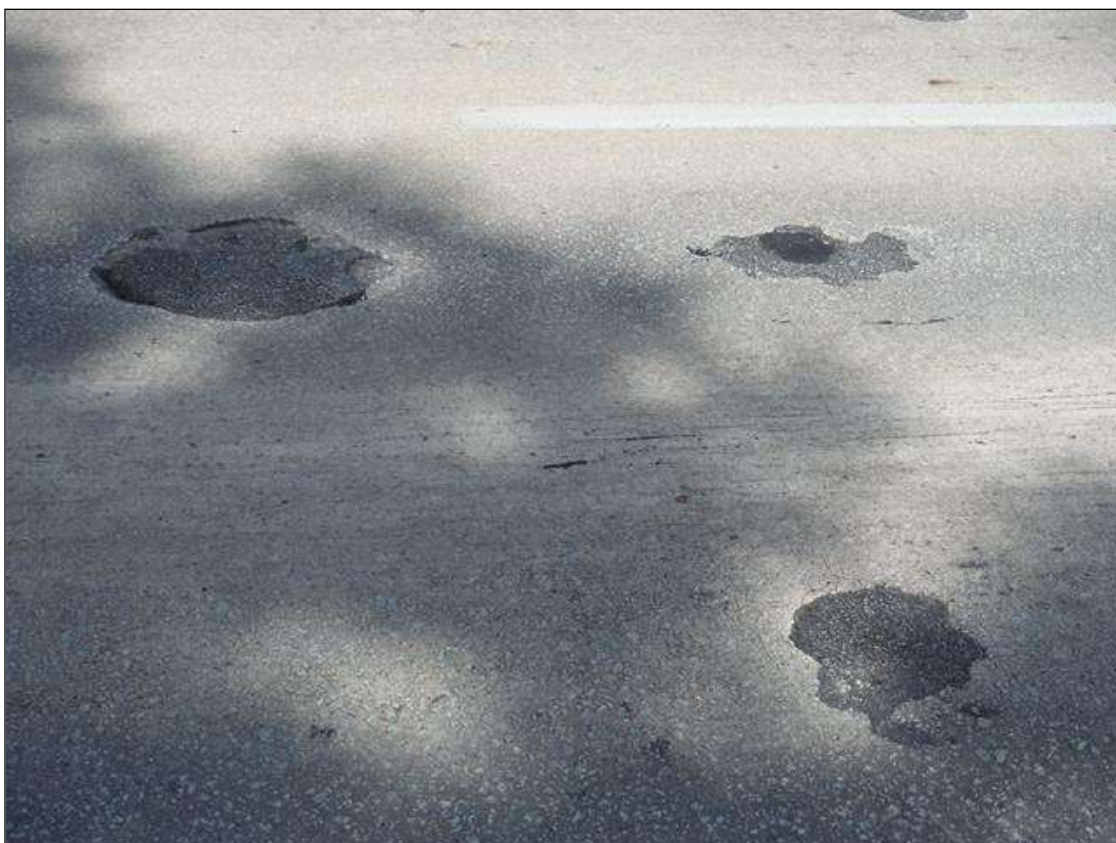
Span 1 Deck: top of deck left lane has scattered patches. patches are from: 10" x 10" up to 20" x 20".

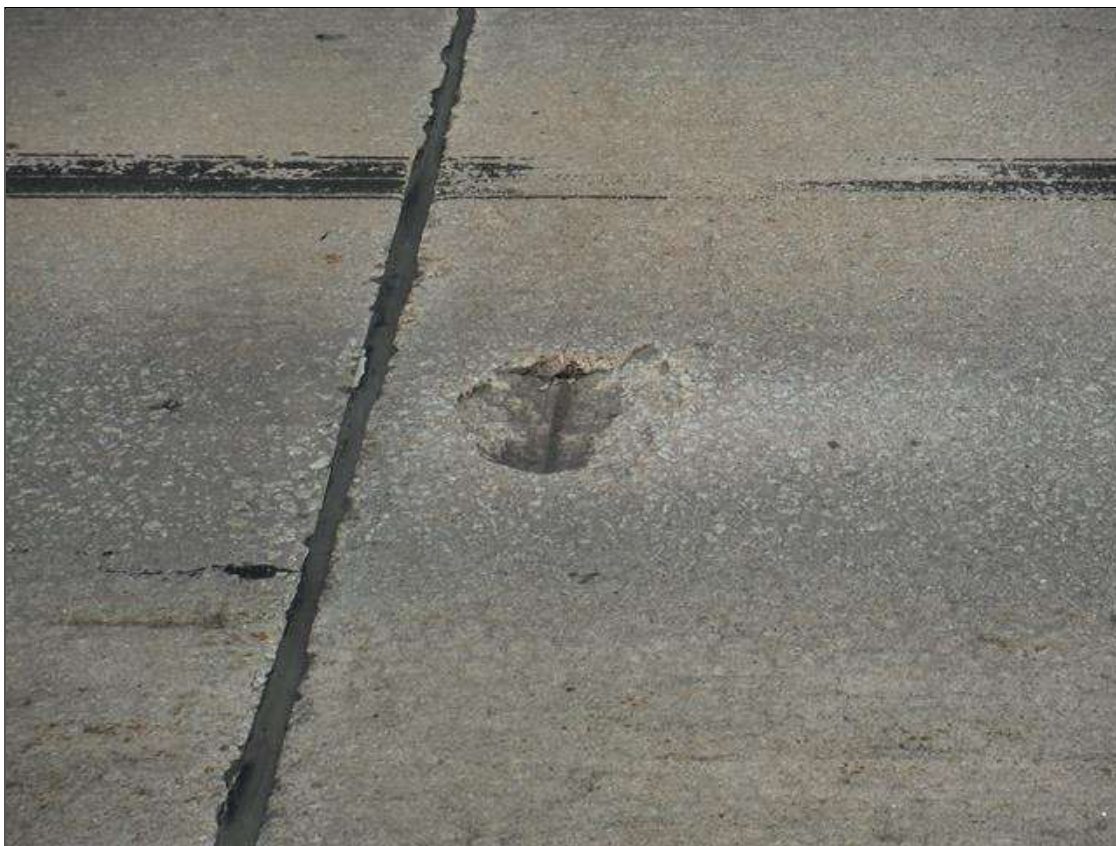
Span 1 Deck: (PAR) 1ft diameter by 1in spall with exposed rebar in left lane at bent 1 joint

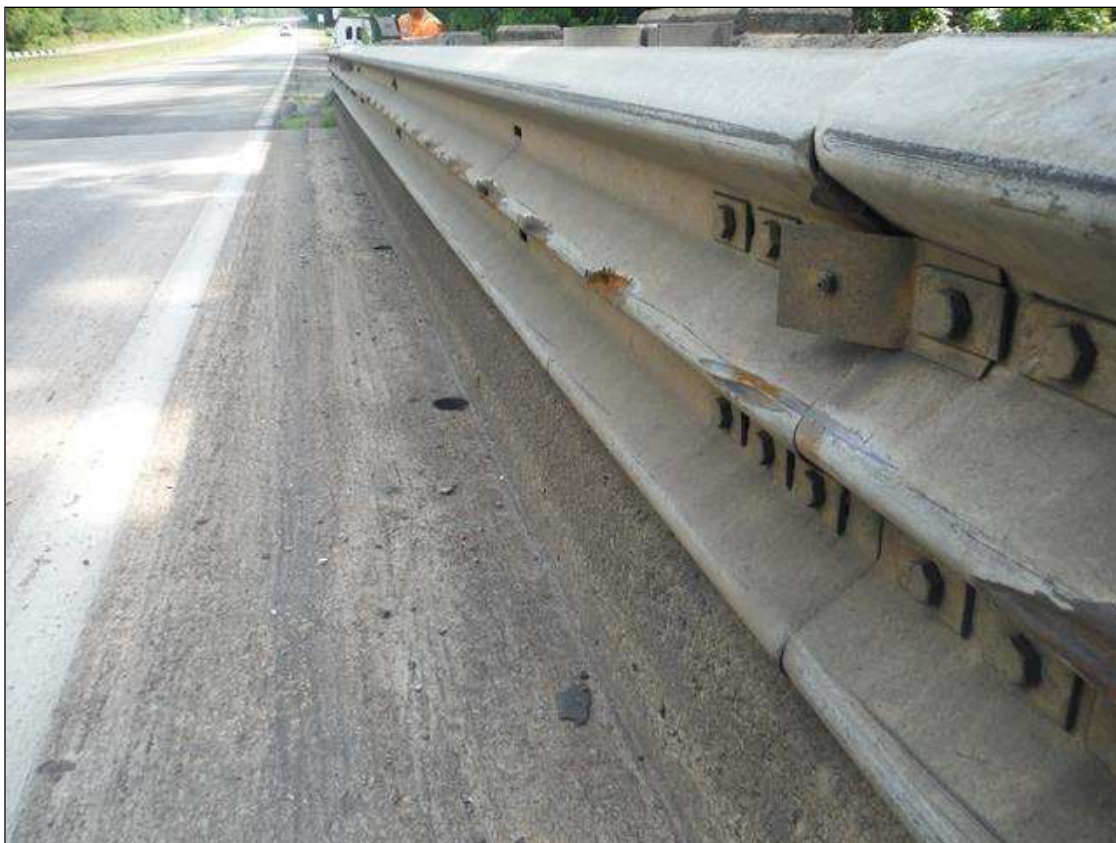
Span 1 Left Bridge Rail: has torn areas due to impact damage.

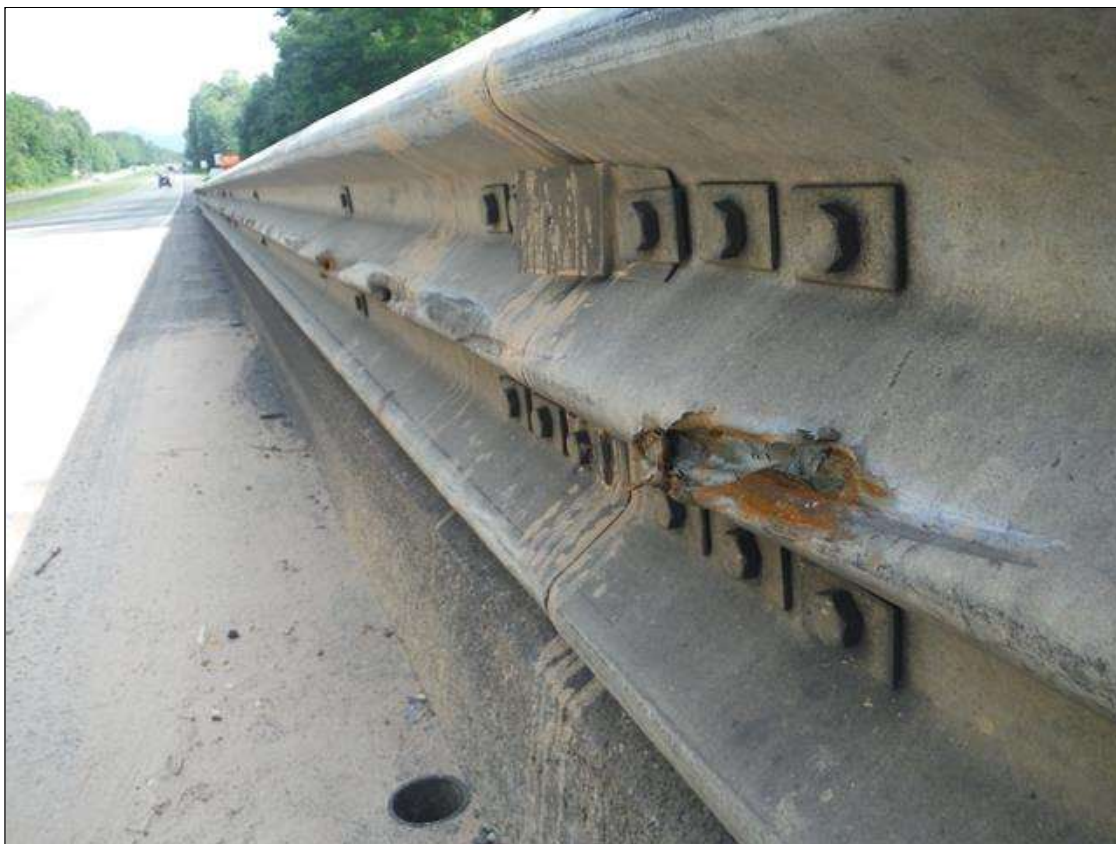
Span 2 Left Bridge Rail: has torn areas due to impact damage.

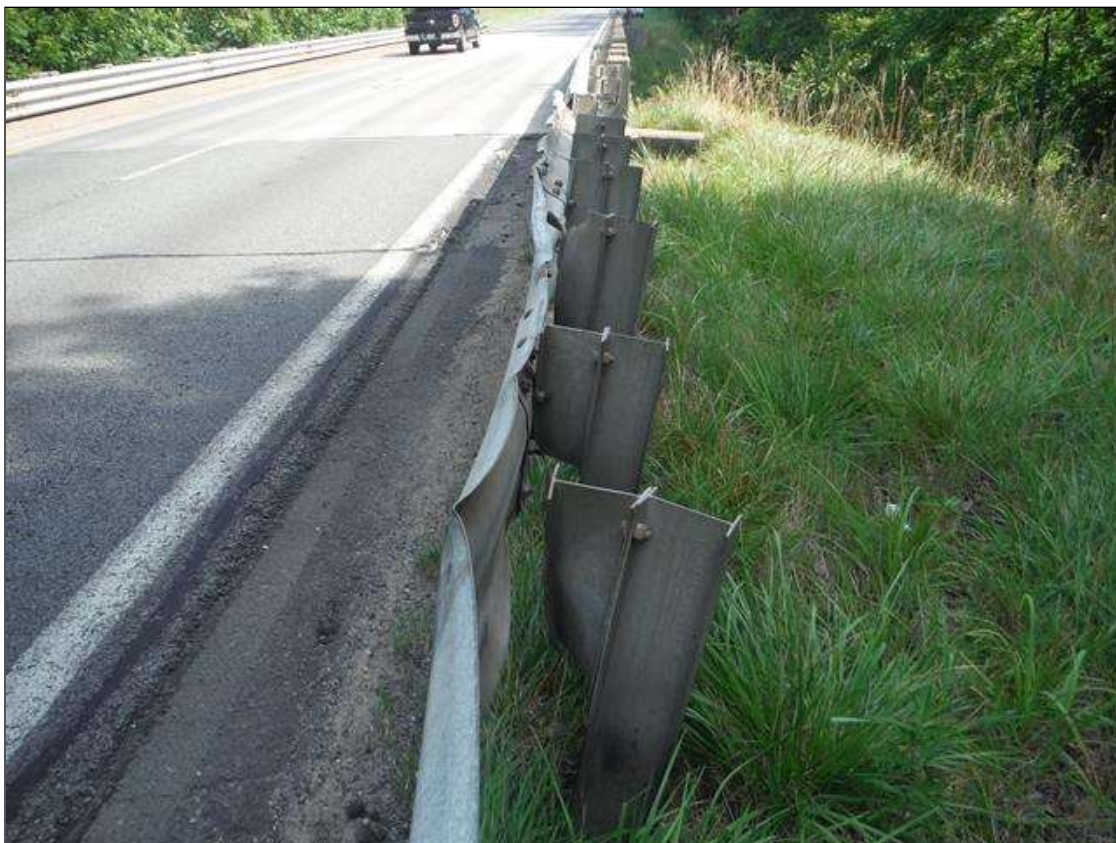
(PAR) 20ft impact damage to far left guardrail at end bent 2

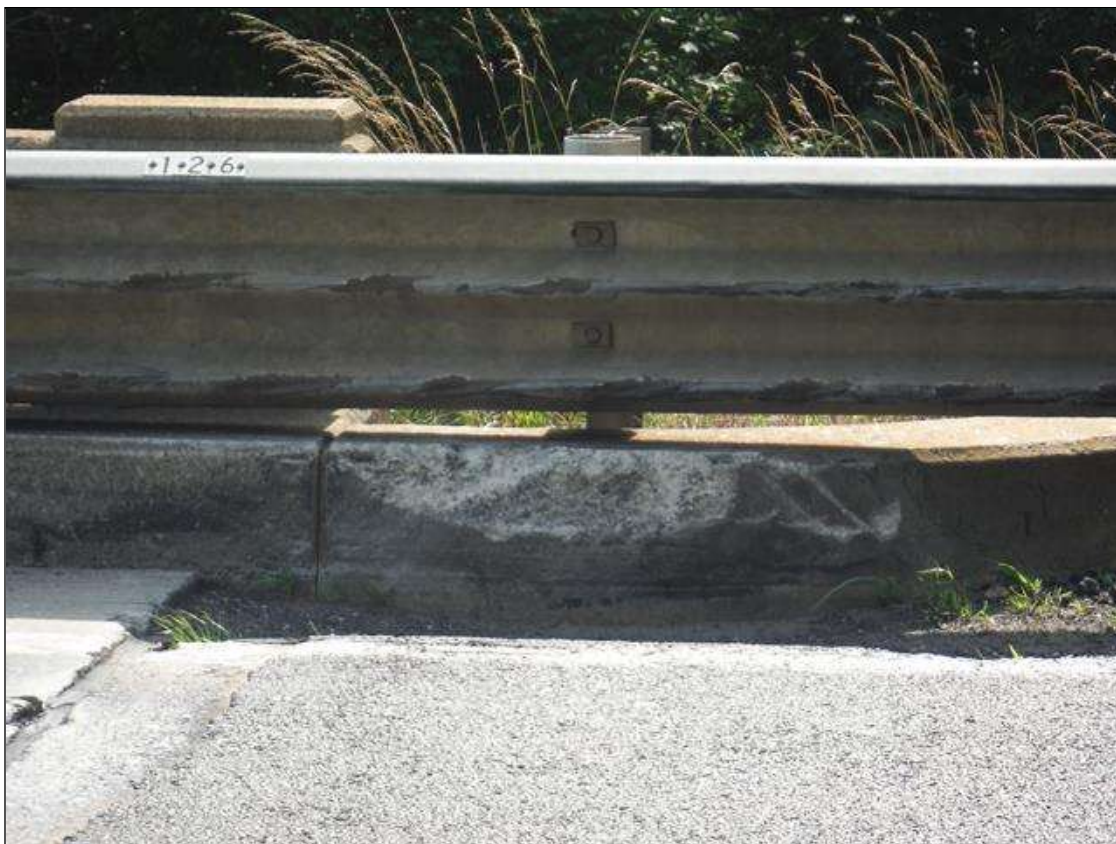
2ft x 1in spall to far left curb on approach

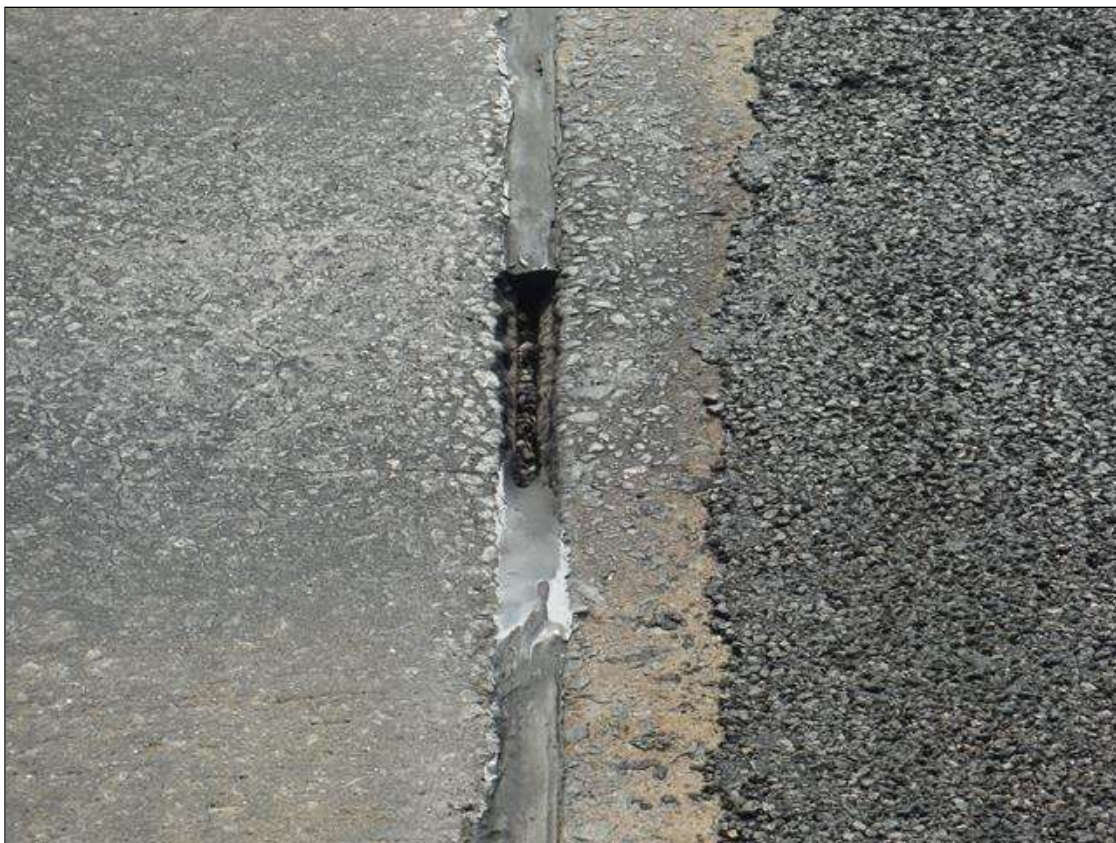
Expansion Joint : over end bent 2 has loss of seal adhesion due to cracking along edge. Material is missing in right lane.

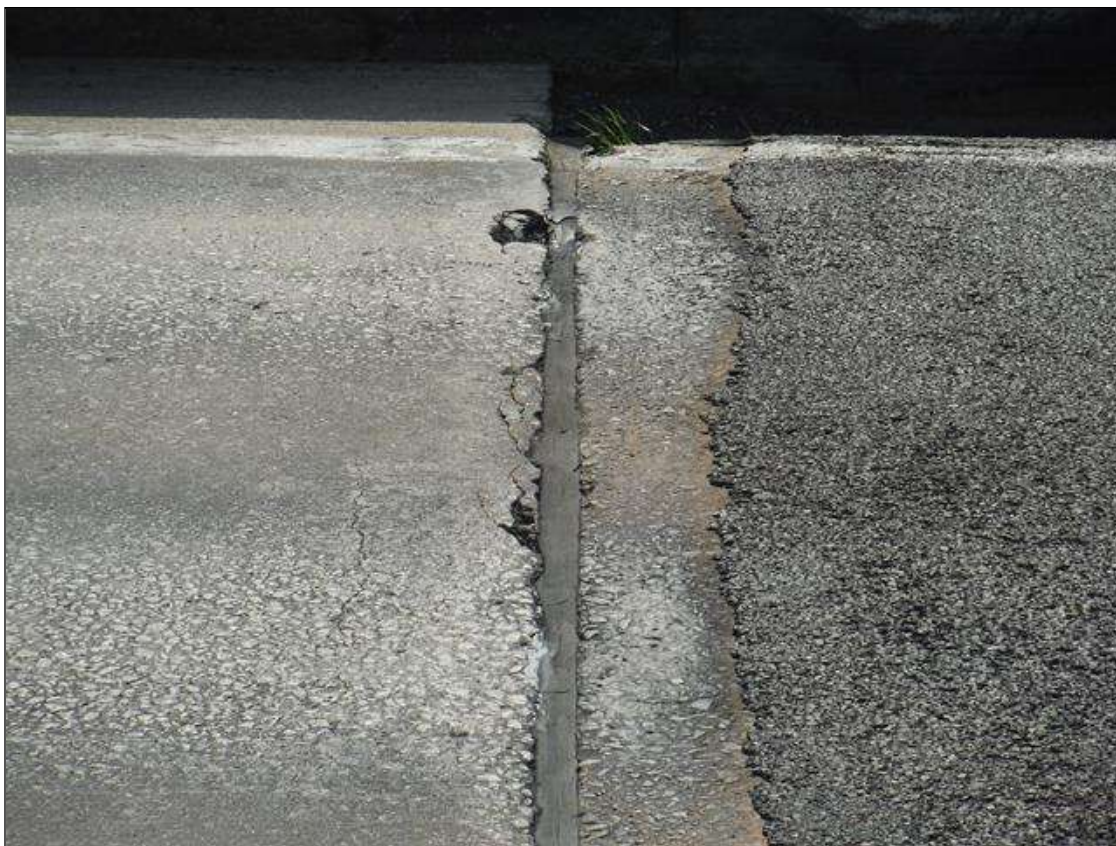
Span 3 Deck: 3ft x 6in x 1in deep cracking and spall in left lane at end bent 2 joint

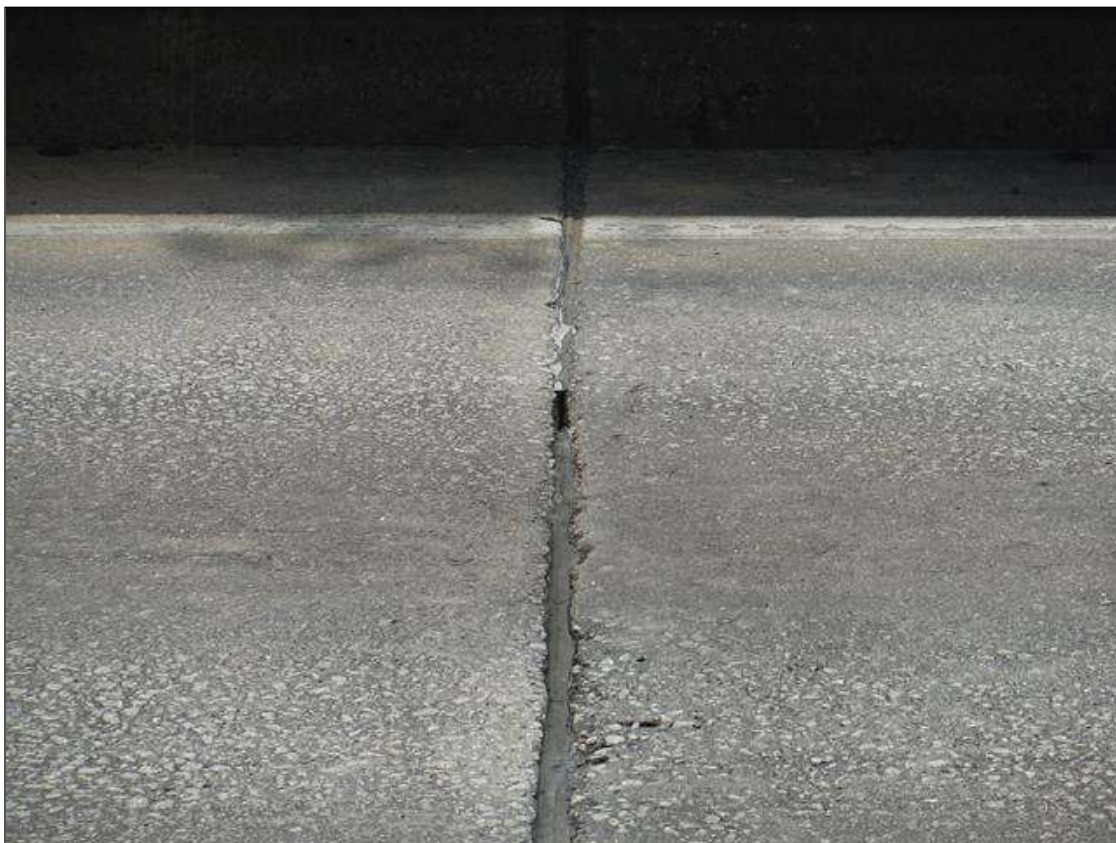
Expansion Joint : over bent 2 has loss of seal adhesion due to cracking along edge in left lane.

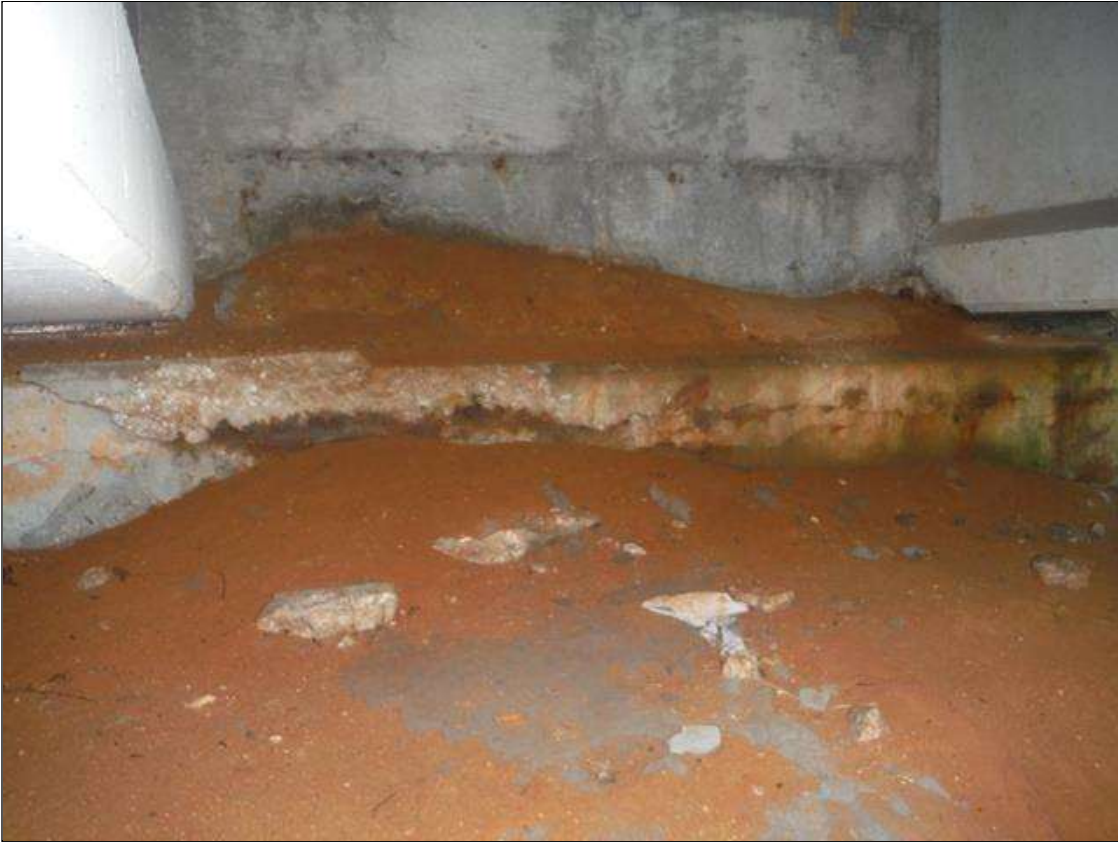
End Bent 1 Cap 1: north face bay 1, has a crack/spall and delaminated area with rebar exposed. Area is: from top edge down 9in x 8ft x 2in deep.

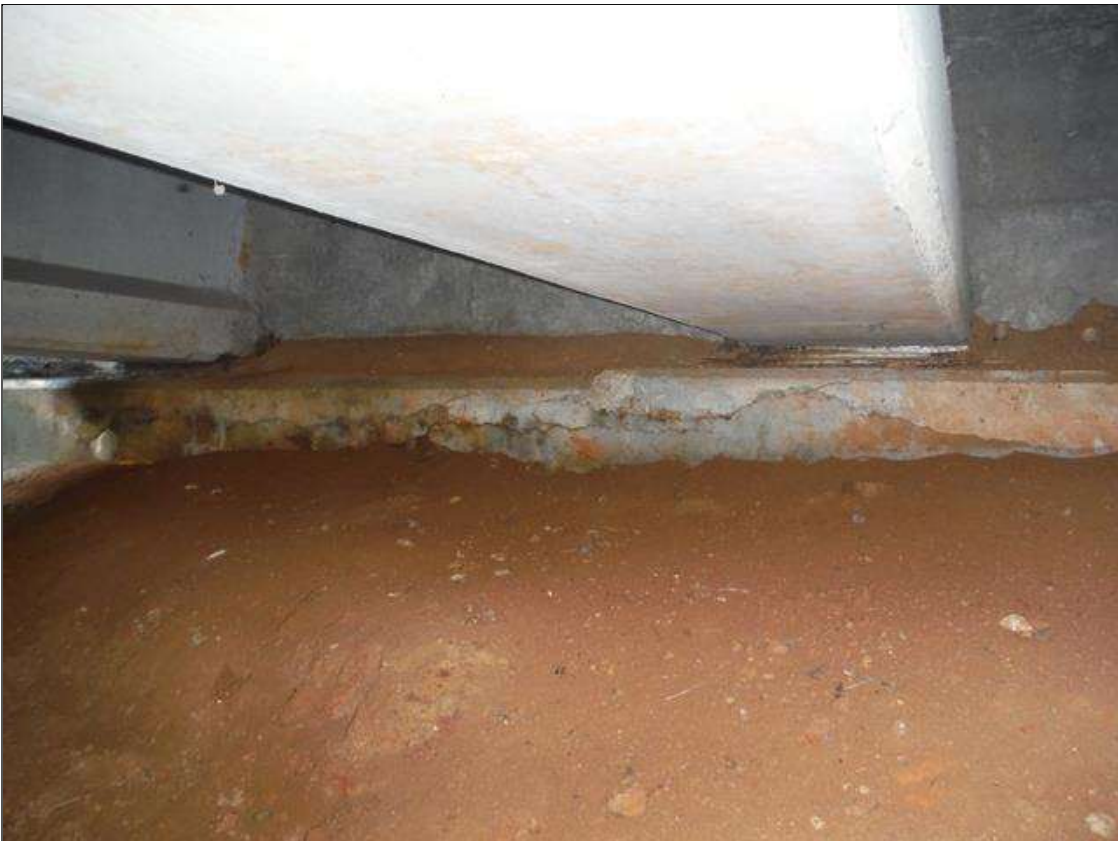
End Bent 1 Cap 1: north face has a crack/spall and delaminated area with efflorescence and rust stains visible. Area begins left of beam 3 and extends to right of beam 4. Area is: from top edge down 9in x 11ft long x 1in deep.

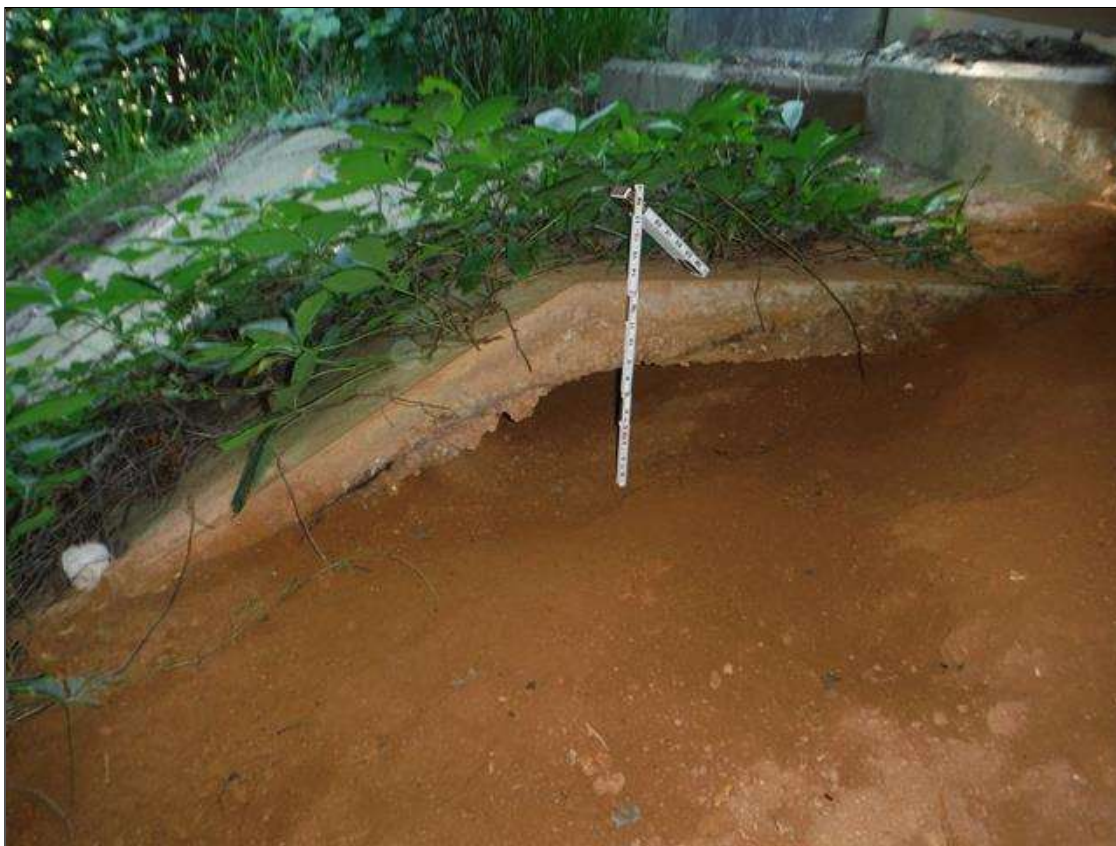
(PAR) near right slope protection is undermined 4ft deep x 3ft x 9in

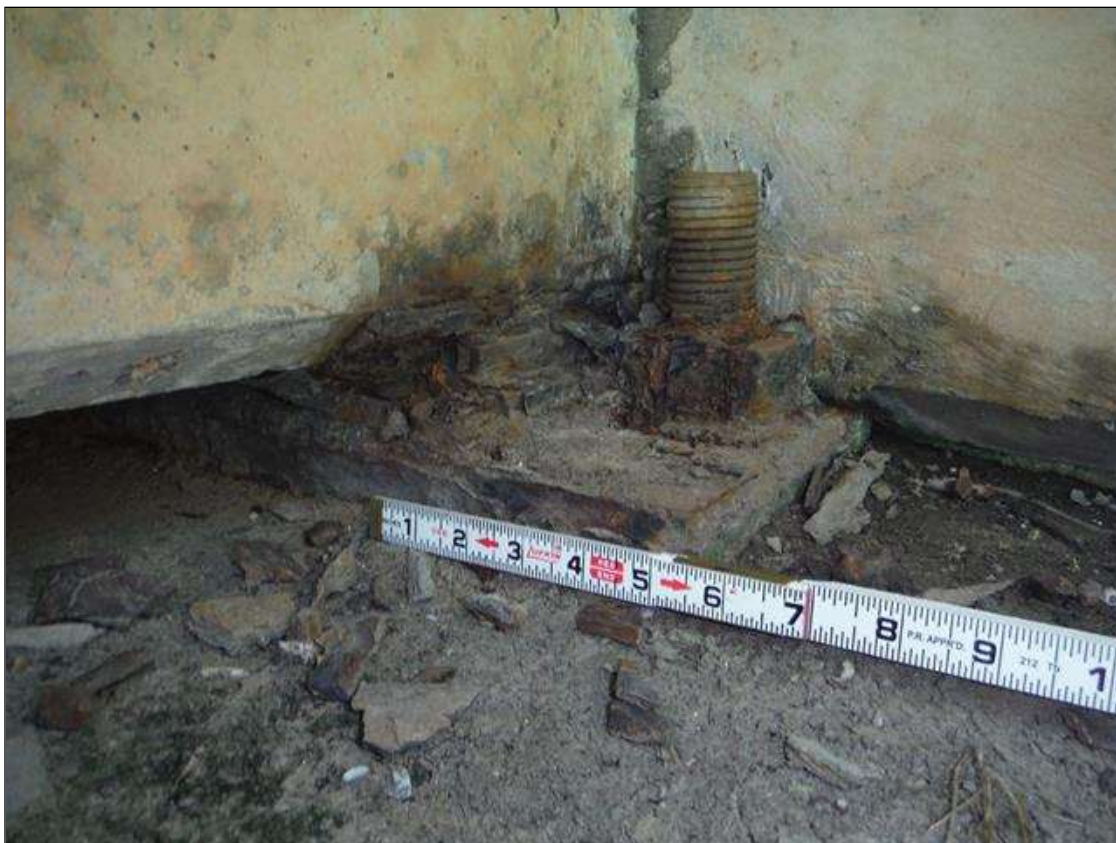
Span 1 Beam 1 Near Bearing: has scattered rust and flaking, anchor nut has 50 percent section loss.

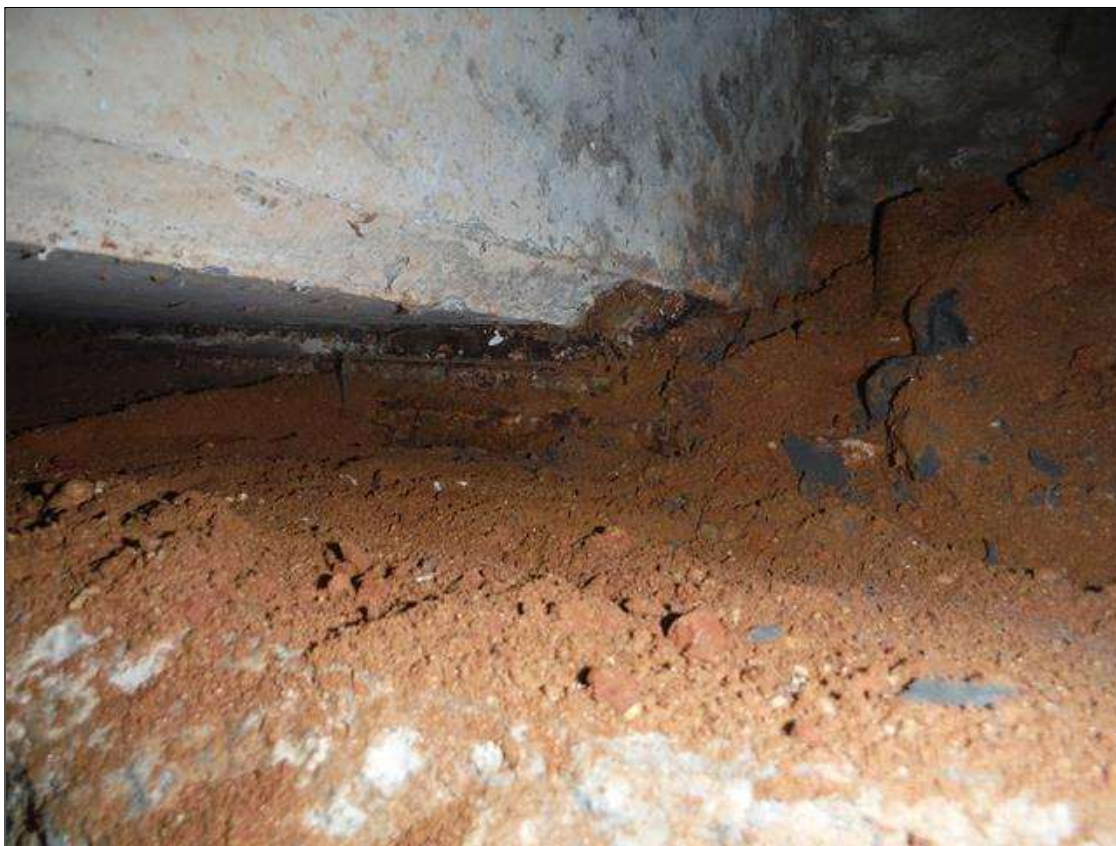
Span 1 Beam 2 Near Bearing: surface corrosion and covered in dirt.

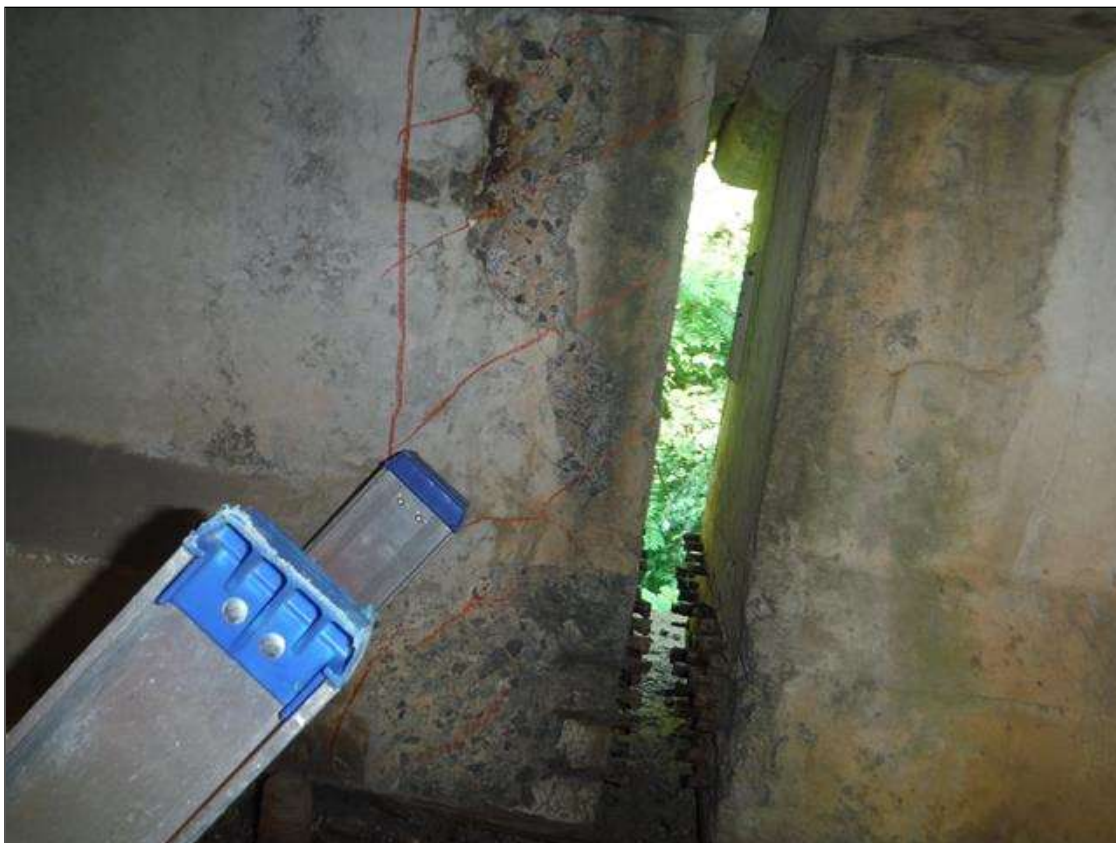
Span 1 Beam 1: (PAR) right bottom flange over bent 1. Has a crack/spall and delaminated area with 3 cables exposed. Area is: from bottom up 8" x 11" x 2" deep with minor section loss to strands.

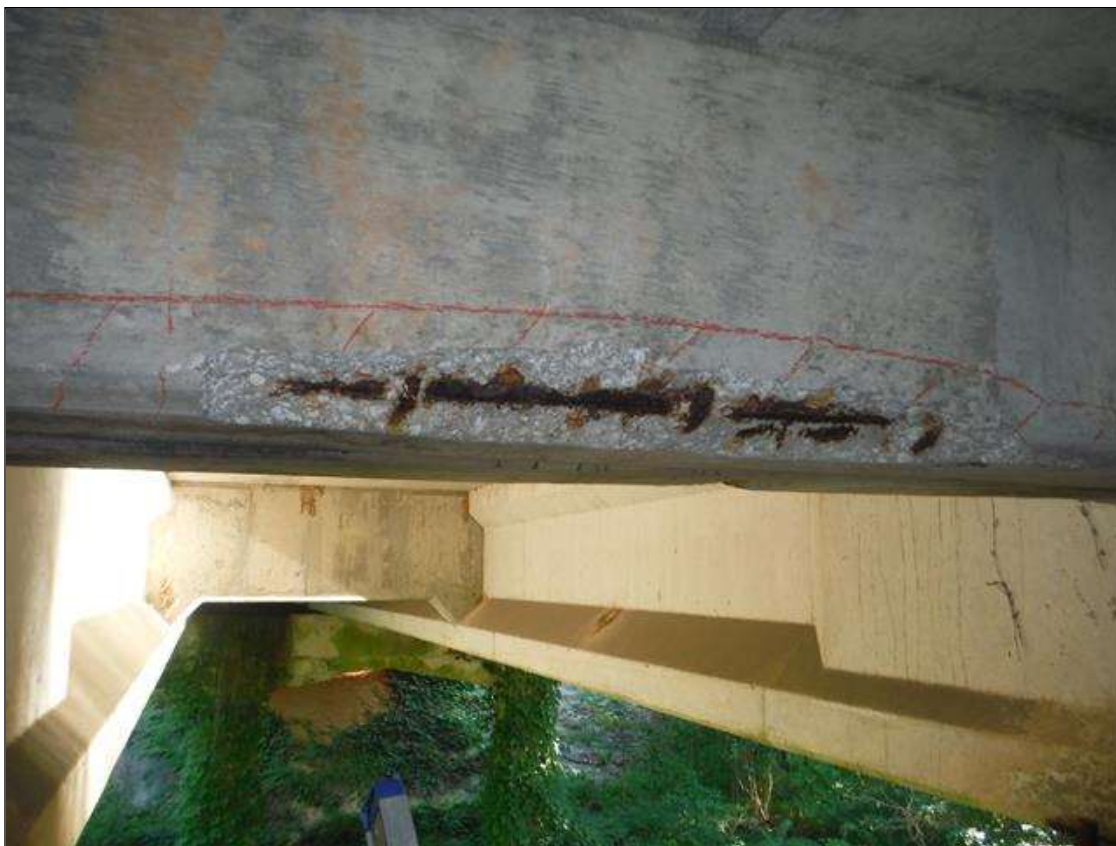
Span 1 Beam 1: (PAR) 4ft x 8in x 2in deep spall with exposed rebar in end diaphragm at bent 1.

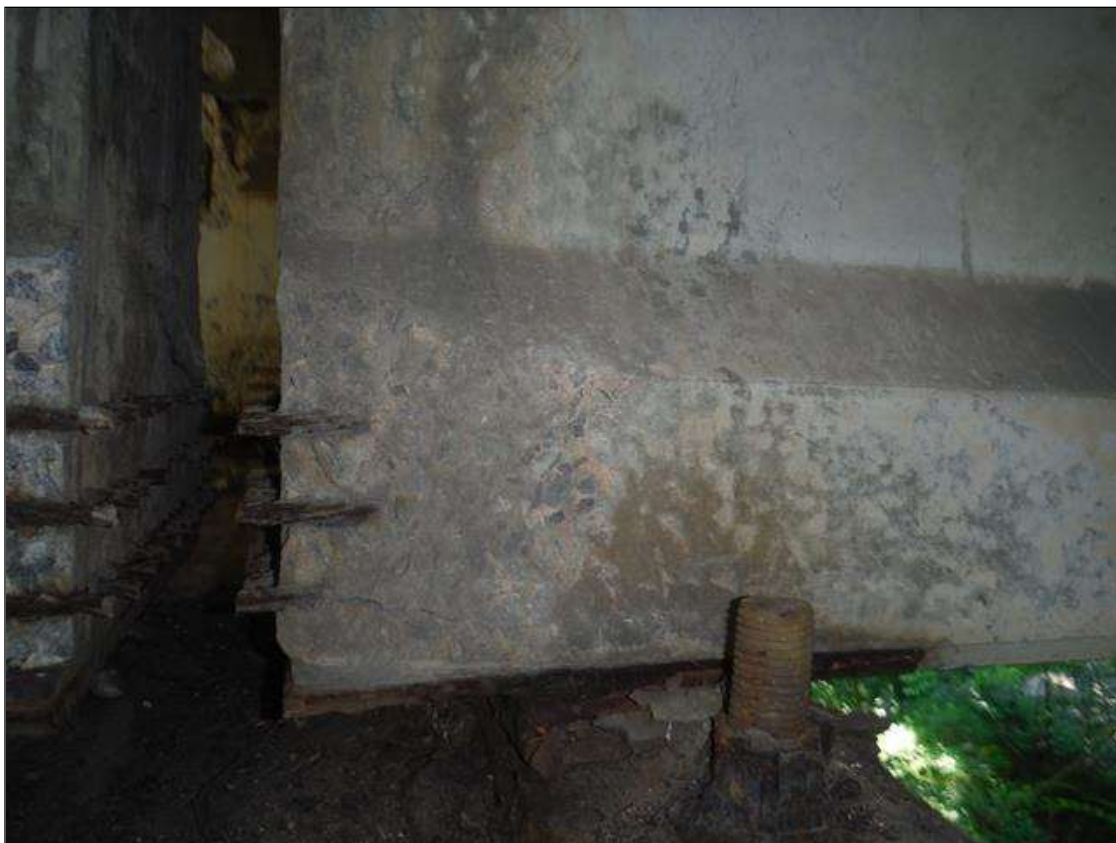
Span 1 Beam 2: (PAR) left bottom flange at bent 1. Has a crack/spall and delaminated area with 3 cables exposed. Area is: from bottom up 9" x 10" x 2" deep with minor section loss to strands.

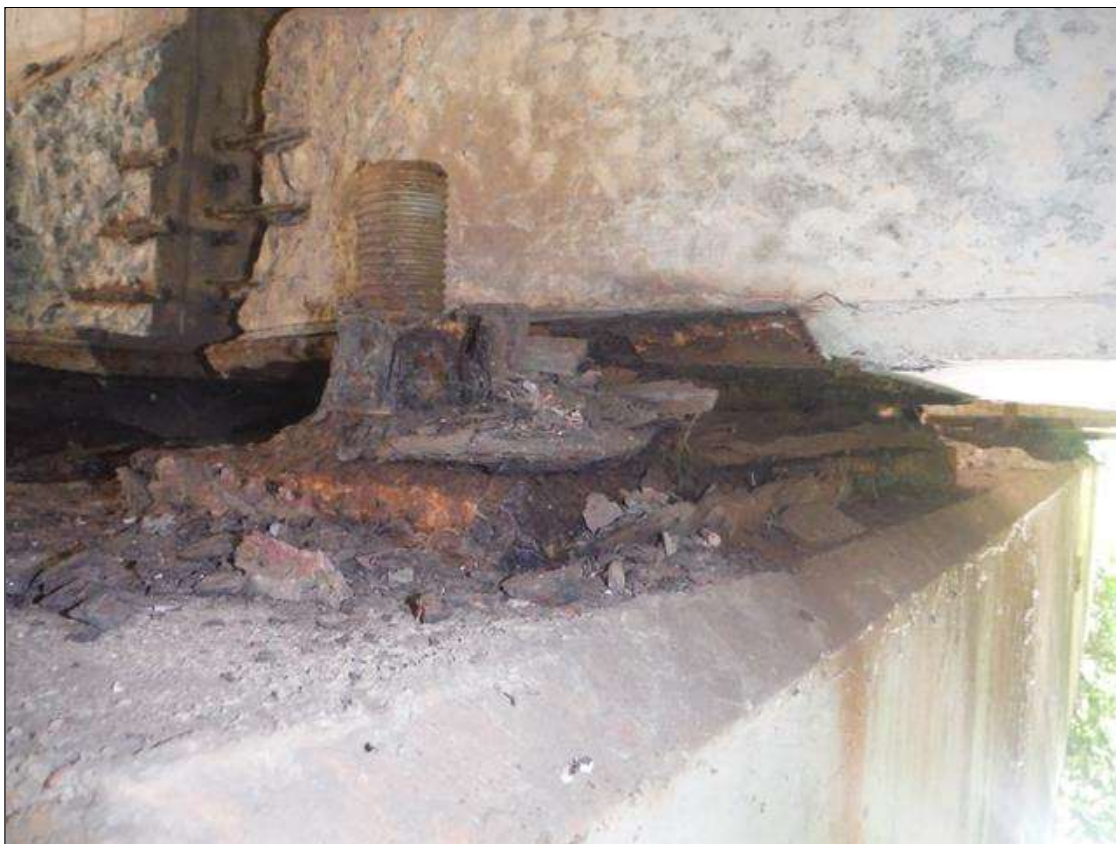
Span 1 Beam 2 Far Bearing: heavy corrosion and scaling with up to 1/4in section loss, typical all bearing at bent 1 and bent 2.

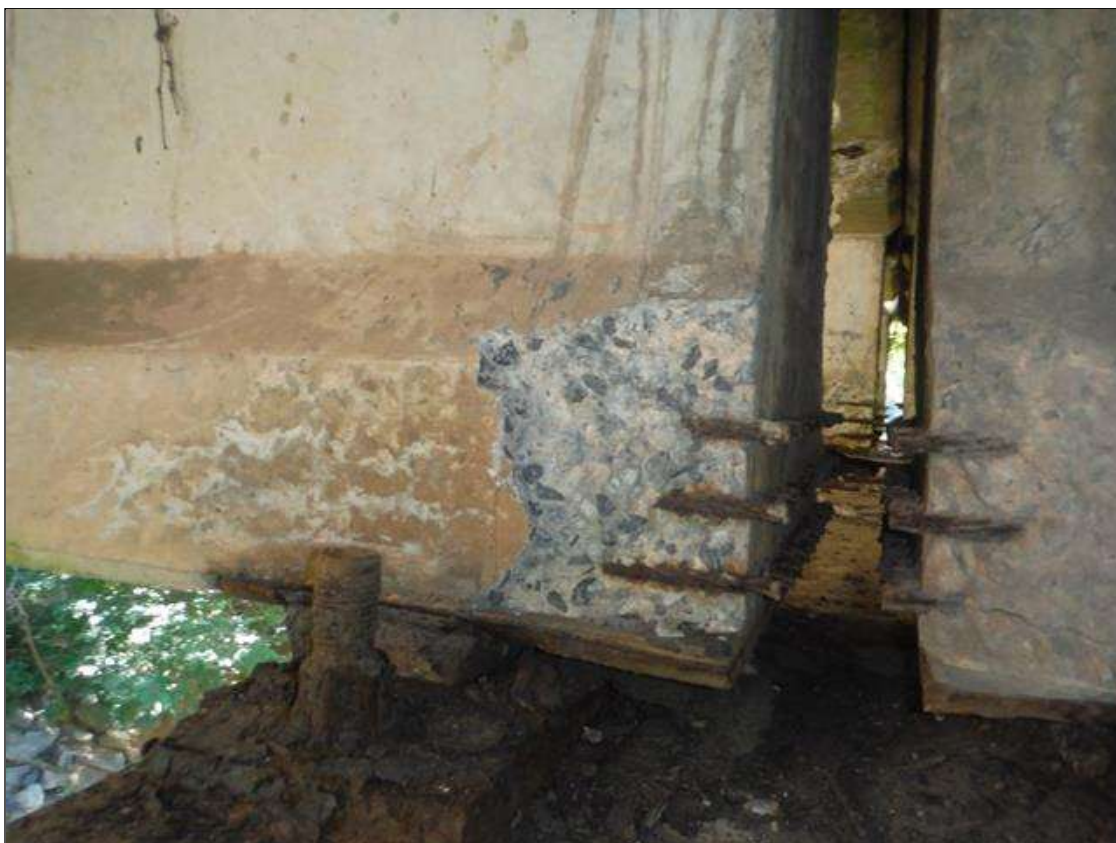
Span 2 Beam 2: (PAR) left bottom flange over bent 1. Has a crack/spall and delaminated area with 3 cables exposed. Area is: from bottom up 8" x 8" x 2" deep with minor section loss to strands.

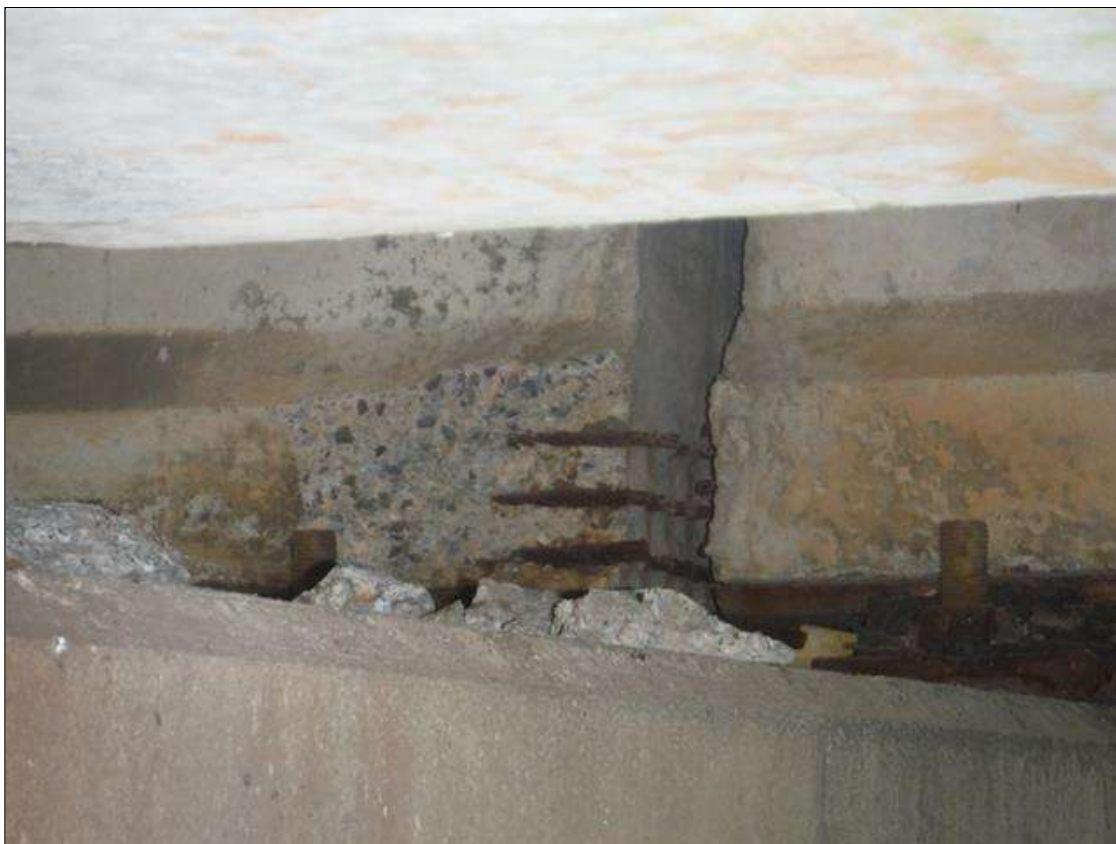
Span 2 Beam 3: (PAR) left bottom flange over bent 1. Has a crack/spall and delaminated area with 3 cables exposed.
Area is: from bottom up 8" x 12" x 2" deep with minor section loss to strands.

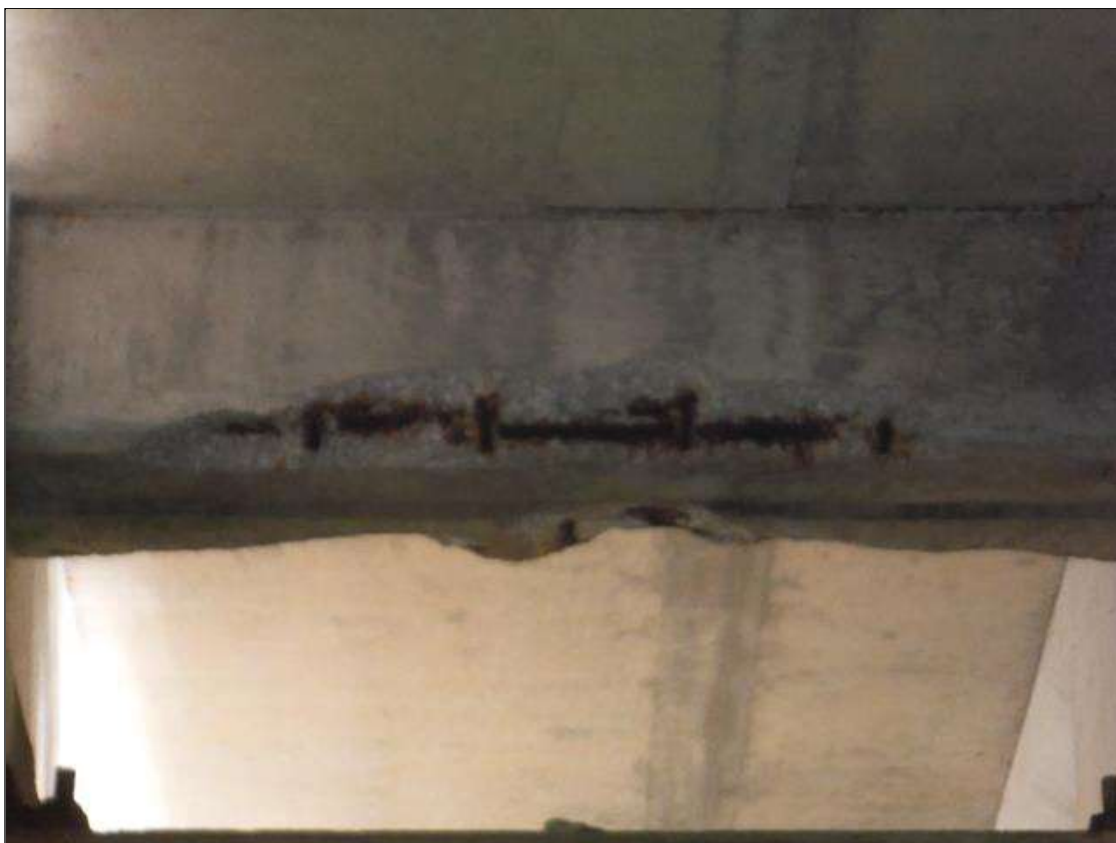
Span 1 Beam 2: (PAR) 3ft x 8in x 2in deep spall with exposed rebar in end diaphragm at bent 1.

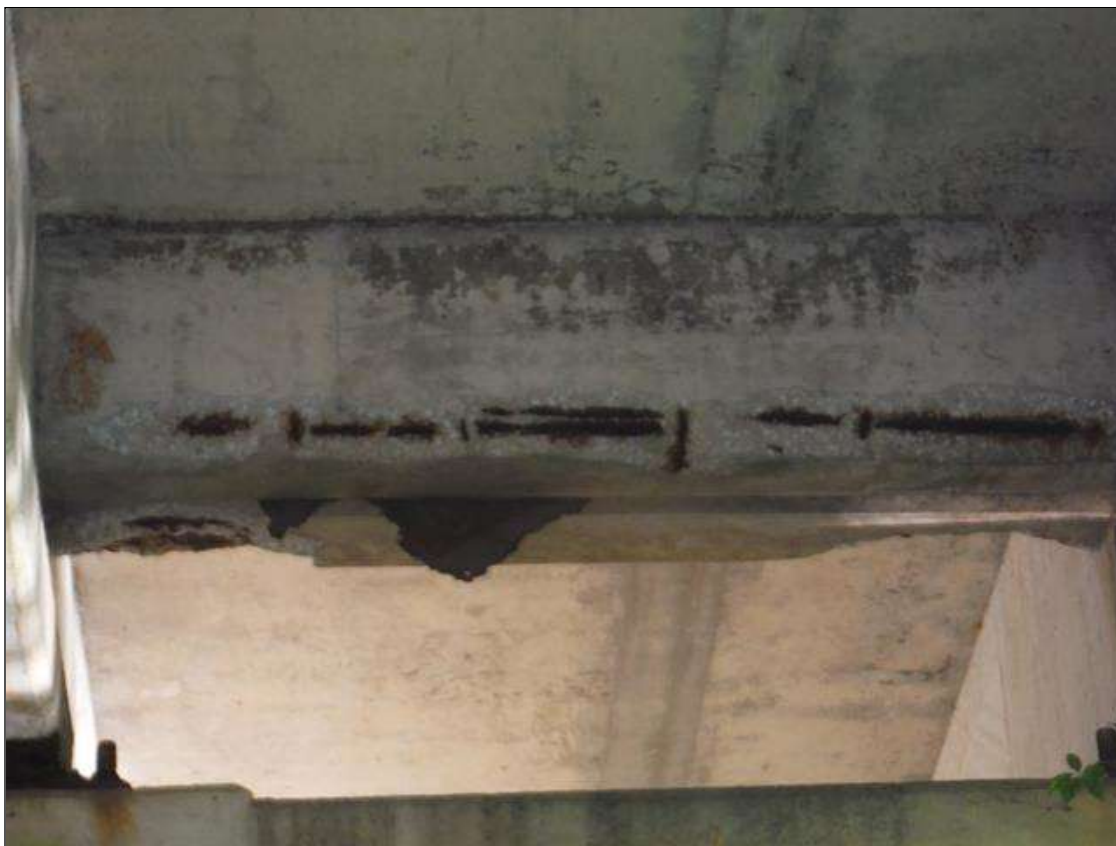
Span 1 Beam 3: (PAR) 4ft x 8in x 2in deep spall with exposed rebar in end diaphragm at bent 1.
