NC DEPARTMENT OF TRANSPORTATION
 DIVISION OF HIGHWAYS
 STRUCTURE MANAGEMENT UNIT

ATTENTION: **Priority Action Requested**
Snooper Recommended next Inspection

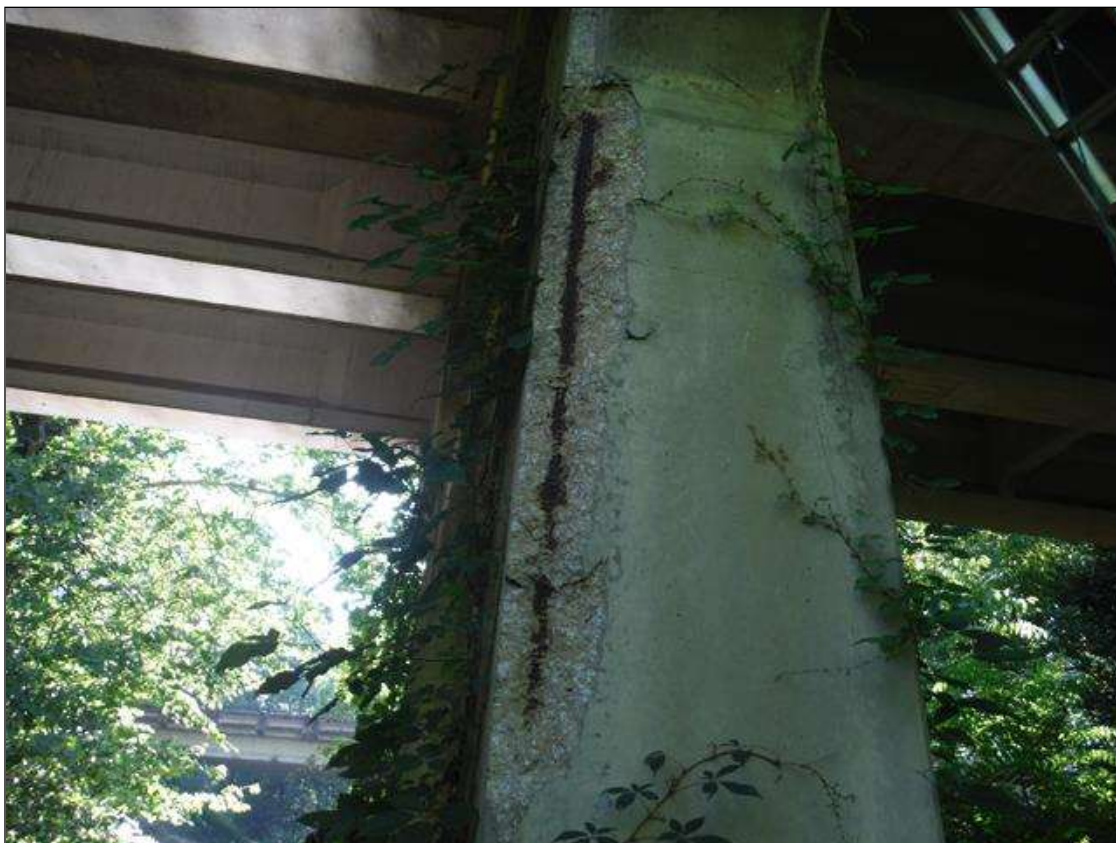
Bent 1 Pile 1: (PAR) northwest corner has a crack/spall and delaminated area. Located 16" below bottom of cap. Area on north face is: 6", area on west face is: 9" x 92" long.

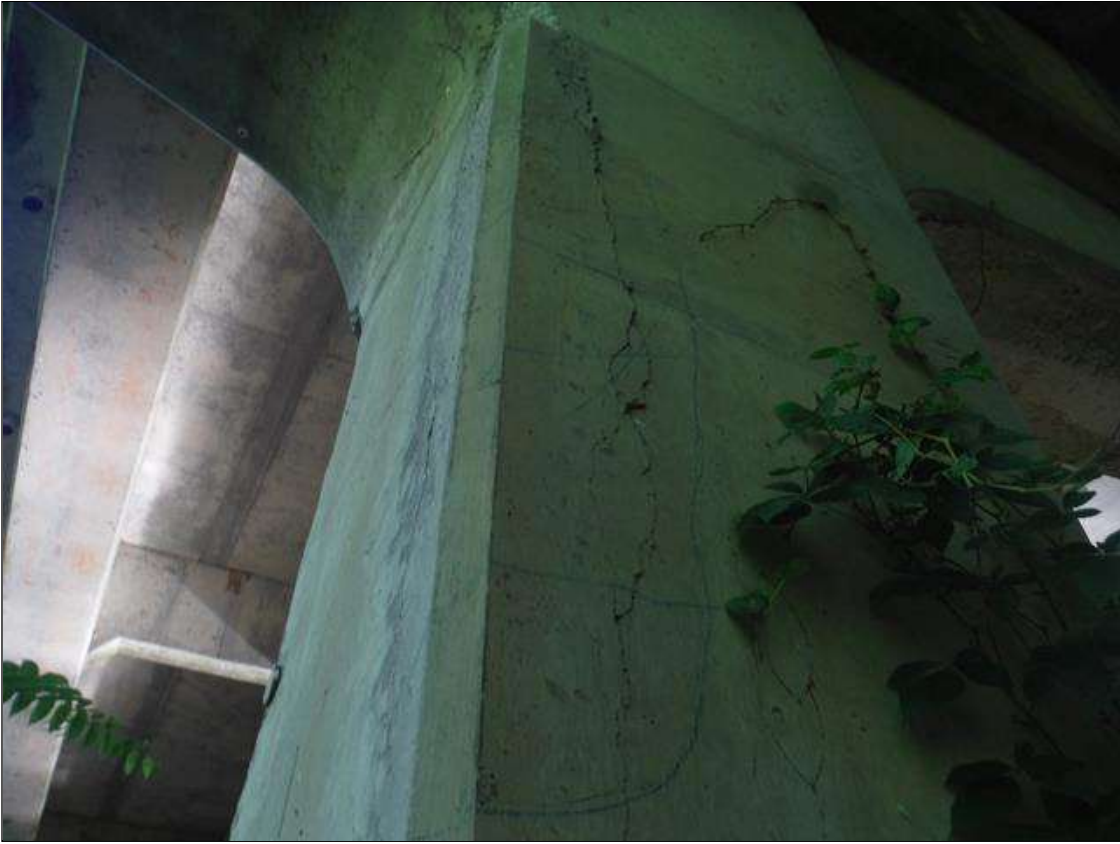
Bent 1 Pile 1: Bent 1 pile 1 southwest corner. Has a crack/spall and delaminated area. Area on west face is: 5", area on south face is: 9" x 60" x 2" deep.

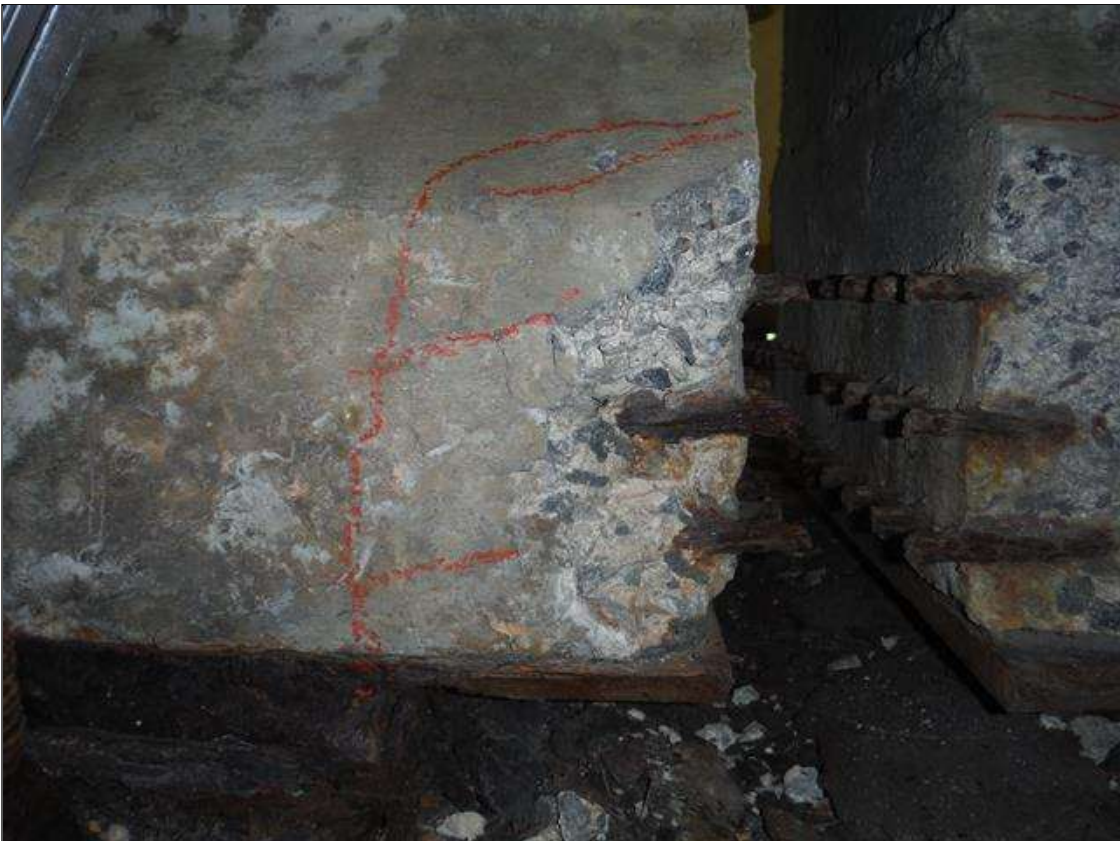
Span 1 Beam 3: (PAR) right bottom flange over bent 1. Has a crack/spall and delaminated area with 2 cables exposed. Area is: from bottom up 8" x 8" x 2" deep with minor section loss to strands.

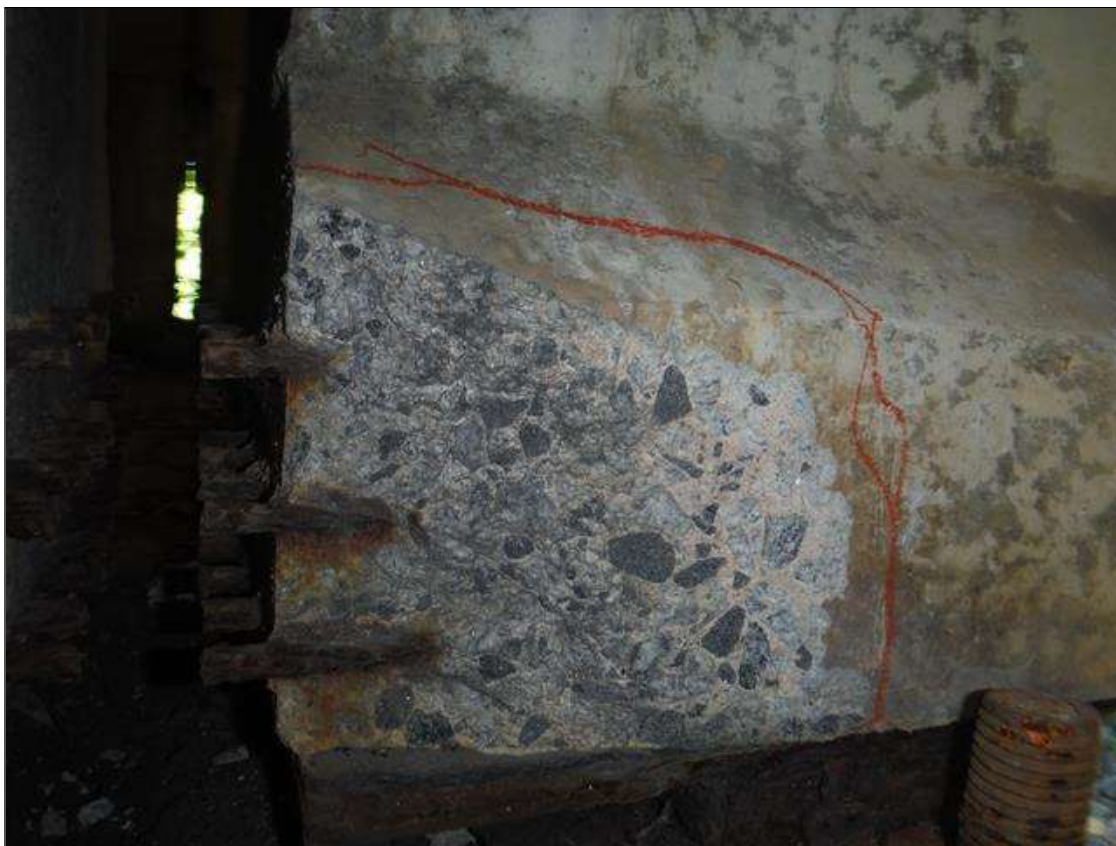
Span 2 Beam 3: (PAR) right bottom flange over bent 1. Has a crack/spall and delaminated area with 3 cables exposed. Area is: from bottom up 8" x 8" x 2" deep with minor section loss to strands.

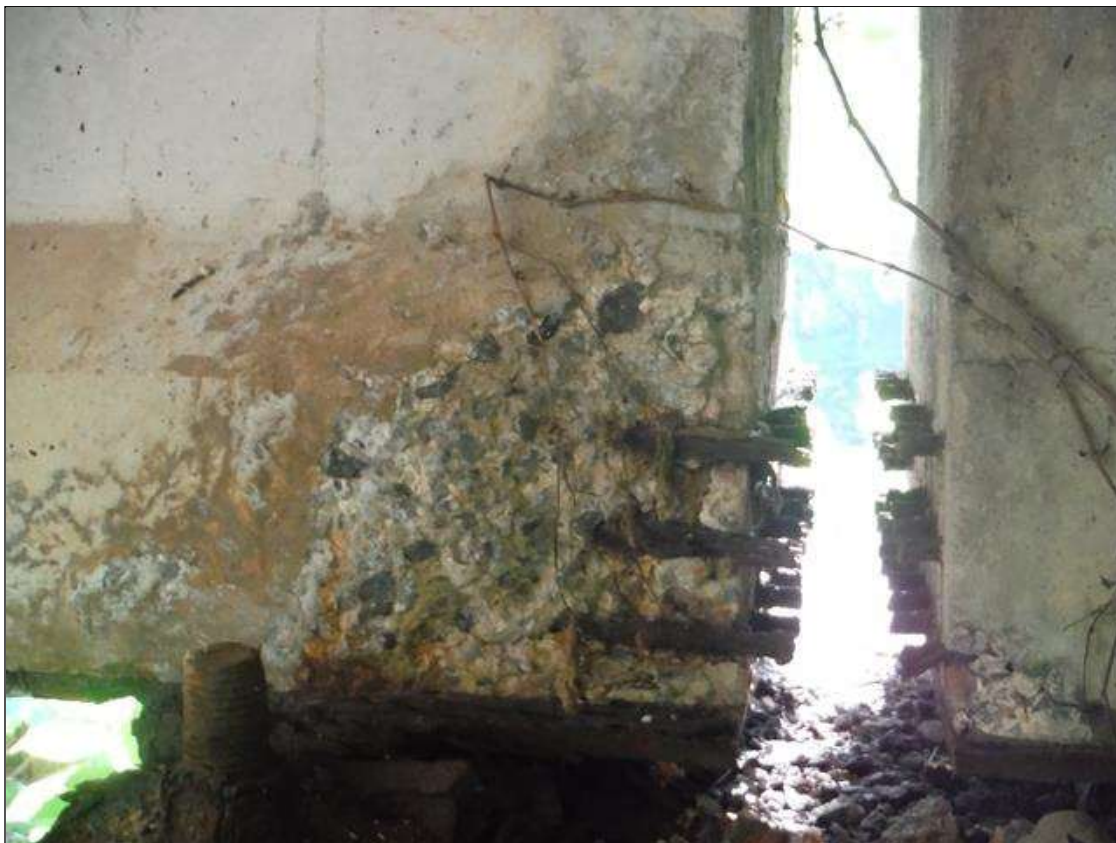
Span 2 Beam 4: (PAR) left bottom flange over bent 1. Has a crack/spall and delaminated area with 3 cables exposed. Area is: from bottom up 9" x 9" x 2" deep with minor section loss to strands.

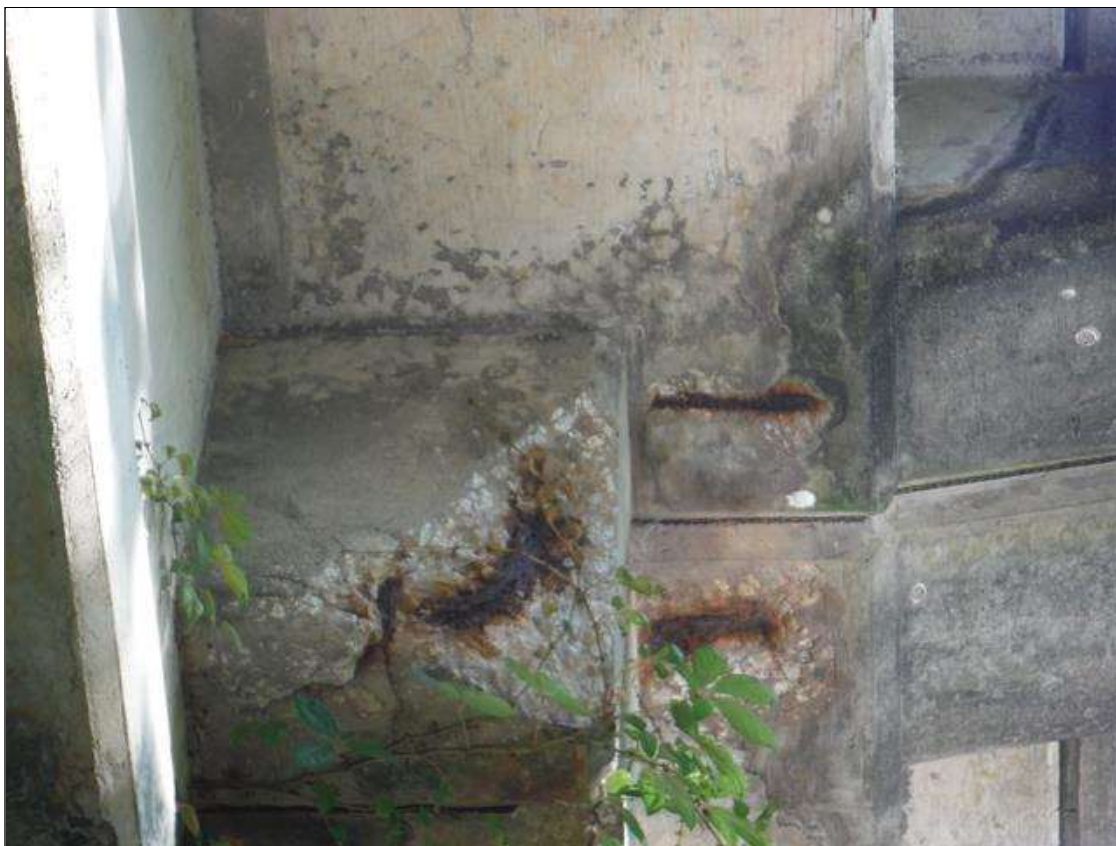
Span 1 Beam 4: (PAR) 2ft x 8in x 2in deep spall with exposed rebar in end diaphragm at bent 1.

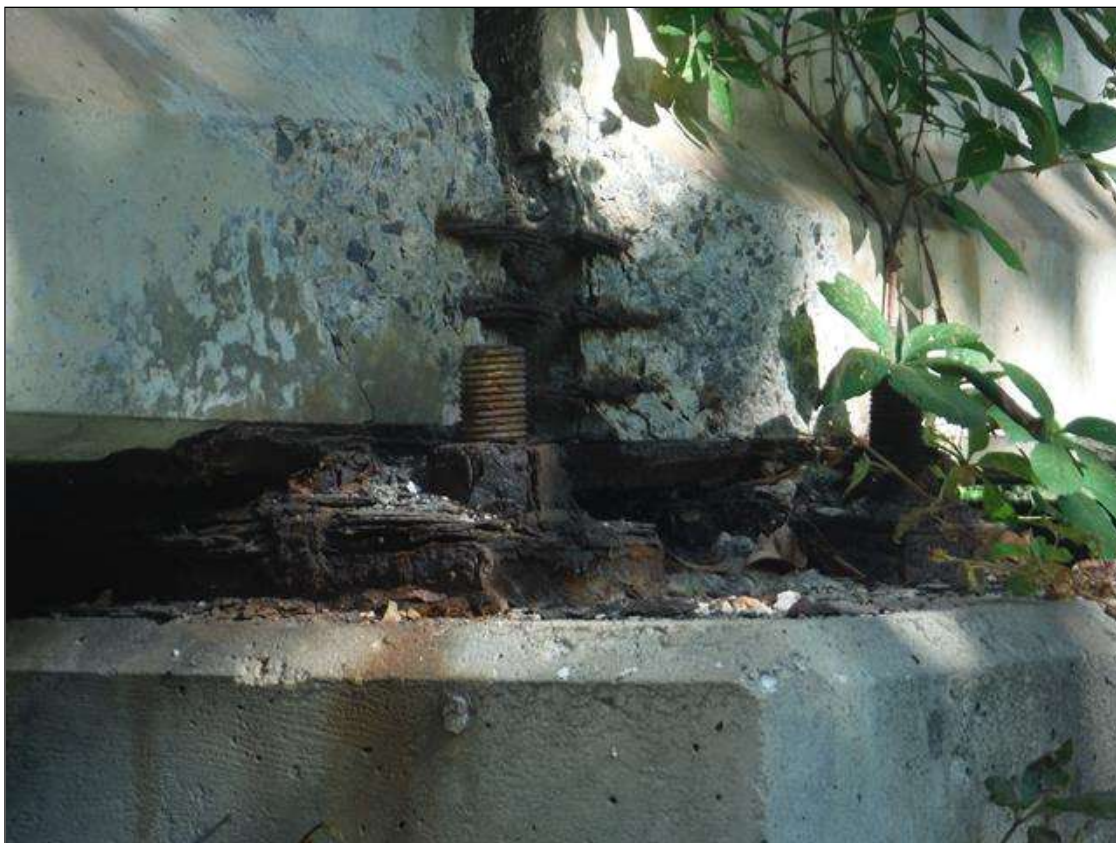
Span 1 Beam 4: (PAR) right bottom flange over bent 1. Has a crack/spall and delaminated area with 3 cables exposed. Area is: from bottom up 10" x 17" x 2" deep with minor section loss to strands.

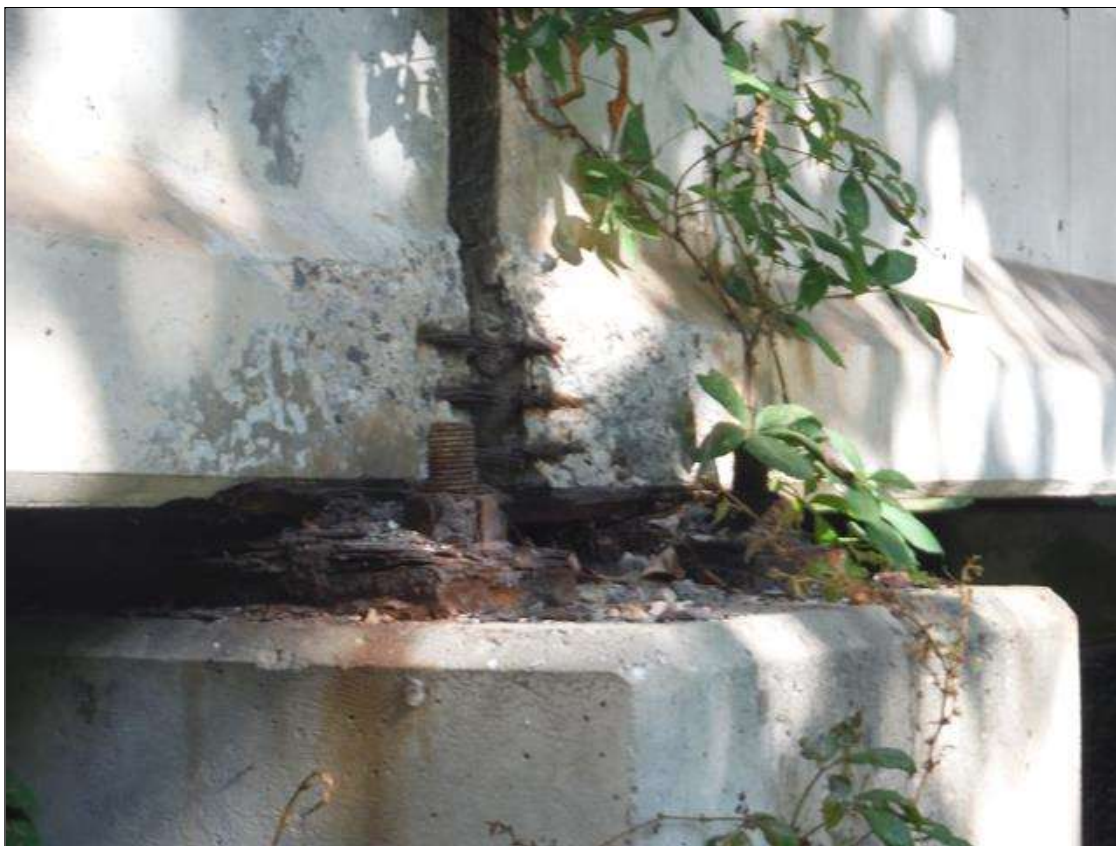
Span 2 Beam 4: (PAR) right bottom over bent 1. Has a crack/spall and delaminated area with 3 cables exposed. Area is: from bottom up 10" x 14" x 2" deep with minor section loss to strands.

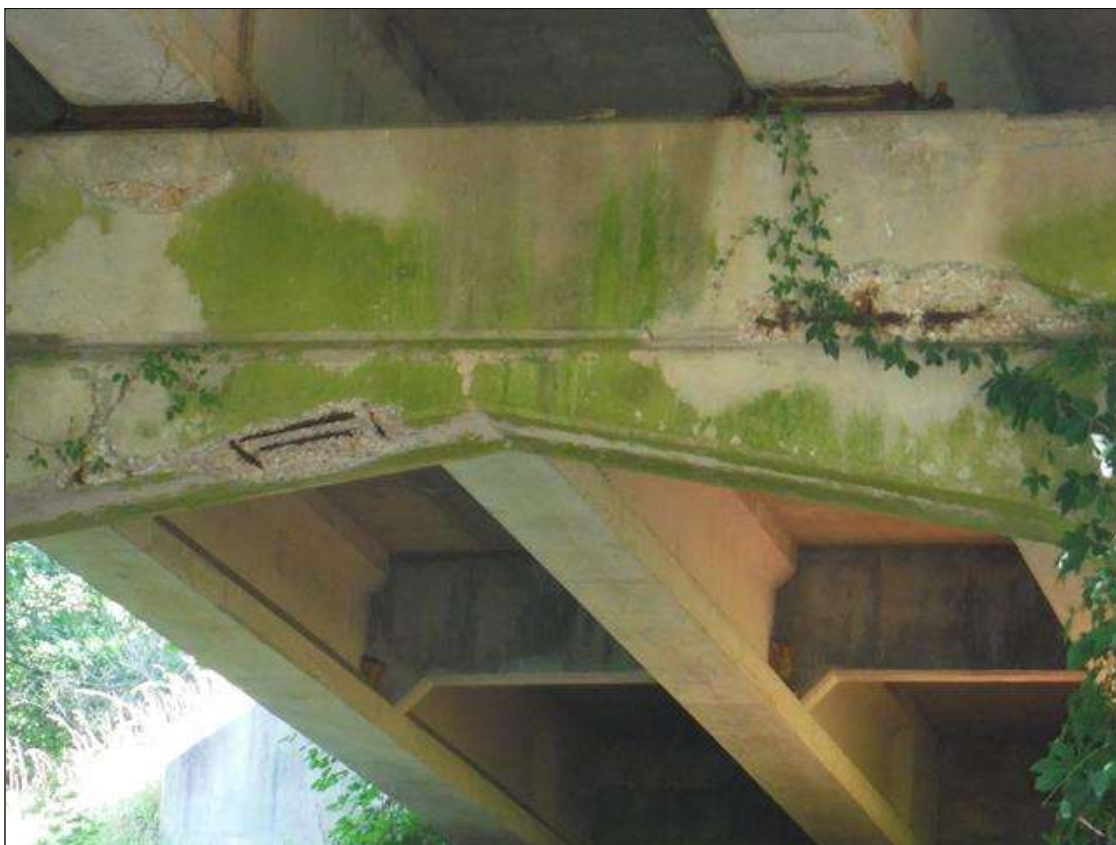
Bent 2 Cap 1: cap south face and bottom between piles 1 and 2. Has a crack/spall and delaminated area with rebar exposed. Area is: from bottom edge up 18", from bottom edge back 21" x 60" long x 2" deep.

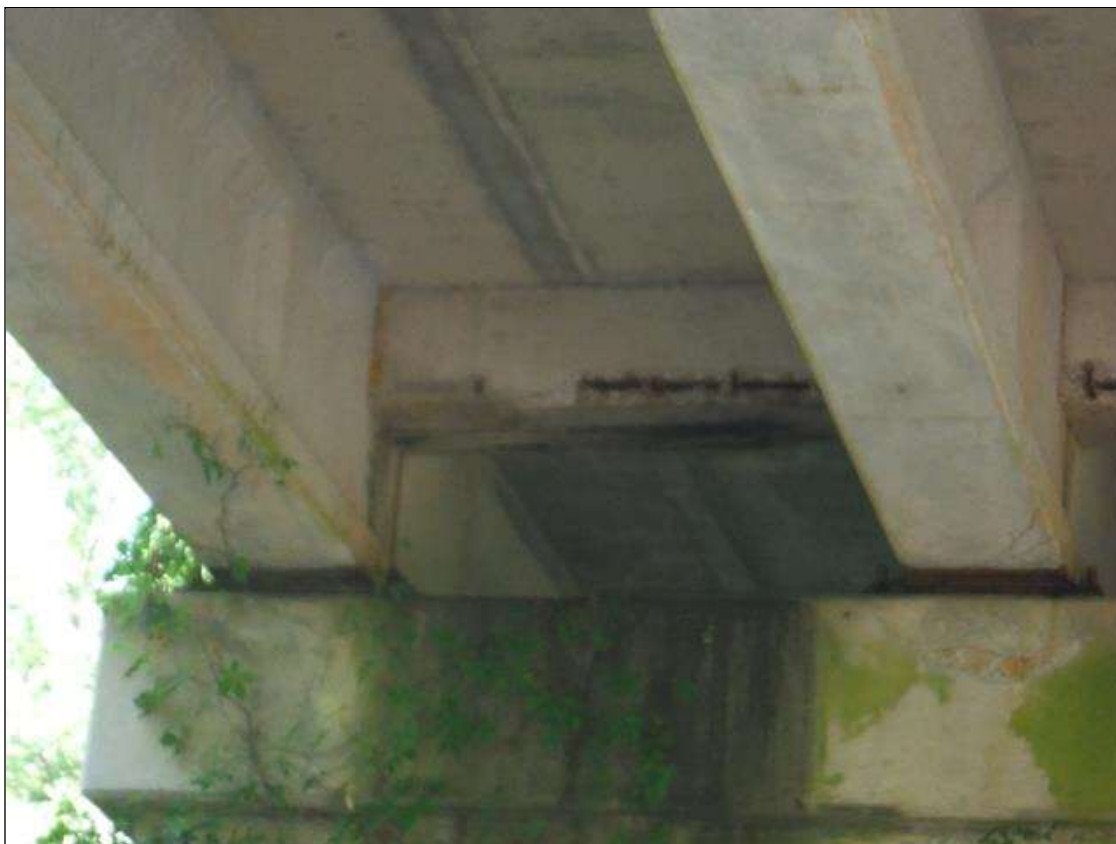
Span 2 Beam 1: (PAR) 4ft x 8in x 2in deep spall with exposed rebar in end diaphragm at bent 2

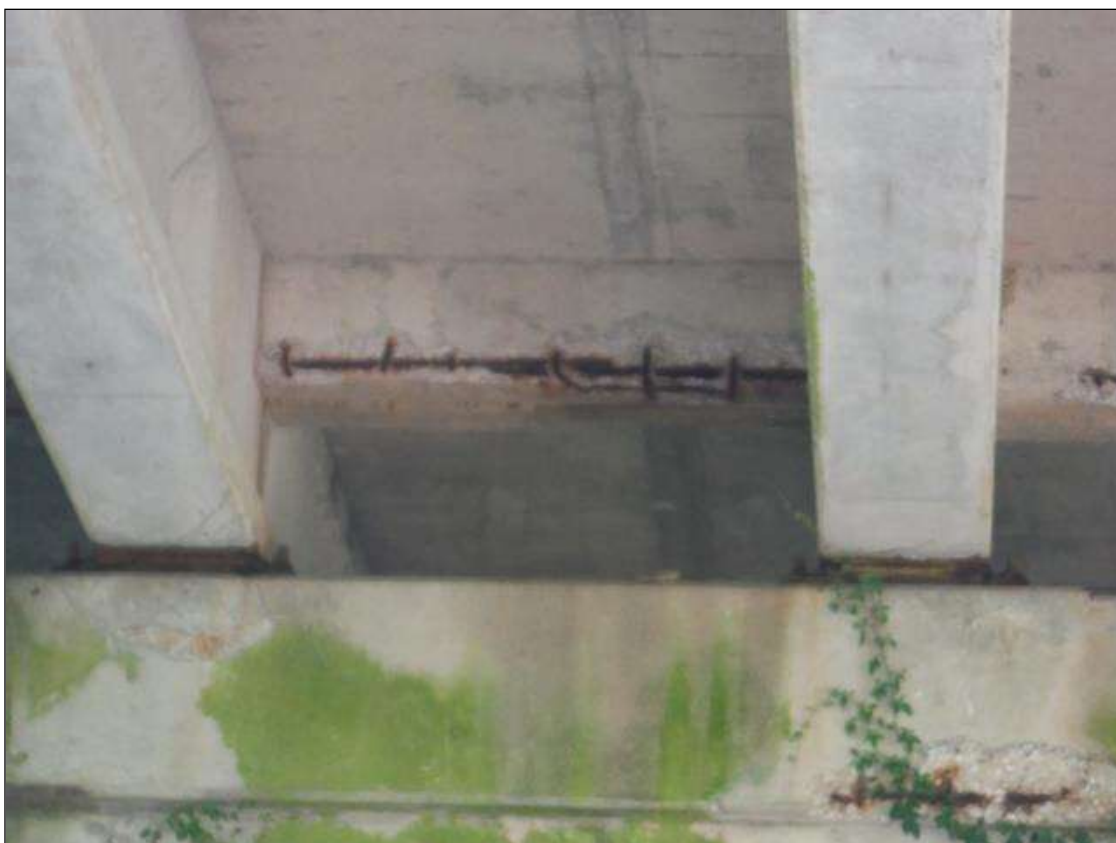
Span 2 Beam 2: (PAR) 4ft x 8in x 2in deep spall with exposed rebar in end diaphragm at bent 2

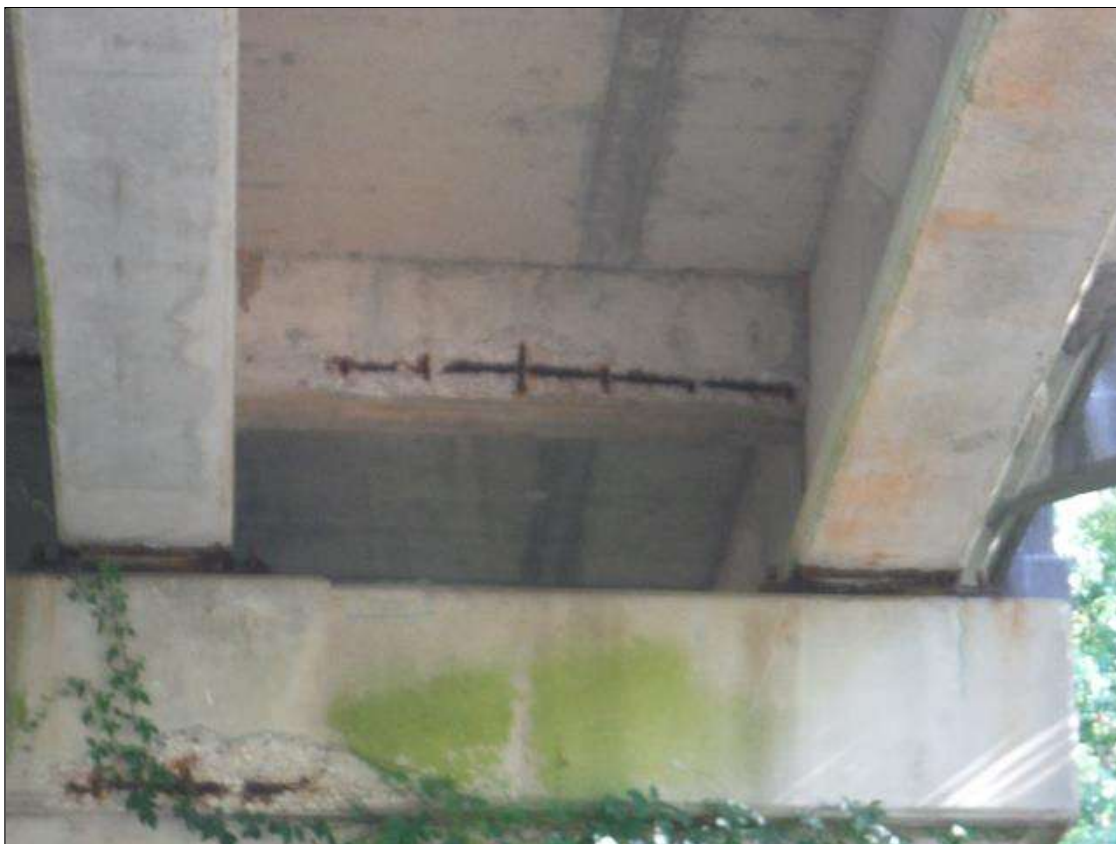
Span 2 Beam 3: (PAR) 4ft x 8in x 2in deep spall with exposed rebar in end diaphragm at bent 2

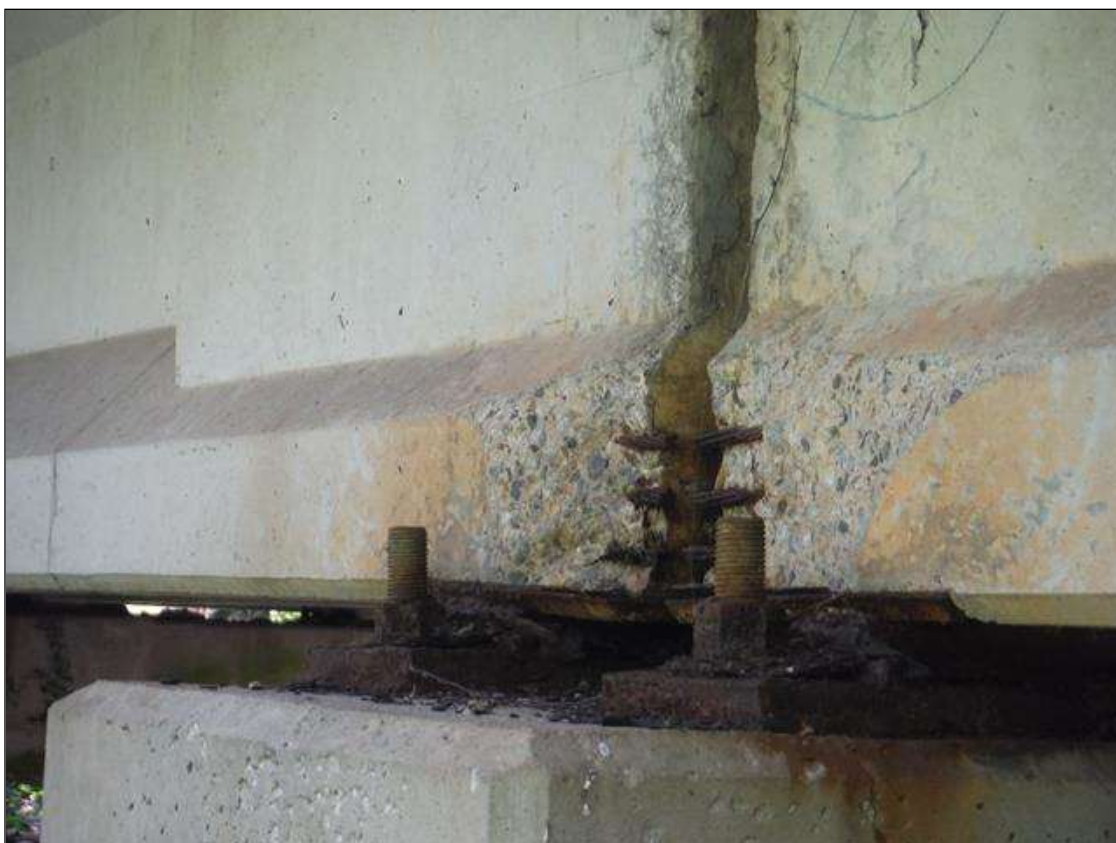
Span 1 Beam 1: (PAR) left bottom flange over bent 1. Has a crack/spall and delaminated area with 3 cables exposed.
Area is: from bottom edge up 8" x 21" x 2" deep with minor section loss to strands.

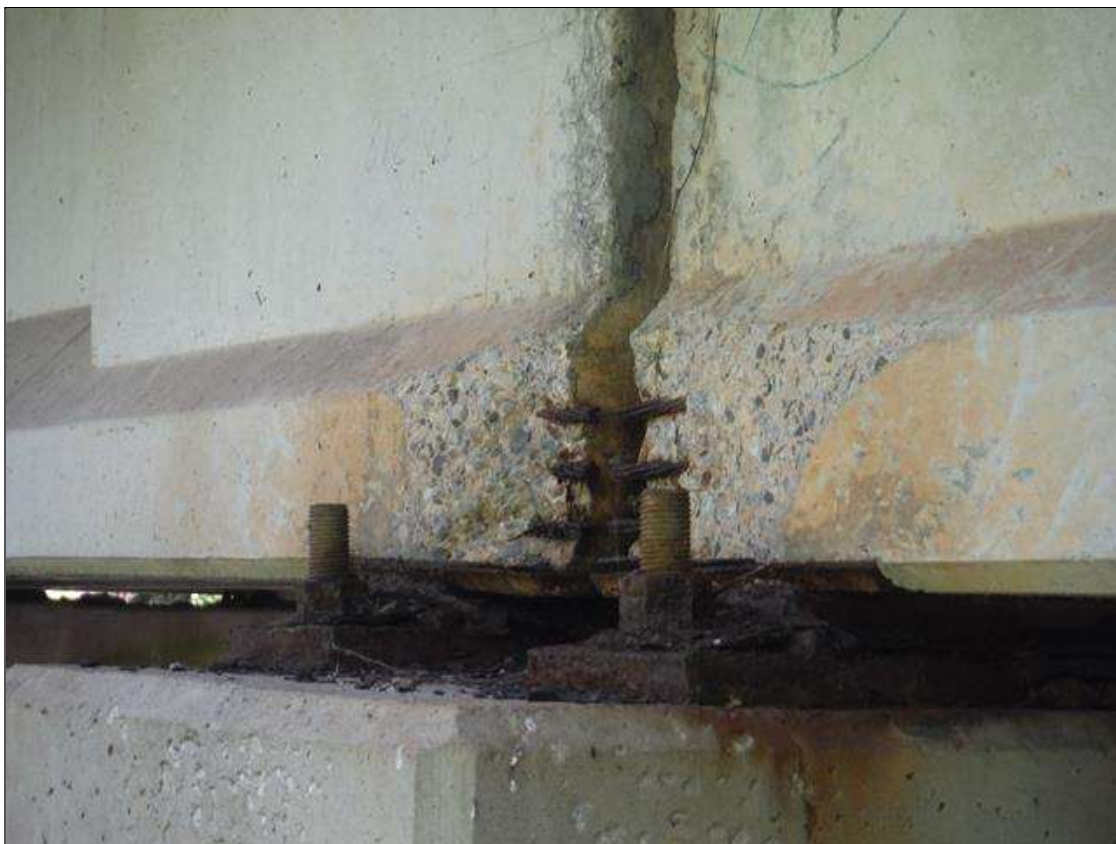
Span 2 Beam 1: (PAR) left bottom flange over bent 1. Has a crack/spall and delaminated with 3 cables exposed. Area is: from bottom edge up 8" x 11" x 2" deep with some section loss to strands.

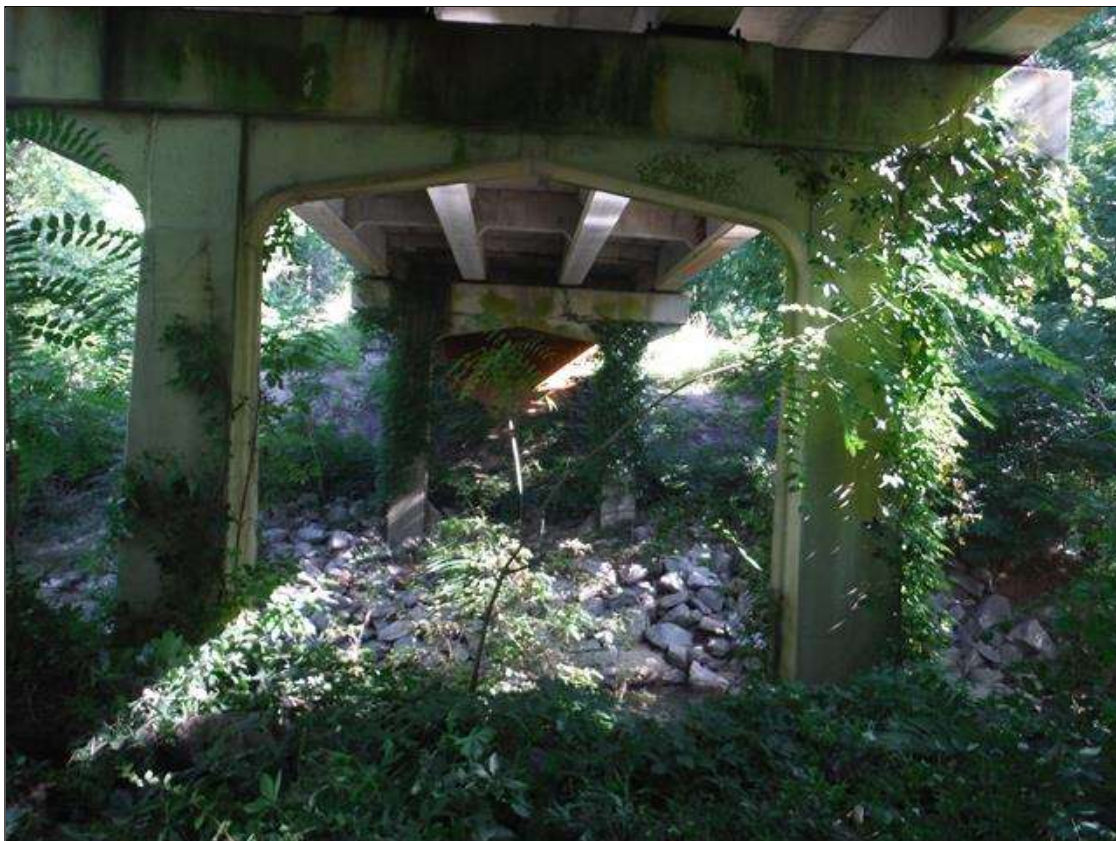
vegetation over growth on bent 1 and bent 2

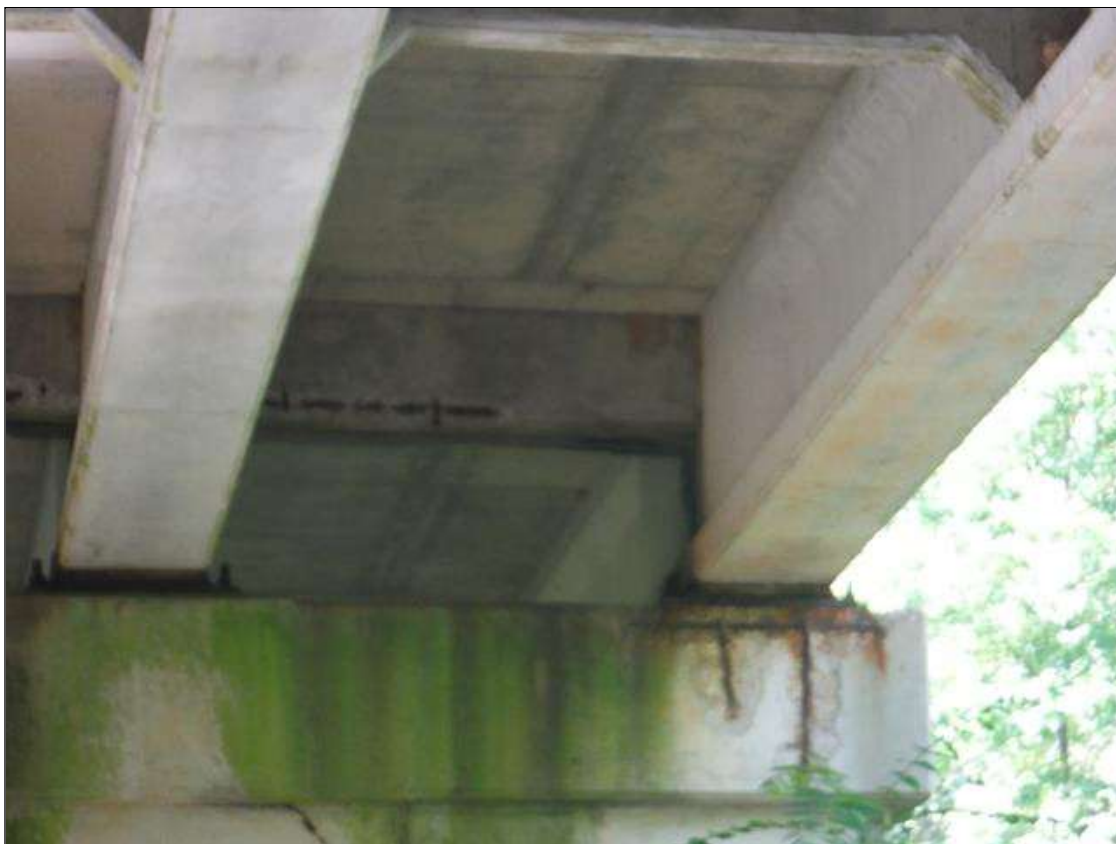
Span 2 Beam 1: (PAR) 3ft x 8in x 2in deep spall with exposed rebar in end diaphragm at bent 1

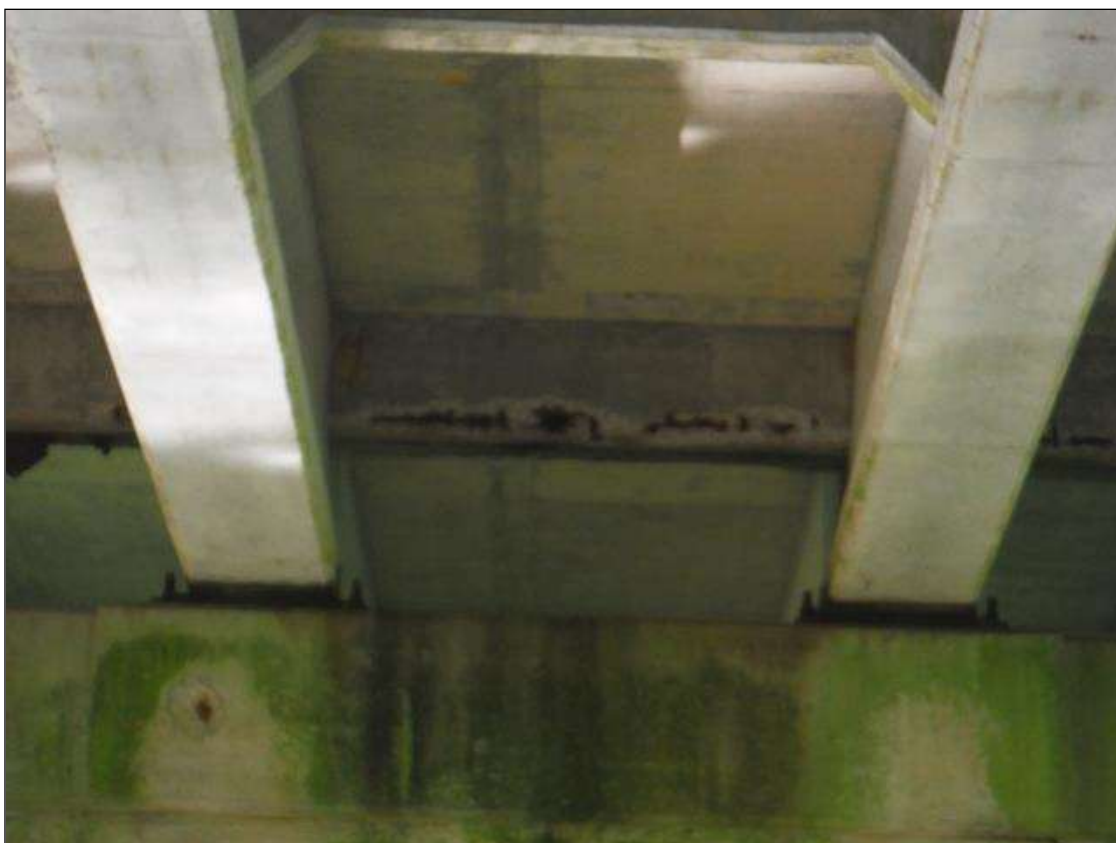
Span 2 Beam 2: (PAR) 4ft x 8in x 2in deep spall with exposed rebar in end diaphragm

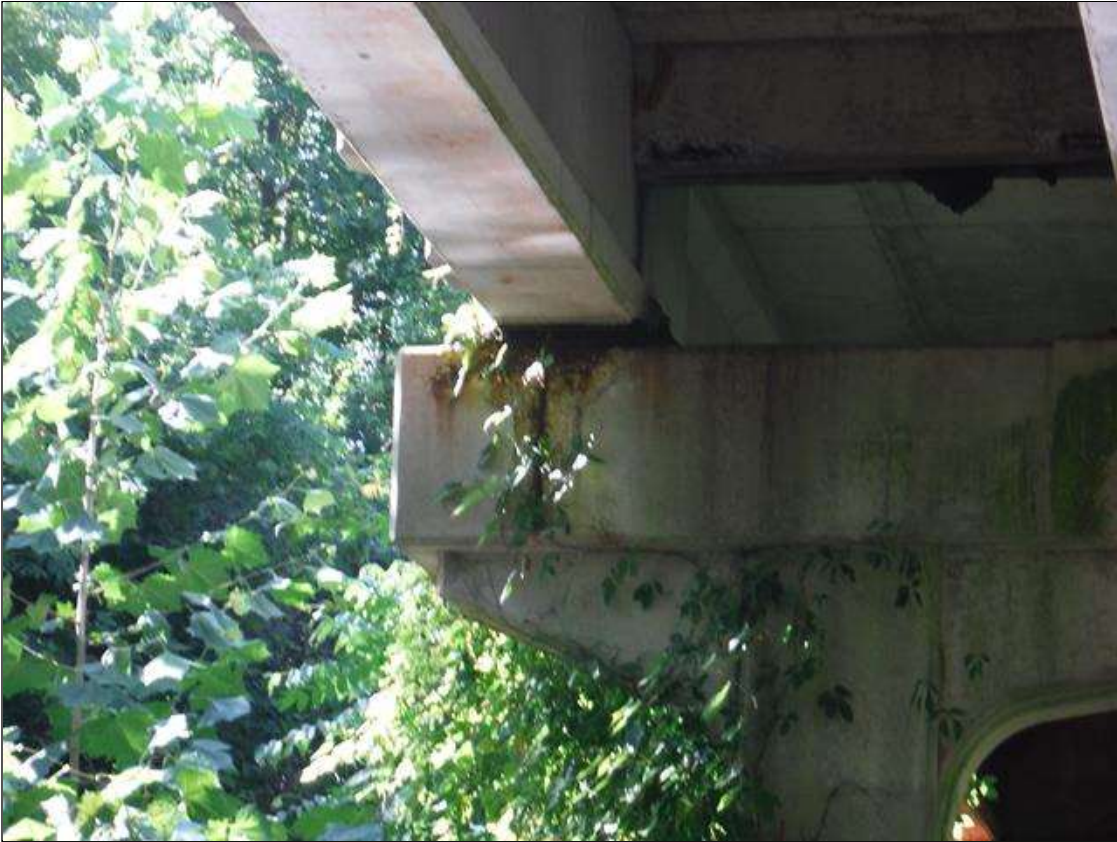
Bent 1 Cap 1: (PAR) cap north face at beam 4. Has a crack/spall and delaminated area with rebar exposed. Area is: from top edge back 2", from top edge down 30" x 36" x 2" deep. With heavy rust and flaking on rebar.

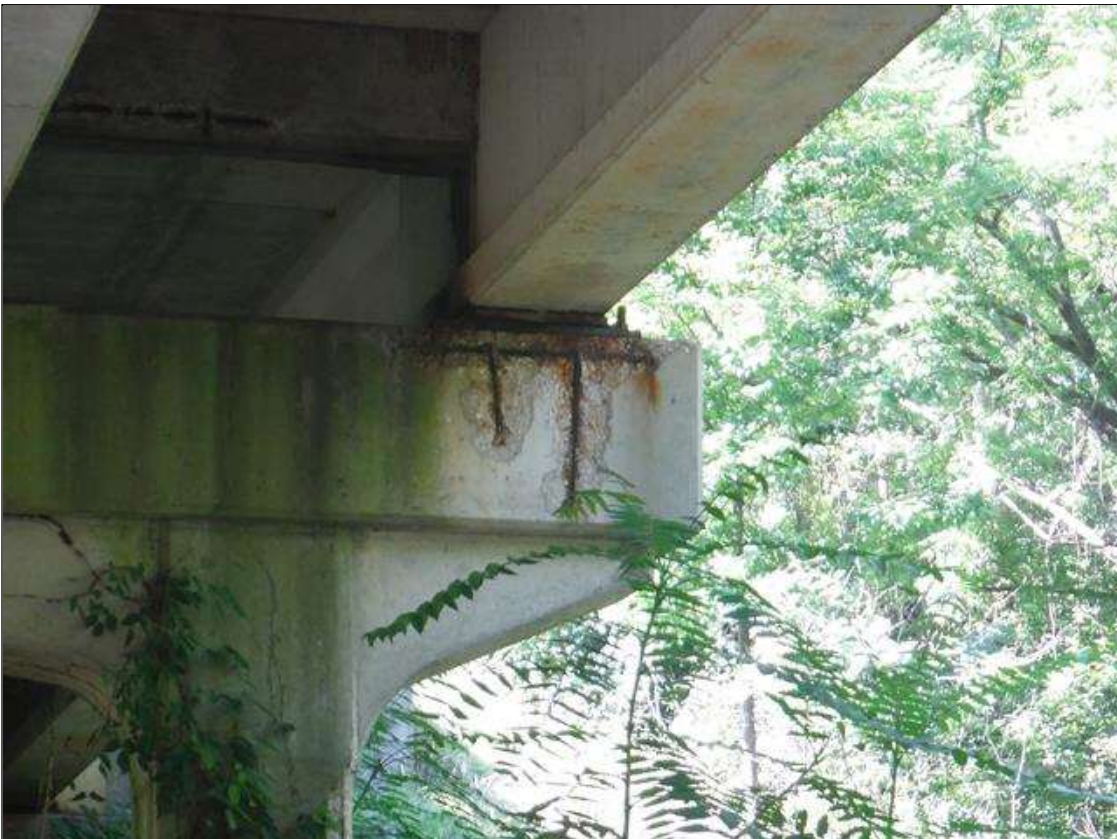
Bent 1 Cap 1: (PAR) cap north face under beam 1. Has a crack/spall and delaminated area with rebar exposed. Area is: from top edge back 3", from top edge down 29" x 54" x 1 1/2" deep with some heavy rust and flaking to rebar.

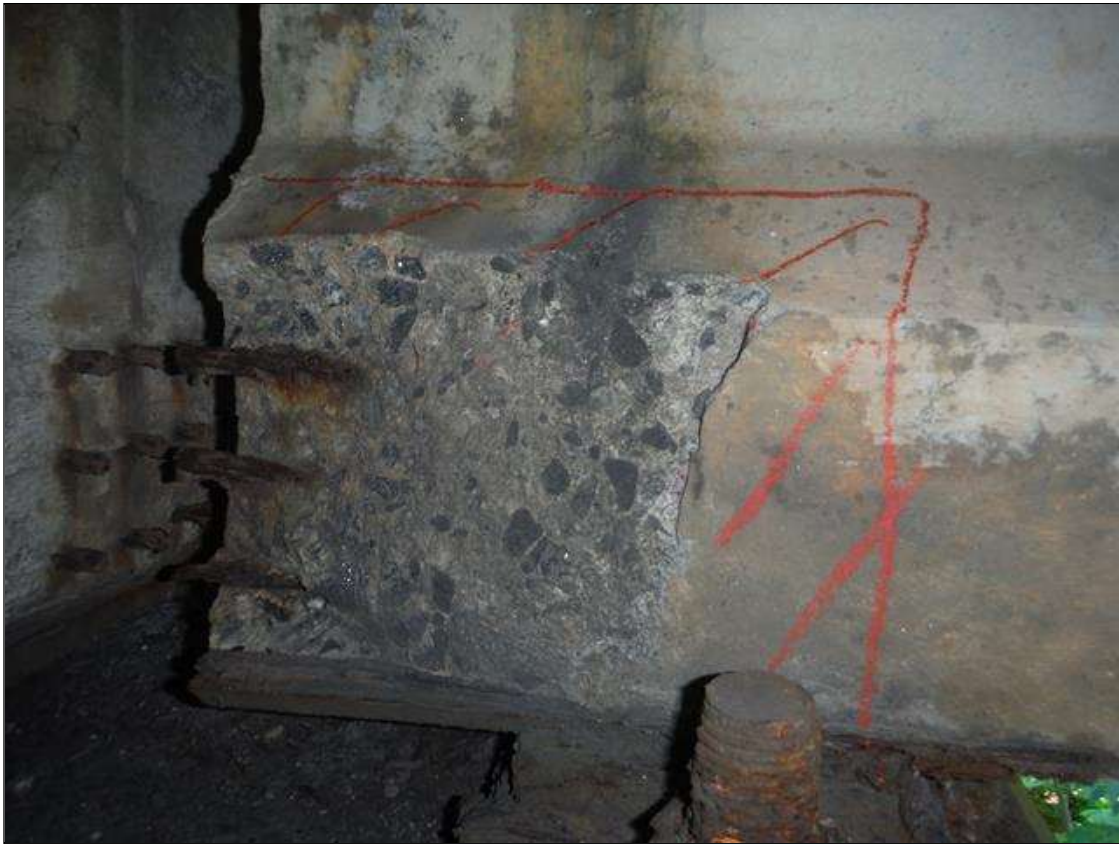
Span 3 Beam 1: (PAR) right bottom flange over bent 2. Has a crack/spall and delaminated area with 3 cables exposed. Area is: from bottom up 7" x 9" x 1 1/2" deep with some section loss to strands.

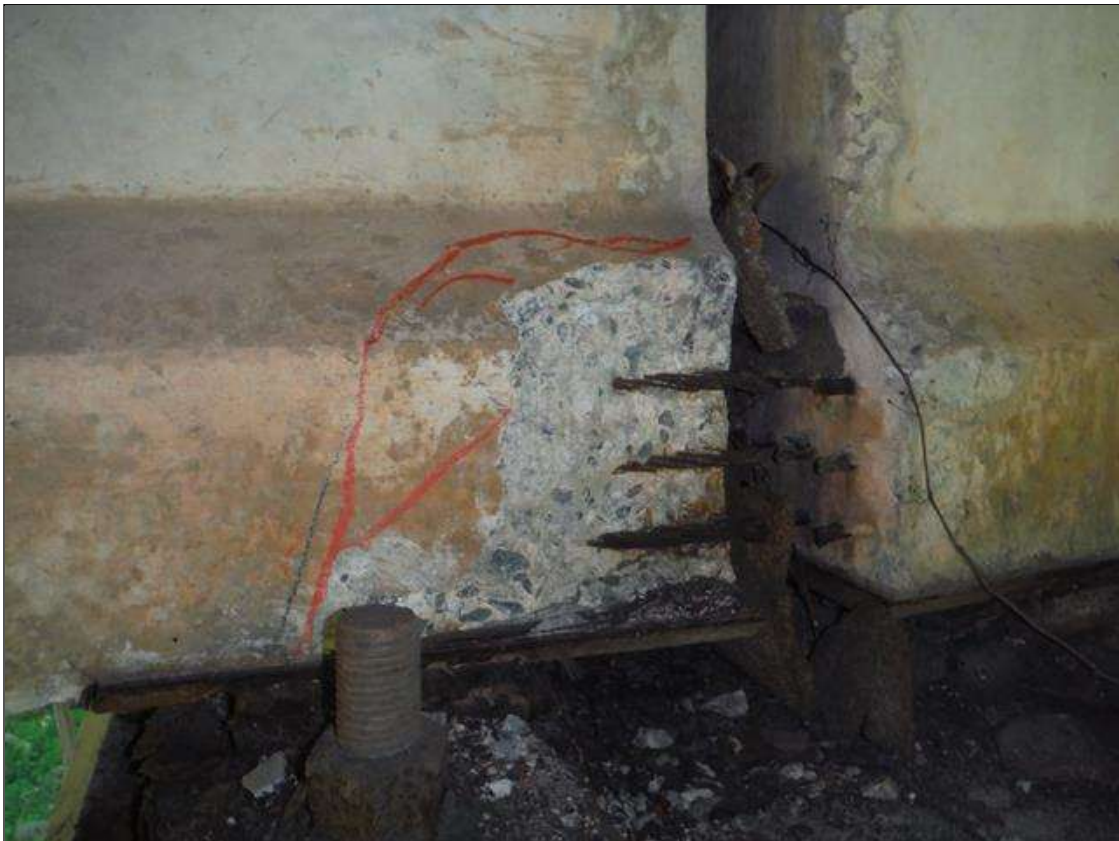
Span 3 Beam 2: (PAR) left bottom flange at bent 2. Has a crack/spall and delaminated area with 3 cables exposed. Area is: from bottom up 8" x 11" x 1 1/2" deep. Strands appear to have some section loss.

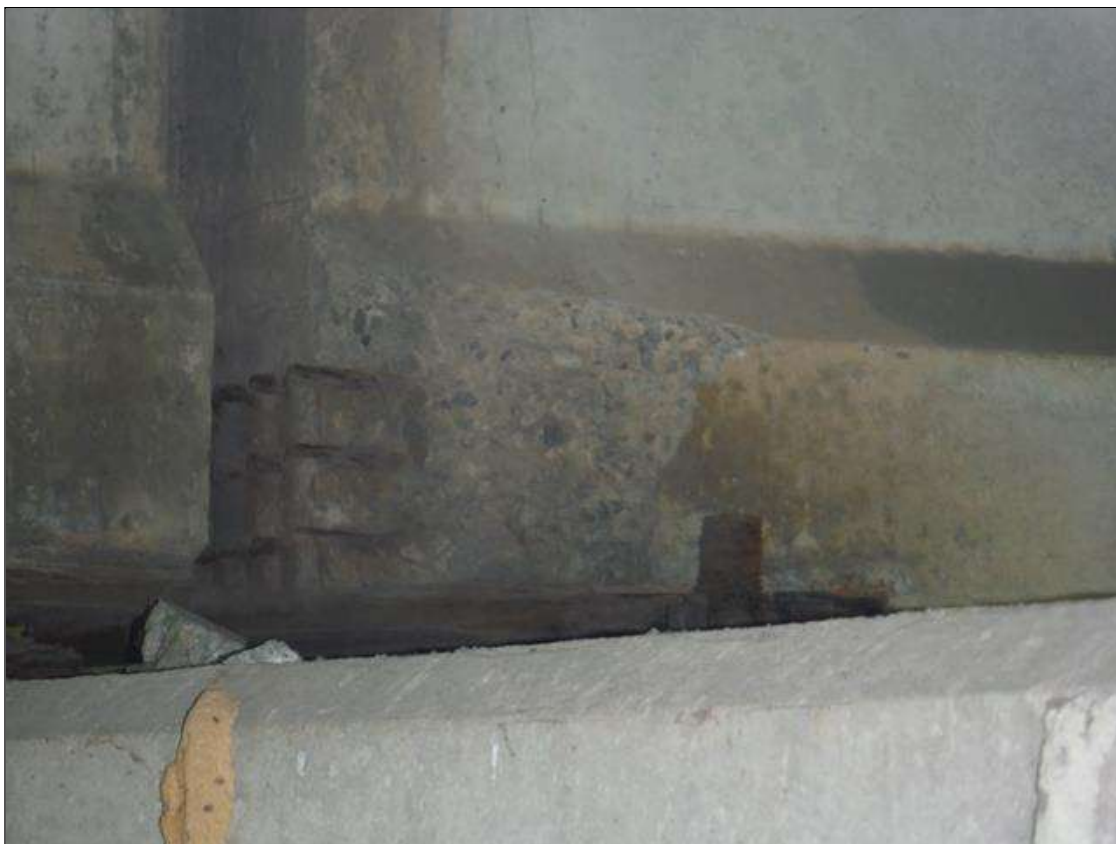
Span 2 Beam 3: (PAR) left bottom flange over bent 2. Has a crack/spall and delaminated area with cables exposed. Area is: from bottom up 8" x 10" x 2" deep with some section loss to strands.

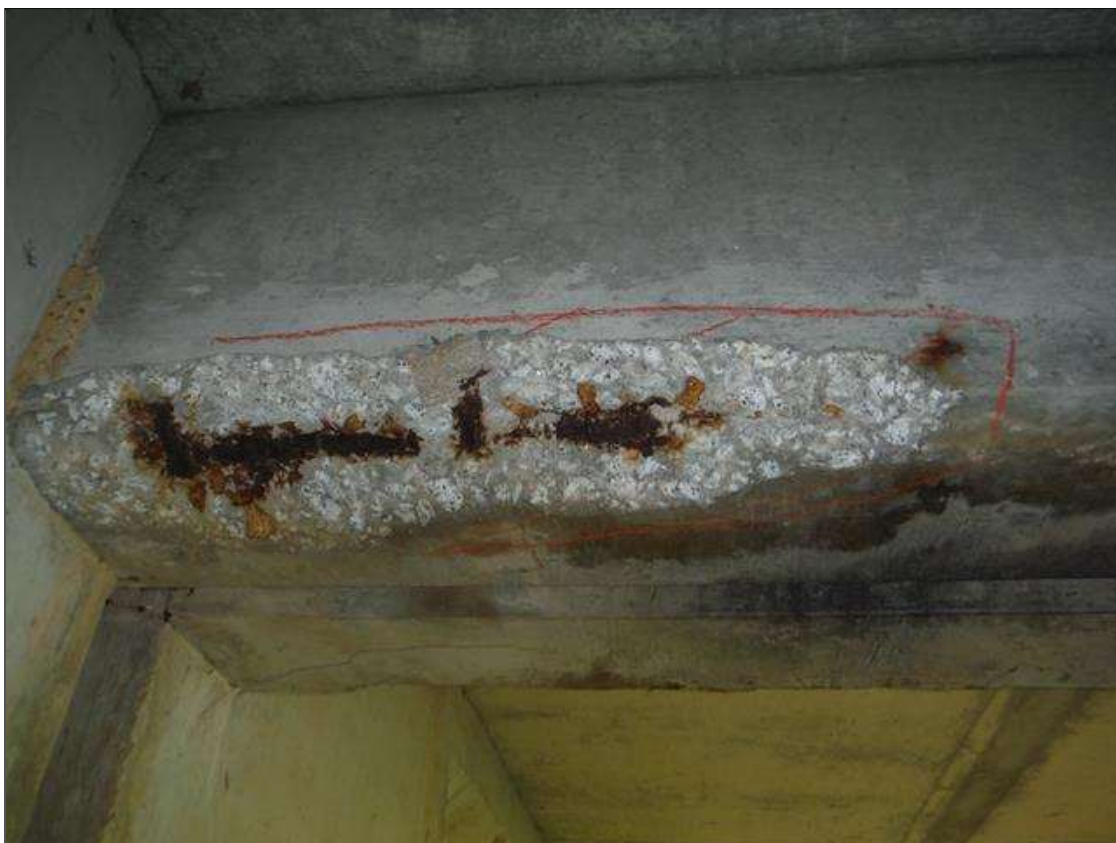
Span 3 Beam 1: (PAR) 2ft x 8in x 2in deep spall with exposed rebar in end diaphragm at bent 2
