NC DEPARTMENT OF TRANSPORTATION
 DIVISION OF HIGHWAYS
 STRUCTURE MANAGEMENT UNIT

ATTENTION: **Priority Action Requested**
Snooper Recommended next Inspection

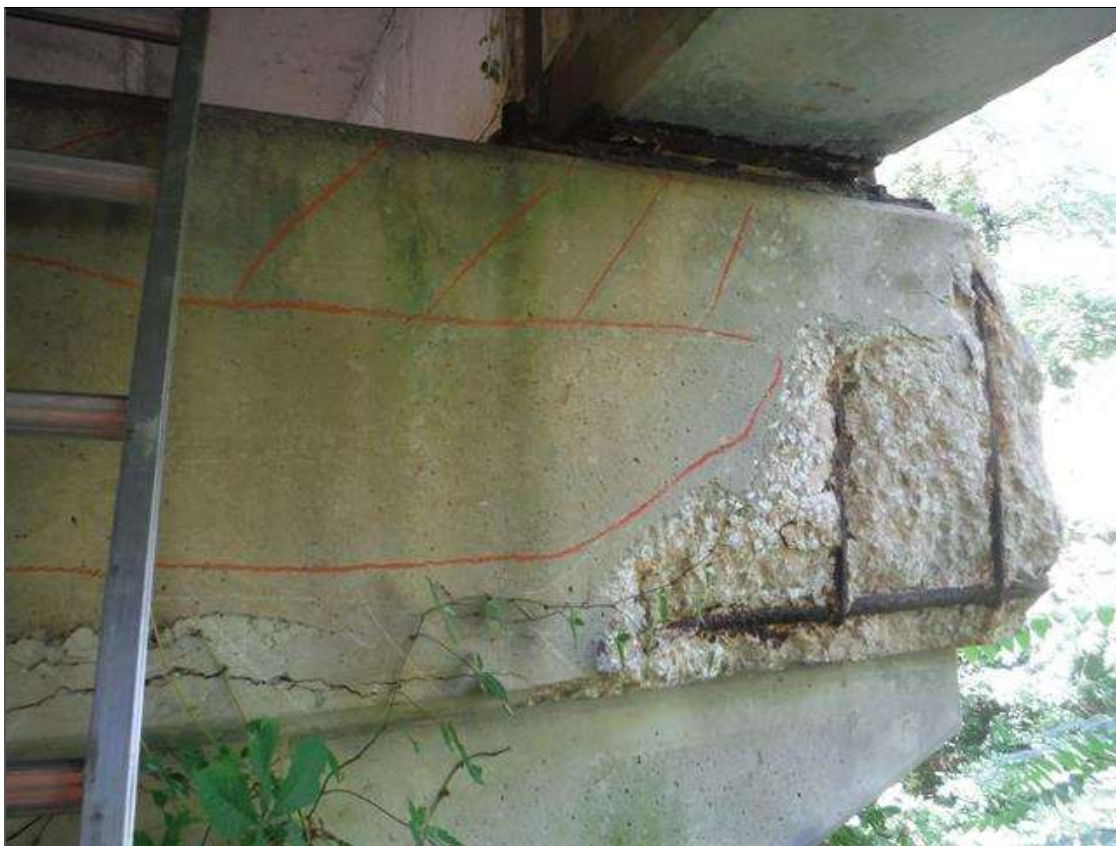
Bent 2 Cap 1: (PAR) cap north face at beam 1. Has a crack/spall and delaminated area with rebar exposed. Area is: from top edge back 2", from bottom edge back 7", from top down 29" x 7' long x 2" deep with heavy rust and flaking on rebar.

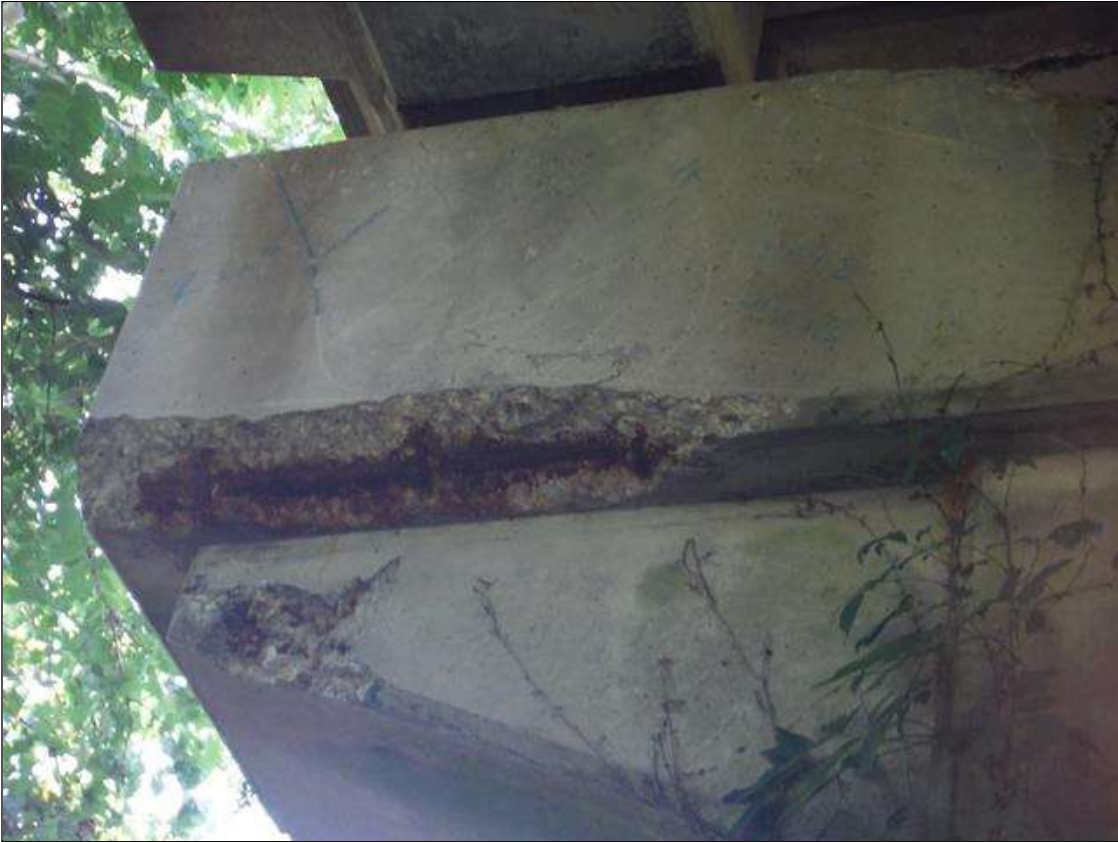
Bent 2 Cap 1: (PAR) cap top, north face and bottom at beam 4. Has a crack/spall and delaminated area with rebar exposed. Area is: from top down 28", from top edge back 2", from bottom edge back 7" x 48".

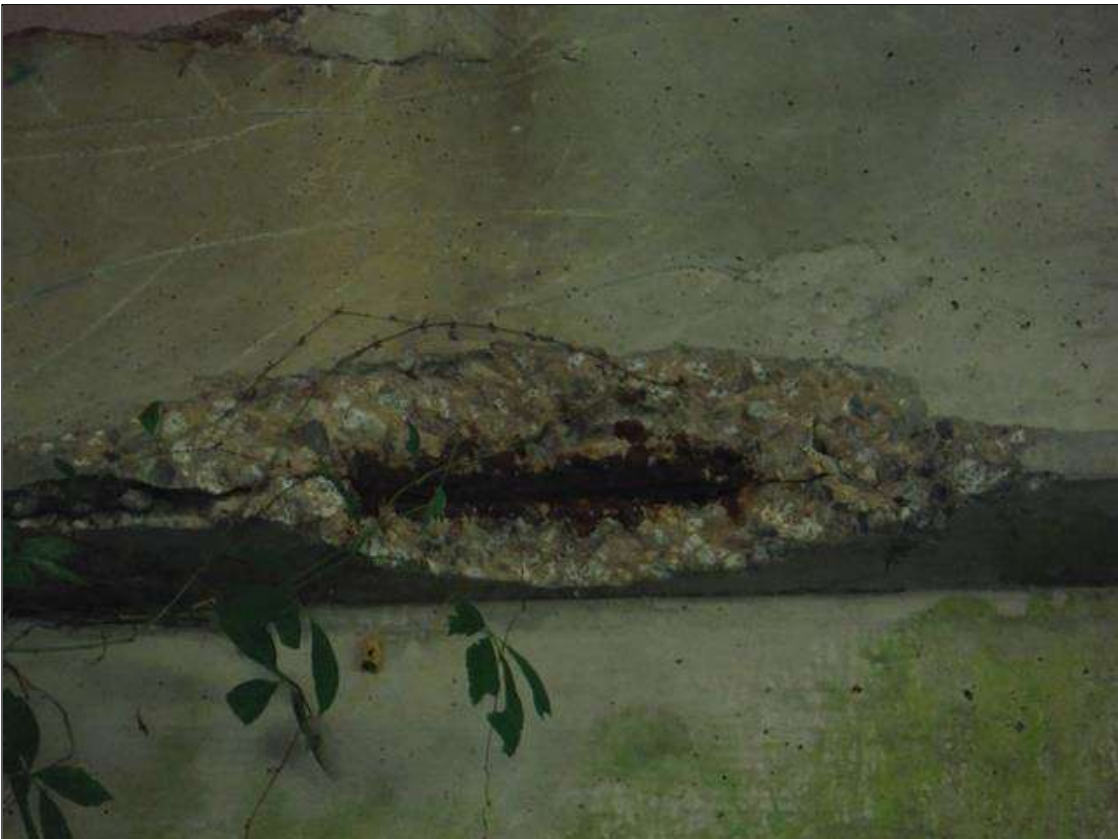
Bent 2 Cap 1: (PAR) cap bottom and north face at beam 3. Has a crack/spall and delaminated area with rebar exposed. Area is: from bottom edge up 12", from bottom edge back 7" x 43" long x 5" deep.

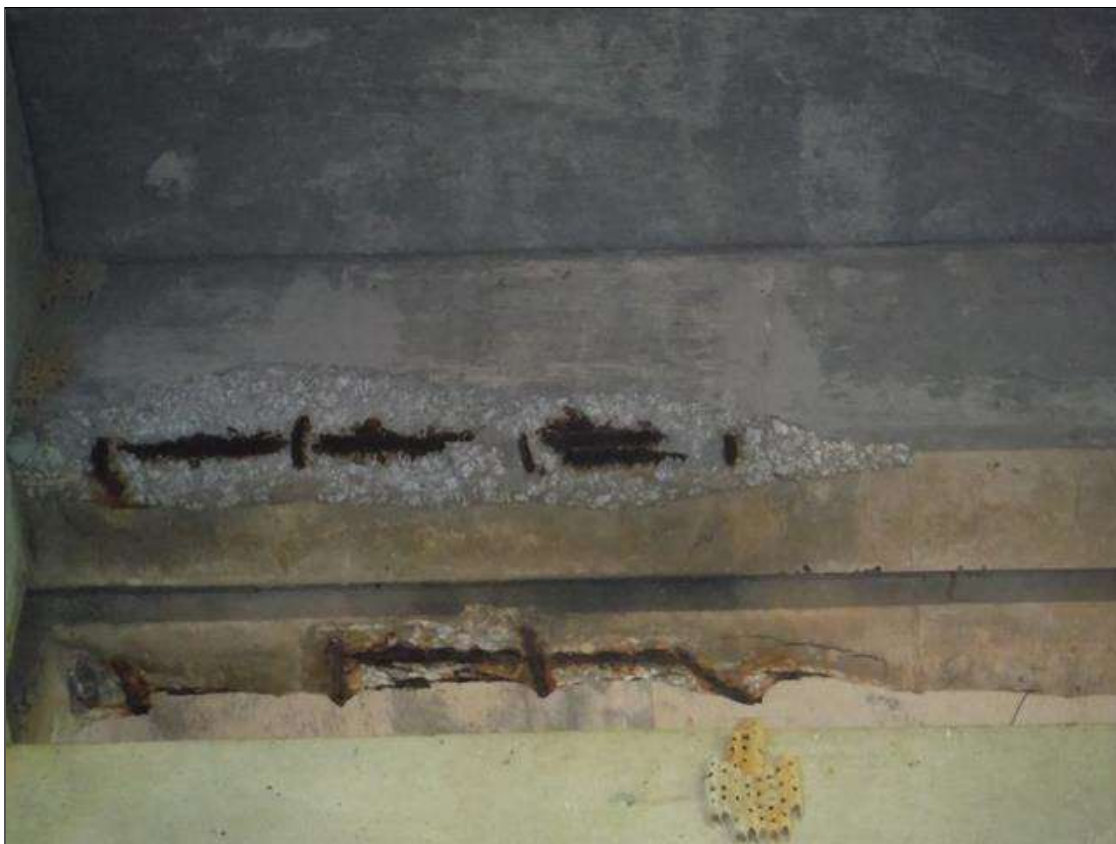
Span 3 Beam 2: (PAR) 3ft x 8in x 2in deep spall with exposed rebar in end diaphragm at bent 2

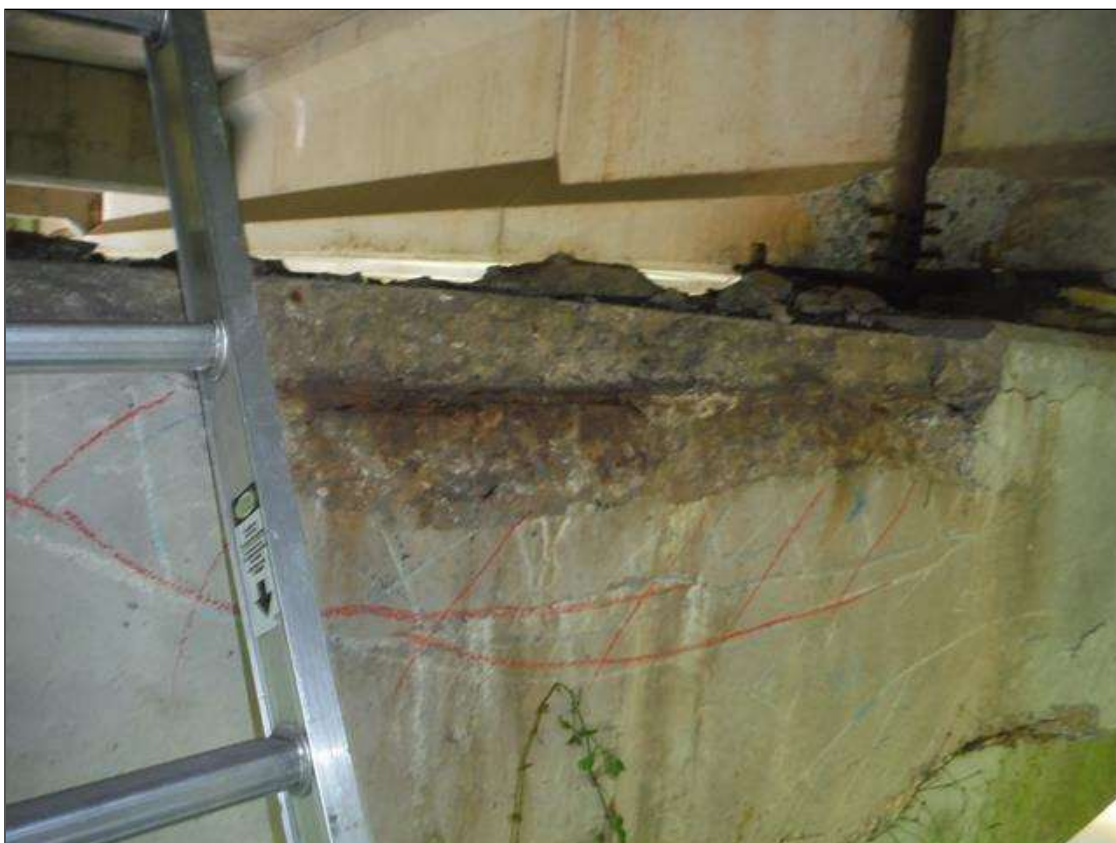
Bent 2 Cap 1: (PAR) cap top, north face in bay 3. Has a crack/spall and delaminated area with rebar exposed. Area is: from top edge down 16", from edge back 12" x 7' x 6" deep.

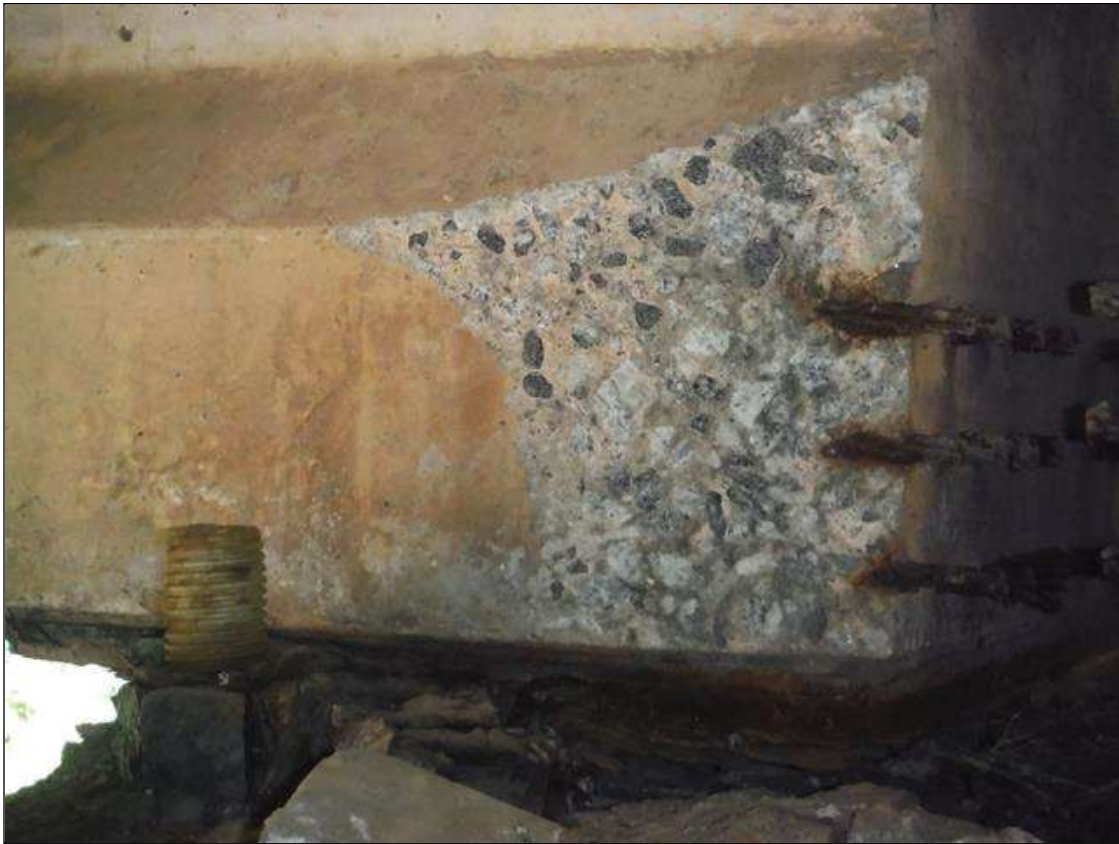
Span 2 Beam 3: (PAR) right bottom flange over bent 2. Has a crack/spall and delaminated area with 3 cables exposed. Area is: from bottom edge up 8" x 10" x 2" deep. Strands appear to have some section loss.

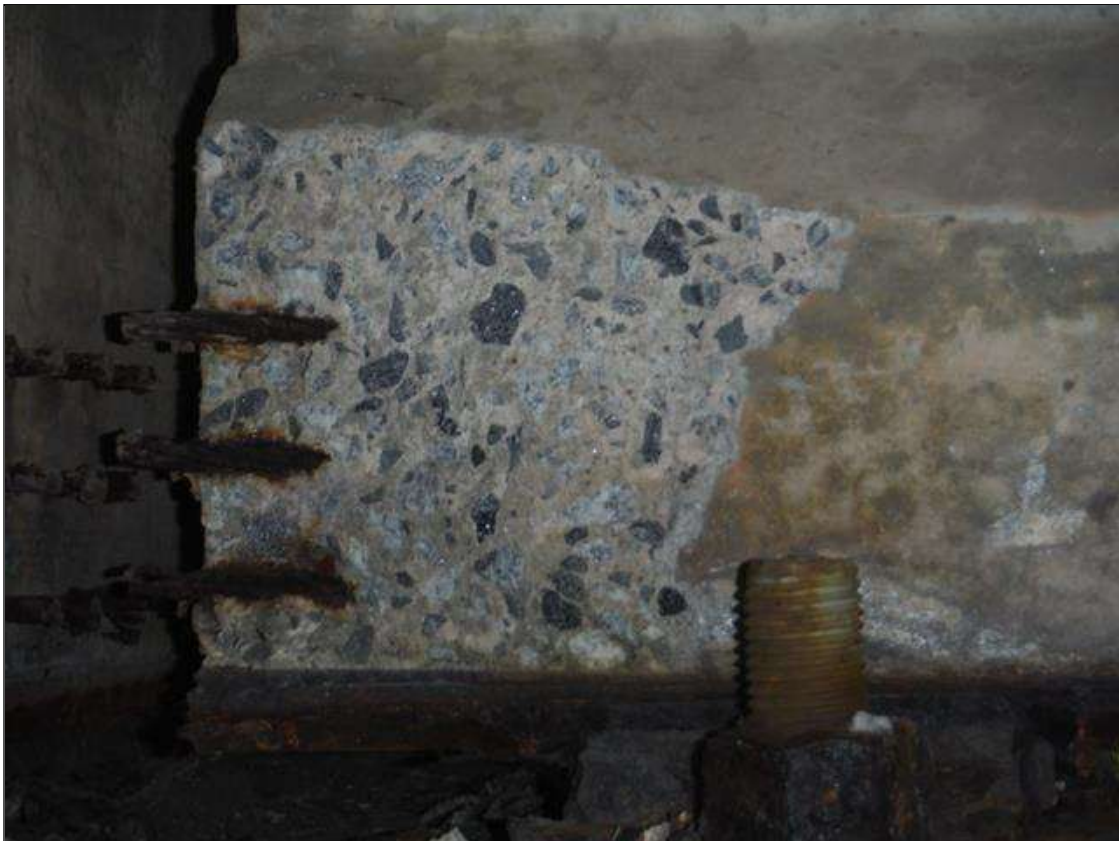
Span 3 Beam 3: (PAR) right bottom flange over bent 2. Has a crack/spall and delaminated area with 3 cables exposed. Area is: from bottom up 8" x 10" x 2" deep. Strands appear to have some section loss.

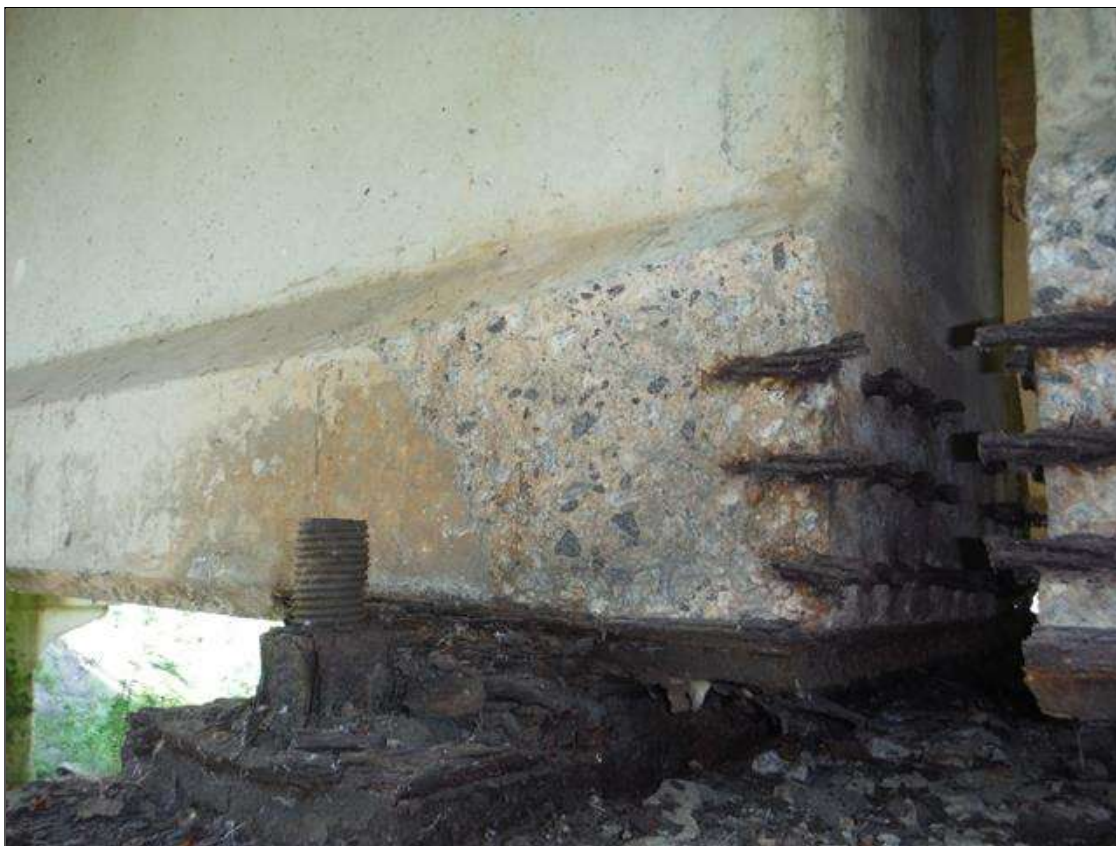
Span 2 Beam 4: (PAR) right bottom flange over bent 2. Has a crack/spall and delaminated area with 3 cables exposed. Area is: 8" x 13" x 1 1/2" deep with some section loss on strands.

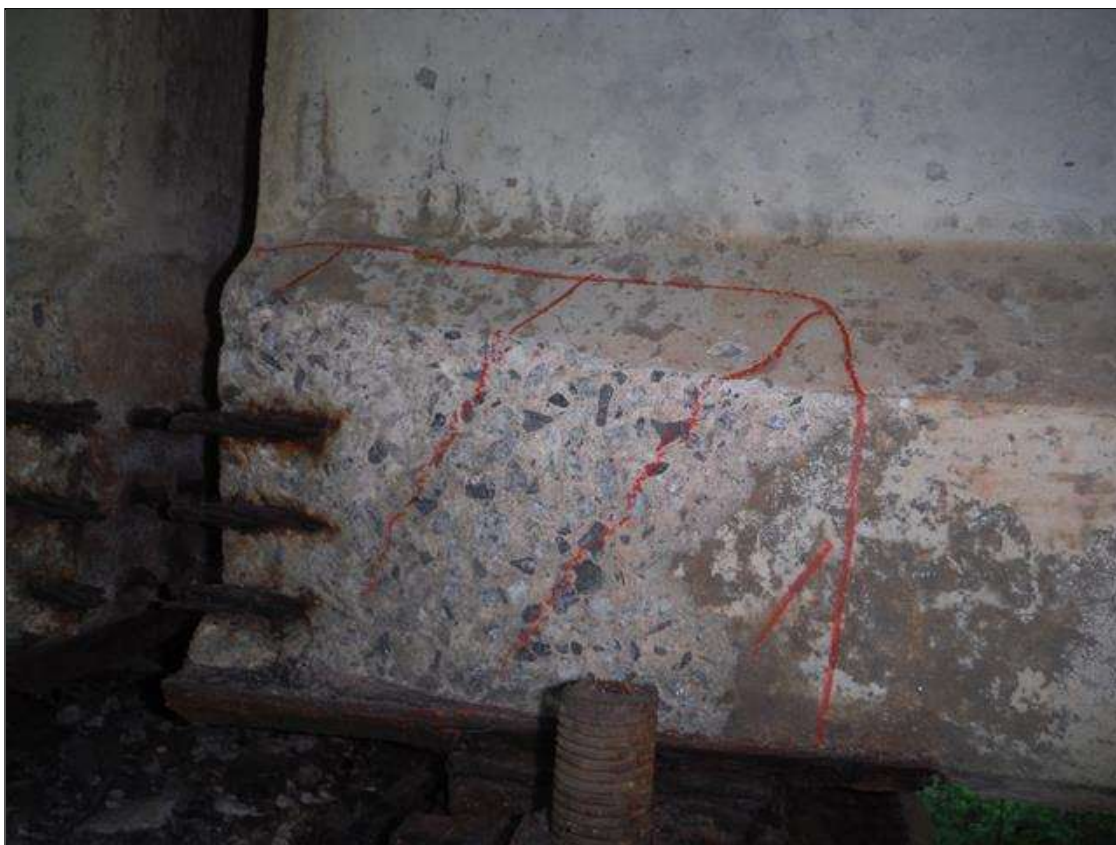
Span 3 Beam 4: (PAR) right bottom flange over bent 2. Has a spalled area with 3 cables exposed. Area is: 8" x 15" x 2" deep with some section loss to strands.

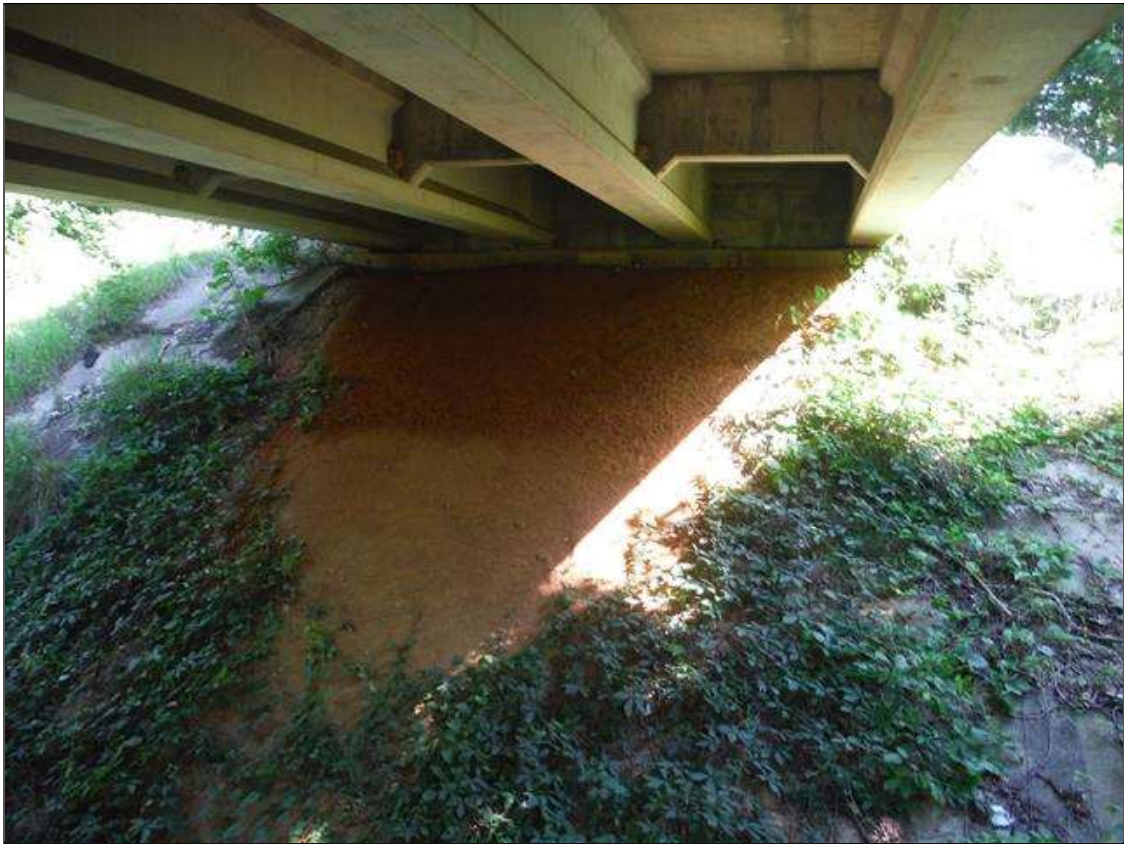
span 2 superstructure

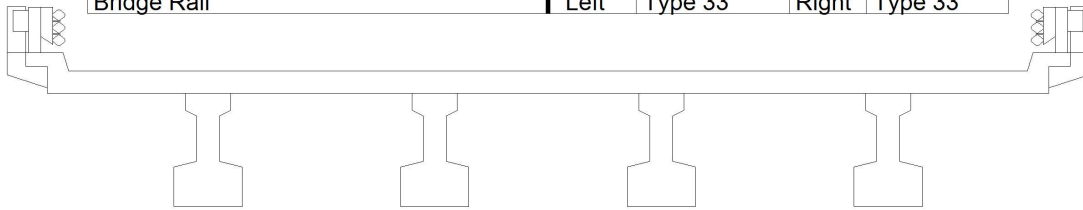
Measurements for Span #	1		
Deck Thickness	0.646	Left Overhang	4.917
Top of Rail to Bottom of Beam	6.917	Right Overhang	4.917

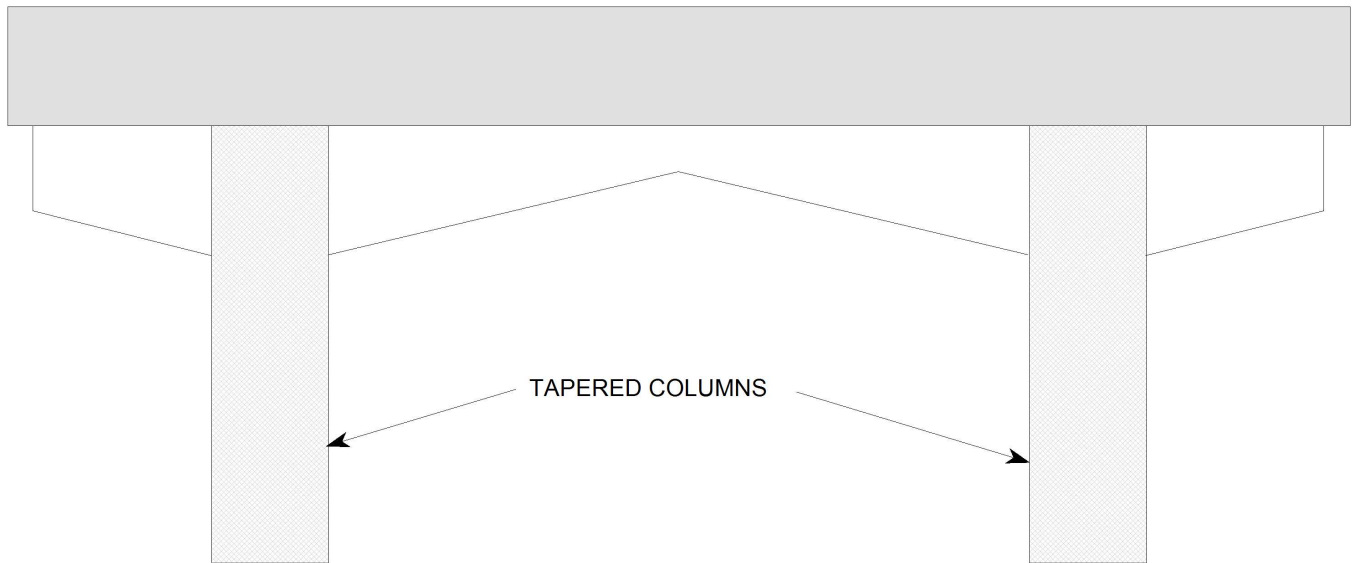
Cap Information			Material Cast-in-Place Concrete							
Length	Width	Height	Left Overhang	Right Overhang	Left Beam to End of Cap.	Right Beam to End of Cap.				
28.167 ft.	3.000 ft.	2.500 ft.	5.500 ft.	5.500 ft.	2.083 ft.	2.083 ft.				
Subcap Information			Material							
Length	Width	Height	Left Overhang	Right Overhang	Left Pile to Splice.					
Sill Information			Material							
Length	Width	Height								
Pile #	Material	Spacing	Width/Dia.	Height	Length	Orientation	Driven?	Replacement?	Removed?	Collar?
1	Concrete	17.167 ft.	2.458 ft.		2.5 ft.	Vertical	No	No	No	No
2	Concrete		2.458 ft.		2.5 ft.	Vertical	No	No	No	No
<p style="font-size: 24px; margin: 0;">VERIFIED 7/2/19 KHC</p>										
Bent/Abutment #: 1			Similar Bents: 2
