NC DEPARTMENT OF TRANSPORTATION  
 DIVISION OF HIGHWAYS  
 STRUCTURE MANAGEMENT UNIT

ATTENTION: **PAR, DATA CHANGES, DAMAGE INSPECTION REQUESTED**

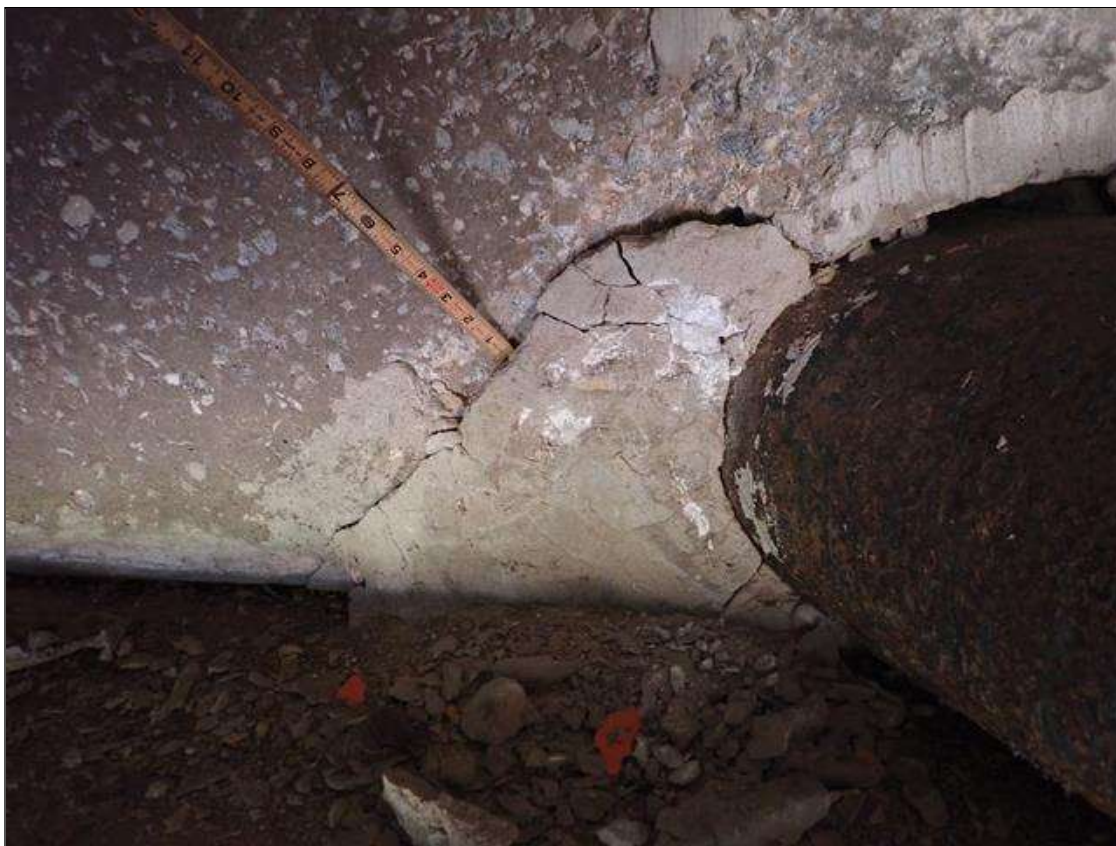
End Bent 1 Abutment: 11 INCH X 12 INCH FAILED REPAIR IN FACE OF ABUTMENT IN BAY 6 ADJACENT TO UTILITY PENETRATION

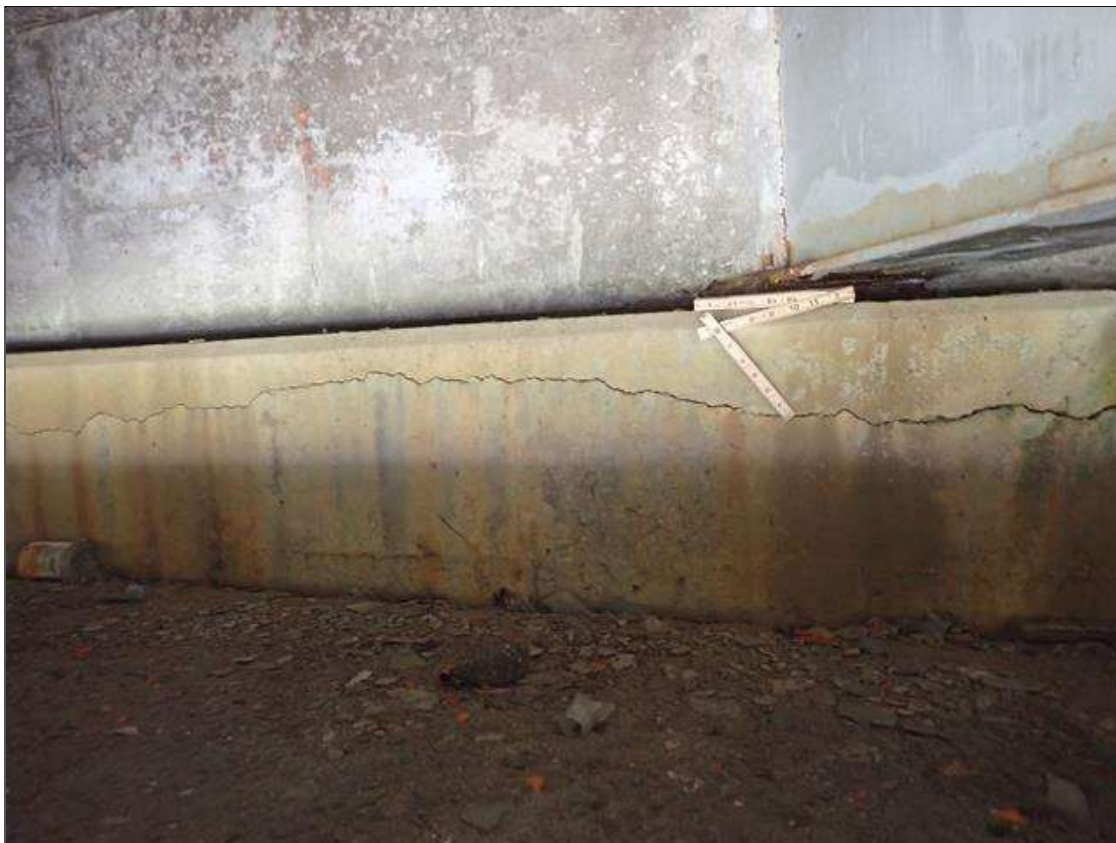
End Bent 1 Cap 1: UP TO 1/8 INCH X 15 FOOT LONG HORIZONTAL CRACK IN FACE OF CAP BENEATH BEAMS 3 AND 4

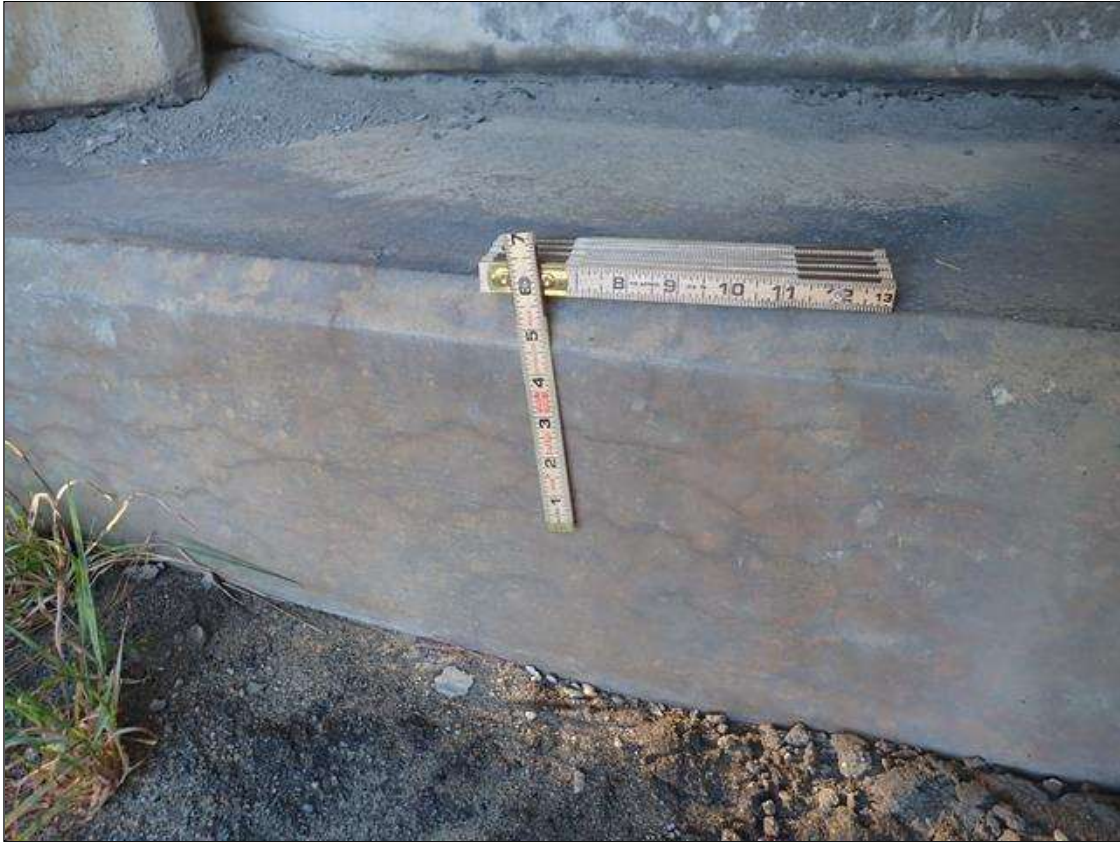
End Bent 1 Cap 1: HAIRLINE MAP CRACKING IN FACE OF CAP AT RIGHT END

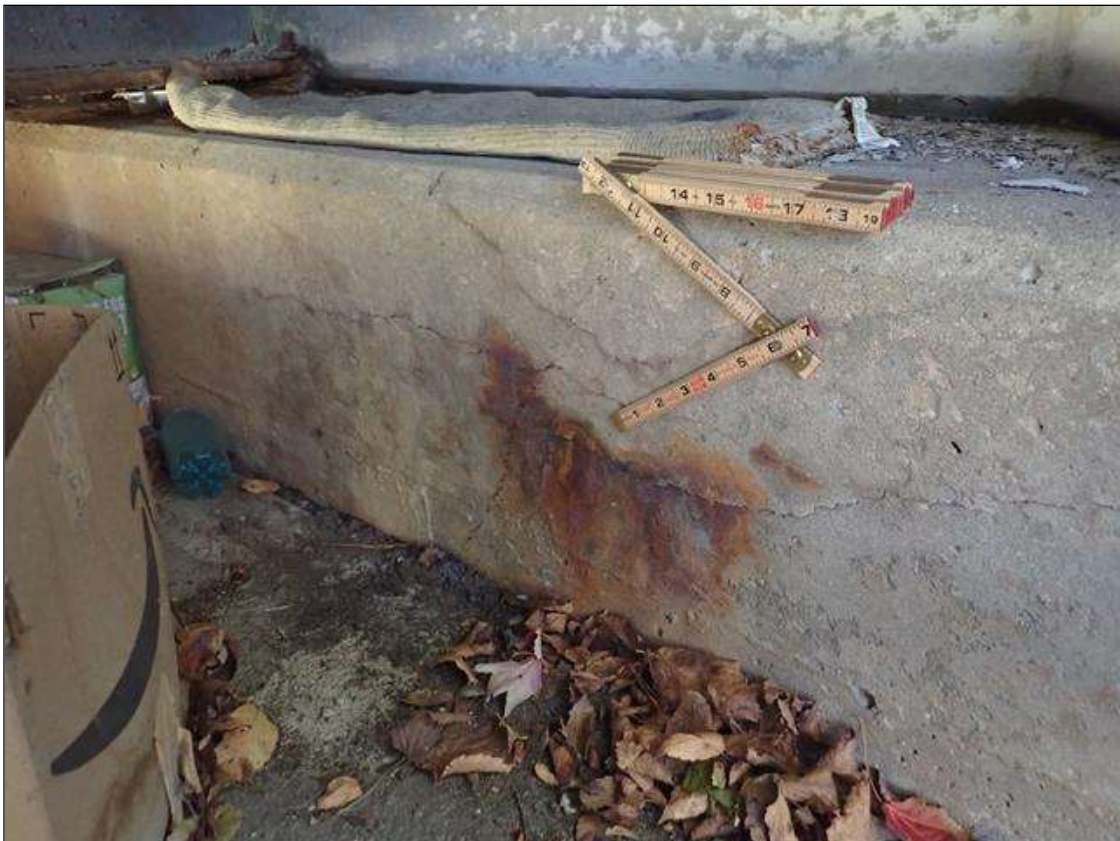
End Bent 1 Cap 1: UP TO 1/16 INCH HORIZONTAL CRACK AND HAIRLINE MAP CRACKING WITH EFFLORESCENCE AND RUST STAINING IN FACE OF CAP AT LEFT END

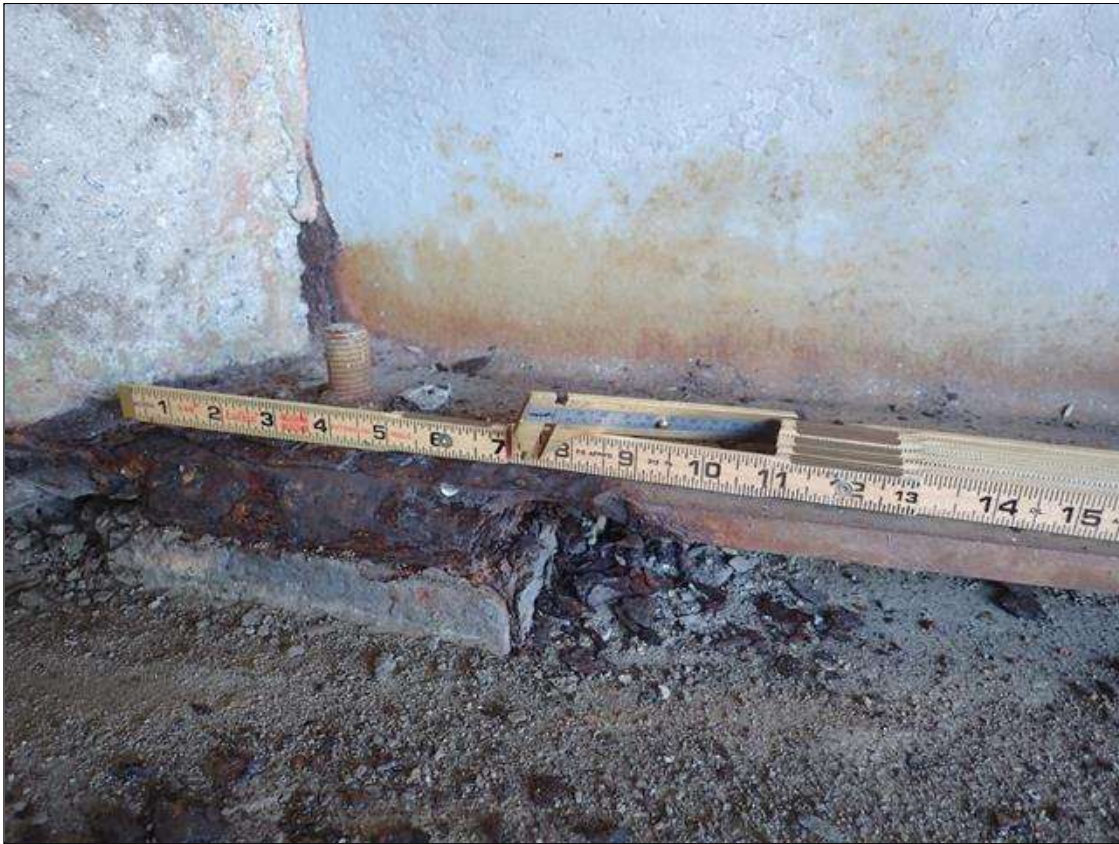
Span 1 Beam 7: PAR: CORROSION ALONG RIGHT EDGE OF BOTTOM FLANGE UP TO 10 INCH LONG X 2 INCH WIDE DOWN TO 3/16 INCH RESIDUAL FLANGE EXTENDING FROM END BENT 1

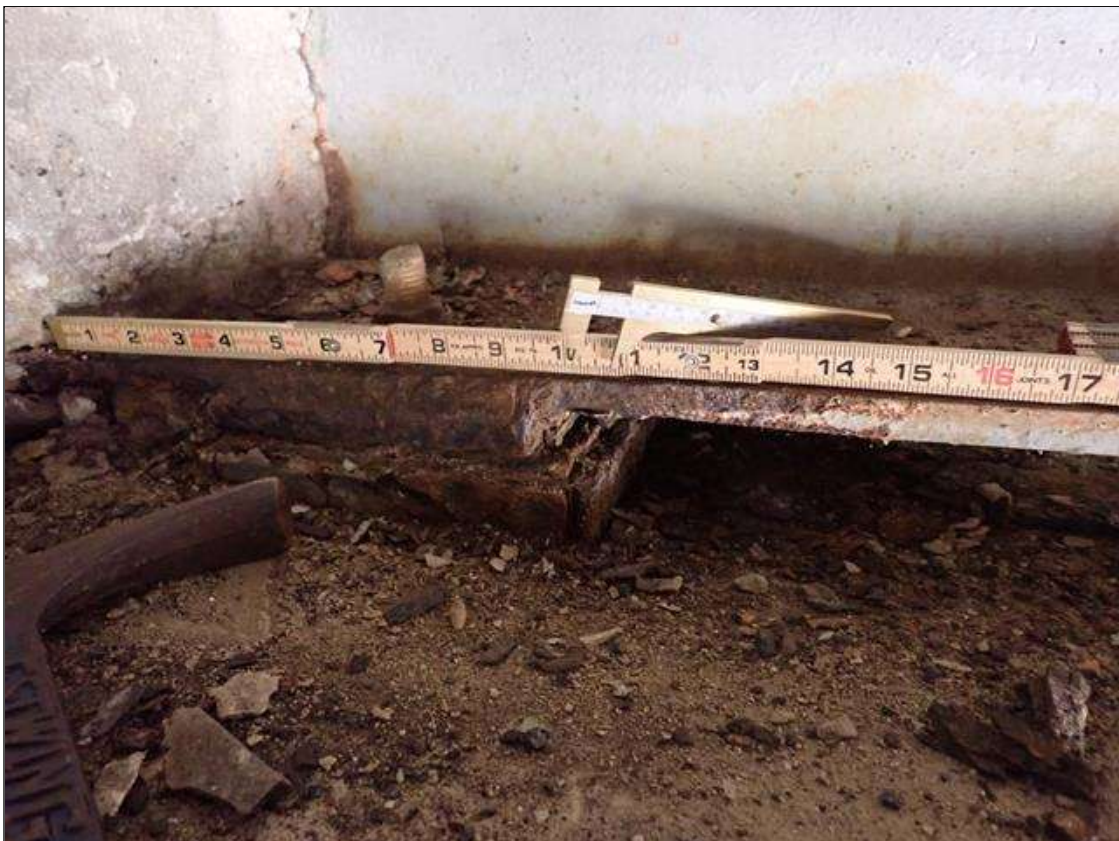
Span 1 Beam 3: PAR: CORROSION ALONG RIGHT EDGE OF BOTTOM FLANGE UP TO 12 INCH LONG X 4 INCH WIDE DOWN TO 1/2 INCH INCH RESIDUAL FLANGE EXTENDING FROM END BENT 1

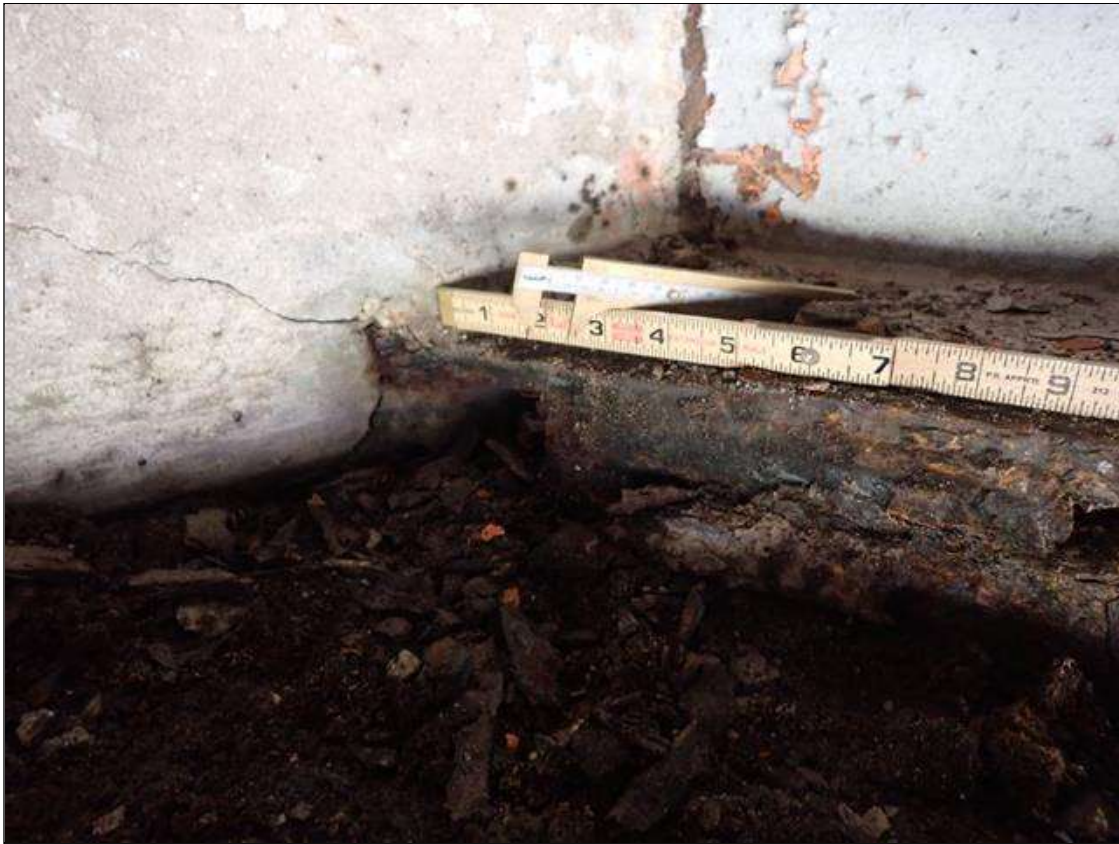
Span 1 Beam 2: PAR: CORROSION ALONG RIGHT EDGE OF BOTTOM FLANGE UP TO 10 INCH LONG X 3 INCH WIDE DOWN TO 5/8 INCH RESIDUAL FLANGE EXTENDING FROM END BENT 1

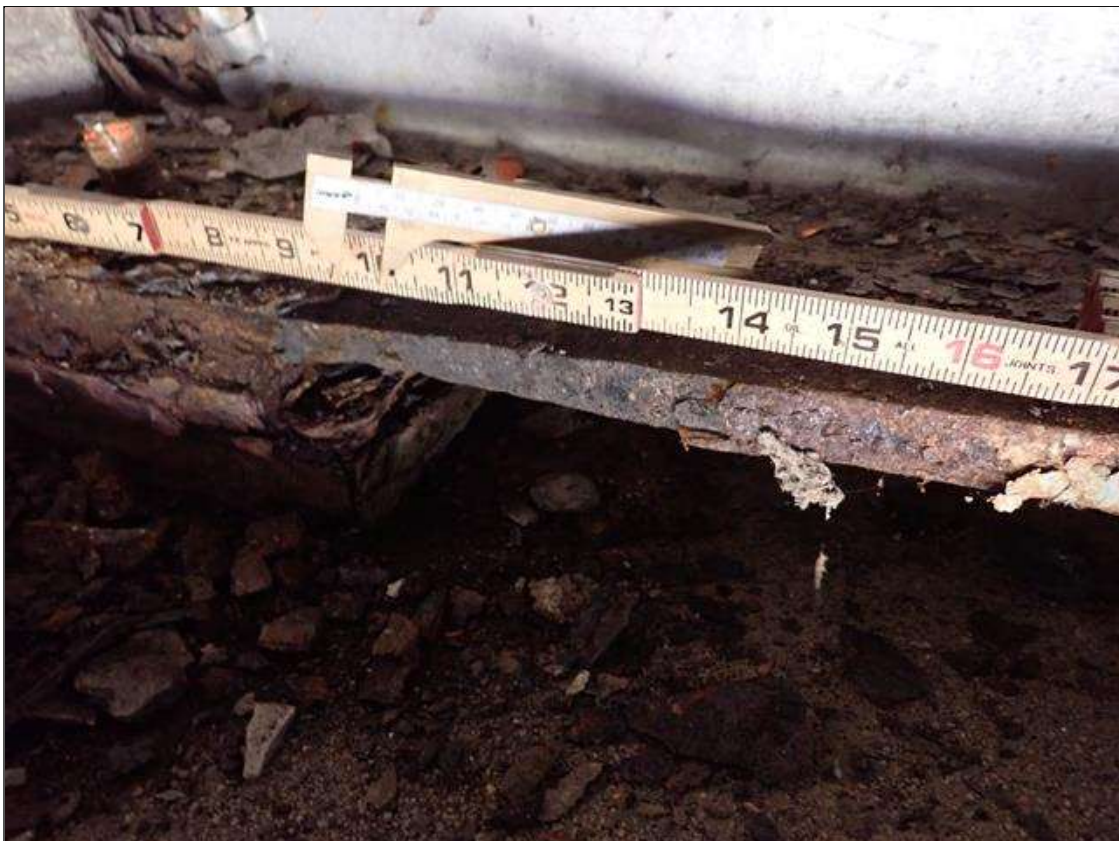
Span 1 Beam 1: PAR: CORROSION ALONG RIGHT EDGE OF BOTTOM FLANGE UP TO 16 INCH LONG X 4 INCH WIDE DOWN TO 5/8 INCH RESIDUAL FLANGE EXTENDING FROM END BENT 1

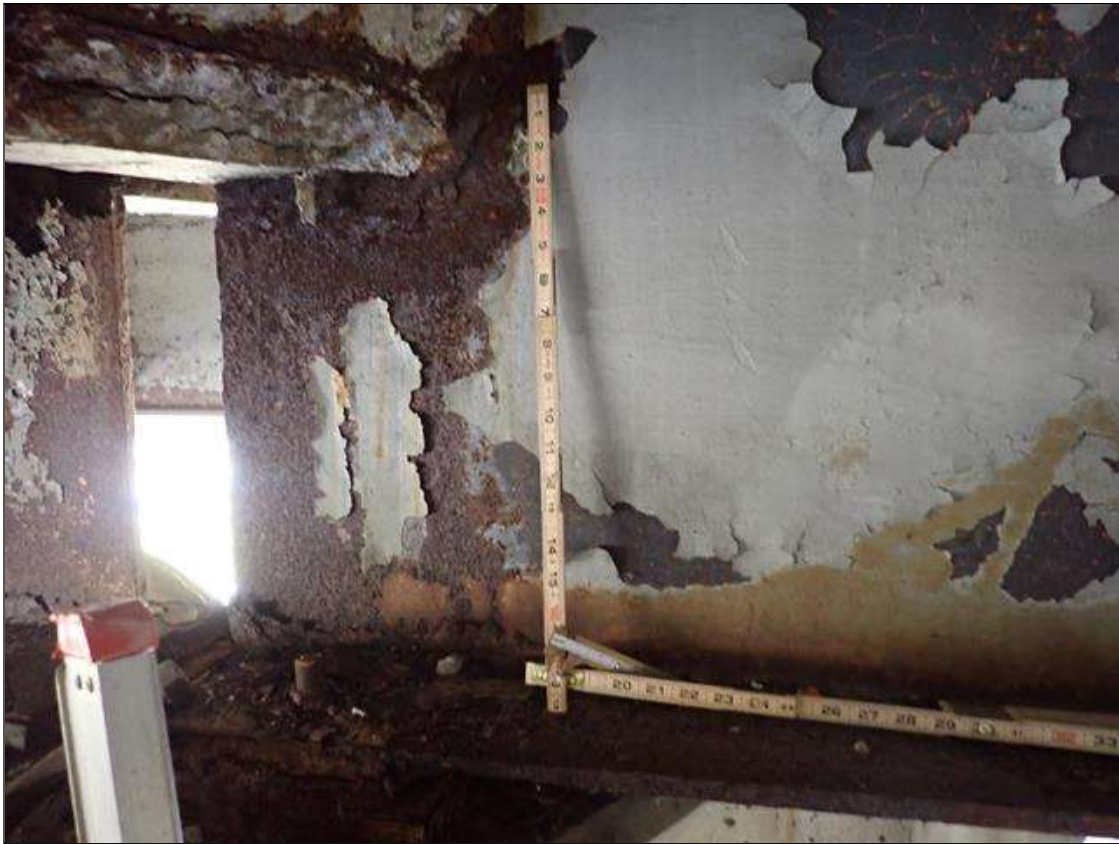
Span 1 Beam 3: PAR: CORROSION ALONG BOTH FACES OF WEB AND BOTTOM FLANGE UP TO 12 INCH LONG X 20 INCH HIGH DOWN TO 5/16 INCH RESIDUAL WEB AND 35 INCH LONG X 10 INCH WIDE DOWN TO 1/2 INCH RESIDUAL BOTTOM FLANGE AT BENT 1

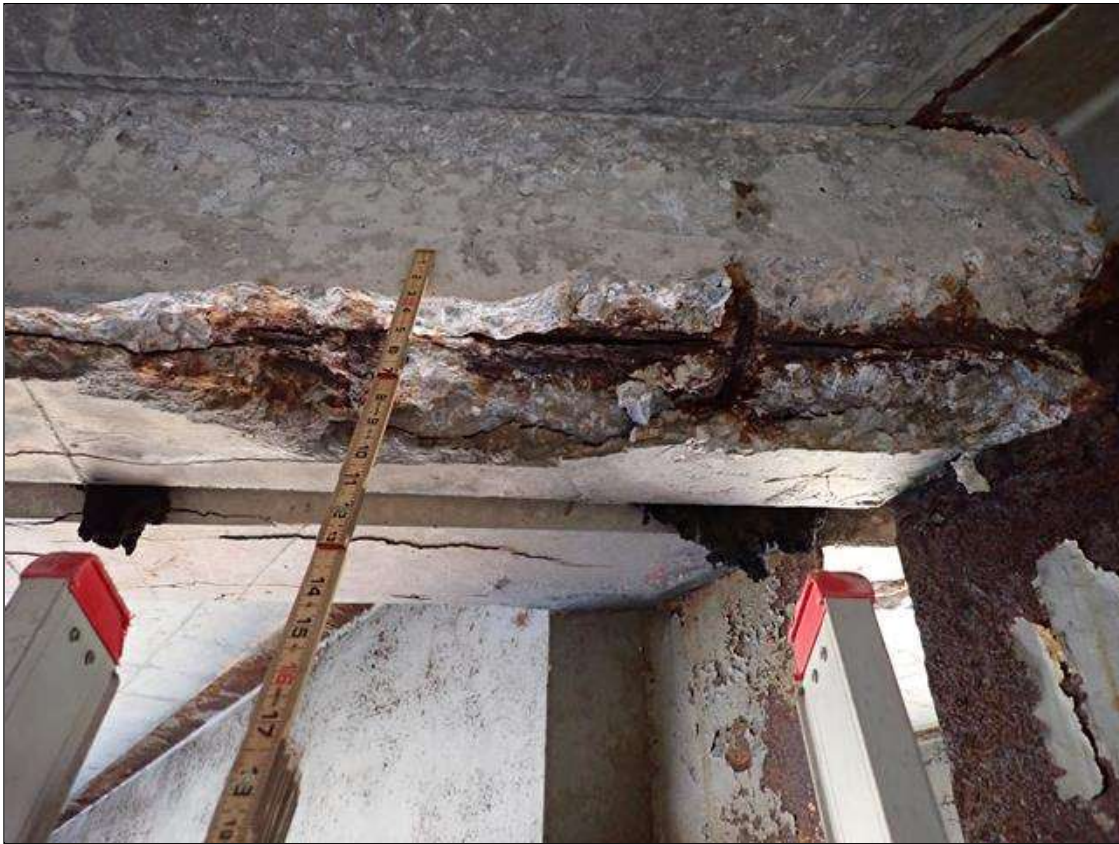
Span 1 Beam 2: 38 INCH LONG X 7 INCH WIDE X 1 INCH DEEP SPALL WITH EXPOSED REBAR IN END DIAPHRAGM ADJACENT TO BEAM 3

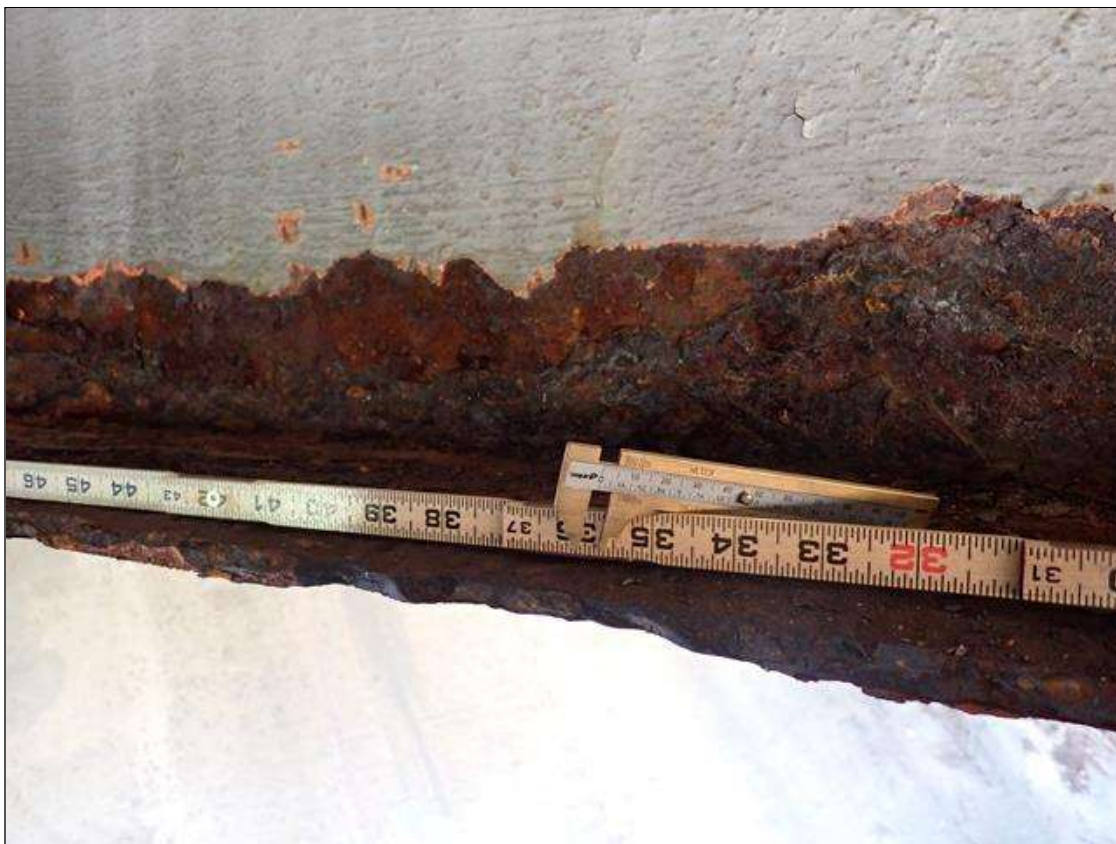
Span 1 Beam 4: PAR: CORROSION ALONG BOTH FACES OF WEB AND BOTTOM FLANGE UP TO 14 INCH LONG X 24 INCH HIGH DOWN TO 1/4 INCH RESIDUAL WEB AND 58 INCH LONG X 10 INCH WIDE DOWN TO 5/16 INCH RESIDUAL BOTTOM FLANGE EXTENDING FROM BENT 1

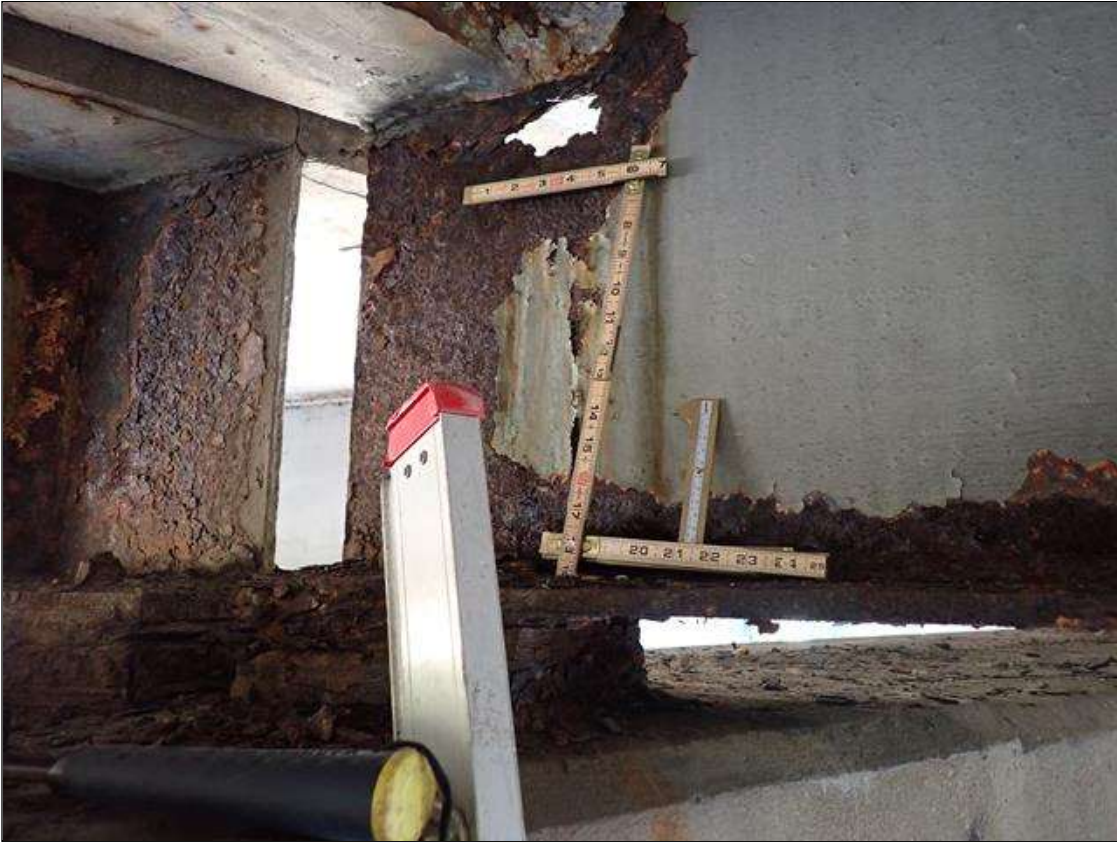
Span 1 Beam 5: PAR: CORROSION ALONG BOTH FACES OF WEB AND BOTTOM FLANGE UP TO 12 INCH LONG X 20 INCH HIGH DOWN TO KNIFES EDGE RESIDUAL WEB WITH 4 INCH X 2 INCH HOLE AT END DIAPHRAGM AND 38 INCH LONG X 10 INCH WIDE DOWN TO 5/8 INCH INCH RESIDUAL BOTTOM FLANGE EXTENDING FROM BENT 1

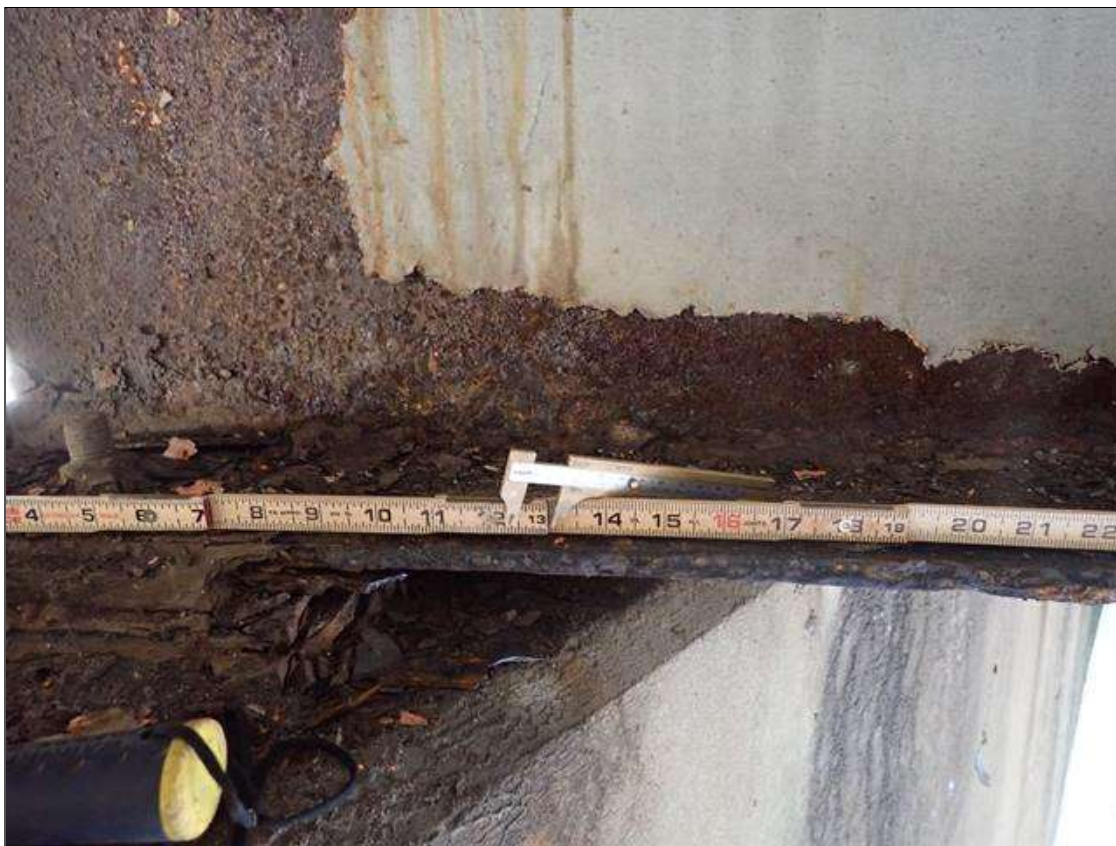
Span 1 Beam 6: PAR: CORROSION ALONG BOTH FACES OF WEB AND BOTTOM FLANGE UP TO 13 INCH LONG X 19 INCH HIGH DOWN TO 1/2 INCH RESIDUAL WEB AND 40 INCH LONG X 10 INCH WIDE DOWN TO 5/8 INCH RESIDUAL BOTTOM FLANGE EXTENDING FROM BENT 1

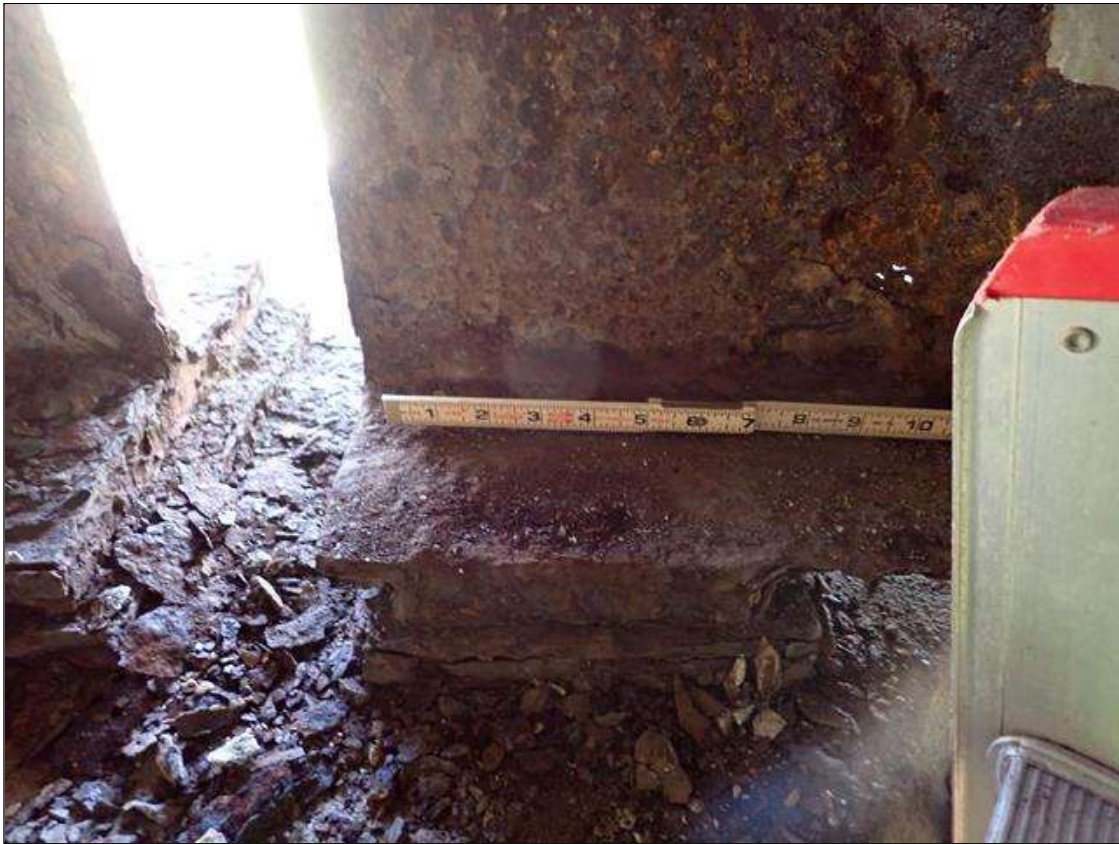
Span 1 Beam 7 - Far Bearing: PAR: MISSING ANCHOR BOLT ON LEFT SIDE

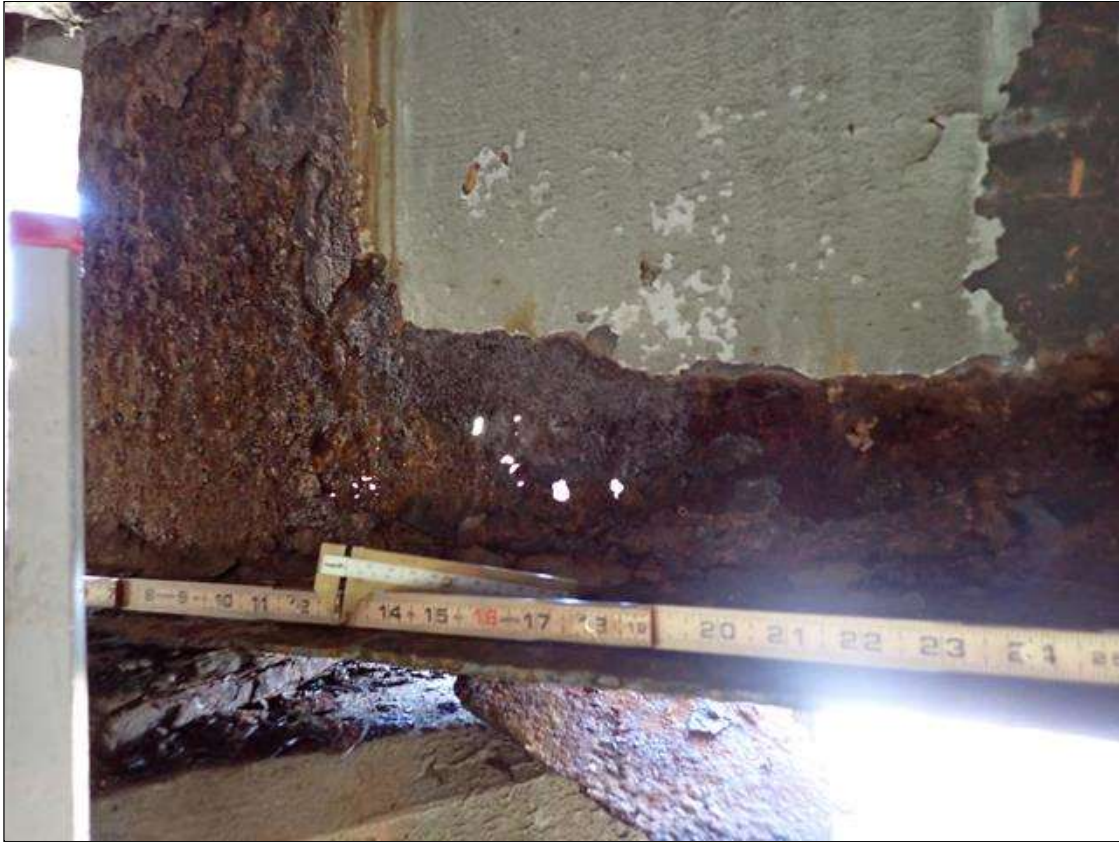
Span 1 Beam 7: PAR: CORROSION ALONG BOTH FACES OF WEB AND BOTTOM FLANGE UP TO 36 INCH LONG X UP TO 21 INCH HIGH DOWN TO KNIFE EDGE RESIDUAL WEB WITH 8 INCH X 3 INCH AREA OF UP TO 1/2 INCH DIAMETER HOLES IN WEB AND 36 INCH LONG X 10 INCH WIDE DOWN TO 1/8 INCH RESIDUAL BOTTOM FLANGE EXTENDING FROM BENT 1

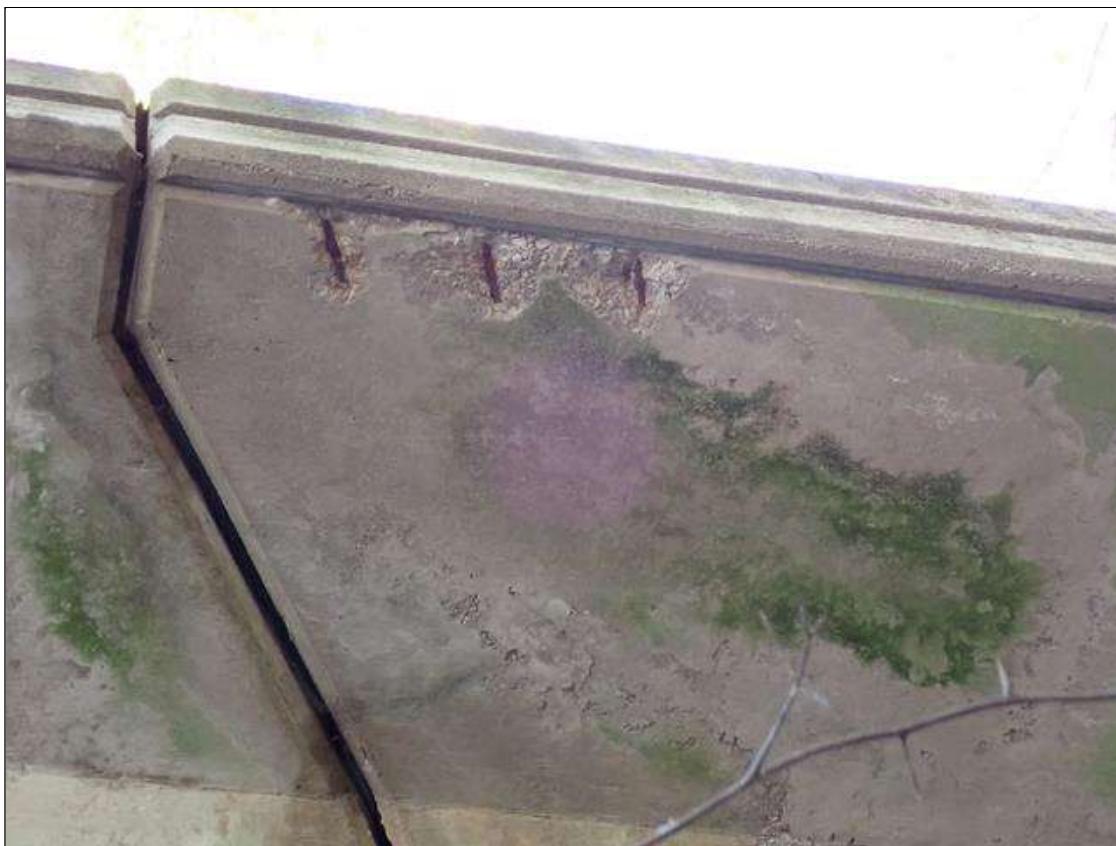
Span 1 Deck: (3) SPALLS UP TO 6 INCH X 6 INCH X 1 INCH DEEP WITH EXPOSED REBAR IN BOTTOM OF LEFT OVERHANG AT FAR END

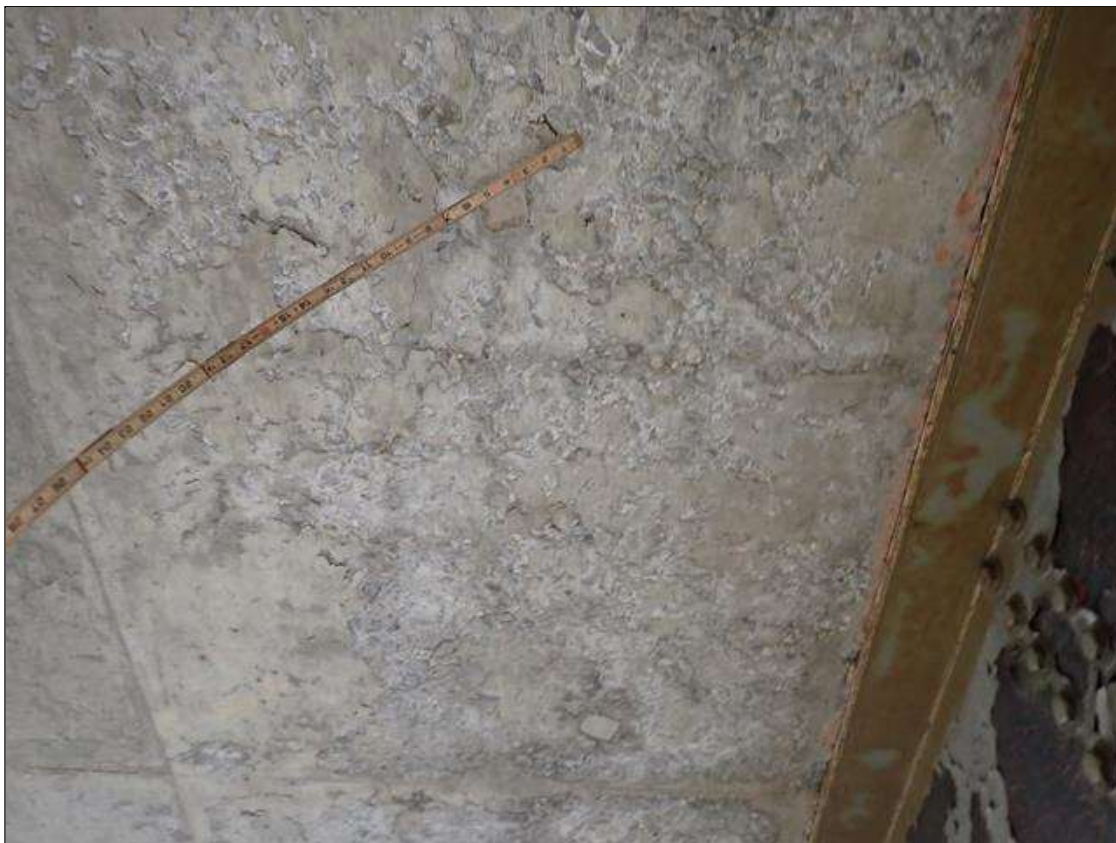
Span 1 Deck: AREAS OF POORLY CONSOLIDATED CONCRETE IN VARIOUS LOCATIONS IN BOTTOM OF DECK

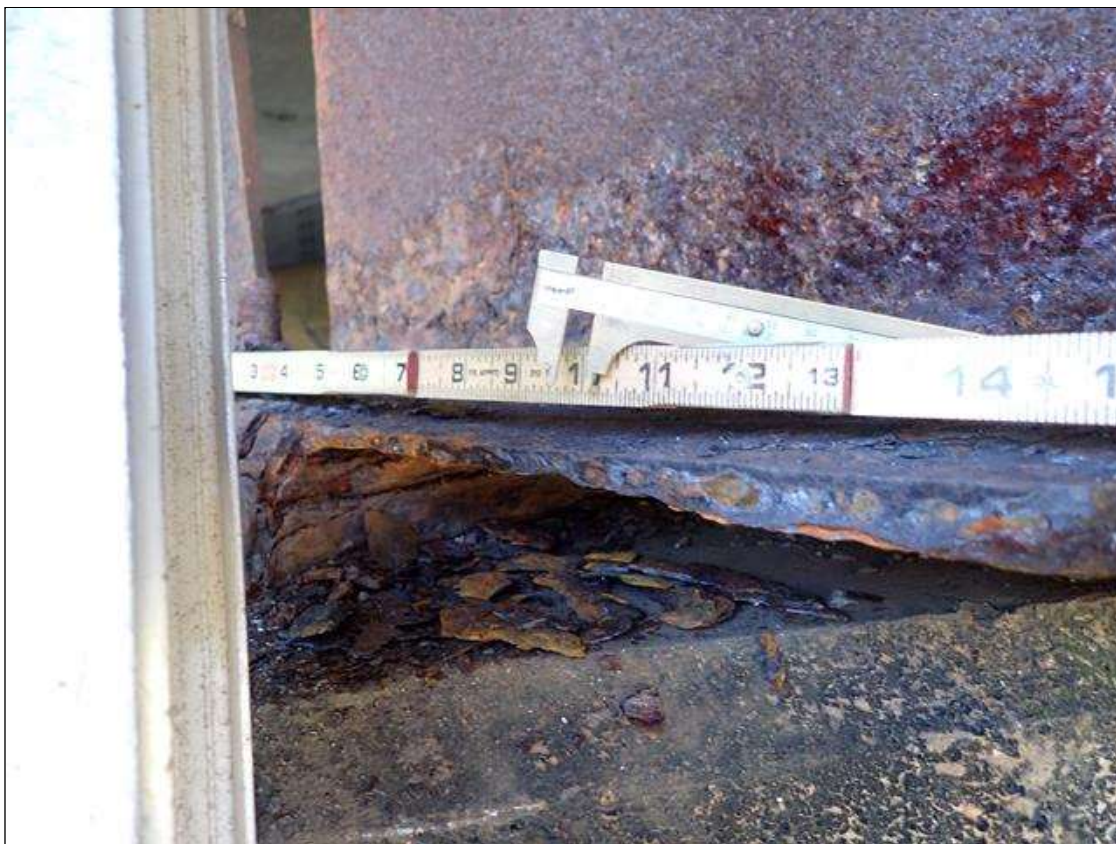
Span 2 Beam 7: PAR: CORROSION ALONG BOTH FACES OF WEB AND BOTTOM FLANGE UP TO 18 INCH LONG X 20 INCH HIGH WITH NO MEASURABLE LOSS OF SECTION IN WEB AND 23 INCH LONG X 10 INCH WIDE DOWN TO 5/16 INCH RESIDUAL BOTTOM FLANGE EXTENDING FROM BENT 1

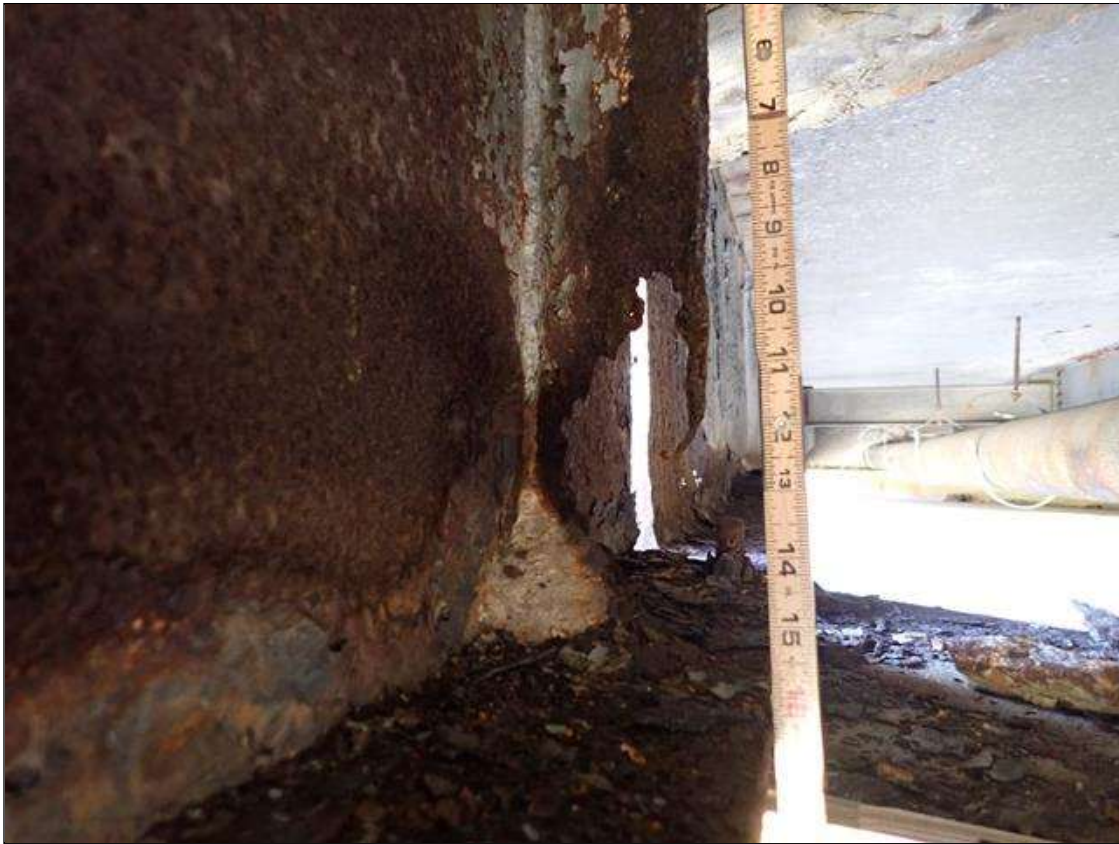
Span 2 Beam 7: PAR: CORROSION THROUGHOUT LEFT SIDE STIFFENER WITH 7 INCH X 4 INCH LOSS OF SECTION AT BENT 1 BEARING

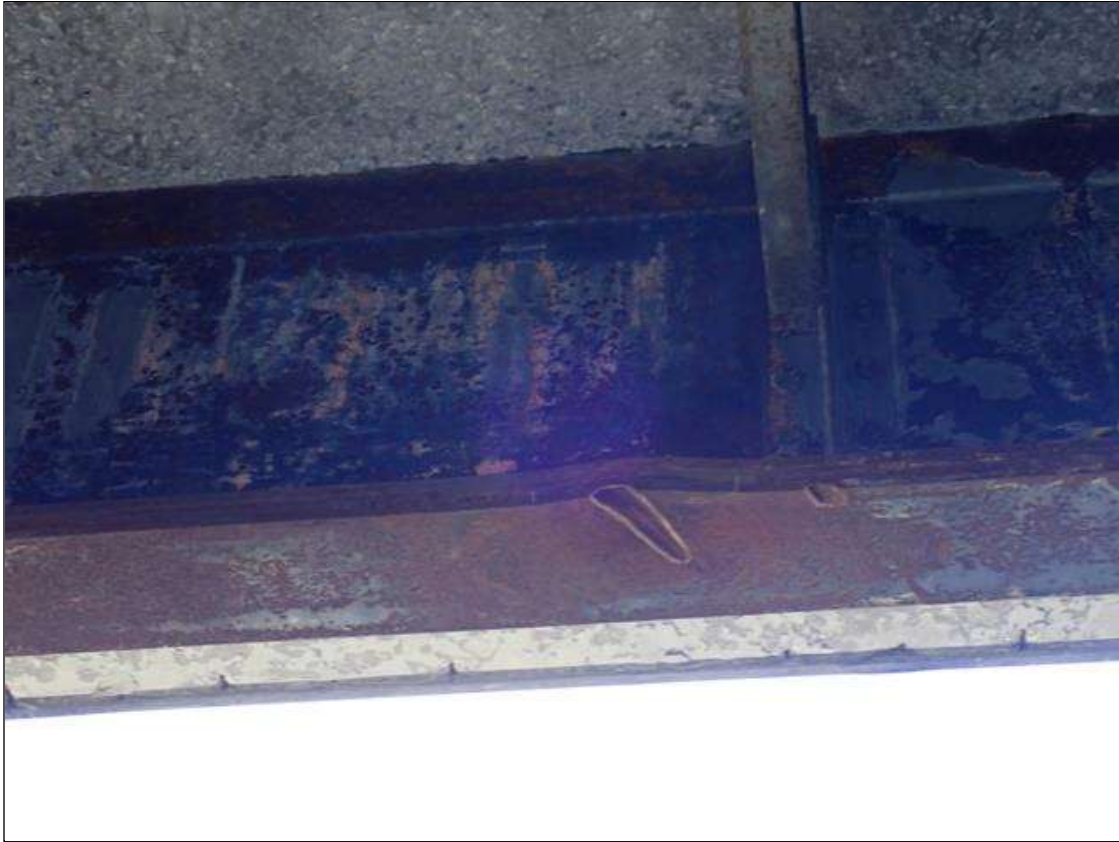
Span 2 Beam 7: PAR: IMPACT DAMAGE TO BOTTOM COVER PLATE WITH 1 1/2 INCH X 1/2 INCH X 1/16 INCH GOUGE AND 11 INCH LONG BROKEN WIELD WITH UP TO 1 INCH OF VERTICAL DEFLECTION LOCATED APPROXIMATELY 21 FOOT FROM BENT 1

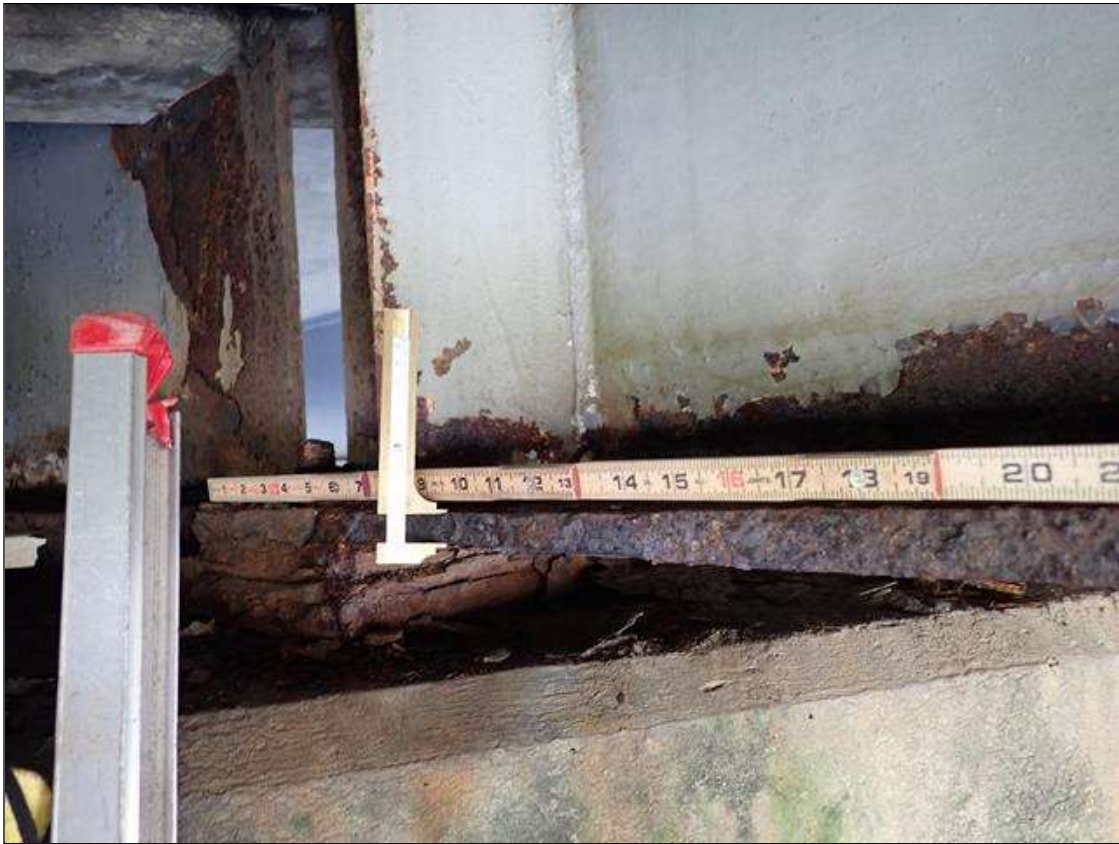
Span 2 Beam 6: PAR: CORROSION ALONG BOTH FACES OF WEB AND BOTTOM FLANGE UP TO 10 INCH LONG X 16 INCH HIGH WITH NO MEASURABLE LOSS OF SECTION IN WEB AND 17 INCH LONG X 4 INCH WIDE DOWN TO 5/8 INCH RESIDUAL BOTTOM FLANGE AT BENT 1

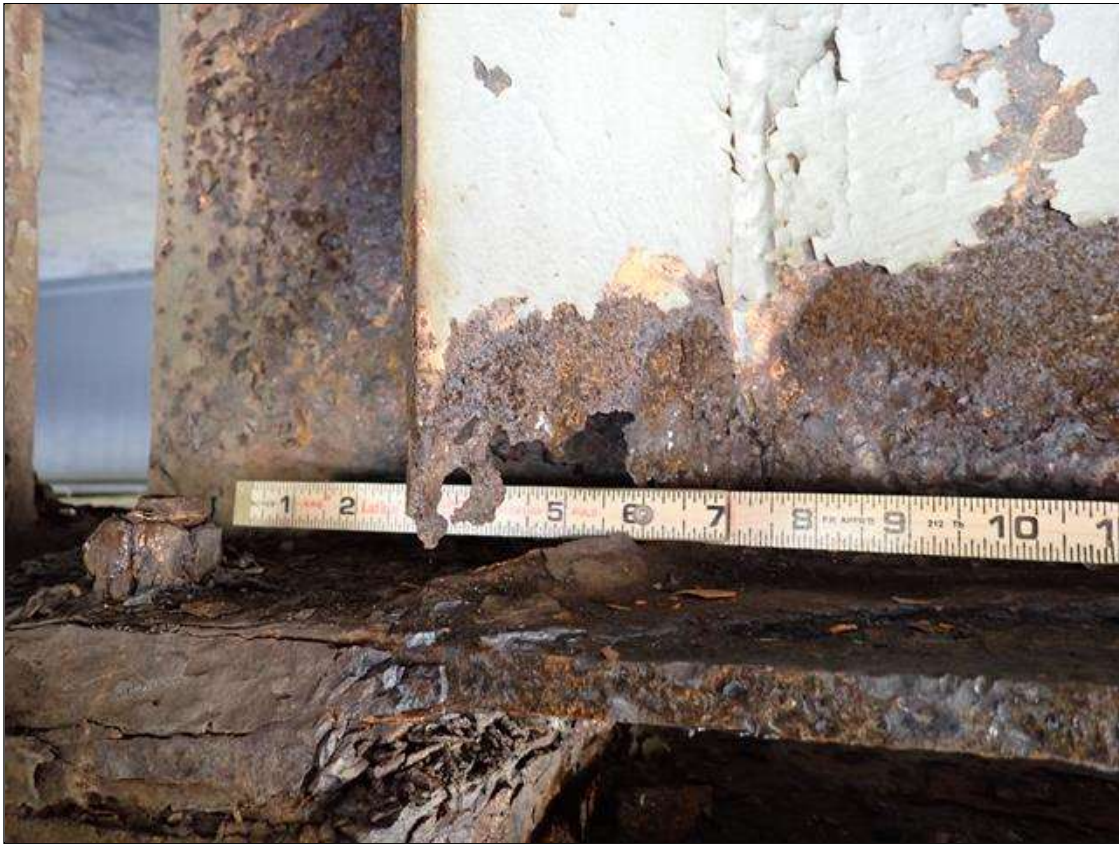
Span 2 Beam 5: PAR: CORROSION THROUGHOUT RIGHT SIDE STIFFENER WITH 4 INCH X 2 INCH LOSS OF SECTION AT BENT 1 BEARING

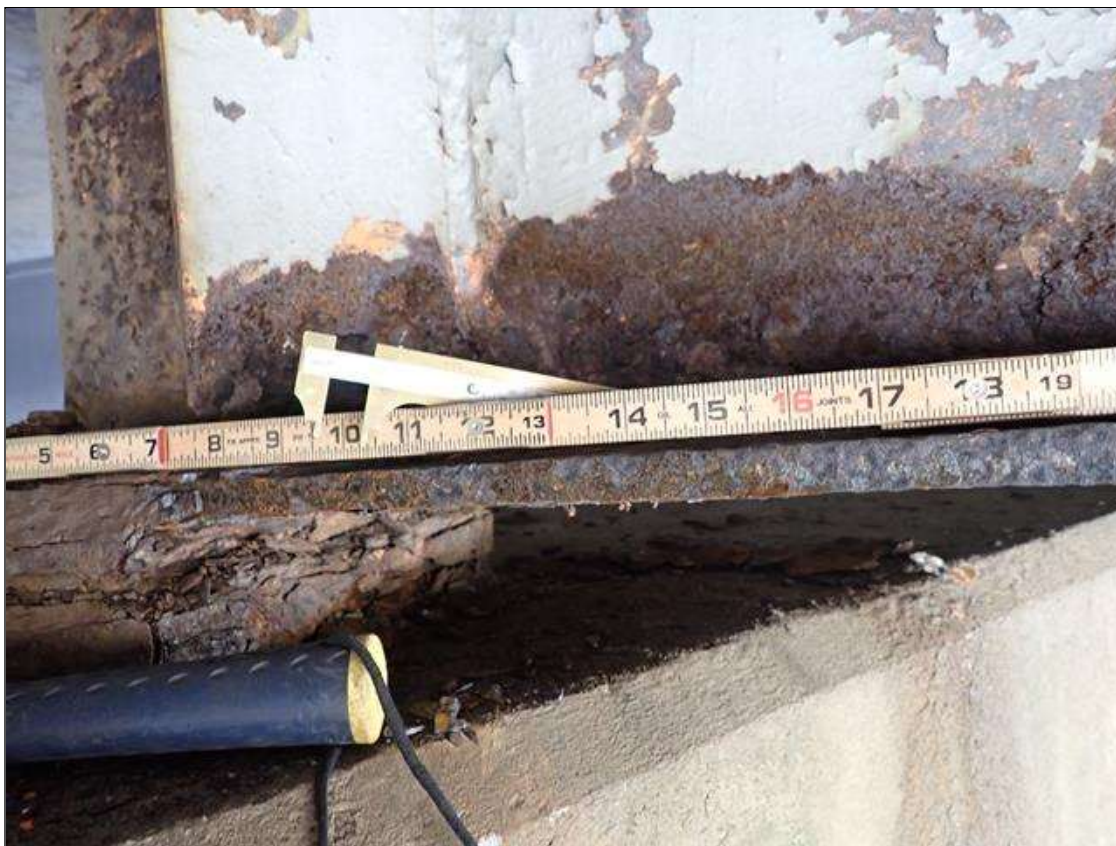
Span 2 Beam 5: PAR: CORROSION ALONG BOTH FACES OF WEB AND BOTTOM FLANGE UP TO 36 INCH LONG X UP TO 17 INCH HIGH WITH NO MEASURABLE LOSS OF SECTION IN RESIDUAL WEB AND 18 INCH LONG X 10 INCH WIDE DOWN TO 9/16 INCH RESIDUAL BOTTOM FLANGE EXTENDING FROM BENT 1
