NC DEPARTMENT OF TRANSPORTATION  
 DIVISION OF HIGHWAYS  
 STRUCTURE MANAGEMENT UNIT

ATTENTION: **PAR, DATA CHANGES, DAMAGE INSPECTION REQUESTED**

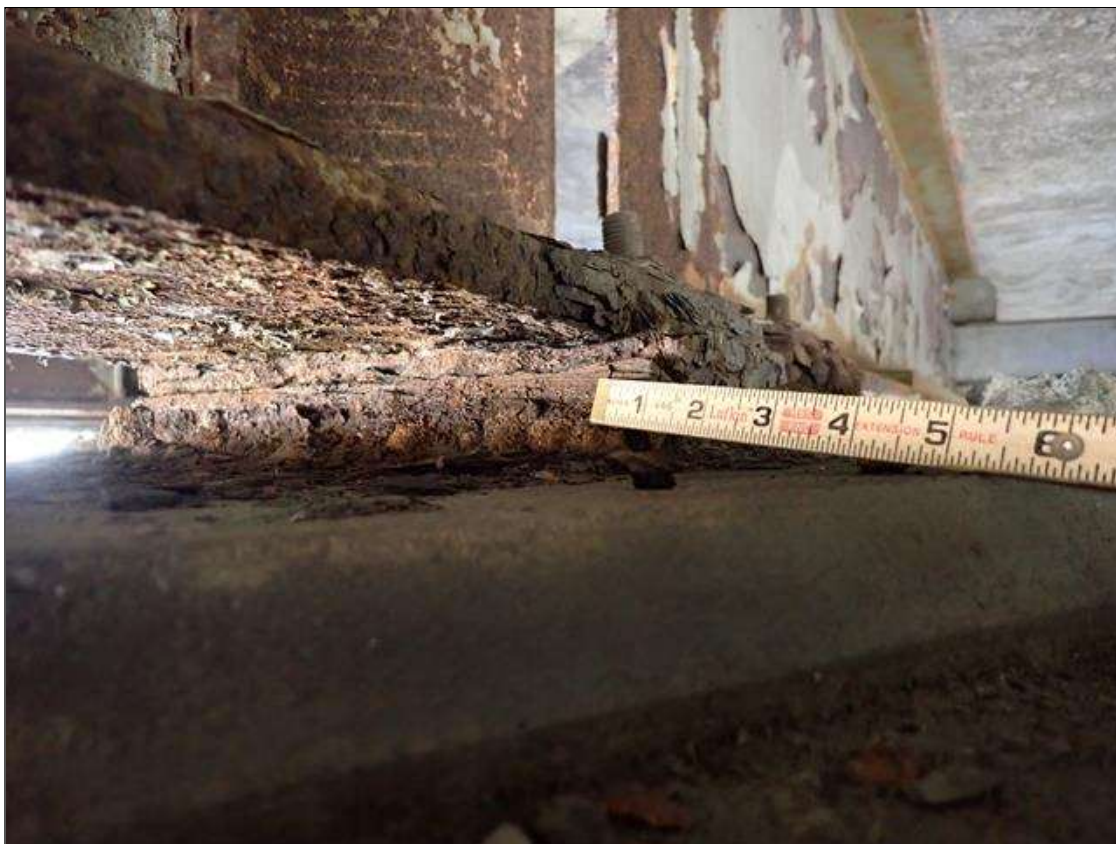
Span 2 Beam 4 - Near Bearing: CORROSION THROUGHOUT

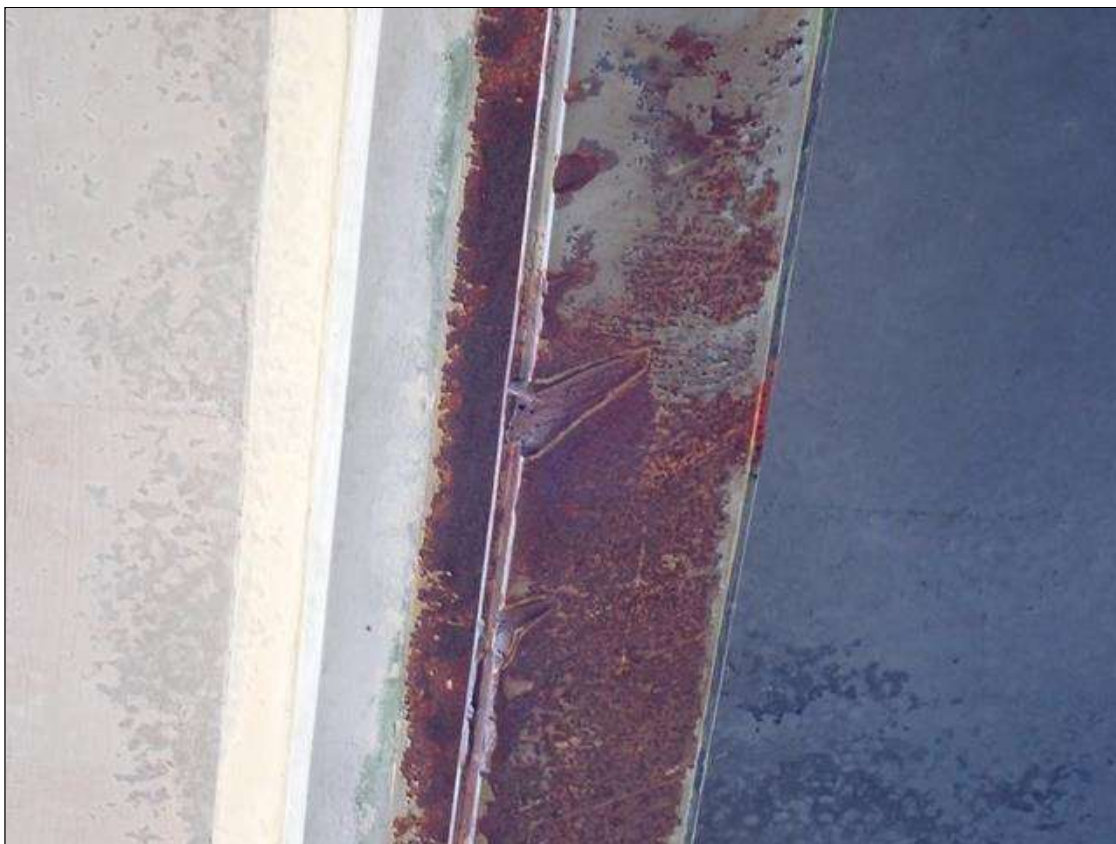
Span 2 Beam 1: PAR: IMPACT DAMAGE TO BOTTOM COVER PLATE WITH 3 INCH X 1 INCH X 1/16 INCH GOUGE AND UP TO 1/2 INCH OF VERTICAL DEFLECTION AND 1/2 INCH OF RIGHT LATTERAL DEFLECTION LOCATED APPROXIMATELY 21 FOOT FROM BENT 1

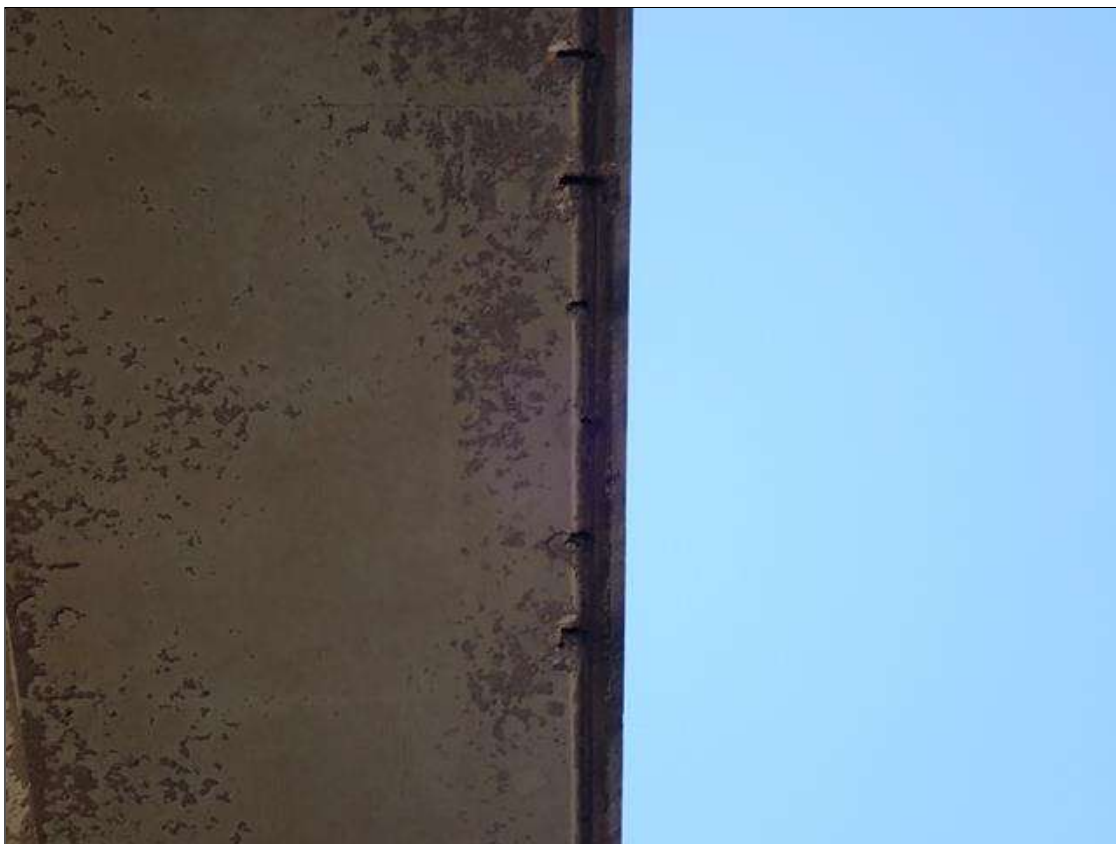
Span 2 Deck: (20) 4 INCH X 1 INCH X 1/2 INCH SPALLS WITH EXPOSED REINFORCING, AT RANDOM ALONG EAST EDGE OF EAST OVERHANG

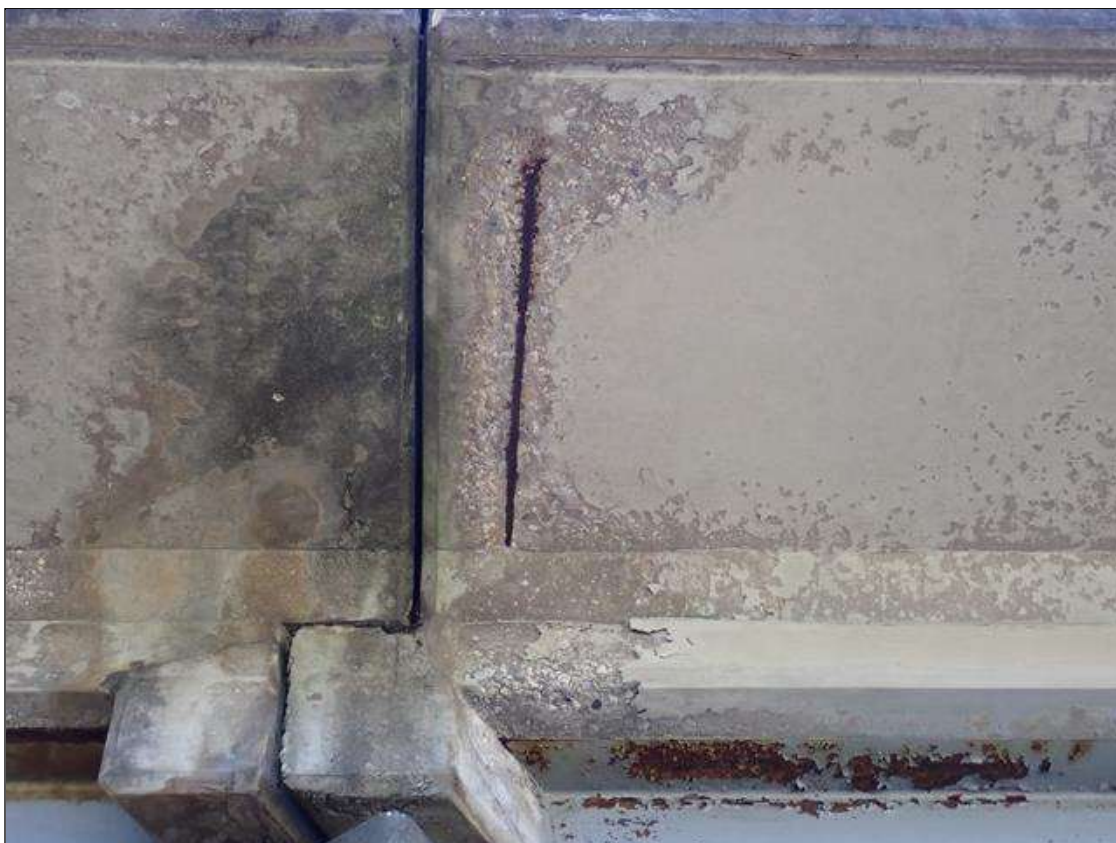
Span 2 Deck: 6 INCH X 36 INCH X 1 INCH DEEP SPALL WITH EXPOSED REINFORCING, EAST OVERHANG AT BENT 1.

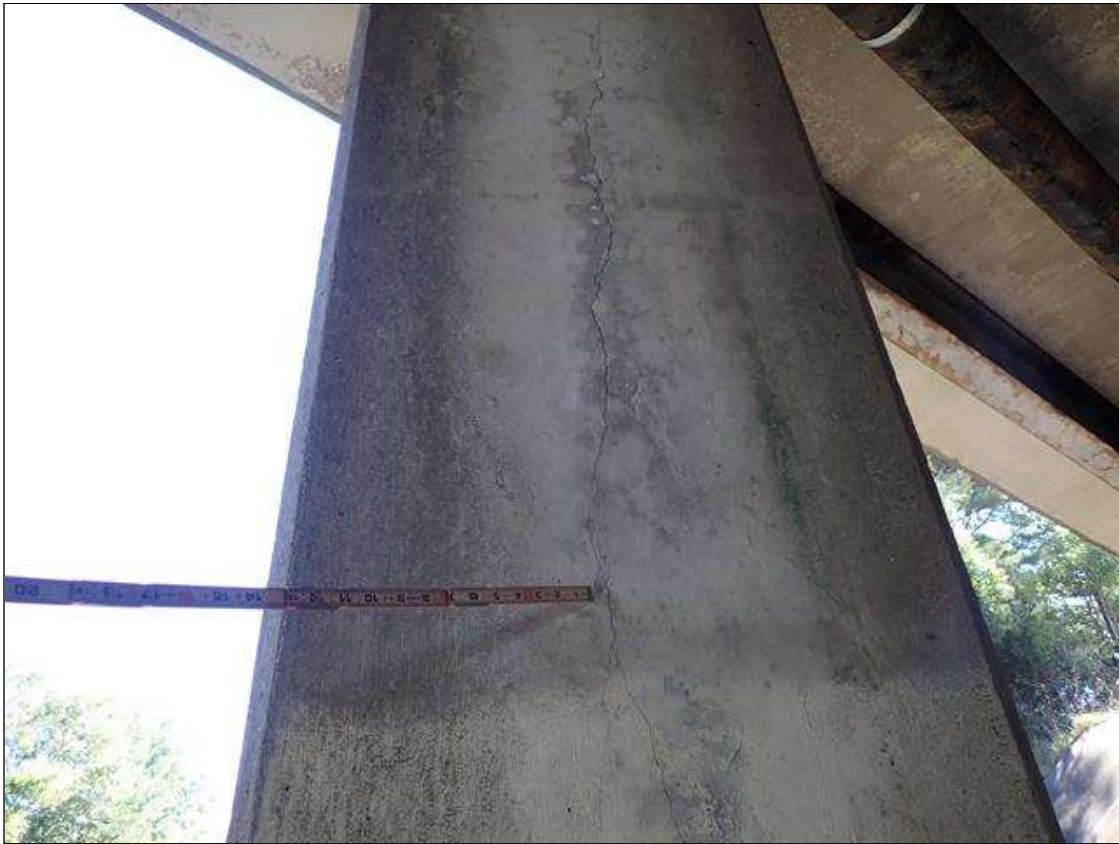
Bent 1 Pile 4: UP TO 1/16 INCH VERTICAL CRACK IN LEFT FACE OF COLUMN FOM BOTTOM OF CAP TO GROUND LINE

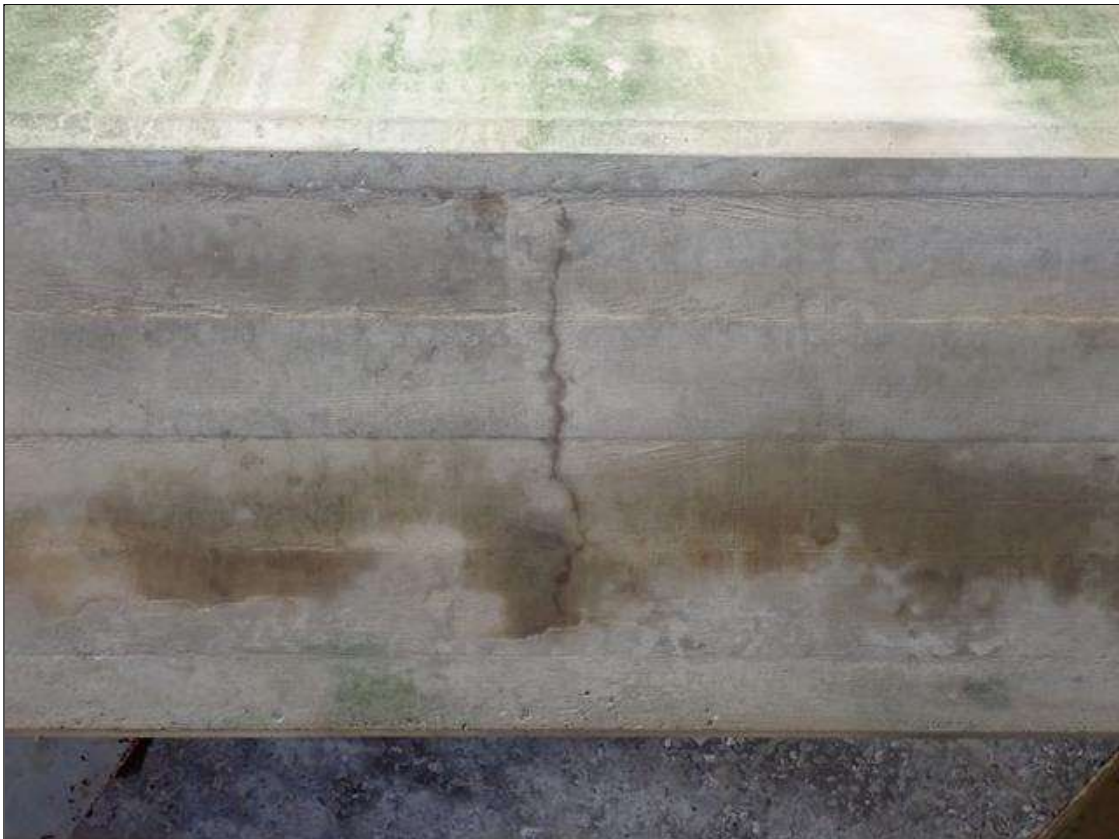
Bent 1 Cap 1: UP TO 0.05 INCH X 20 INCH TRANSVERSE CRACK IN BOTTOM OF CAP BETWEEN COLUMNS 2 AND 3

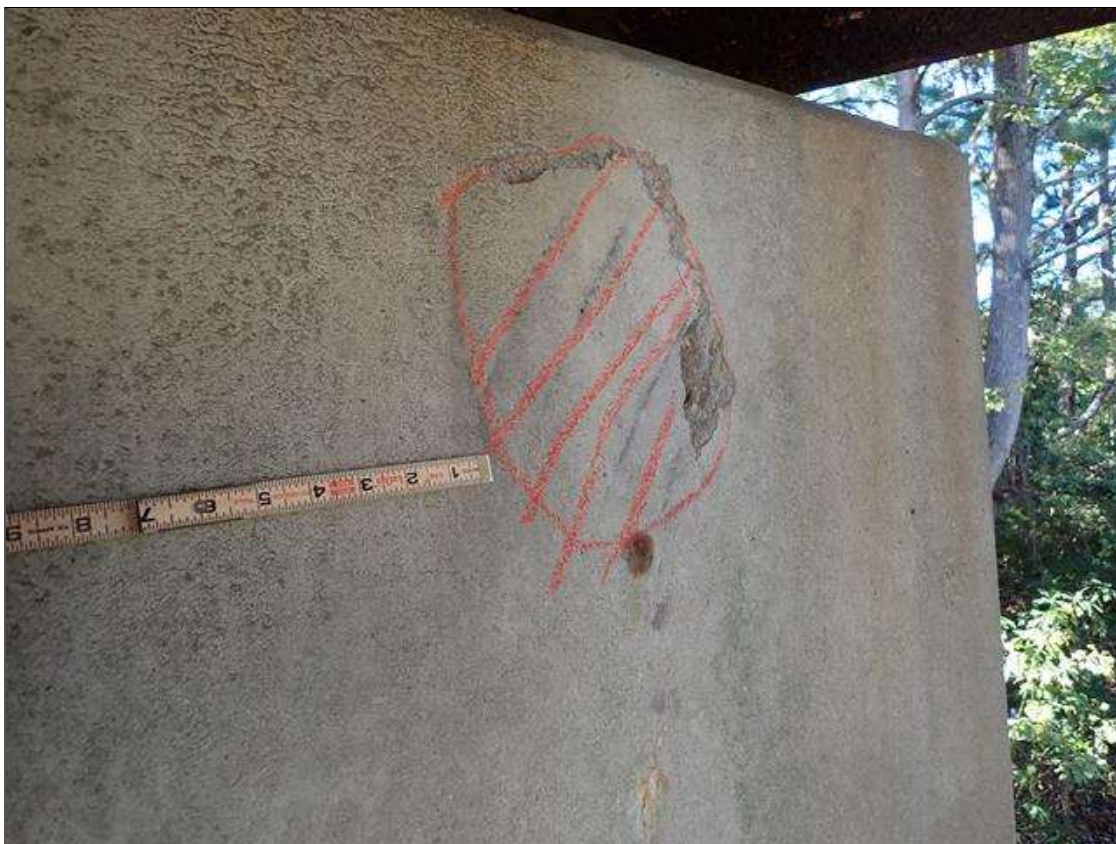
Bent 1 Cap 1: 10 INCH X 8 INCH AREA OF DELAMINATION IN SPAN 2 FACE OF CAP BENEATH BEAM 1

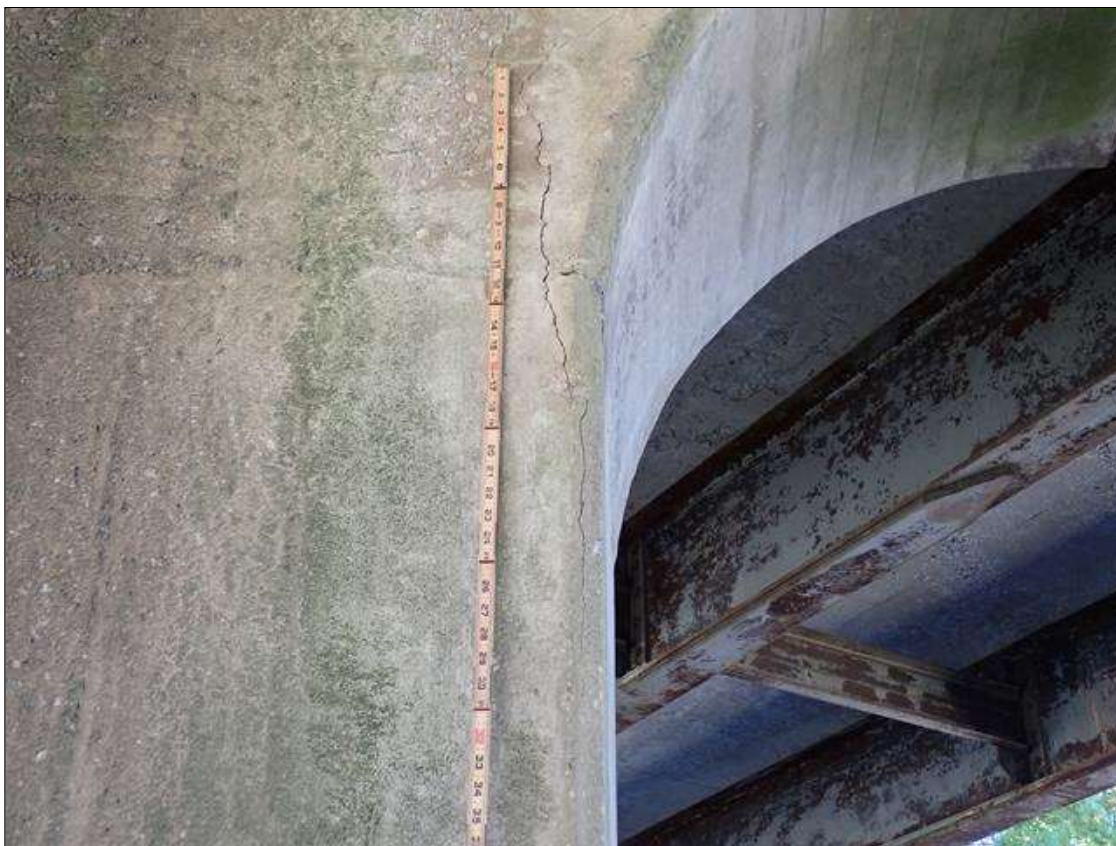
Bent 2 Pile 3: UP TO 1/16 INCH X 28 INCH VERTICAL CRACK IN NORTHWEST CORNER AT BOTTOM OF CAP

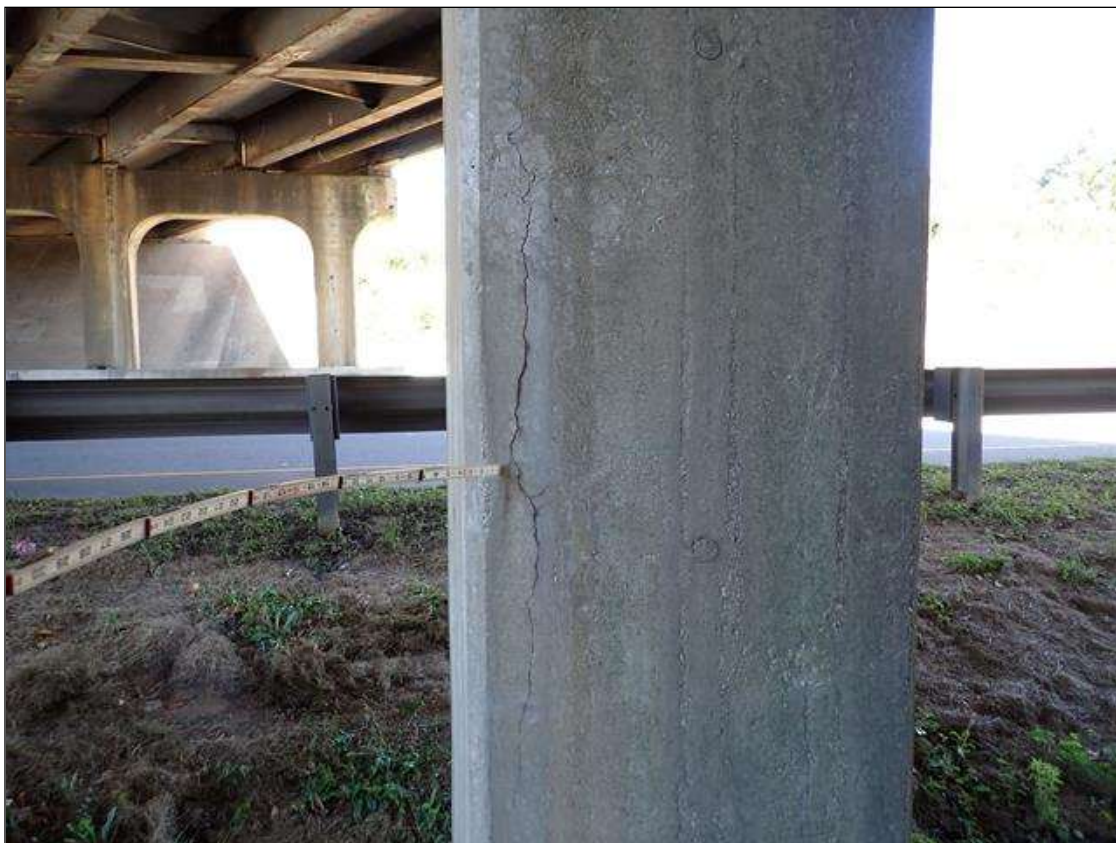
Bent 2 Pile 3: UP TO 1/16 INCH VERTICAL CRACK IN SPAN 2 FACE ALONG LEFT EDGE AT MID HEIGHT

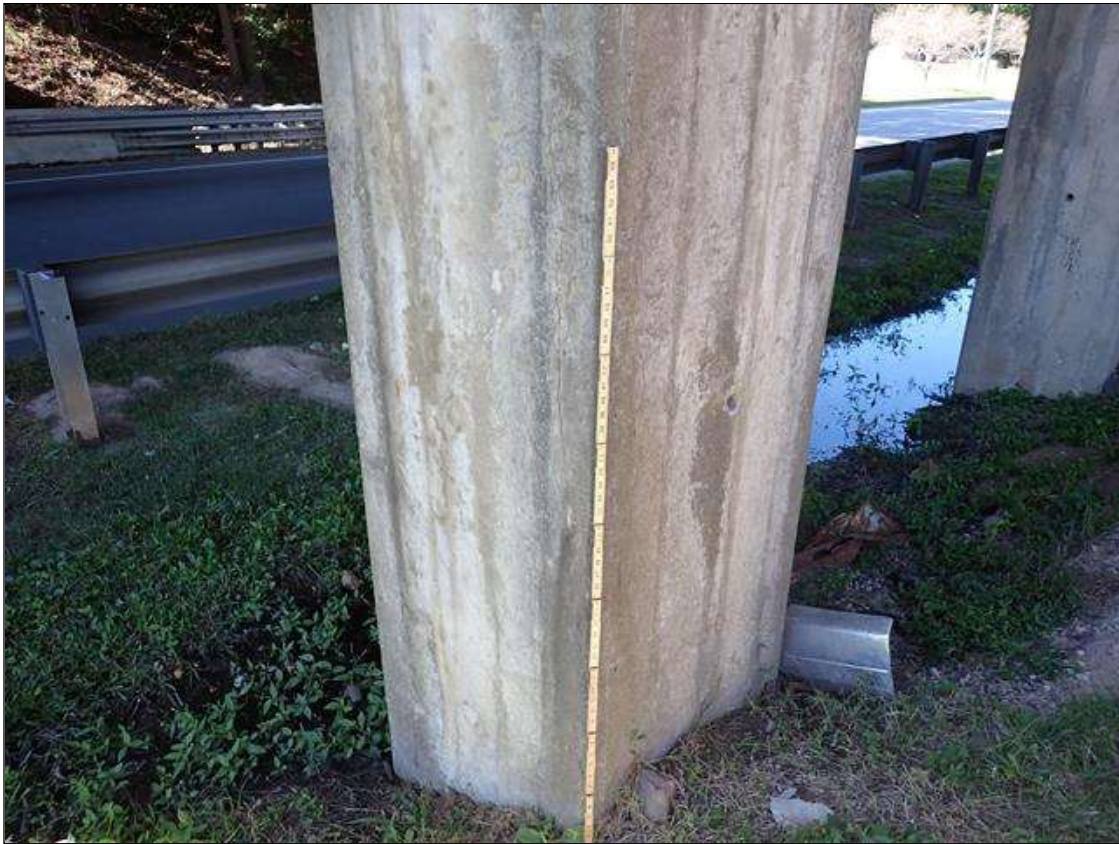
Bent 2 Pile 5: UP TO 1/16 INCH X 40 INCH VERTICAL CRACKS IN SPAN 3 AND EAST FACE OF COLUMN NEAR GROUND LINE

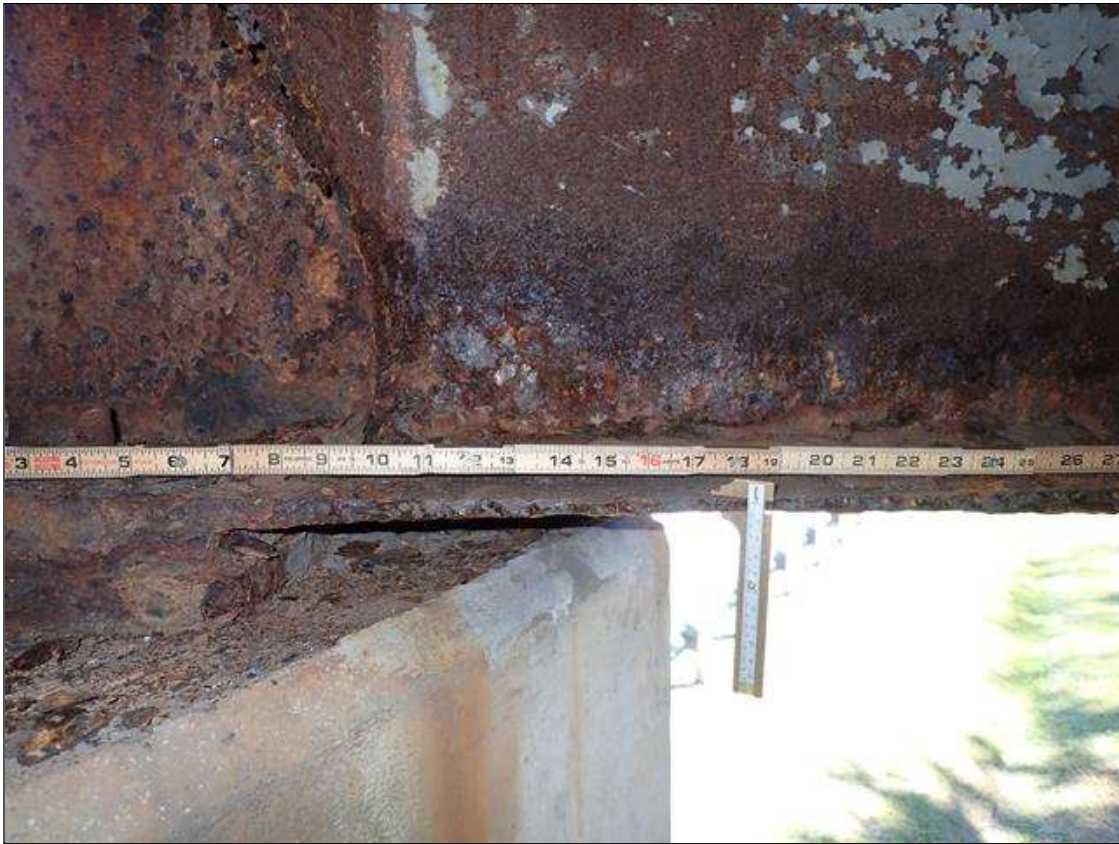
Span 2 Beam 7: PAR: CORROSION ALONG BOTH FACES OF WEB AND BOTTOM FLANGE UP TO 52 INCH LONG X 20 INCH HIGH DOWN TO 1/2 INCH RESIDUAL WEB AND 36 INCH LONG X 10 INCH WIDE DOWN TO 5/16 INCH RESIDUAL BOTTOM FLANGE EXTENDING FROM BENT 2

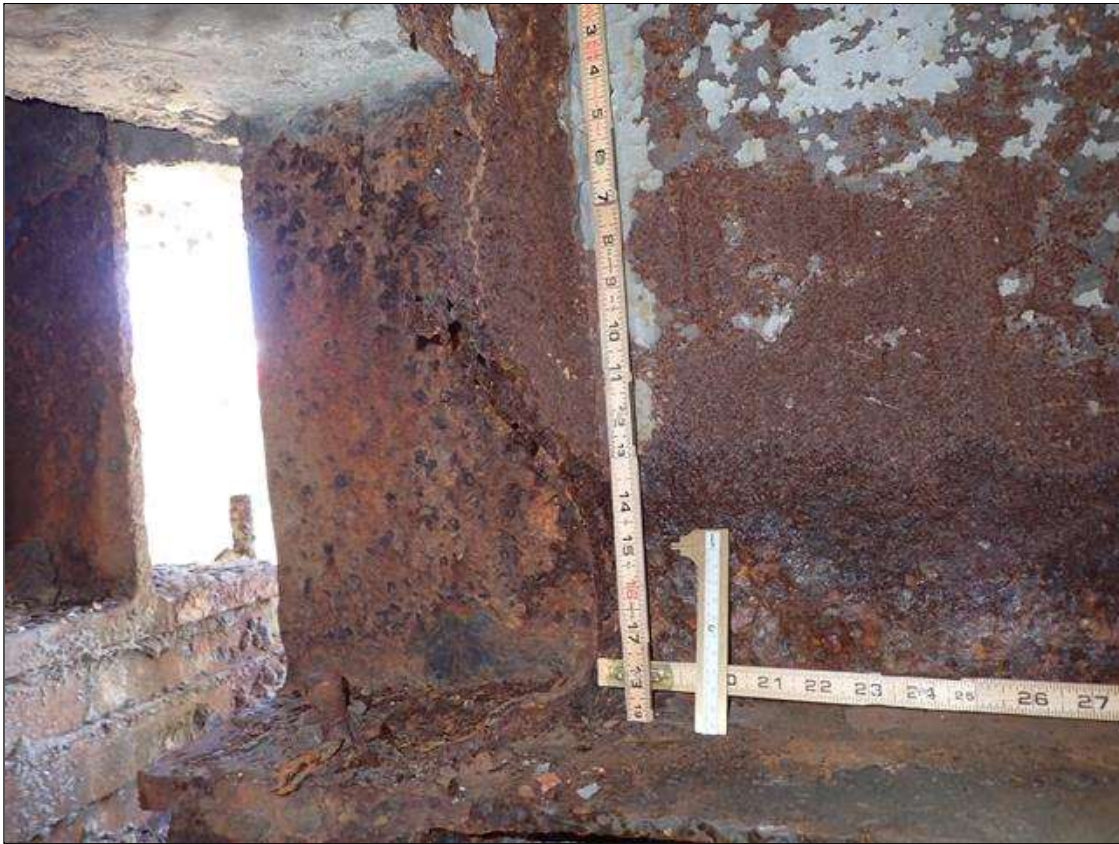
Span 2 Beam 7: PAR: CORROSION THROUGHOUT VERTICAL STIFFENER WITH 15 INCH X 5 INCH LOSS OF SECTION ON LEFT SIDE AT BENT 2 BEARING

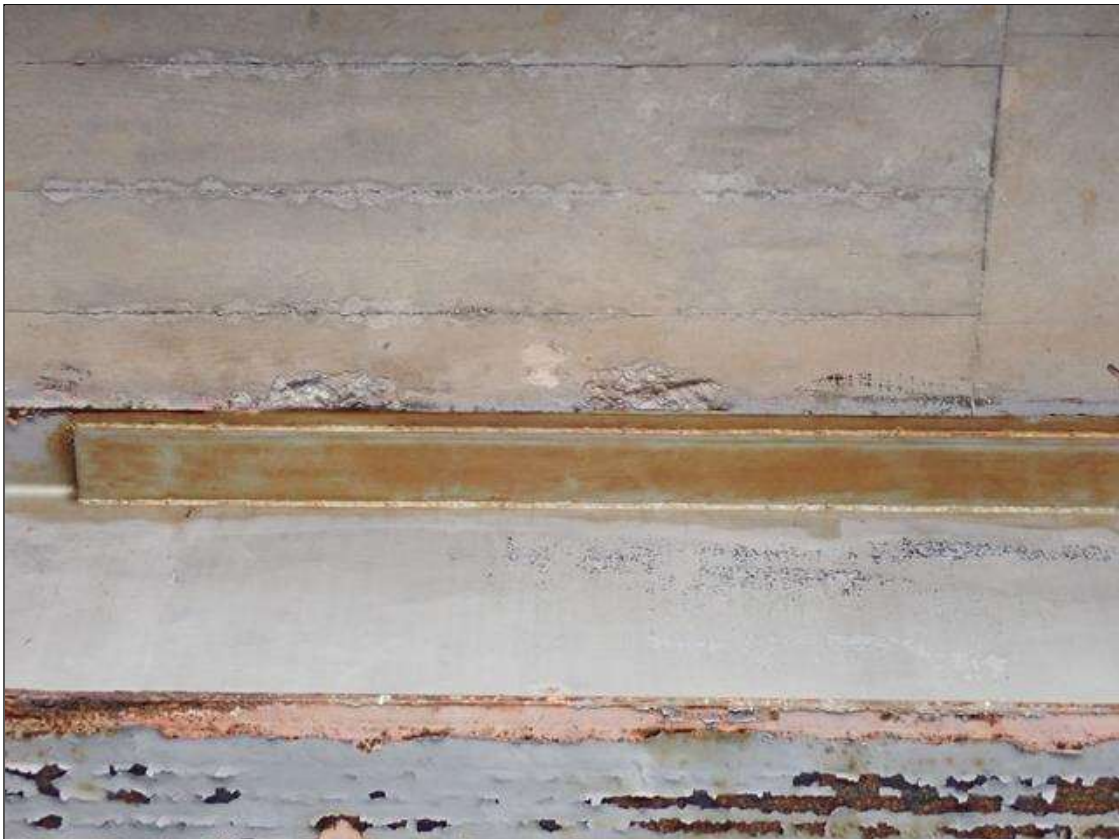
Span 3 Deck: SPALLING UP TO 6 INCH DIAMETER X 3/4 INCH DEEP IN VARIOUS LOCATIONS ALONG EDGES OF BEAMS 3, 4 AND 5 TOP FLANGE

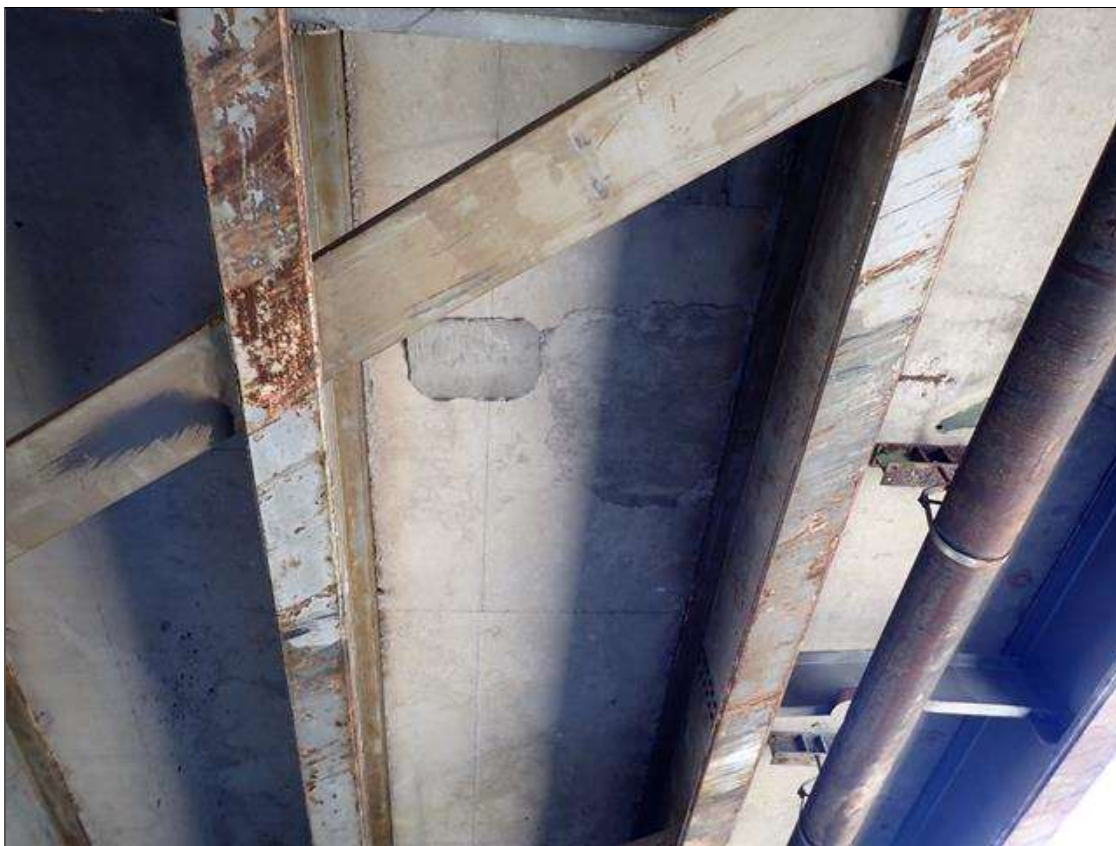
Span 3 Deck: 20 SQUARE FEET PATCHING TO UNDERSIDE OF DECK IN BAY 5, AT MIDSPAN.

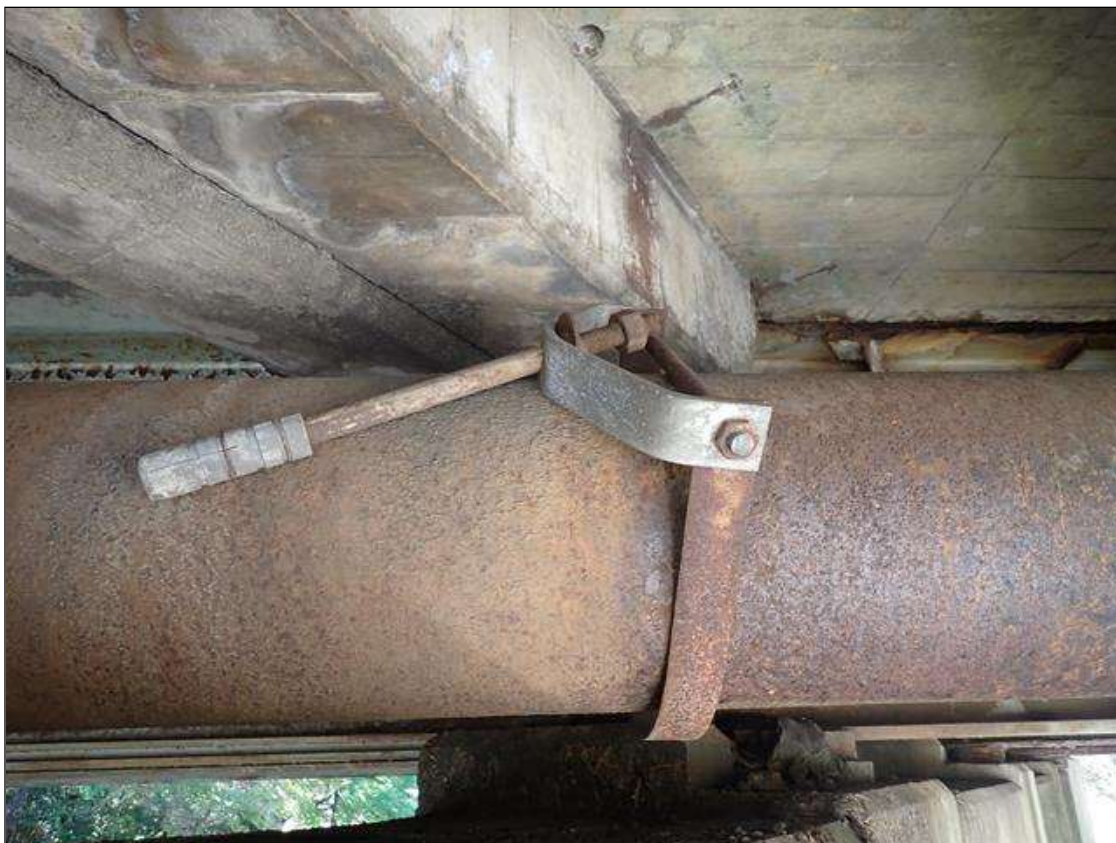
APPROXIMATELY 5 BROKEN UTILITY HANGERS IN VARIOUS LOCATIONS

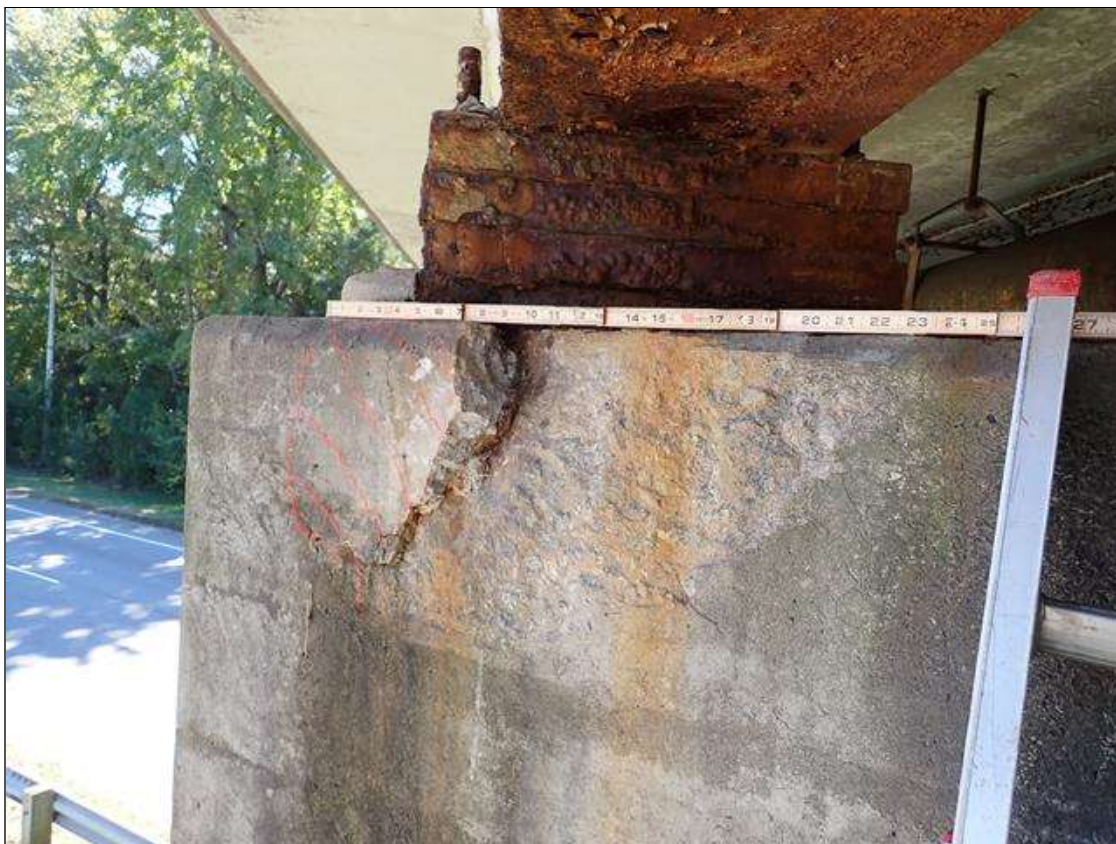
Bent 2 Cap 1: PAR: 9 INCH WIDE X 10 INCH HIGH AREA OF DELAMINATION WITH 15 INCH WIDE X 10 INCH HIGH X 3 INCH DEEP SPALL WITH EXPOSED REBAR IN TOP AND SPAN 3 FACE OF CAP BENEATH BEAM 7 BEARING

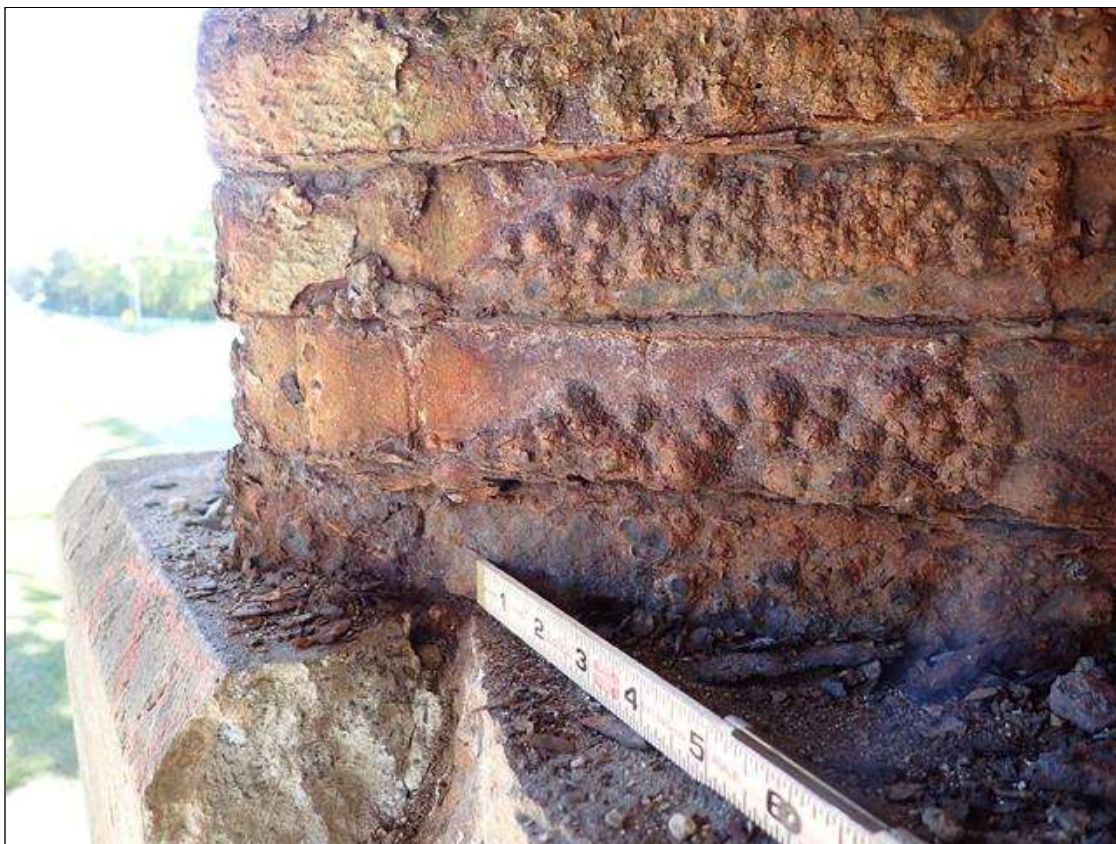
Span 3 Beam 7 - Near Bearing: AREA OF DELAMINATION IN SPAN 3 FACE OF CAP BENEATH BEAM 7 NEAR BEARING WITH APPROXIMATELY 3 INCH X 3 INCH LOSS OF BEARING

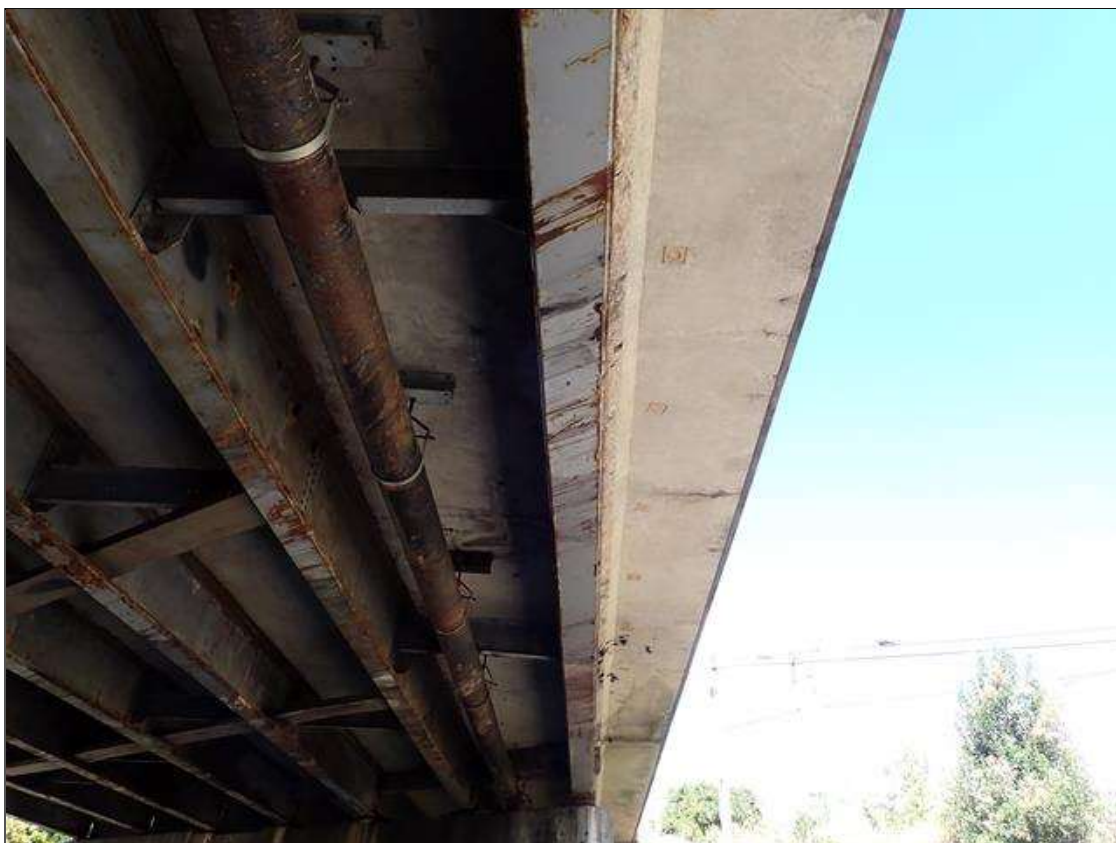
Span 3 Beam 7: 30 FOOT OF IMPACT DAMAGE WITH UP TO 1/16 INCH GOUGING THROUGHOUT (BEAM STRUCK BY TRACKER TRAILER DURING INSPECTION, DAMAGE INSPECTION REQUESTED)

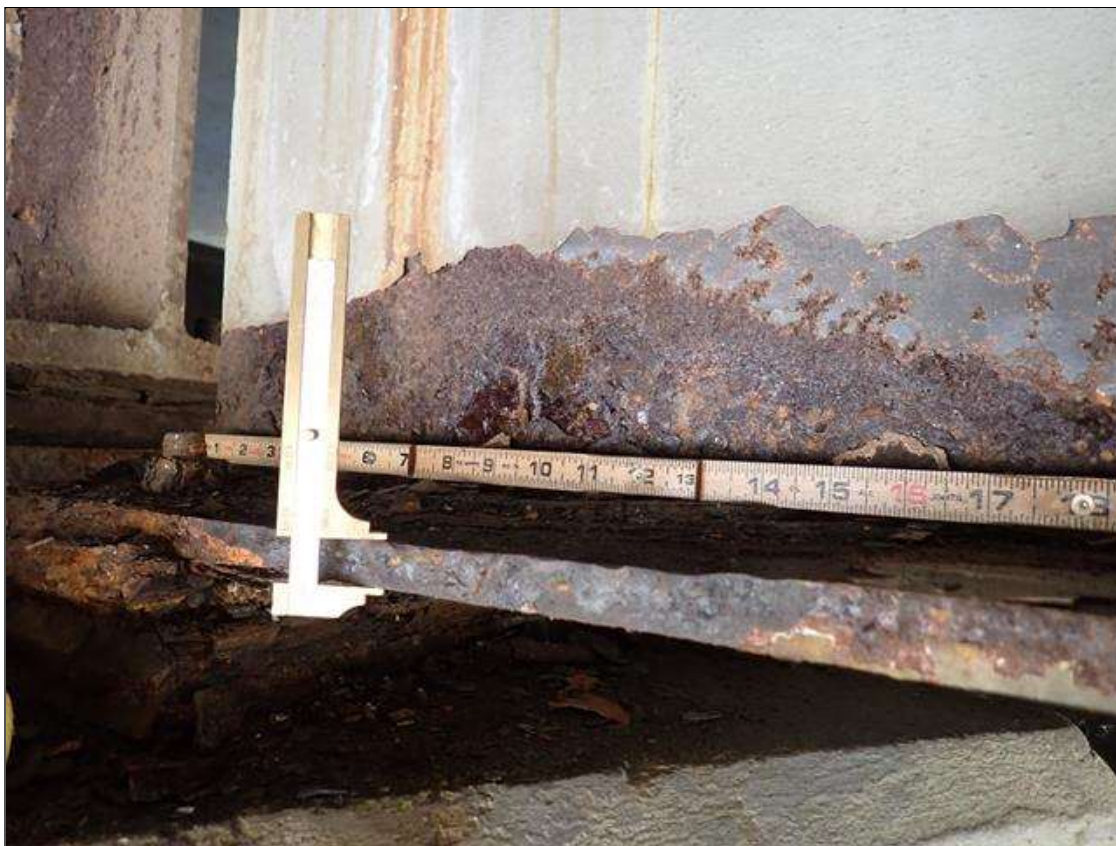
Span 3 Beam 5: PAR: CORROSION ALONG BOTH FACES OF WEB AND BOTTOM FLANGE UP TO 30 INCH LONG X 6 INCH HIGH WITH NO MEASURABLE LOSS OF SECTION IN WEB AND 17 INCH LONG X 5 INCH WIDE DOWN TO 5/8 INCH RESIDUAL BOTTOM FLANGE EXTENDING FROM BENT 2

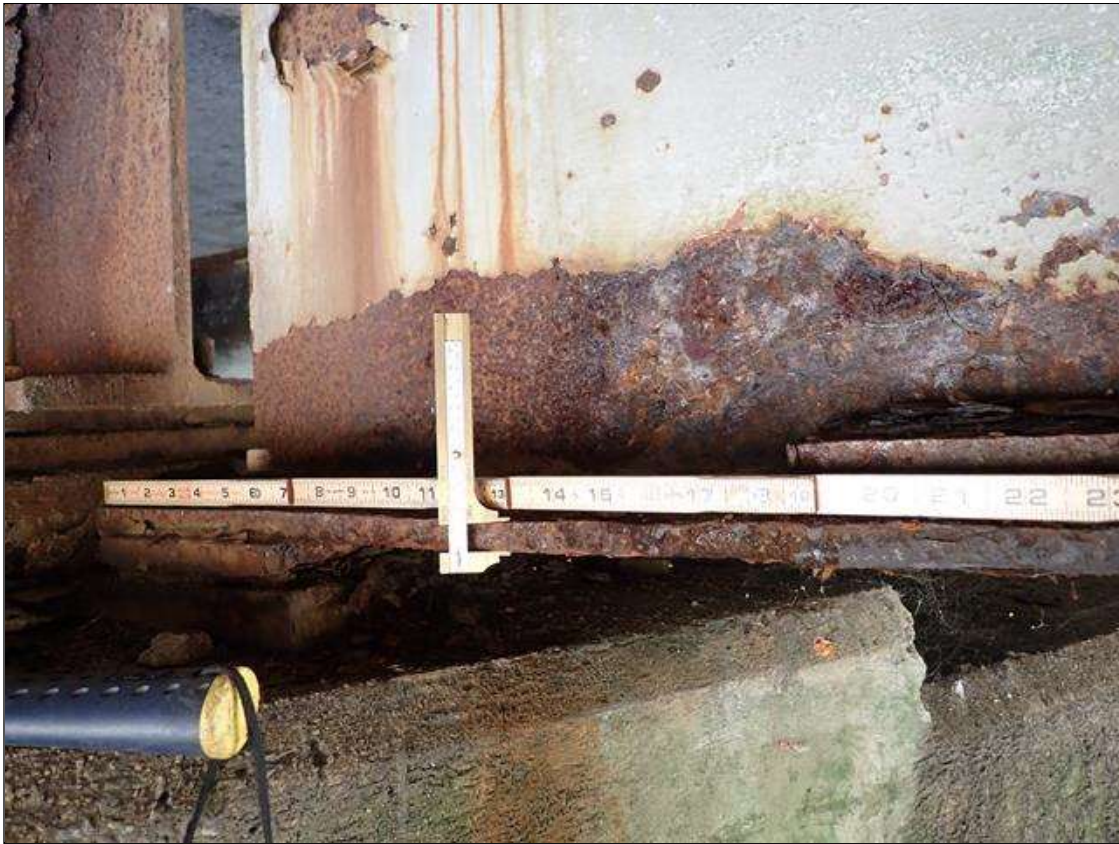
Span 3 Beam 4: PAR: CORROSION ALONG BOTH FACES OF WEB AND BOTTOM FLANGE UP TO 26 INCH LONG X 6 INCH HIGH DOWN TO 1/2 INCH RESIDUAL WEB AND 34 INCH LONG X 10 INCH WIDE DOWN TO 9/16 INCH RESIDUAL BOTTOM FLANGE EXTENDING FROM BENT 2

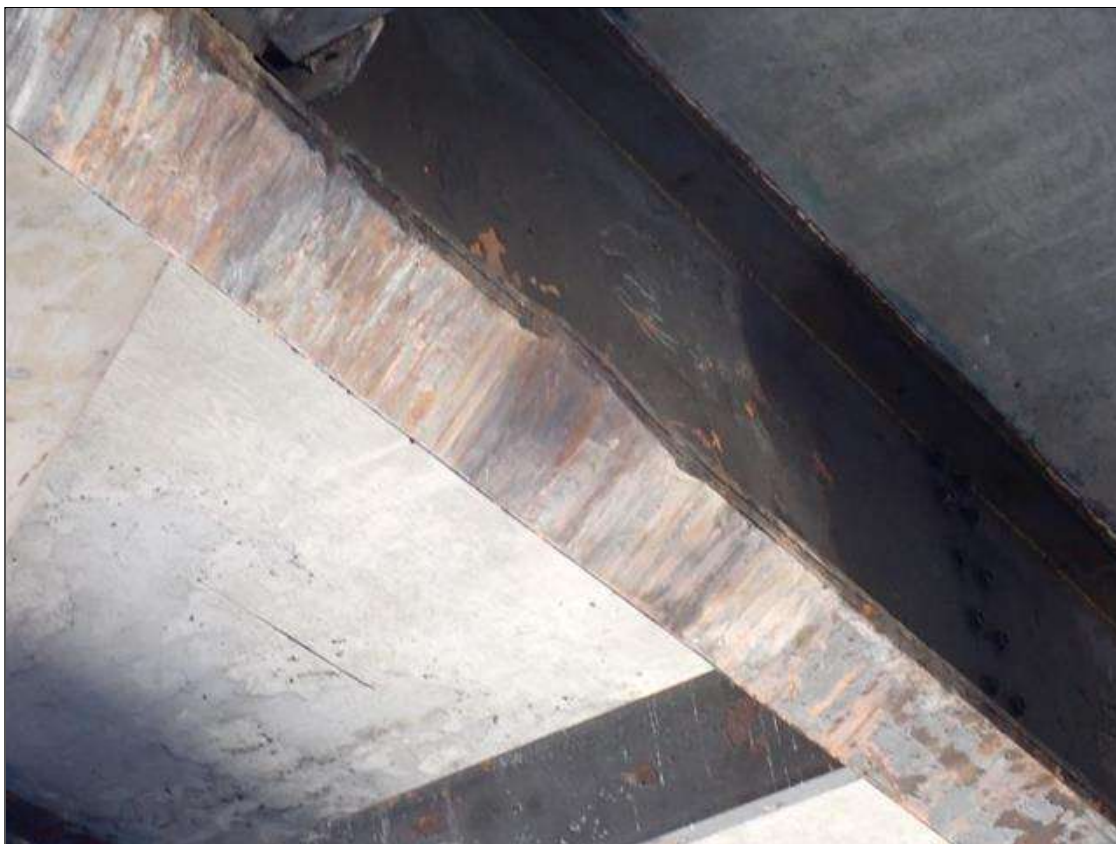
Span 3 Beam 3: UP TO 1 INCH VERTICAL DEFLECTION FROM IMPACT DAMAGE NEAR MIDSPAN

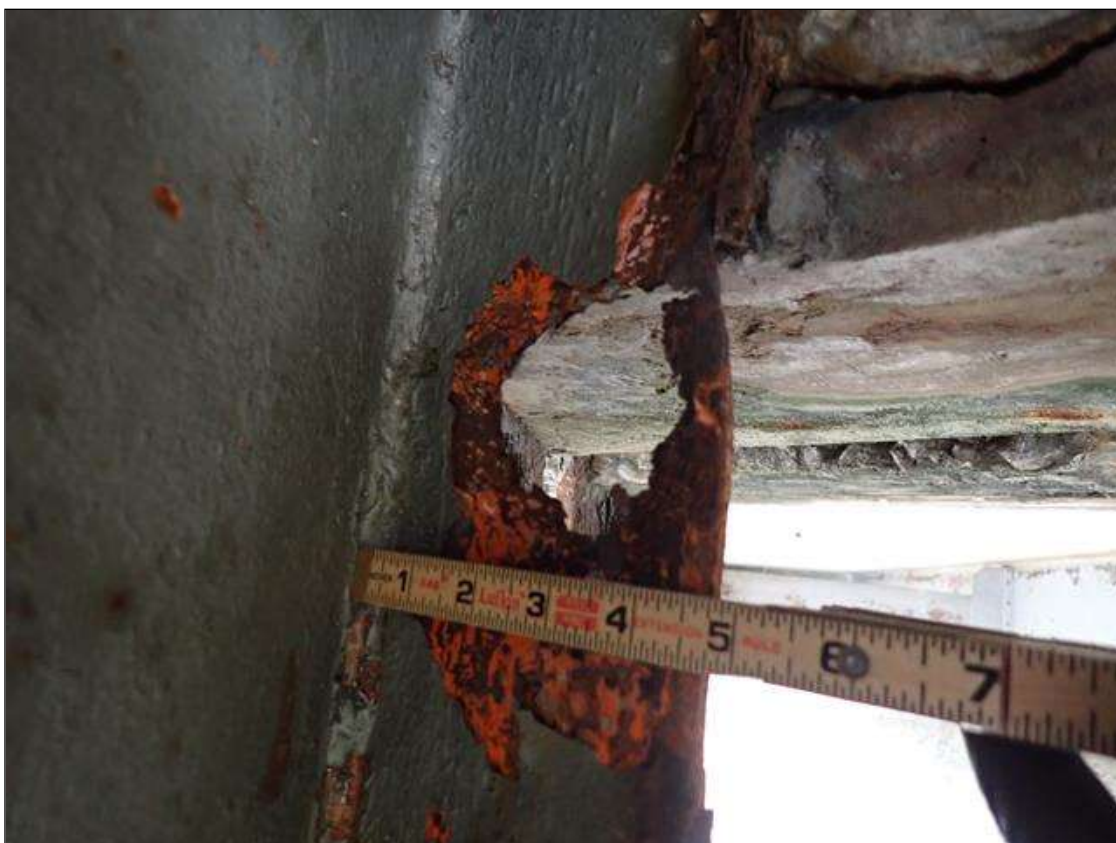
Span 3 Beam 1: PAR: CORROSION THROUGHOUT RIGHT SIDE STIFFENER DOWN TO KNIFES EDGE WITH (2) HOLES UP TO 4 INCH X 4 INCH AT BENT 3

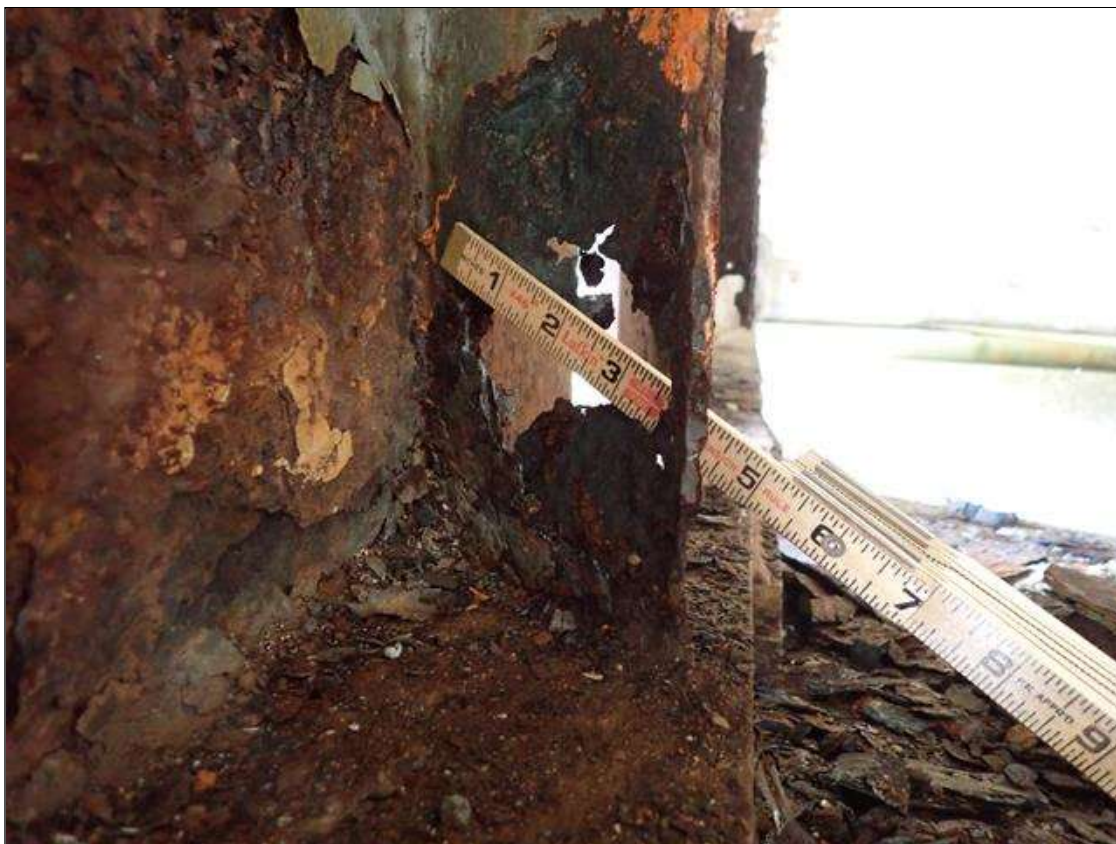
Span 3 Beam 1: PAR: CORROSION THROUGHOUT RIGHT SIDE STIFFENER DOWN TO KNIFES EDGE WITH (2) HOLES UP TO 4 INCH X 4 INCH AT BENT 3
