NC DEPARTMENT OF TRANSPORTATION  
 DIVISION OF HIGHWAYS  
 STRUCTURE MANAGEMENT UNIT

ATTENTION: **PAR, DATA CHANGES, DAMAGE INSPECTION REQUESTED**

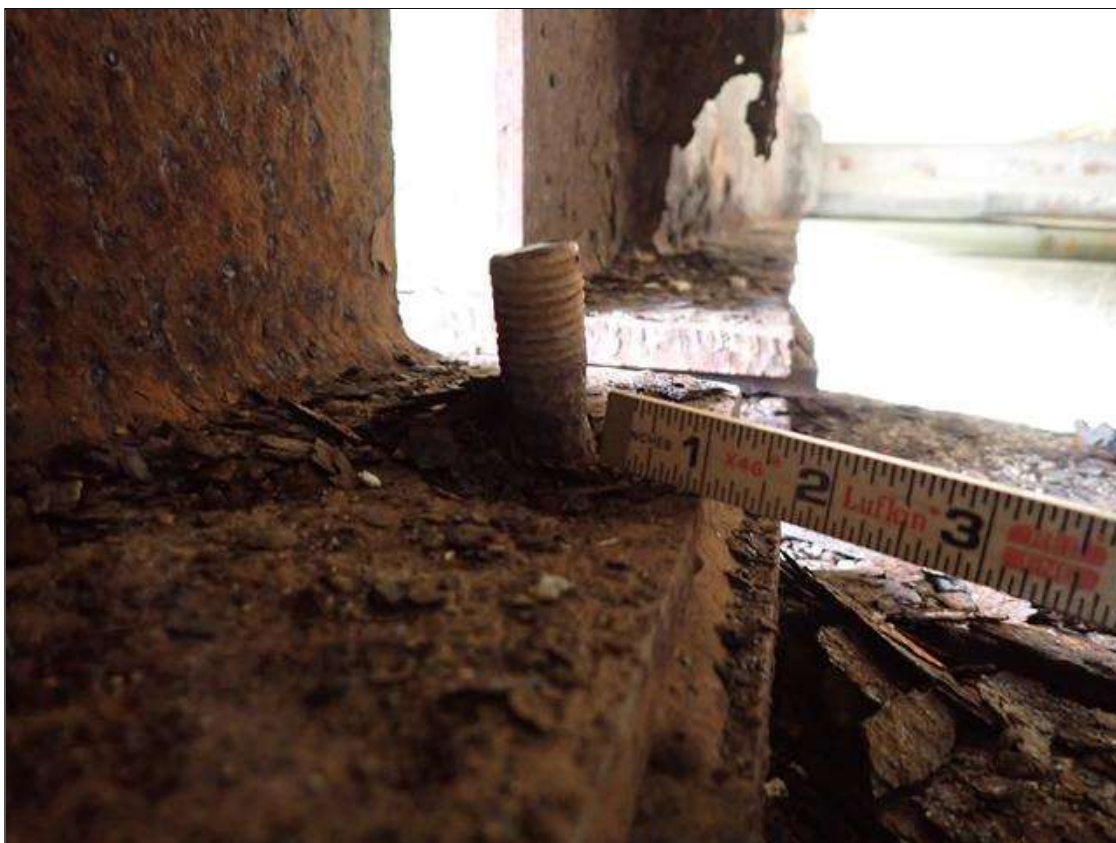
Span 3 Beam 1 - Far Bearing: PAR: MISSING ANCHOR NUT ON EAST SIDE

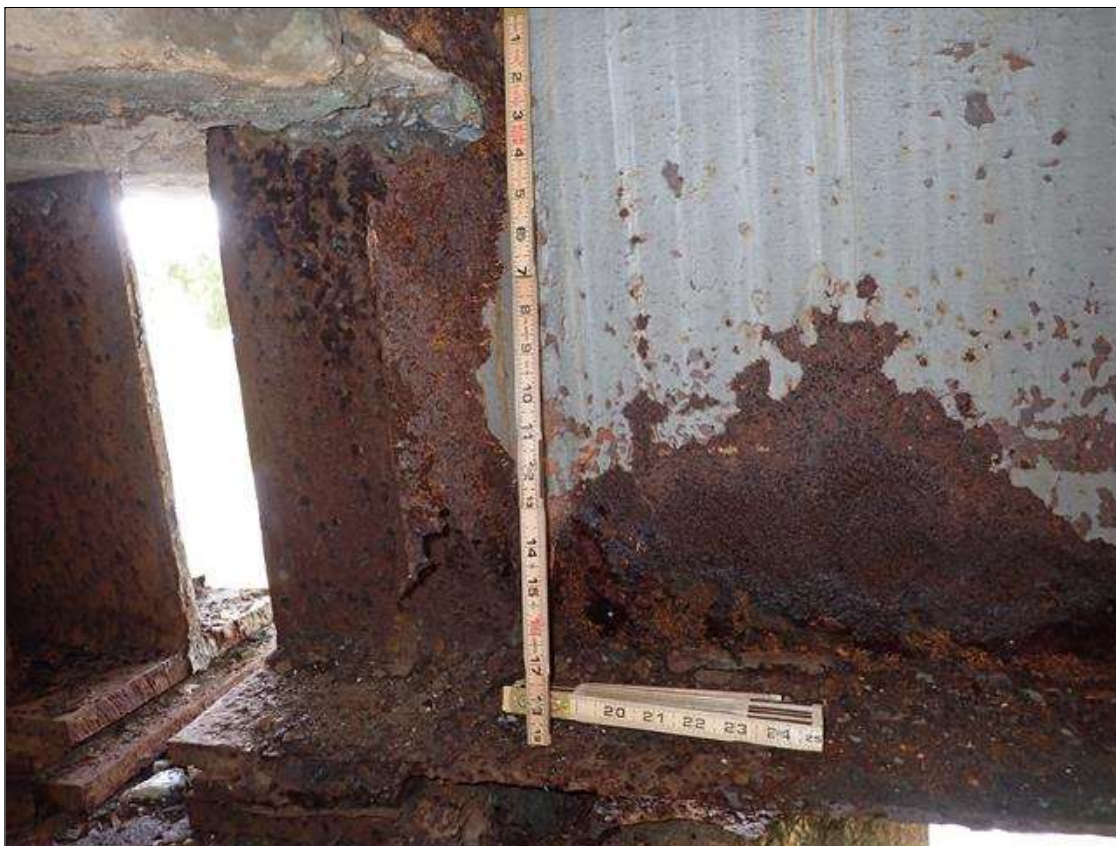
Span 4 Beam 1: PAR: CORROSION THROUGHOUT RIGHT SIDE STIFFENER DOWN TO KNIFES EDGE WITH (2) HOLES UP TO 5 INCH X 4 INCH AT BENT 3

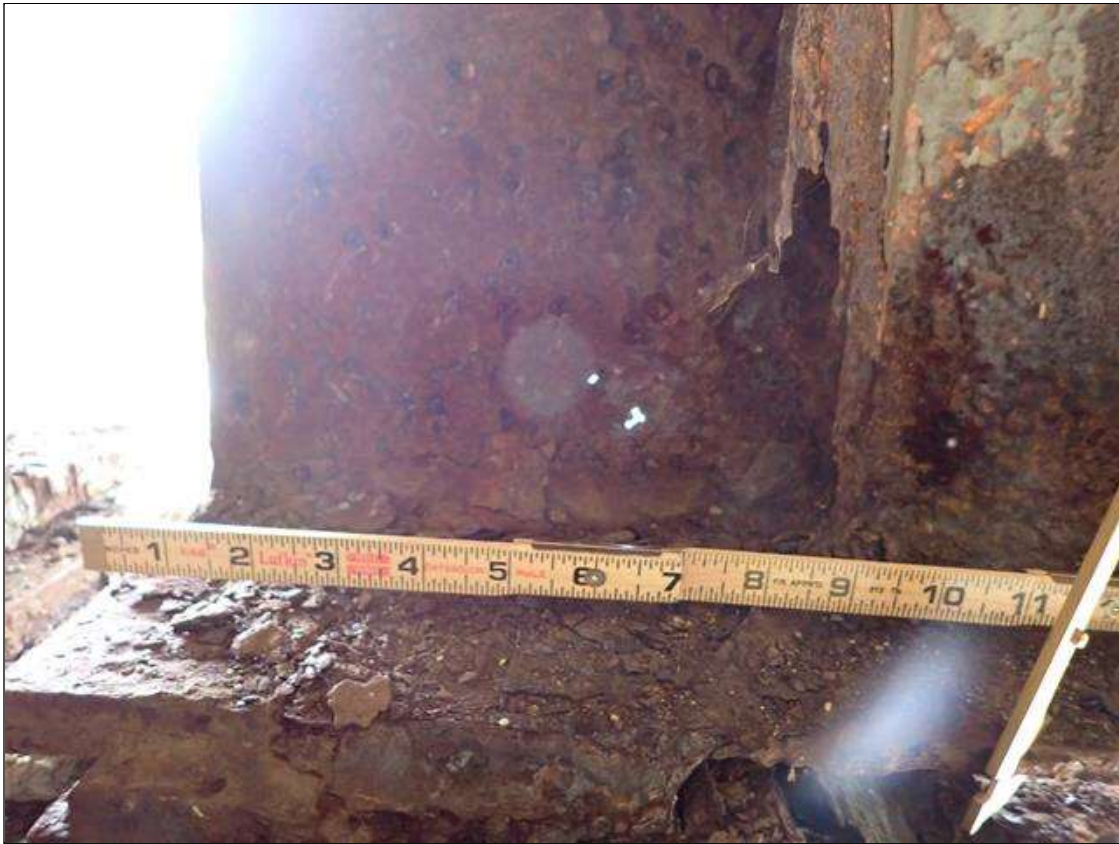
Span 4 Beam 1: PAR: CORROSION ALONG BOTH FACES OF WEB AND BOTTOM FLANGE UP TO 68 INCH LONG X UP TO 20 INCH HIGH DOWN TO 1/4 INCH RESIDUAL WEB WITH PIN HOLES BEHIND STIFFENER AND 52 INCH LONG X 10 INCH WIDE DOWN TO 5/16 INCH RESIDUAL BOTTOM FLANGE EXTENDING FROM BENT 3

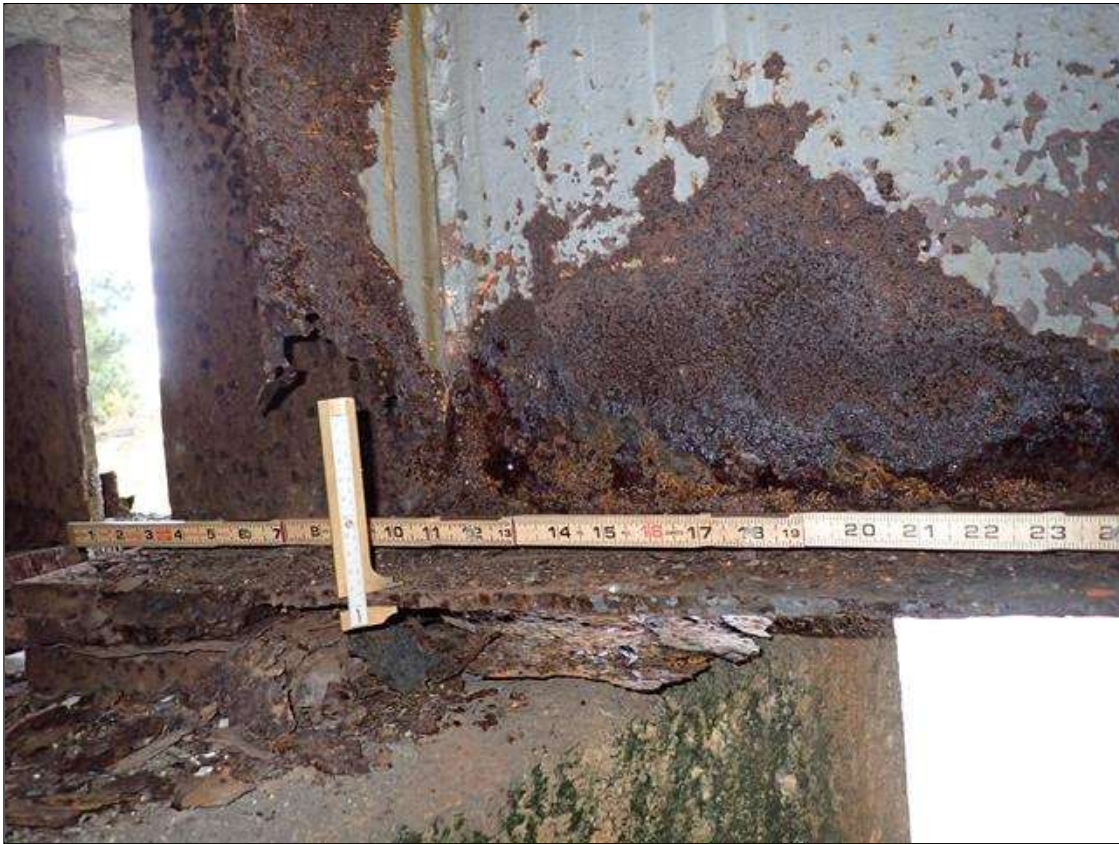
Span 4 Beam 1: PAR: CORROSION ALONG BOTH FACES OF WEB AND BOTTOM FLANGE UP TO 68 INCH LONG X UP TO 20 INCH HIGH DOWN TO 1/4 INCH RESIDUAL WEB WITH PIN HOLES BEHIND STIFFENER AND 52 INCH LONG X 10 INCH WIDE DOWN TO 5/16 INCH RESIDUAL BOTTOM FLANGE EXTENDING FROM BENT 3

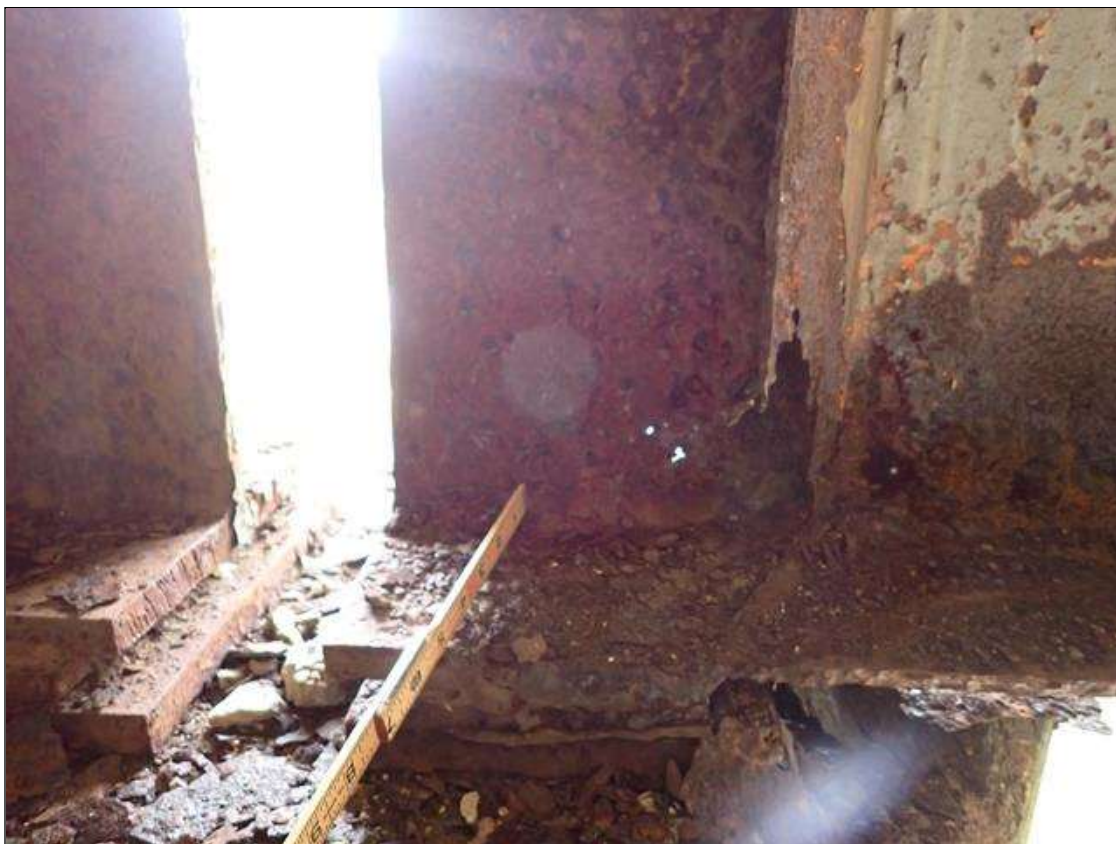
Span 4 Beam 1 - Near Bearing: PAR: MISSING ANCHOR ROD ON BOTH SIDES

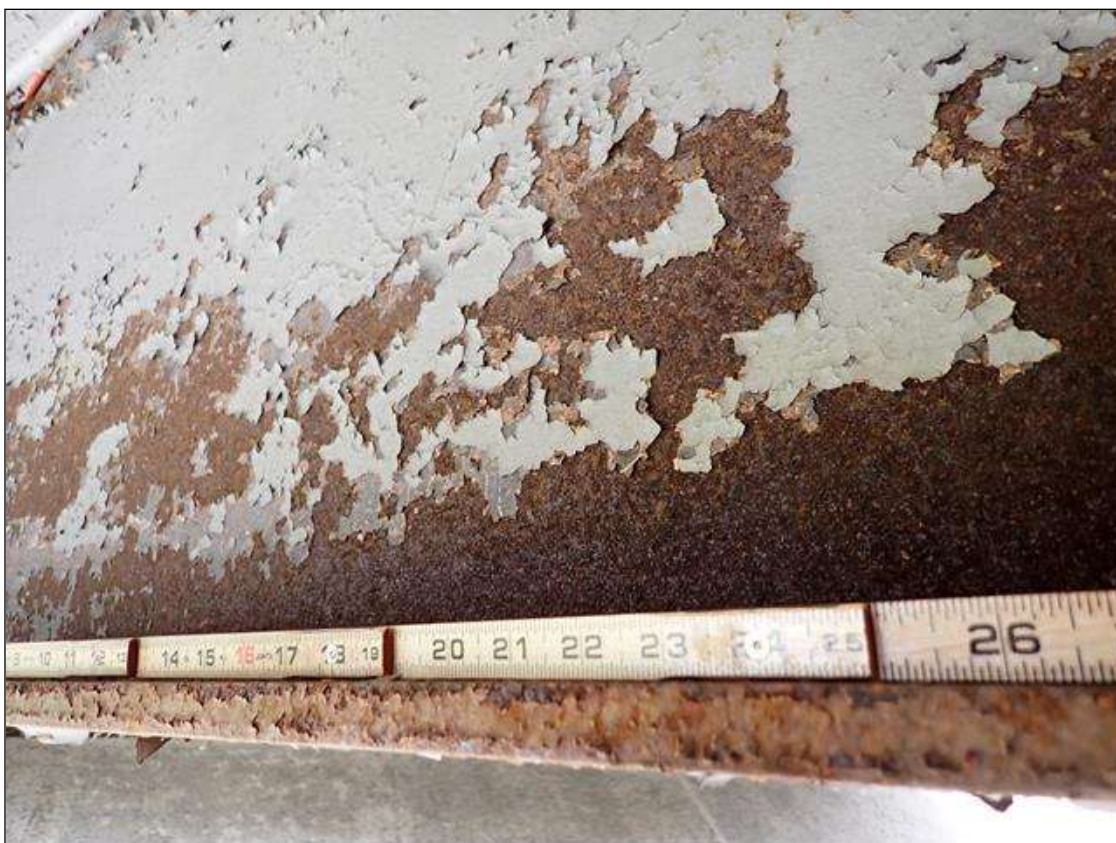
Span 4 Beam 2: AREAS OF SURFACE CORROSION THROUGHOUT

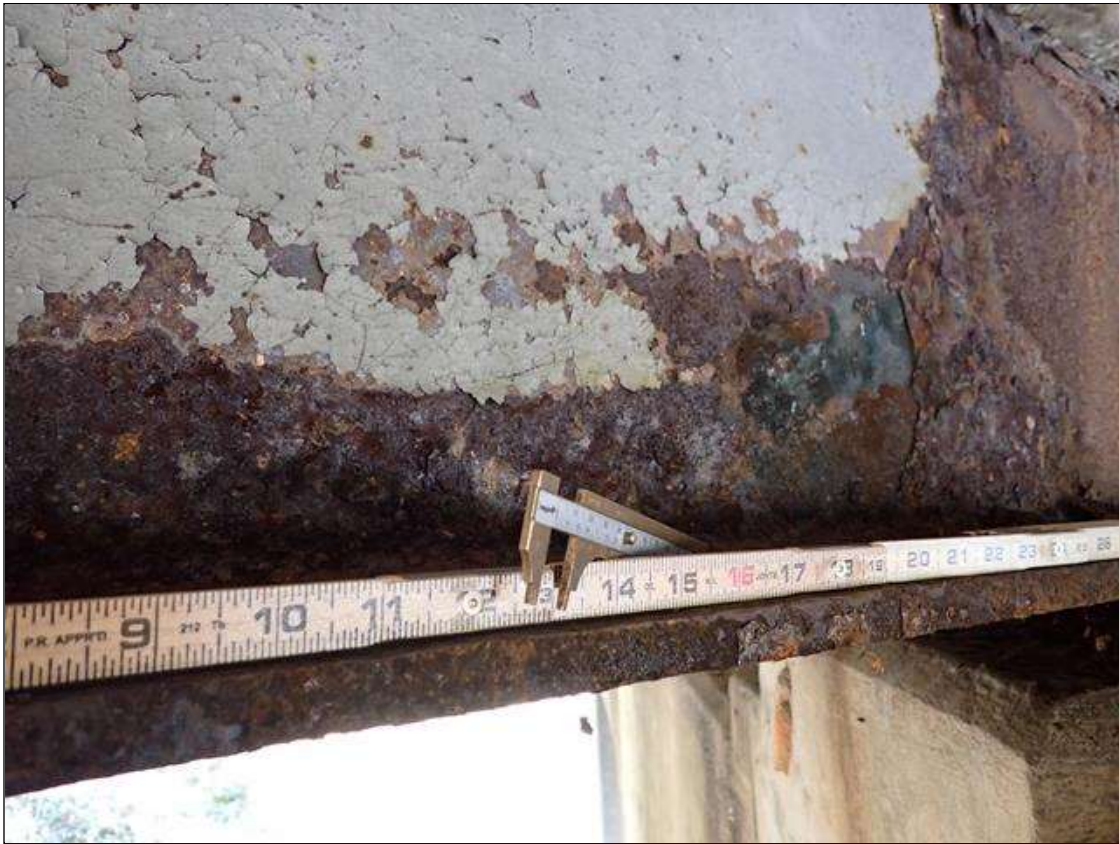
Span 4 Beam 4: PAR: CORROSION ALONG BOTH FACES OF WEB AND BOTTOM FLANGE UP TO 47 INCH LONG X 18 INCH HIGH DOWN TO 1/2 INCH RESIDUAL WEB AND 52 INCH LONG X 10 INCH WIDE DOWN TO 5/8 INCH RESIDUAL BOTTOM FLANGE EXTENDING FROM BENT 3

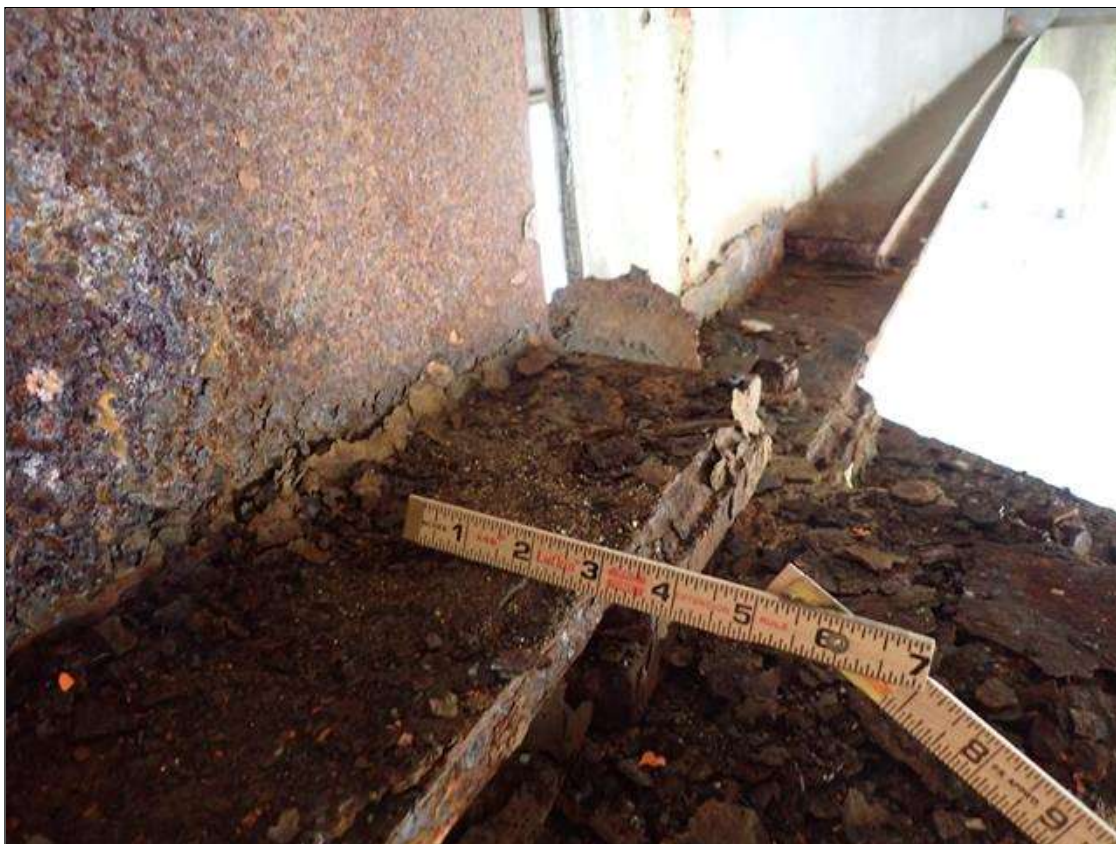
Span 4 Beam 4 - Near Bearing: PAR: MISSING ANCHOR ROD ON WEST SIDE

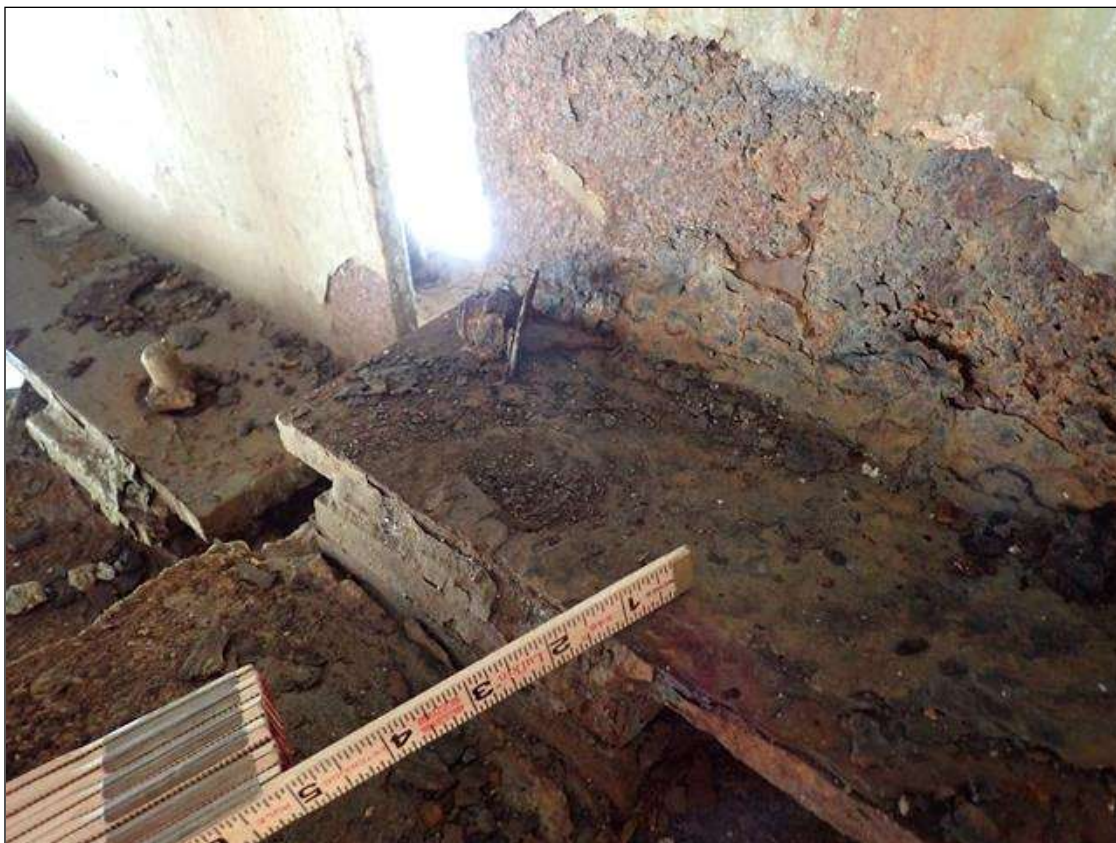
Span 4 Beam 5 - Near Bearing: PAR: MISSING ANCHOR ROD ON EAST SIDE

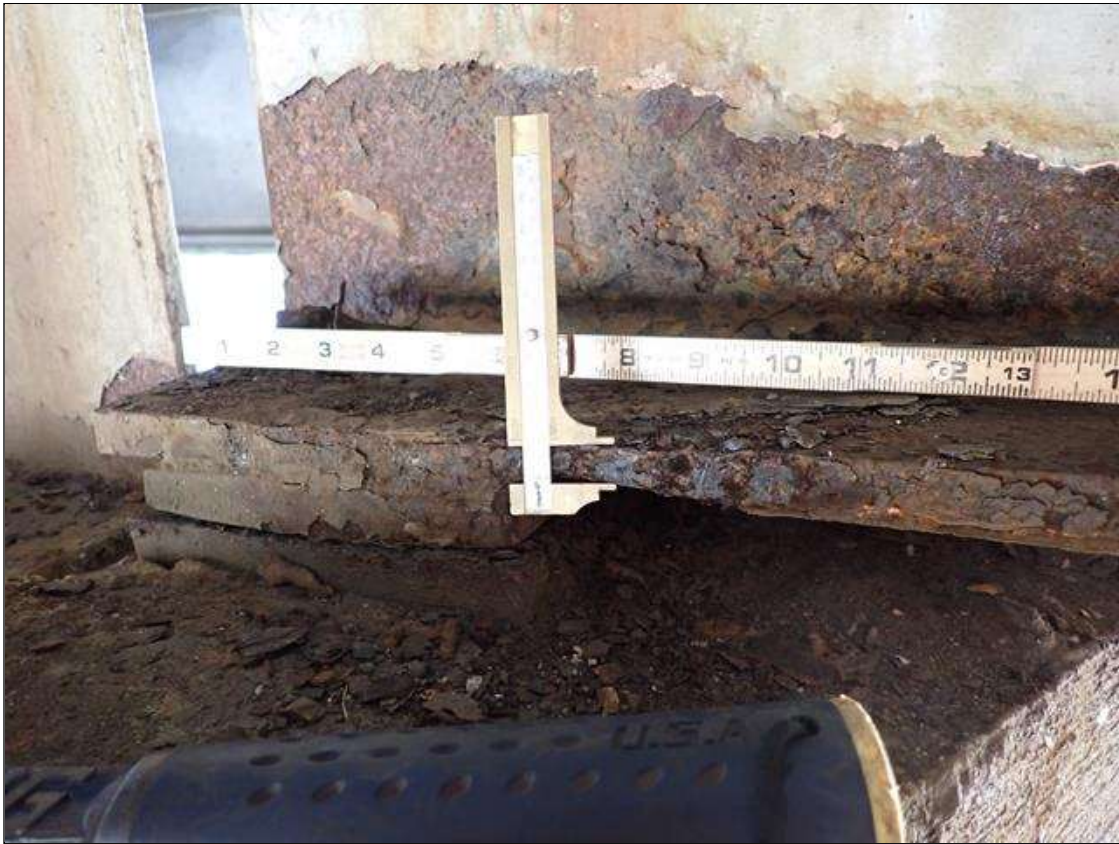
Span 4 Beam 5: PAR: CORROSION ALONG BOTH FACES OF WEB AND BOTTOM FLANGE UP TO 16 INCH LONG X 6 INCH HIGH WITH NO MEASURABLE LOSS OF SECTION IN WEB AND 14 INCH LONG X 4 INCH WIDE DOWN TO 1/2 INCH RESIDUAL BOTTOM FLANGE EXTENDING FROM BENT 3

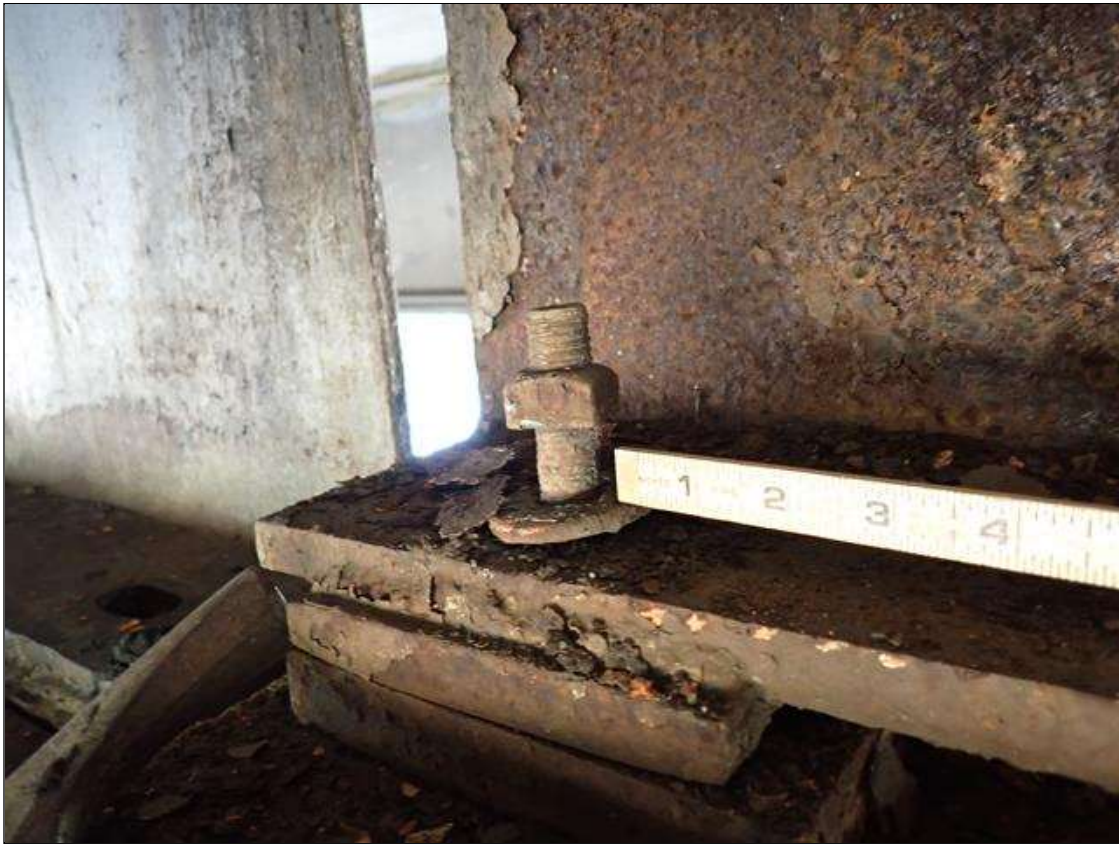
Span 4 Beam 6 - Near Bearing: ANCHOR NUT IS NOT FULLY TIGHT ON THE EAST SIDE.

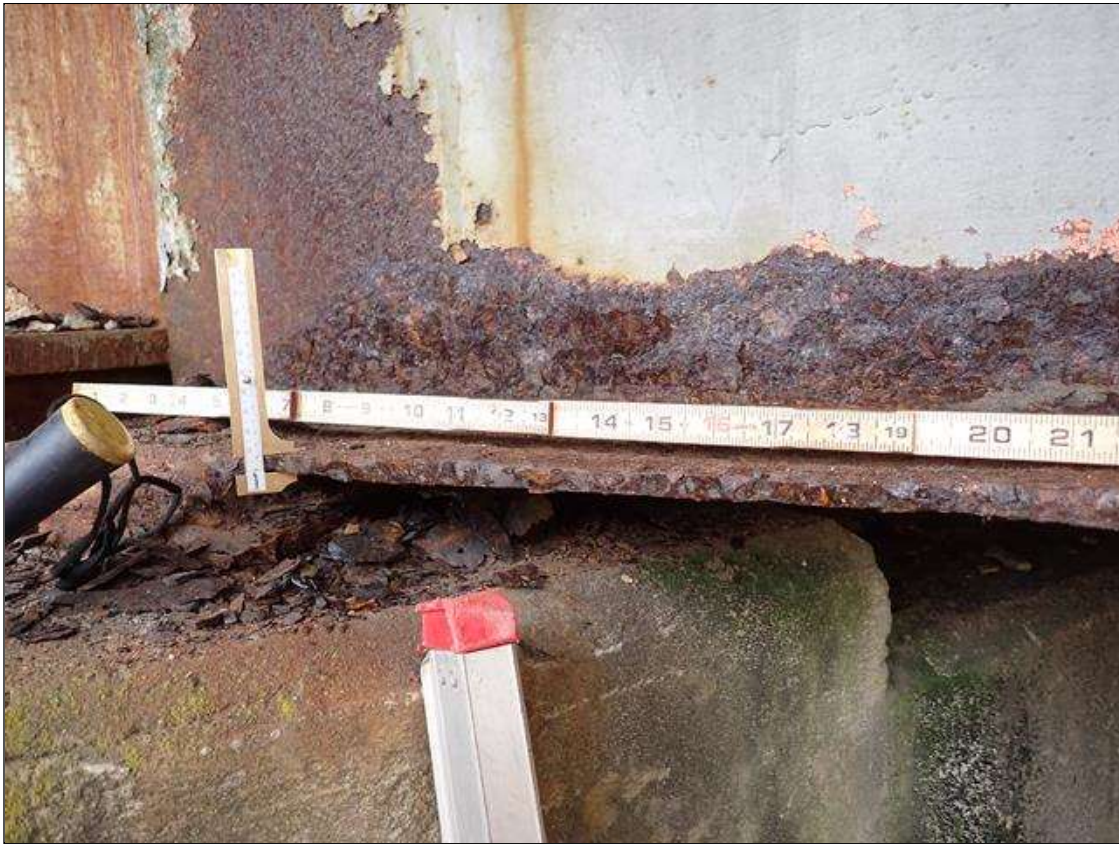
Span 4 Beam 7: PAR: CORROSION ALONG BOTH FACES OF WEB AND BOTTOM FLANGE UP TO 36 INCH LONG X 19 INCH HIGH DOWN TO 3/8 INCH RESIDUAL WEB AND 36 INCH LONG X 10 INCH WIDE DOWN TO 3/8 INCH RESIDUAL BOTTOM FLANGE EXTENDING FROM BENT 3

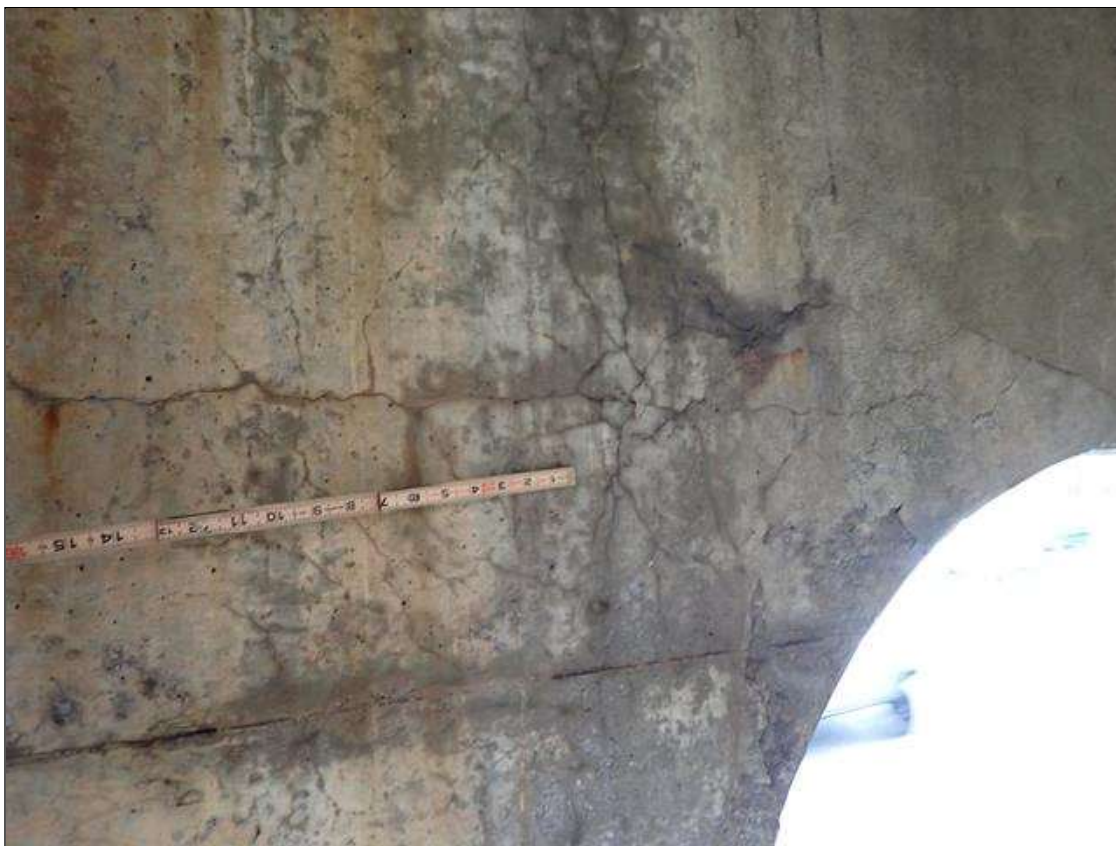
Bent 3 Cap 1: 34 INCH X 30 INCH AREA OF DELAMINATION WITH MAP CRACKING UP TO 1/16 INCH IN SPAN 4 FACE OF CAP BENEATH BEAM 5

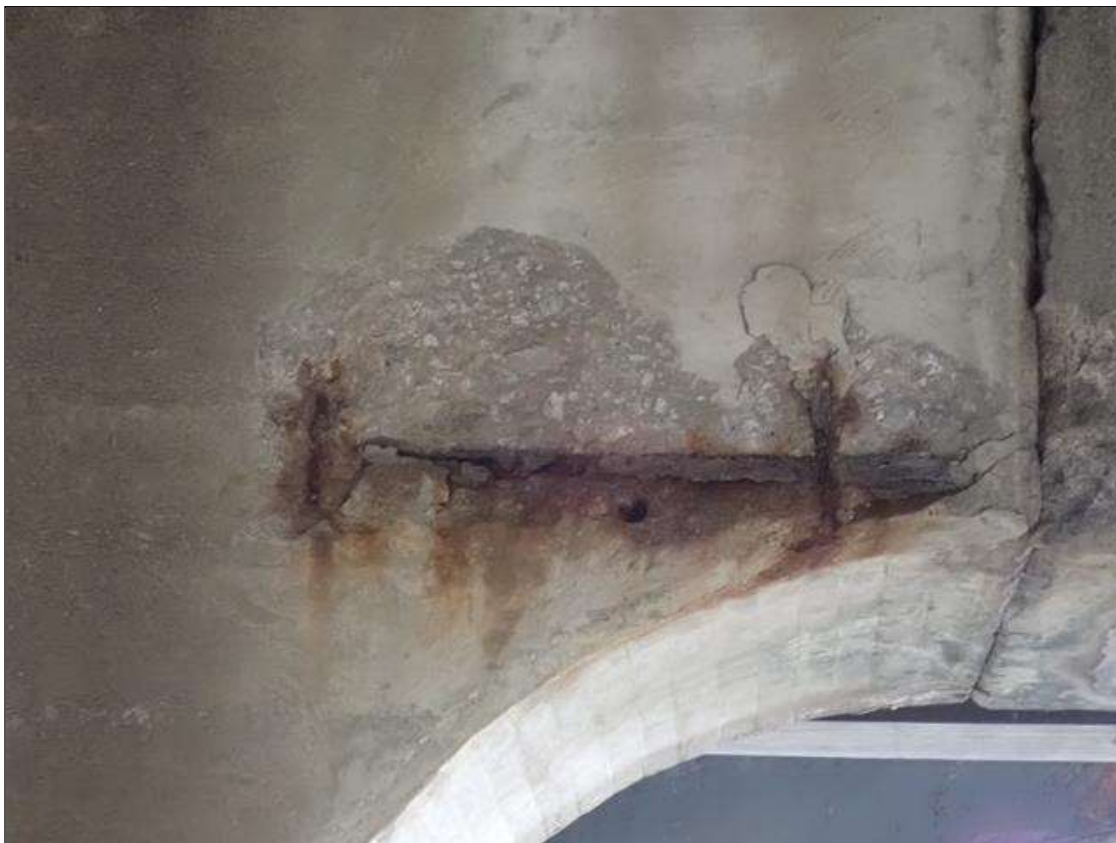
Bent 3 Cap 1: PAR: 28 INCH LONG X 12 INCH HIGH X 2 INCH DEEP SPALL WITH EXPOSED REBAR IN SPAN 4 FACE OF CAP BENEATH BEAM 3

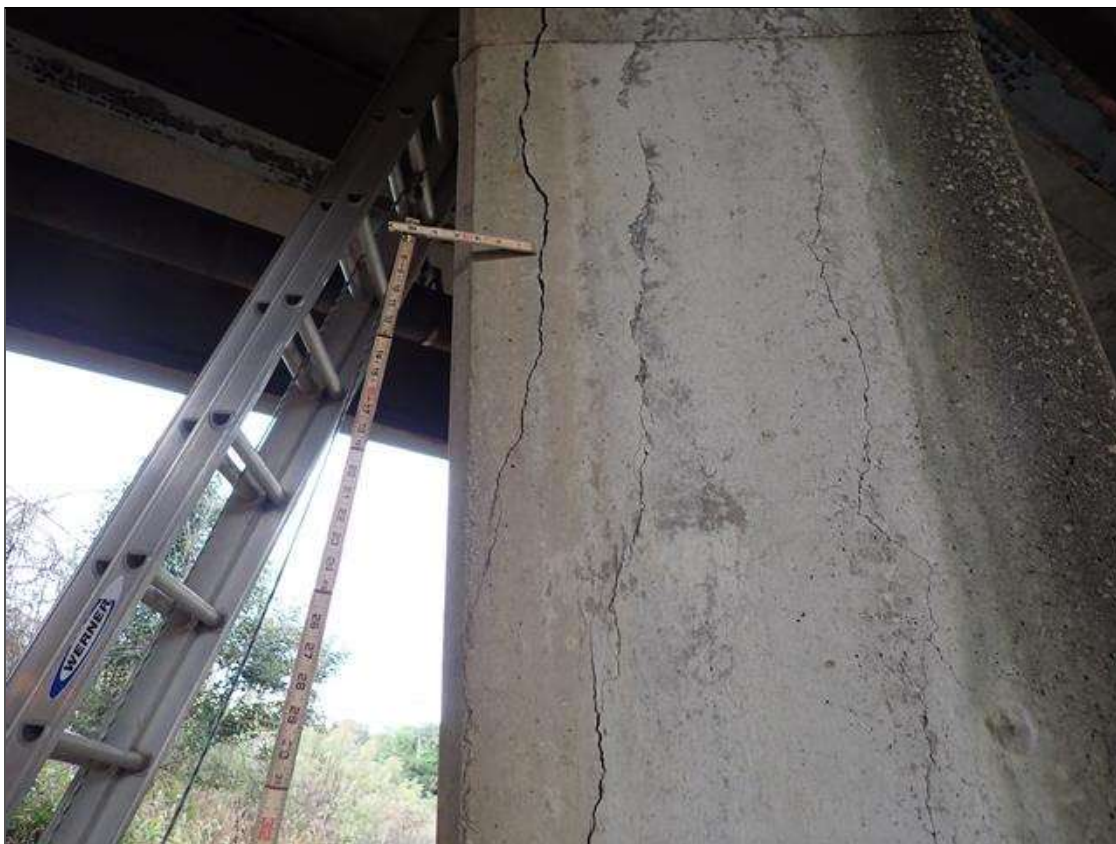
Bent 3 Pile 4: UP TO 1/8 INCH X 74 INCH LONG VERTICAL CRACKS IN LEFT FACE OF COLUMN AT BOTTOM OF CAP

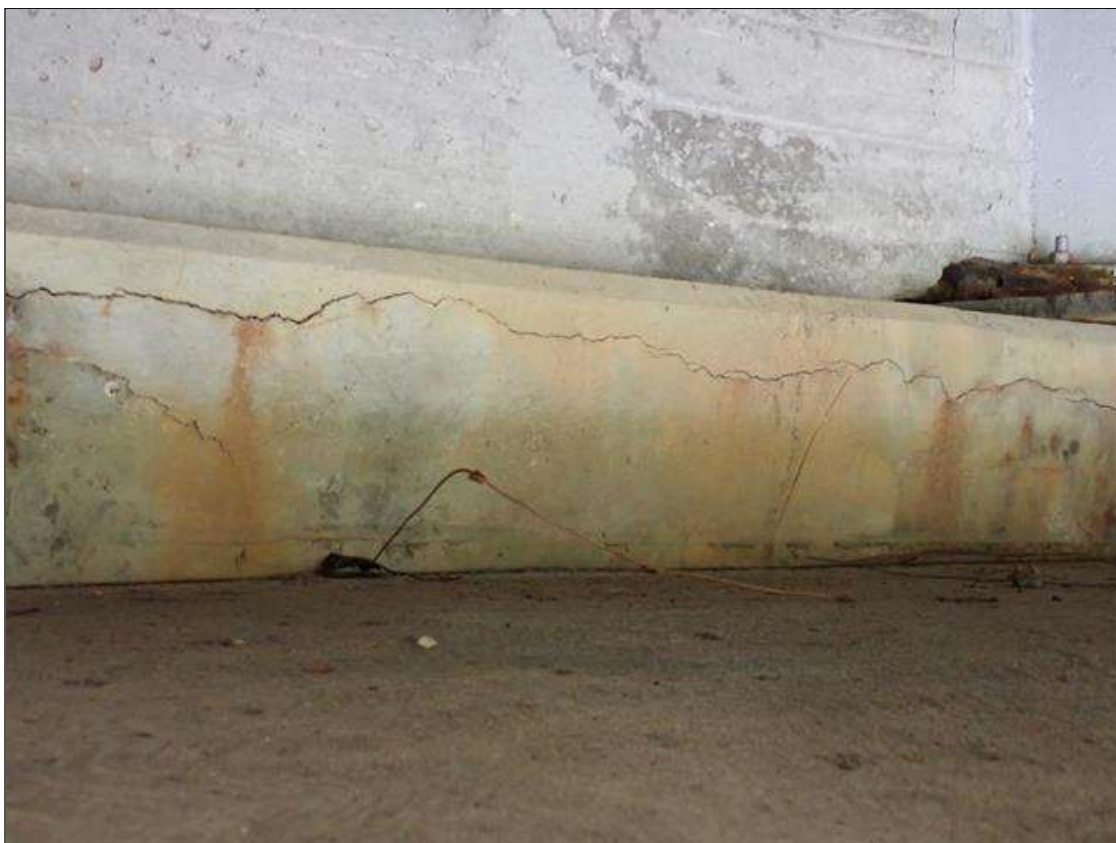
End Bent 2 Cap 1: UP TO 1/8 INCH HORIZONTAL CRACKS WITH RUST STAINING IN FACE OF CAP FROM BEAM 2 TO BEAM 3

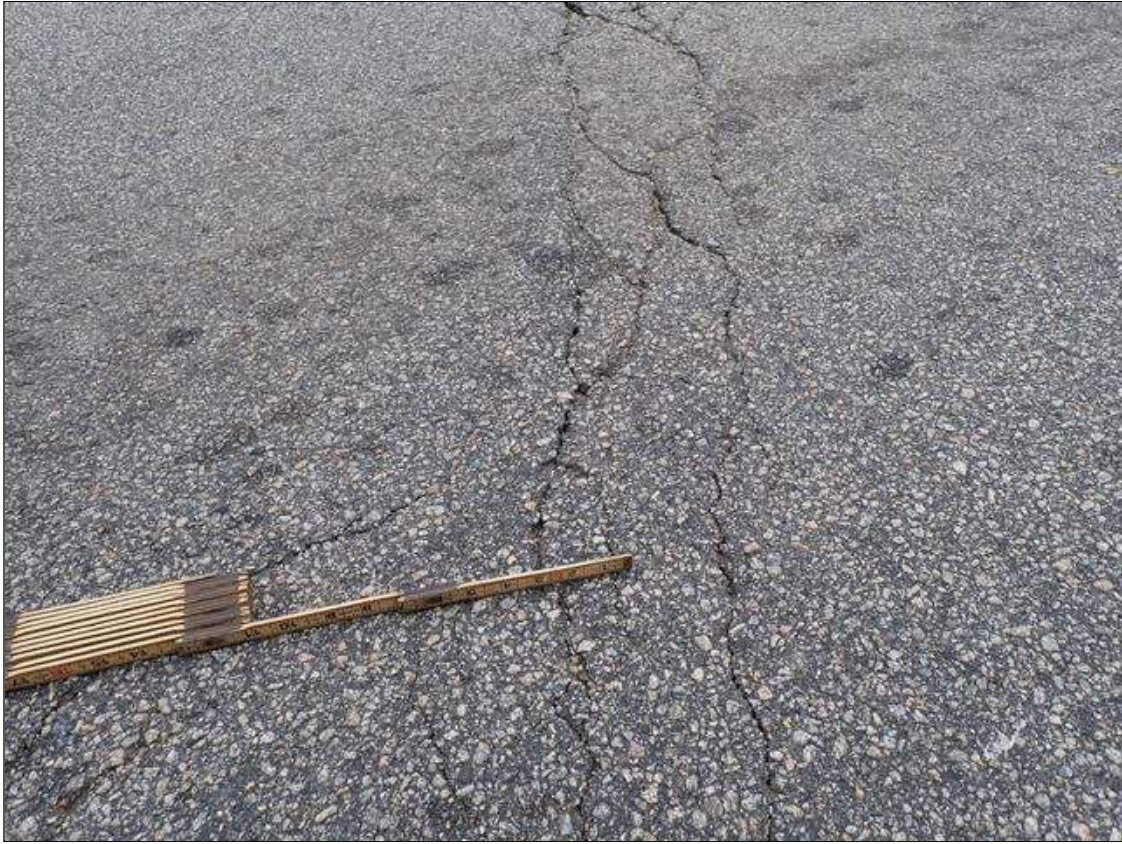
Span 1 Wearing Surface: UP TO 1/8 INCH TRANSVERSE CRACKS ALONG END BENT 1

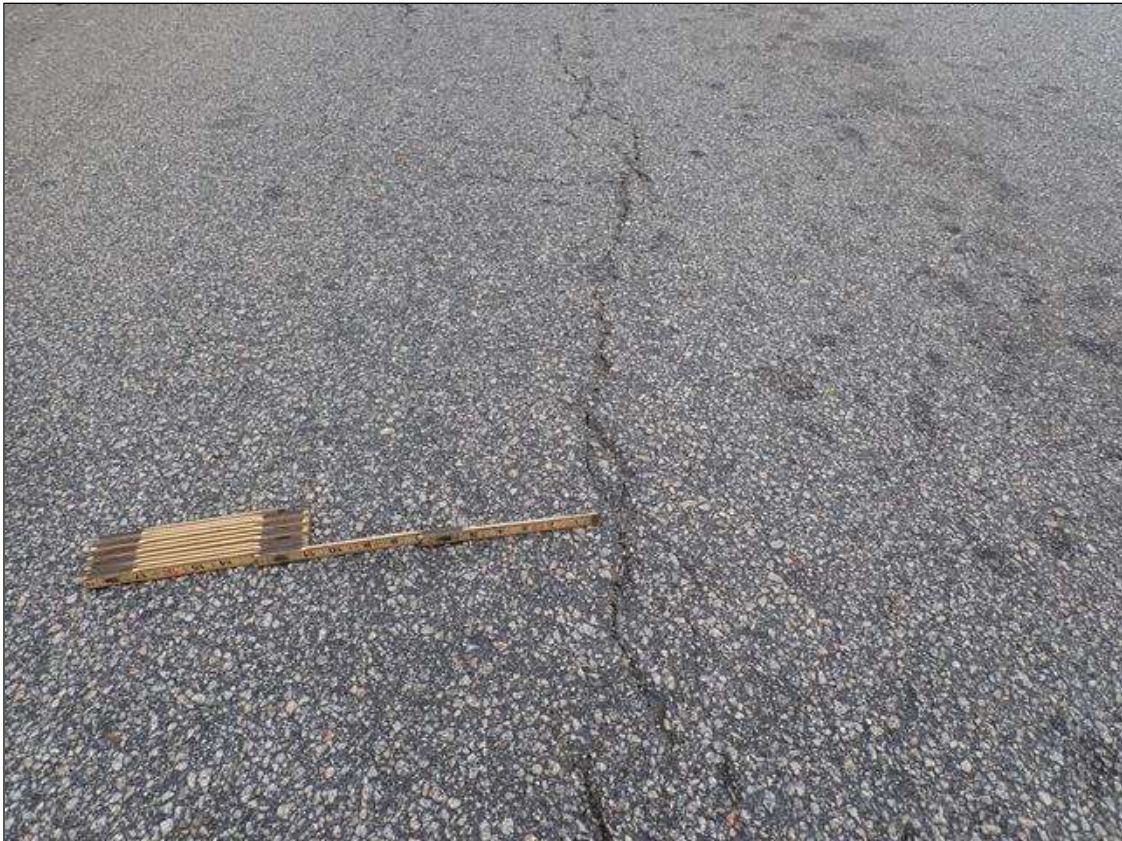
Span 1 Wearing Surface: INTERMITTENT LONGITUDINAL AND TRANSVERSE CRACKING (UP TO 1/4 INCH) THROUGHOUT ASPHALT WEARING SURFACE.

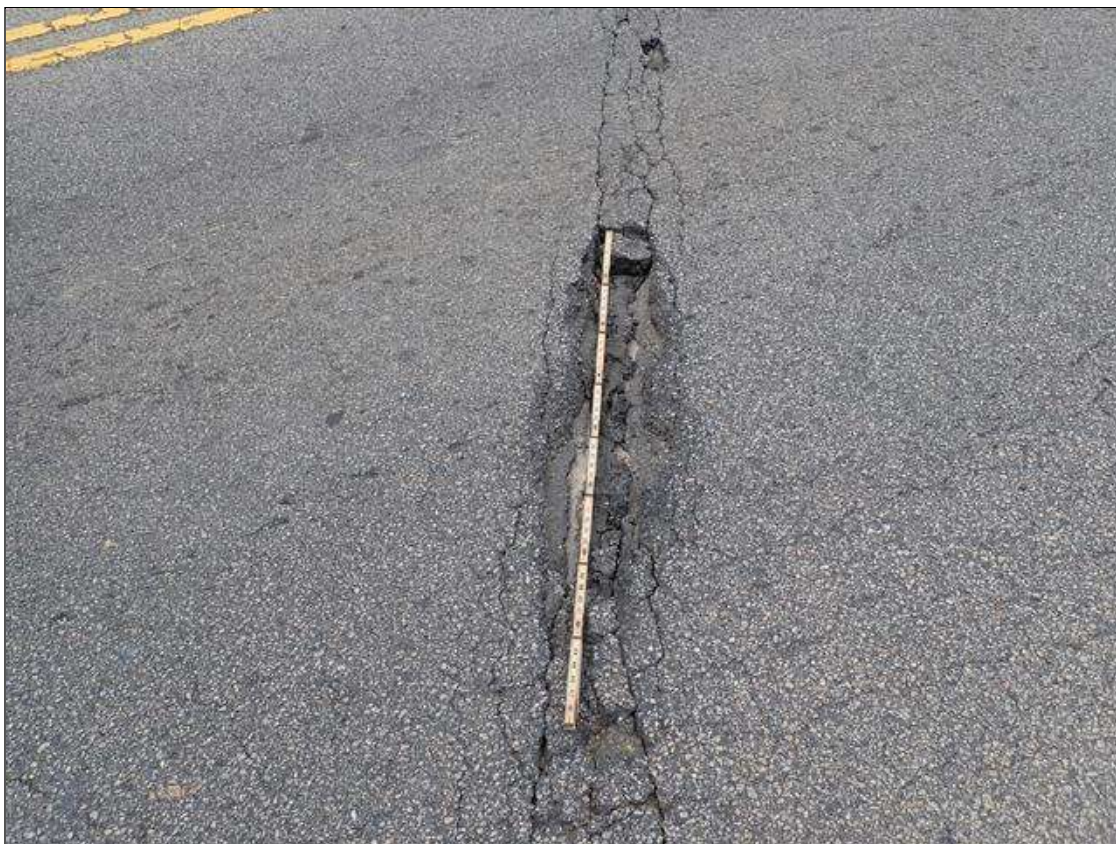
Span 2 Wearing Surface: PAR: 42 INCH X 8 INCH X 3 INCH DEEP POTHOLE IN CENTER OF NORTHBOUND LANE ABOVE BENT 1

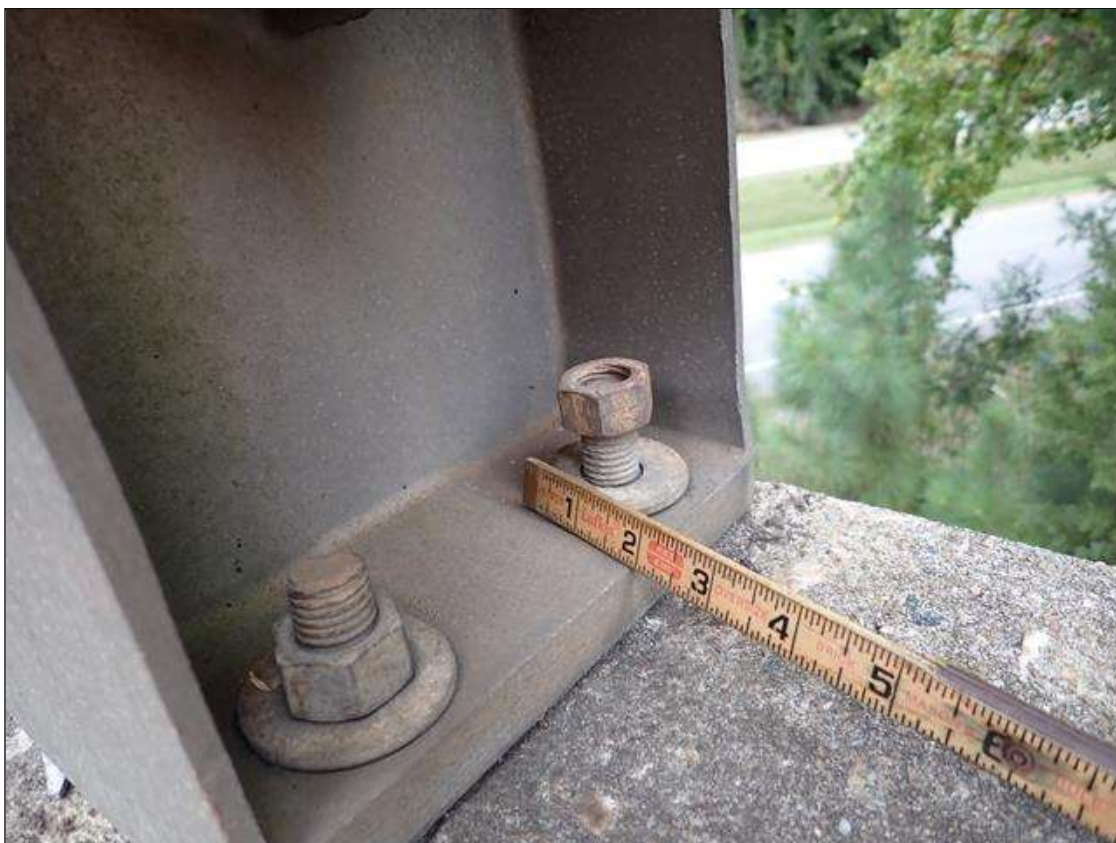
Span 1 Right Bridge Rail: LOOSE ANCHOR NUT AT SOUTHEAST CORNER OF RAIL POST 2

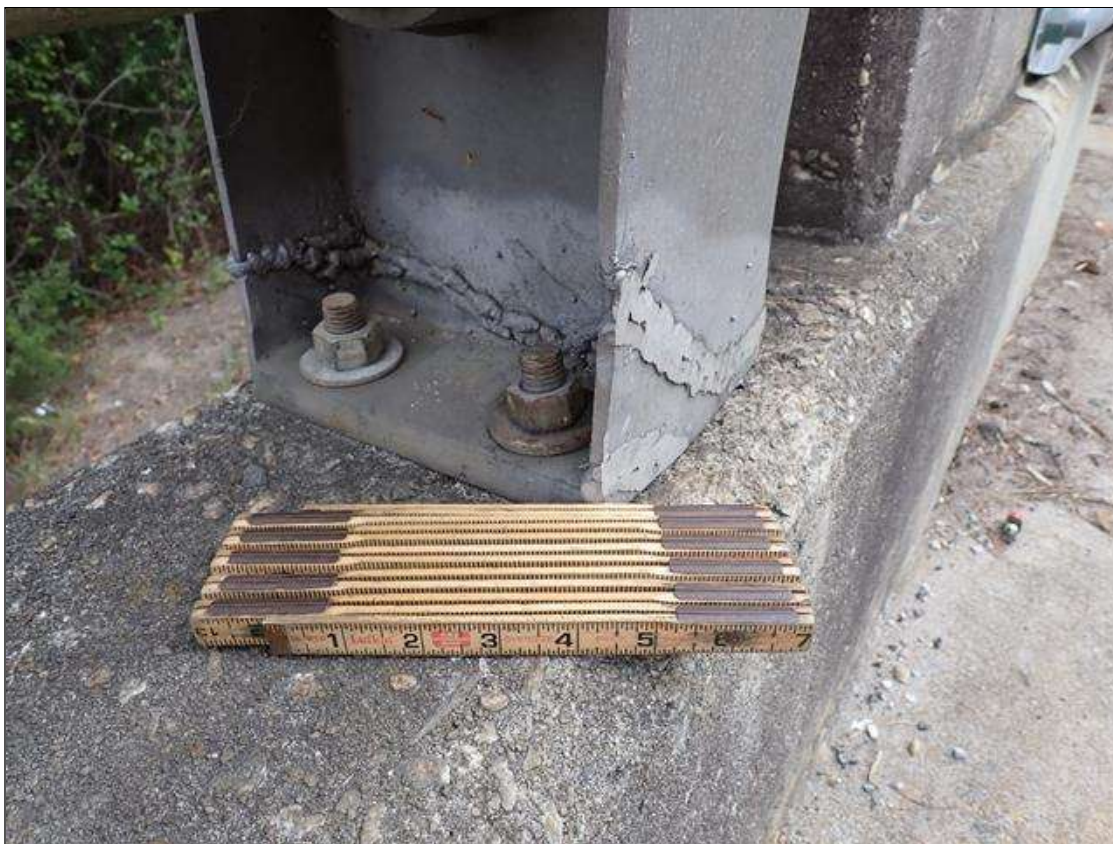
Span 1 Right Bridge Rail: WELDED REPAIR TO BOTTOM OF ALUMINUM POST 1

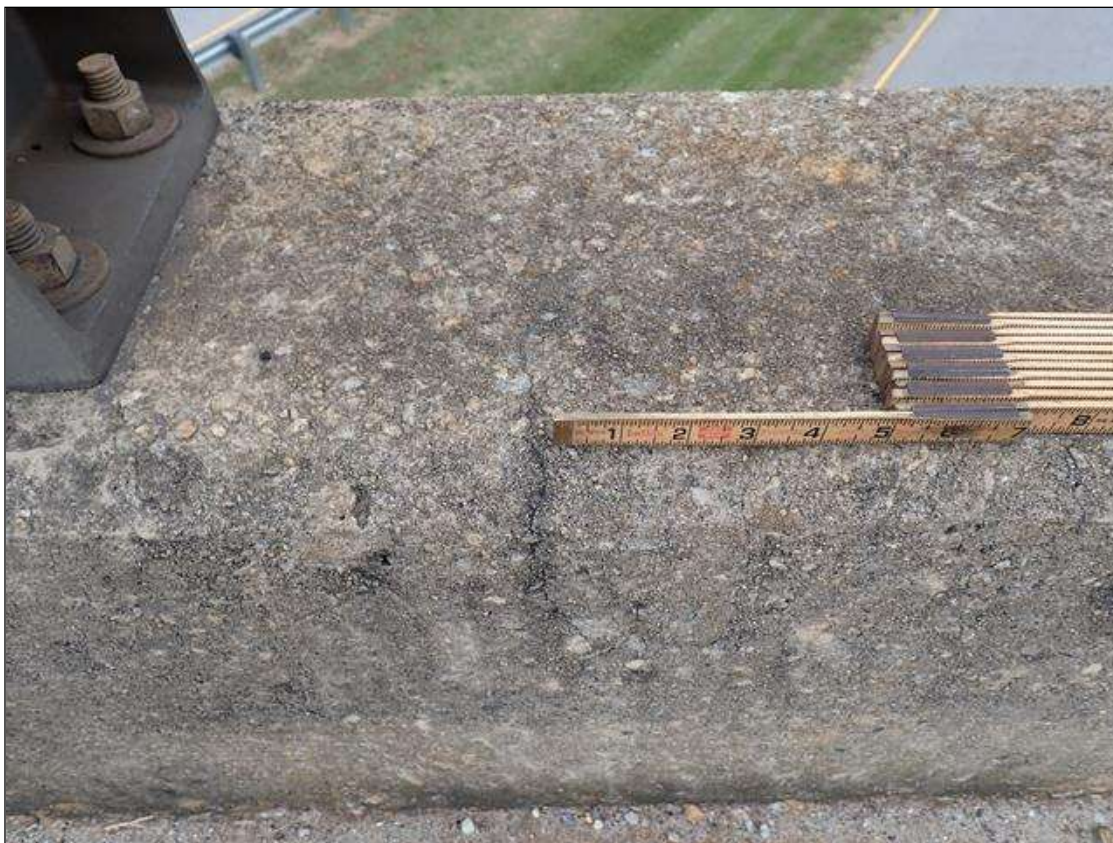
Span 2 Right Bridge Rail: UP TO 0.016 INCH TRANSVERSE AND VERTICAL CRACKS IN TOP AND BOTH FACES OF PARAPET IN VARIOUS LOCATIONS

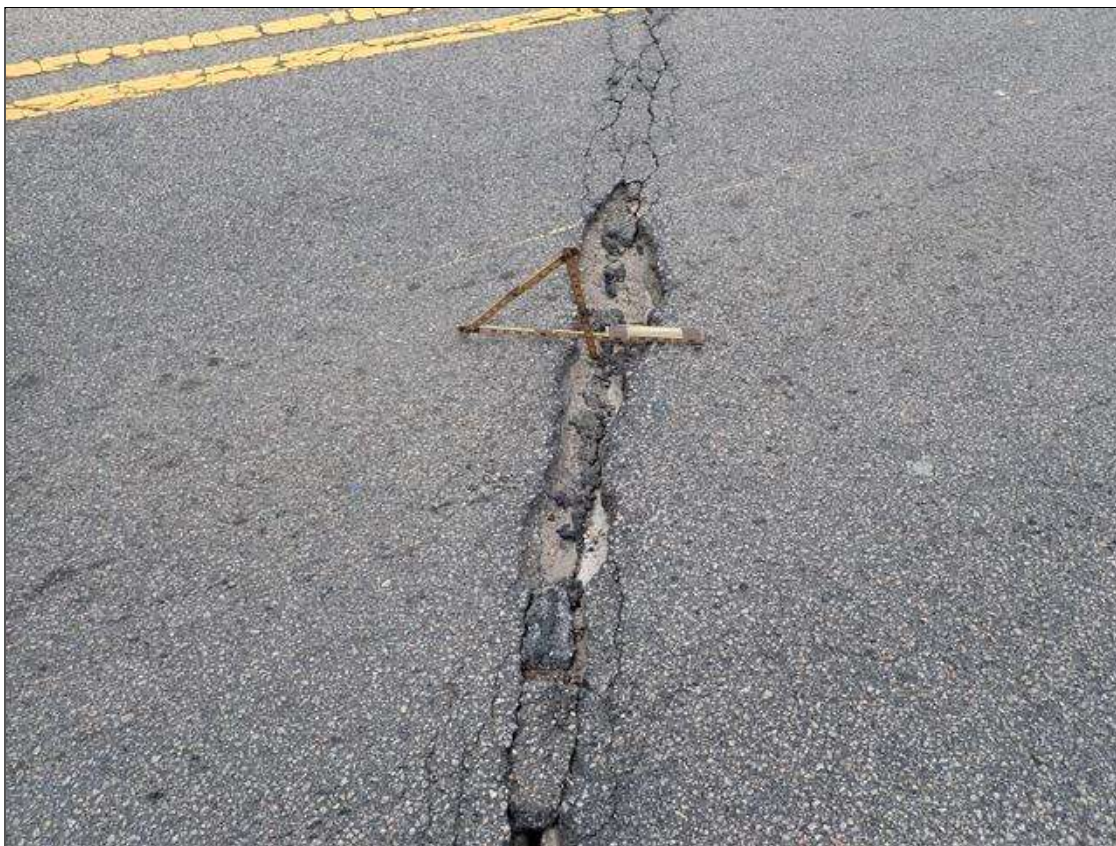
Span 3 Wearing Surface: PAR: 96 INCH LONG X 8 INCH WIDE X 3 INCH DEEP POTHOLE IN FAILED REPAIR IN CENTER OF NORTHBOUND LANE ABOVE BENT 2
