NC DEPARTMENT OF TRANSPORTATION  
 DIVISION OF HIGHWAYS  
 STRUCTURE MANAGEMENT UNIT

ATTENTION: **PAR, DATA CHANGES, DAMAGE INSPECTION REQUESTED**

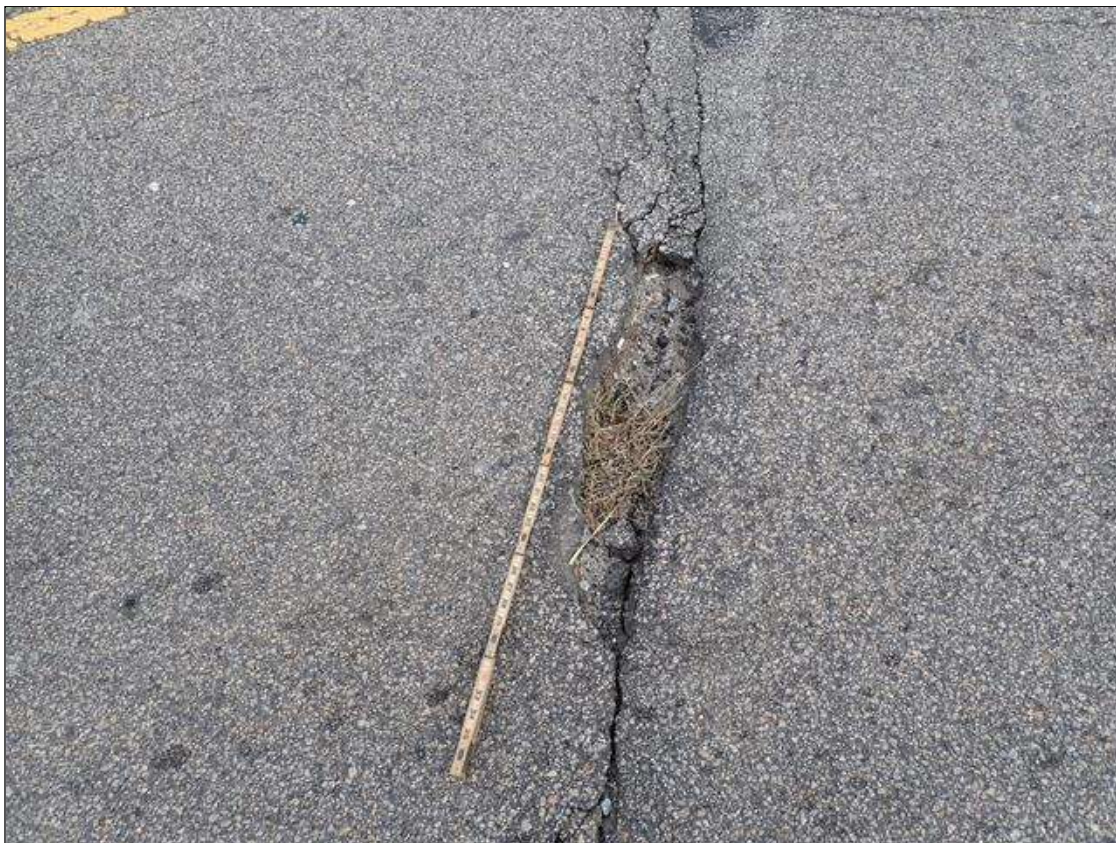
Span 4 Wearing Surface: PAR: 28 INCH X 8 INCH X 3 INCH DEEP POTHOLE IN CENTER OF SOUTHBOUND LANE ABOVE BENT 3

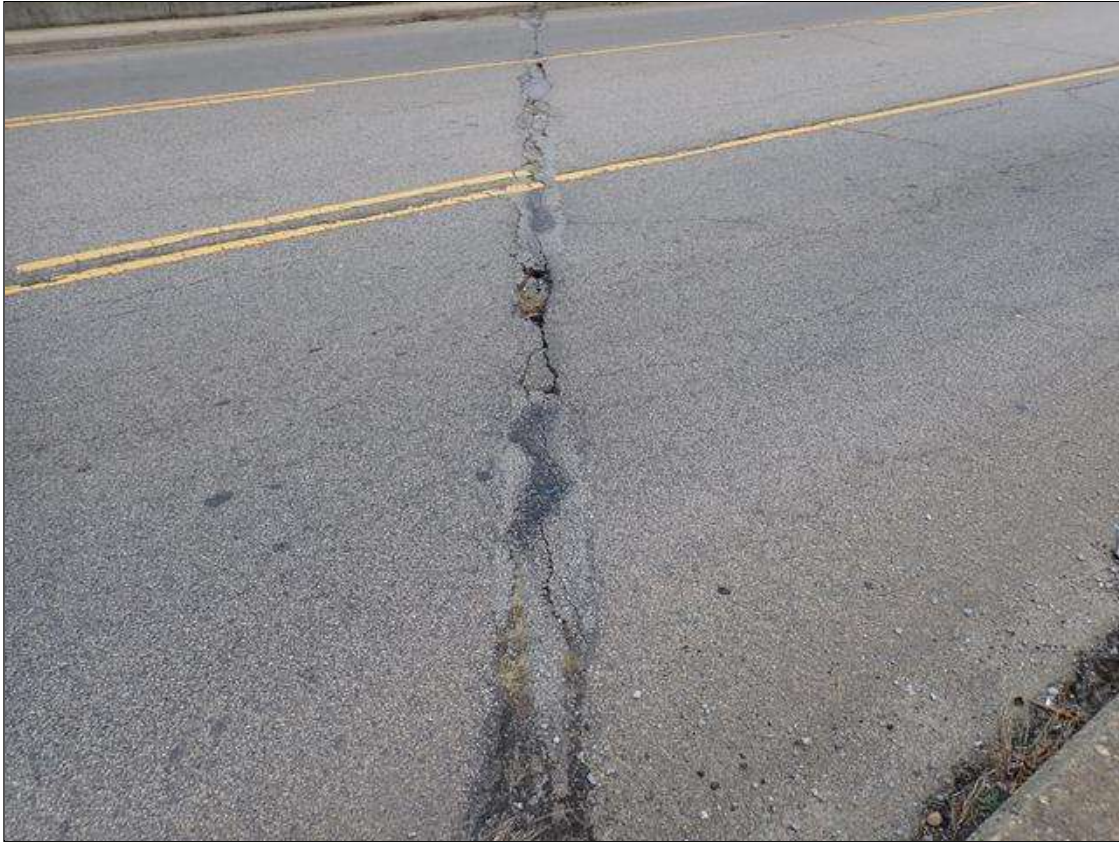
Span 4 Wearing Surface: 18 FOOT OF FAILED REPAIR PRIMARILY IN CENTER LANE ALONG BENT 3

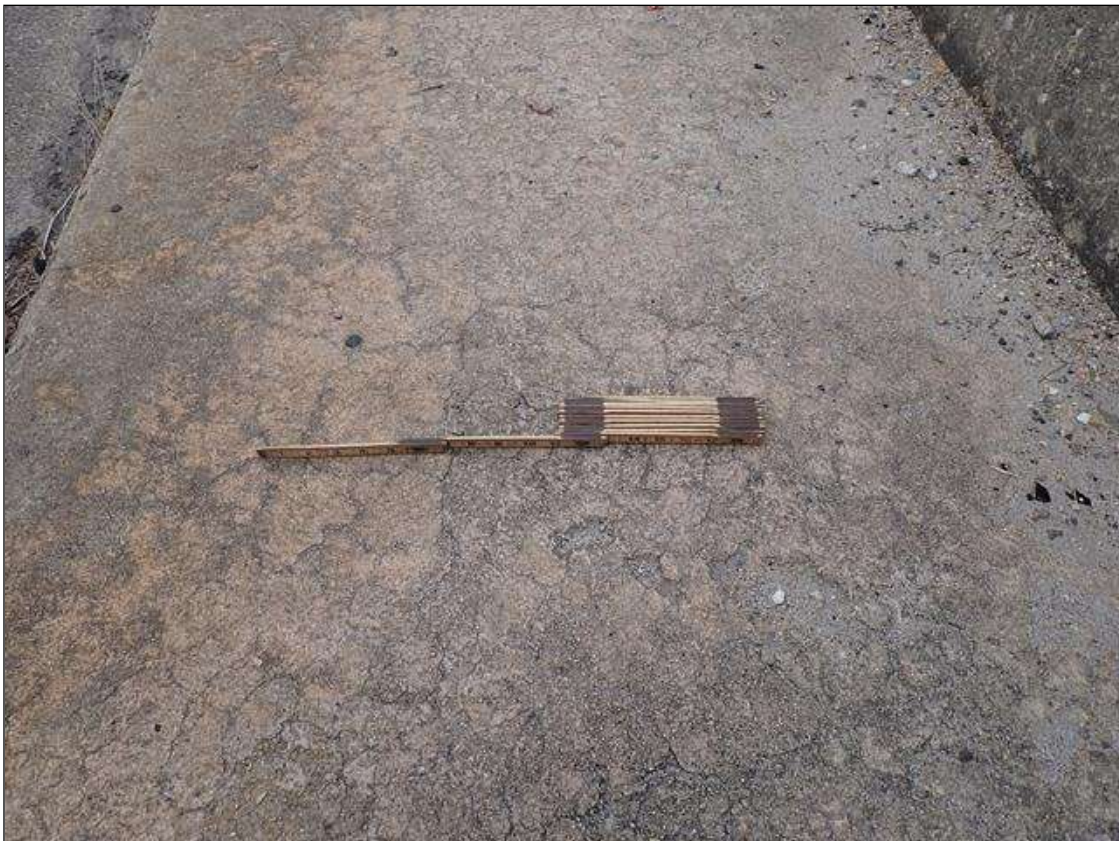
UP TO 1/16 INCH LONGITUDINAL CRACKS AND HAIRLINE MAP CRACKING IN TOP OF SIDEWALKS IN VARIOUS LOCATIONS THROUGHOUT

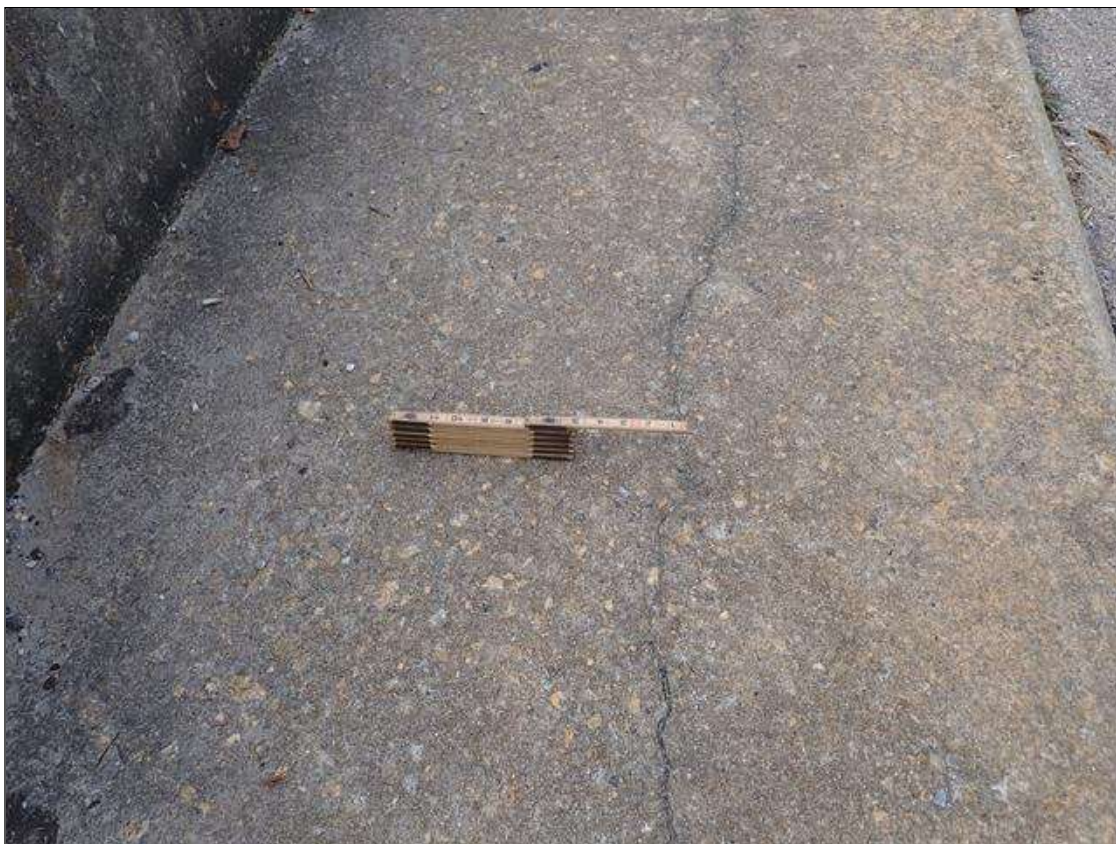
UP TO 1/16 INCH LONGITUDINAL CRACKS AND HAIRLINE MAP CRACKING IN TOP OF SIDEWALKS IN VARIOUS LOCATIONS THROUGHOUT

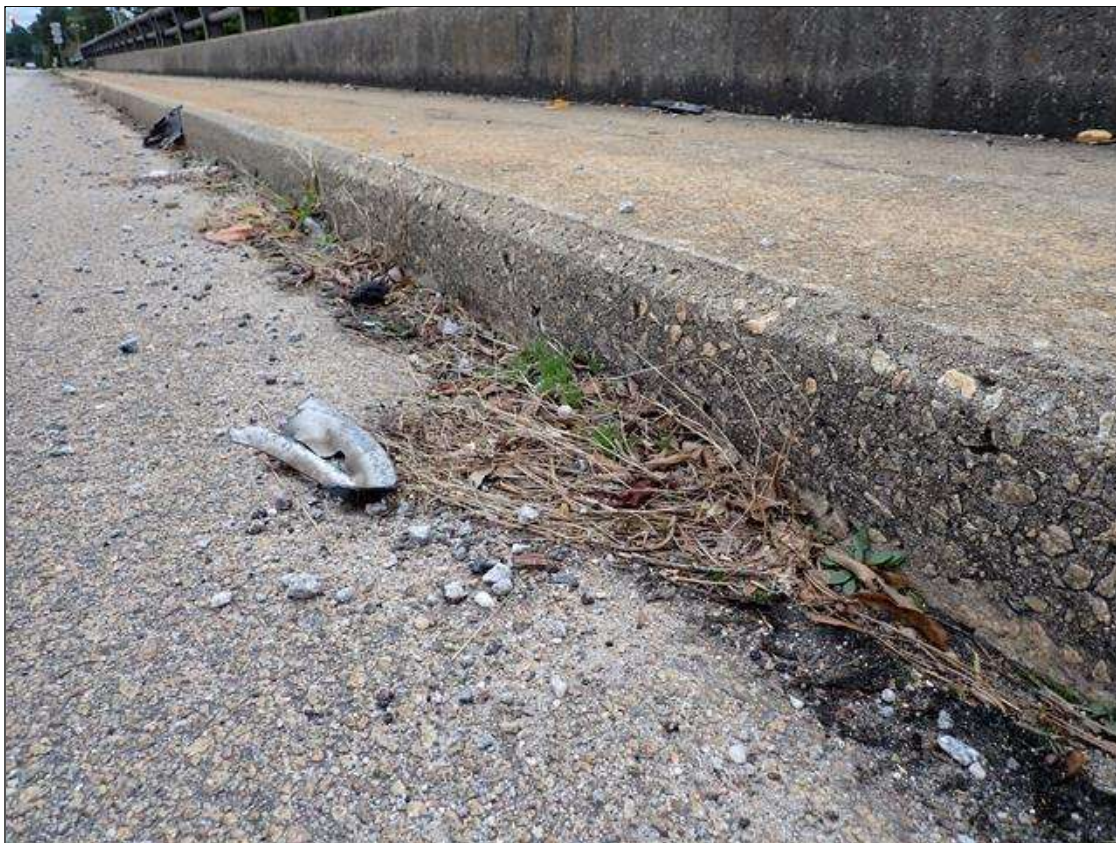
DIRT AND DEBRIS ACCUMULATION ALONG BOTH SHOULDERS

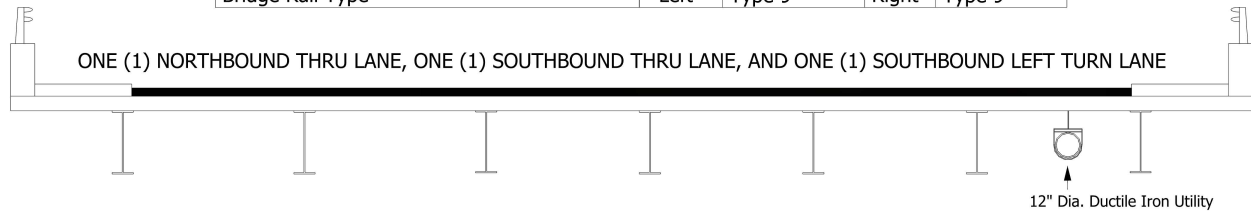
Measurements for Spans	1 thru 4		
Deck Thickness	7.25in	Left Overhang	4.625ft
Top of Rail to Bottom of Beam (Avg)	7.125ft	Right Overhang	4.625ft
